# TOWN OF HOLLYWOOD PARK, TX

2024 Winter Inspection

# HOLLYWOOD PARK 2024 WINTER INSPECTION REPORT

**Subject:** Annual Municipal Separate Storm Sewer System (MS4) Inspection

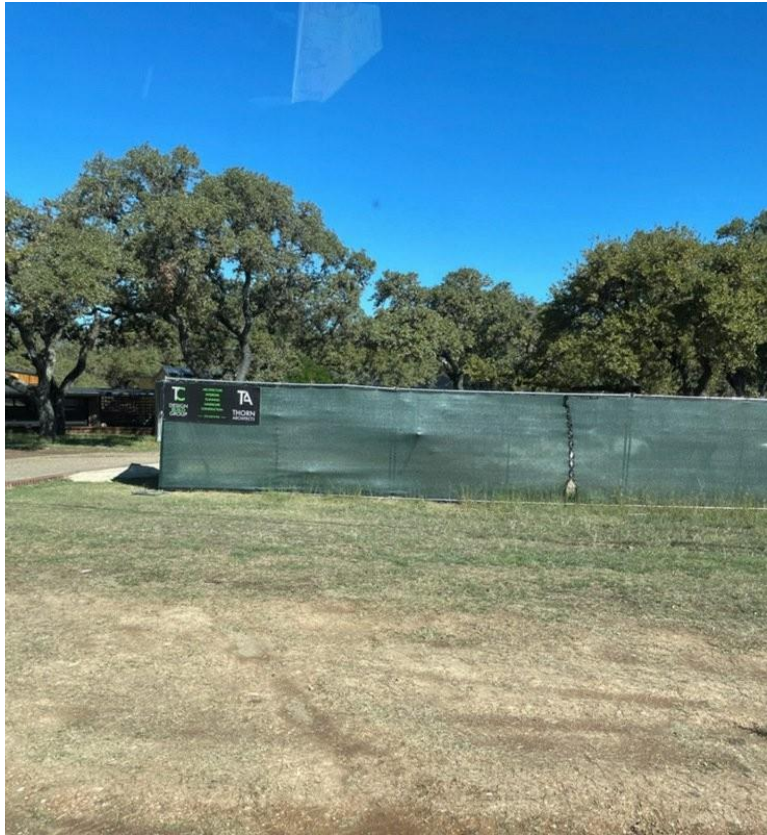
## Active Home Build

Field Notes: Looks good monitor for runoff.

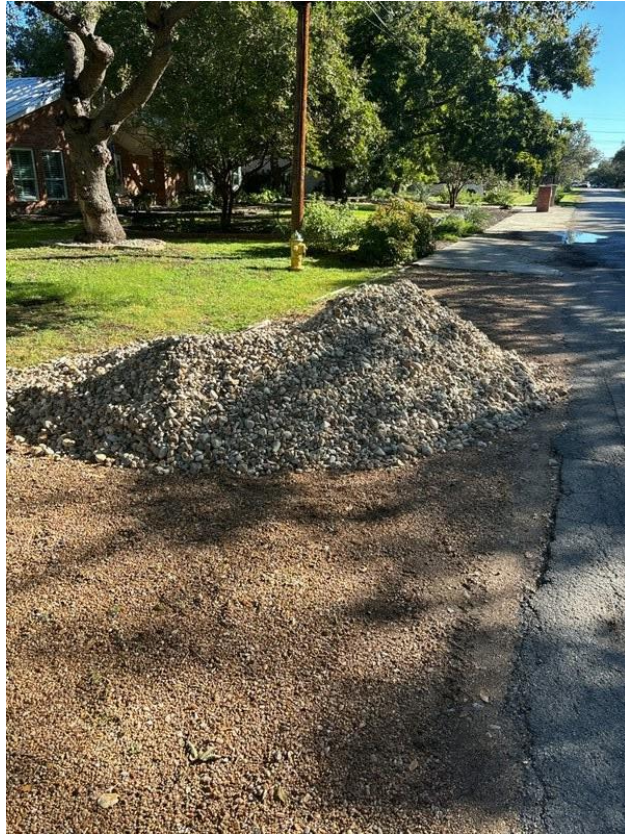
## Aggregate Pile Near Road

Field Notes: Monitor rock pile.

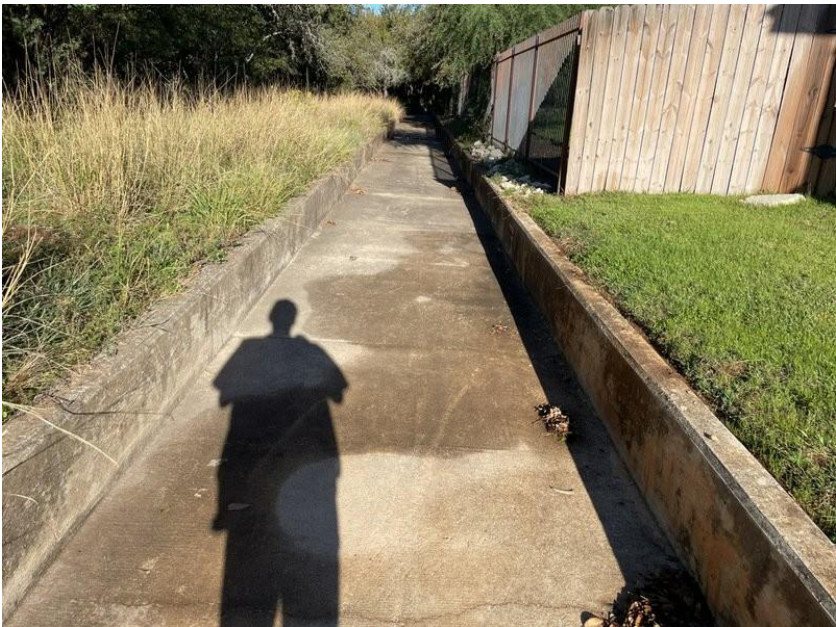
## Amber Creek Drainage Channel

Field Notes: Monitor minor sediment buildup.

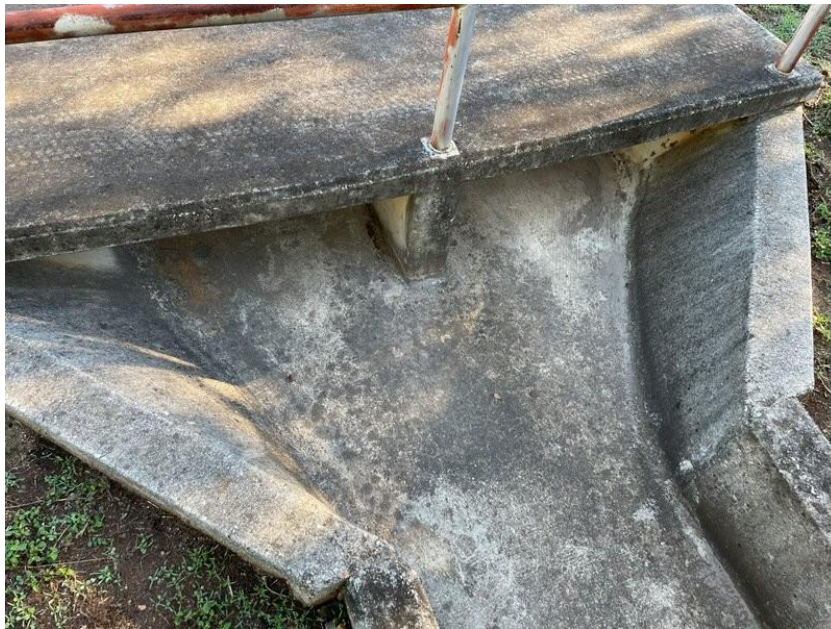
## Amber Creek Inlet

Field Notes: Looks good.

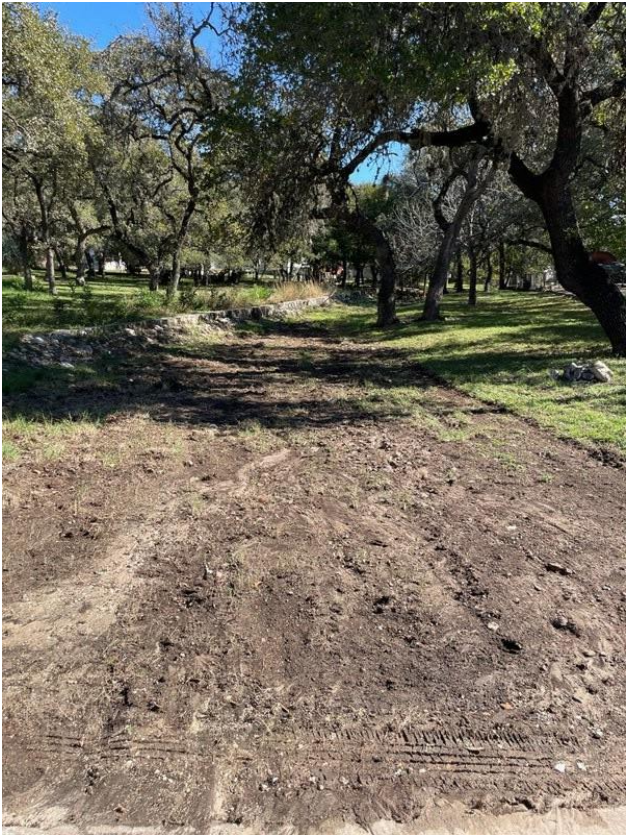
## Antelope Dr Low Water Crossing

Field Notes: Looks good.

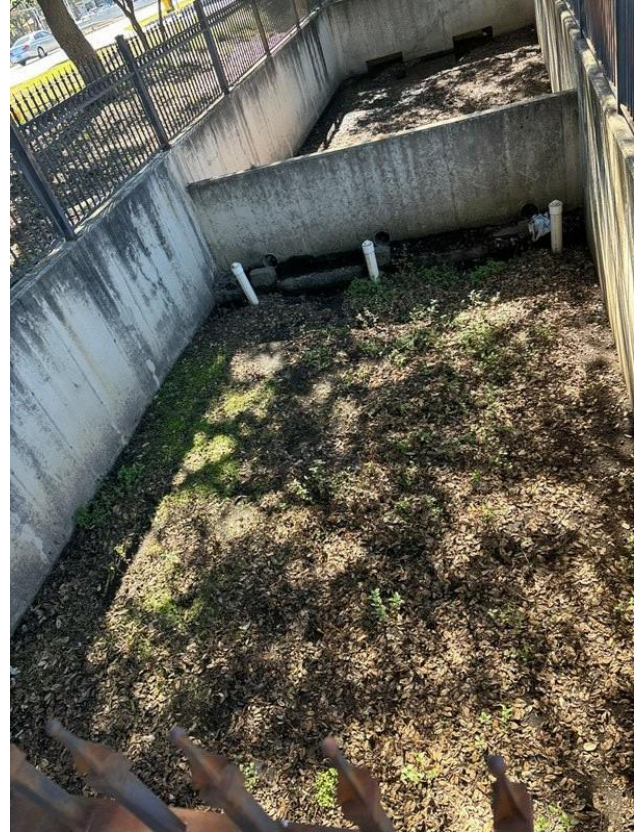
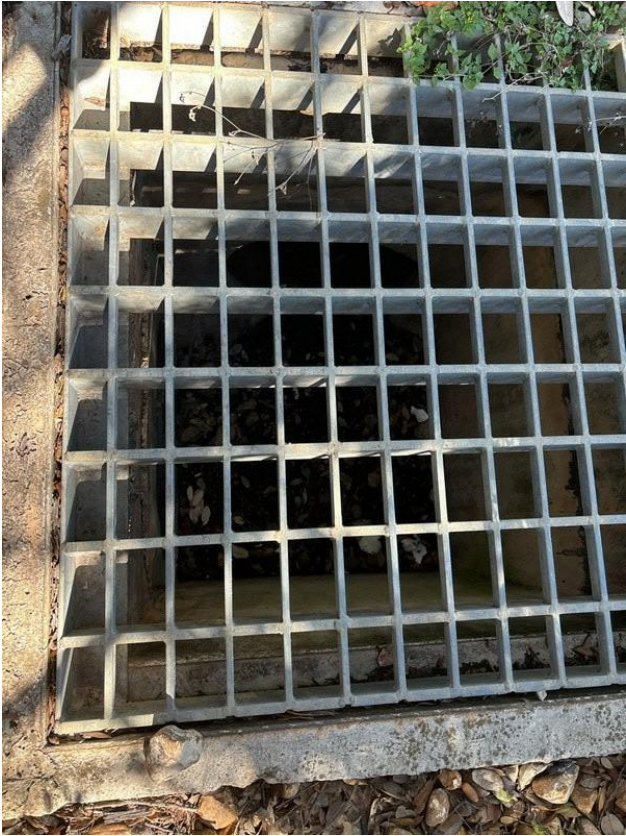
Field Notes: Remove rocks and sediment from inlets and basins

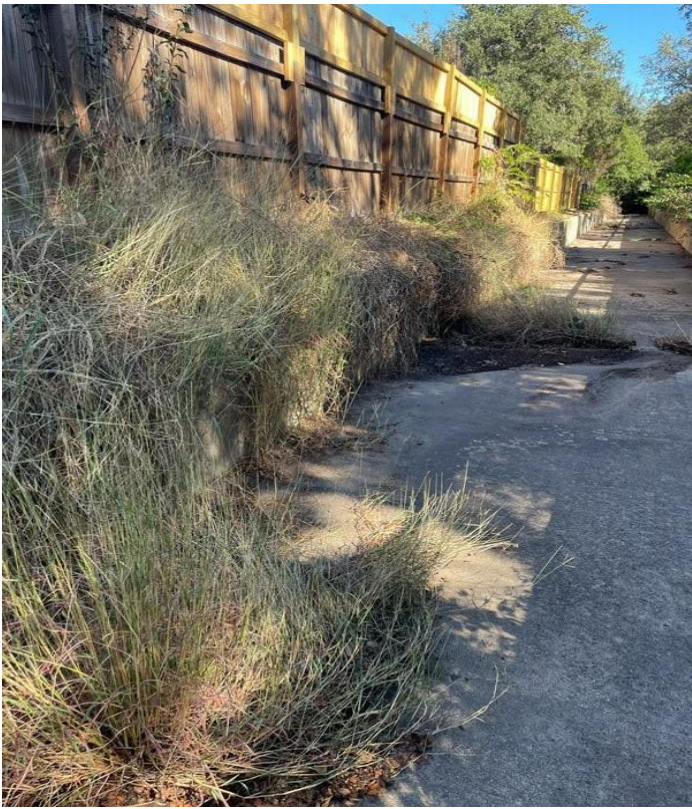
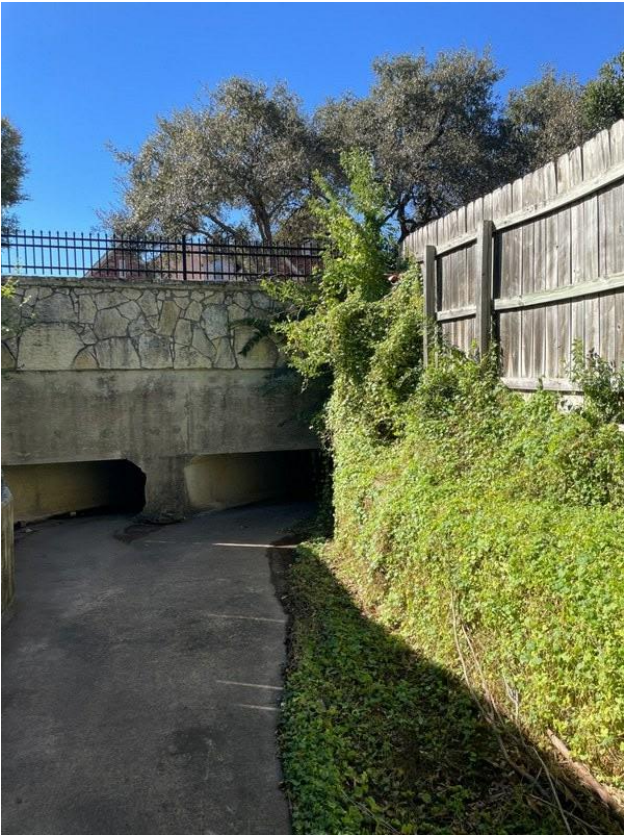
## Channel

Field Notes: Neighbors complain of brush and hackberry tree over growing on downstream end of Navato Crossing causing intensive splashing during flood events. Channel has large leaf and sediment deposits. Needs thorough cleaning and trimming.

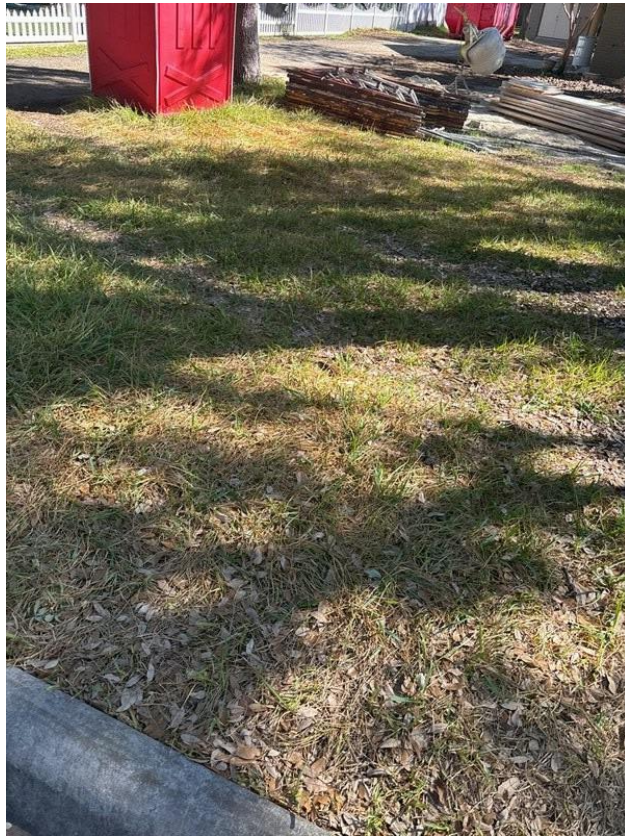
Field Notes: Monitor construction site for erosion and sediment control.

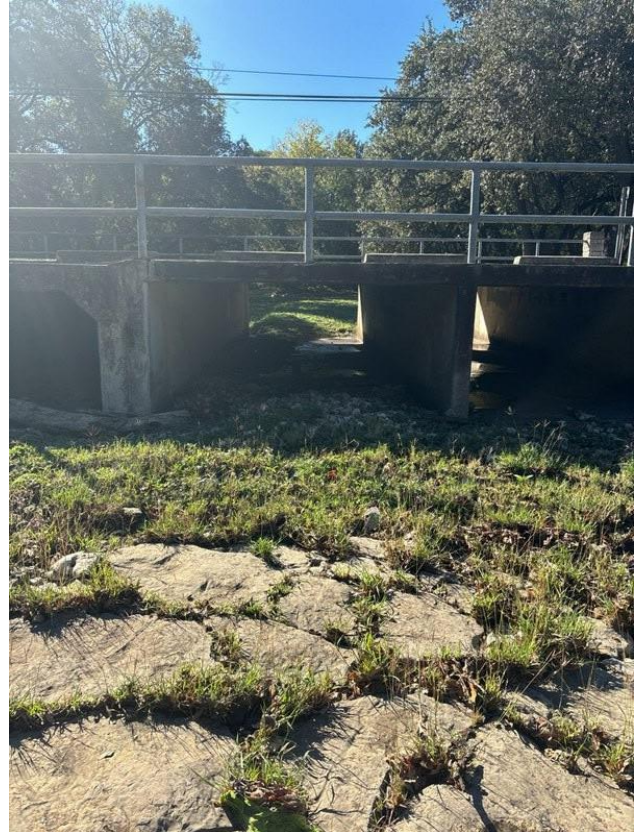
### Curb Outlet, 1

Field Notes: No Maintenance Required.

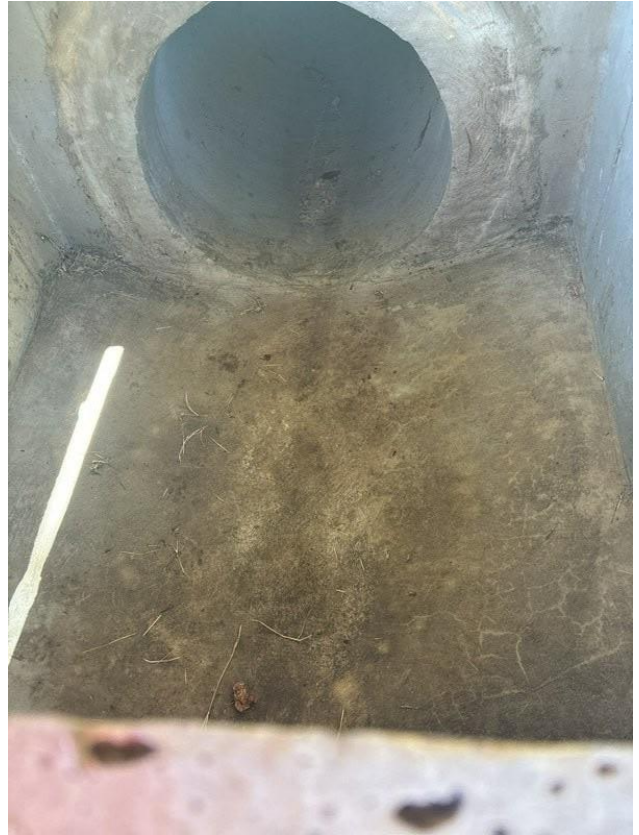
### Donella Inlet Box

Field Notes: No maintenance required.

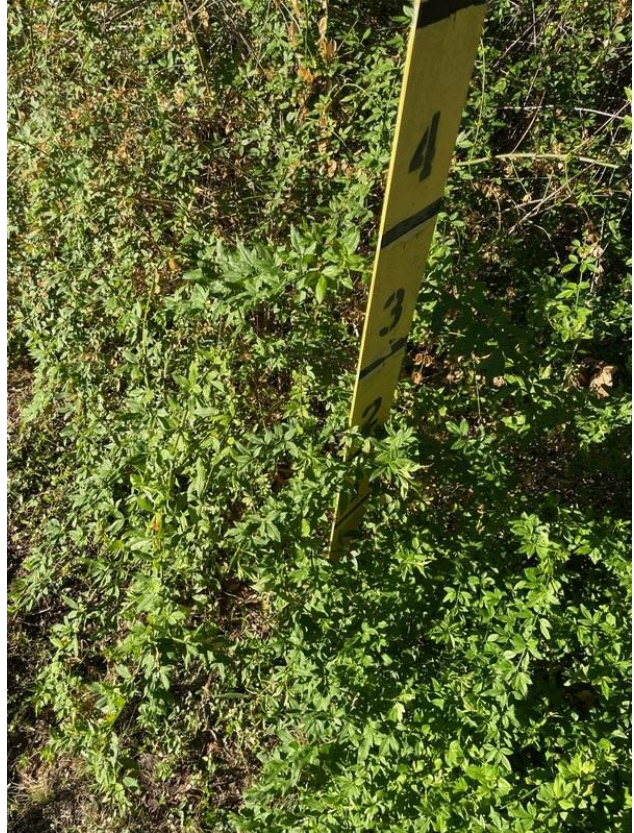
## Drash Rear Parking Lot Inlet

Field Notes: Mow base of flood gauge.

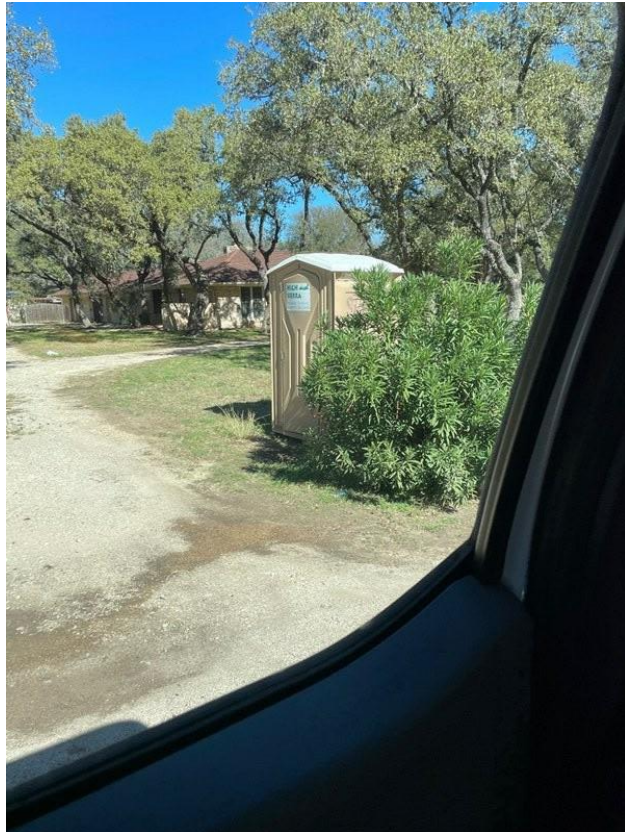
## Fleetwood Dr Portable Bathroom Facility

Field Notes: Monitor that no effluent leaks out of facility.

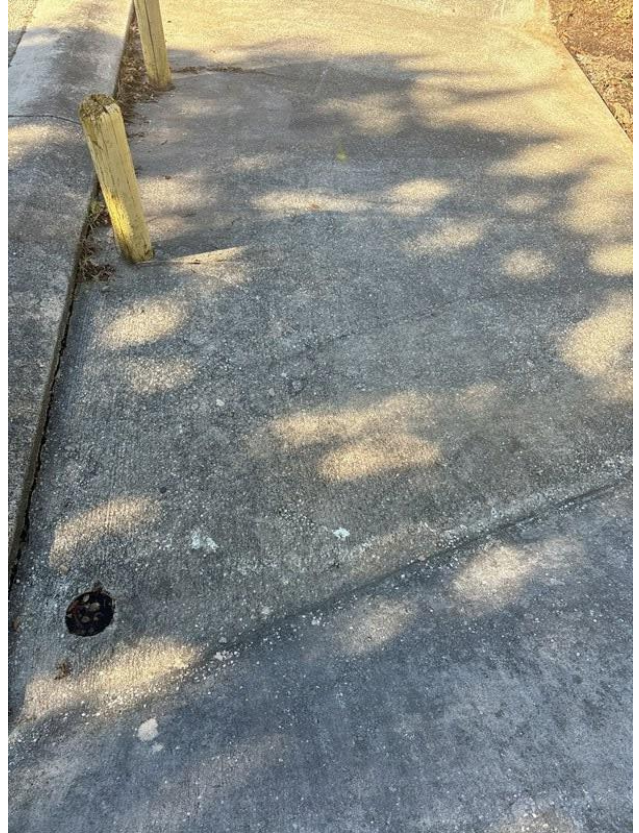
## Garrapata Storm Water Inflow

Field Notes: No Maintenance Required

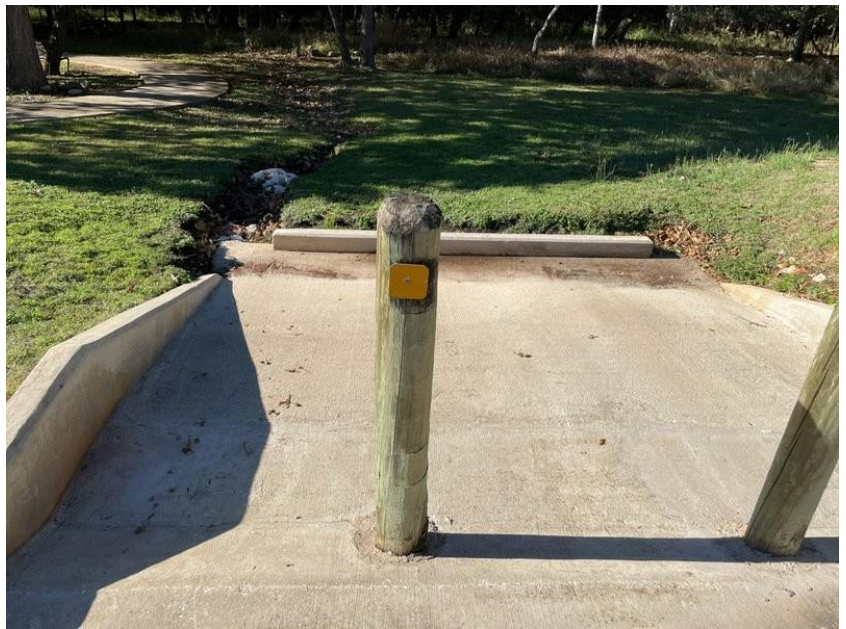
## Great Wood Street Outfall

Field Notes: Looks good.

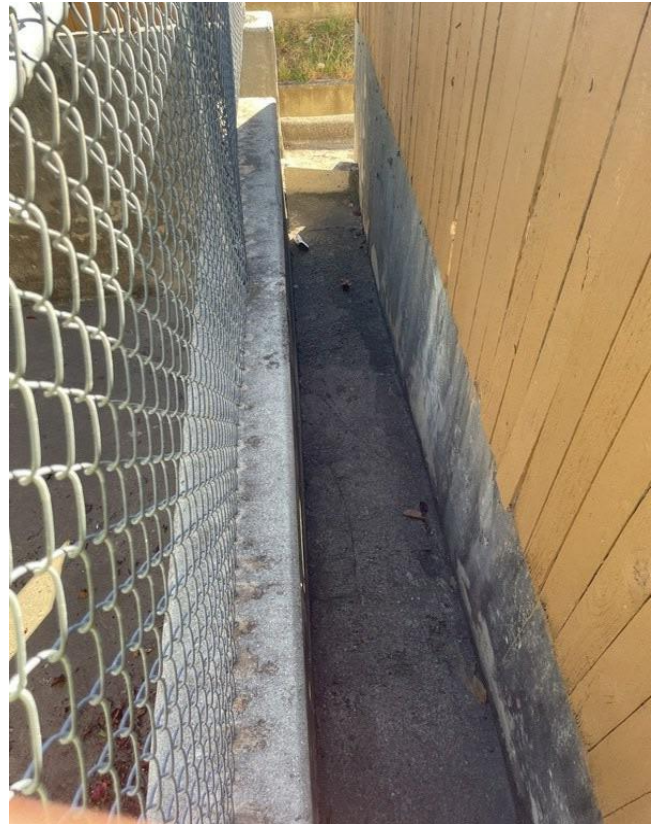
## Holiday Inn PCD

Field Notes: Looks good. Ensure lock is properly installed.

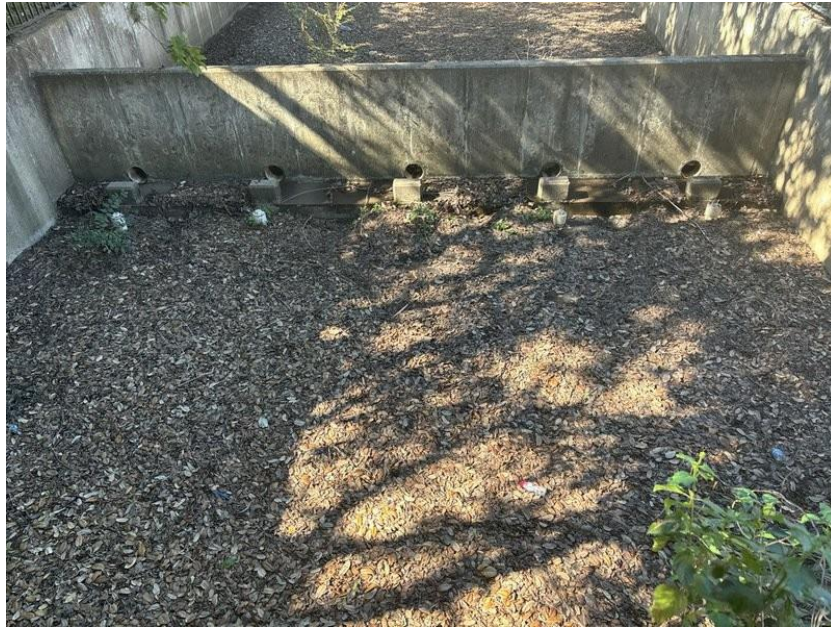
## Large Channel Drain Inlet

Field Notes: Remove branch from fence and remove leaves and debris from basin.

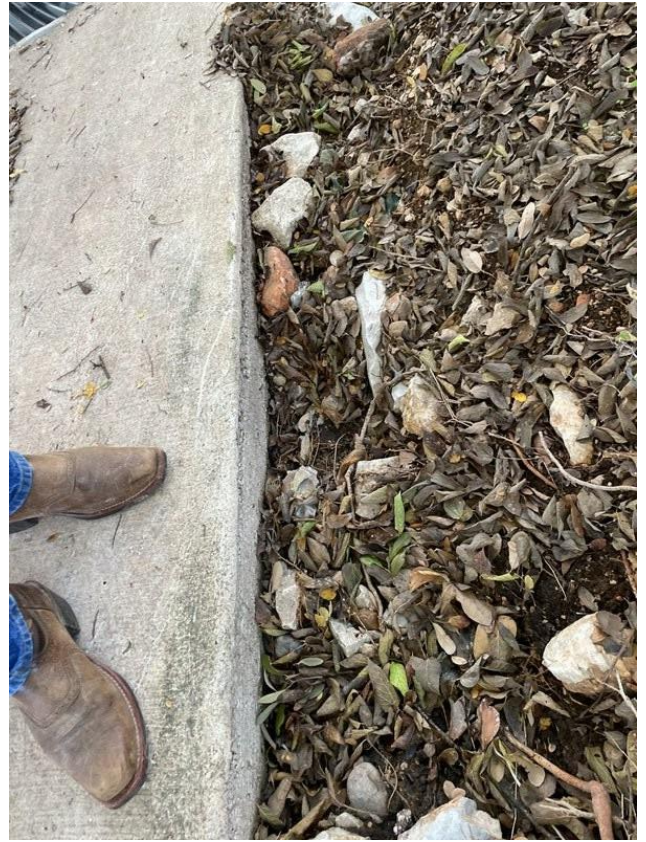
## Mecca Inlets Outfall

Field Notes: Monitor parking lot runoff as it is beginning to undermine outfall riprap

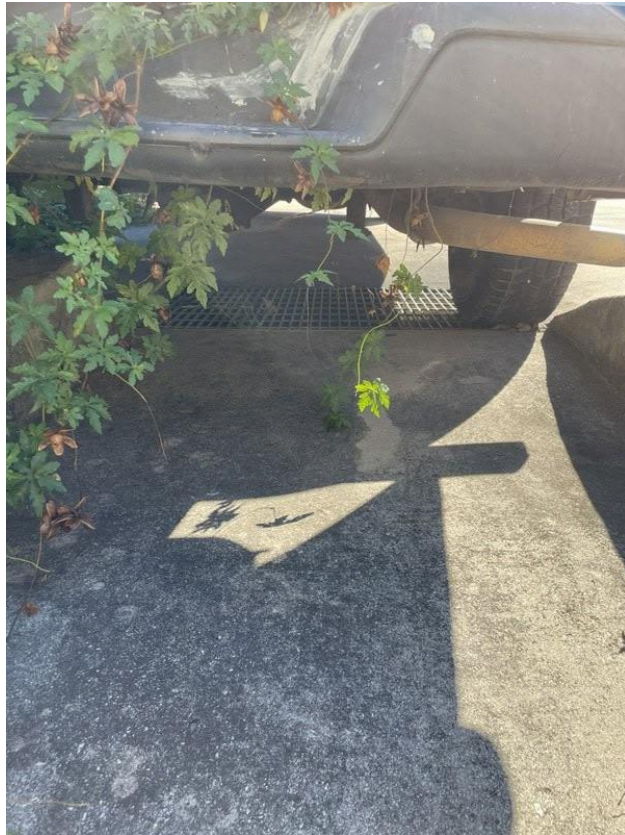
### MEC-I-1(M)

Field Notes: Looks good.

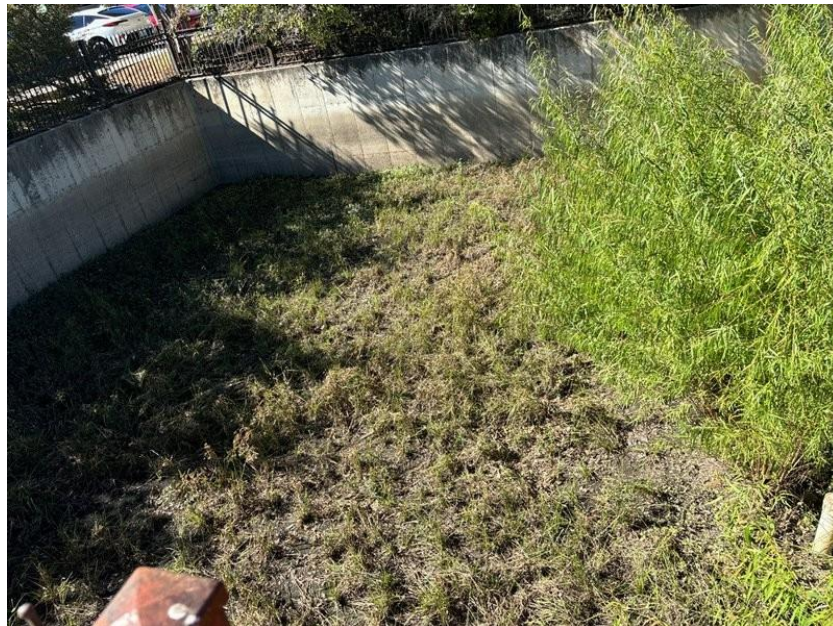
### Miner Fleet Parking Lot Inlet

Field Notes: Remove all debris and vegetation.

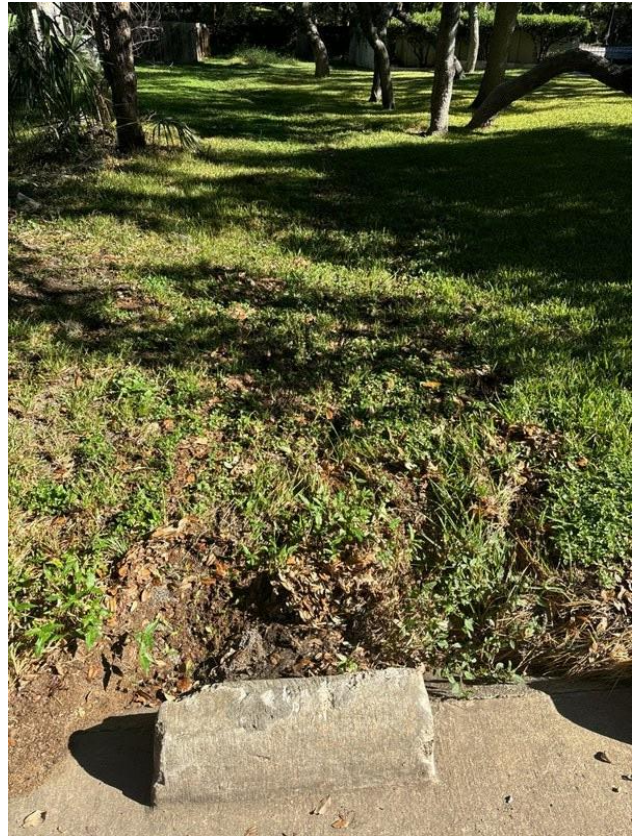
## Mustang Circle

Field Notes: Remove vegetation at front to allow for flow and prevent stagnation

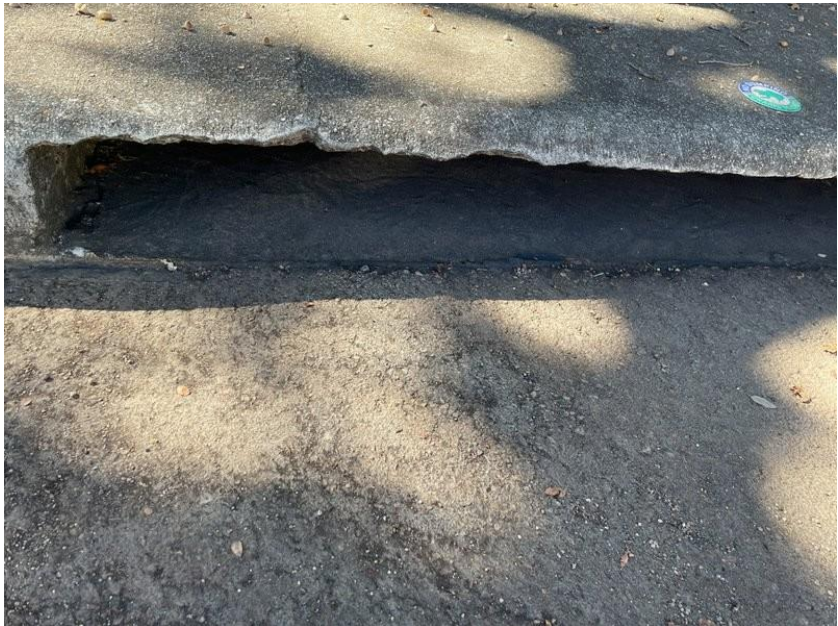
### Navato Blvd Inlet

Field Notes:  
Looks good

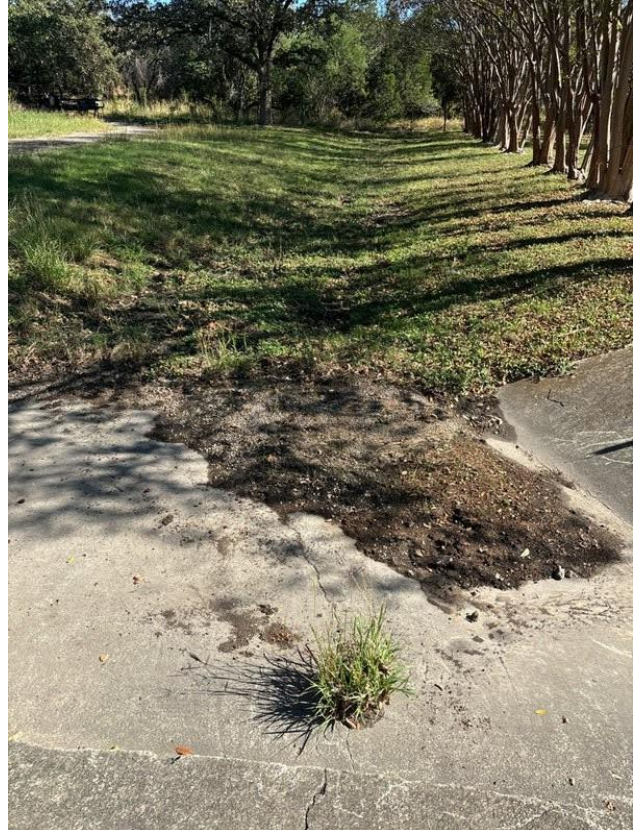
## Navato Residential Drains

Field Notes: Trim vegetation and remove sediment from concrete.

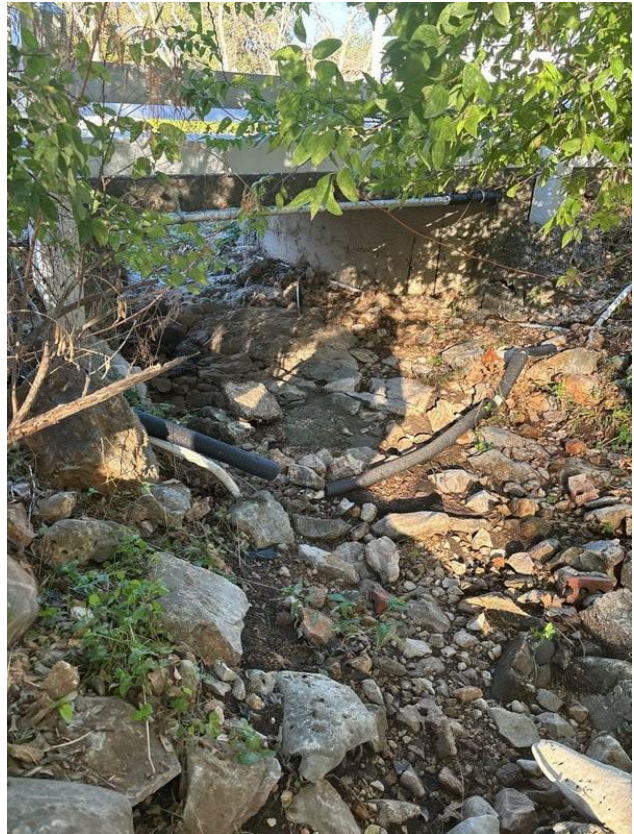
## North Oak Private Crossing East

Field Notes: Looks good.

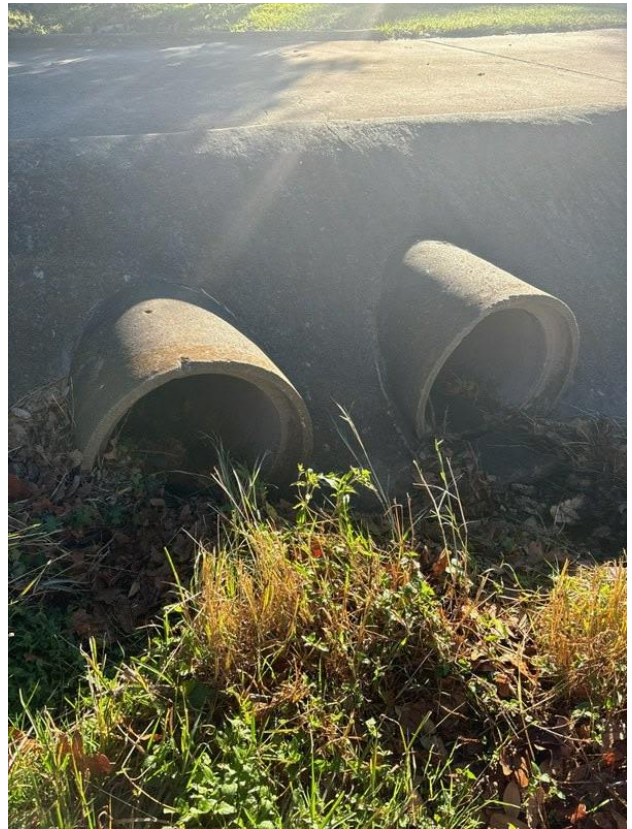
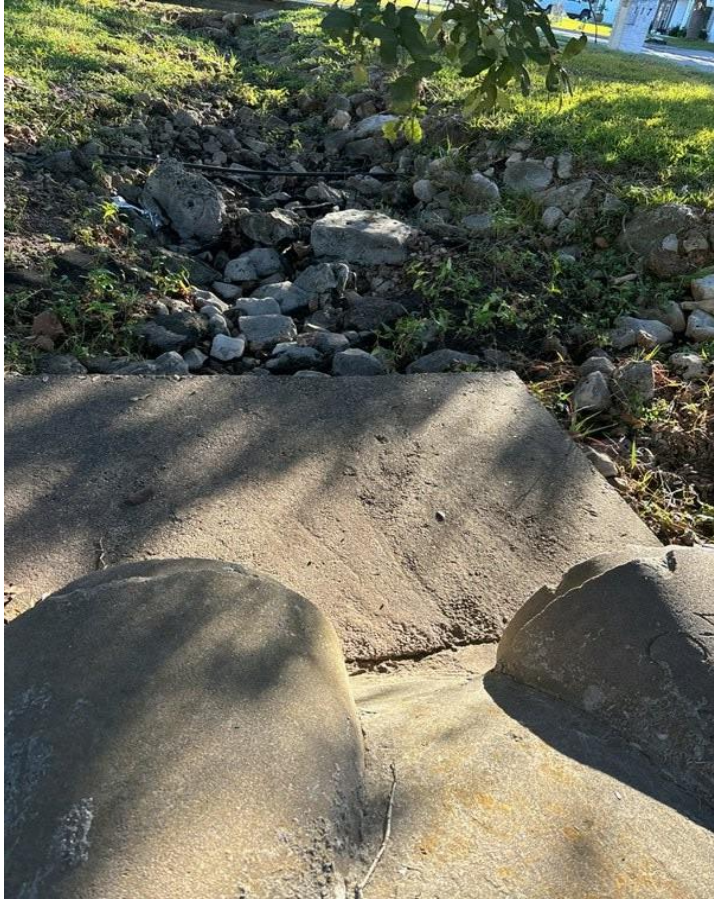
## North Oak Private Crossing West

Field Notes: Remove soil and vegetation blocking the outlets.

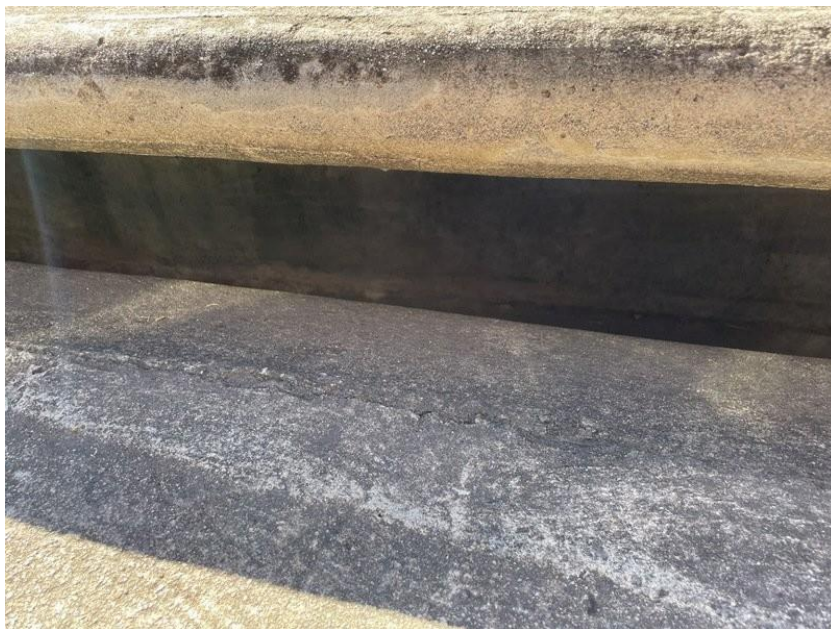
### Oak-I-1(M)

Field Notes: Looks good.

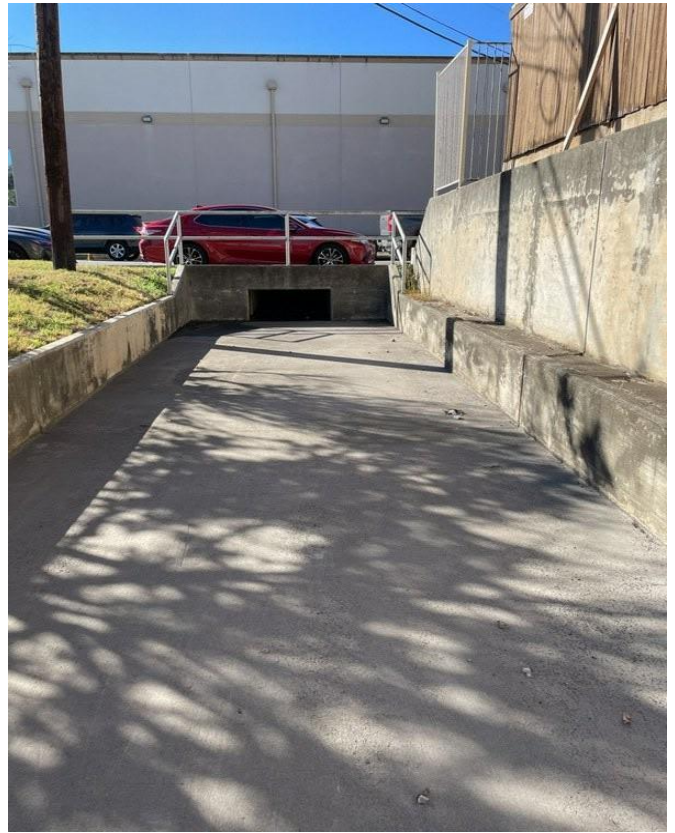
### Oak-I-2(M)

Field Notes: Clear brush at downstream end

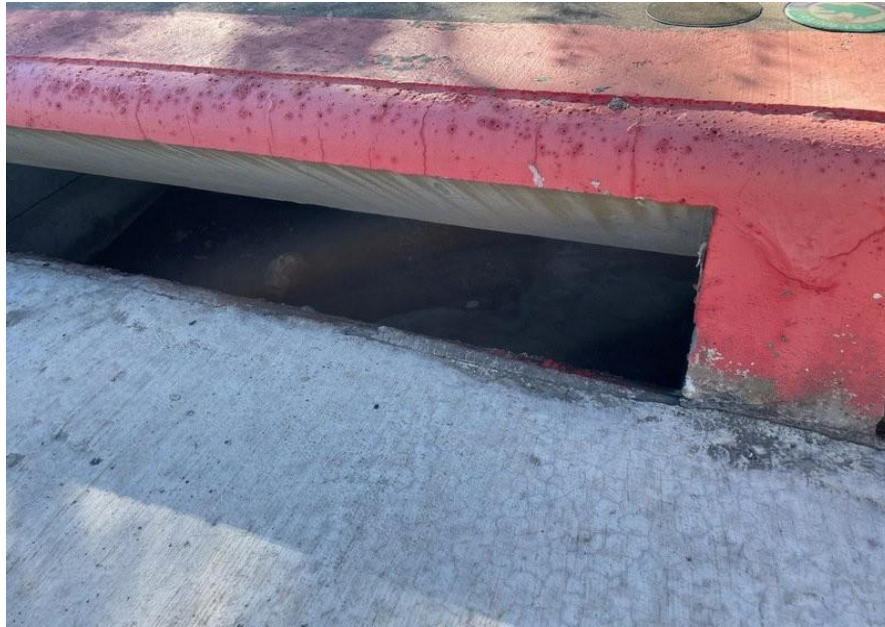
## Oak Creek Circle Inlet

Field Notes: Looks good

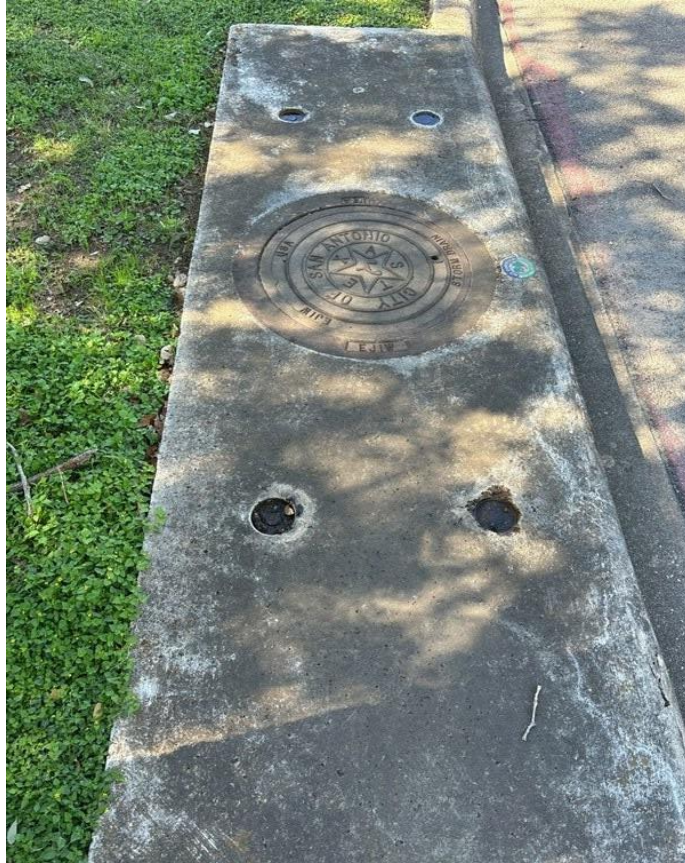
### Parking Lot Box Inlet

Field Notes: No maintenance required.

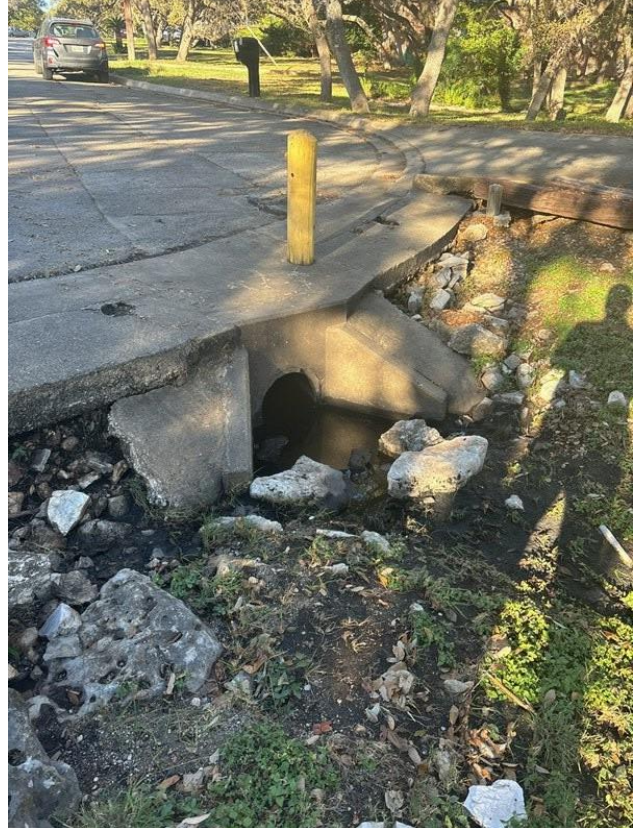
## Paseo Canada Outfall 1

Field Notes: Remove rocks and soil blocking outfall.

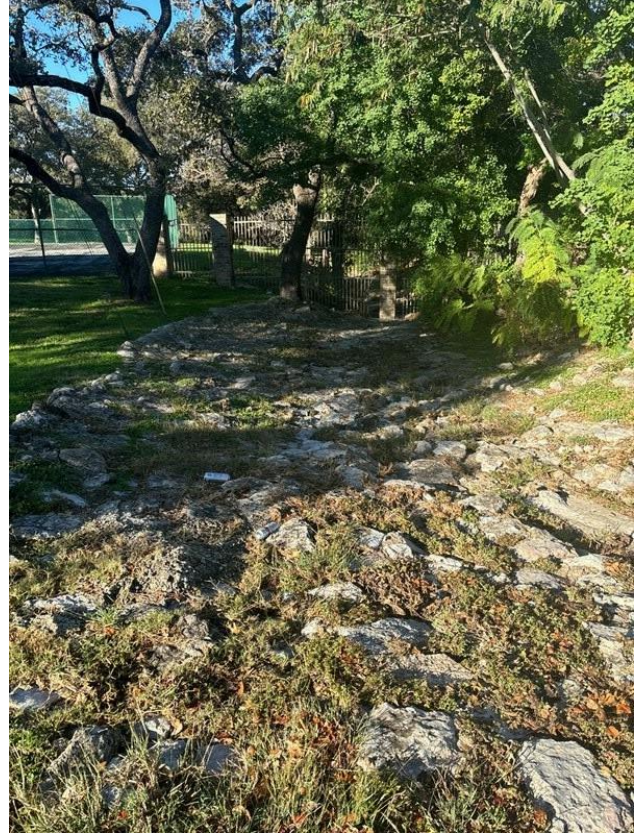
## Paseo Canada Outfall 2

Field Notes: Mild trash, but otherwise looks good.

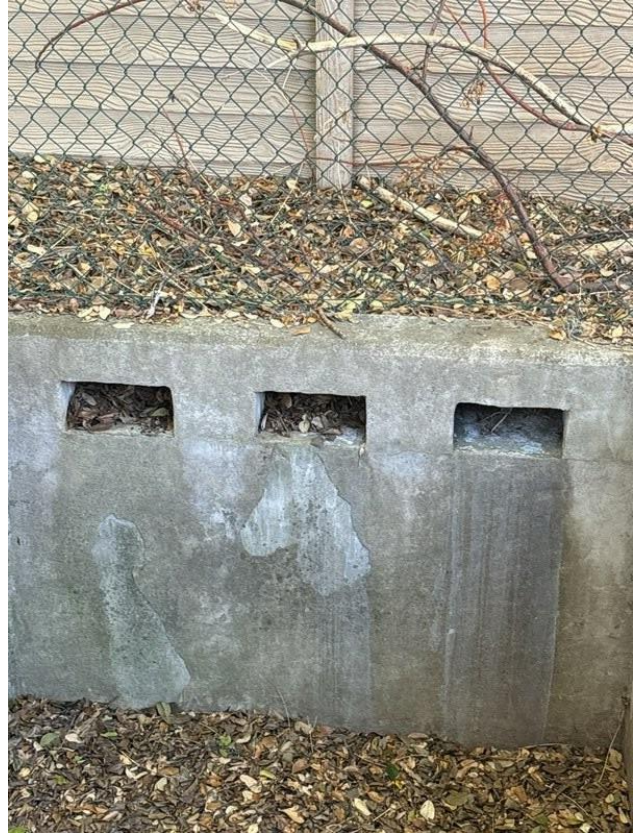
## PCD2 Pediatrics

Field Notes: Remove leaves from inlets and basin.

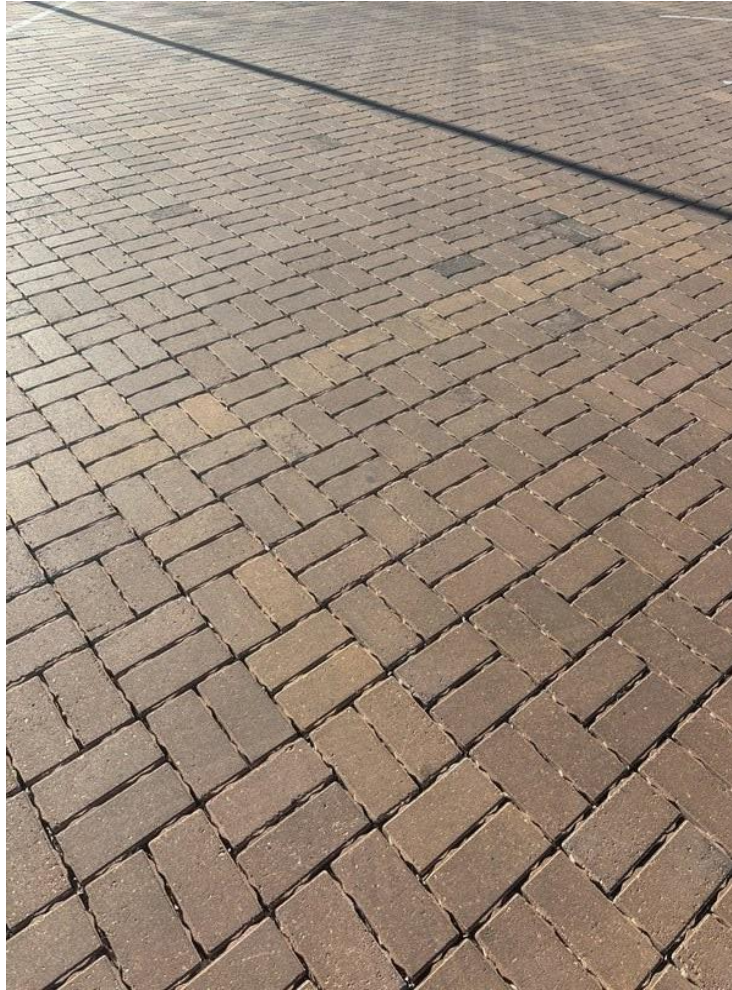
## Pediatric Dentistry Office PCD

Field Notes: No maintenance required.

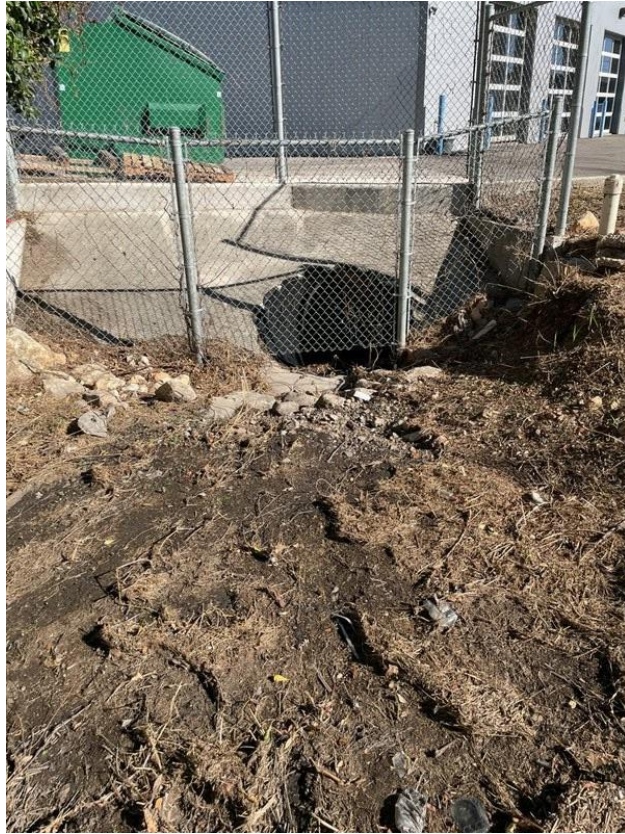
## Premier 1 Auto Care Inlet

Field Notes: Minor sediment looks good otherwise.

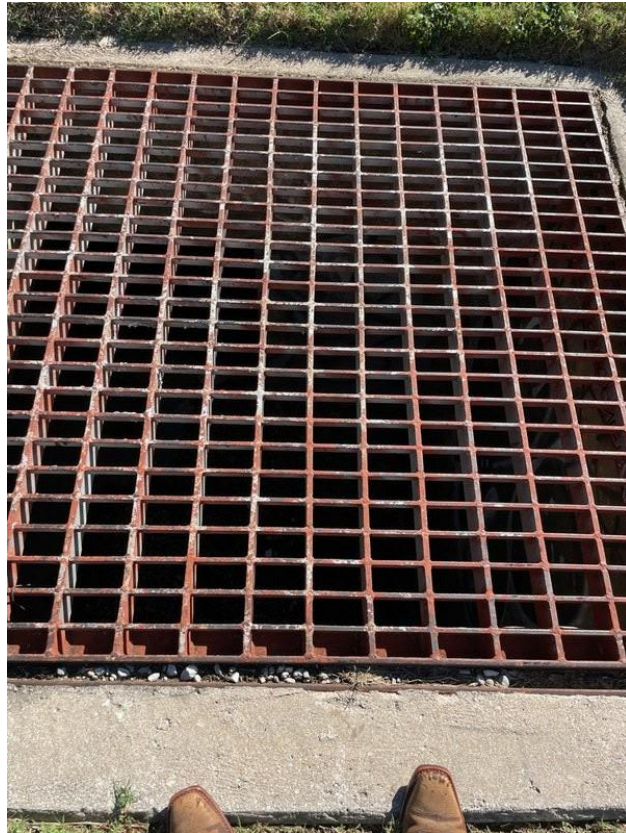
## Premier 1 Autocare Inlet 1

Field Notes: Looks good.

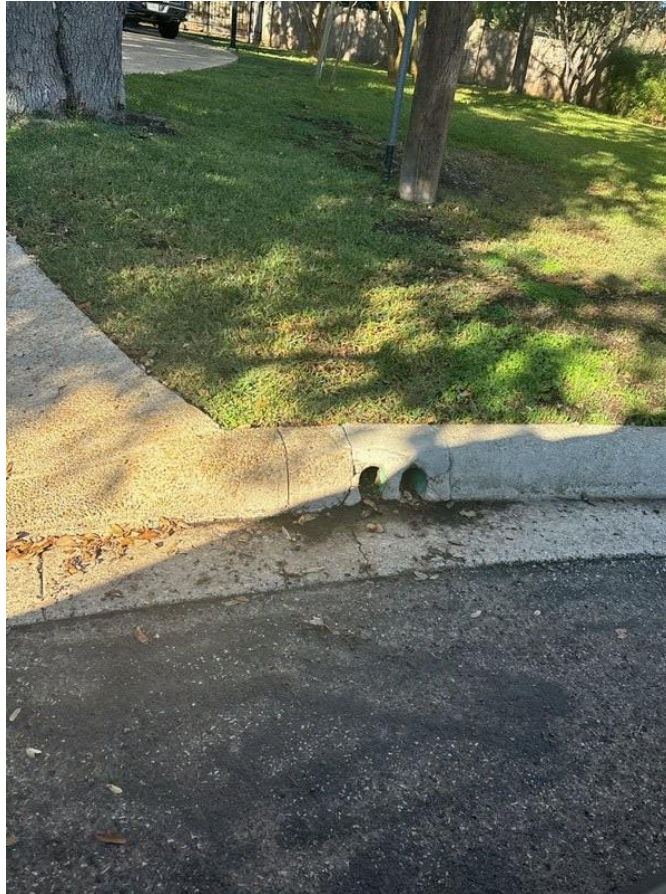
## Premier Autocare Inlet 2

Field Notes: Private outfall looks good.

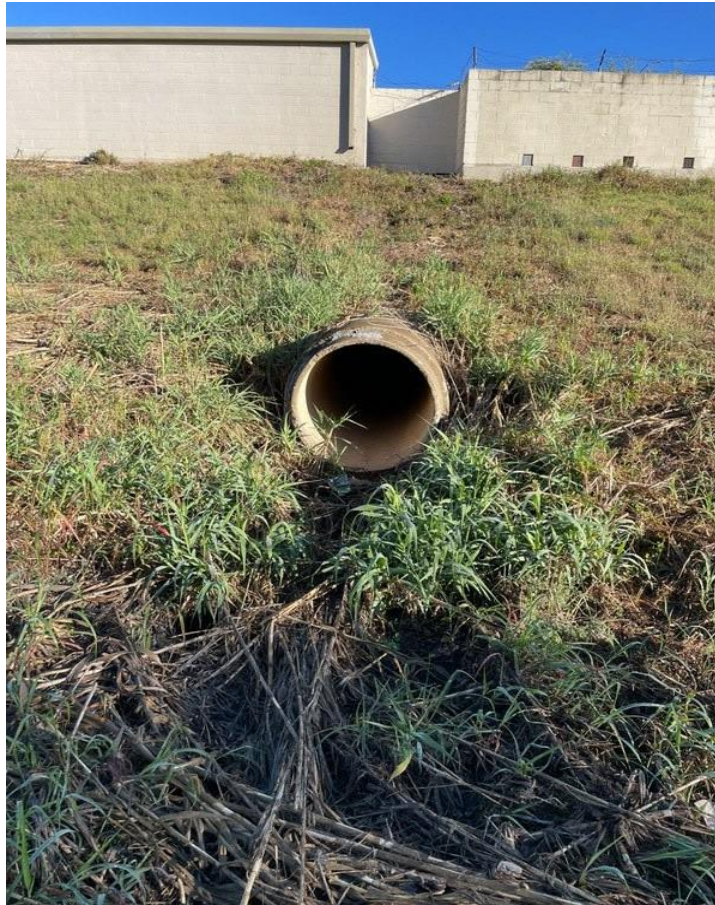
## Public Storage Outfall

Field Notes: Looks good.
