# TOWN OF HOLLYWOOD PARK, TX

2024 Winter Inspection

# HOLLYWOOD PARK 2024 WINTER INSPECTION REPORT

**Subject:** Annual Municipal Separate Storm Sewer System (MS4) Inspection

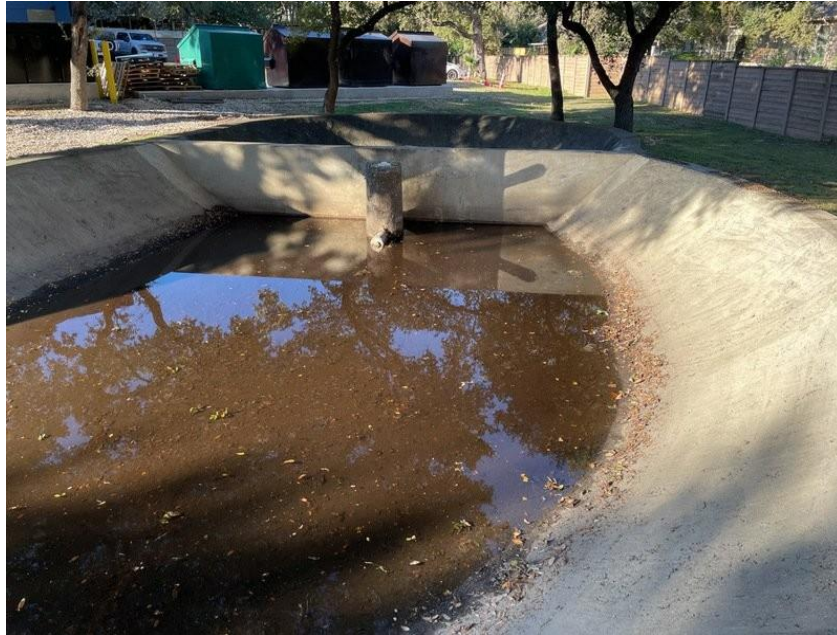
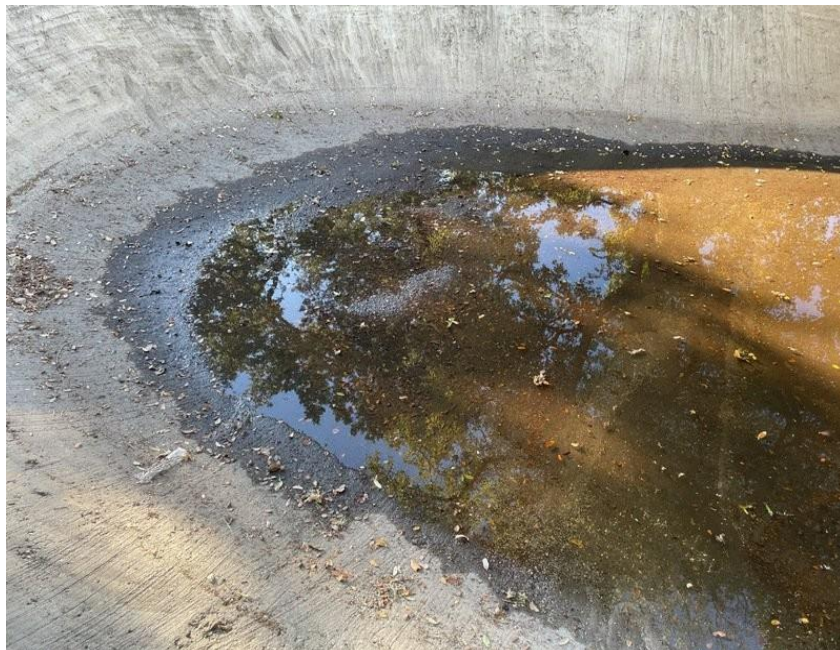
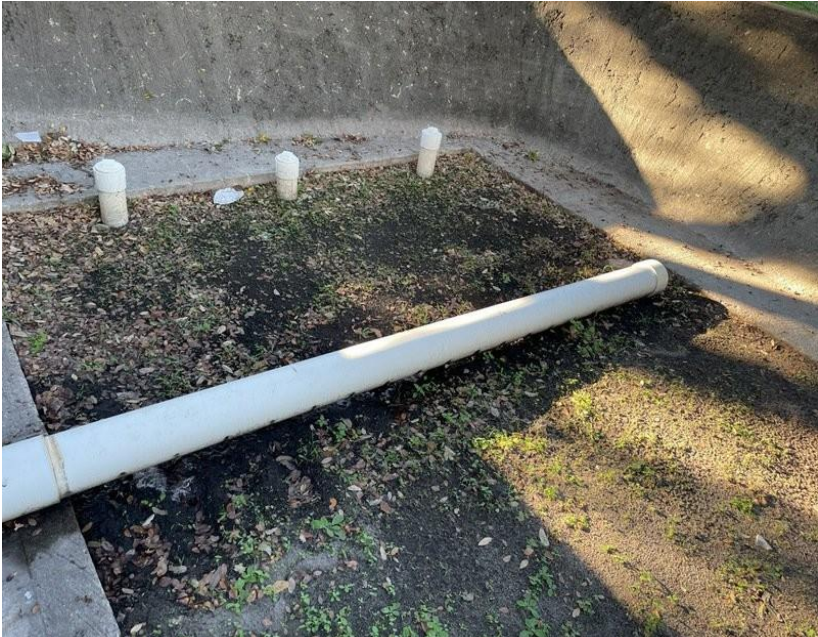
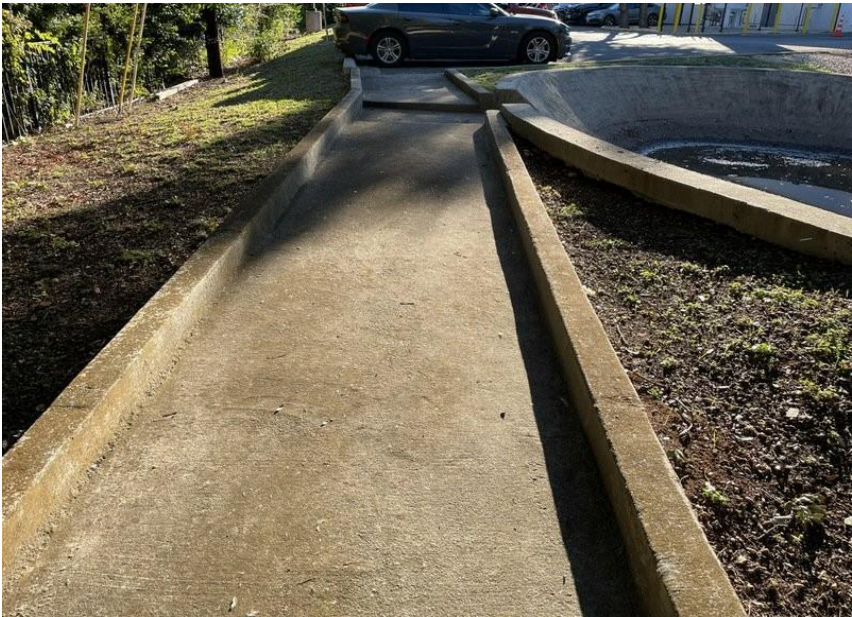
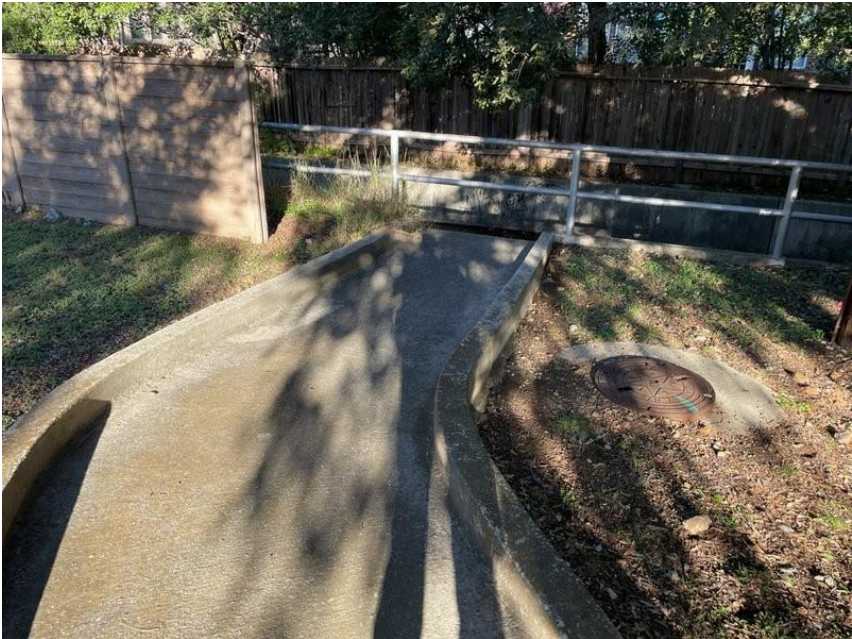
## Retention Pond W/ Infiltration

Field Notes: Looks good. Functioning correctly after storm event.

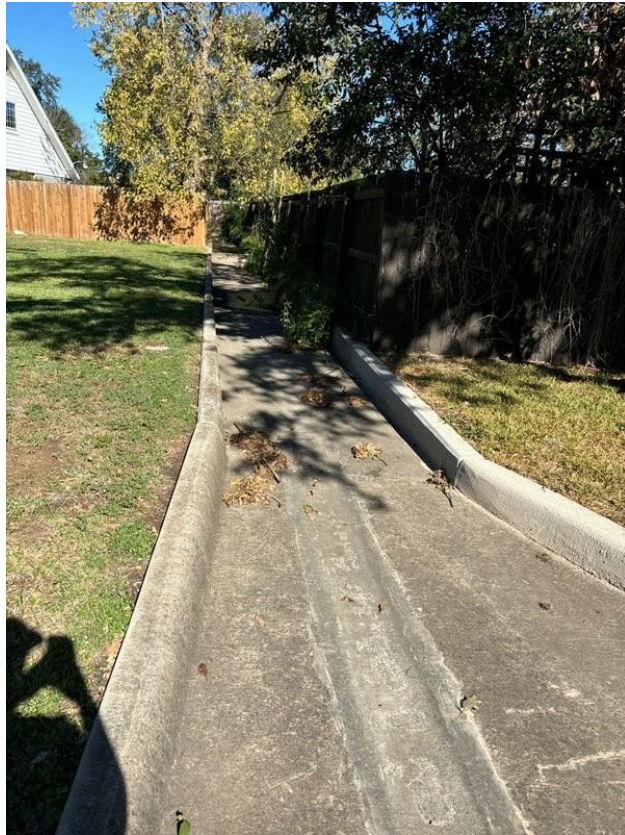
## Rua De Matta Street Channel Outfall

Field Notes: Remove debris from channel and trim vegetation from sides.

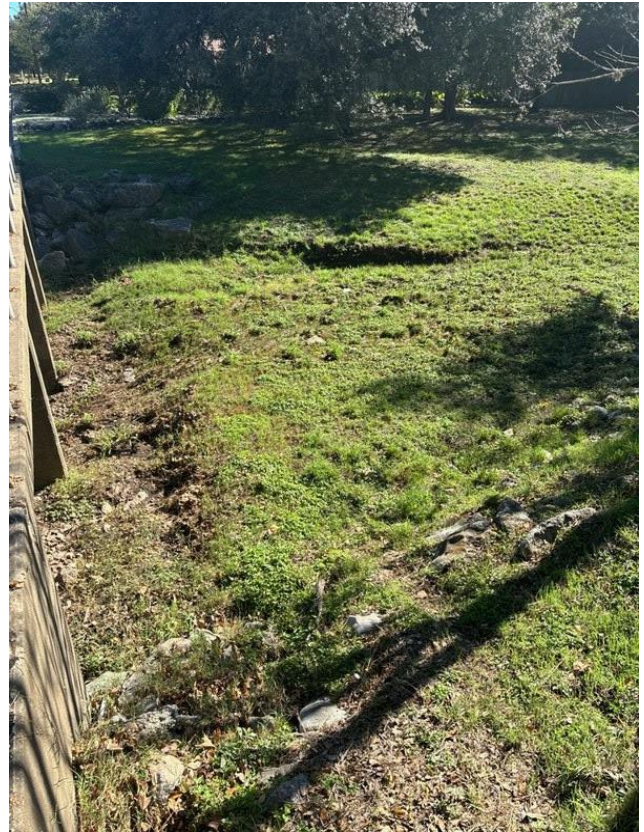
## Rua De Matta

Field Notes: No Maintenance Required.

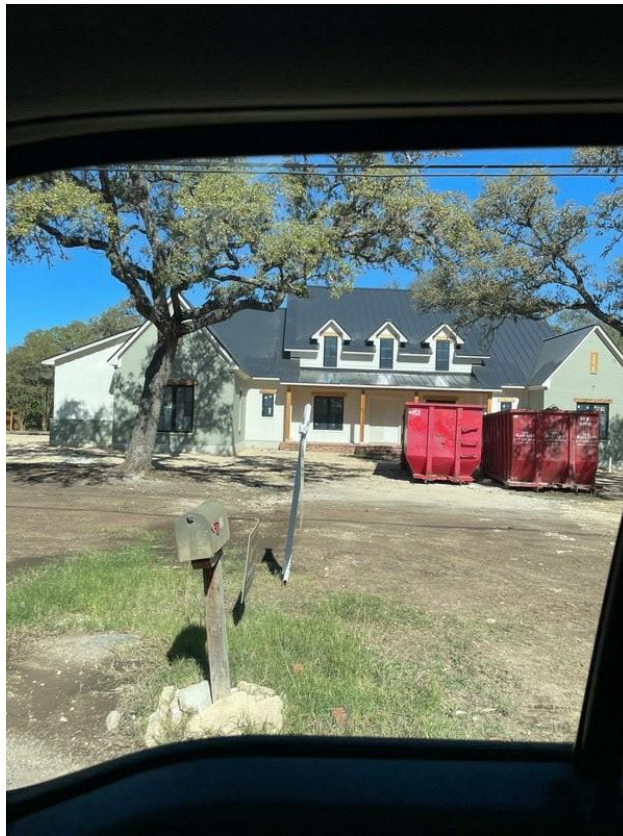
Field Notes: Looks good monitor for runoff

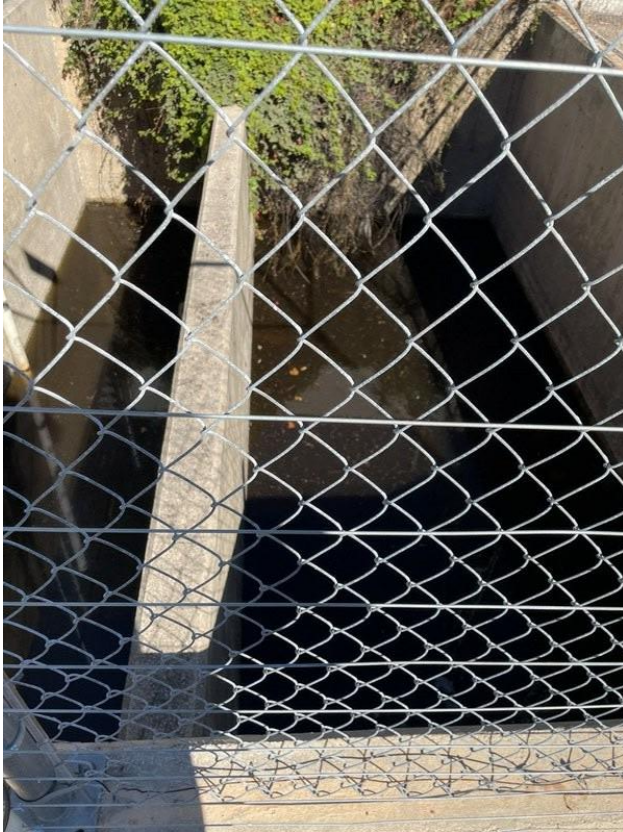
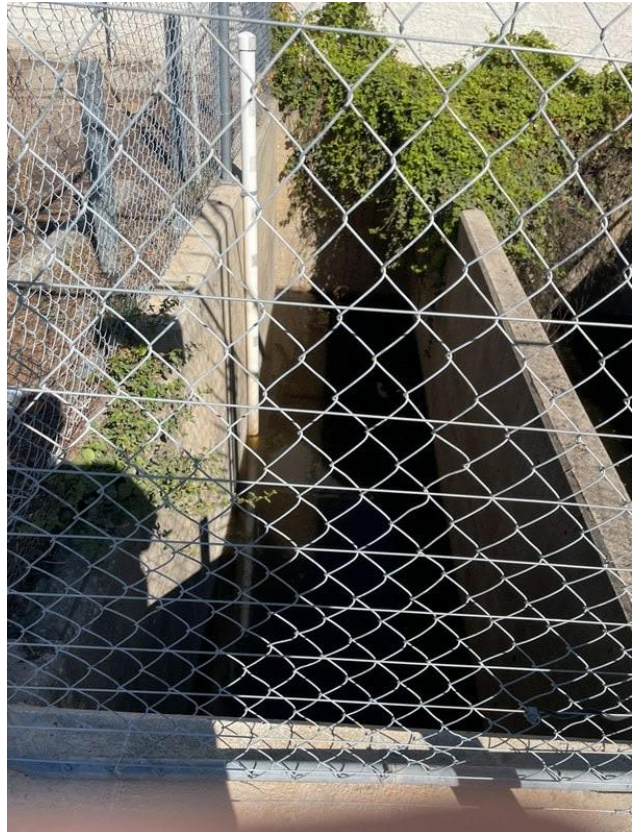
## Service King Collision Repair Extended Parking Lot PCD

Field Notes: Looks good.

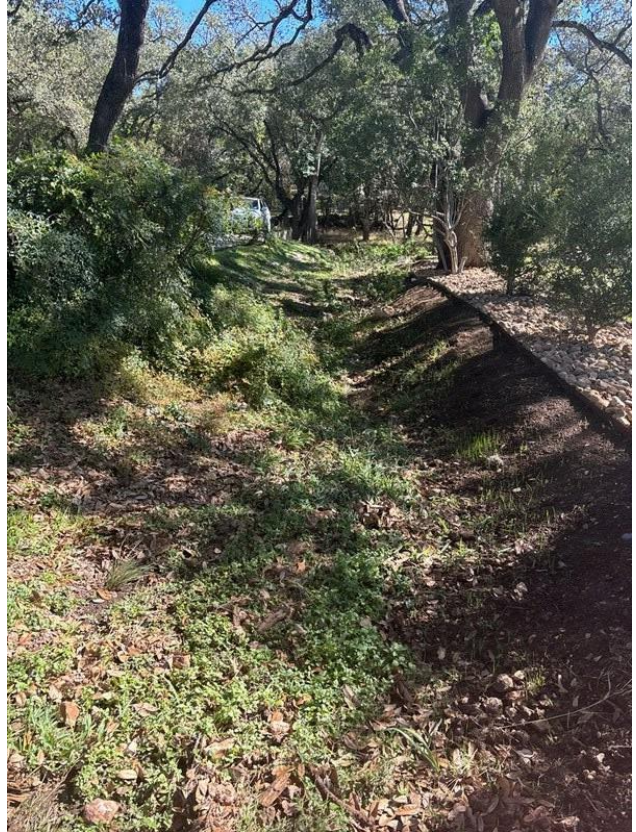
## Service King Collision Repair PCD

Field Notes: Trim overgrown vegetation, otherwise looks good.

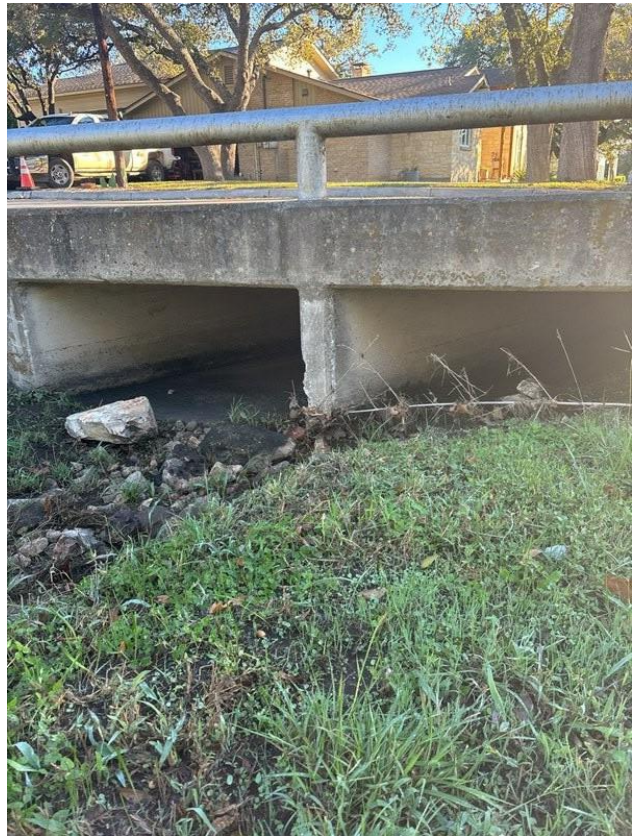
## Spillway Structure

Field Notes: Remove rocks and branches from inlets.

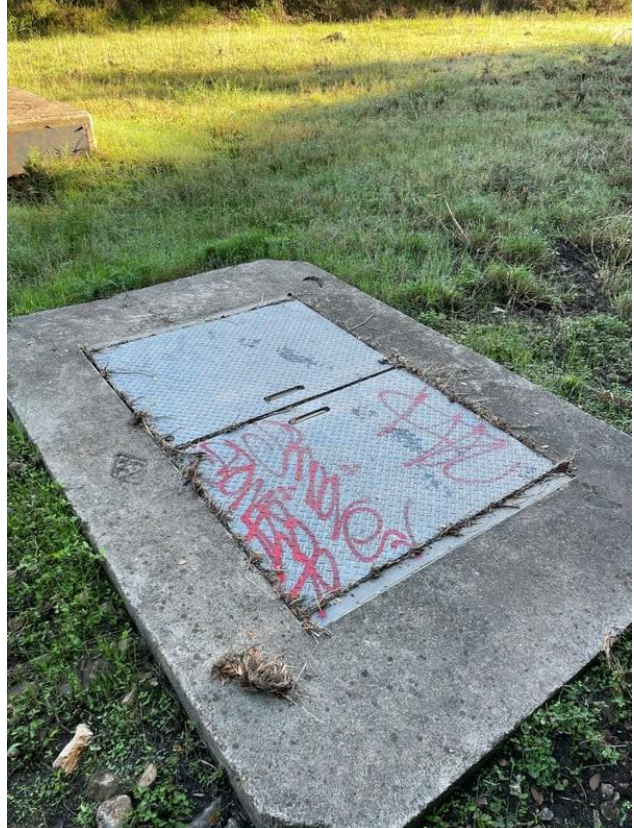
## Stream Gauge

Field Notes: Looks good.
