# TOWN OF HOLLYWOOD PARK, TX

2023 Summer Inspection

# HOLLYWOOD PARK 2023 SUMMER INSPECTION REPORT

**Subject:** Annual Municipal Separate Storm Sewer System (MS4) Inspection

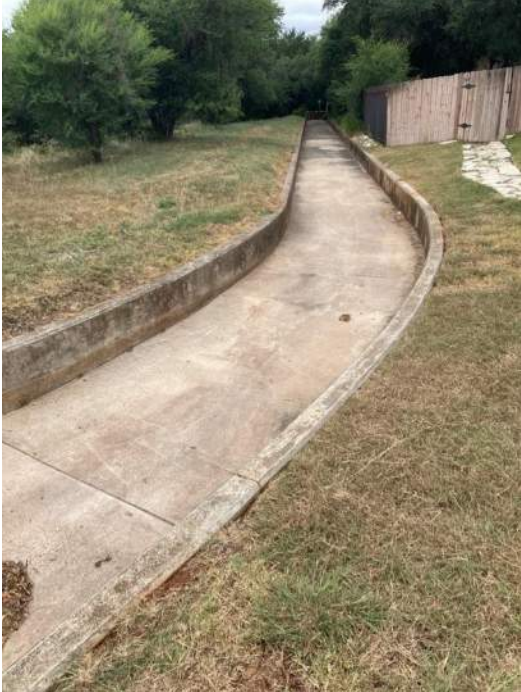
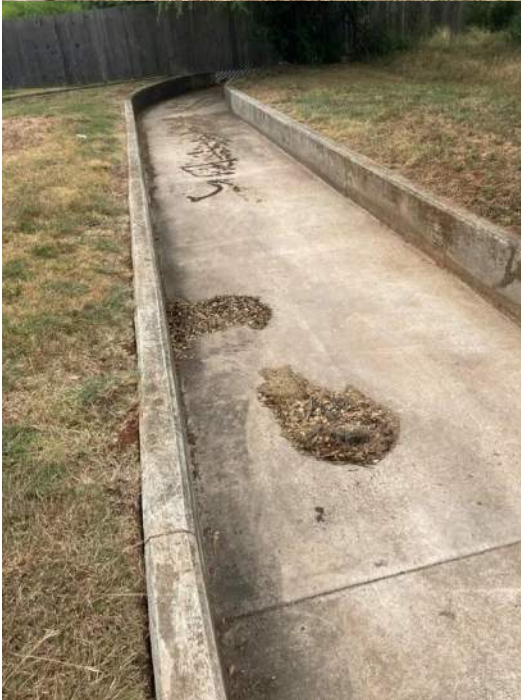
## Amber Creek Drainage Channel

Field Notes: Good condition

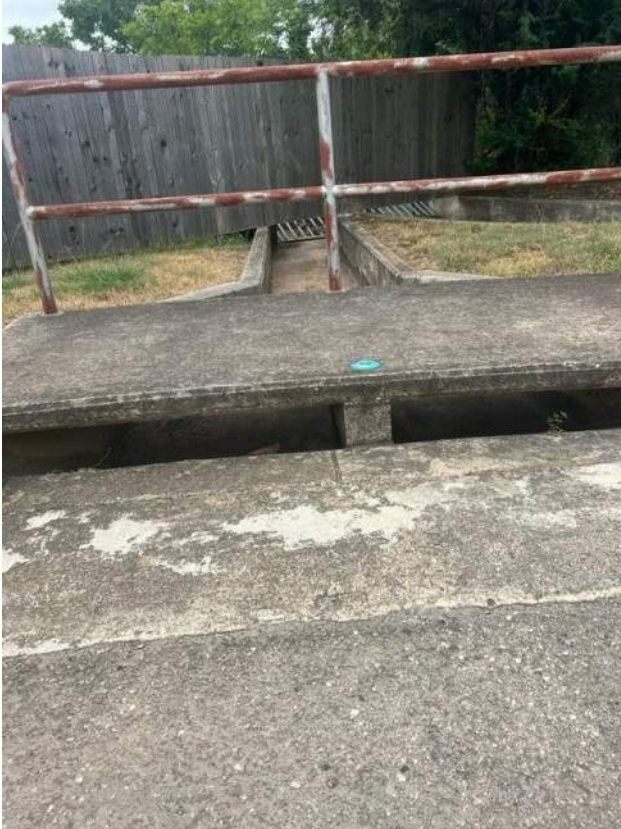
## Amber Creek Inlet

Field Notes: In good condition

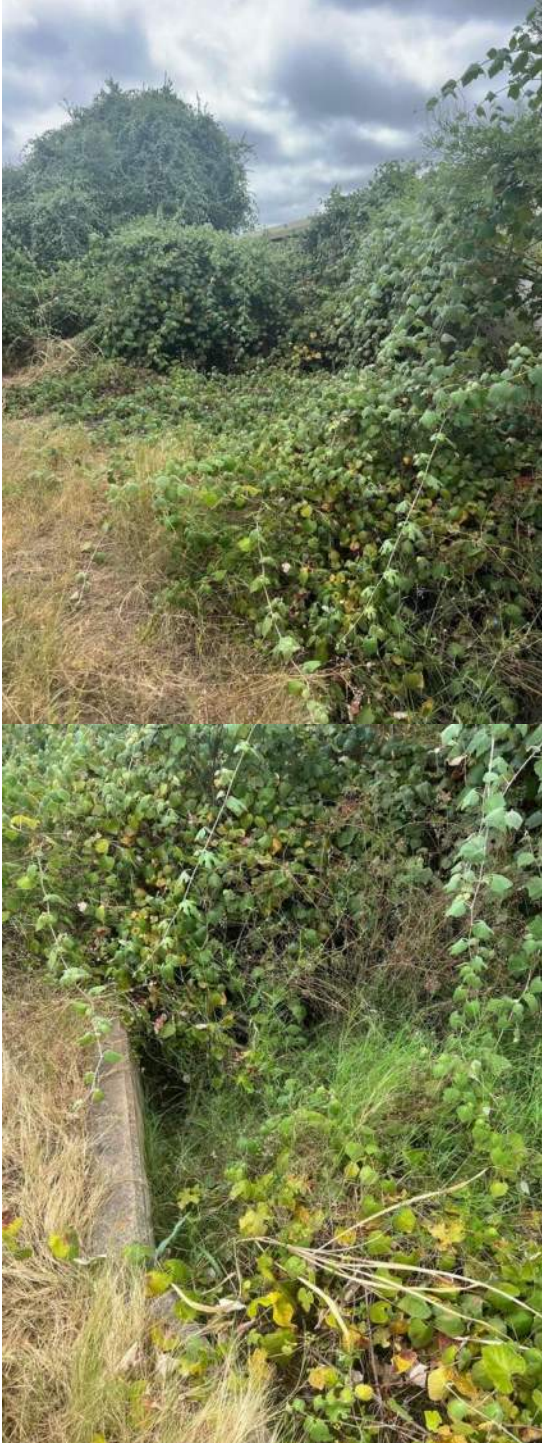
## Amber Creek Southern Outfall and Channel

Field Notes: Overgrown vegetation and trash

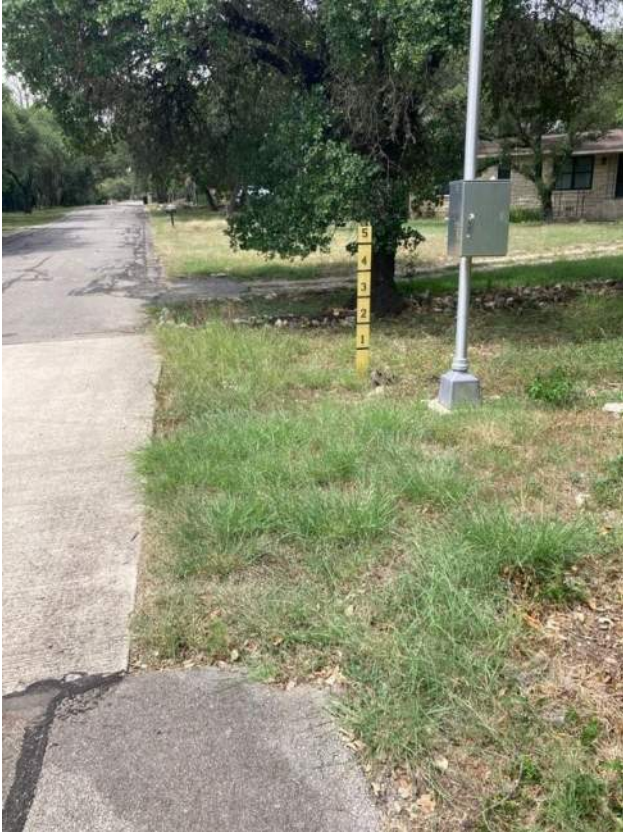
## Antelope Dr Low Water Crossing

Field Notes: Good condition.

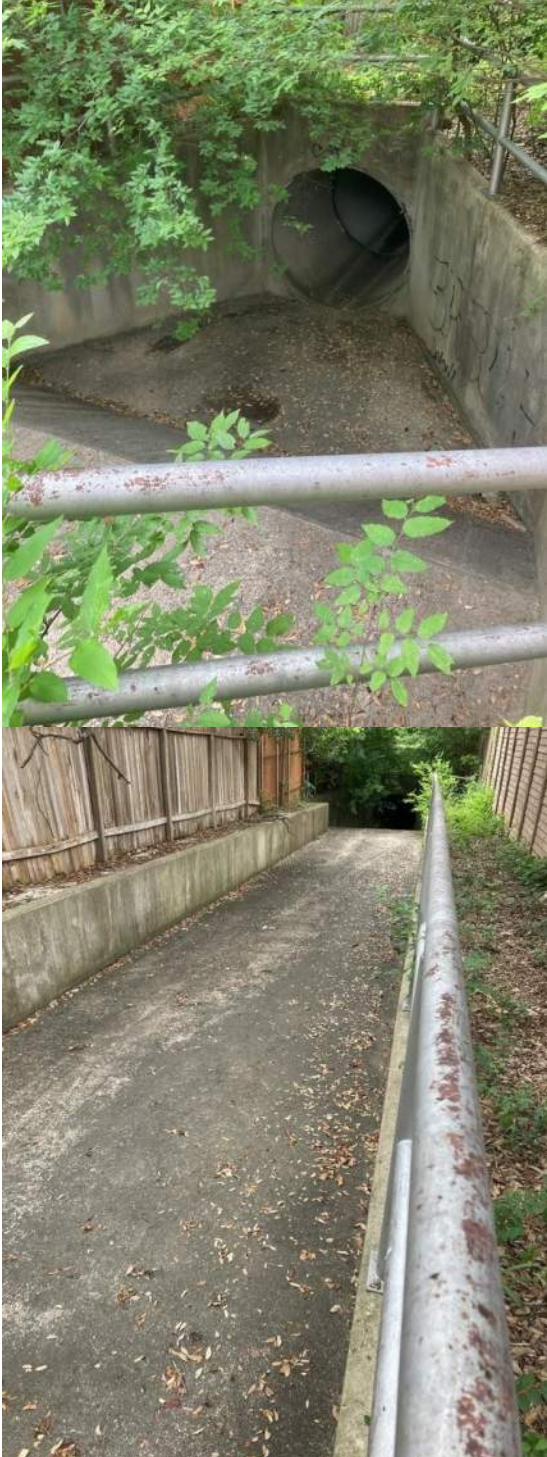
## Channel

Inspection Date: 2023-07-07  
Inspector: Cade Wenberg  
Field Inspection:  
 No Maintenance Required  
 Needs Maintenance  
 Illicit Discharge  
Field Notes: Good Condition

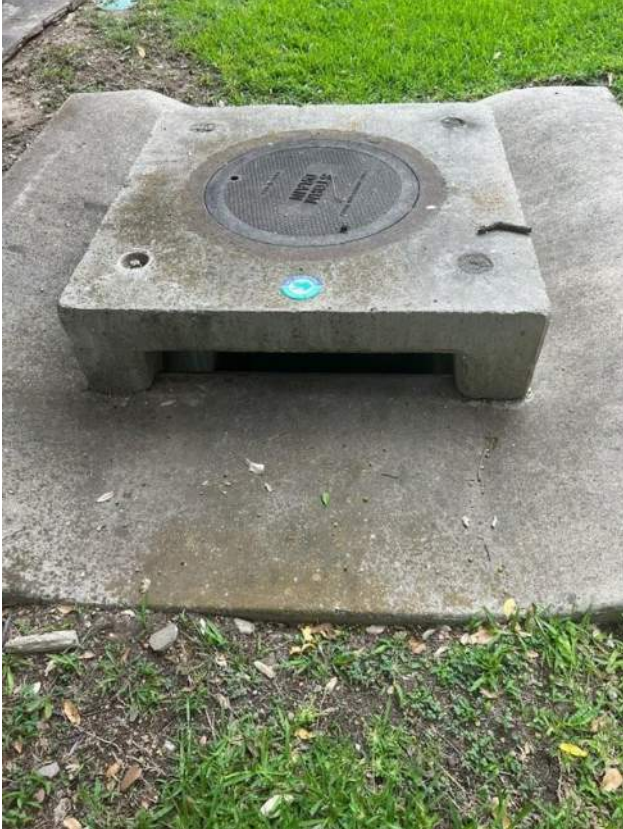
## Chula Vista Dr Inlet

Field Notes: Good Condition

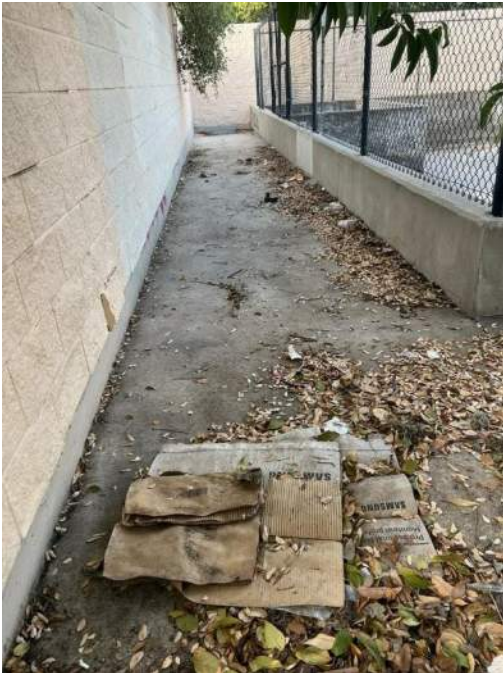
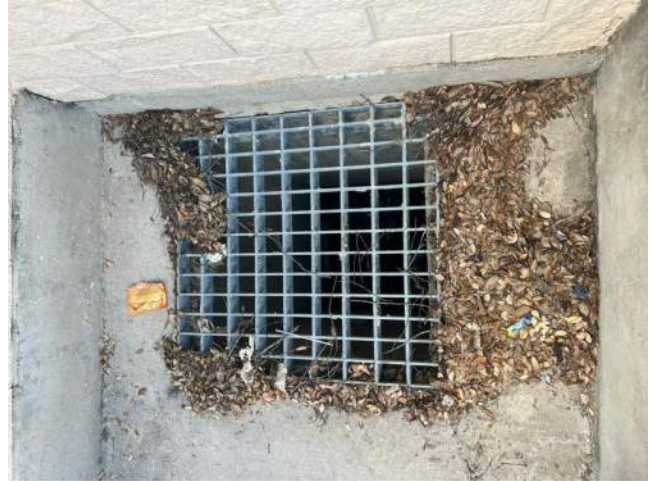
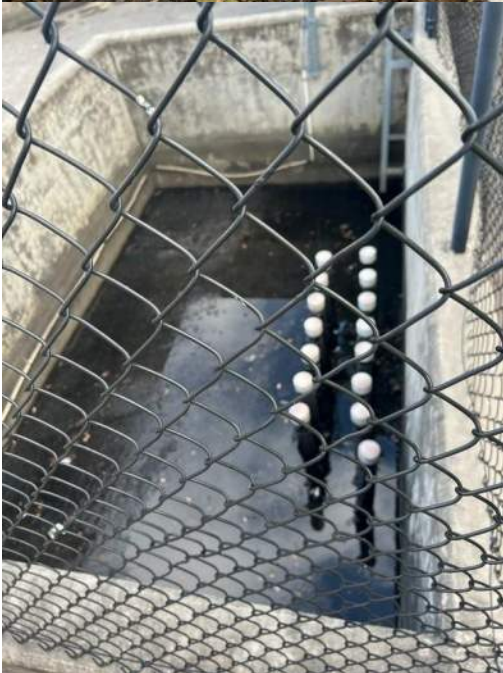
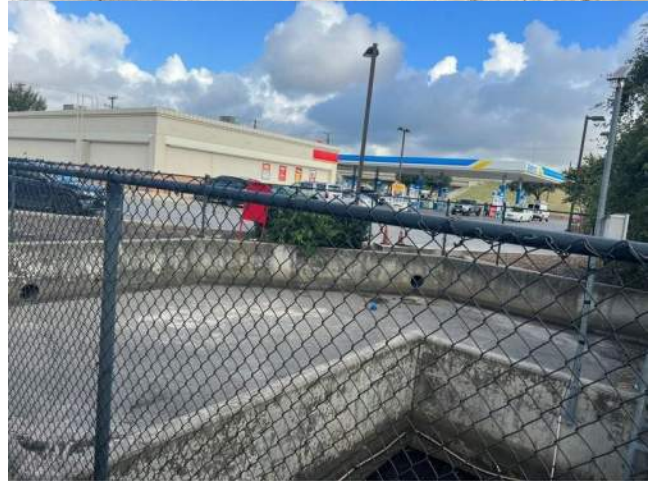
### Corner Store PCD

Field Notes: Debris needs cleaning. Filters are in good condition. Trash needs to be picked up.

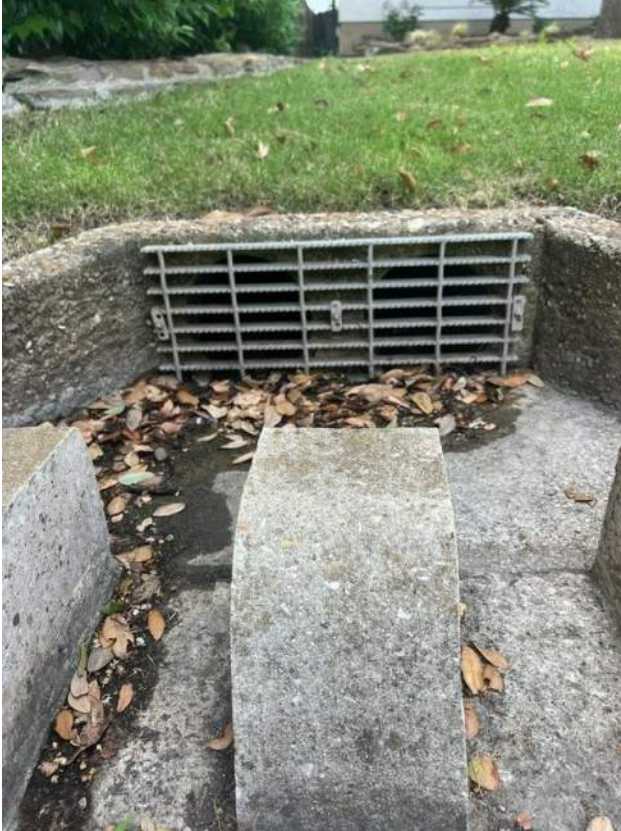
## Curb Outlet, 1

Field Notes: In good condition

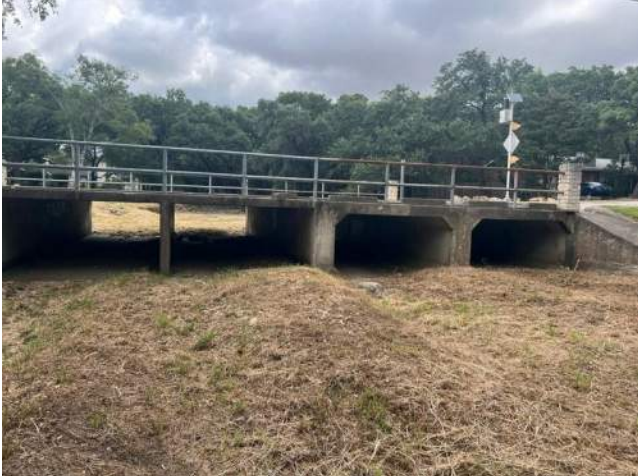
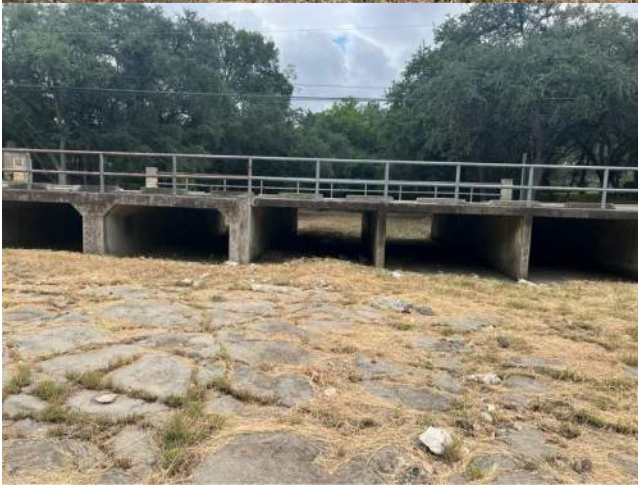
## Donella Crossing

Field Notes: Pipes in good condition.

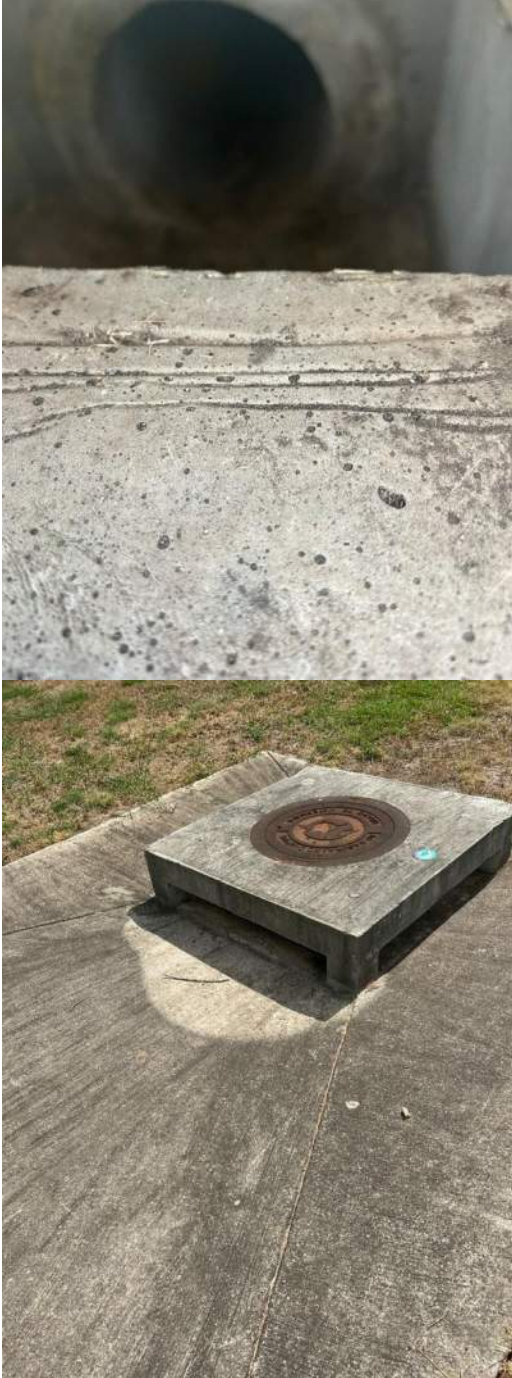
## Donella Inlet box

Field Notes: Good condition

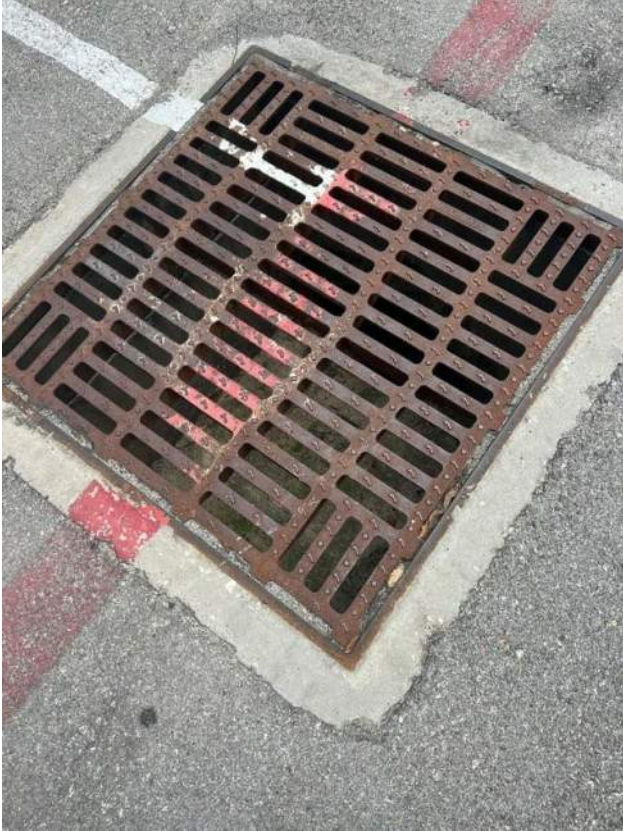
## Drash Rear Parking Lot Inlet

Field Notes: In good condition

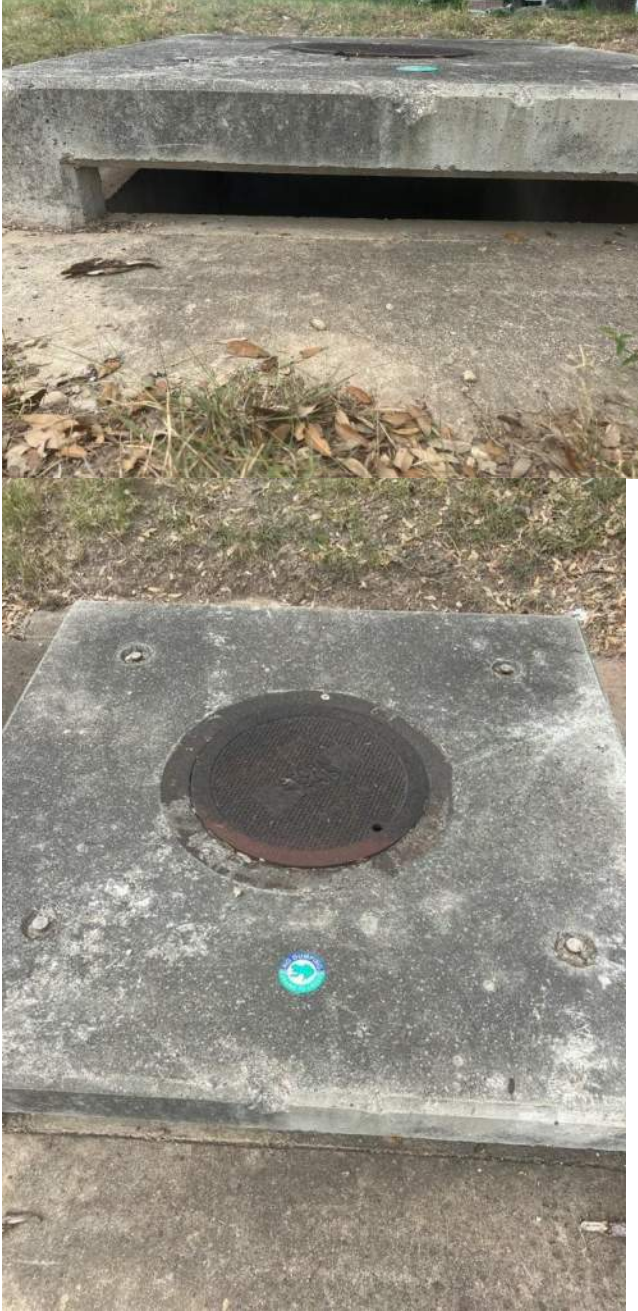
### MEC-I-1(M)

Field Notes: Good condition

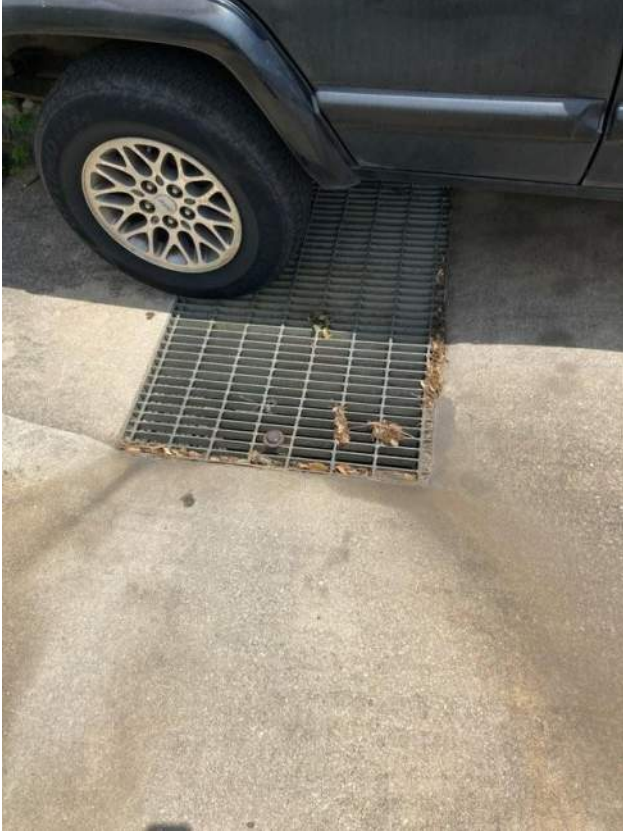
## Midas Inlet In Rear

Field Notes: Good condition

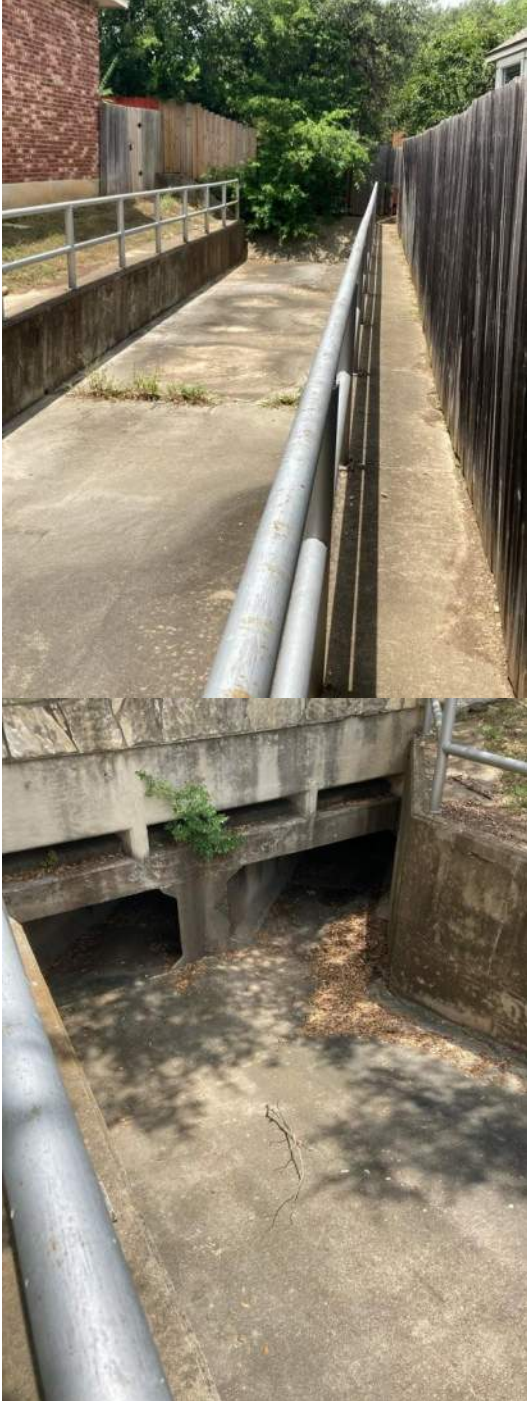
## Mustang Circle

Field Notes: Clean leaves and cut tree

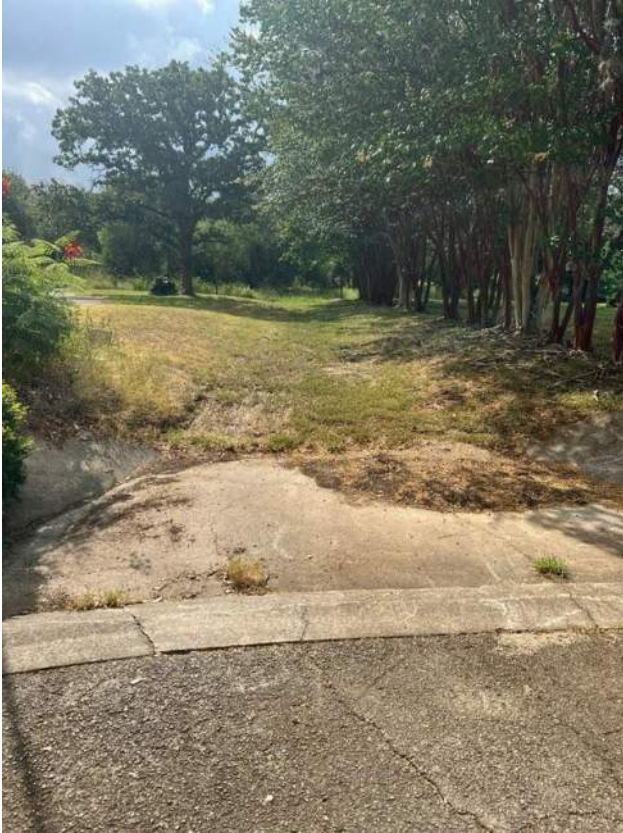
## New Drash Parking Lot Box Inlet

Field Notes: Good condition

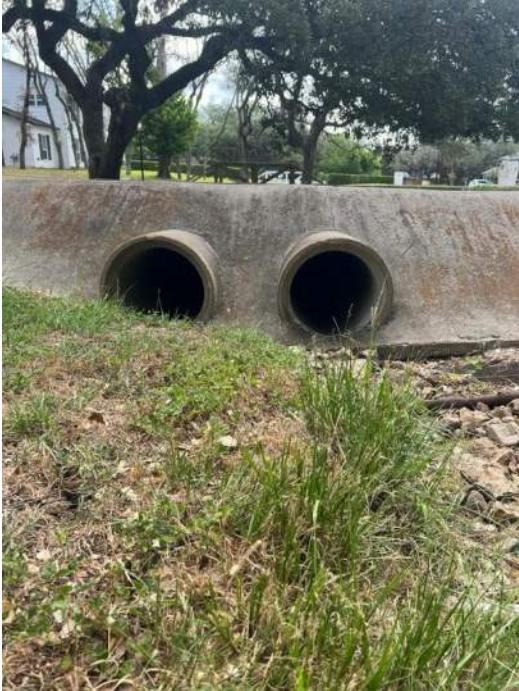
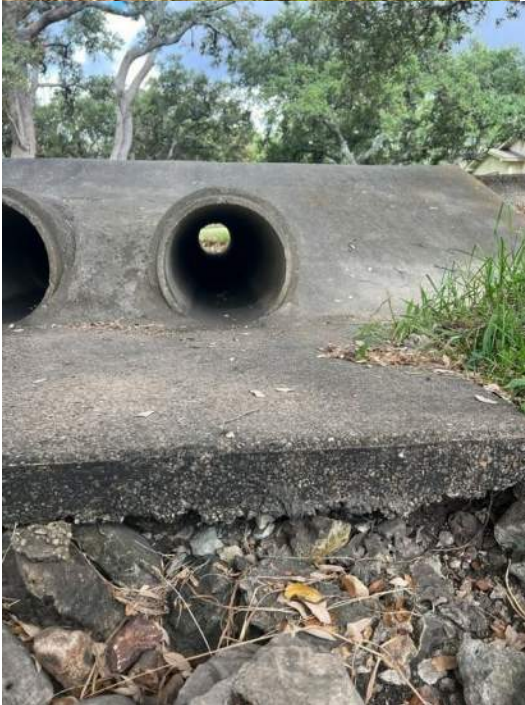
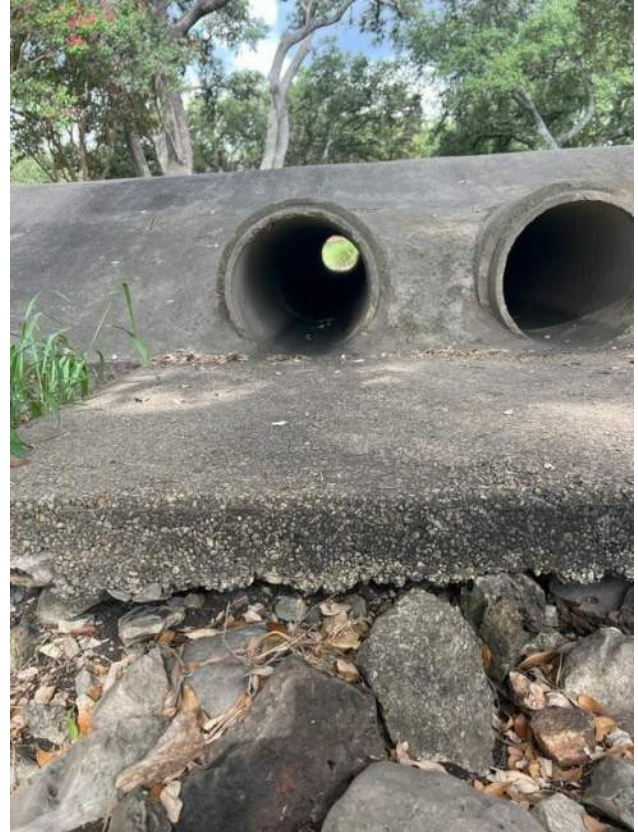
## North Oak Private Crossing East

Field Notes: Good condition

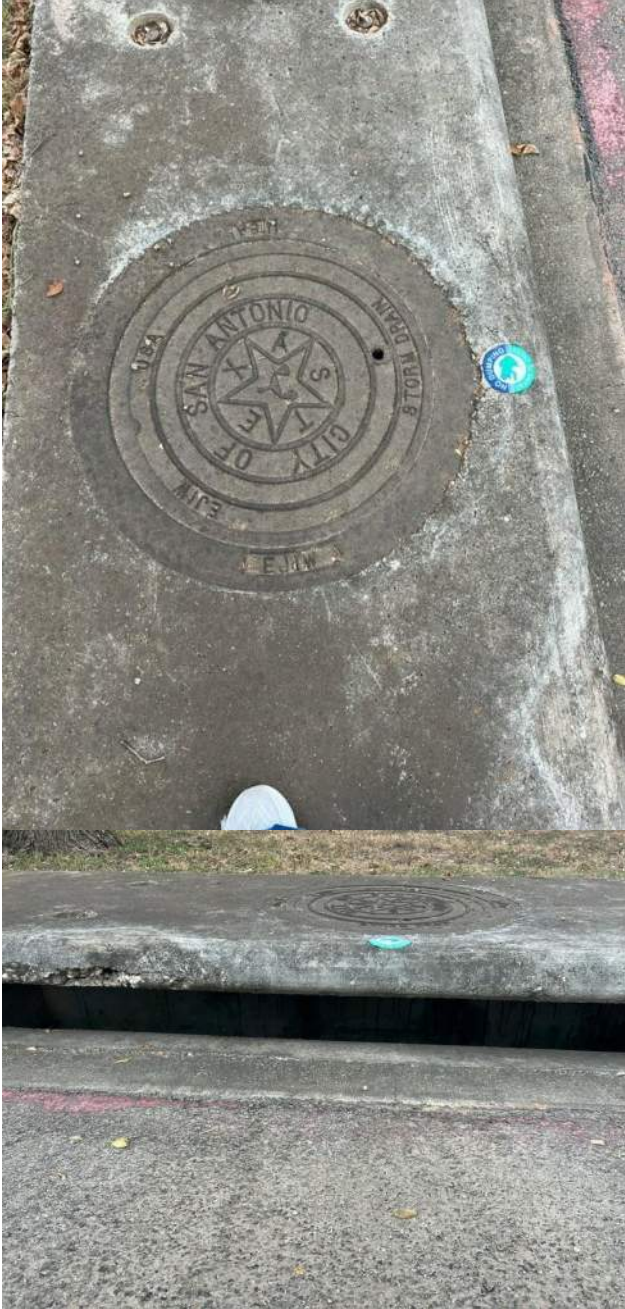
## Optometrist Roundabout PCD

Field Notes: Clean and in good condition

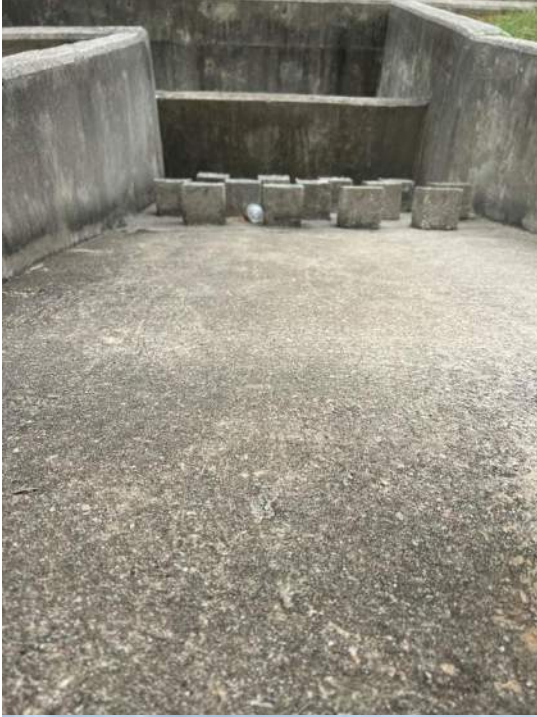
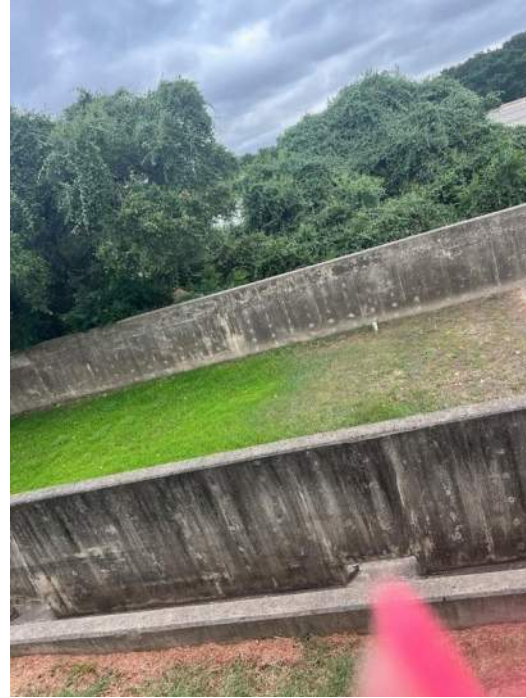
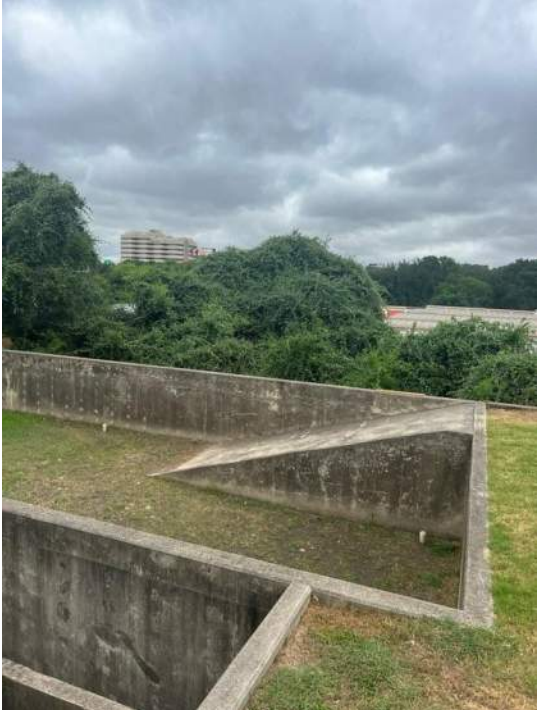
## Pantheon Commercial Strip PCD

10064	Pantheon Commercial Strip PCD	Other	PCD in good condition, remove overgrown vegetation behind southern wall of PCD.
10041	Park Oak Outfall	Outfall	Trim vegetation, clean light debris
10048	Paseo Canada Outfall 2	Outfall	Clear weeds and trash
10057	PCD2 Pediatrics	BMP	Clear debris/trash and lock gate
10066	Pediatric Dentistry Office	BMP	Clean pipe out
10068	Public Storage Outfall	Outfall	Clear vegetation
10071	Retention Pond with Infiltration	Pond	Clear debris and vegetation
10047	Rua De Matta Street Channel Outfall	Outfall	Trim vegetation to fence line to allow flow
10661	Sagecrest Crossing East	Pipe	Trim vegetation
10663	Sagecrest Crossing West	Other	Pipes look good. Vegetation needs to be mowed down.
10032	Sediment	Other	Remove sediment build up
10913	Sediment Buildup at Tall Oak	Other	Clear sediment
10040	Sediment Buildup in Street	Other	Large pile of leaves
10923	Sediment Near Marriott Global	Other	Clear sediment

Field Notes: In good condition

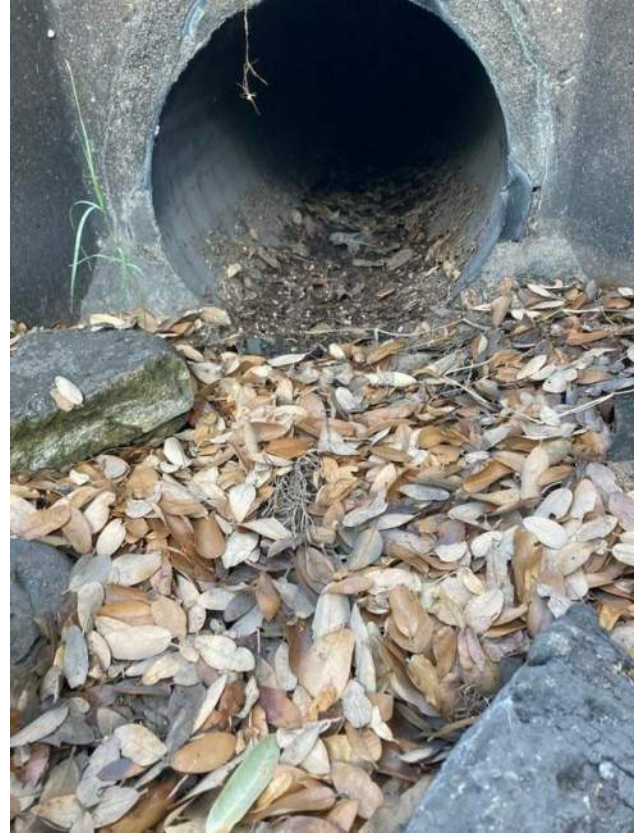
## Park Oak Outfall

Pretty clean

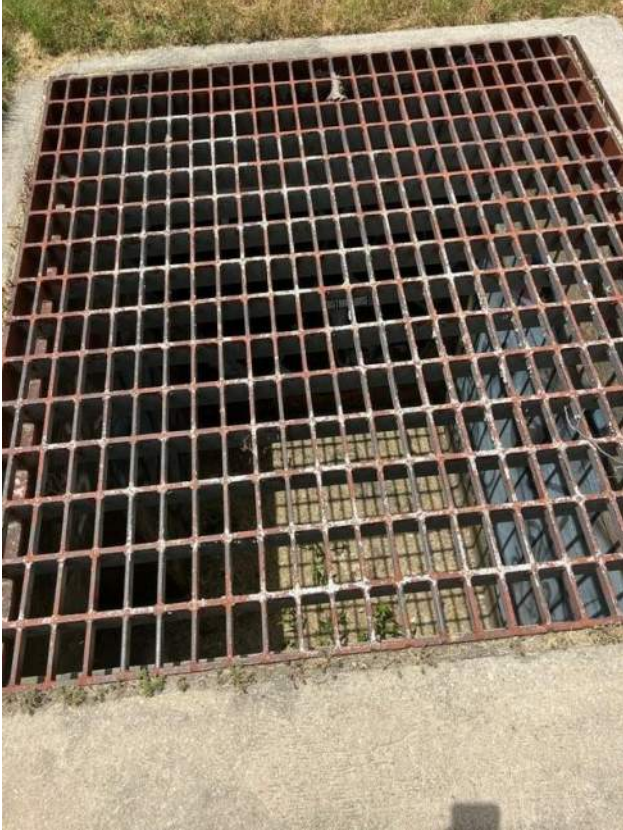
## Premier 1 Autocare Inlet 1

Field Notes: In good condition

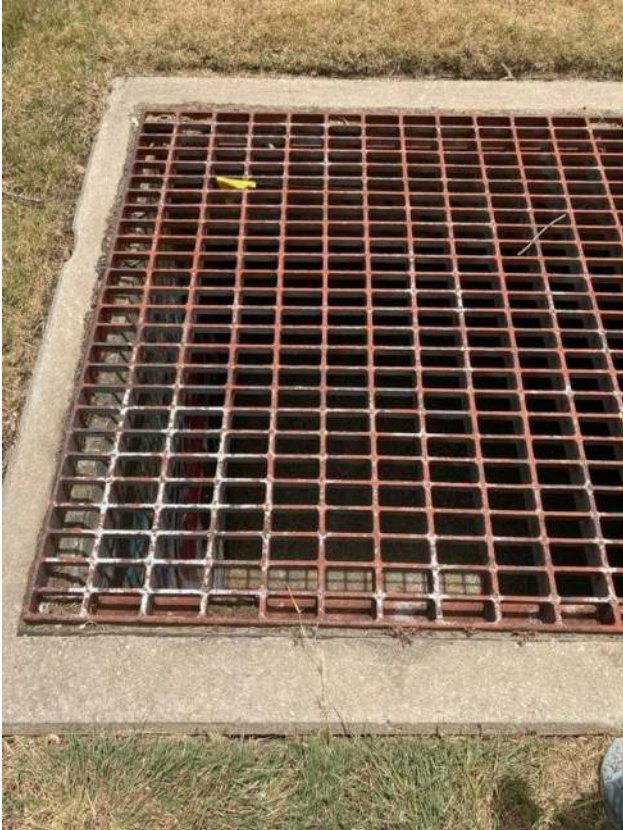
## Premier 1 Autocare Inlet 2

Field Notes: Good condition

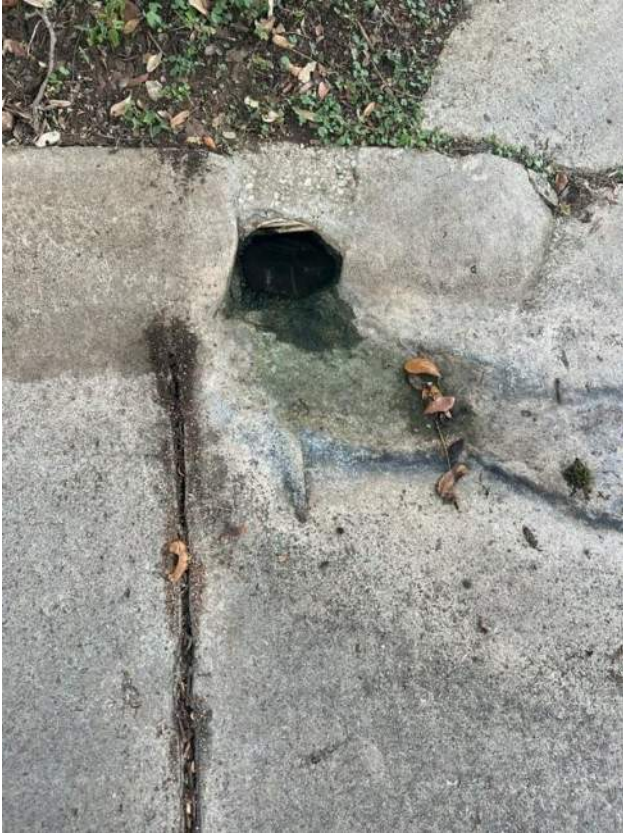
## Public Storage Outfall

Field Notes: Pipe is capped, no longer an issue

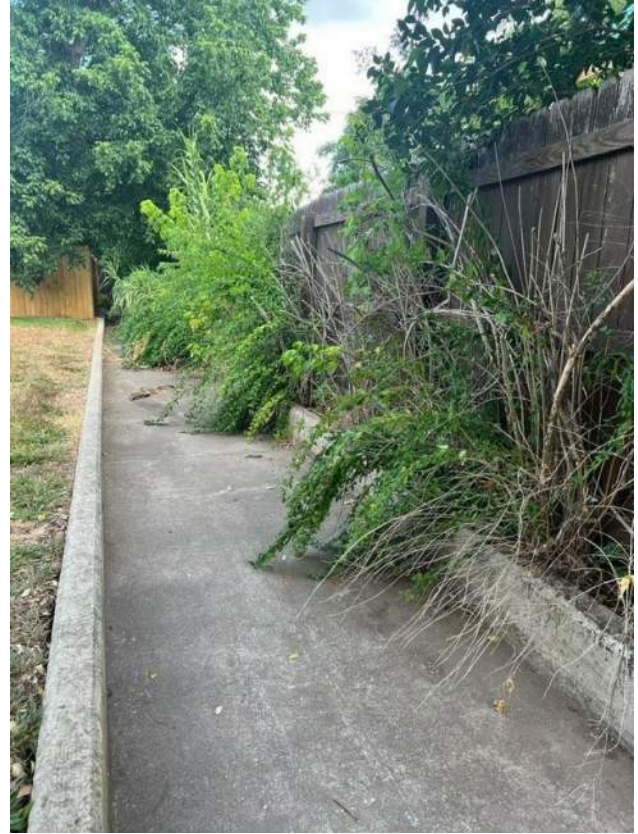
## Rua De Matta Street Channel Outflow

Field Notes: Trim vegetation to fence line to allow flow

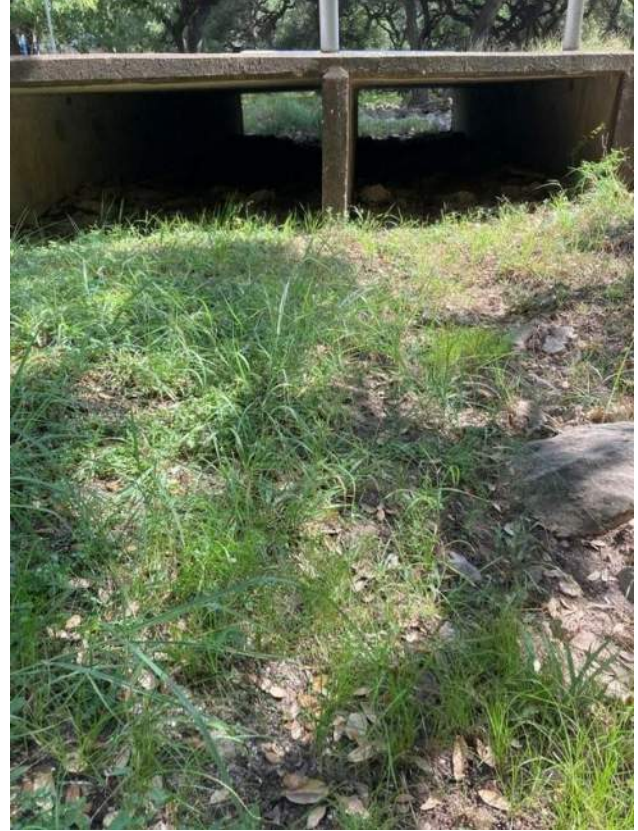
## Sagecrest Crossing East

### Field Notes: Trim vegetation

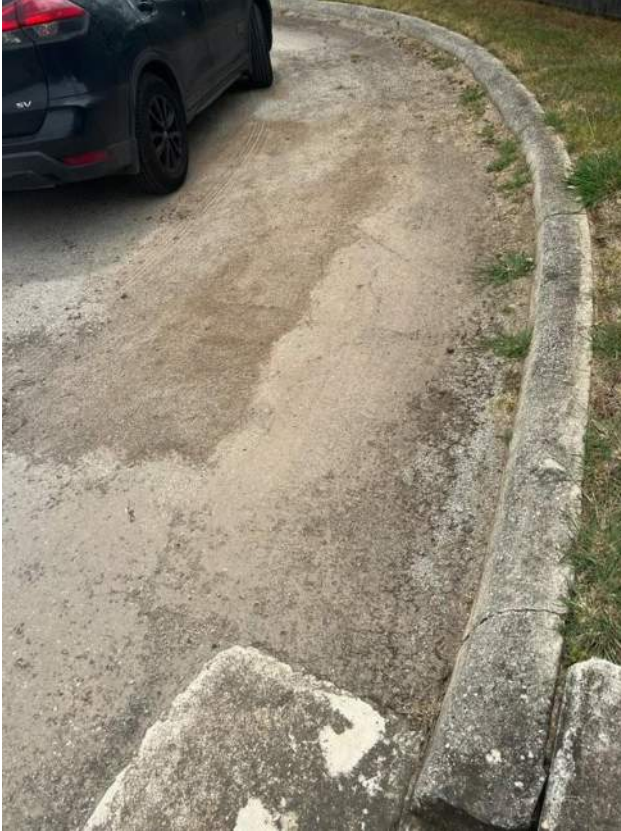
Field Notes: Clear sediment

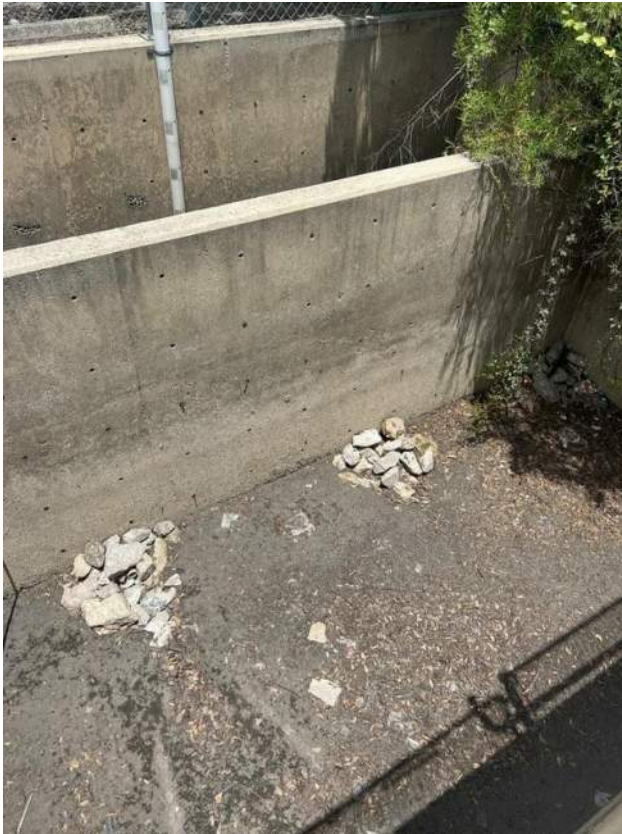
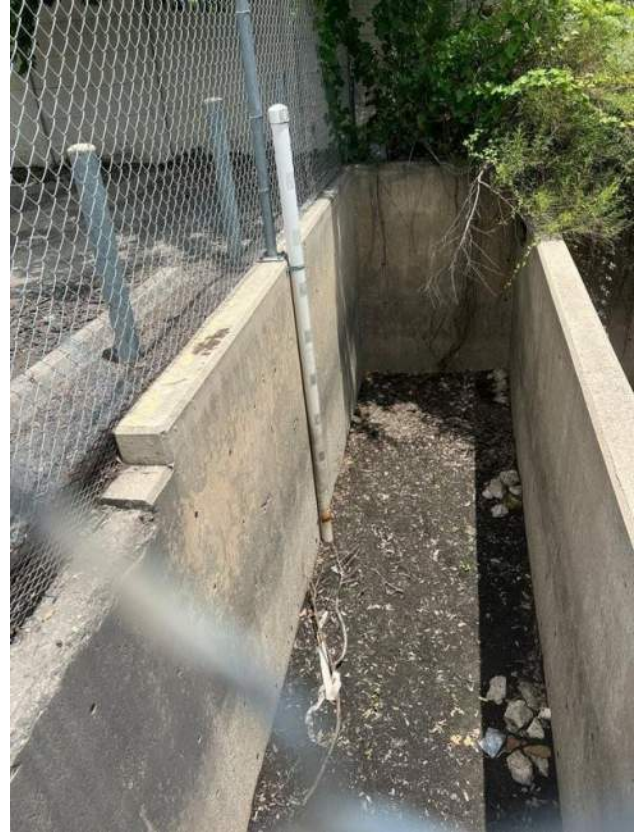
## Service King Collision Repair Extended Parking Lot PCD

Field Notes: Clear rocks from opening of pipe, Rocks on and around pipe are okay.

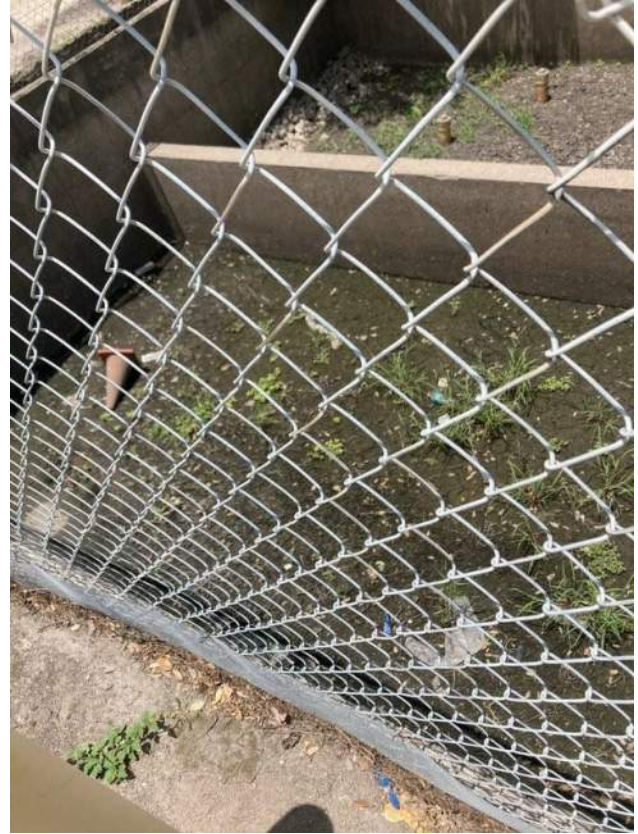
## Service King Collision Repair PCD

Field Notes: Clean out all trash and debris

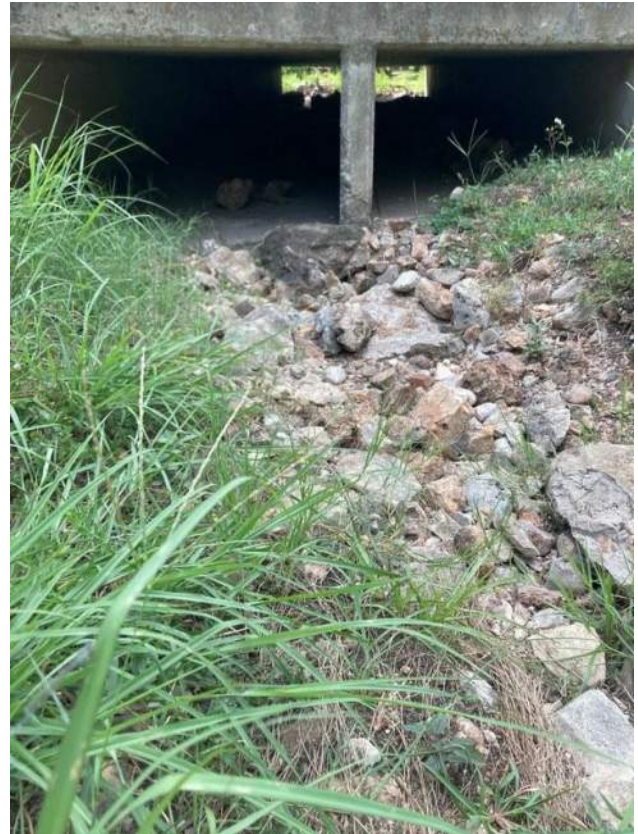
Field Notes: Clear large rocks from inside of culverts, otherwise pretty clean.

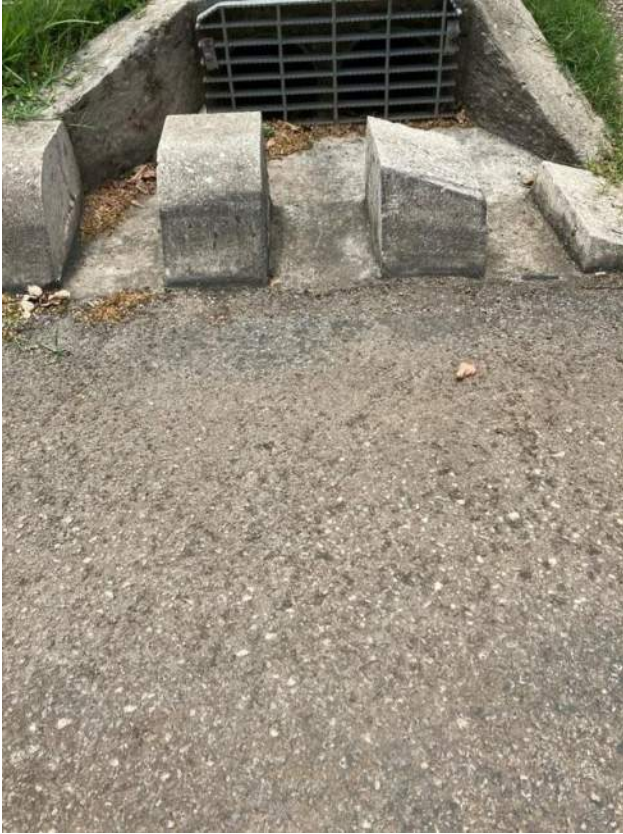
## Stream Gauge

Field Notes: Good condition

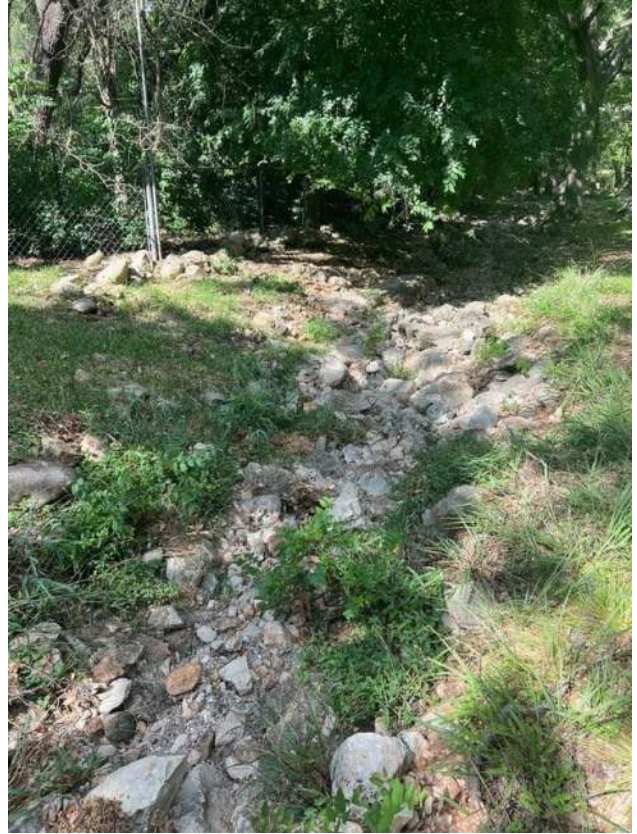
## Tall Oak Outfall

Field Notes: Good condition

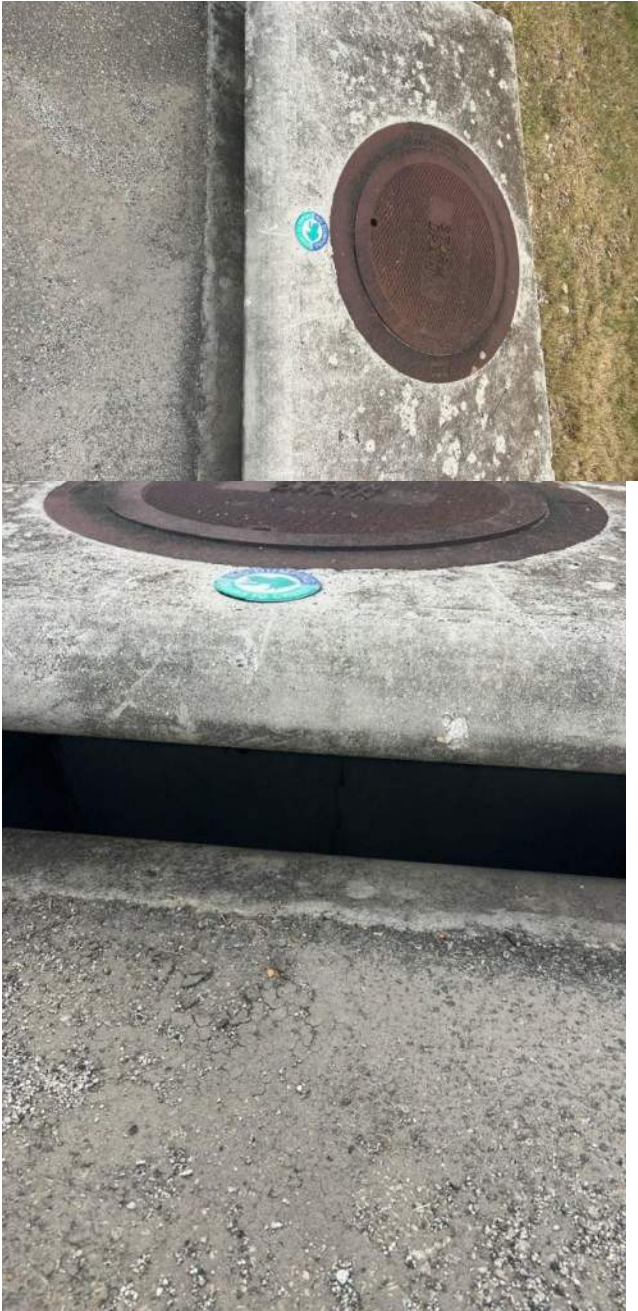
## Valvoline PCD

Field Notes: In good condition

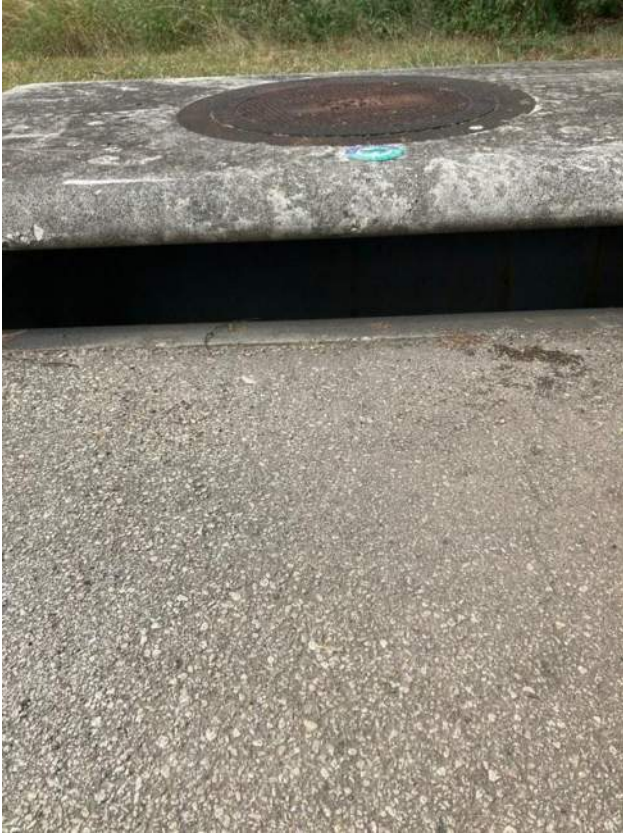
## Varco 2

Inspection Date: 2023-07-07  
Inspector: Cade Wenberg  
Field Inspection:  
 No Maintenance Required  
 Needs Maintenance  
 Illicit Discharge  
Field Notes: In good condition
