# TOWN OF HOLLYWOOD PARK, TX

2023 Summer Inspection

# HOLLYWOOD PARK 2023 SUMMER INSPECTION REPORT

**Subject:** Annual Municipal Separate Storm Sewer System (MS4) Inspection

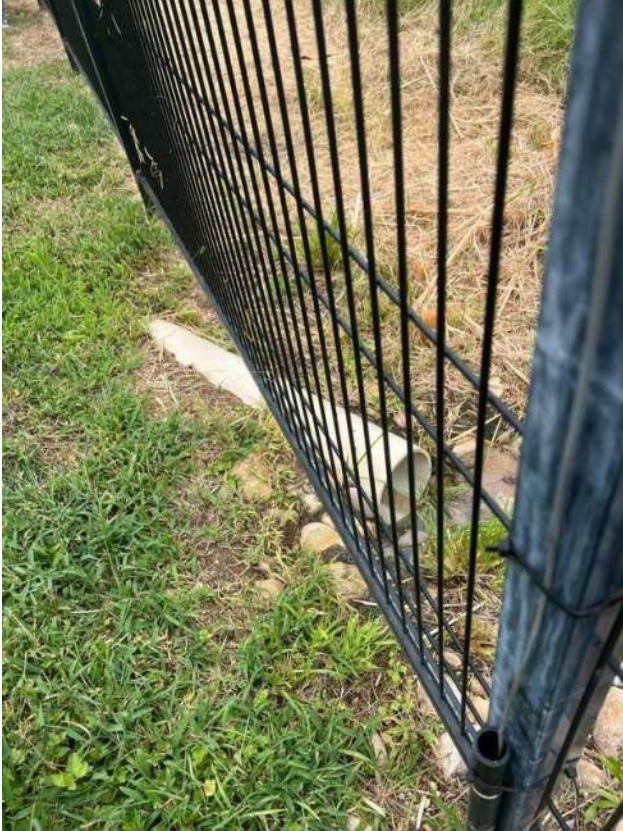
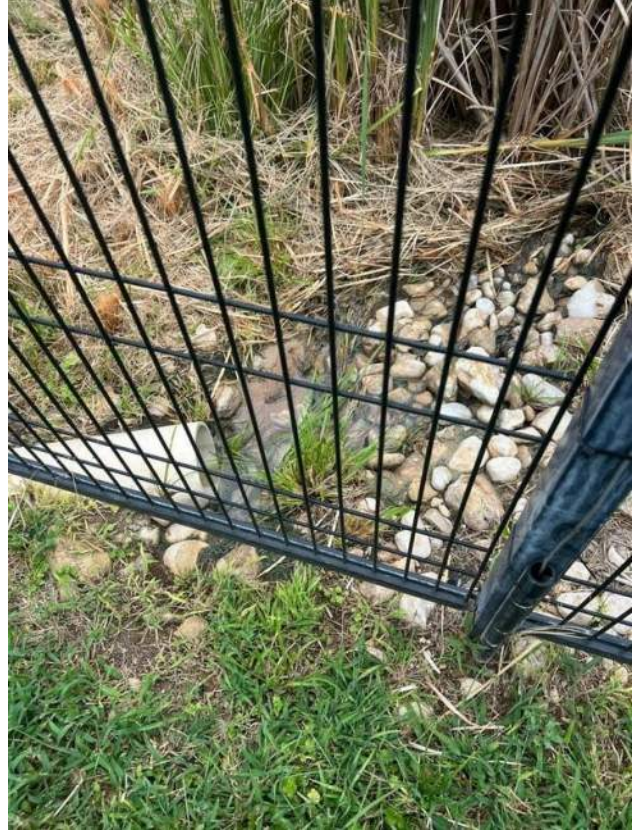
## Voigt Park Inlet

Field Notes: In good condition

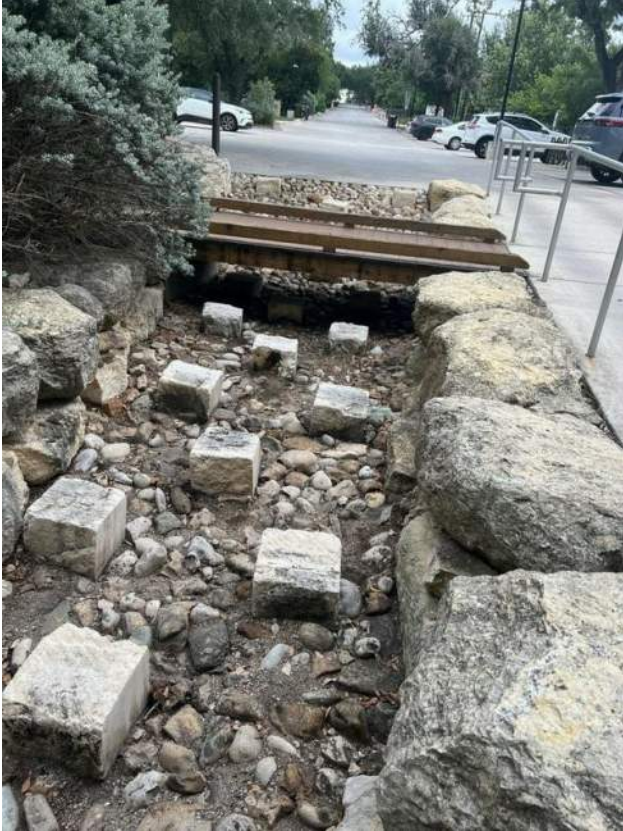
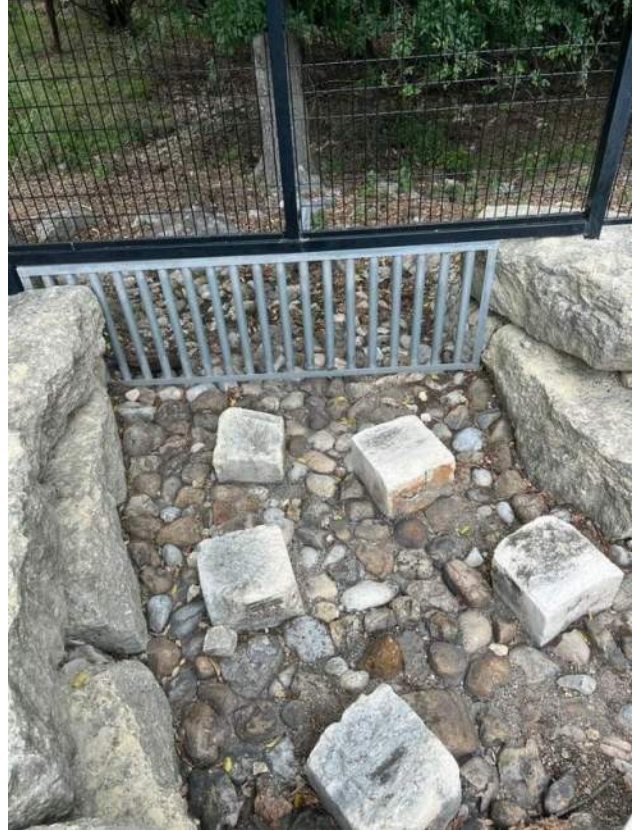
## Voigt Park Outfall

Field Notes: Clear and in good condition

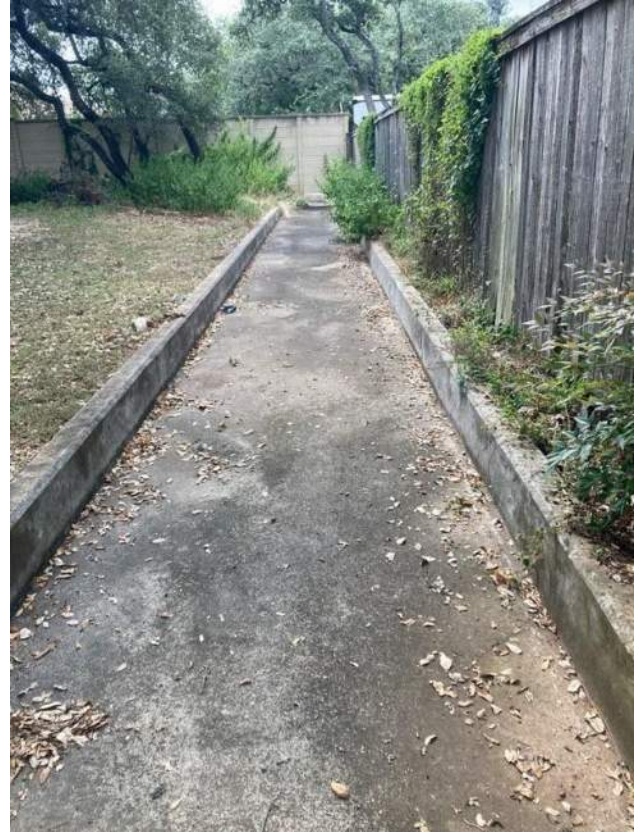
## Voigt UG Pipe

Field Notes: Trim vegetation so not in channel, otherwise good.

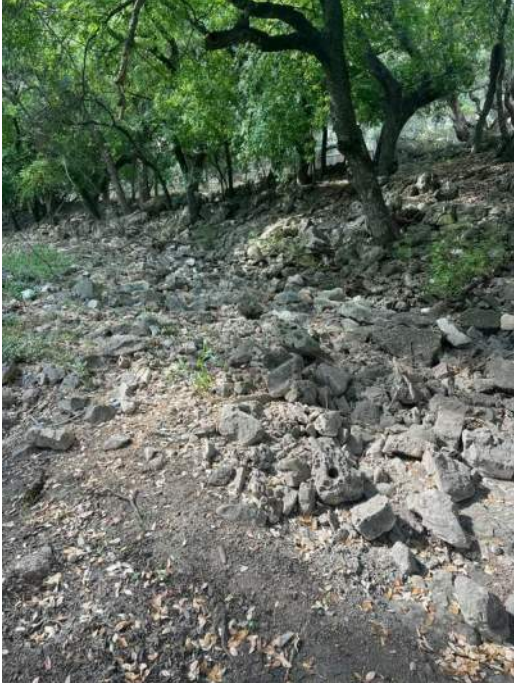
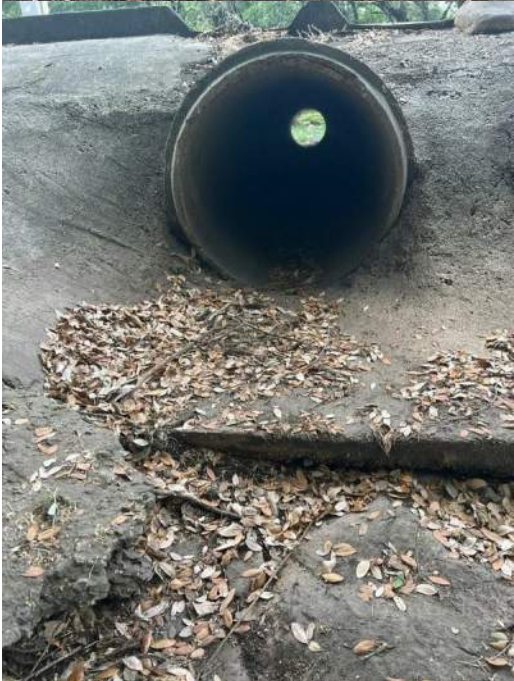
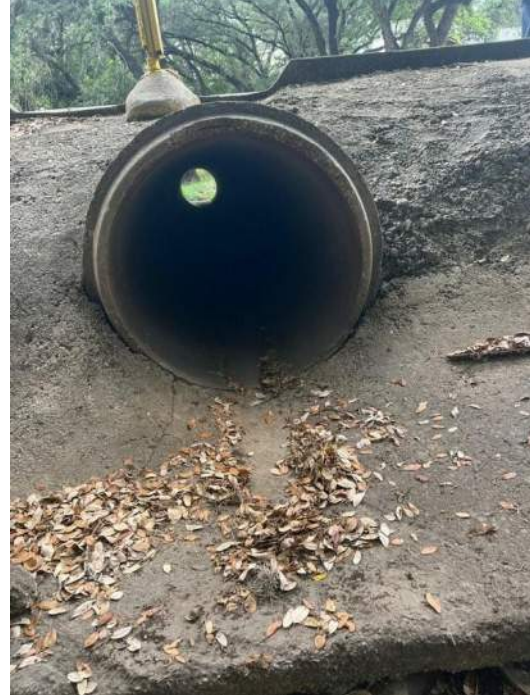
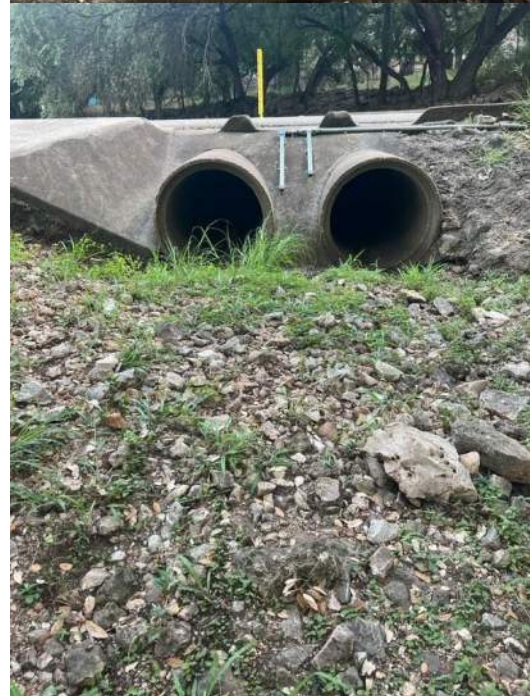
## Yosemite Crossing East

Field Notes: Pipes in good condition
