# TOWN OF HOLLYWOOD PARK, TX

2023 Winter Inspection

# HOLLYWOOD PARK 2023 WINTER INSPECTION REPORT

**Subject:** Annual Municipal Separate Storm Sewer System (MS4) Inspection

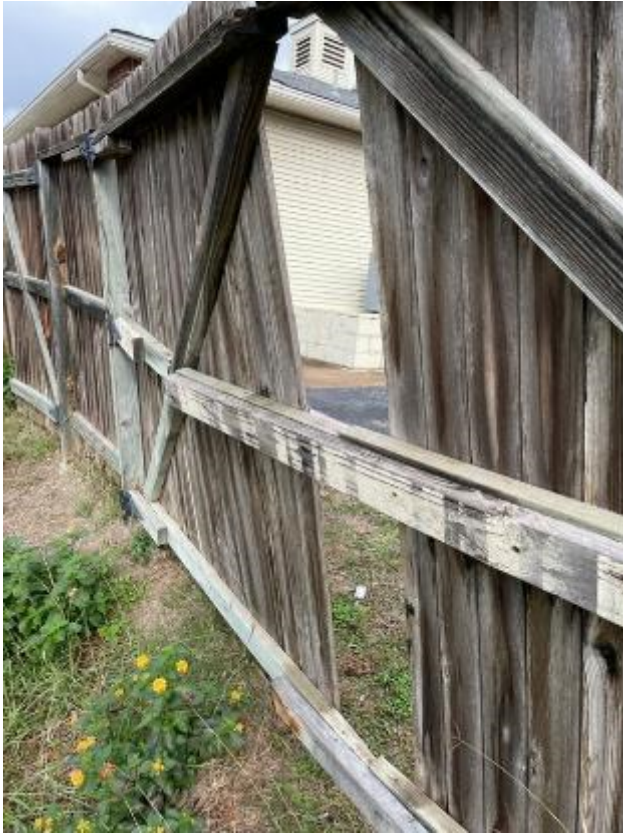
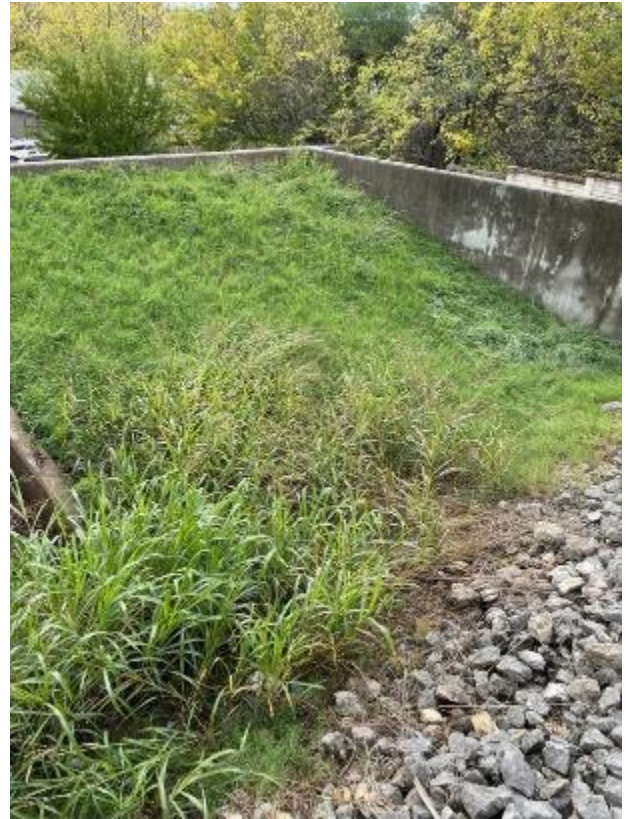
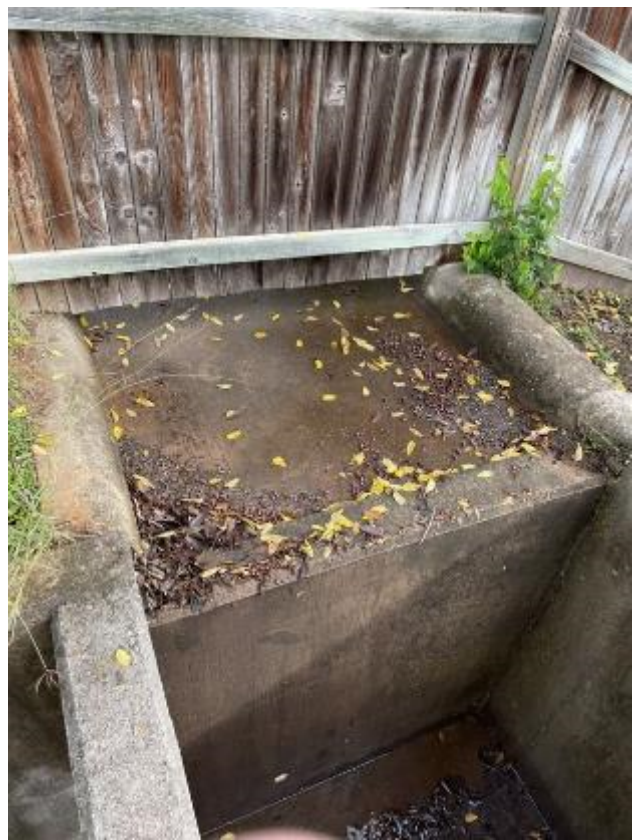
## Brookdale PCD

Field Notes: Mow and remove sediment. The fence needs repair.

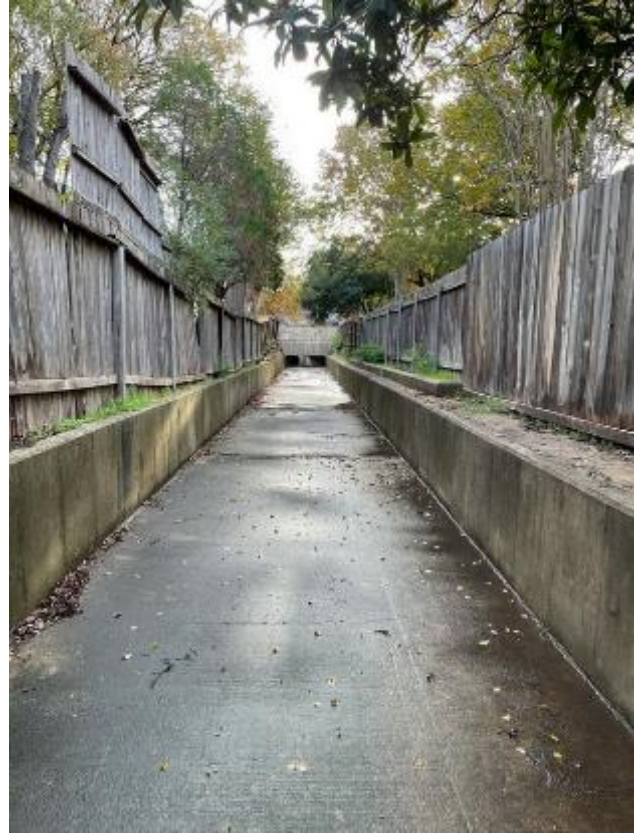
## Channel

Field Notes: Looks good.

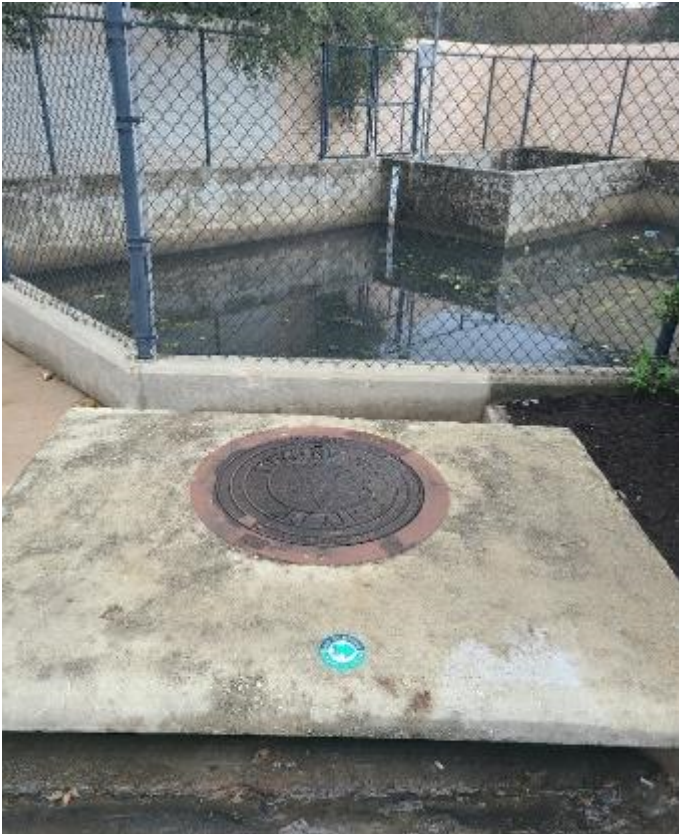
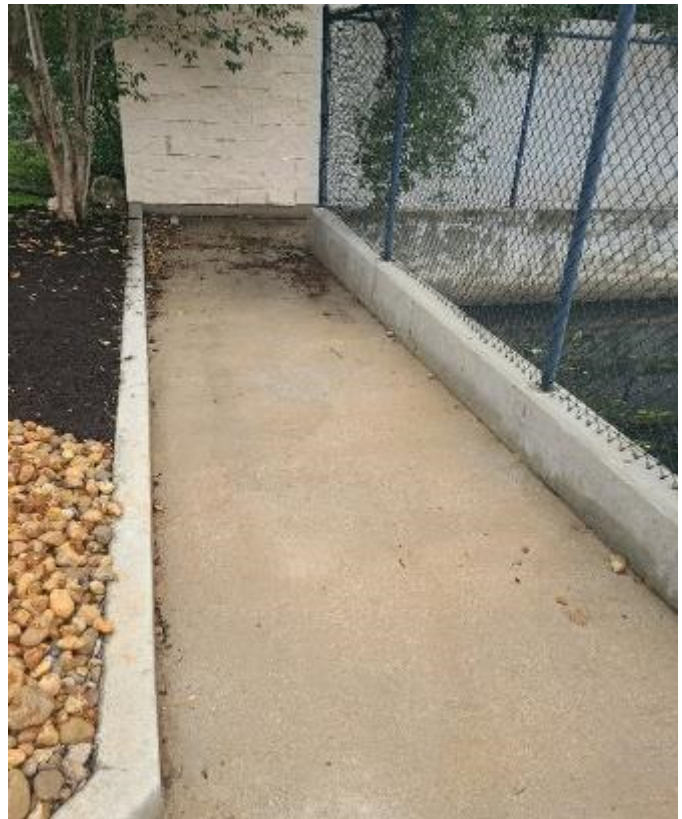
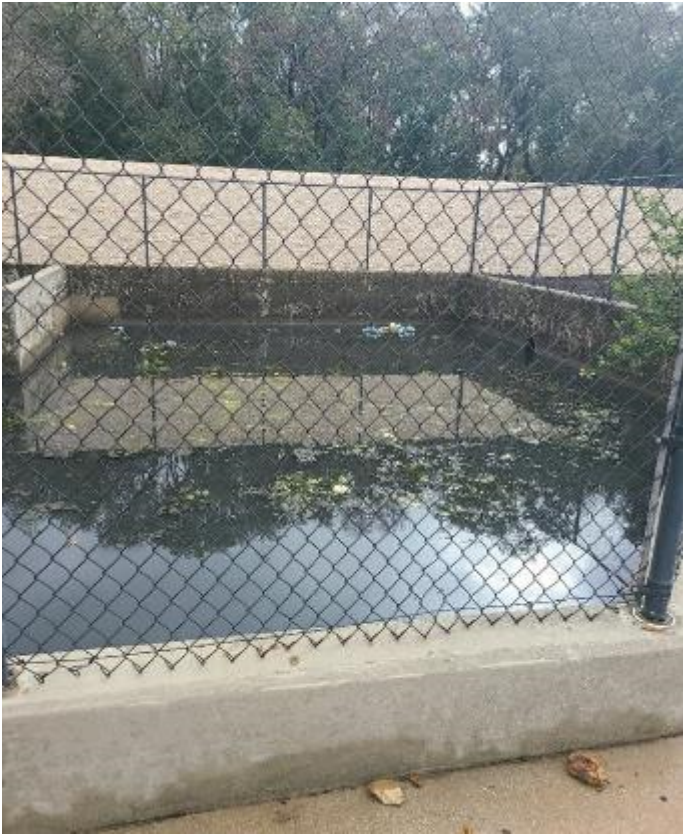
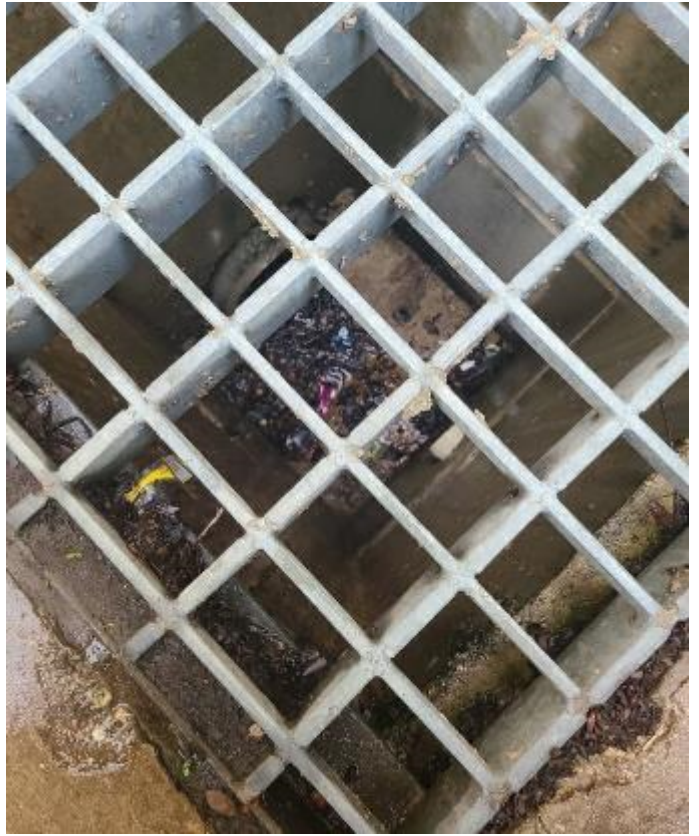
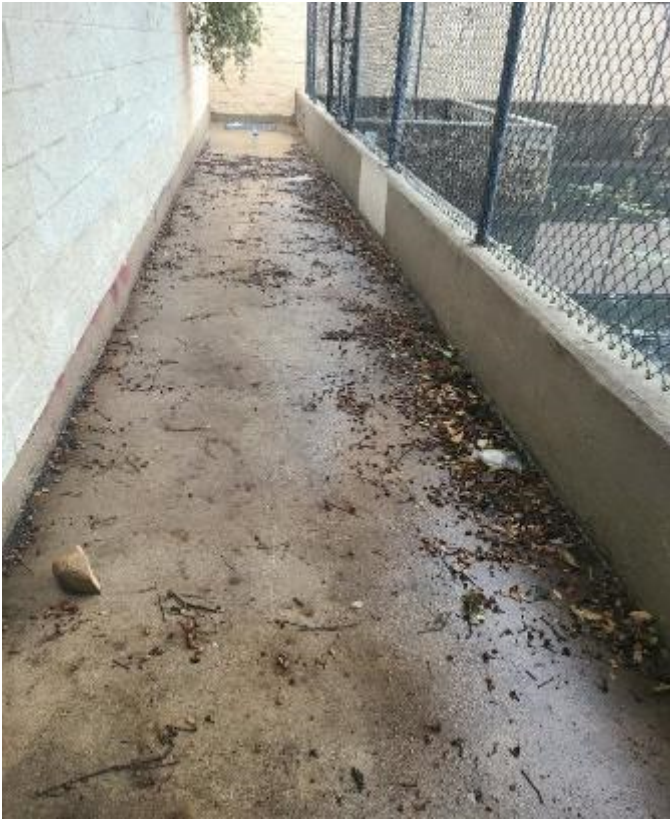
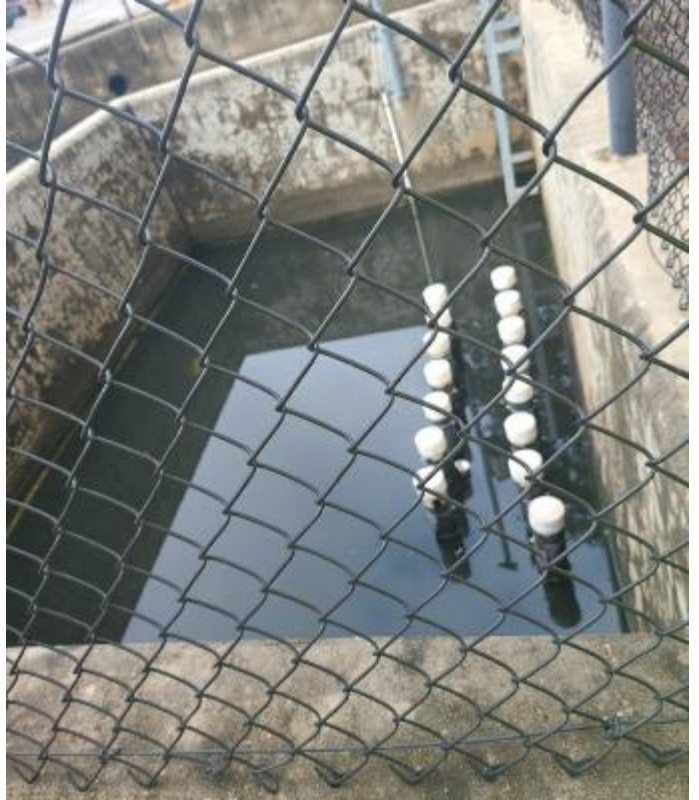
### Corner Store PCD

Field Notes: Rain event this morning. About 1" in pond at time of inspection. Drain out looks to be steady trickling. Several items of litter, trash, and sediment within the pond and surrounding area. These need to be removed.

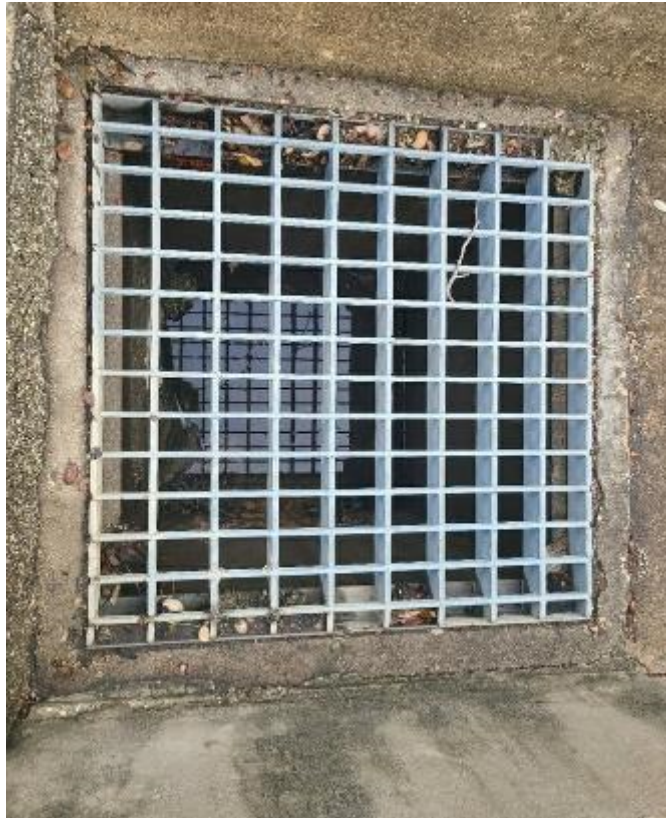
### CRT Flooring Concepts PCD

Field Notes: Rainfall event this morning. Pond shows to have collected about 6" of rainfall in rain gauge. Pond shows to only have about an inch left in. Overall clean.

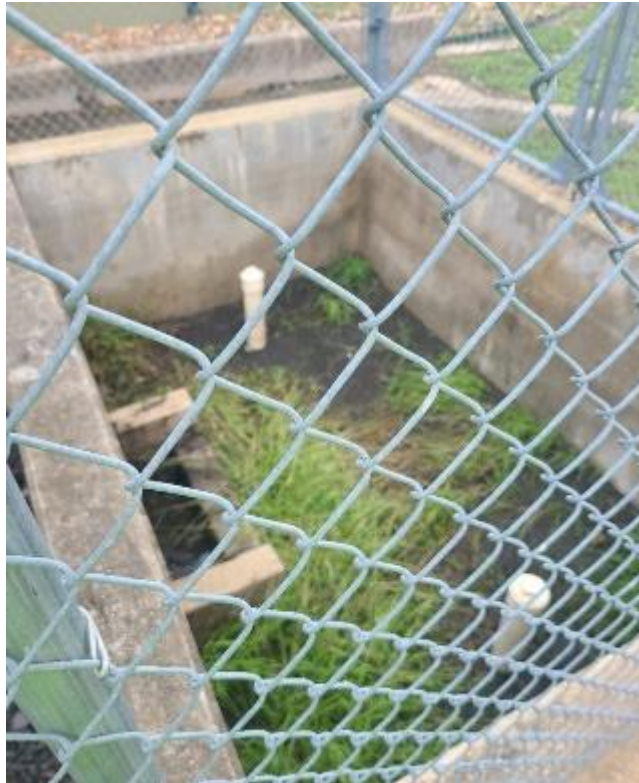
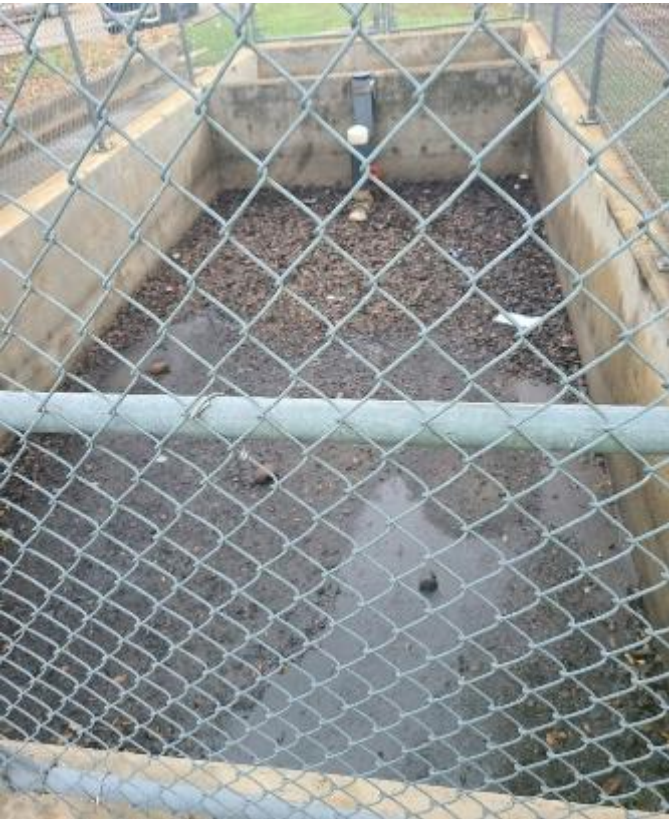
## Express Lube PCD

Field Notes: Rainfall event morning of inspection. Basin is wet but doesn't have any lingering water. The basin does have overgrown grass as well as illicit discharge in form of transmission fluid. Recommended to trim grass and remove all trash and illicit items from pond area.

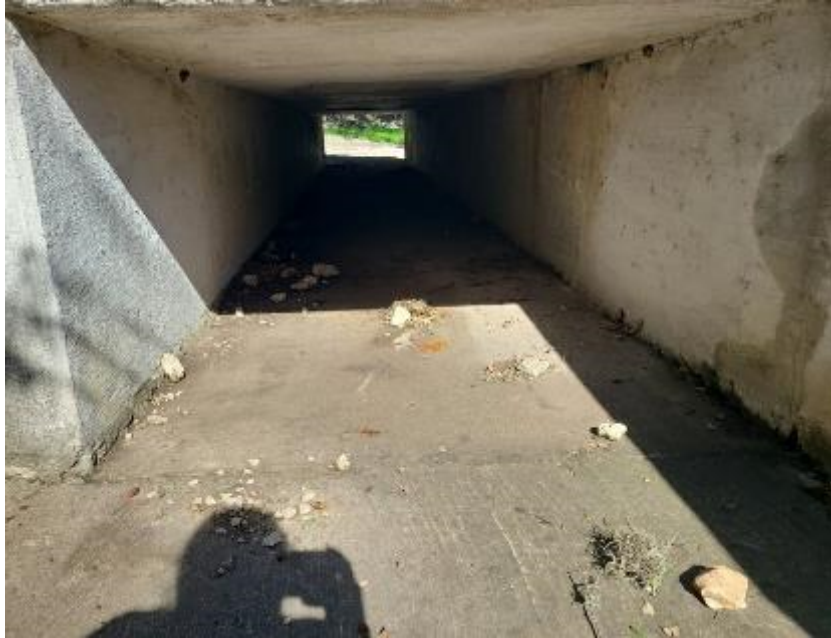
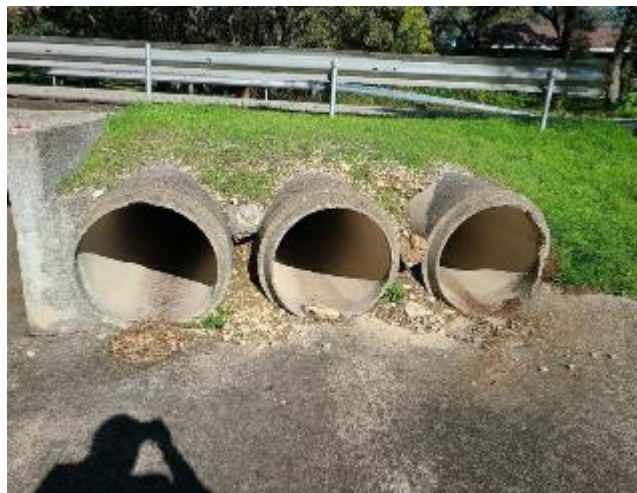
## Fleetwood Crossing

Field Notes: Pipes in good condition. There is a buildup of sediment in the middle pipe which has caused a pooling of backflow water. Recommended to remove sediment to allow proper flow.

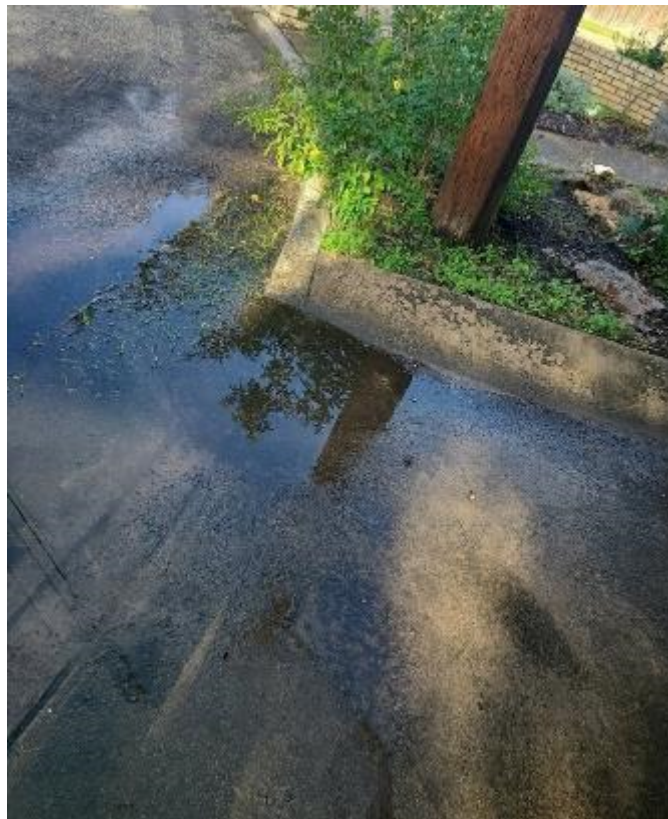
## Garrapata Storm Water Inflow

Field Notes: Rain event this morning. Water pools in front of channel. Channel Inlet need vegetation trimmed.

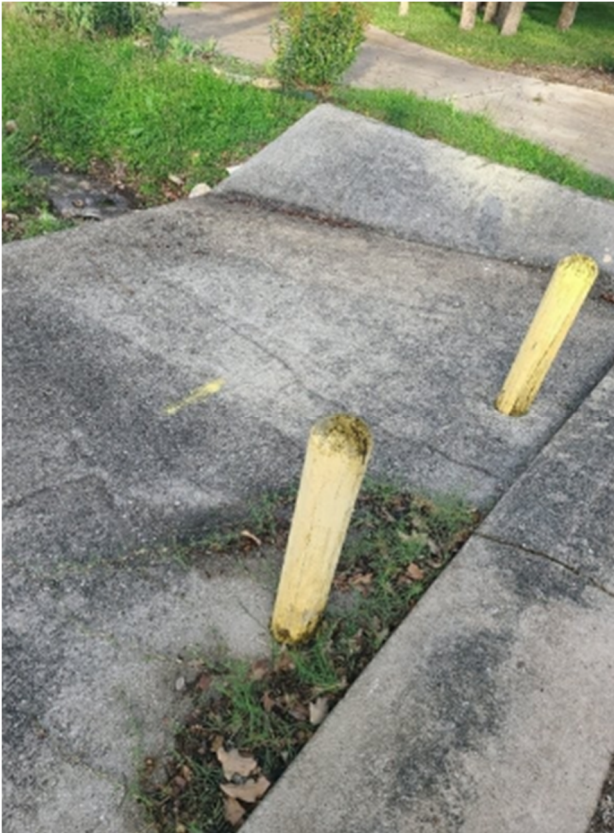
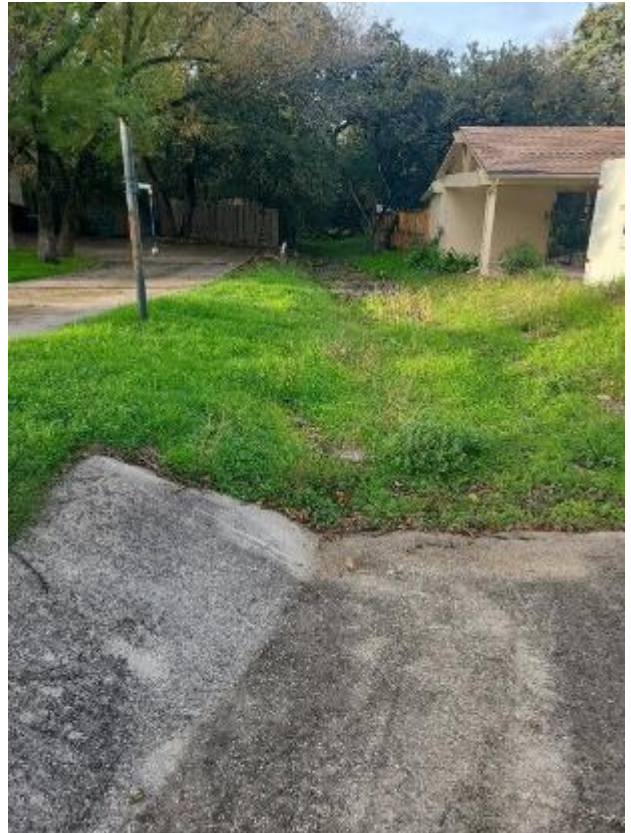
## Grand Oak Outfall

Field Notes: Good condition.

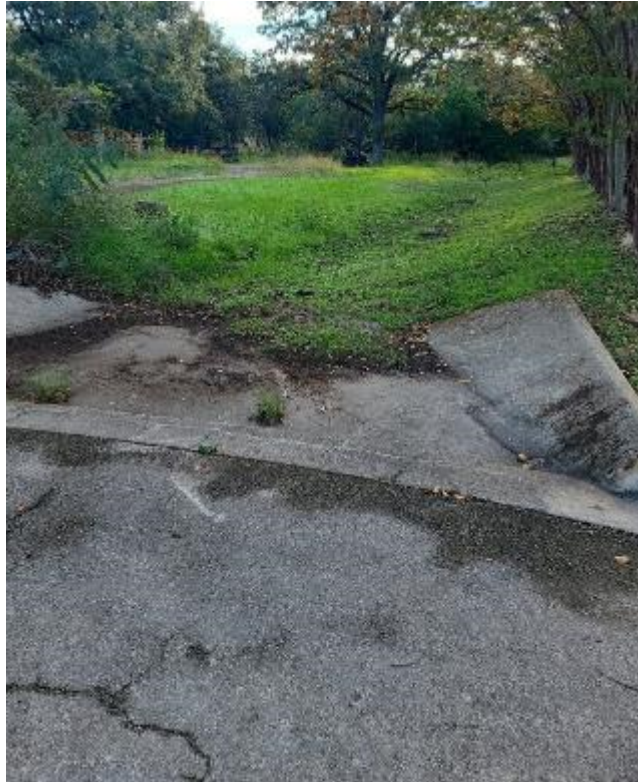
Field Notes: Clean and good condition.

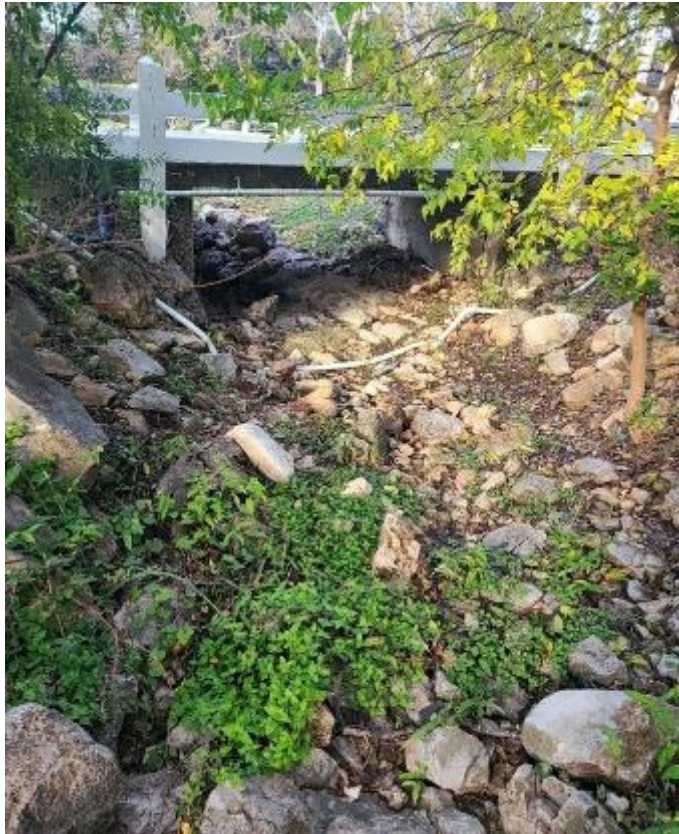
## North Oak Private Crossing East

Field Notes: Pipe in good condition.

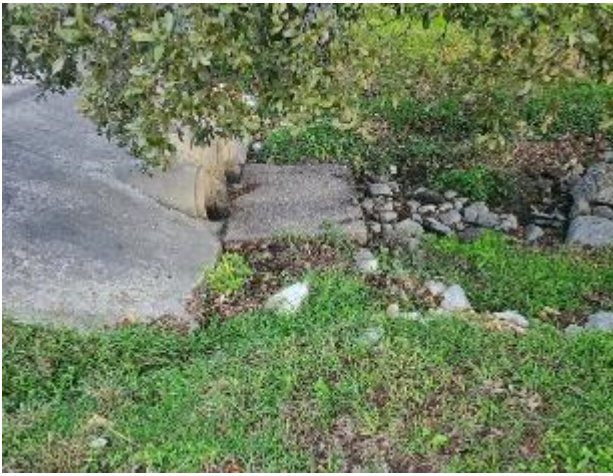
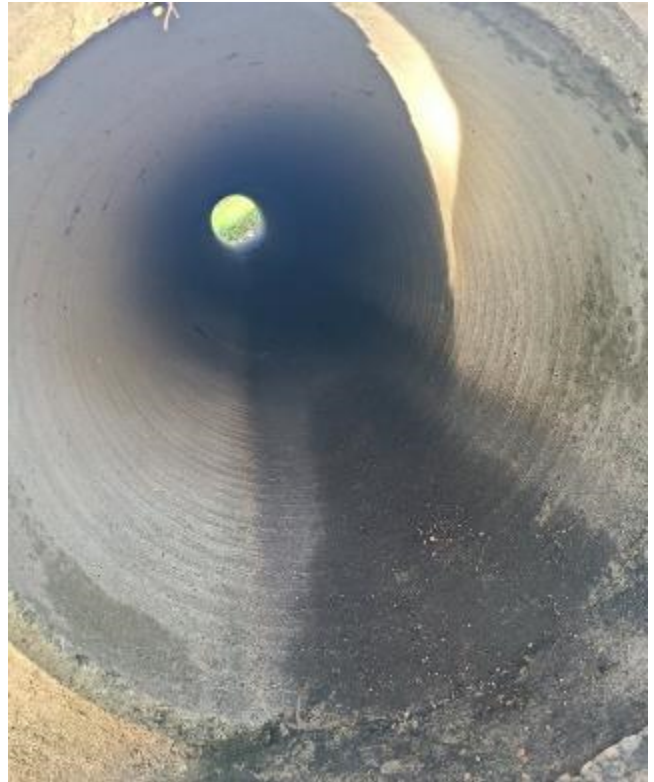
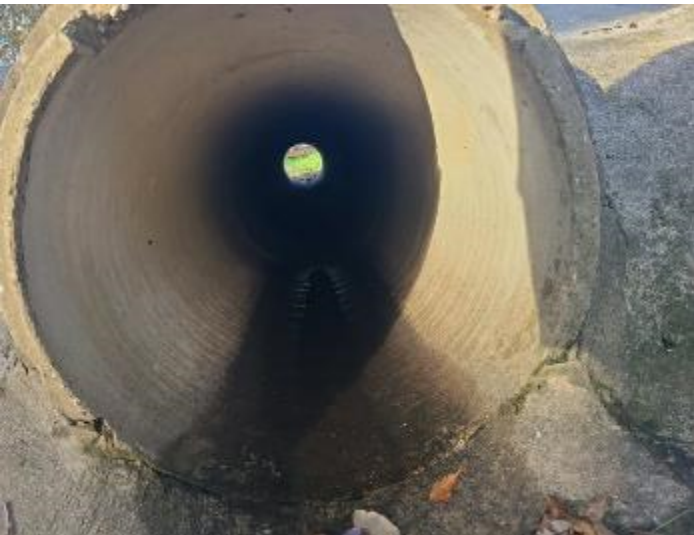
## North Oak Private Crossing West

Field Notes: Pipes are in good condition.

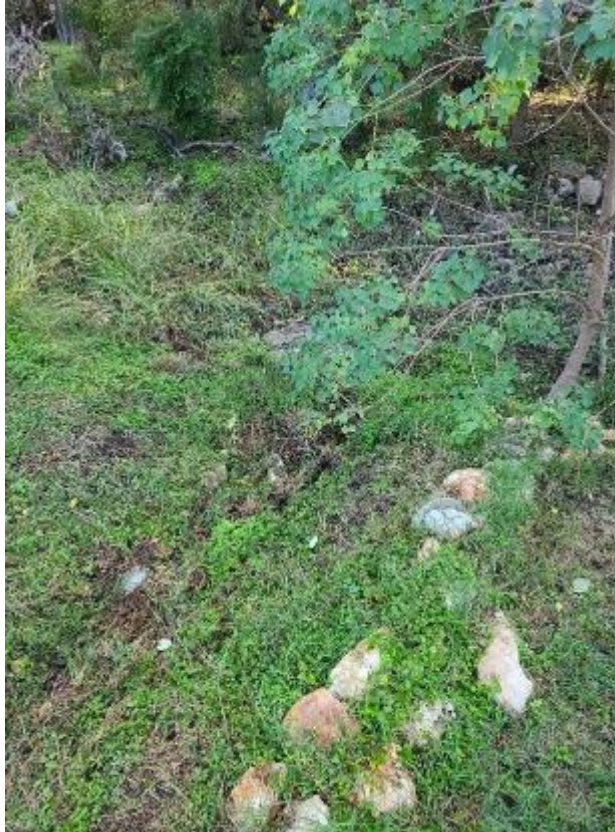
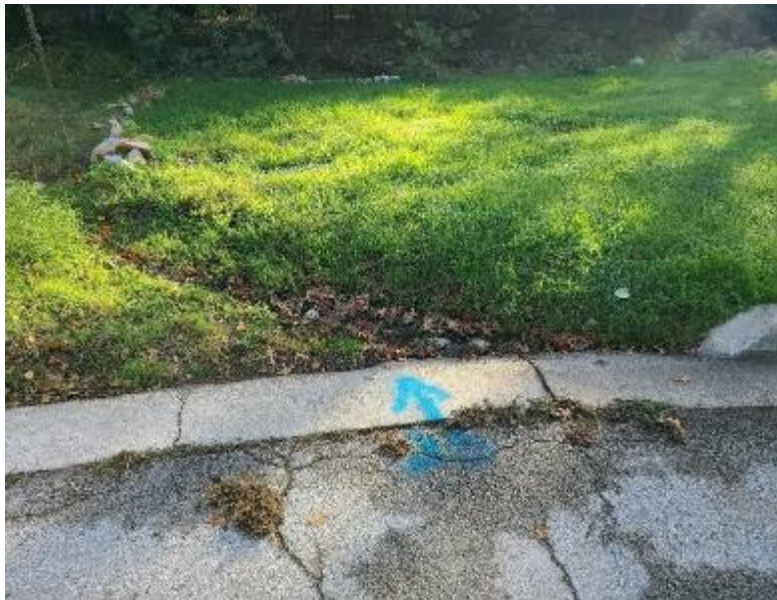
Field Notes: Trash and litter in outfall. Broken concrete pipe also disposed in outfall.

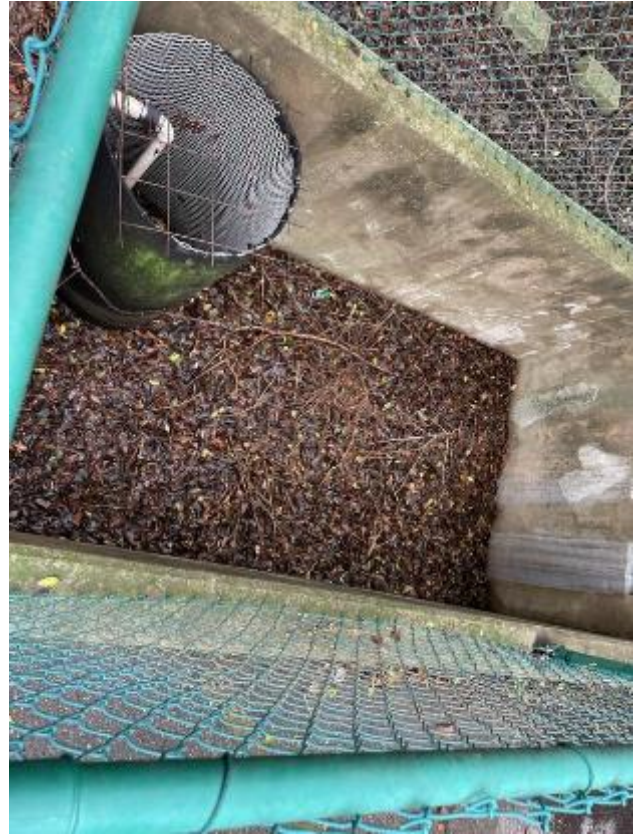
Field Notes: Clean out inside of basin and debris blocking inlet.

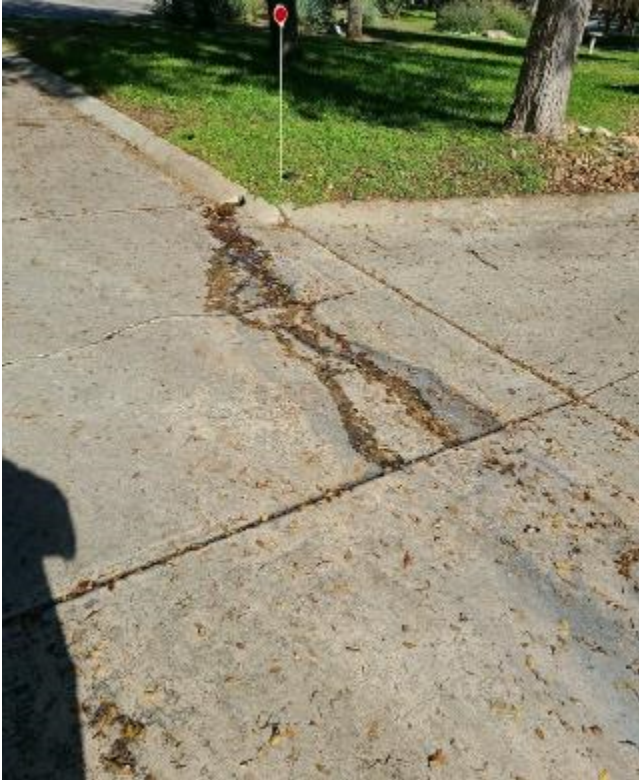
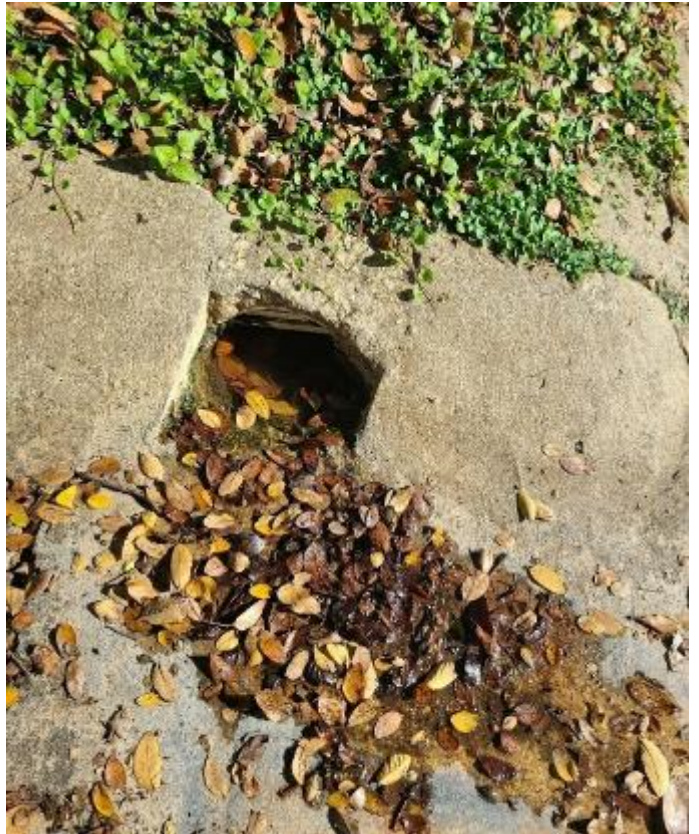
Field Notes: Residential drainpipe draining contaminants directly into outfall and into creek. Needs to be corrected.

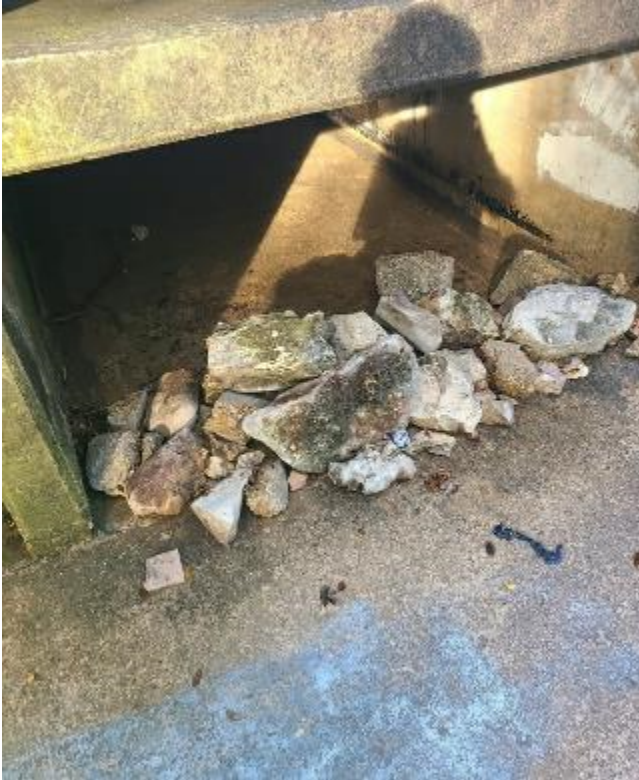
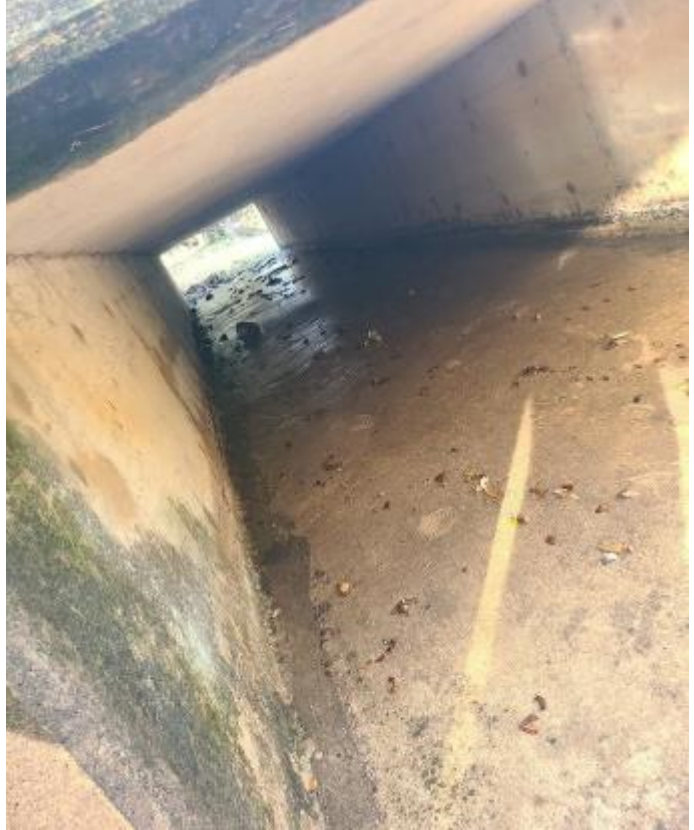
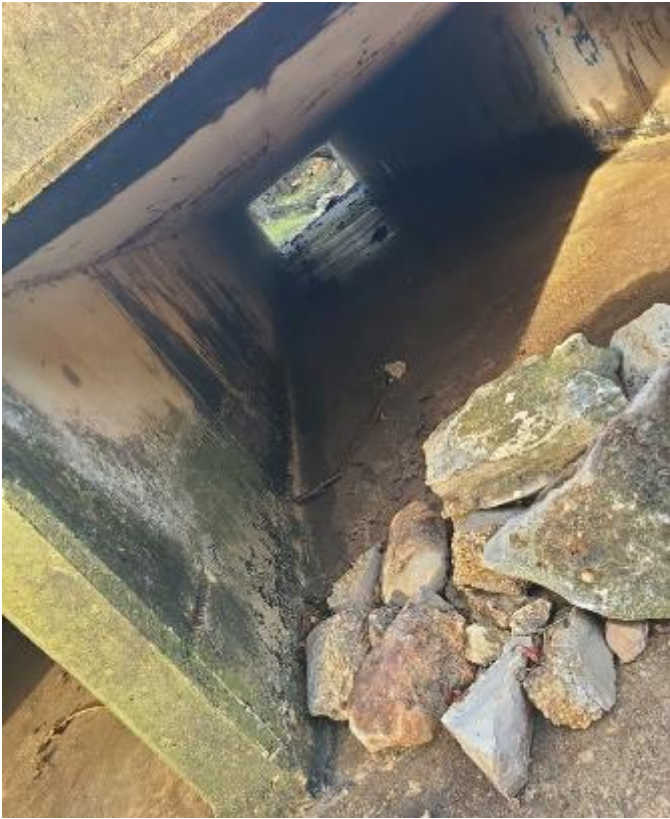
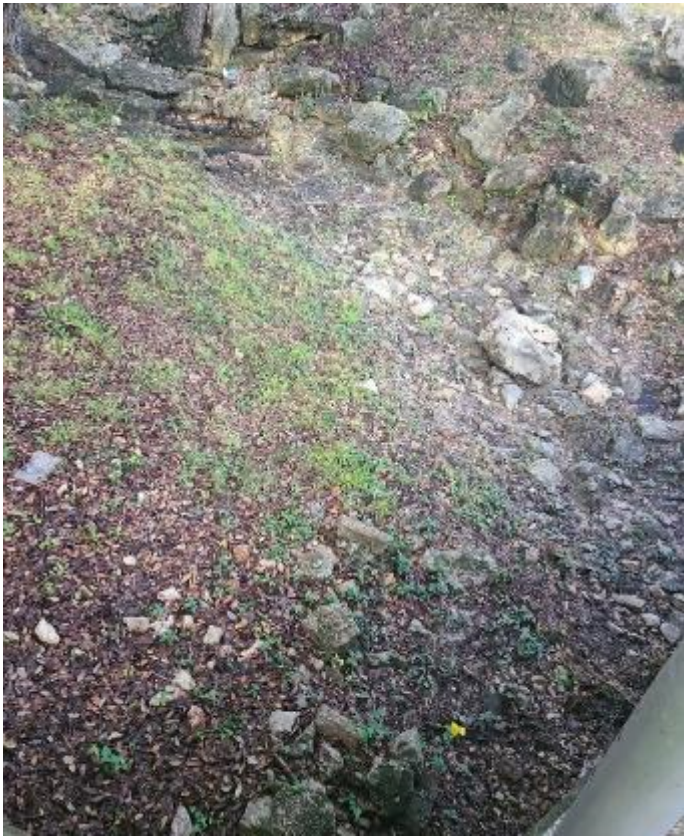
Field Notes: Pipes in good condition. Move pile of rocks in pipe to provide full flow. Remove litter around area.

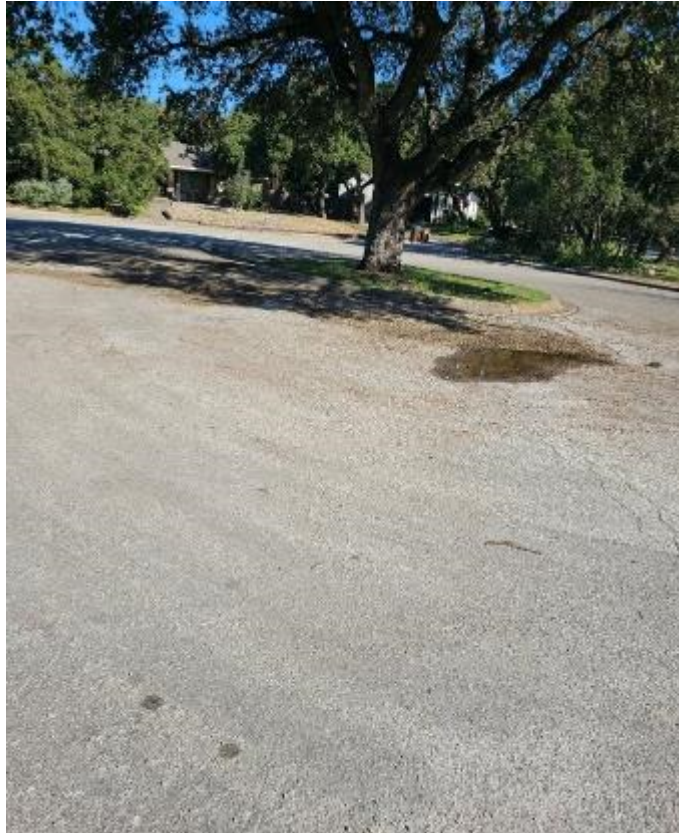
## Sagecrest Crossing West

Field Notes: Continue monitoring sediment to make sure it doesn't get into the nearby channel outfall.

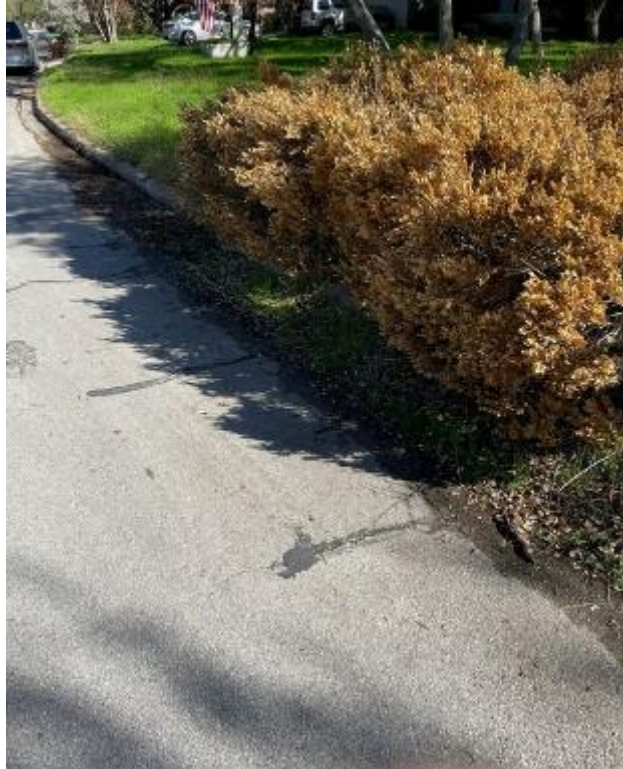
## Sediment Buildup Tiger Trail & Will Classen

Field Notes: Remove sediment.

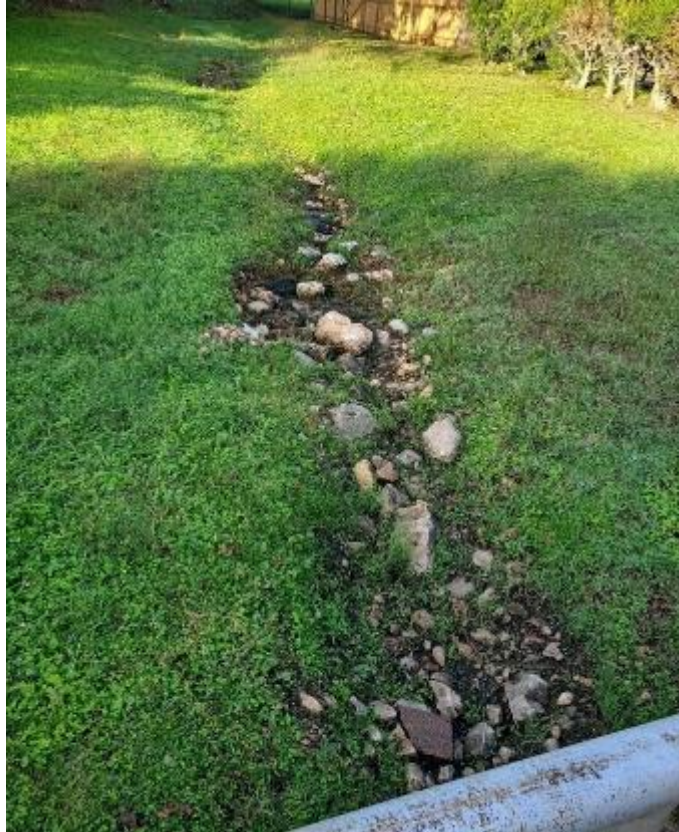
## Spillway Structure

Field Notes: Recent rainfall event. Remove sediment from channel and pipes.

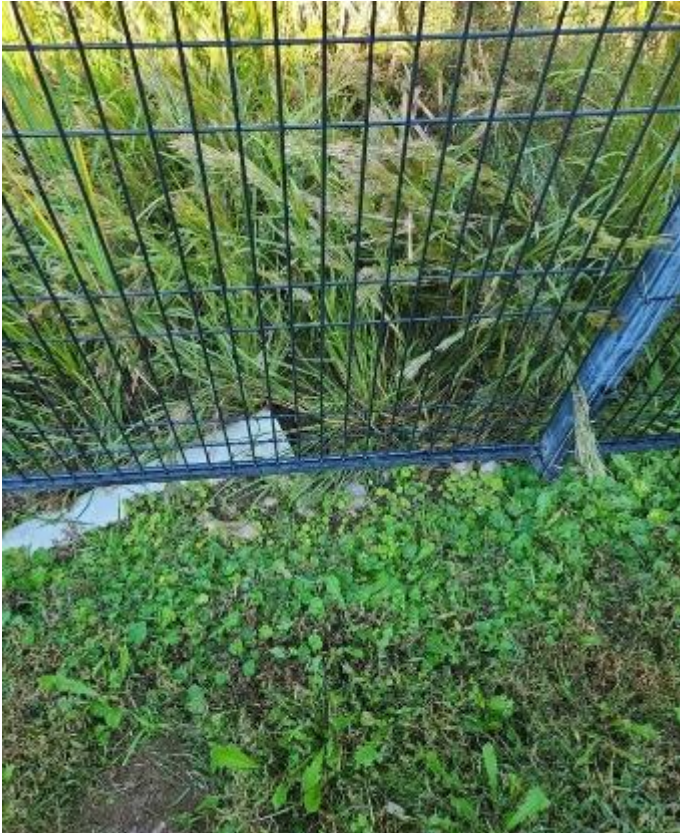
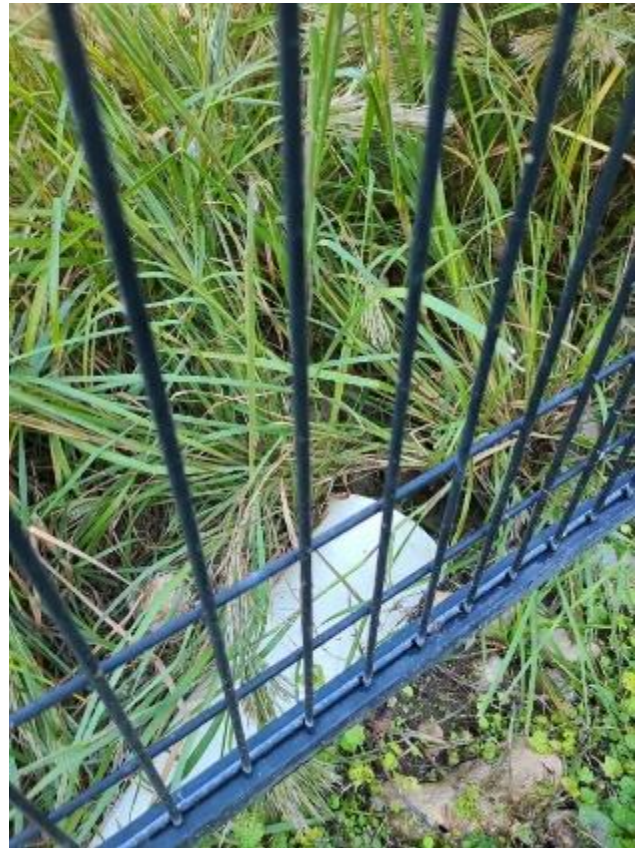
## Voigt Park Outfall Pipe

Field Notes: Trim vegetation directly outside of pipe.

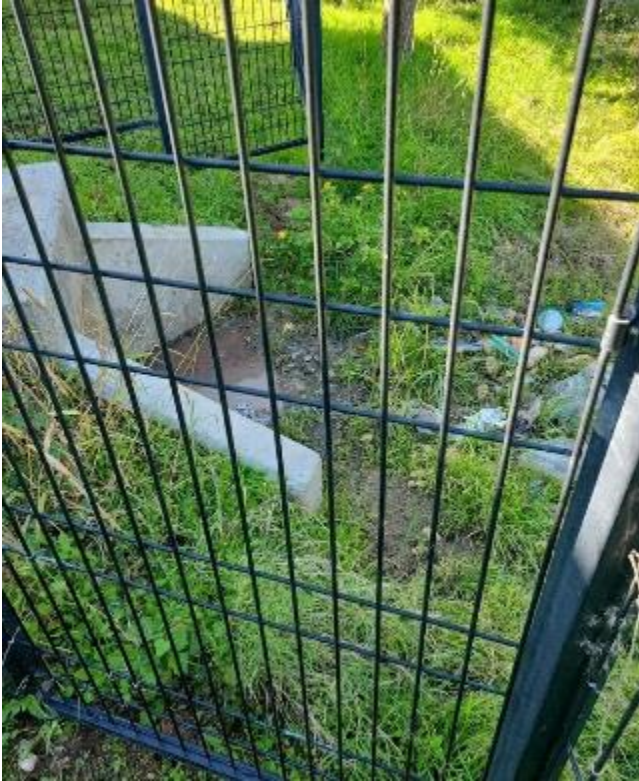
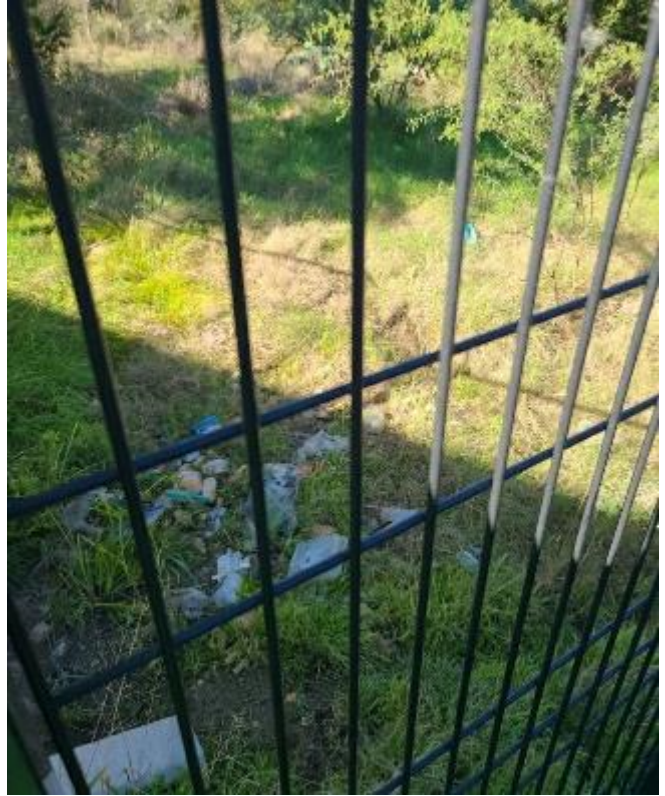
## Voigt Park Outfall

Field Notes: Pipe in good condition. Lots of trash in/directly outside of outfall of pipe. Please remove trash.
