# TOWN OF HOLLYWOOD PARK, TX

2024 Summer Inspection

## HOLLYWOOD PARK 2024 SUMMER INSPECTION REPORT

**Subject:** Annual Municipal Separate Storm Sewer System (MS4) Inspection

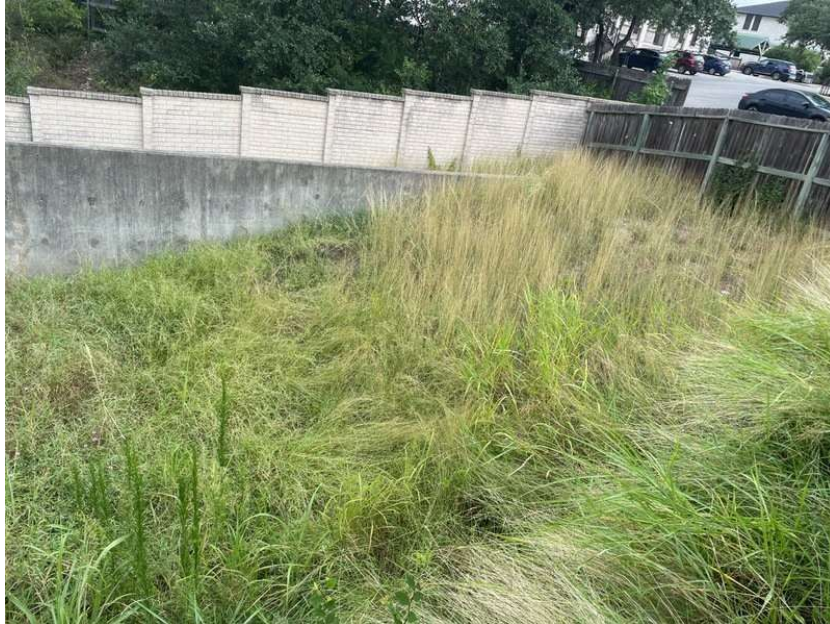
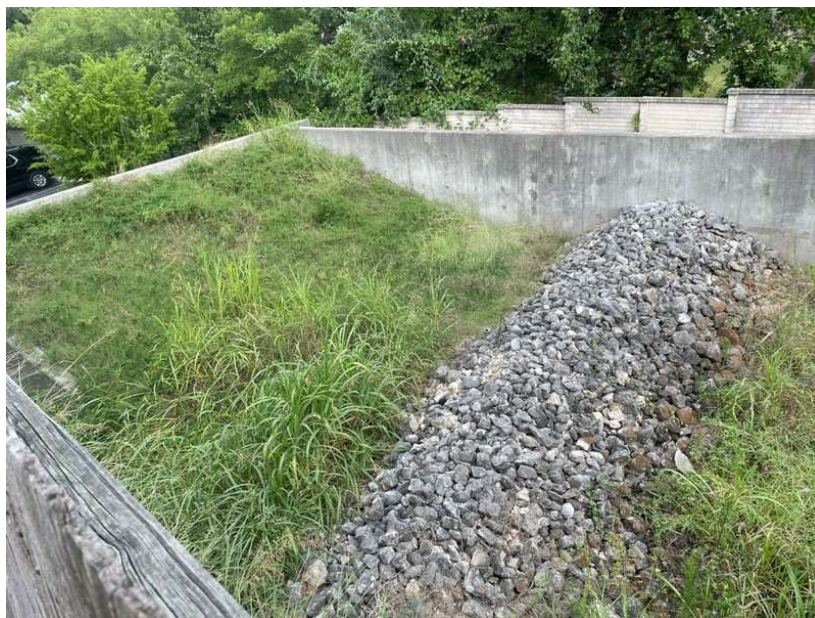
Field Notes: Mow vegetation, repair fence, monitor sediment buildup.

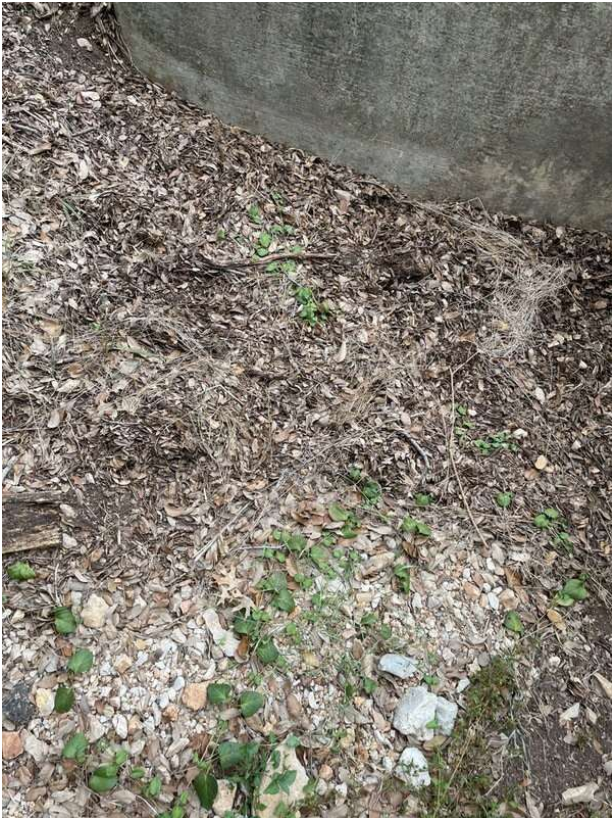
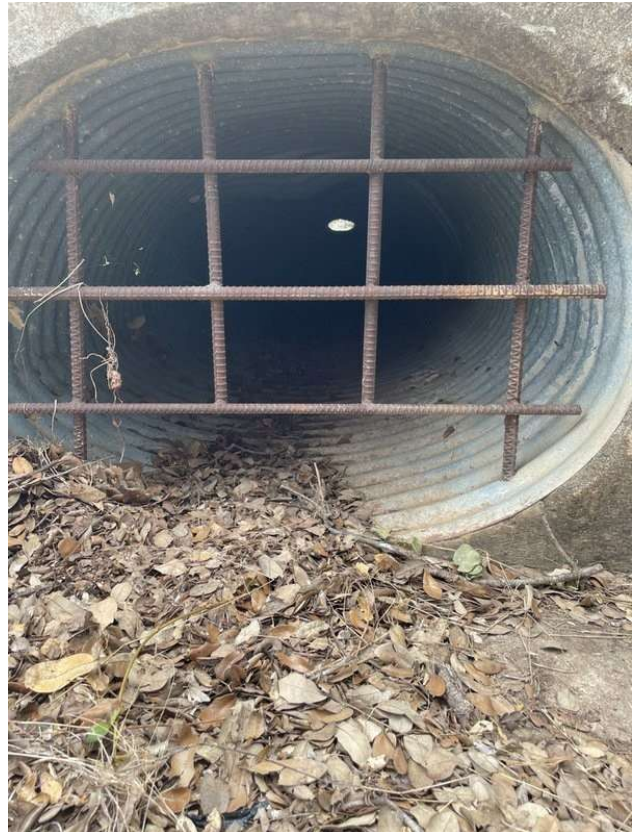
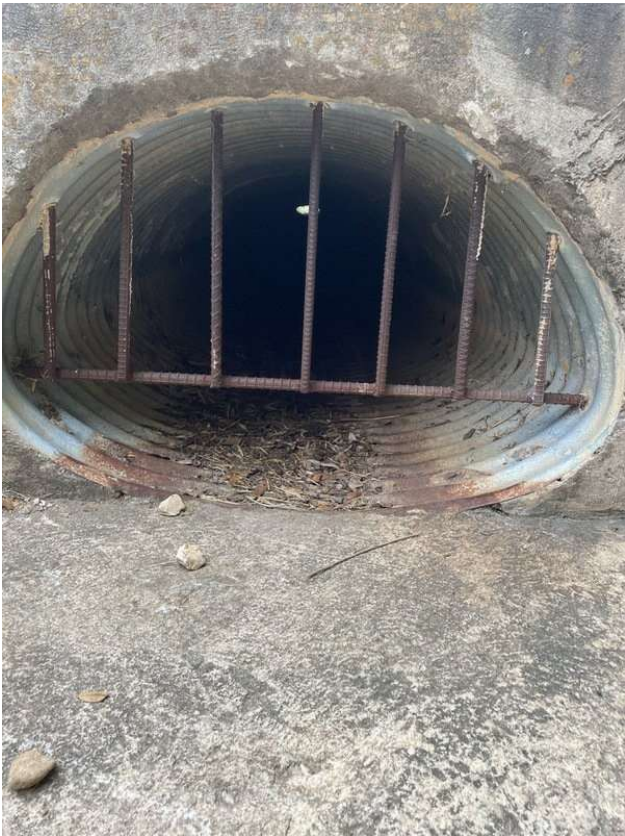
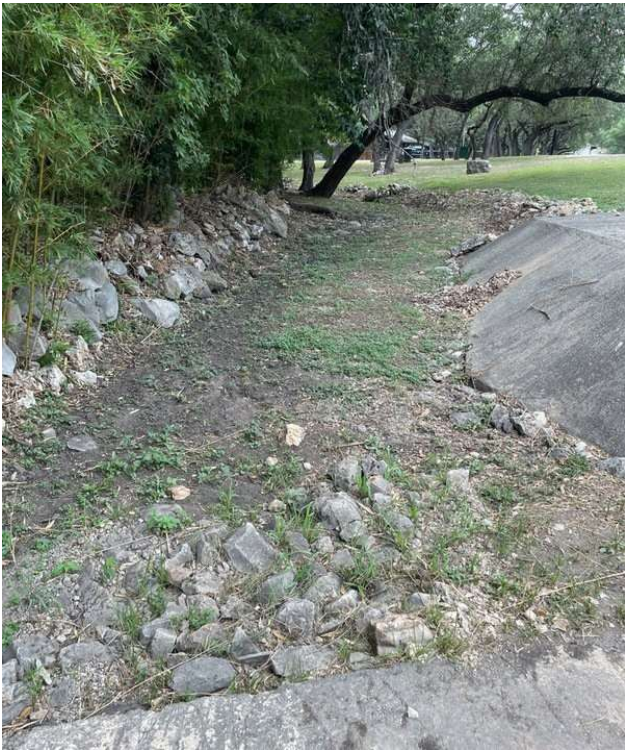
Field Notes: Remove upstream leaves, monitor CMP structure, may need replacement.

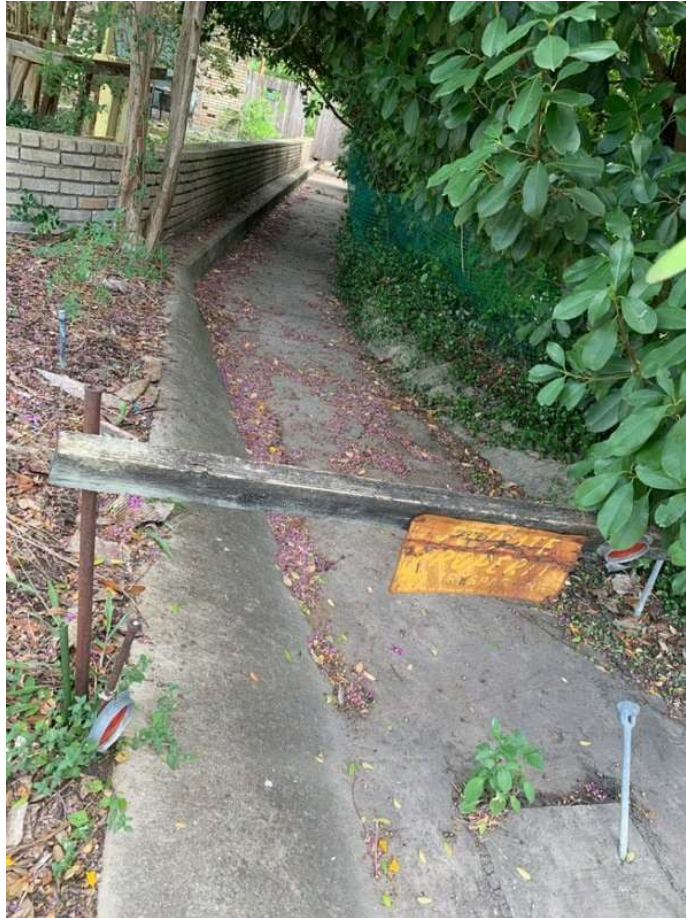
Field Notes: Clear sediment and vegetation at channel inlet.

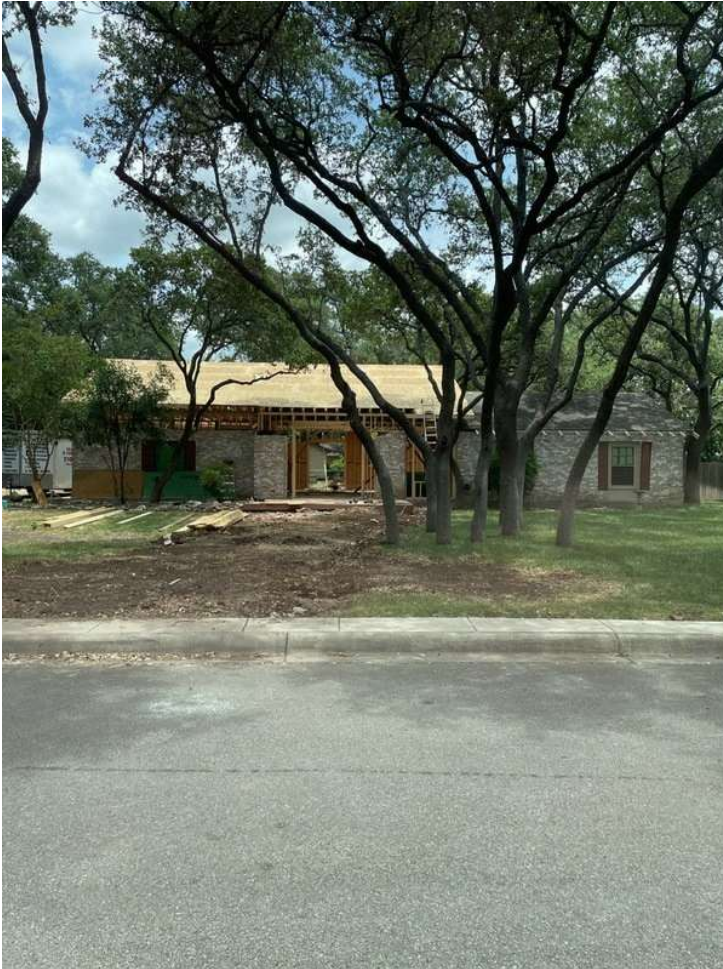
Field Notes: Looks good, currently no SWPPP appear to be in place.

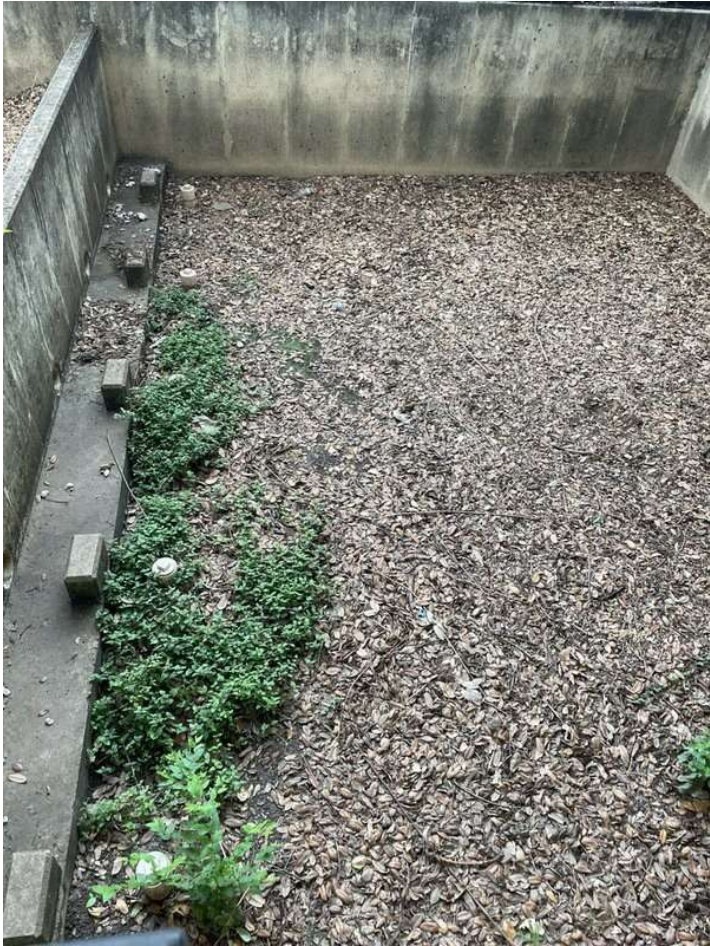
Field Notes: Remove leaves and trash in PCD.

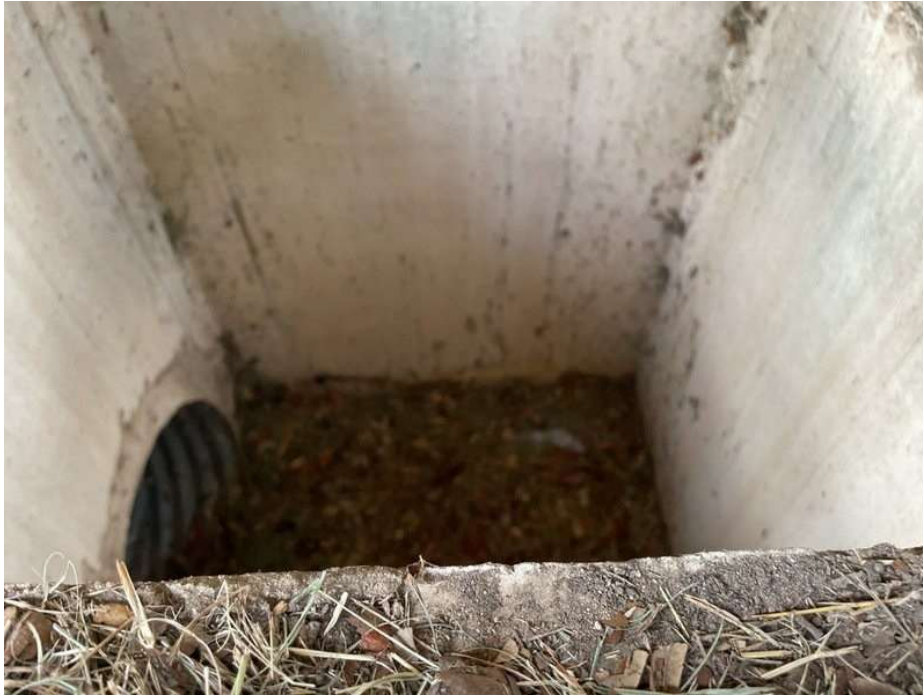
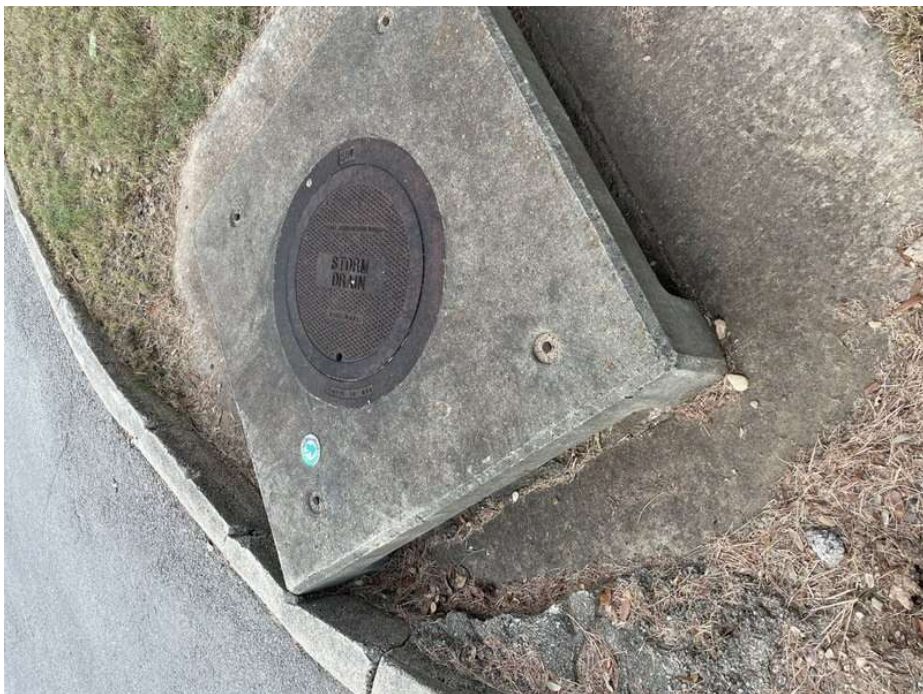
### MEC-I-1(M)

Field Notes: Looks good minor debris.

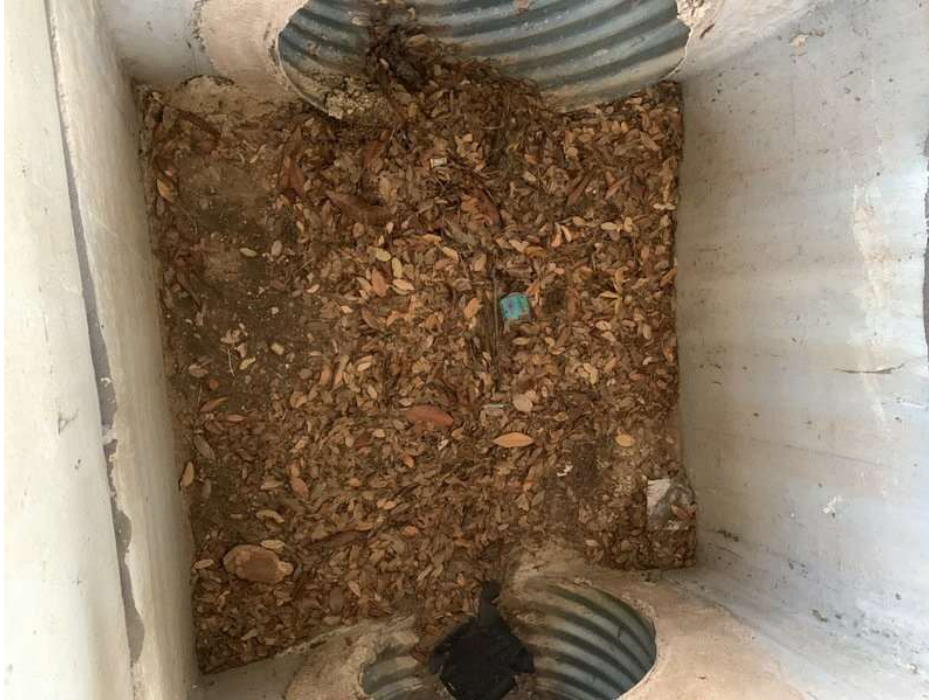
### MEC-I-2(M)

Field Notes: Clean leaves and debris.

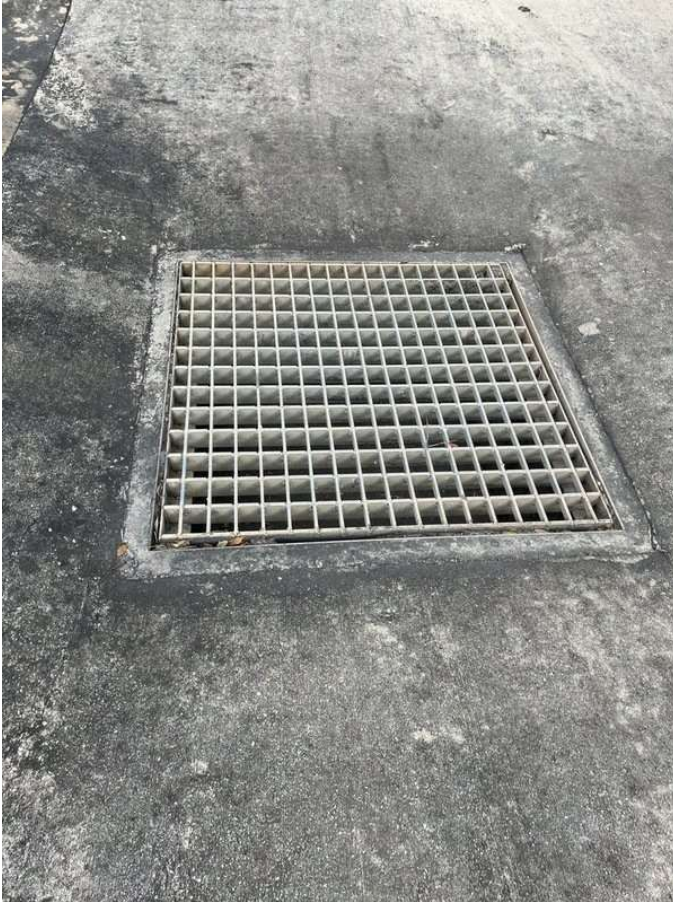
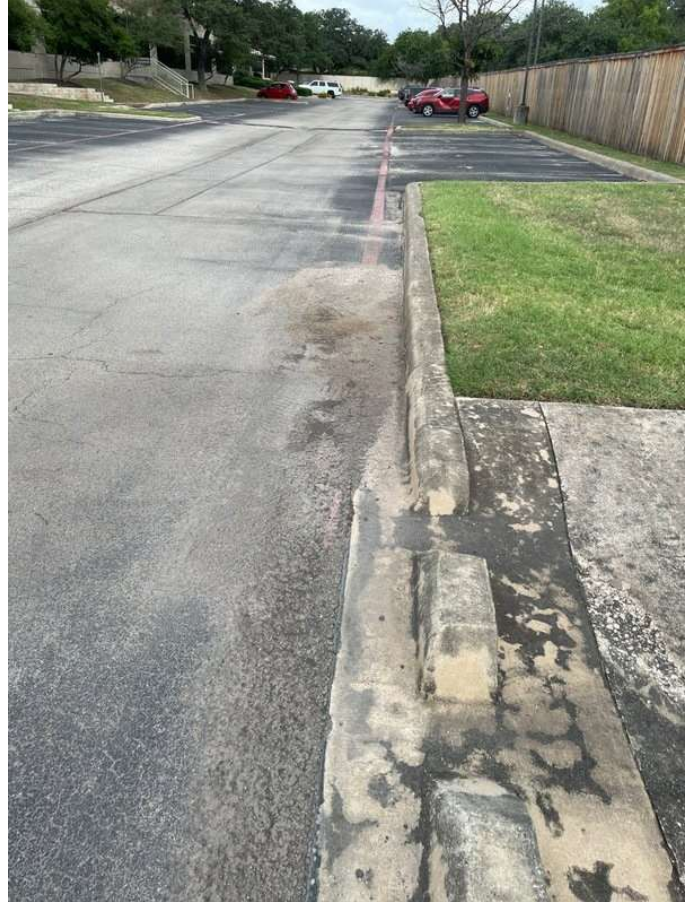
## Miner Fleet Parking Lot Inlet

Field Notes: Looks good. Monitor sediment buildup.

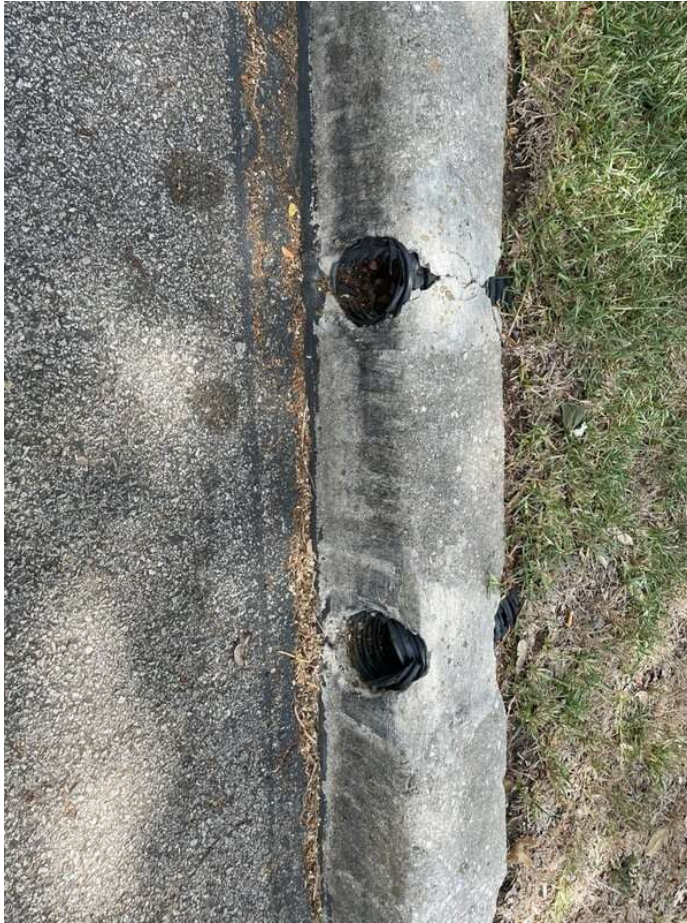
## Navato Residential Drains

Field Notes: Monitor spalling.

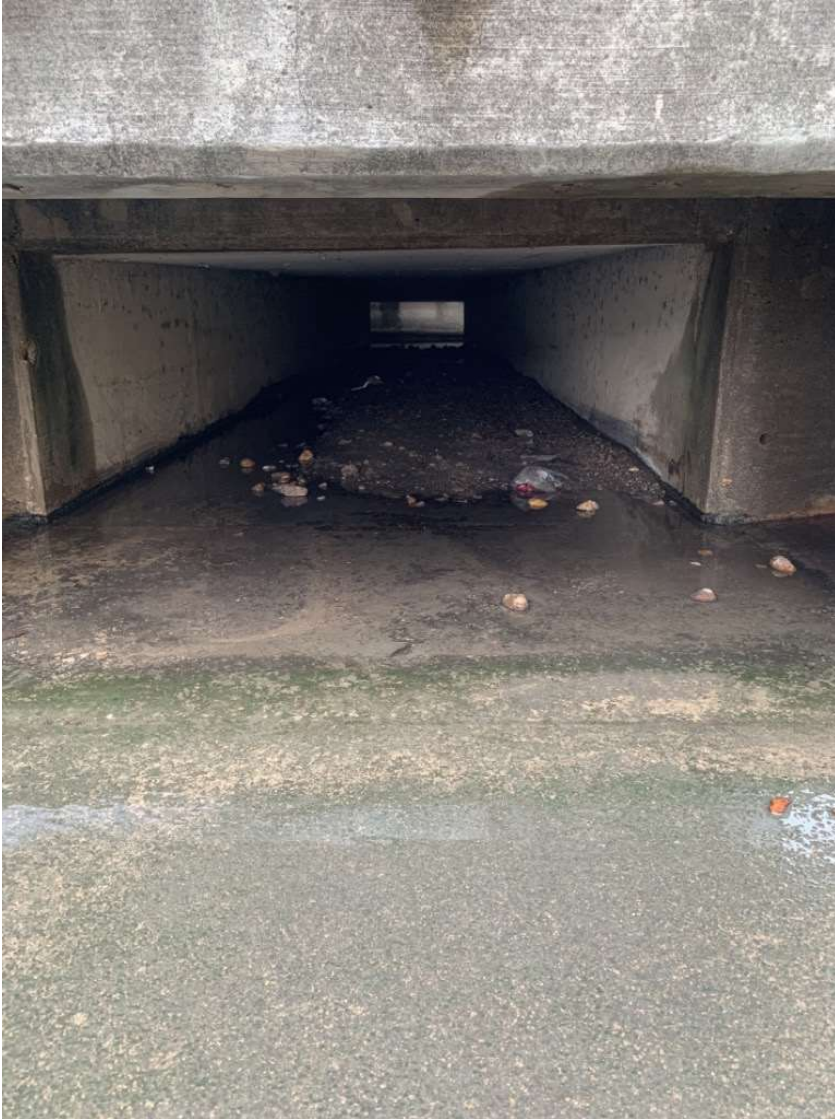
## Oak Creek Circle Storm Sewer Pipe

Field Notes: Remove sediment from middle of pipe.

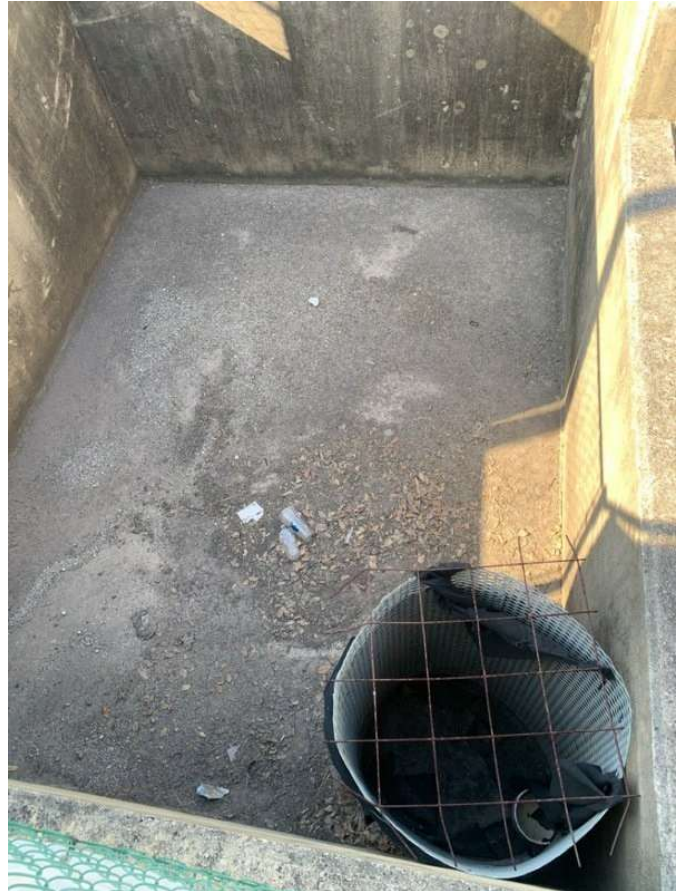
### Pediatric Dentistry Office PCD

Field Notes: Clean trash and sediment and mow vegetation.

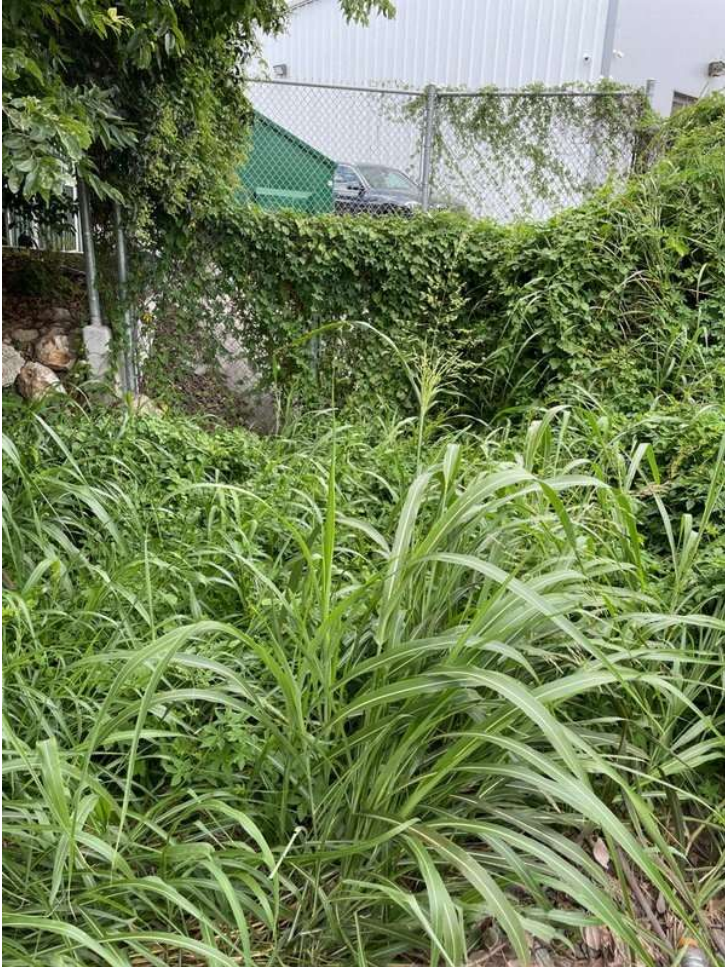
## Permeable Pavers

Field Notes: Mow vegetation, remove trash, sediment, and debris.

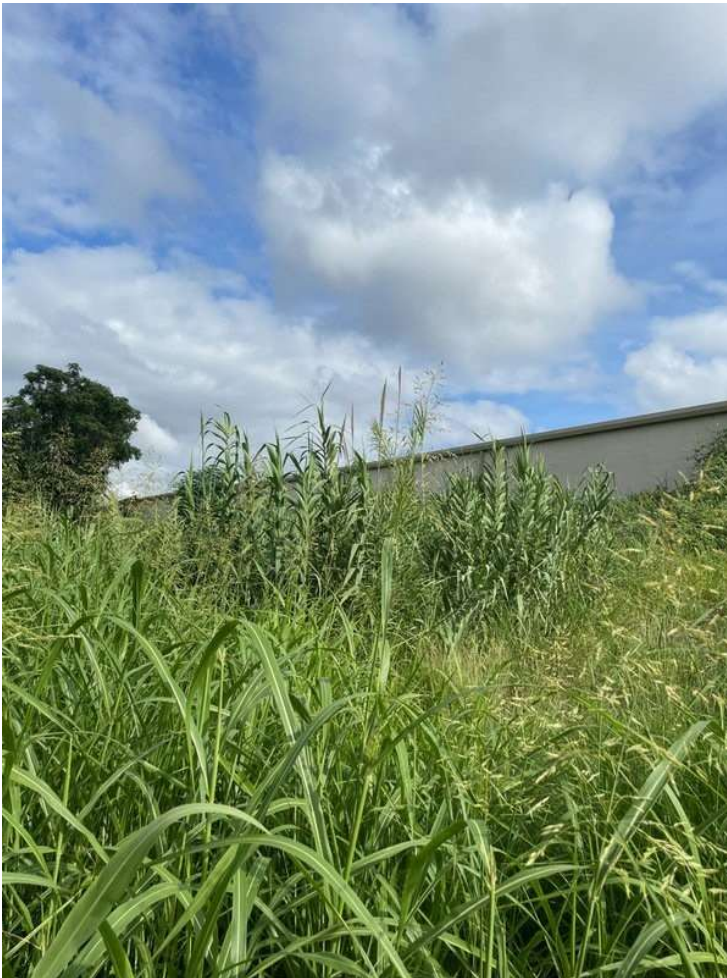
Field Notes: Vegetation overgrown needs mowing.

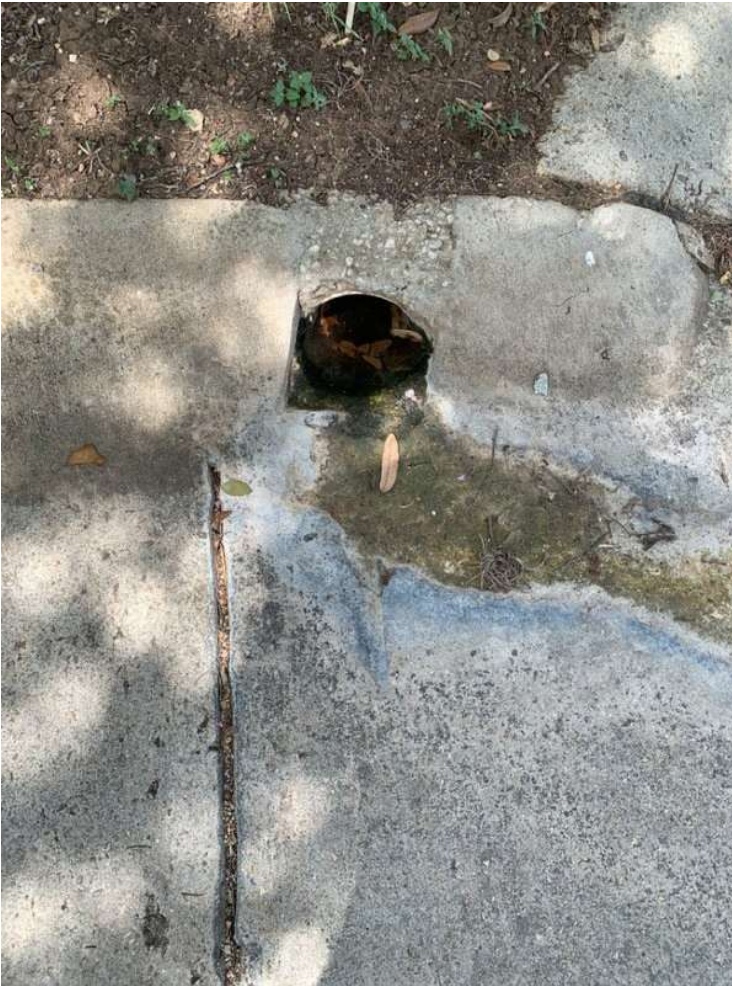
## Residential Drain Pipe

Field Notes: Pipe appears to backflow. Monitor to ensure it is not affecting MS4 system.

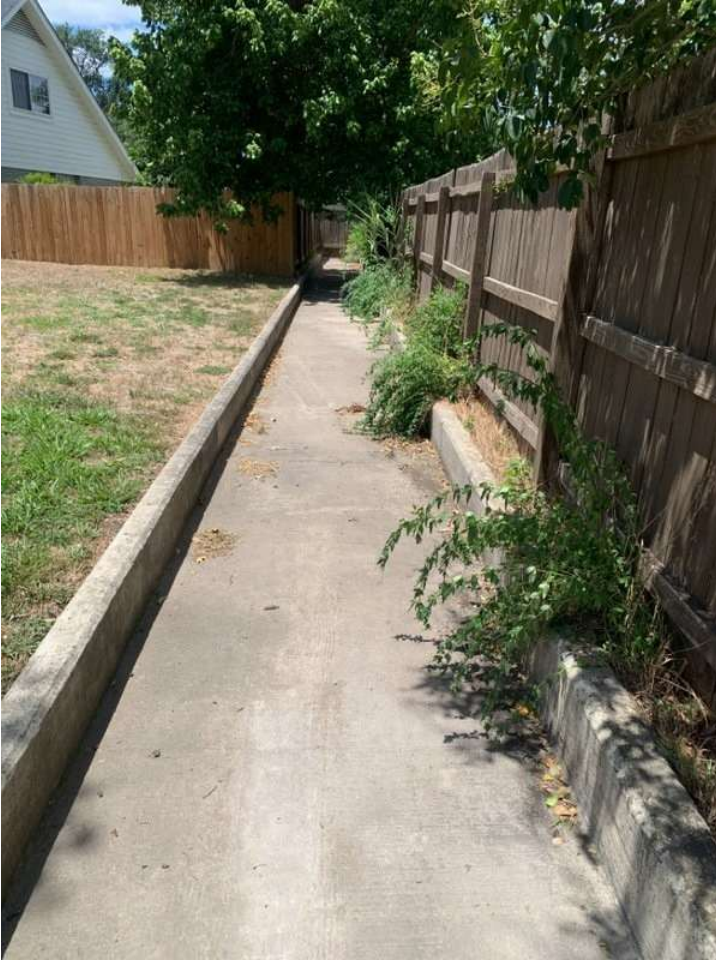
Field Notes: Trim vegetation by fence next to outfall.

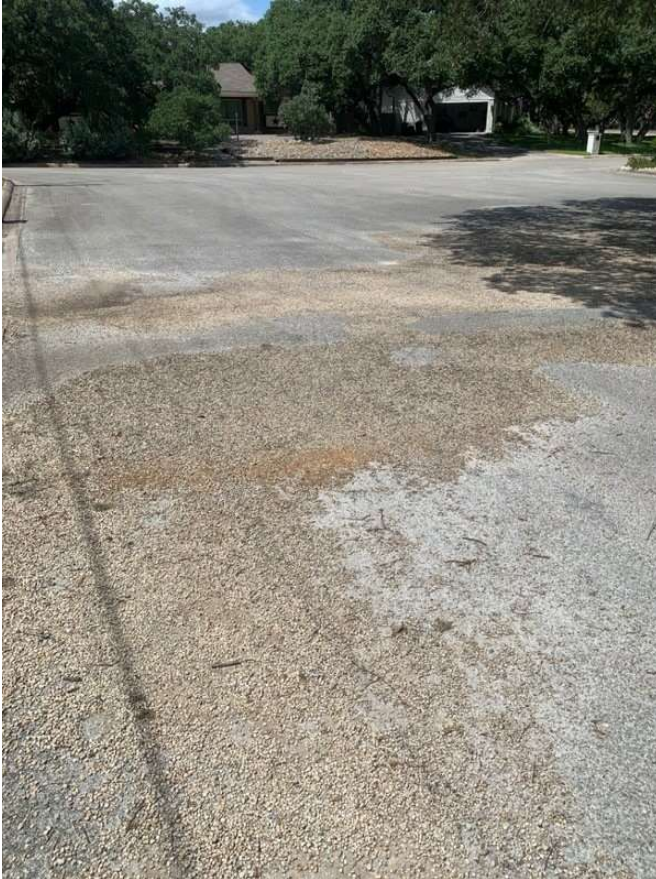
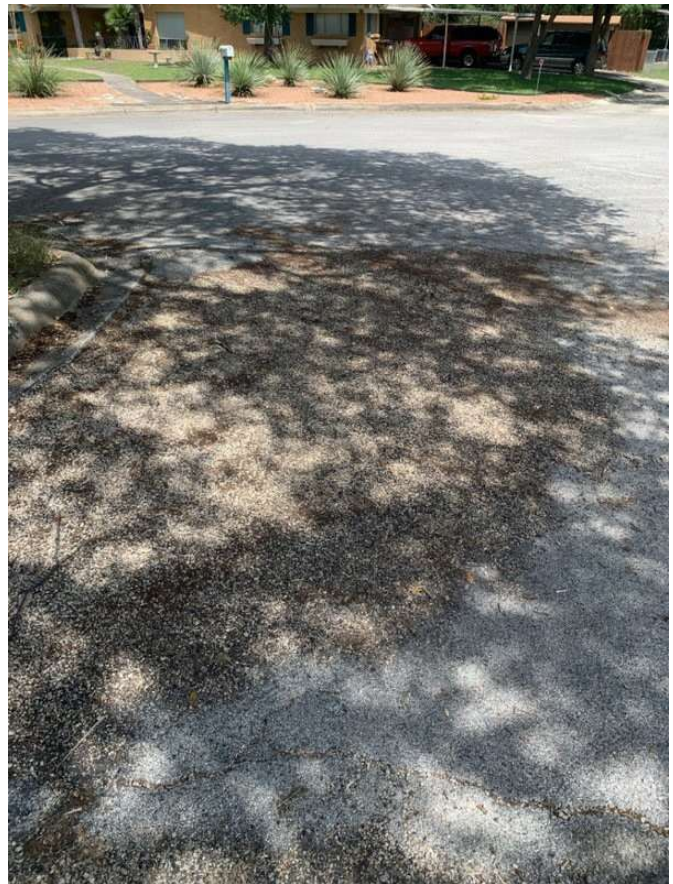
## Sagecrest Crossing East

Field Notes: Monitor loose sediment to make sure it does not affect nearby outfall.

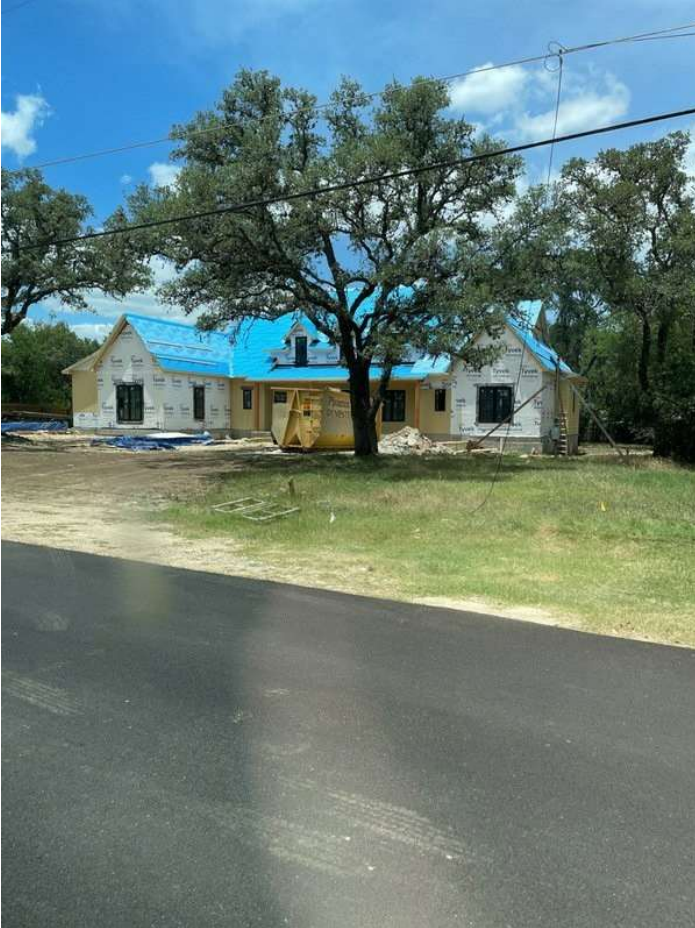
## Sequoia Dr Home Construction

Field Notes: Monitor for runoff.

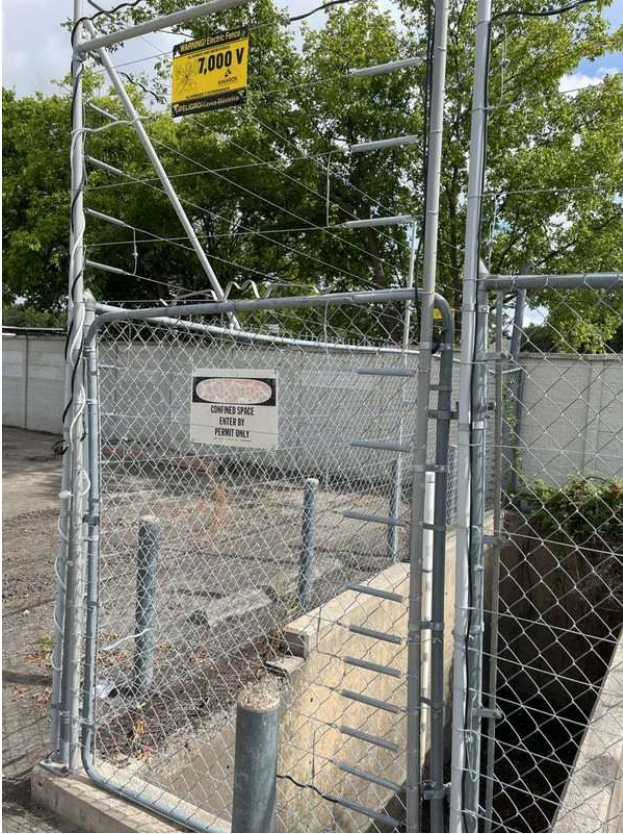
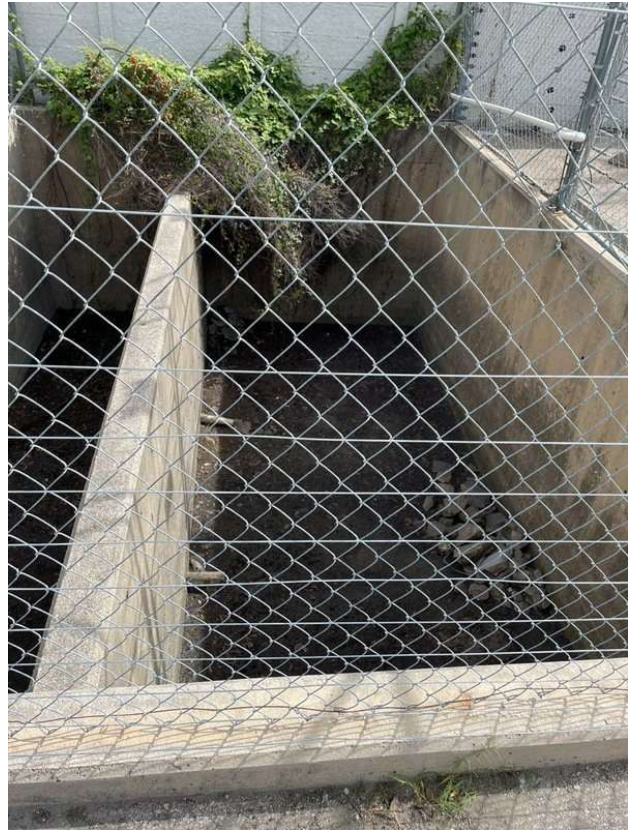
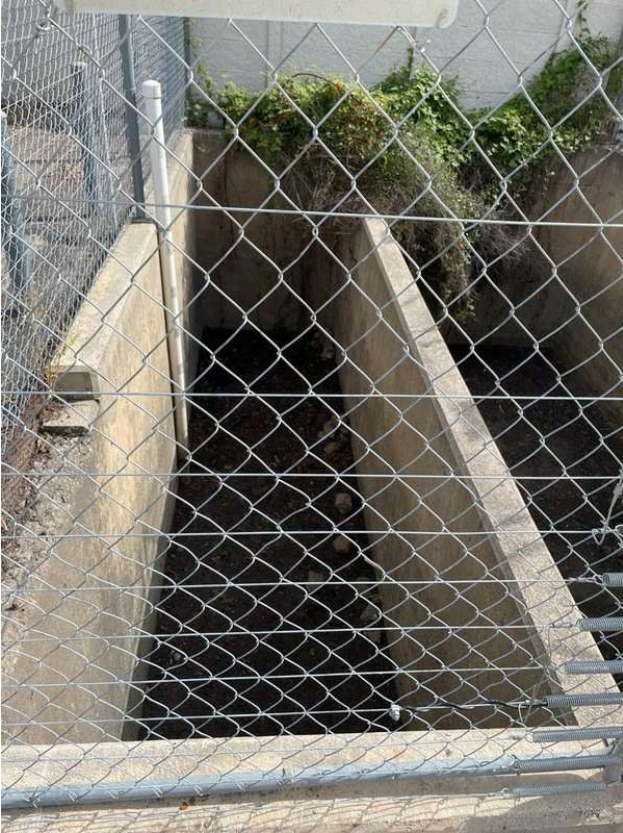
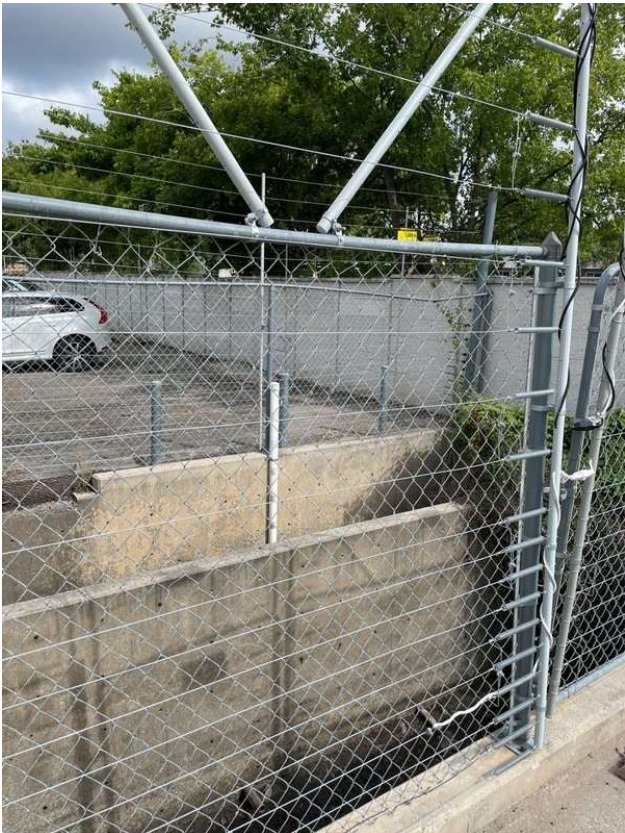
## Service King Collision Repair Extended Parking Lot PCD

Field Notes: Trim vegetation. Electric fence put up, verify with city/TCEQ on regulations.

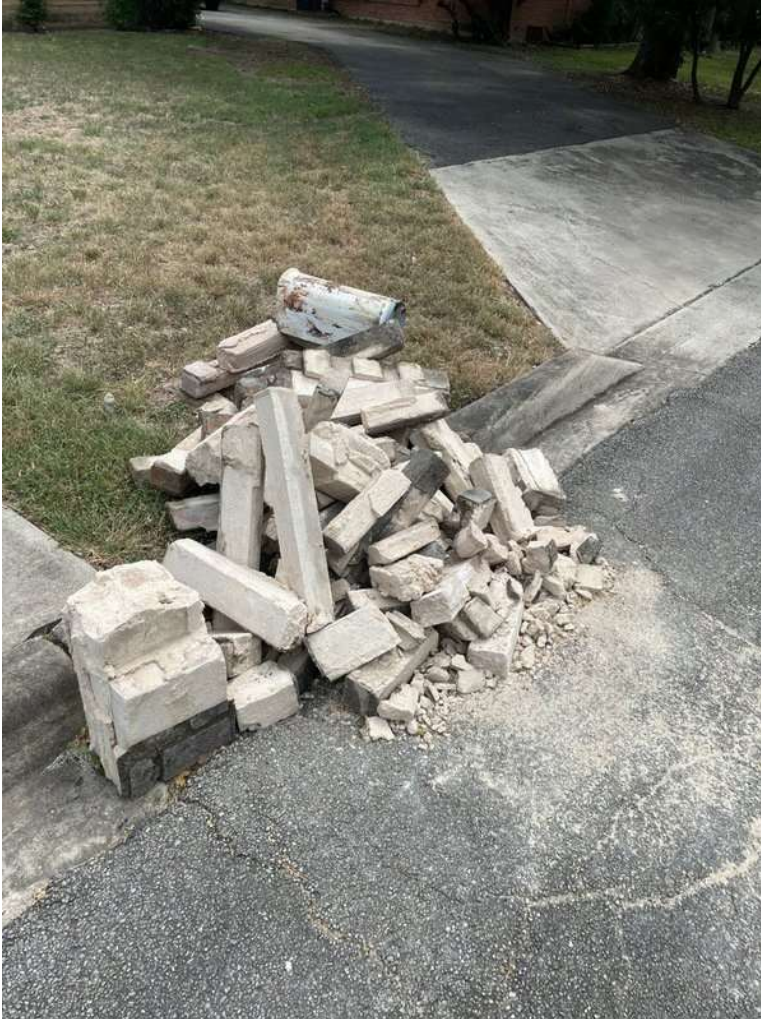
## Sky Forest Residential Debris

Field Notes: Debris from demolished mailbox.

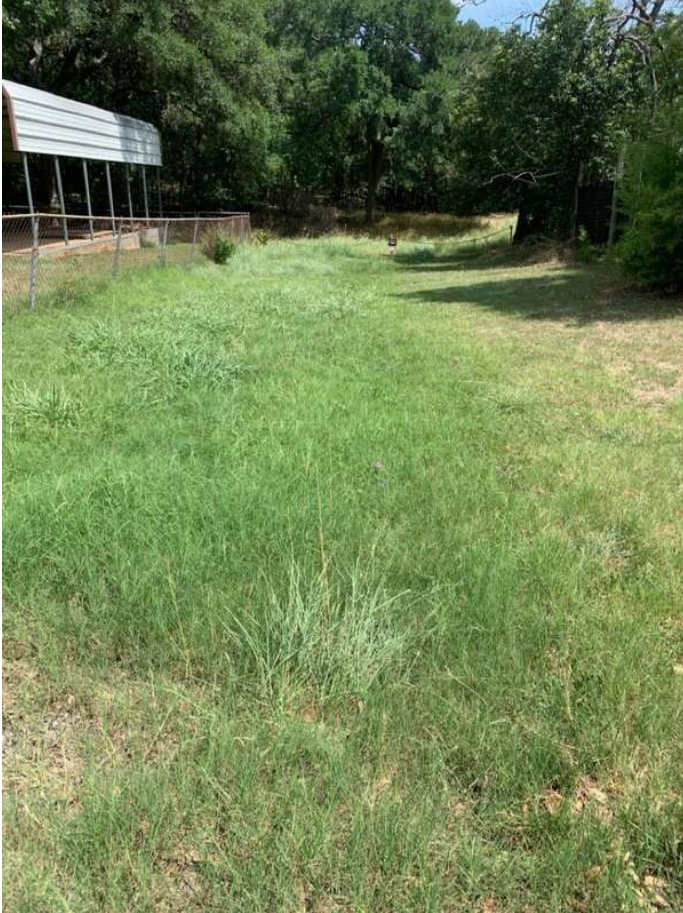
## Tall Oak Outfall

Field Notes: Vegetation needs mowing. Otherwise looks good.

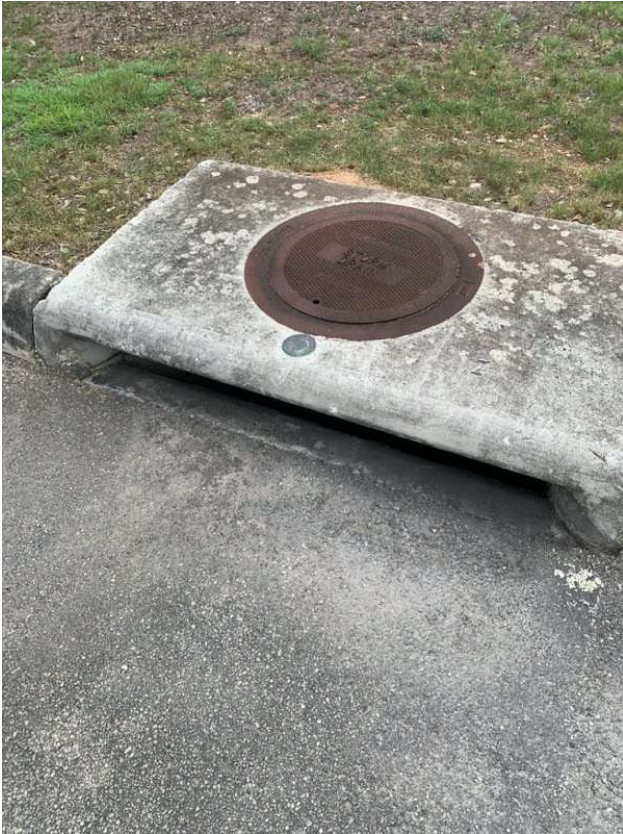
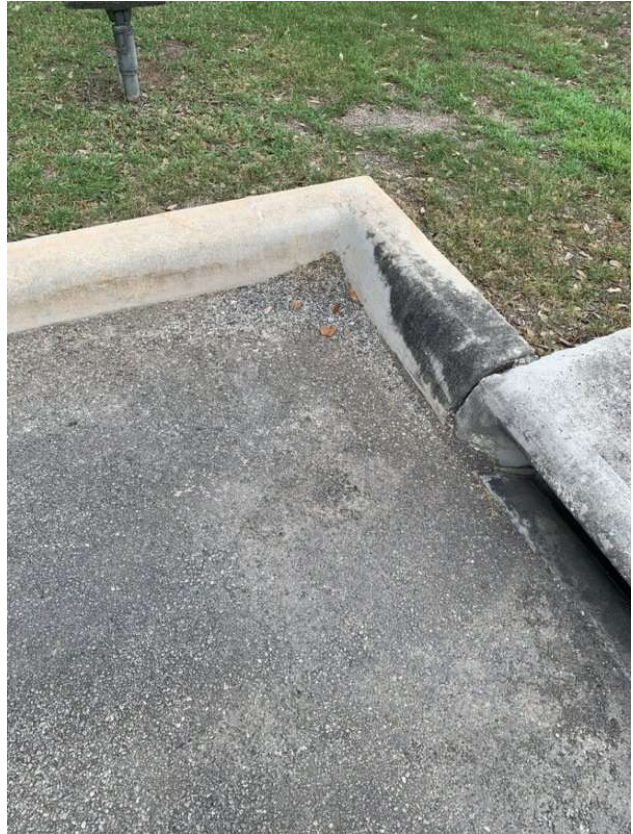
## Valvoline PCD

Field Notes: Sediment buildup on east side of inlet. Medallion may need replacement soon.

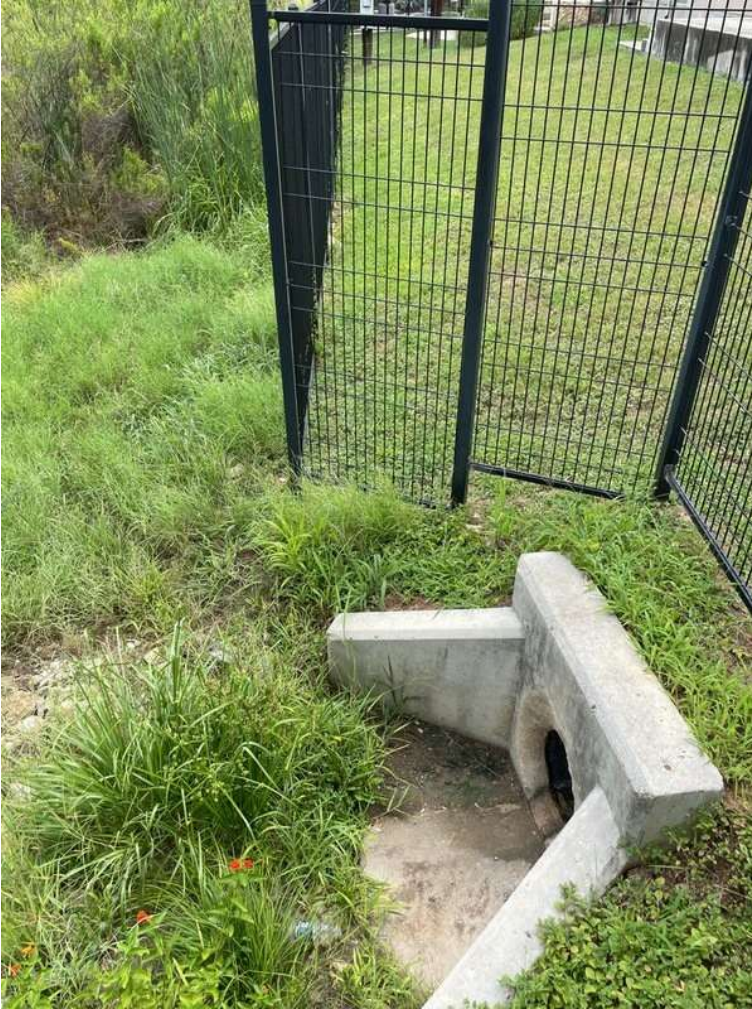
## Voigt Park Outfall

Field Notes: Trim vegetation, remove trash.

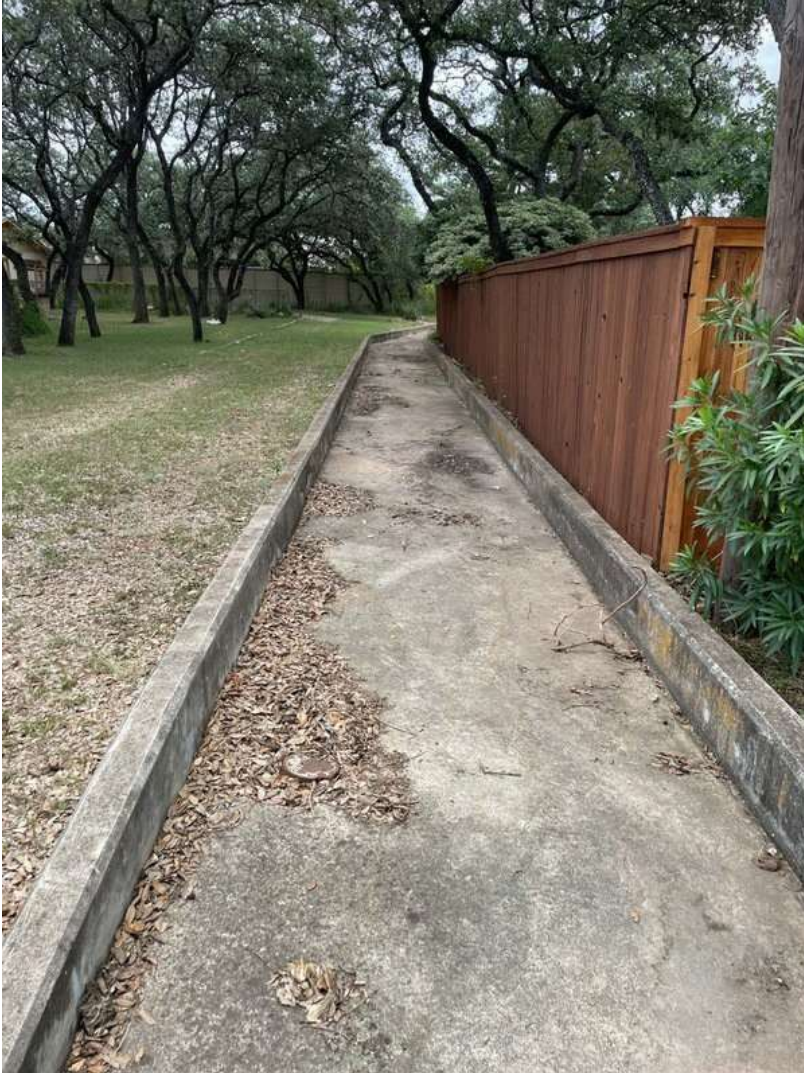
## Voigt Park Outfall Pipe

Field Notes: Clean out debris.

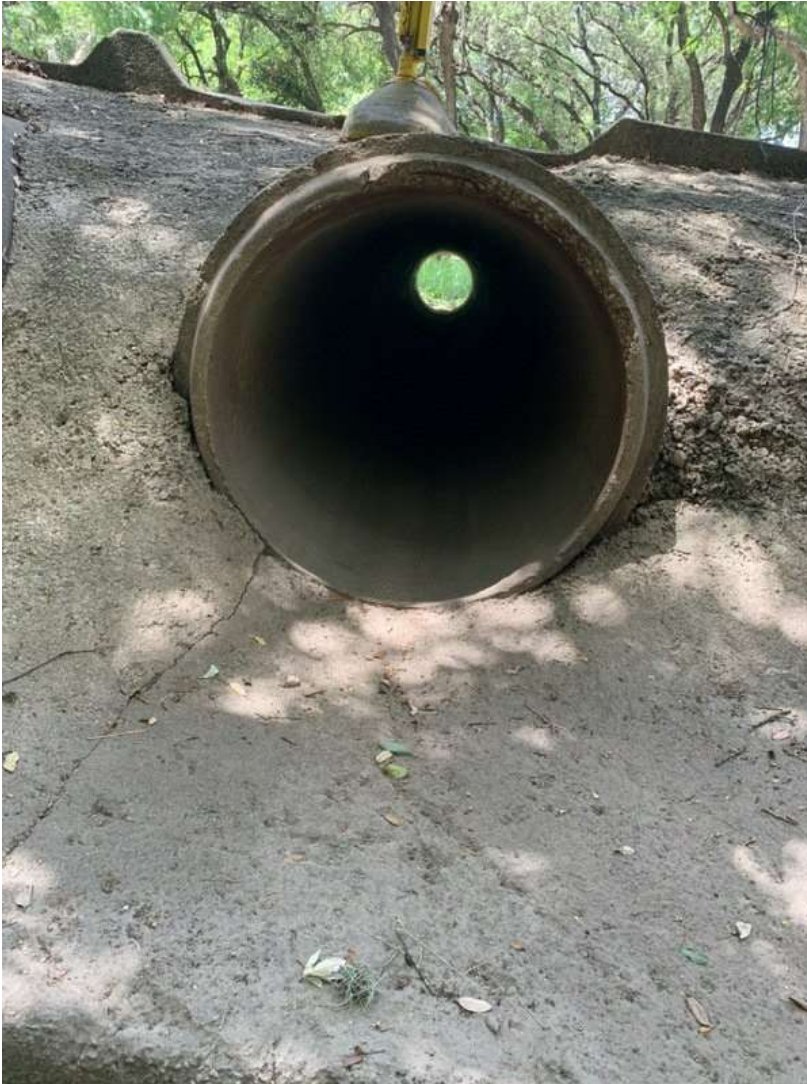
## Yosemite Crossing East

Field Notes: Trim vegetation and remove branches near north inlets.
