TOWN OF HOLLYWOOD PARK, TX

2025 Summer Inspection

HOLLYWOOD PARK 2025 SUMMER INSPECTION REPORT

Subject: Annual Municipal Separate Storm Sewer System (MS4) Inspection

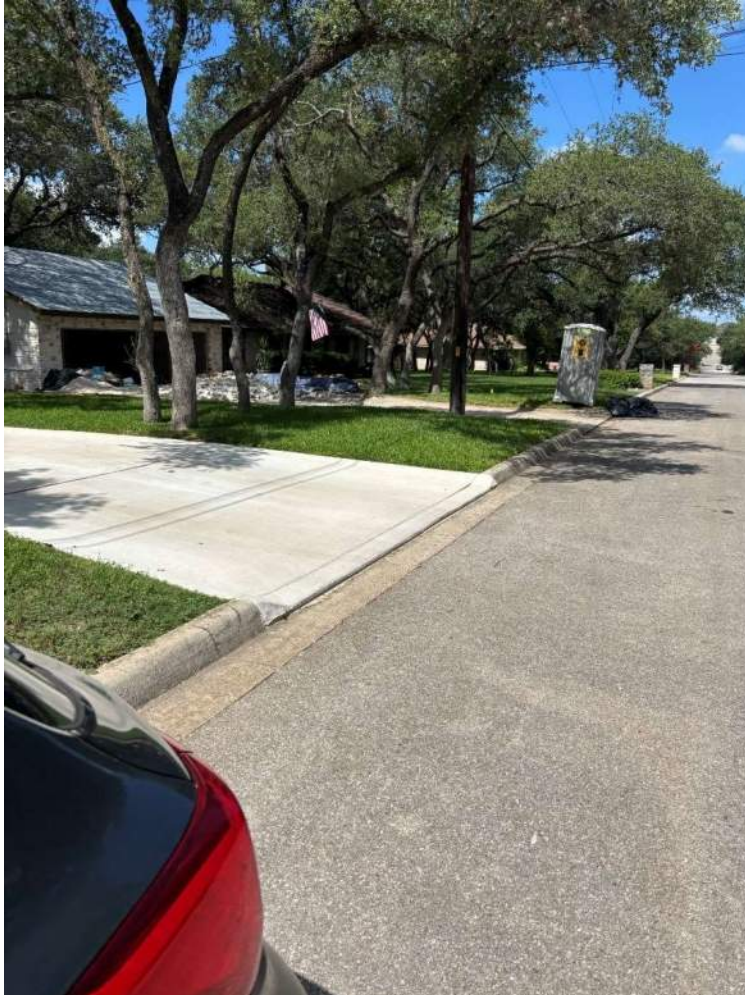
Active Home Build

Field Notes: Active home build. Monitor to ensure stormwater prevention measures are being followed and trash is not placed in the street.

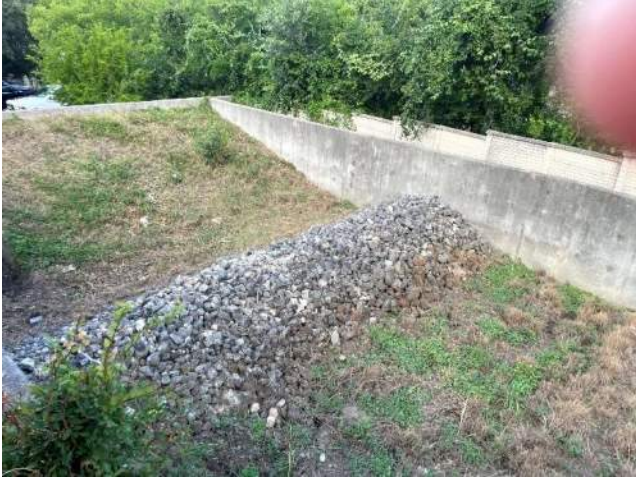
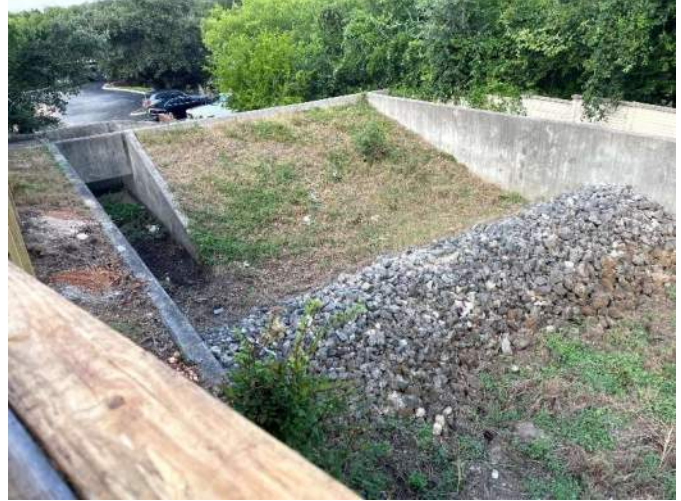
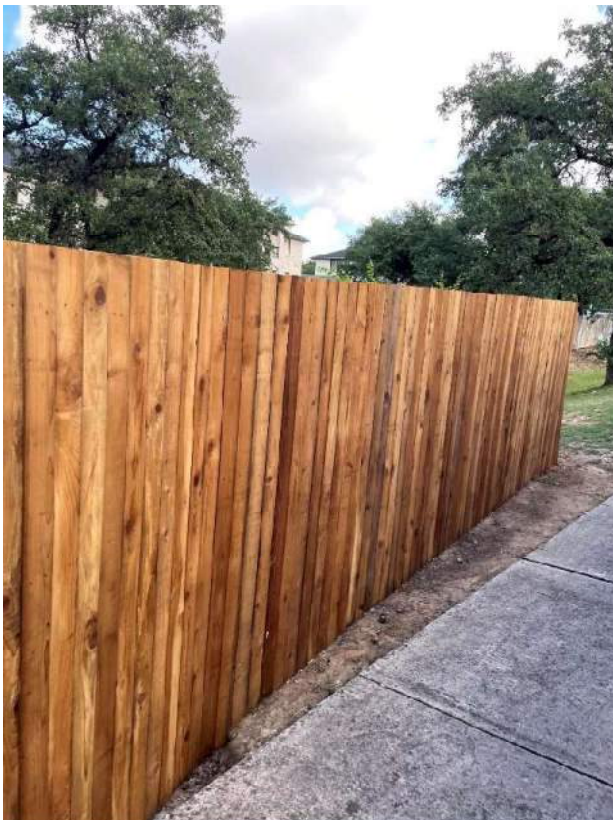
Field Notes: Looks good, fence has been repaired since last inspection.

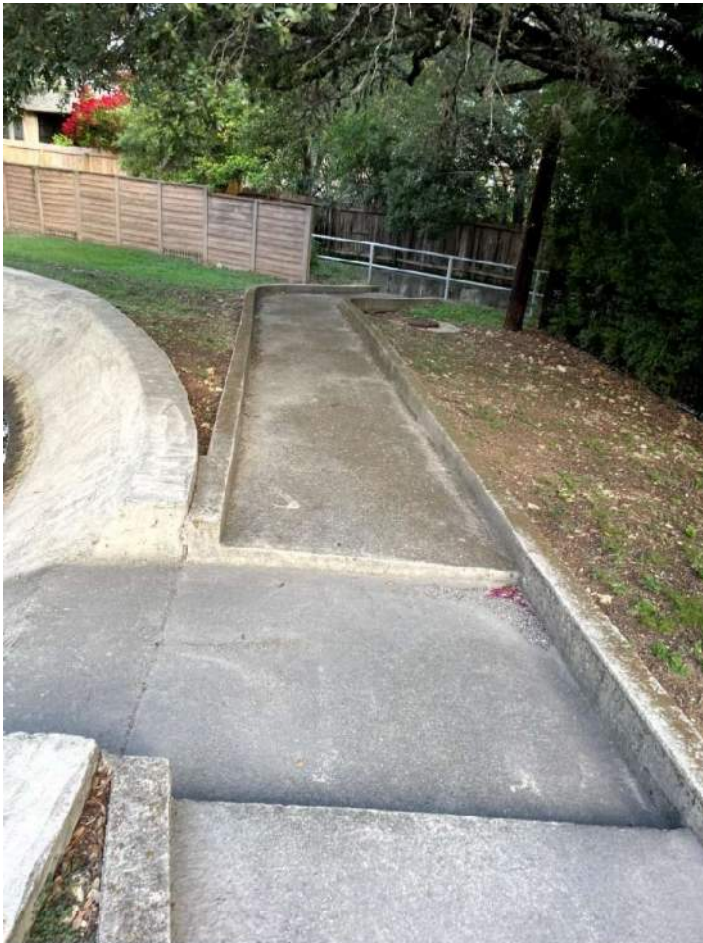
Cascade Glen Sidewalk Drain

Field Notes: Looks good.

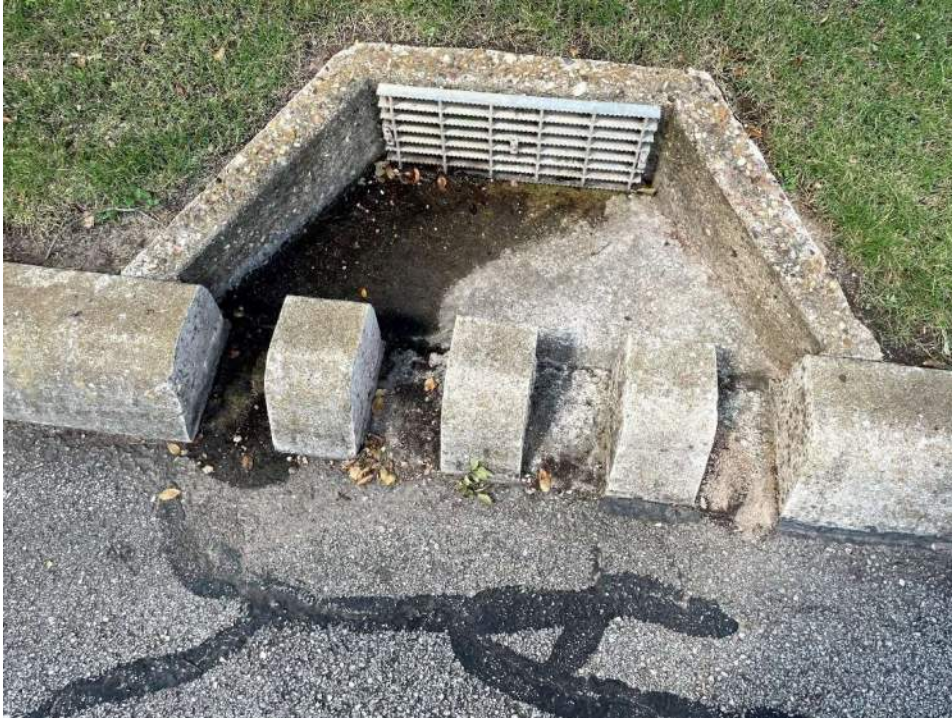
Curb Outlet, 1

Field Notes: Looks good.

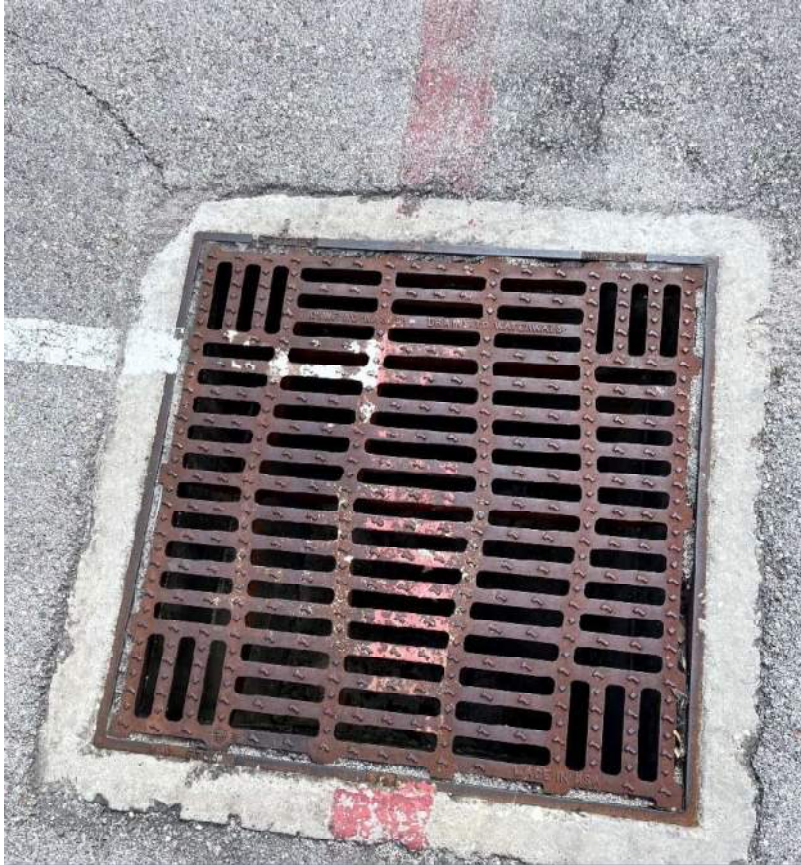
Field Notes: Looks good.

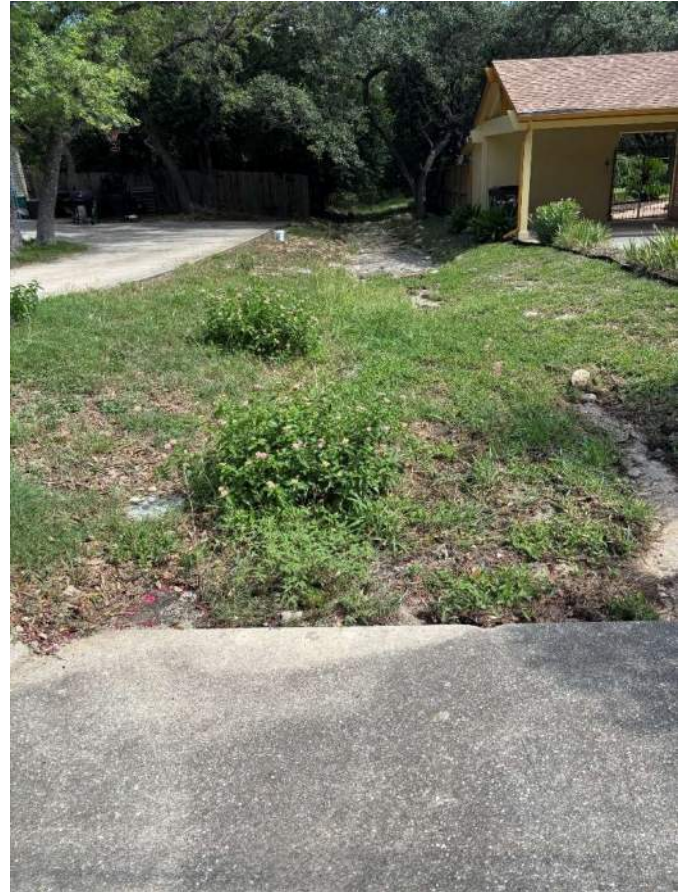
Field Notes: Mild vegetation overgrowth; trim.

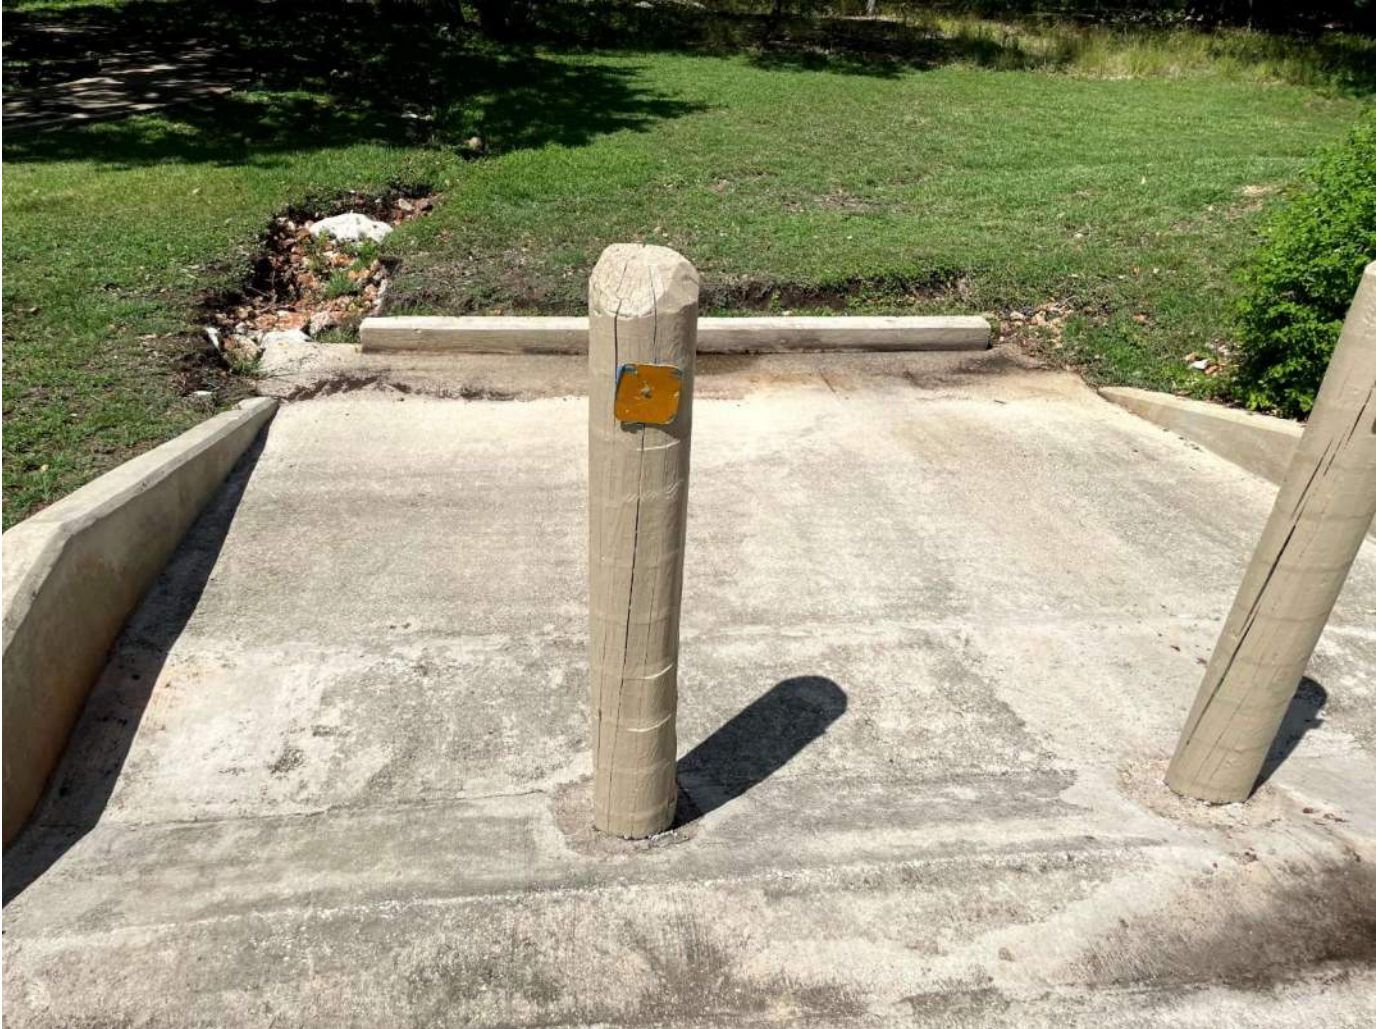
Great Wood Street Outfall

Field Notes: Looks good.

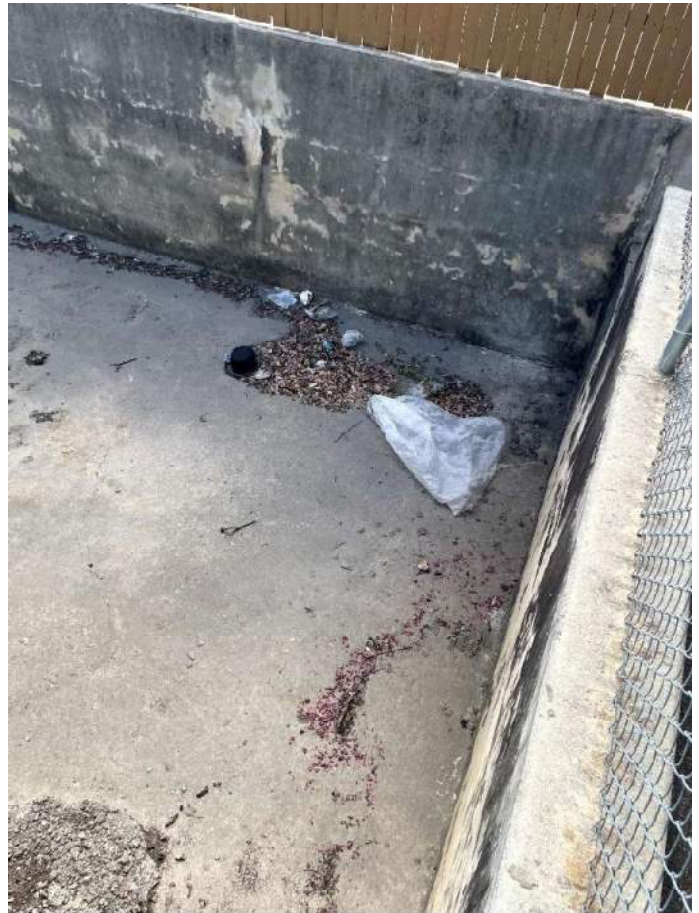
Holiday Inn PCD

Field Notes: Clear trash out and lock gate, looks good otherwise

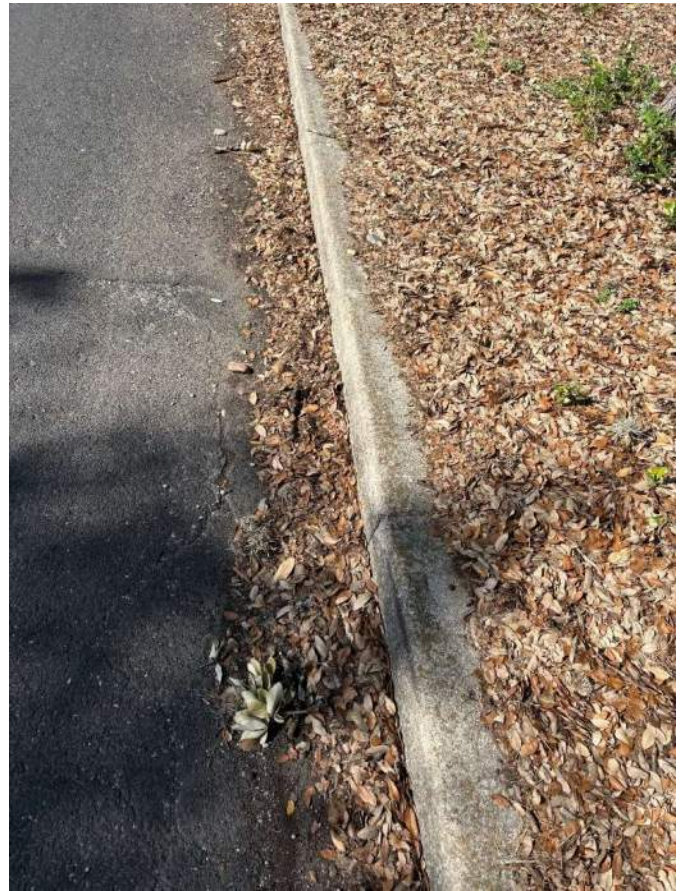
Large Channel Drain Inlet

Field Notes: Remove the leaves piled up in the roadway towards the curb.

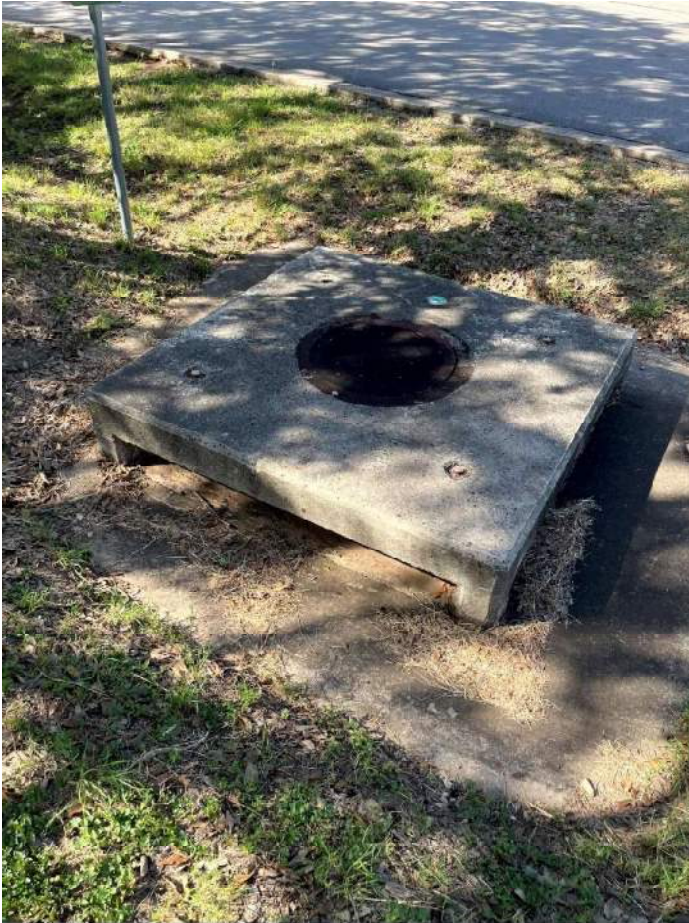
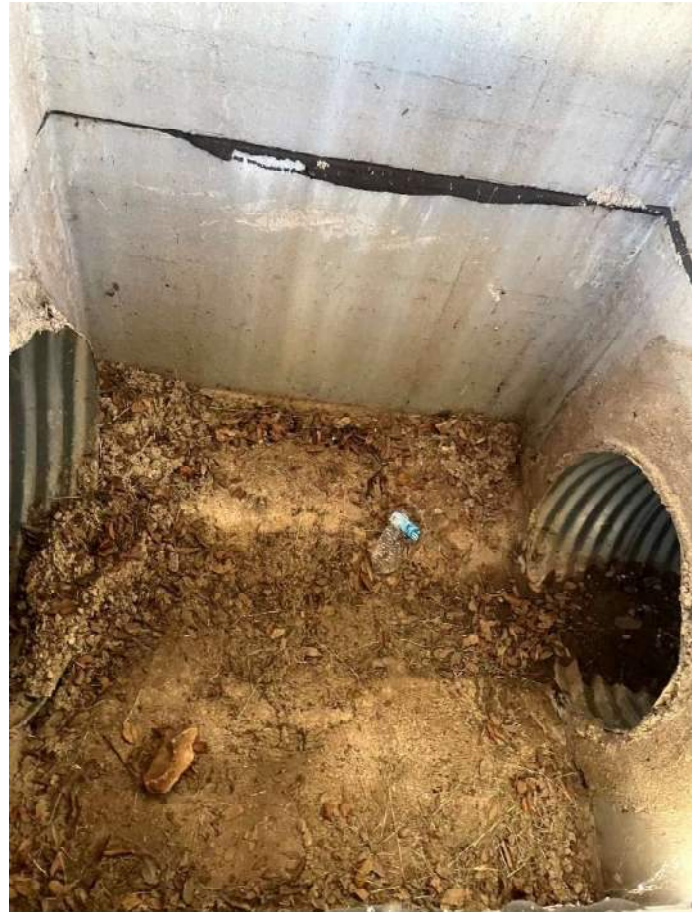
Mecca Inlets Outfall

Field Notes: Remove sediment and leaves looks good otherwise.

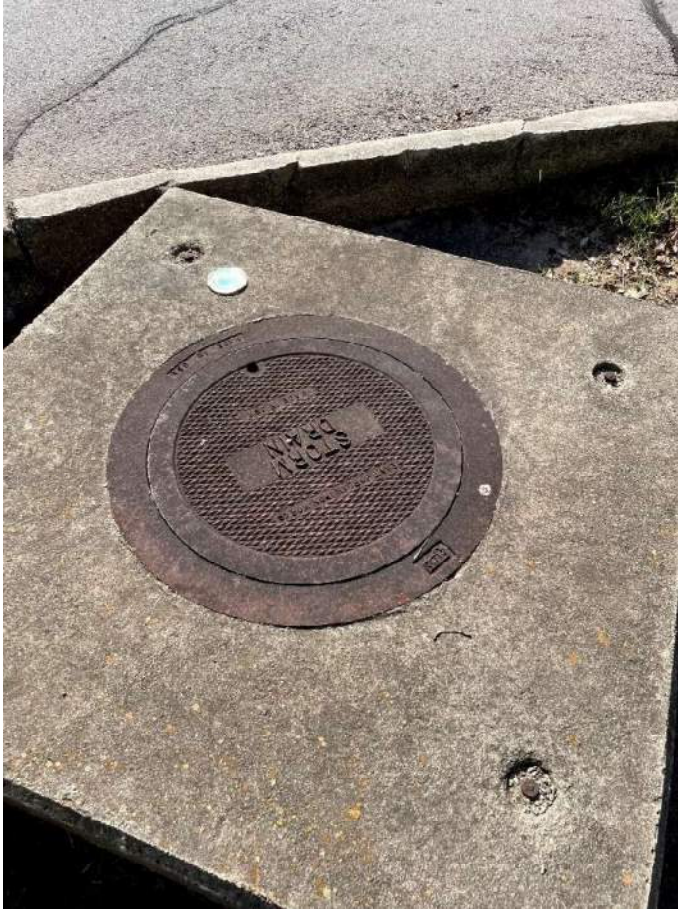
MEC-I-2(M)

Field Notes: Looks good.

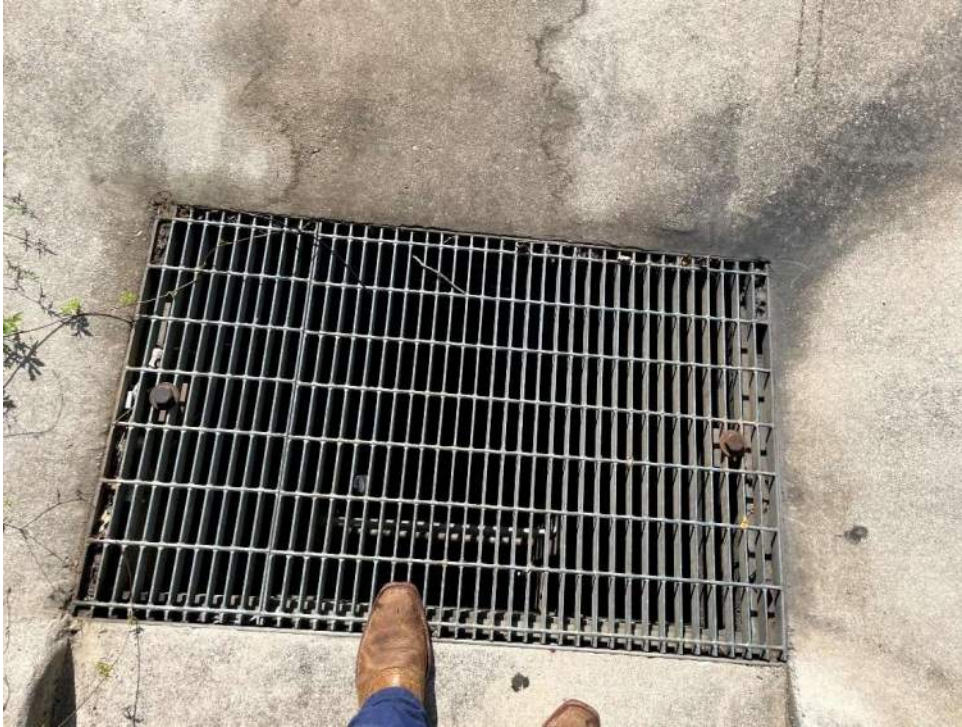
Midas Inlet in Rear

Field Notes: Looks good.

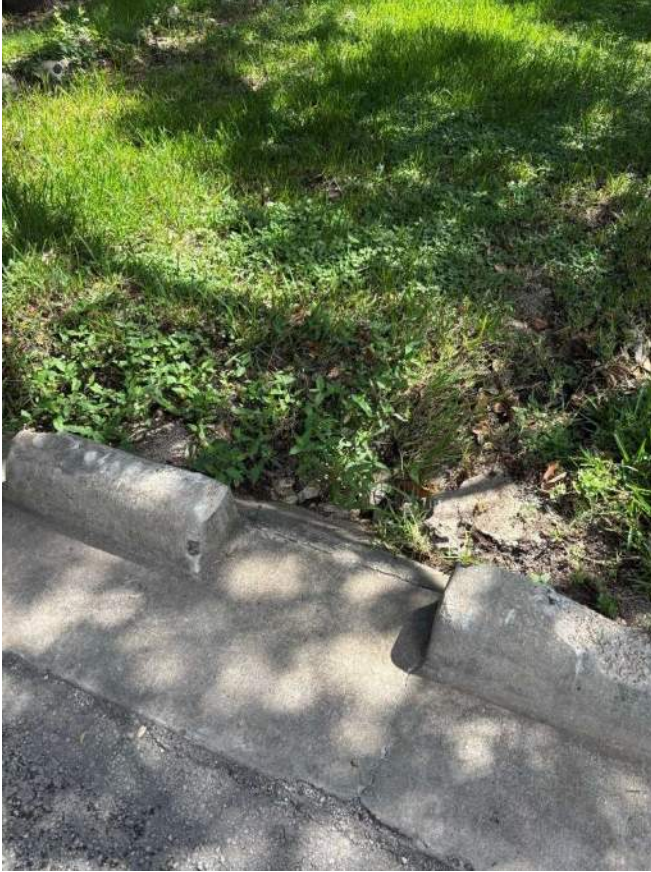
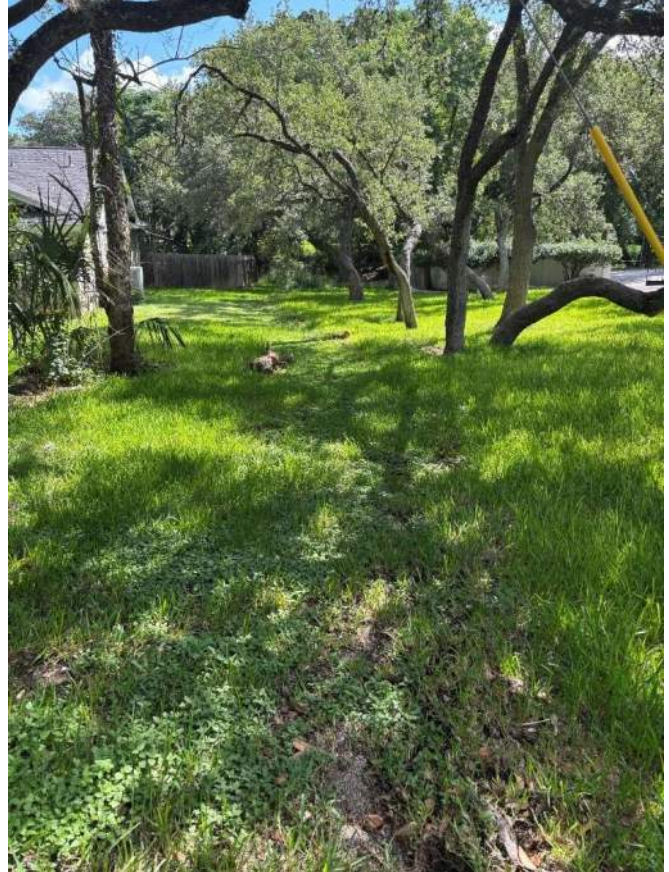
Field Notes: Mild debris noted, but looks fine.

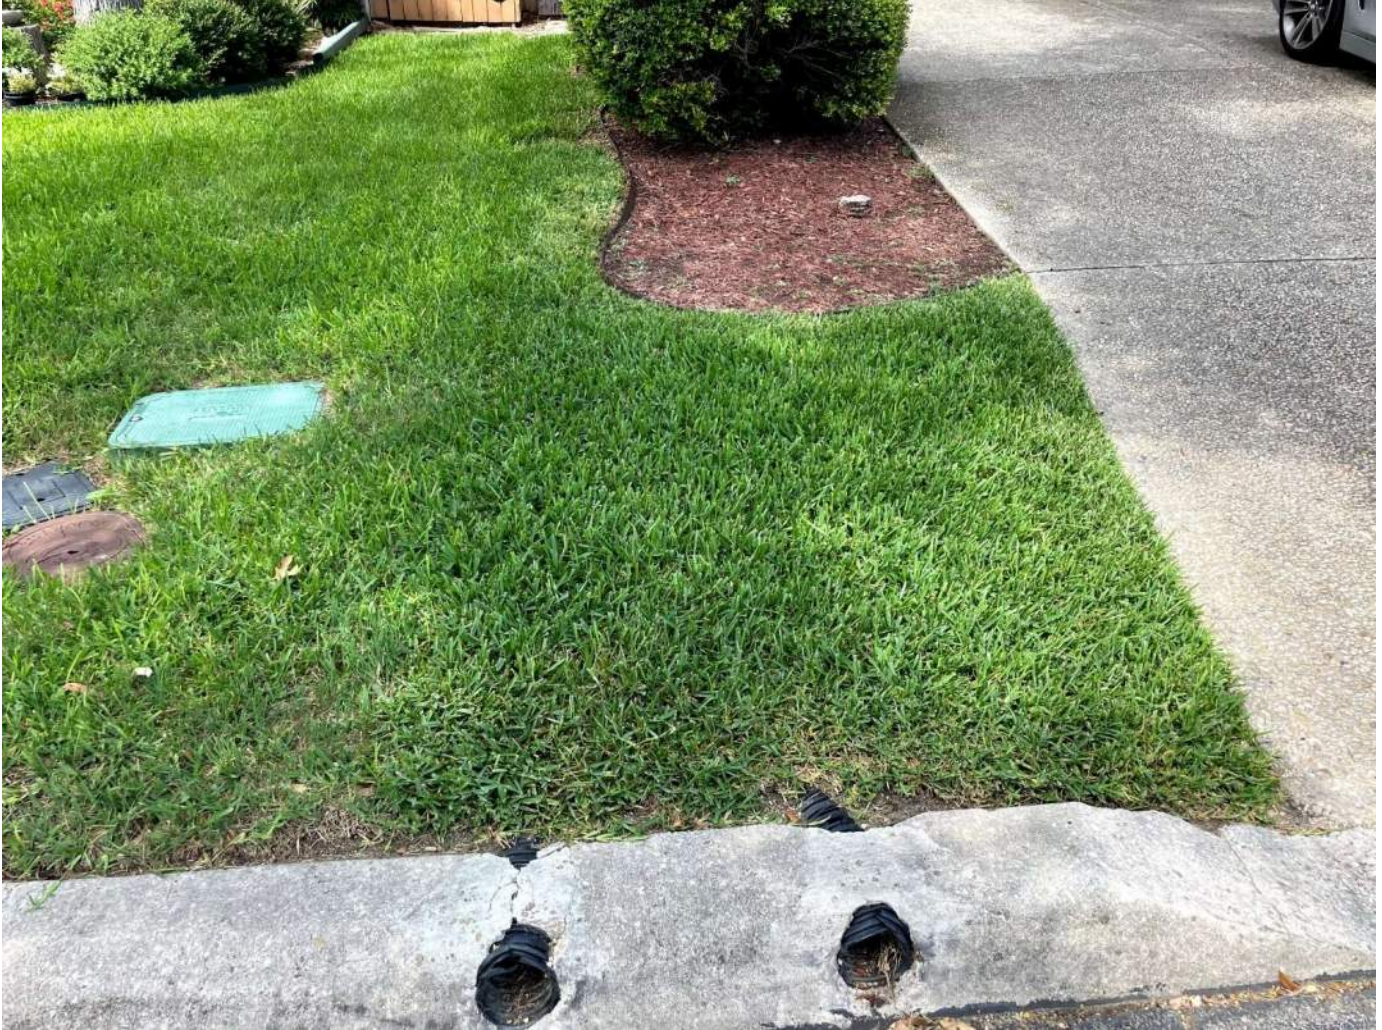
Navato Residential Drains

Field Notes: Looks good.

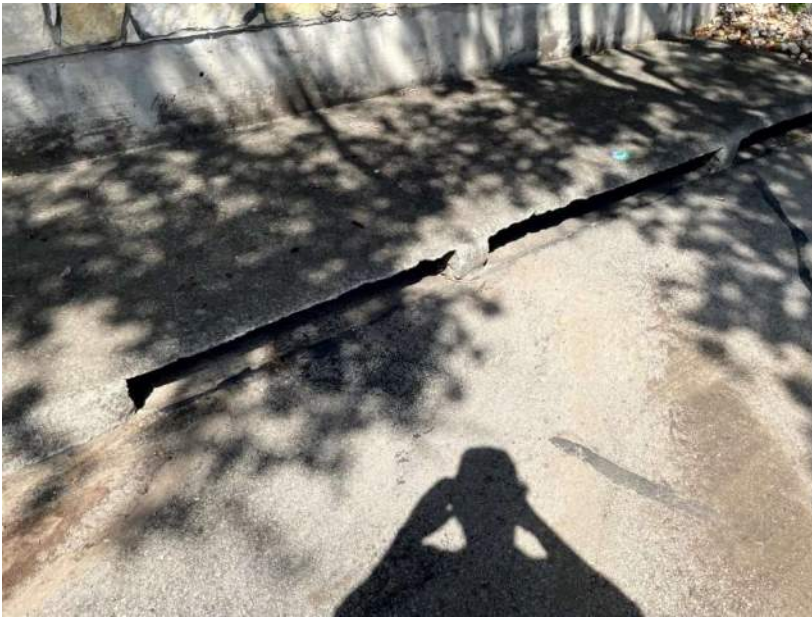
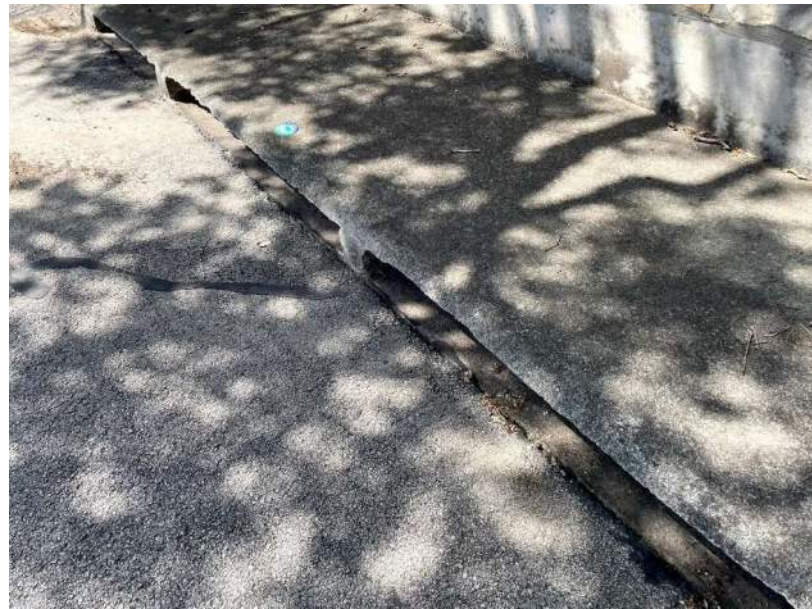
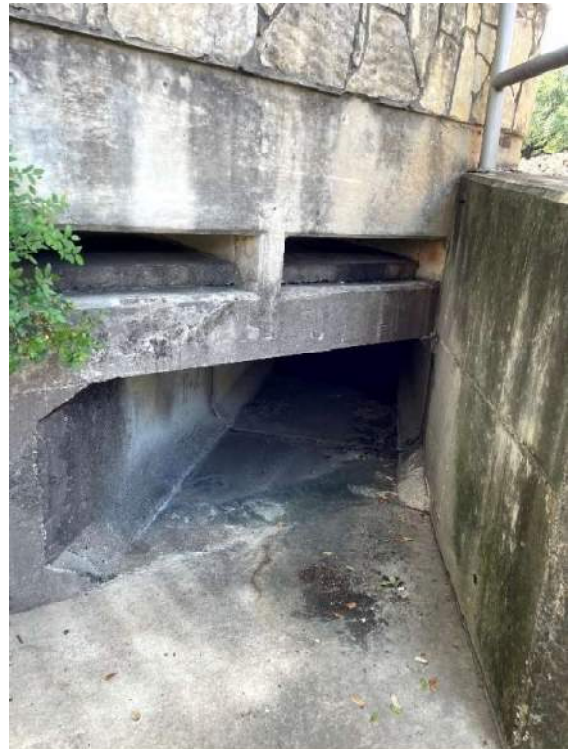
Navato Blvd Inlet

Field Notes: Remove vegetation, monitor spalling.

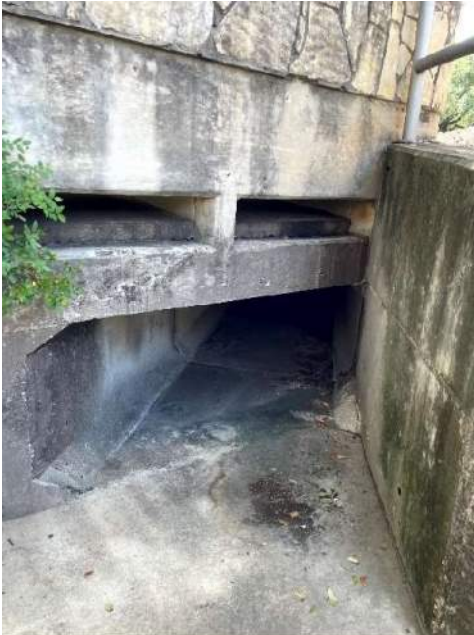
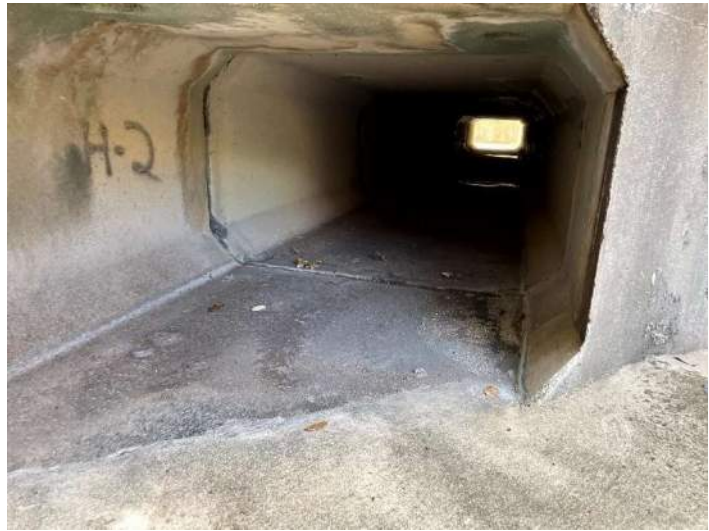
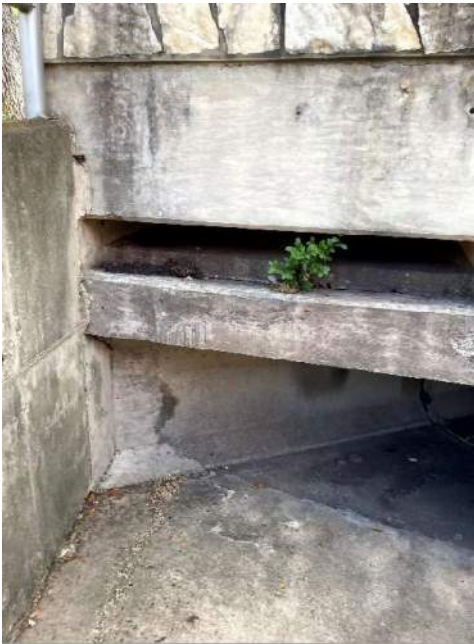
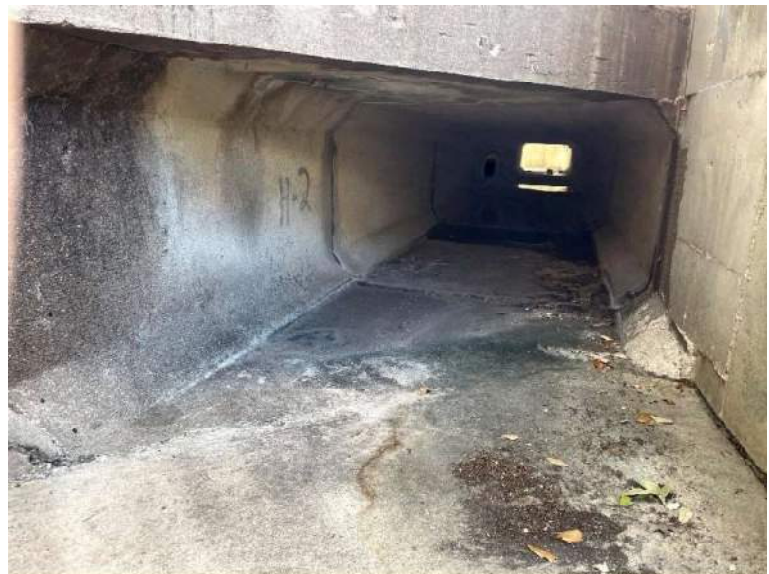
Navato Storm Sewer Pipe

Field Notes: Looks good, monitor spalling.

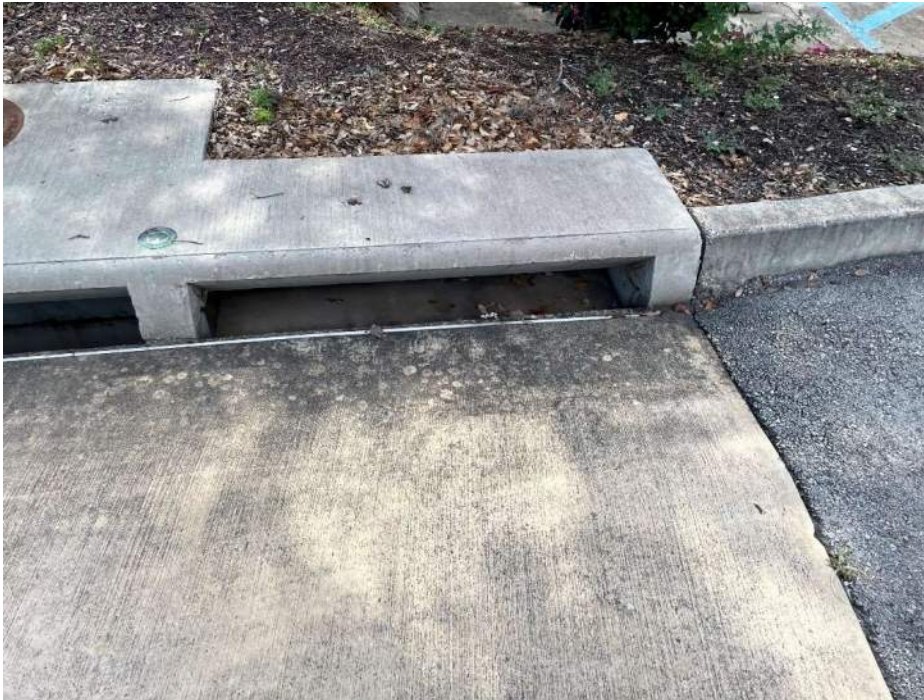
New Drash Parking Lot Inlet

Field Notes: Looks good.

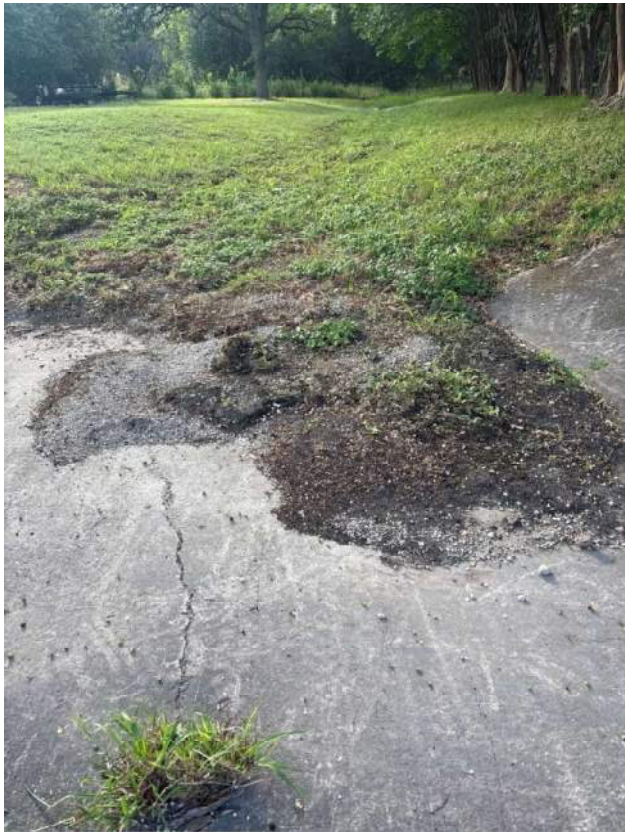
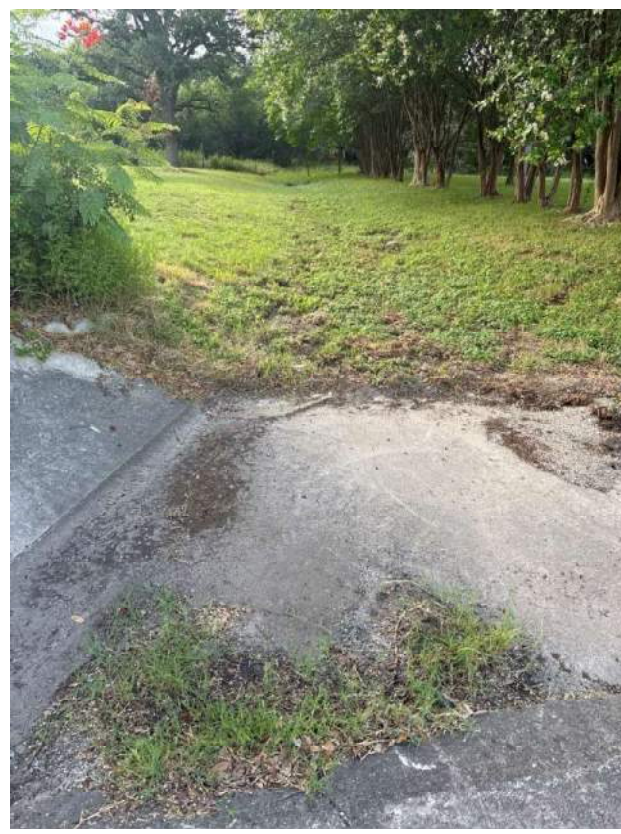
Field Notes: Collect and remove loose sediment and trim weeds on the outfall.

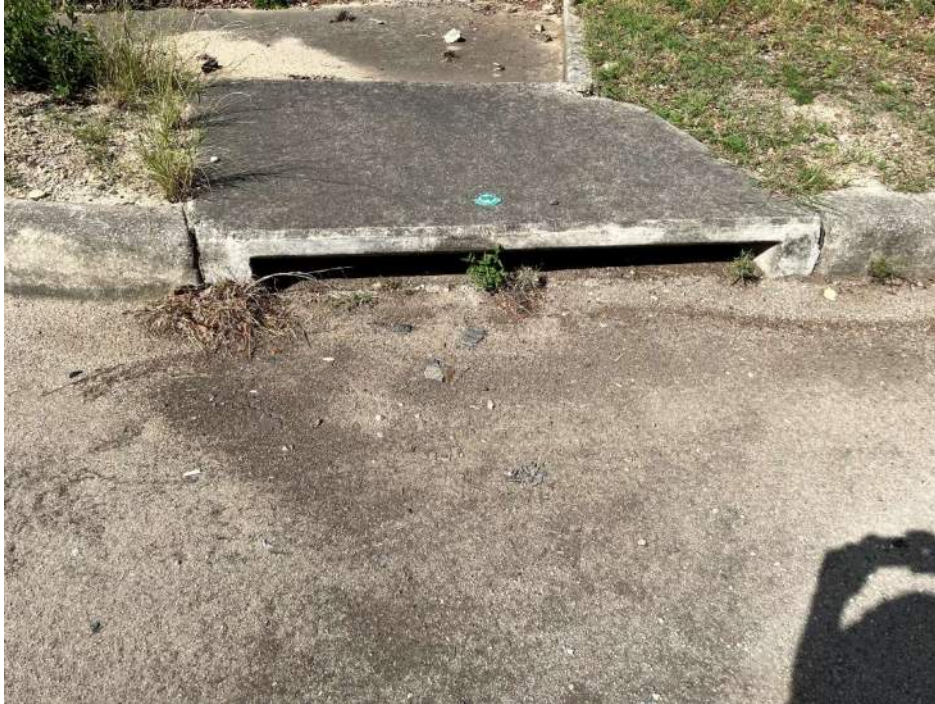
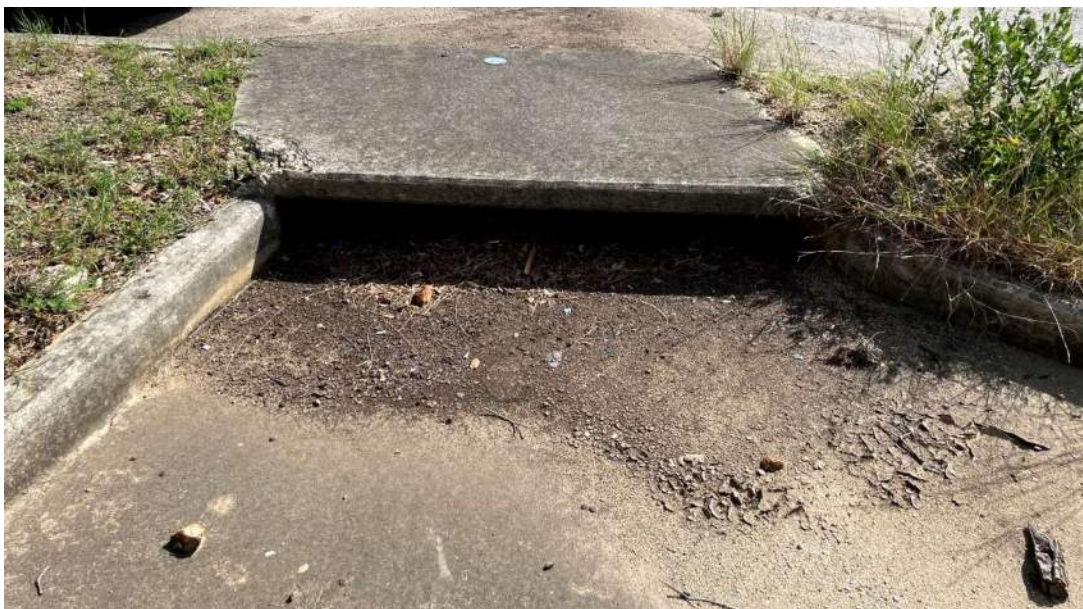
Field Notes: Monitor sediment buildup, looks good otherwise.

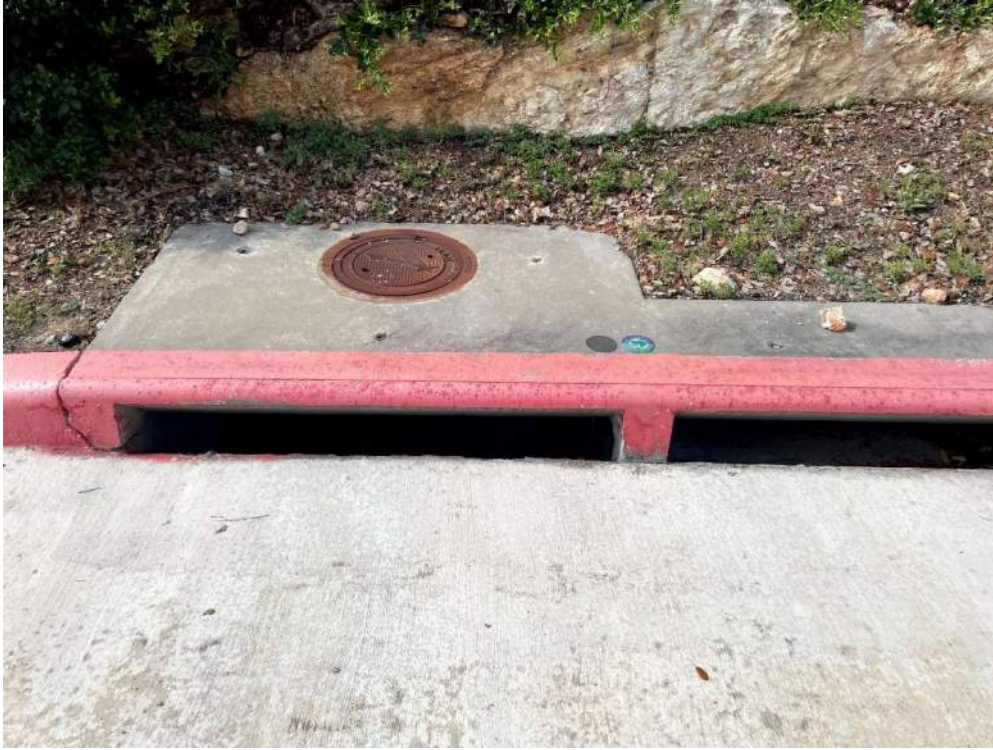
Oak Creek Circle Inlet 2

Field Notes: Looks good.

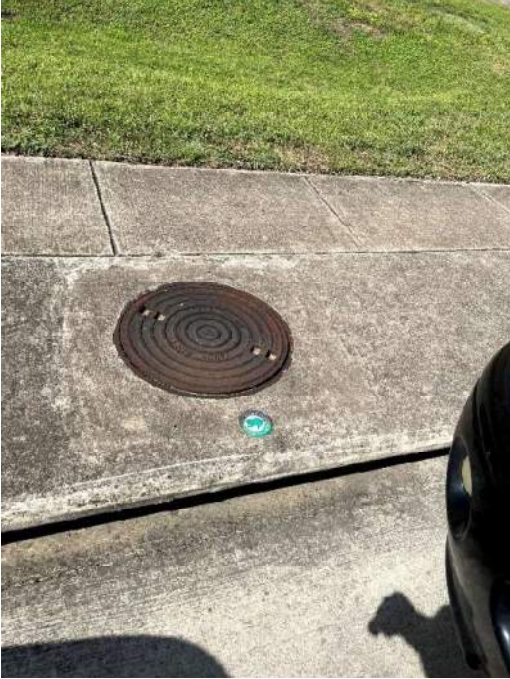
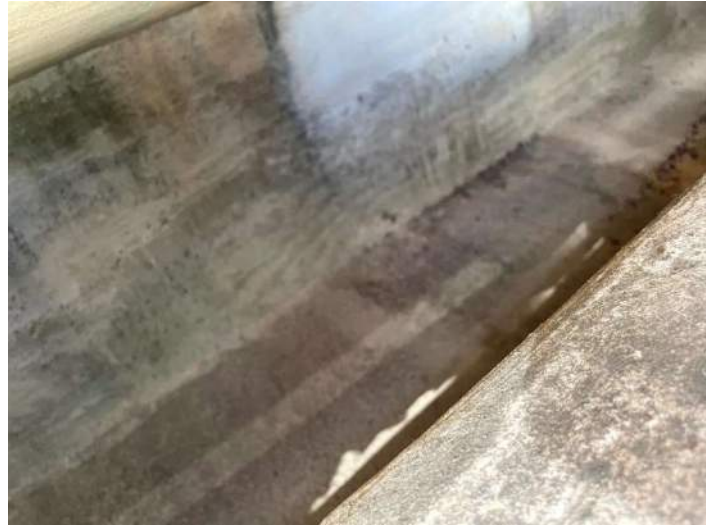
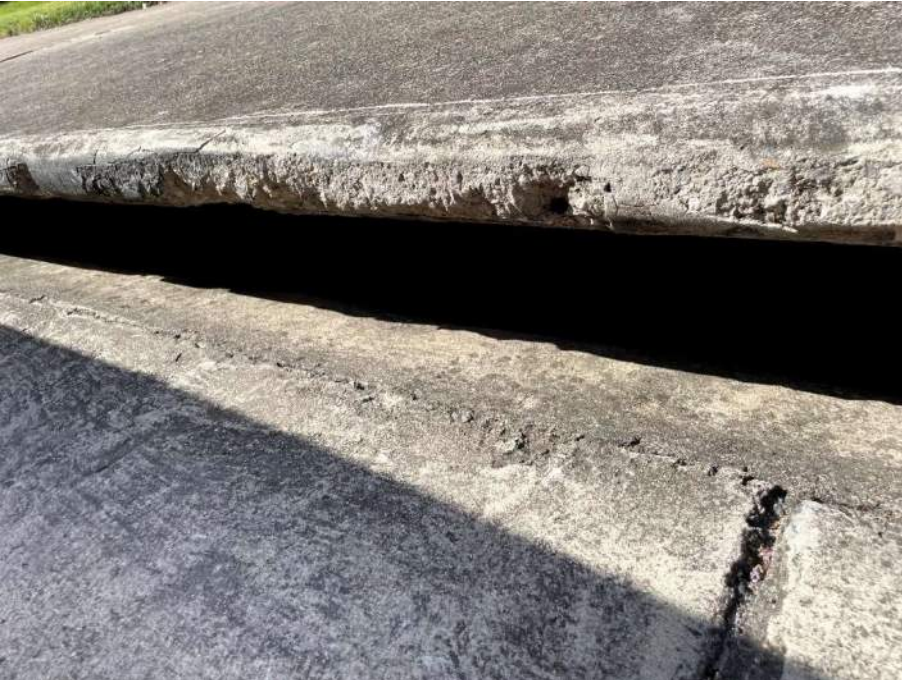
Field Notes: Looks good monitor spalling.

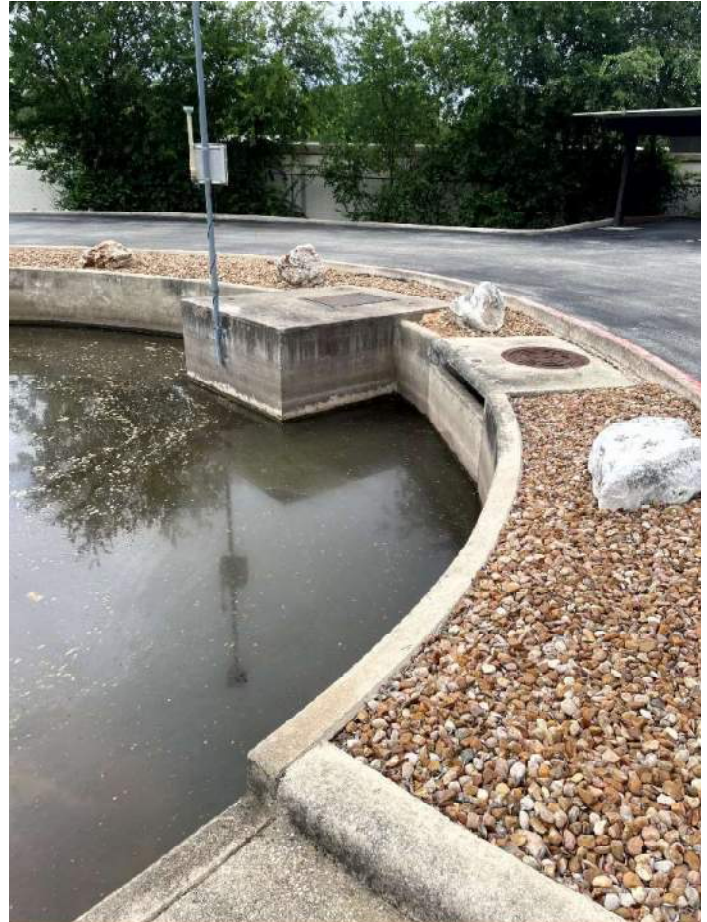
Field Notes: Looks good, may need to monitor sediment buildup.
Nearby rain gauge shows 0.5" precipitation

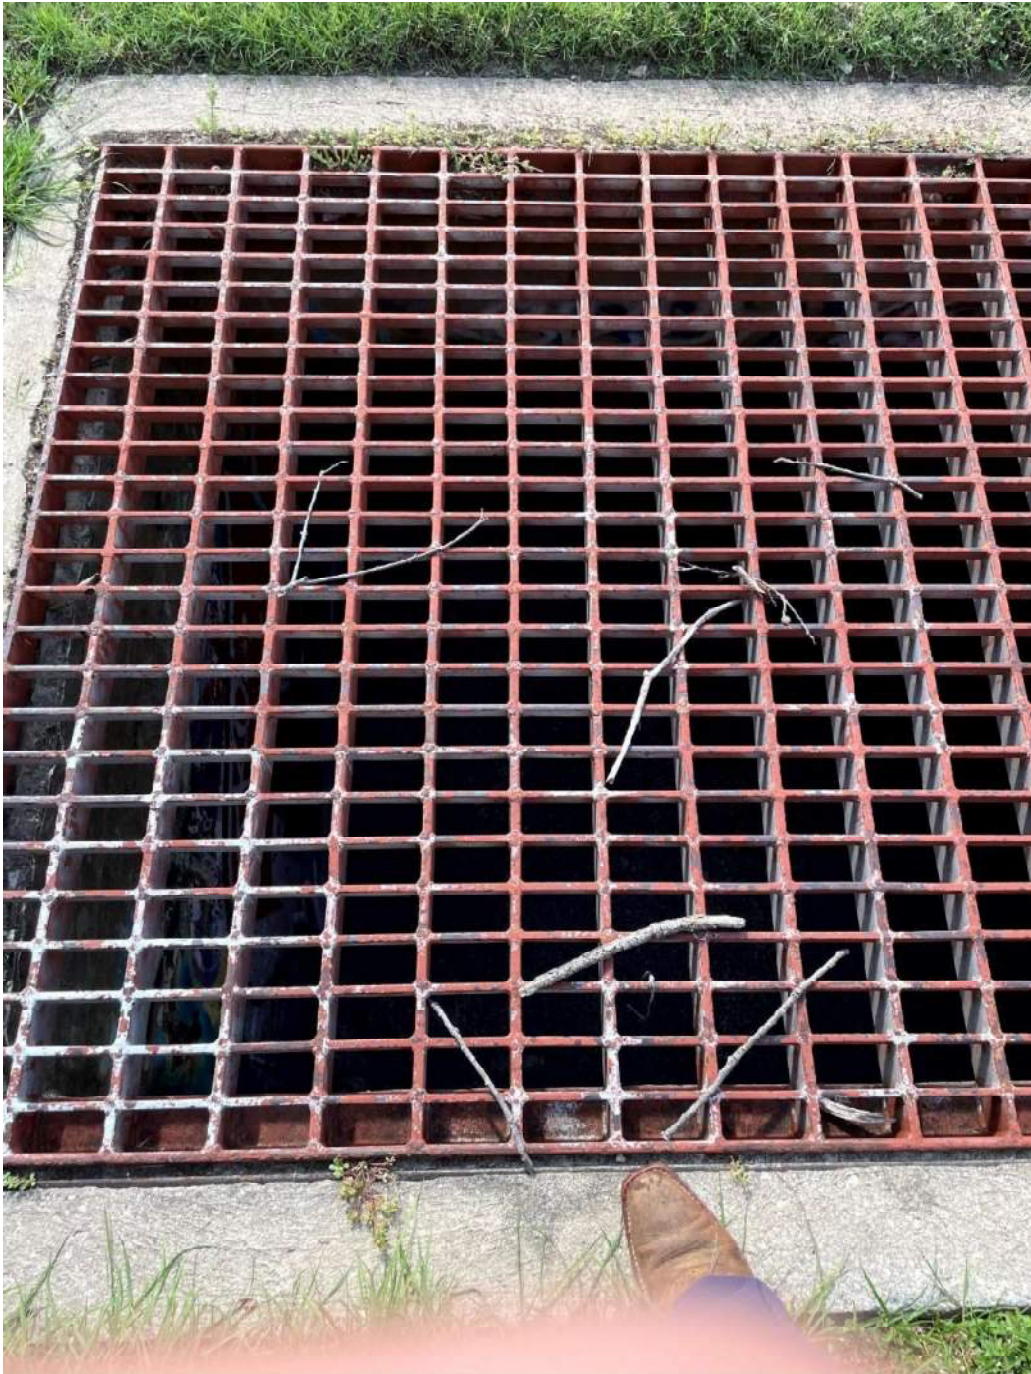
Field Notes: Looks good.
