TOWN OF HOLLYWOOD PARK, TX

2025 Summer Inspection

HOLLYWOOD PARK 2025 SUMMER INSPECTION REPORT

Subject: Annual Municipal Separate Storm Sewer System (MS4) Inspection

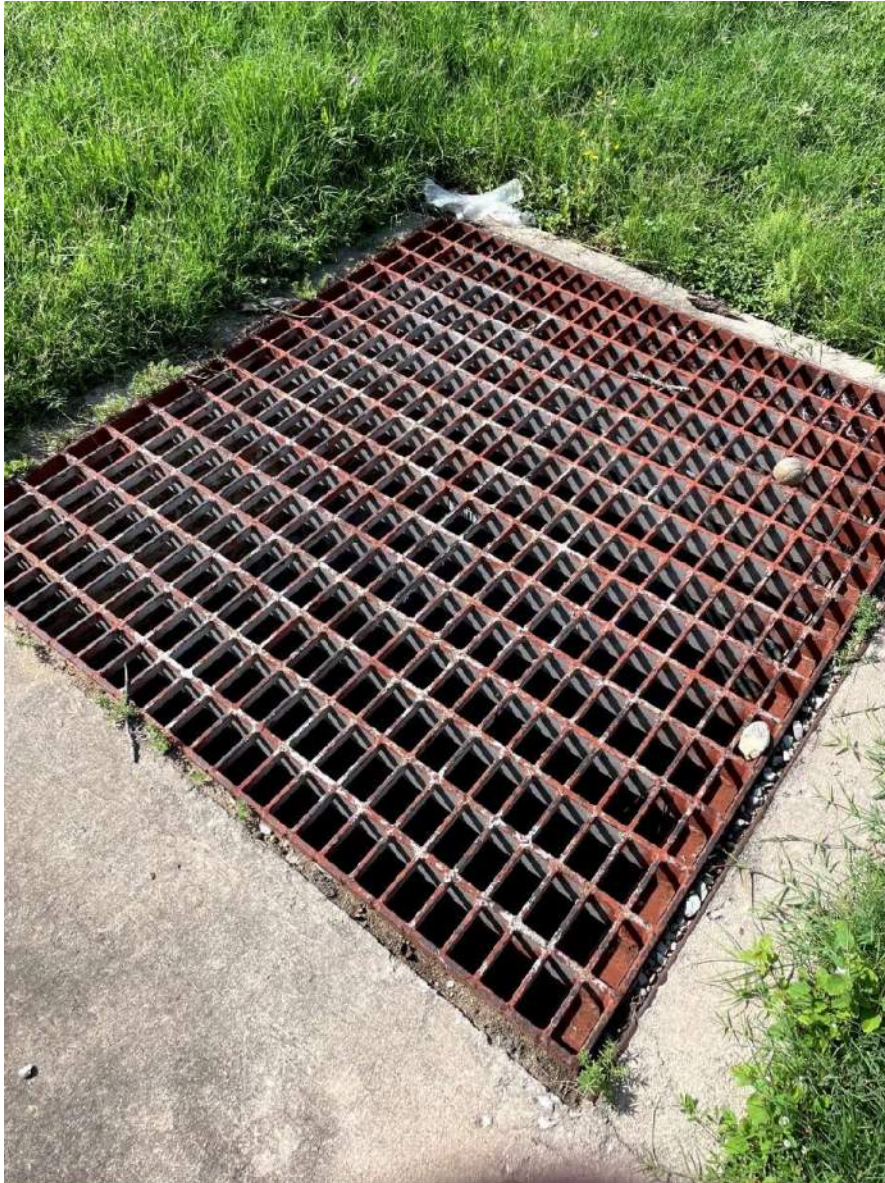
Premier Autocare Inlet 2

Field Notes: Looks good.

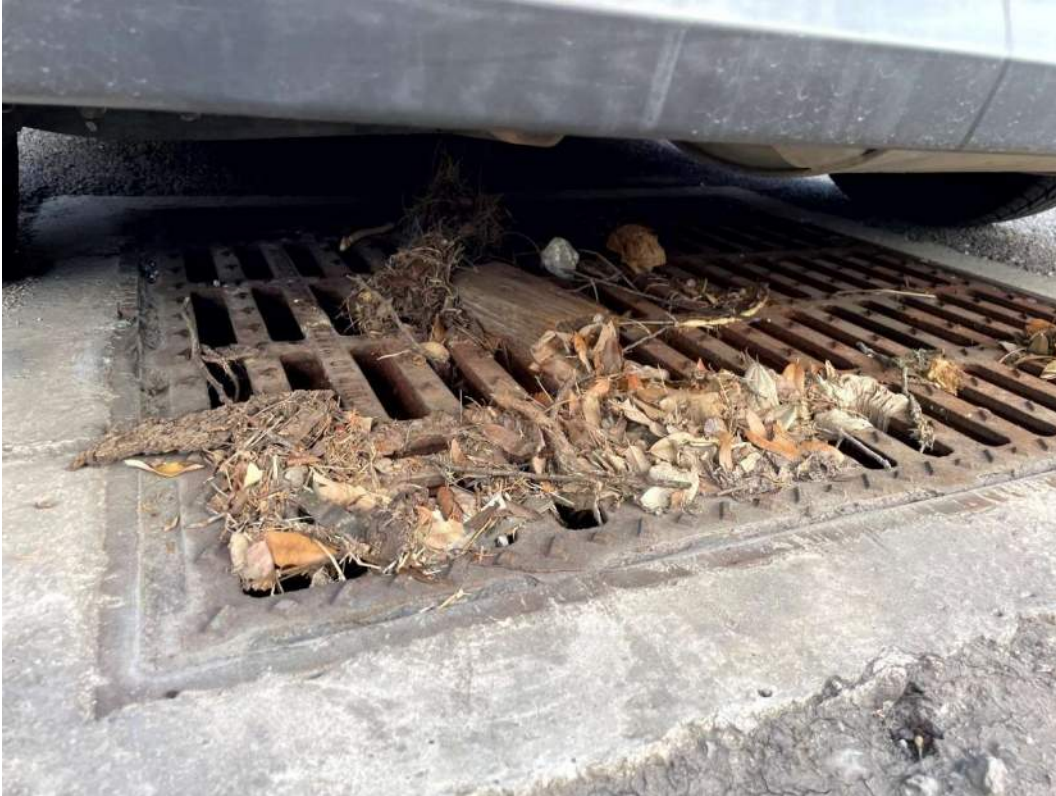
Premier 1 Autocare Parking Lot Inlet

Field Notes: Minor debris on grate looks good otherwise.

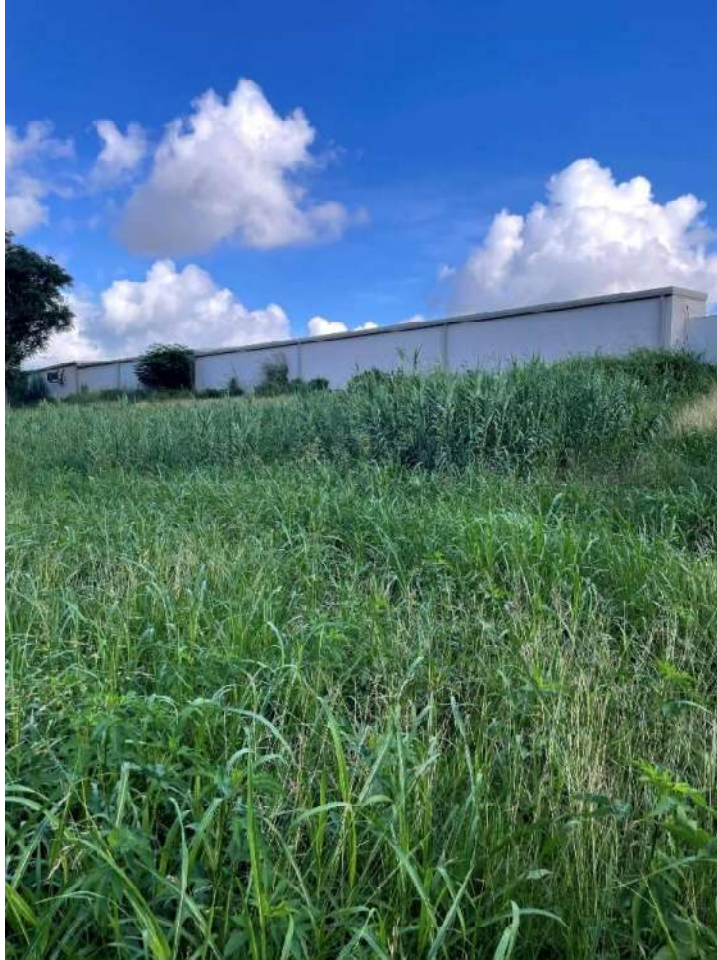
Field Notes: Unable to locate, needs mowing.

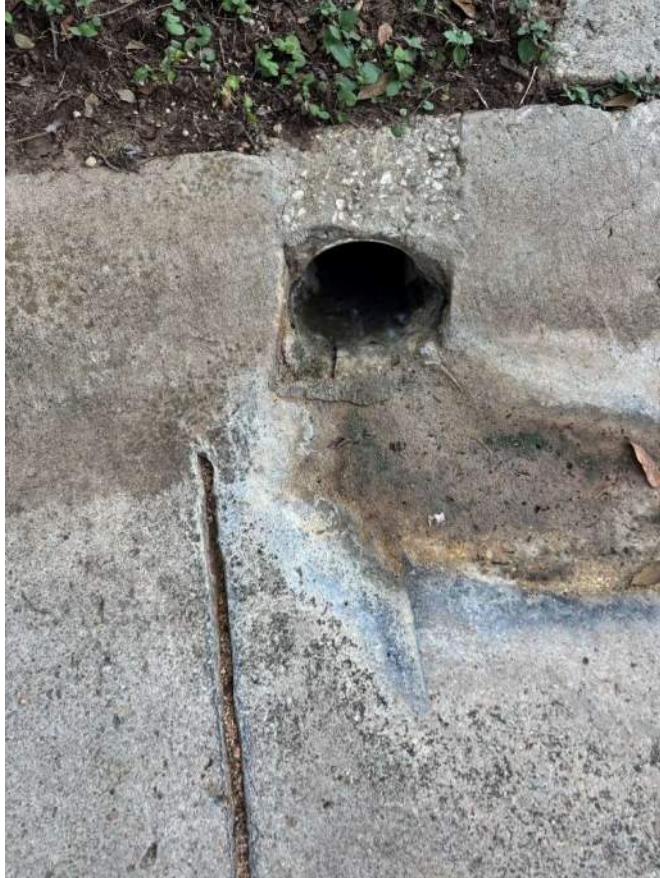
Residential Drain Pipe

Field Notes: Looks good.

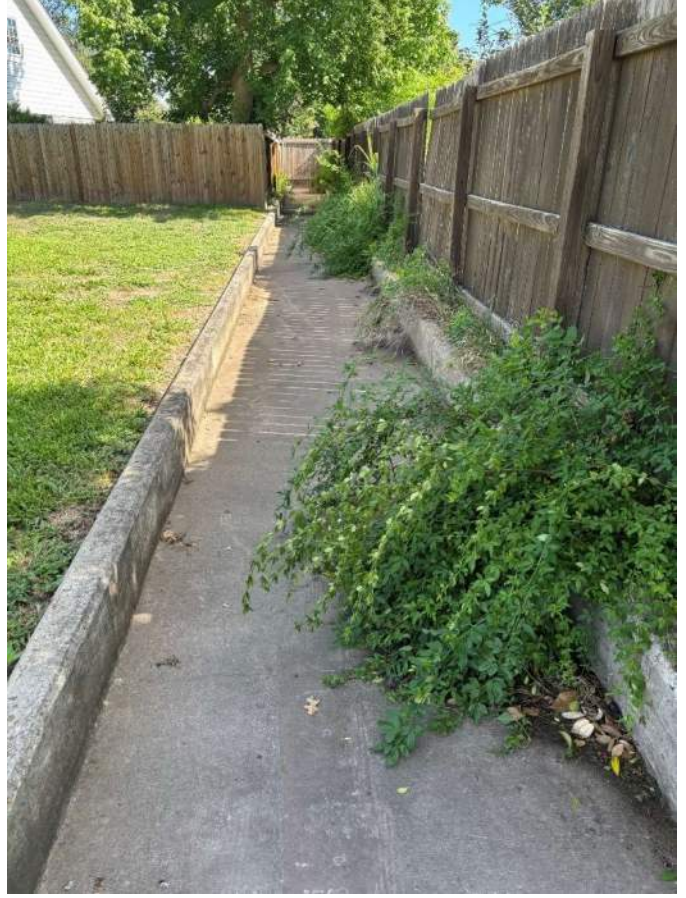
Field Notes: Clear vegetation and debris from channel.

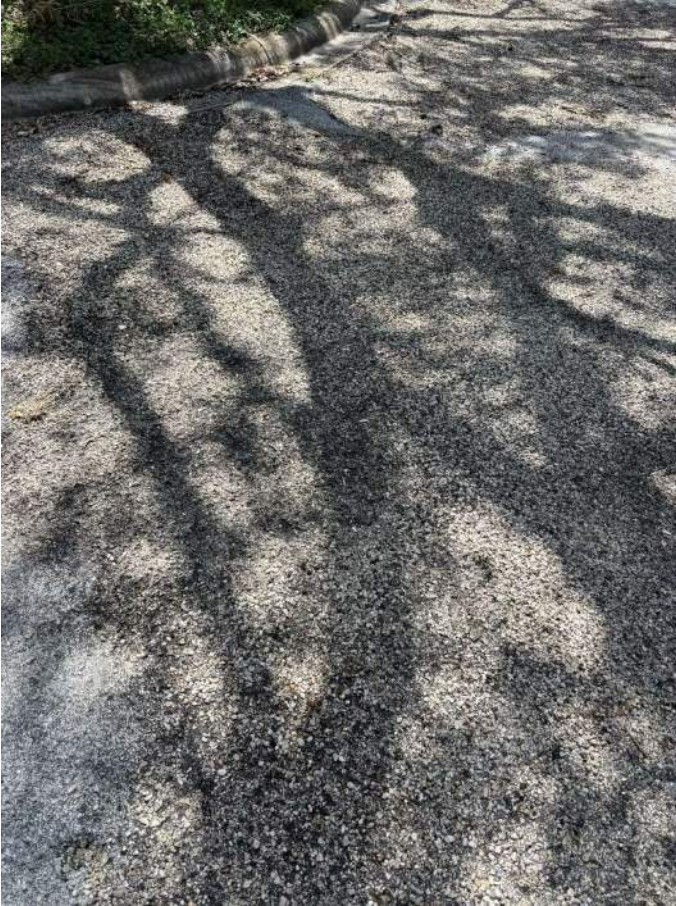
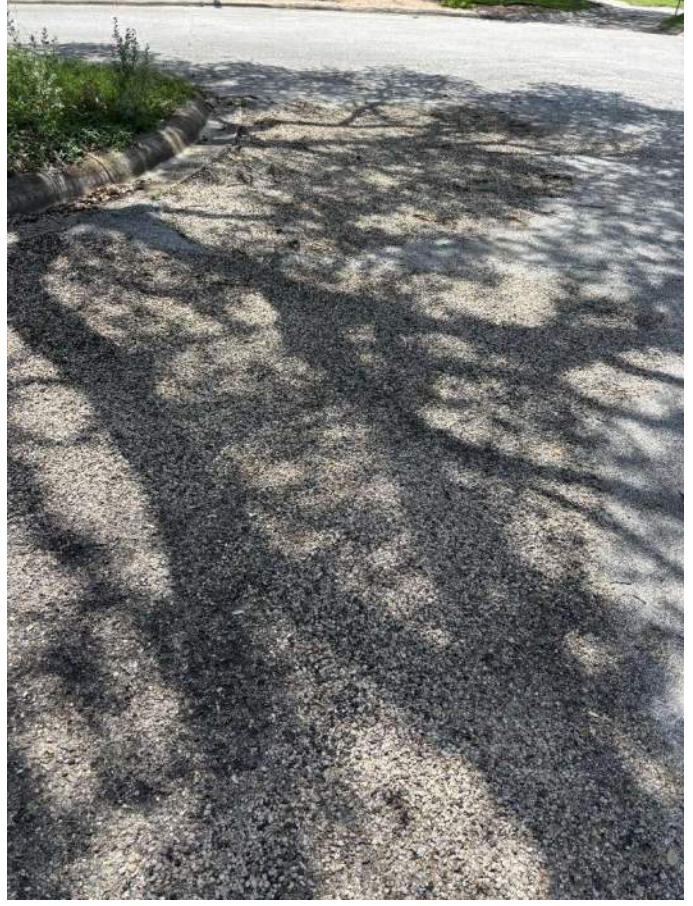
Sediment Buildup at Tall Oak

Field Notes: Remove loose sediment that has collected in the roadway.

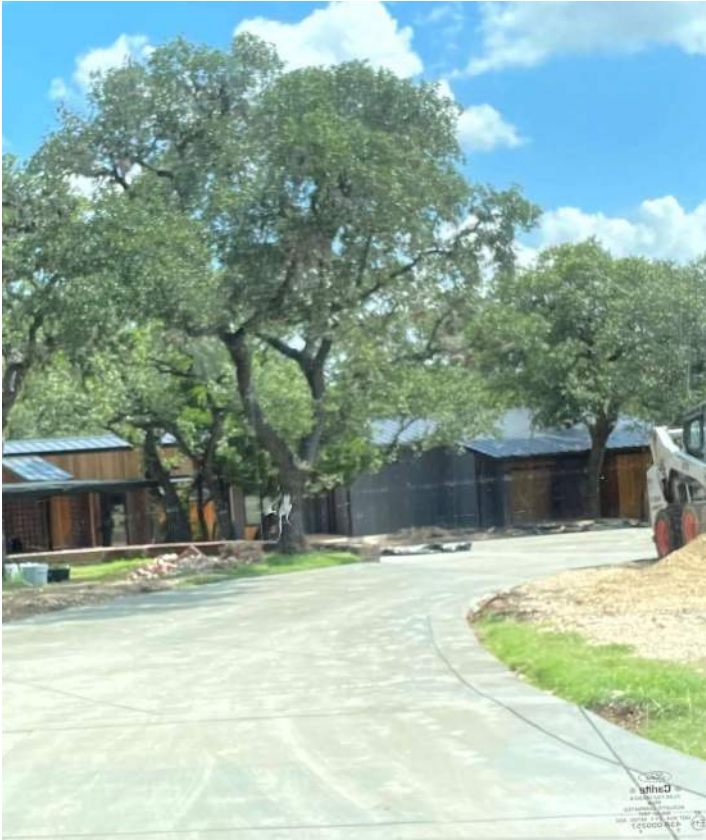
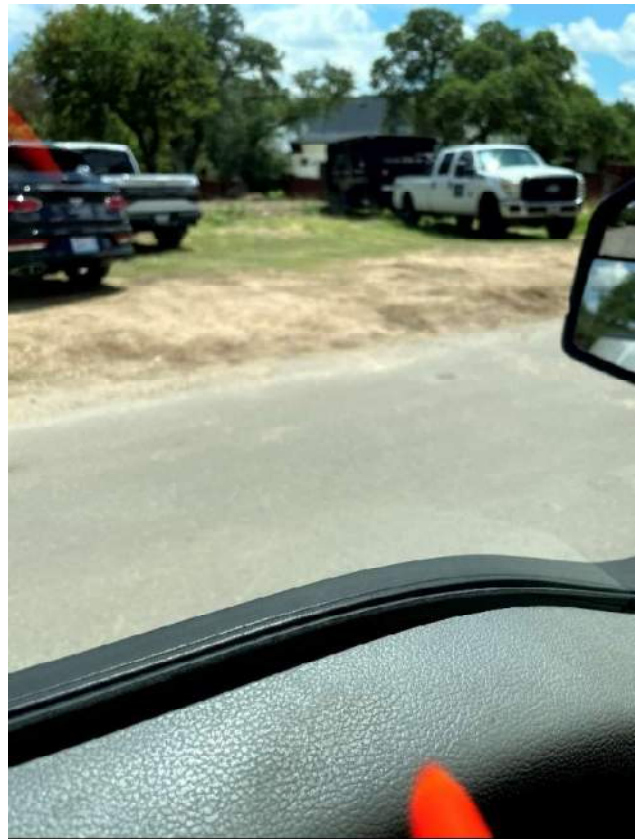
Sequoia Dr Home Construction

Field Notes: Active construction site, looks good monitor for sediment runoff.

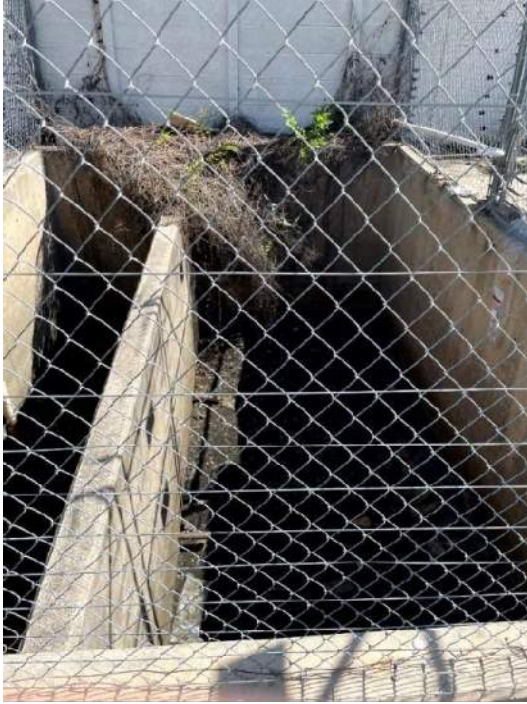
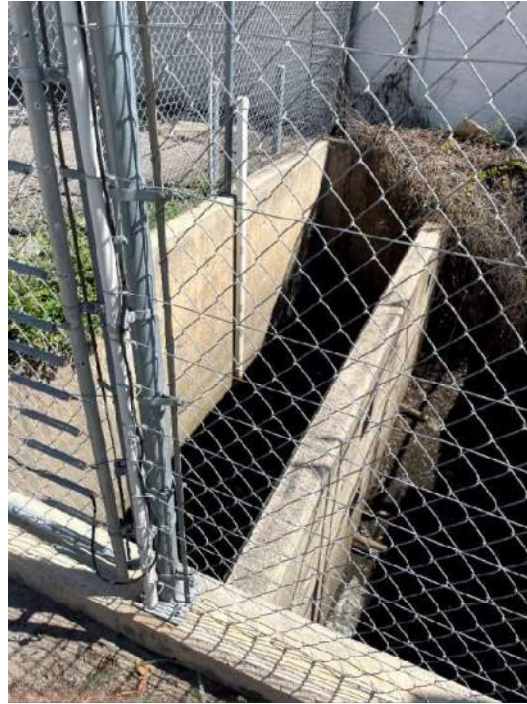
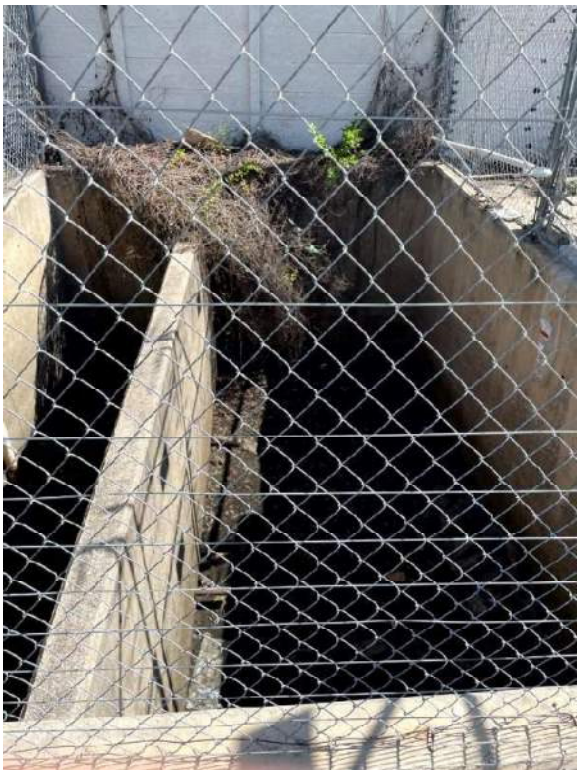
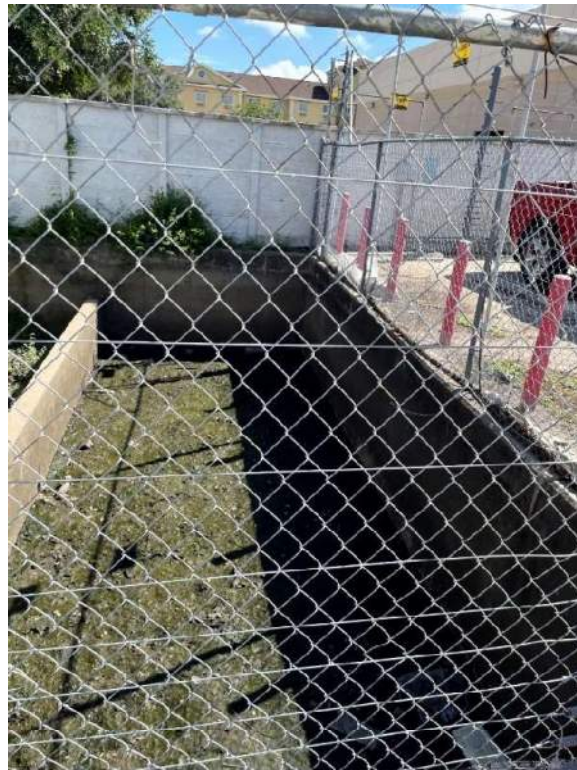
Field Notes: Remove overgrown vegetation, looks good otherwise.

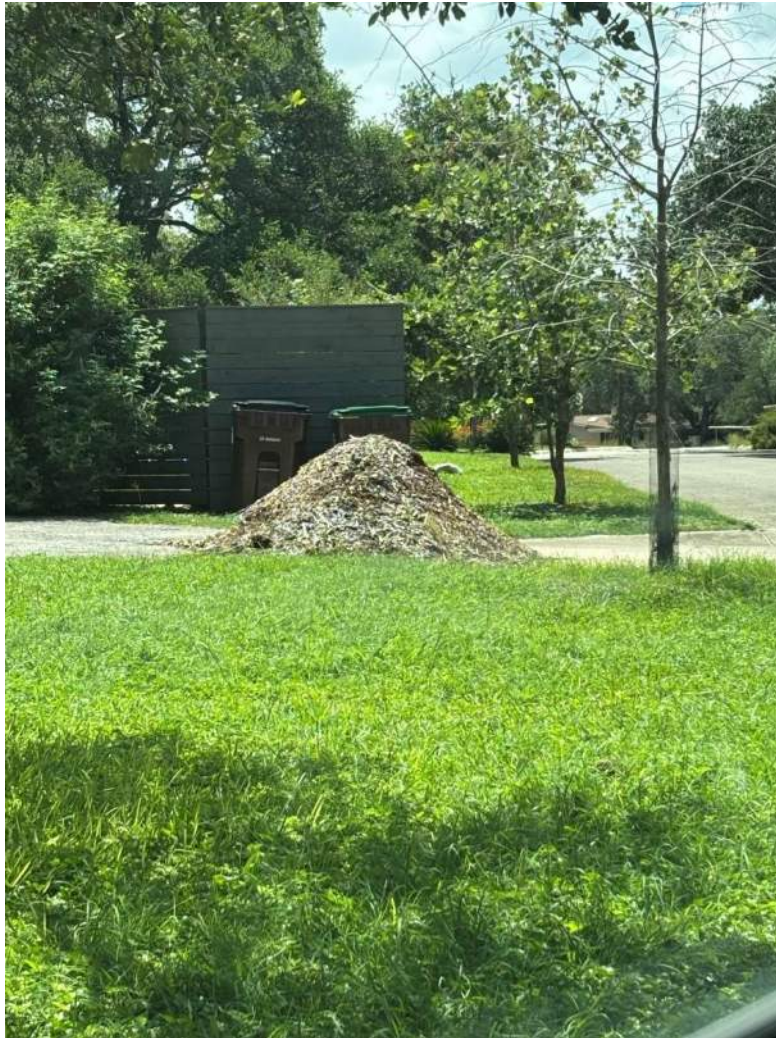
Spoil Pile

Field Notes: Onsite spoil pile. Monitor to ensure there is no discharge into the road.

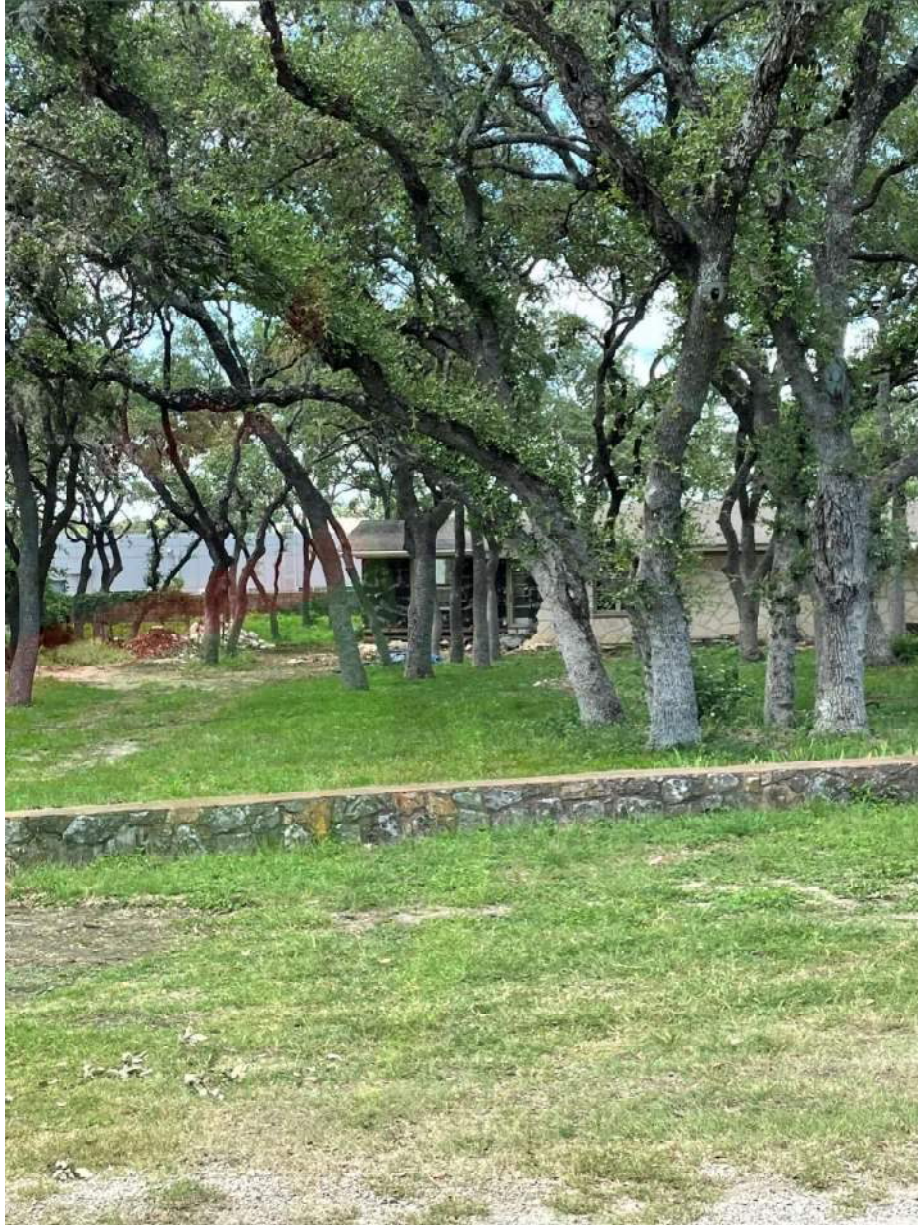
Field Notes: Home construction, monitor for runoff.

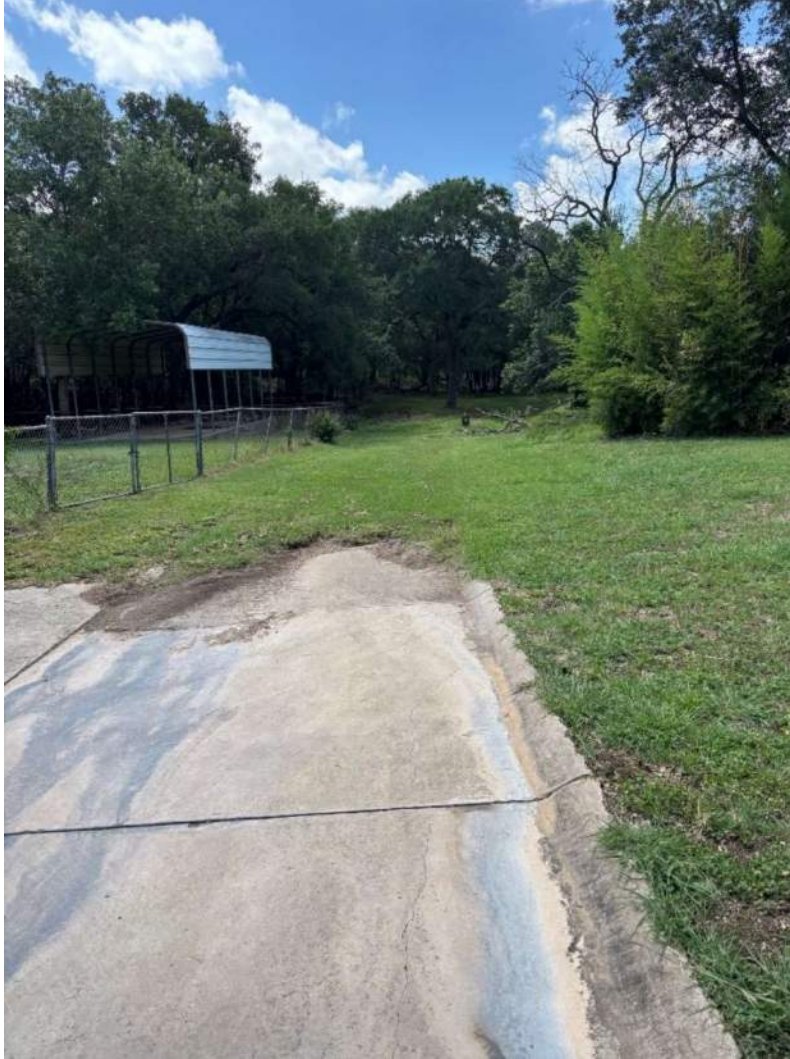
Tall Oak Outfall

Field Notes: Looks good.

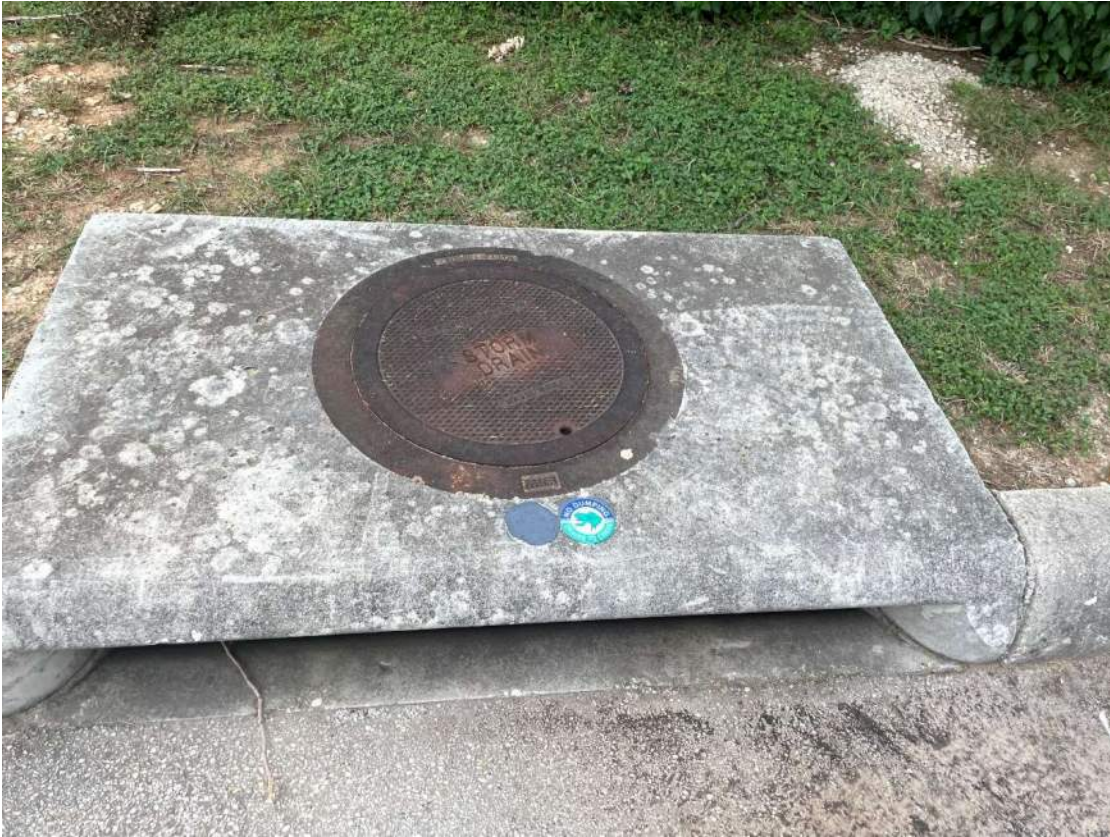
Field Notes: Looks good.

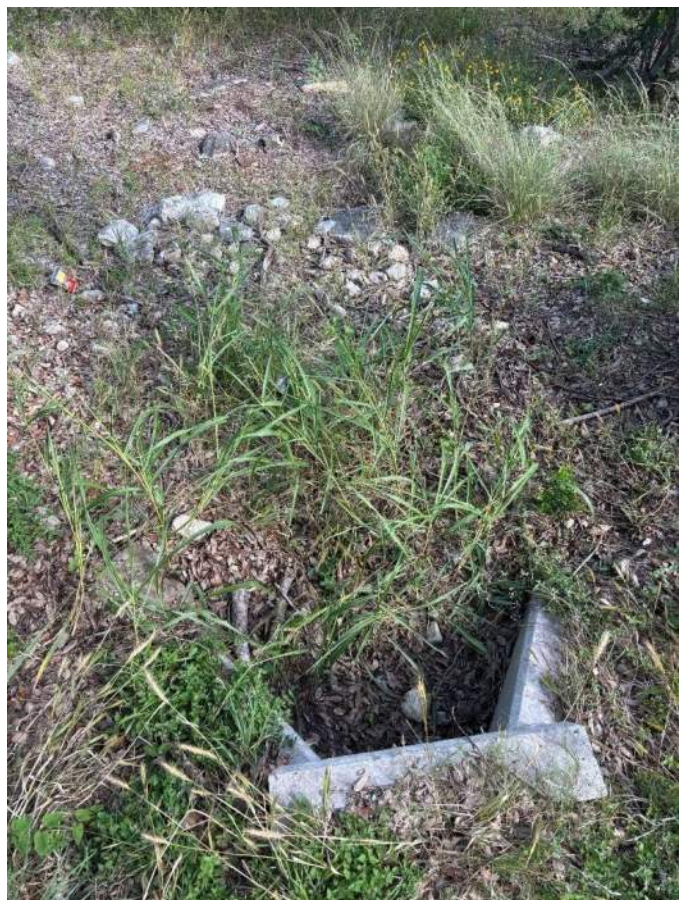
Field Notes: Clear rocks, leaves, and overgrown vegetation from culvert outfall.

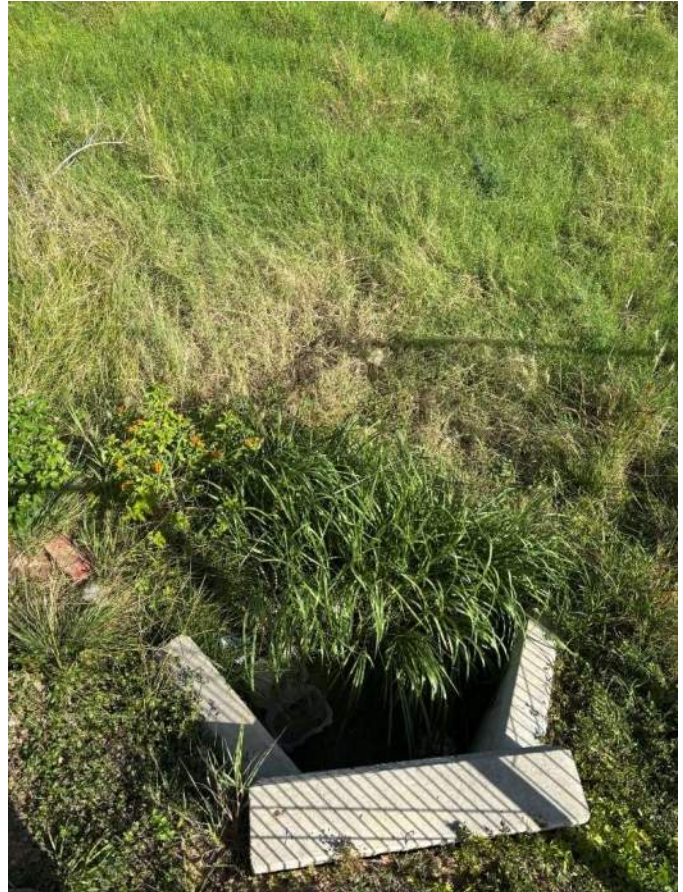
Voigt Park Outfall

Field Notes: Trim overgrown vegetation and remove trash around outfall.
