TOWN OF HOLLYWOOD PARK, TX

2025 Winter Inspection

HOLLYWOOD PARK 2025 WINTER INSPECTION REPORT

Subject: Semiannual Municipal Separate Storm Sewer System (MS4) Inspection

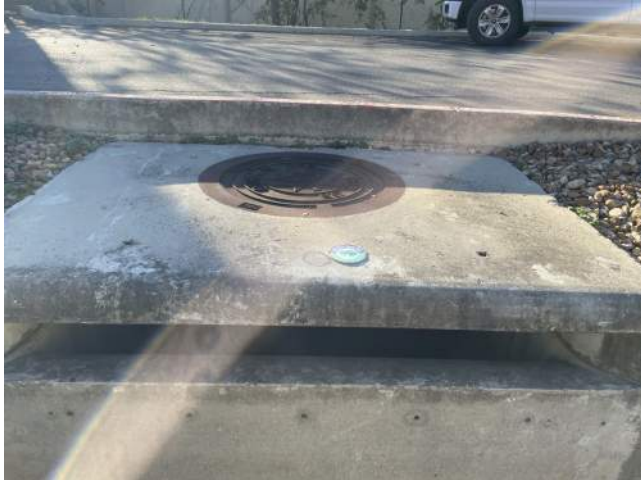
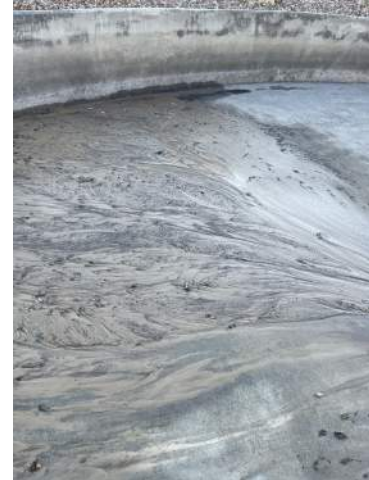
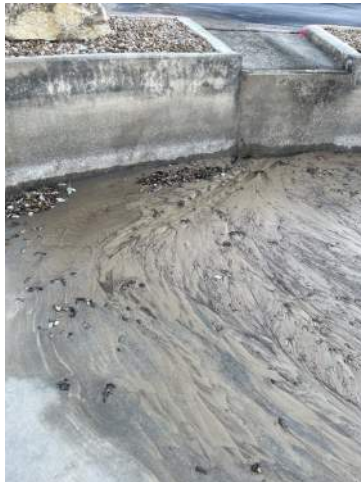
Location ID: B-002
Location Description: Optometrist Roundabout PCD
Type: BMP
Latitude: 29.595278
Longitude: -98.47408
Current Maintenance Status: Needs Maintenance

Inspection Date	Inspector Name	Maintenance Type	Notes
12/9/2025	John Sablan	Remove Leaves/Sediment	Replaced placard

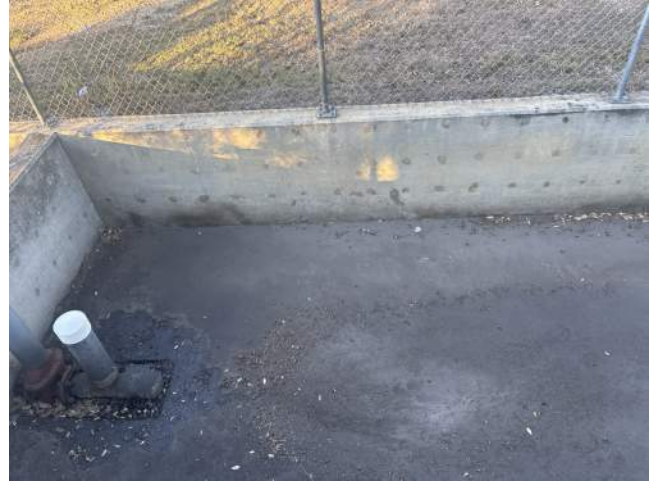
Location ID: B-005
Location Description: Express Lube PCD
Type: BMP
Latitude: 29.607812
Longitude: -98.491341
Current Maintenance Status: Needs Maintenance

Inspection Date	Inspector Name	Maintenance Type	Notes
12/9/2025	Jones Ard	Remove Leaves/Sediment	Remove additional trash/rag near fence.

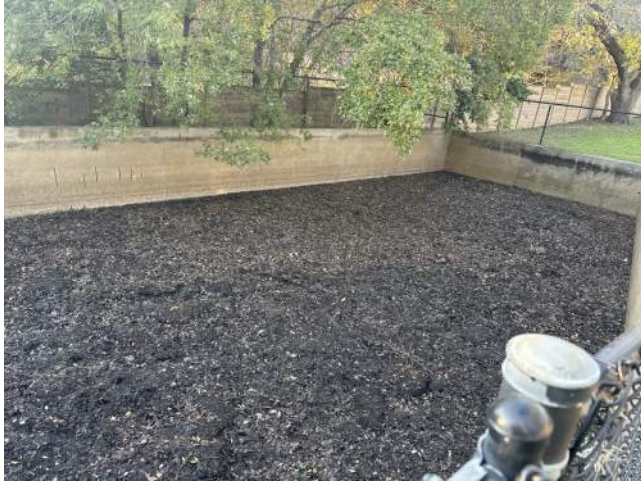
Location ID: B-006
Location Description: CRT Flooring Concepts
Type: BMP
Latitude: 29.607619
Longitude: -98.490902
Current Maintenance Status: Needs Maintenance

Inspection Date	Inspector Name	Maintenance Type	Notes
12/9/2025	Jones Ard	Remove Leaves/Sediment

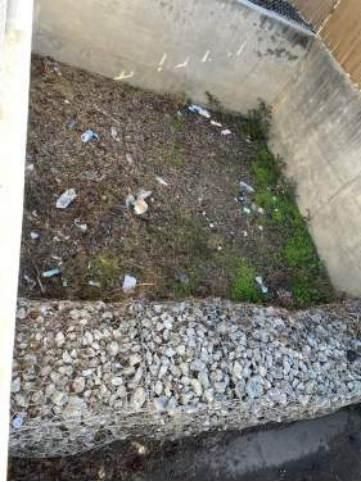
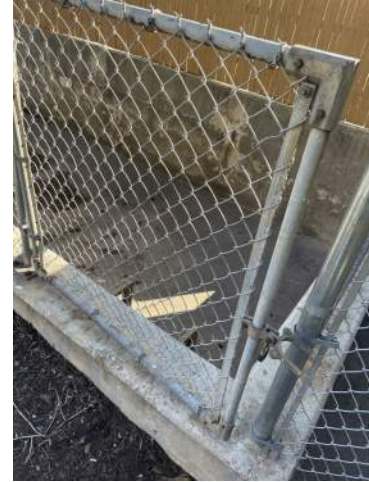
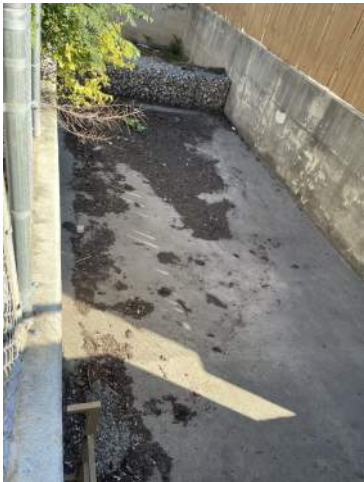
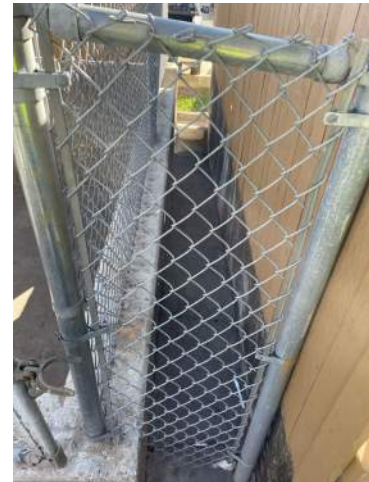
Location ID: B-008
Location Description: Pantheon commercial Strip PCD
Type: BMP
Latitude: 29.595683
Longitude: -98.474413
Current Maintenance Status: Needs Maintenance

Inspection Date	Inspector Name	Maintenance Type	Notes
12/9/2025	John Sablan	Remove Trash/Debris	Fix gate latch and lock

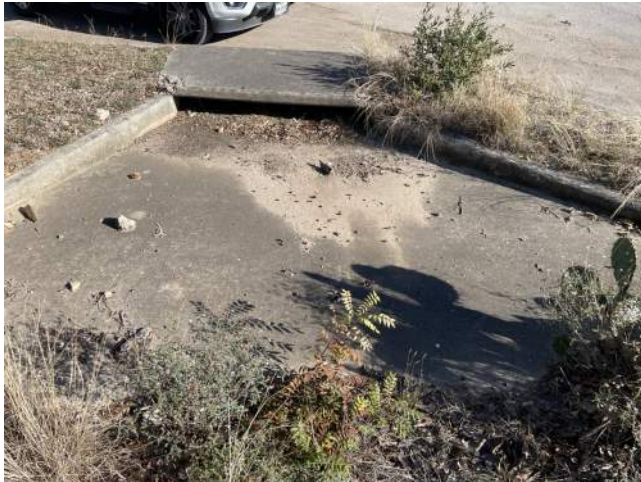
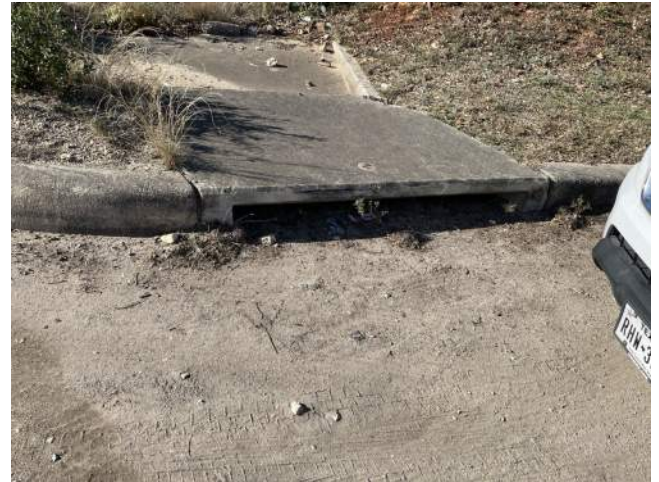
Location ID: I-008
Location Description: Oak Creek Ct
Type: Inlet
Latitude: 29.59115
Longitude: -98.475654
Current Maintenance Status: Needs Maintenance

Inspection Date	Inspector Name	Maintenance Type	Notes
12/10/2025	John Sablan	Trim Vegetation	Replacing medallion

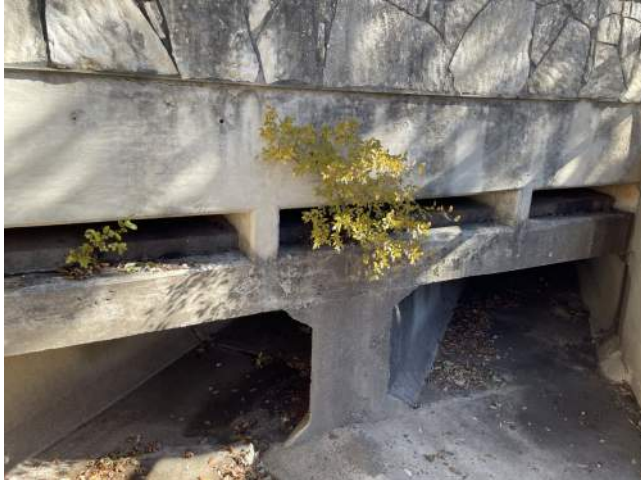
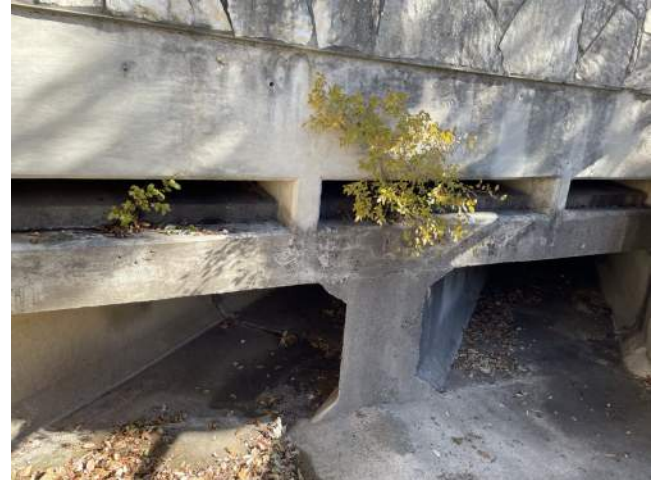
Location ID: I-015
Location Description: Navato Blvd 2
Type: Inlet
Latitude: 29.589509
Longitude: -98.47854
Current Maintenance Status: Needs Maintenance

Inspection Date	Inspector Name	Maintenance Type	Notes
12/9/2025	John Sablan	Trim Vegetation	Remove bush

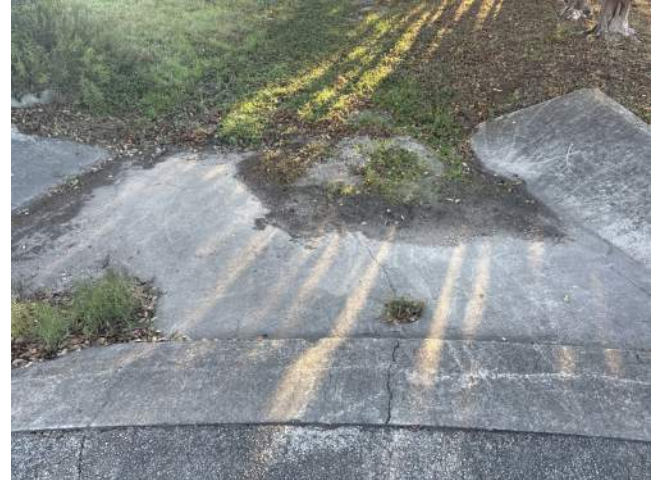
Location ID: O-001
Location Description: Voigt Park 4
Type: Outfall
Latitude: 29.599268
Longitude: -98.501333
Current Maintenance Status: Needs Maintenance

Inspection Date	Inspector Name	Maintenance Type	Notes
12/10/2025	Jones Ard	Remove Leaves/Sediment	Remove sediment from concrete riprap

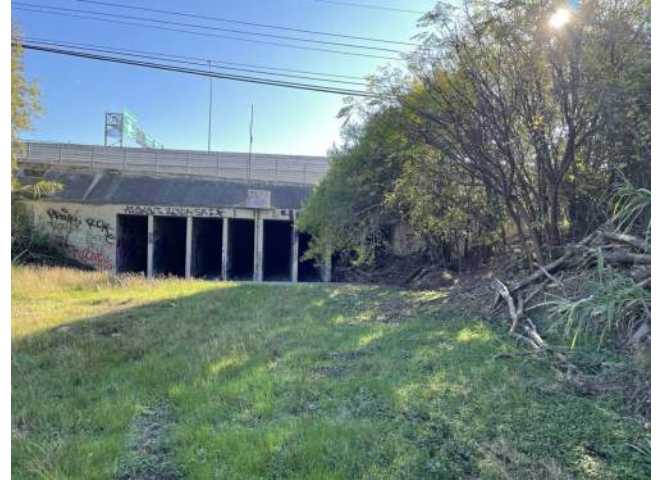
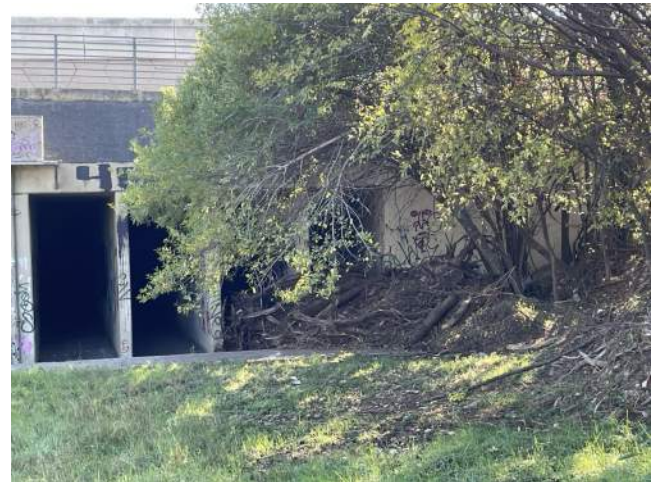
O-007	TXDOT at Lorence Creek	Outfall	Remove brush blocking 2 southern most box culverts
B-001	Valvoline PCD	BMP	Remove leaves/sediment
I-012	Voigt Dr Grate	Inlet	Remove trash/debris and monitor nearby traffic equipment
OT-009	Voigt Dr Leaves	Other	Remove leaves from the street
O-016	Voigt Park 3	Outfall	Trim vegetation
O-001	Voigt Park 4	Outfall	Trim vegetation
O-025	Voigt Park Outfall North	Outfall	Remove glass bottle and leaves from outfall
O-017	William Classen Dr	Outfall	Remove leaves/sediment
P-001	Yosemite Dr Crossing East	Pipe	Remove pumpkins from channel
P-002	Yosemite Dr Crossing West	Pipe	Remove pumpkins from channel

Inspection Date	Inspector Name	Maintenance Type	Notes
12/9/2025	John Sablan	Remove Trash/Debris	Remove brush blocking 2 southern most box culverts

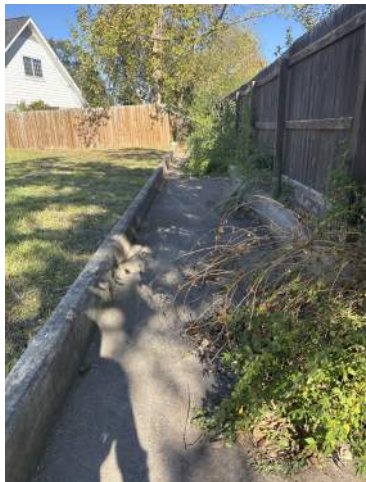
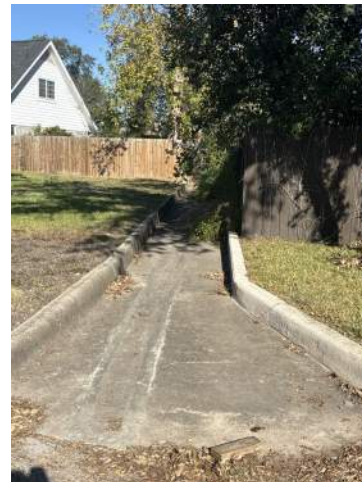
Location ID: O-024
Location Description: Shady Trails St Rundown
Type: Outfall
Latitude: 29.606344
Longitude: -98.477446
Current Maintenance Status: No Maintenance Required

Inspection Date	Inspector Name	Maintenance Type	Notes
12/10/2025	Jones Ard	Trim Vegetation	Also remove wood from channel

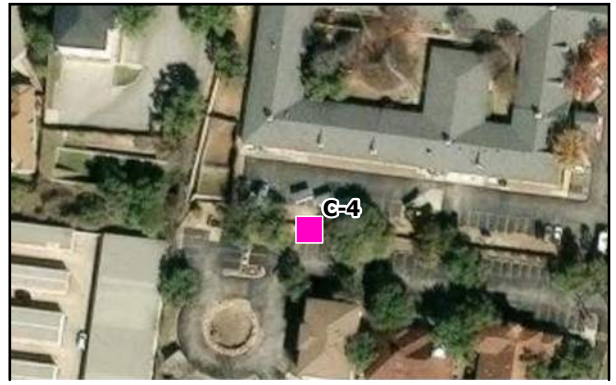
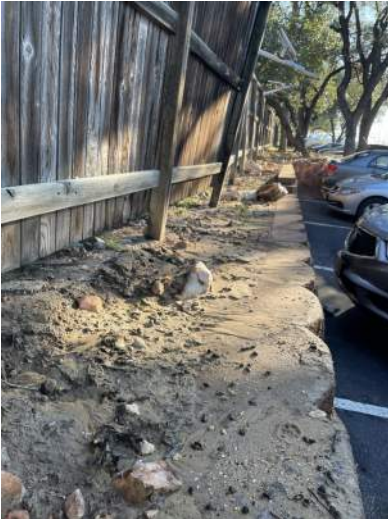
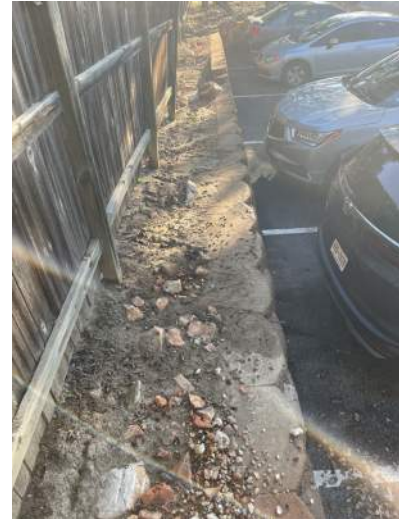
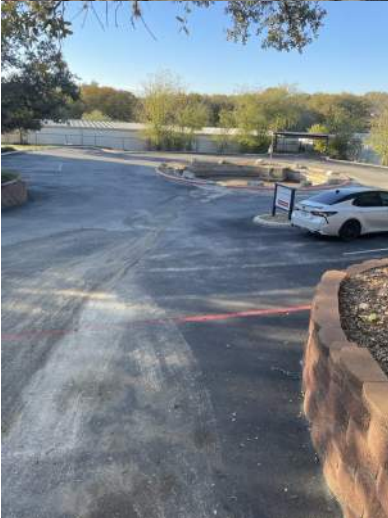
Location ID: C-4
Location Description: Orthodontist parking lot
Type: Construction
Latitude: 29.59553
Longitude: -98.473849
Current Maintenance Status: Needs Maintenance
Current Inspection Date: 12/9/2025 8:41:11.071 PM
Inspector Name: Jones Ard
Maintenance Type: Runoff/Sediment Control
Notes: Runoff from Brookdale pushing lots of sediment to BMP in parking lot. Assuming may be broken sprinkler head on Brookdale side.
