TOWN OF HOLLYWOOD PARK, TX

2026 MS4 Summer Inspections Report

Date: July 24, 2026

Subject: Semiannual Municipal Separate Storm Sewer System (MS4) Inspection

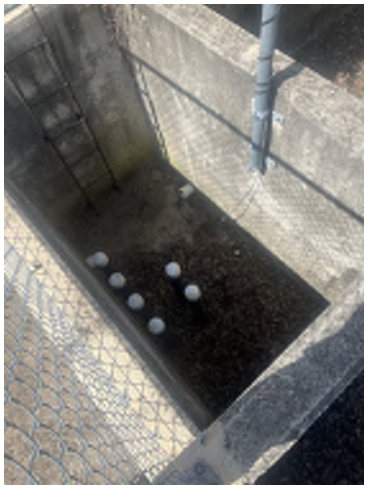
Location ID: B-006
Location Description: CRT Flooring Concepts
Type: BMP
Latitude: 29.607619
Longitude: -98.490902
Current Maintenance Status: Needs Maintenance

Inspection Date	Inspector Name	Maintenance Type	Notes
7/8/2026	Jones Ard	Remove Leaves/Sediment

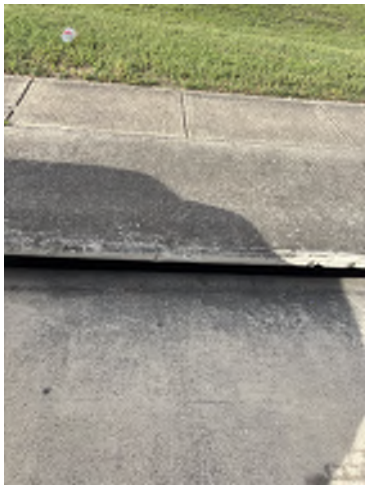
Location ID: I-001
Location Description: OAK-1-1
Type: Inlet
Latitude: 29.591142
Longitude: -98.474825
Current Maintenance Status: No Maintenance Required

Inspection Date	Inspector Name	Maintenance Type	Notes
7/8/2026	Jones Ard	None

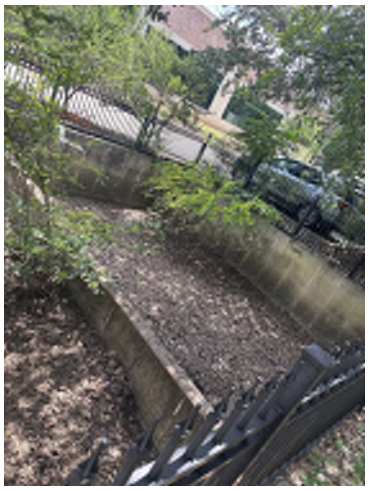
Location ID: I-009
Location Description: Marriott Global Reservation PCD
Type: Inlet
Latitude: 29.59983
Longitude: -98.474616
Current Maintenance Status: Needs Maintenance

Inspection Date	Inspector Name	Maintenance Type	Notes
7/8/2026	Jones Ard	Remove Leaves/Sediment

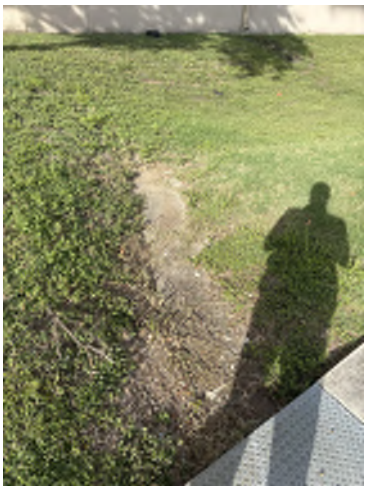
Location ID: I-011
Location Description: Monarch Trophy Swale
Type: Inlet
Latitude: 29.591094
Longitude: -98.474776
Current Maintenance Status: No Maintenance Required

Inspection Date	Inspector Name	Maintenance Type	Notes
7/8/2026	Jones Ard	None

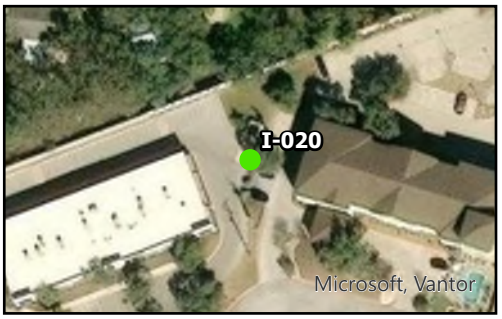
Location ID: I-020
Location Description: New Drash Parking Lot
Type: Inlet
Latitude: 29.591729
Longitude: -98.475521
Current Maintenance Status: Needs Maintenance

Inspection Date	Inspector Name	Maintenance Type	Notes
7/8/2026	Jones Ard	Remove Trash/Debris

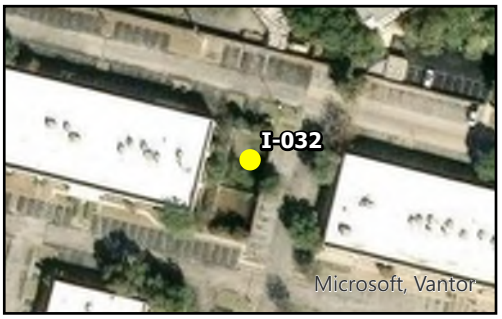
Location ID: I-032
Location Description: Miner fleet PCD
Type: Inlet
Latitude: 29.600847
Longitude: -98.47291
Current Maintenance Status: Needs Maintenance

Inspection Date	Inspector Name	Maintenance Type	Notes
7/8/2026	Jones Ard	Trim Vegetation

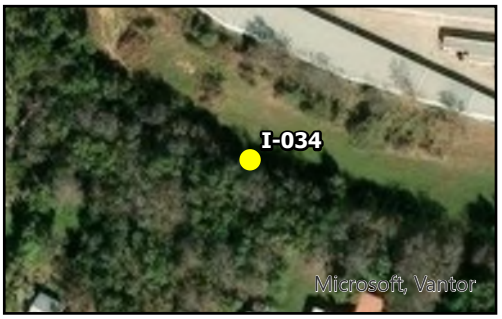
Location ID: I-034
Location Description: Stream Gauge
Type: Inlet
Latitude: 29.594943
Longitude: -98.47544
Current Maintenance Status: No Maintenance Required

Inspection Date	Inspector Name	Maintenance Type	Notes
7/8/2026	Jones Ard	None

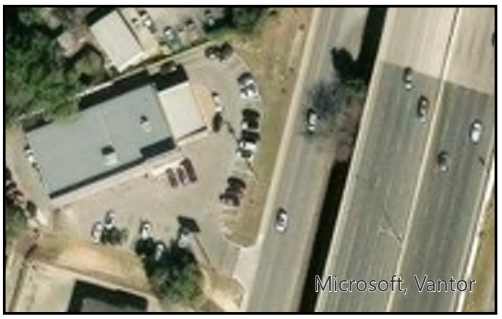
Location ID: I-035
Location Description: Premier Autocare Grate
Type: Inlet
Latitude: 29.592145
Longitude: -98.473866
Current Maintenance Status: No Maintenance Required

Inspection Date	Inspector Name	Maintenance Type	Notes
7/8/2026	Jones Ard

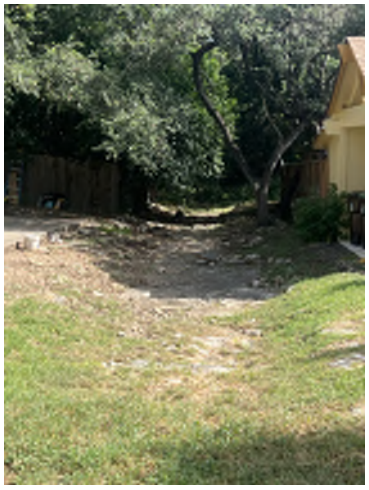
Location ID: O-021
Location Description: Grand Oak St
Type: Outfall
Latitude: 29.605509
Longitude: -98.482092
Current Maintenance Status: No Maintenance Required

Inspection Date	Inspector Name	Maintenance Type	Notes
7/8/2026	Kyle Kinnett	None

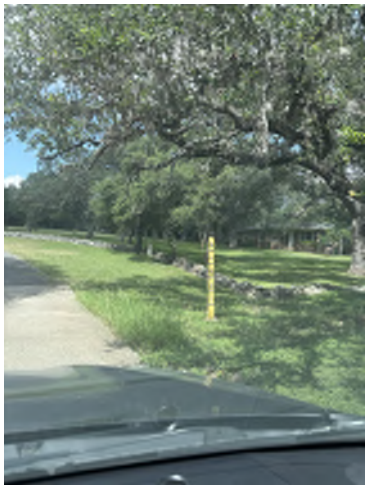
Location ID: OT-004
Location Description: Coolway Dr Low Water Crossing
Type: Other
Latitude: 29.591331
Longitude: -98.480204
Current Maintenance Status: No Maintenance Required

Inspection Date	Inspector Name	Maintenance Type	Notes
7/8/2026	Jones Ard	None

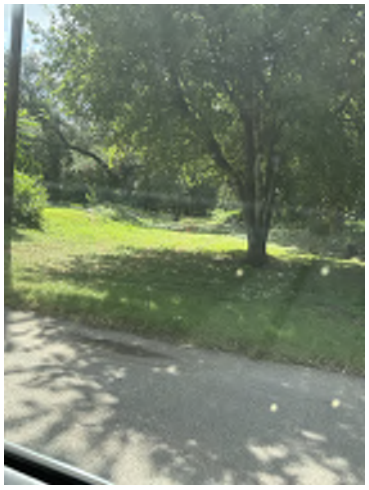
Location ID: OT-005
Location Description: El Cerrito Cir 2 LWC
Type: Other
Latitude: 29.59319
Longitude: -98.484912
Current Maintenance Status: No Maintenance Required

Inspection Date	Inspector Name	Maintenance Type	Notes
7/8/2026	Jones Ard	None
