TOWN OF HOLLYWOOD PARK, TX

2025 Winter Inspection

HOLLYWOOD PARK 2025 WINTER INSPECTION REPORT

Subject: Semiannual Municipal Separate Storm Sewer System (MS4) Inspection

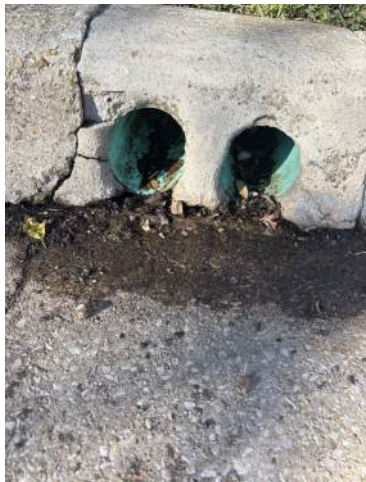
Location ID: B-001
Location Description: Valvoline PCD
Type: BMP
Latitude: 29.591517
Longitude: -98.474603
Current Maintenance Status: Needs Maintenance

Inspection Date	Inspector Name	Maintenance Type	Notes
12/9/2025	John Sablan	Remove Leaves/Sediment

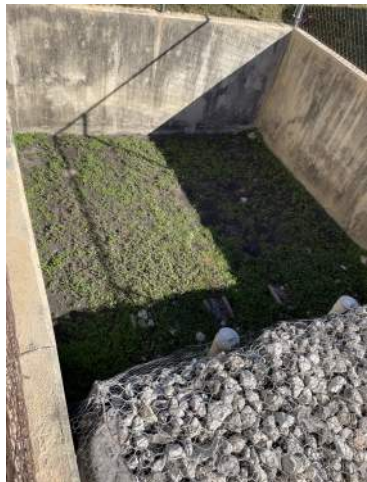
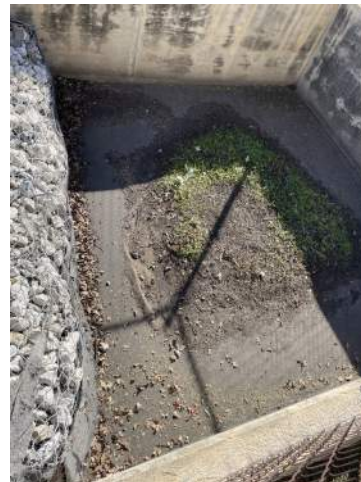
Location ID: B-002
Location Description: Optometrist Roundabout PCD
Type: BMP
Latitude: 29.595278
Longitude: -98.47408
Current Maintenance Status: Needs Maintenance

Inspection Date	Inspector Name	Maintenance Type	Notes
12/9/2025	John Sablan	Remove Leaves/Sediment	Replaced placard

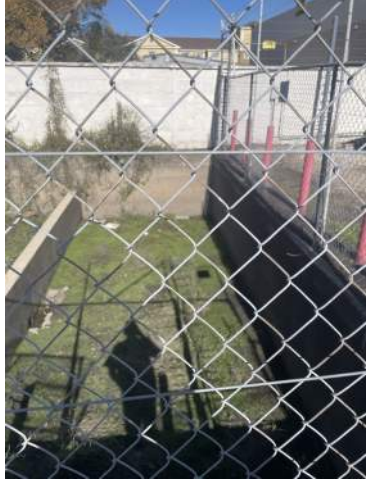
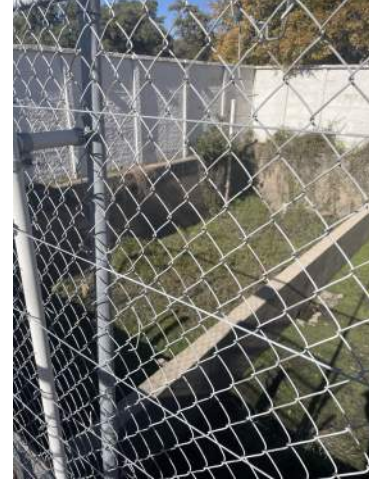
Location ID: B-003
Location Description: Service King Collision Repair PCD
Type: BMP
Latitude: 29.59075
Longitude: -98.475436
Current Maintenance Status: Needs Maintenance

Inspection Date	Inspector Name	Maintenance Type	Notes
12/9/2025	John Sablan	Trim Vegetation

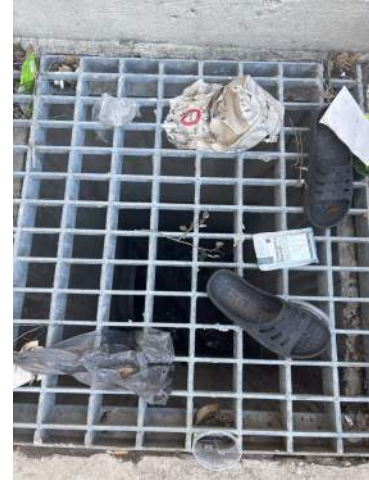
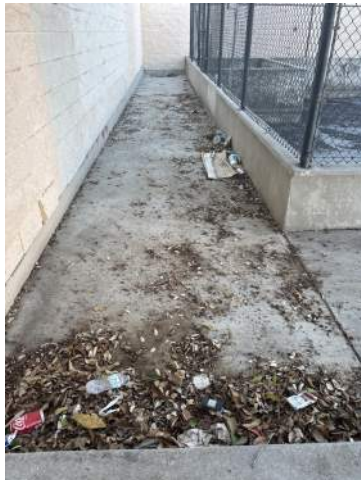
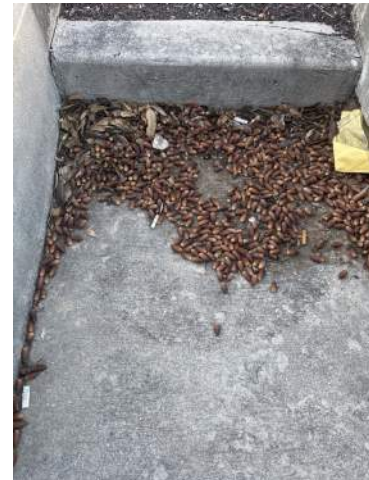
Location ID: B-004
Location Description: Corner Store PCD
Type: BMP
Latitude: 29.607578
Longitude: -98.491624
Current Maintenance Status: Illicit Discharge

Feature ID	Feature name/Location	Feature	Illicit Discharge
B-004	Corner Store PCD	BMP	Cigarette Butts around the outside of BMP
I-009	Marriott Global Reservation PCD	Inlet	Cigarettes in channel

12/9/2025	Jones Ard	Remove Trash/Debris	Remove cigarette butts around the outside of BMP and clean up acorns and trash that have collected in the channel, grate, and basin.
-----------	-----------	---------------------	--

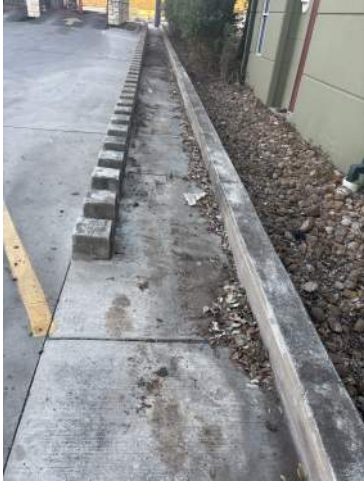
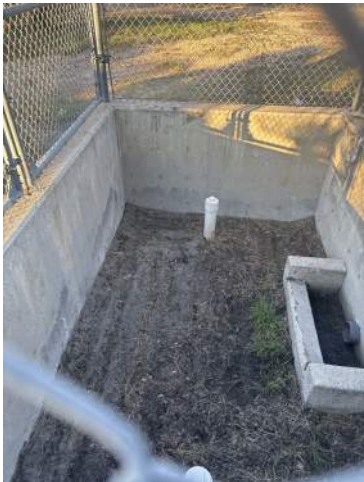
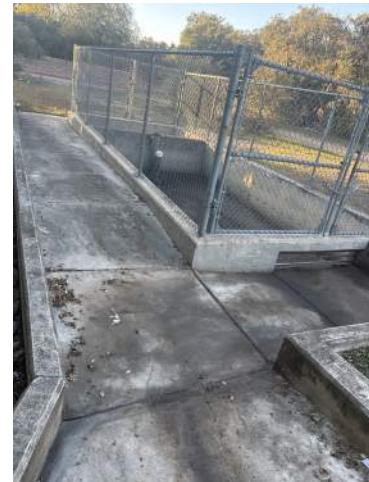
Location ID: B-005
Location Description: Express Lube PCD
Type: BMP
Latitude: 29.607812
Longitude: -98.491341
Current Maintenance Status: Needs Maintenance

Inspection Date	Inspector Name	Maintenance Type	Notes
12/9/2025	Jones Ard	Remove Leaves/Sediment	Remove additional trash/rag near fence.

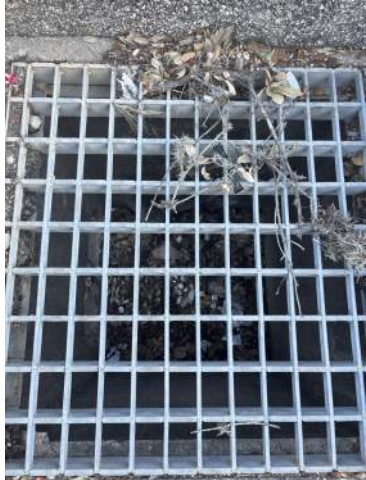
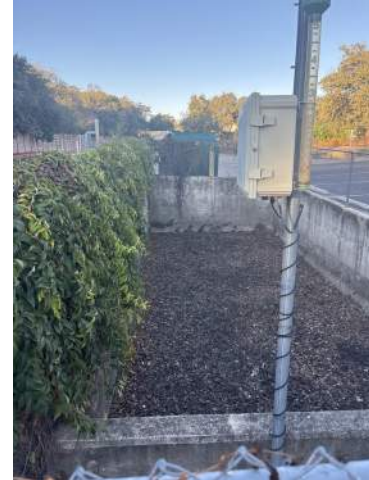
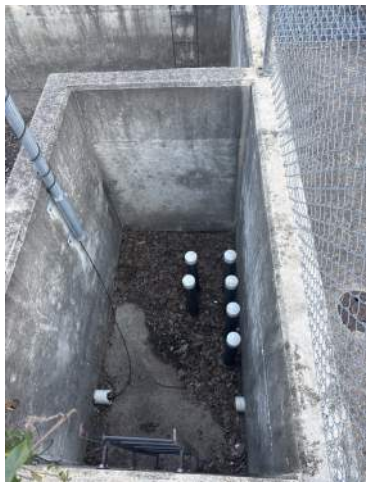
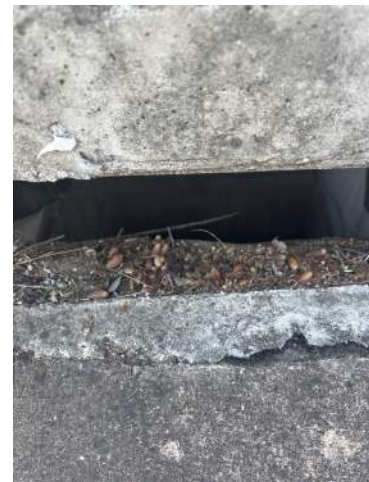
Location ID: B-006
Location Description: CRT Flooring Concepts
Type: BMP
Latitude: 29.607619
Longitude: -98.490902
Current Maintenance Status: Needs Maintenance

Inspection Date	Inspector Name	Maintenance Type	Notes
12/9/2025	Jones Ard	Remove Leaves/Sediment	Also remove vines from fence and trash from grate.

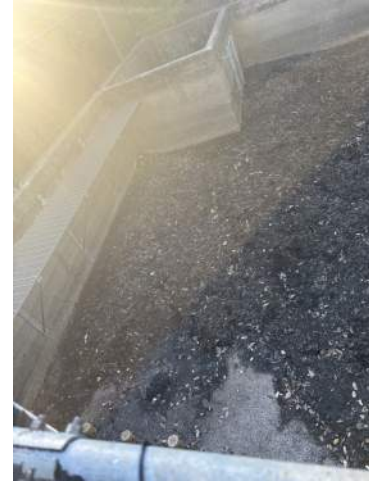
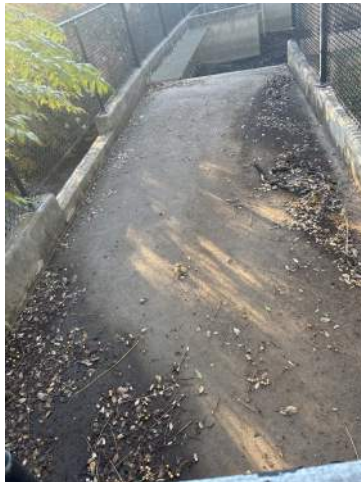
Location ID: B-007
Location Description: Chicago Title PCD
Type: BMP
Latitude: 29.607645
Longitude: -98.489883
Current Maintenance Status: Needs Maintenance

Inspection Date	Inspector Name	Maintenance Type	Notes
12/9/2025	Jones Ard	Remove Leaves/Sediment

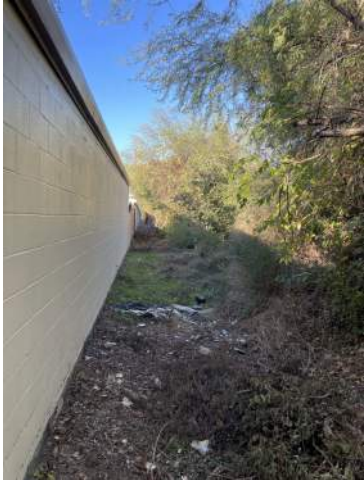
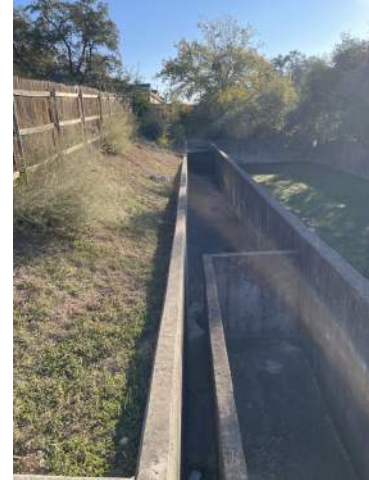
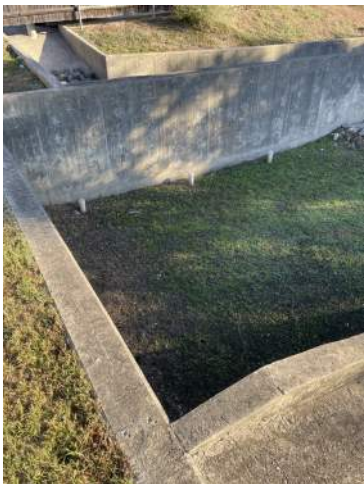
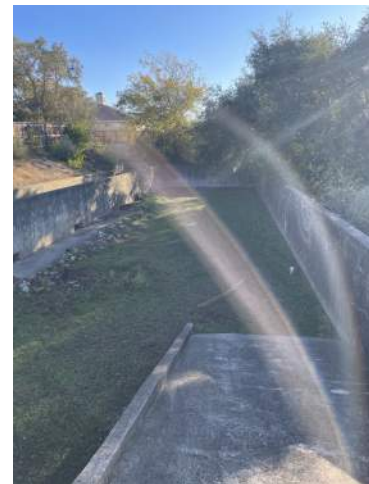
Location ID: B-008
Location Description: Pantheon commercial Strip PCD
Type: BMP
Latitude: 29.595683
Longitude: -98.474413
Current Maintenance Status: Needs Maintenance

Inspection Date	Inspector Name	Maintenance Type	Notes
12/9/2025	John Sablan	Remove Trash/Debris	Remove trash in BMP, adjacent channel full of sediment, vegetation, and trash

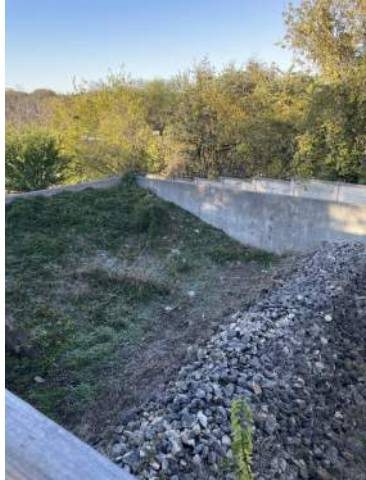
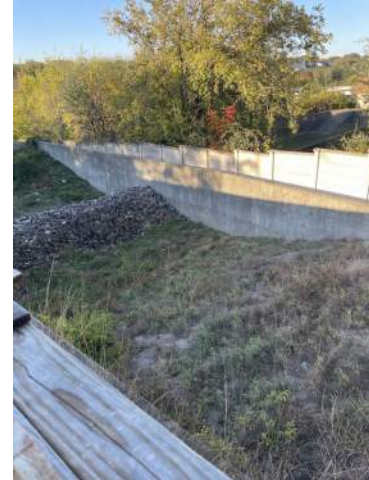
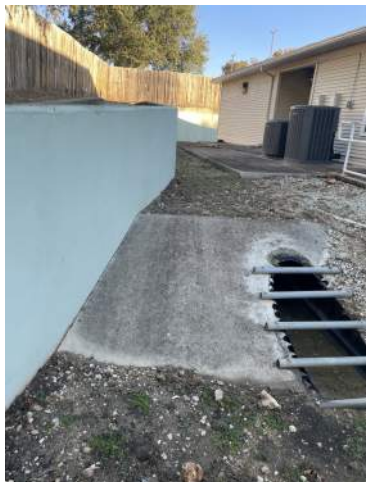
Location ID: B-009
Location Description: Brookdale PCD
Type: BMP
Latitude: 29.595694
Longitude: -98.474113
Current Maintenance Status: No Maintenance Required

Inspection Date	Inspector Name	Maintenance Type	Notes
12/9/2025	John Sablan		Looks good monitor sediment buildup

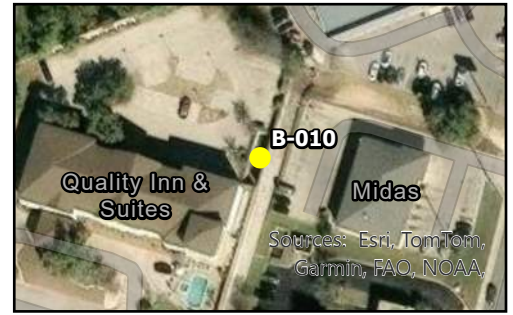
Location ID: B-010
Location Description: Holiday Inn PCD
Type: BMP
Latitude: 29.591731
Longitude: -98.47466
Current Maintenance Status: Needs Maintenance

O-021	Grand Oak St	Outfall	Remove pumpkin from channel
B-010	Holiday Inn PCD	BMP	Remove trash/debris, fix gate latch and lock
I-009	Marriott Global Reservation PCD	Inlet	Remove cigarettes from channel and leaves from basin
I-003	MEC-I-2	Inlet	Remove debris preventing cover from closing
I-032	Miner Fleet PCD	Inlet	Trim vegetation and remove sediment
I-015	Navato Blvd 2	Inlet	Trim vegetation, remove brush
O-003	Northoak Dr	Outfall	Remove loose sediment from concrete riprap
P-005	Northoak Dr Crossing	Pipe	Trim vegetation
P-008	Northoak Dr Private Crossing West	Pipe	Trim vegetation
I-008	Oak Creek Ct	Pipe	Remove trash/debris
B-002	Optometrist Roundabout PCD	BMP	Replaced placard
B-008	Pantheon Commercial Strip PCD	BMP	Remove trash in BMP, adjacent channel full of sediment, vegetation, and trash
O-002	Park Oak	Outfall	Trim vegetation and remove hay bale from channel
O-015	Paseo Canada St 1	Outfall	Remove pumpkins from channel and rocks blocking culvert outfall

Inspection Date	Inspector Name	Maintenance Type	Notes
12/9/2025	John Sablan	Remove Trash/Debris	Fix gate latch and lock

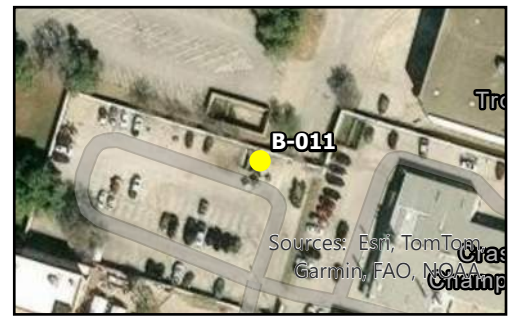
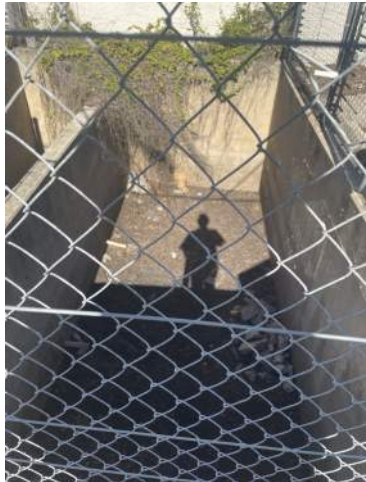
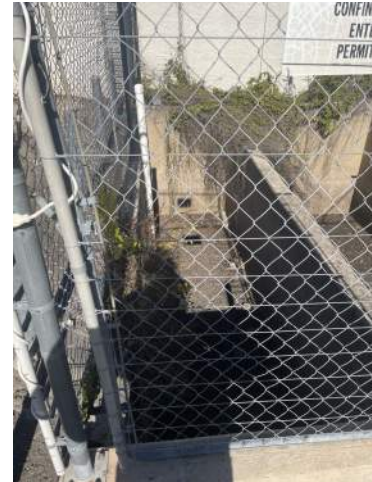
Location ID: B-011
Location Description: Service King Collision Repair Extended Parking PCD
Type: BMP
Latitude: 29.590678
Longitude: -98.475728
Current Maintenance Status: Needs Maintenance

Inspection Date	Inspector Name	Maintenance Type	Notes
12/9/2025	John Sablan	Runoff/Sediment Control

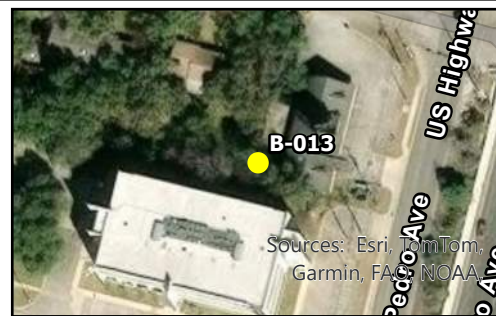
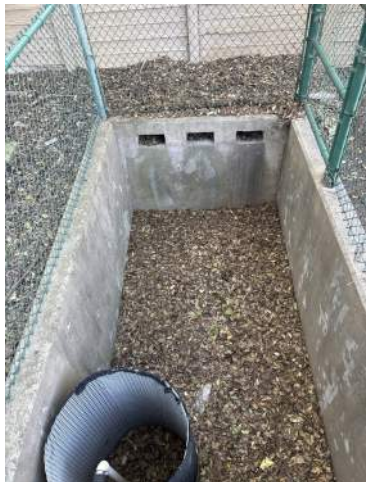
Location ID: B-013
Location Description: PCD2 Pediatrics
Type: BMP
Latitude: 29.598283
Longitude: -98.472417
Current Maintenance Status: Needs Maintenance

O-012	Paseo Canada St 2	Outfall	Remove glass bottle and pieces of paper in channel
B-013	PCD2 Pediatrics	BMP	Remove leaves/sediment
B-014	Pediatric Dentistry Office PCD	BMP	Remove trash/debris and remove sign and vegetation from basin
I-019	Premier 1 Autocare 2	Inlet	Trim vegetation
O-008	Public Storage	Outfall	Trim vegetation
O-026	Rua De Matta St Channel	Outfall	Trim vegetation and remove wood
P-003	Sagecrest Dr Crossing West	Pipe	Remove bucket from underneath culvert and pumpkins from channel
B-011	Service King Collision Repair Extended Parking PCD	BMP	Runoff/sediment control
B-003	Service King Collision Repair PCD	BMP	Trim vegetation
C-11	Spoil Pile Tall Oak Dr	Other	Spoil pile left out after construction. Needs a long term storage solution.
P-006	Sterling Browning Crossing	Pipe	Remove leaves/sediment and remove rocks from culvert inlets
I-034	Stream Gauge	Inlet	Remove leaves/sediment and trim vegetation

Inspection Date	Inspector Name	Maintenance Type	Notes
12/9/2025	Jones Ard	Remove Leaves/Sediment

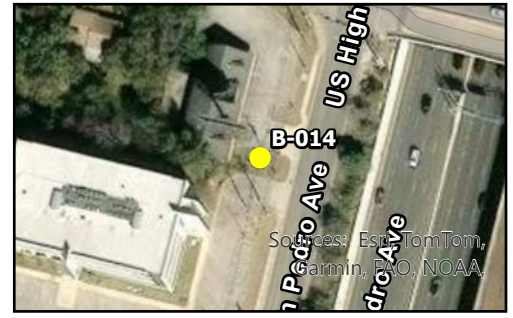
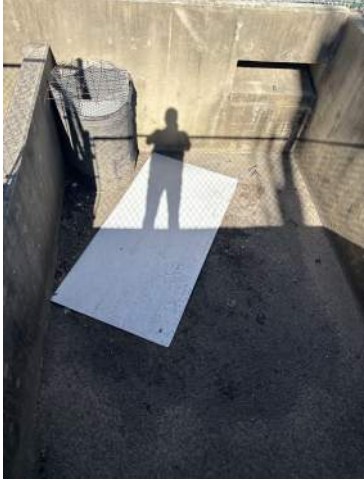
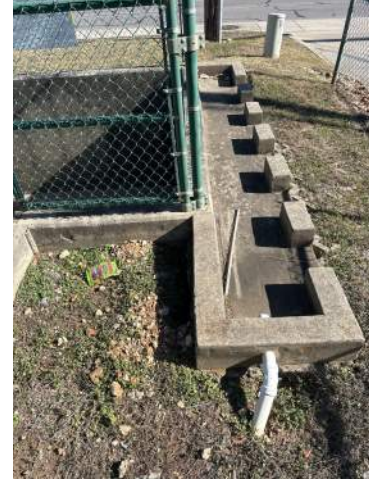
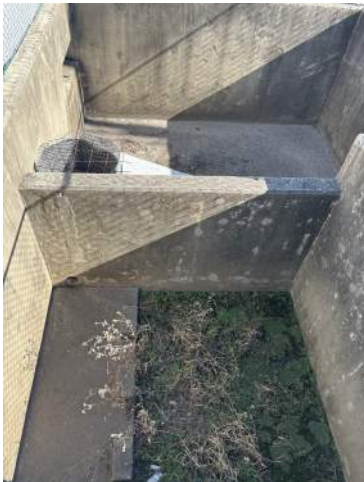
Location ID: B-014
Location Description: Pediatric Dentistry Office PCD
Type: BMP
Latitude: 29.598186
Longitude: -98.472159
Current Maintenance Status: Needs Maintenance

Inspection Date	Inspector Name	Maintenance Type	Notes
12/9/2025	Jones Ard	Remove Trash/Debris	Remove sign and vegetation

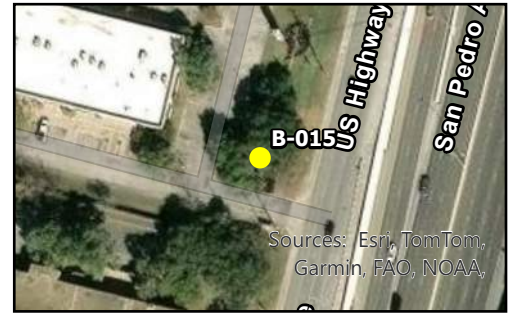
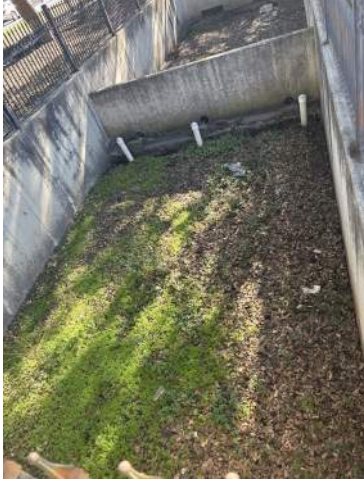
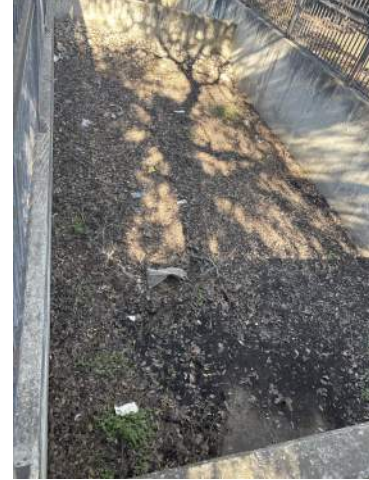
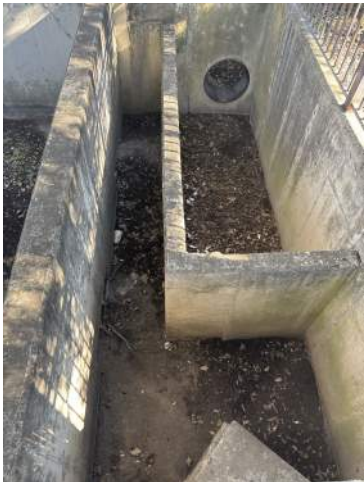
Location ID: B-015
Location Description: Chandler Signs North Park Corporate Center
Type: BMP
Latitude: 29.599954
Longitude: -98.471723
Current Maintenance Status: Needs Maintenance

Inspection Date	Inspector Name	Maintenance Type	Notes
12/9/2025	Jones Ard	Remove Leaves/Sediment	Also trim vegetation

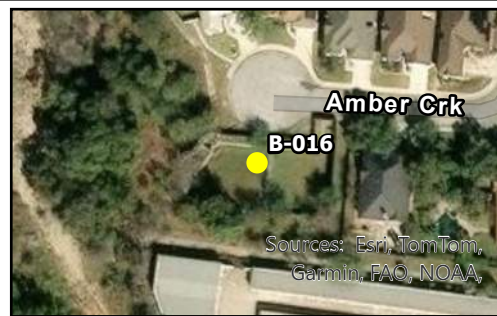
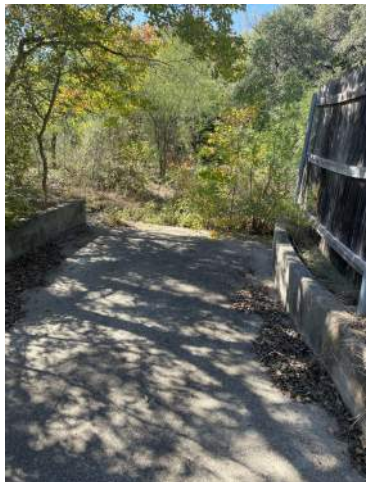
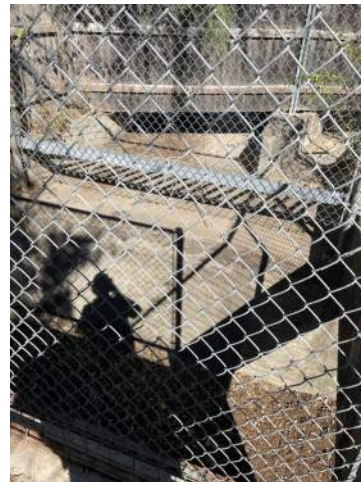
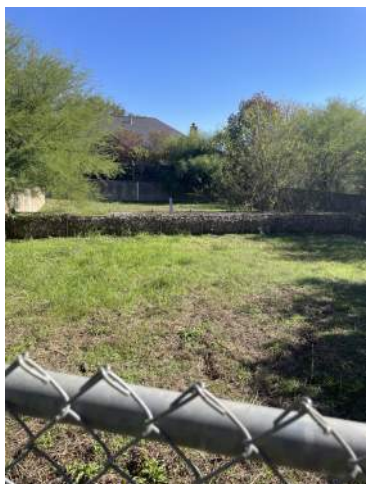
Location ID: B-016
Location Description: Amber Creek PCD
Type: BMP
Latitude: 29.595877
Longitude: -98.475487
Current Maintenance Status: Needs Maintenance

Inspection Date	Inspector Name	Maintenance Type	Notes
12/9/2025	John Sablan	Trim Vegetation	Trim vegetation at overflow channel

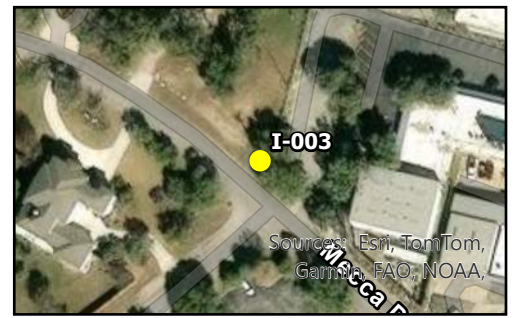
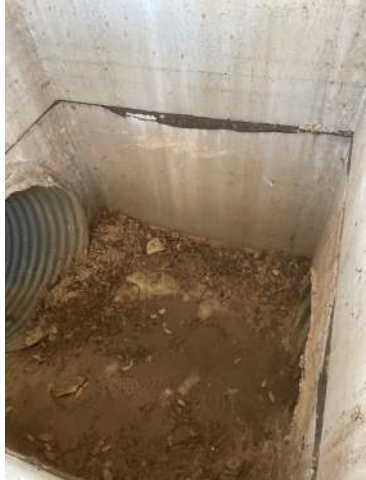
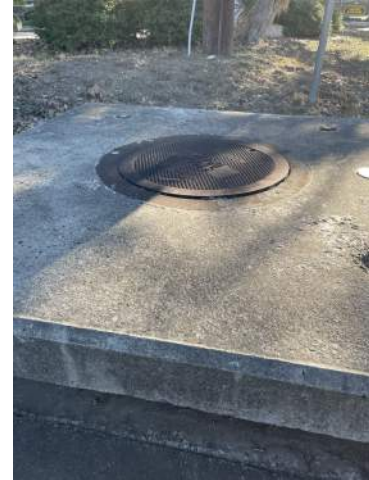
Location ID: I-003
Location Description: MEC-I-2
Type: Inlet
Latitude: 29.59357
Longitude: -98.474433
Current Maintenance Status: Needs Maintenance

Inspection Date	Inspector Name	Maintenance Type	Notes
12/10/2025	John Sablan	Other	Remove debris preventing cover from closing

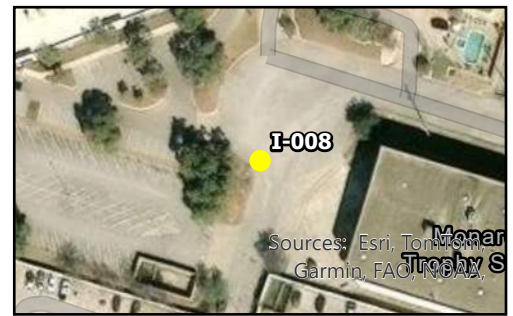
Location ID: I-008
Location Description: Oak Creek Ct
Type: Inlet
Latitude: 29.59115
Longitude: -98.475654
Current Maintenance Status: Needs Maintenance

Inspection Date	Inspector Name	Maintenance Type	Notes
12/10/2025	John Sablan	Trim Vegetation	Replacing medallion

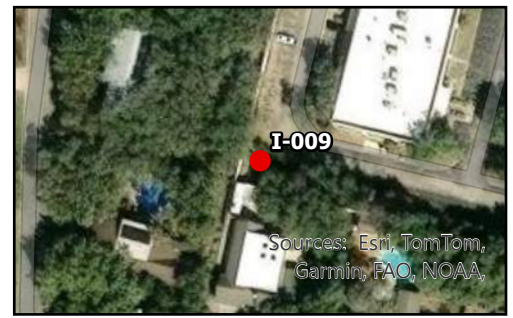
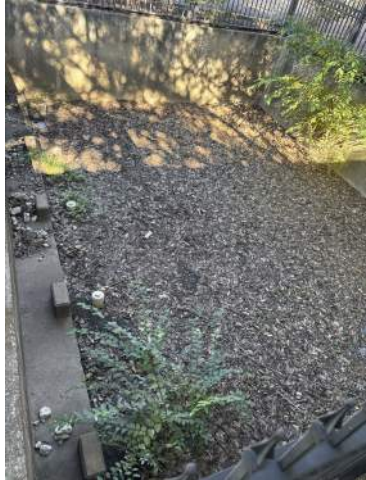
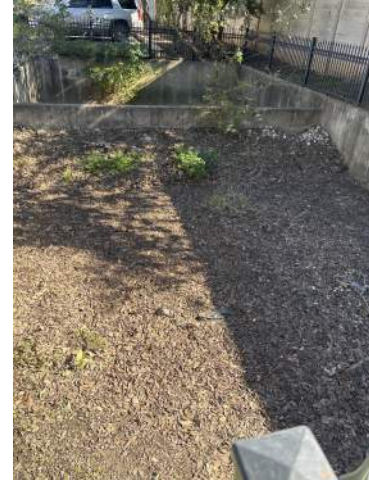
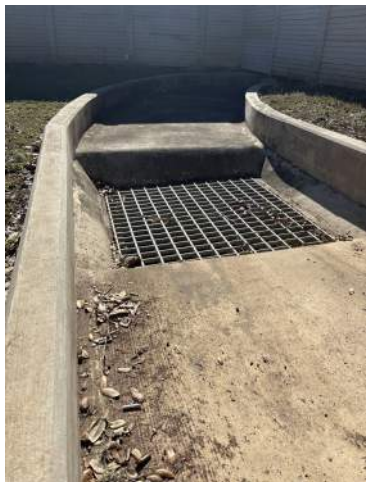
Location ID: I-009
Location Description: Marriott Global Reservation PCD
Type: Inlet
Latitude: 29.59983
Longitude: -98.474616
Current Maintenance Status: Illicit Discharge

Inspection Date	Inspector Name	Maintenance Type	Notes
12/9/2025	Jones Ard	Remove Leaves/Sediment	Cigarettes in channel. Also remove leaves from basin.

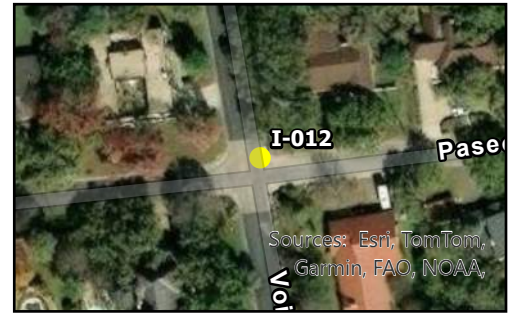
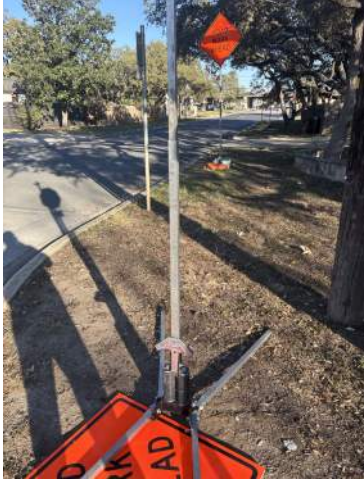
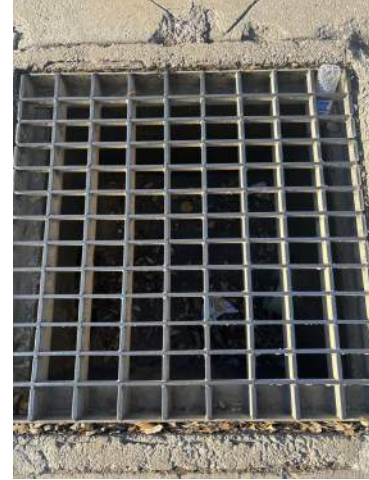
Location ID: I-012
Location Description: Voigt Dr Grate
Type: Inlet
Latitude: 29.606858
Longitude: -98.492292
Current Maintenance Status: Needs Maintenance

Inspection Date	Inspector Name	Maintenance Type	Notes
12/10/2025	Jones Ard	Remove Trash/Debris	Monitor nearby traffic equipment

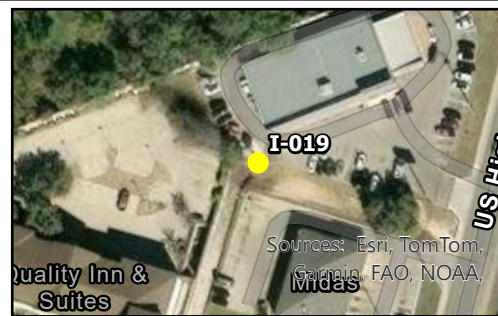
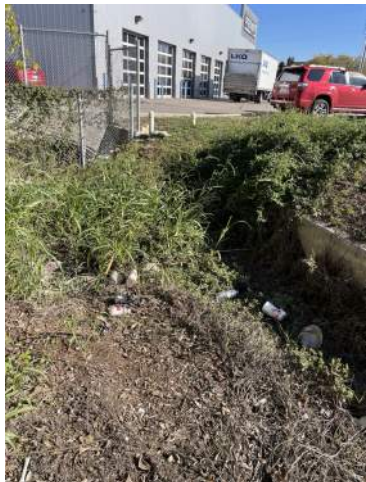
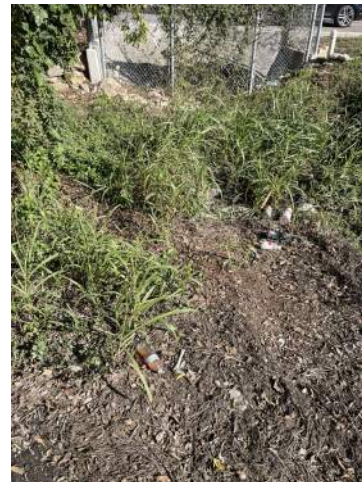
Location ID: I-019
Location Description: Premier 1 Autocare 2
Type: Inlet
Latitude: 29.591965
Longitude: -98.474525
Current Maintenance Status: Needs Maintenance

Inspection Date	Inspector Name	Maintenance Type	Notes
12/9/2025	John Sablan	Trim Vegetation

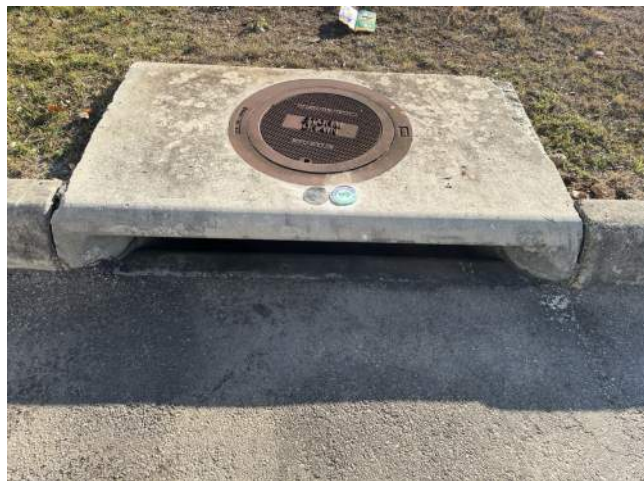
Location ID: I-022
Location Description: Varco 1
Type: Inlet
Latitude: 29.597591
Longitude: -98.472356
Current Maintenance Status: No Maintenance Required

Inspection Date	Inspector Name	Maintenance Type	Notes
12/9/2025	John Sablan		Replaced medallion

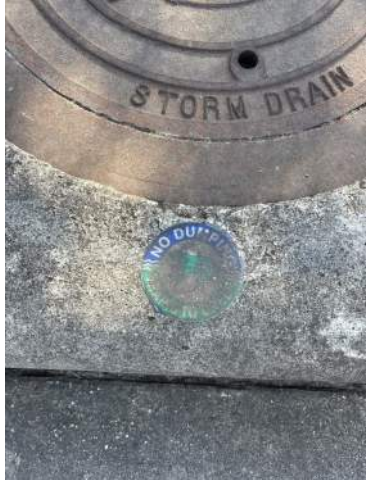
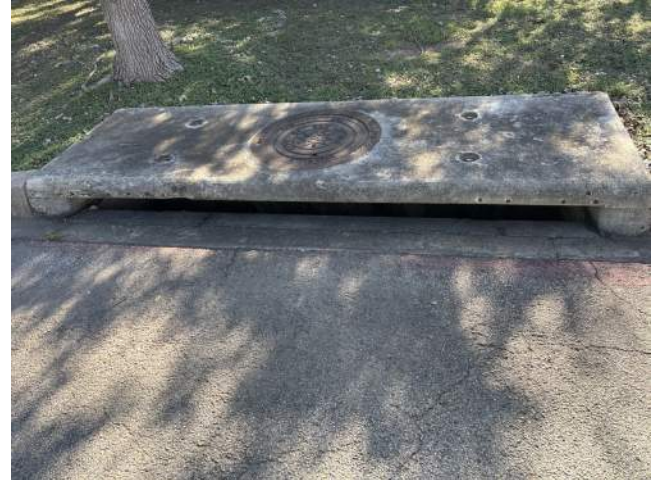
Location ID: I-026
Location Description: Parking lot box
Type: Inlet
Latitude: 29.599806
Longitude: -98.471909
Current Maintenance Status: No Maintenance Required

Inspection Date	Inspector Name	Maintenance Type	Notes
12/9/2025	Jones Ard		Monitor stormwater medallion. May need to replace.

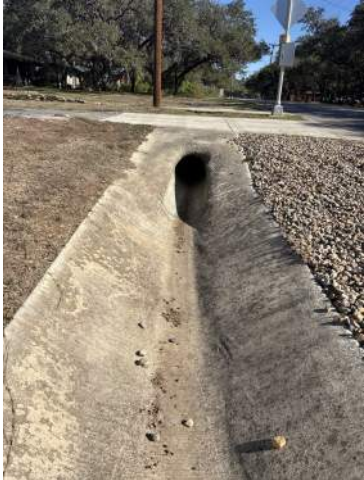
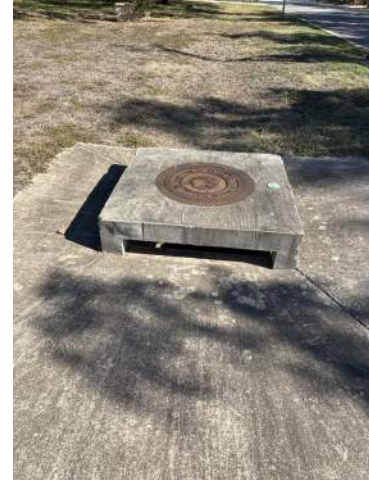
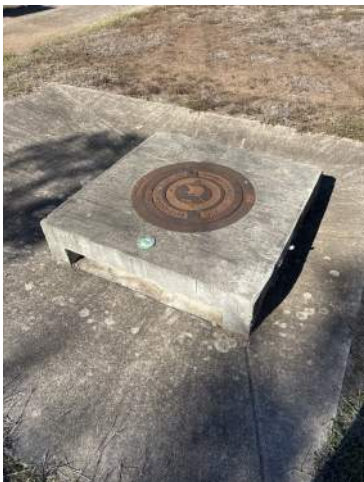
Location ID: I-028
Location Description: Donella Dr 1
Type: Inlet
Latitude: 29.599448
Longitude: -98.476156
Current Maintenance Status: No Maintenance Required

Inspection Date	Inspector Name	Maintenance Type	Notes
12/9/2025	Jones Ard		Monitor stormwater medallion. May need to replace.

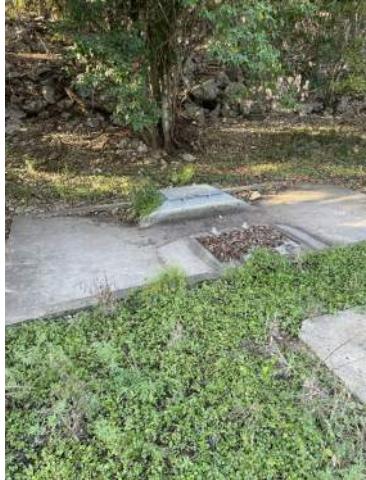
Location ID: I-034
Location Description: Stream Gauge
Type: Inlet
Latitude: 29.594943
Longitude: -98.47544
Current Maintenance Status: Needs Maintenance

Inspection Date	Inspector Name	Maintenance Type	Notes
12/10/2025	John Sablan	Remove Leaves/Sediment	Also trim vegetation

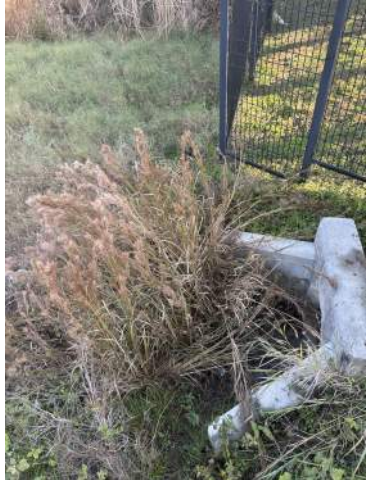
Location ID: O-001
Location Description: Voigt Park 4
Type: Outfall
Latitude: 29.599268
Longitude: -98.501333
Current Maintenance Status: Needs Maintenance

Inspection Date	Inspector Name	Maintenance Type	Notes
12/9/2025	Jones Ard	Trim Vegetation

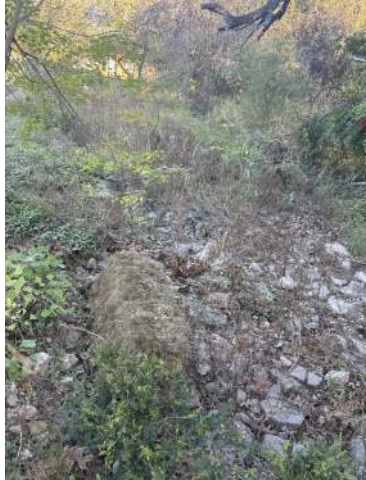
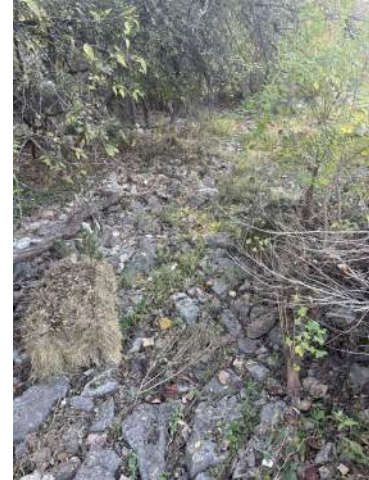
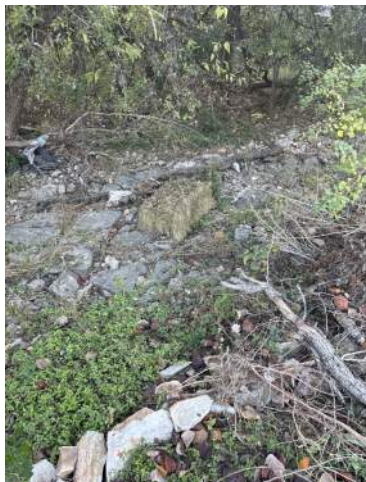
Location ID: O-002
Location Description: Park Oak
Type: Outfall
Latitude: 29.606363
Longitude: -98.487024
Current Maintenance Status: Needs Maintenance

Inspection Date	Inspector Name	Maintenance Type	Notes
12/9/2025	Jones Ard	Trim Vegetation	Also remove hay bale from channel

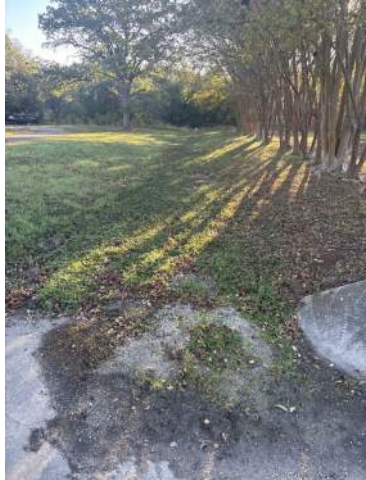
Location ID: O-003
Location Description: Northoak Dr
Type: Outfall
Latitude: 29.607314
Longitude: -98.487046
Current Maintenance Status: Needs Maintenance

Inspection Date	Inspector Name	Maintenance Type	Notes
12/10/2025	Jones Ard	Remove Leaves/Sediment	Remove sediment from concrete riprap

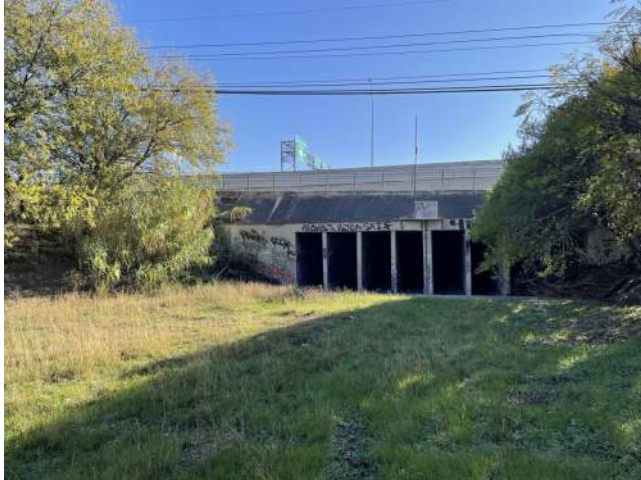
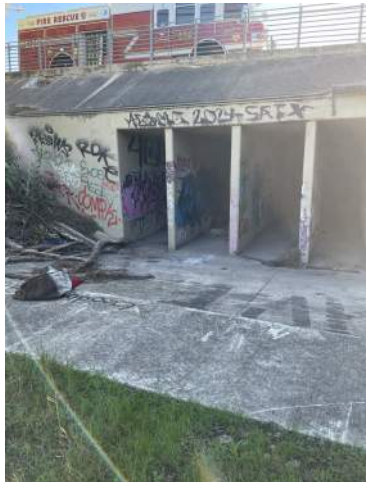
Location ID: O-007
Location Description: TXDOT at Lorence Creek
Type: Outfall
Latitude: 29.594381
Longitude: -98.473226
Current Maintenance Status: Needs Maintenance

Inspection Date	Inspector Name	Maintenance Type	Notes
12/9/2025	John Sablan	Remove Trash/Debris	Remove brush blocking 2 southern most box culverts

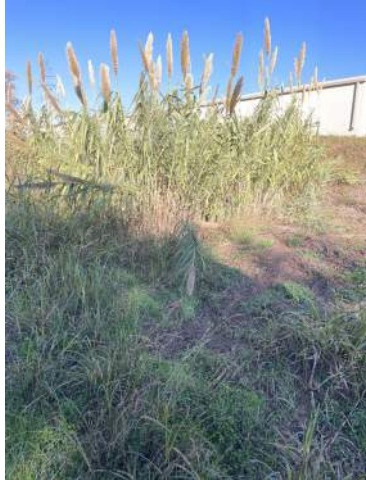
Location ID: O-008
Location Description: Public Storage
Type: Outfall
Latitude: 29.594819
Longitude: -98.47438
Current Maintenance Status: Needs Maintenance

Inspection Date	Inspector Name	Maintenance Type	Notes
12/9/2025	John Sablan	Trim Vegetation

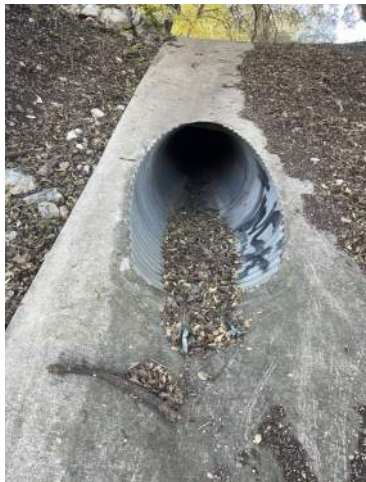
Location ID: O-009
Location Description: Mecca Inlets
Type: Outfall
Latitude: 29.594519
Longitude: -98.474119
Current Maintenance Status: No Maintenance Required

Inspection Date	Inspector Name	Maintenance Type	Notes
12/9/2025	John Sablan		Minor vegetation buildup

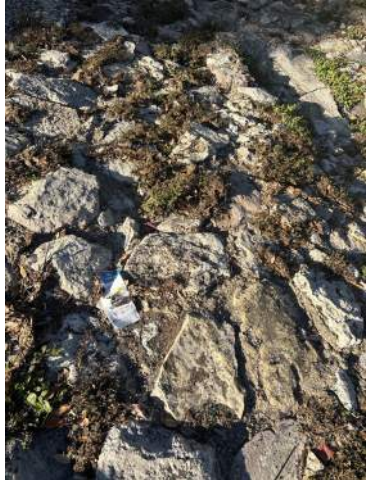
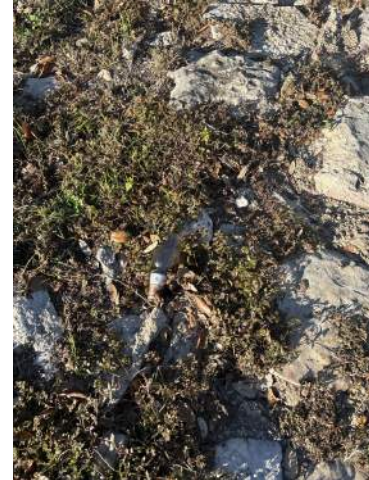
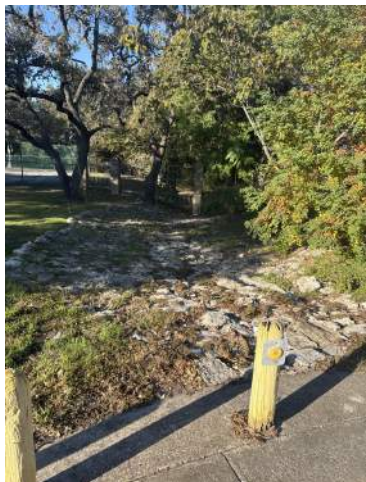
Location ID: O-012
Location Description: Paseo Canada St 2
Type: Outfall
Latitude: 29.606516
Longitude: -98.49506
Current Maintenance Status: Needs Maintenance

Inspection Date	Inspector Name	Maintenance Type	Notes
12/9/2025	Jones Ard	Remove Trash/Debris	Remove glass bottle and pieces of paper in channel

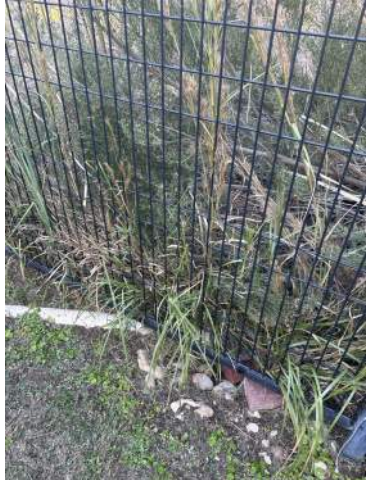
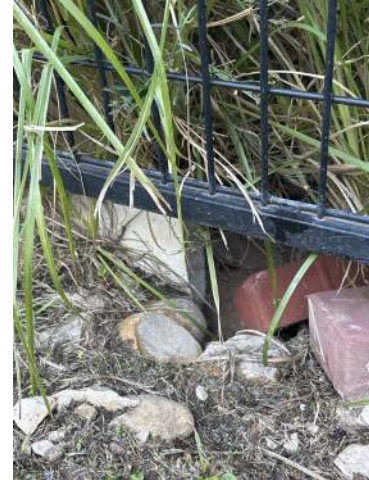
Location ID: O-017
Location Description: William Classen Dr
Type: Outfall
Latitude: 29.599871
Longitude: -98.475263
Current Maintenance Status: Needs Maintenance

Inspection Date	Inspector Name	Maintenance Type	Notes
12/9/2025	Jones Ard	Remove Leaves/Sediment

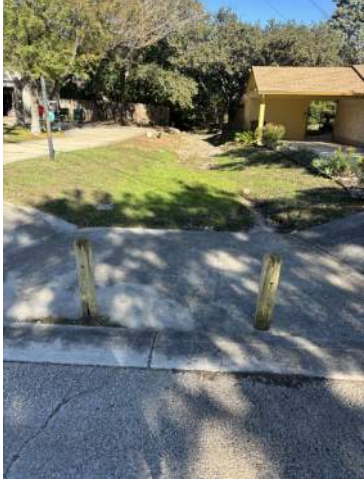
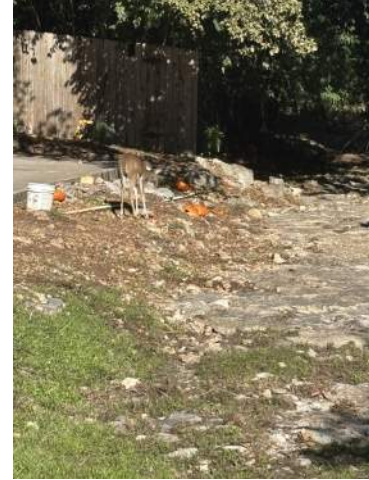
Location ID: 0-022
Location Description: Amber Creek Southern Outfall and Channel
Type: Outfall
Latitude: 29.59141
Longitude: -98.477155
Current Maintenance Status: Needs Maintenance

Inspection Date	Inspector Name	Maintenance Type	Notes
12/9/2025	John Sablan	Remove Leaves/Sediment

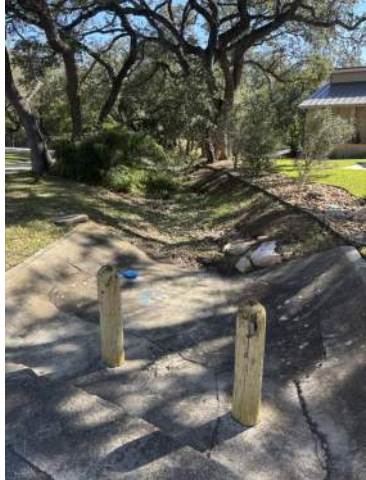
Location ID: O-025
Location Description: Voigt Park Outfall North
Type: Outfall
Latitude: 29.599617
Longitude: -98.500961
Current Maintenance Status: Needs Maintenance

Inspection Date	Inspector Name	Maintenance Type	Notes
12/9/2025	Jones Ard	Remove Trash/Debris	Remove glass bottle and leaves from outfall

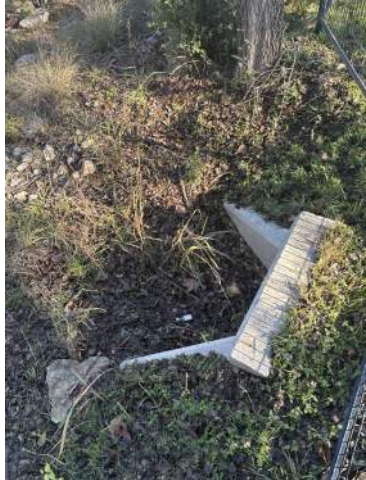
Location ID: O-026
Location Description: Rua De Matta St Channel
Type: Outfall
Latitude: 29.600984
Longitude: -98.487902
Current Maintenance Status: Needs Maintenance

Inspection Date	Inspector Name	Maintenance Type	Notes
12/10/2025	Jones Ard	Trim Vegetation	Also remove wood from channel

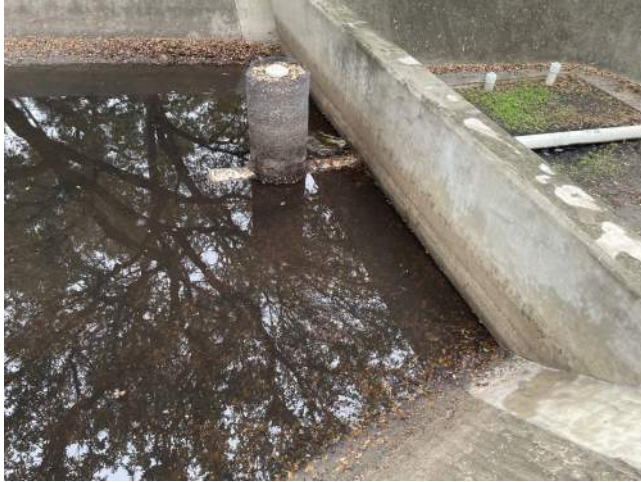
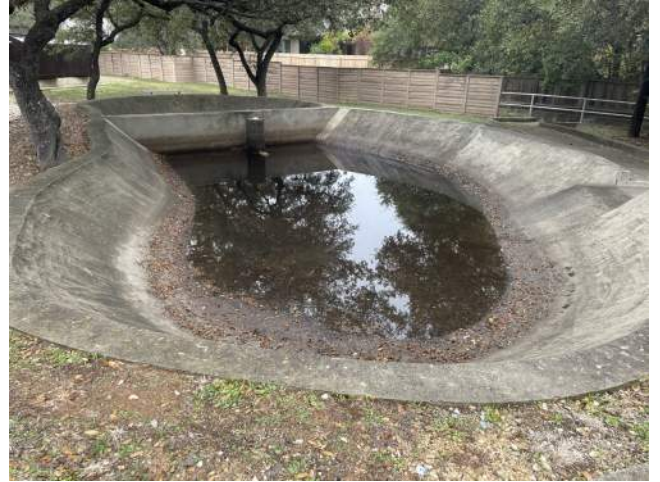
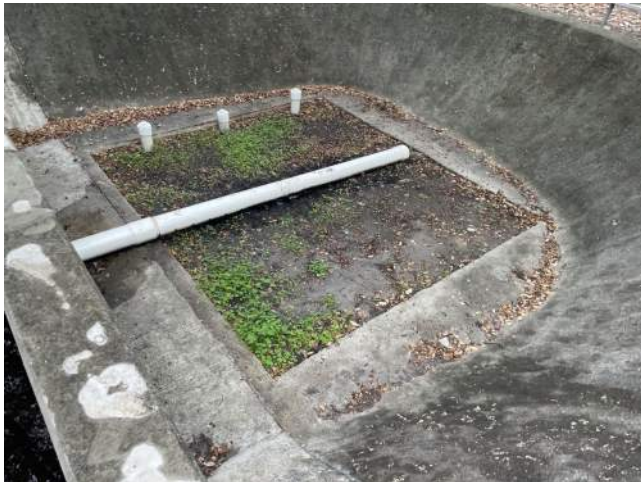
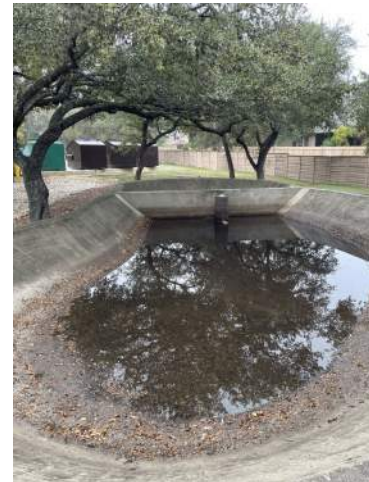
Location ID: OT-001
Location Description: Retention Pond w/ Infiltration
Type: Other
Latitude: 29.590116
Longitude: -98.477304
Current Maintenance Status: No Maintenance Required

Inspection Date	Inspector Name	Maintenance Type	Notes
12/12/2025	John Sablan

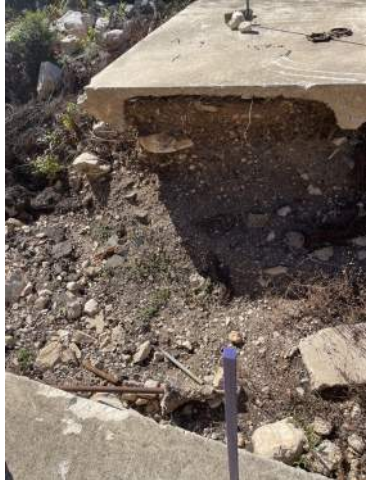
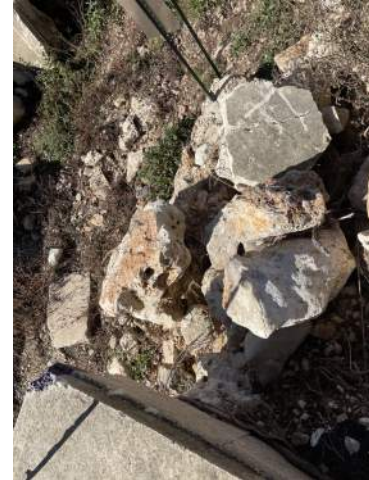
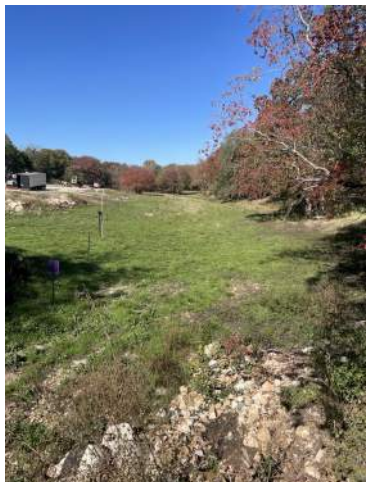
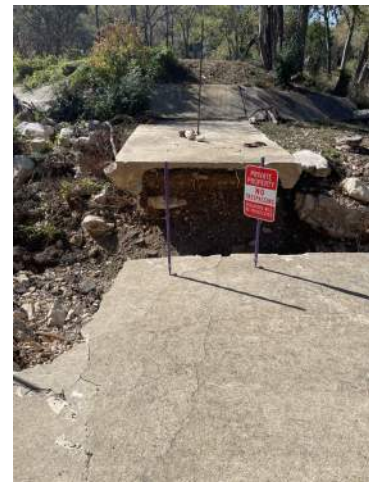
Location ID: OT-002
Location Description: Spillway Structure Skimmer/Weir
Type: Other
Latitude: 29.596296
Longitude: -98.476181
Current Maintenance Status: No Maintenance Required

Inspection Date	Inspector Name	Maintenance Type	Notes
12/9/2025	John Sablan

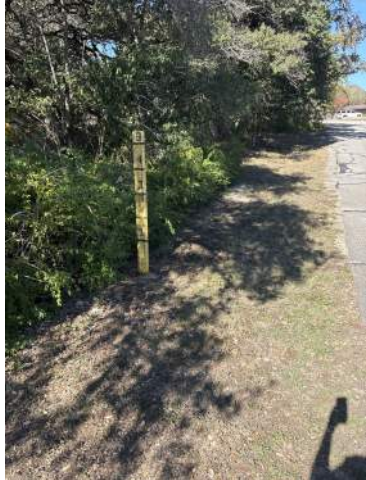
Location ID: OT-003
Location Description: El Cerrito Cir 1 LWC
Type: Other
Latitude: 29.59913
Longitude: -98.48204
Current Maintenance Status: No Maintenance Required

Inspection Date	Inspector Name	Maintenance Type	Notes
12/9/2025	Jones Ard

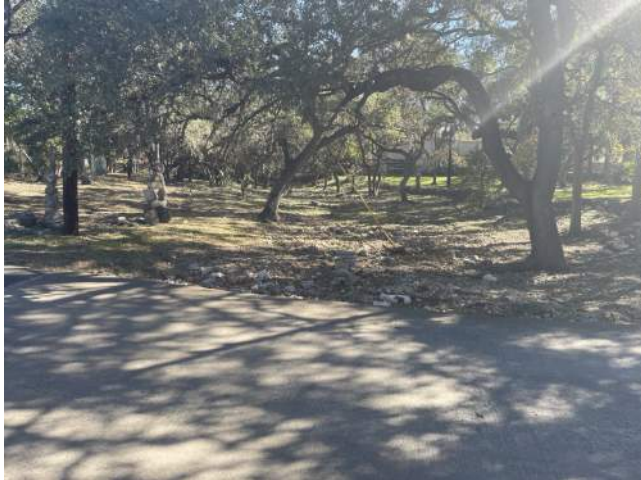
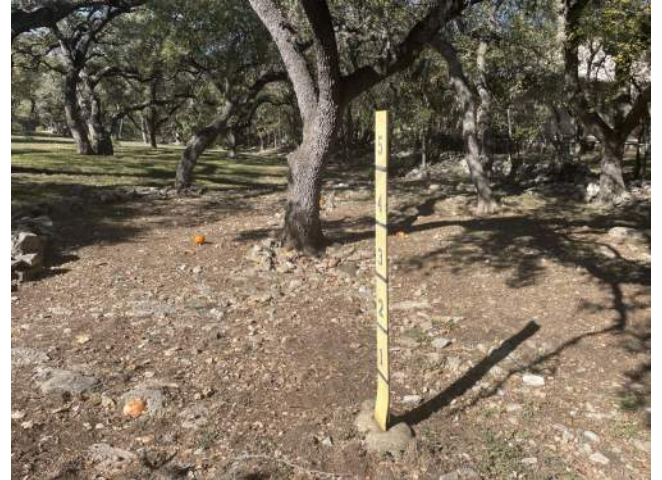
Location ID: OT-004
Location Description: Coolway Dr Low Water Crossing
Type: Other
Latitude: 29.591331
Longitude: -98.480204
Current Maintenance Status: No Maintenance Required

Inspection Date	Inspector Name	Maintenance Type	Notes
12/9/2025	John Sablan

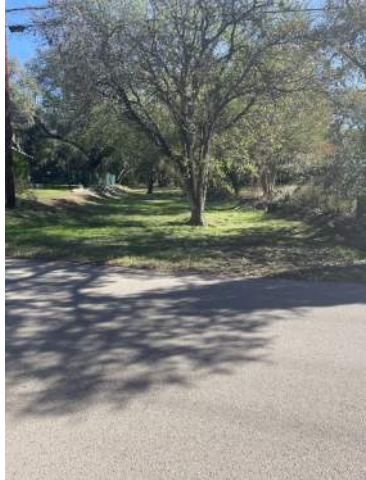
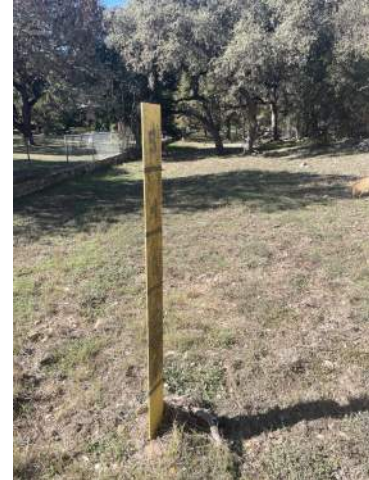
Location ID: OT-005
Location Description: El Cerrito Cir 2 LWC
Type: Other
Latitude: 29.59319
Longitude: -98.484912
Current Maintenance Status: Needs Maintenance

Inspection Date	Inspector Name	Maintenance Type	Notes
12/9/2025	John Sablan	Other	Clean flood gauge

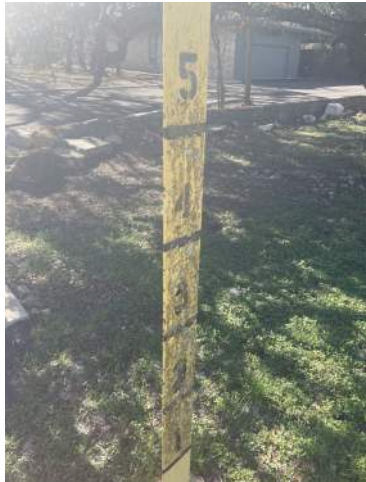
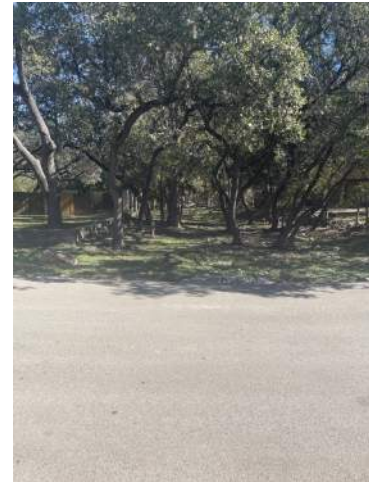
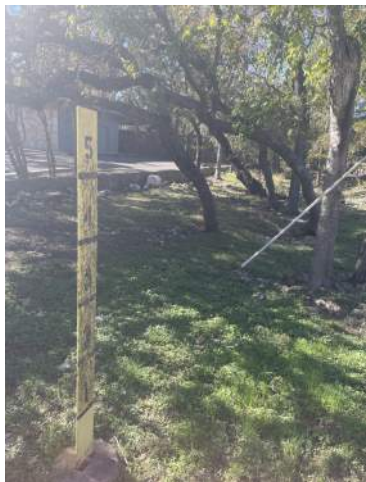
Location ID: OT-006
Location Description: El Cerrito Cir LWC West
Type: Other
Latitude: 29.593676
Longitude: -98.487364
Current Maintenance Status: Needs Maintenance

Inspection Date	Inspector Name	Maintenance Type	Notes
12/9/2025	John Sablan	Other	Clean flood gauge

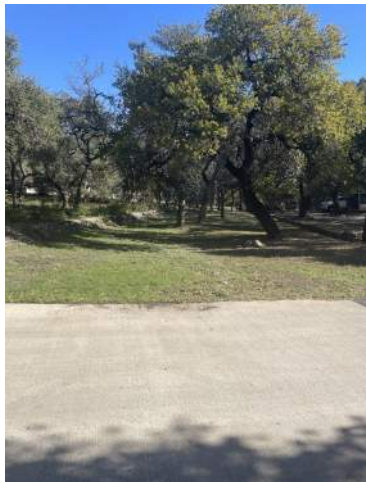
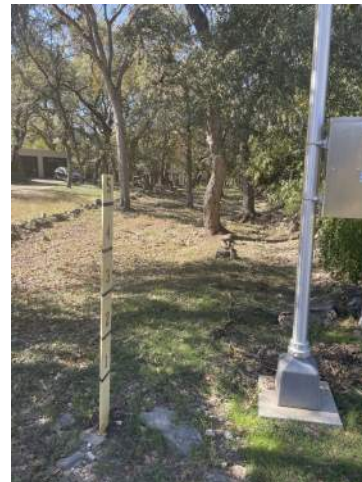
Location ID: OT-007
Location Description: Antelope Dr Low Water Crossing
Type: Other
Latitude: 29.593664
Longitude: -98.486038
Current Maintenance Status: No Maintenance Required

Inspection Date	Inspector Name	Maintenance Type	Notes
12/9/2025	John Sablan

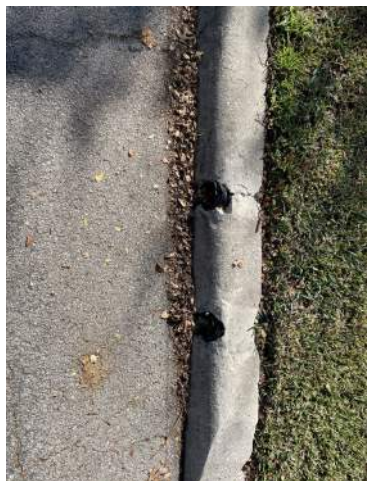
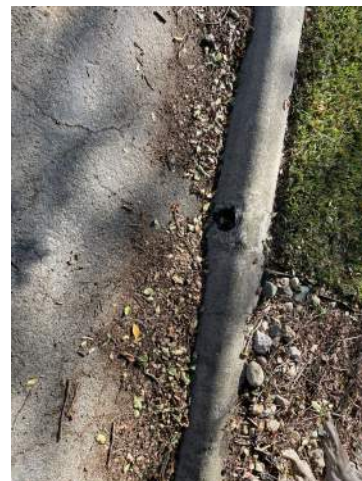
Location ID: OT-008
Location Description: Navato Residential Drains
Type: Other
Latitude: 29.589695
Longitude: -98.478718
Current Maintenance Status: No Maintenance Required

Inspection Date	Inspector Name	Maintenance Type	Notes
12/9/2025	John Sablan

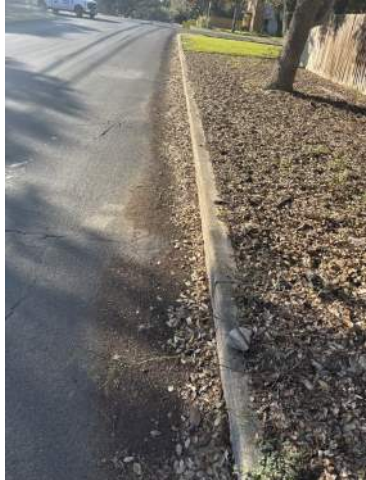
Location ID: OT-009
Location Description: Voigt Dr Leaves
Type: Other
Latitude: 29.600576
Longitude: -98.493055
Current Maintenance Status: Needs Maintenance

Inspection Date	Inspector Name	Maintenance Type	Notes
12/9/2025	Jones Ard	Remove Leaves/Sediment	Remove leaves from the street
