TOWN OF HOLLYWOOD PARK, TX

2025 Winter Inspection

HOLLYWOOD PARK 2025 WINTER INSPECTION REPORT

Subject: Semiannual Municipal Separate Storm Sewer System (MS4) Inspection

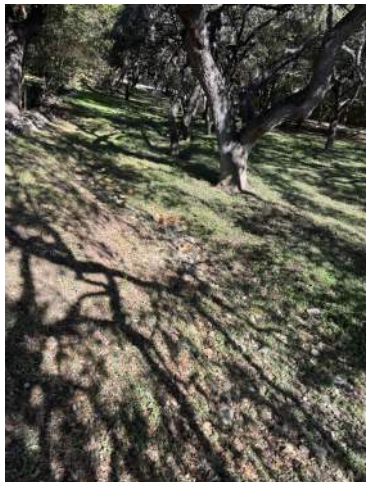
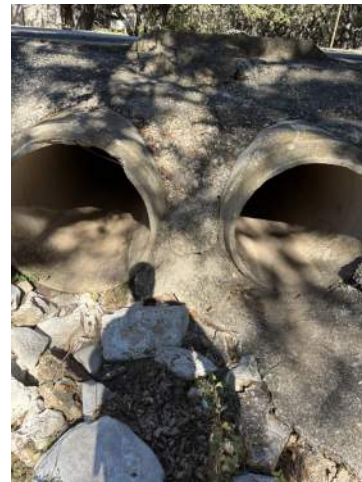
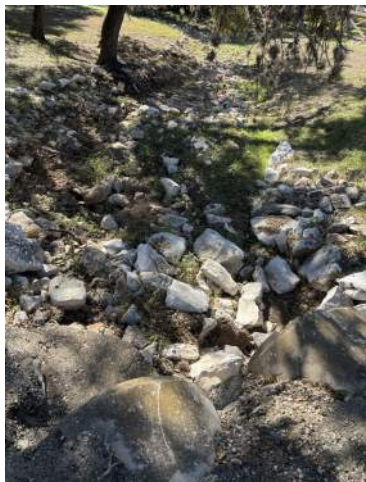
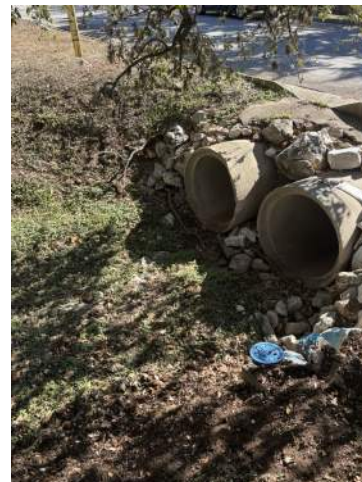
Location ID: P-001
Location Description: Yosemite Dr Crossing East
Type: Pipe
Latitude: 29.604268
Longitude: -98.477669
Current Maintenance Status: Needs Maintenance

Inspection Date	Inspector Name	Maintenance Type	Notes
12/9/2025	Jones Ard	Remove Trash/Debris	Remove pumpkin from channel

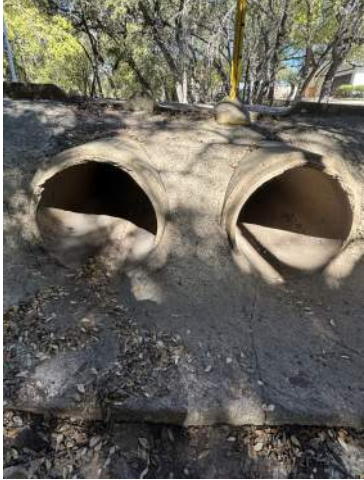
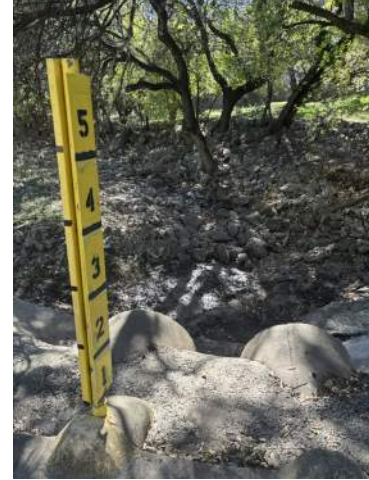
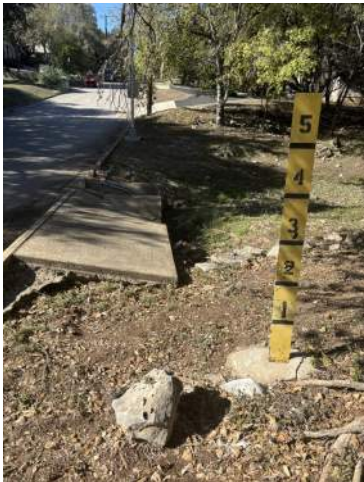
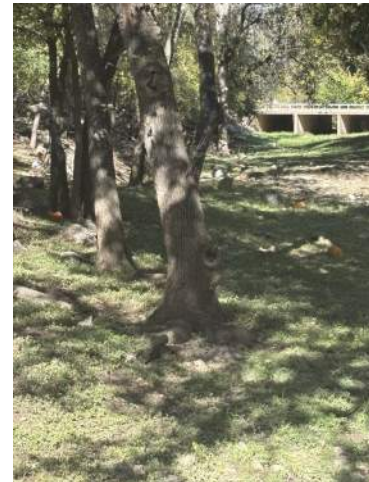
Location ID: P-002
Location Description: Yosemite Dr Crossing West
Type: Pipe
Latitude: 29.603893
Longitude: -98.482024
Current Maintenance Status: Needs Maintenance

Inspection Date	Inspector Name	Maintenance Type	Notes
12/9/2025	Jones Ard	Remove Trash/Debris	Remove pumpkins from channel

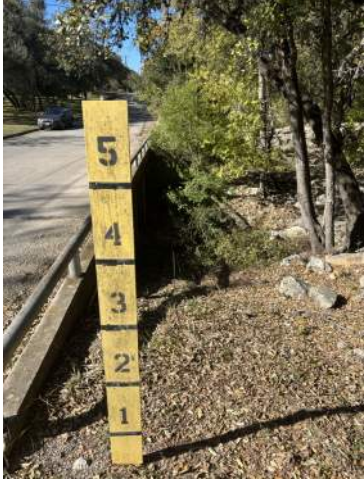
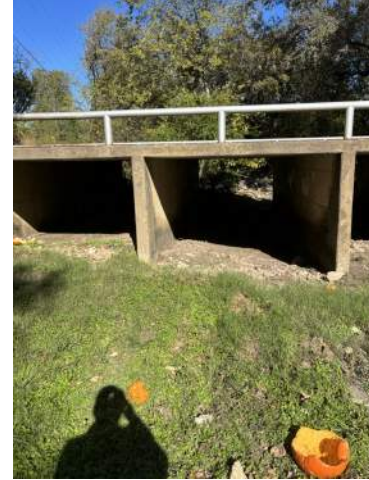
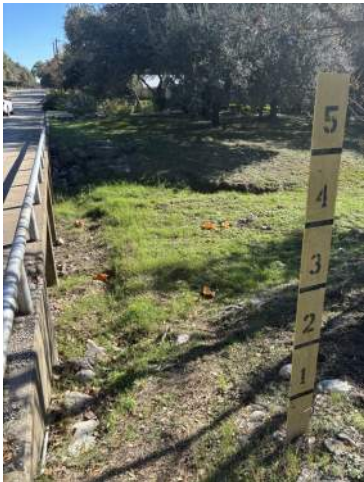
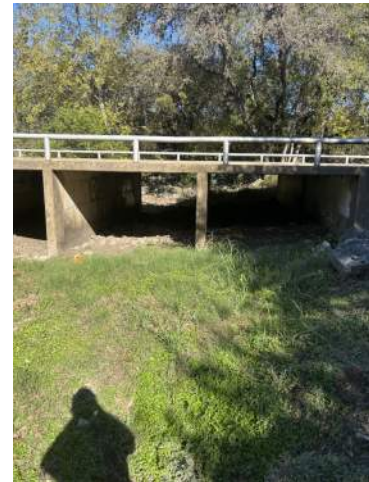
Inspection Date	Inspector Name	Maintenance Type	Notes
12/9/2025	Jones Ard	Remove Trash/Debris	Remove pumpkin from channel and bucket from inside culvert

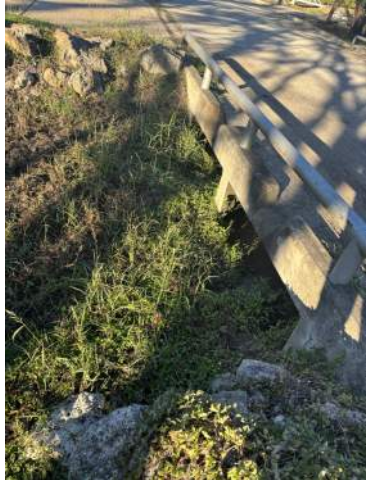
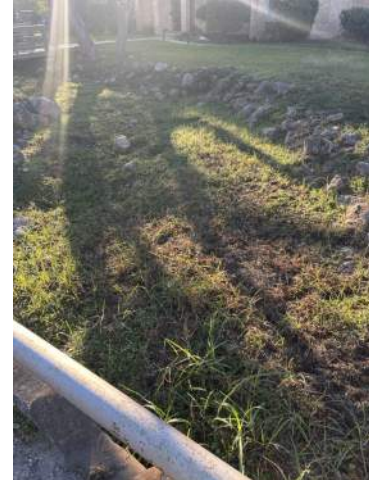
Location ID: P-005
Location Description: Northoak Dr Crossing
Type: Pipe
Latitude: 29.607261
Longitude: -98.487769
Current Maintenance Status: Needs Maintenance

Inspection Date	Inspector Name	Maintenance Type	Notes
12/9/2025	Jones Ard	Trim Vegetation

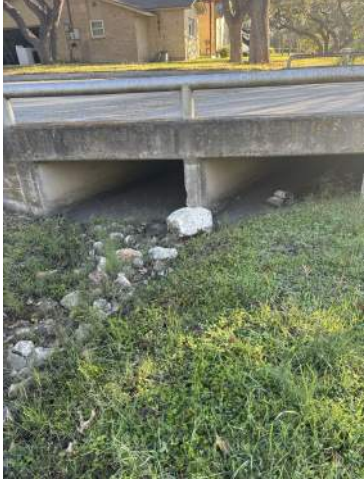
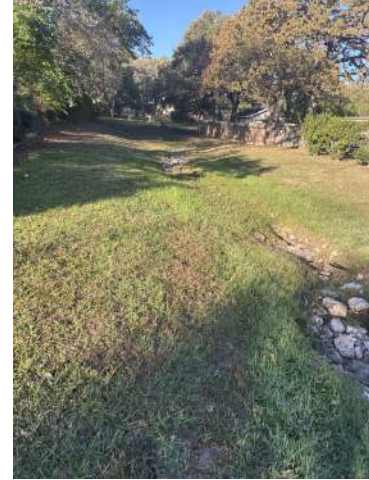
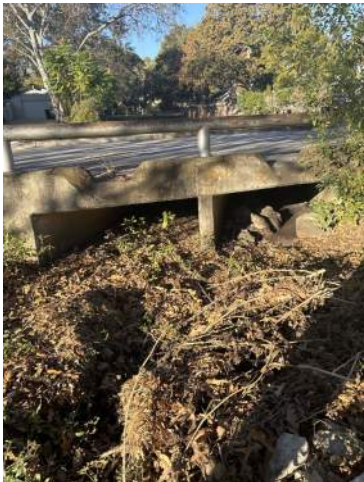
Location ID: P-006
Location Description: Sterling Browning Crossing
Type: Pipe
Latitude: 29.607364
Longitude: -98.489097
Current Maintenance Status: Needs Maintenance

Inspection Date	Inspector Name	Maintenance Type	Notes
12/9/2025	Jones Ard	Remove Leaves/Sediment	Also remove rocks from culvert inlets

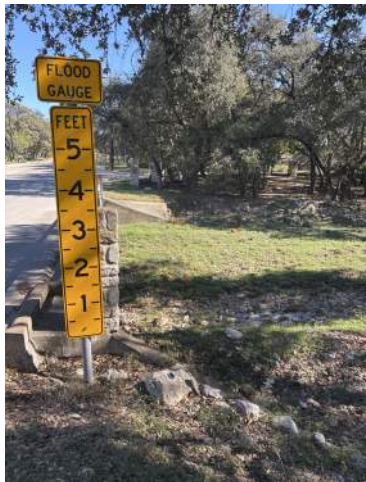
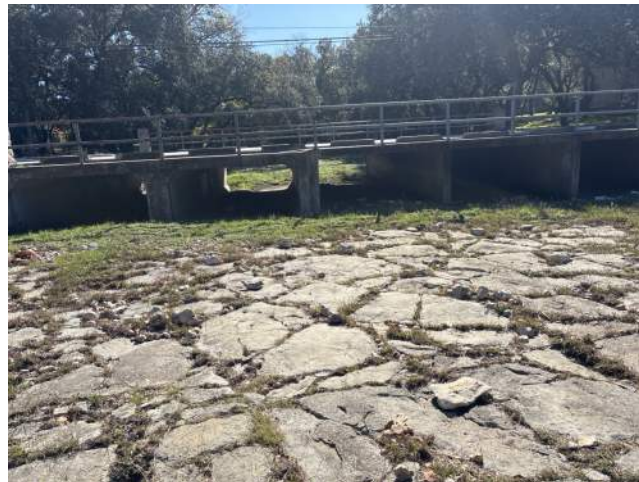
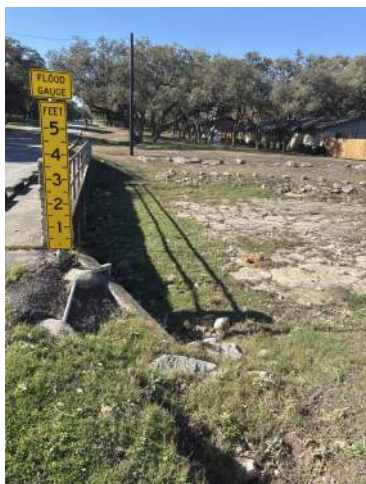
Location ID: P-007
Location Description: Donella Dr 2
Type: Pipe
Latitude: 29.599491
Longitude: -98.478822
Current Maintenance Status: Needs Maintenance

Inspection Date	Inspector Name	Maintenance Type	Notes
12/9/2025	Jones Ard	Remove Trash/Debris	Remove pumpkins from channel

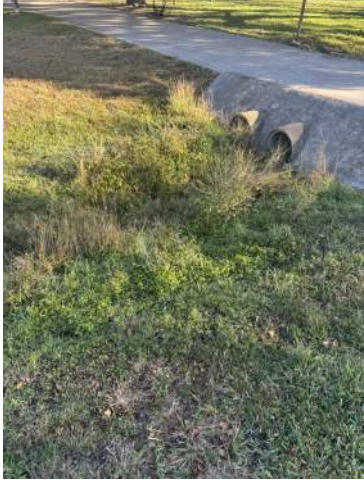
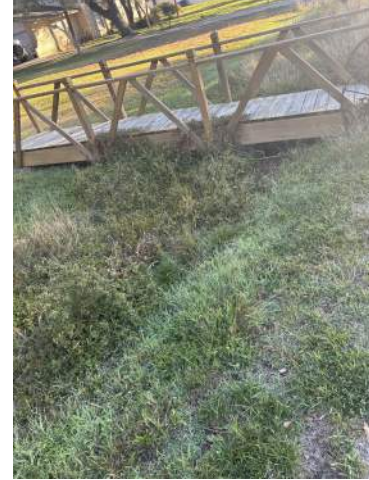
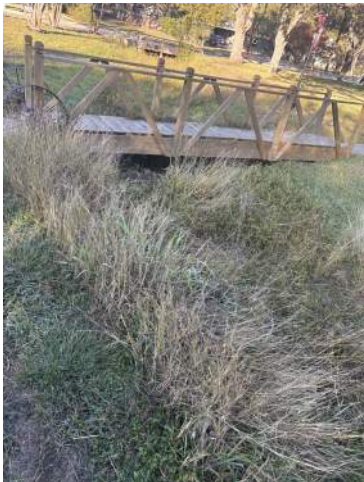
Location ID: P-008
Location Description: Northoak Dr Private Crossing West
Type: Pipe
Latitude: 29.607324
Longitude: -98.488624
Current Maintenance Status: Needs Maintenance

Inspection Date	Inspector Name	Maintenance Type	Notes
12/9/2025	Jones Ard	Trim Vegetation

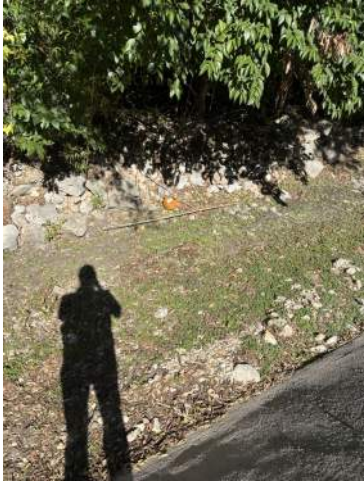
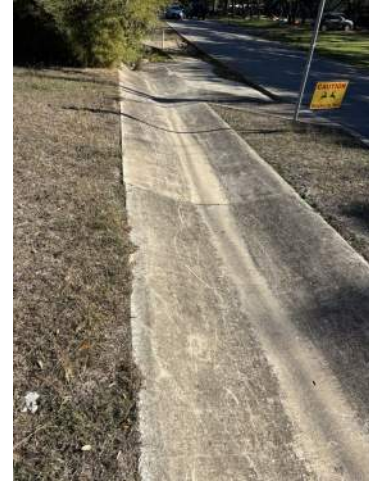
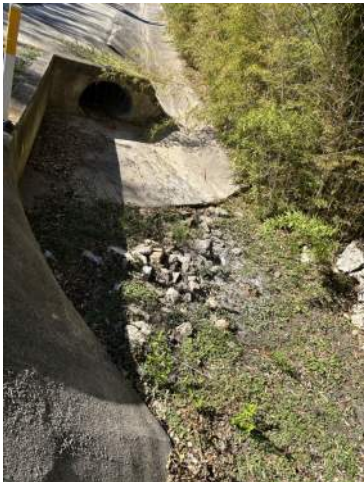
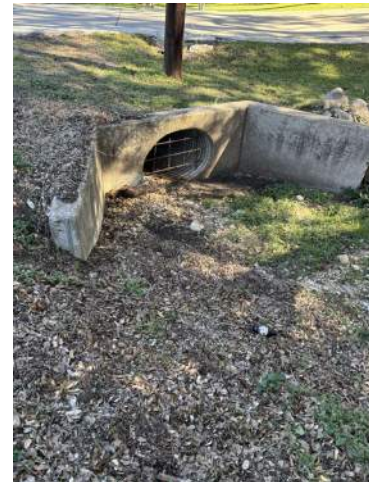
Location ID: P-010
Location Description: Donella Culvert Crossing at Mustang
Type: Pipe
Latitude: 29.599516
Longitude: -98.480642
Current Maintenance Status: Needs Maintenance

Inspection Date	Inspector Name	Maintenance Type	Notes
12/10/2025	Jones Ard	Remove Trash/Debris	Remove pumpkins

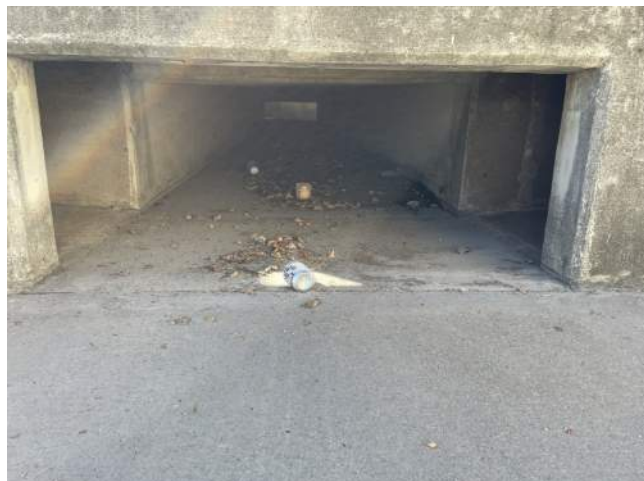
Location ID: P-012
Location Description: Oak Creek Ct
Type: Pipe
Latitude: 29.591205
Longitude: -98.474802
Current Maintenance Status: Needs Maintenance

Inspection Date	Inspector Name	Maintenance Type	Notes
12/10/2025	John Sablan	Remove Trash/Debris

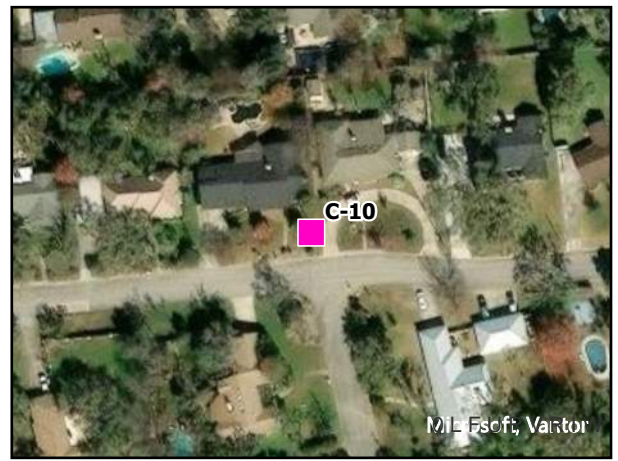
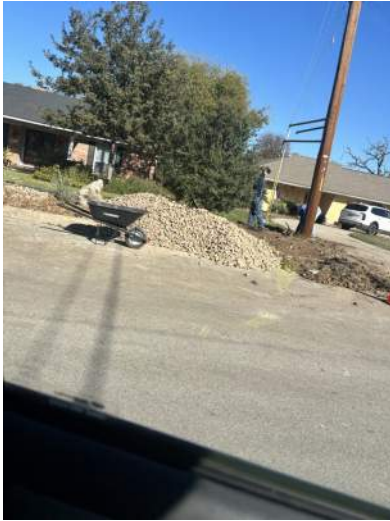
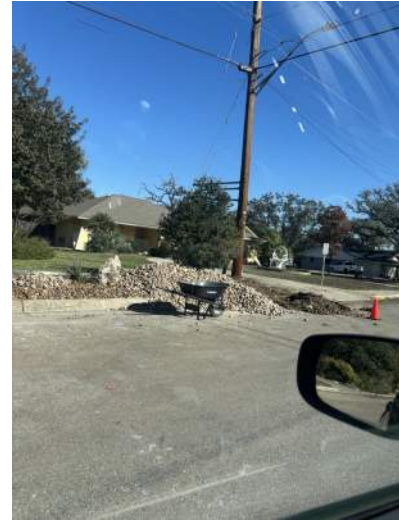
Location ID: C-10
Location Description: Active Construction Yosemite
Type: Construction
Latitude: 29.603732
Longitude: -98.485641
Current Maintenance Status: No Maintenance Required
Current Inspection Date: 12/9/2025 10:41:31.163 PM
Inspector Name: Jones Ard
Maintenance Type:
Notes: Monitor active construction site for stormwater measures

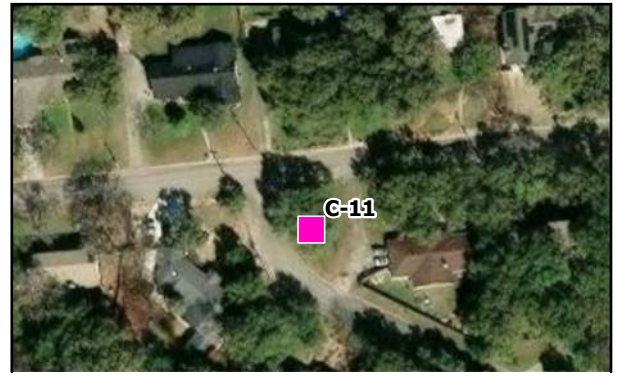
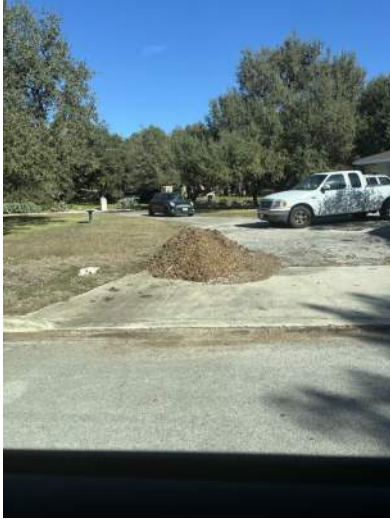
Feature ID	Feature name/Location	Feature	Construction Activity
C-4	Orthodontist Parking Lot	Construction	Runoff from Brookdale pushing lots of sediment to BMP in parking lot. Assuming may be broken sprinkler head on Brookdale side.
C-5	Home Build Canada Verde	Construction	Follow up on old construction site. Everything looks good.
C-6	Pool build near Voigt Park	Construction	Follow up inspection on home build. Looks good.
C-7	Home Build Fleetwood Dr	Construction	Monitor home build to ensure stormwater practices are in place
C-8	Active Construction Fleetwood	Construction	Monitor active construction site for appropriate stormwater measures
C-9	Construction Casa del Vista	Construction	Follow up inspection of construction site
C-10	Active Construction Yosemite	Construction	Monitor active construction site for stormwater measures
C-11	Spoil Pile Tall Oak Dr	Other	Spoil pile left out after construction. Needs a long term storage solution.

Location ID: C-11
Location Description: Spoil Pile Tall Oak Dr
Type: Construction
Latitude: 29.603846
Longitude: -98.480627
Current Maintenance Status: Needs Maintenance
Current Inspection Date: 12/9/2025 11:38:28.780 PM
Inspector Name: Jones Ard
Maintenance Type: Other
Notes: Spoil pile left out after construction. Needs a long term storage solution.

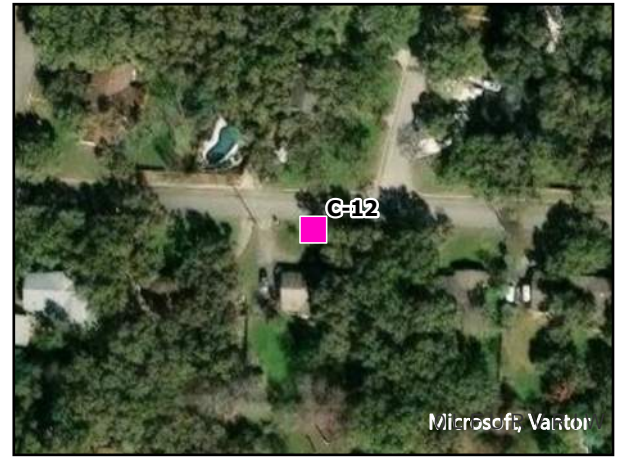
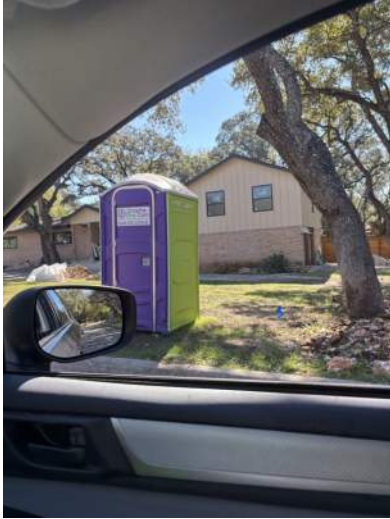
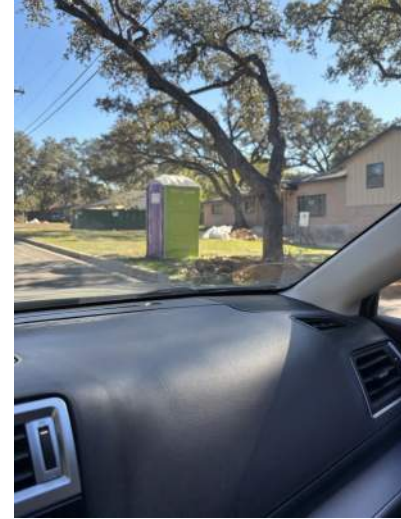
Location ID: C-12
Location Description: Active construction
Type: Construction
Latitude: 29.600372
Longitude: -98.476694
Current Maintenance Status: No Maintenance Required
Current Inspection Date: 12/10/2025 12:49:03.123 AM
Inspector Name: Jones Ard
Maintenance Type:
Notes: Monitor active construction for stormwater measures

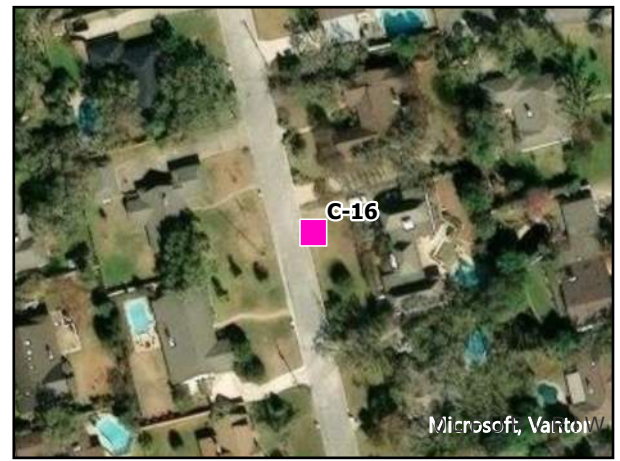
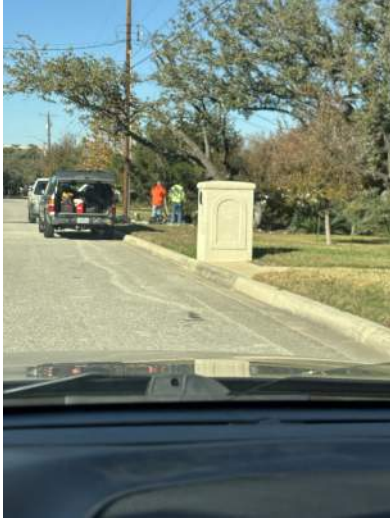
Location ID: C-16
Location Description: Active Construction Alcalde Moreno
Type: Construction
Latitude: 29.605621
Longitude: -98.489701
Current Maintenance Status: No Maintenance Required
Current Inspection Date: 12/10/2025 3:30:54.393 AM
Inspector Name: Jones Ard
Maintenance Type:
Notes: Active construction, monitor stormwater measures

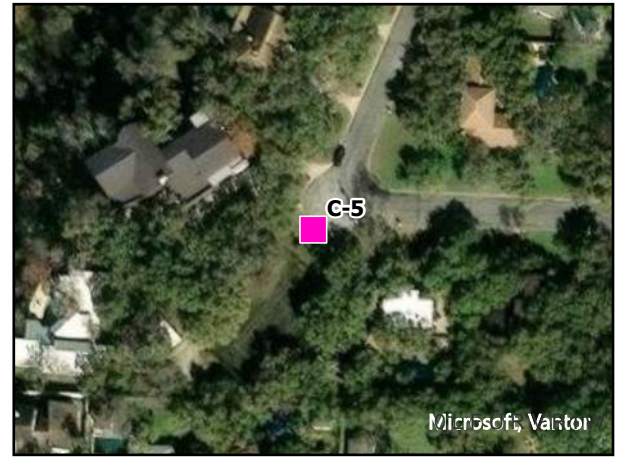
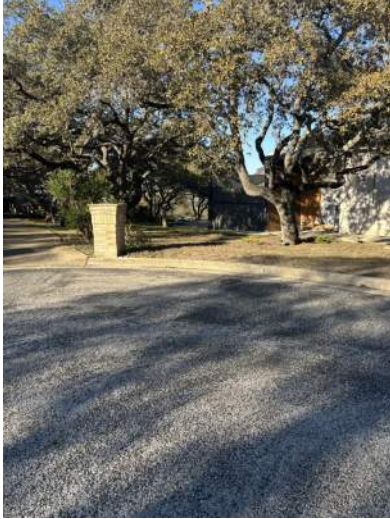
Location ID: C-5
Location Description: Home Build Canada Verde
Type: Construction
Latitude: 29.601246
Longitude: -98.495087
Current Maintenance Status: No Maintenance Required
Current Inspection Date: 12/9/2025 9:11:23.033 PM
Inspector Name: Jones Ard
Maintenance Type:
Notes: Follow up on old construction site. Everything looks good.

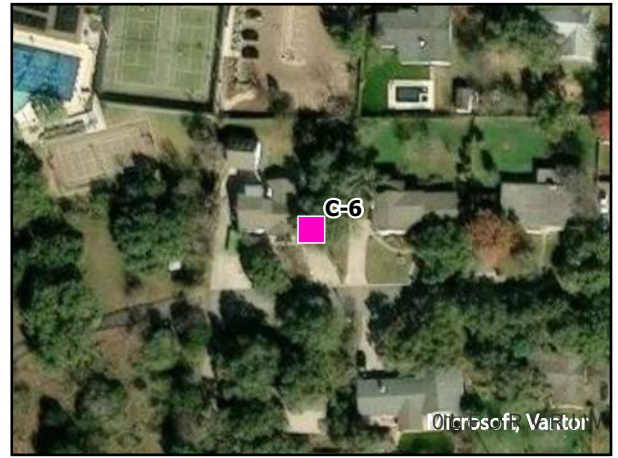
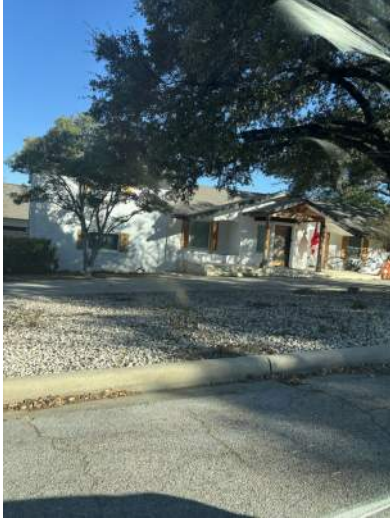
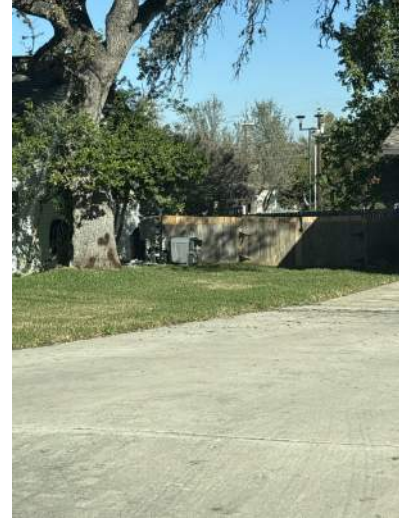
Location ID: C-6
Location Description: Pool build near Voigt Park
Type: Construction
Latitude: 29.598688
Longitude: -98.500127
Current Maintenance Status: No Maintenance Required
Current Inspection Date: 12/9/2025 9:52:06.792 PM
Inspector Name: Jones Ard
Maintenance Type:
Notes: Follow up inspection on home build. Looks good.

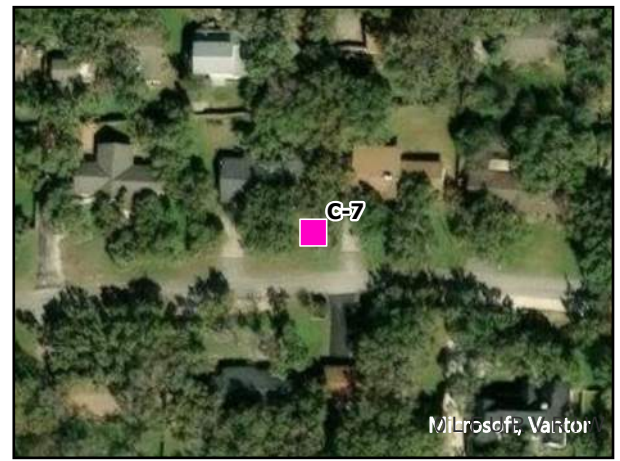
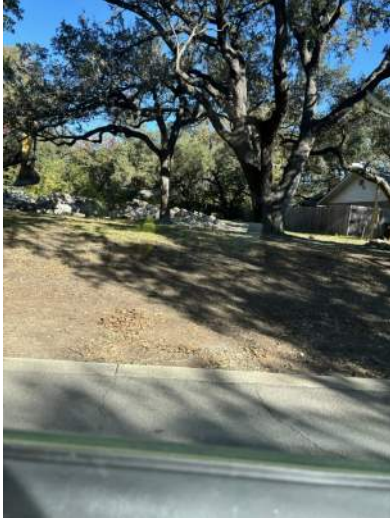
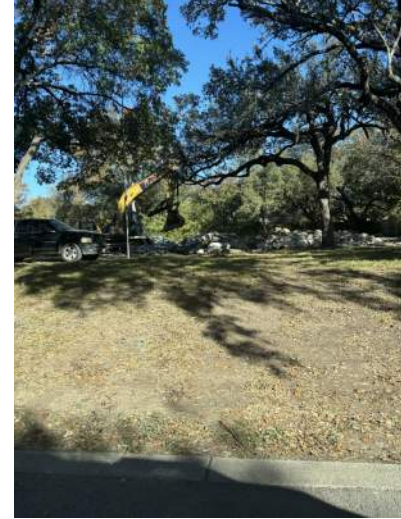
Location ID: C-7
Location Description: Home build
Type: Construction
Latitude: 29.597835
Longitude: -98.497115
Current Maintenance Status: No Maintenance Required
Current Inspection Date: 12/9/2025 10:23:48.029 PM
Inspector Name: Jones Ard
Maintenance Type:
Notes: Monitor home build to ensure stormwater practices are in place

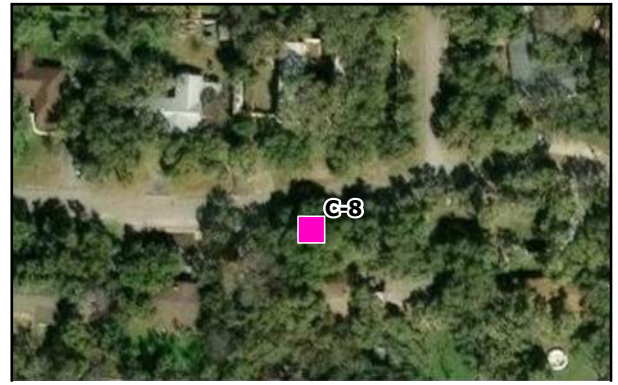
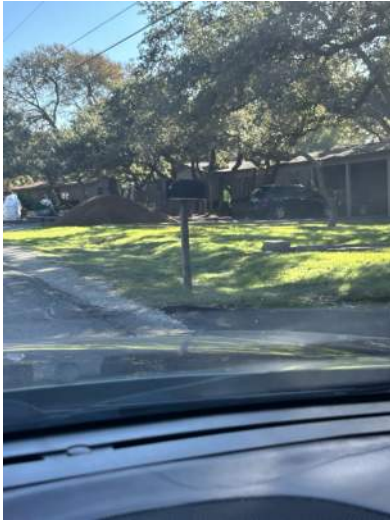
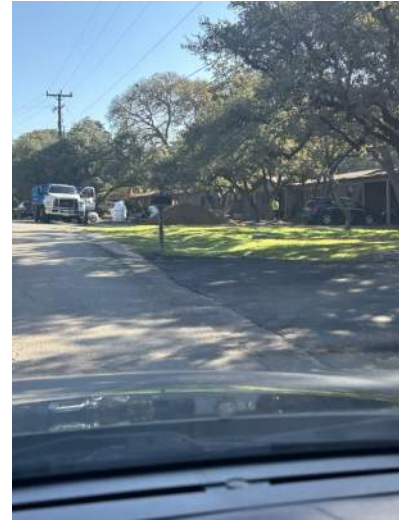
Location ID: C-8
Location Description: Active Construction Fleetwood
Type: Construction
Latitude: 29.597108
Longitude: -98.489047
Current Maintenance Status: No Maintenance Required
Current Inspection Date: 12/9/2025 10:26:06.614 PM
Inspector Name: Jones Ard
Maintenance Type:
Notes: Monitor active construction site for appropriate stormwater measures

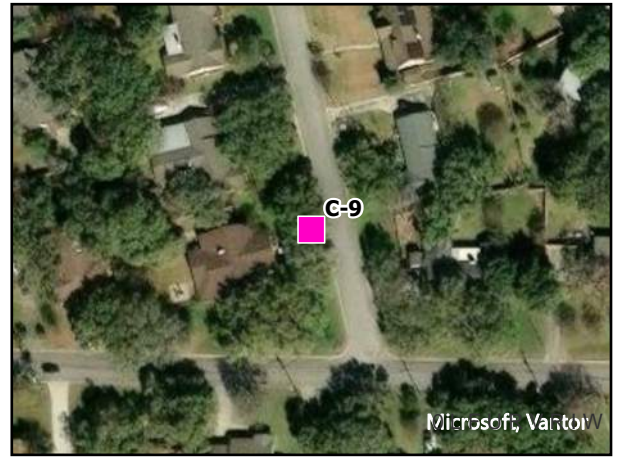
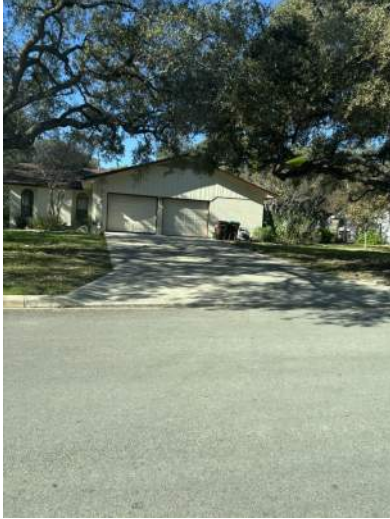
Location ID: C-9
Location Description: Construction Casa del Vista
Type: Construction
Latitude: 29.601343
Longitude: -98.483887
Current Maintenance Status: No Maintenance Required
Current Inspection Date: 12/9/2025 10:40:15.221 PM
Inspector Name: Jones Ard
Maintenance Type:
Notes: Follow up inspection of construction site
