# TOWN OF HOLLYWOOD PARK, TX

2024 Winter Inspection

# HOLLYWOOD PARK 2024 WINTER INSPECTION REPORT

**Subject:** Annual Municipal Separate Storm Sewer System (MS4) Inspection

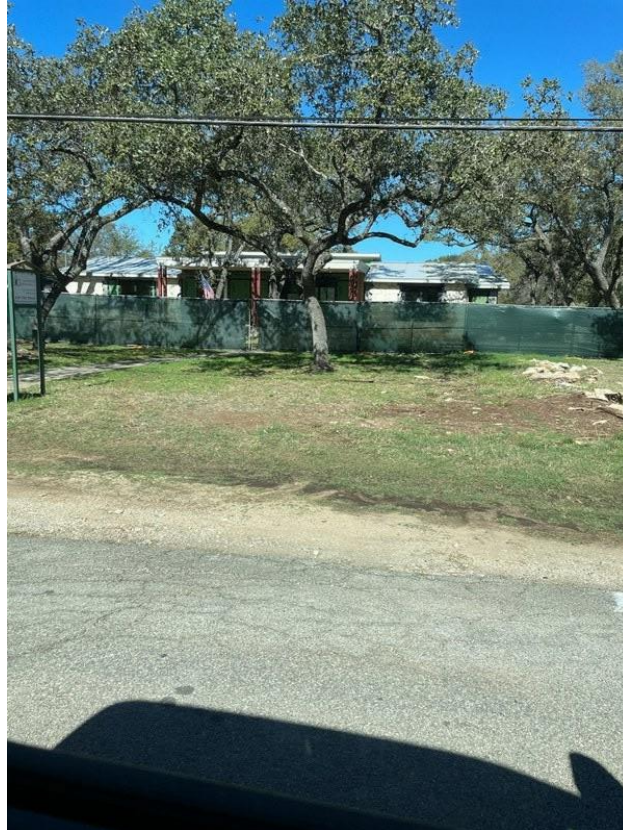
Field Notes: Looks good monitor for runoff.

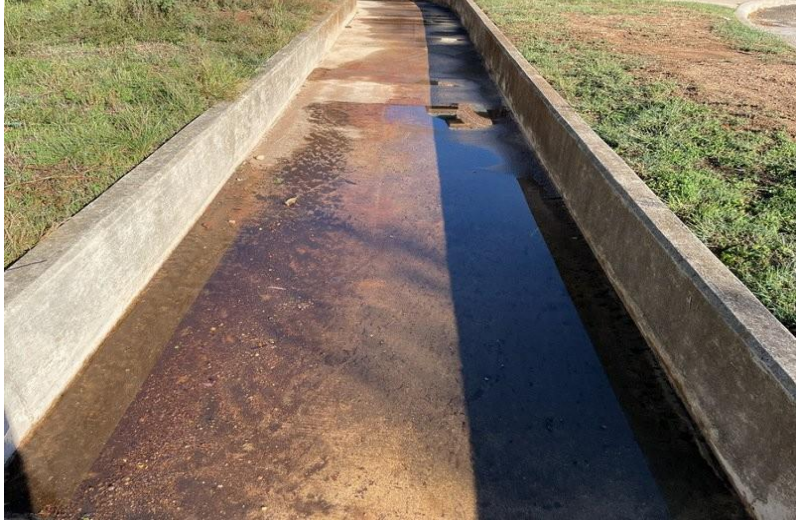
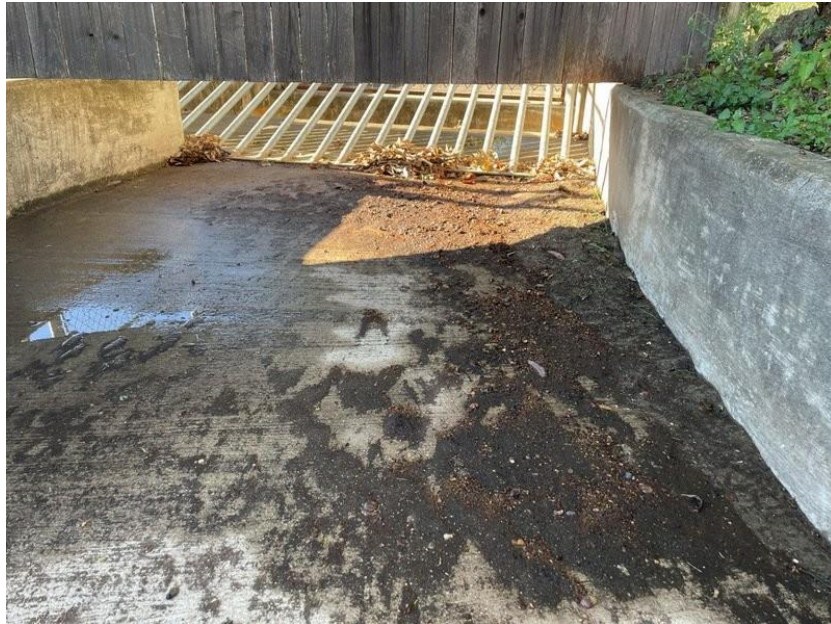
Field Notes: Monitor minor sediment buildup.

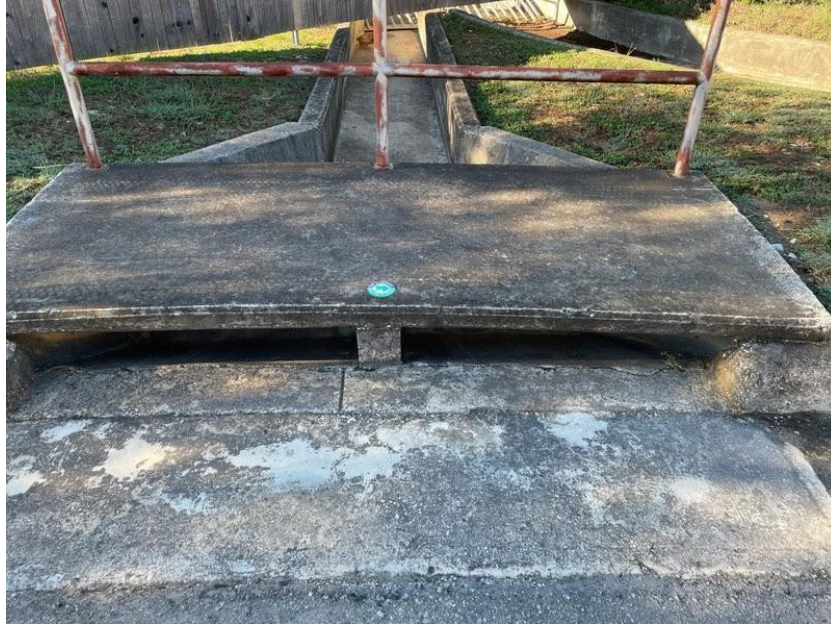
Field Notes: Looks good.

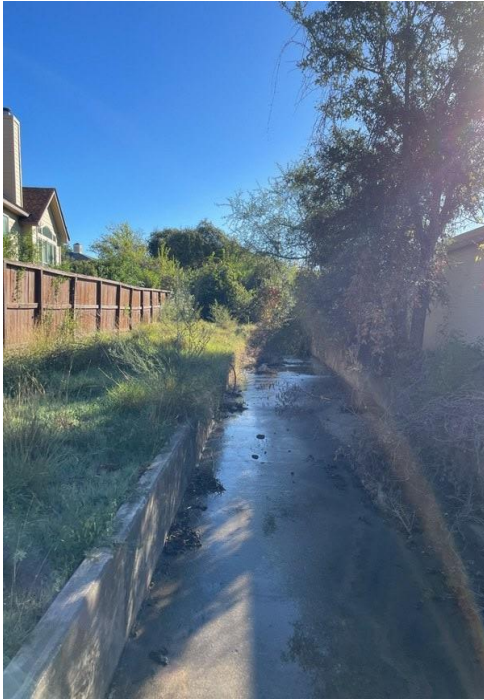
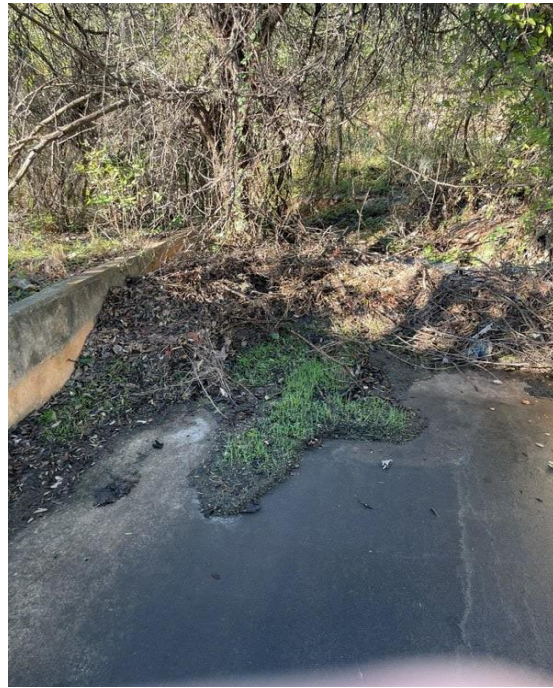
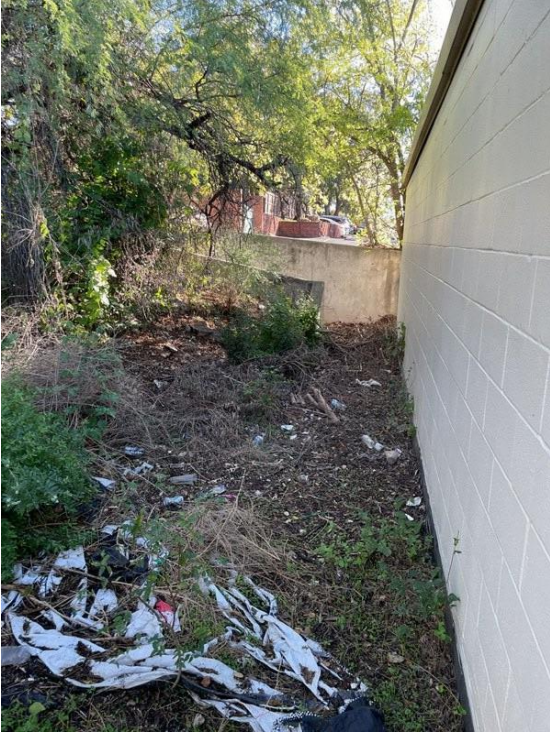
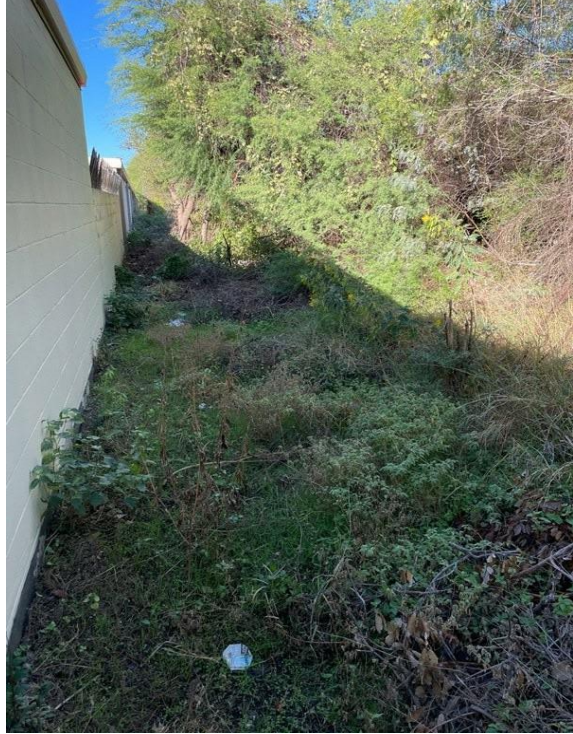
## Amber Creek Southern Outfall and Channel

Field Notes: Downstream outfall silted out remove sediment for positive drainage.  
Clear litter and brush at upstream end

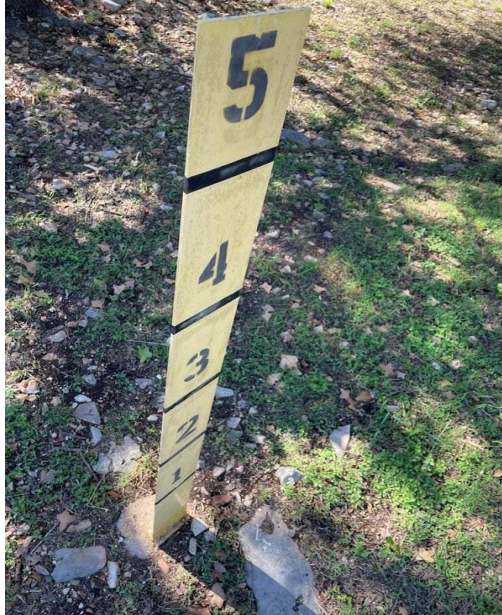
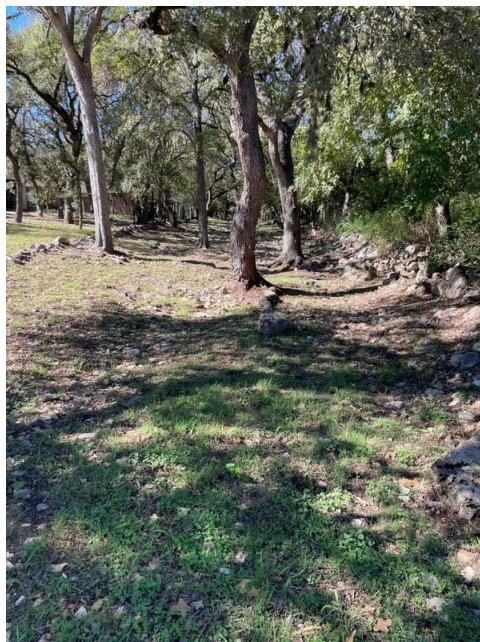
## Antelope Dr Low Water Crossing

Field Notes: Looks good.

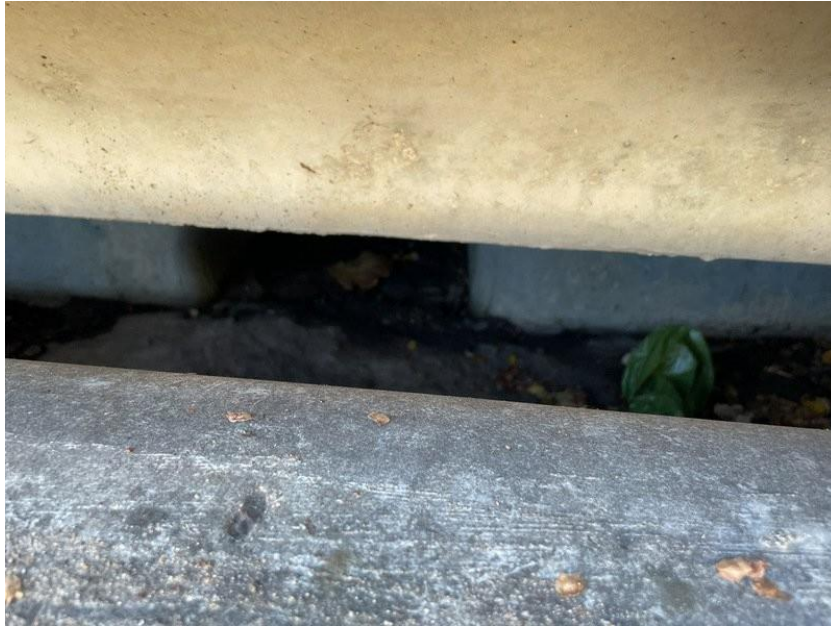
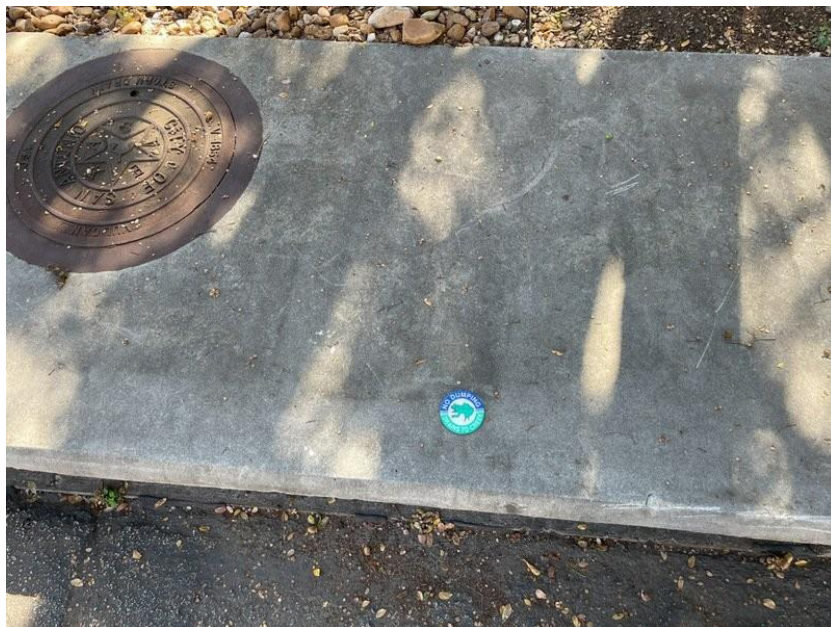
### ANT-I-1

Field Notes: Looks good.

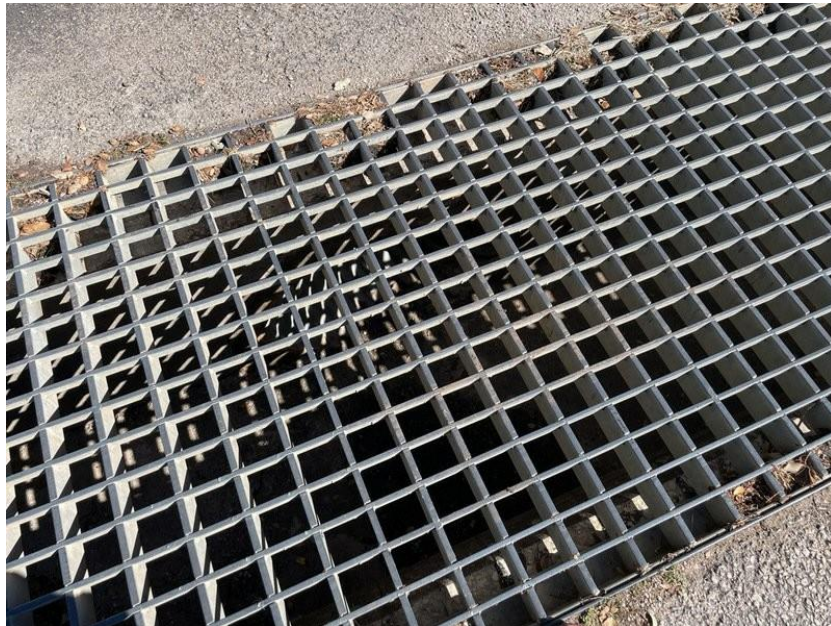
## ANT-I-2

Field Notes: Looks good.

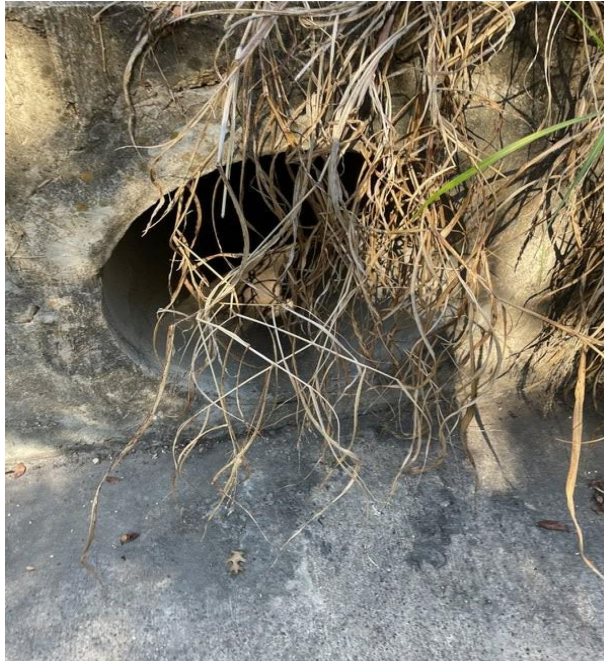
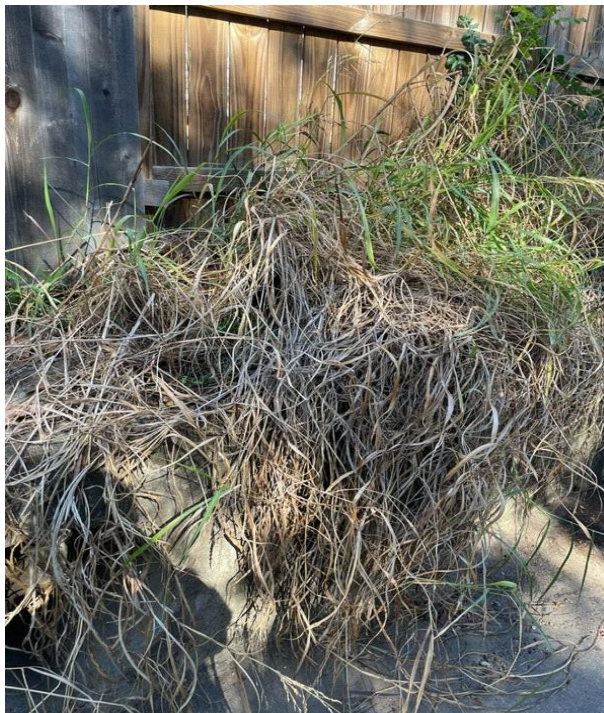
## Antler 1 Storm Sewer Pipe

Field Notes: Looks good, clear surrounding vegetation

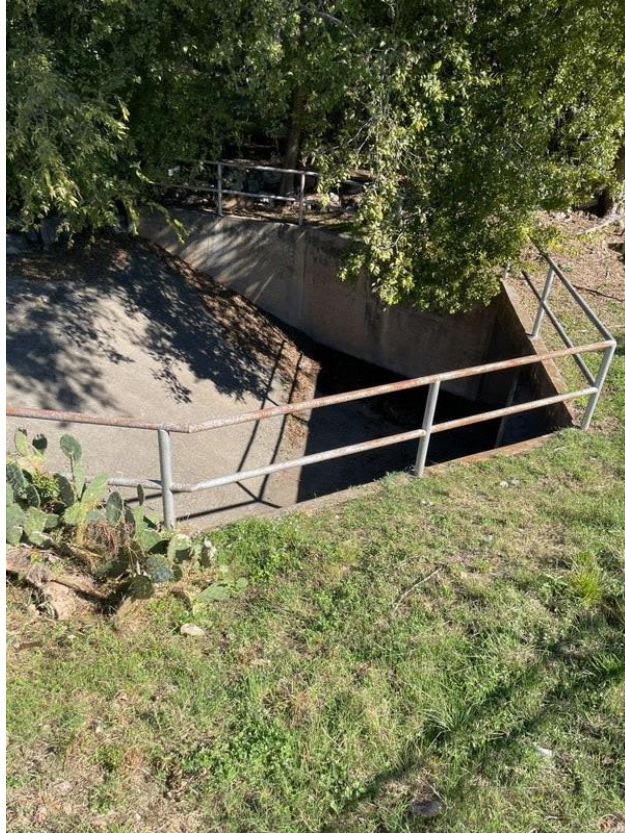
## Antler 2 Storm Sewer Pipe

Field Notes: Looks good.

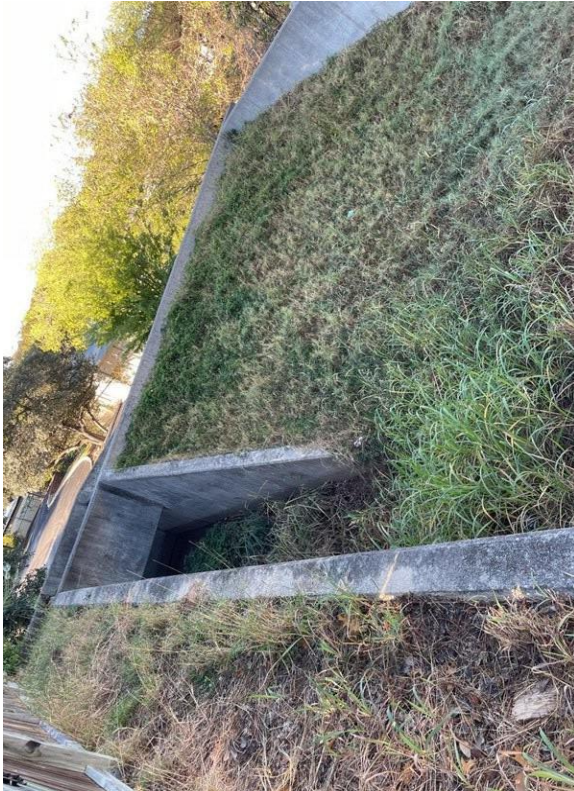
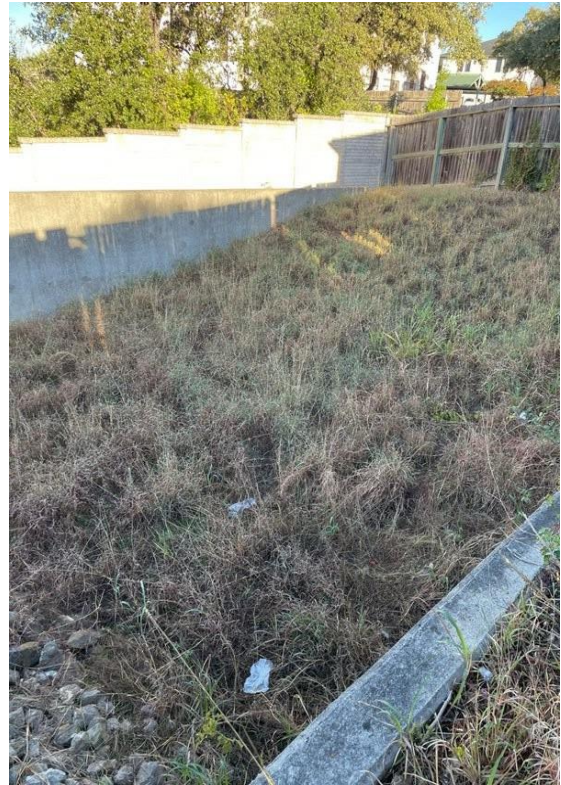
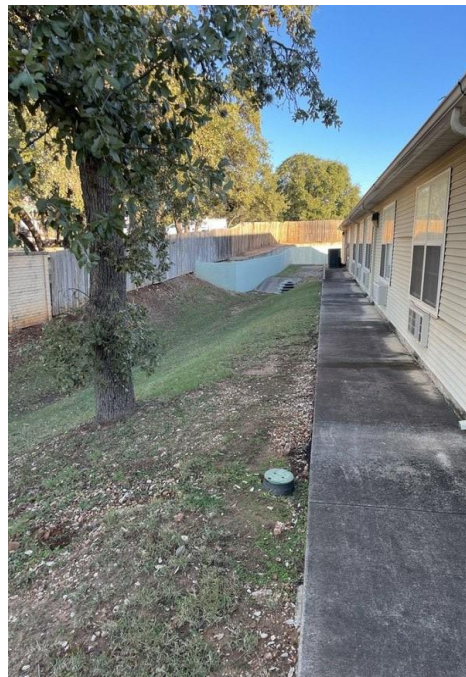
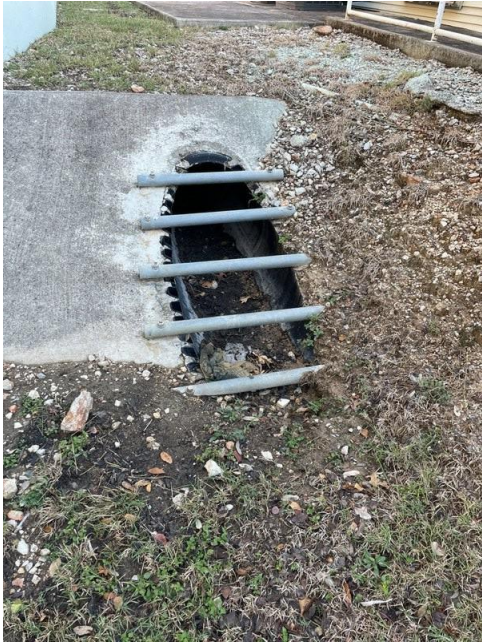
## Brookdale PCD

Field Notes: Culvert behind Brookdale needs silt removed for positive drainage.

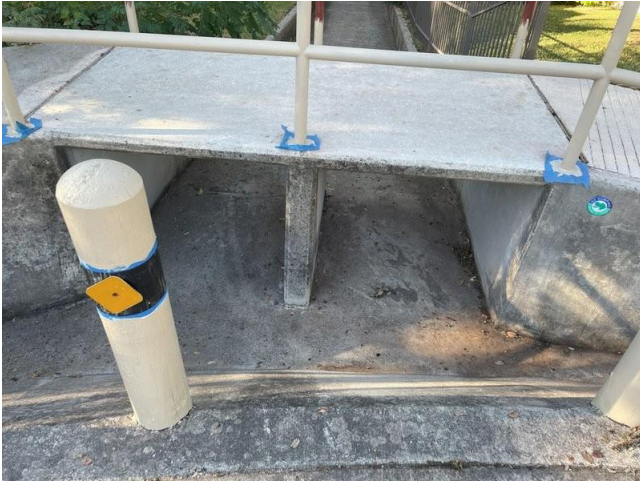
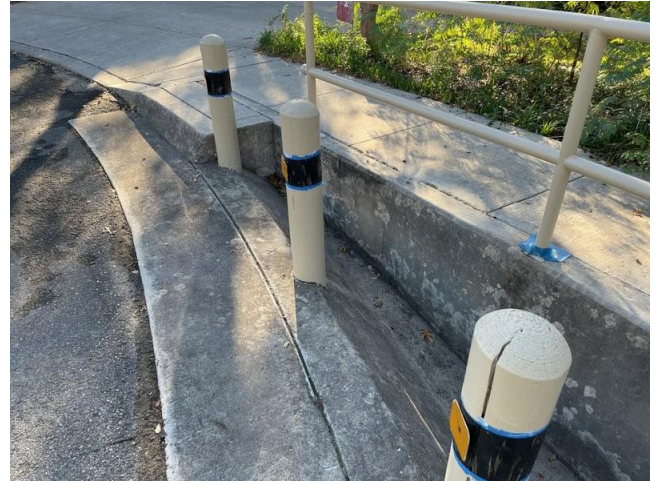
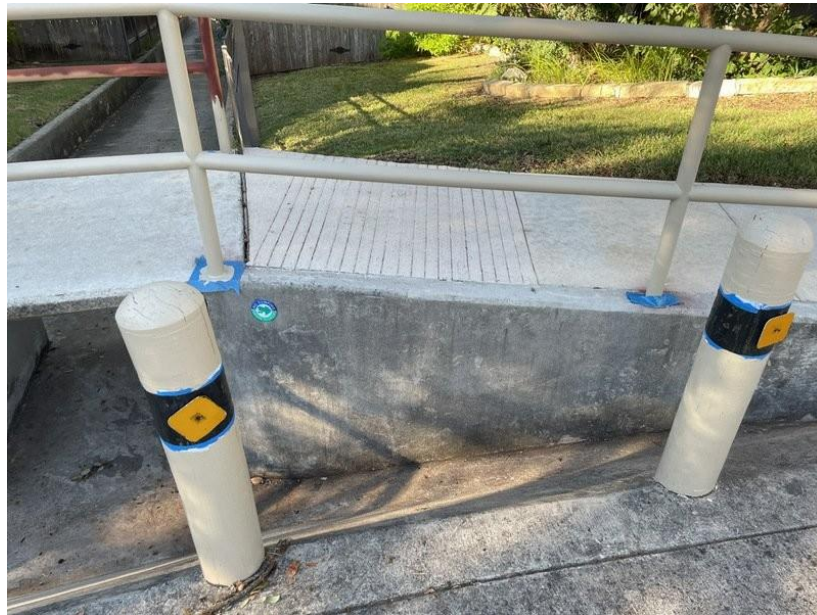
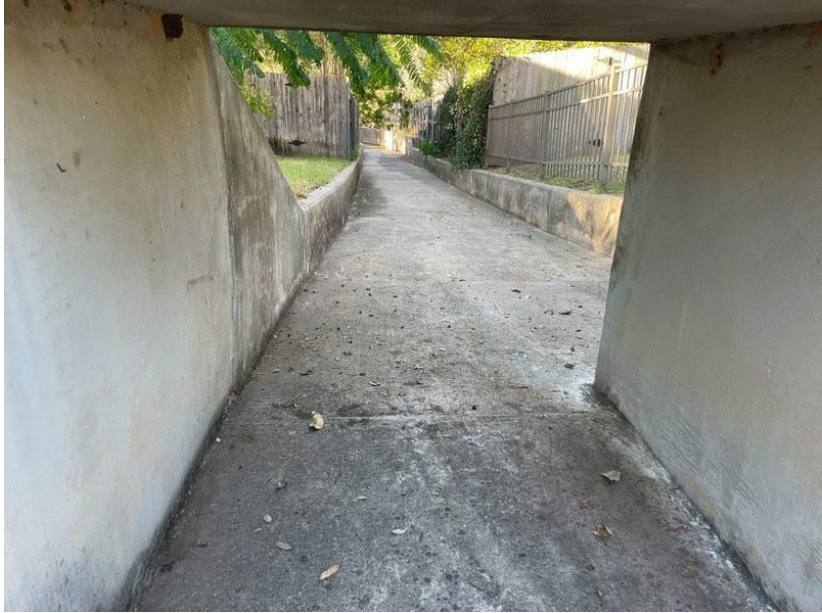
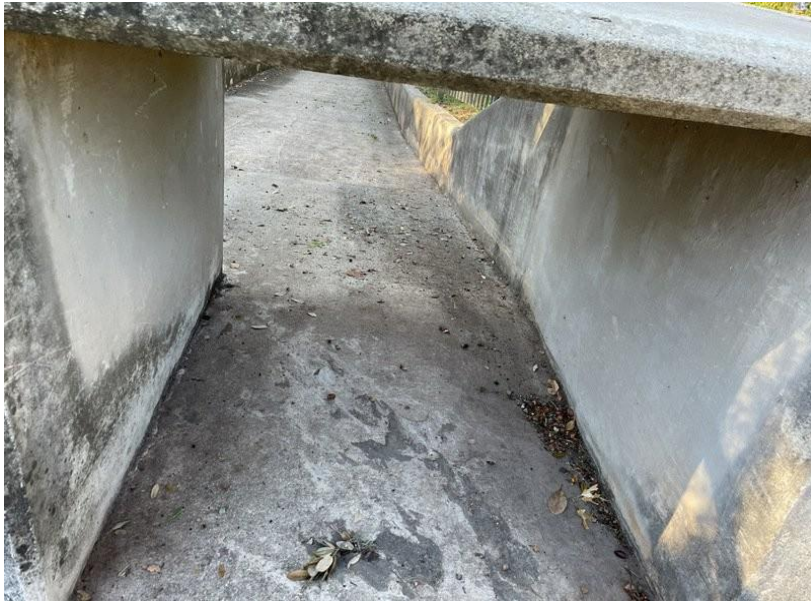
### Cascade Glen Sidewalk Drain

Field Notes: Looks good.

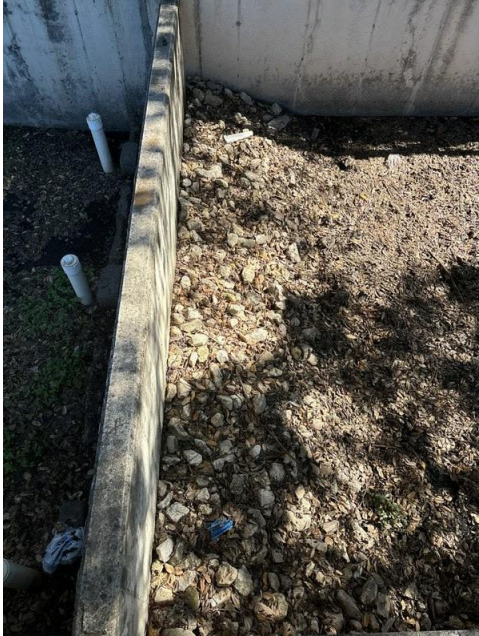
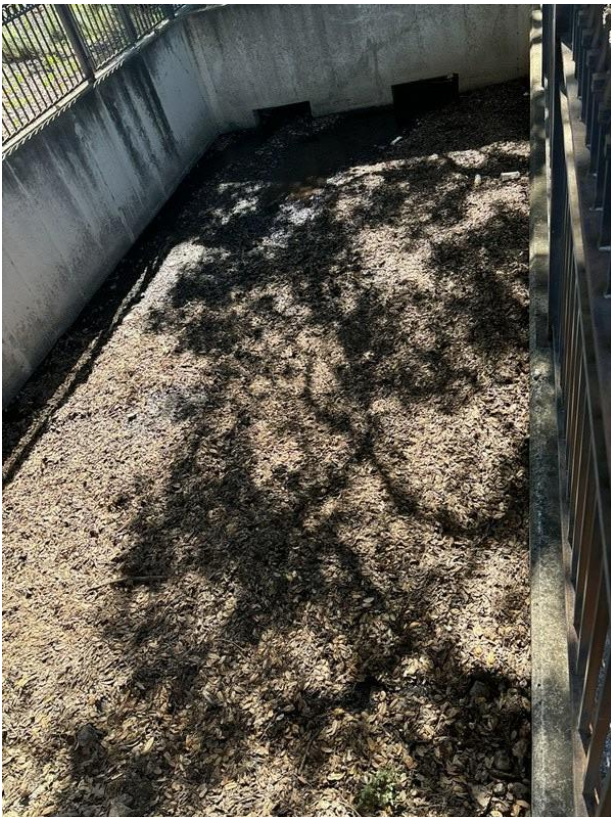
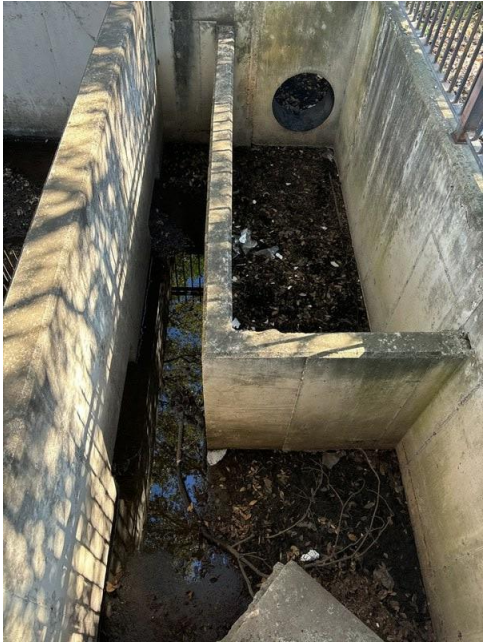
## Chandler Signs PCD In North Park Corporate Center Parking Lot

Field Notes: Remove rocks and sediment from inlets and basins

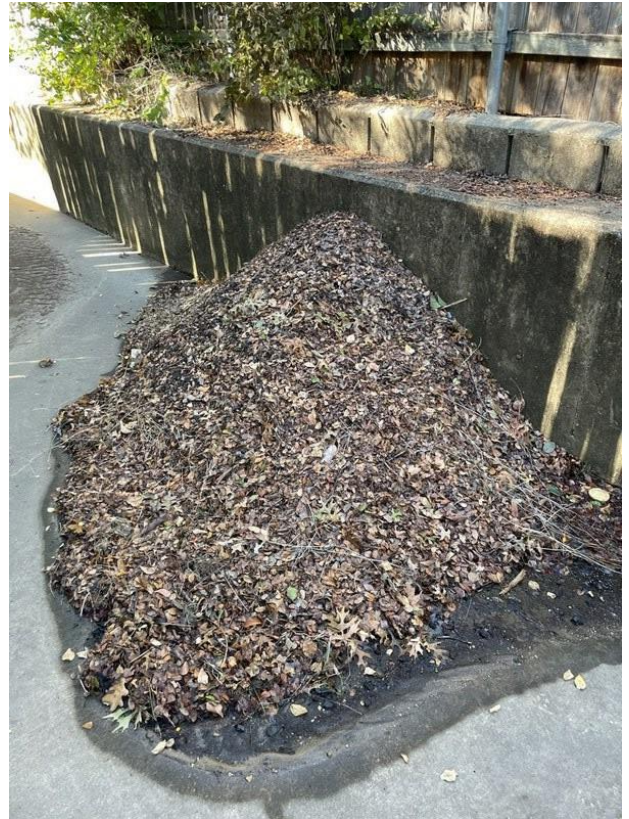
## Channel

Field Notes: Neighbors complain of brush and hackberry tree over growing on downstream end of Navato Crossing causing intensive splashing during flood events. Channel has large leaf and sediment deposits. Needs thorough cleaning and trimming.

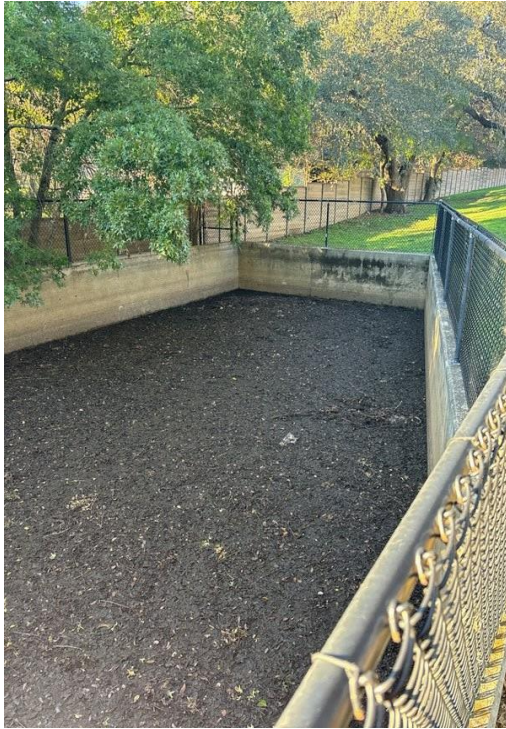
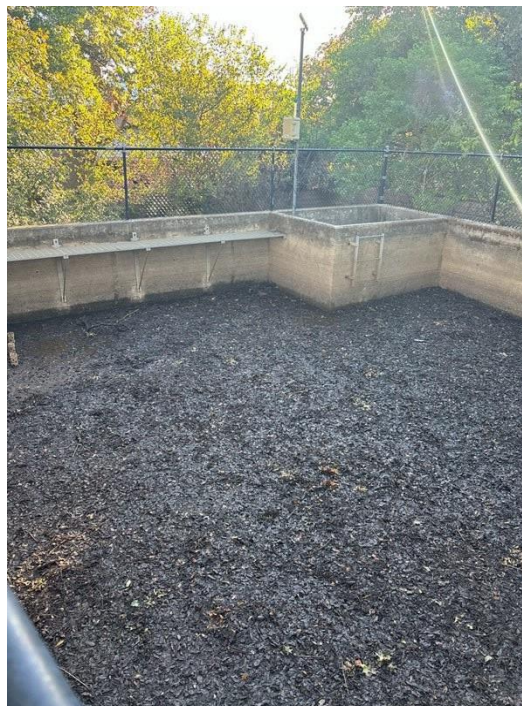
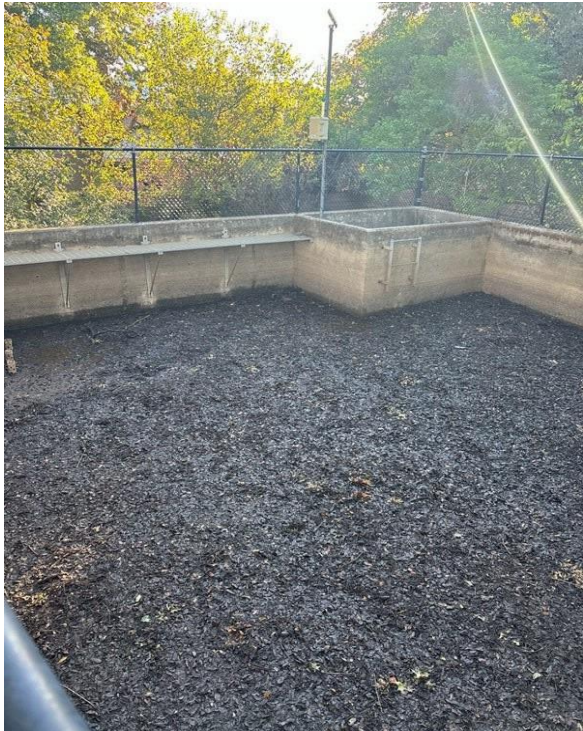
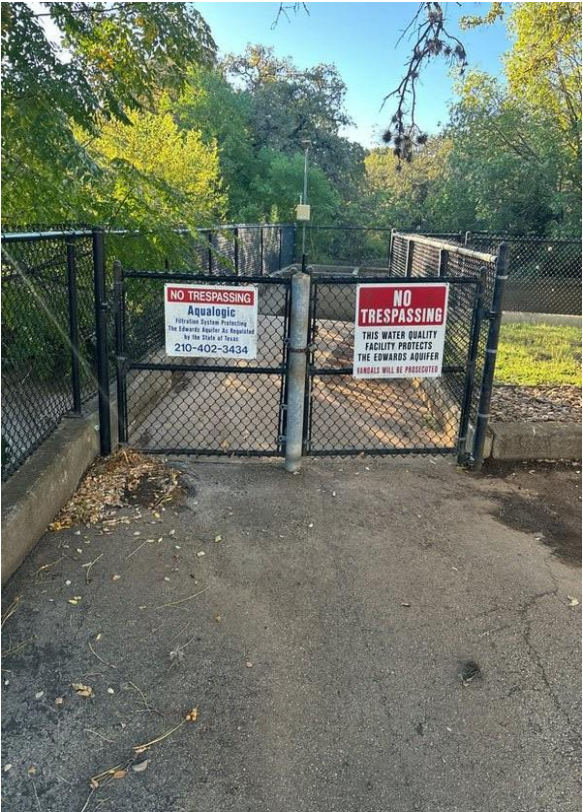
Field Notes: Remove leaves by entrance gate and in basin

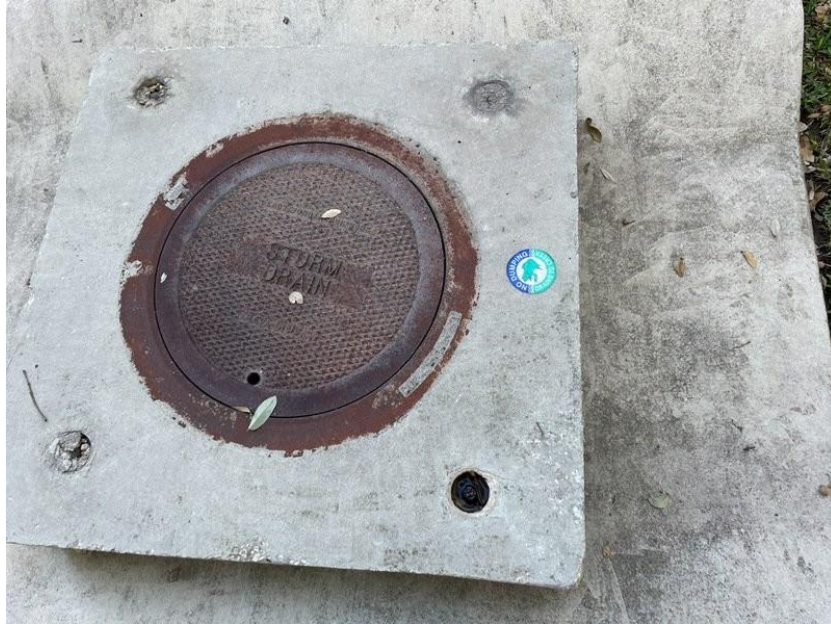
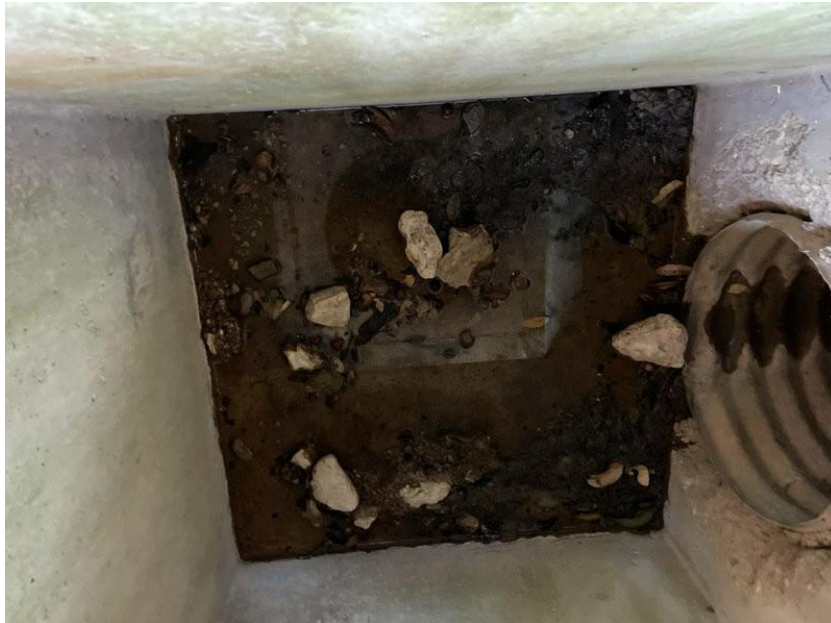
### Chula Vista Dr Inlet

Field Notes: Looks good.

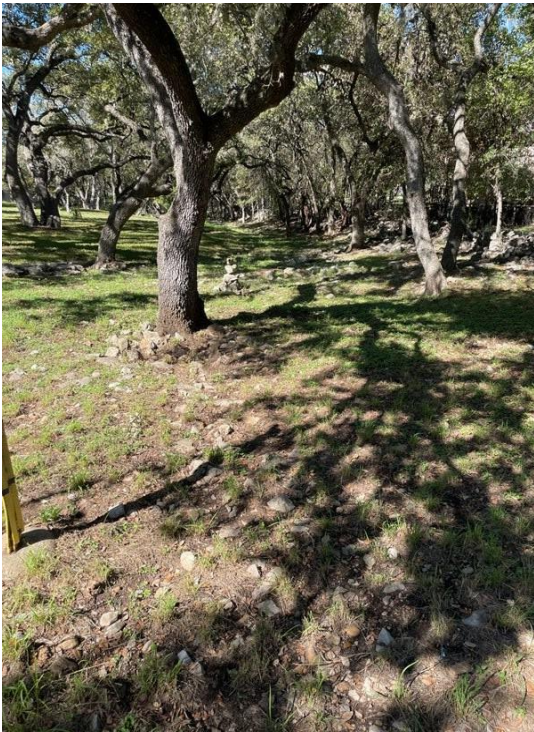
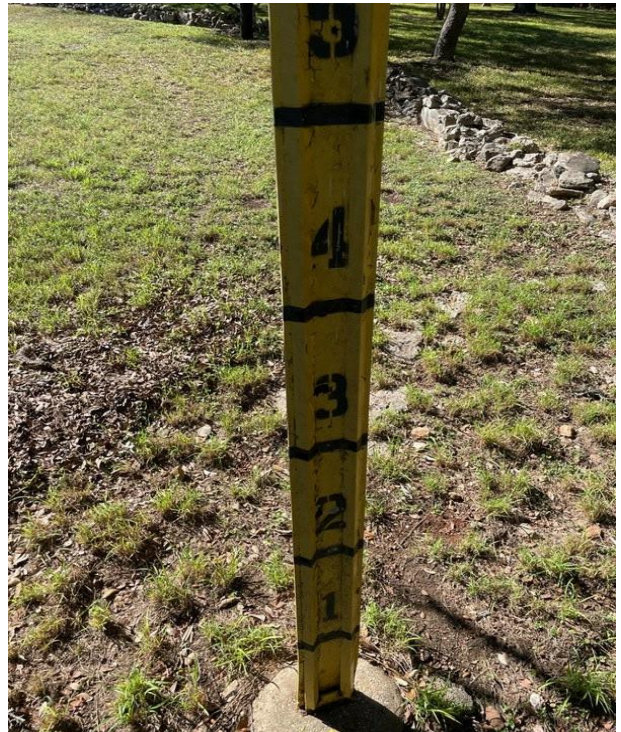
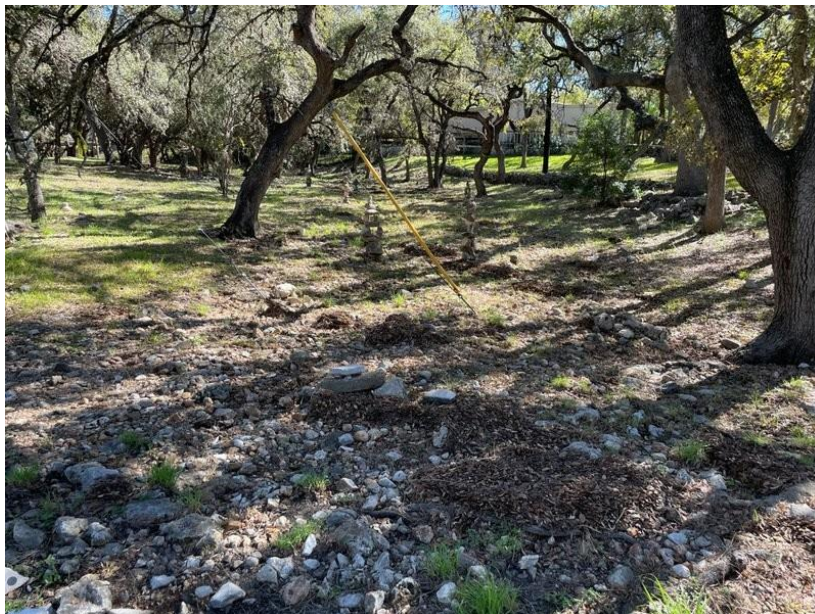
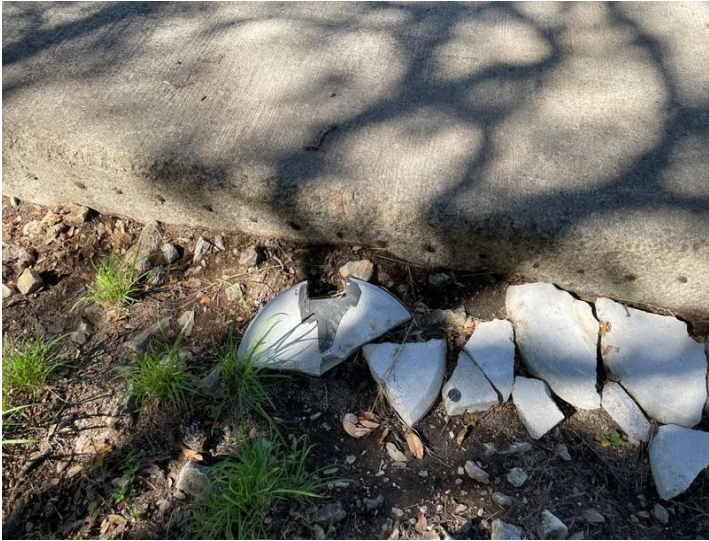
Field Notes: Looks good.

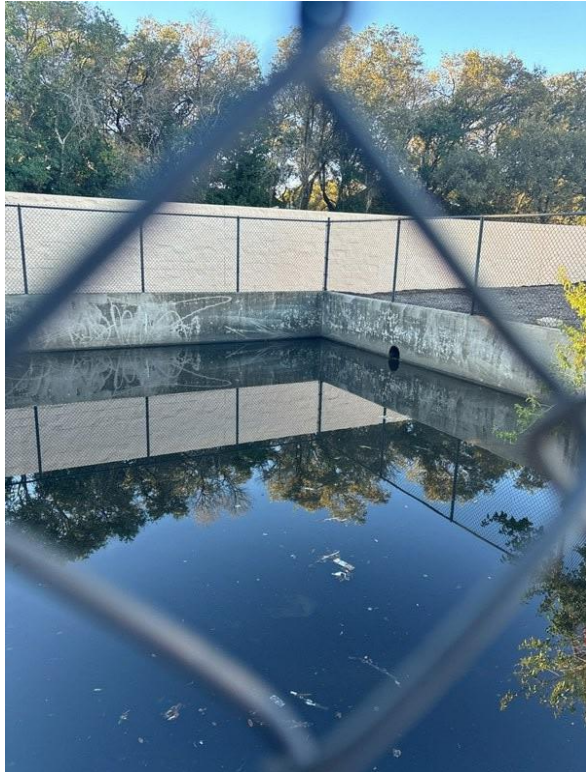
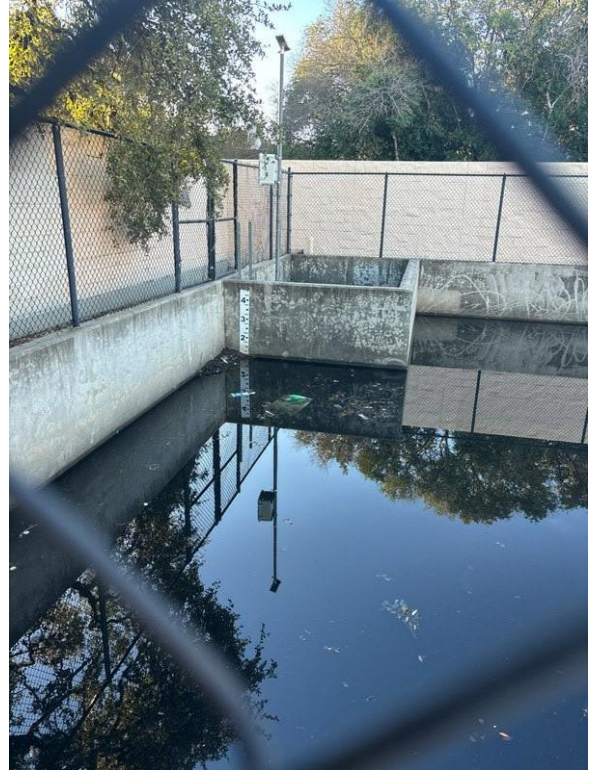
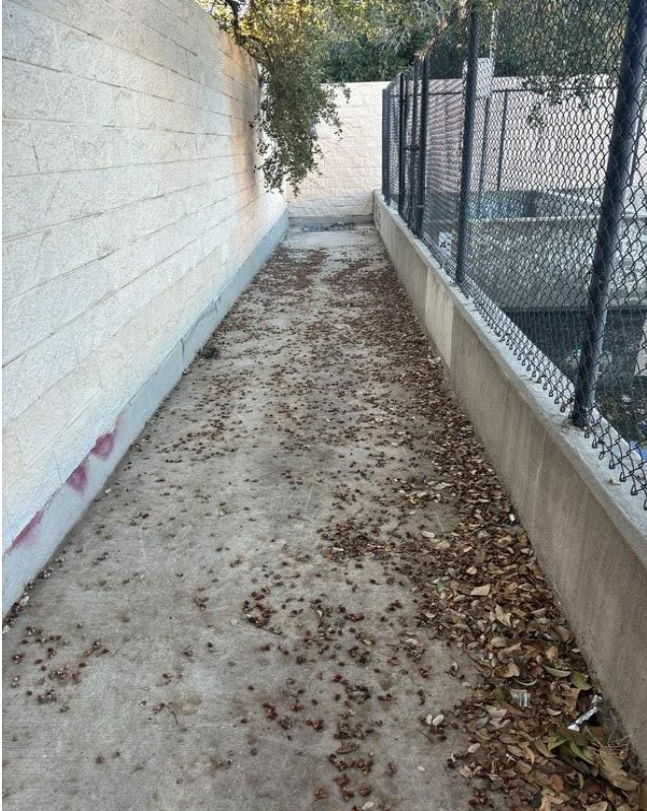
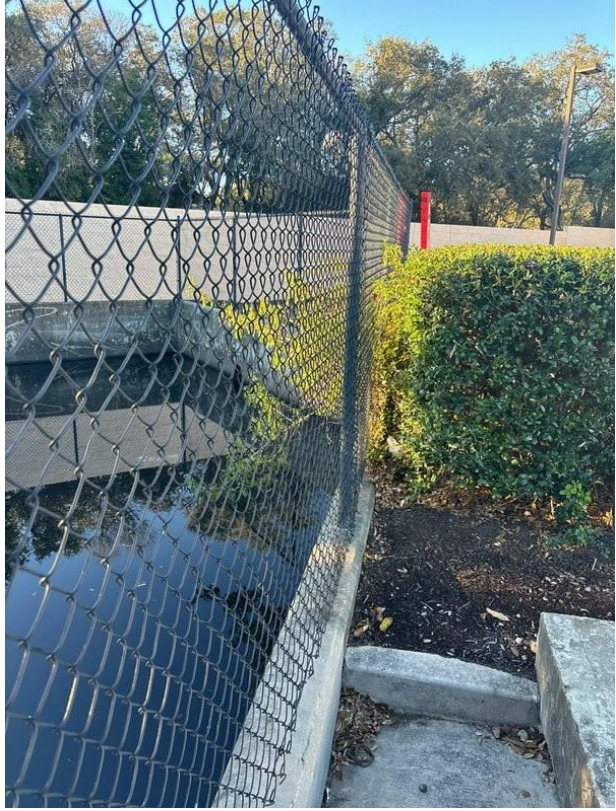
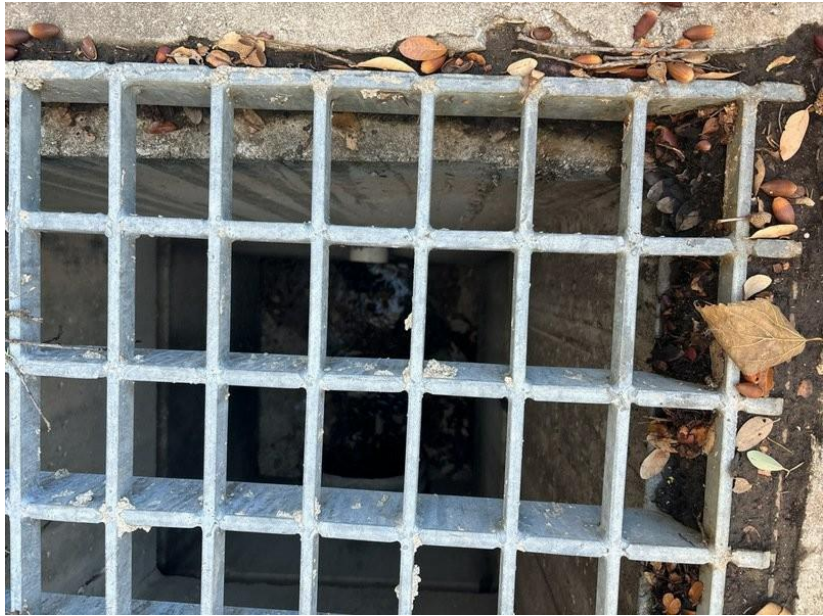
### Corner Store PCD

Field Notes: Clean trash from inside pond, rake away debris and trim vegetation from fence line.

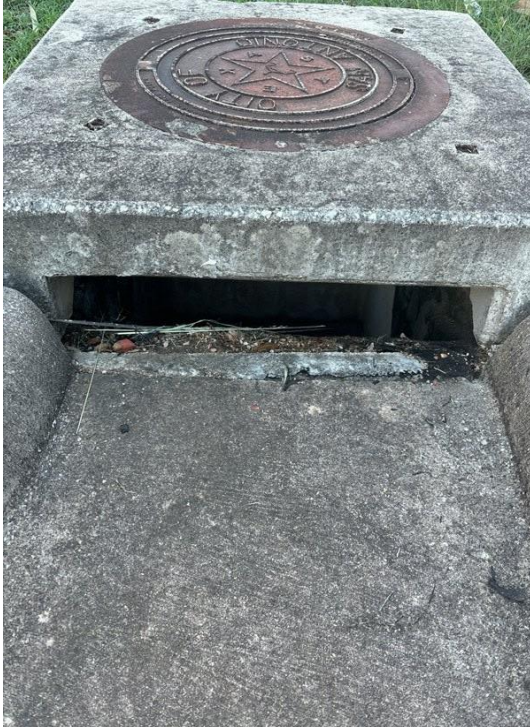
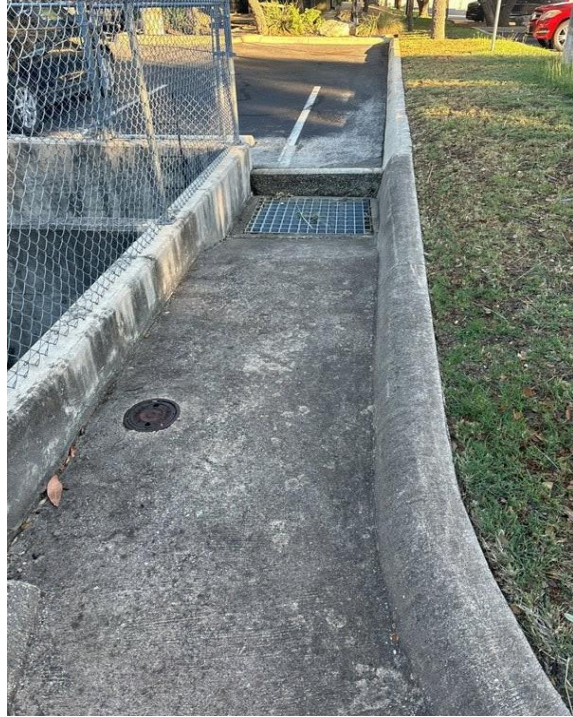
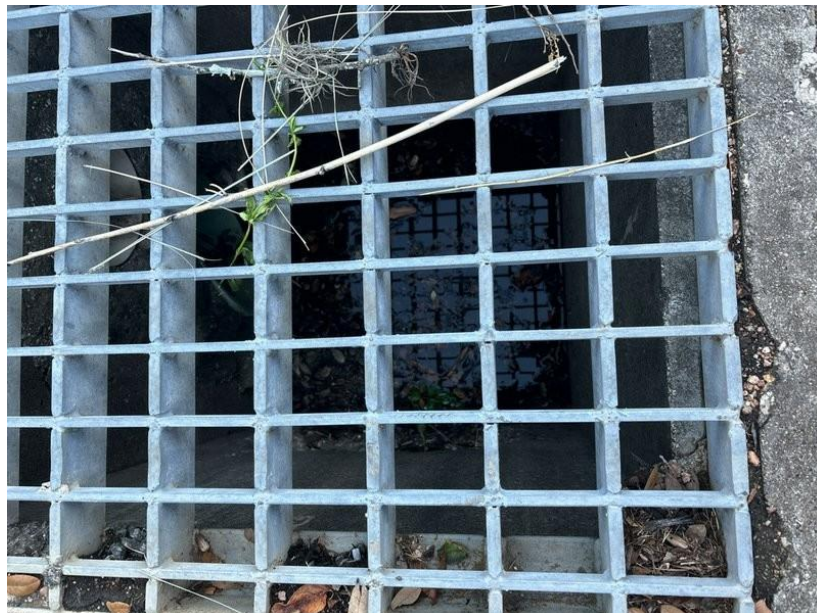
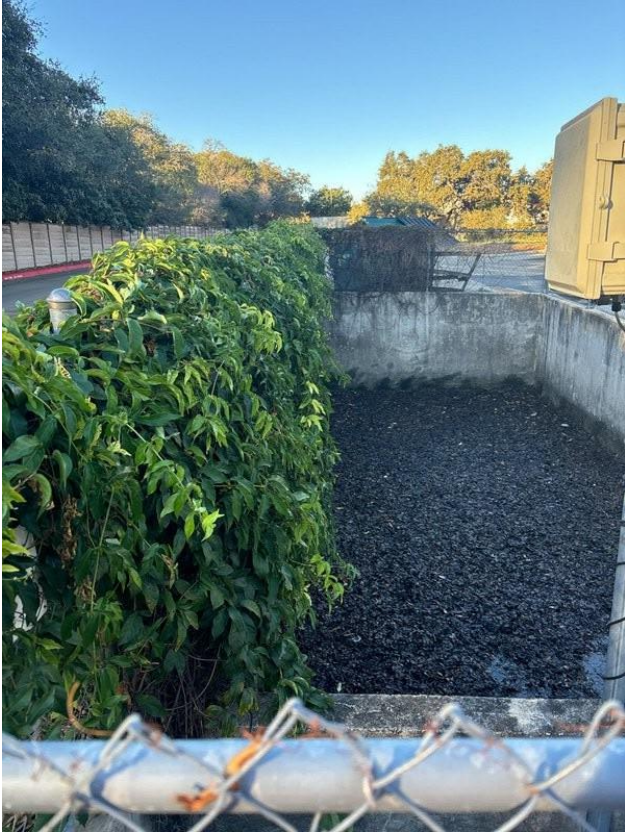
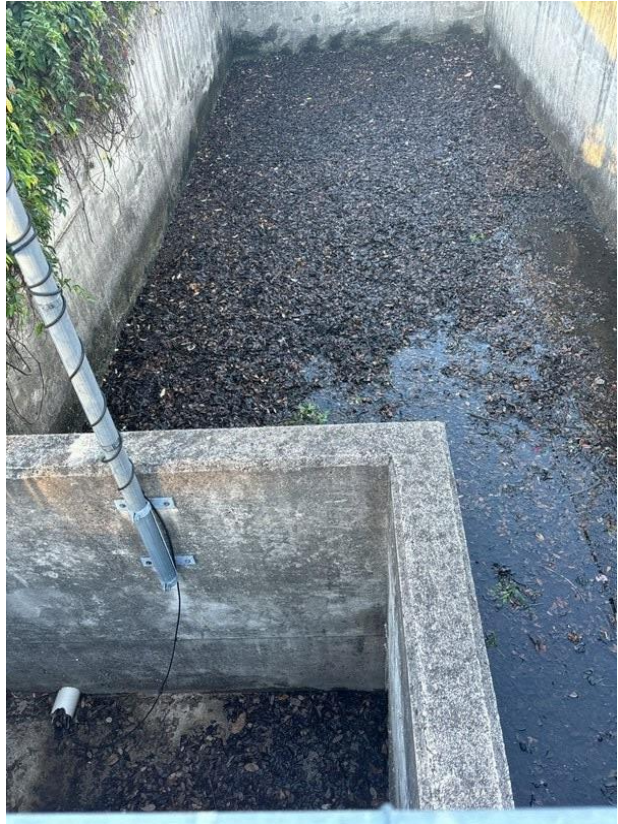
### CRT Flooring Concepts PCD

Field Notes: Trim vines from fence and remove leaves from pond basin.
