# TOWN OF HOLLYWOOD PARK, TX

2024 Winter Inspection

# HOLLYWOOD PARK 2024 WINTER INSPECTION REPORT

**Subject:** Annual Municipal Separate Storm Sewer System (MS4) Inspection

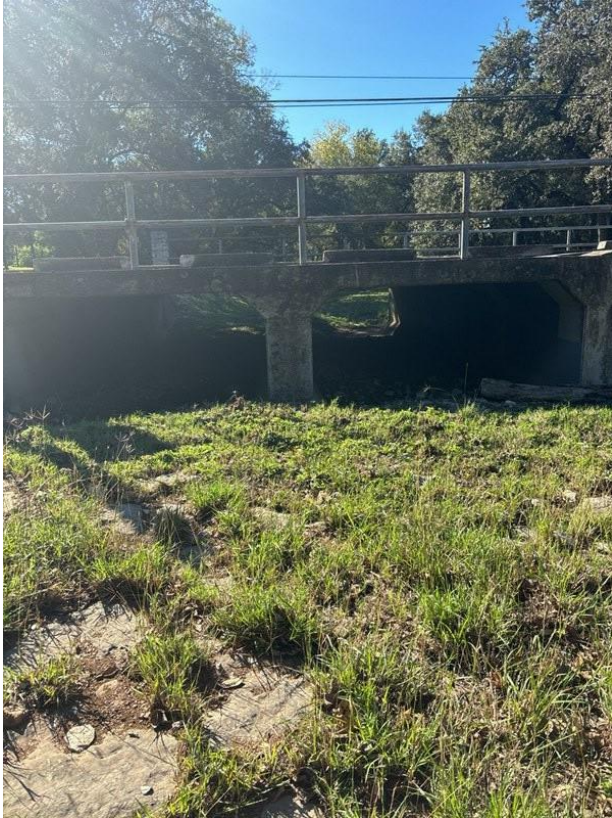
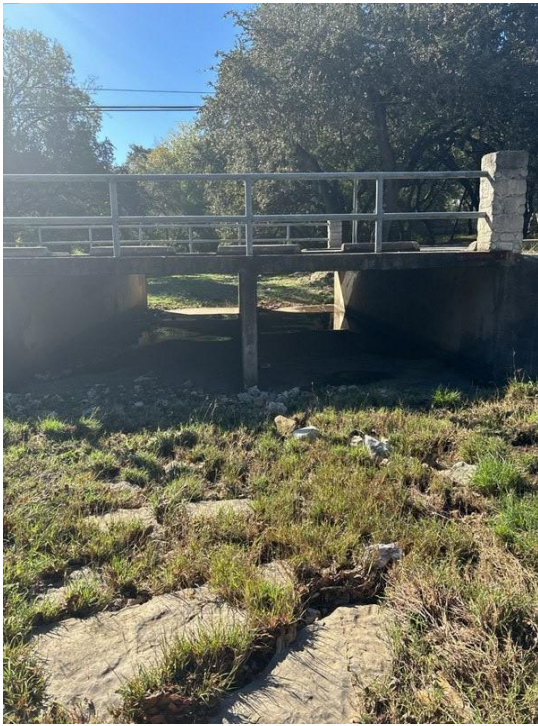
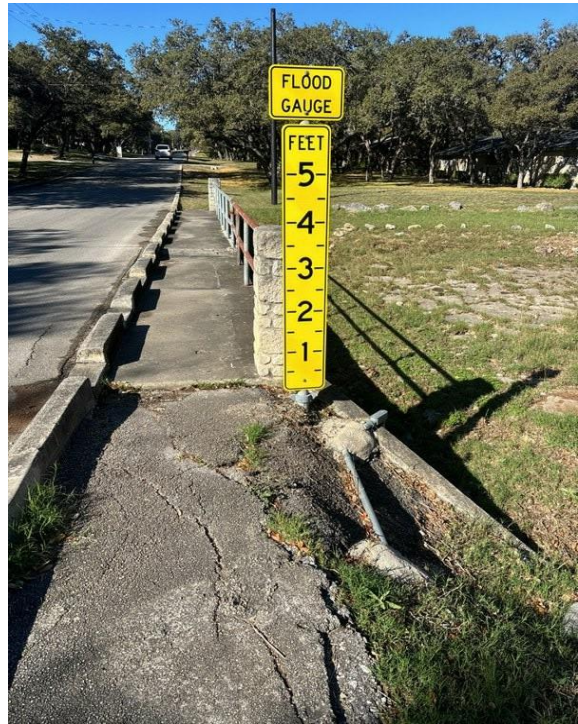
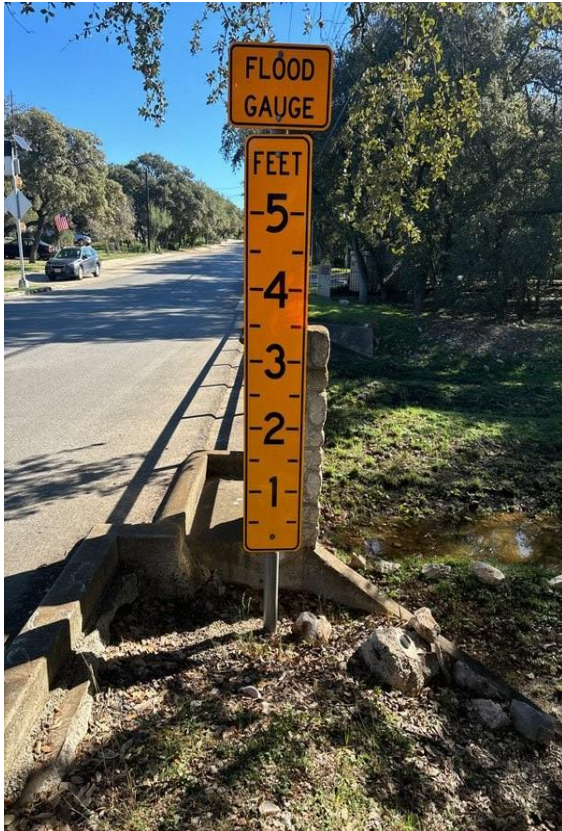
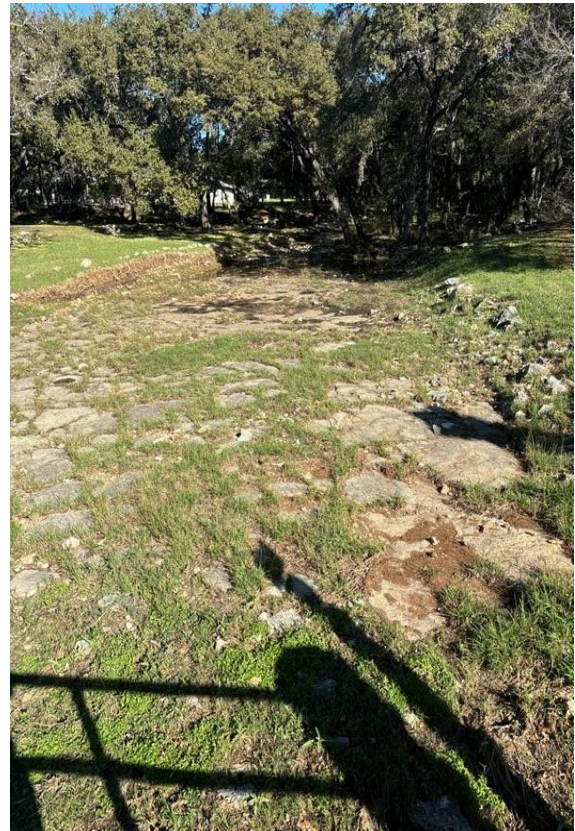
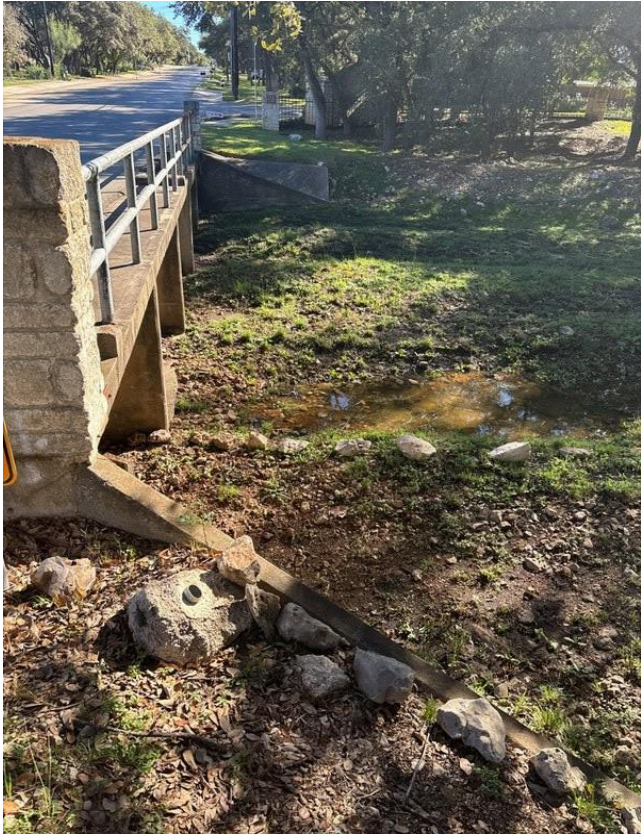
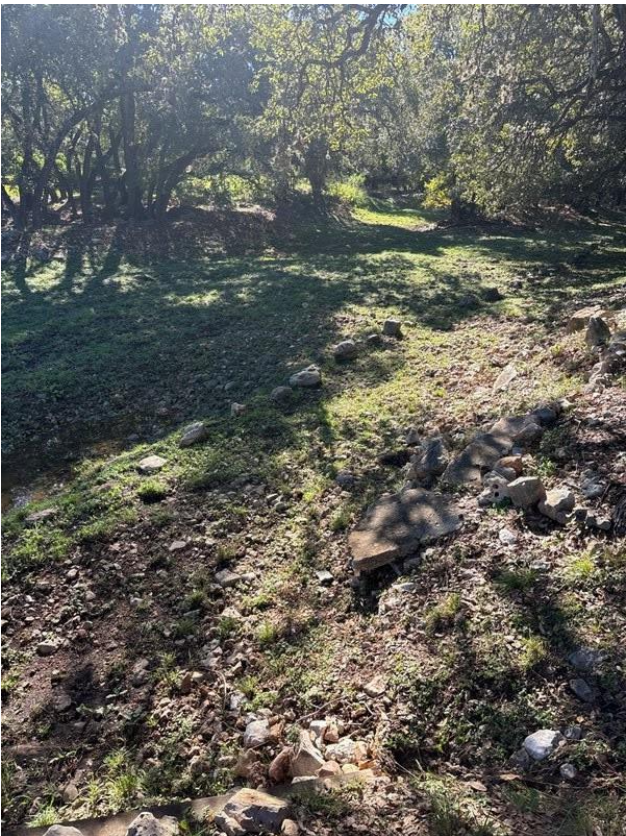
## Donella Crossing

Field Notes: No Maintenance Required.

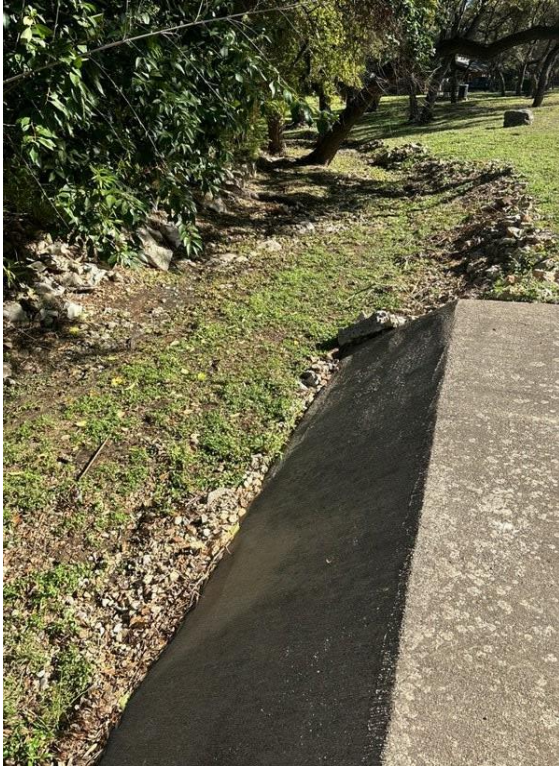
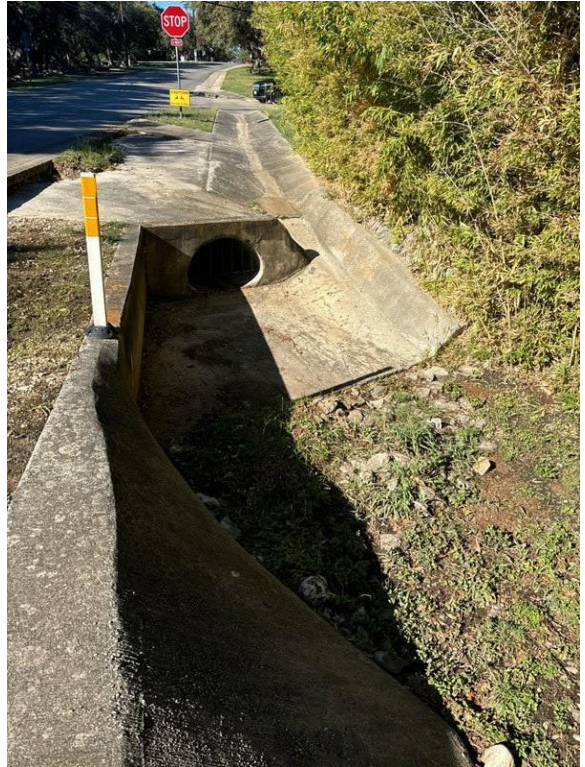
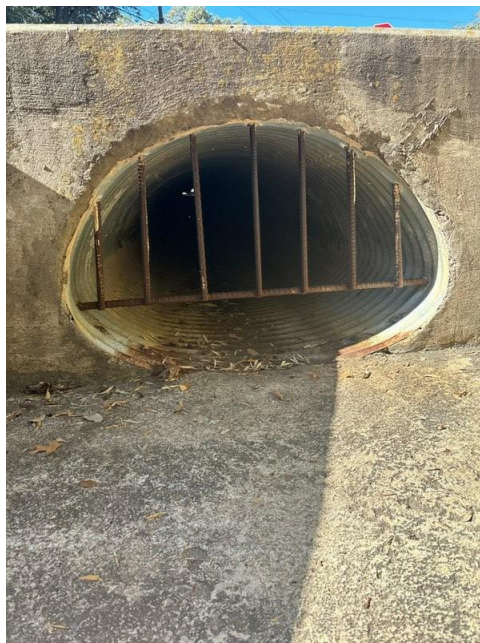
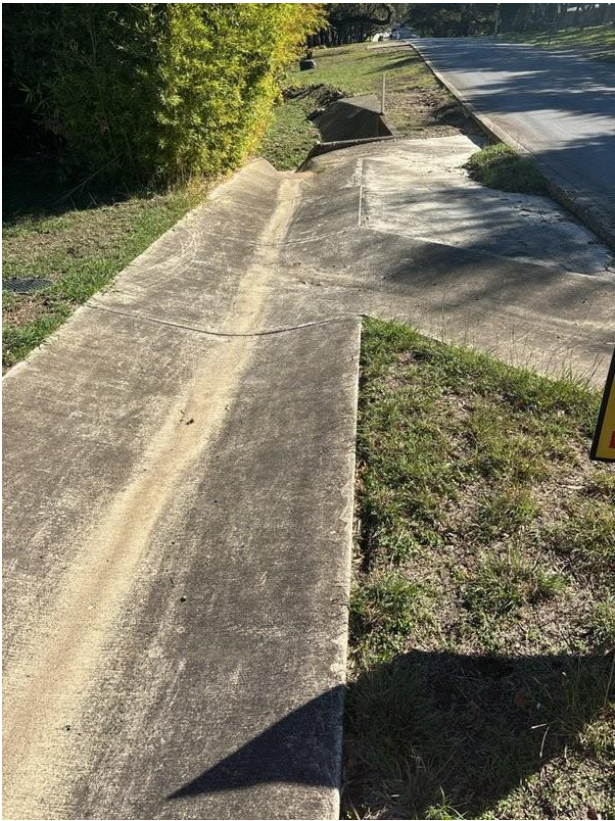
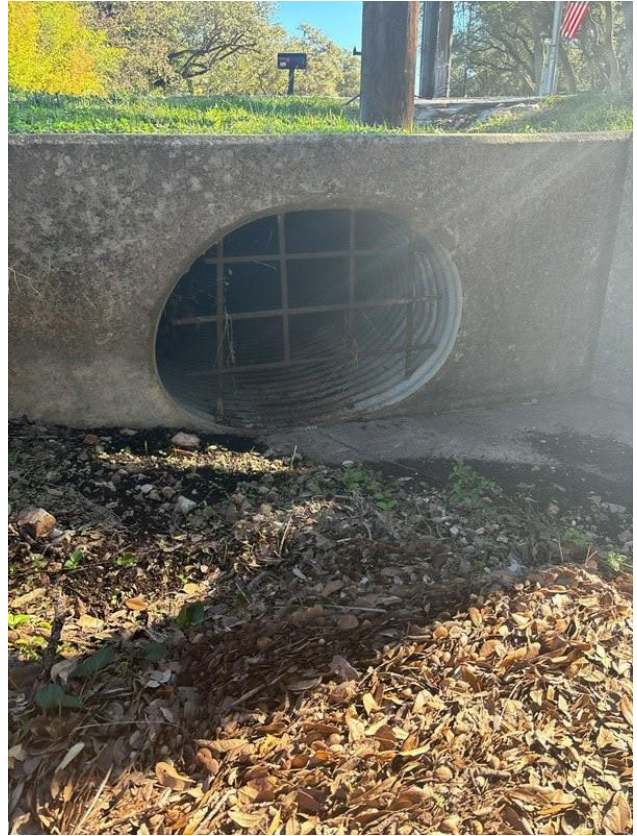
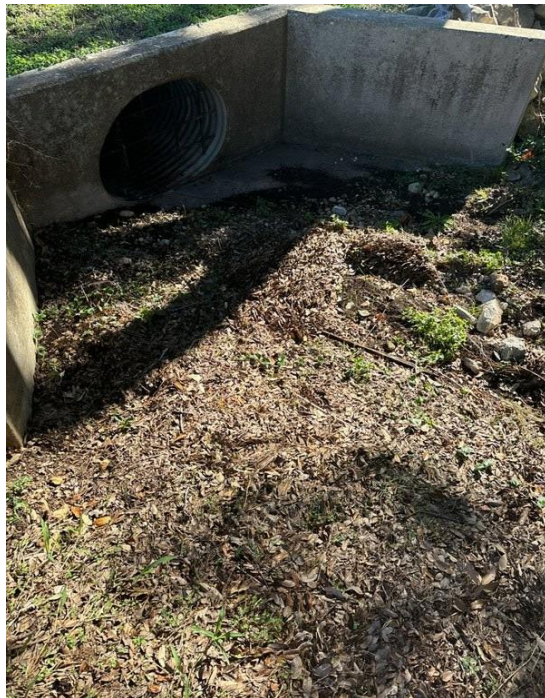
## Donella Culvert Crossing at Mustang Circle

Field Notes: Remove leaves in front of inlet.

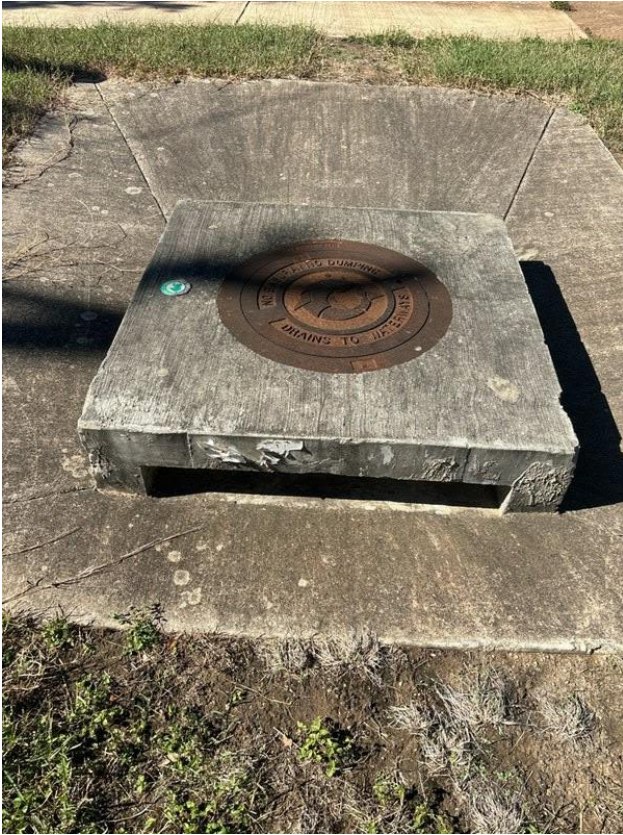
### Donella Inlet Box

Field Notes: No maintenance required.

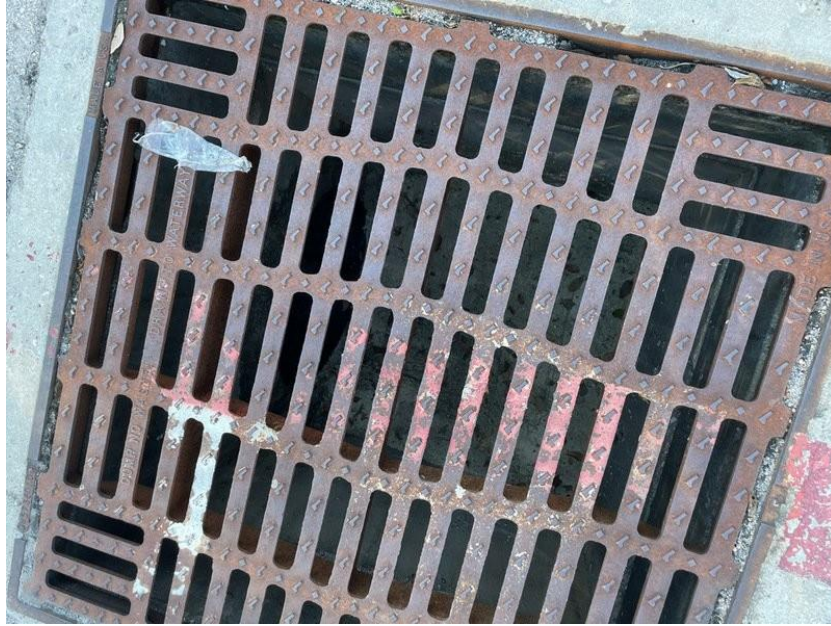
## Drash Rear Parking Lot Inlet

Field Notes:  
Looks good.

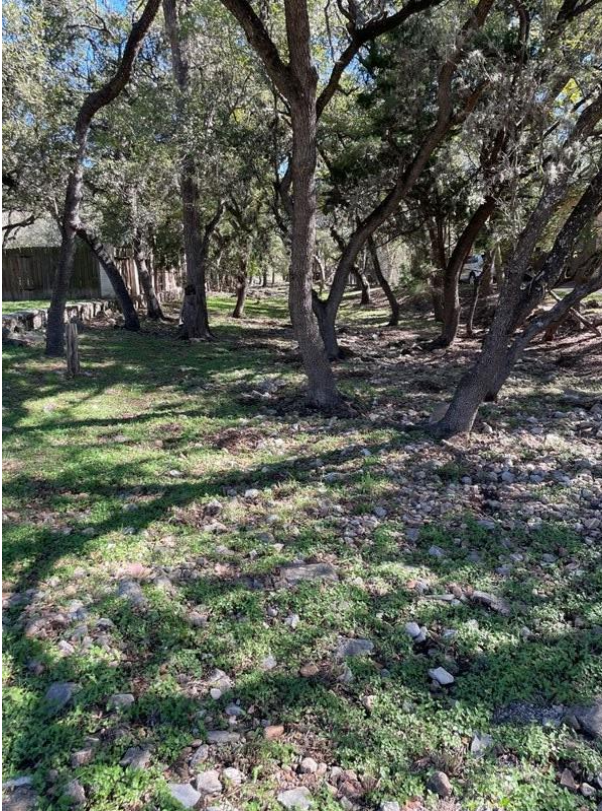
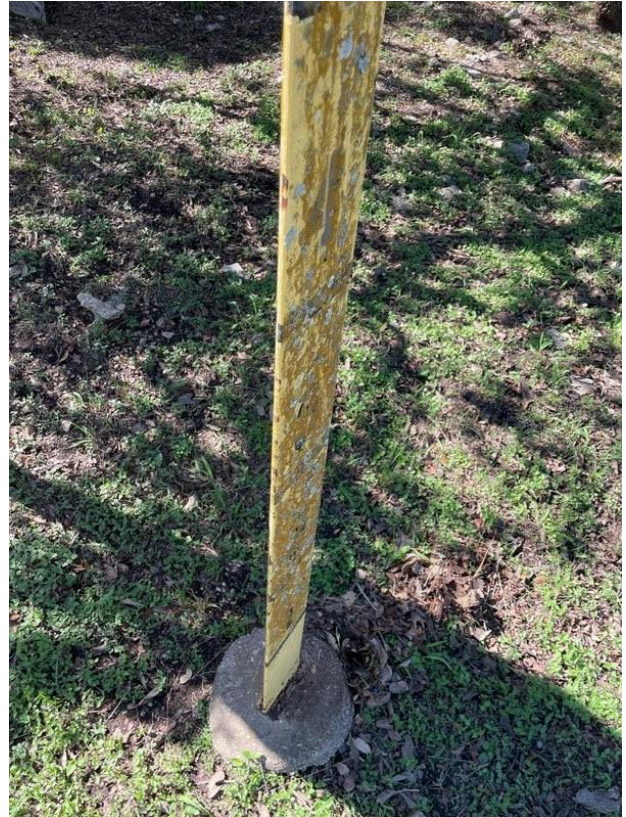
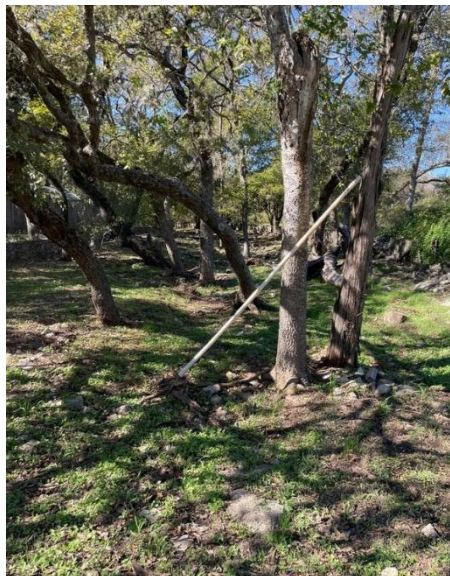
Field Notes: Looks good.

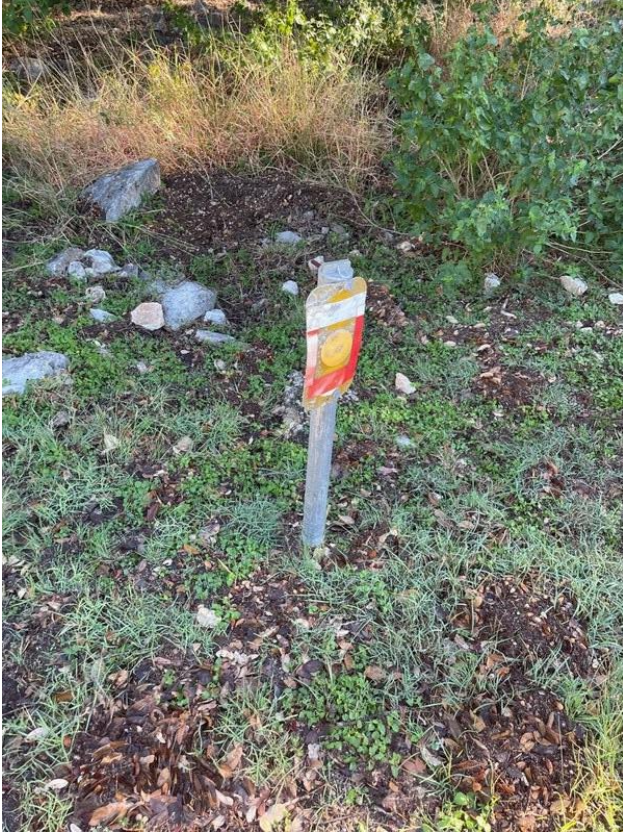
## El Cerrito Cr Low Water Crossing

Field Notes: Mow base of flood gauge.

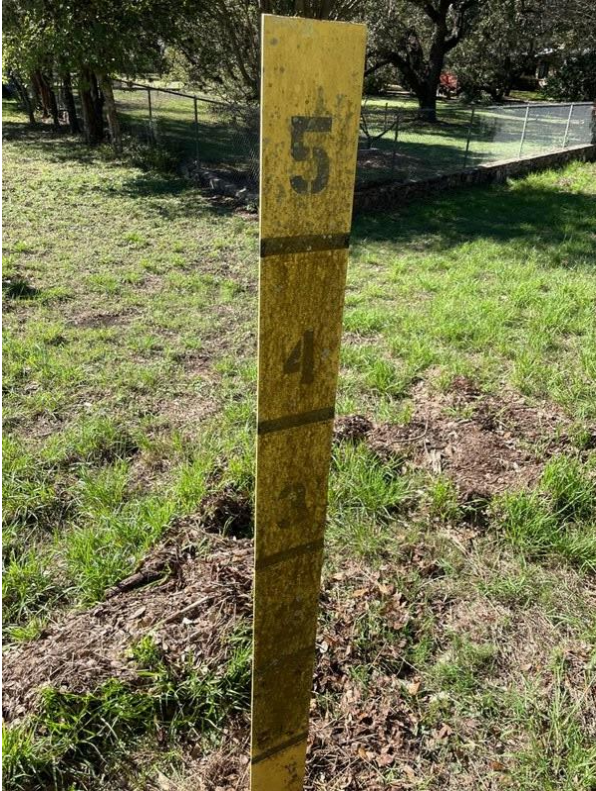
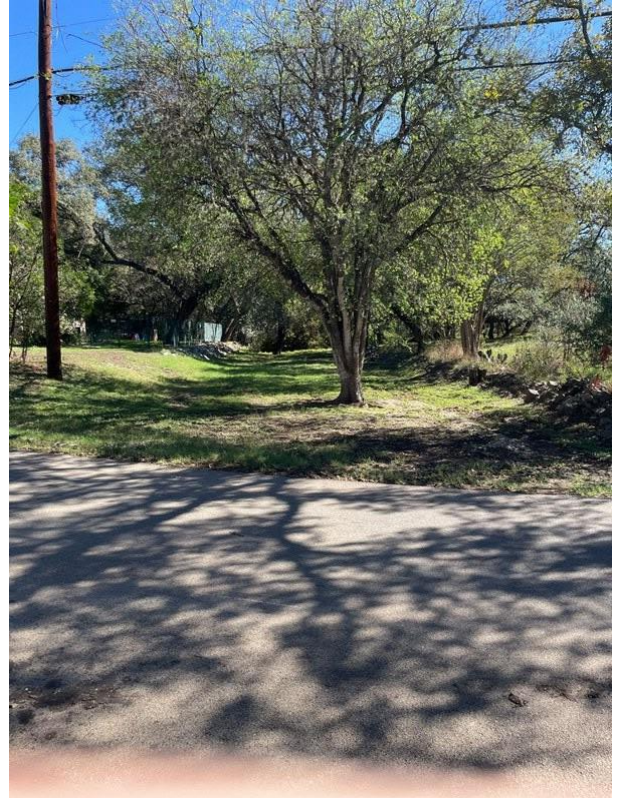
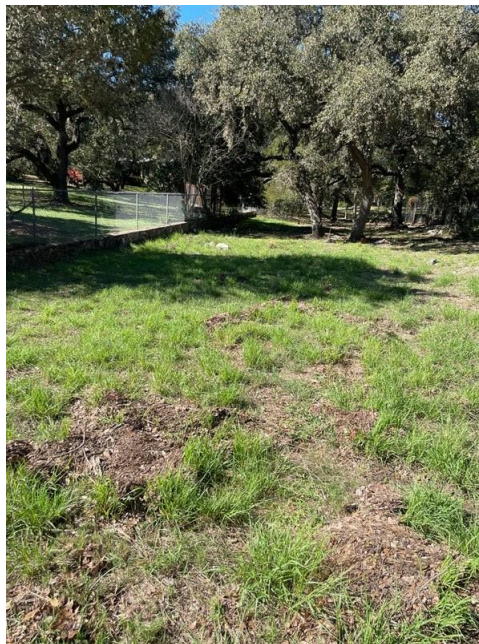
## El Cerrito Low Water Crossing

Field Notes: Looks good clear moss of off gauge.

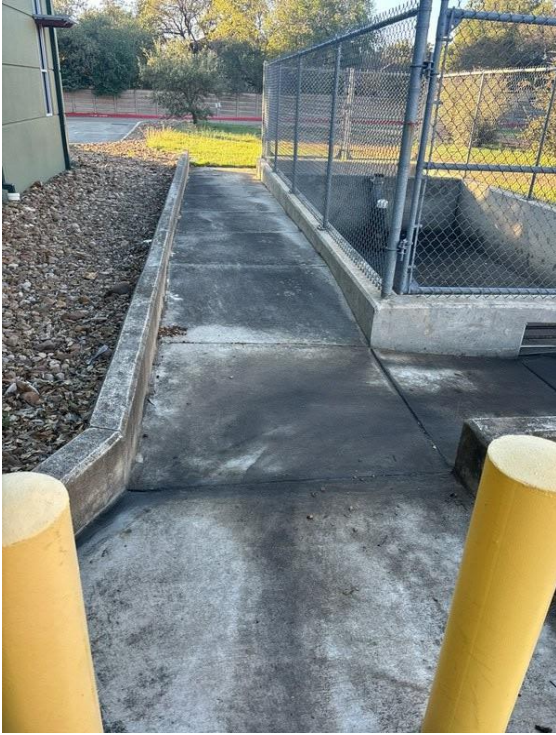
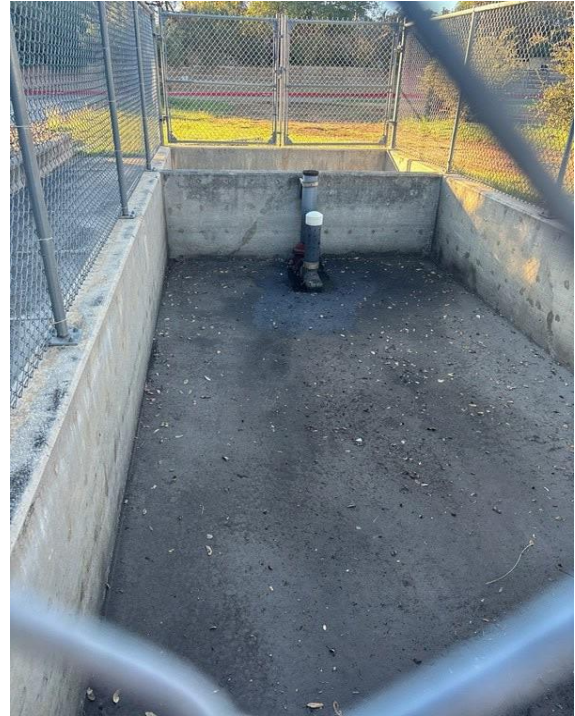
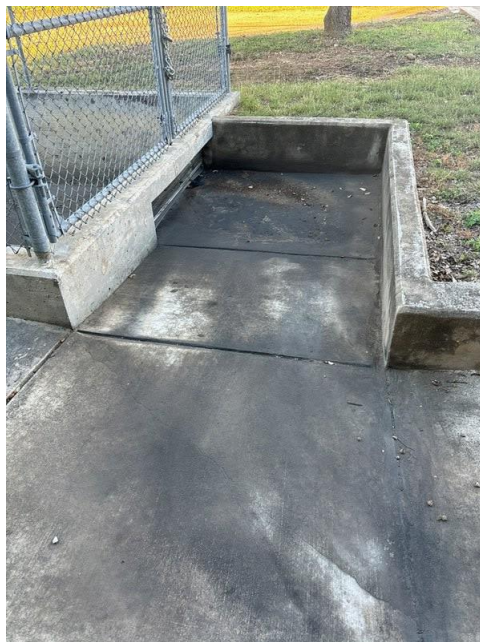
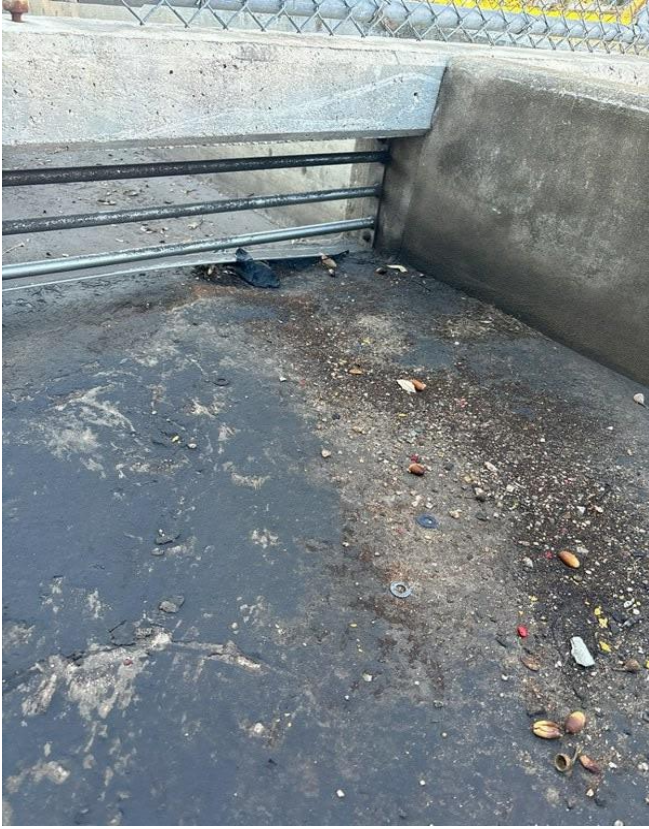
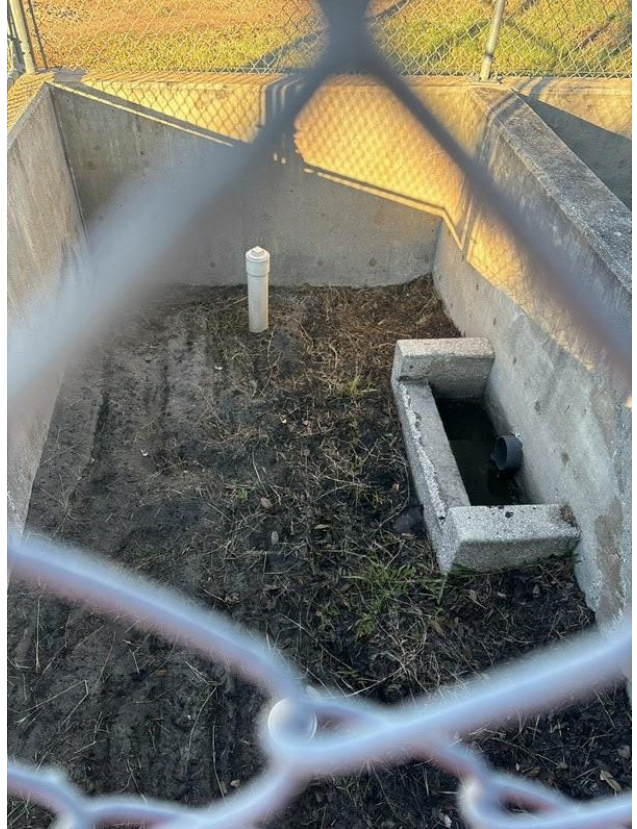
## Express Lube PCD

Field Notes: Clean trash at pond inlet and remove vegetation and debris from the back of pond basin.

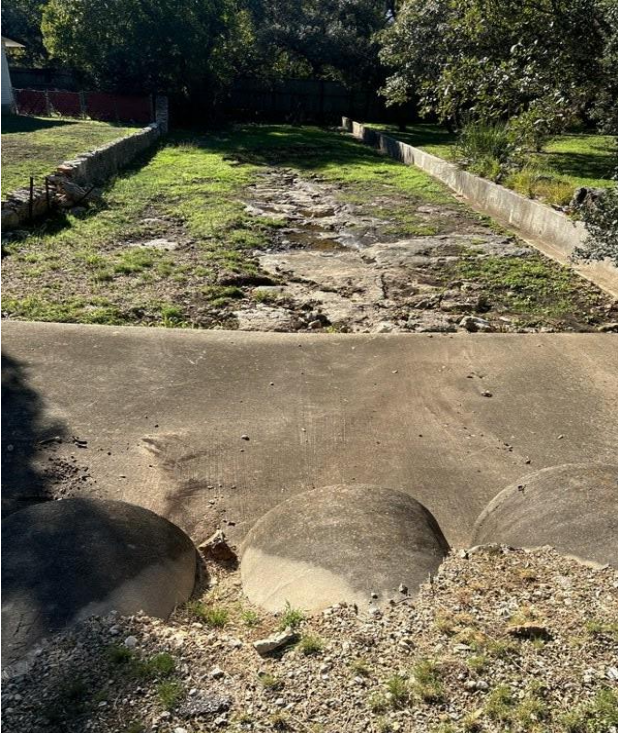
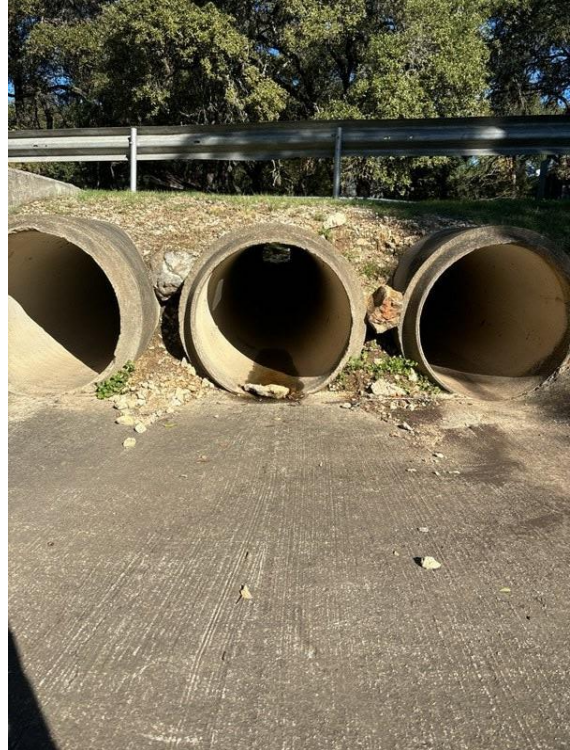
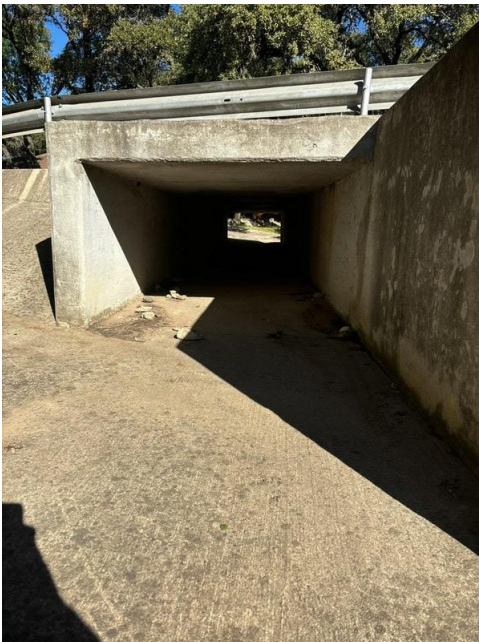
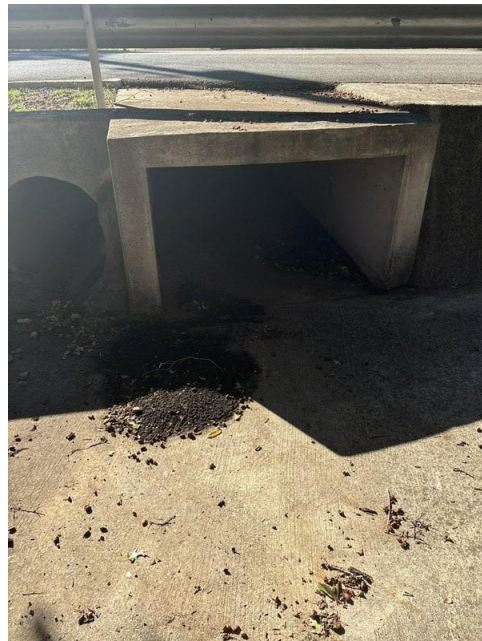
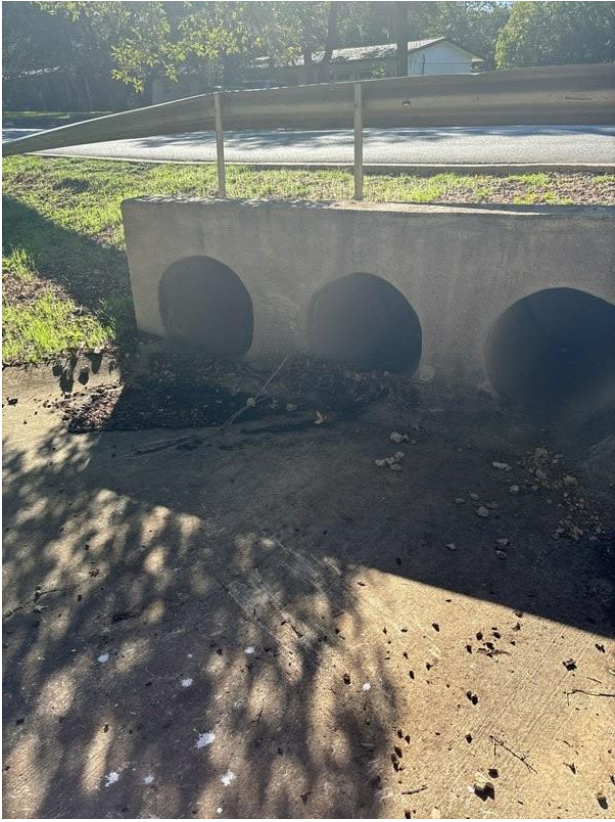
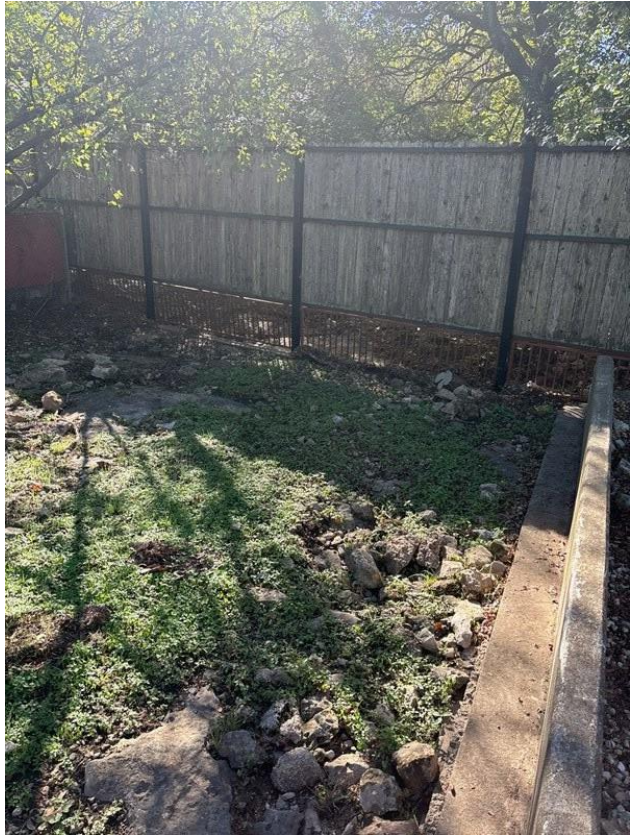
Field Notes: Remove sediment and branches near outfall.

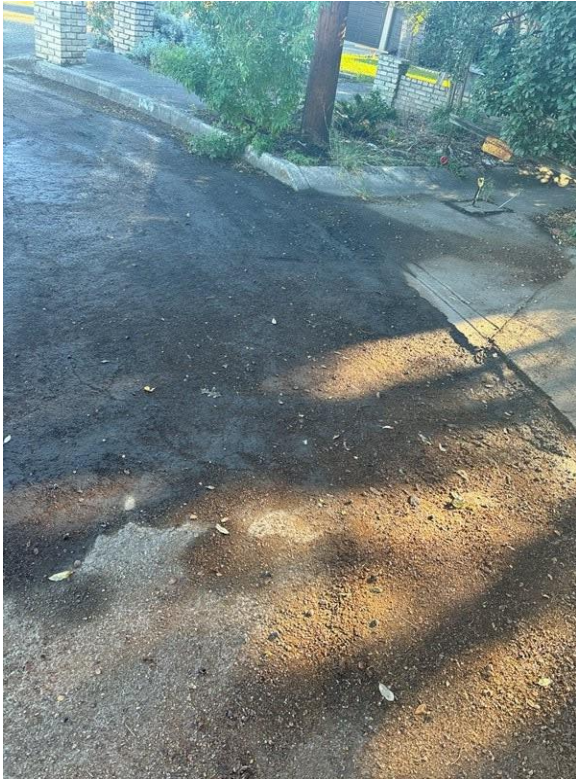
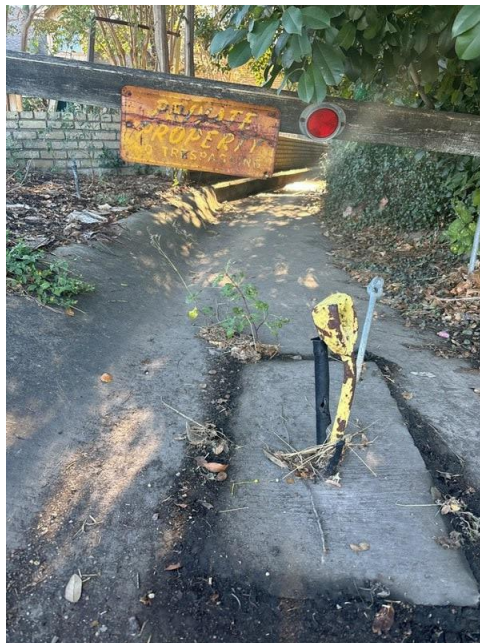
## Garrapata Storm Water Inflow

Field Notes: Remove sediment from road/entry and trim vegetation at channel entrance.

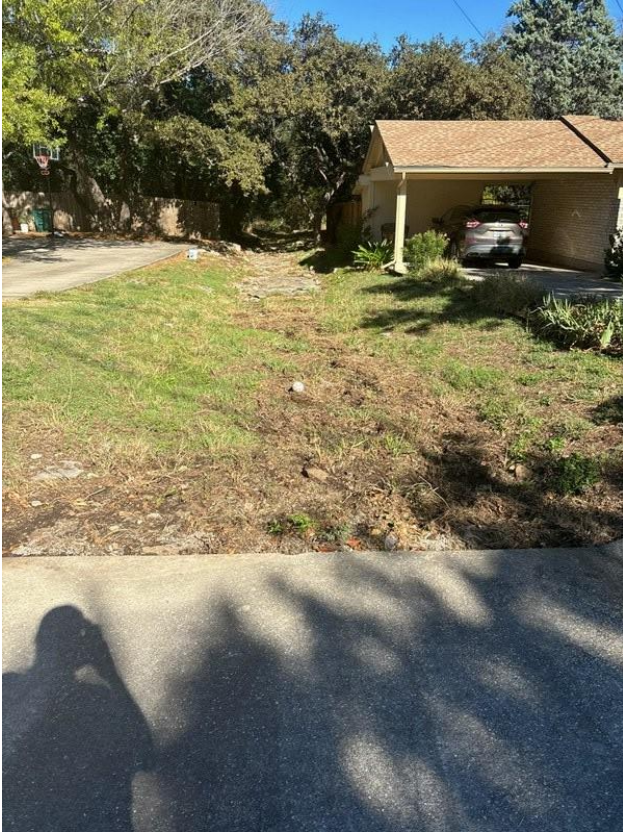
## Grand Oak Outfall

Field Notes: No Maintenance Required

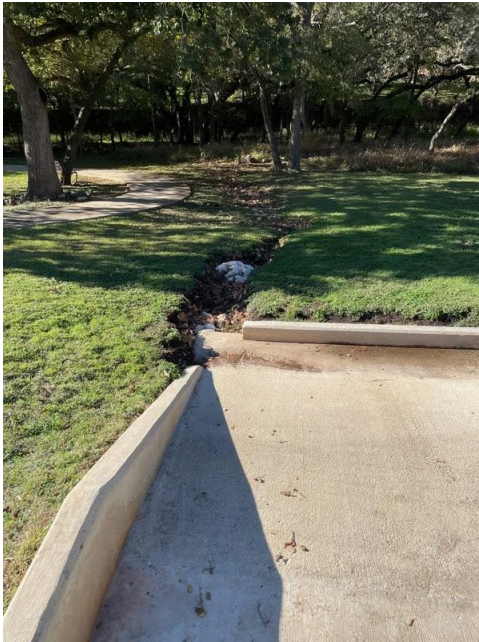
## Great Wood Street Outfall

Field Notes: Looks good.

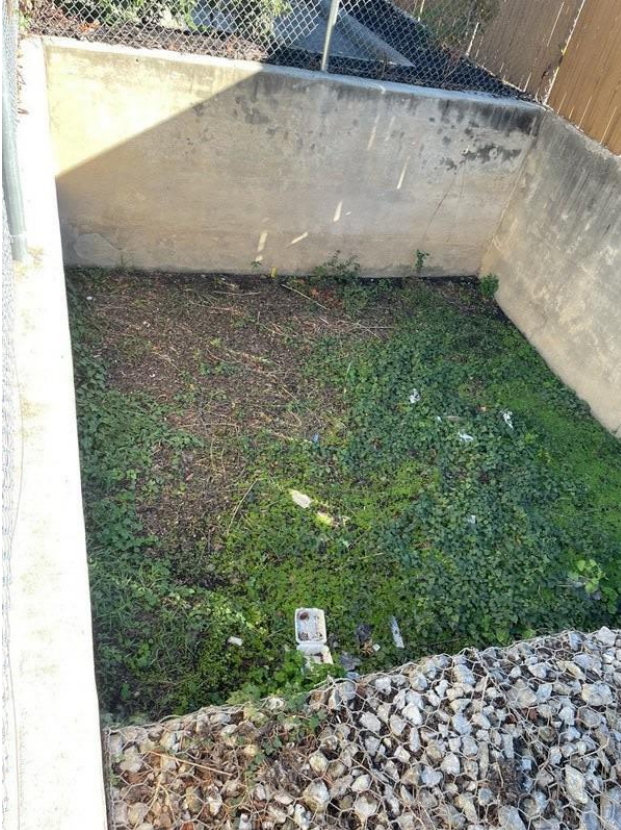
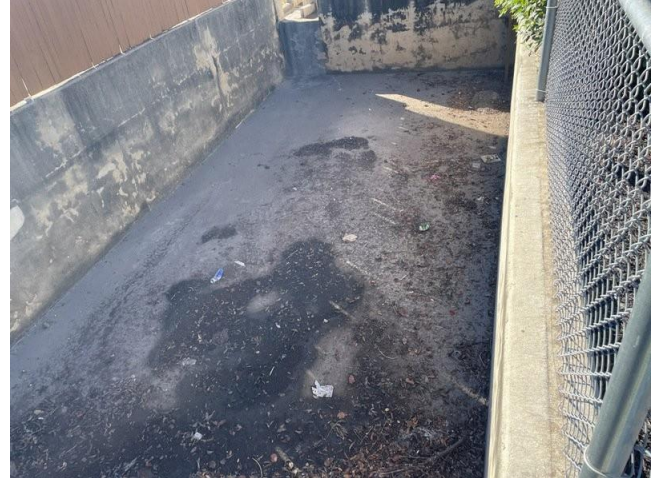
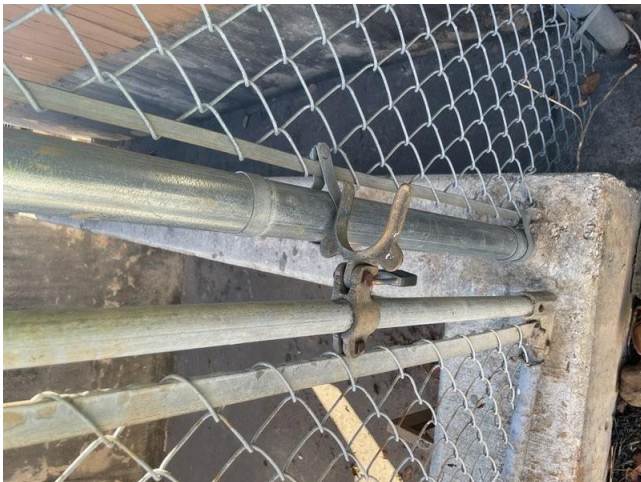
## Holiday Inn PCD

Field Notes: Looks good. Ensure lock is properly installed.

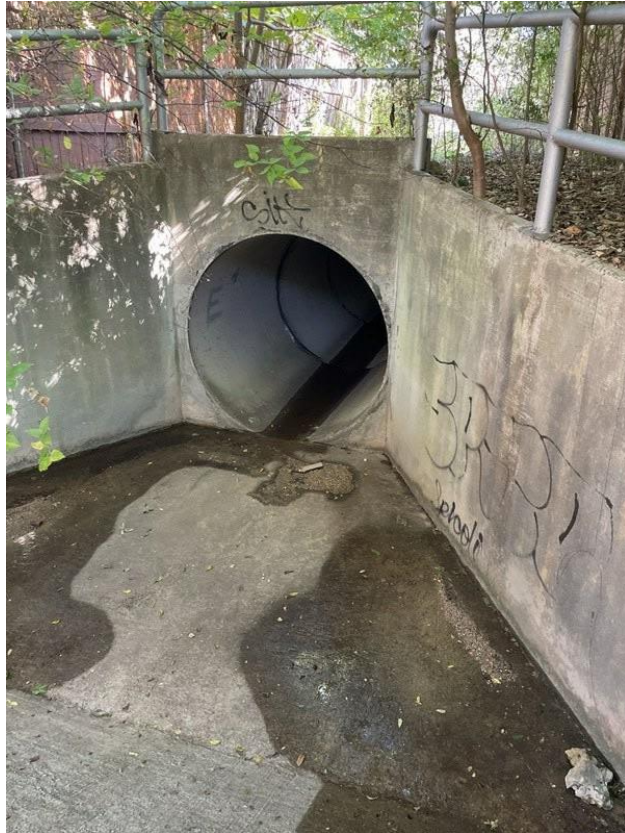
## Large Channel Drain Inlet

Field Notes: Looks good.

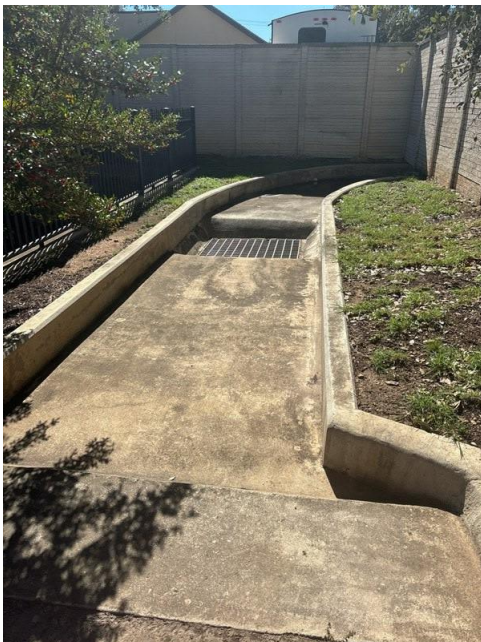
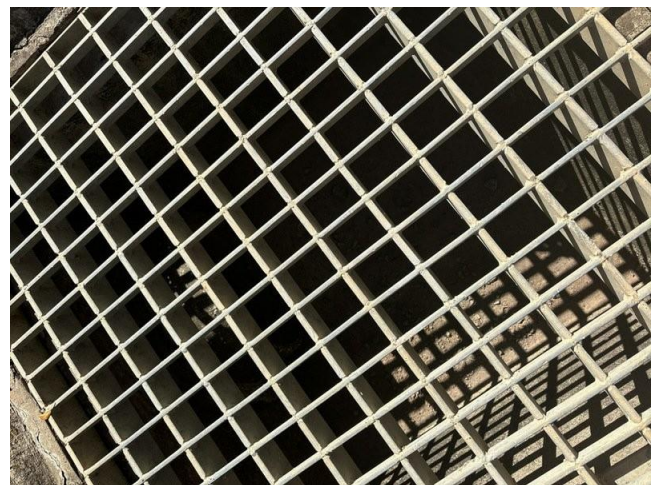
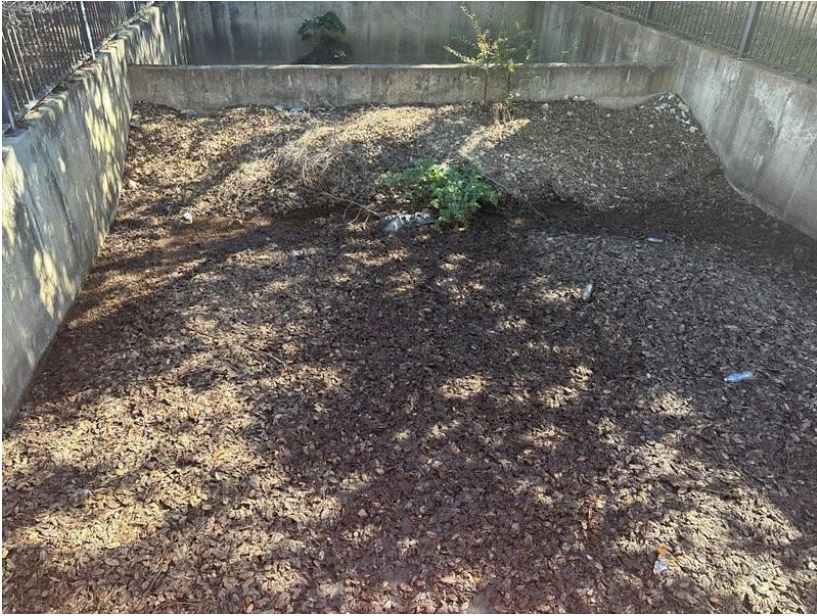
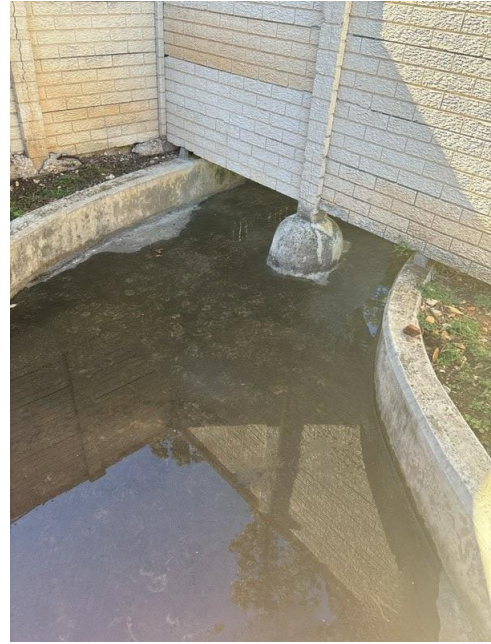
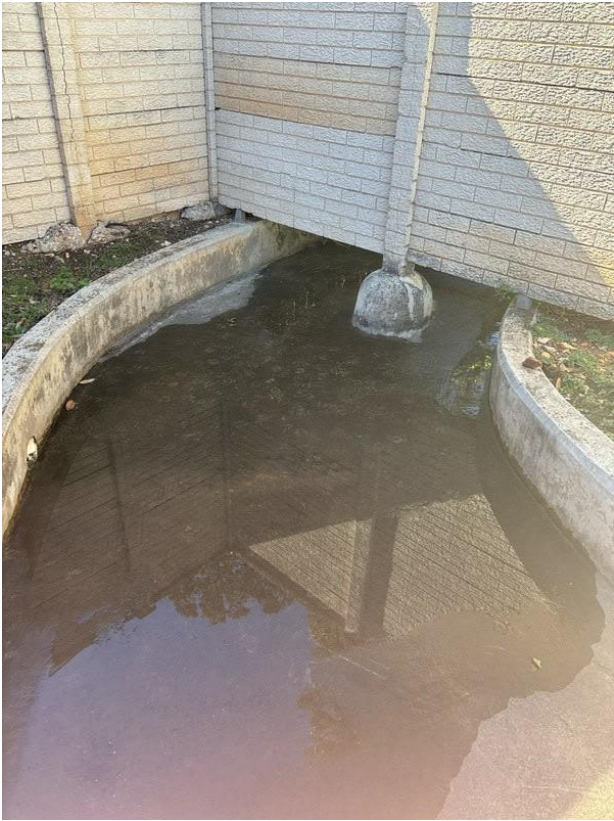
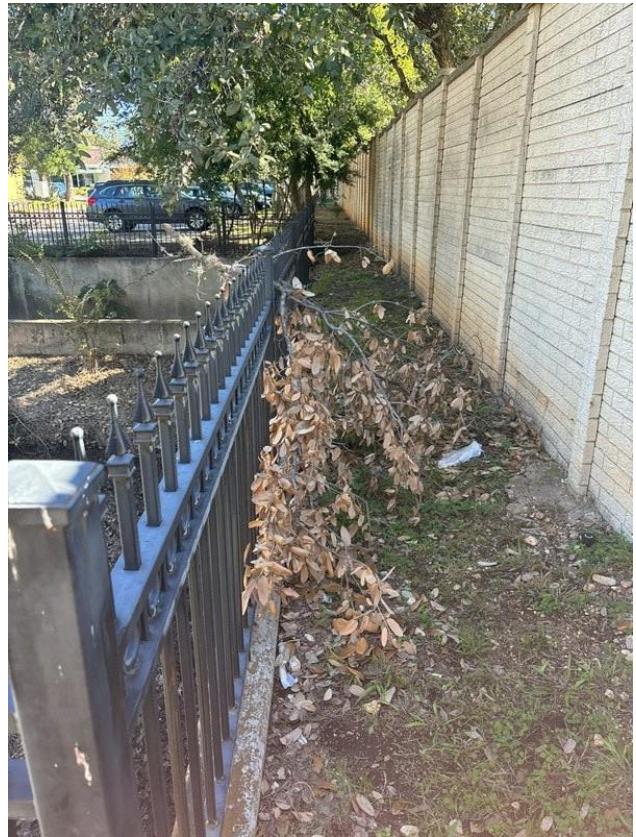
## Marriott Global Reservation PCD

Field Notes: Remove branch from fence and remove leaves and debris from basin.

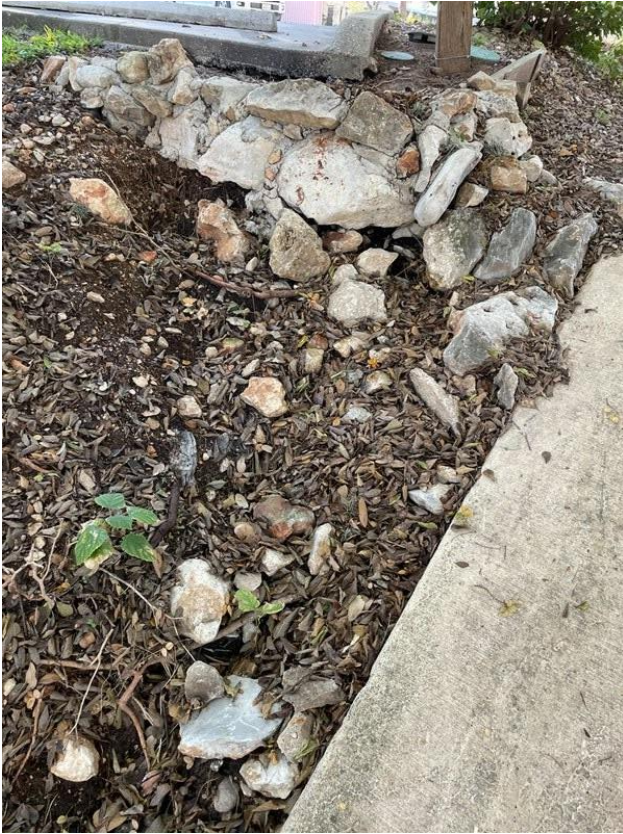
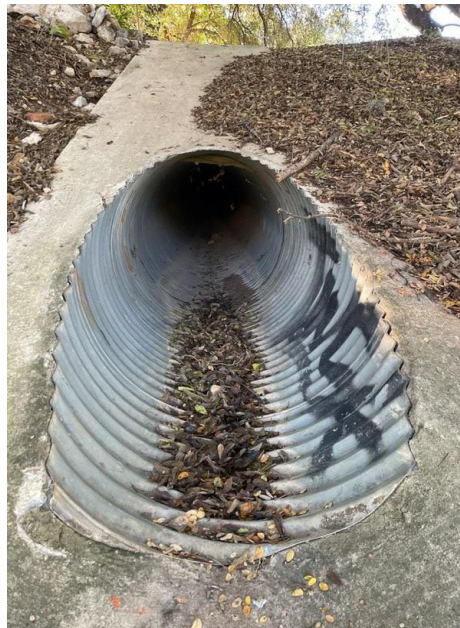
## Mecca Inlets Outfall

Field Notes: Monitor parking lot runoff as it is beginning to undermine outfall riprap

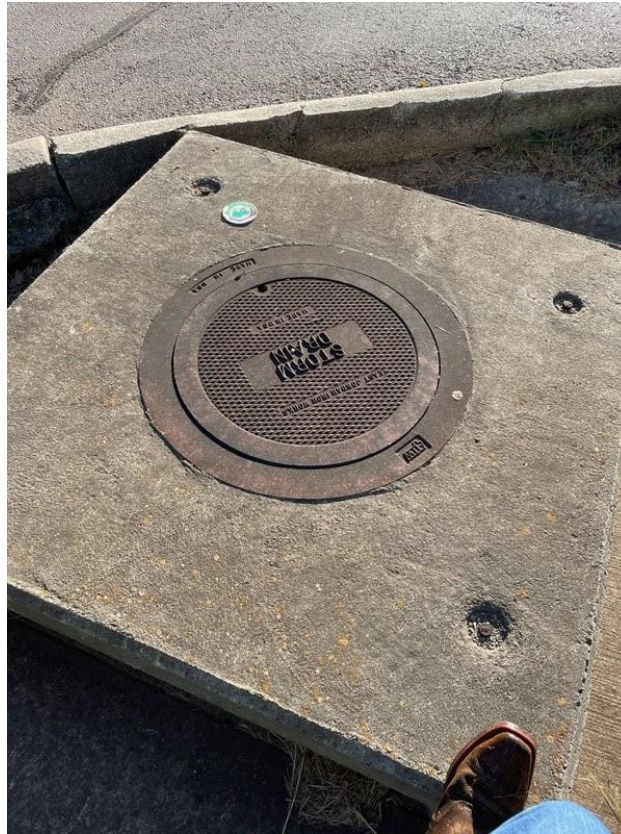
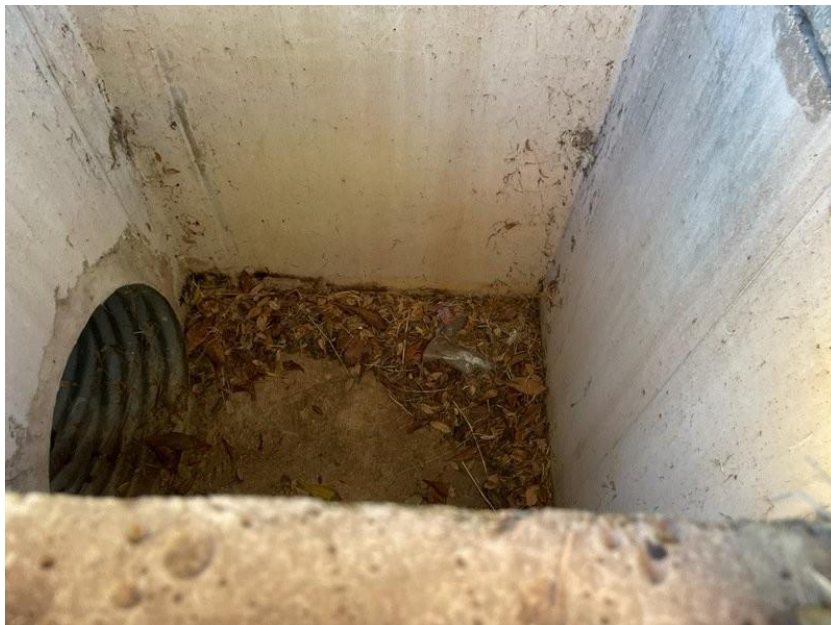
### MEC-I-1(M)

Field Notes: Looks good.
