# TOWN OF HOLLYWOOD PARK, TX

2024 Winter Inspection

# HOLLYWOOD PARK 2024 WINTER INSPECTION REPORT

**Subject:** Annual Municipal Separate Storm Sewer System (MS4) Inspection

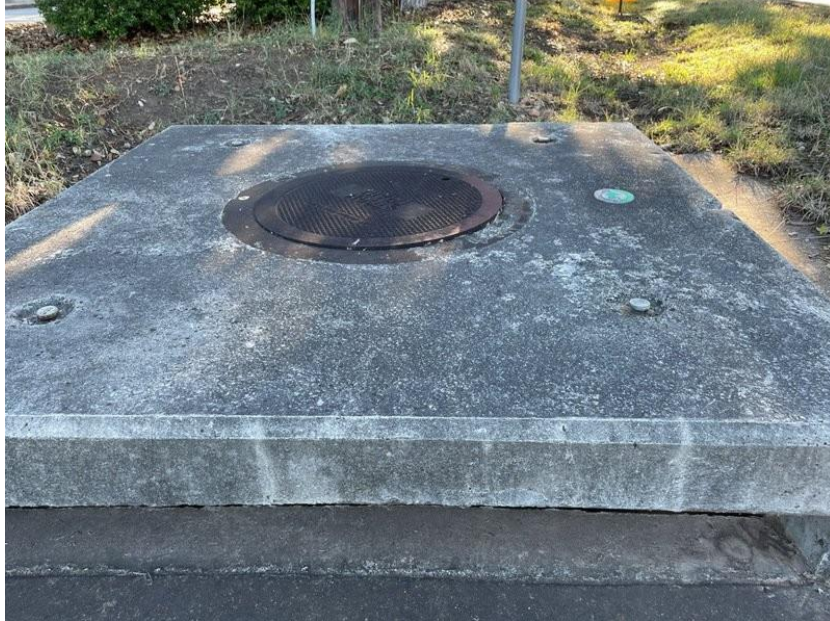
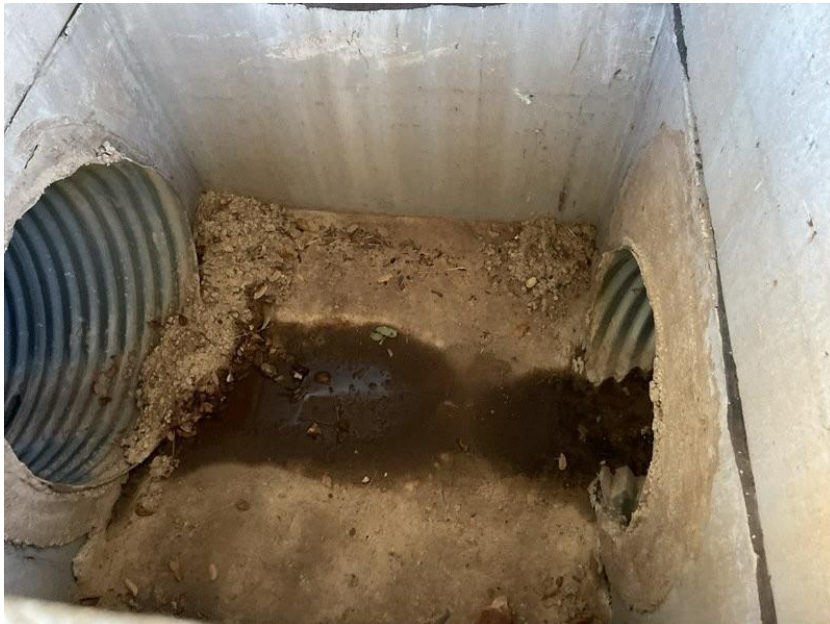
Field Notes: Looks good.

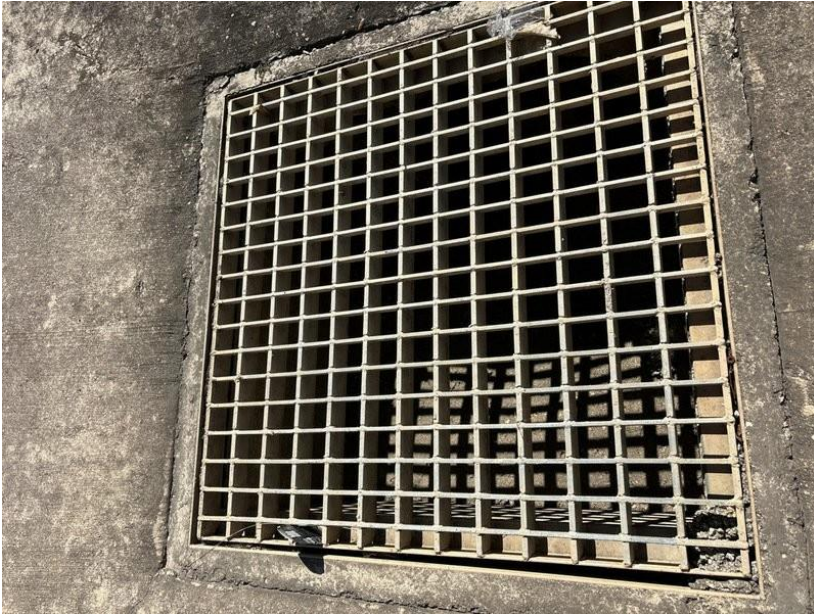
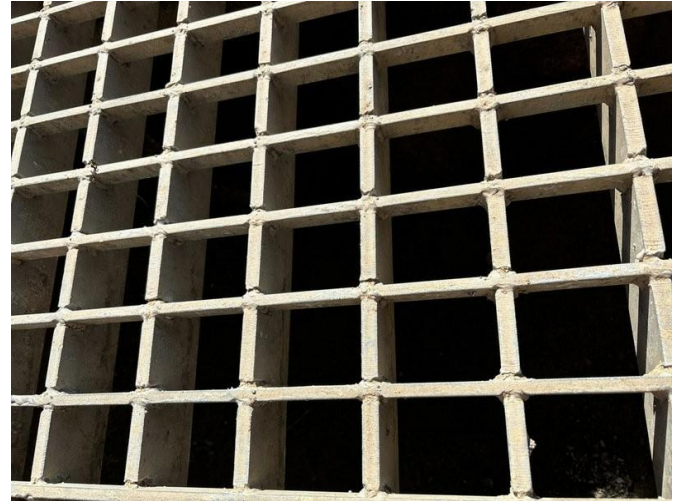
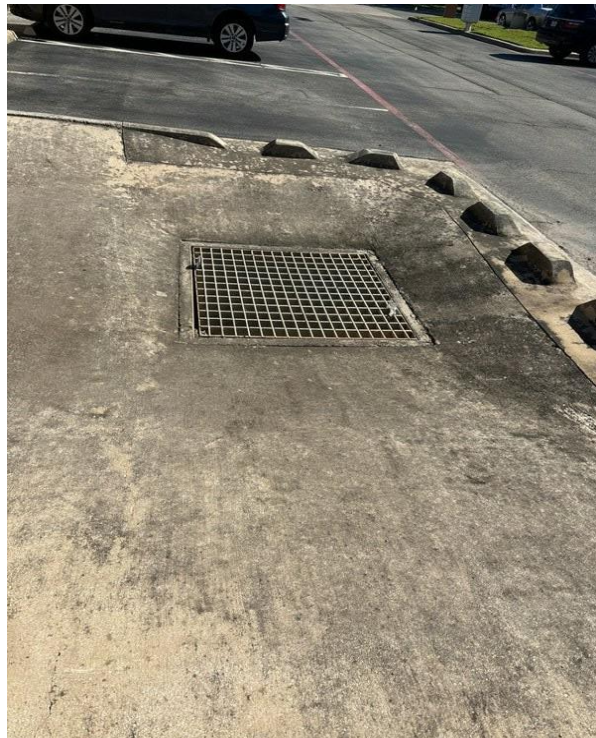
### Miner Fleet Parking Lot Inlet

Field Notes: No maintenance required.

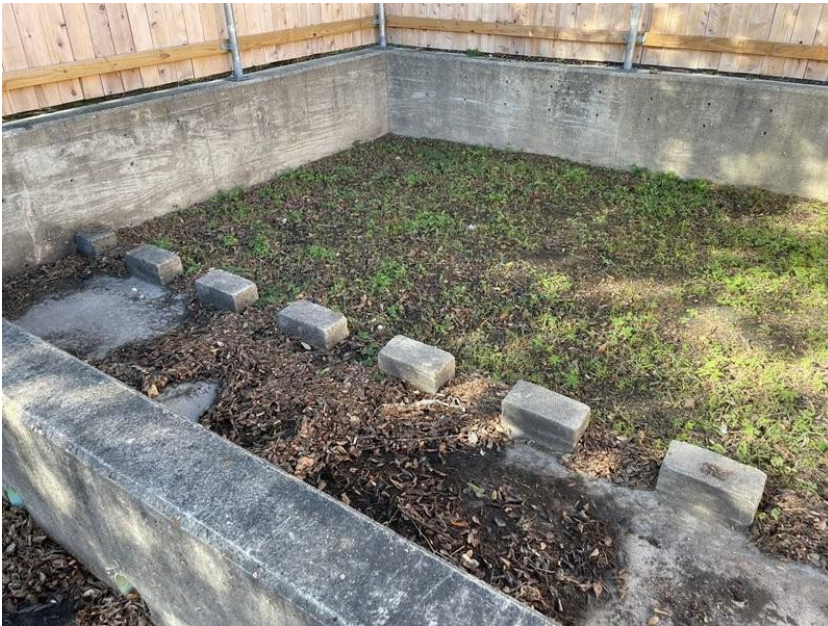
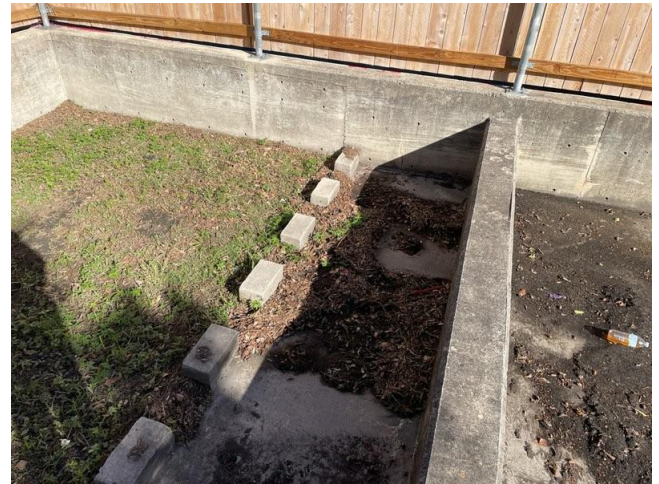
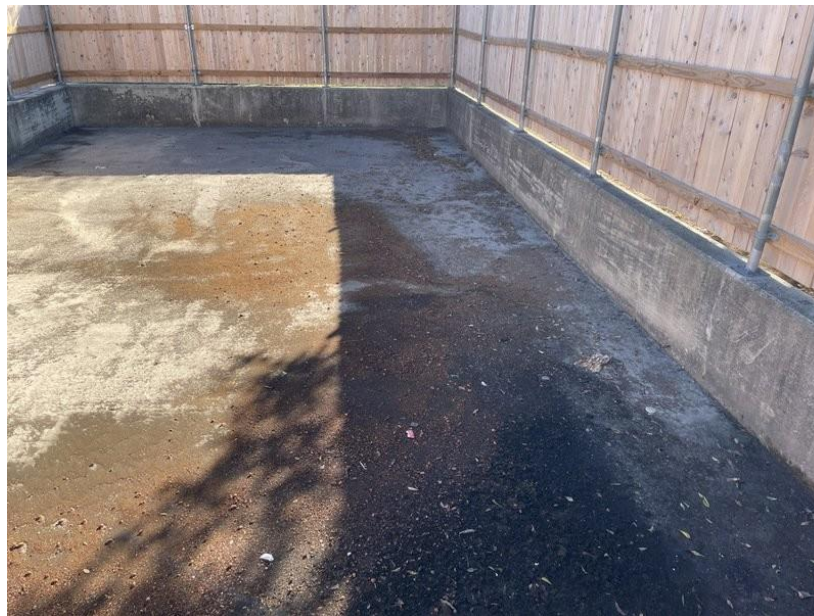
## Monarch Trophy PCD

Field Notes: Minor debris, looks good otherwise.

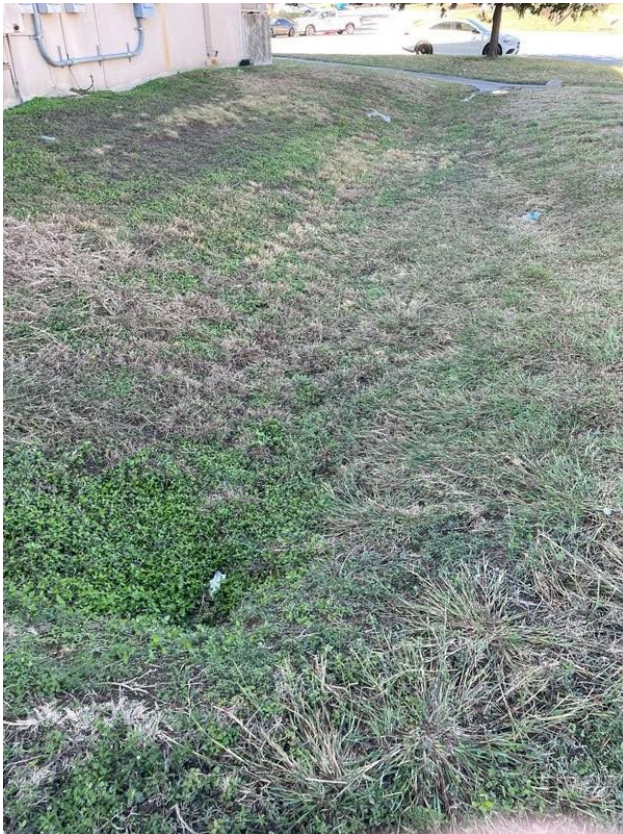
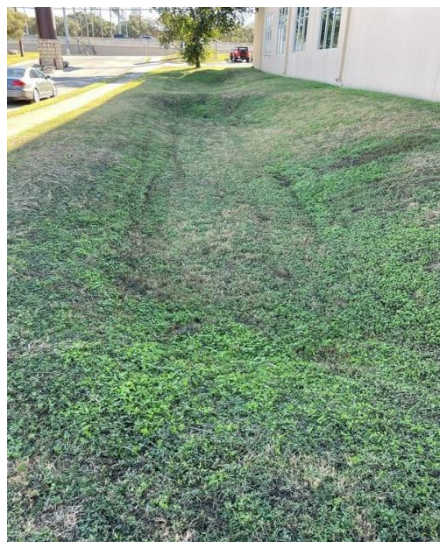
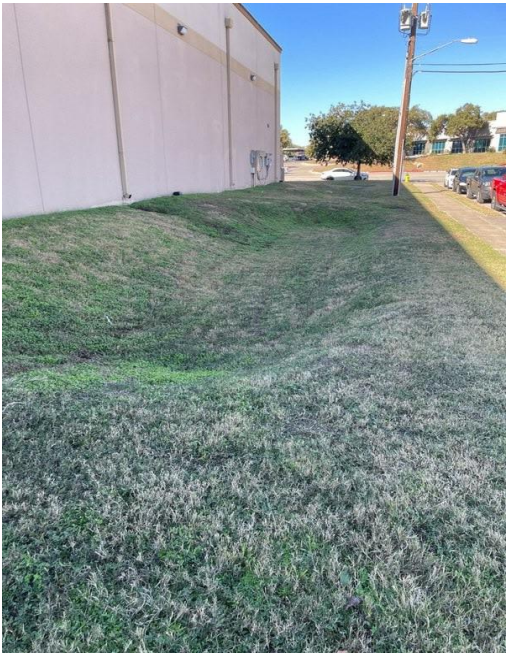
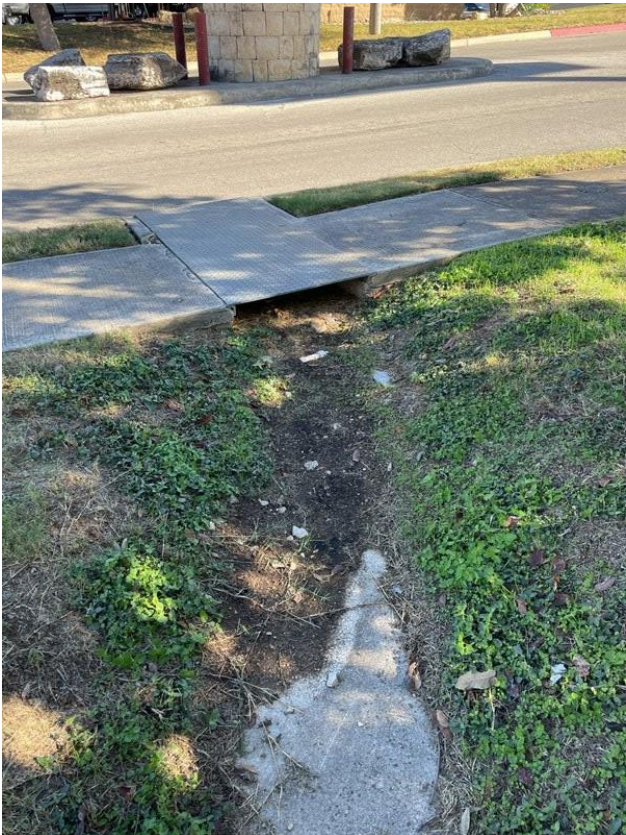
## Monarch Trophy Swale

Field Notes: Looks good.

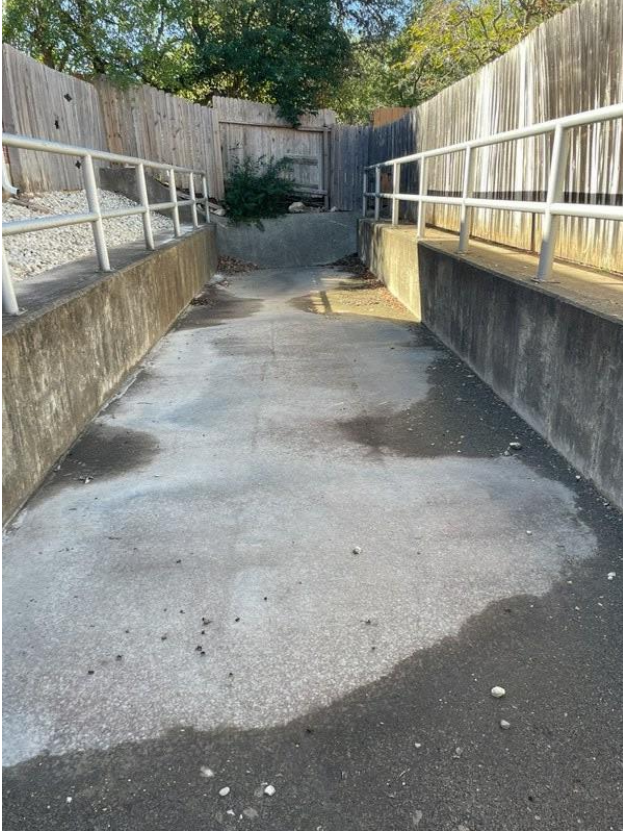
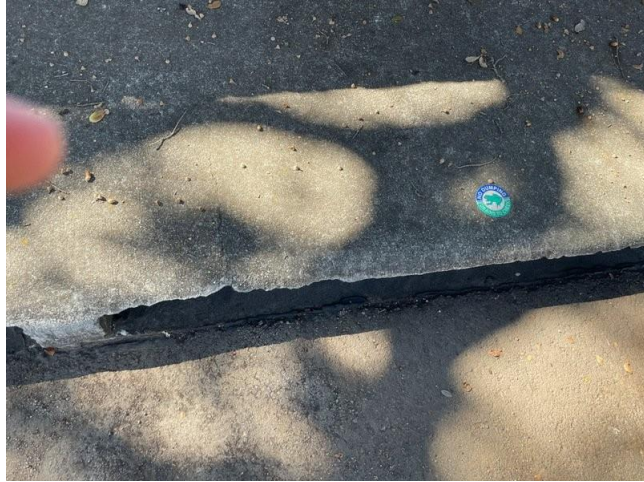
### Navato Blvd Inlet

Field Notes:  
Looks good

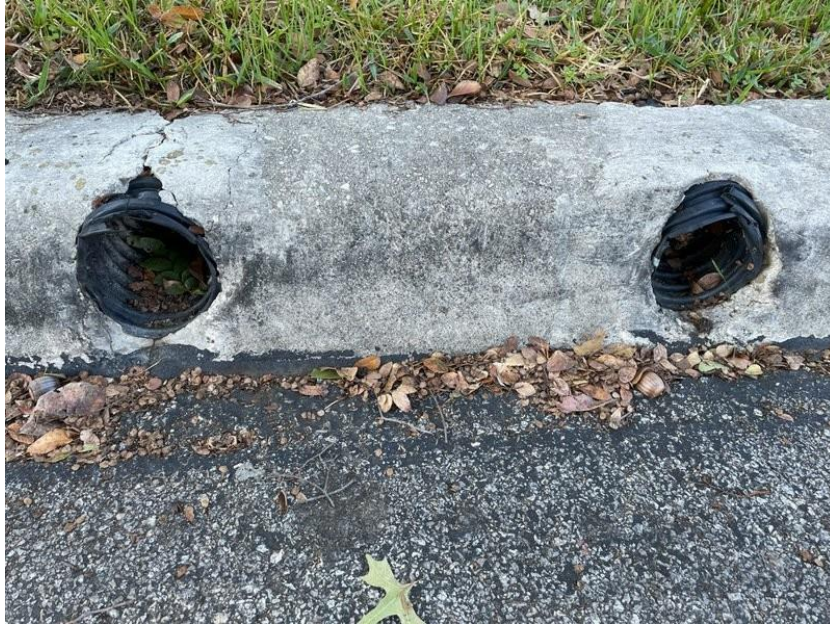
## Navato Residential Drains

Field Notes: Looks good.

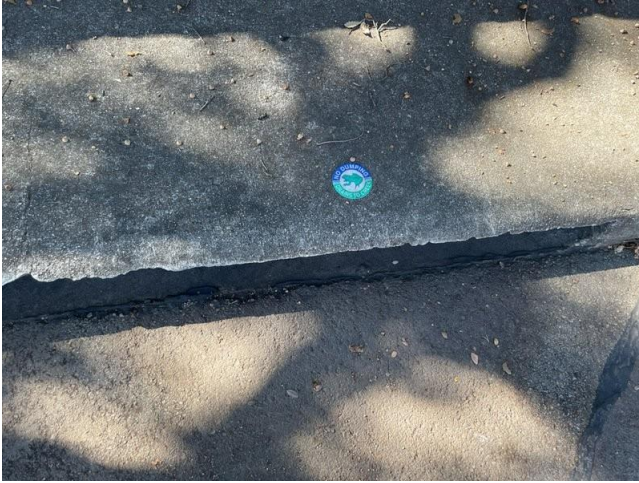
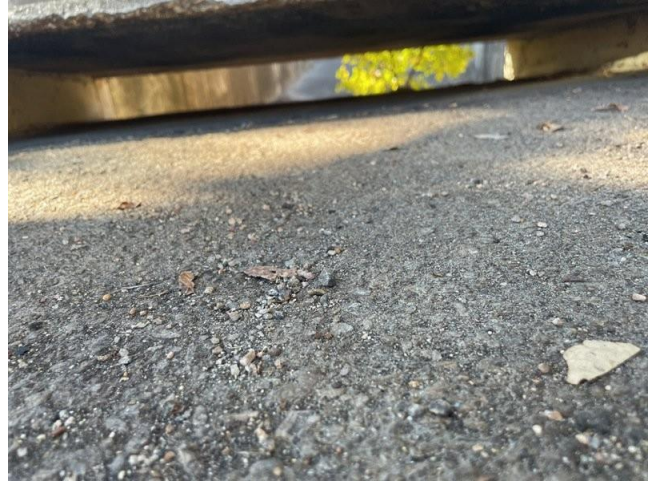
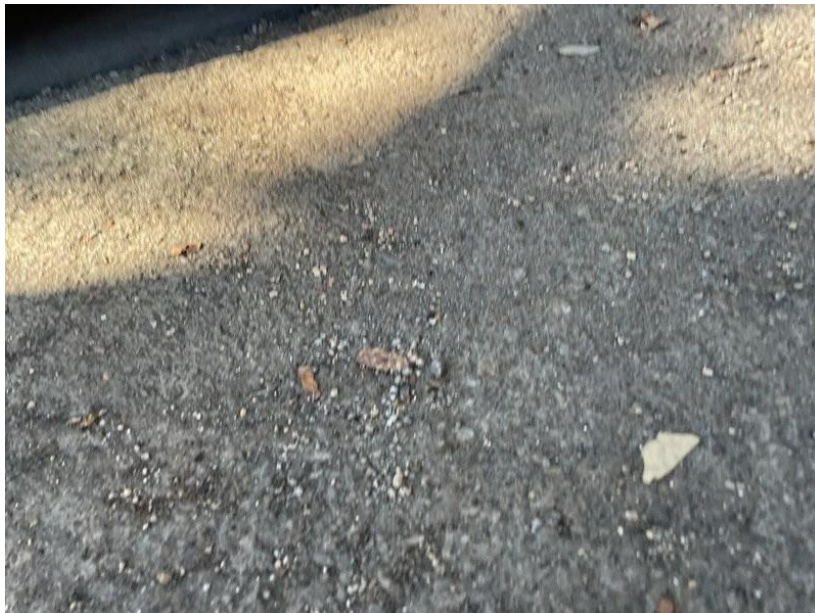
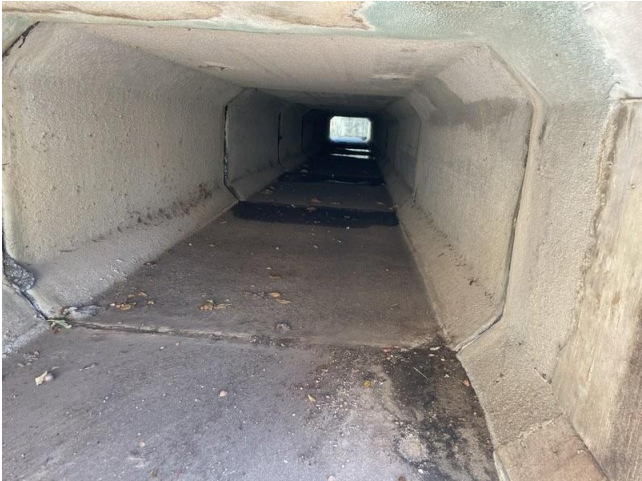
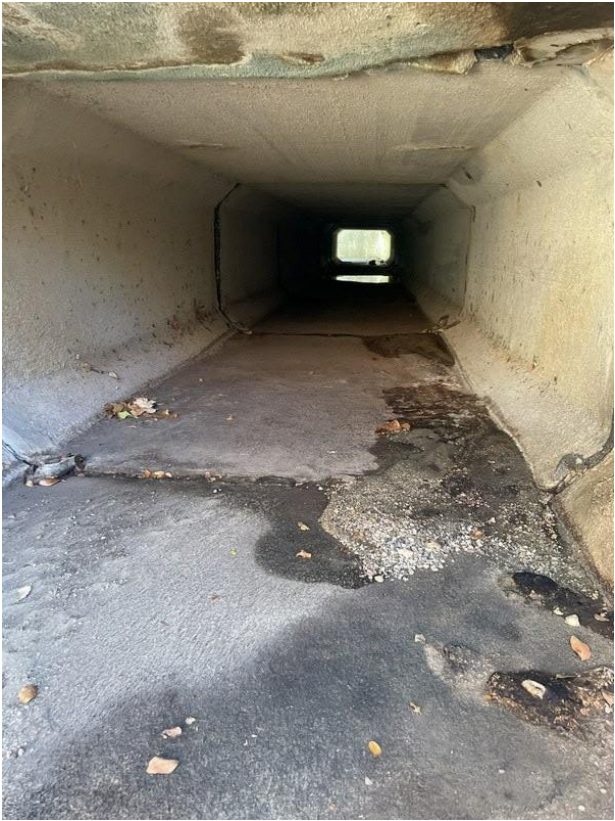
## Navato Storm Sewer Pipe

Field Notes: Looks good.

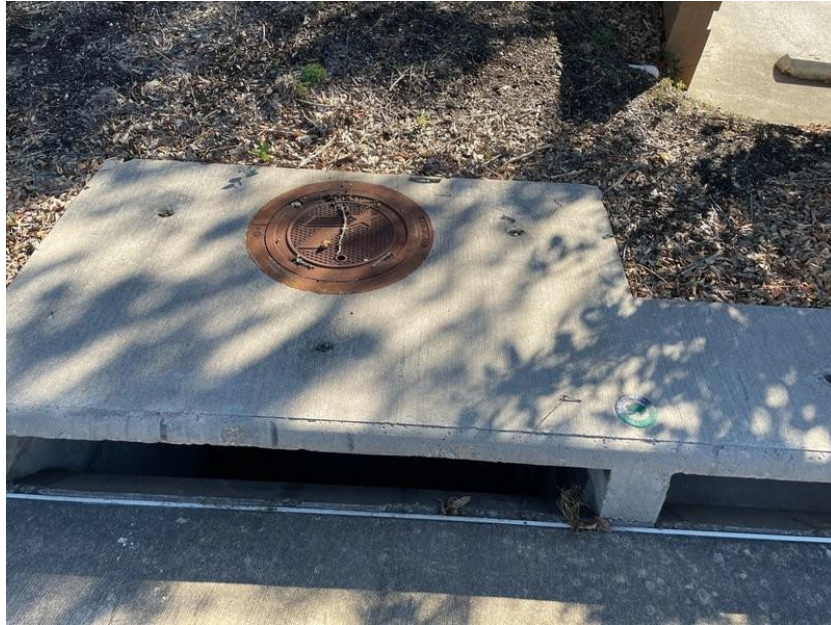
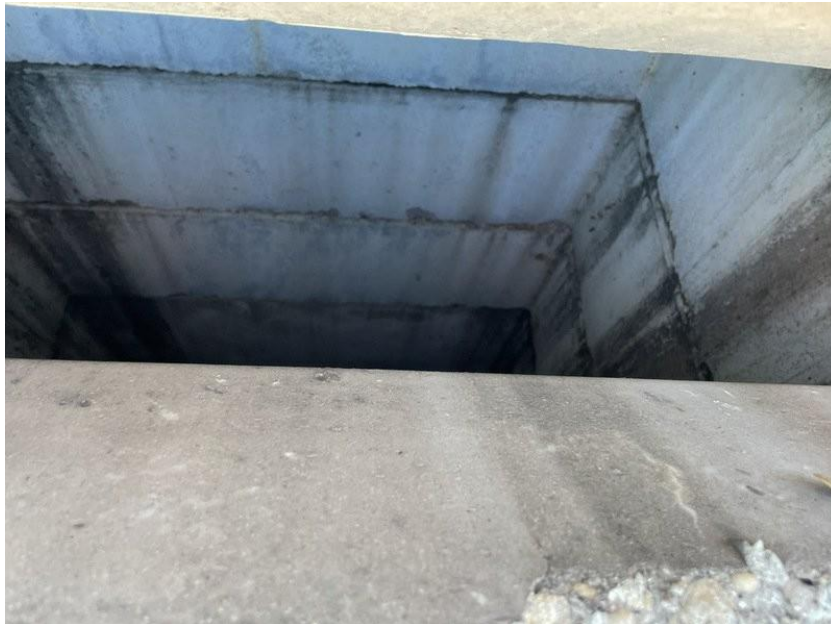
### New Drash Parking Lot Box Inlet

Field Notes: Looks good.

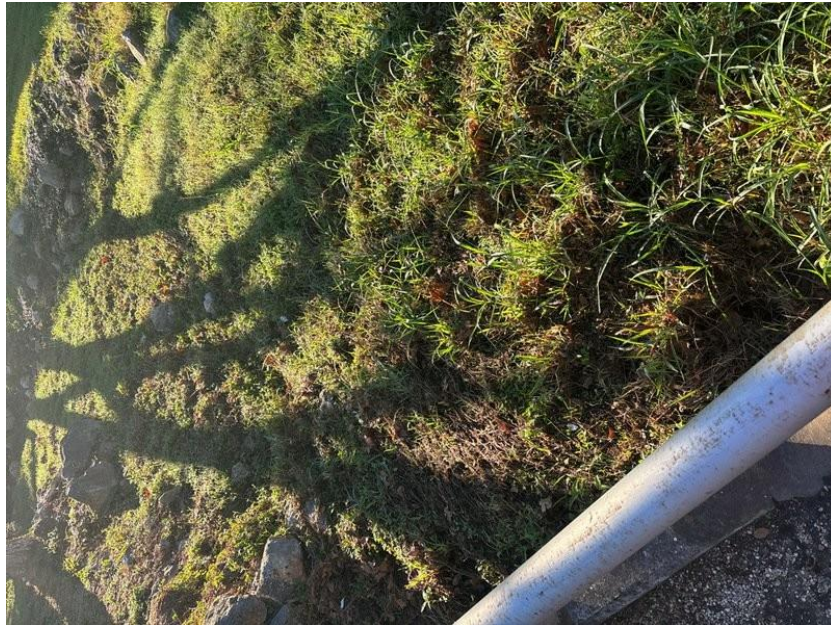
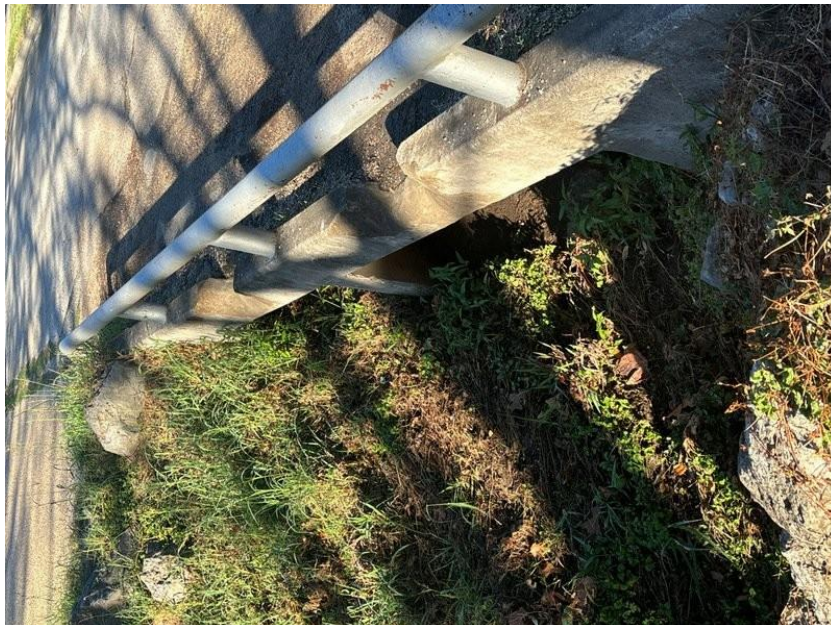
## North Oak Crossing

Field Notes: No maintenance required.

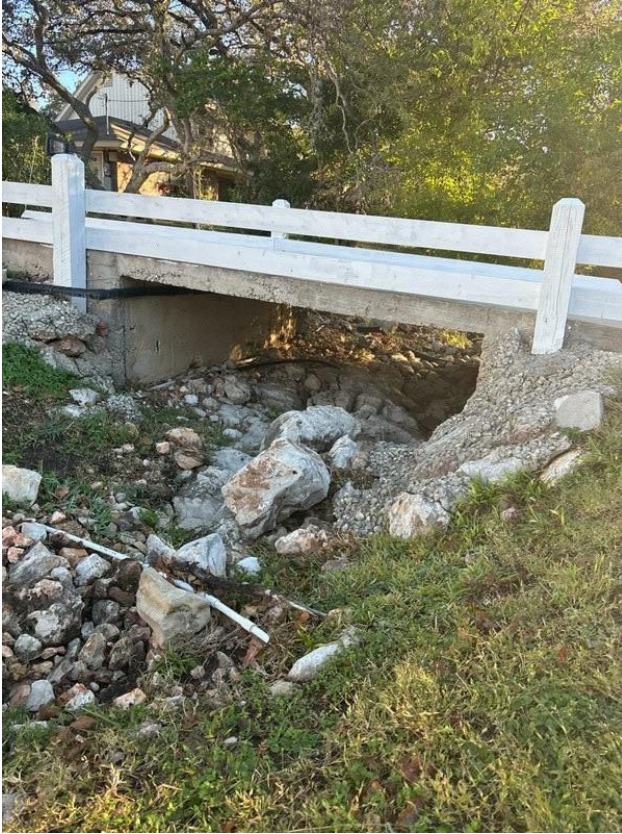
## North Oak Private Crossing East

Field Notes: Looks good.

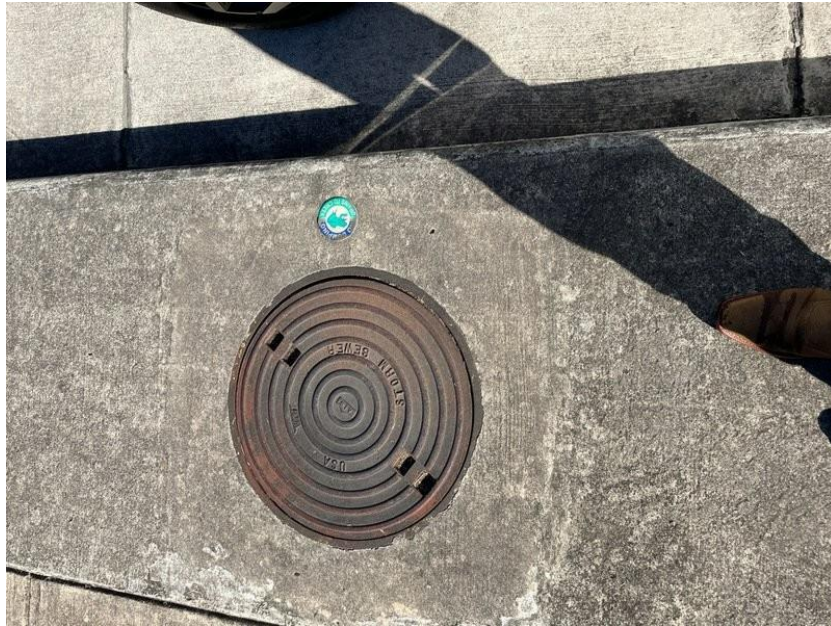
### Oak-I-1(M)

Field Notes: Looks good.

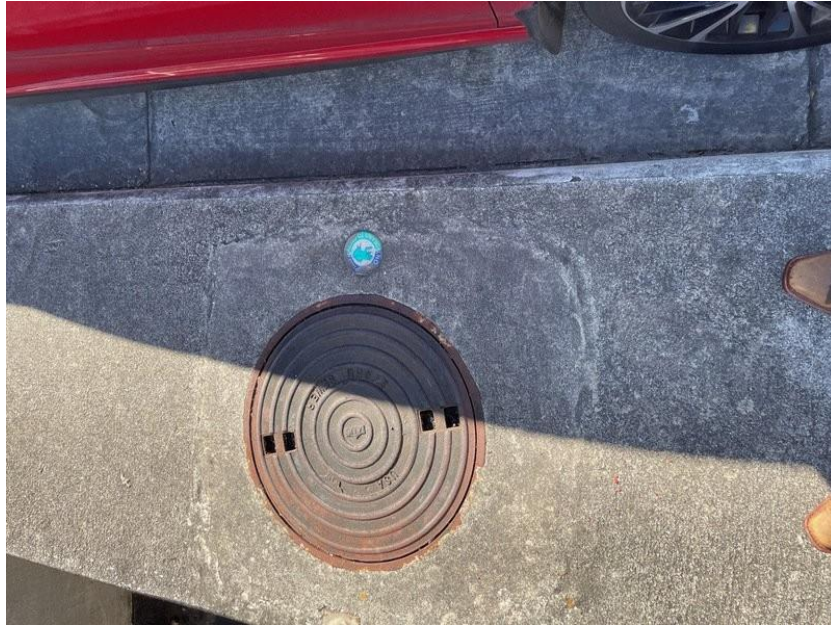
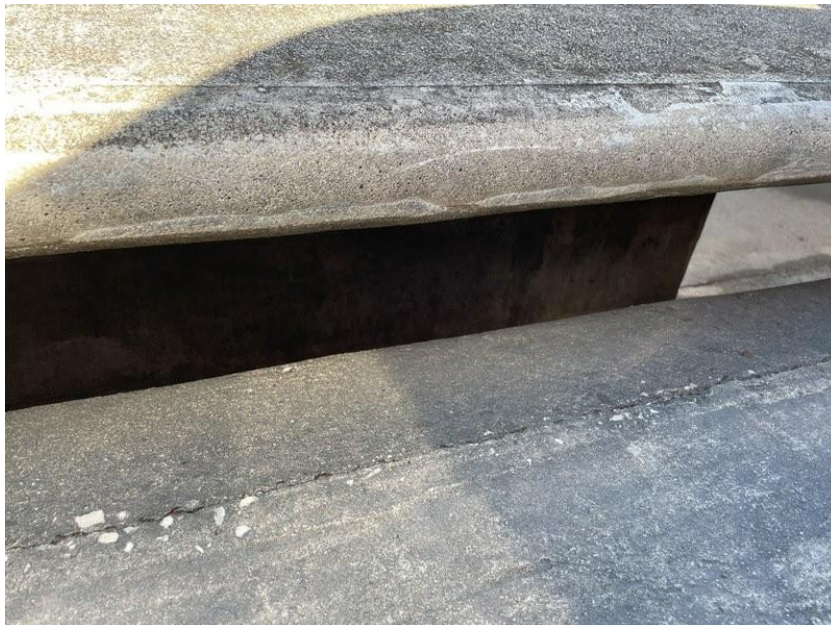
### Oak-I-2(M)

Field Notes: Looks good.

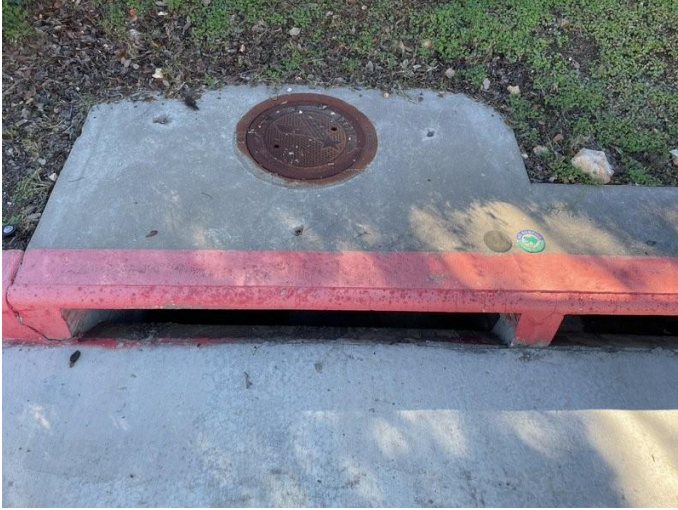
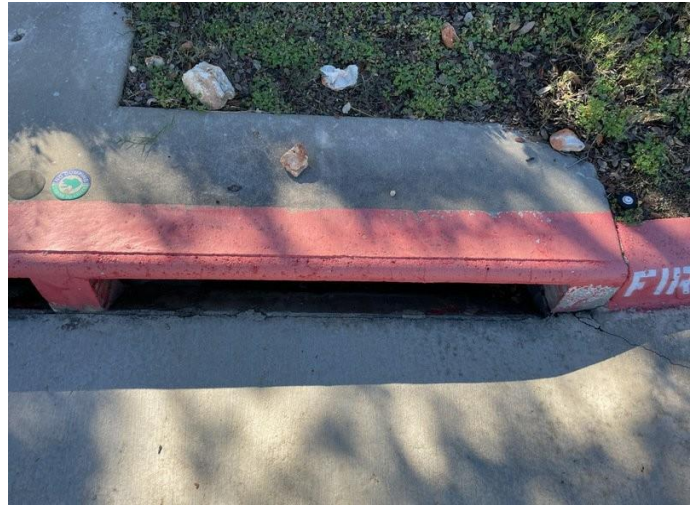
## Oak Creek Circle Inlet

Field Notes: Looks good

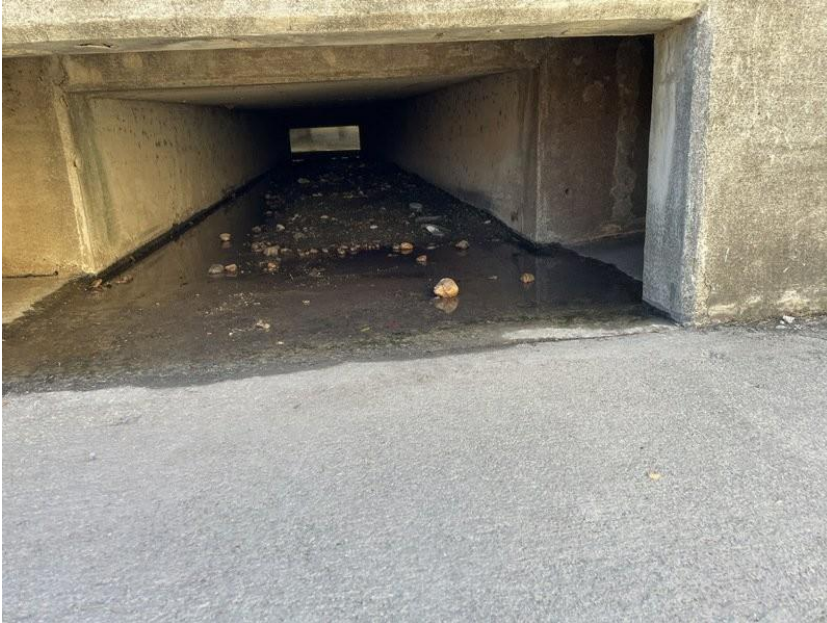
Field Notes: Minor sediment looks good otherwise

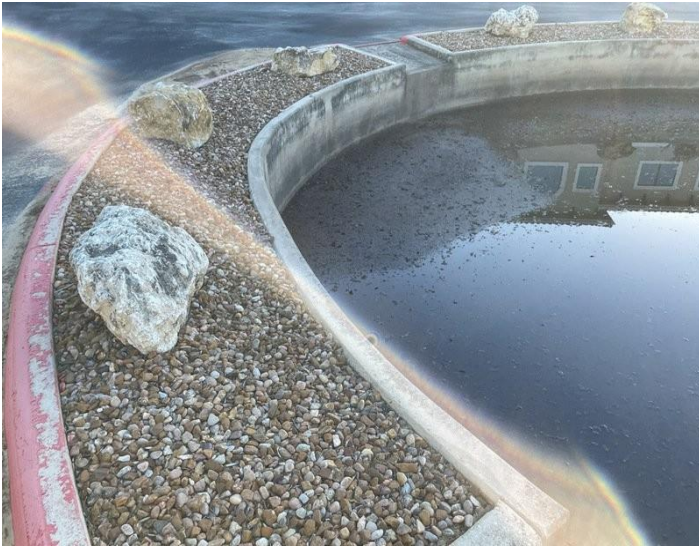
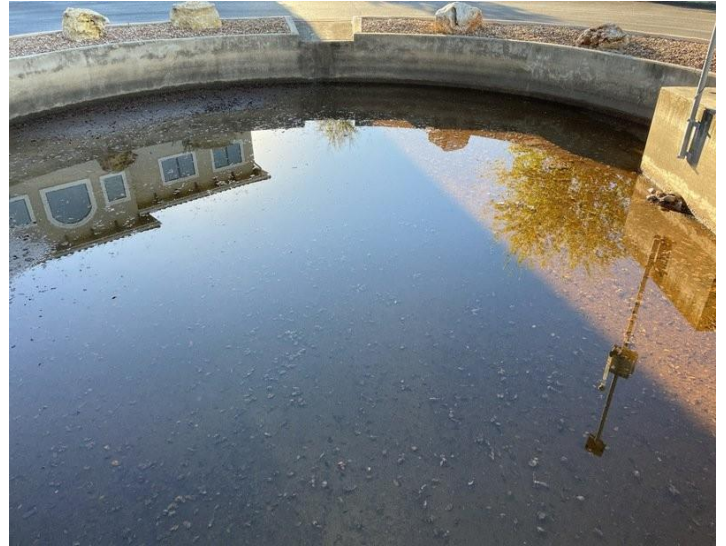
## Optometrist Roundabout PCD

Field Notes: Looks good.

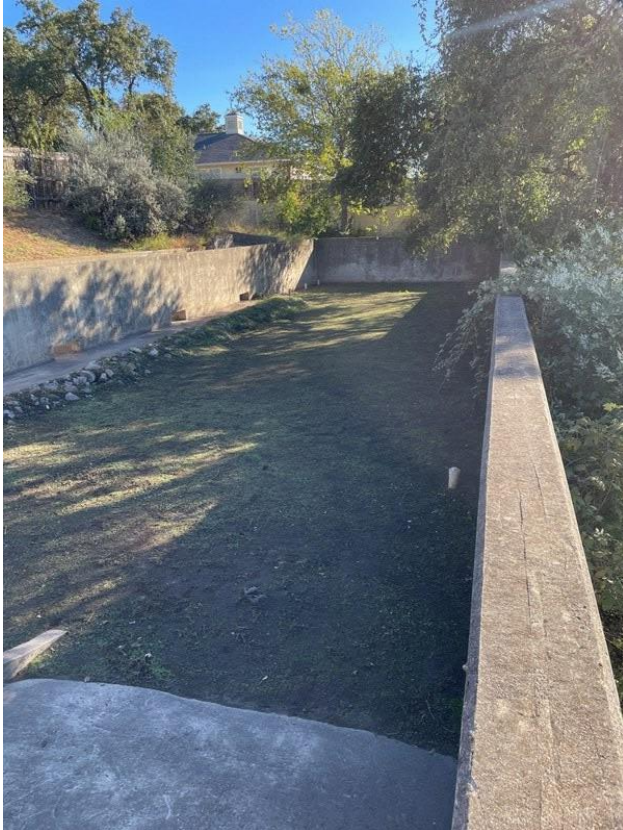
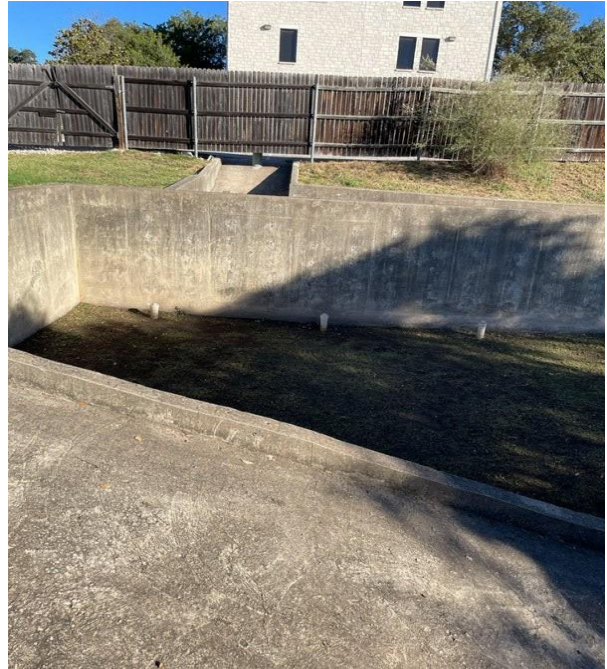
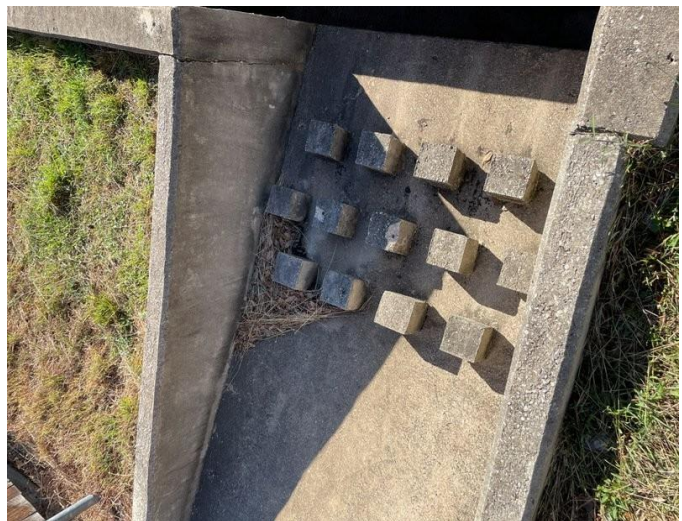
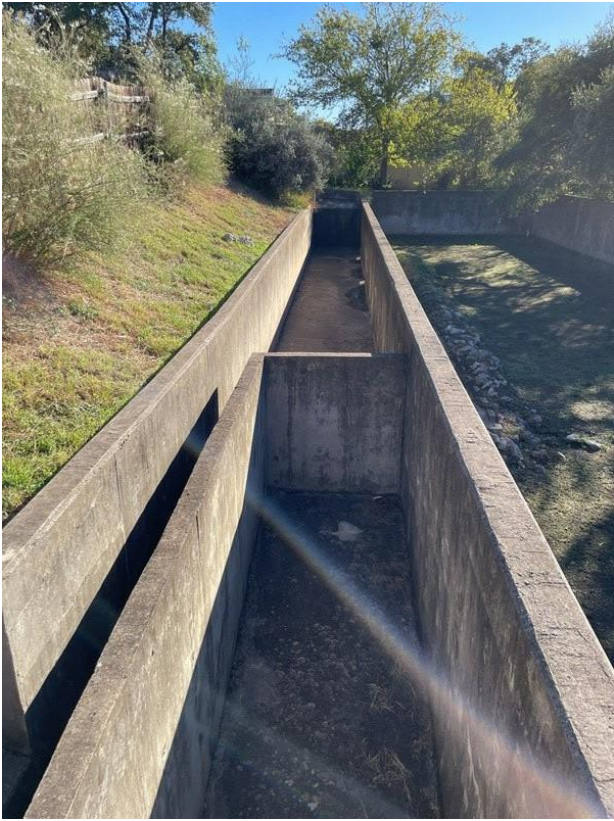
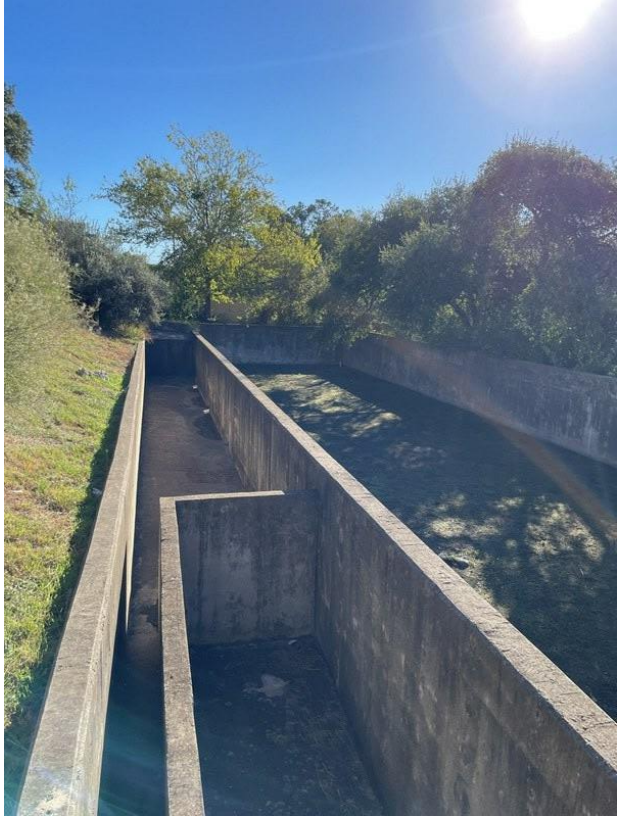
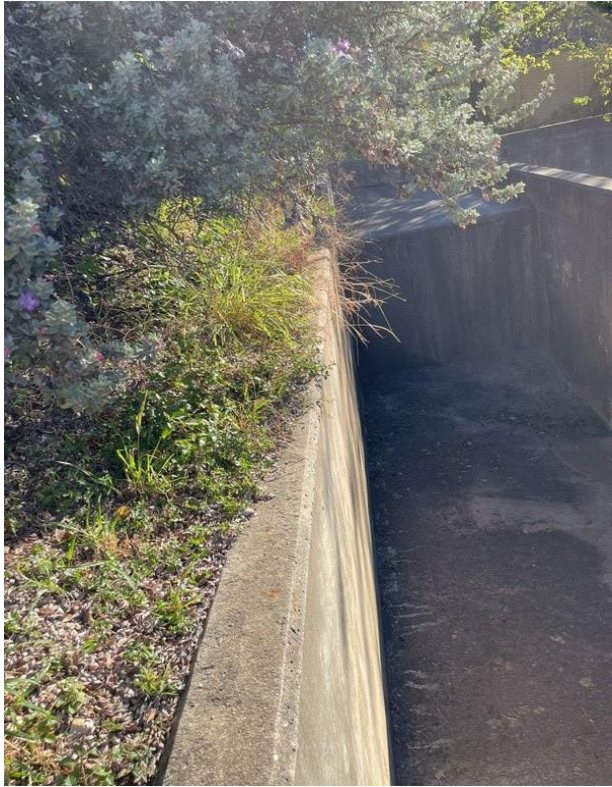
## Pantheon Commercial Strip PCD

Field Notes: Looks good.

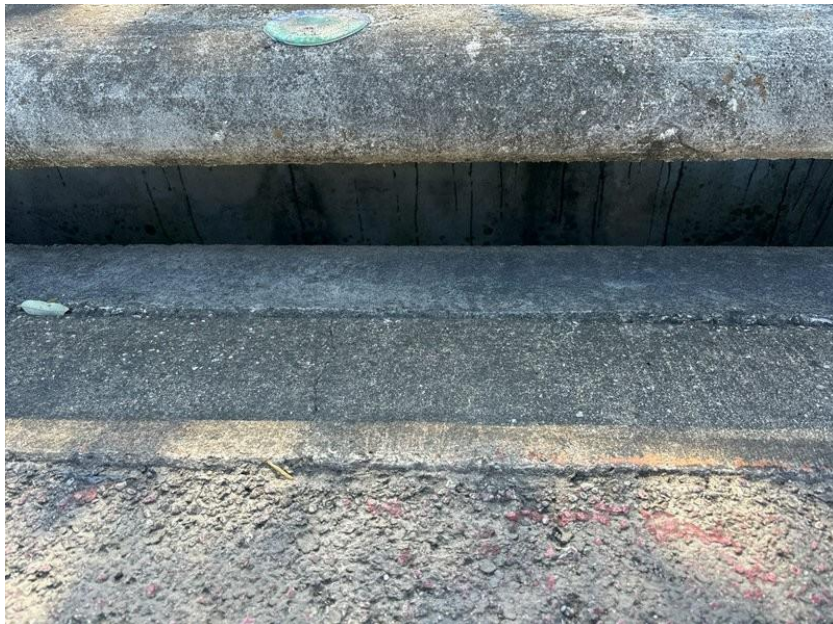
### Parking Lot Box Inlet

Field Notes: No maintenance required.

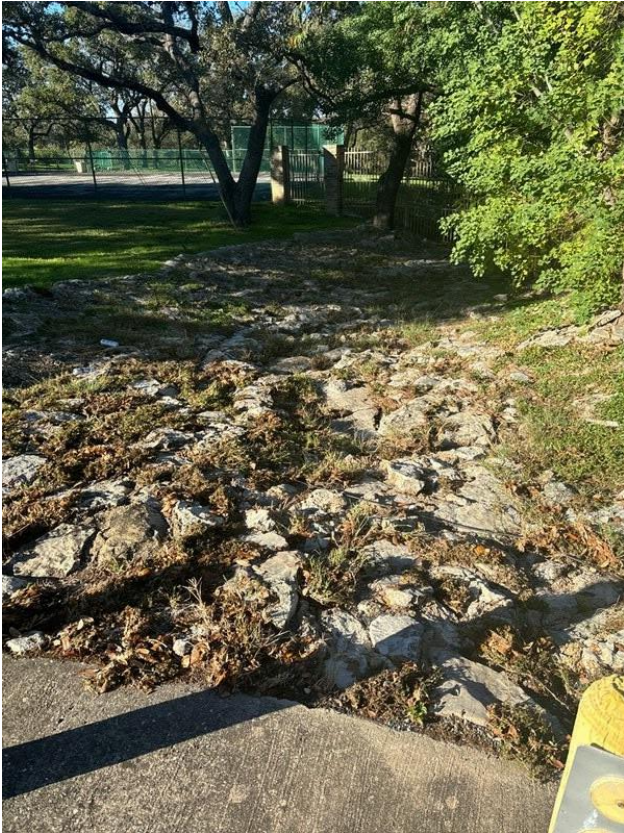
## Paseo Canada Outfall 2

Field Notes: Mild trash, but otherwise looks good.

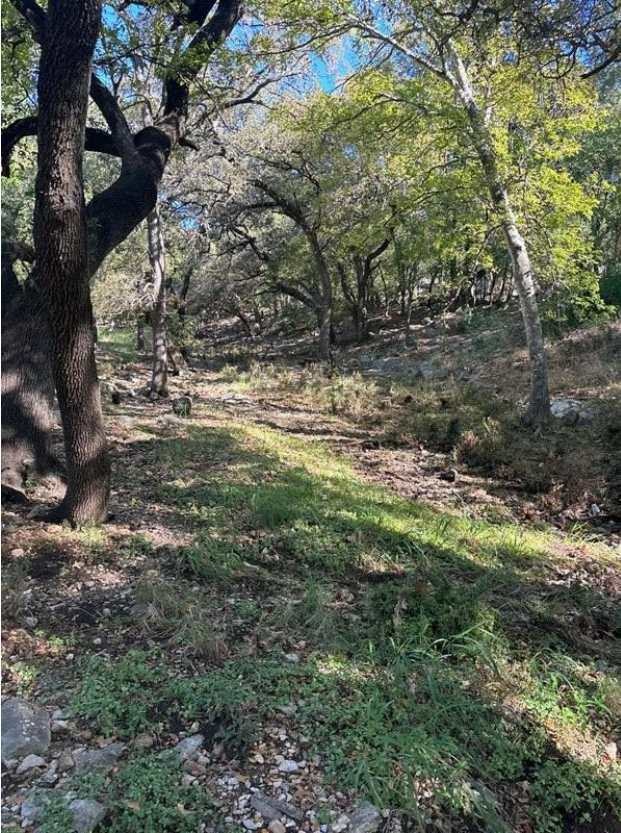
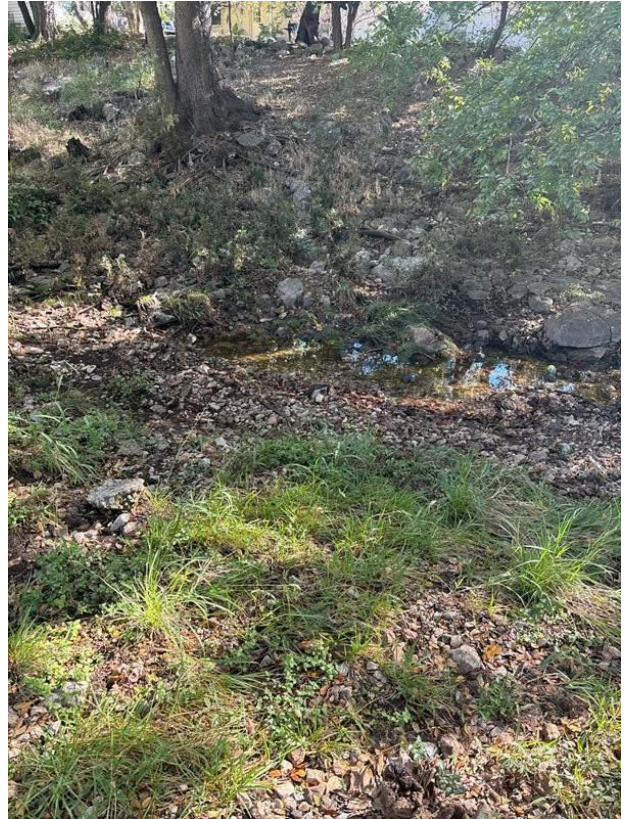
## Rua De Matta Street Channel Outfall

Field Notes: Mild debris but looks good.

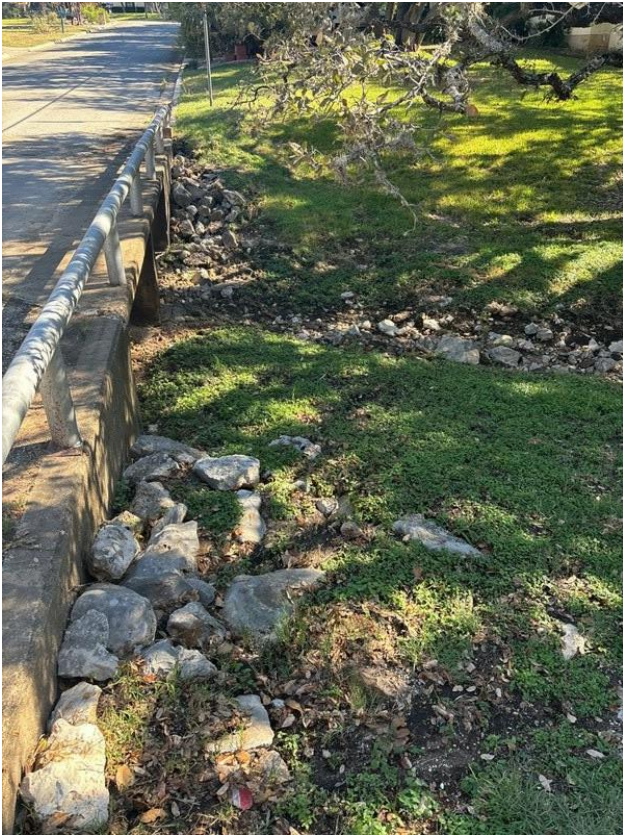
## Sagecrest Crossing East

Field Notes: No Maintenance Required.

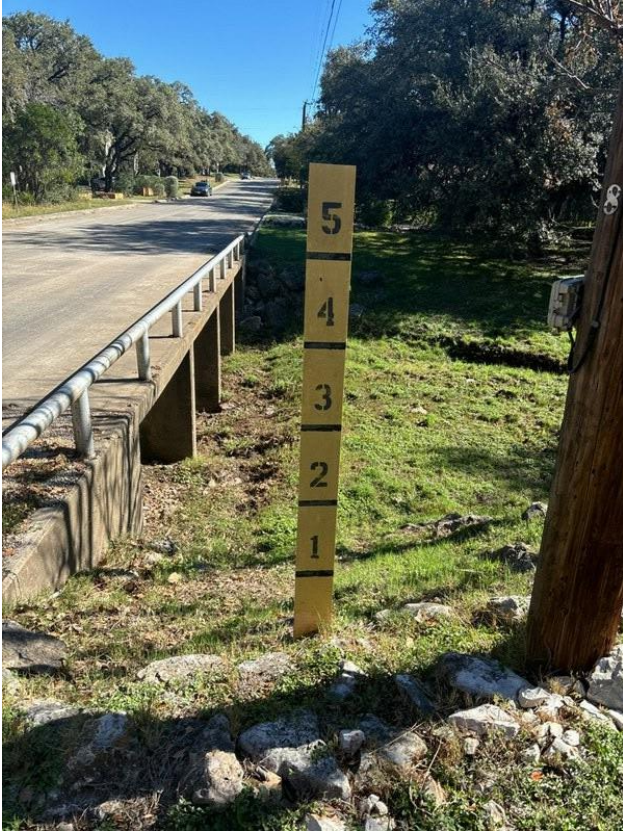
## Sagecrest Crossing West

Field Notes: No Maintenance Required.

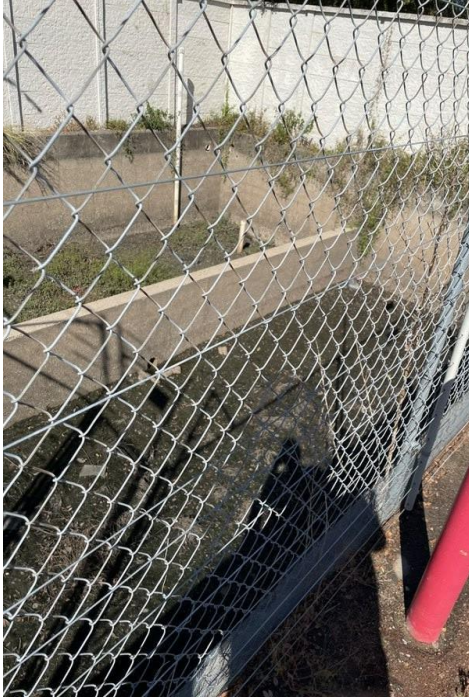
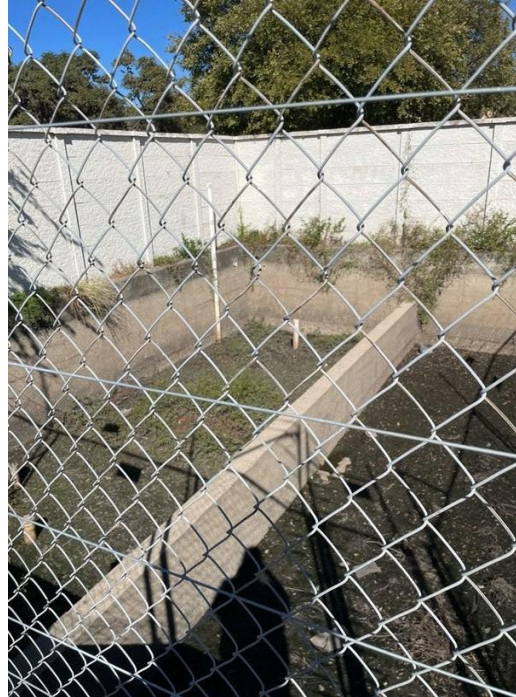
## Service King Collision Repair PCD

Field Notes: Looks good.
