# TOWN OF HOLLYWOOD PARK, TX

2024 Winter Inspection

# HOLLYWOOD PARK 2024 WINTER INSPECTION REPORT

**Subject:** Annual Municipal Separate Storm Sewer System (MS4) Inspection

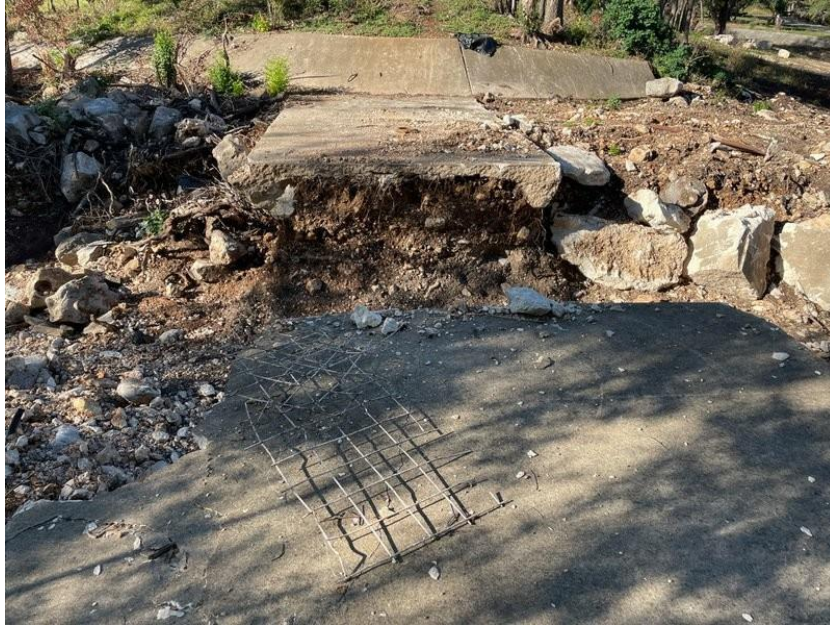
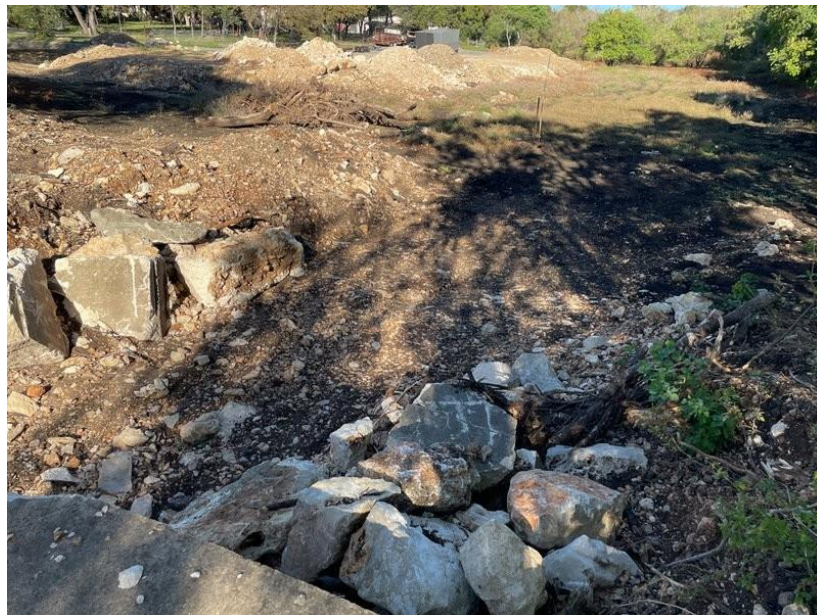
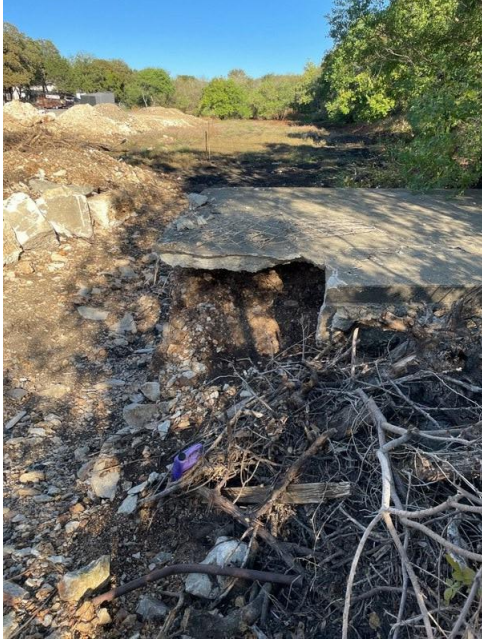
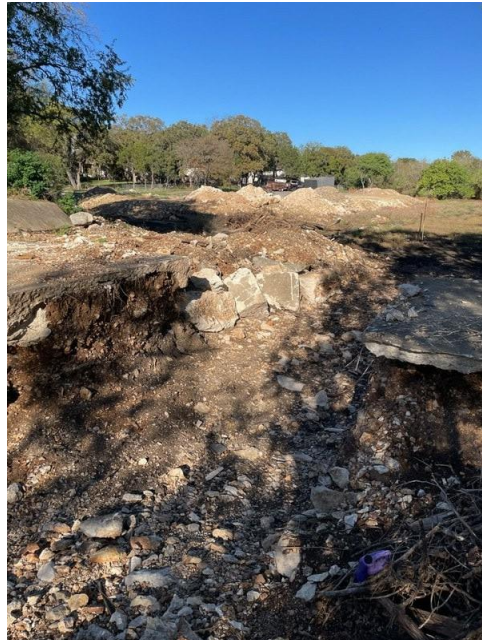
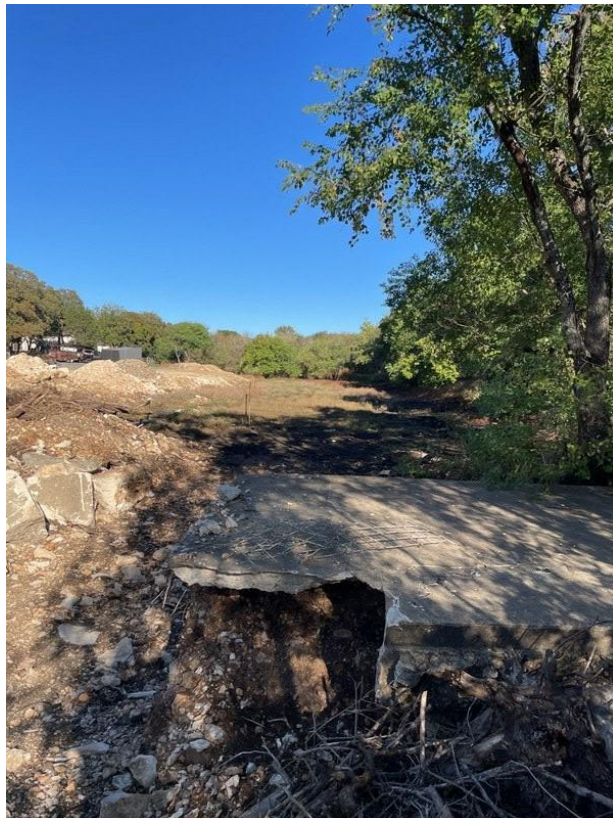
## Spillway Structure

Weir structure is compromised, fill at upstream ends appears unchanged from summer inspection. Eastern end of weir structure severely under-mined. Not safe to walk on.

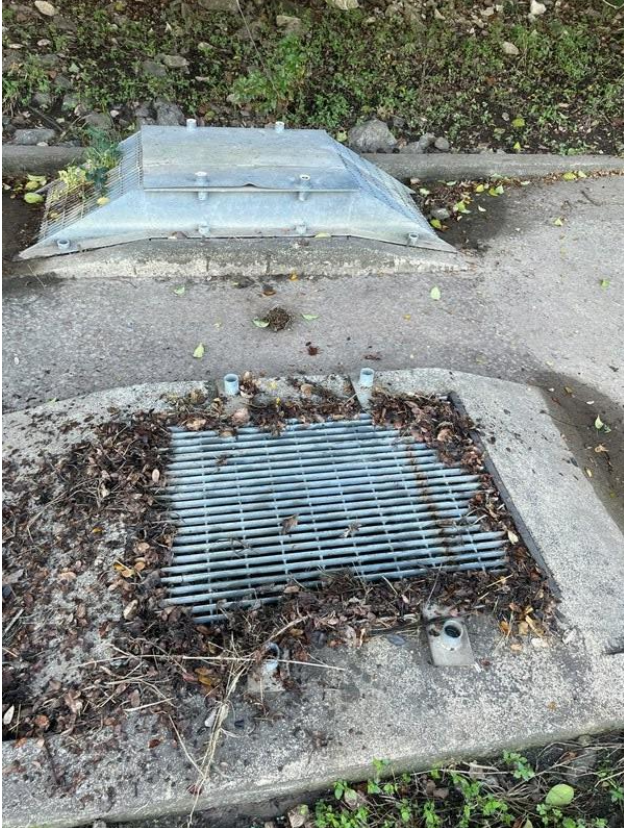
## Stream Gauge

Field Notes: Looks good.

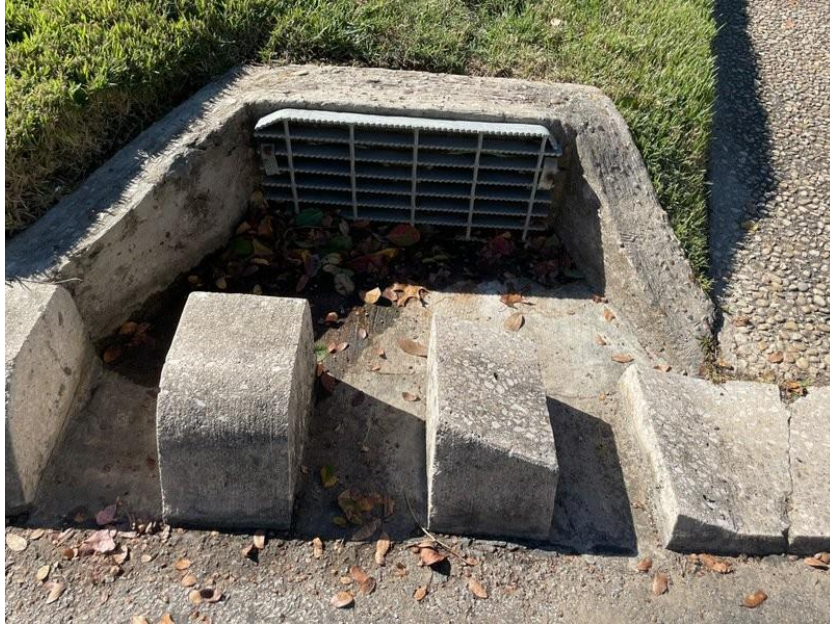
## Street Outlet 1

Field Notes: Looks good.

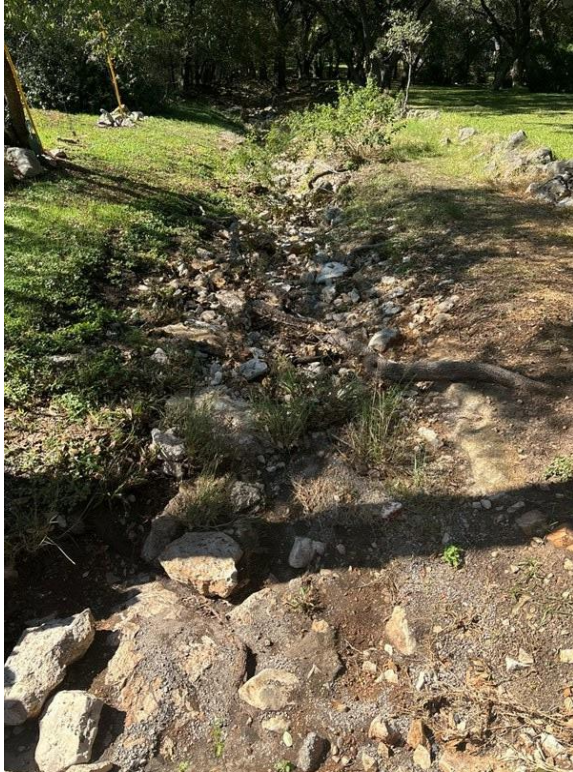
## Tiger Tail Outfall

Field Notes: Monitor curb erosion, but otherwise looks fine.

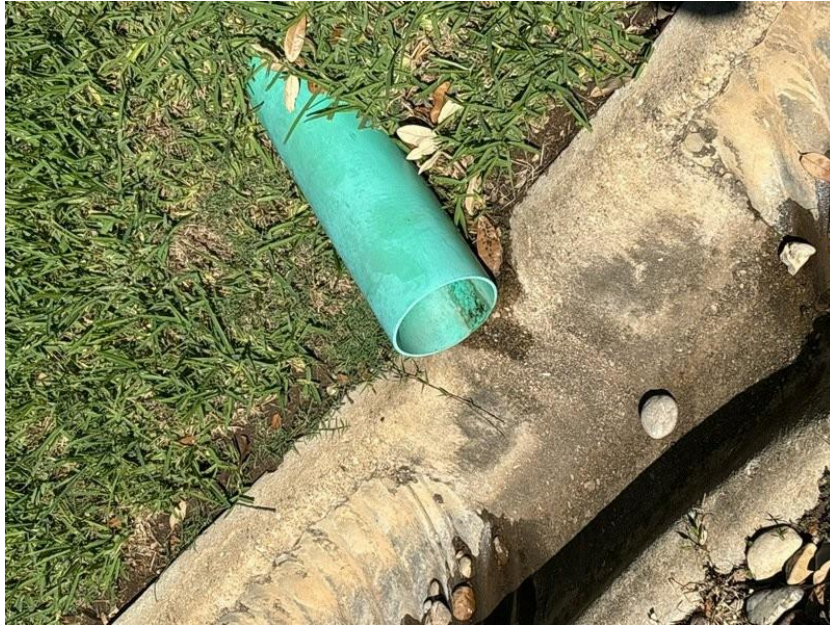
## Unknown Residential Drain Pipe Into MS4 System

Field Notes: No Maintenance Required

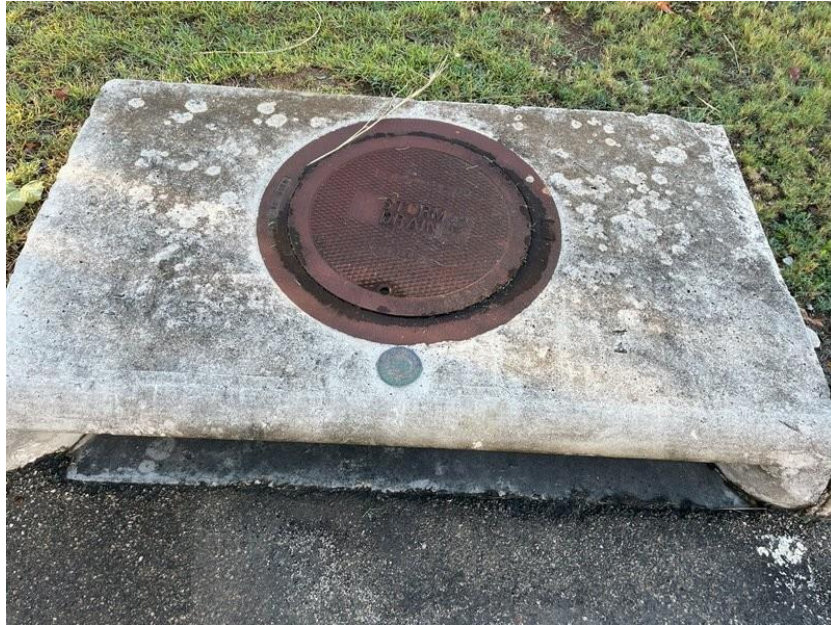
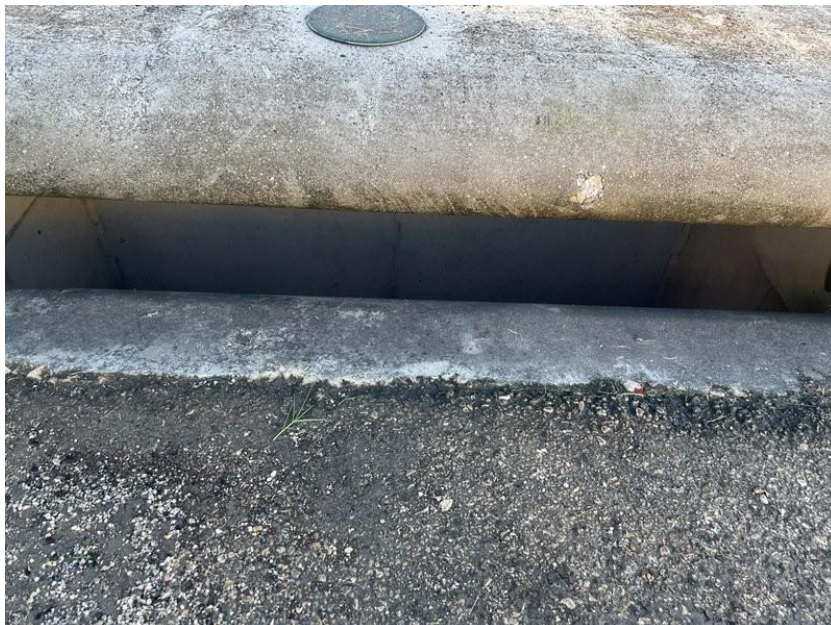
Field Notes: Looks good, monitor sediment buildup.

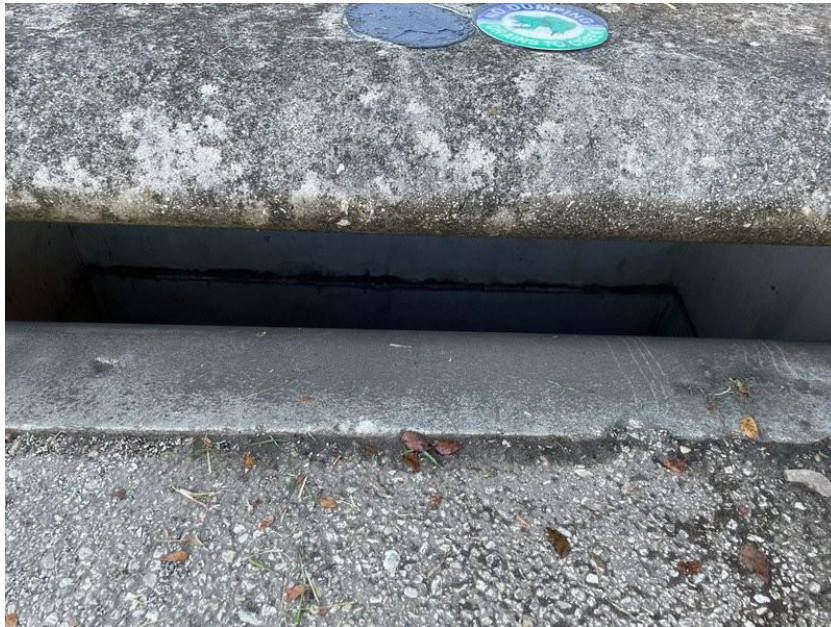
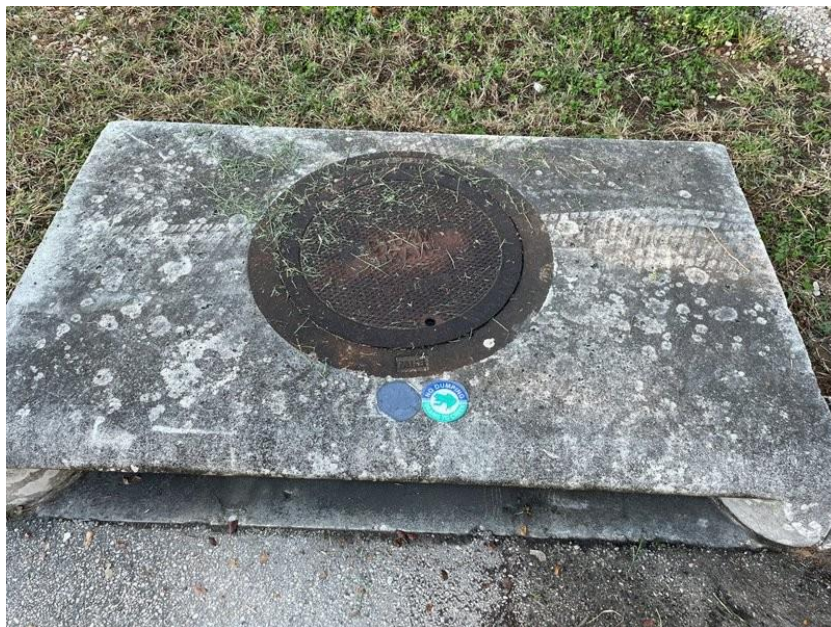
## Varco 2

Field Notes: Looks good.

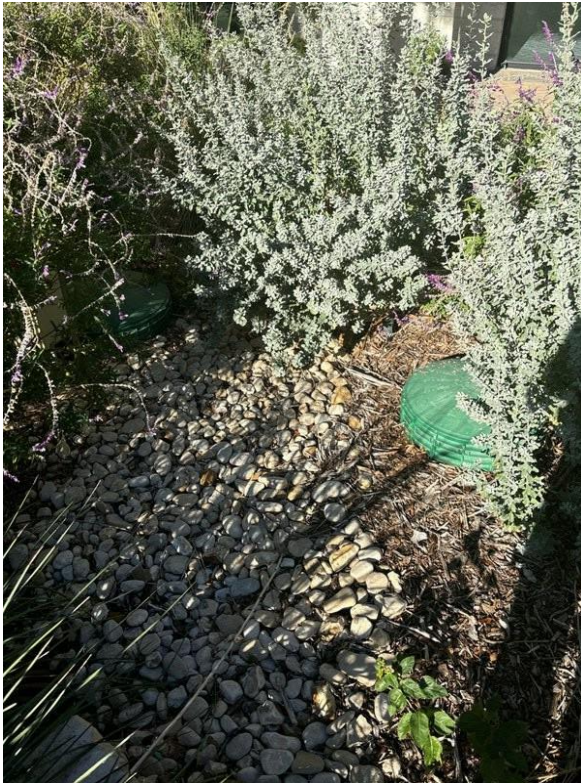
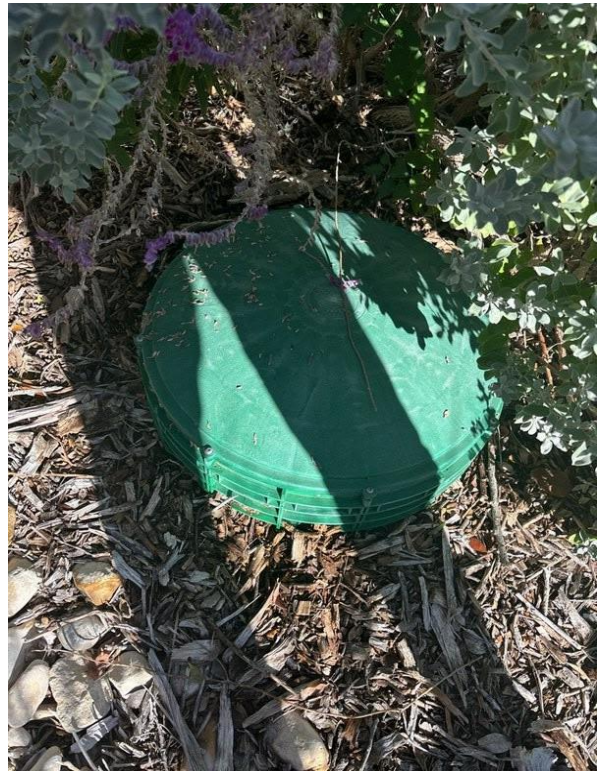
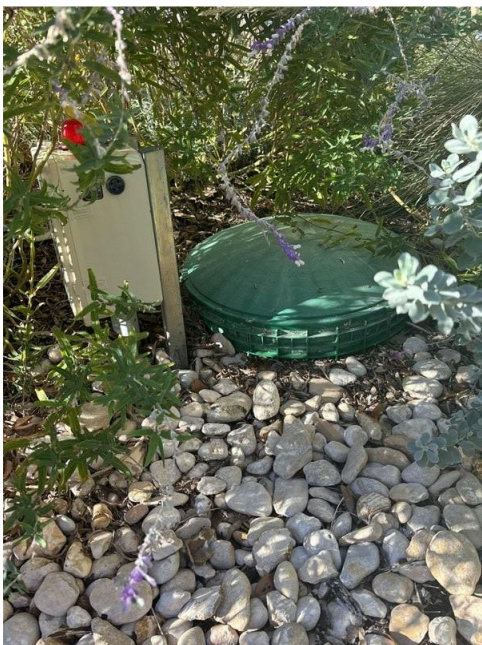
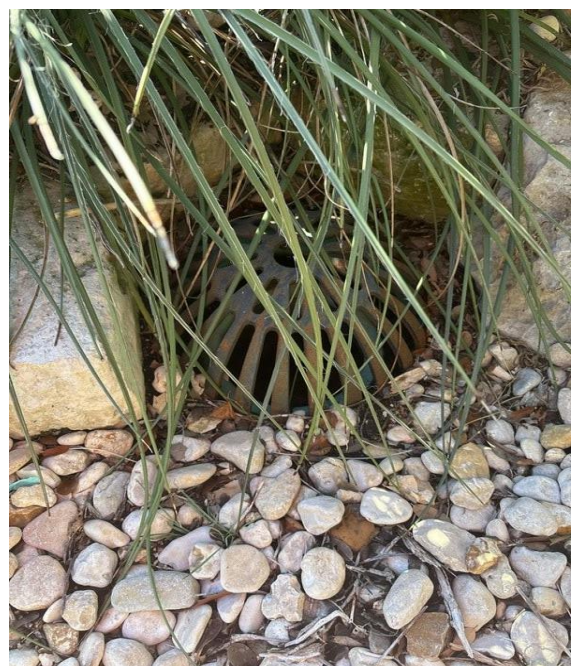
## Voigt Park Inlet

Field Notes: No maintenance required.

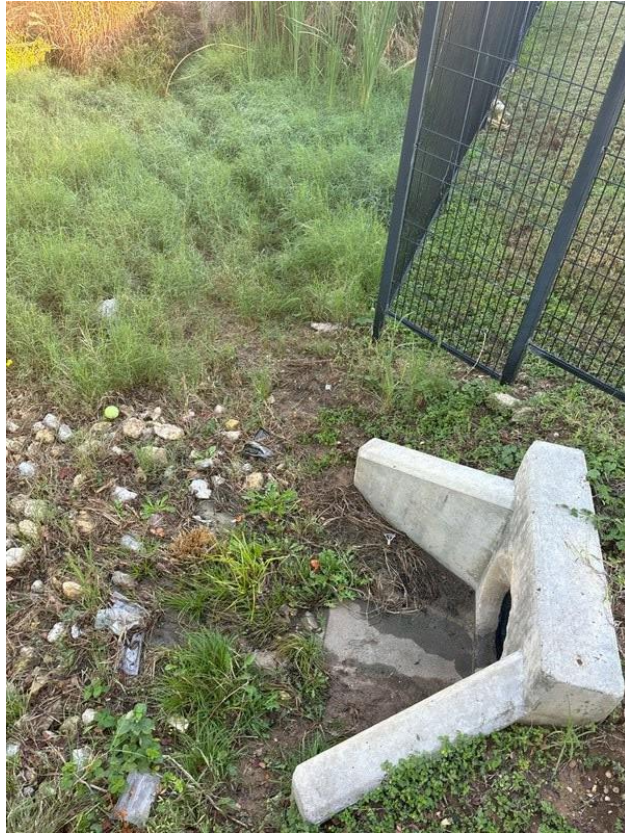
## Voigt Park Outfall

Field Notes: Mild vegetation but looks good.

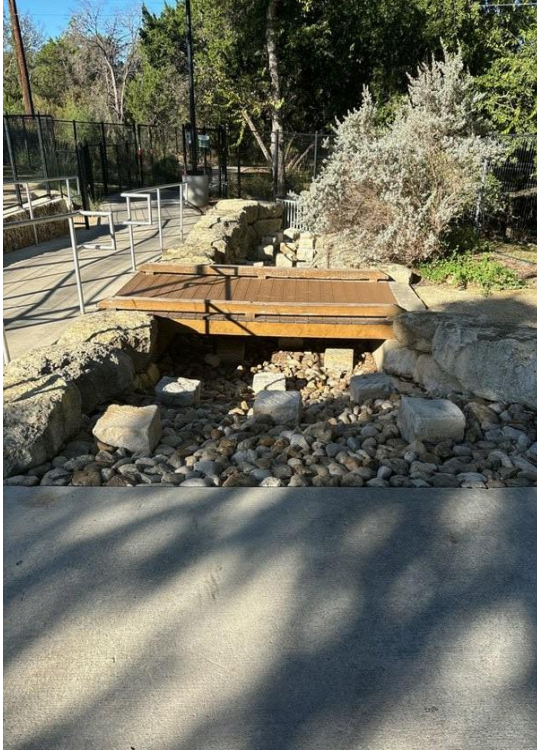
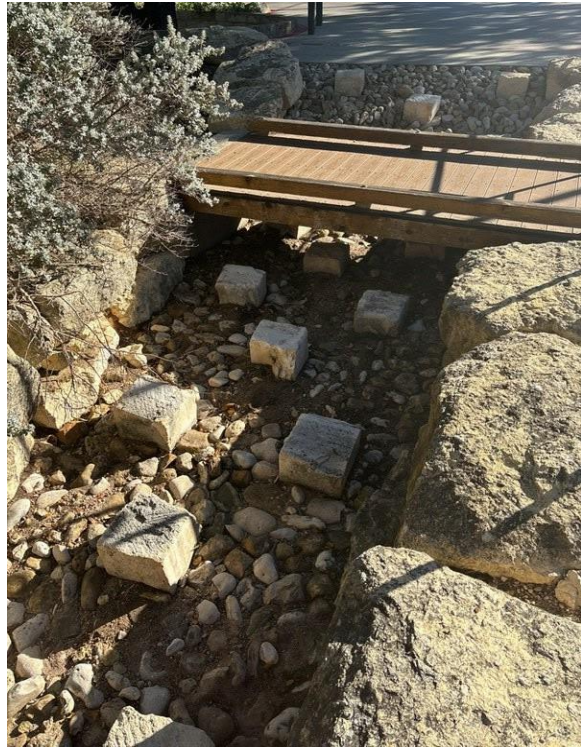
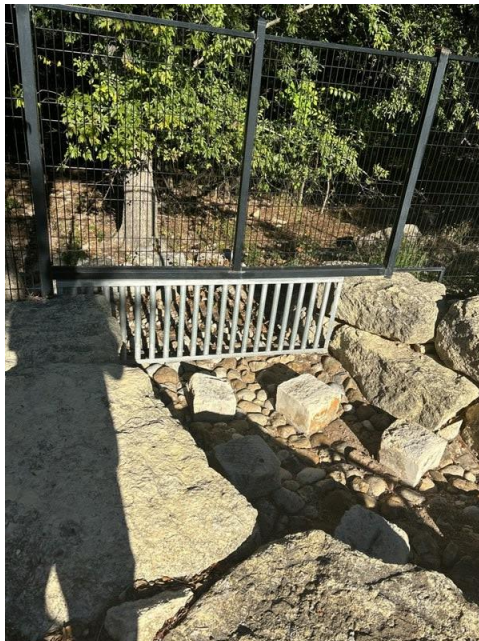
## Voigt Park Storm Sewer Outfall

Field Notes: No maintenance required.

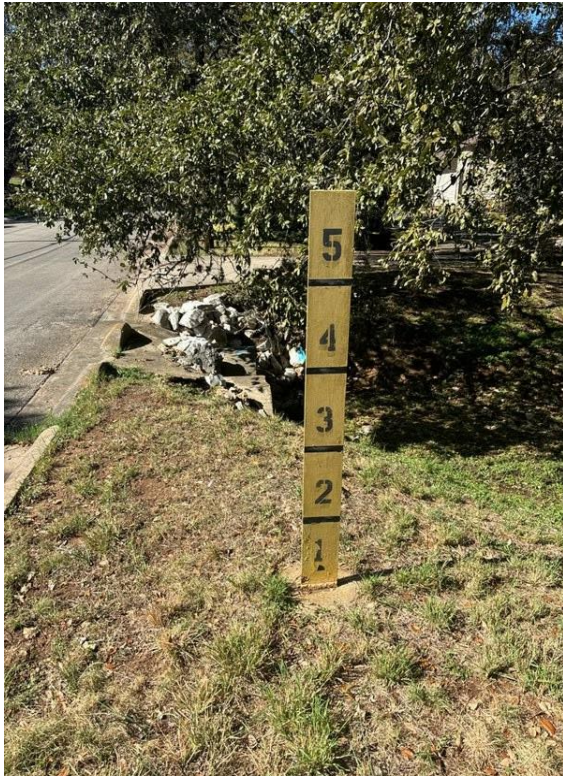
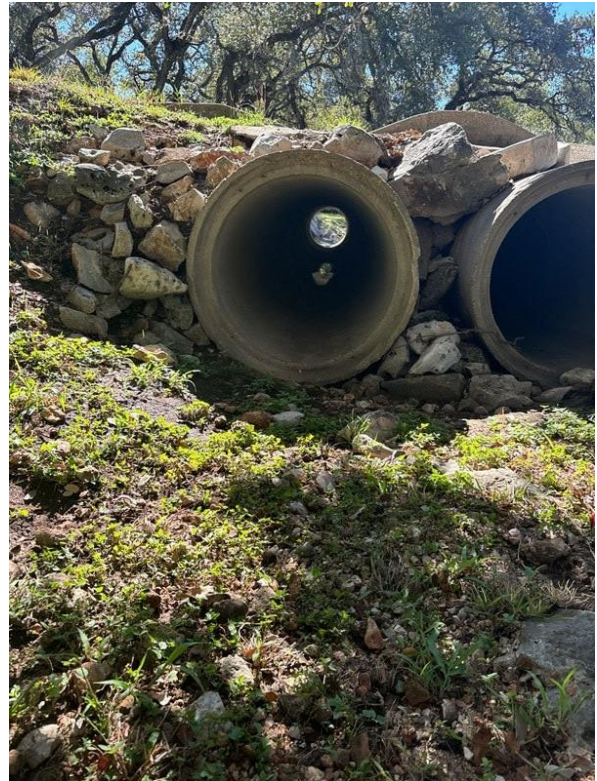
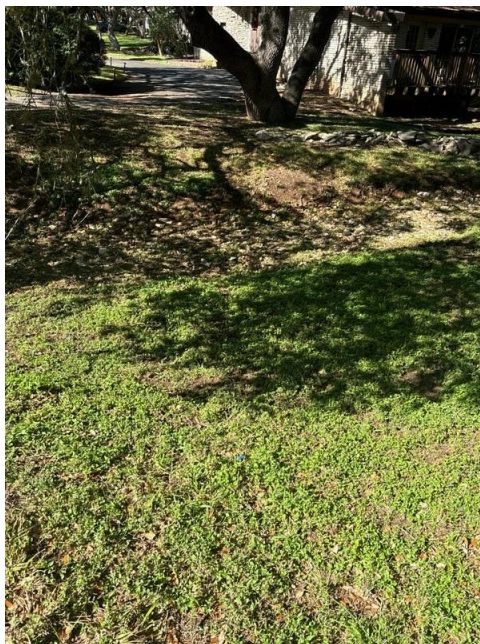
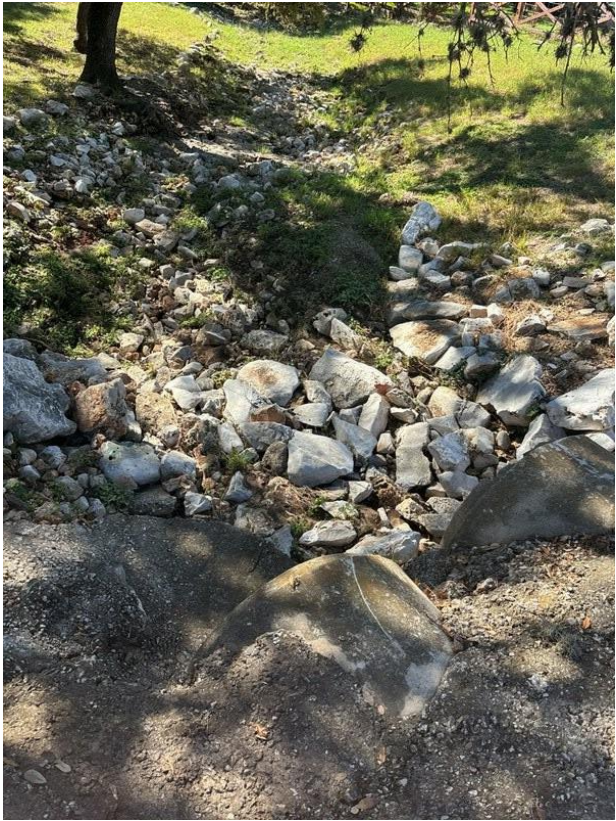
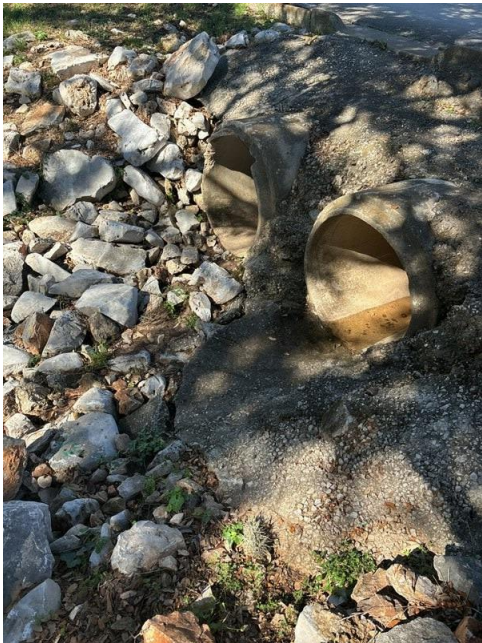
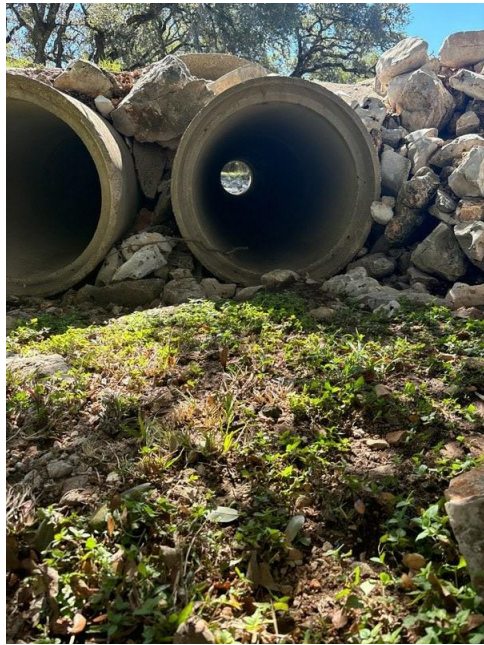
## Yosemite Crossing East

Field Notes: No maintenance required.

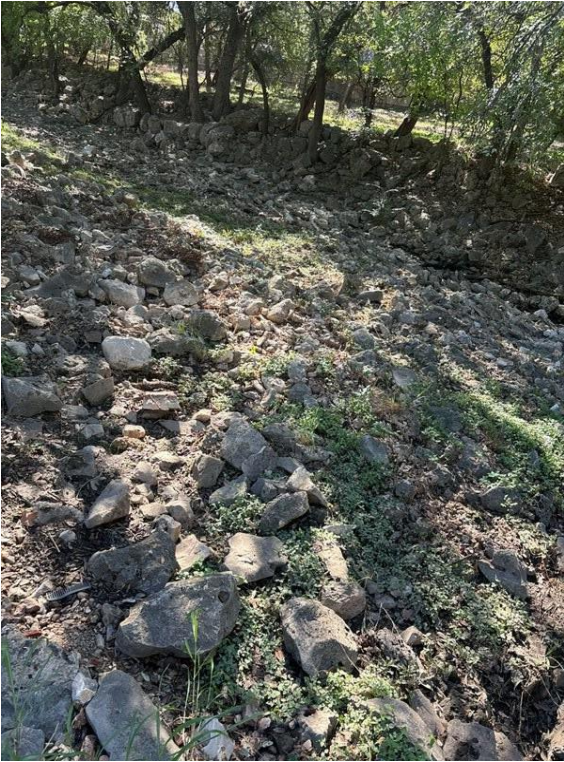
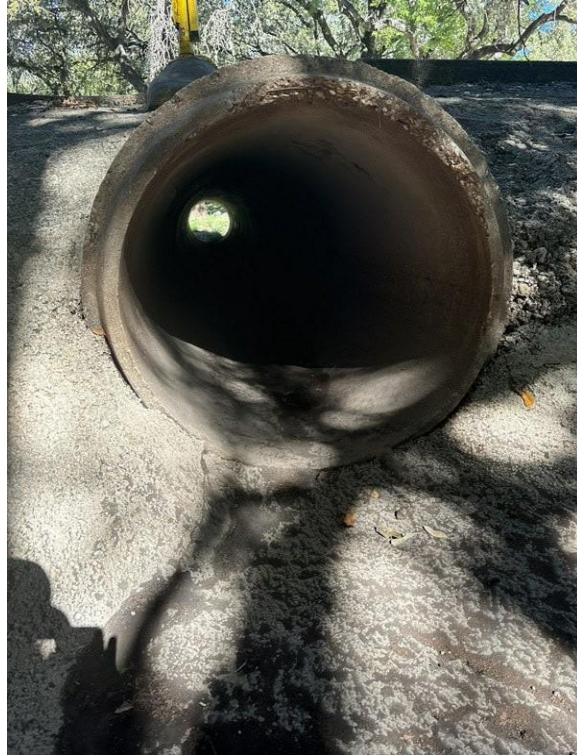
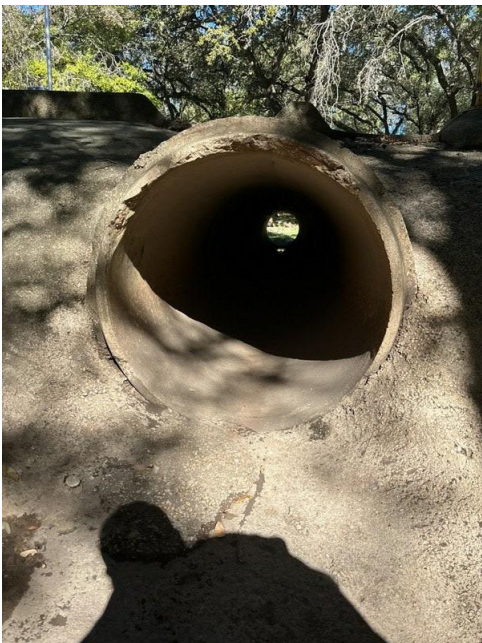
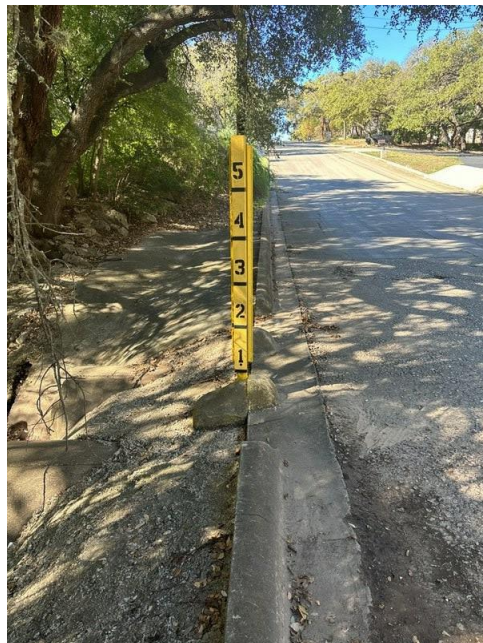
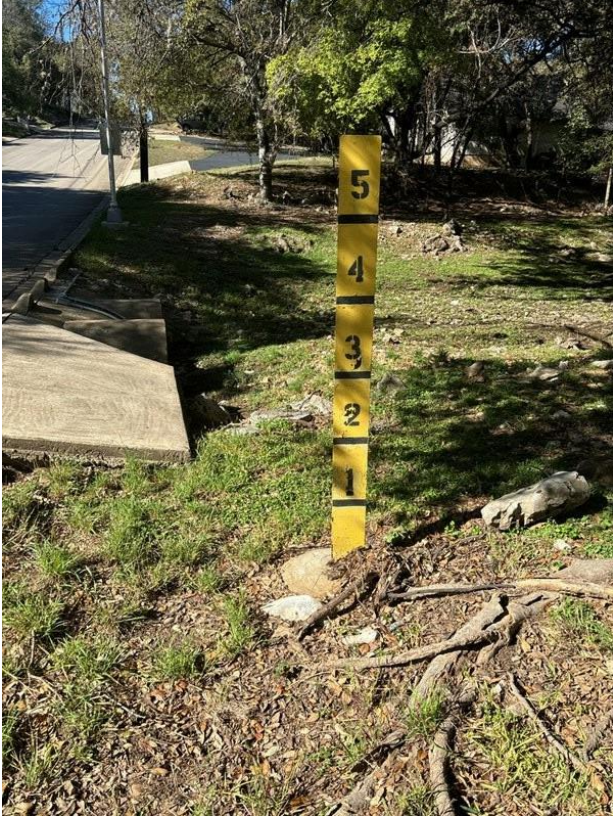
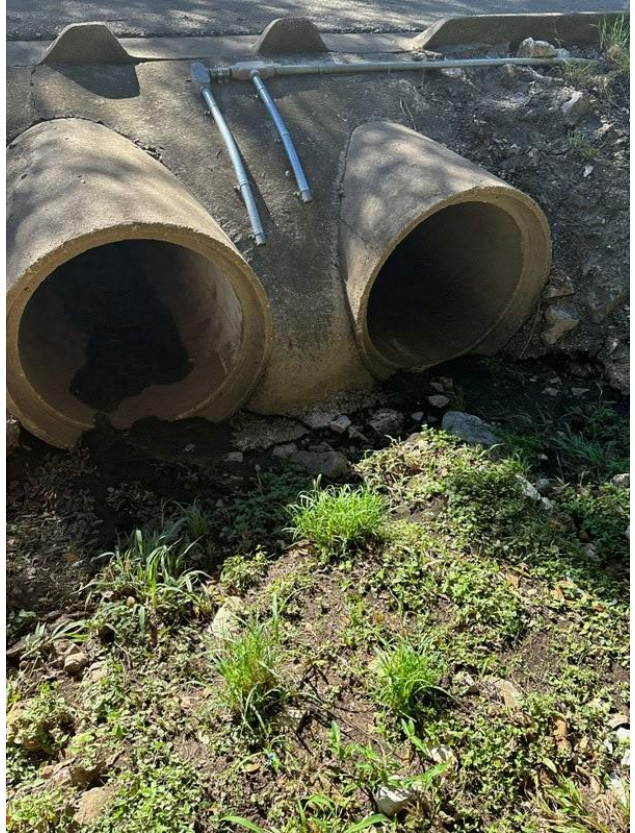
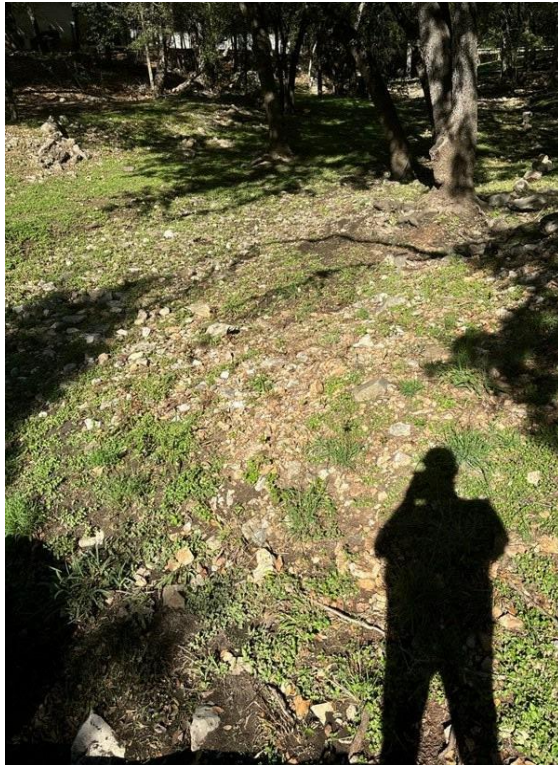
## Yosemite Crossing West

Field Notes: No maintenance required.
