# TOWN OF HOLLYWOOD PARK, TX

2023 Summer Inspection

# HOLLYWOOD PARK 2023 SUMMER INSPECTION REPORT

**Subject:** Annual Municipal Separate Storm Sewer System (MS4) Inspection

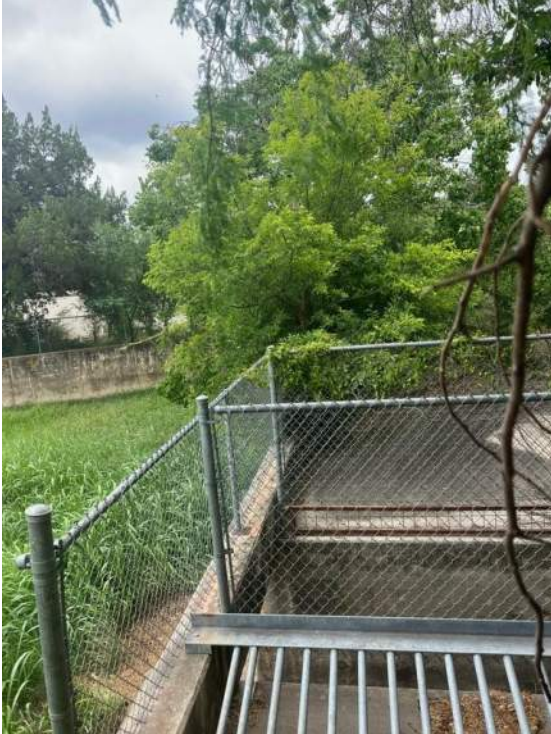
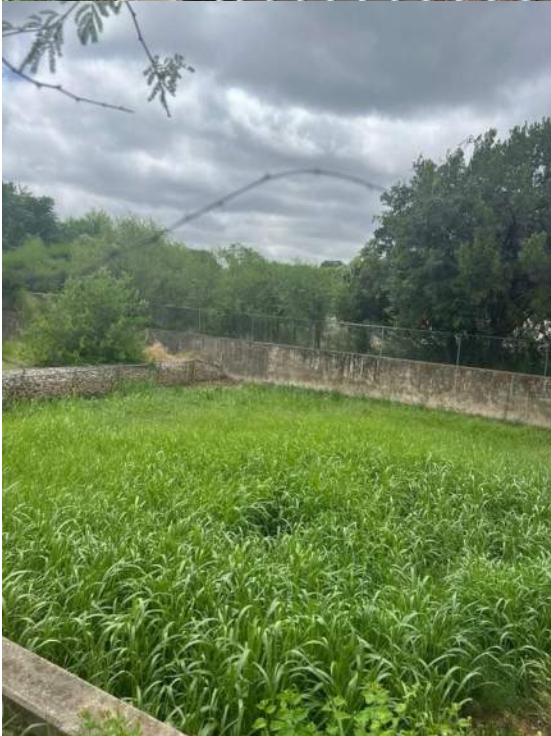
Field Notes: Clear vegetation

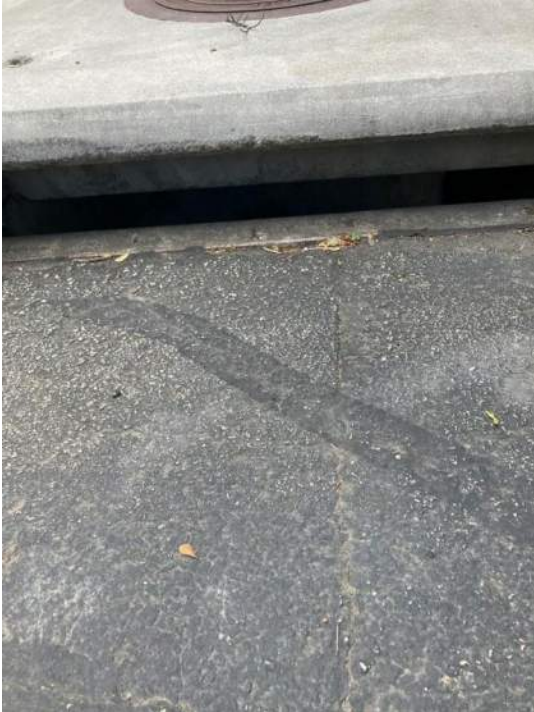
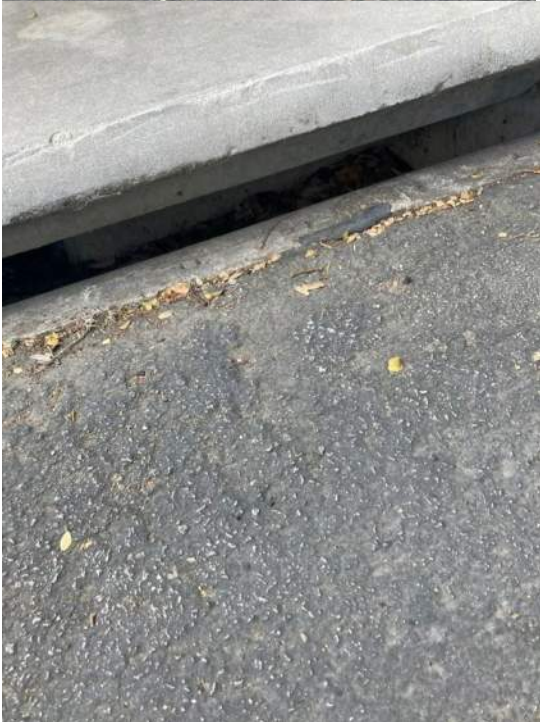
Field Notes: Remove buildup of sediment and leaves

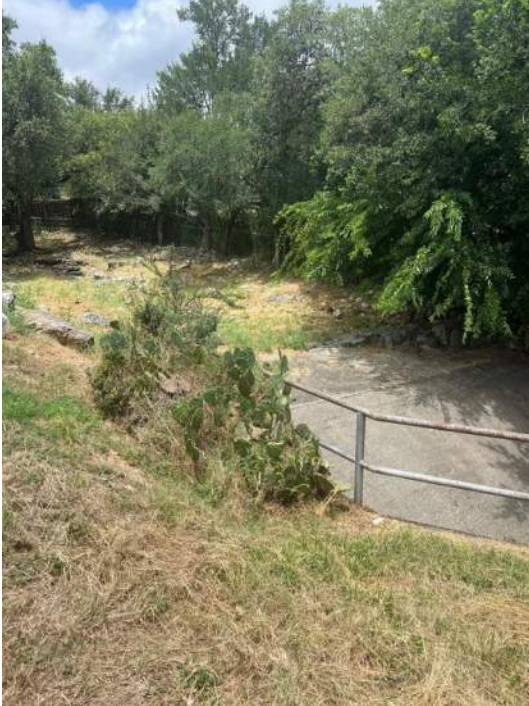
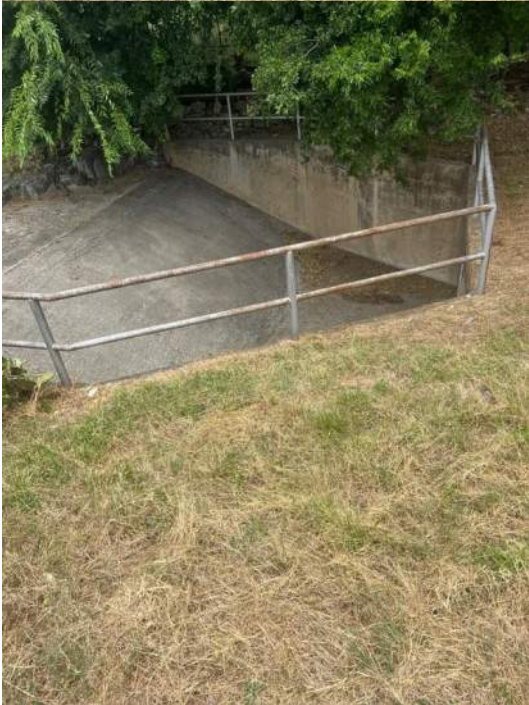
## ANT-I-2

Field Notes: Clear overgrown vegetation

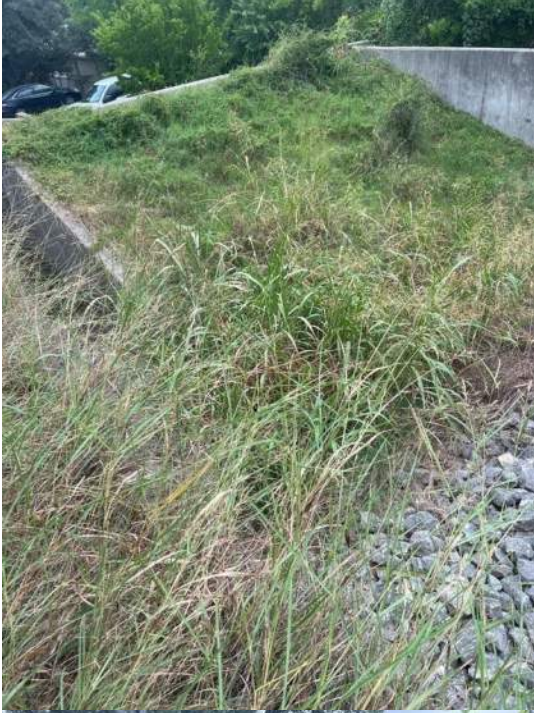
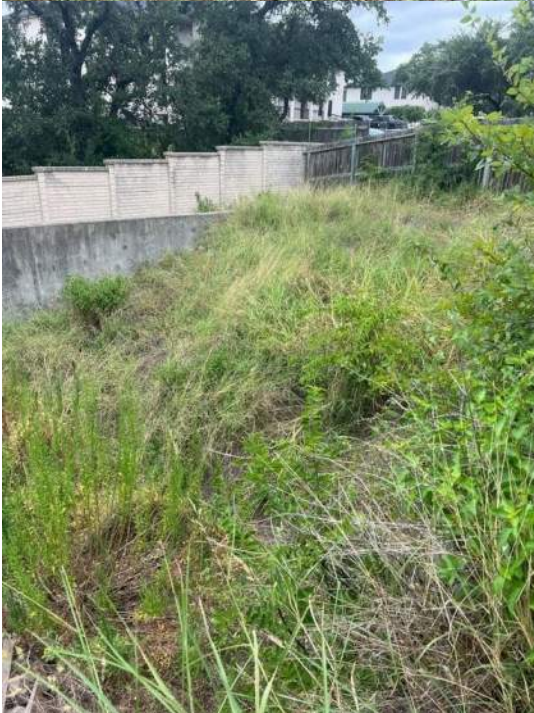
## Brookdale PCD

Field Notes: Remove all vegetation

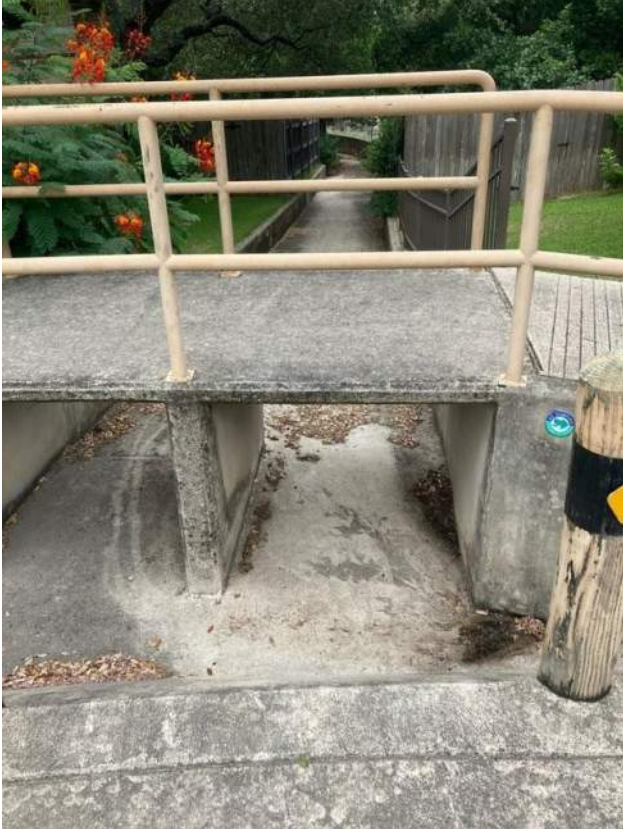
## Cascade Glen Sidewalk Drain

Field Notes: Remove leaves from channel.

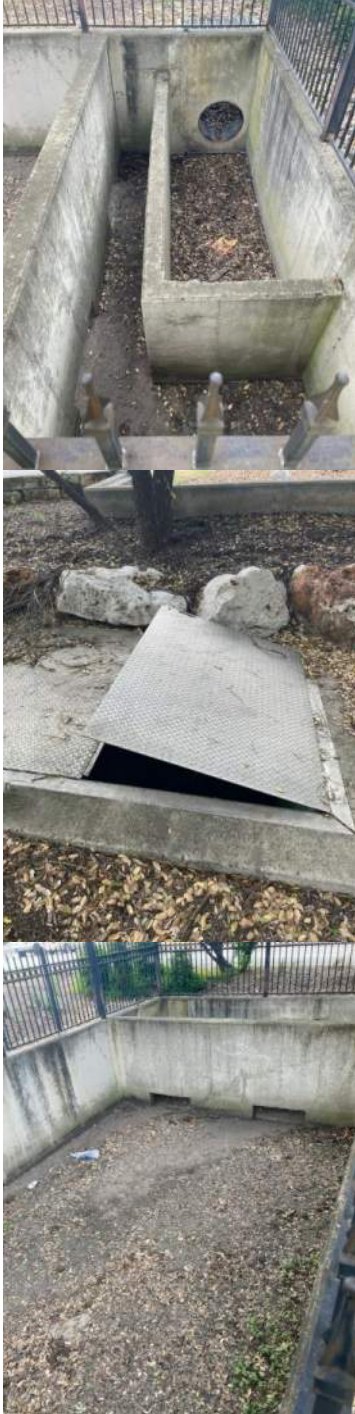
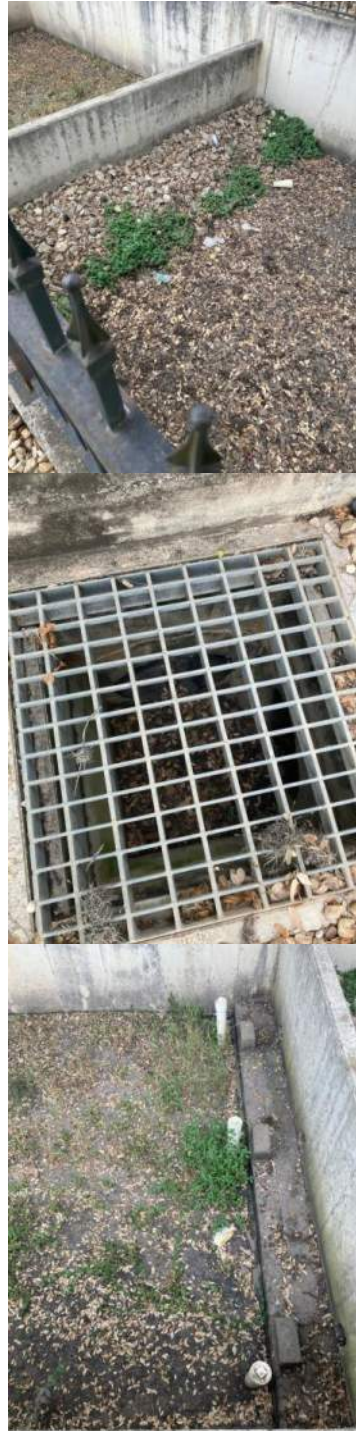
## Chandler Signs PCD in North Park Corporate Center Parking Lot

Field Notes: Trim vegetation and clean debris/trash. Remove leaves in the pipes under grate. Ensure pump station lid is closed and locked.

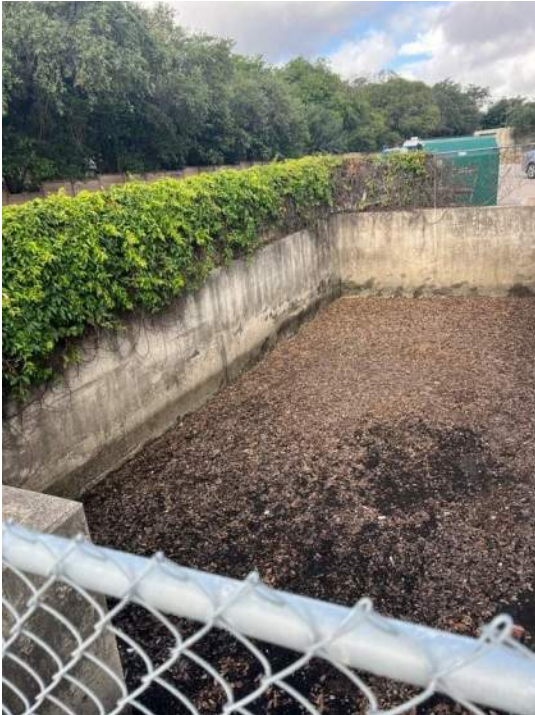
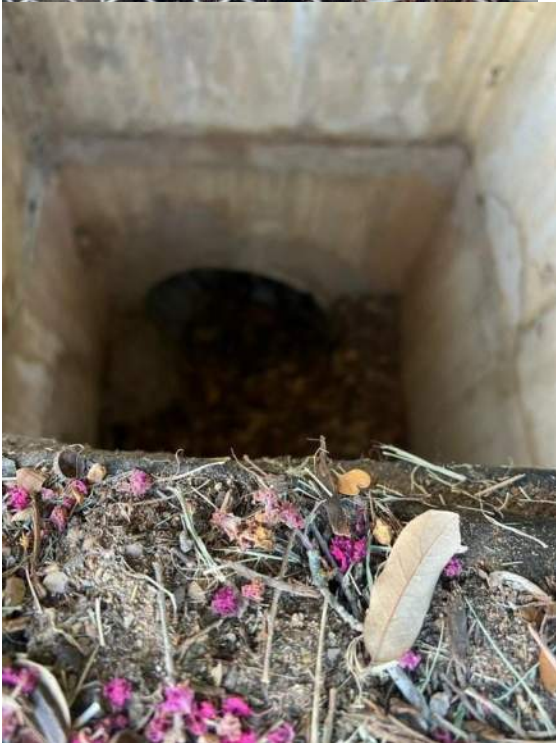
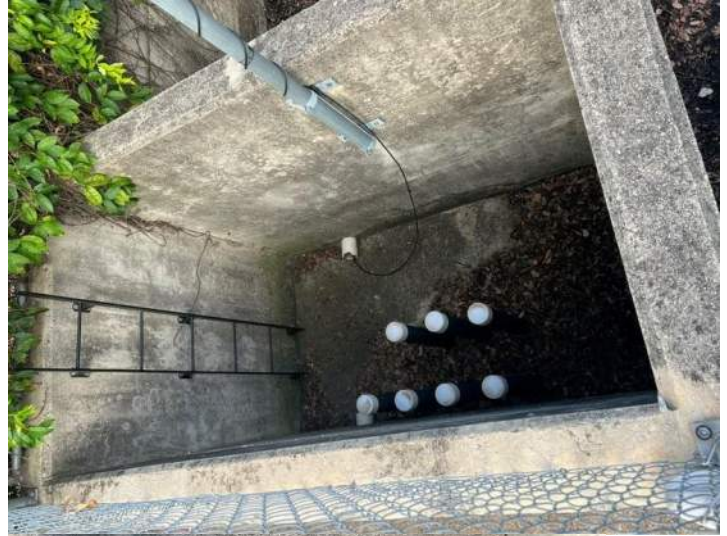
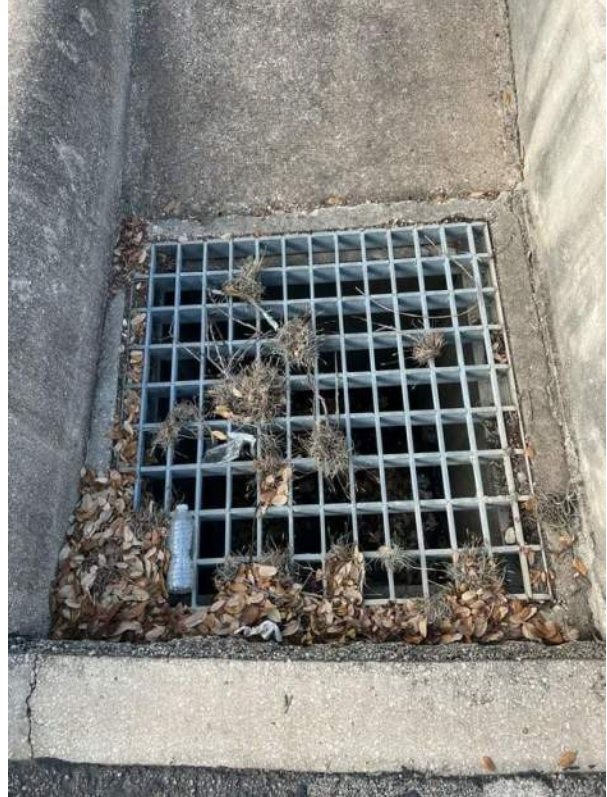
Field Notes: Debris needs to be cleared. Filters look good.

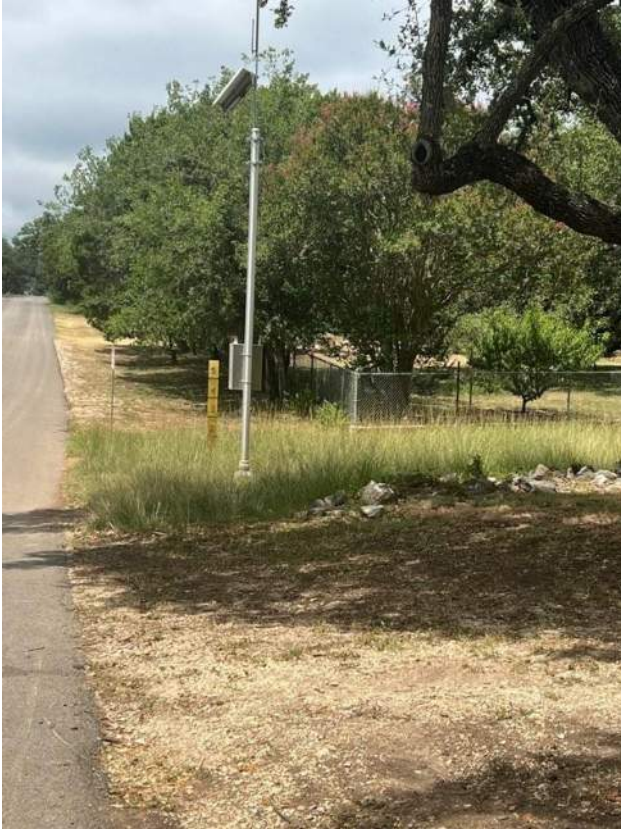
Field Notes: Clear vegetation for sign visibility

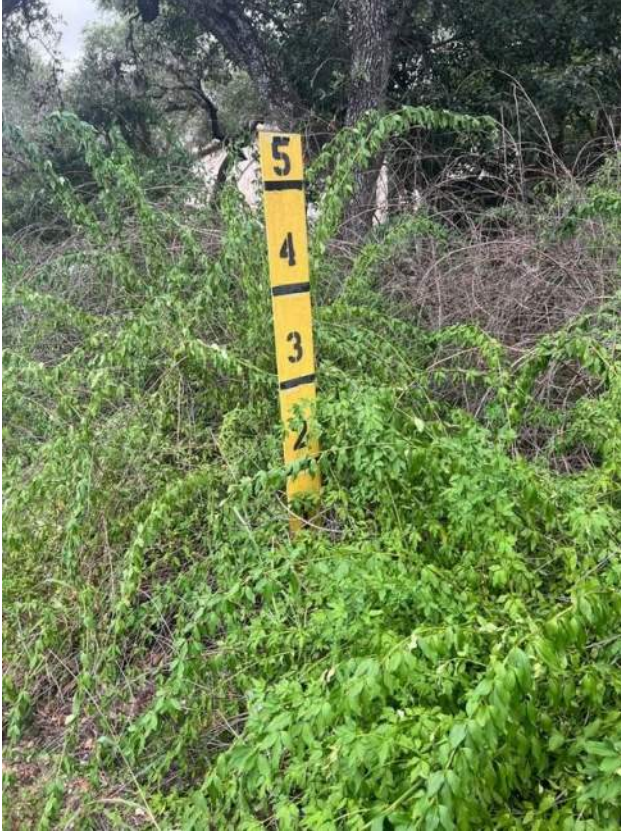
## El Cerrito Cr Low Water Crossing

Field Notes: Trim vegetation to clearly see sign

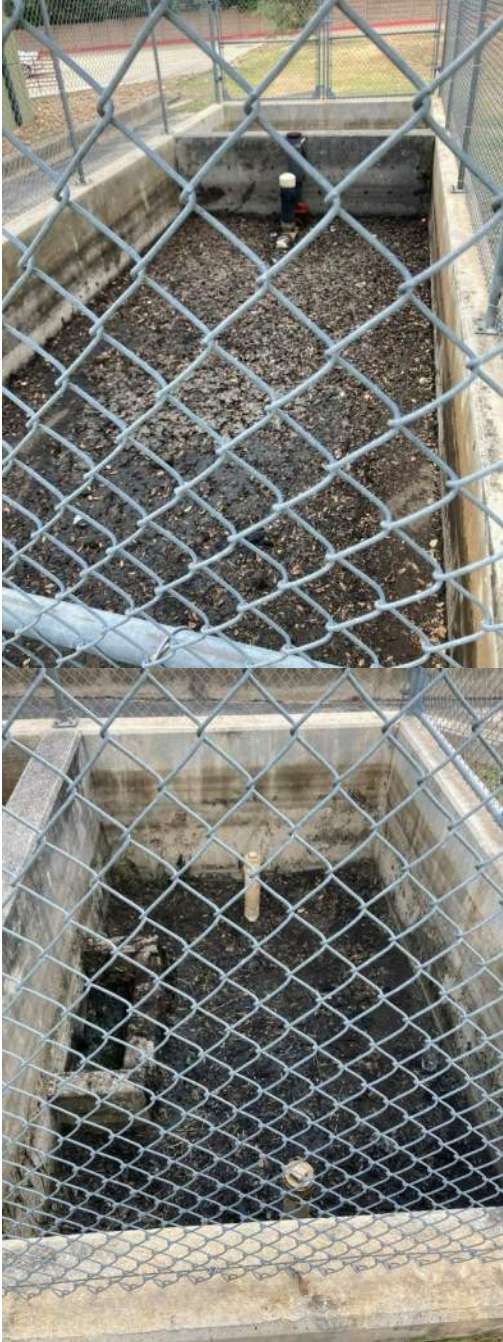
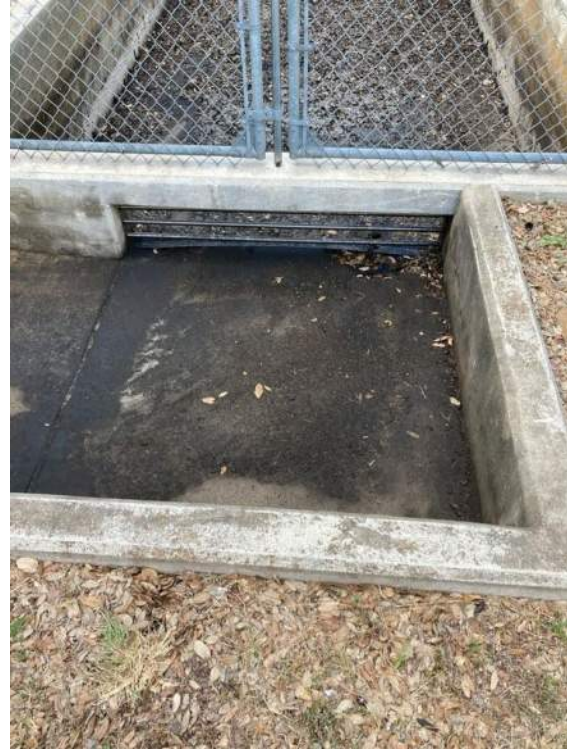
## Express Lube PCD

Field Notes: Needs debris cleanup. Filters look good.

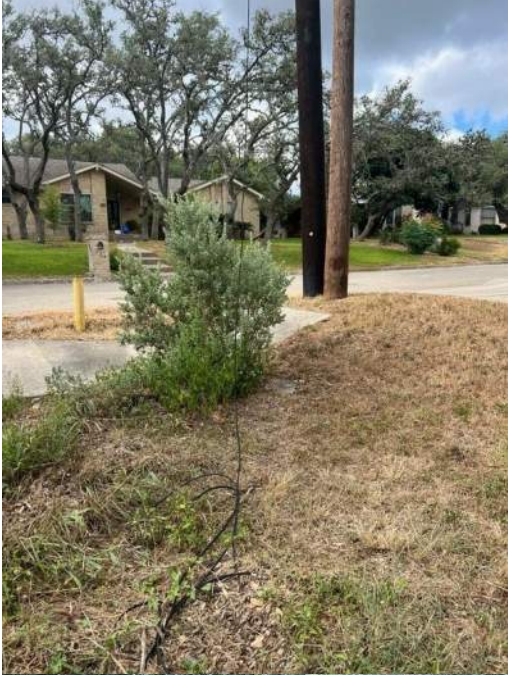
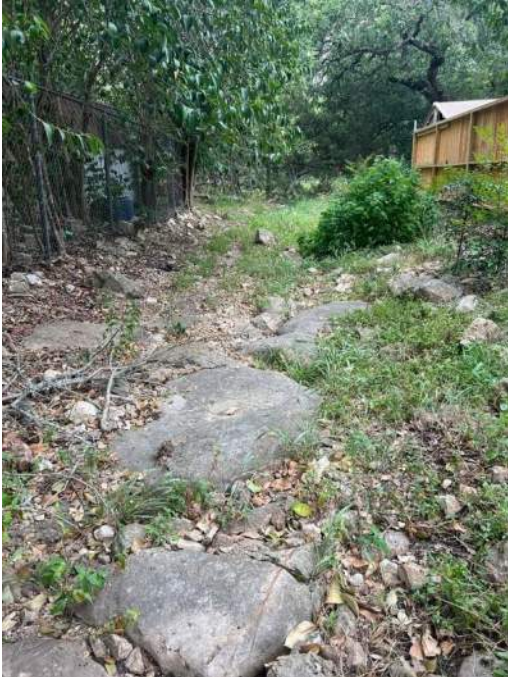
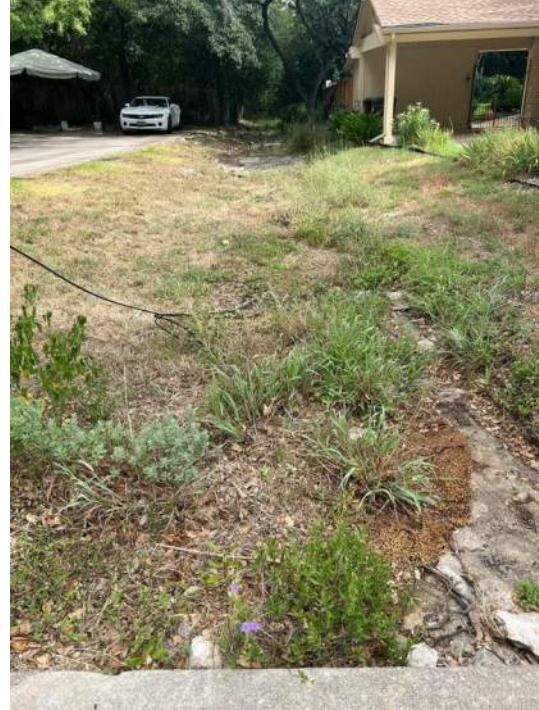
## Grand Oak Outfall

Field Notes: Clear telephone wire and vegetation

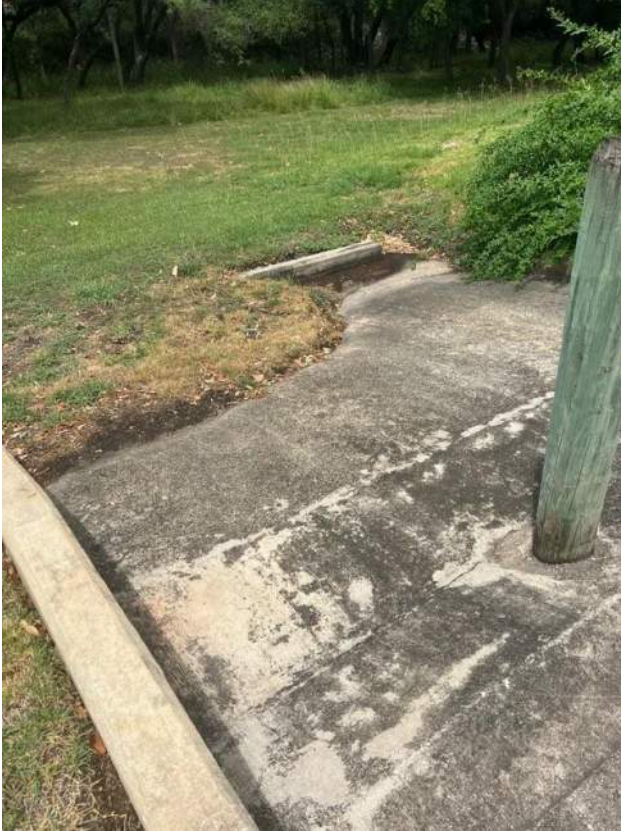
## Great Wood Street Outfall

Field Notes: Remove vegetation

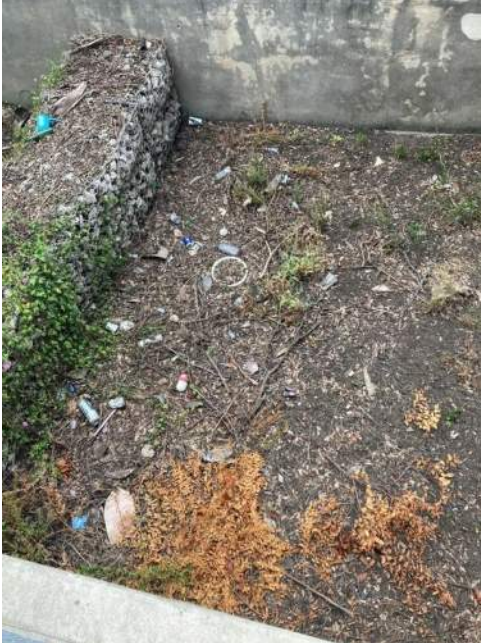
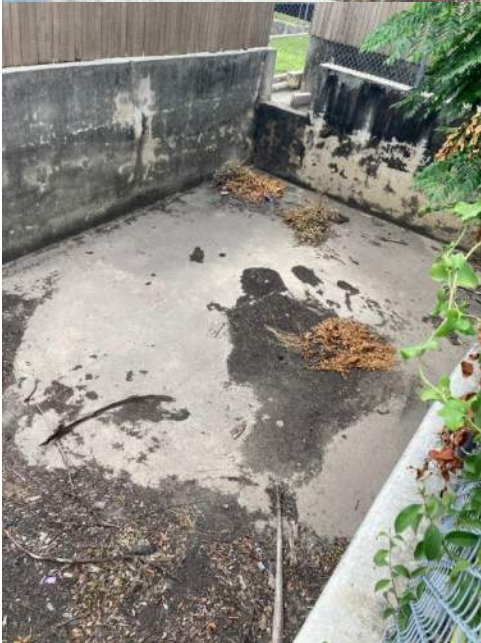
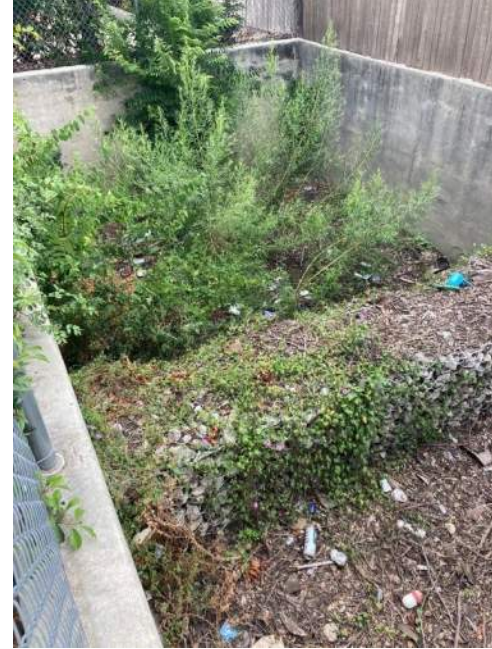
## Holiday Inn PCD

Field Notes: Clear trash, debris. And vegetation

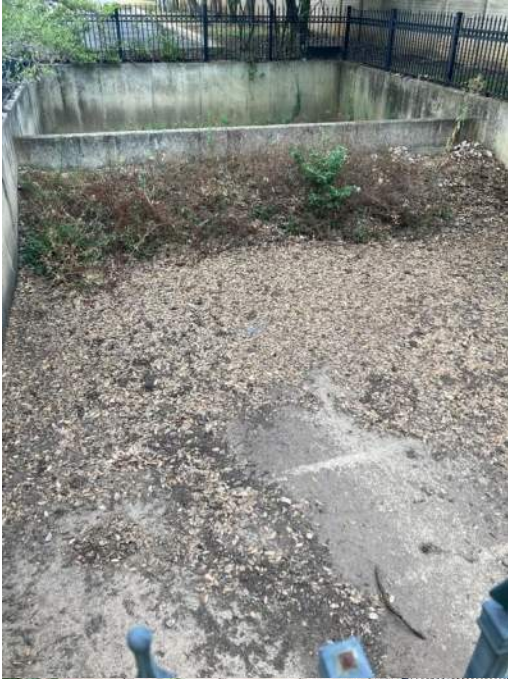
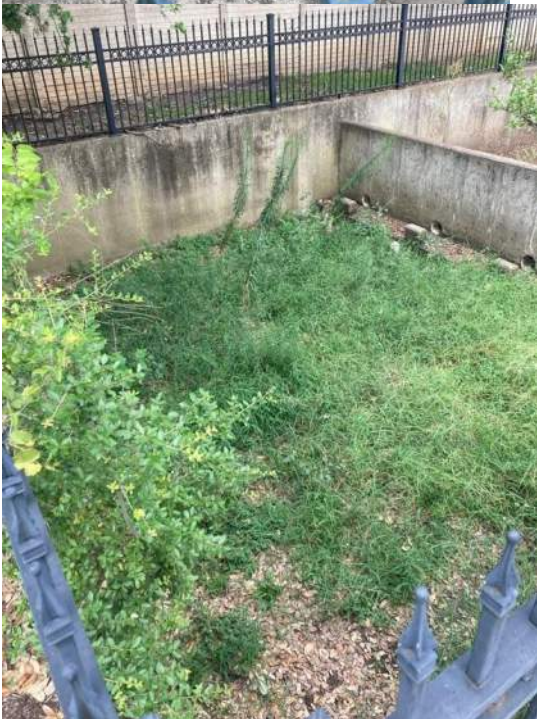
## Marriott Global Reservation PCD

Field Notes: Trim and control weeds/vegetation

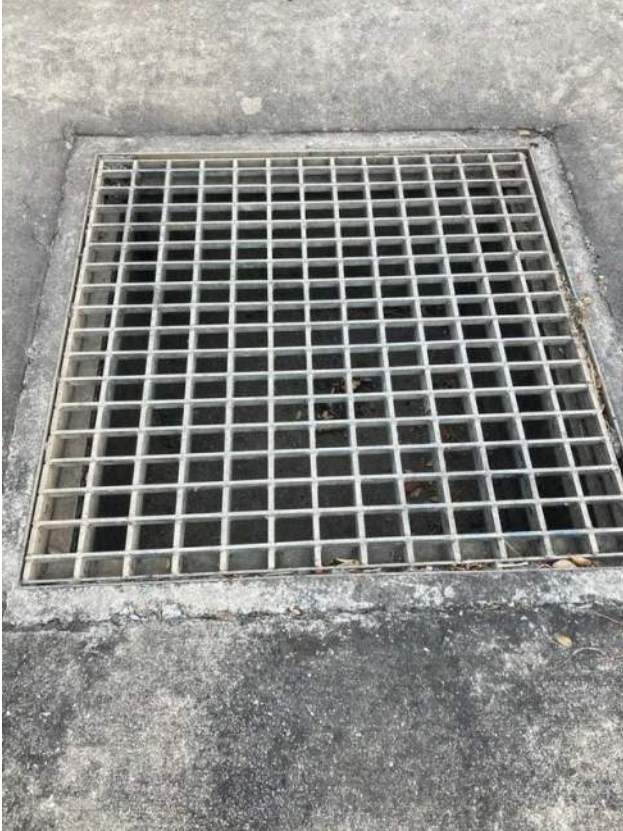
## Miner Fleet Parking Lot Inlet

Field Notes: Looks good

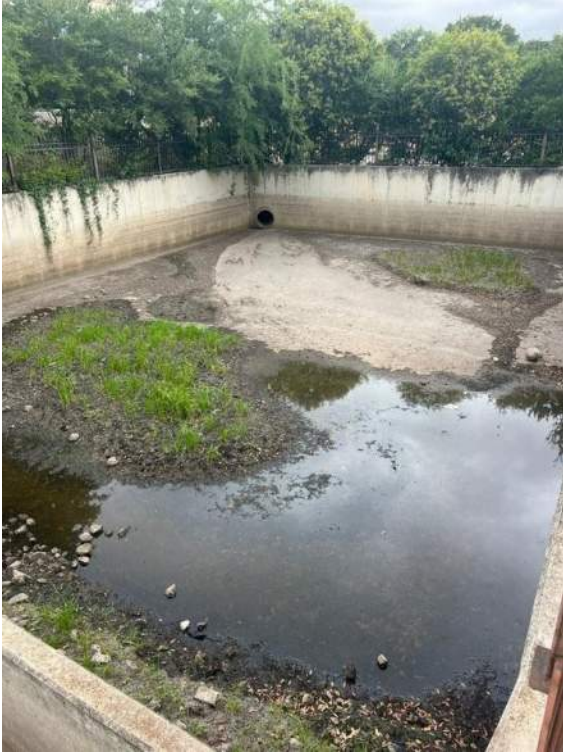
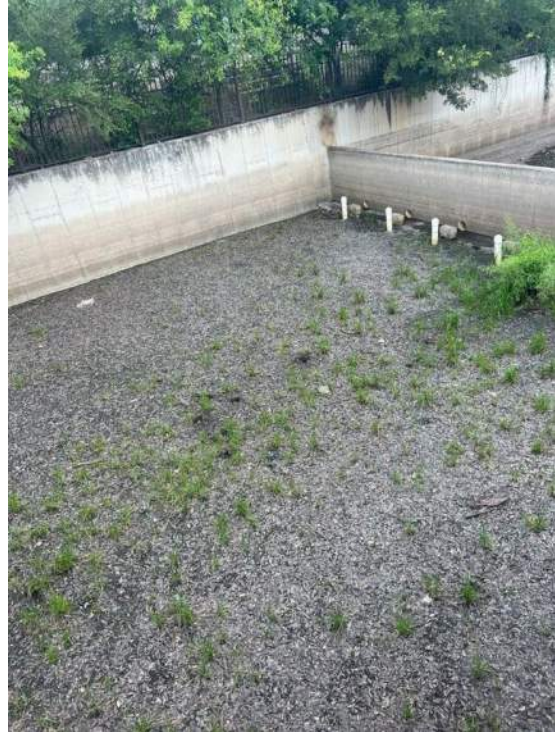
### Miner Fleet PCD

Field Notes: Clear out debris and vegetation. Filters look good. Pipe is clear.

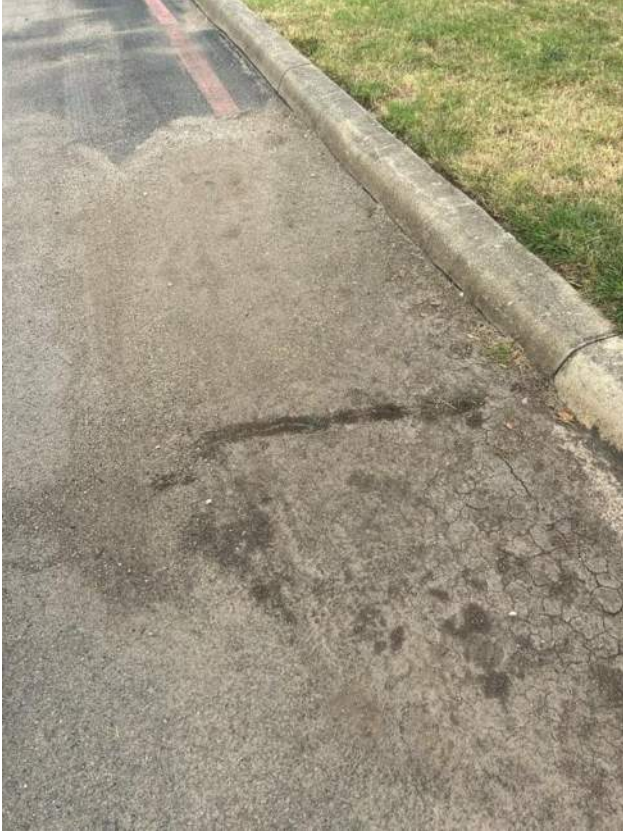
## Minor Sediment

Field Notes: Clear Sediment

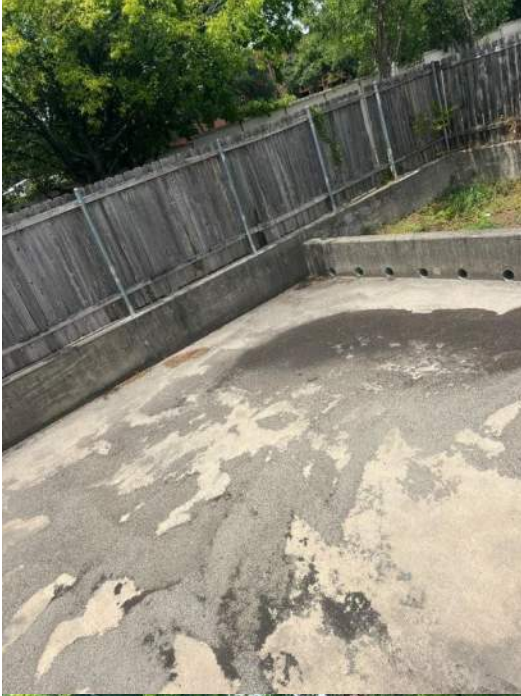
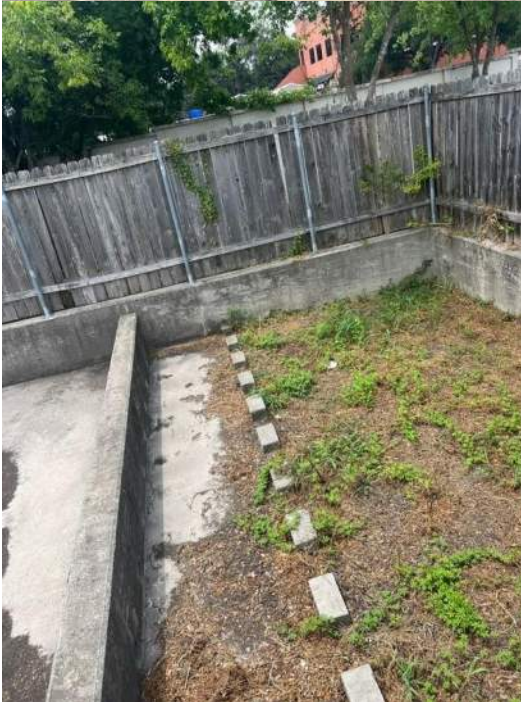
## Monarch Trophy PCD

Field Notes: Clear vegetation and debris

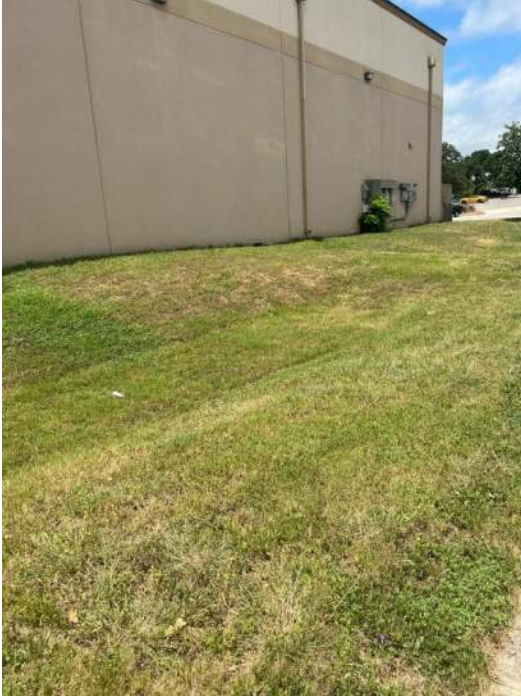
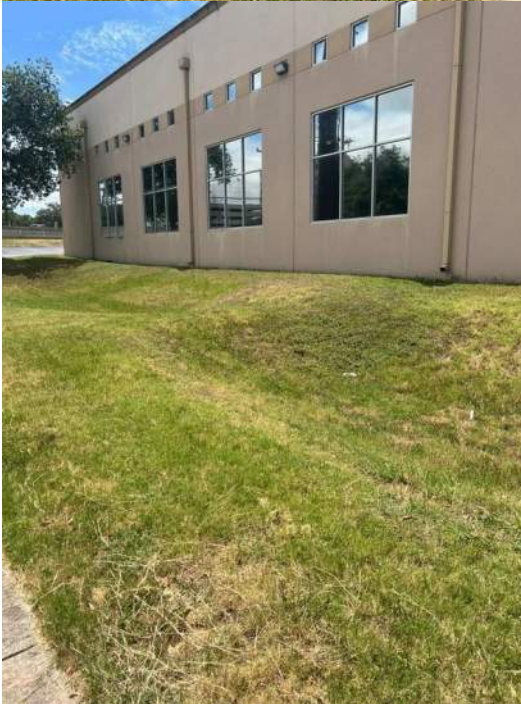
## Monarchy Trophy Swale

Field Notes: In good condition

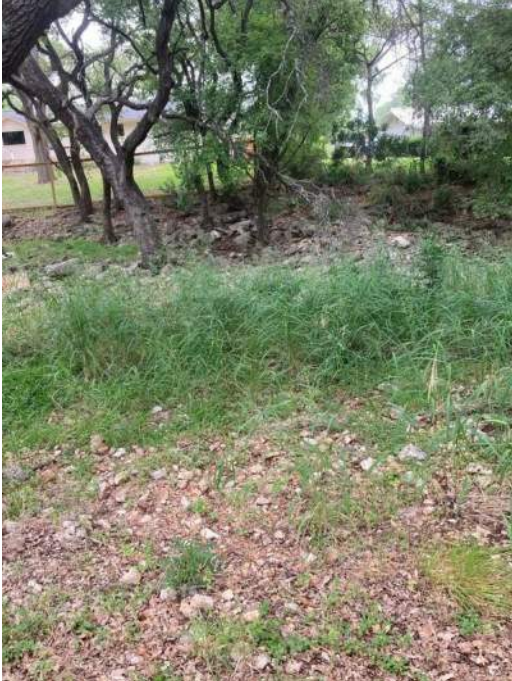
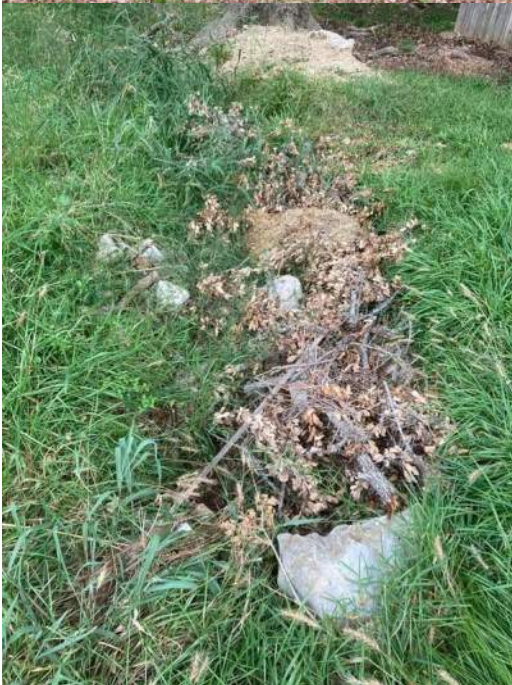
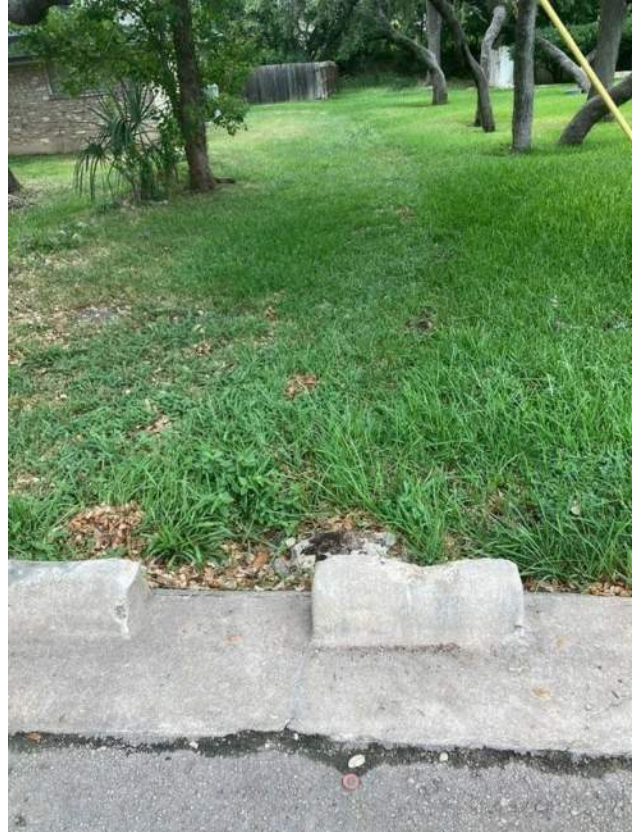
## Mustang Circle

Field Notes: Clear channel of tall vegetation and debris. Otherwise good.

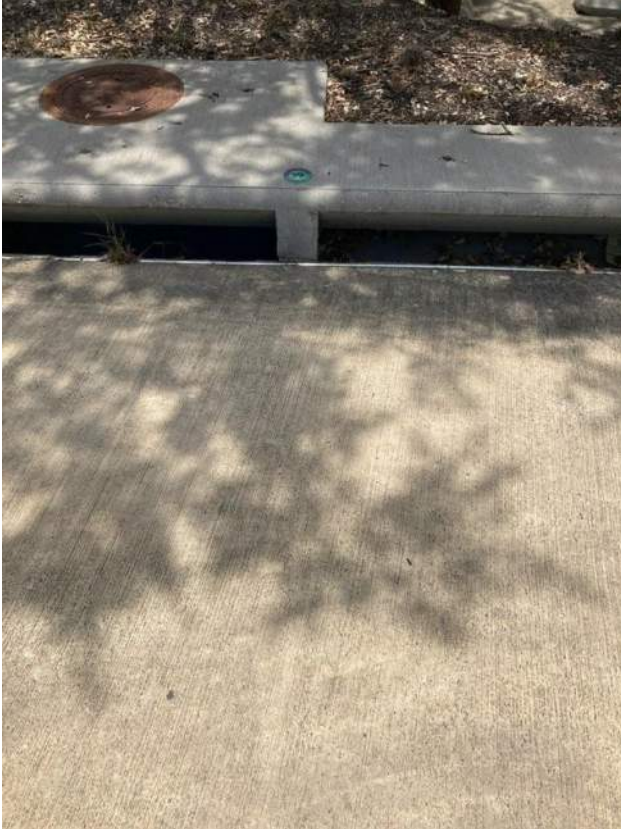
## Navato Blvd Inlet

Field Notes: Clear debris

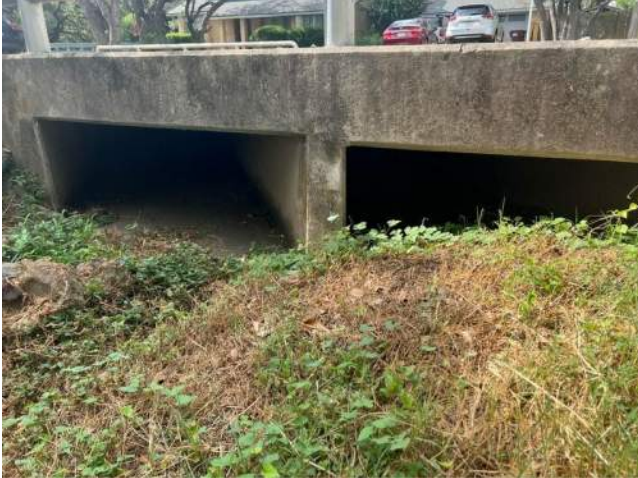
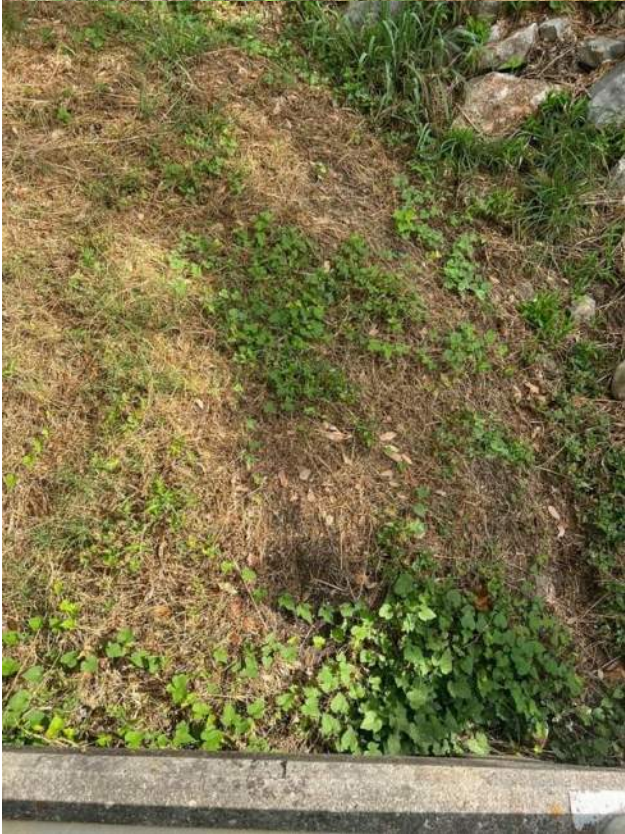
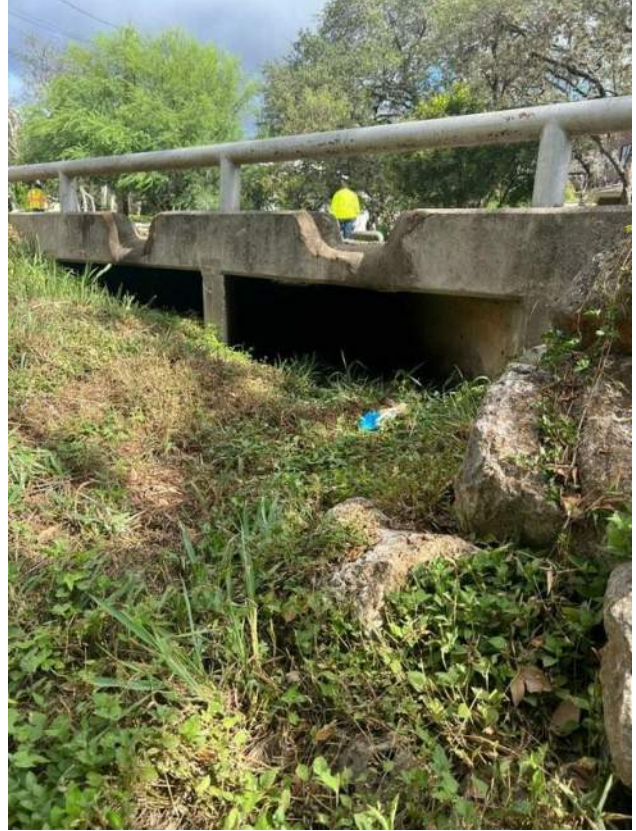
## North Oak Crossing

Field Notes: Clear vegetation out of culvert.

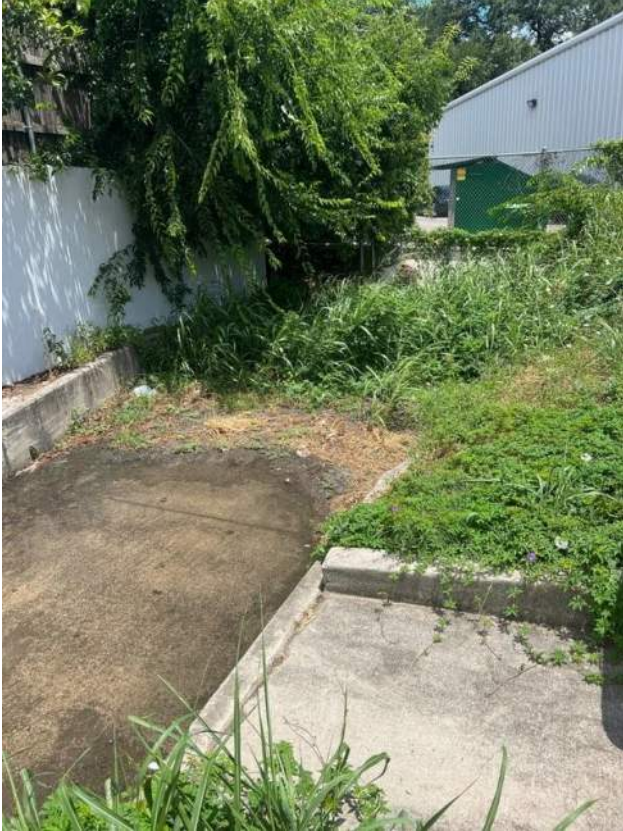
Field Notes: Clear debris

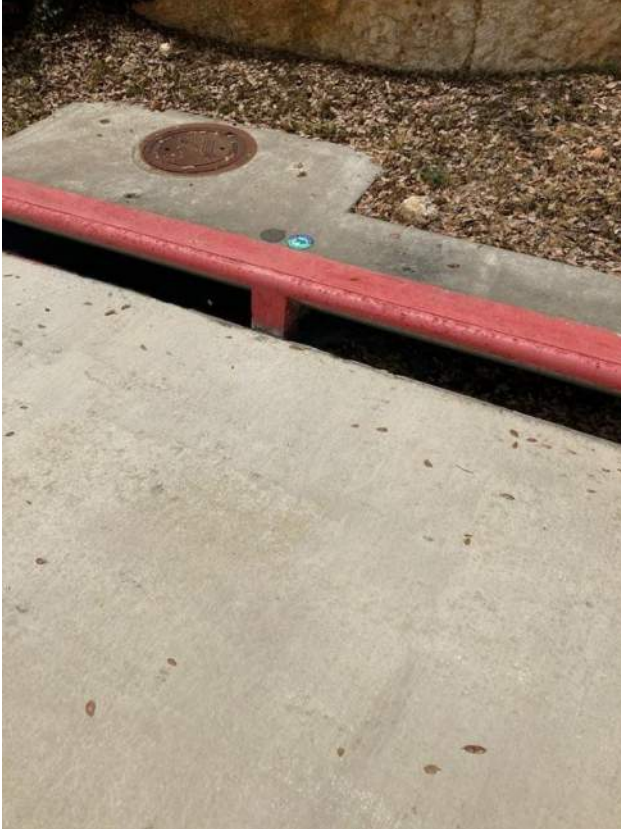
## Oak Creek Circle Inlet

Field Notes: Clear out debris

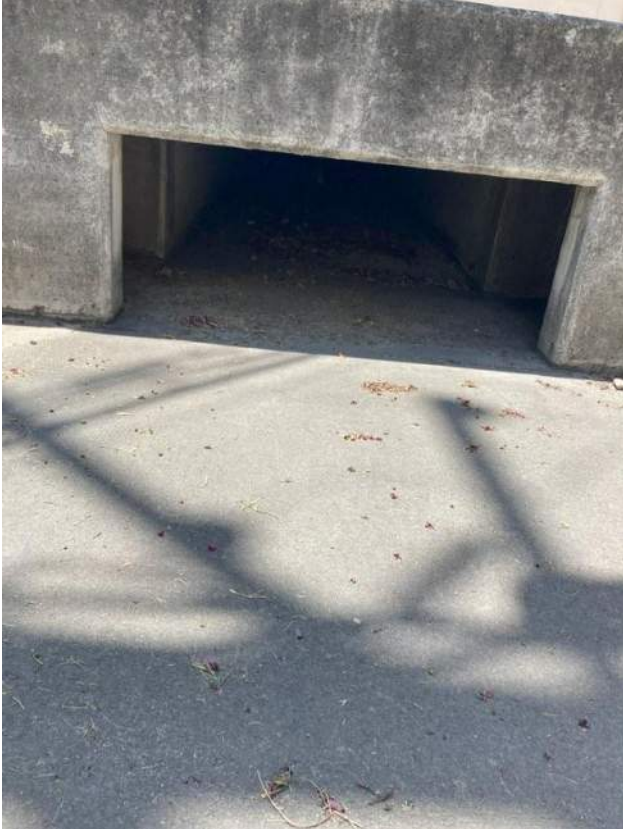
## Oak Creek Circle Storm Sewer Pipe

Field Notes: Clear debris buildup

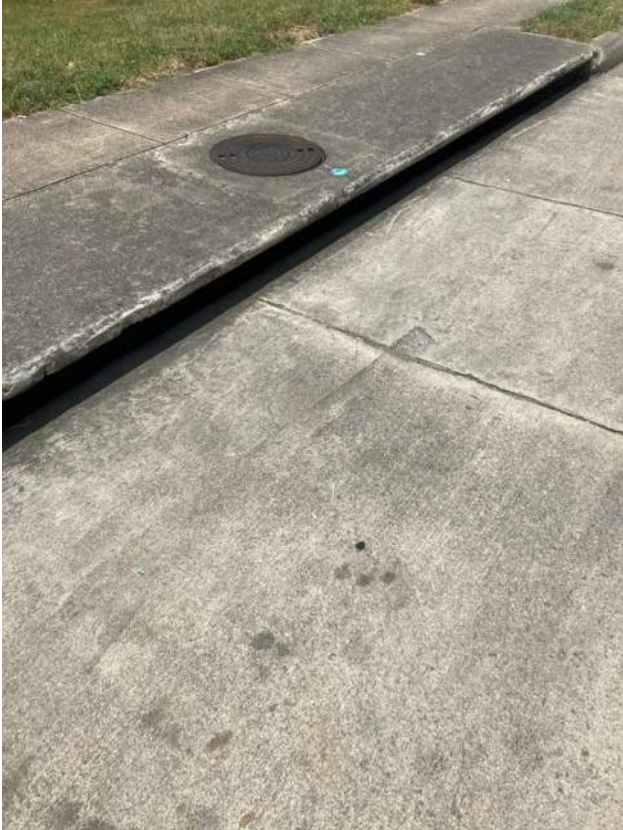
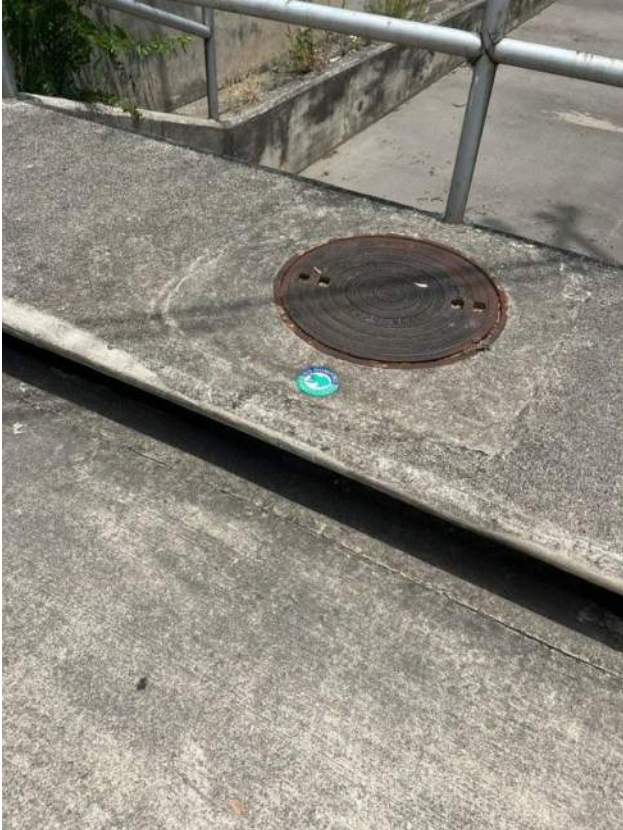
### OAK-I-1 (M)

Inspection Date: 2023-07-07  
Inspector: Cade Wenberg  
Field Inspection:  
 No Maintenance Required  
 Needs Maintenance  
 Illicit Discharge  
Field Notes: Good condition

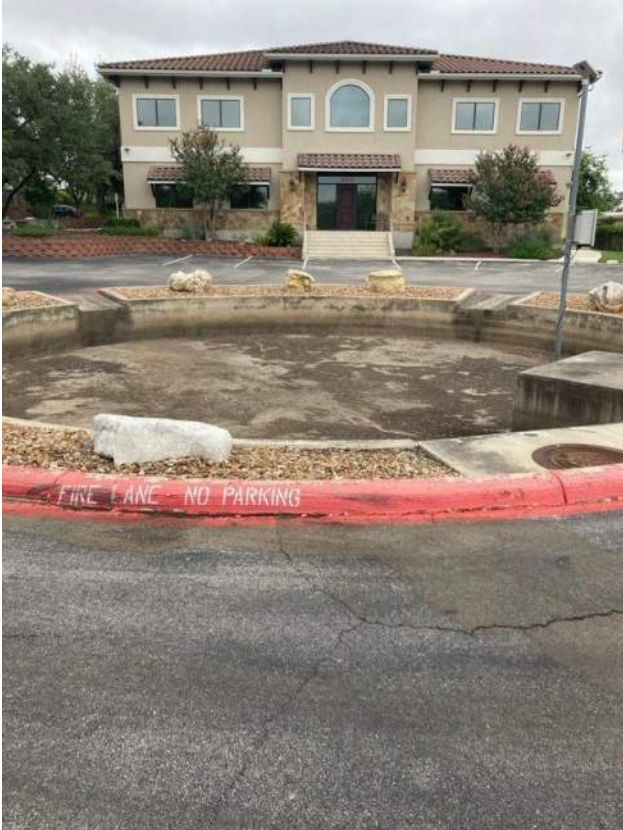
## Optometrist Roundabout PCD

Field Notes: Looks good

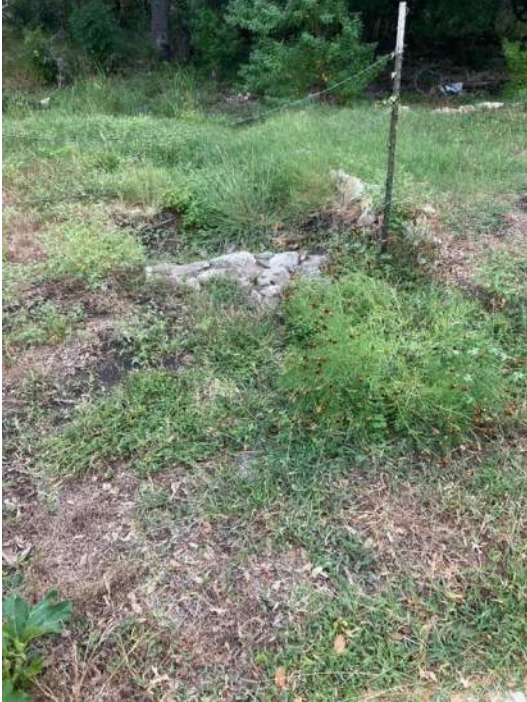
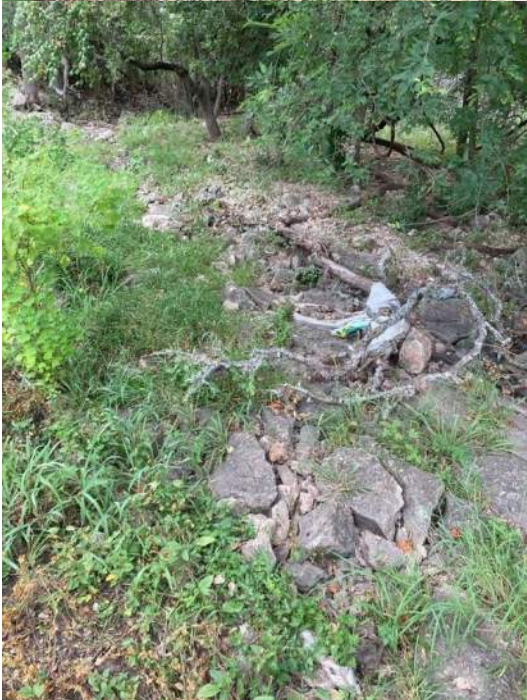
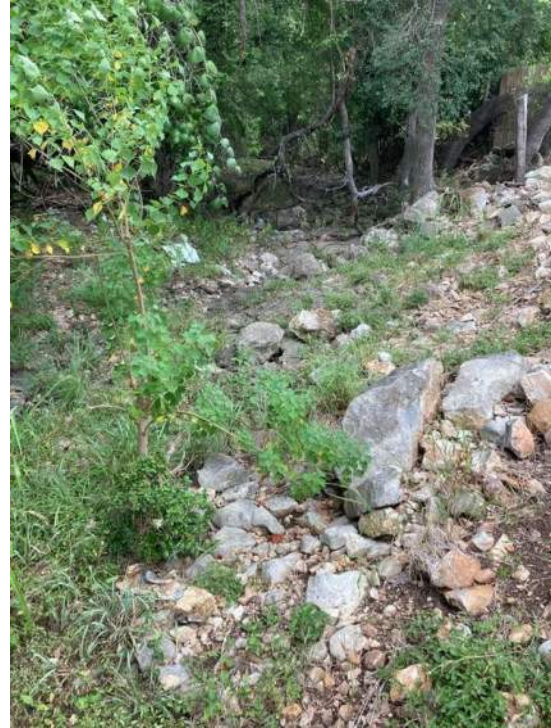
Field Notes: Trim vegetation and clean light debris
