# TOWN OF HOLLYWOOD PARK, TX

2023 Summer Inspection

# HOLLYWOOD PARK 2023 SUMMER INSPECTION REPORT

**Subject:** Annual Municipal Separate Storm Sewer System (MS4) Inspection

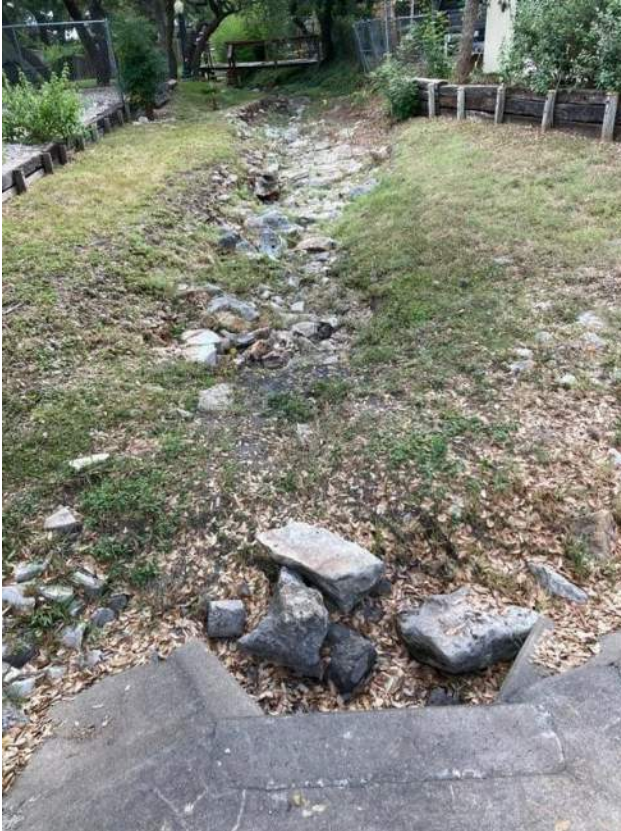
## Paseo Canada Outfall 1

Pretty clean

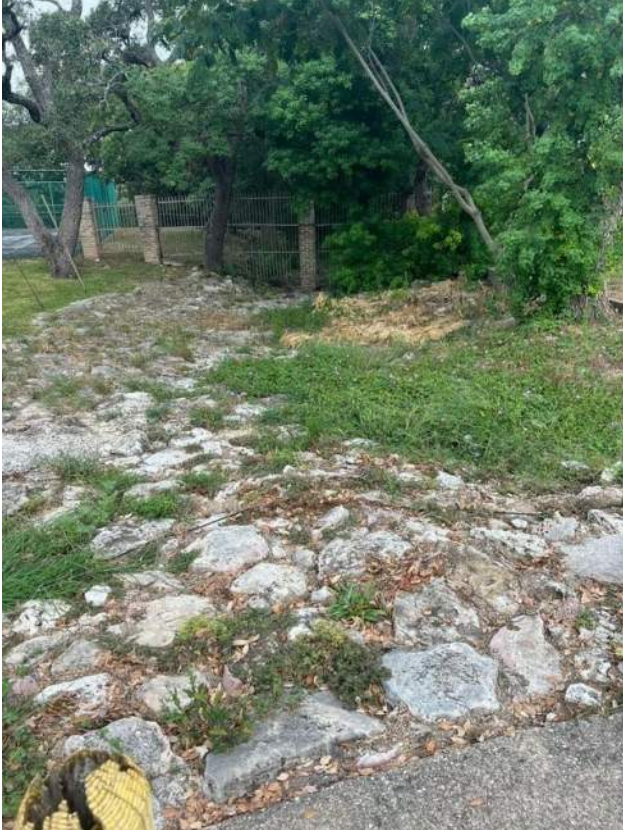
Field Notes: Clear weeds and trash

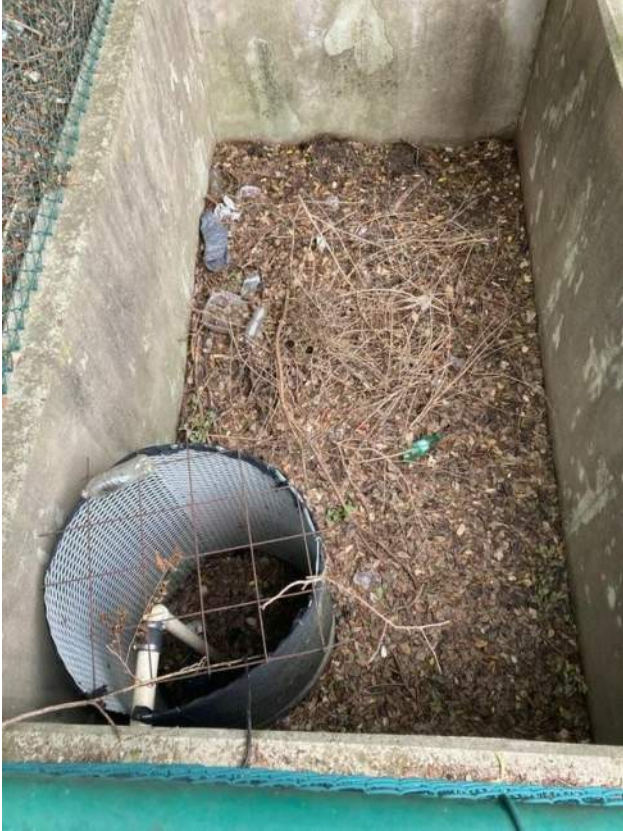
## Paseo Canada UG Pipe

Field Notes: Clean debris and lock gate

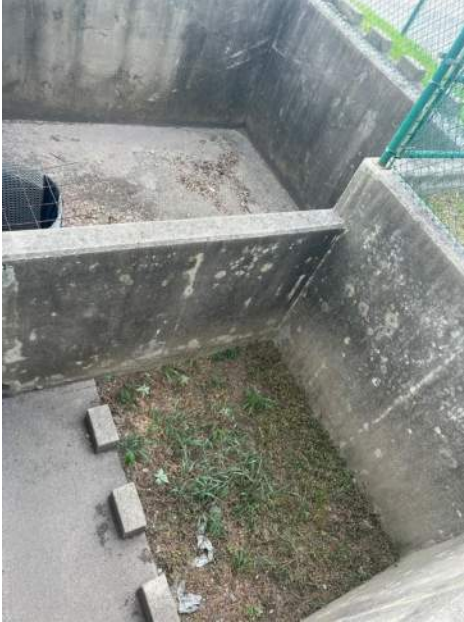
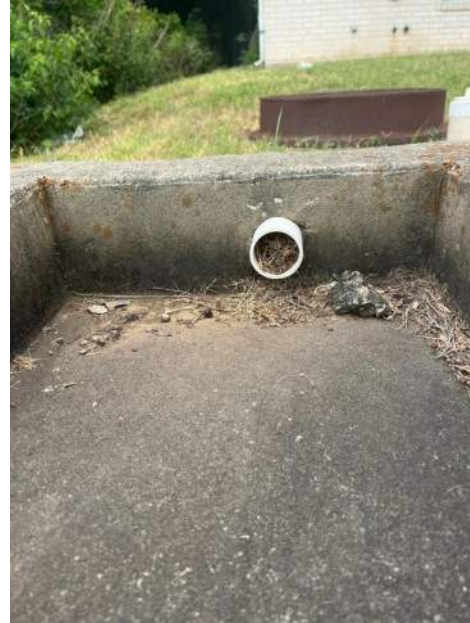
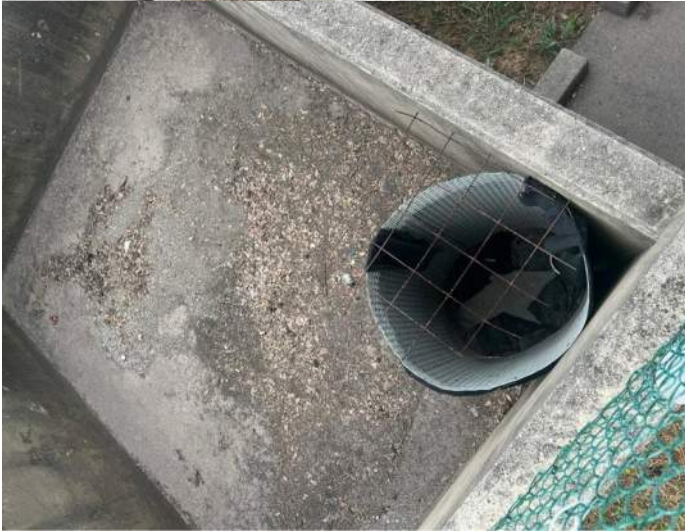
## Pediatric Dentistry Office PCD

Field Notes: Clean pipe out

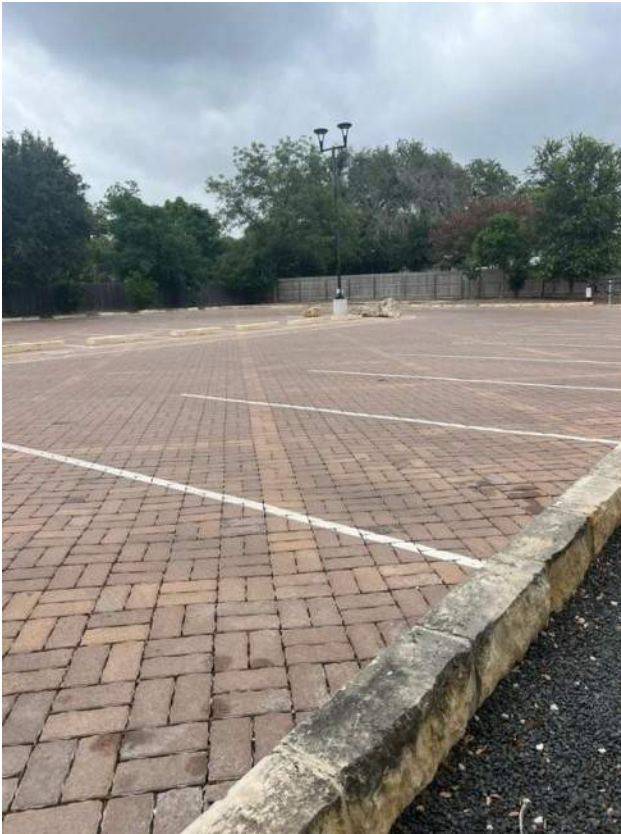
## Permeable Pavers

Field Notes: Clean and in good condition

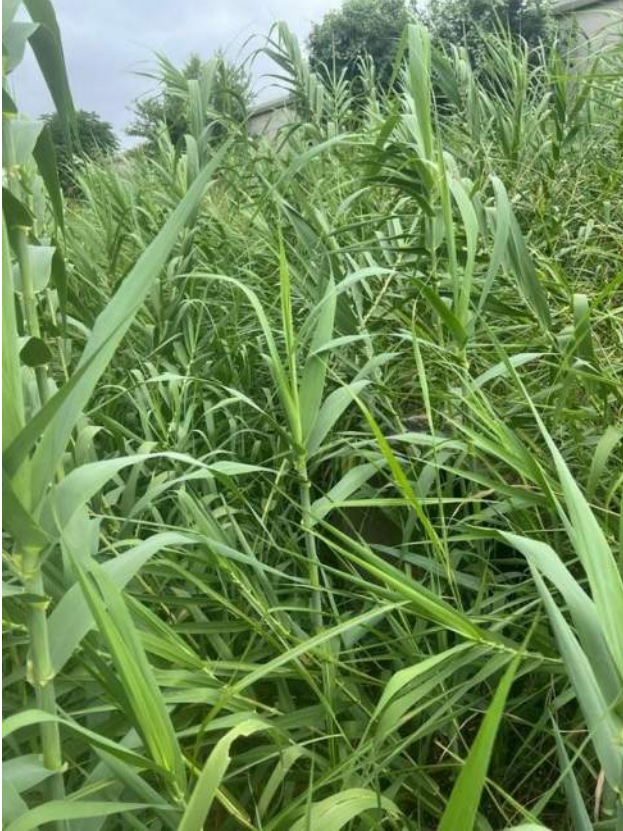
Field Notes: Clear vegetation

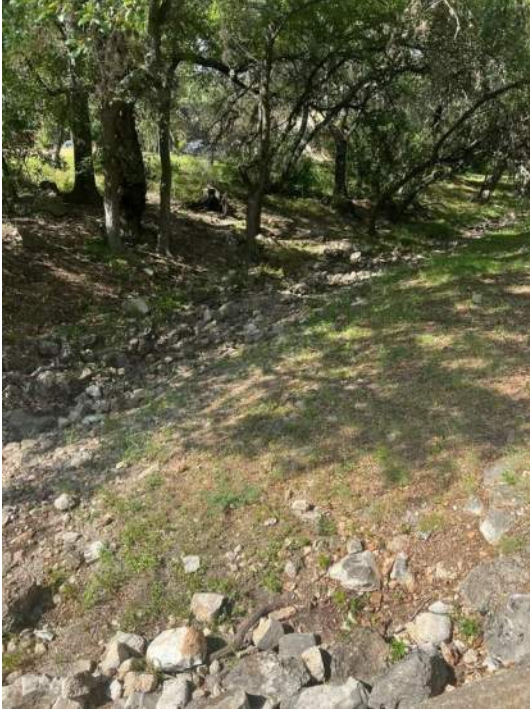
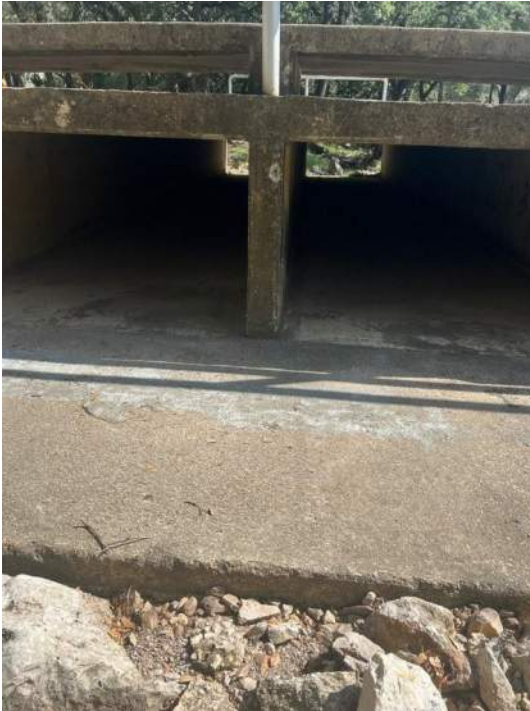
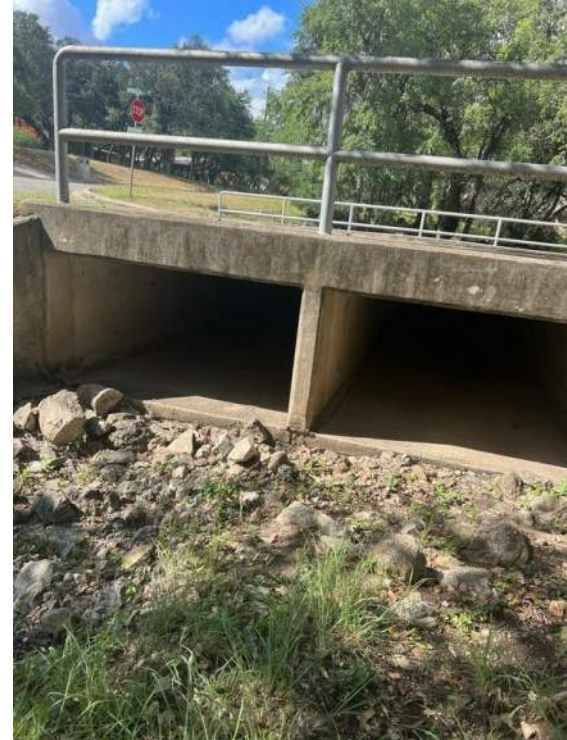
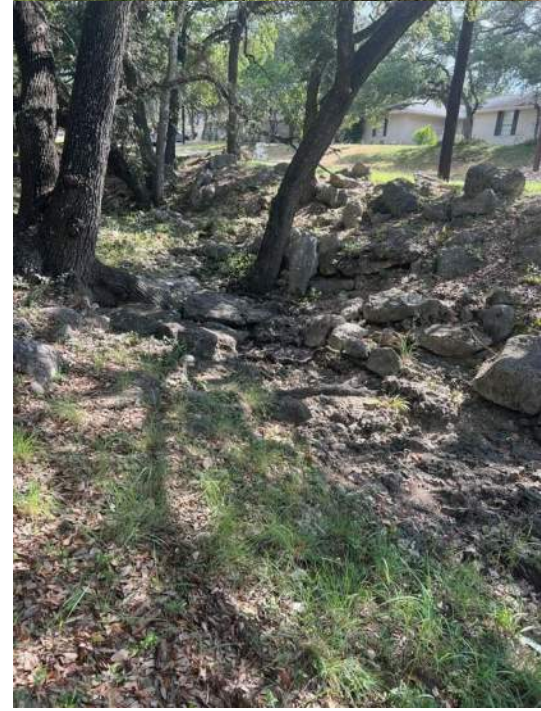
Field Notes: Pipes and vegetation in good condition

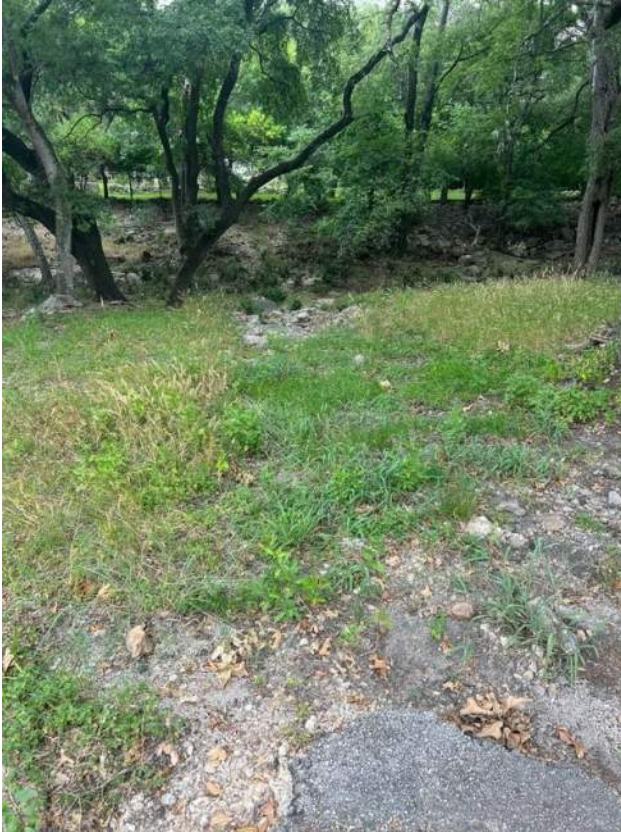
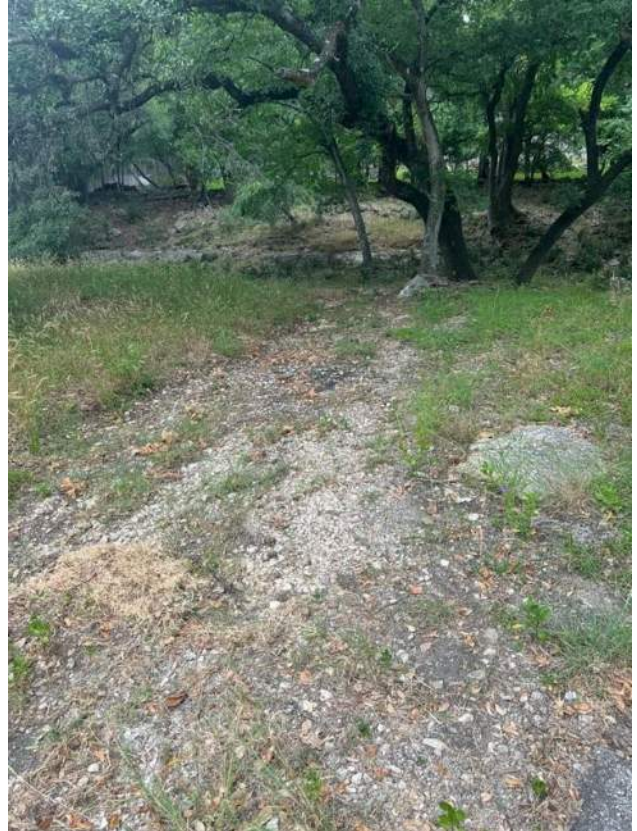
## Rua De Matta

Field Notes: Good condition

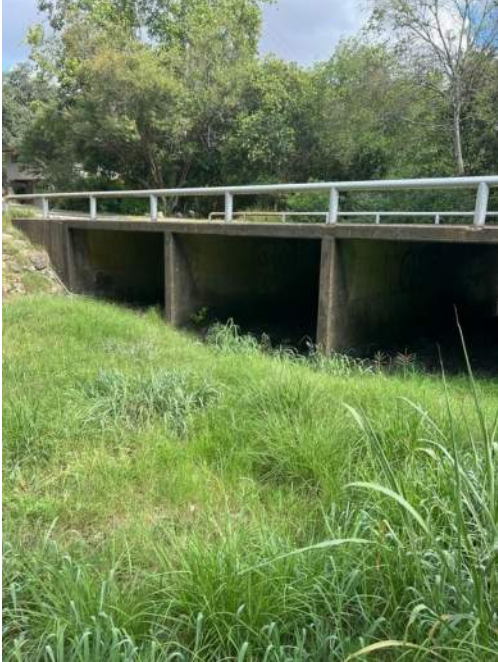
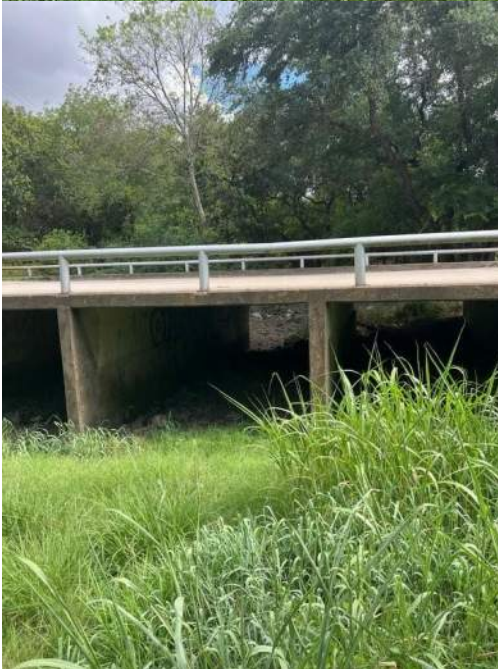
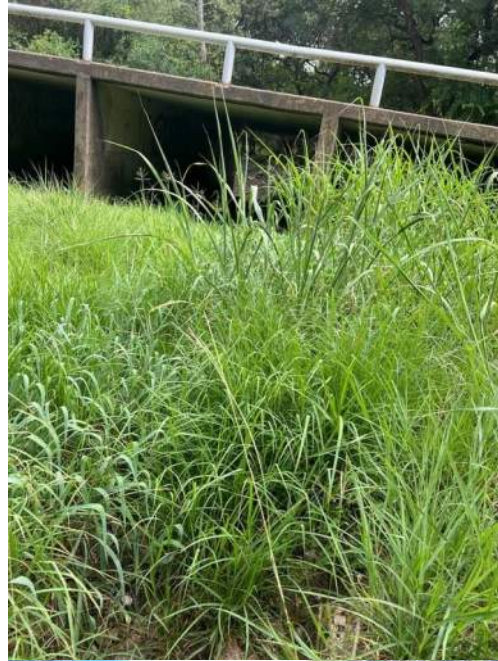
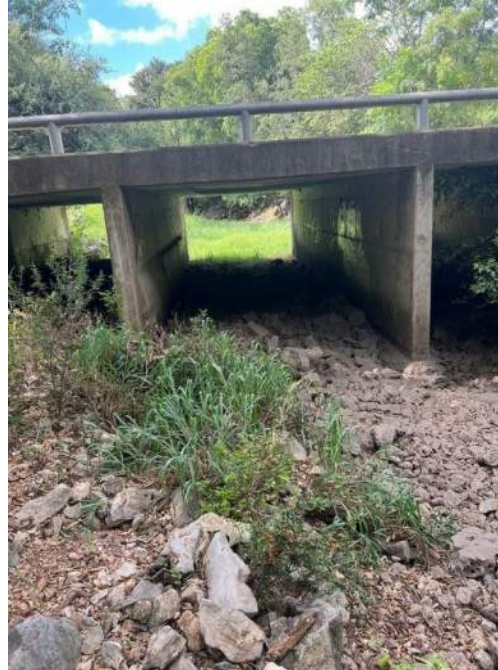
## Sagecrest Crossing West

Field Notes: Pipes look good. Vegetation needs to be mowed down.

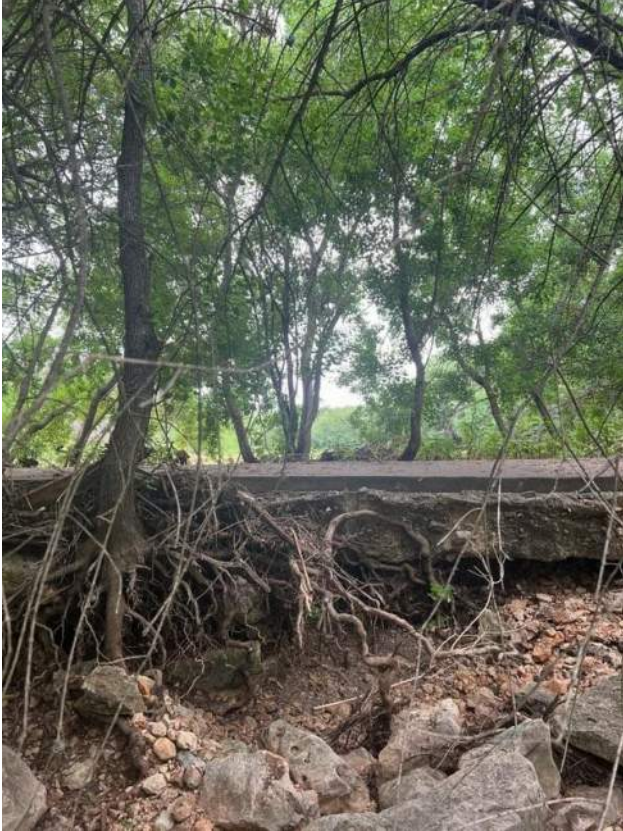
## Spillway Structure

Field Notes: Monitor Erosion
