# TOWN OF HOLLYWOOD PARK, TX

2023 Winter Inspection

# HOLLYWOOD PARK 2023 WINTER INSPECTION REPORT

**Subject:** Annual Municipal Separate Storm Sewer System (MS4) Inspection

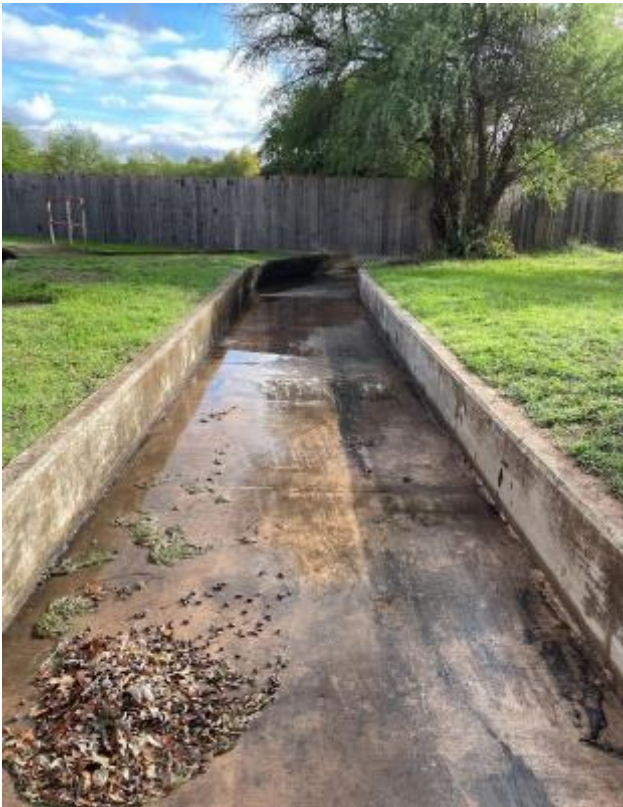
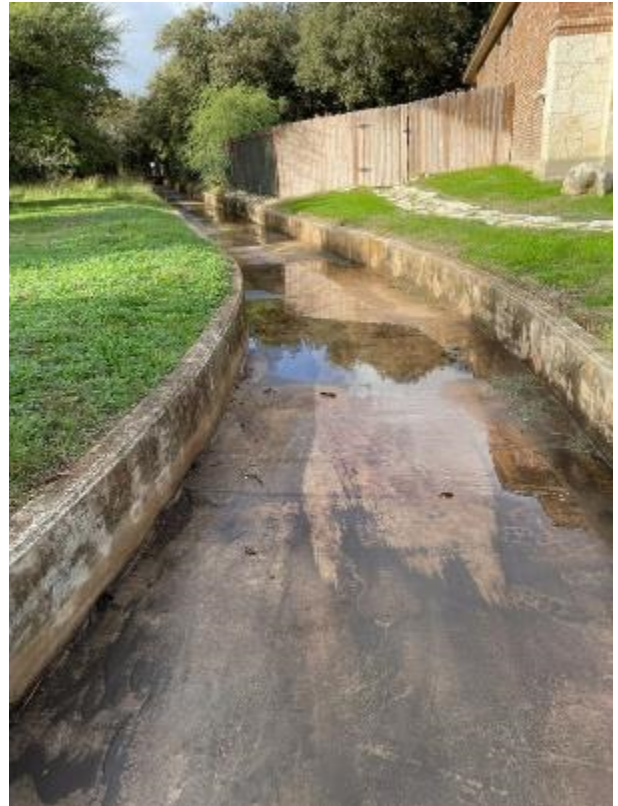
### Amber Creek Drainage Channel

Field Notes: Looks good.

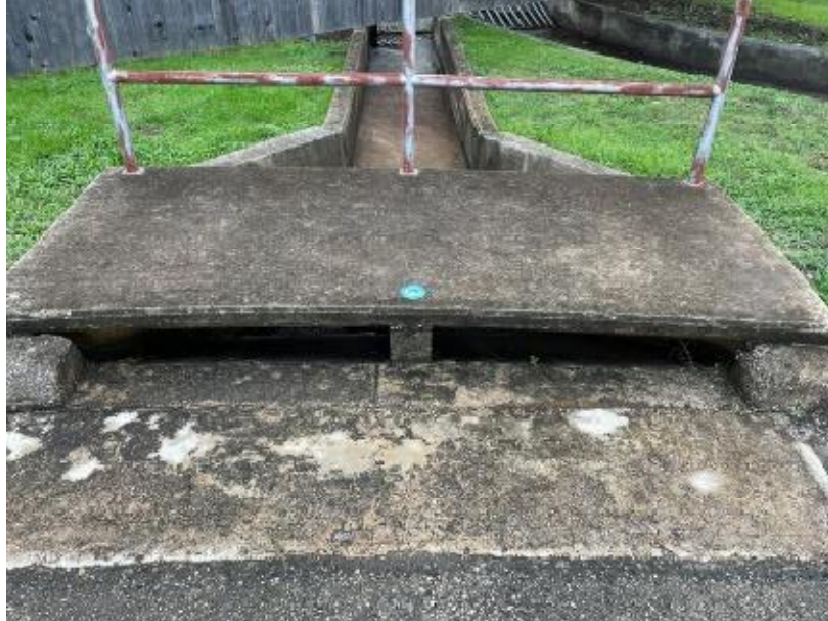
## Amber Creek Inlet

Field Notes: Looks good.

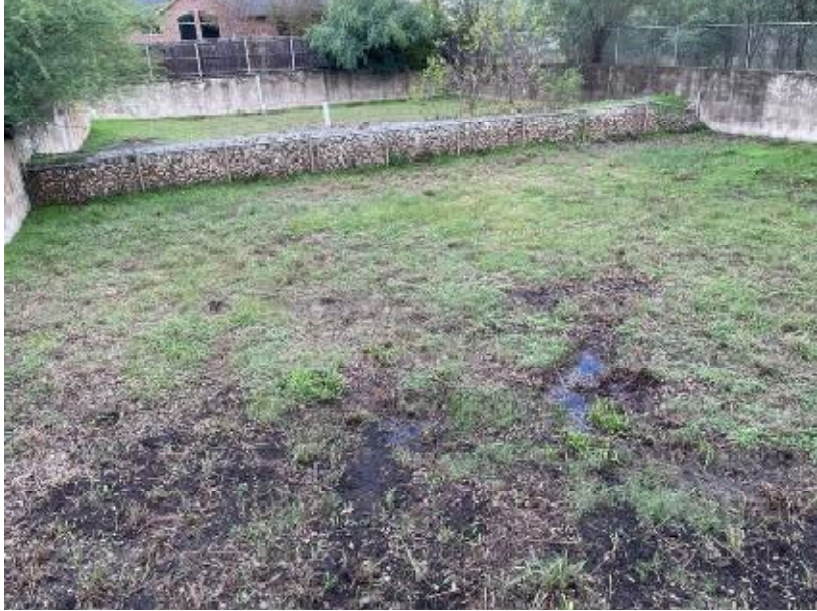
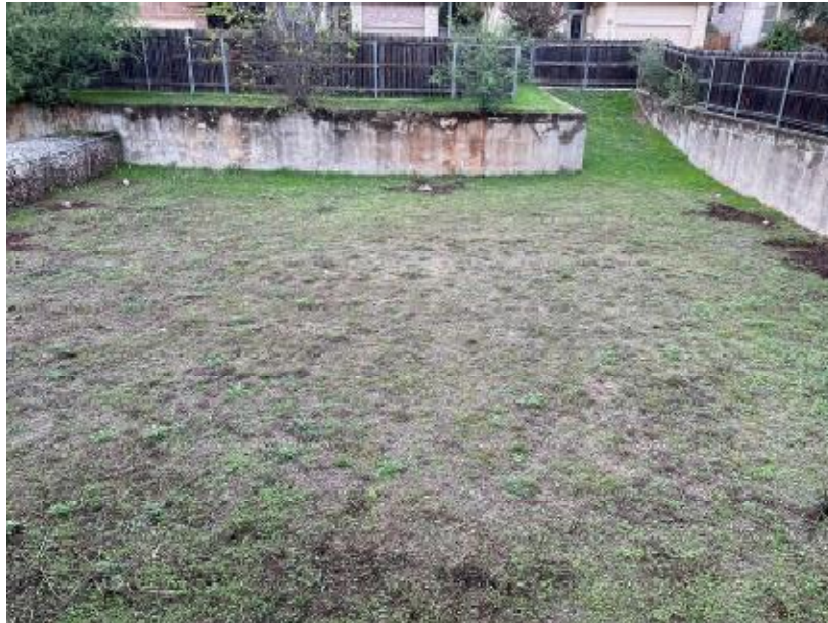
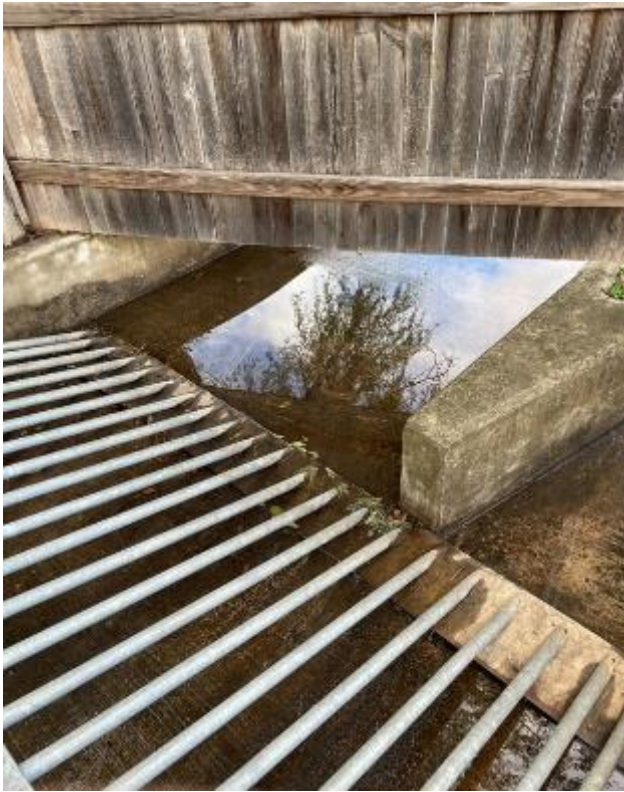
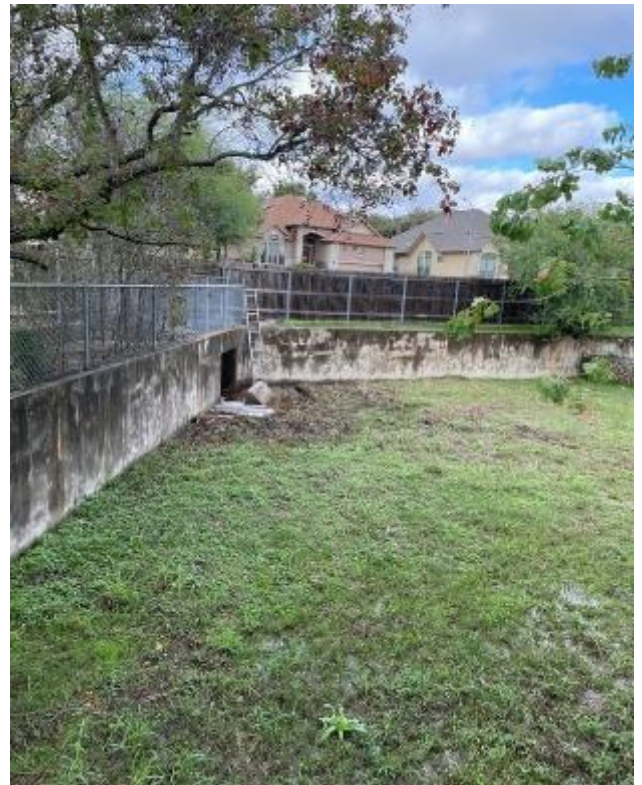
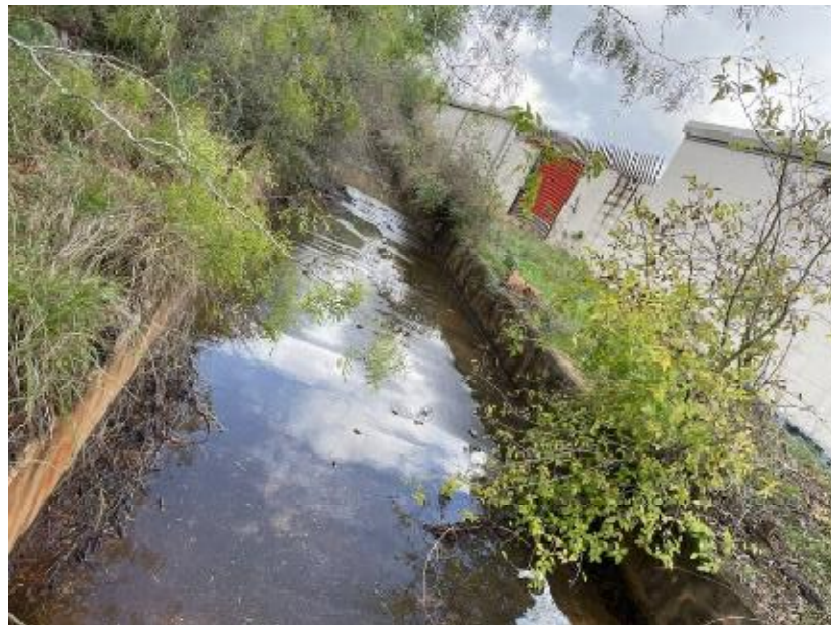
## Amber Creek PCD

Field Notes: Looks good. The downstream channel severely overgrown.

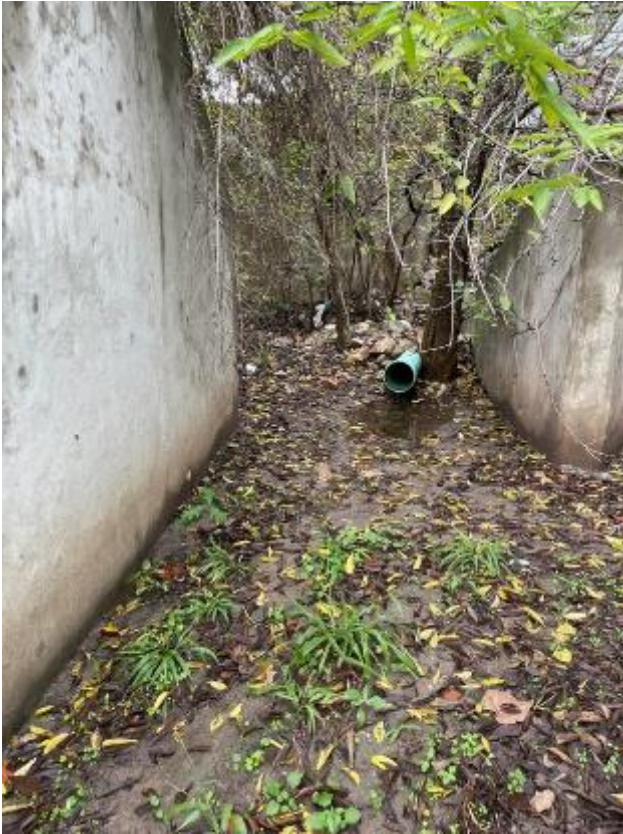
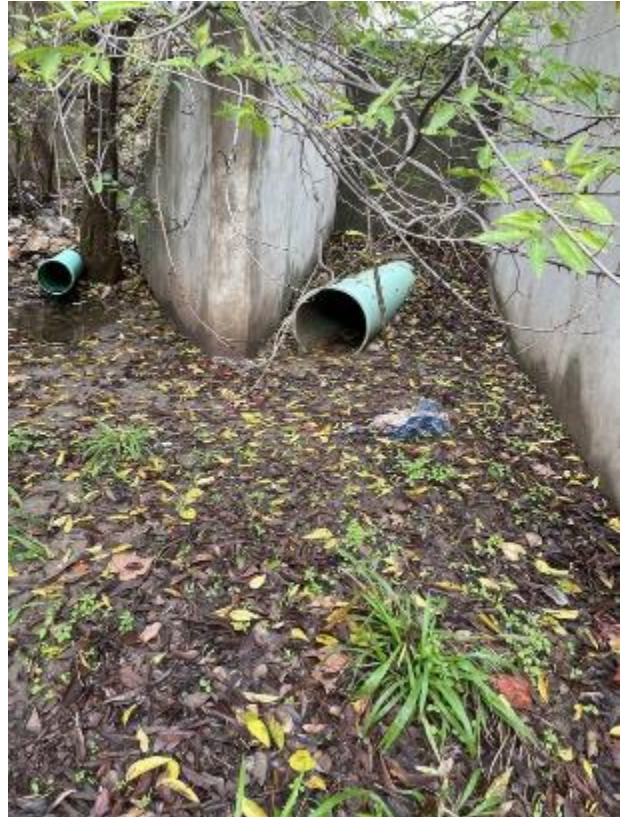
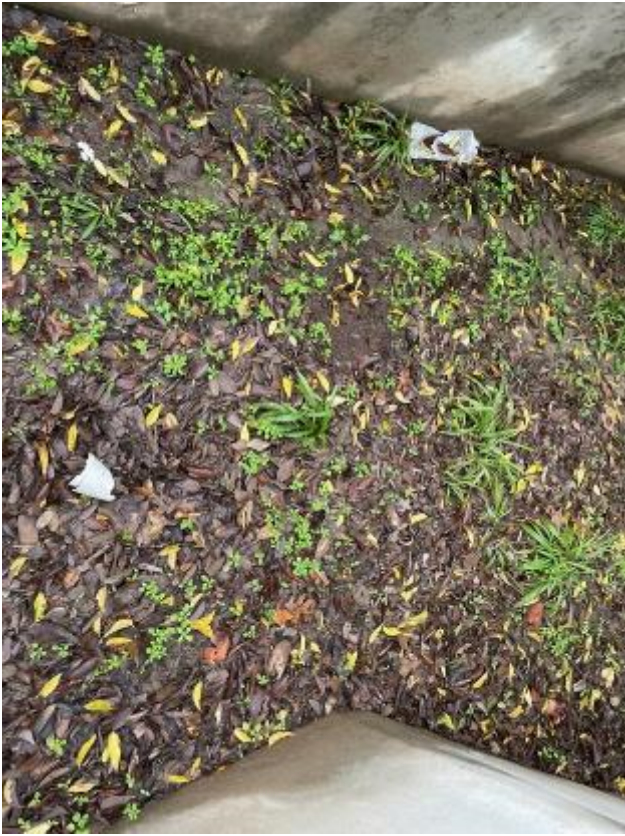
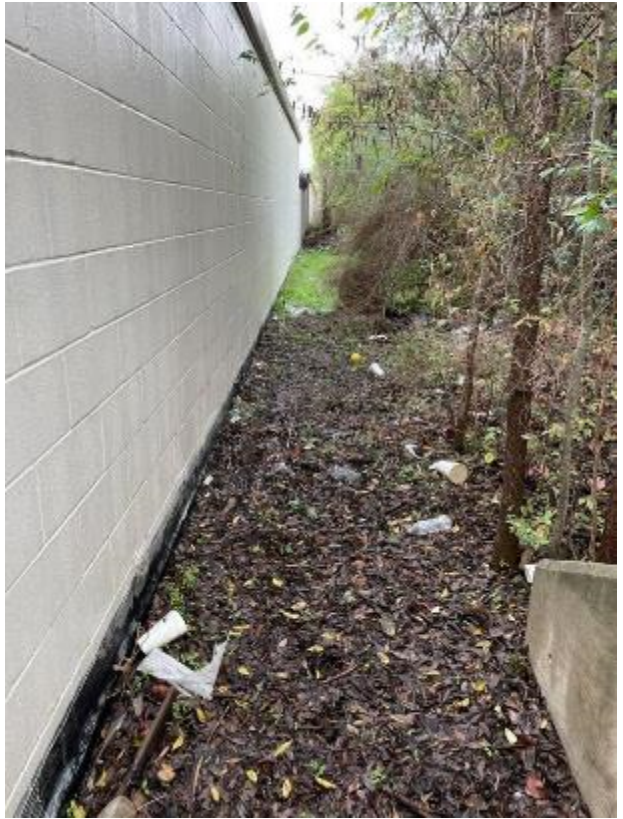
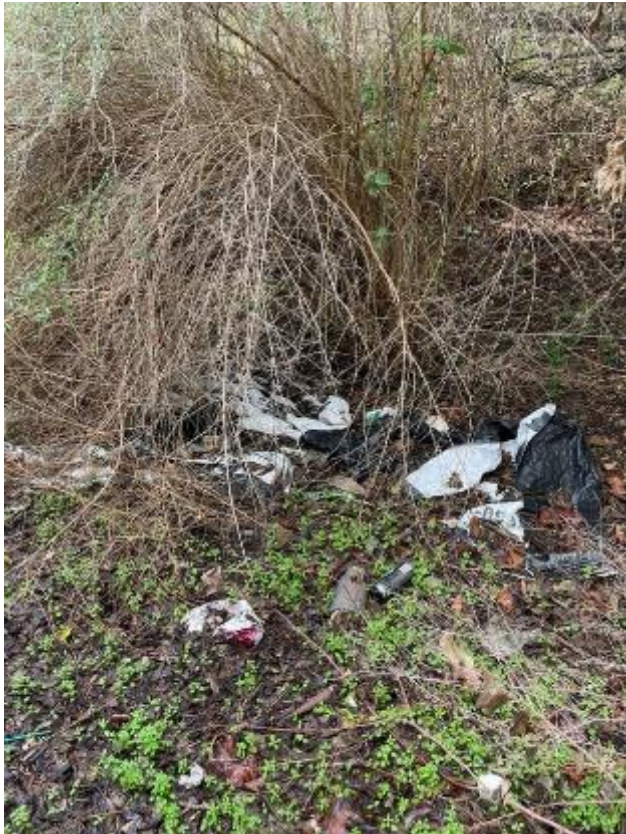
## Amber Creek Southern Outfall and Channel

Field Notes: Clean out sediment and debris from outfall. Appears there is homeless encampment in channel.

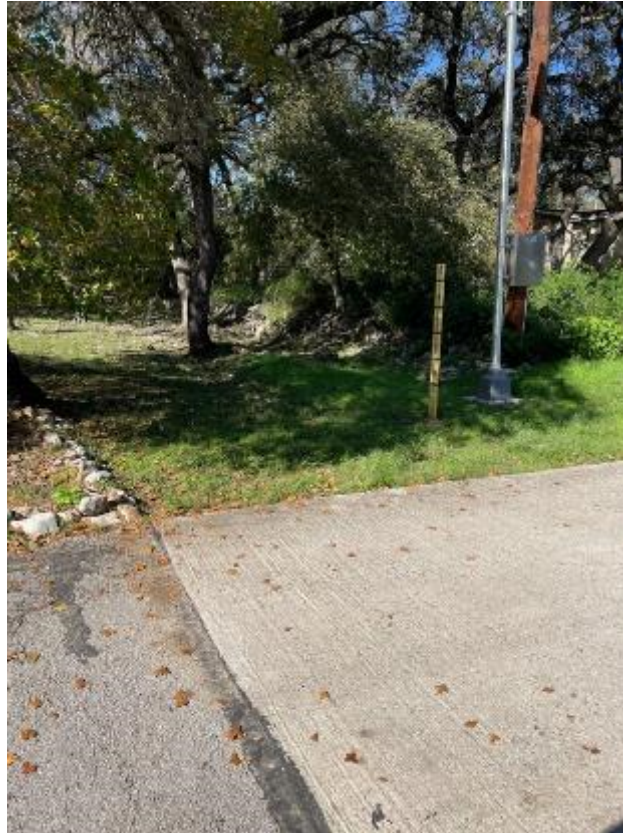
## Antelope Drive Low Water Crossing

Field Notes: Looks good.

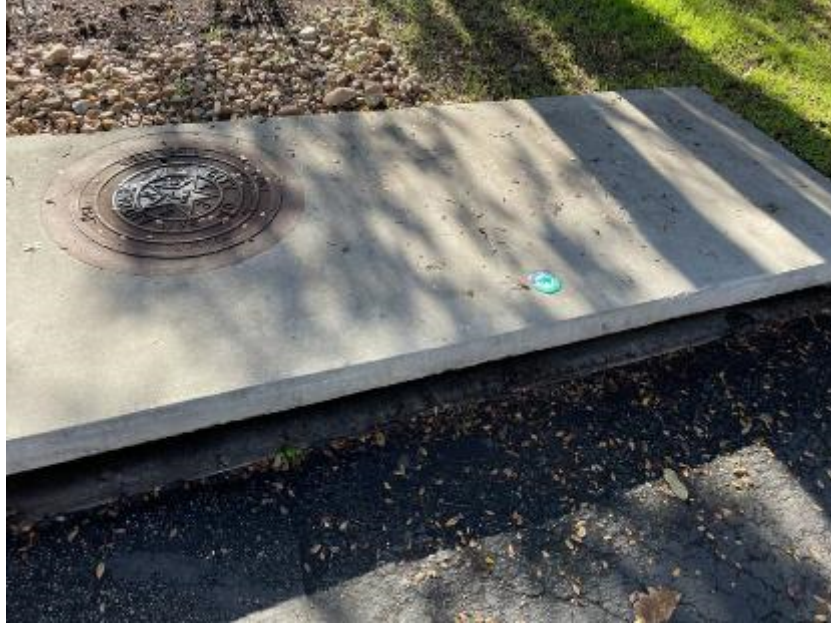
### ANT-I-1

Field Notes: Looks good.

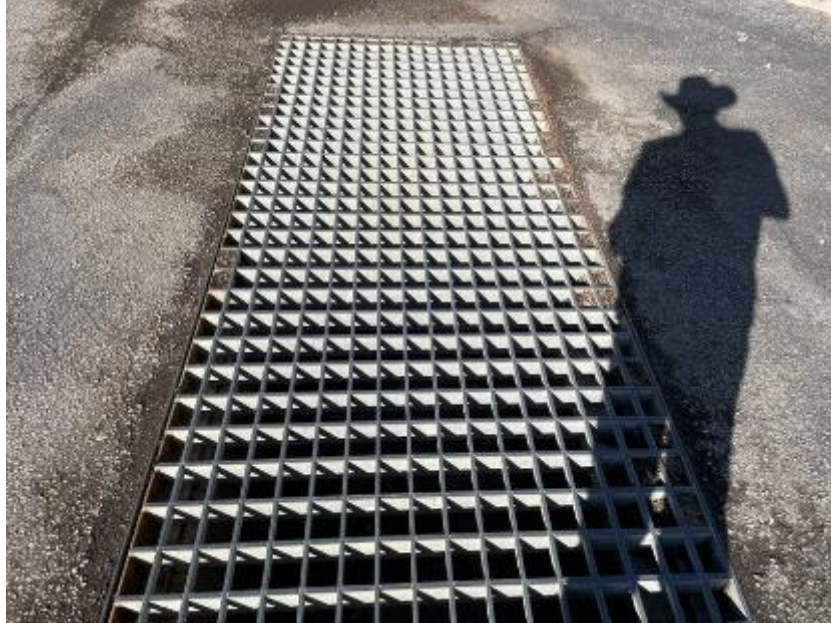
## ANT-I-2

Field Notes: Looks good.

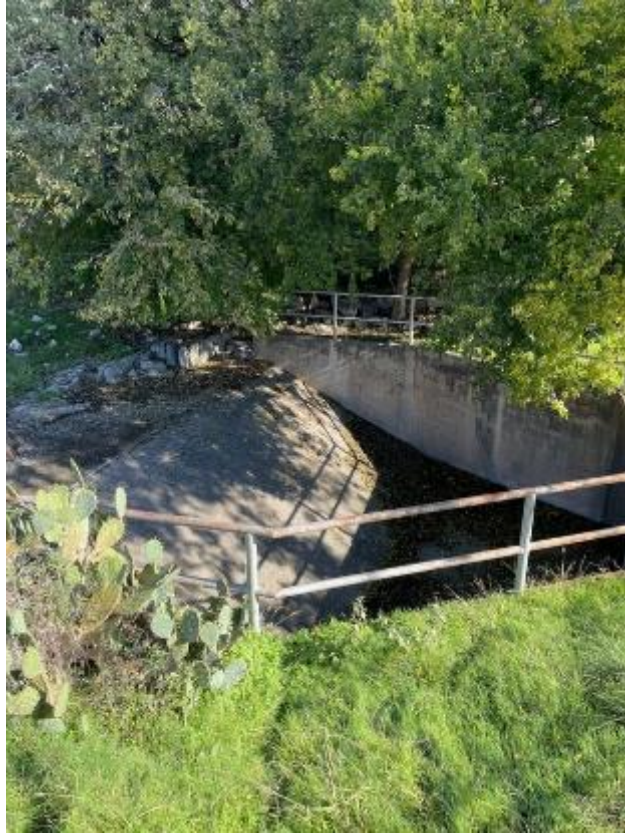
## Antler 2 Storm Sewer Pipe

Field Notes: Looks good.

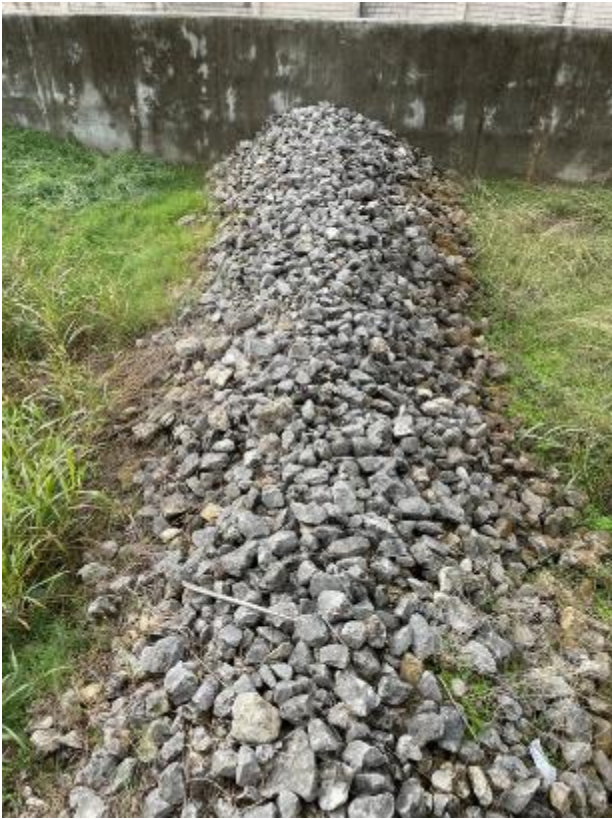
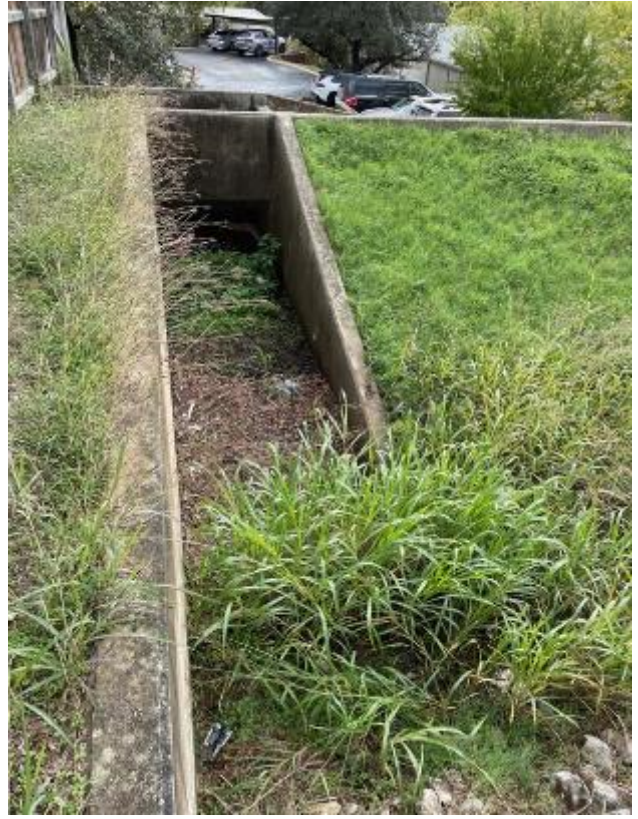
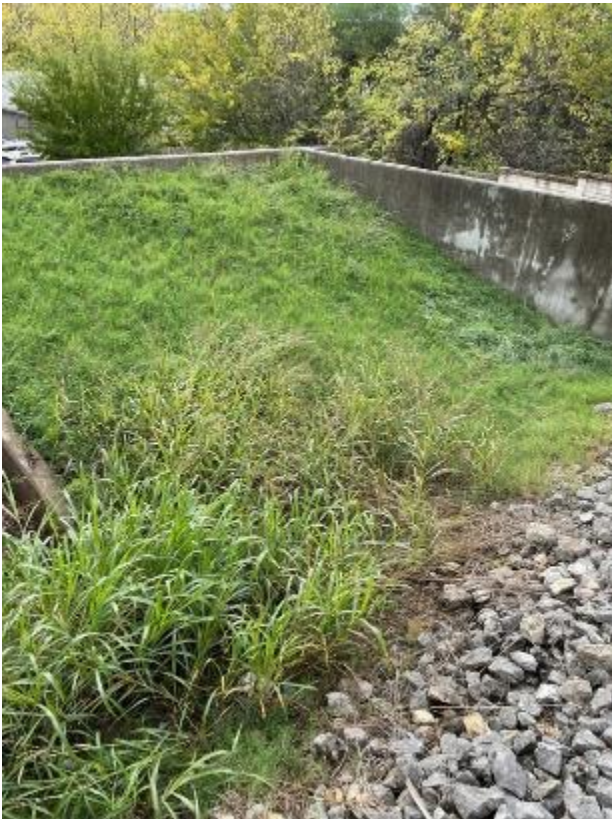
## Brookdale PCD

Field Notes: Mow and remove sediment. The fence needs repair.

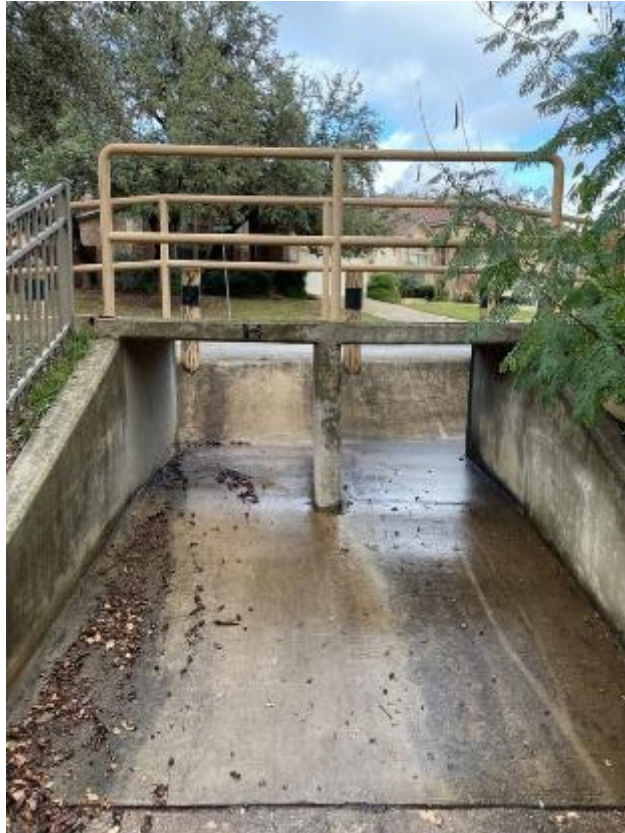
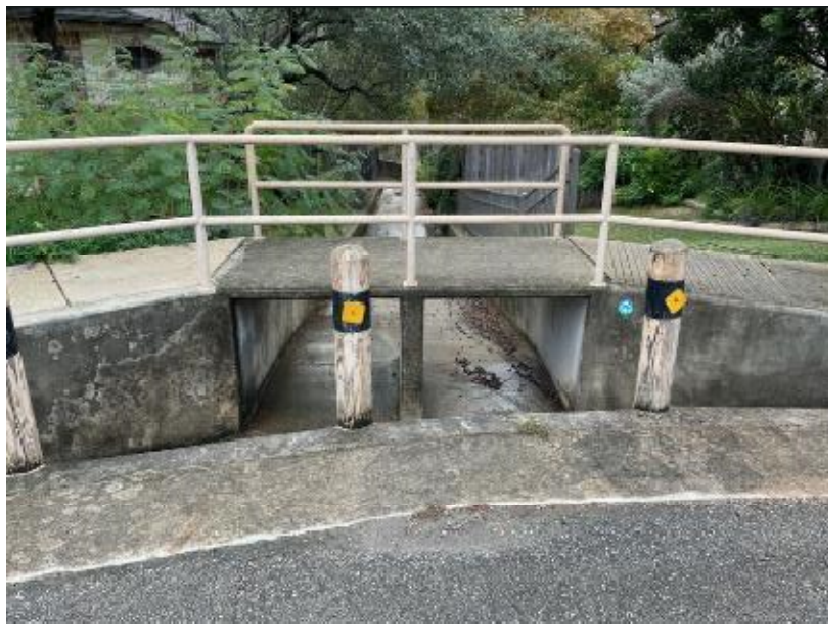
## Cascade Glen Sidewalk Drain

Field Notes: Looks good.

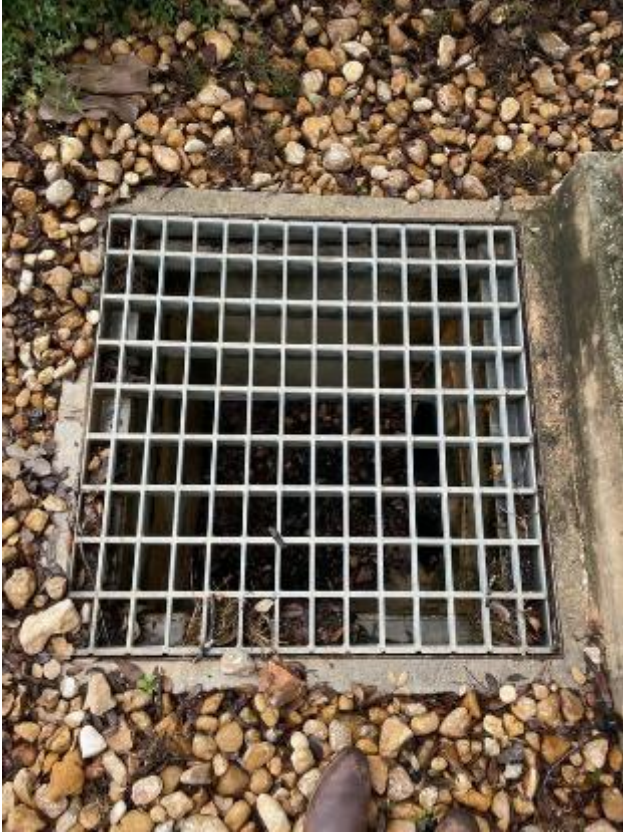
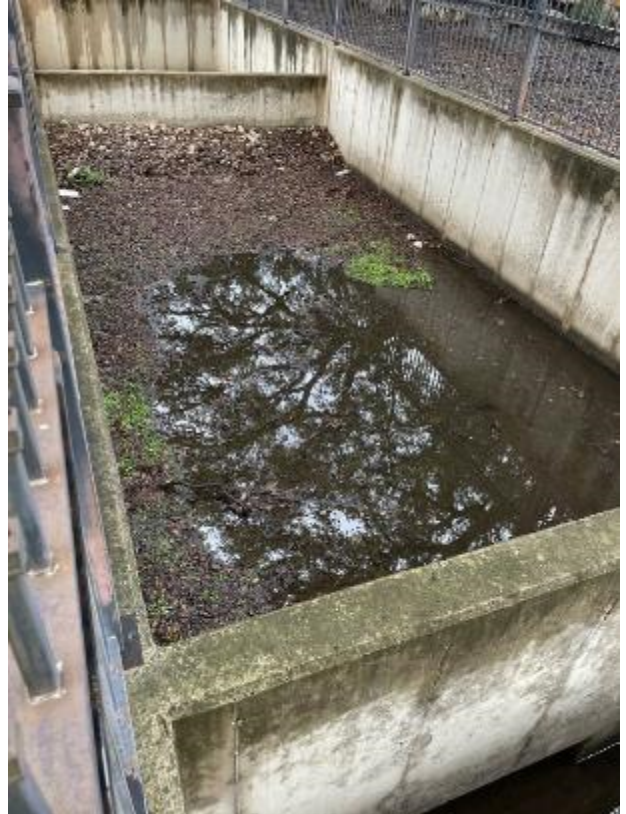
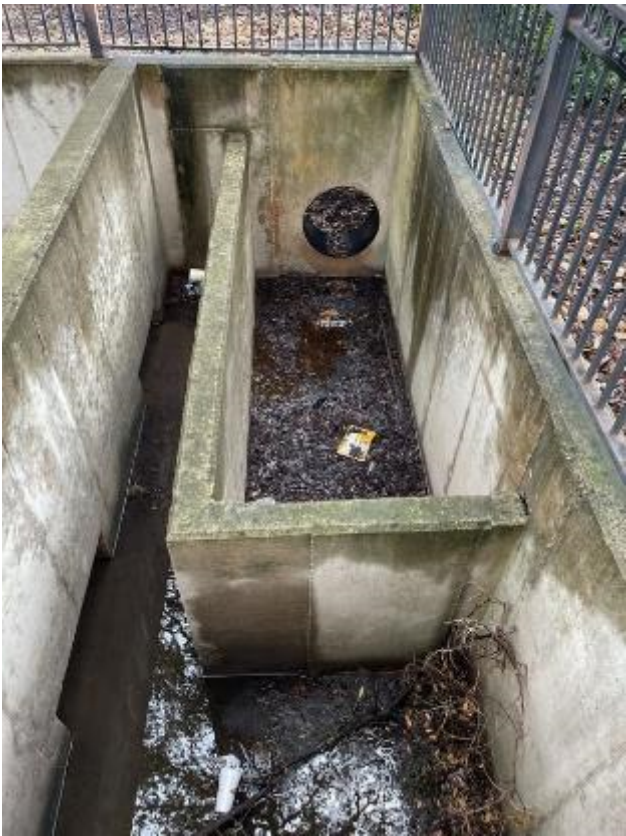
## Chandler Signs PCD in North Park Corporate Center Parking Lot

Field Notes: Clean out leaves and sediment in basin. Water vault is open,

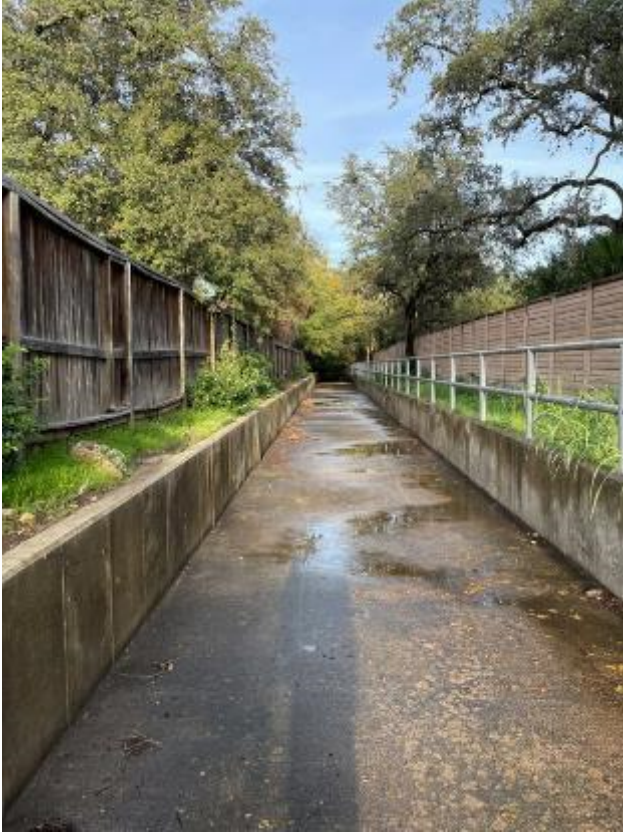
## Channel

Field Notes: Looks good.

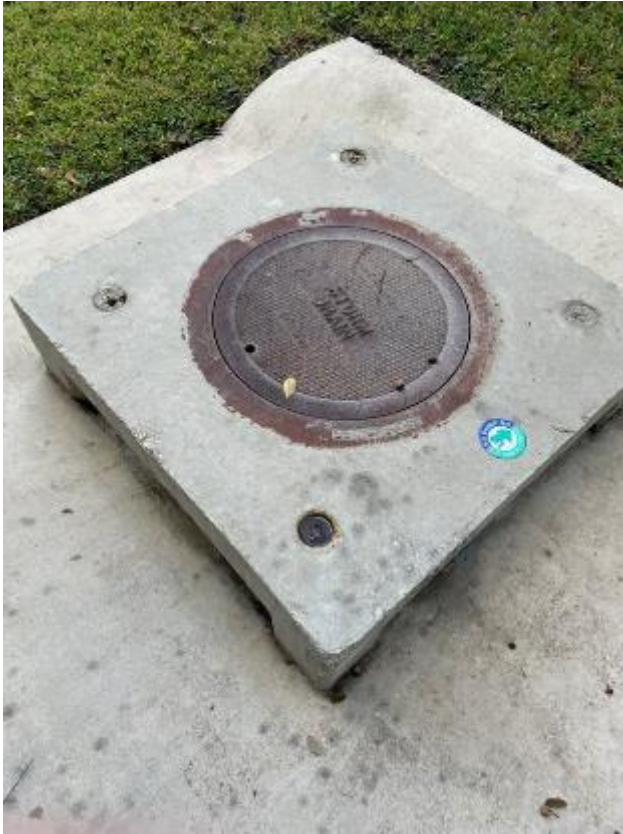
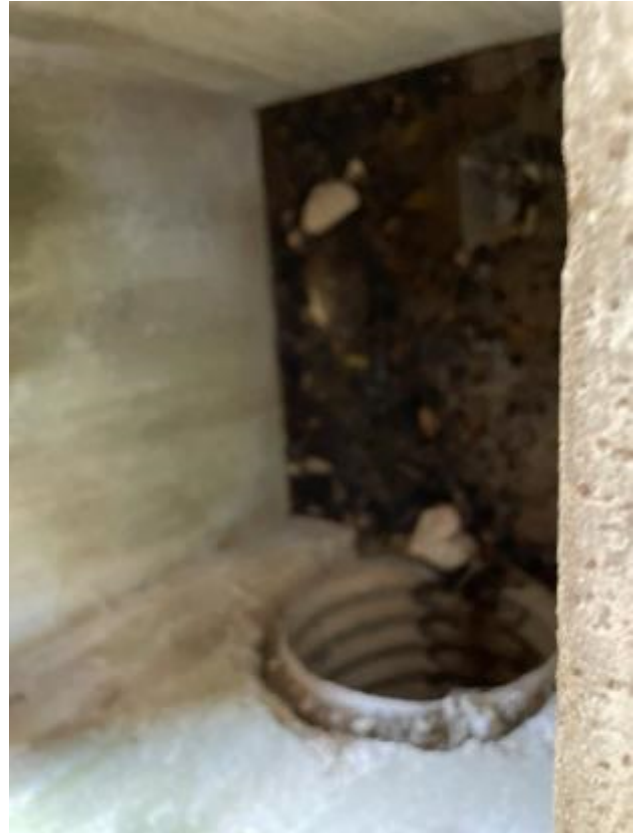
### Chula Vista Drive Inlet

Field Notes: Looks good.

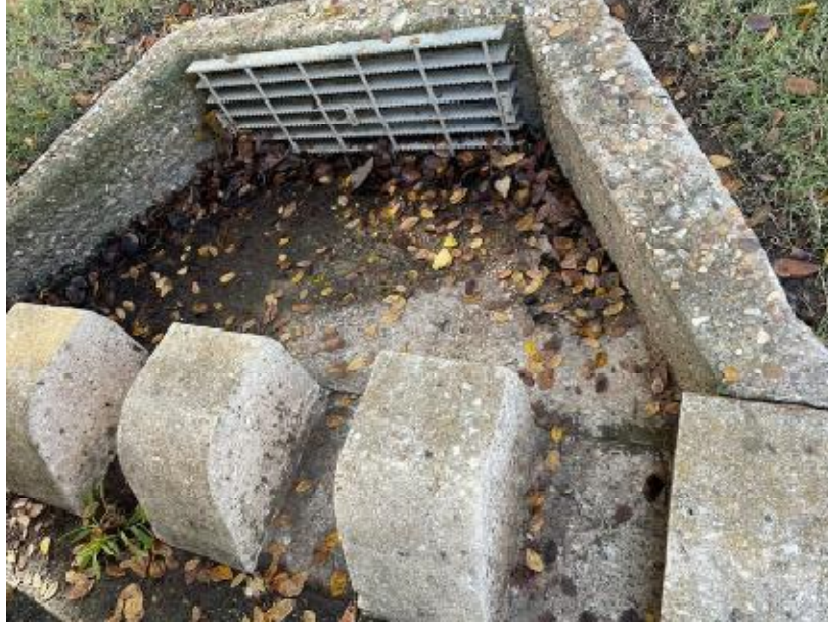
Field Notes: Looks good.

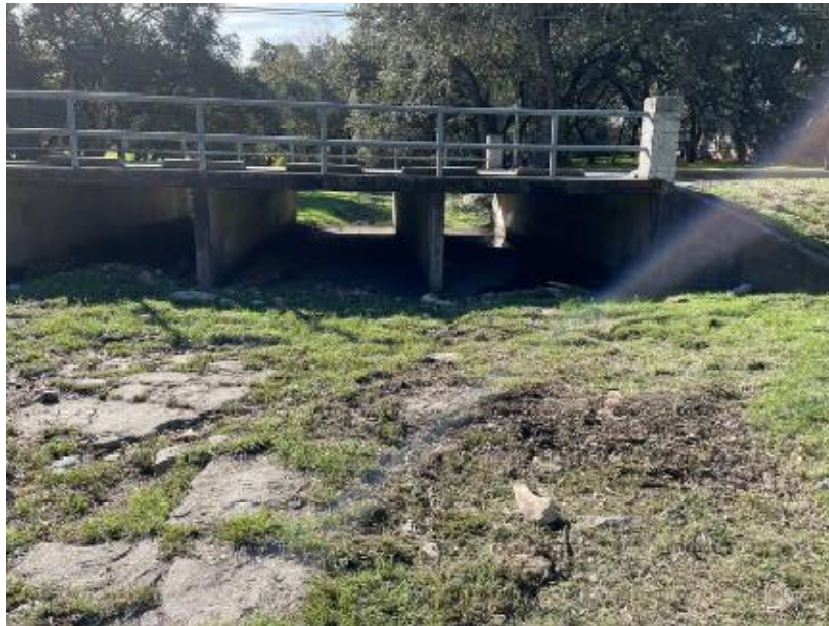
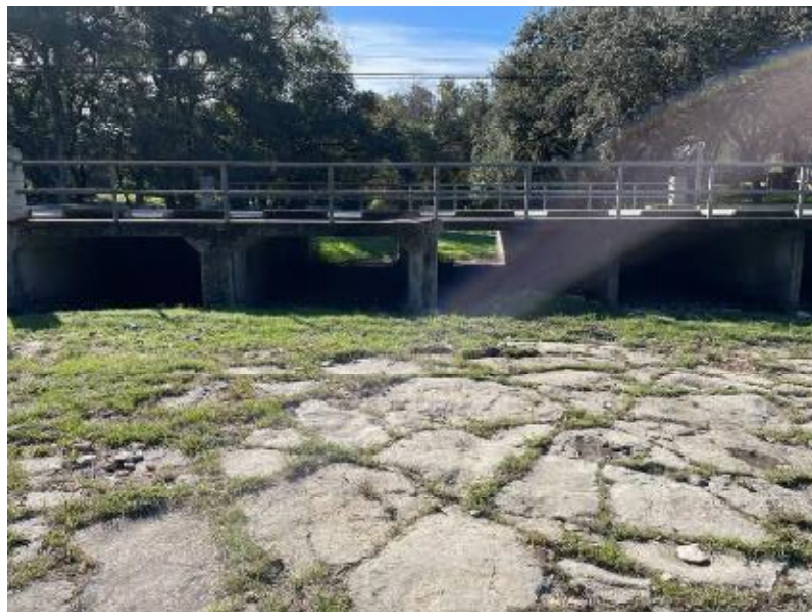
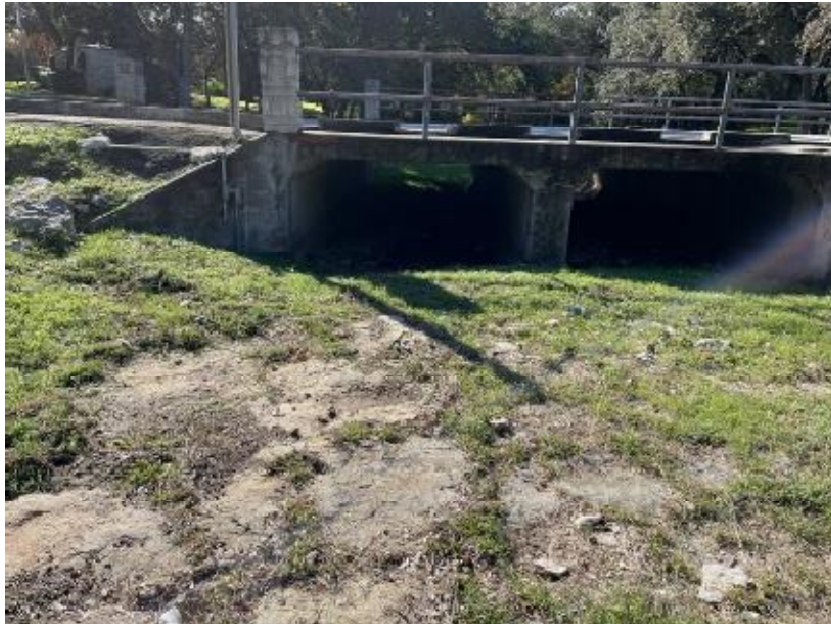
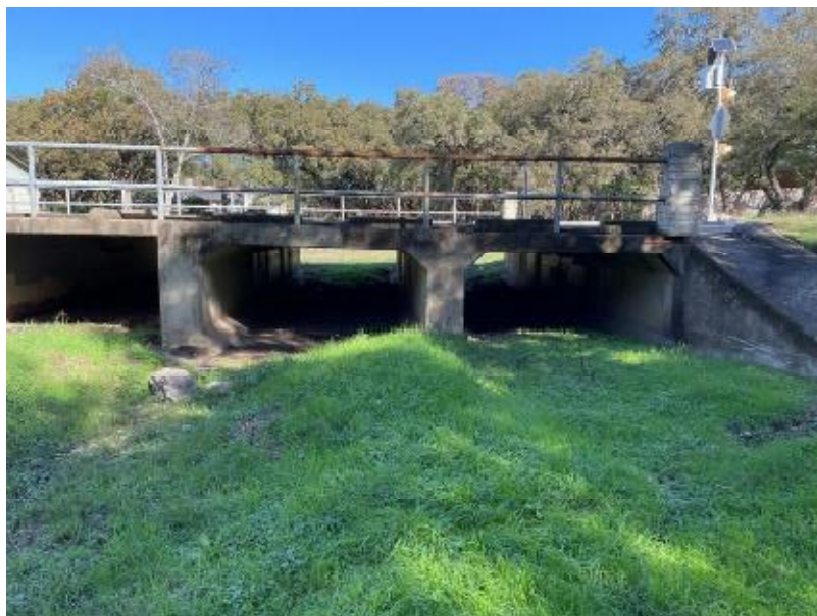
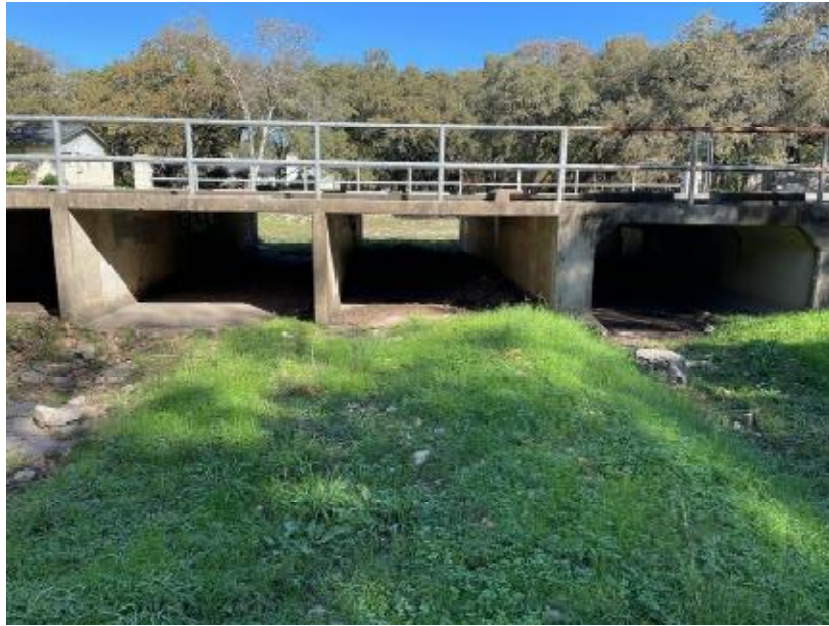
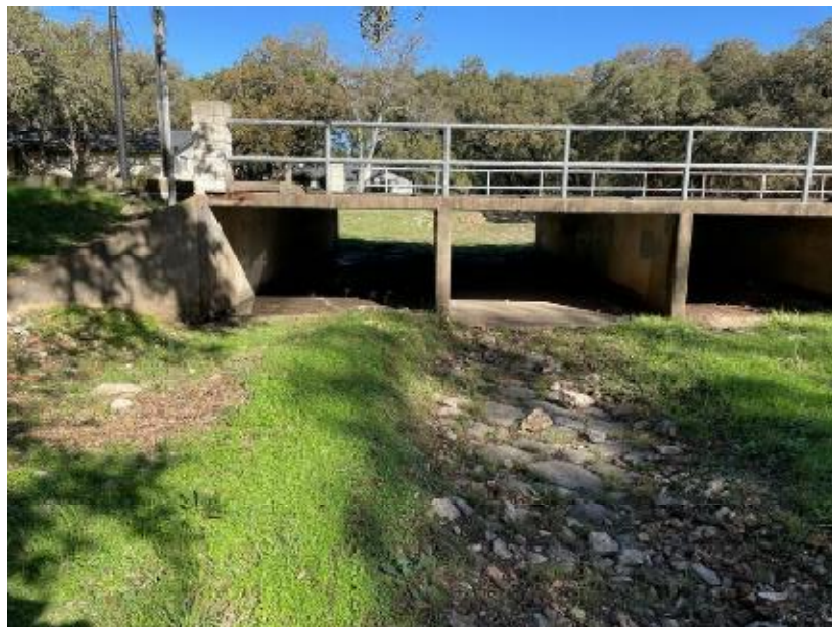
## Donella Crossing

Field Notes: Looks good monitor sediment buildup.

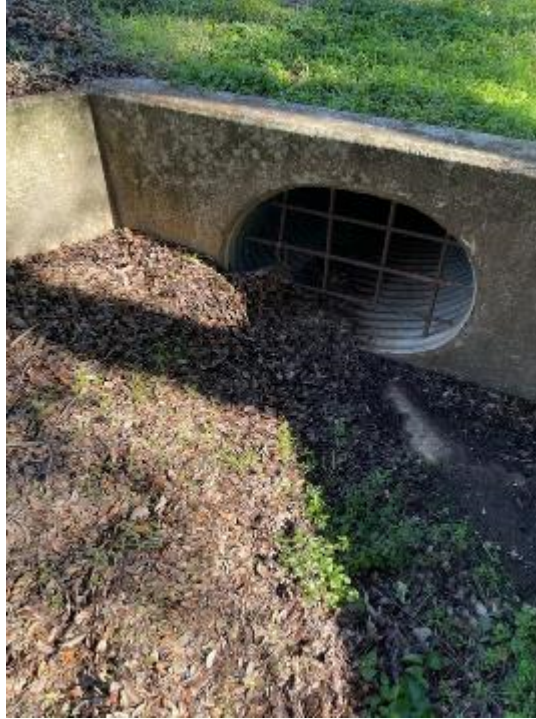
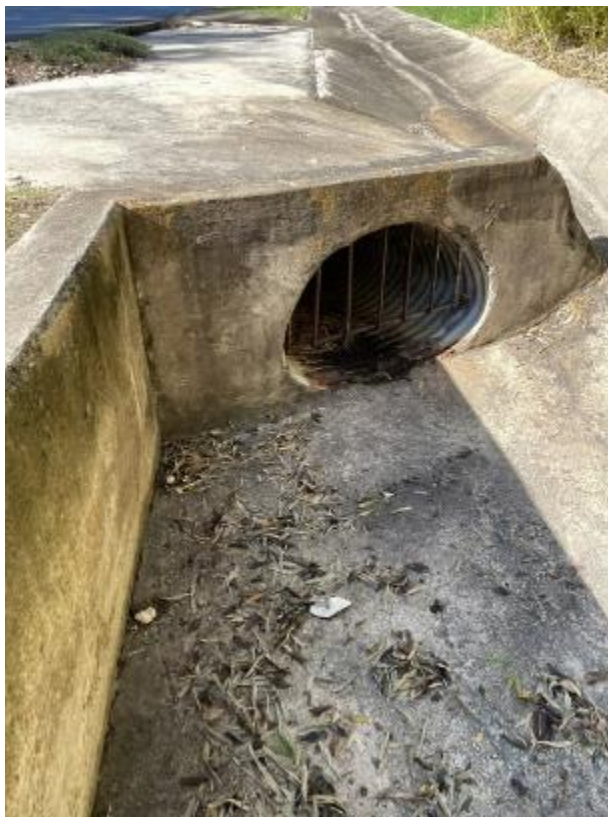
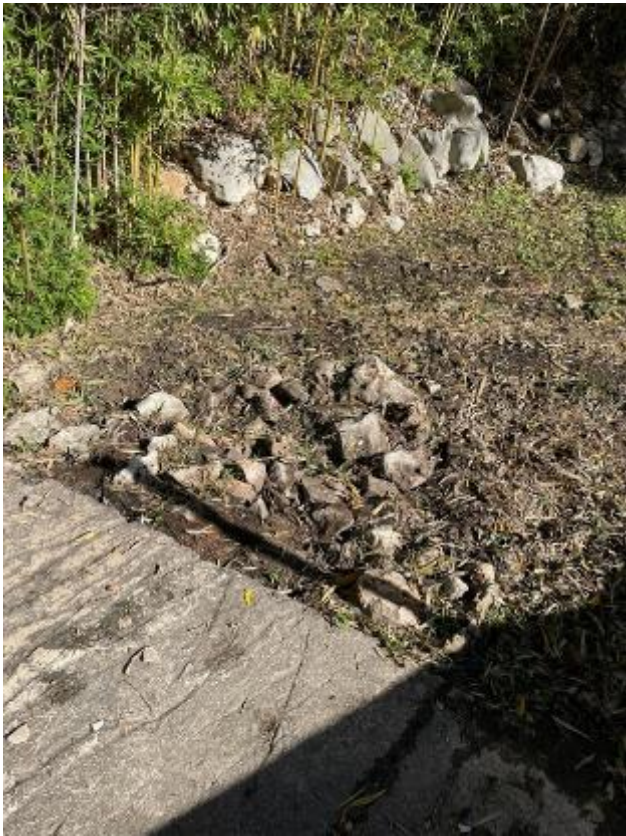
## Donella Culvert Crossing at Mustang Circle

Field Notes: Clear out entrance of leaves. Downstream looks good, pipe clear.

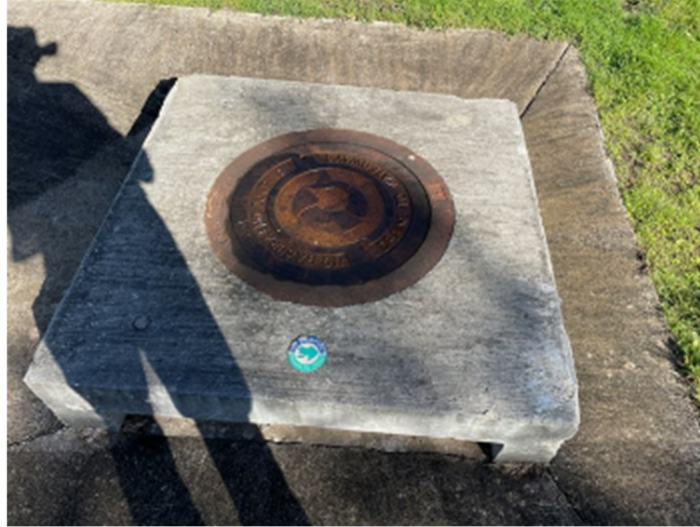
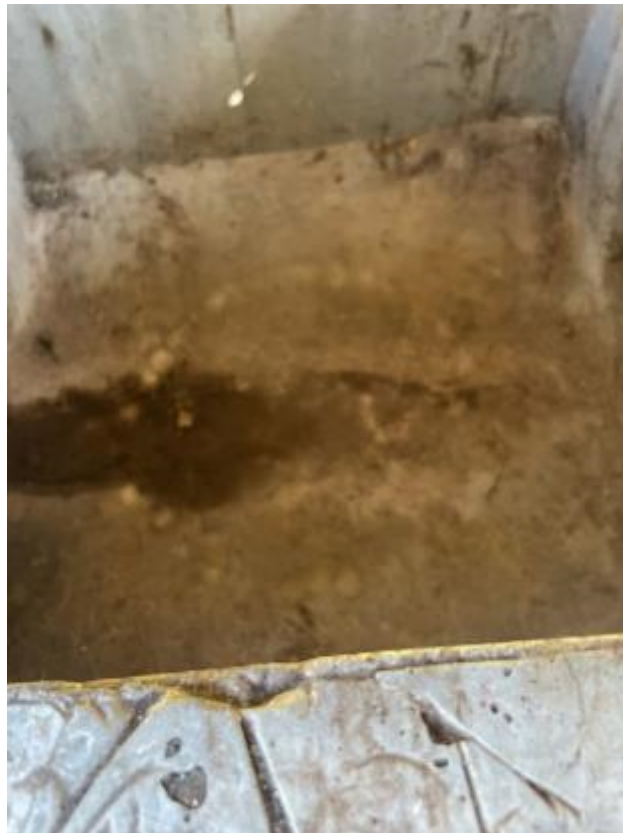
### Donella Inlet Box

Field Notes: Looks good.

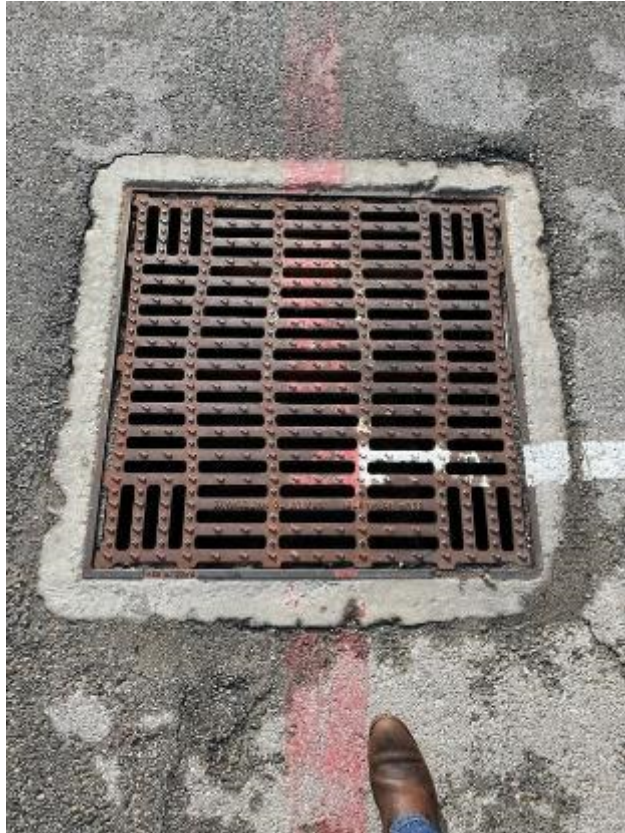
## Drash Rear Parking Lot Inlet

Field Notes: Looks good.

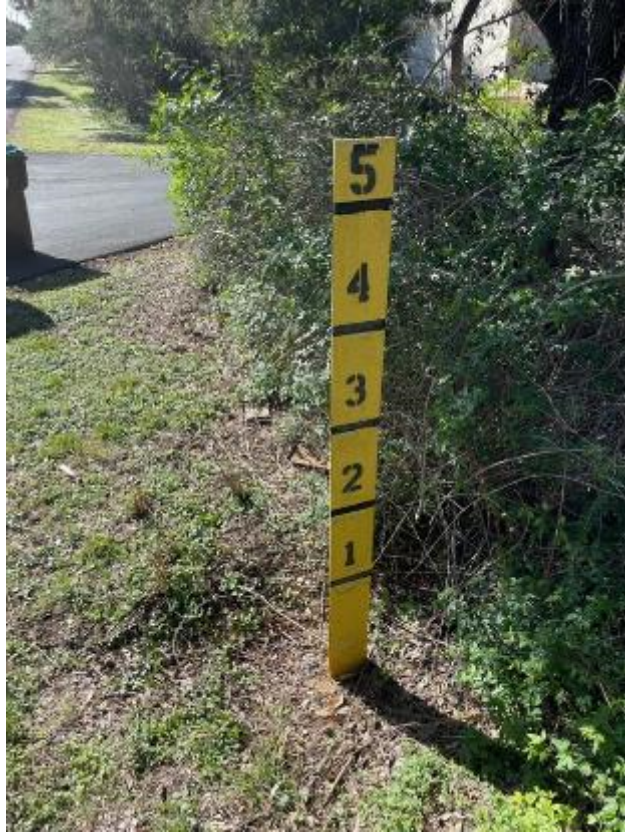
## El Cerrito Circle Low Water Crossing

Field Notes: Looks good.

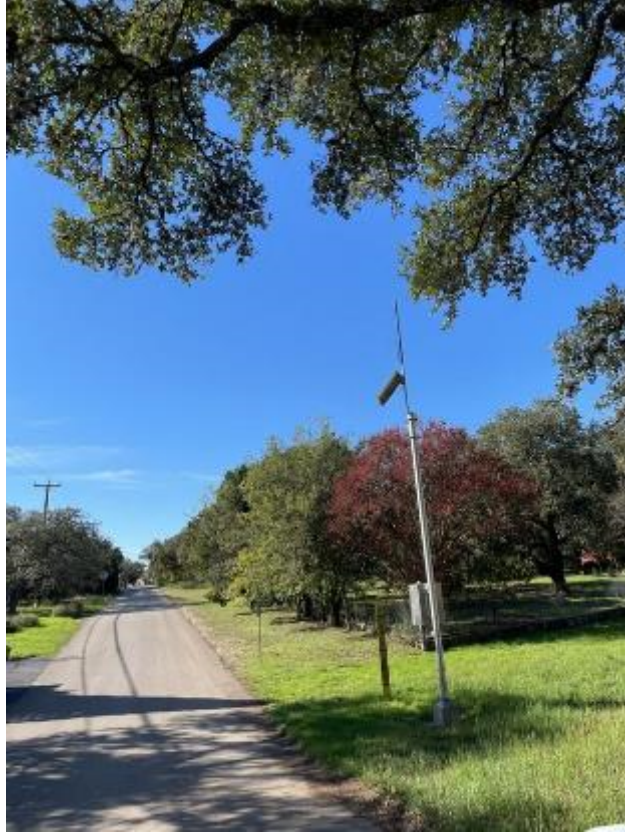
## El Cerrito Low Water Crossing

Field Notes: Looks good.

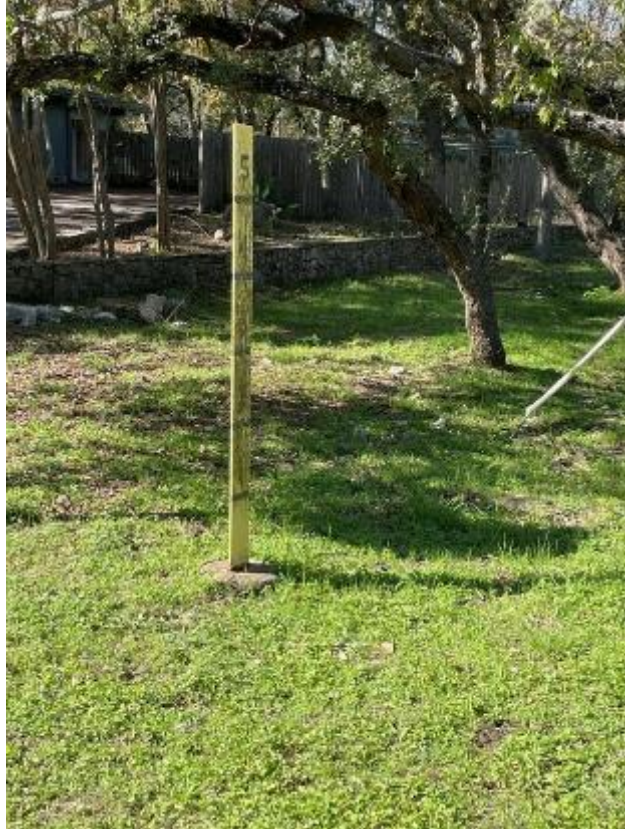
## El Cerrito Low Water Crossing West

Field Notes: Looks good, may need to clear markings of mud.

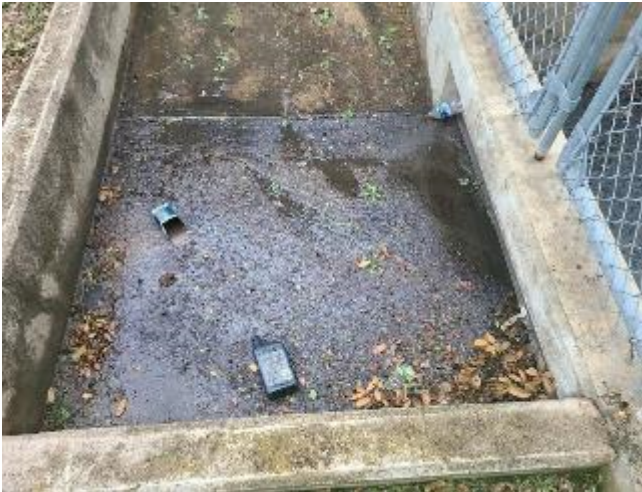
## Express Lube PCD

Field Notes: Rainfall event morning of inspection. Basin is wet but doesn't have any lingering water. The basin does have overgrown grass as well as illicit discharge in form of transmission fluid. Recommended to trim grass and remove all trash and illicit items from pond area.
