# TOWN OF HOLLYWOOD PARK, TX

2023 Winter Inspection

# HOLLYWOOD PARK 2023 WINTER INSPECTION REPORT

**Subject:** Annual Municipal Separate Storm Sewer System (MS4) Inspection

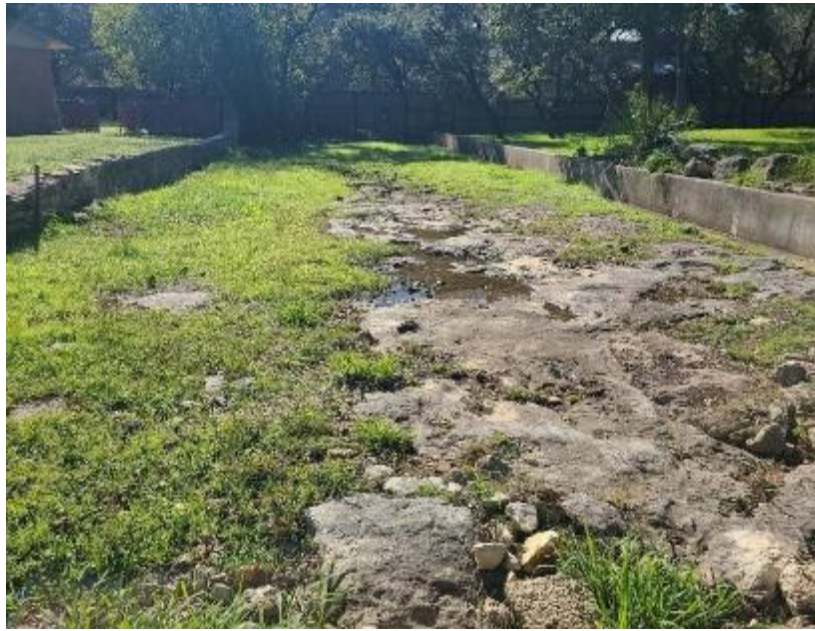
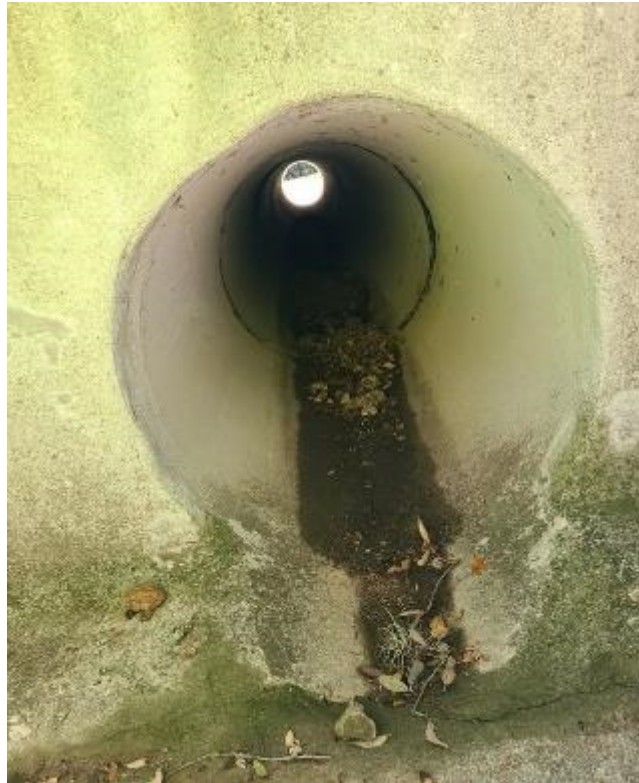
## Fleetwood Crossing

Field Notes: Pipes in good condition. There is a buildup of sediment in the middle pipe which has caused a pooling of backflow water. Recommended to remove sediment to allow proper flow.

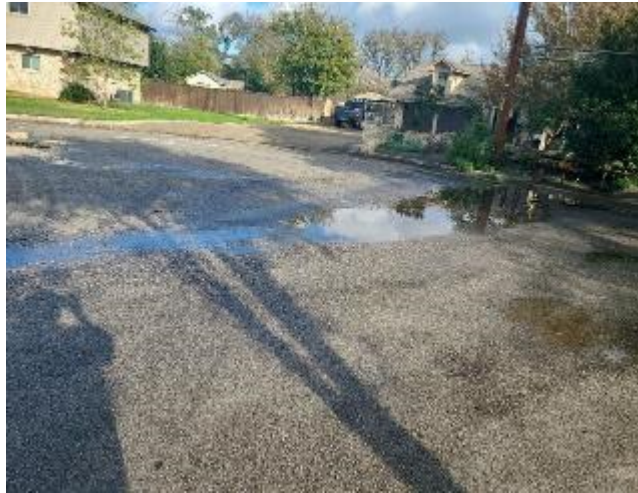
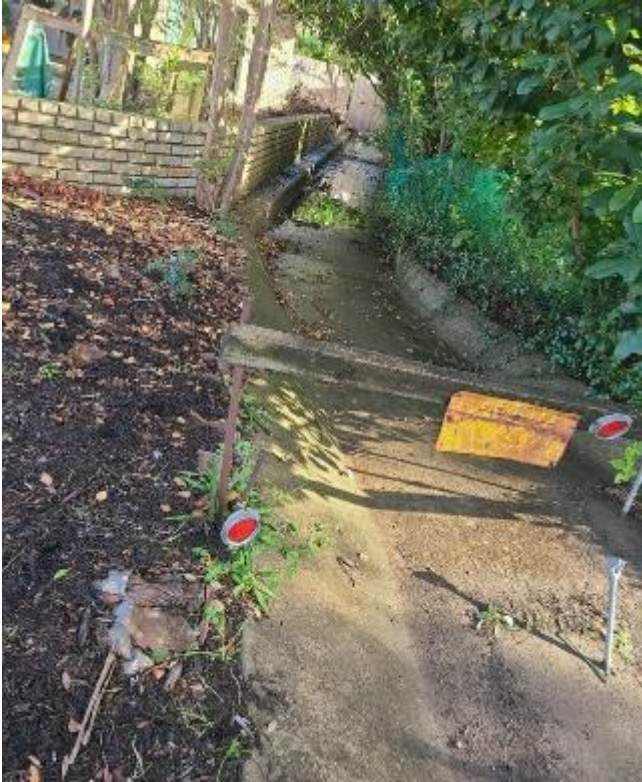
## Garrapata Storm Water Inflow

Field Notes: Rain event this morning. Water pools in front of channel. Channel Inlet need vegetation trimmed.

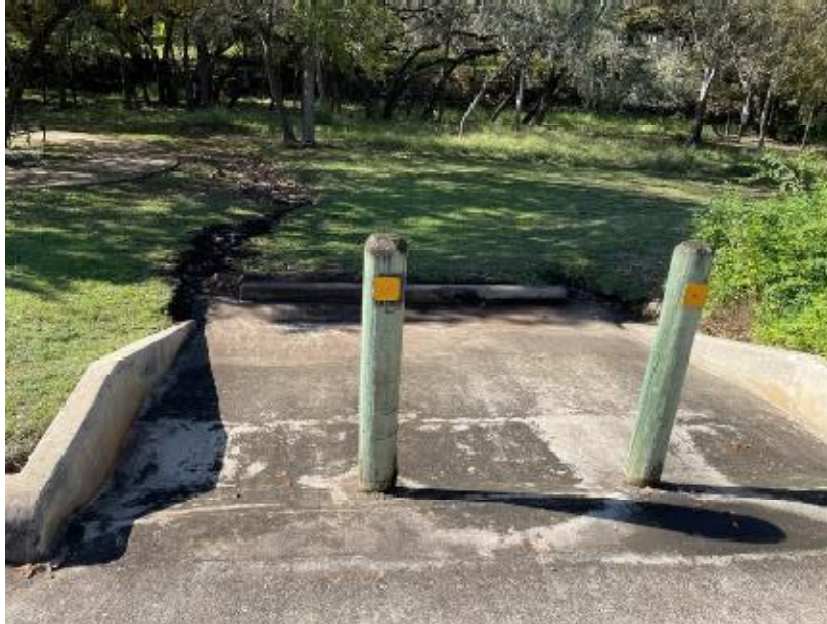
Field Notes: Looks good.

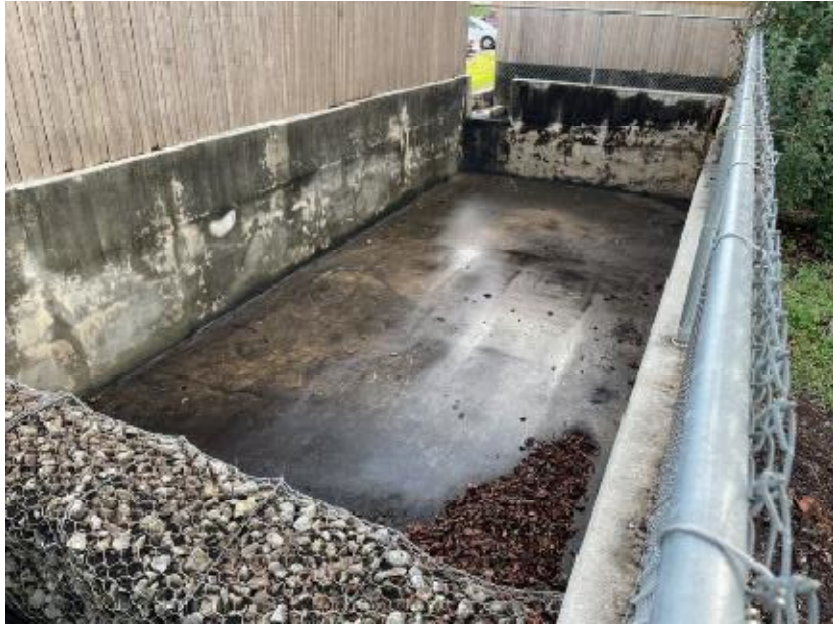
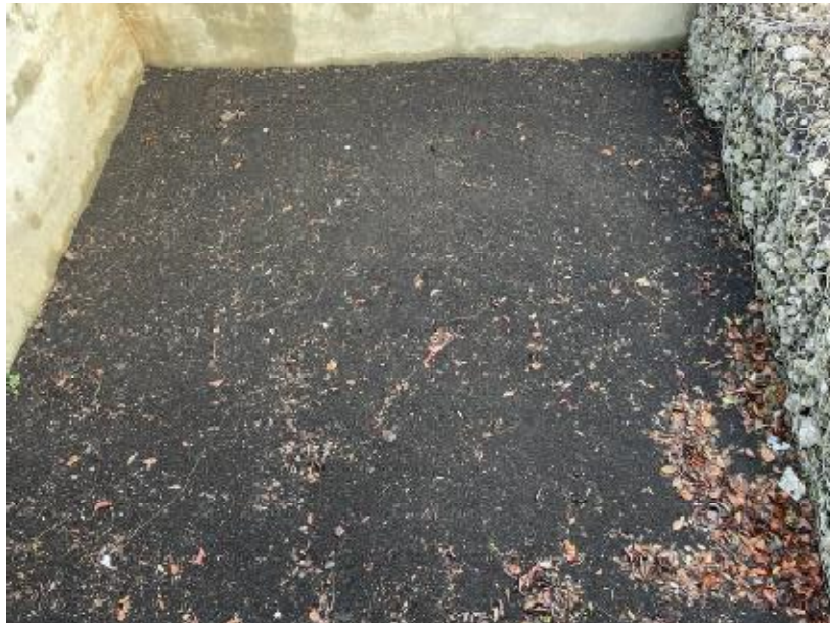
## Holiday Inn PCD

Field Notes: Looks good.

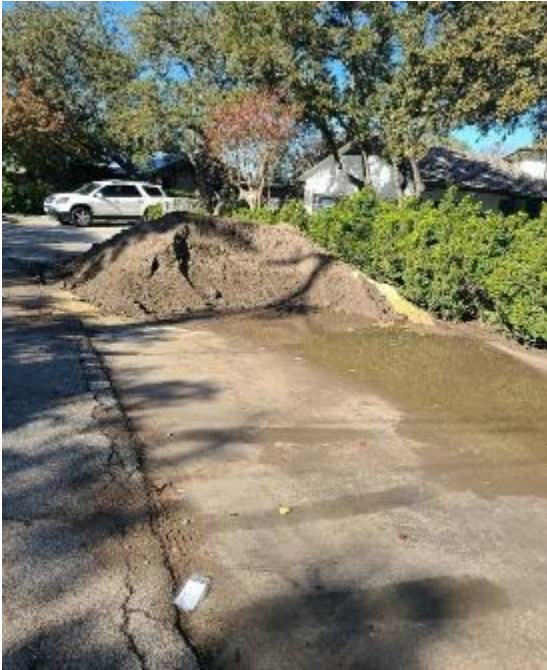
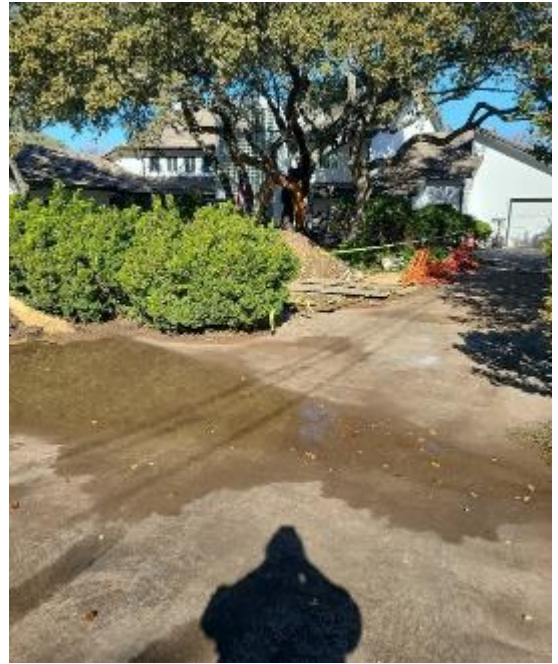
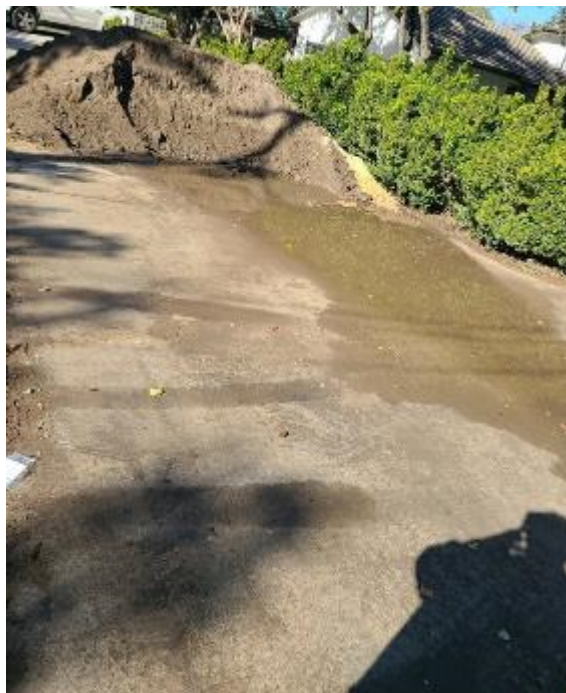
## Home Construction

Field Notes: Keep an eye on site of construction. Watch for any residue getting into stormwater. Water currently pools around pile of dirt.

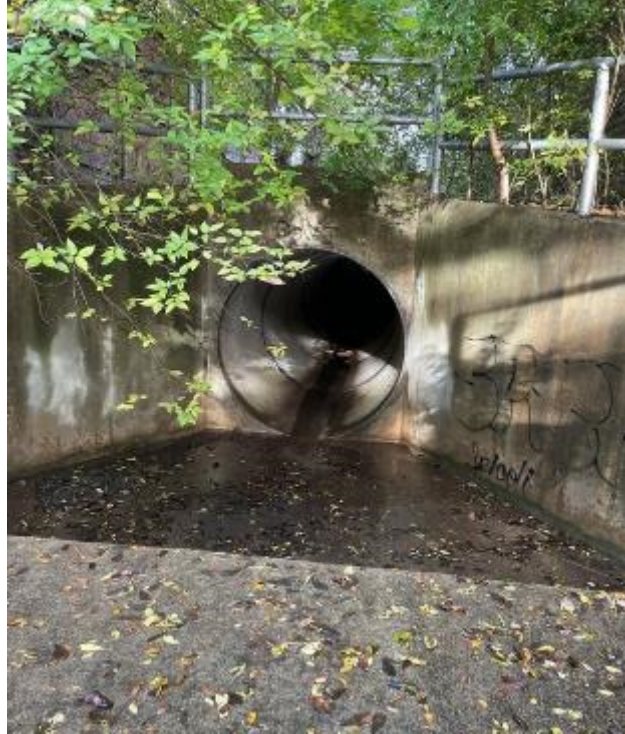
## Large Channel Drain Inlet

Field Notes: Looks good.

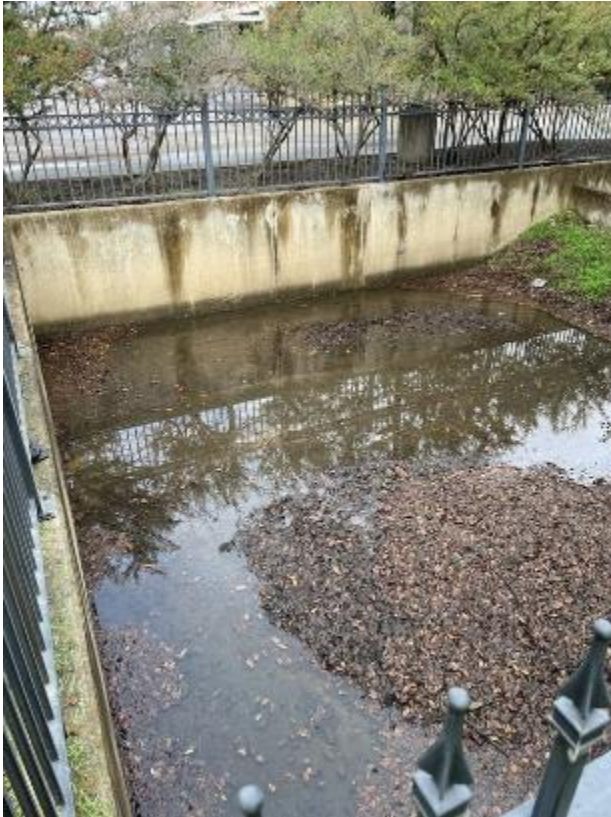
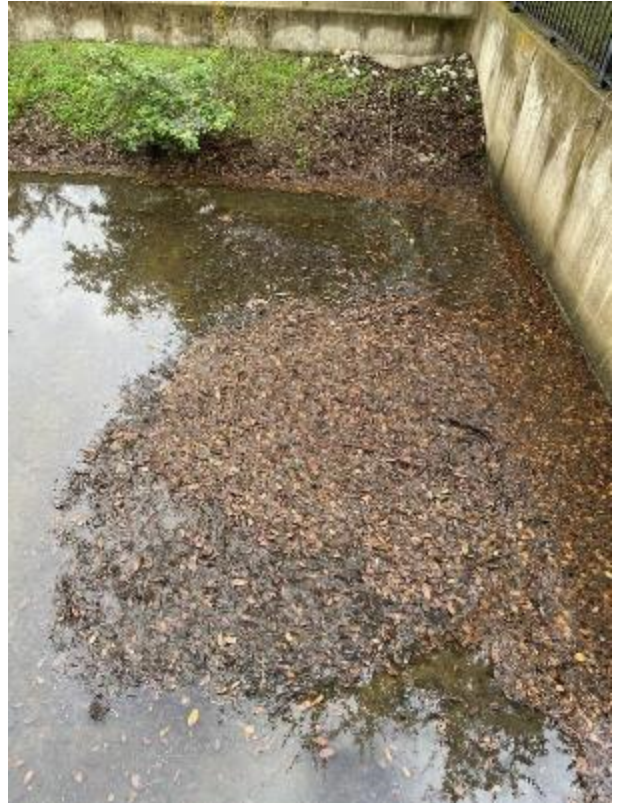
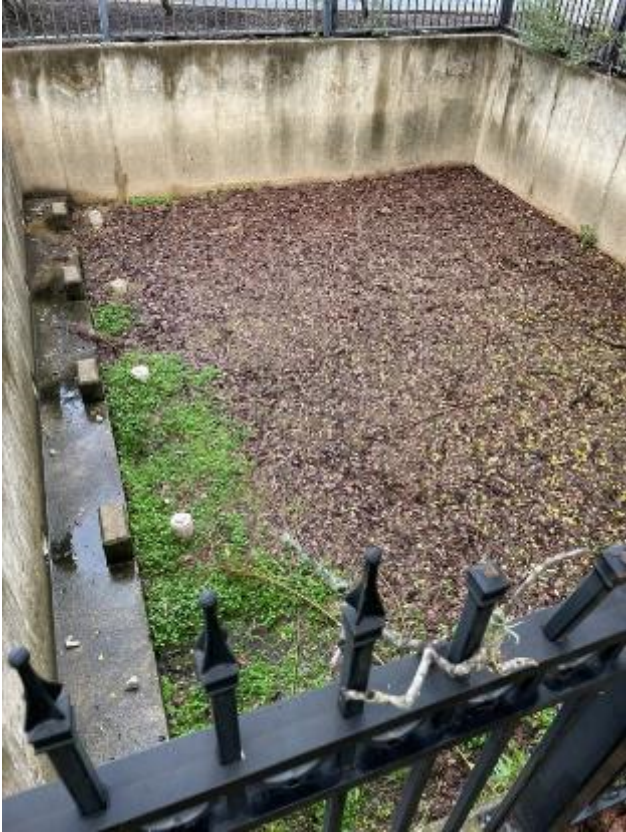
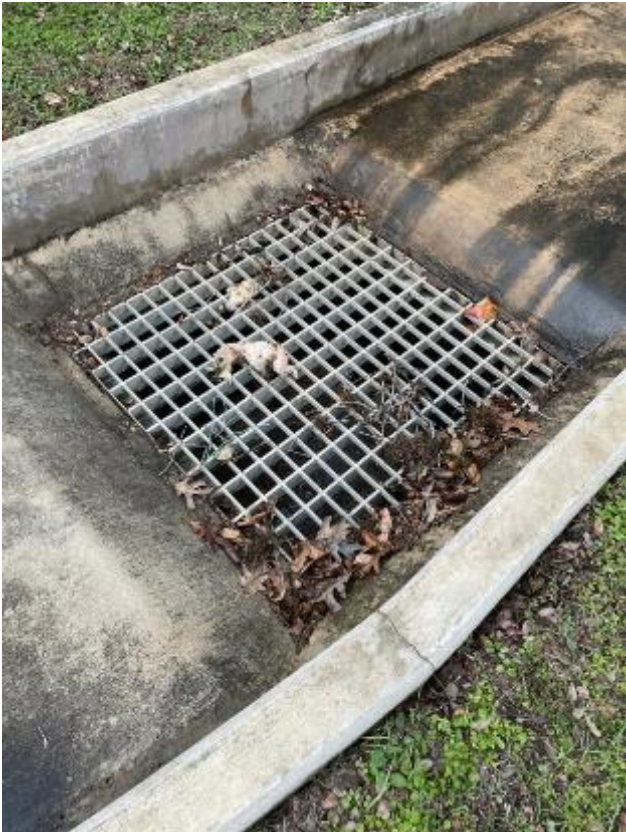
## Marriott Global Reservation PCD

Field Notes: Clean trash from grate, remove leaves and sediment from basin.

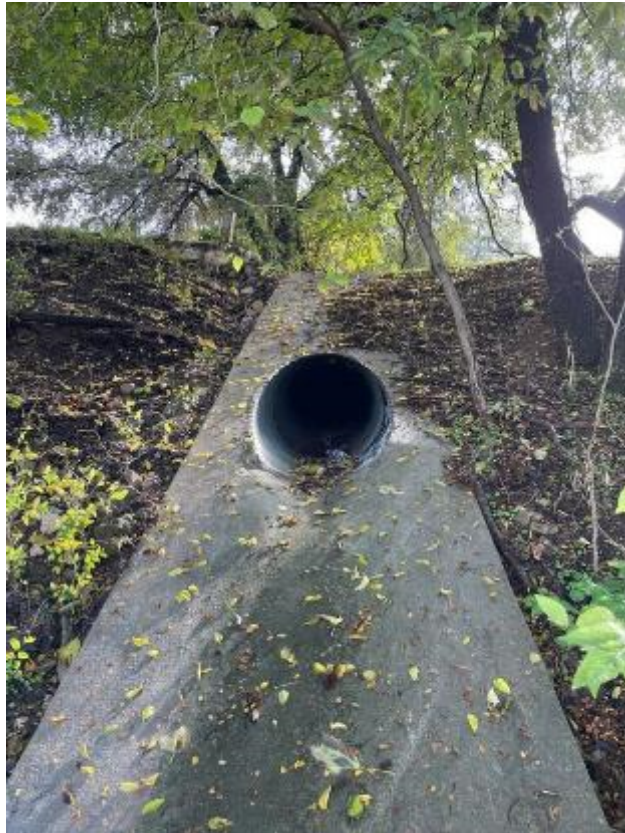
## Mecca Inlets Outfall

Field Notes: Looks good.

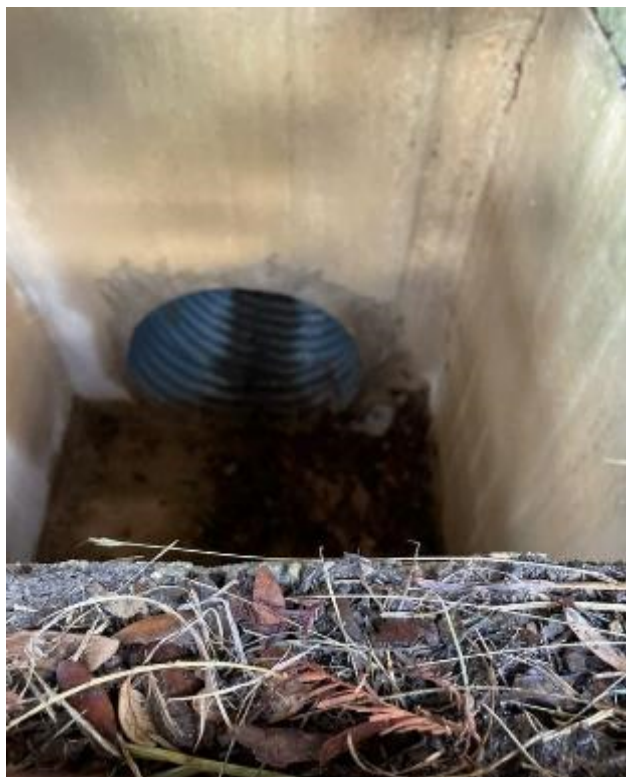
### MEC-I-1(M)

Field Notes: Looks good.

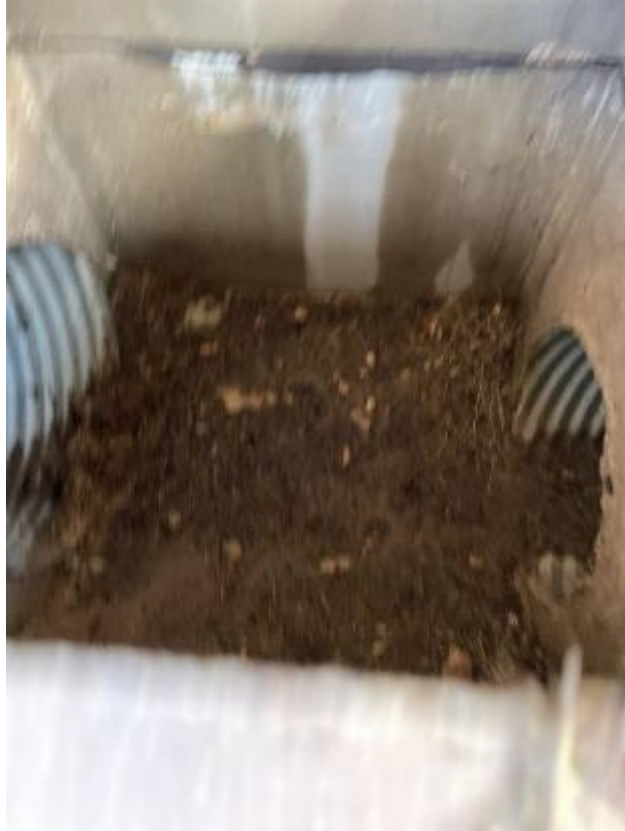
### MEC-I-2(M)

Field Notes: Looks good.

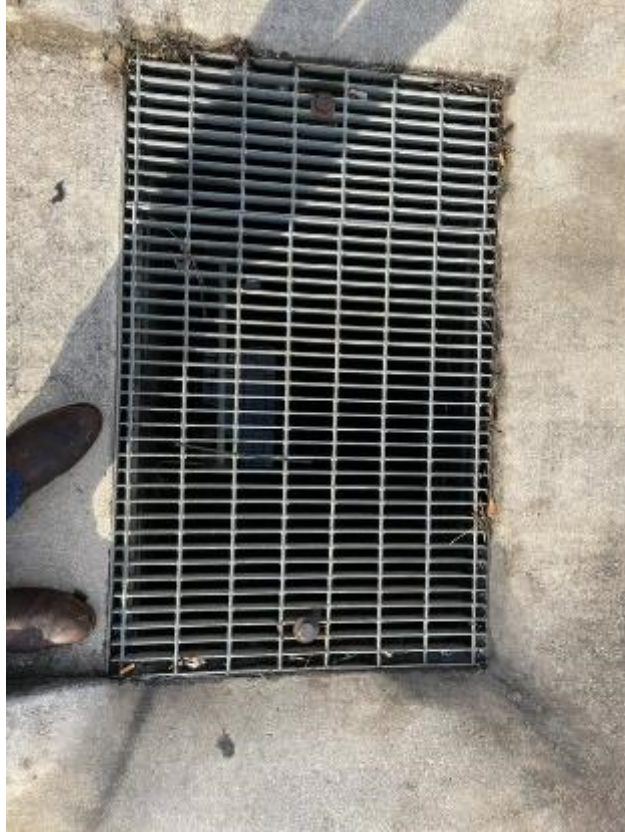
## Midas Inlet in Rear

Field Notes: Looks good.

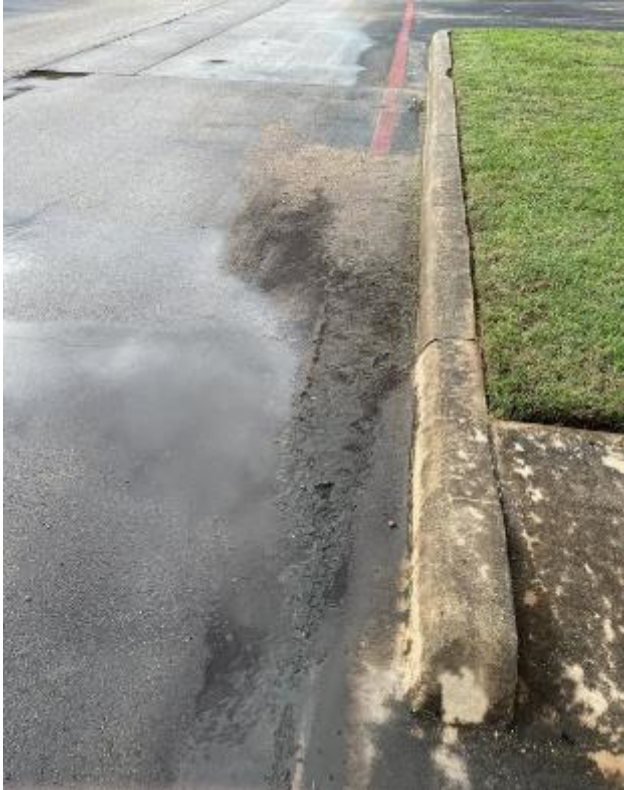
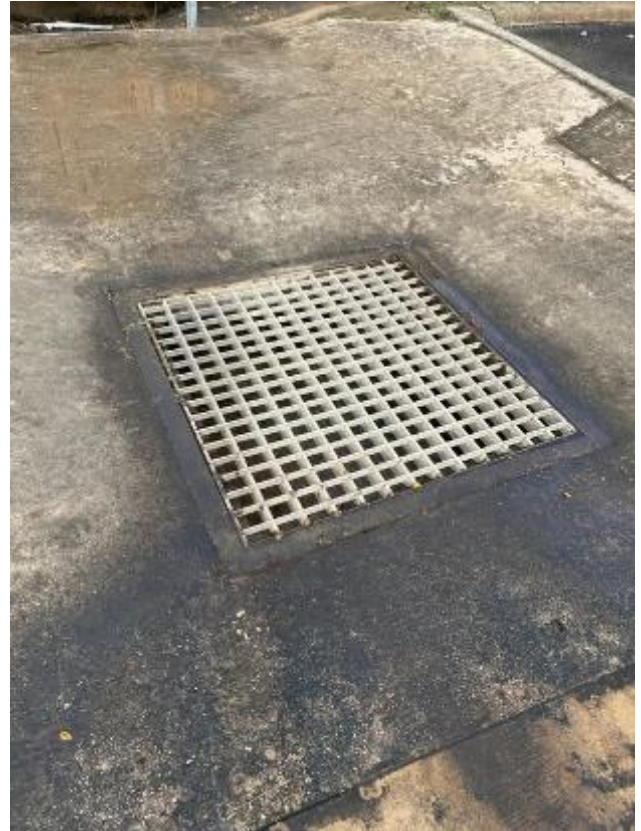
## Miner Fleet Parking Lot Inlet

Field Notes: Sediment buildup near inlet looks good otherwise.

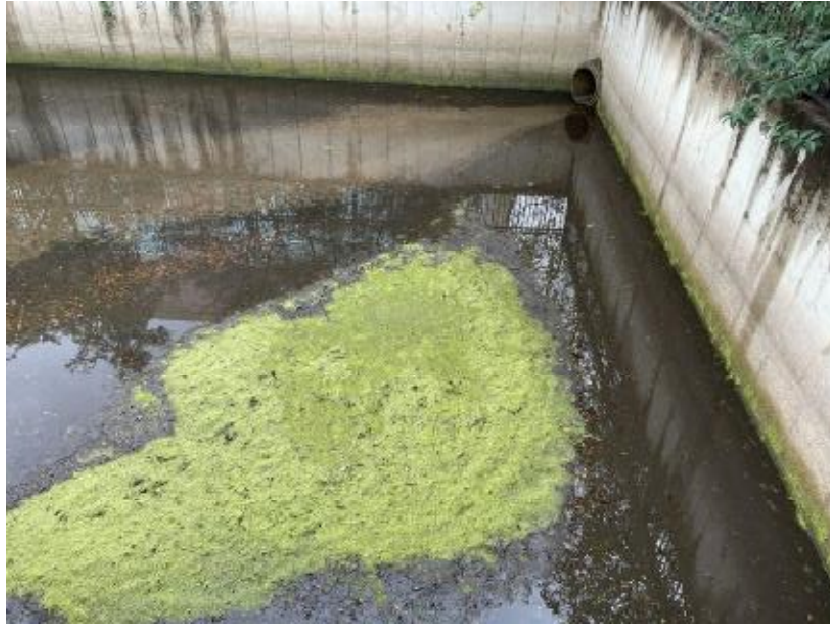
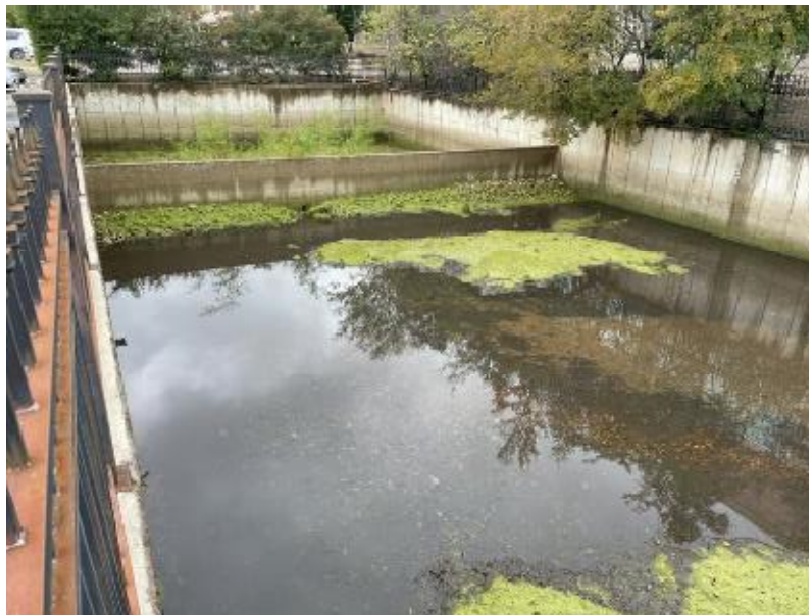
### Miner Fleet PCD

Field Notes: Clean out sediment and vegetation.

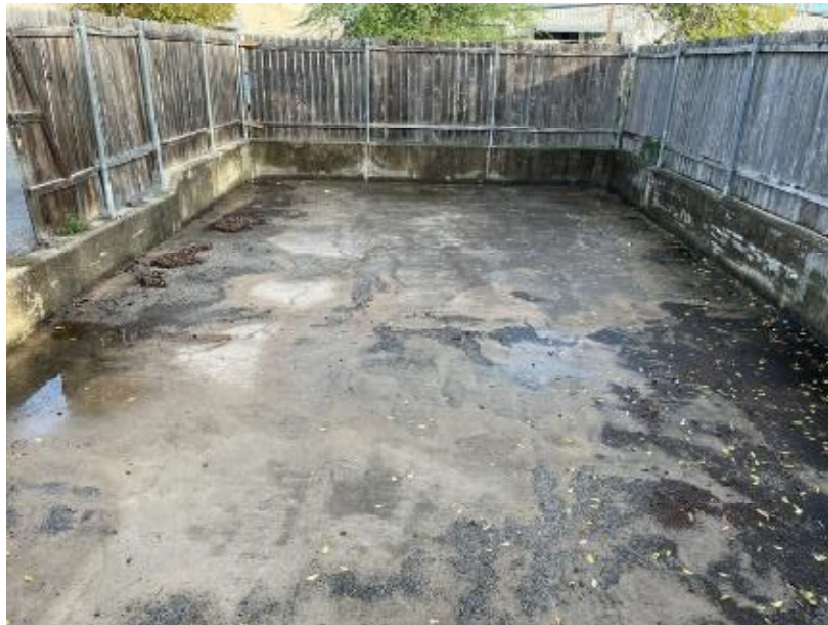
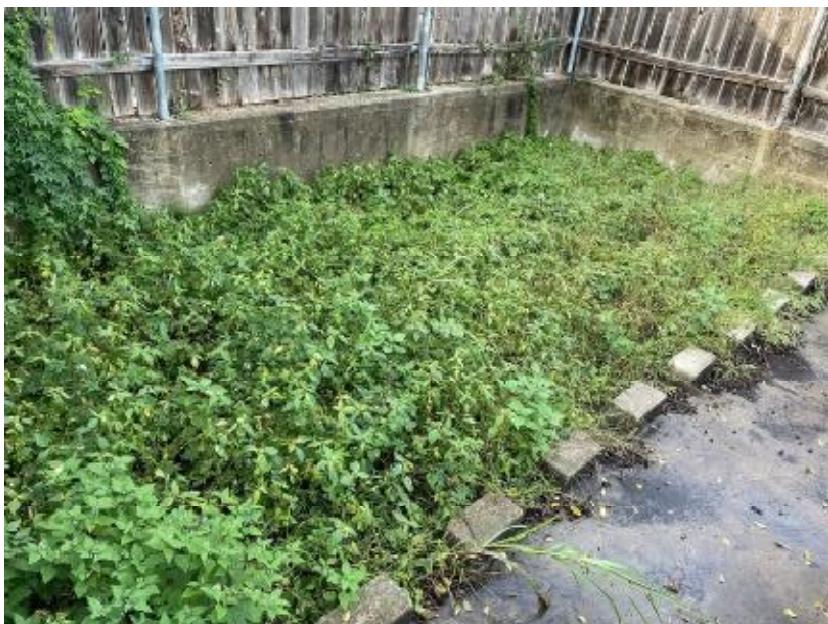
## Monarch Trophy PCD

Field Notes: Mow overgrown vegetation.

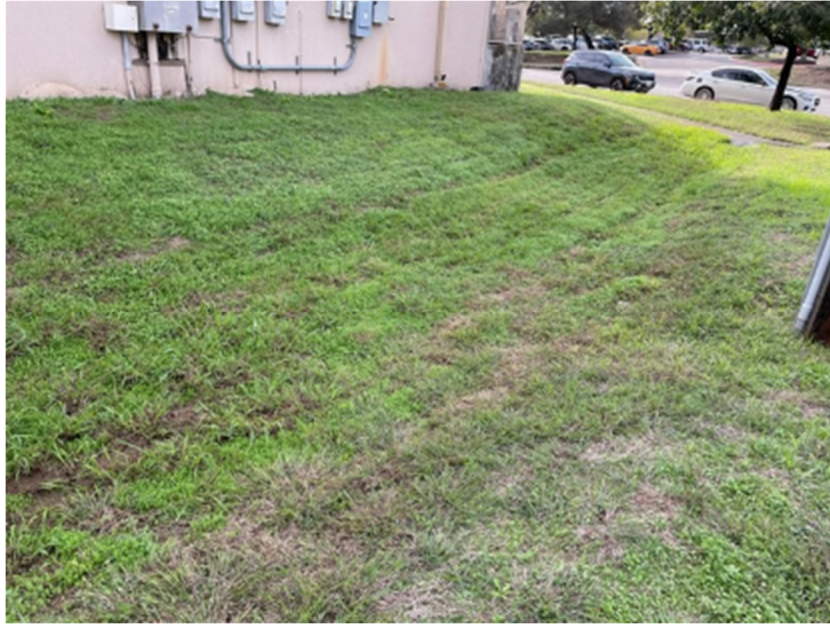
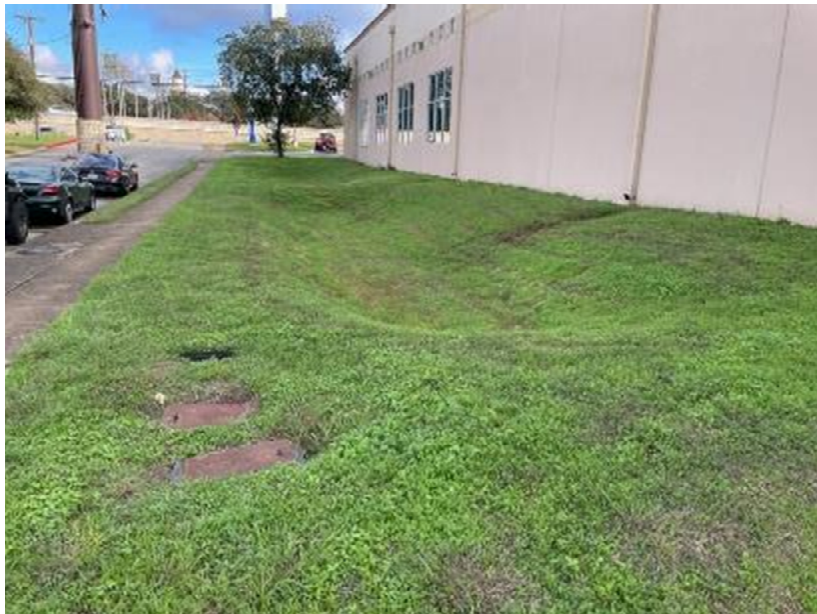
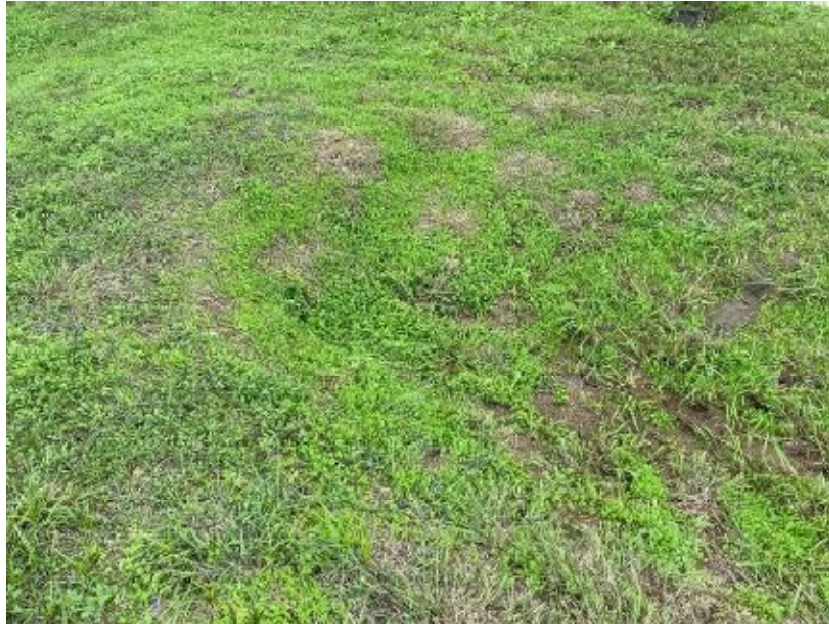
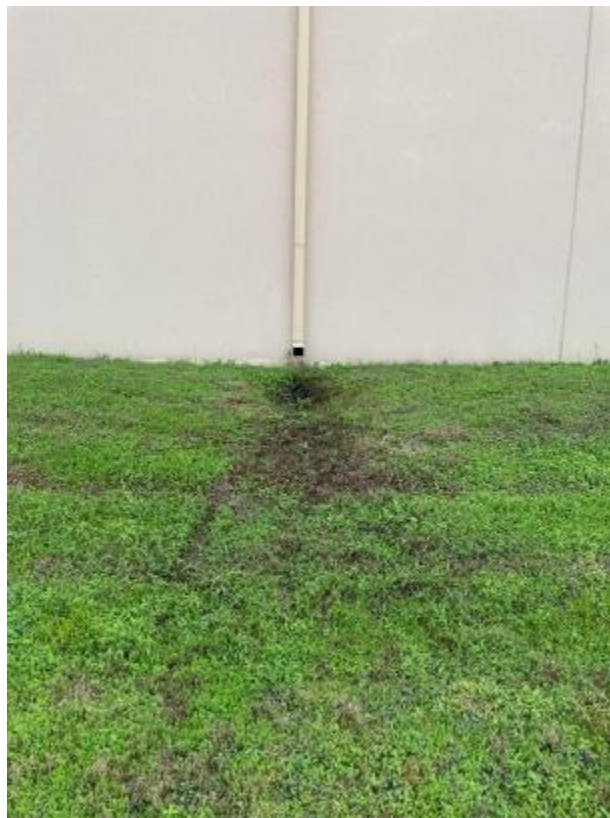
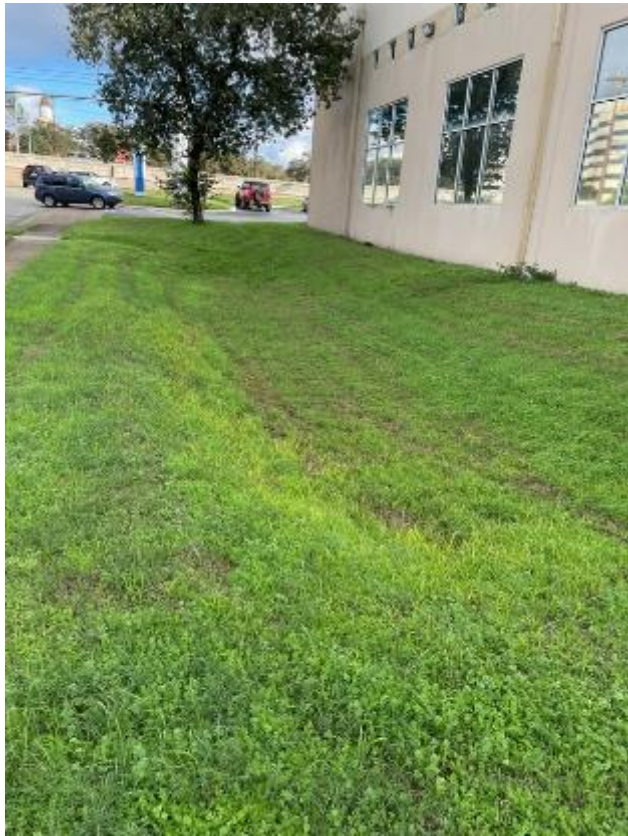
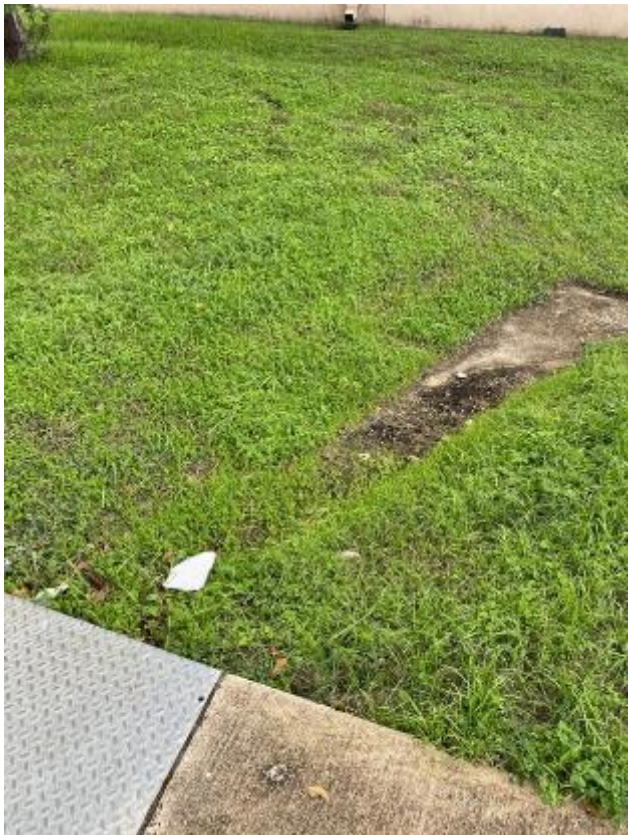
## Monarch Trophy Swale

Field Notes: Minor sediment from sidewalk bridge. Gutter scouring middle swale.

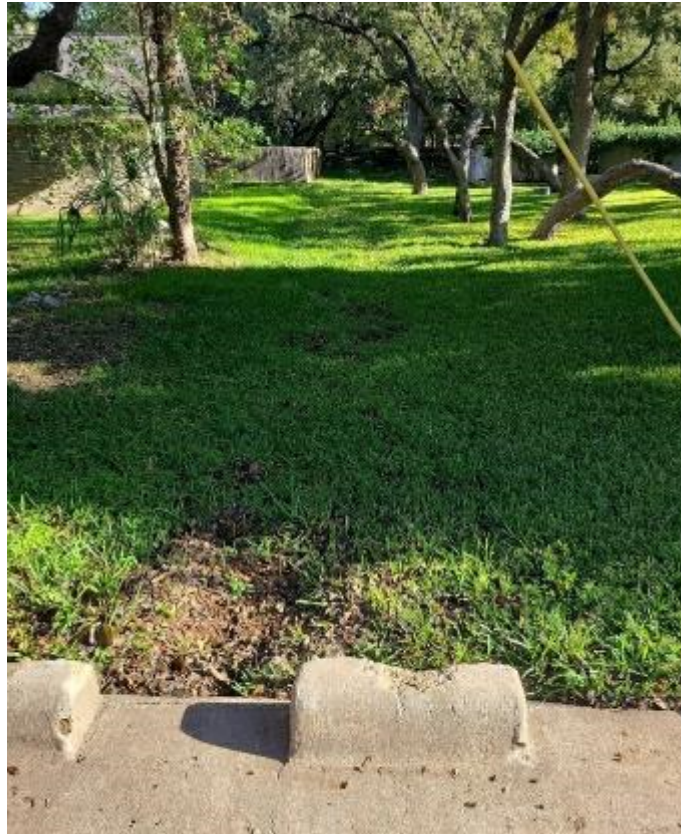
## Mustang Circle

Field Notes: Good condition.

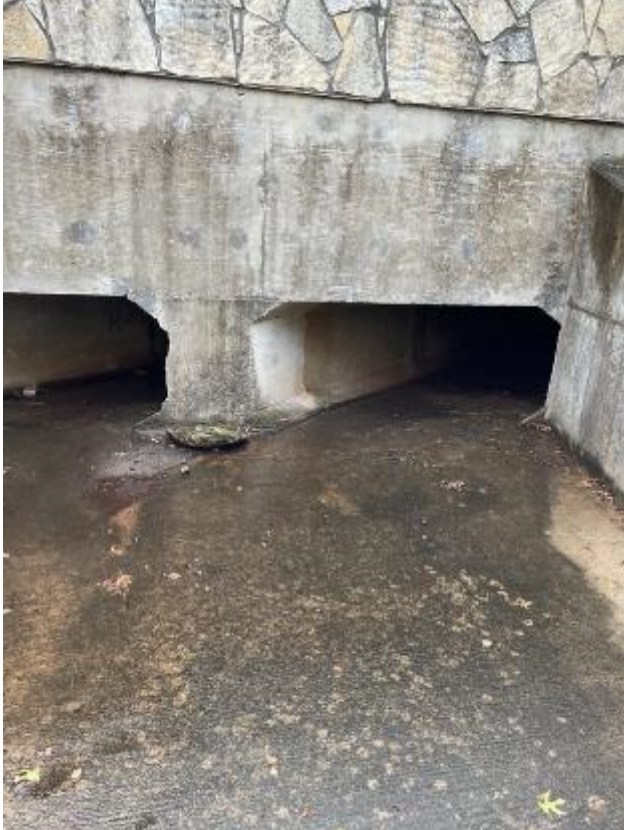
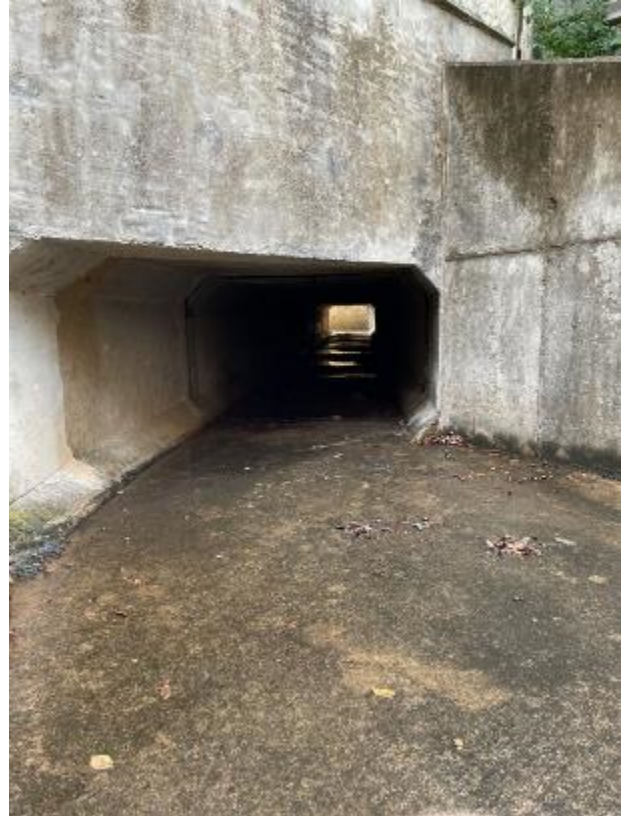
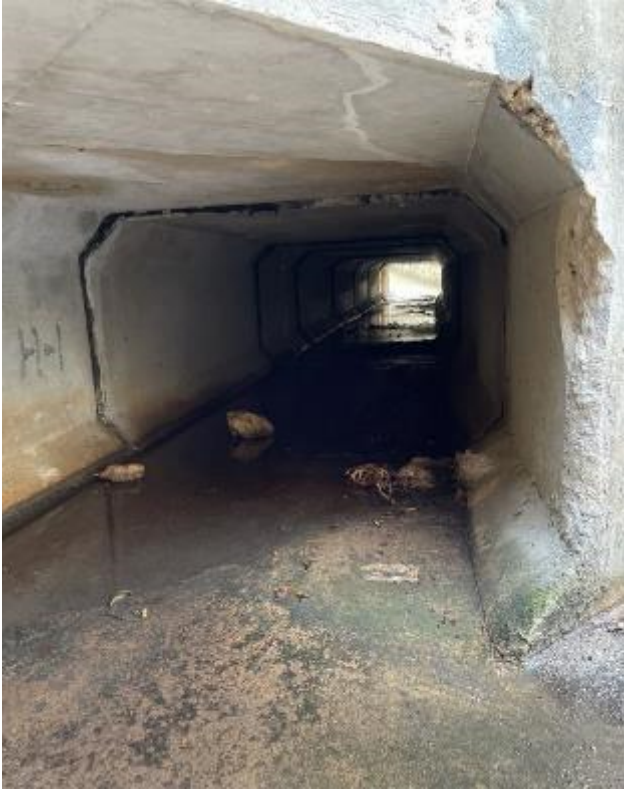
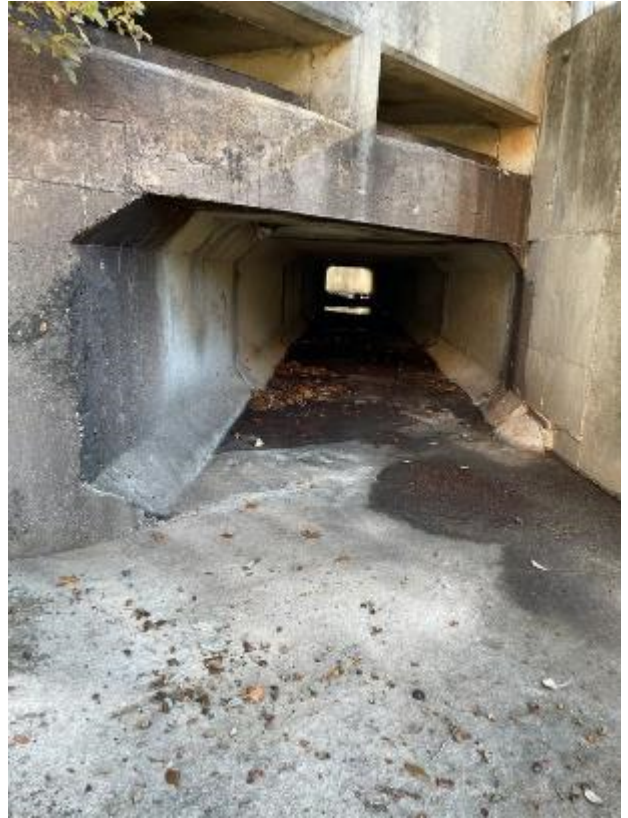
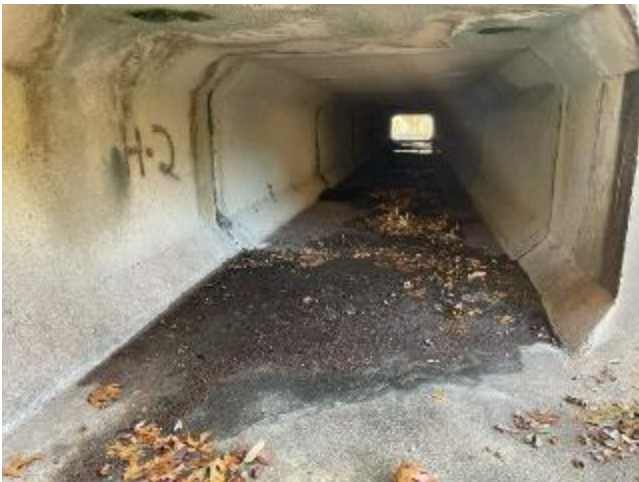
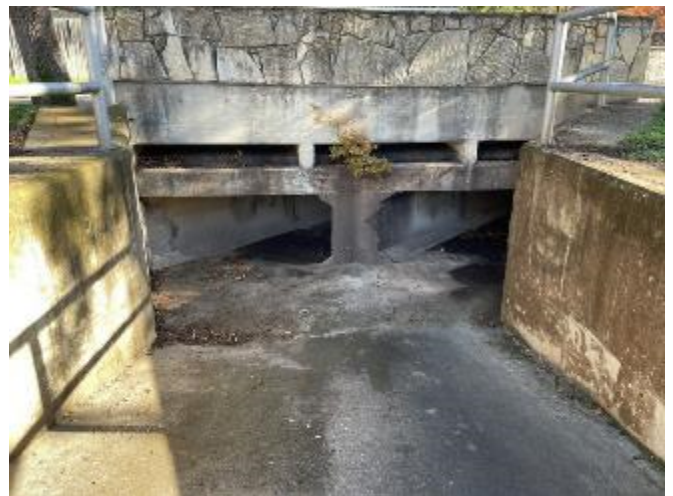
## Navato Storm Sewer Pipe

Field Notes: Looks good.

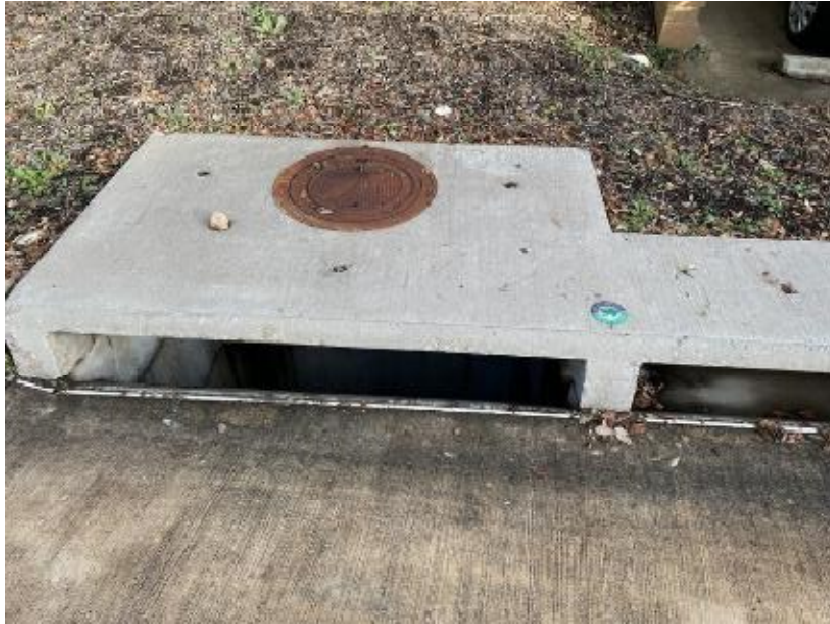
## New Drash Parking Lot Box Inlet

Field Notes: Looks good.

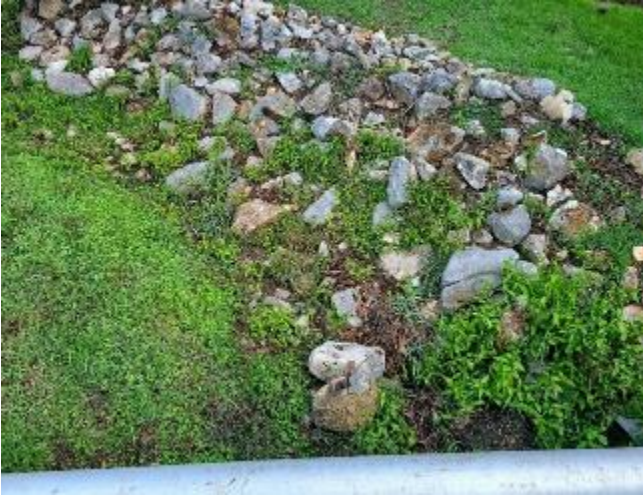
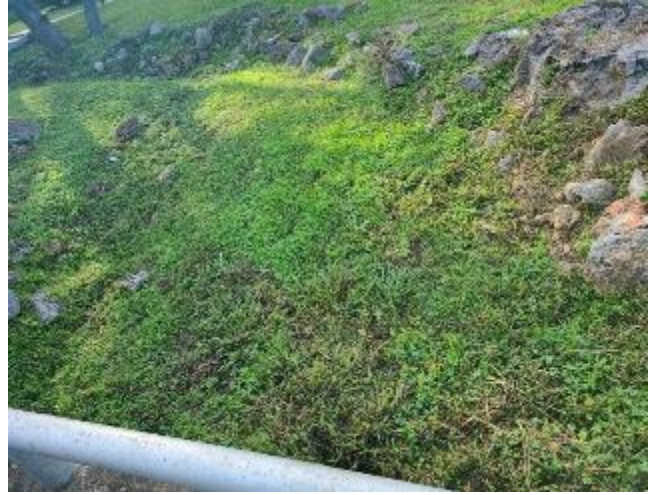
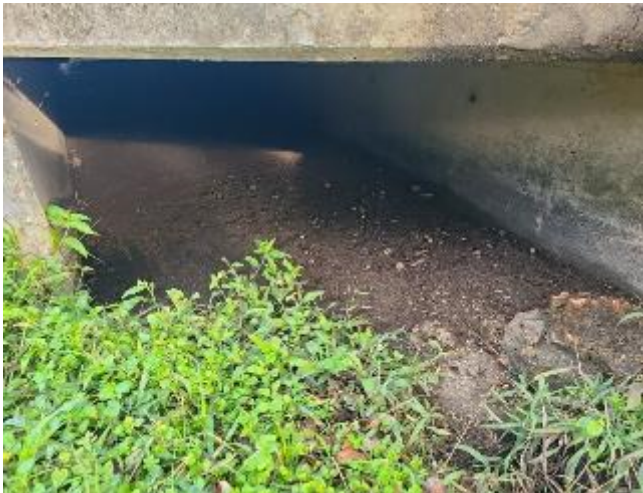
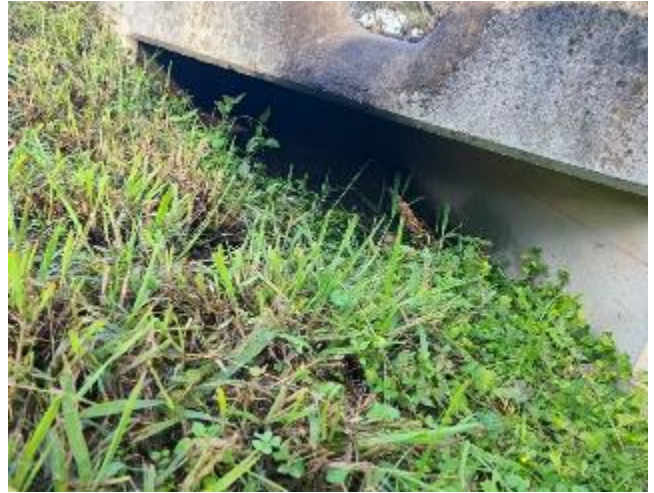
## North Oak Crossing

Field Notes: Sediment and vegetation buildup in pipes

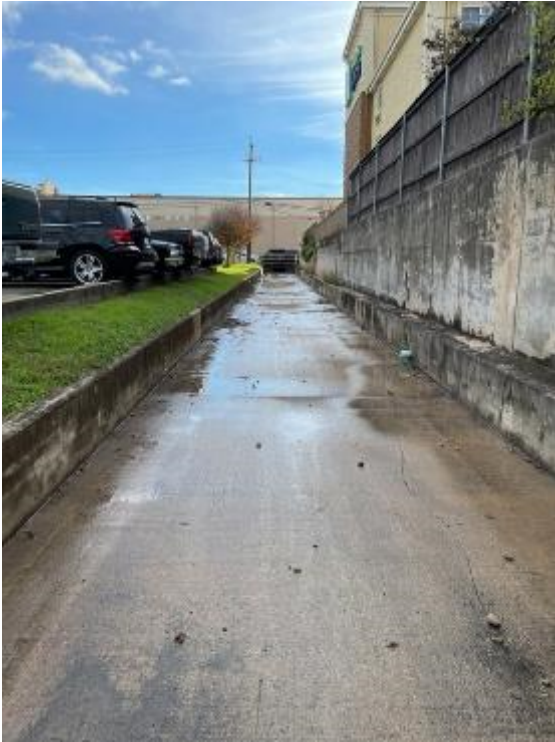
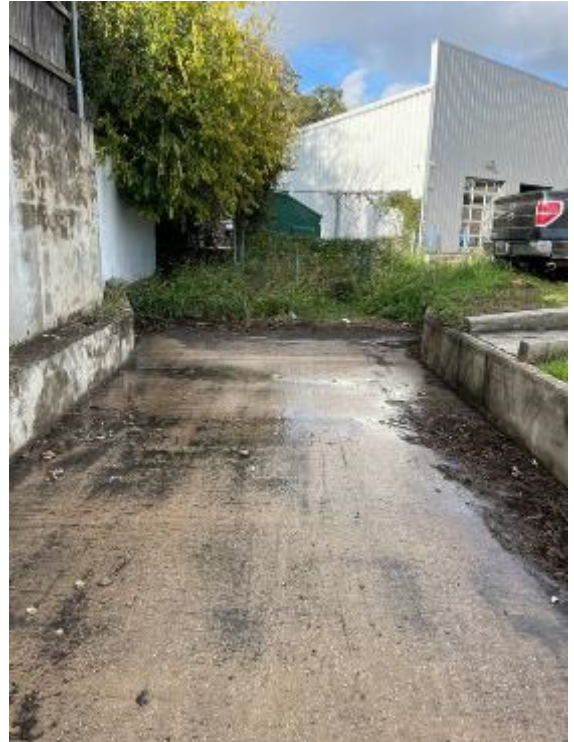
Field Notes: Minor debris

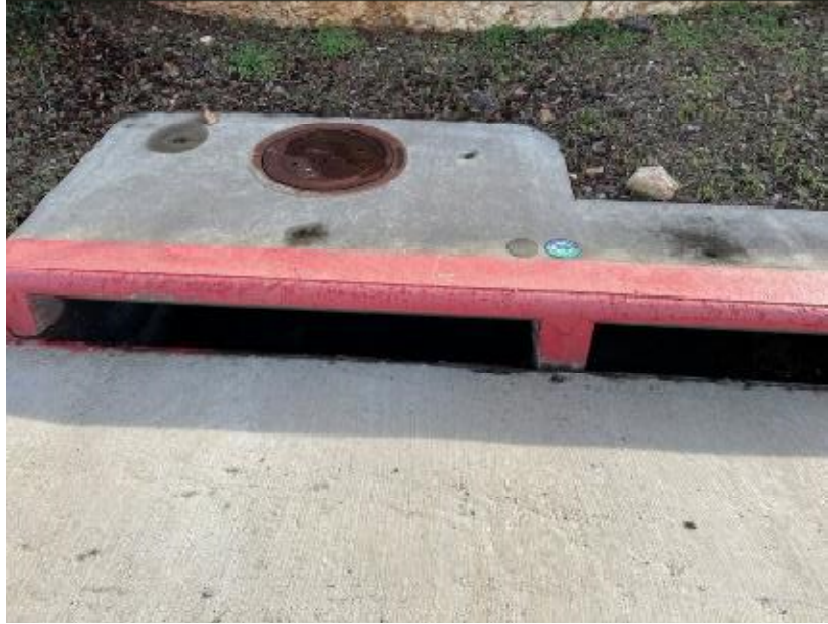
## Oak Creek Circle Inlet

Field Notes: Looks good minor sediment.

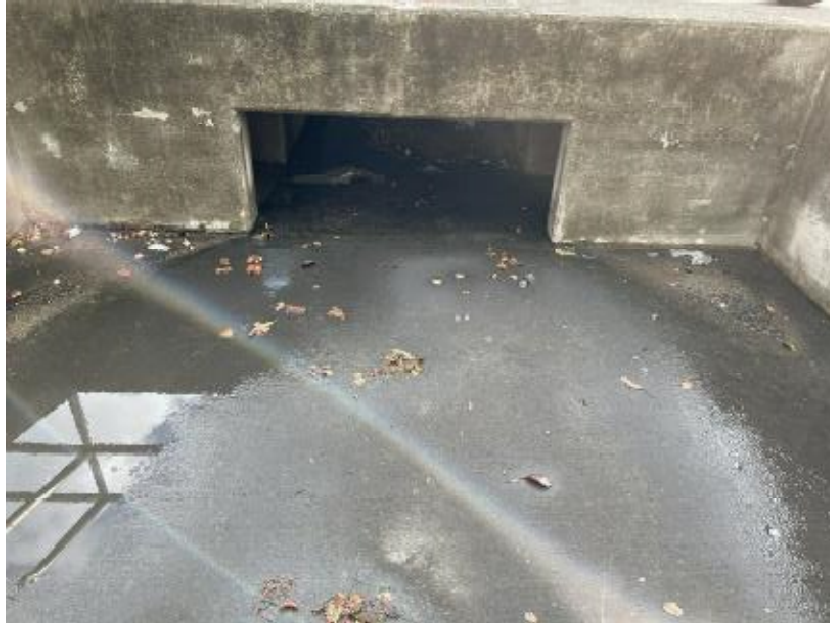
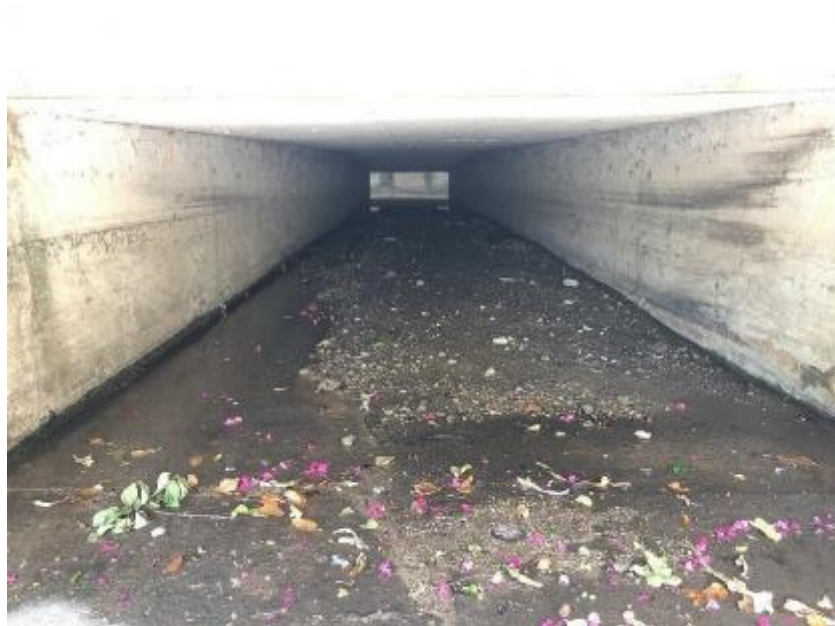
## Oak Creek Circle Storm Sewer Pipe

Field Notes: Looks good.
