# TOWN OF HOLLYWOOD PARK, TX

2023 Winter Inspection

# HOLLYWOOD PARK 2023 WINTER INSPECTION REPORT

**Subject:** Annual Municipal Separate Storm Sewer System (MS4) Inspection

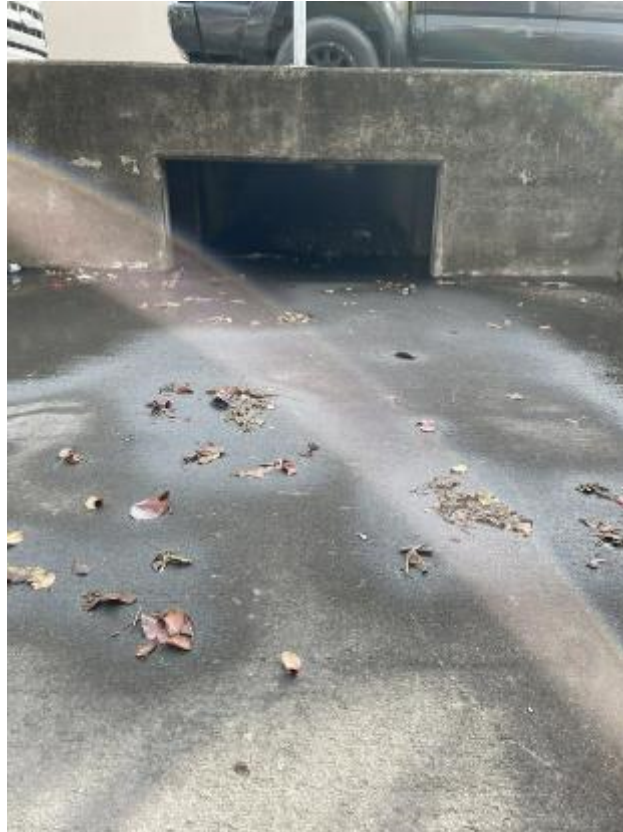
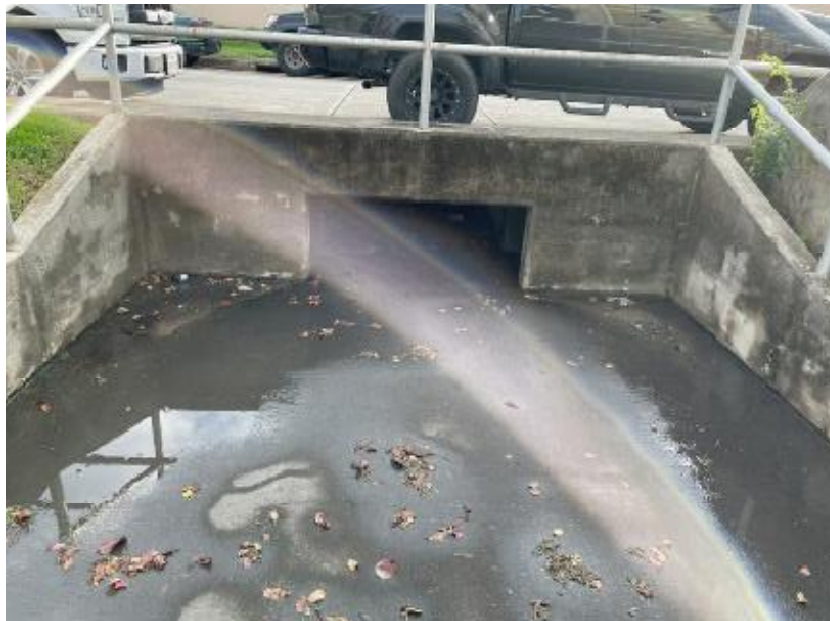
### Oak-I-2(M)

Field Notes: Looks good.

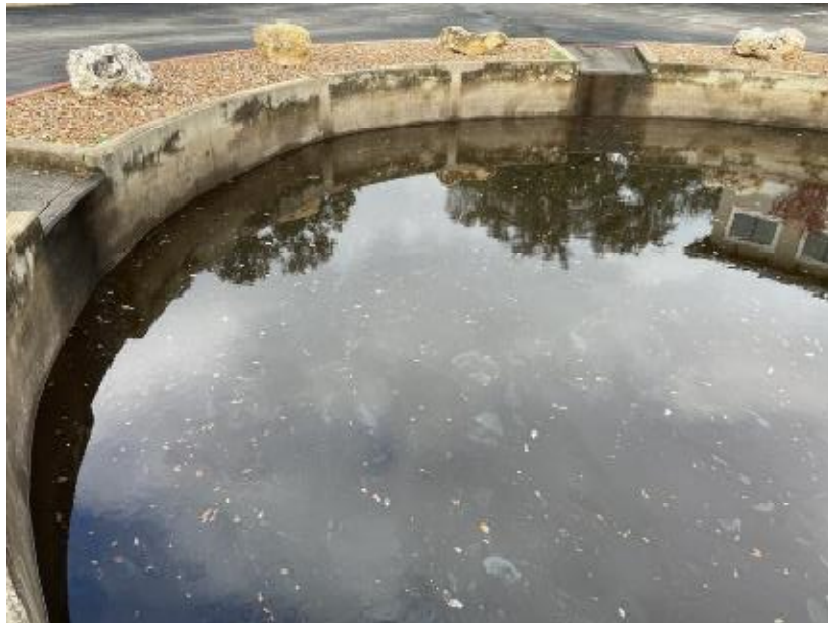
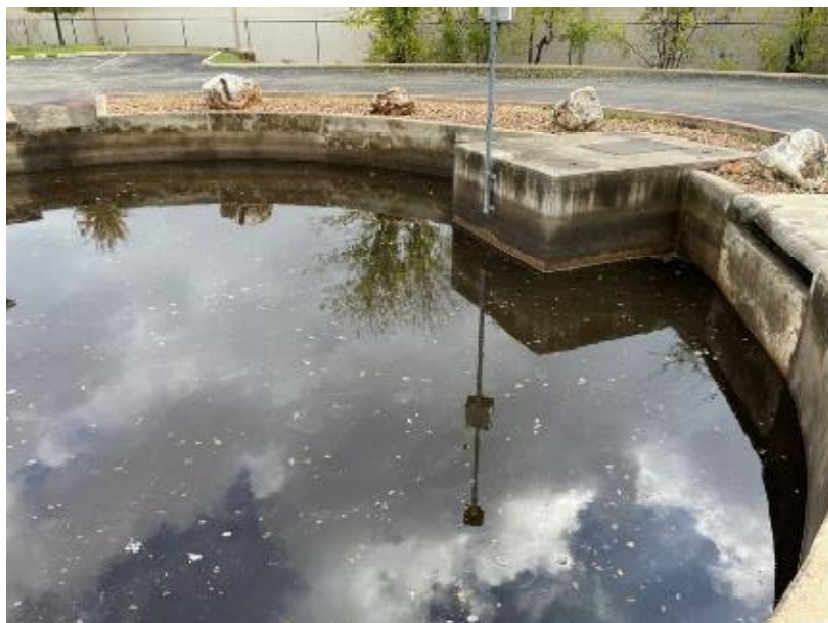
## Optometrist Roundabout PCD

Field Notes: Clean leaves out of basin appear to be clogging it.

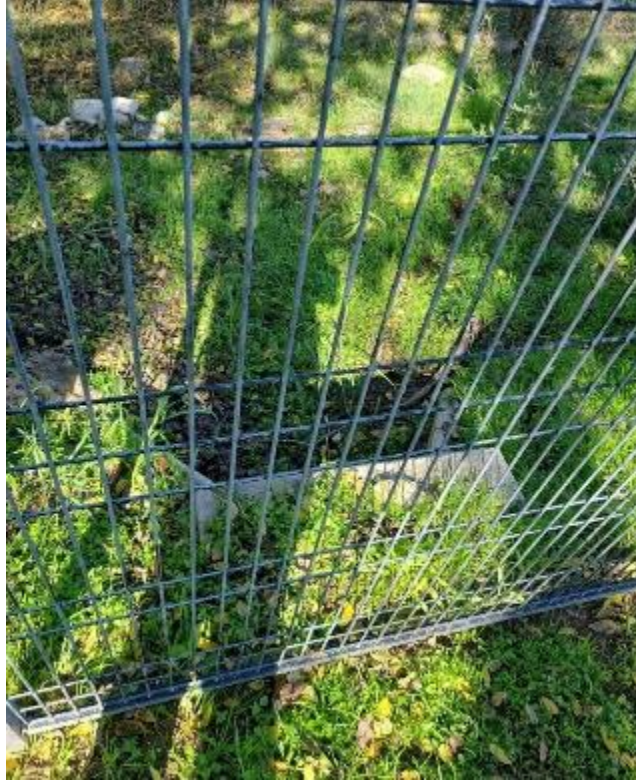
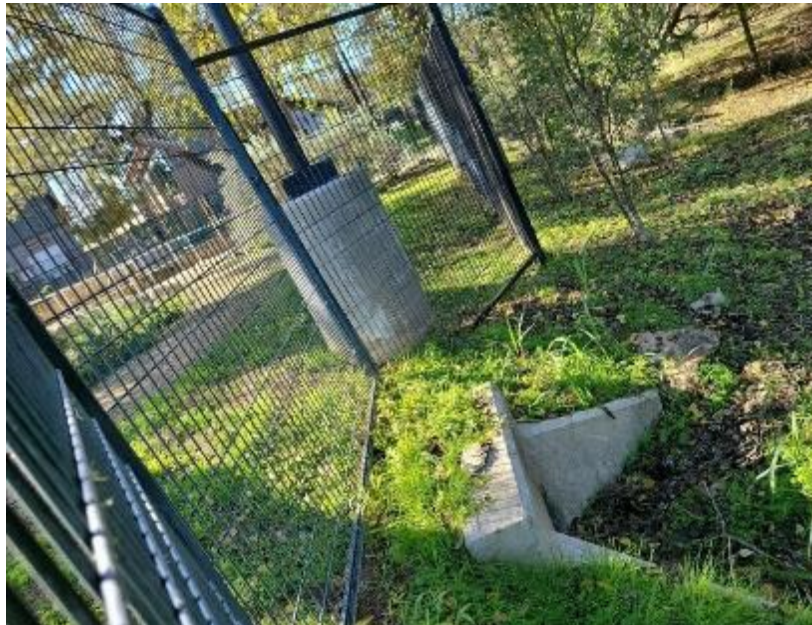
## Outfall

Field Notes: Outfall looks good and clean.

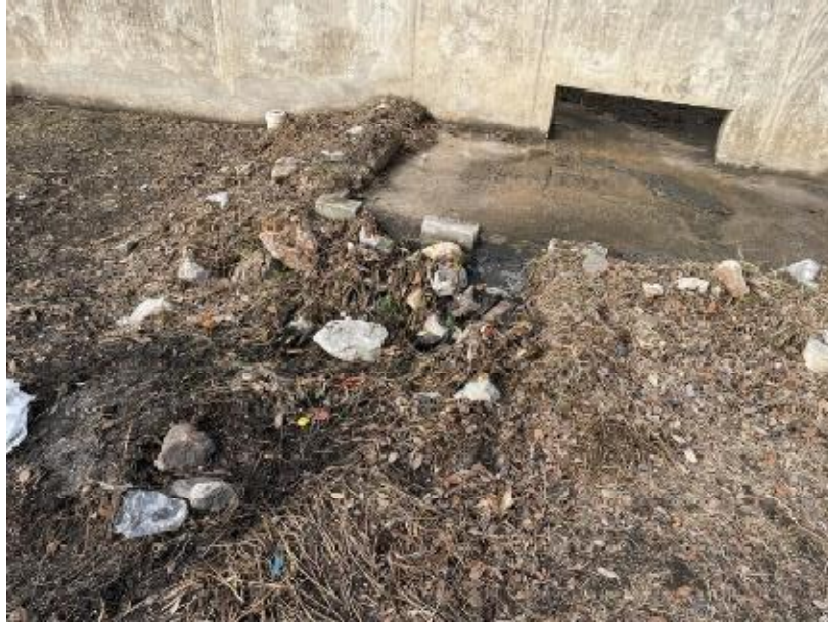
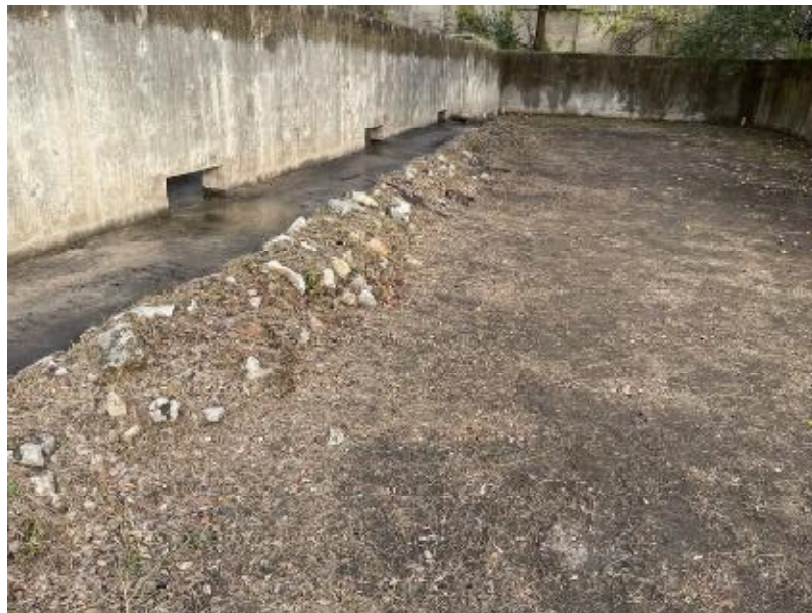
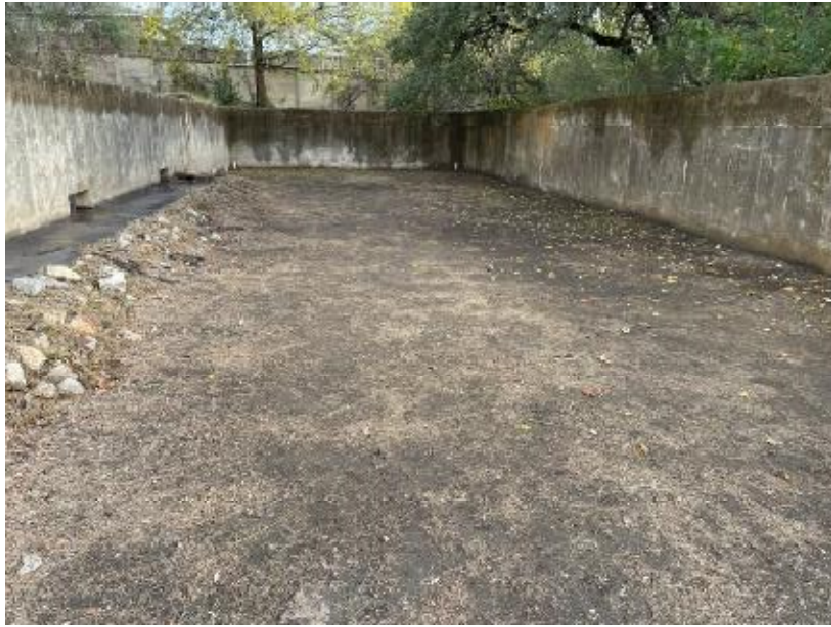
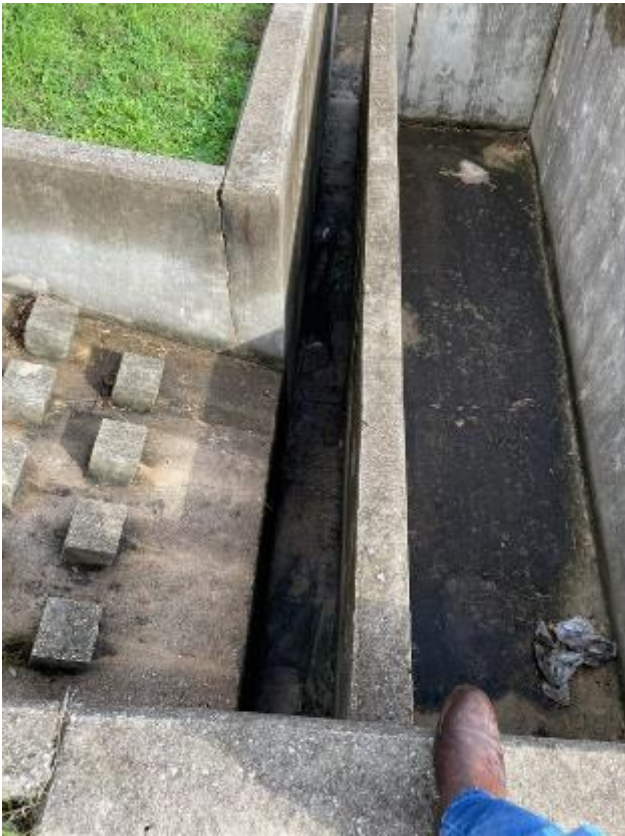
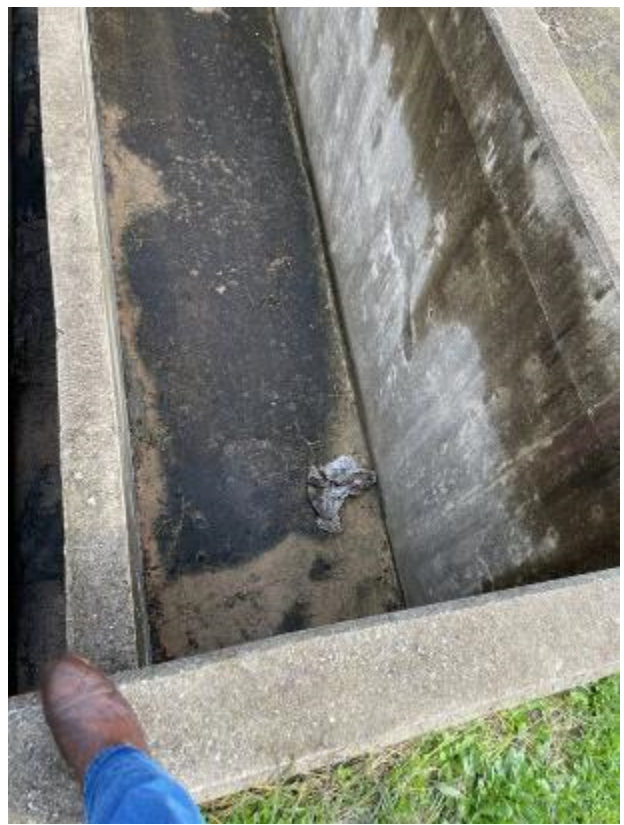
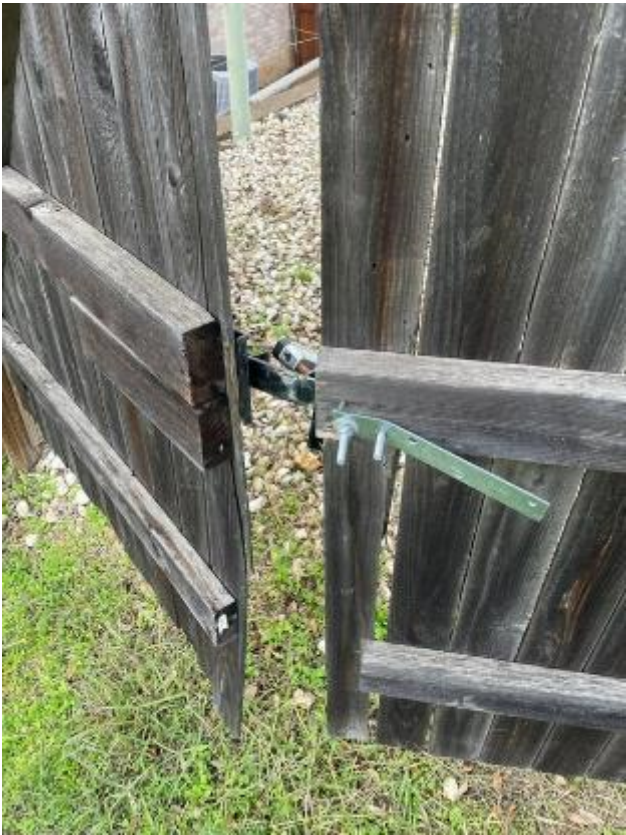
## Outfall Channel

Field Notes: Clear sediment and trash out. Gate appears to have been vandalized.

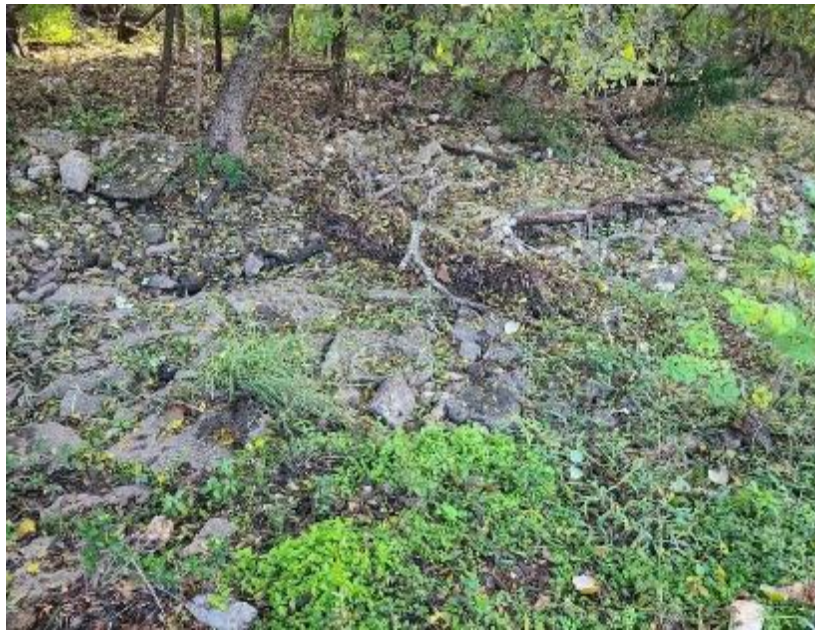
Field Notes: Trash and litter in outfall. Broken concrete pipe also disposed in outfall.

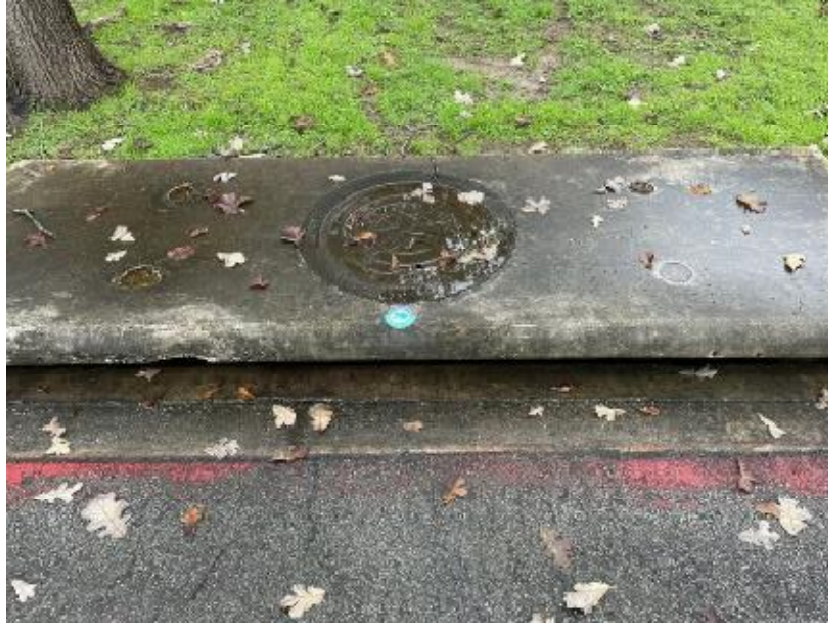
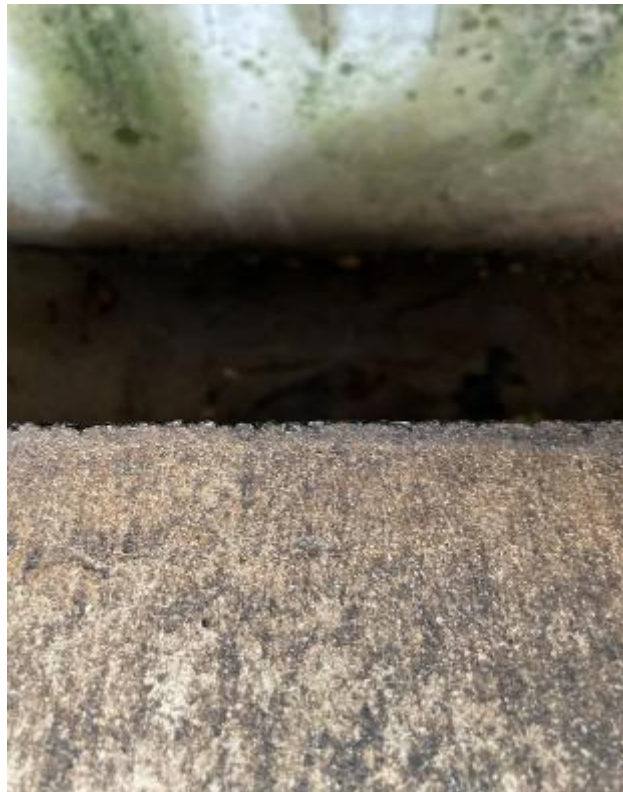
### Parking Lot Box Inlet

Field Notes: Looks good.

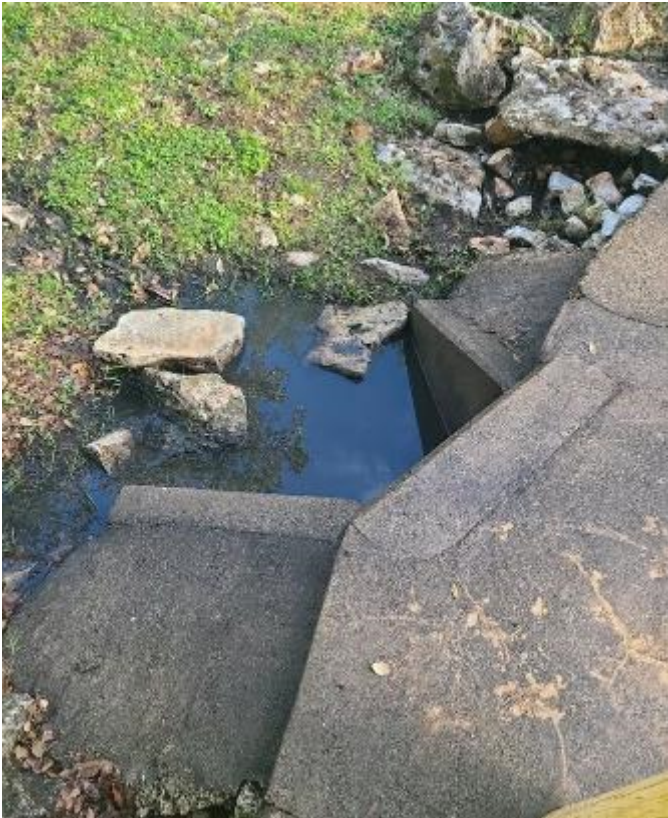
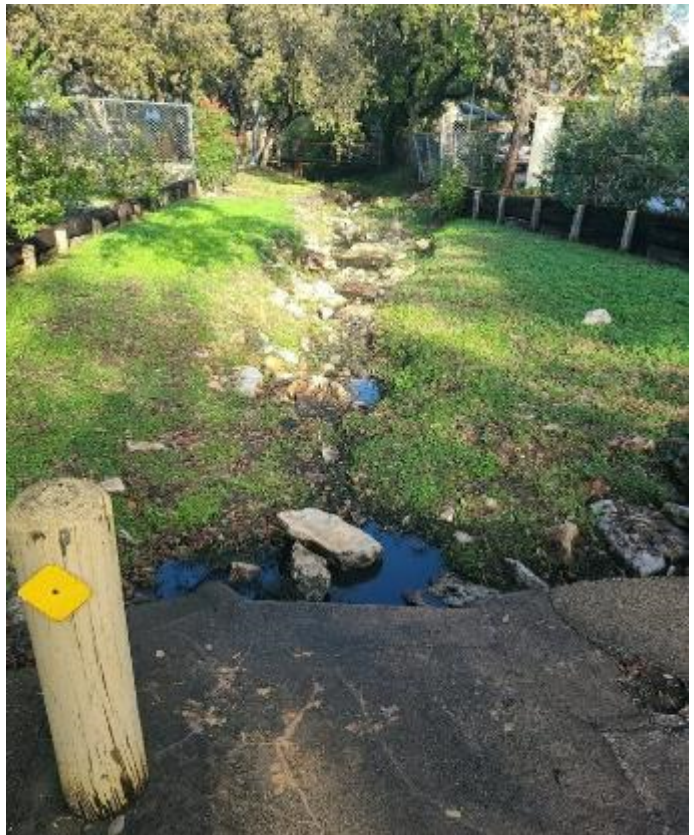
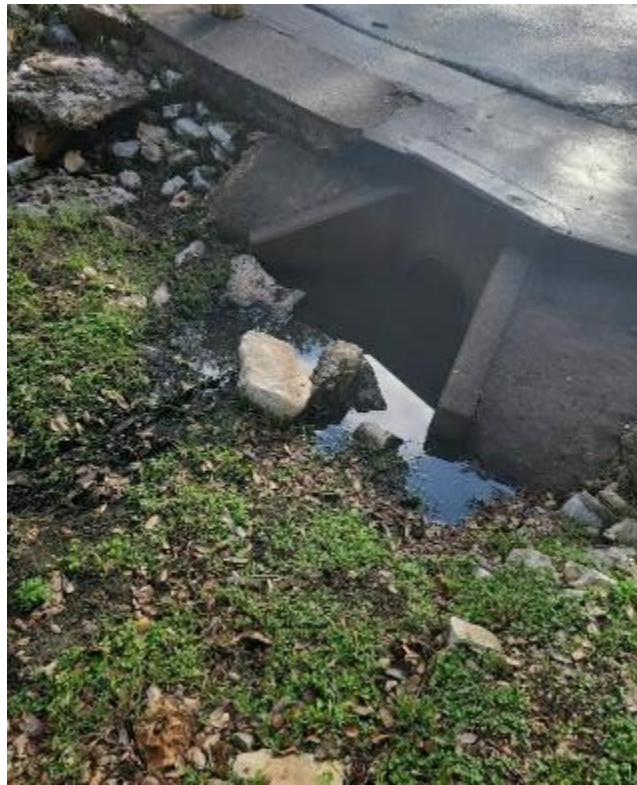
## Paseo Canada Outfall 1

Field Notes: Good condition. Steady flow.

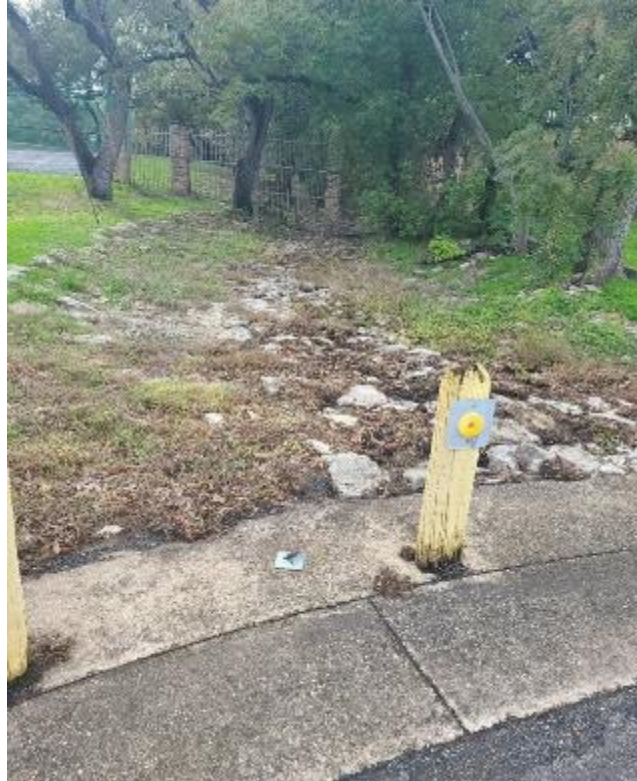
## Paseo Canada Outfall 2

Field Notes: Sediment is piling up. Please remove excess sediment and trim vegetation.

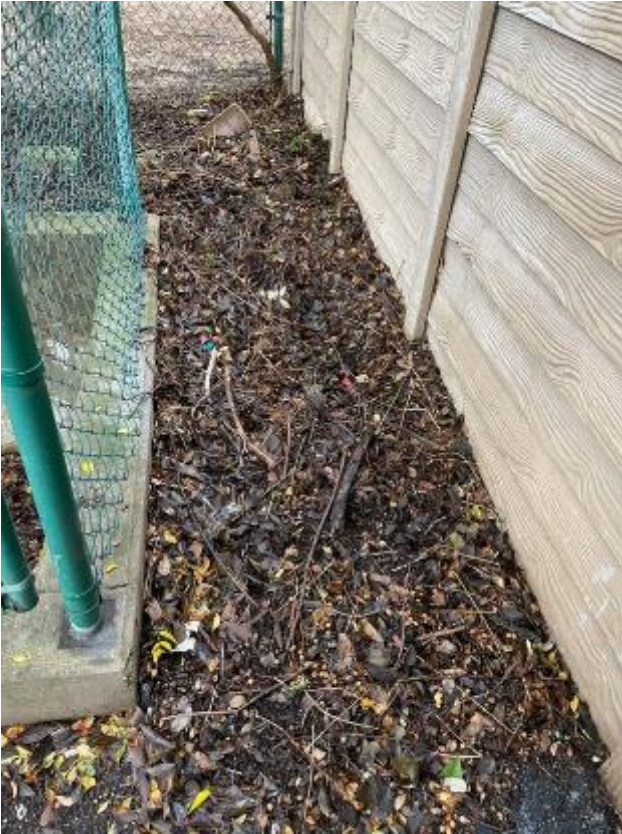
### PCD2 Pediatrics

Field Notes: Clean out inside of basin and debris blocking inlet.

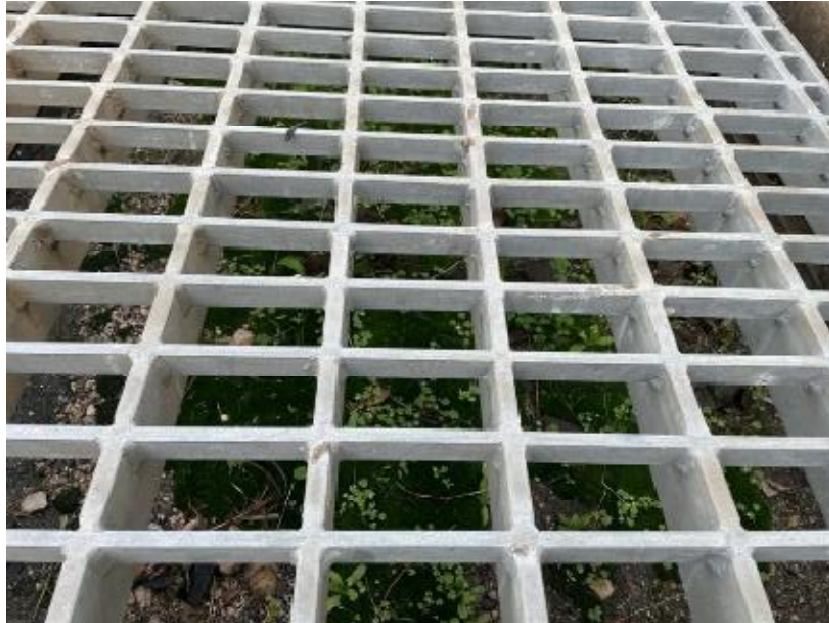
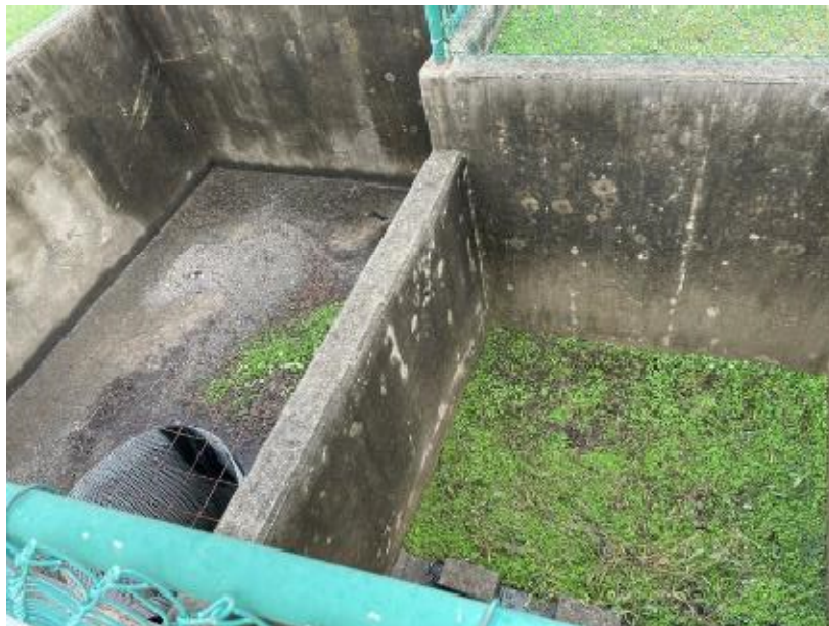
### Pediatric Dentistry Office PCD

Field Notes: Clean out vegetation in grate. Remove sediment in basin.

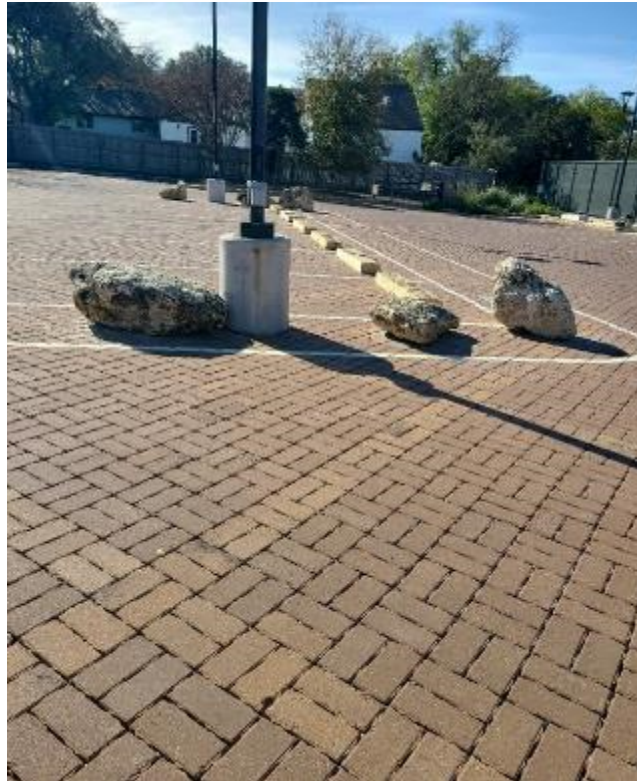
## Permeable Pavers

Field Notes: Good condition. Clean of any trash.

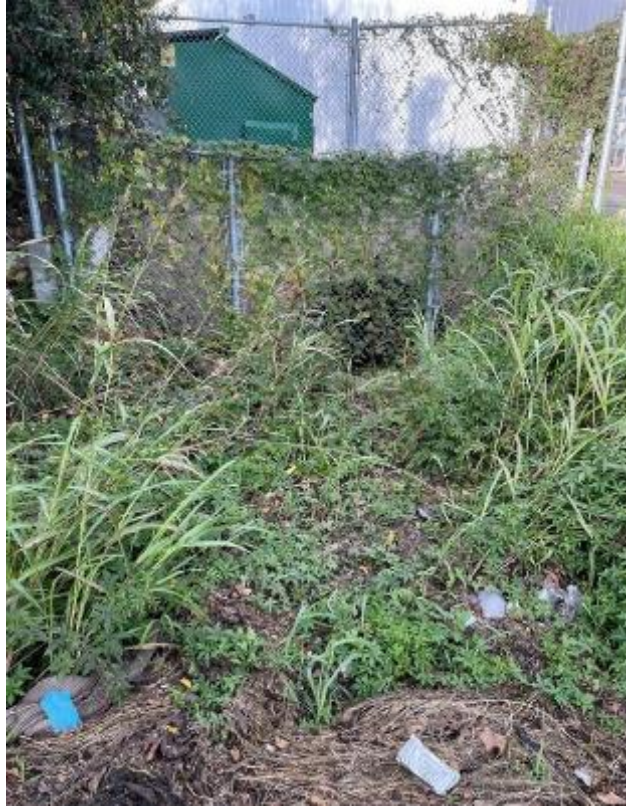
## Premier 1 Autocare Inlet

Field Notes: Mow vegetation.

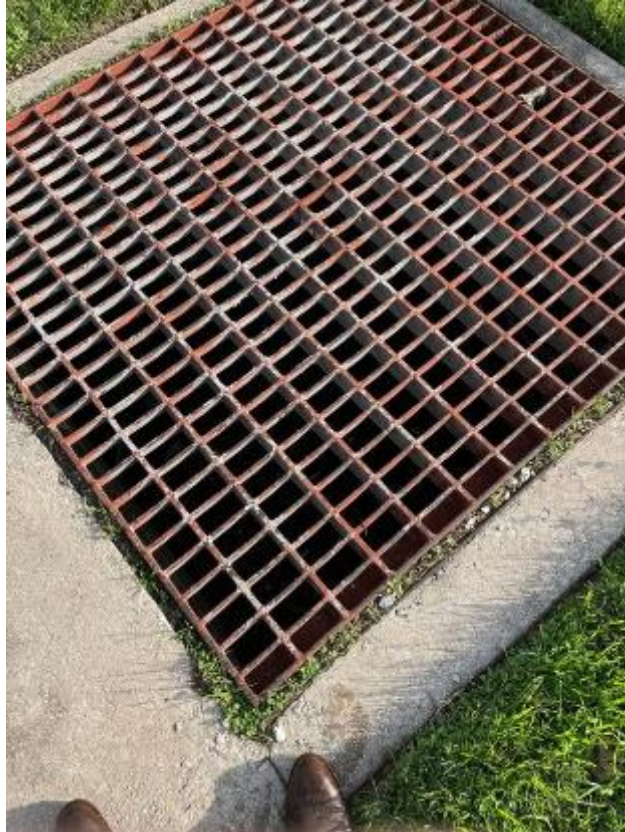
## Premier 1 Autocare Inlet 1

Field Notes: Looks good.

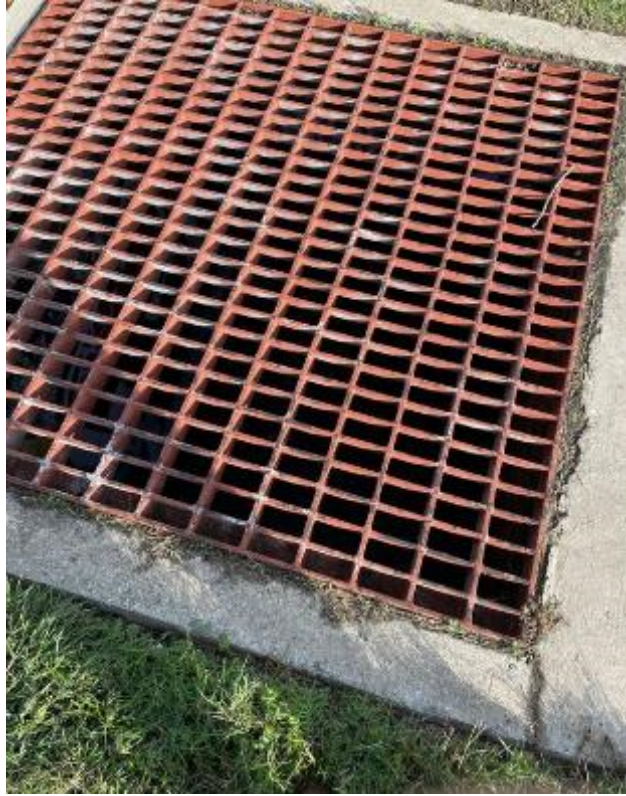
## Premier Autocare Inlet 2

Field Notes: Looks good.

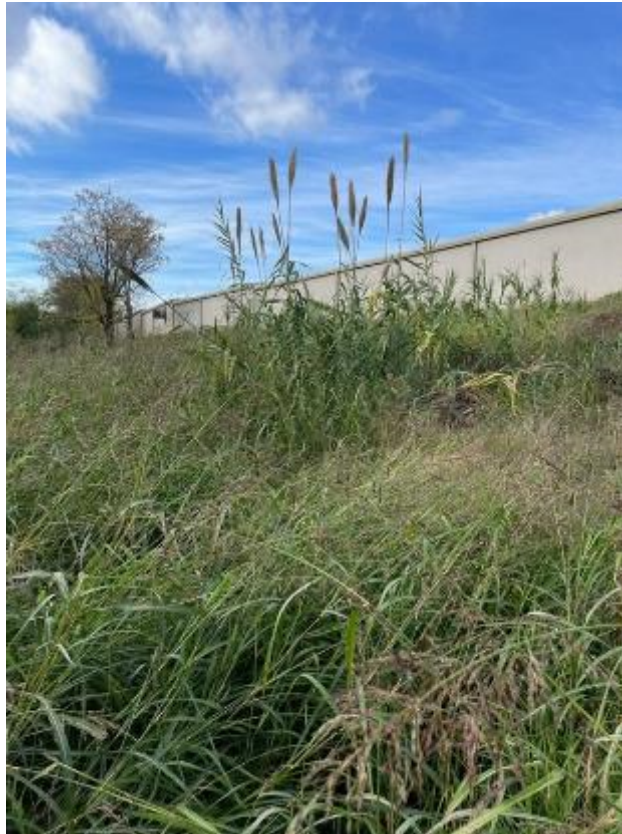
## Public Storage Outfall

Field Notes: Needs mowing.

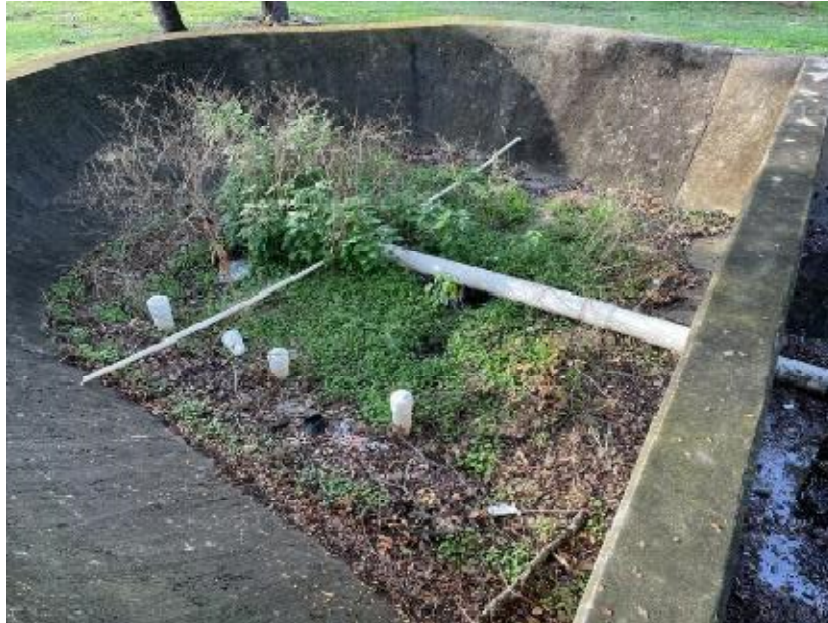
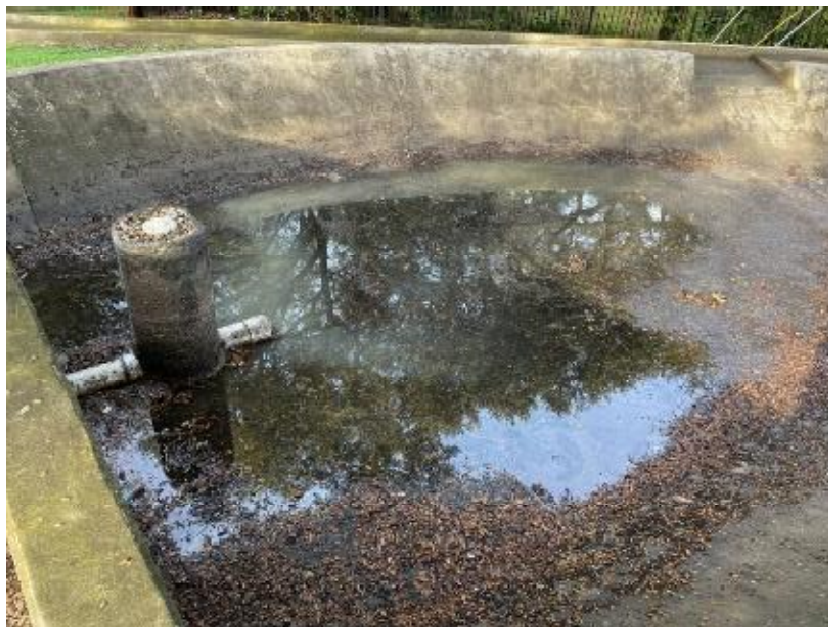
## Retention Pond w/ Infiltration

Field Notes: Minor sediment. Mow vegetation

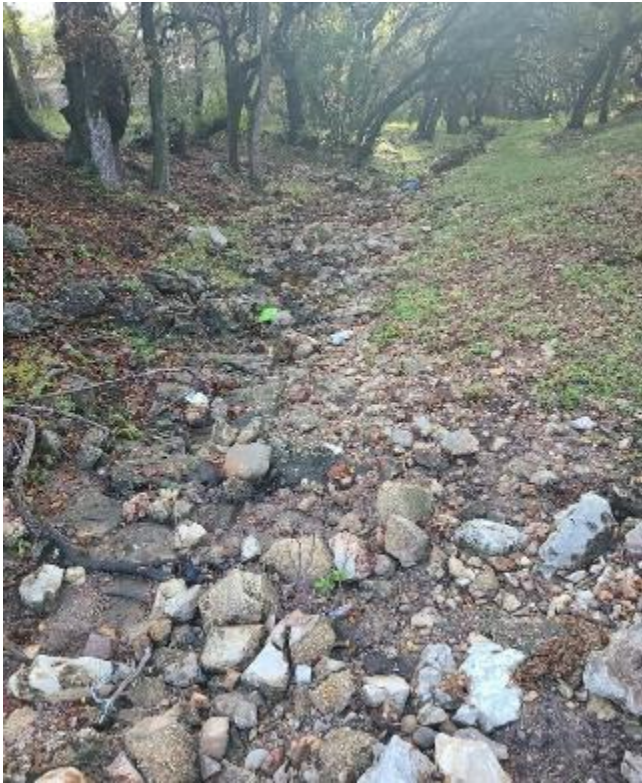
## Ridge Trail Crossing

Field Notes: Pipes in good condition. Move pile of rocks in pipe to provide full flow. Remove litter around area.

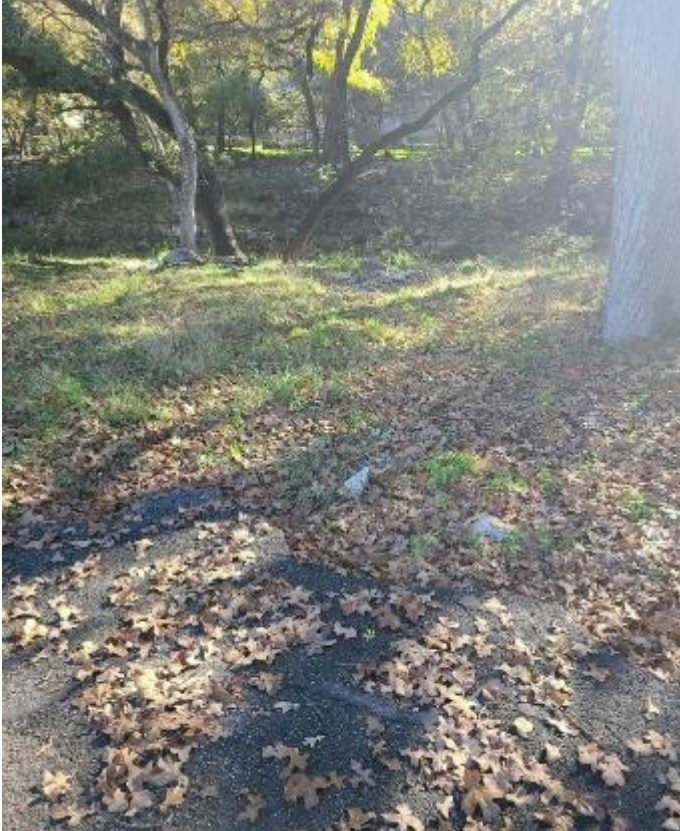
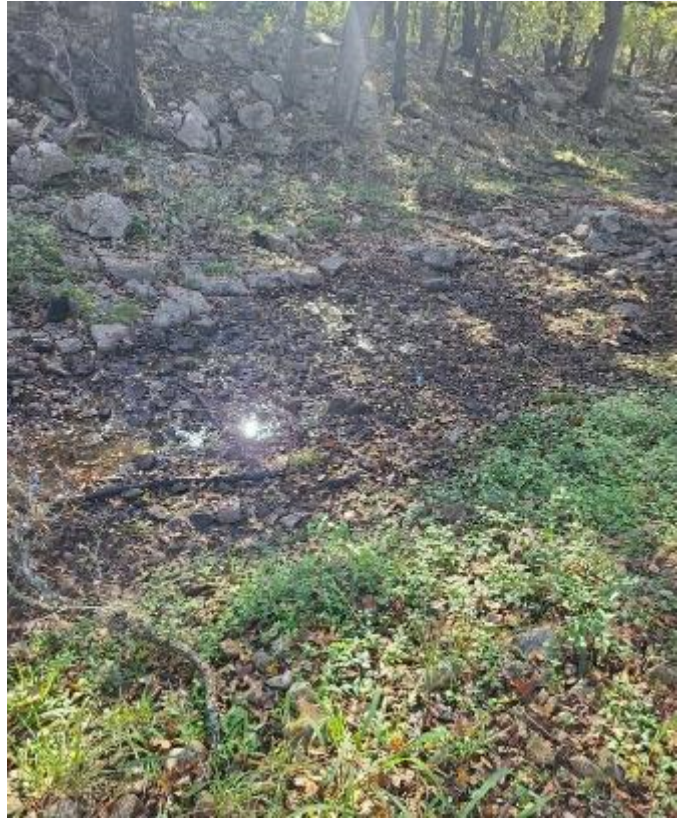
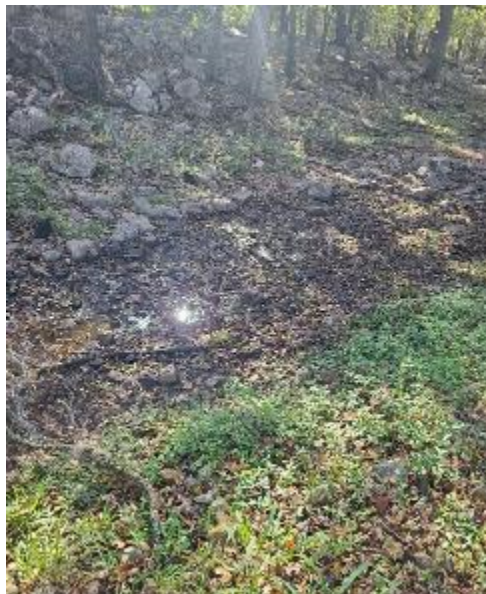
## Rua De Matta

Field Notes: Good condition.

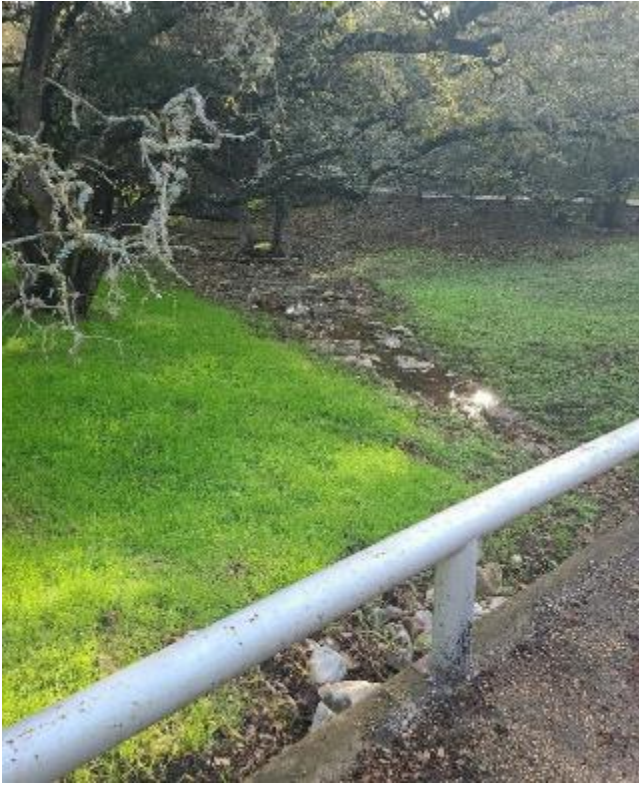
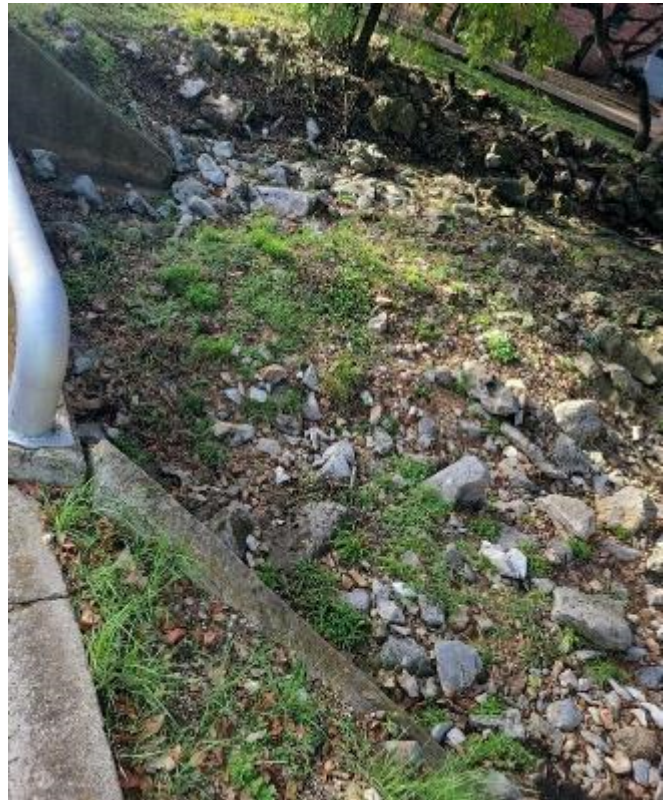
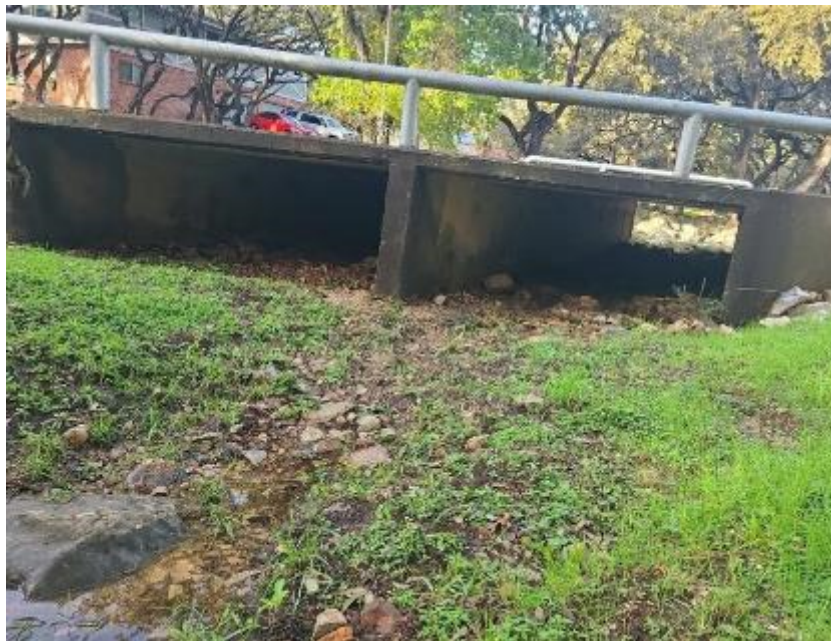
## Sagecrest Crossing East

Field Notes: Good condition.

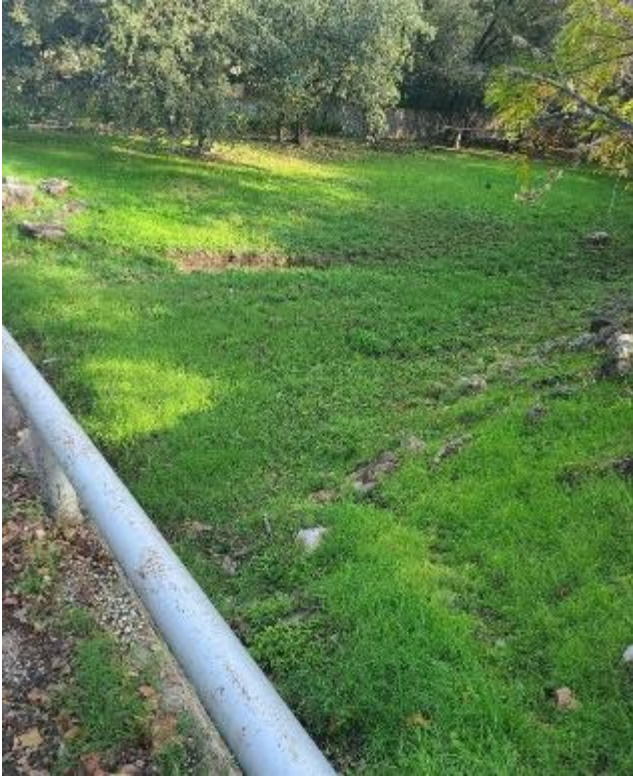
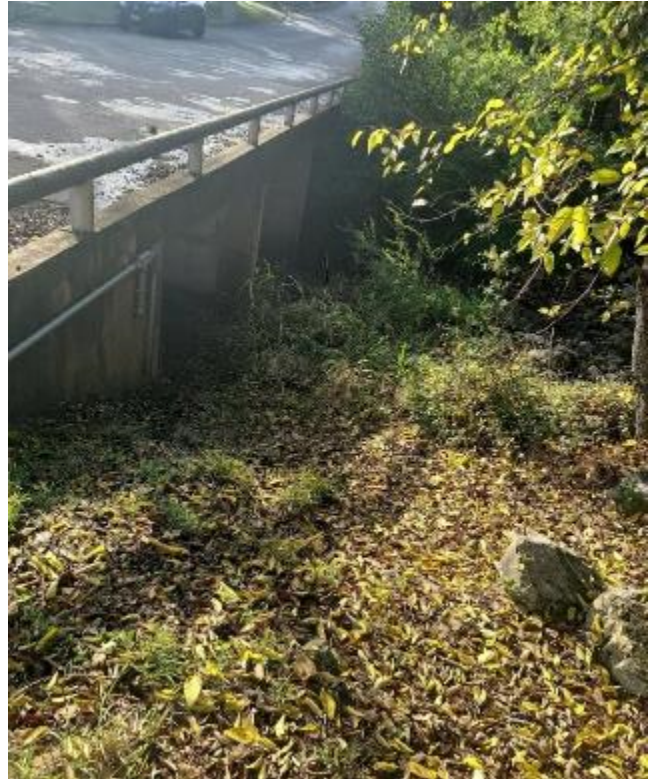
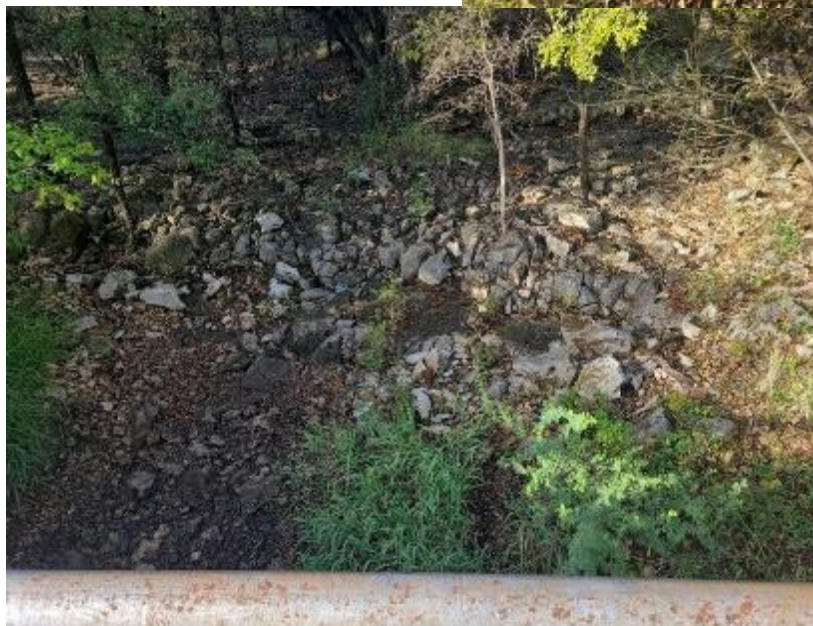
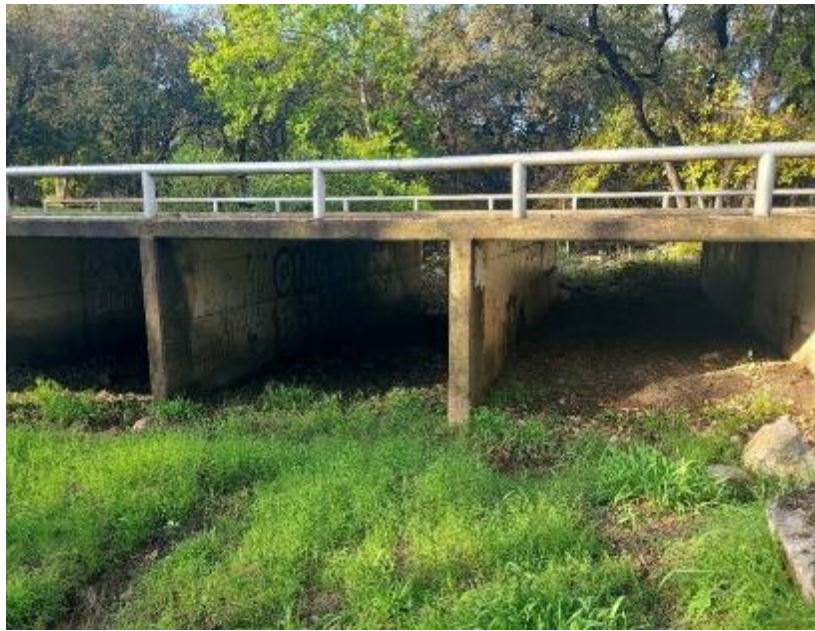
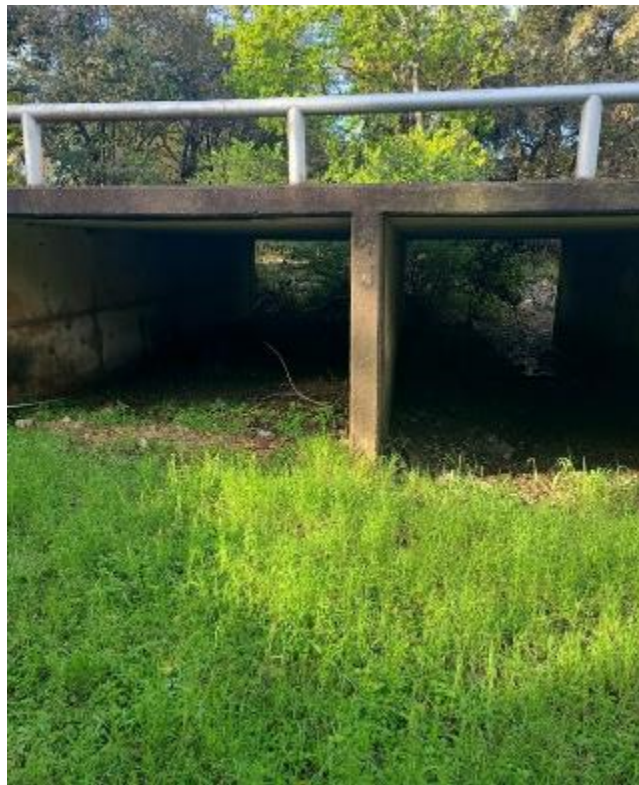
## Sagecrest Crossing West

Field Notes: Vegetation on the North side of bridge is overgrown.

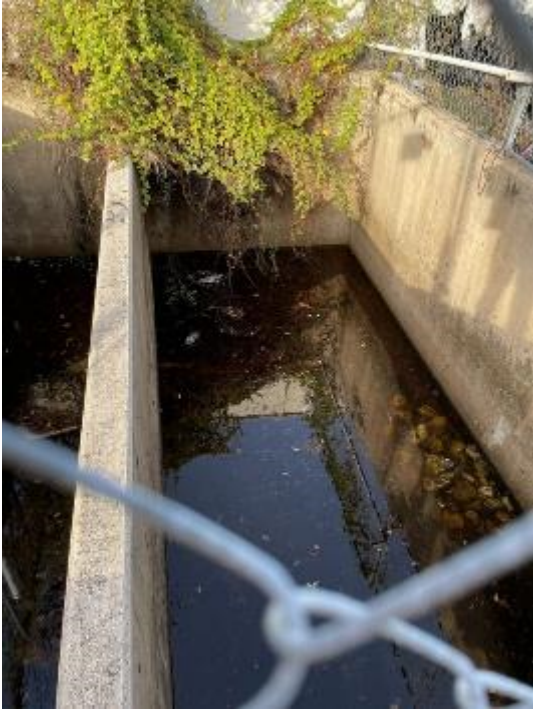
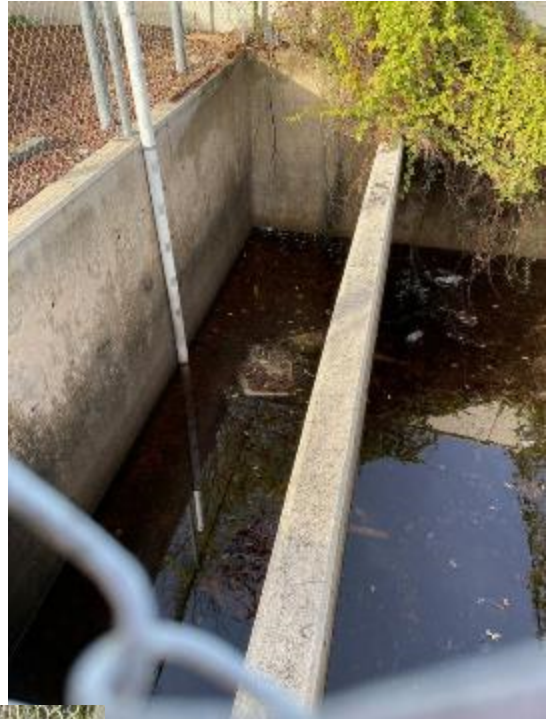
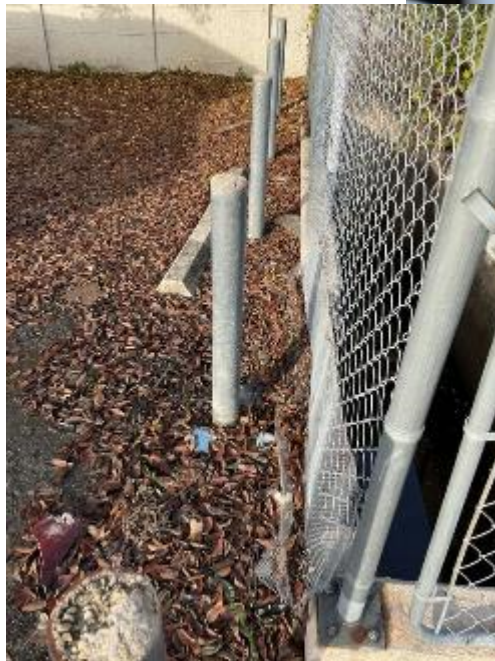
### Service King Collision Repair Extended Parking Lot PCD

Field Notes: Clear sediment blocking inlet on West side.
