# TOWN OF HOLLYWOOD PARK, TX

2023 Winter Inspection

# HOLLYWOOD PARK 2023 WINTER INSPECTION REPORT

**Subject:** Annual Municipal Separate Storm Sewer System (MS4) Inspection

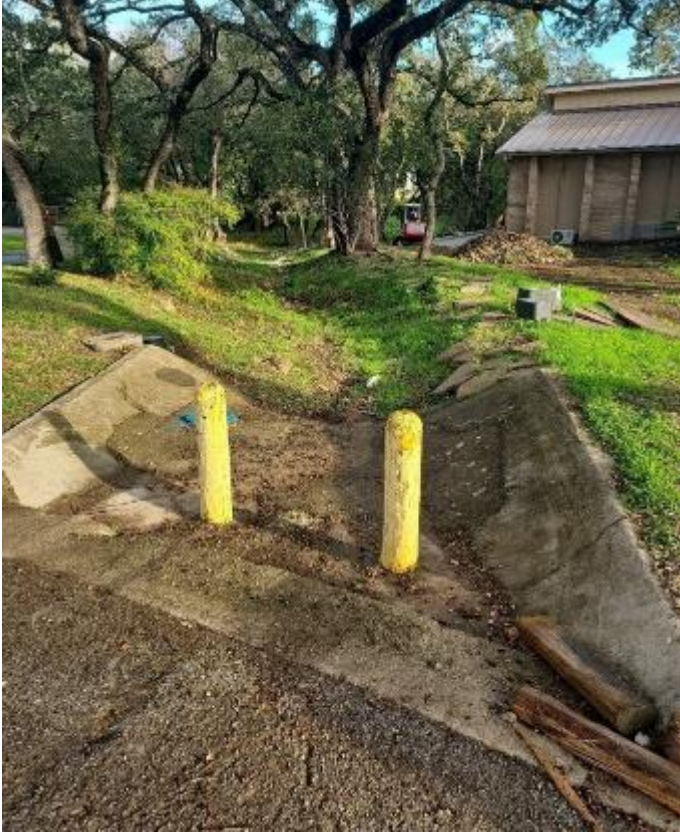
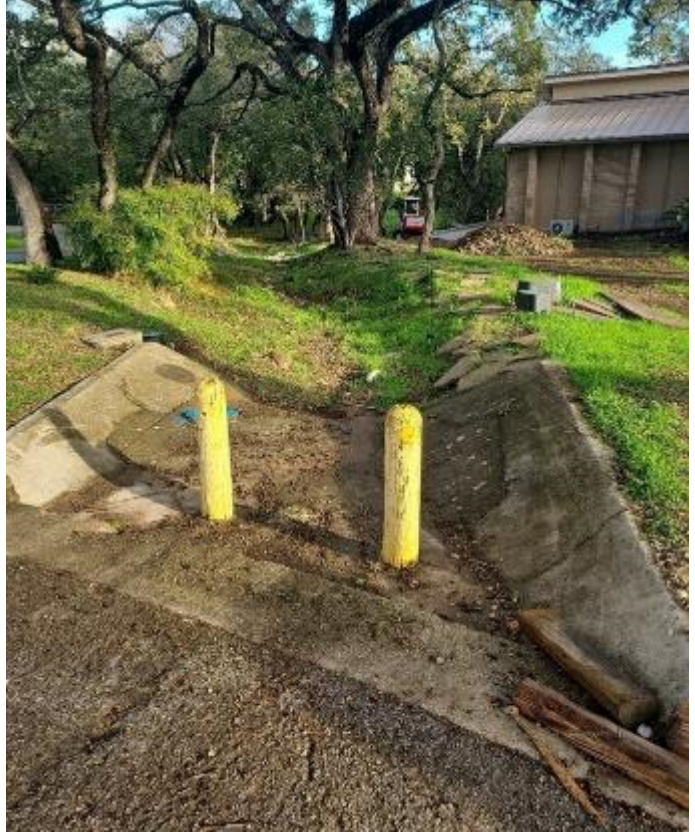
## Shady Trails Rundown

Field Notes: Good condition.

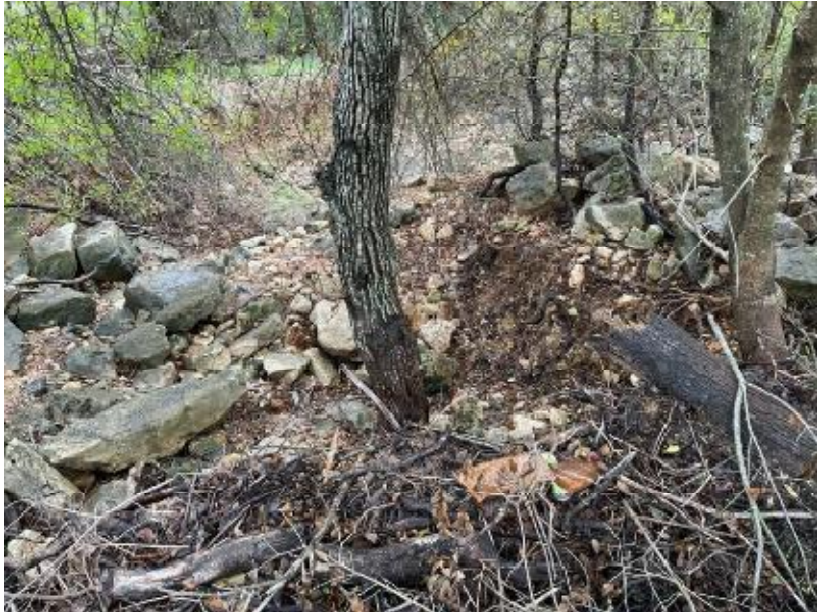
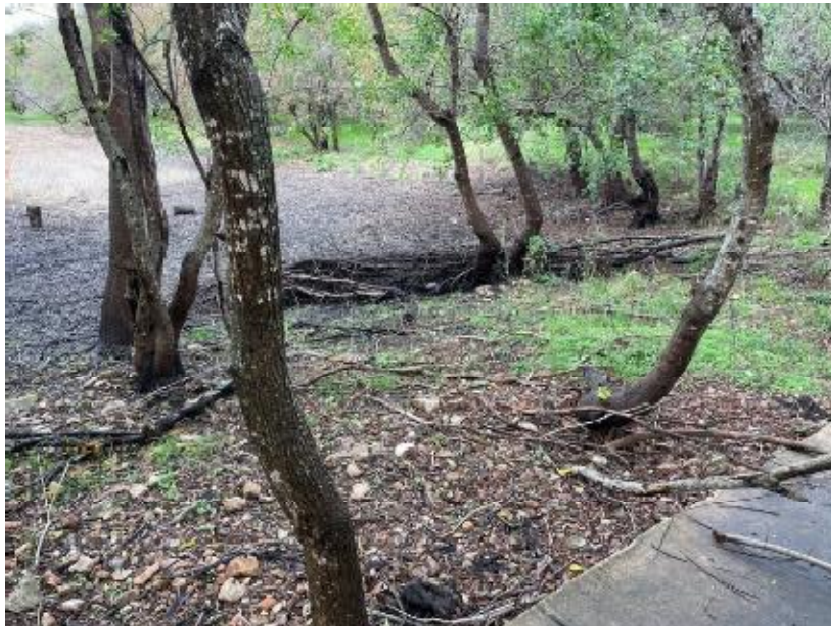
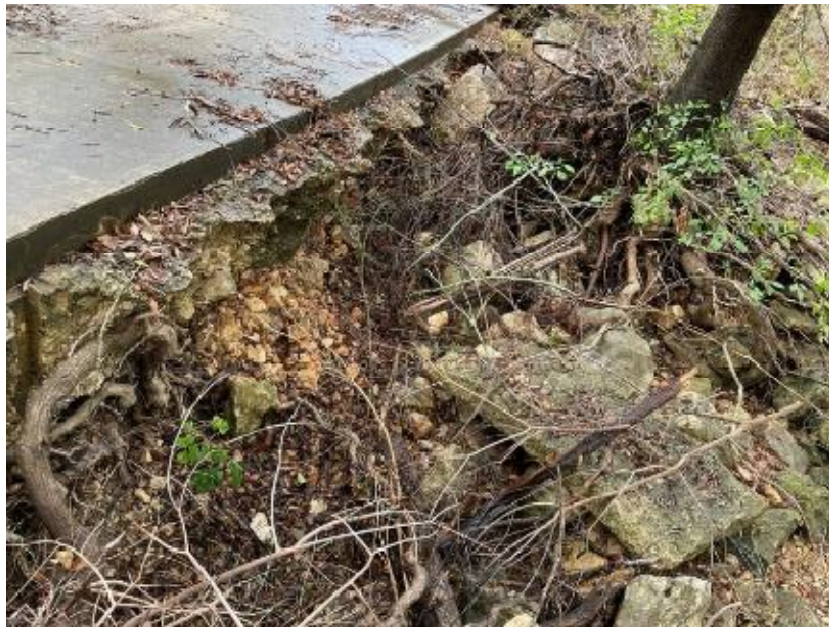
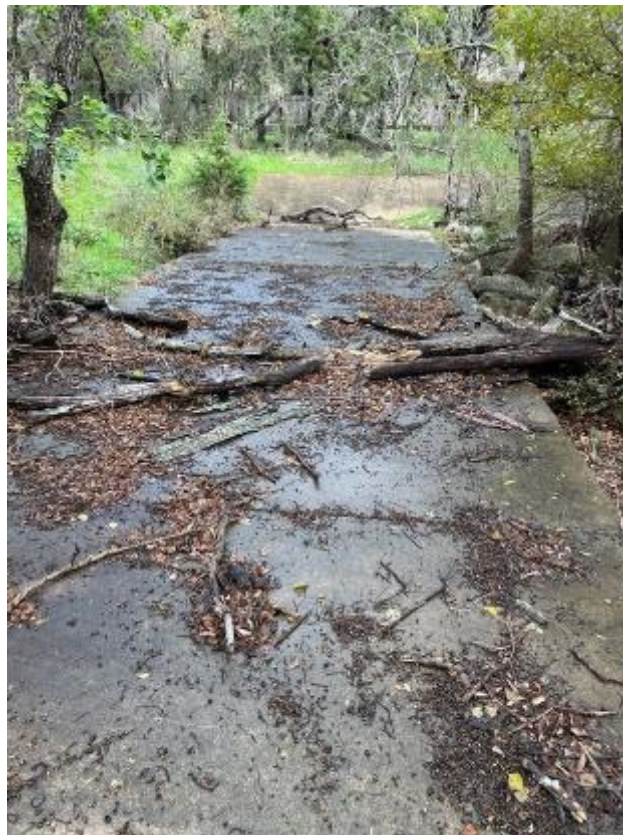
## Spillway Structure

Field Notes: Remove vegetation monitor scouring.

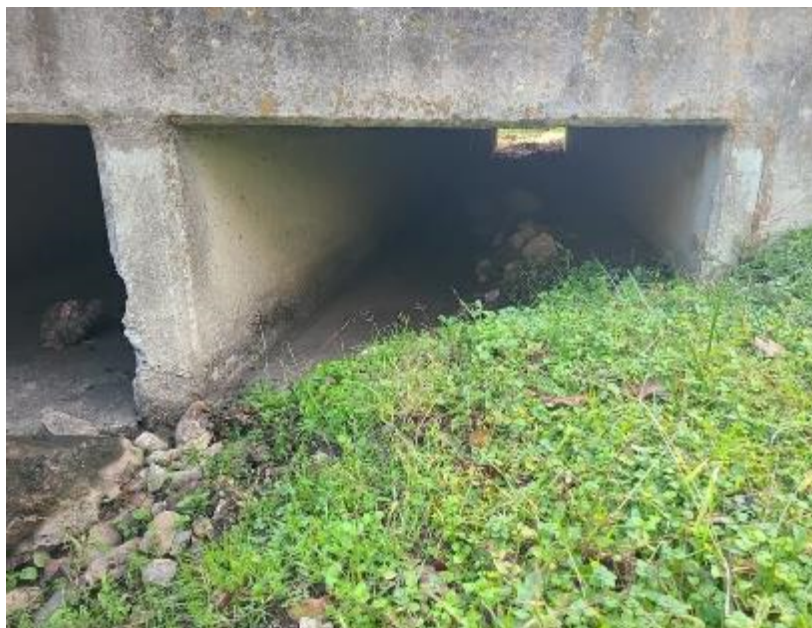
## Sterling Browning Crossing

Field Notes: Recent rainfall event. Remove sediment from channel and pipes.

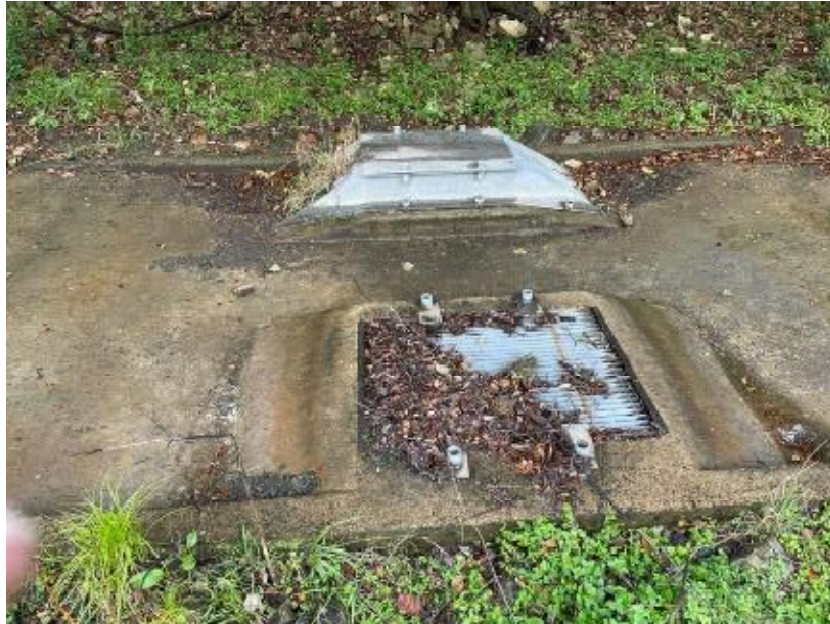
## Stream Gauge

Field Notes: Clear leaves and vegetation from grate.

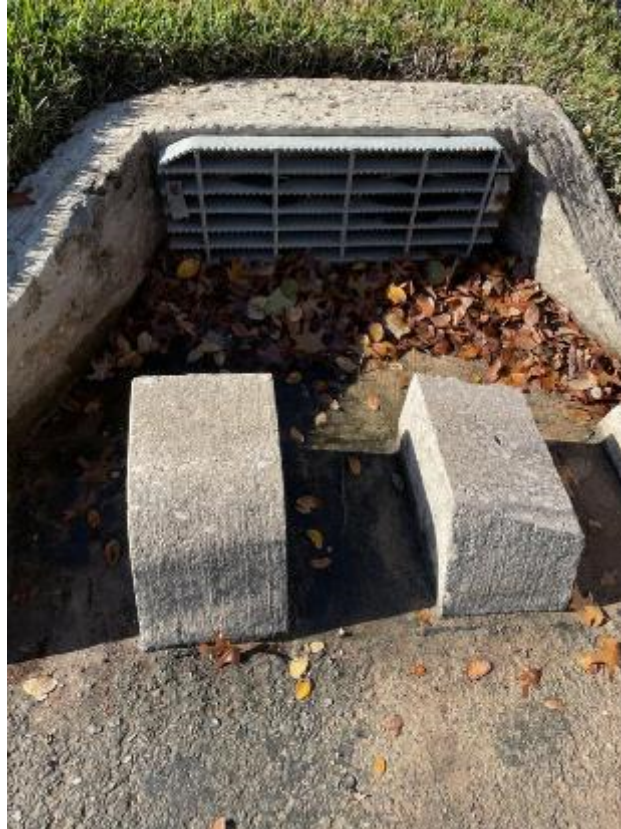
## Street Outlet, 1

Field Notes: Minor leaf deposit looks good otherwise.

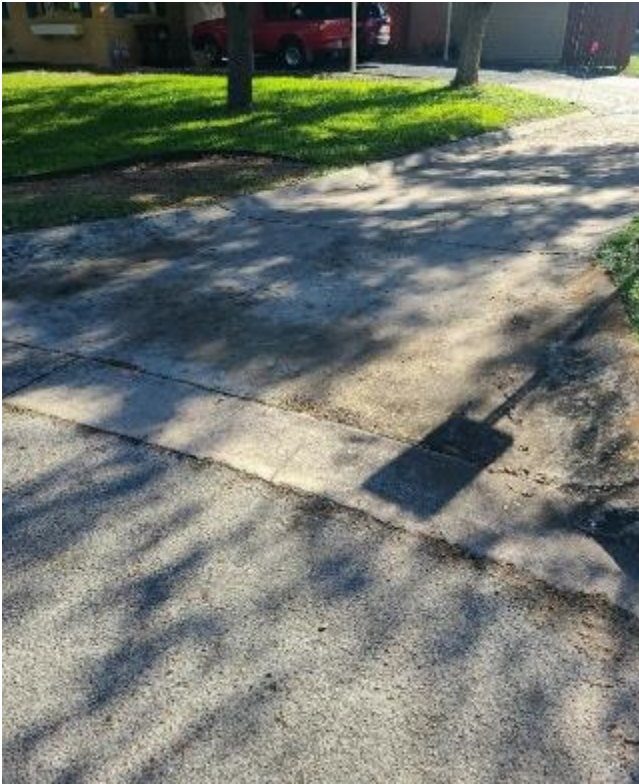
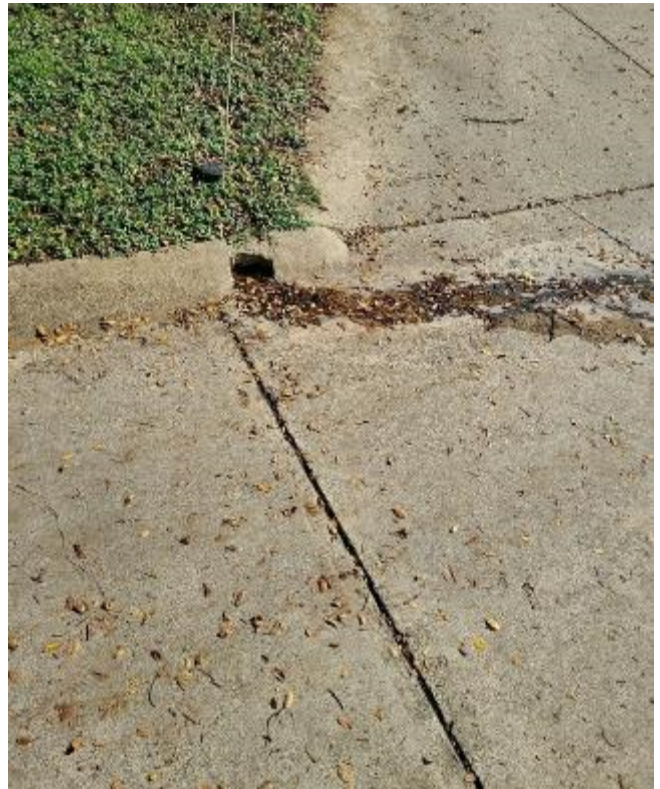
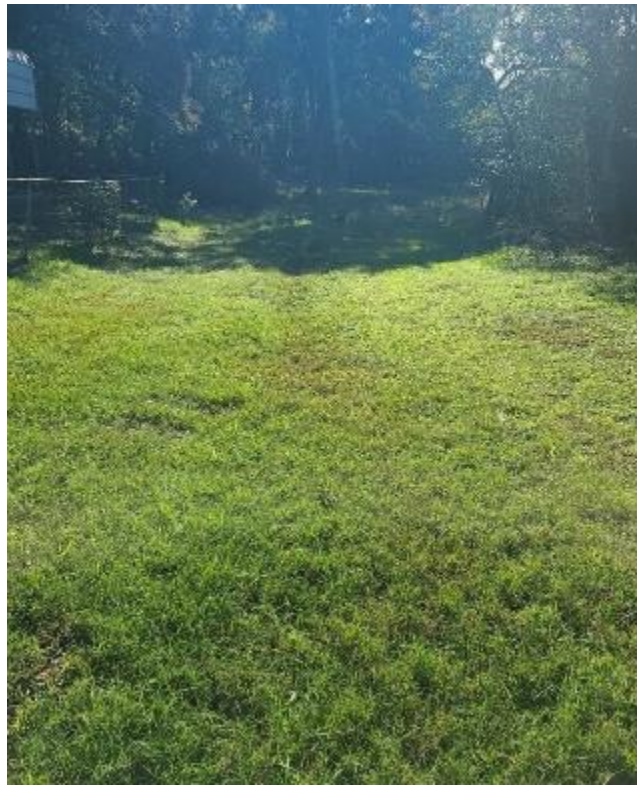
## Tall Oak Outfall

Field Notes: Outfall in good condition.

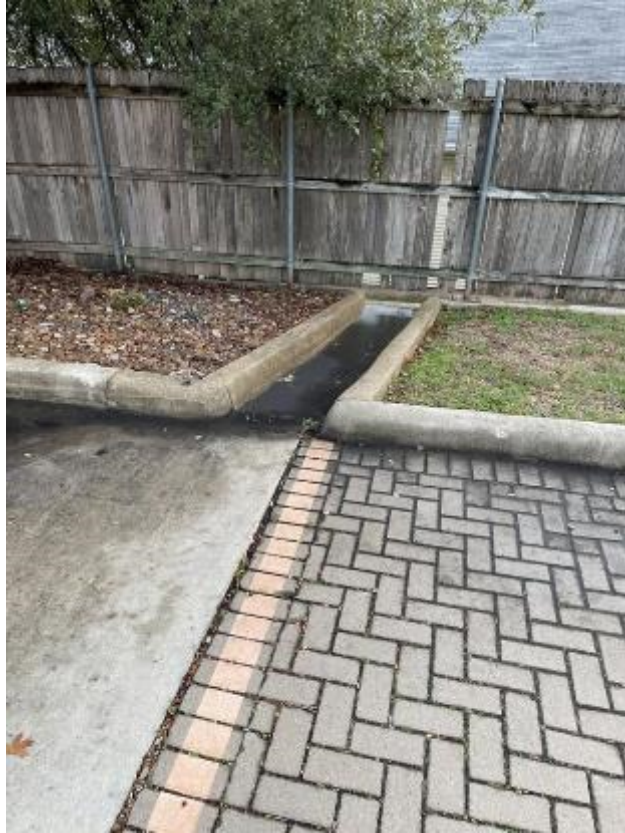
## Texas Roadhouse

Field Notes: Looks good, monitor sediment, vegetation, and trash buildup.

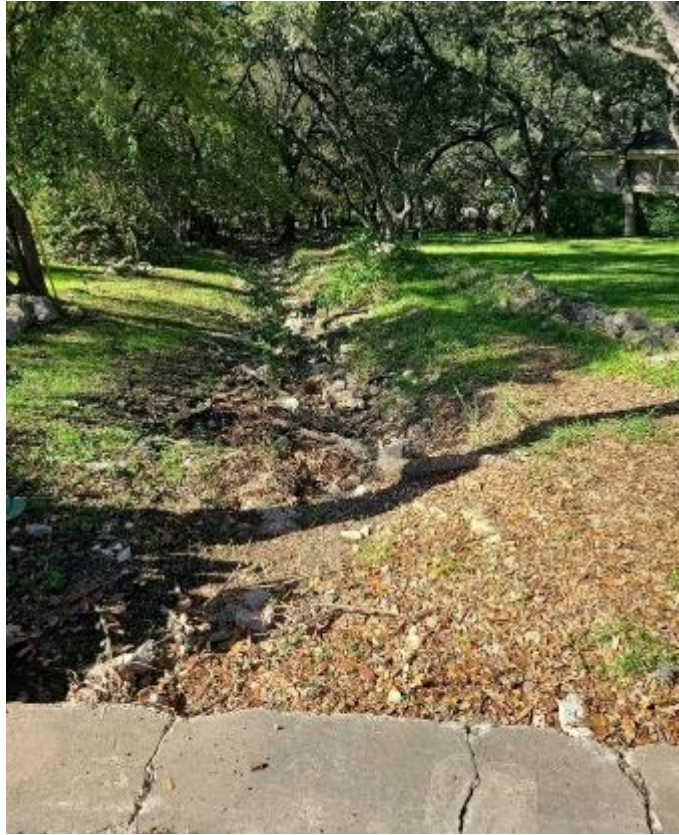
## Tiger Tail Outfall

Field Notes: Outfall in good condition.

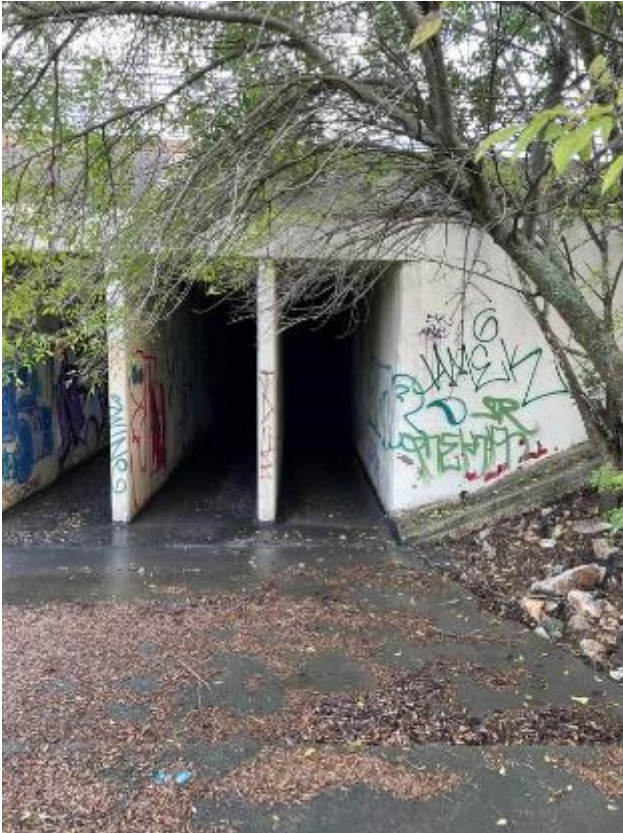
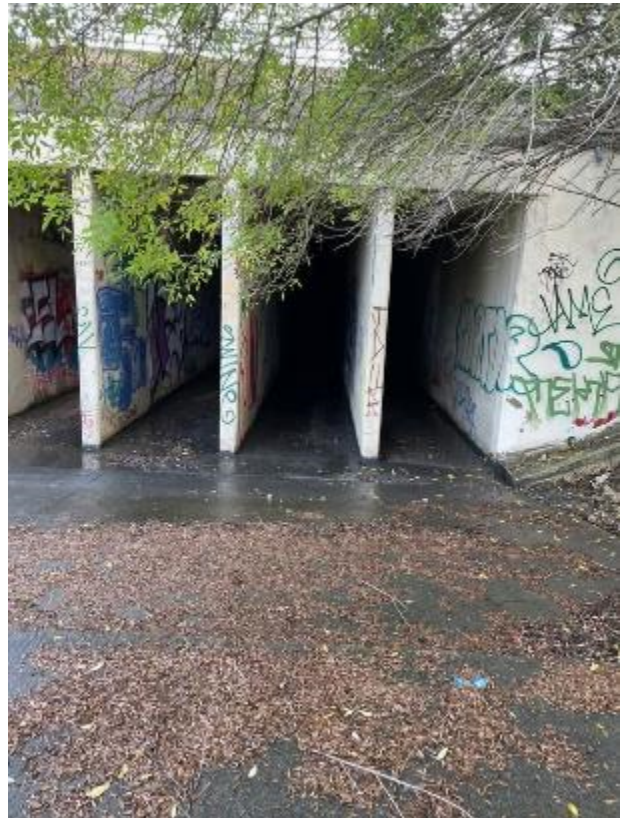
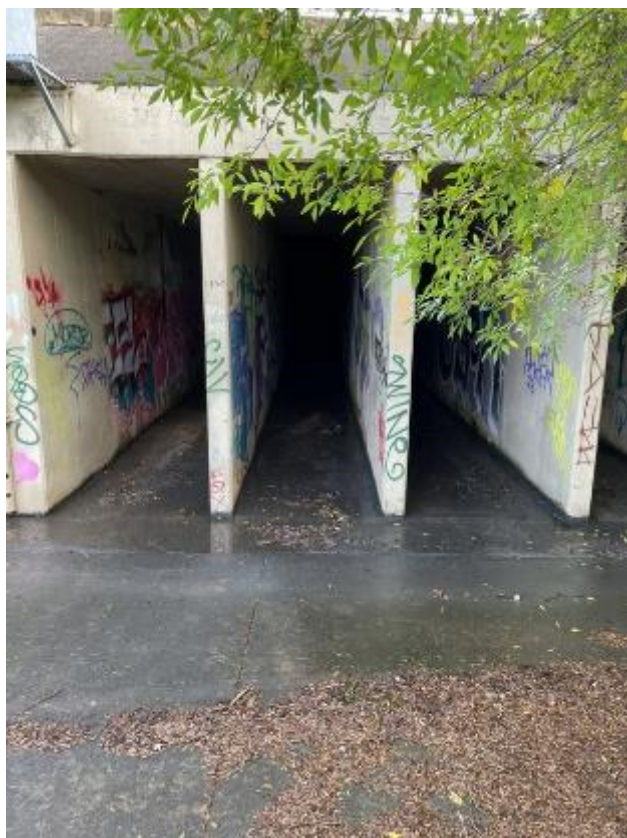
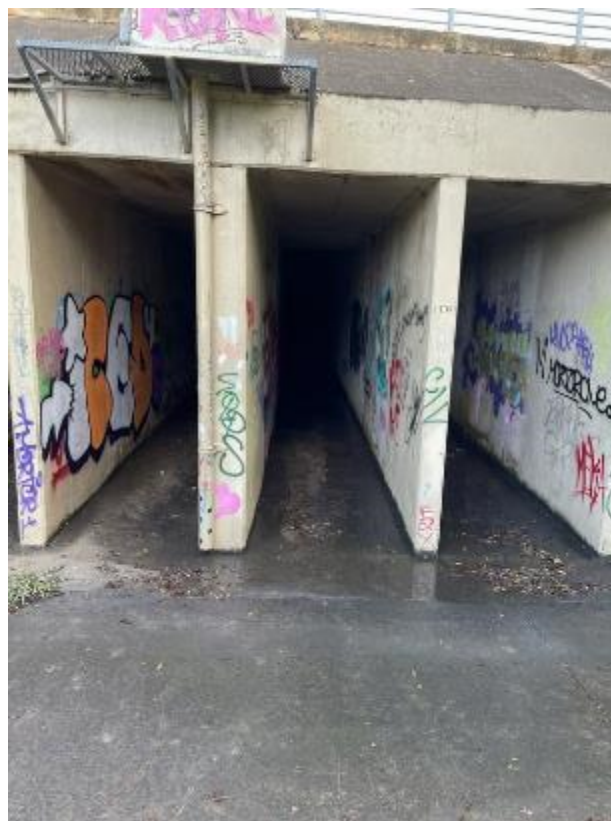
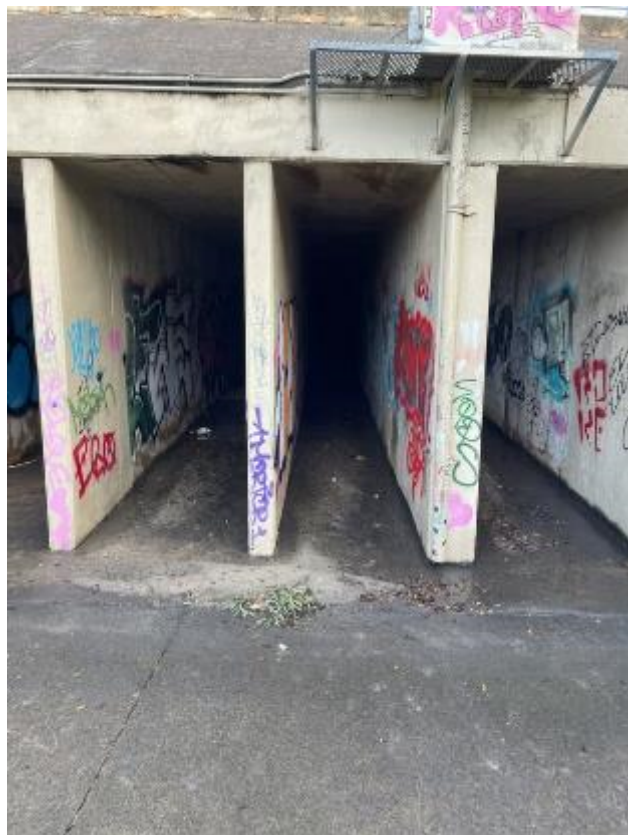
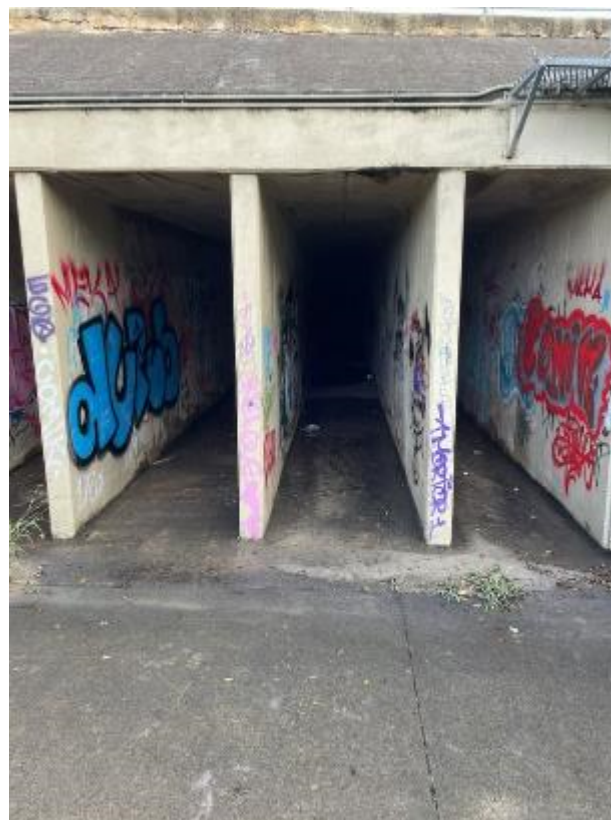
## TXDOT Creek at Lorence

Field Notes: Looks good.

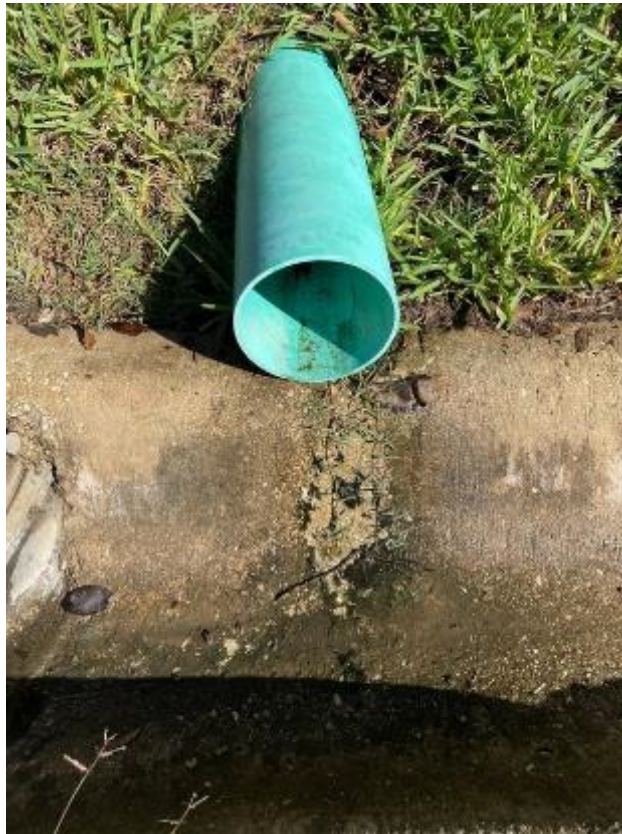
## Unknown Residential Drainpipe into MS4 System

Field Notes: Looks good.

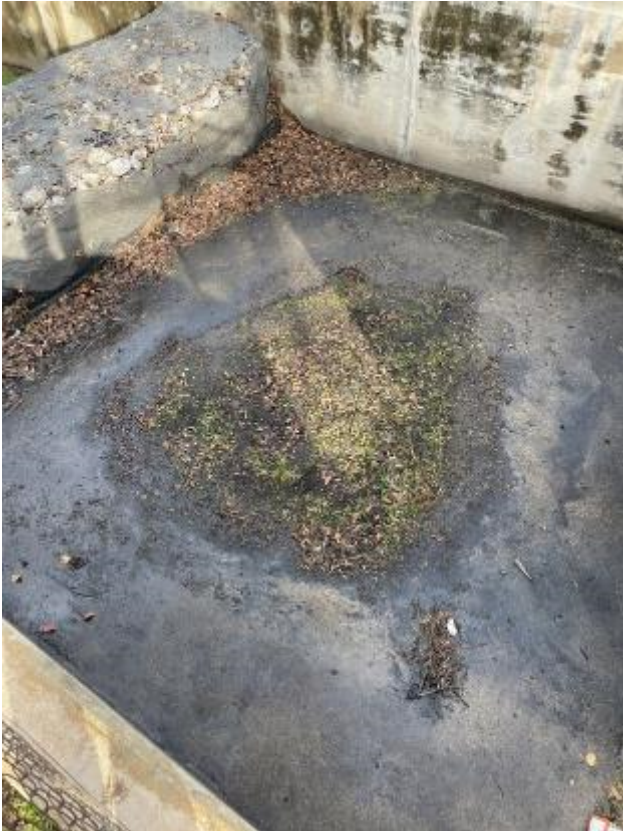
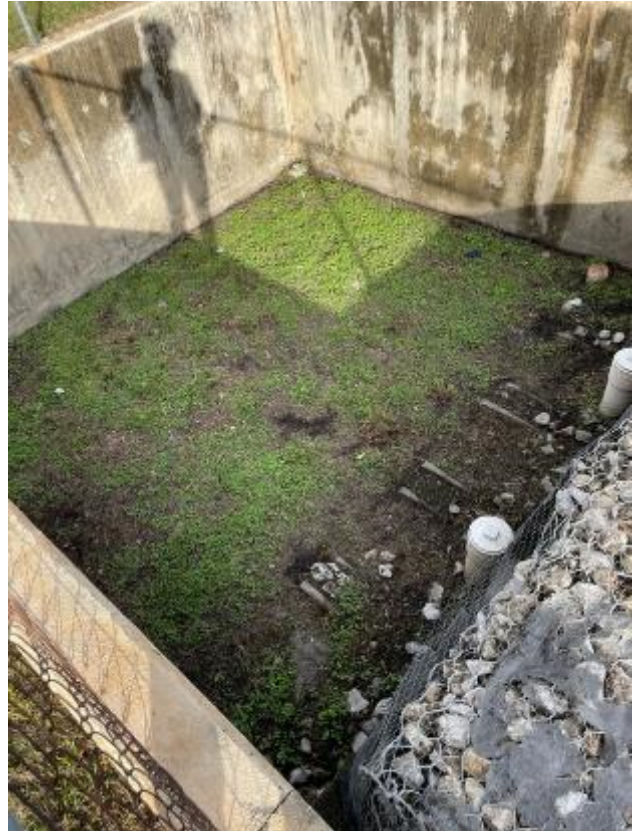
## Valvoline PCD

Field Notes: Minor sediment.

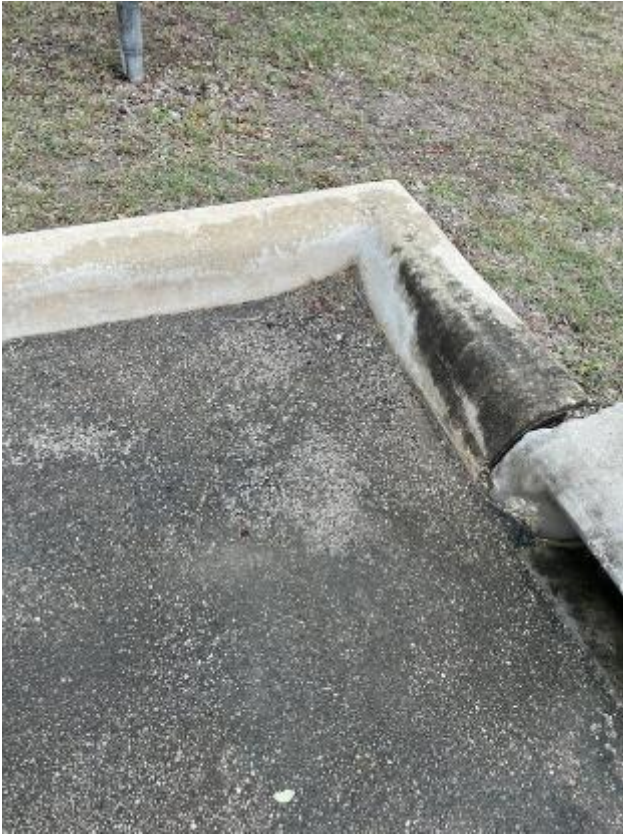
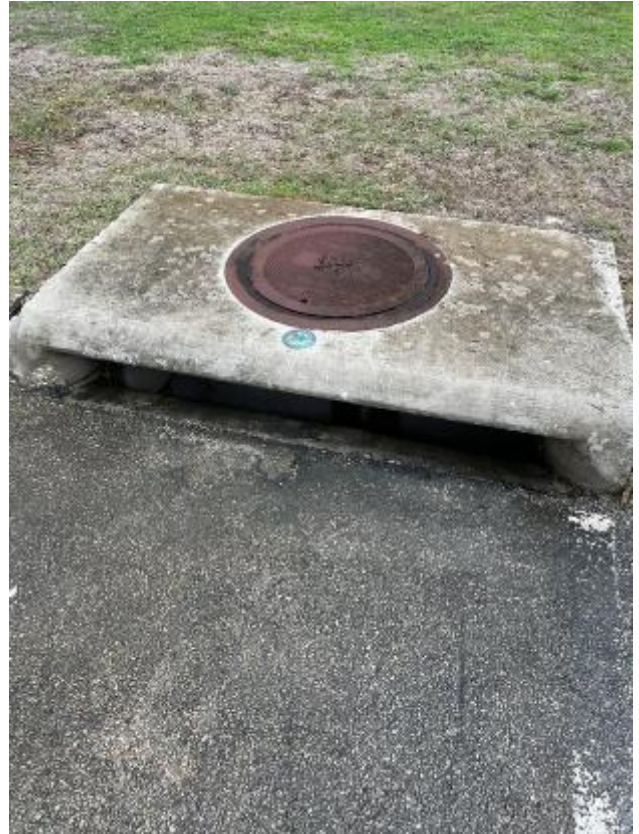
## Varco

Field Notes: Sediment buildup east side of inlet

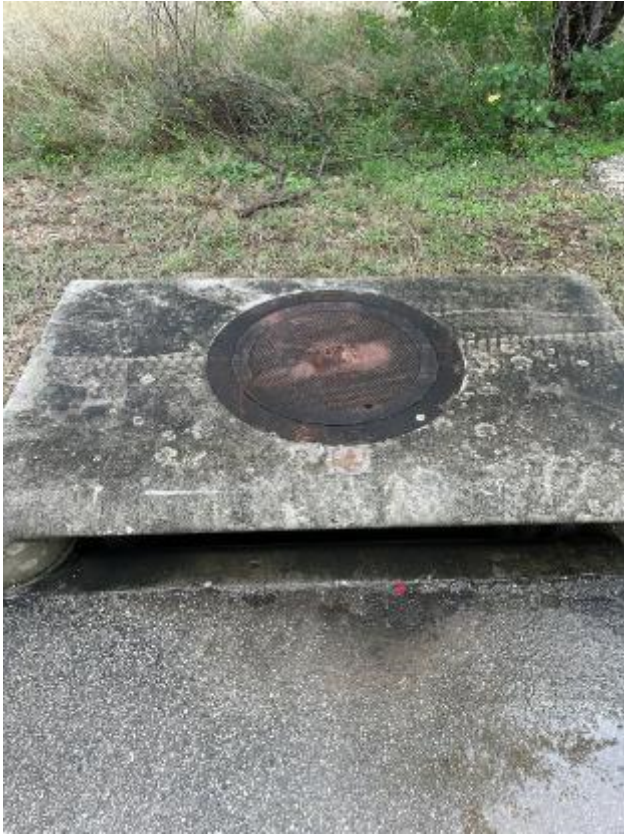
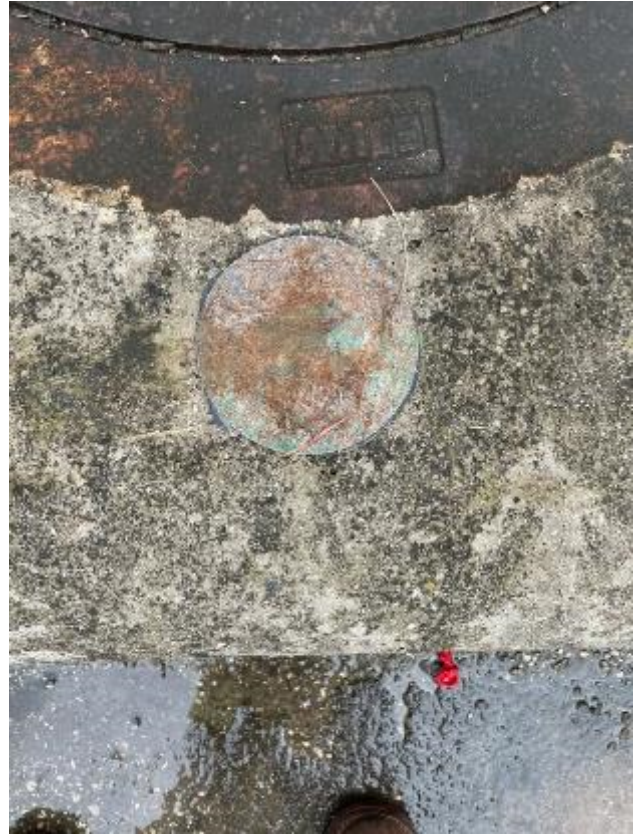
## Varco 2

Field Notes: Looks good. The medallion has been replaced.

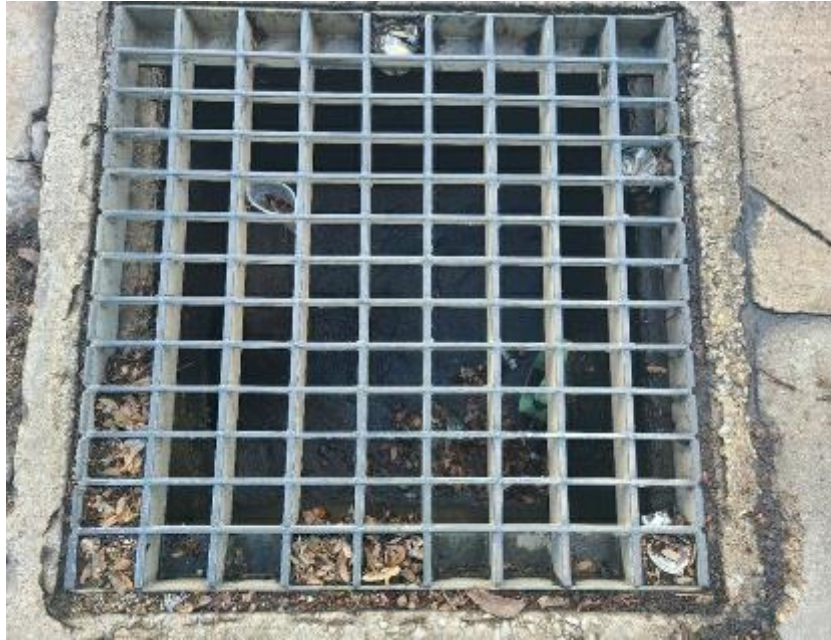
## Voigt Grate Inlet

Field Notes: Inlet in good condition. Looks clean.

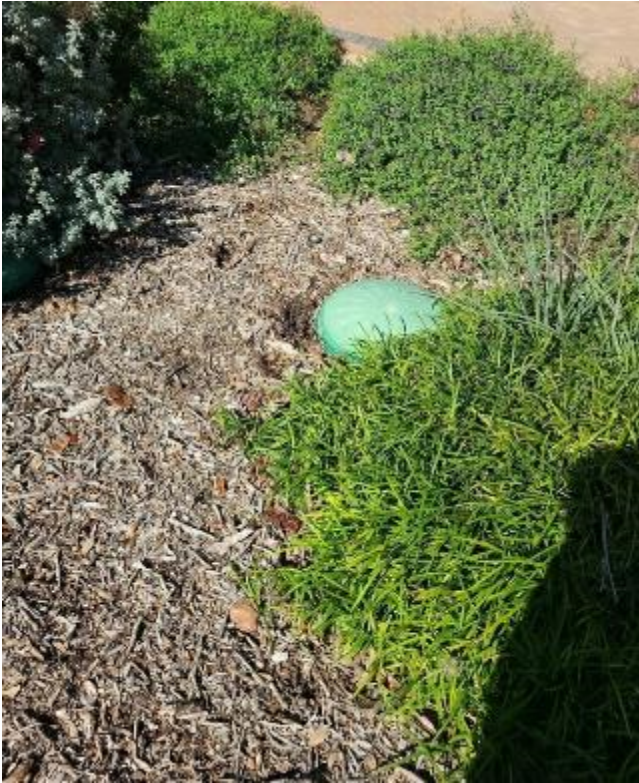
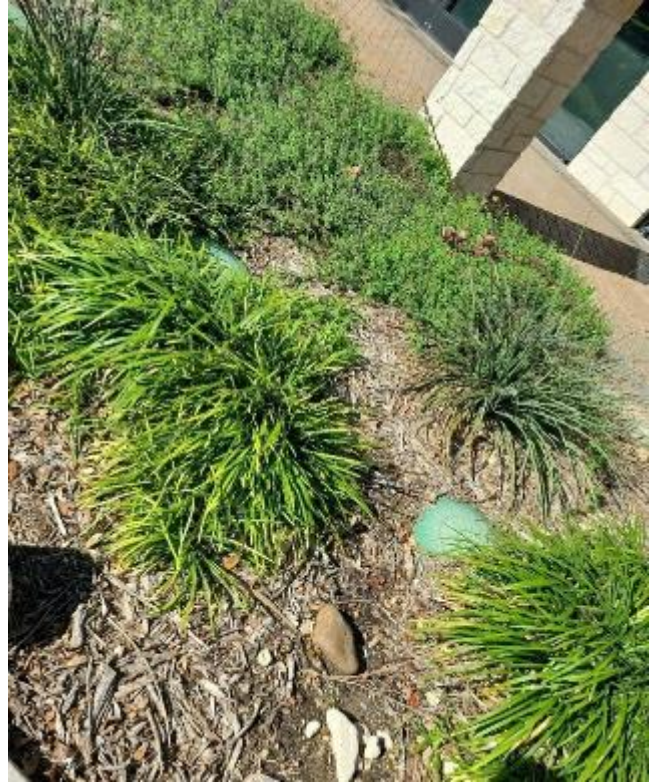
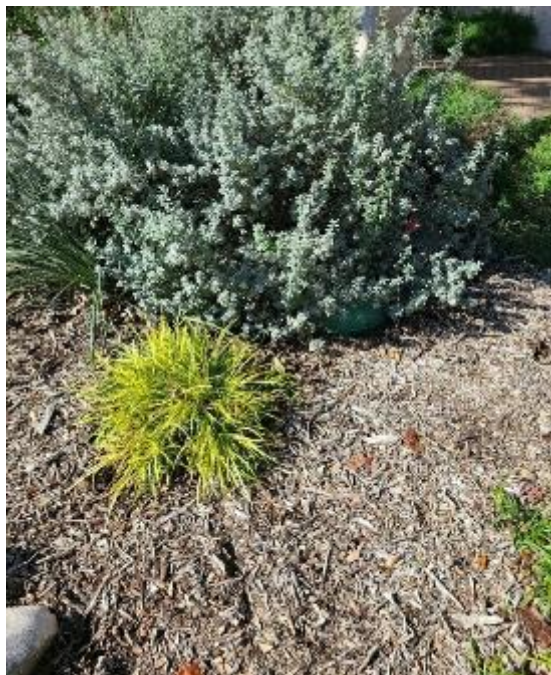
## Voigt Park Inlet

Field Notes: Inlets are in good condition.

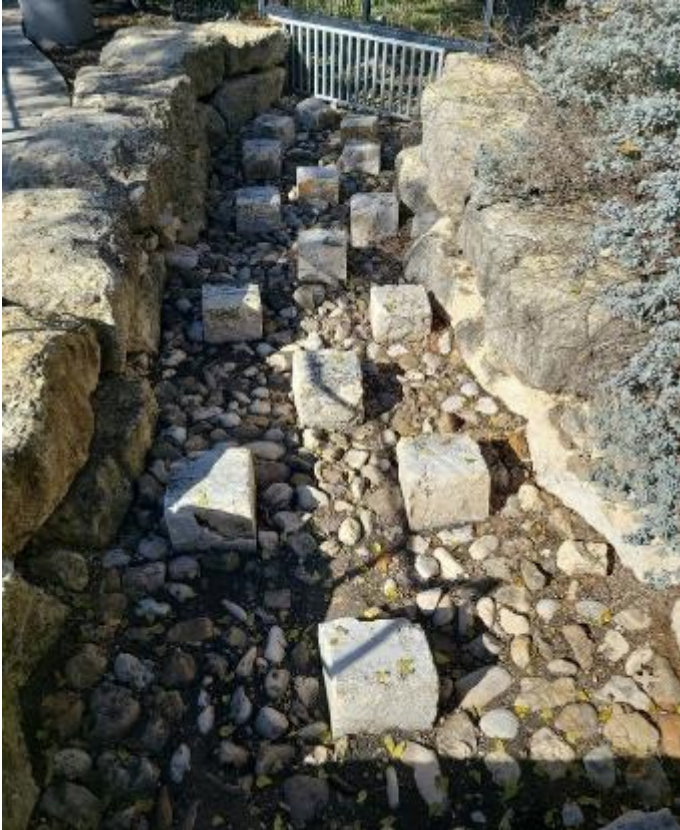
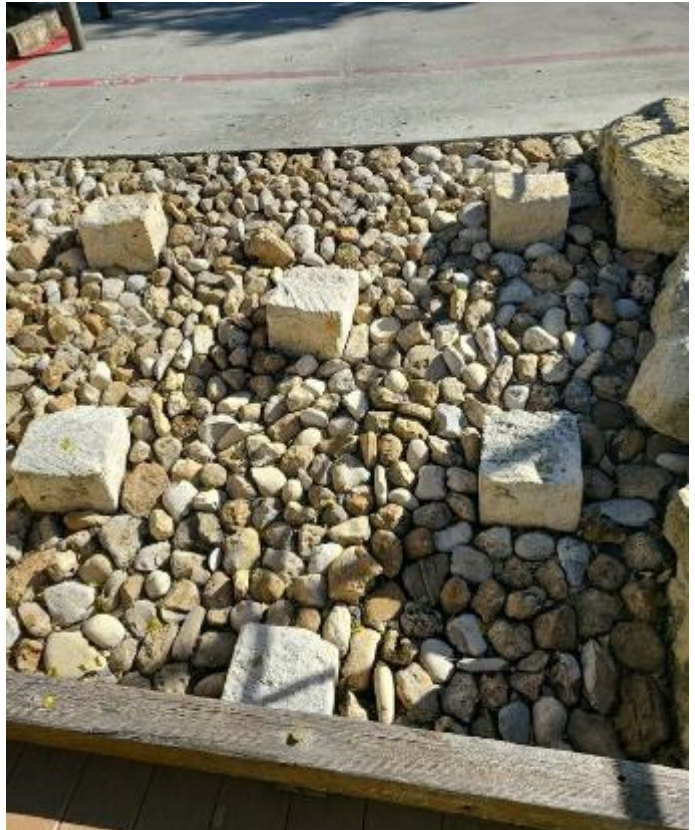
Field Notes: Channel area is clean.

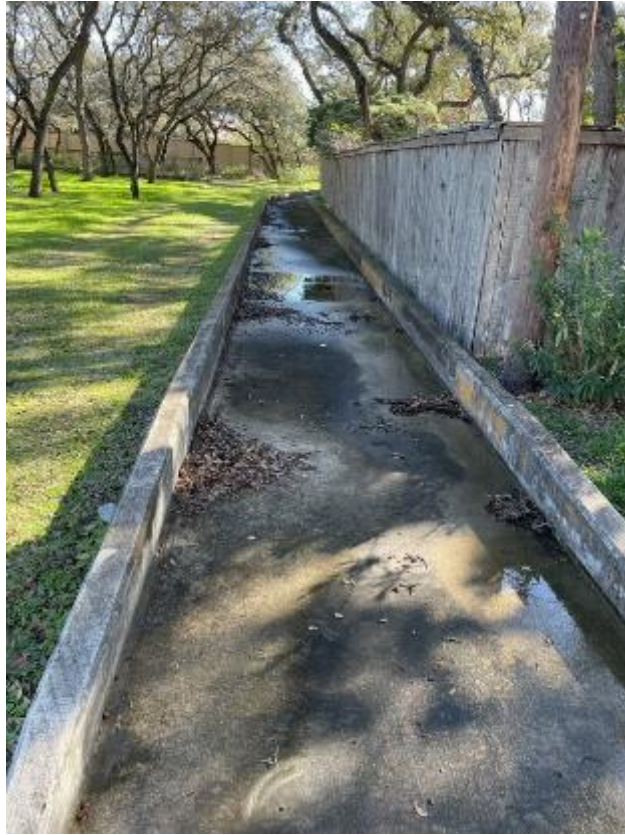
## William Classen Outfall

Field Notes: Looks good.

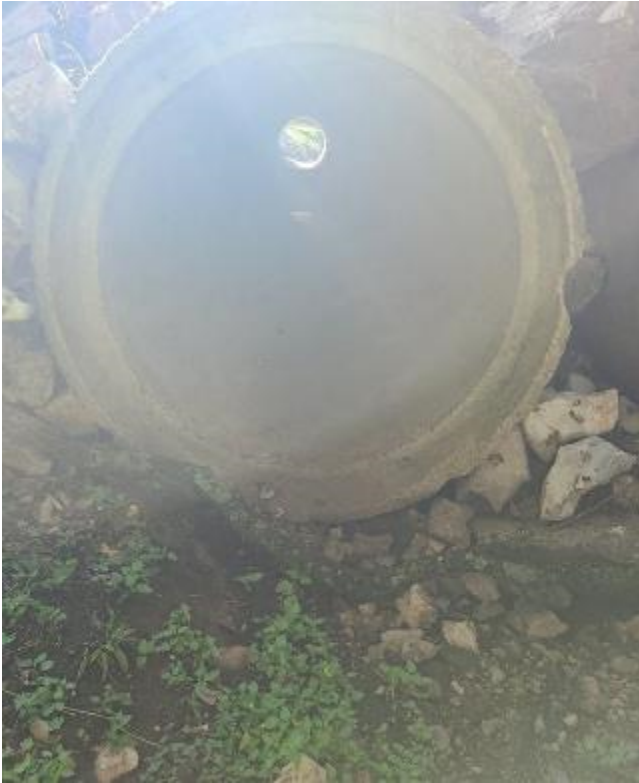
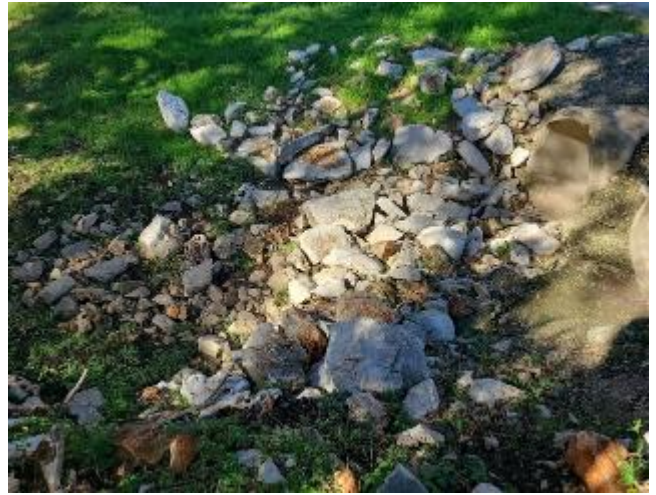
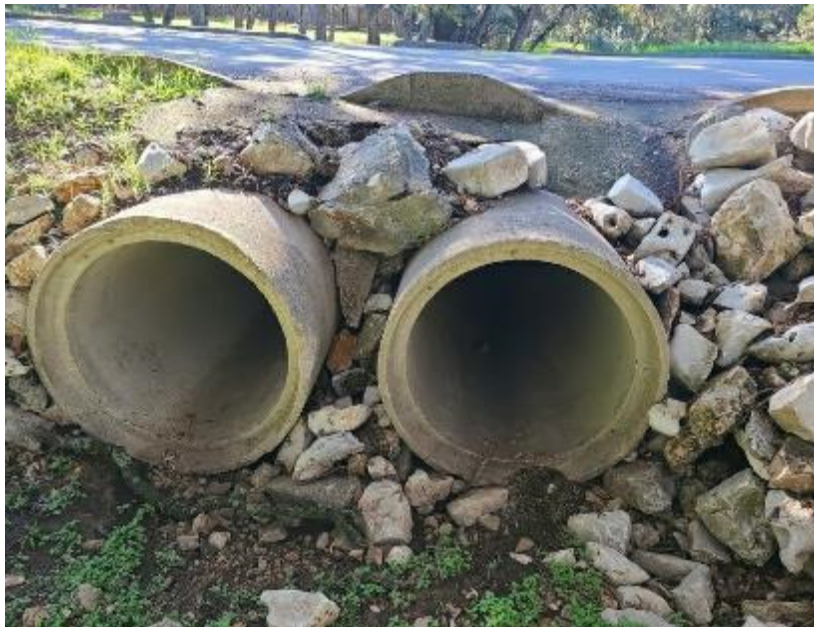
## Yosemite Crossing East

Field Notes: Pipes in good condition. Channel is clean.

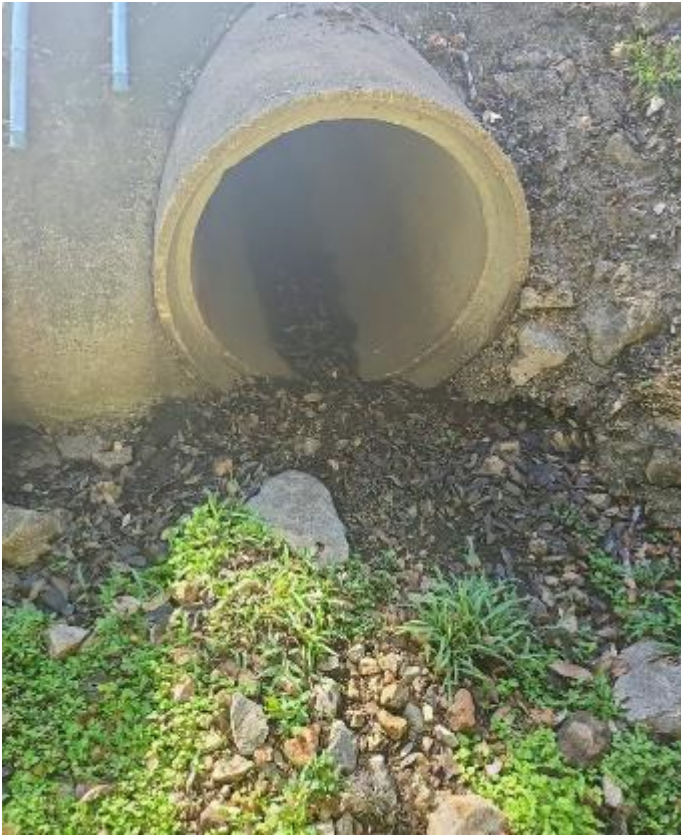
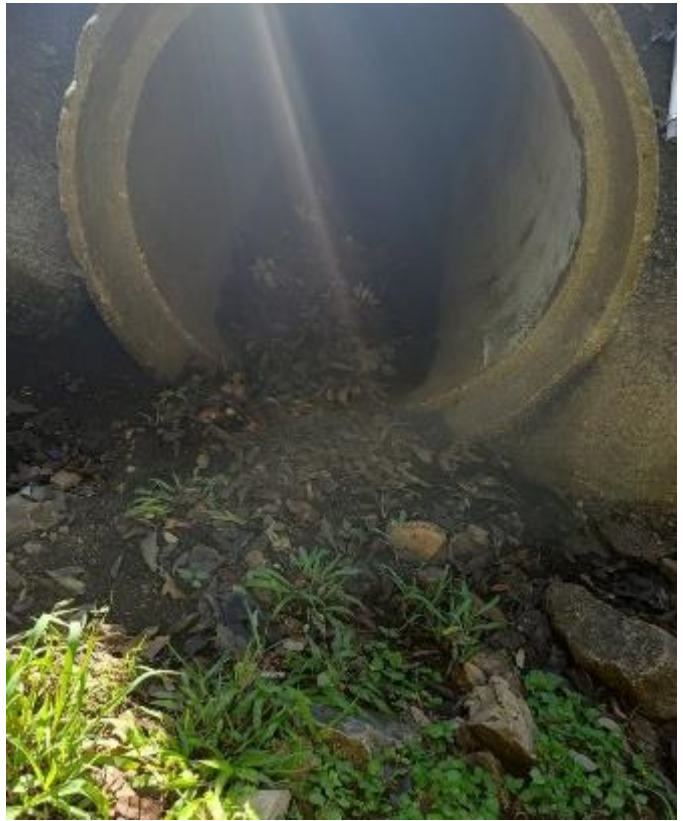
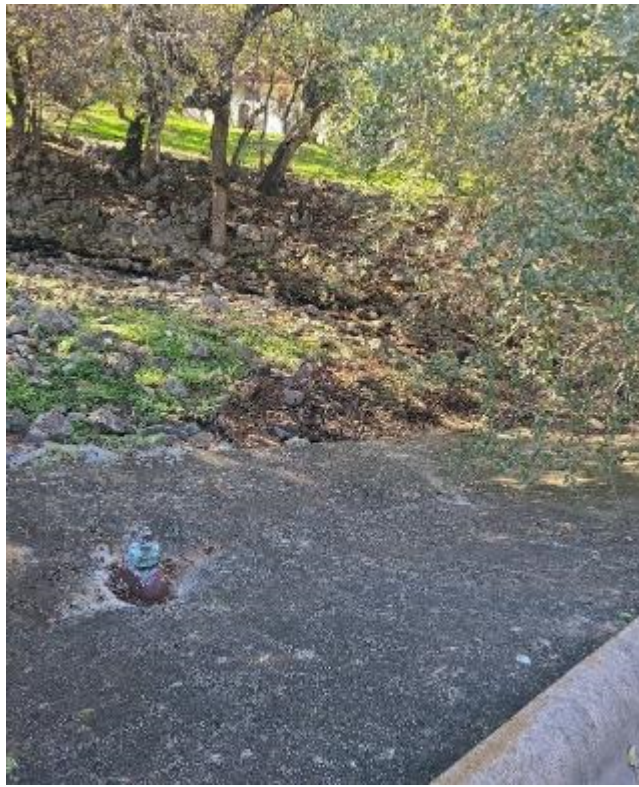
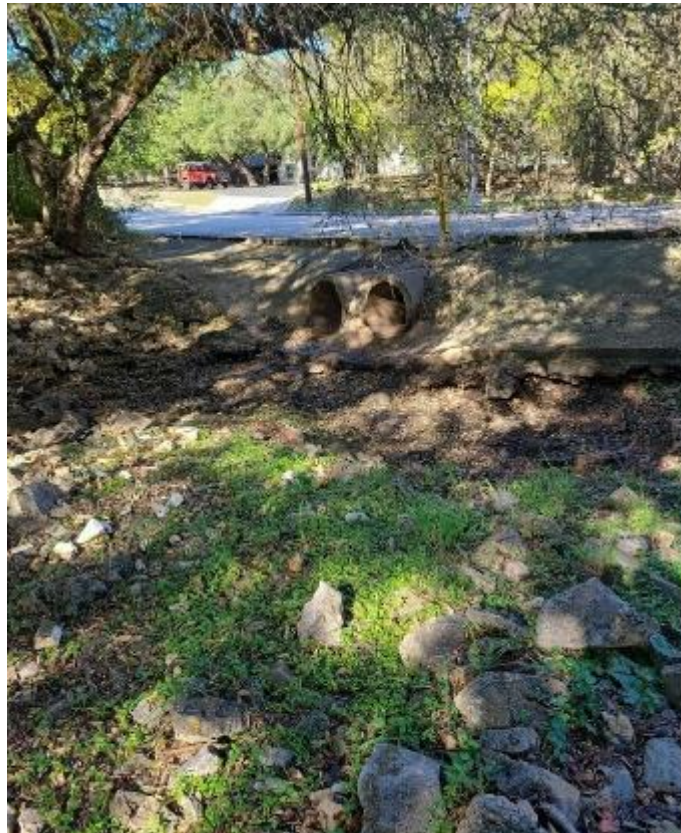
## Yosemite Crossing West

Field Notes: Pipes in good condition. Channel is clean.
