# TOWN OF HOLLYWOOD PARK, TX

2024 Summer Inspection

## HOLLYWOOD PARK 2024 SUMMER INSPECTION REPORT

**Subject:** Annual Municipal Separate Storm Sewer System (MS4) Inspection

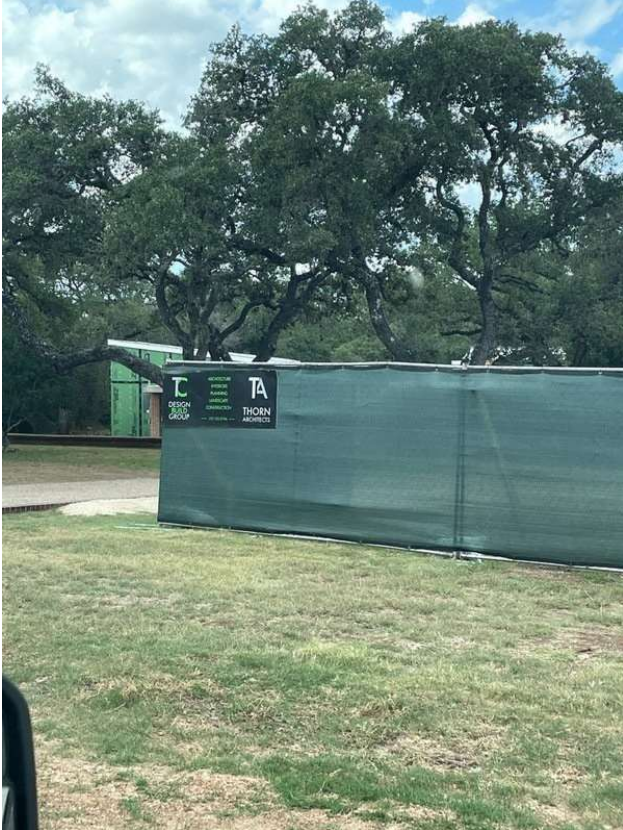
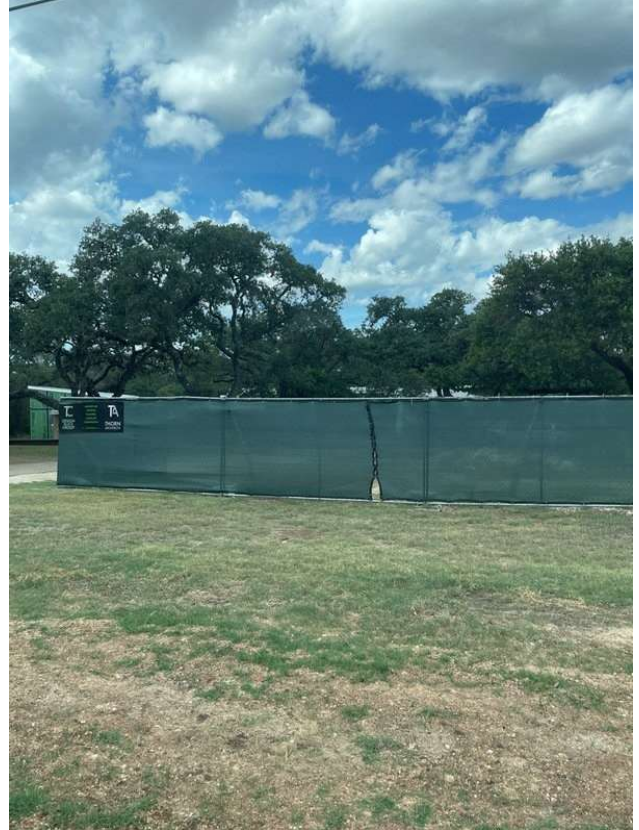
Field Notes: Monitor for runoff.

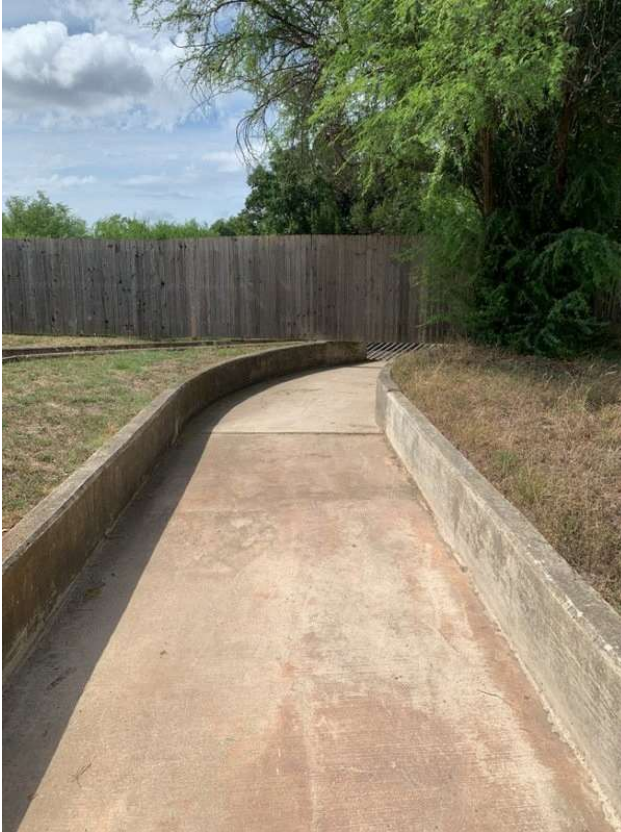
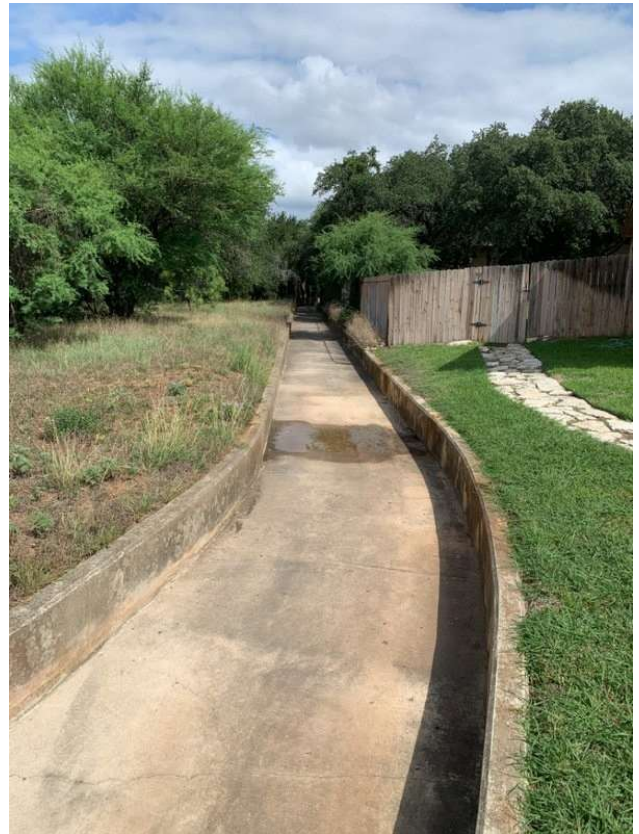
## Amber Creek Drainage Channel

Field Notes: Looks good.

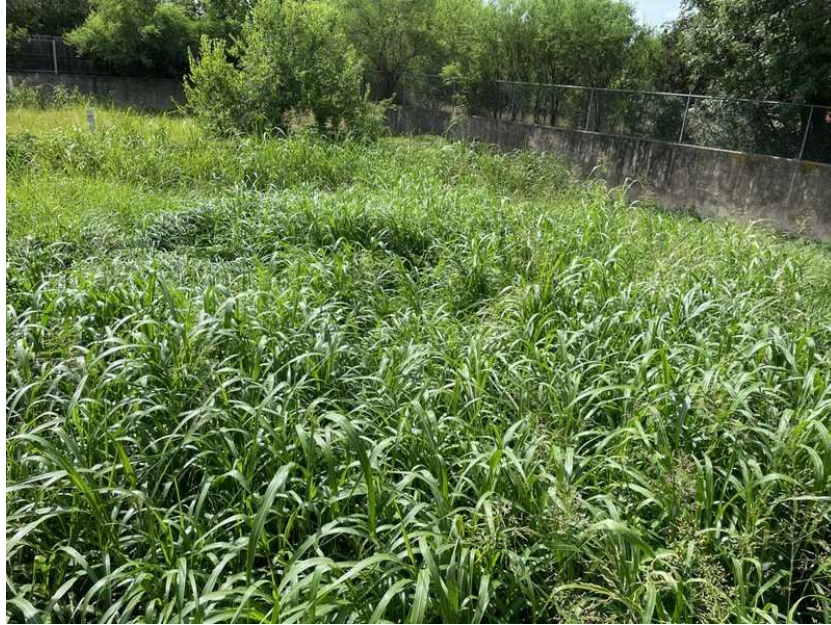
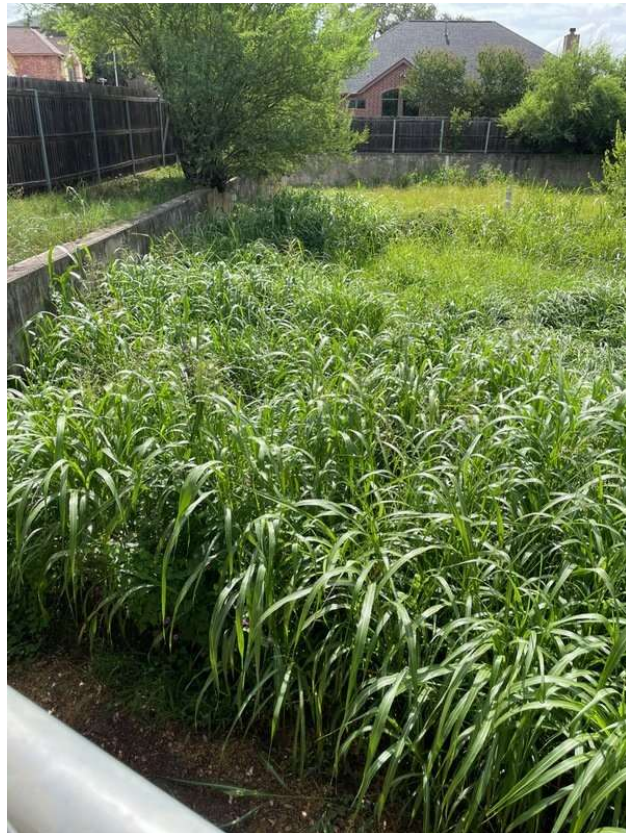
## Amber Creek PCD

Field Notes: Needs mowing.

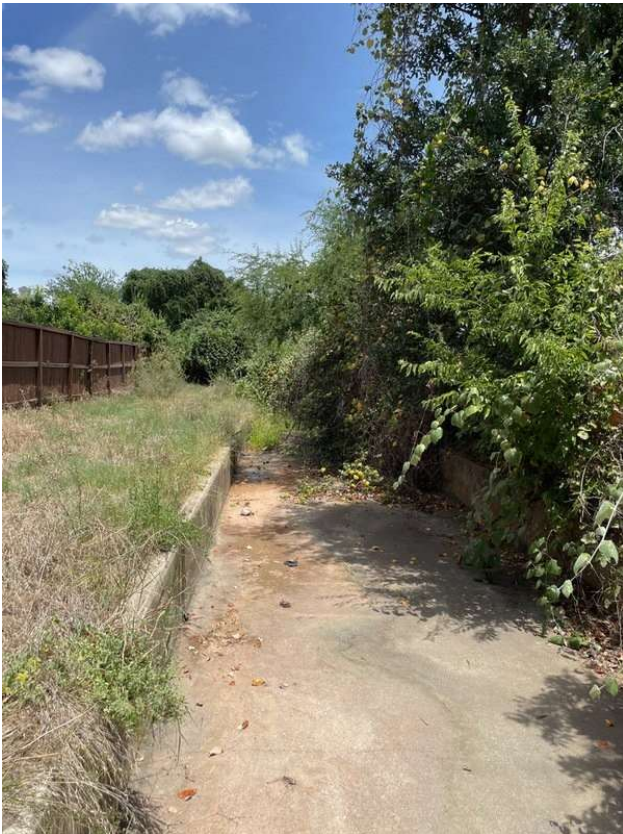
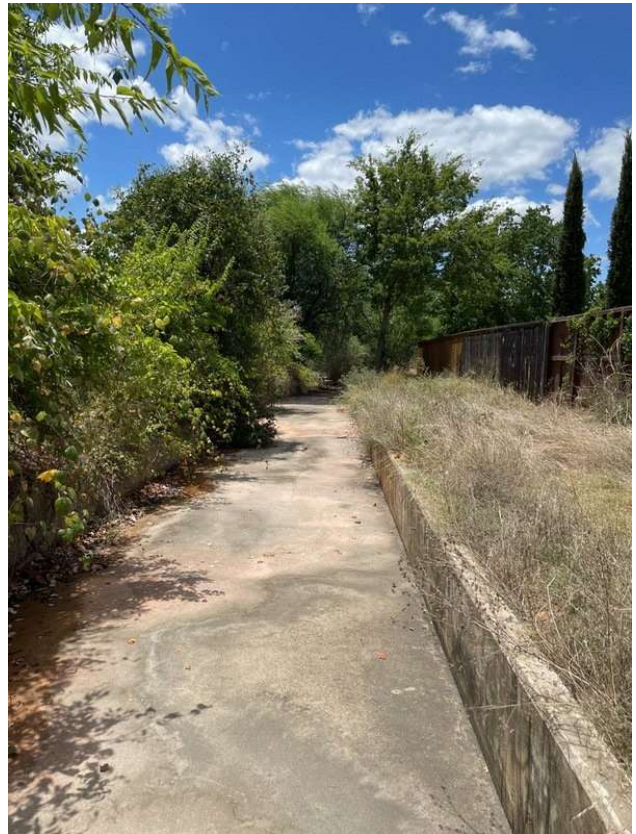
## Amber Creek Southern Outfall and Channel

Field Notes: Clear out vegetation on Eastern most channel extents otherwise good.

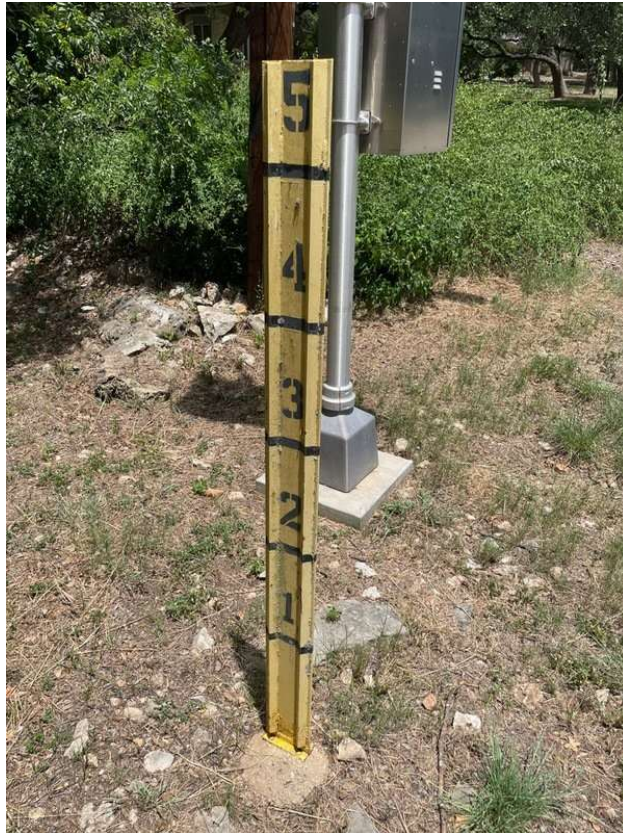
## Antelope Dr Low Water Crossing

Field Notes: Looks good.

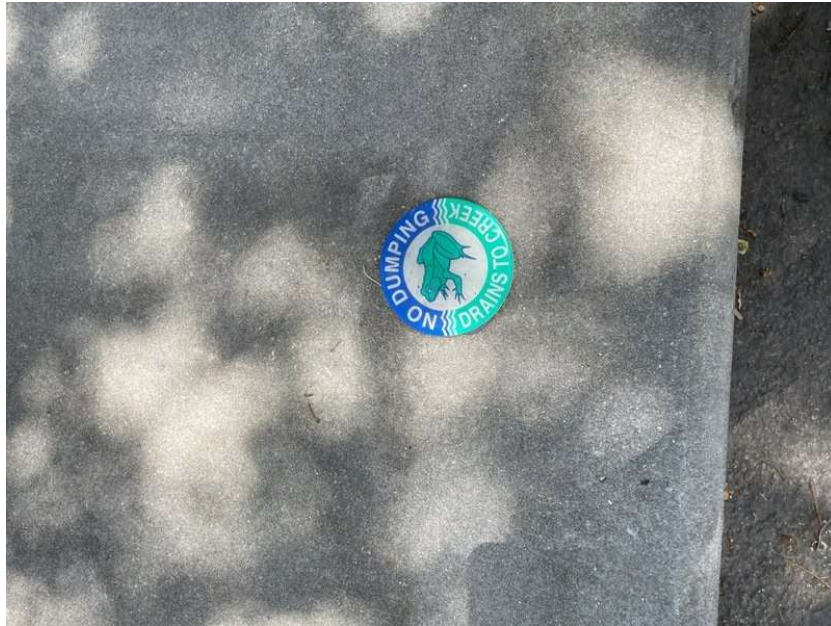
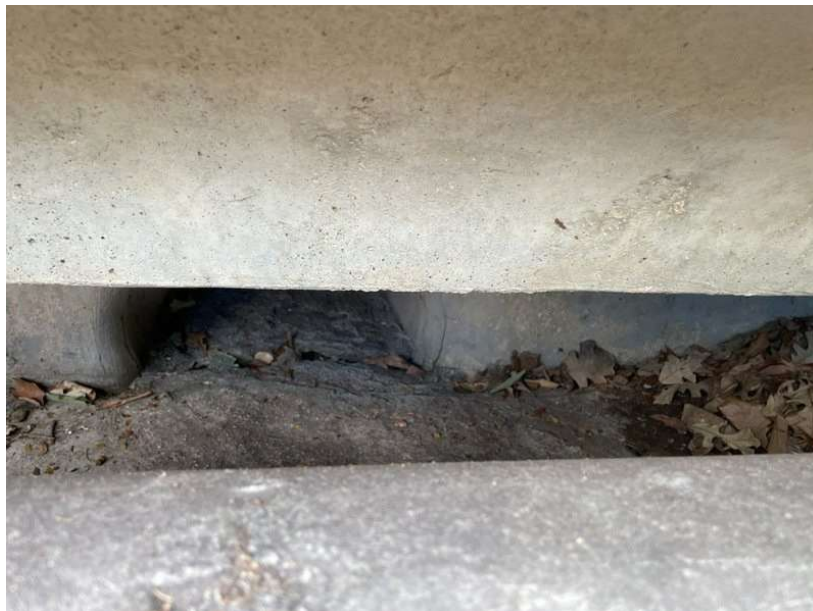
### ANT-I-1

Field Notes: Looks good.

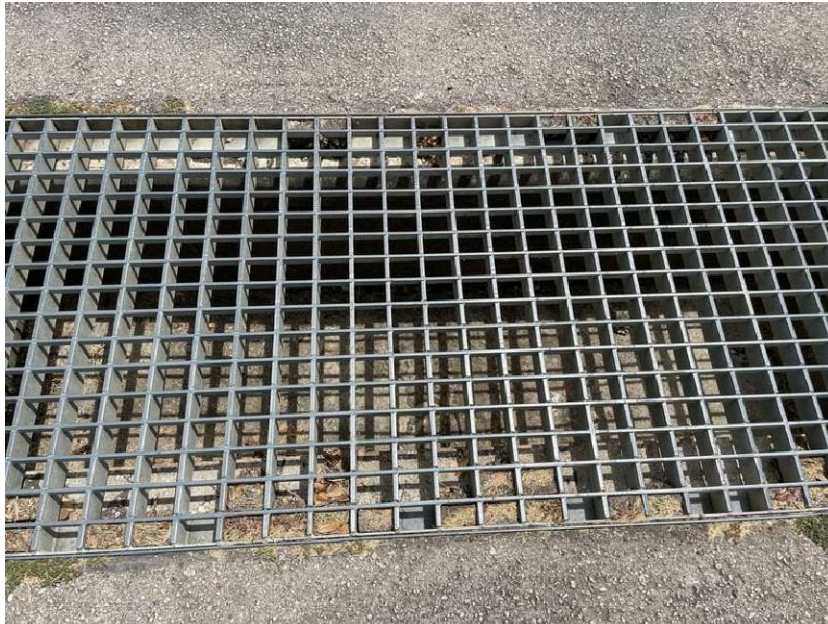
## ANT-I-2

Field Notes: Looks good.

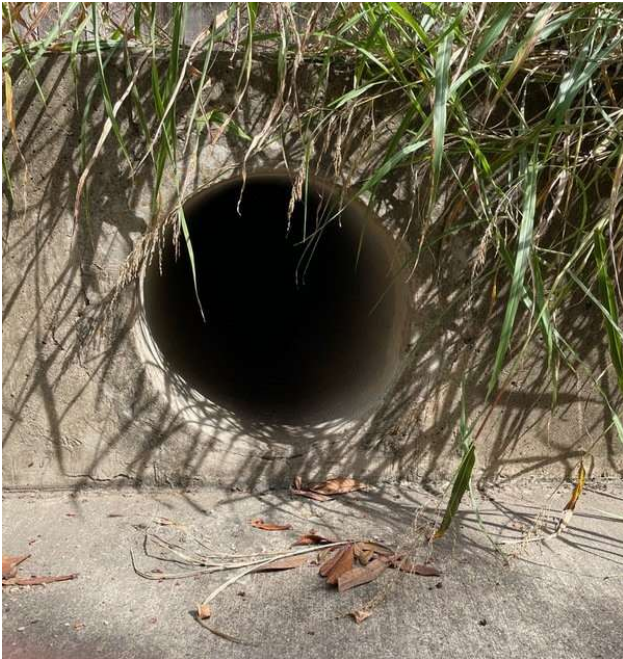
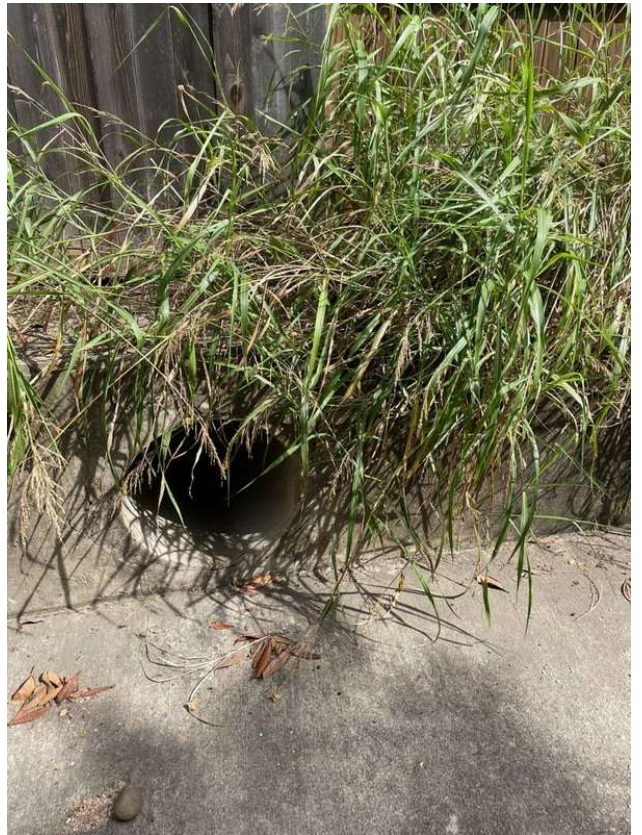
## Antler 1 Storm Sewer Pipe

Field Notes: Looks good monitor vegetation growth.

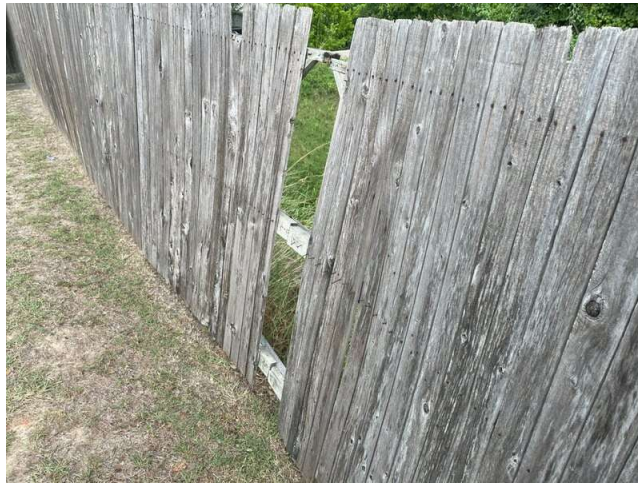
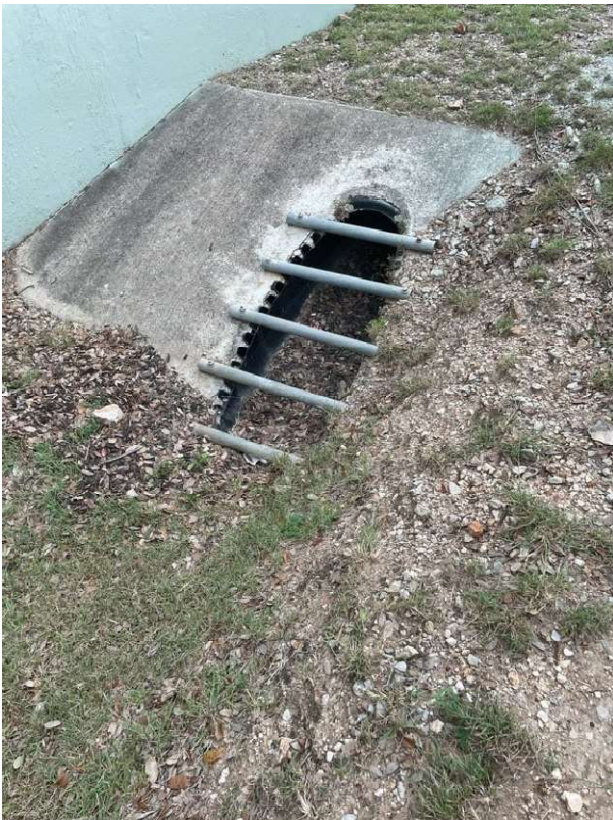
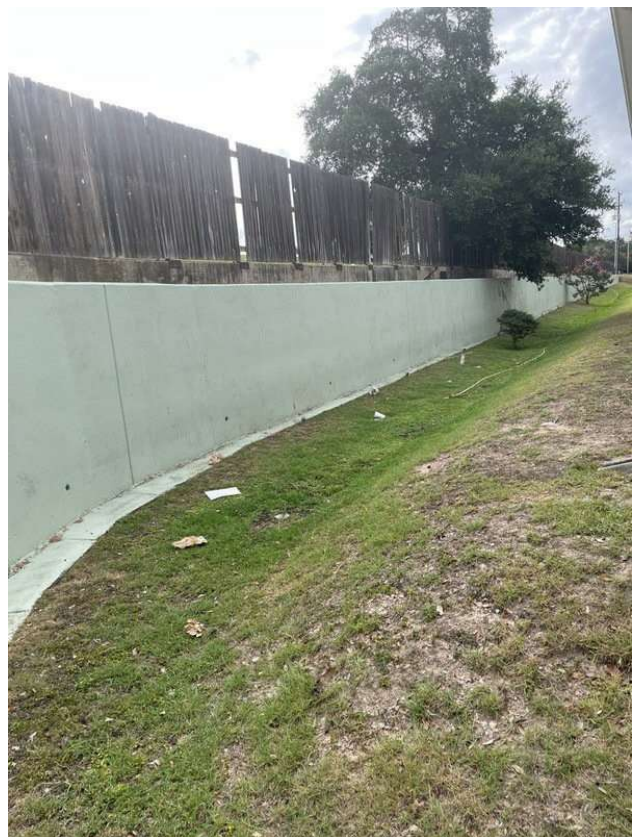
## Brookdale PCD

Field Notes: Mow vegetation, repair fence, monitor sediment buildup.

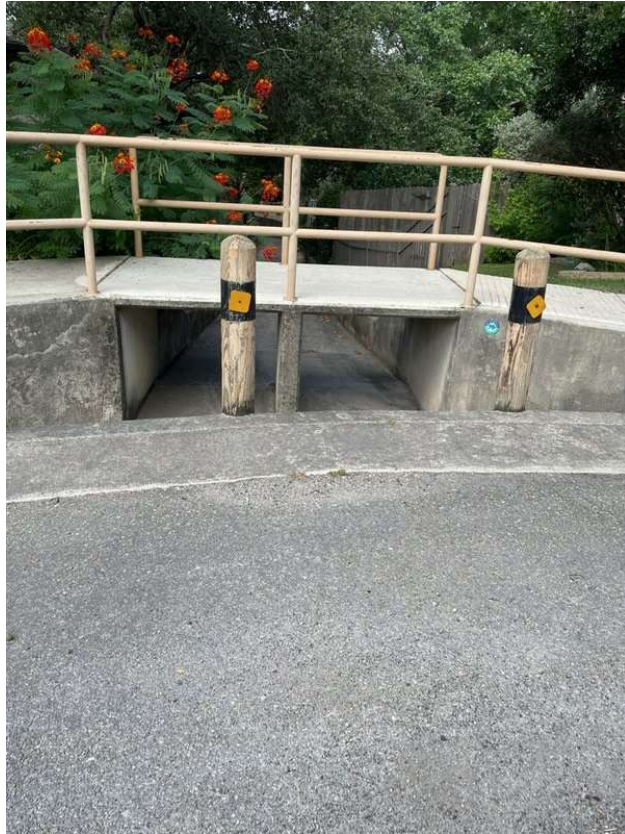
## Cascade Glen Sidewalk Drain

Field Notes: Looks good.

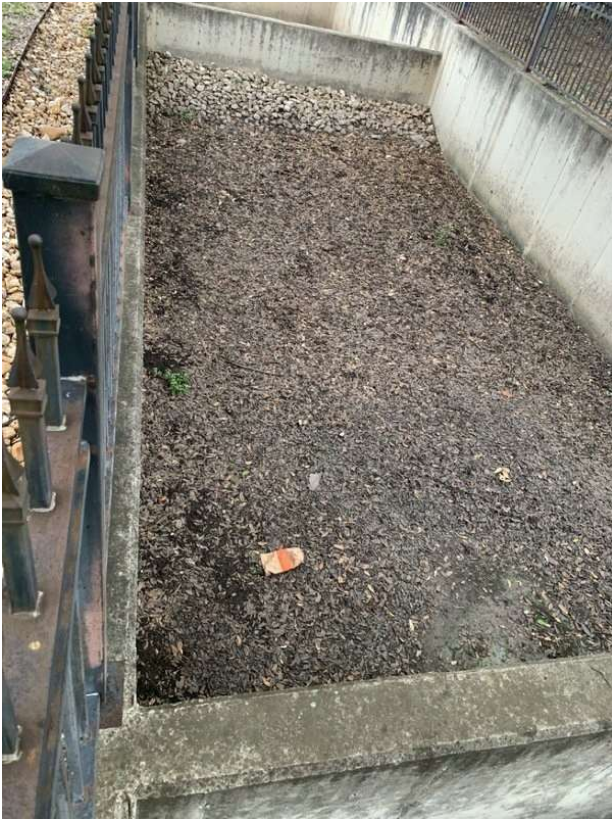
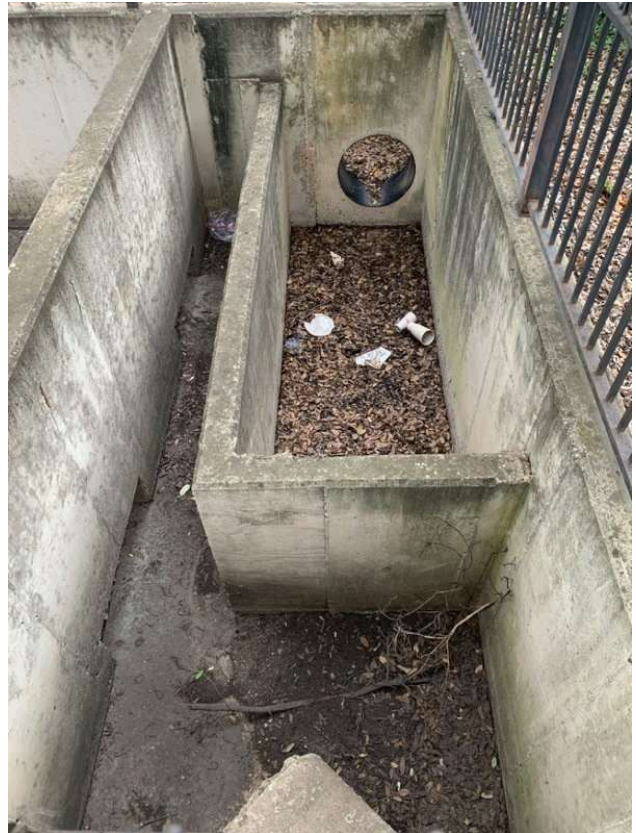
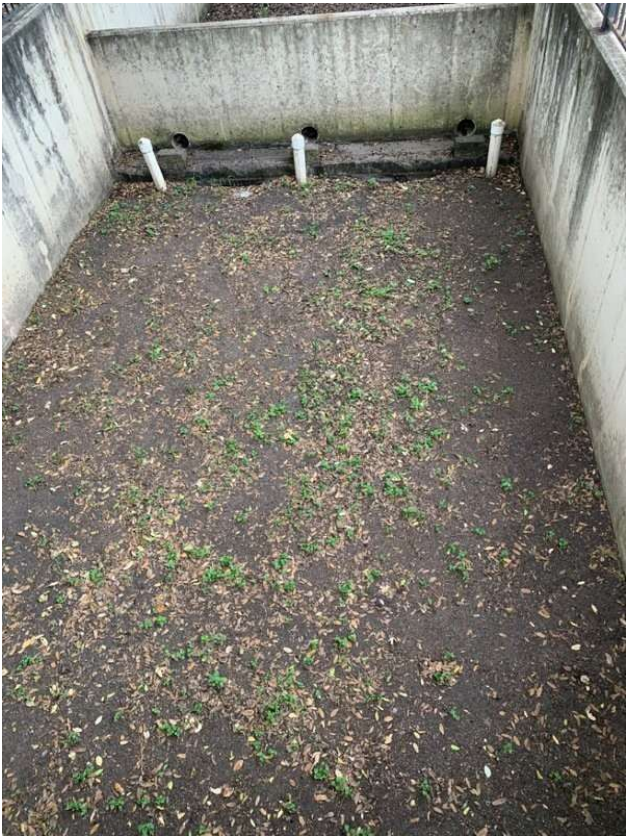
## Chandler Signs PCD in North Park Corporate Center Parking Lot

Field Notes: Clean out trash and leaves.

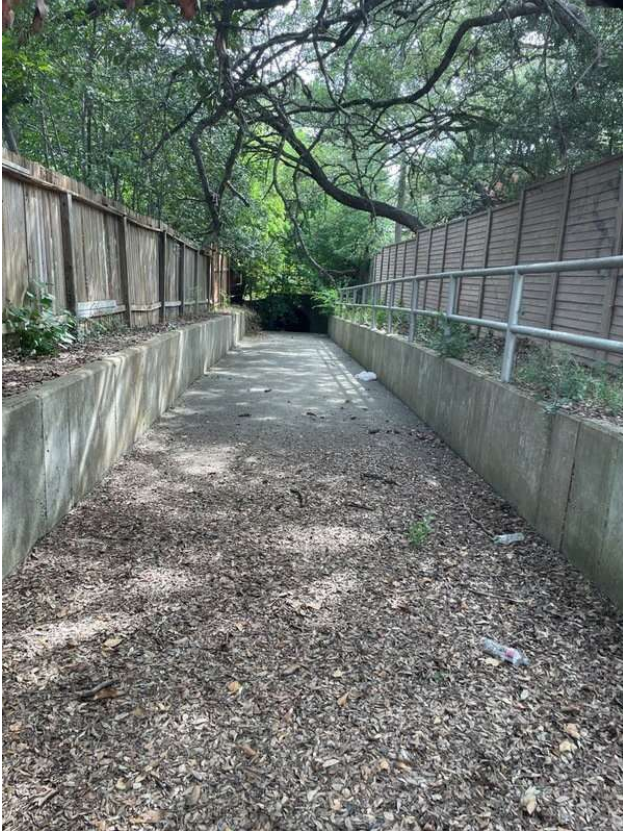
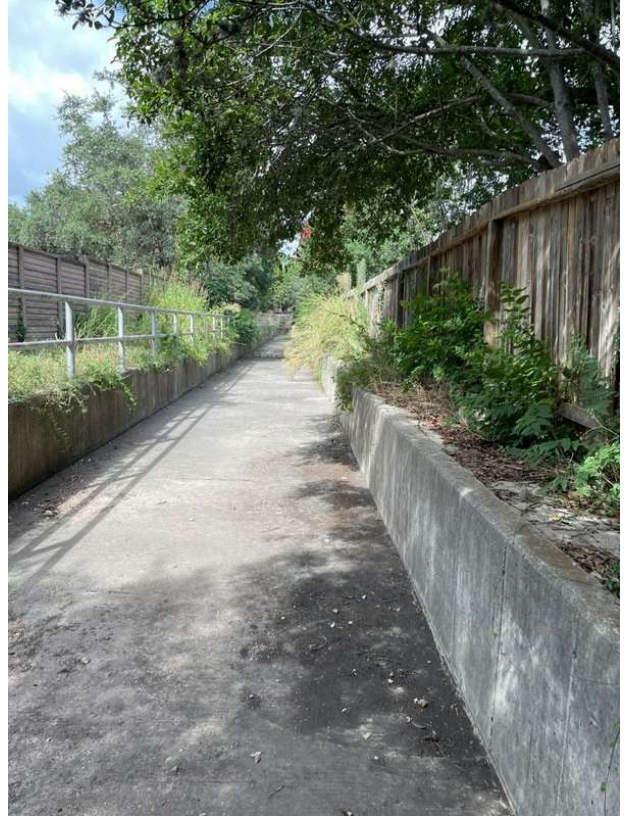
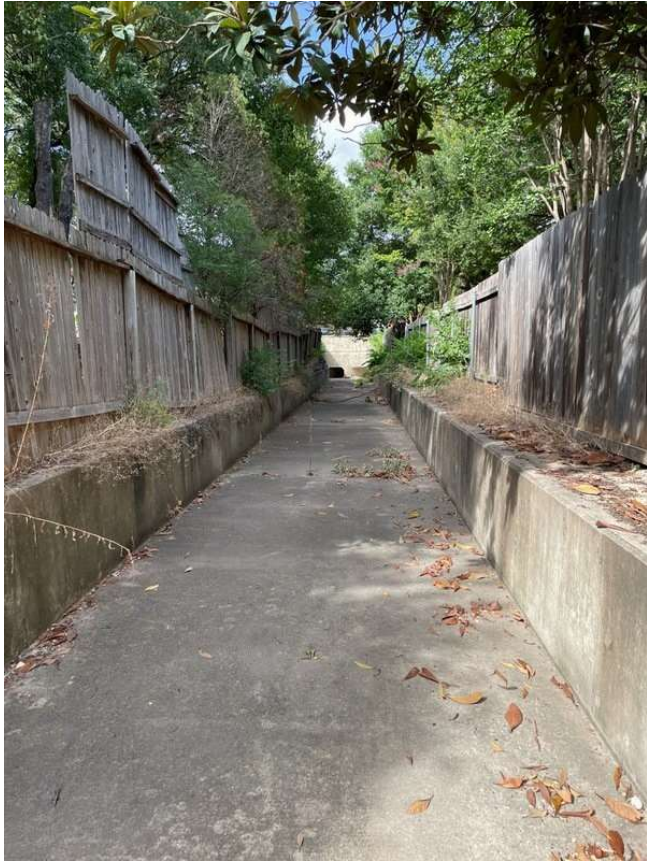
## Channel

Field Notes: Clean out vegetation, looks good otherwise.

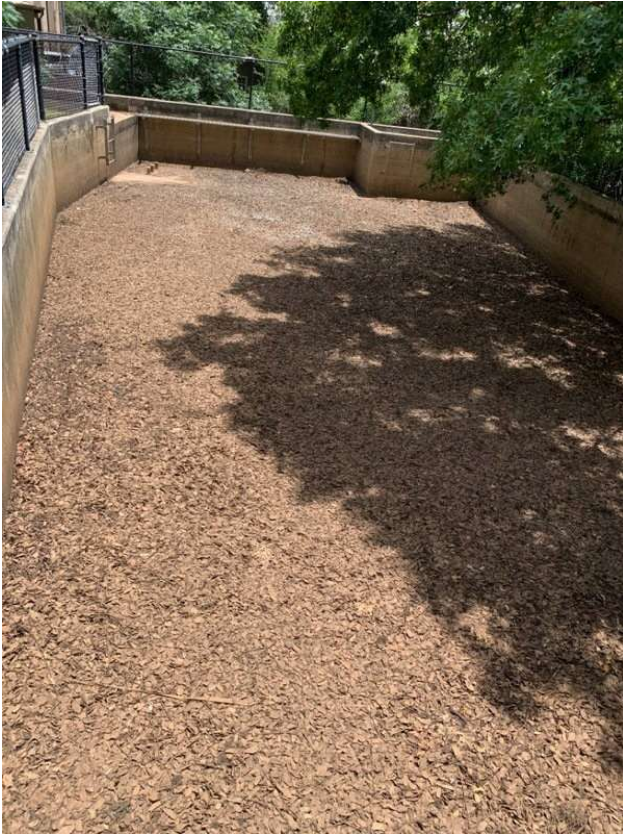
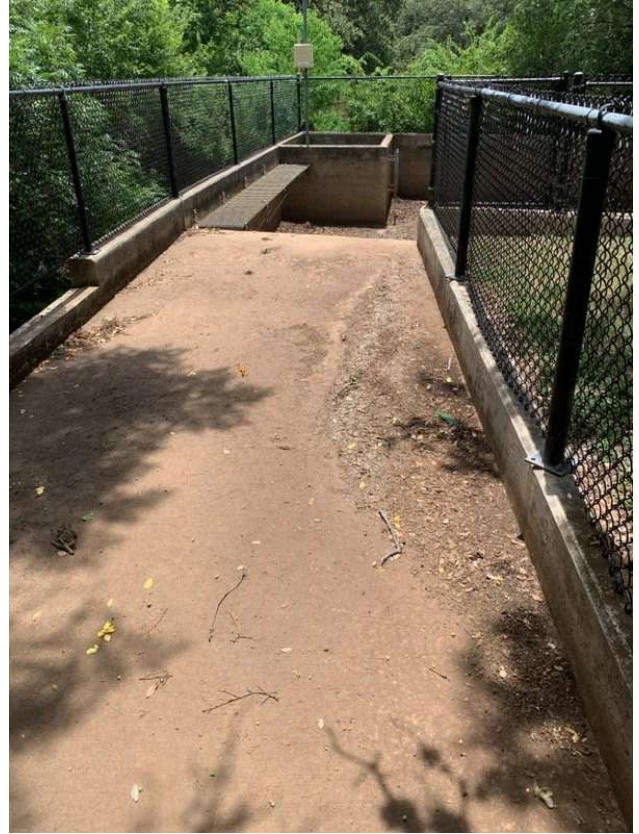
## Chicago Title PCD

Field Notes: Remove leaves, otherwise looks good.

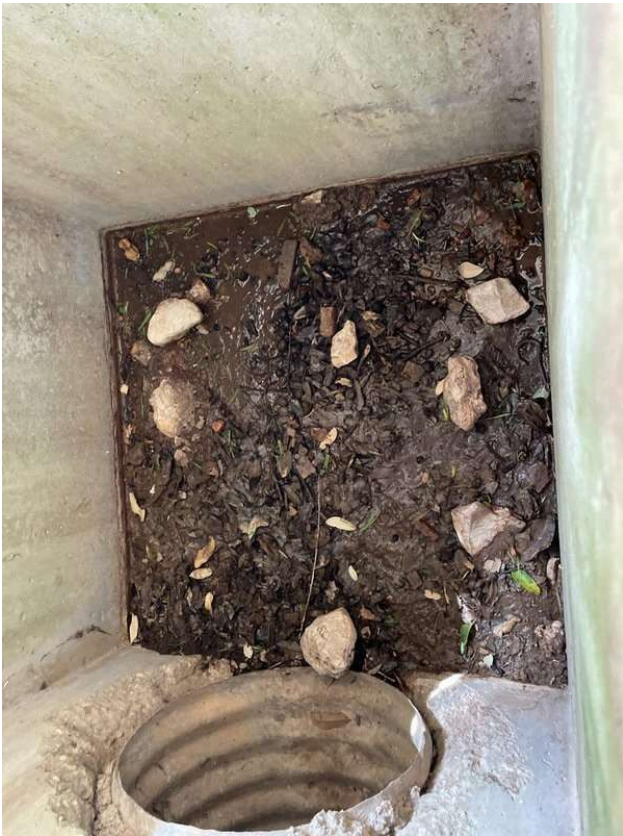
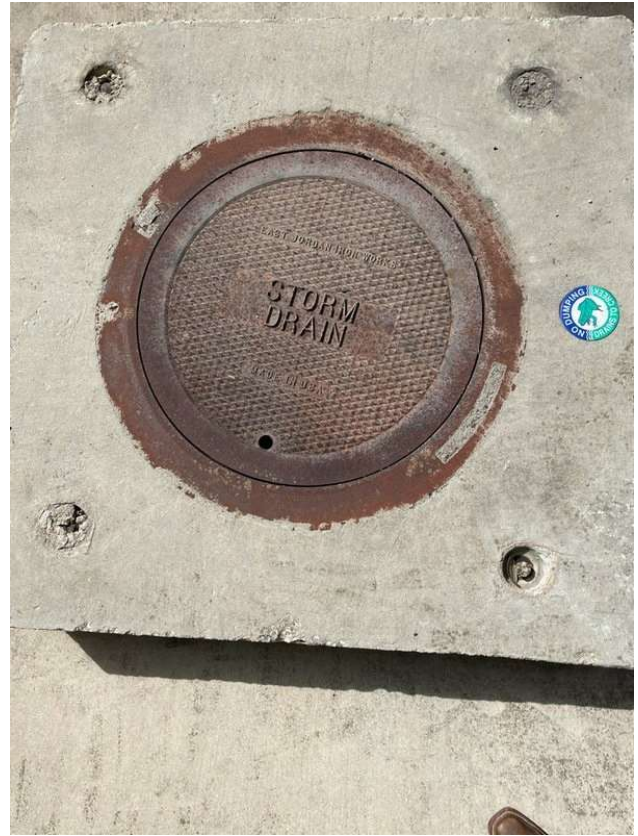
## Chula Vista Dr Inlet

Field Notes: Minor debris looks good otherwise.

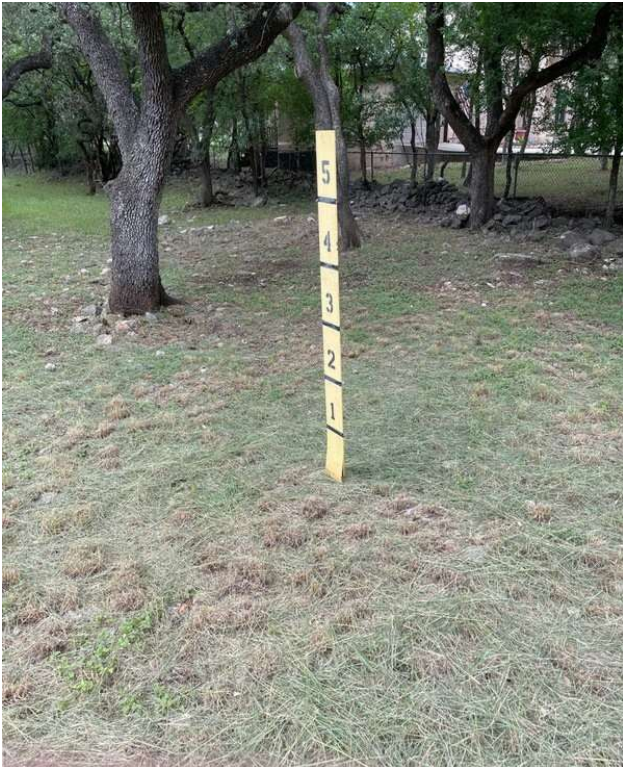
## Coolway Dr Low Water Crossing

Field Notes: Looks good.

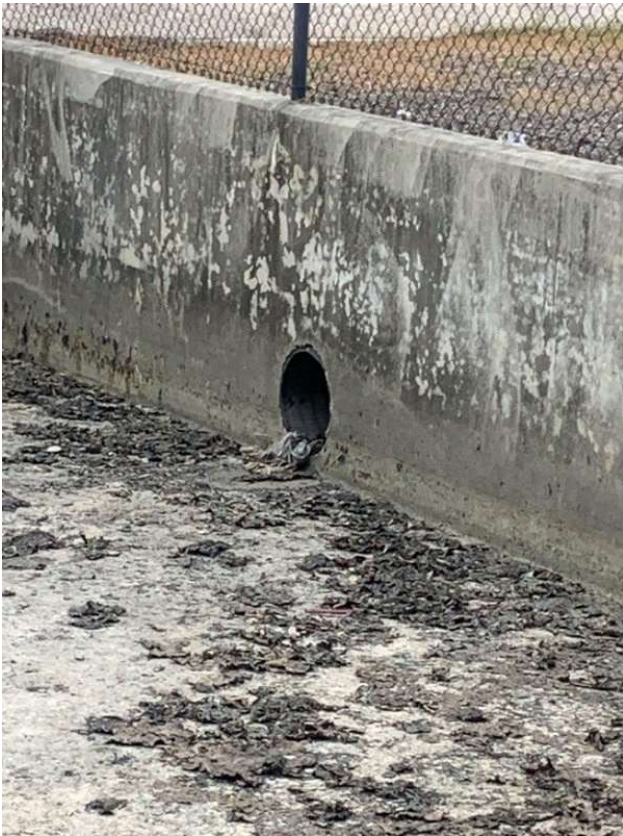
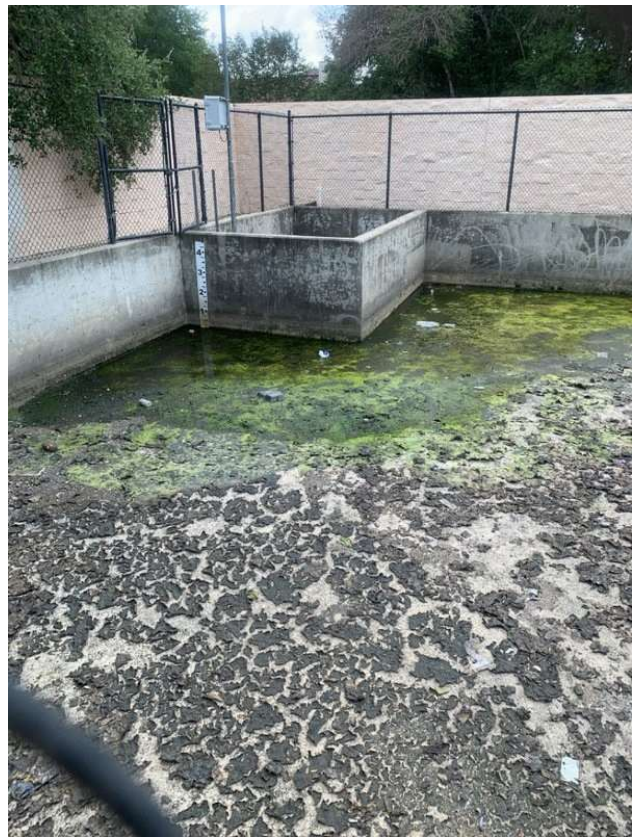
### Corner Store PCD

Field Notes: Clean trash and clear debris at inlets.

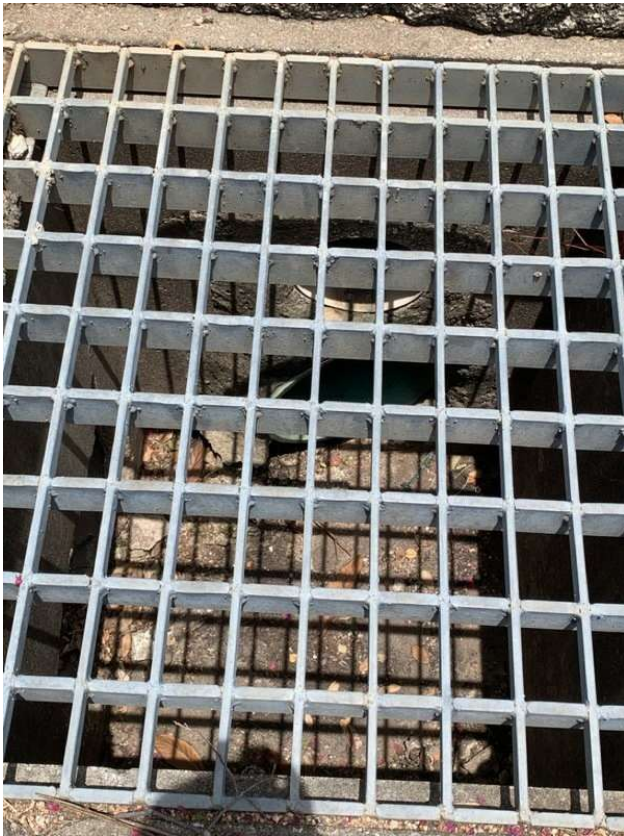
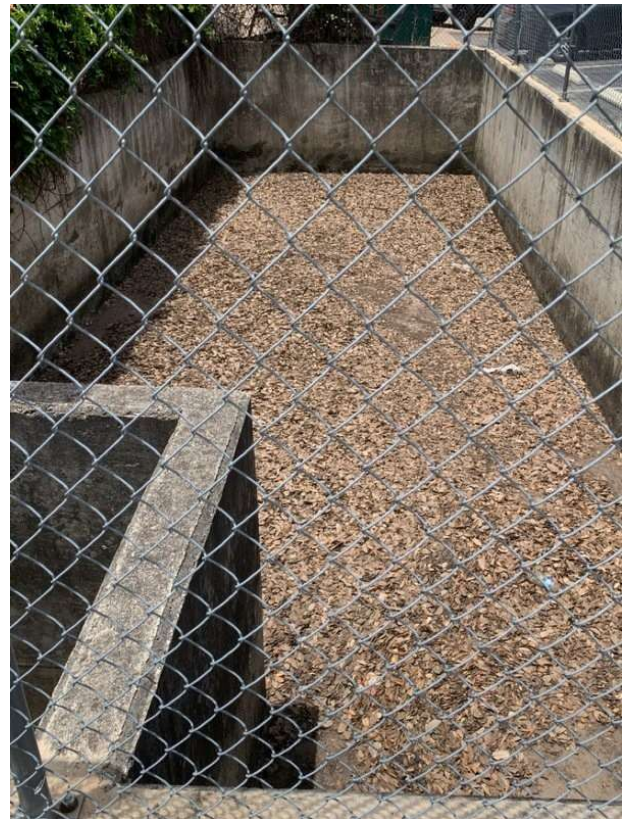
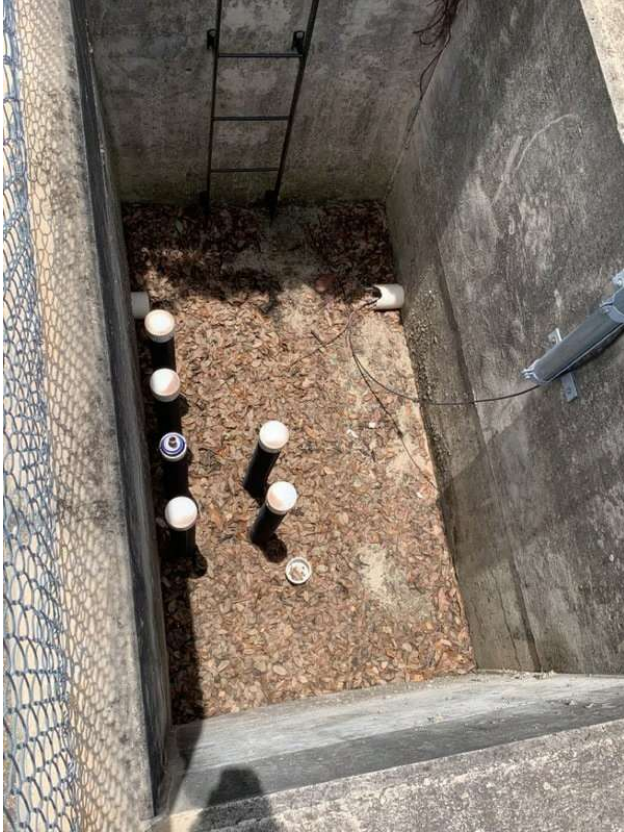
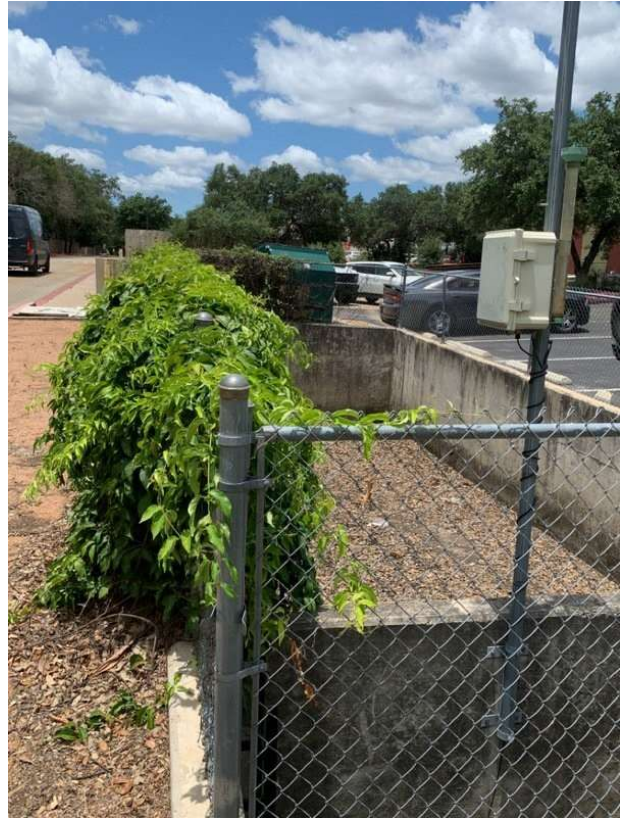
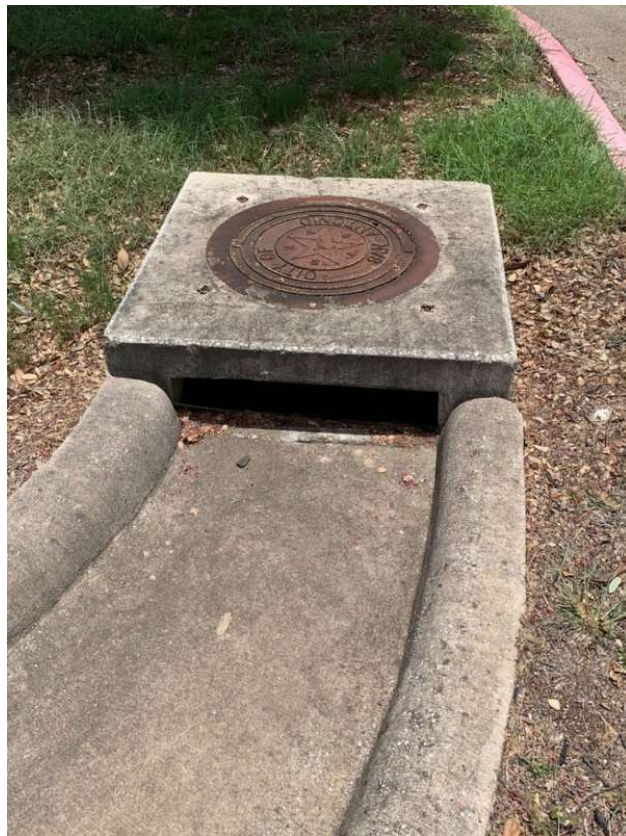
## CRT Flooring Concepts PCD

Field Notes: Clean leaves and trim vegetation on fence.

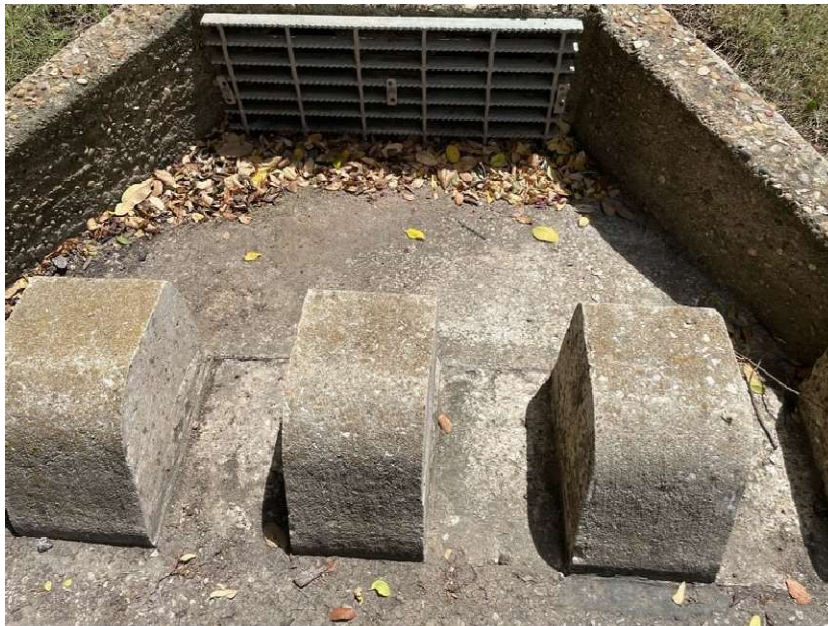
## Curb Outlet, 1

Field Notes: Looks good.

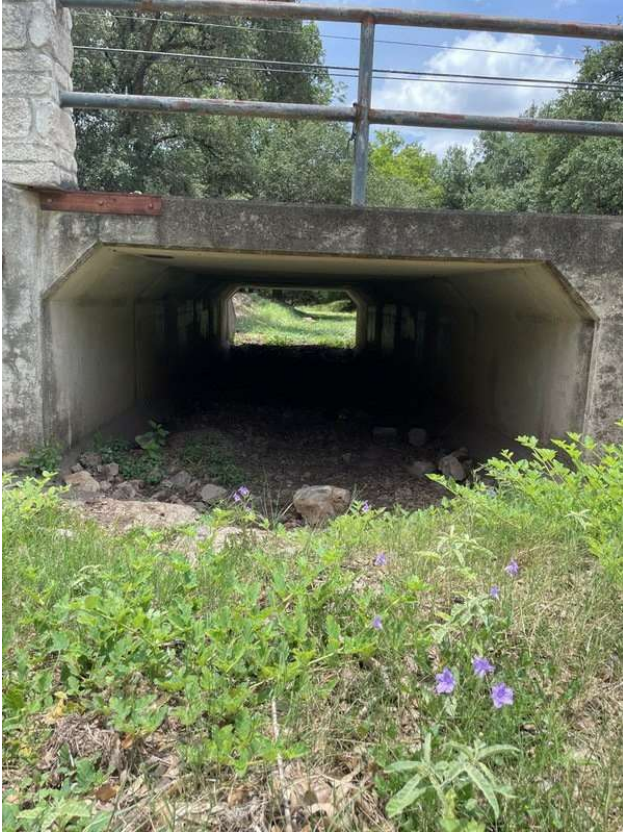
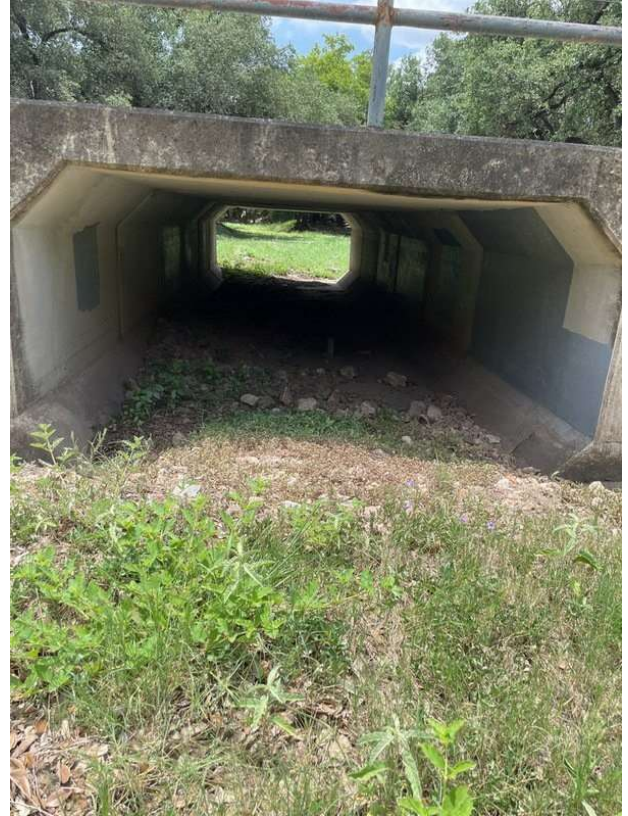
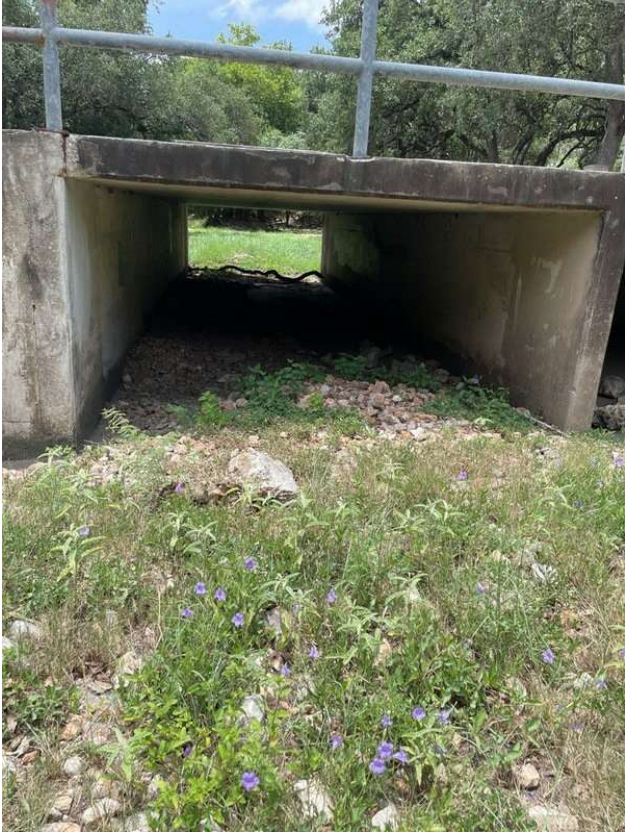
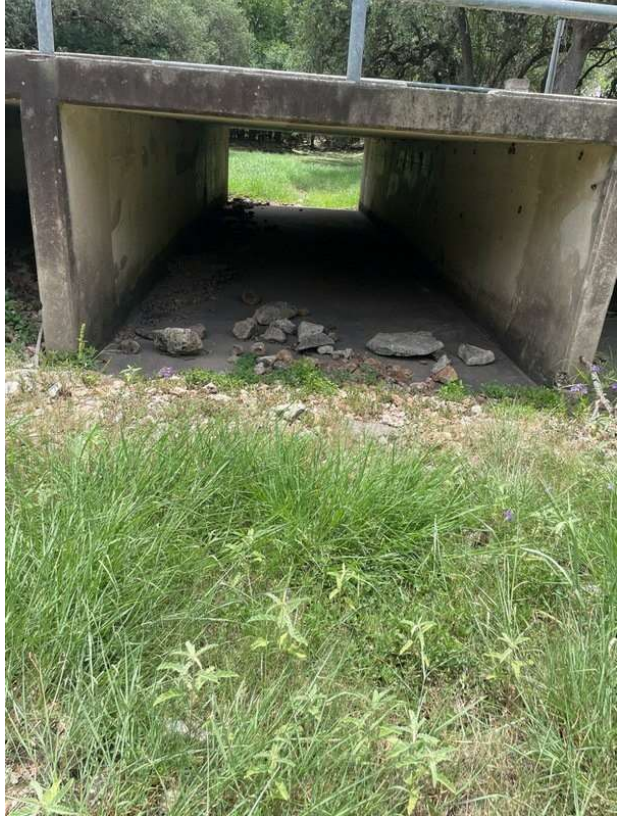
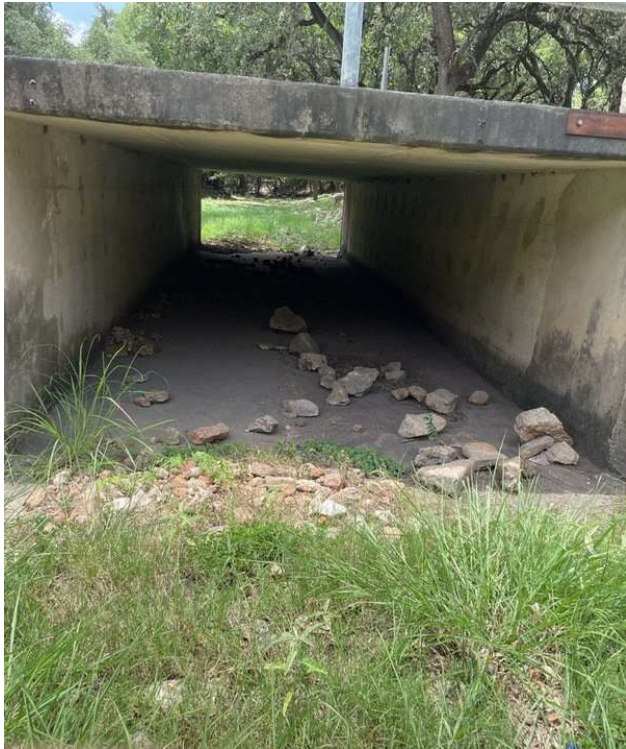
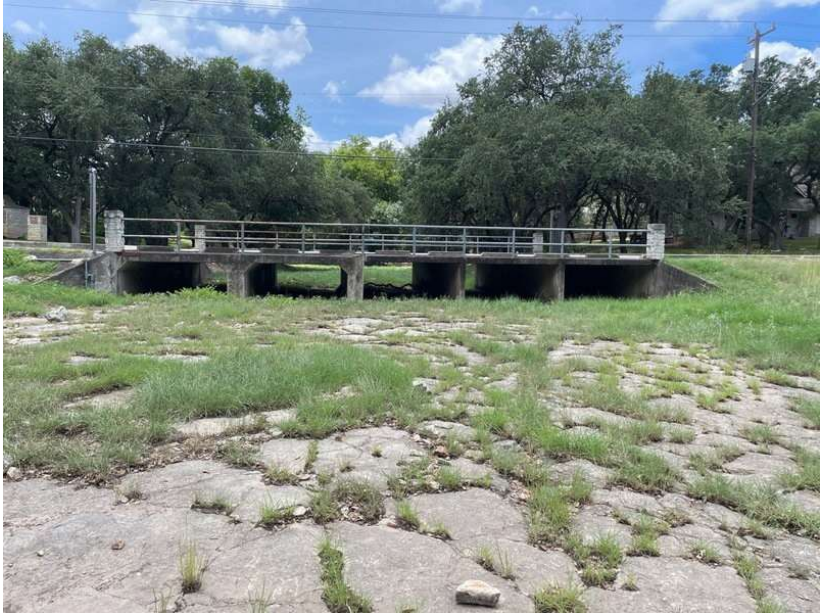
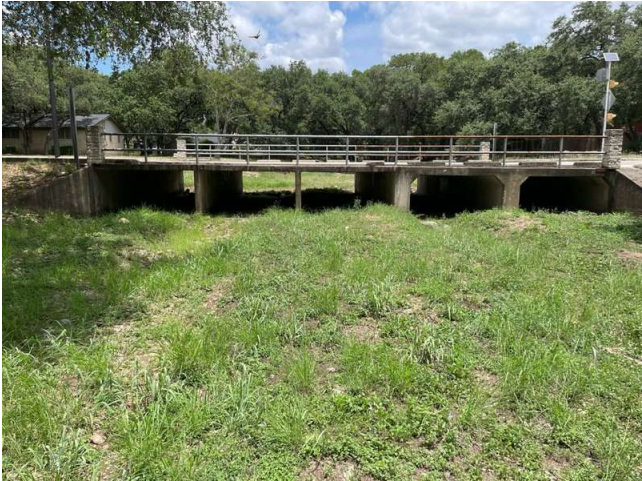
## Donella Crossing

Field Notes: Looks good, minor debris.
