# TOWN OF HOLLYWOOD PARK, TX

2024 Summer Inspection

## HOLLYWOOD PARK 2024 SUMMER INSPECTION REPORT

**Subject:** Annual Municipal Separate Storm Sewer System (MS4) Inspection

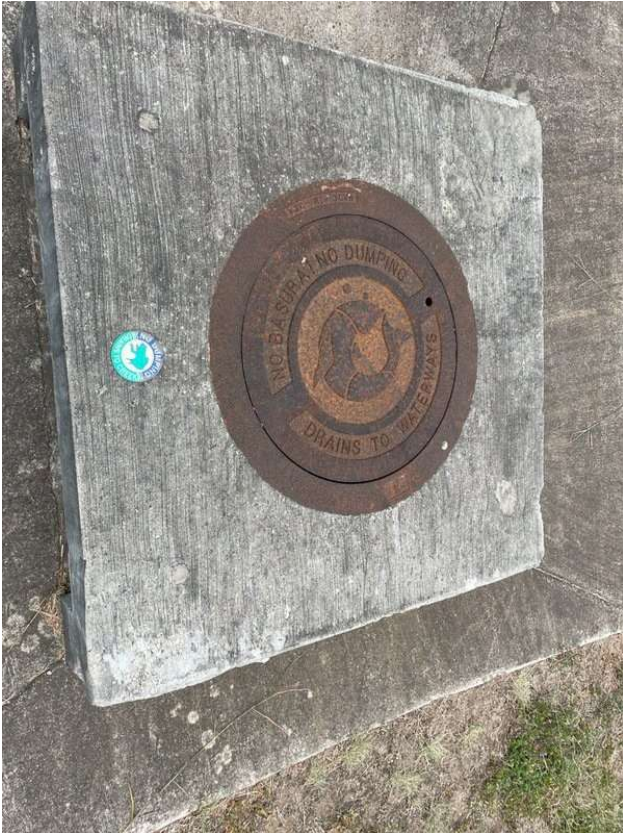
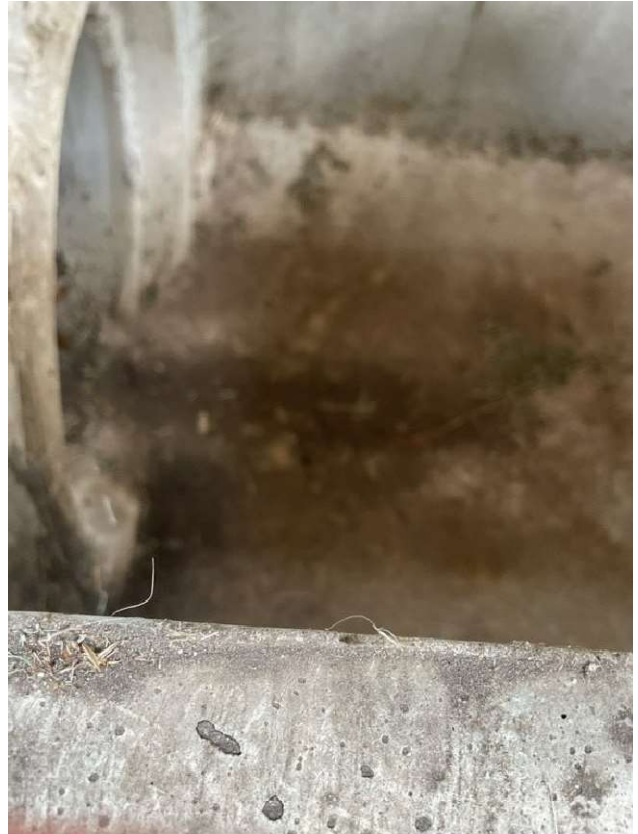
Field Notes: Looks good.

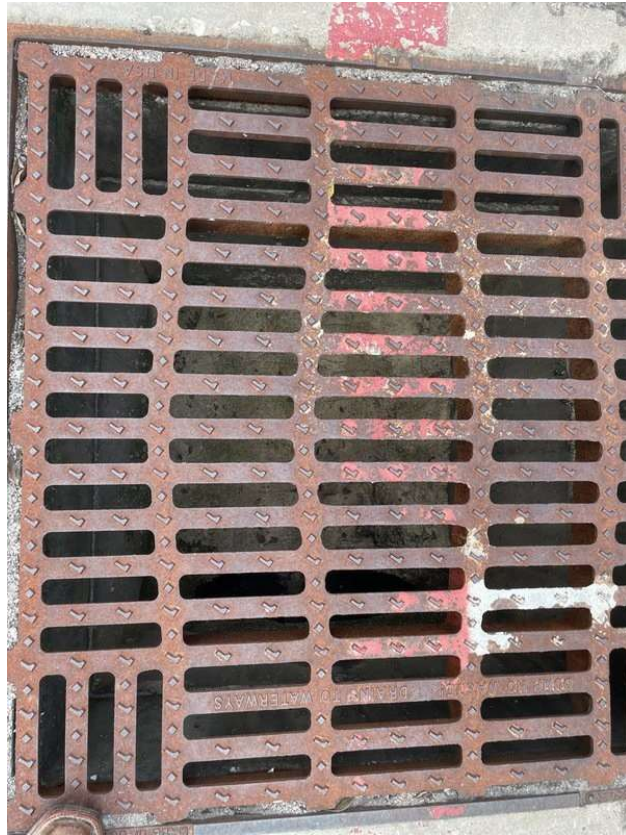
## Drash Rear Parking Lot Inlet

Field Notes: Looks good.

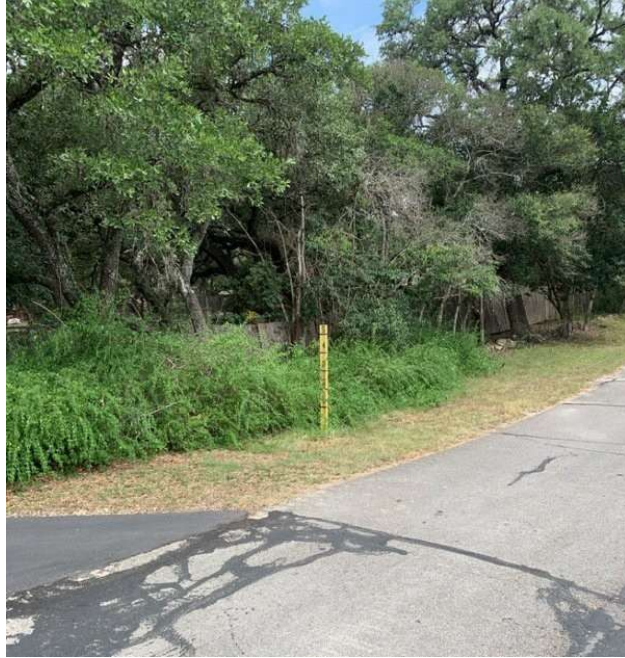
## El Cerrito Cr Low Water Crossing

Field Notes: Looks good.

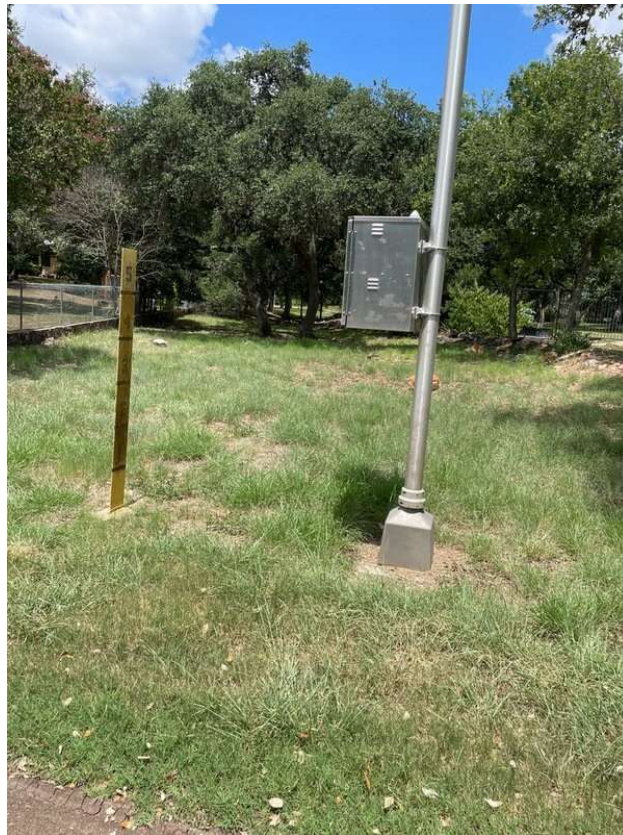
## El Cerrito Low Water Crossing

Field Notes: Looks good.

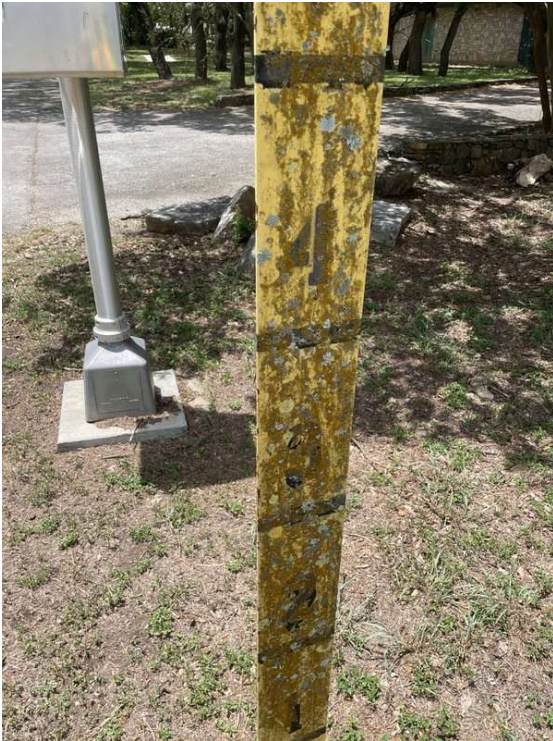
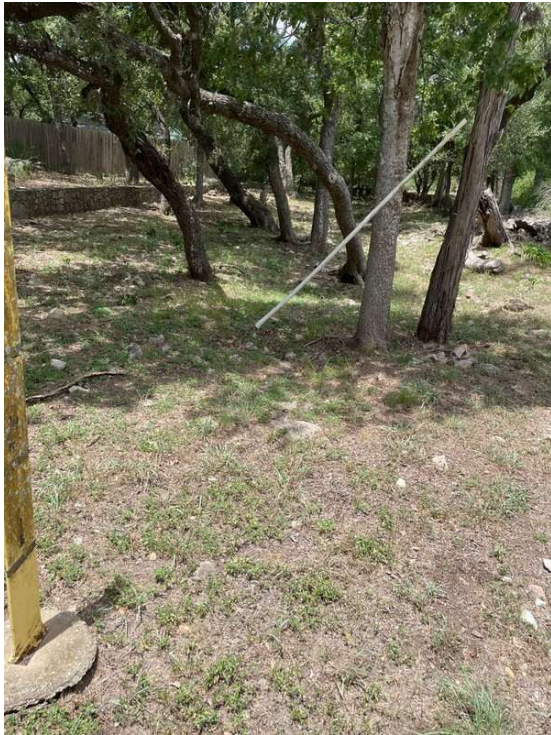
## El Cerrito Low Water Crossing West

Field Notes: Remove moss buildup on gauge.

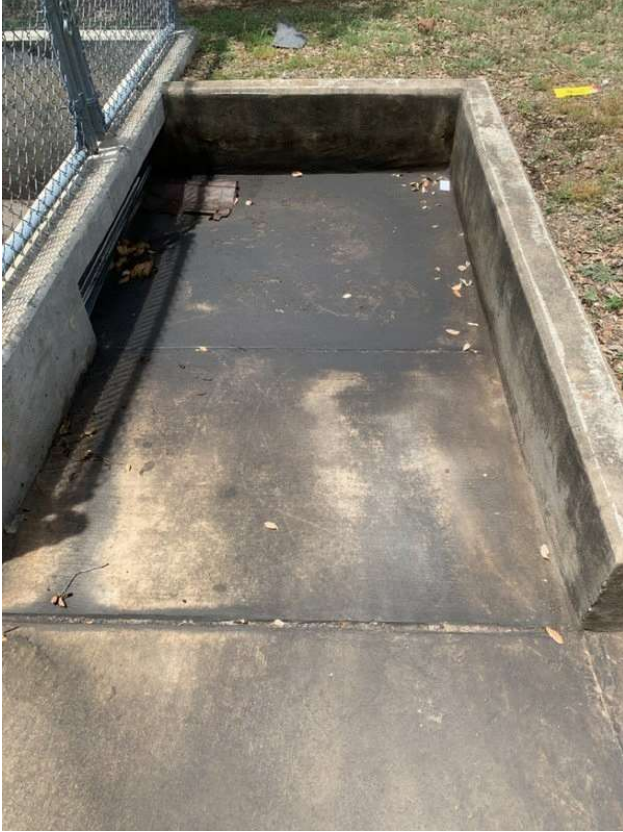
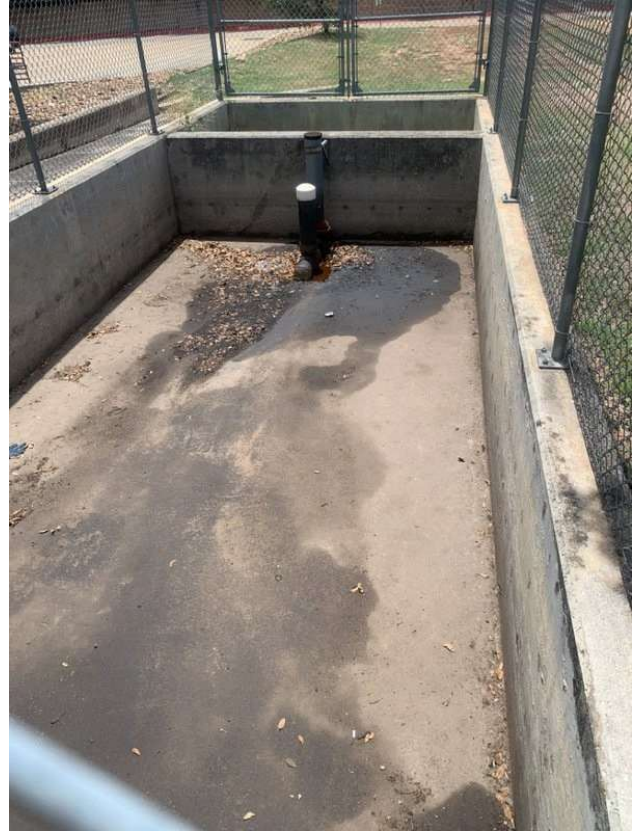
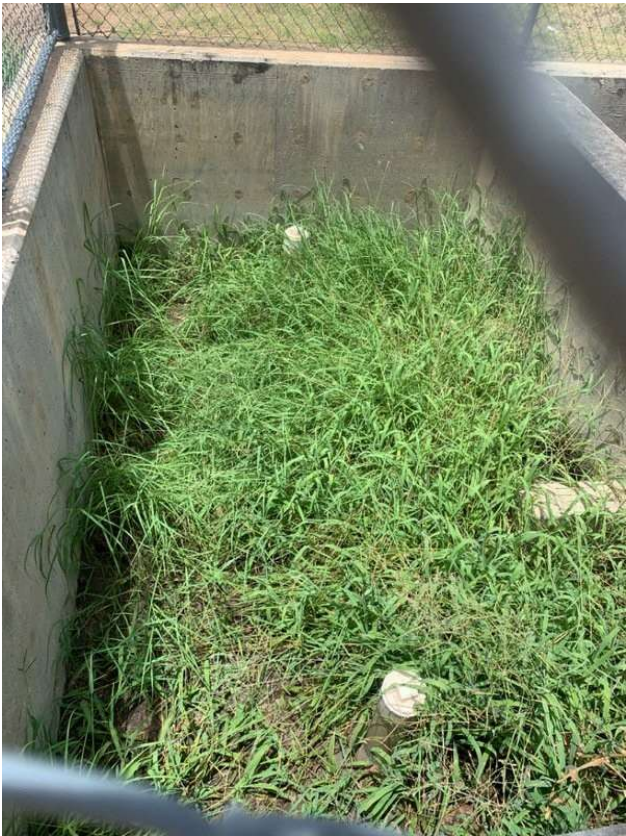
## Express Lube PCD

Field Notes: Mow vegetation.

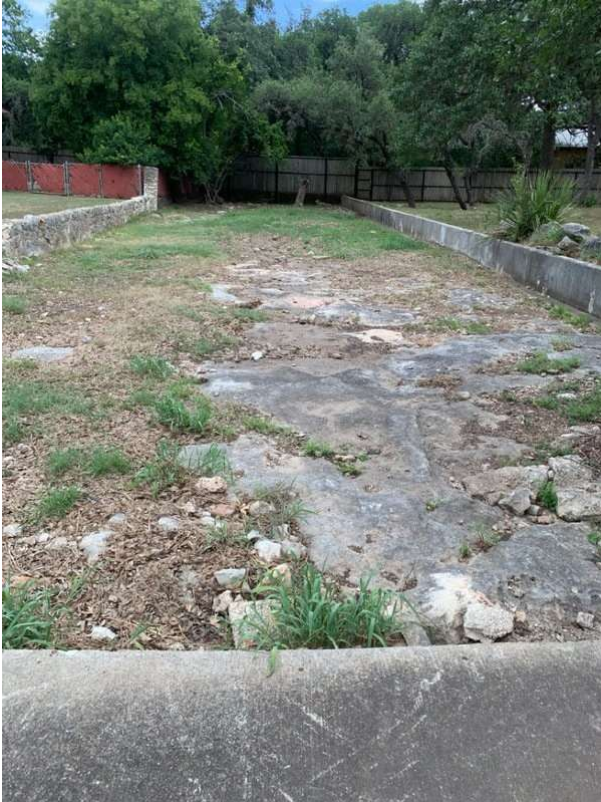
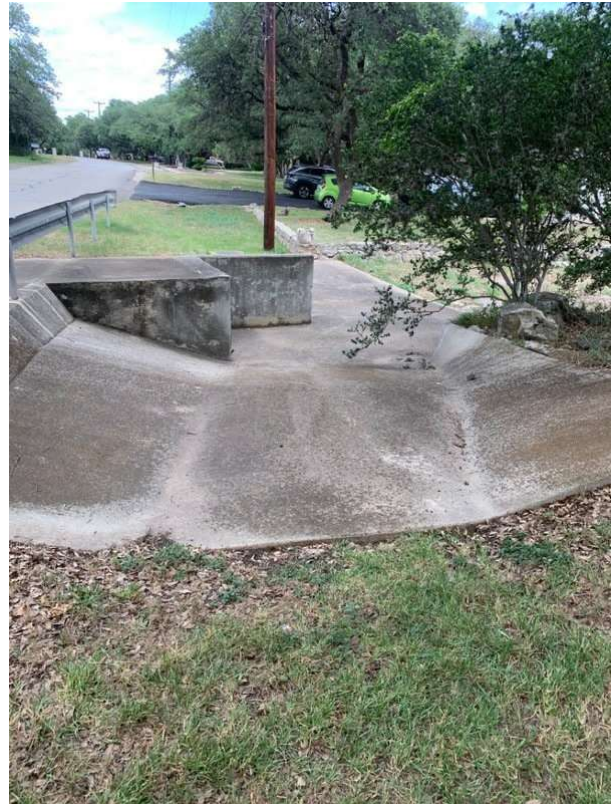
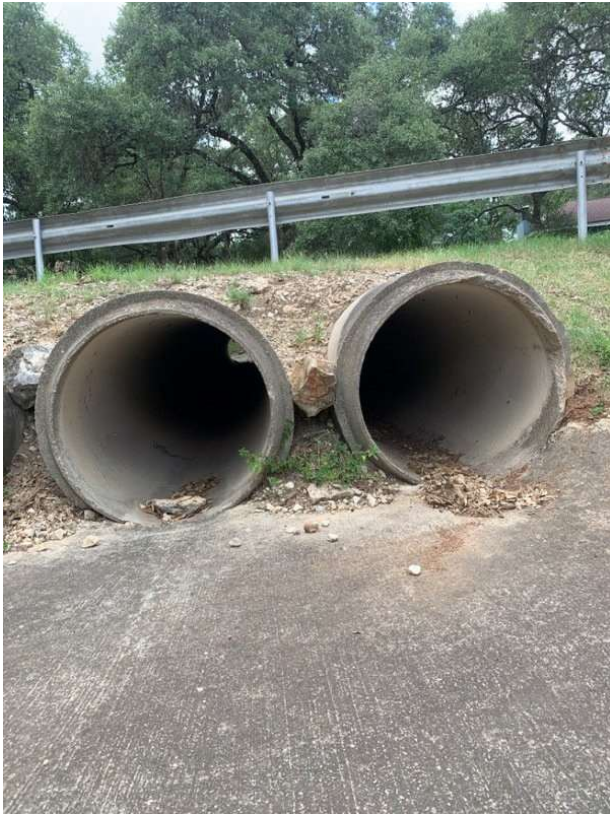
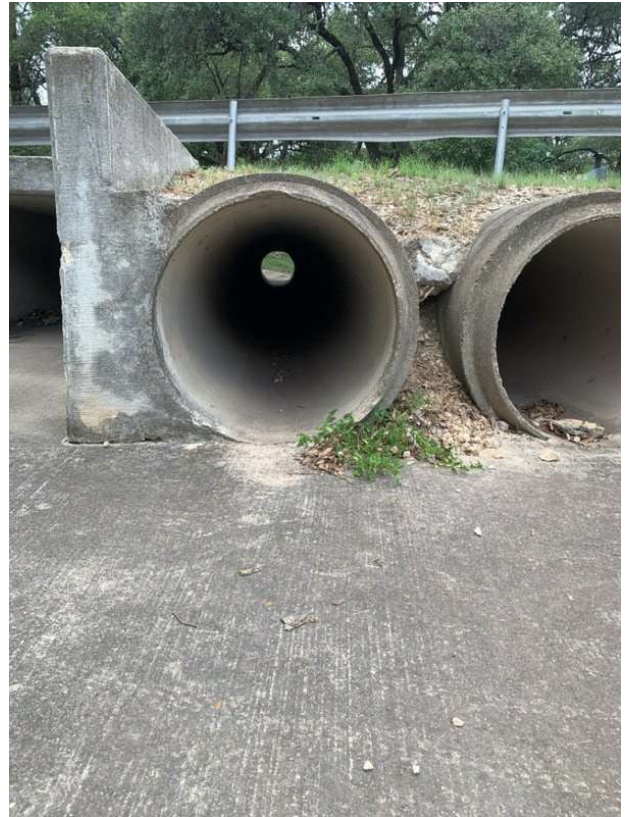
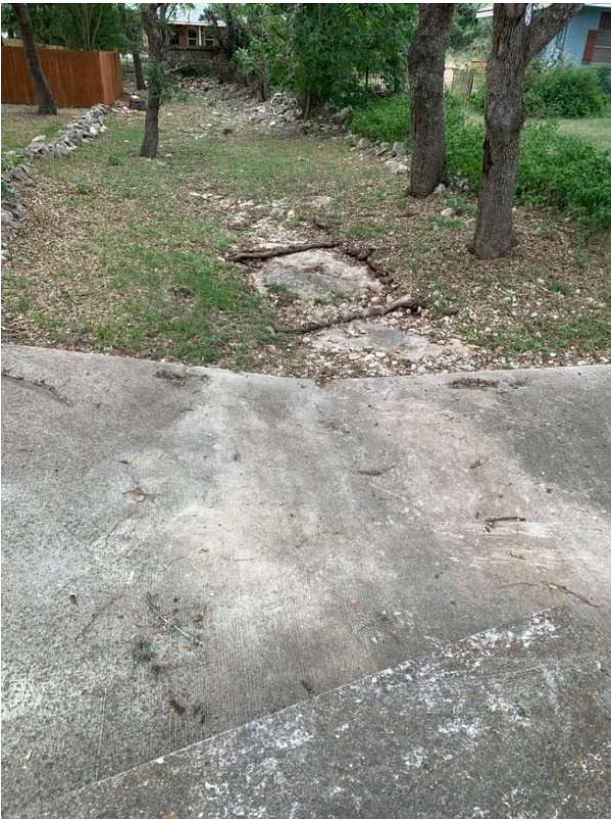
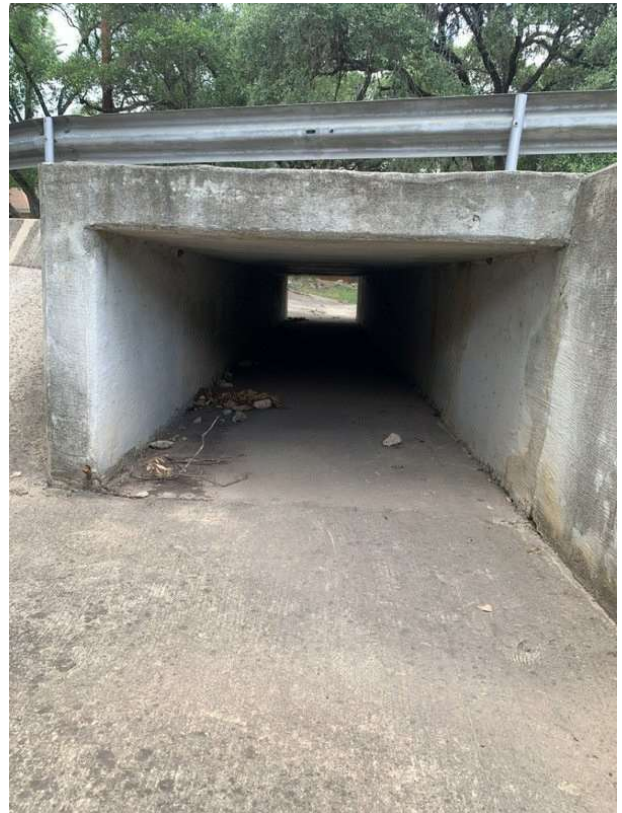
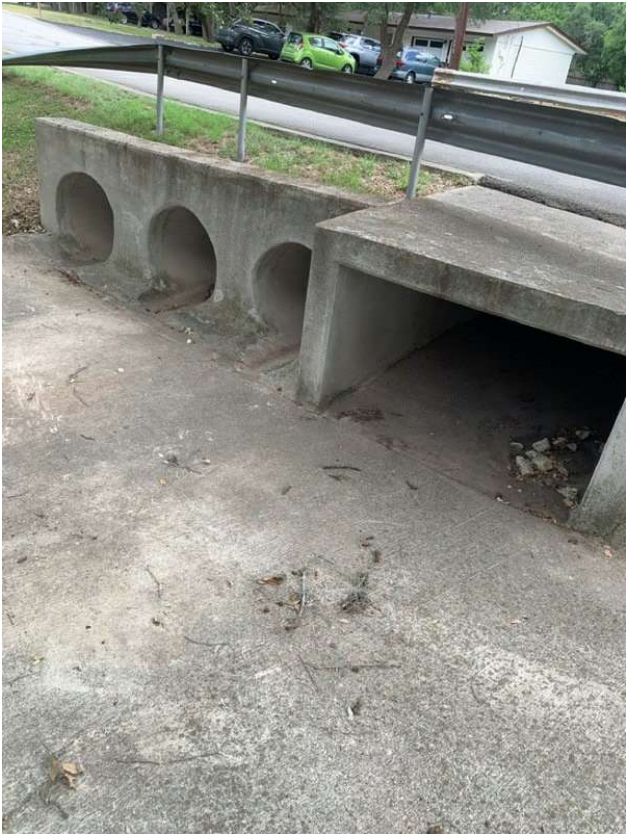
## Fleetwood Crossing

Field Notes: Minor sediment inside of pipes.

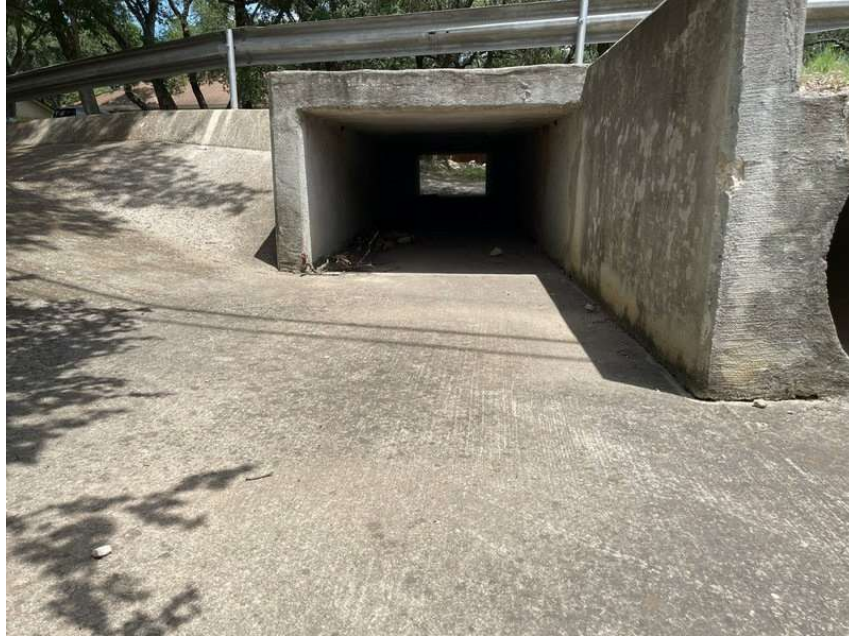
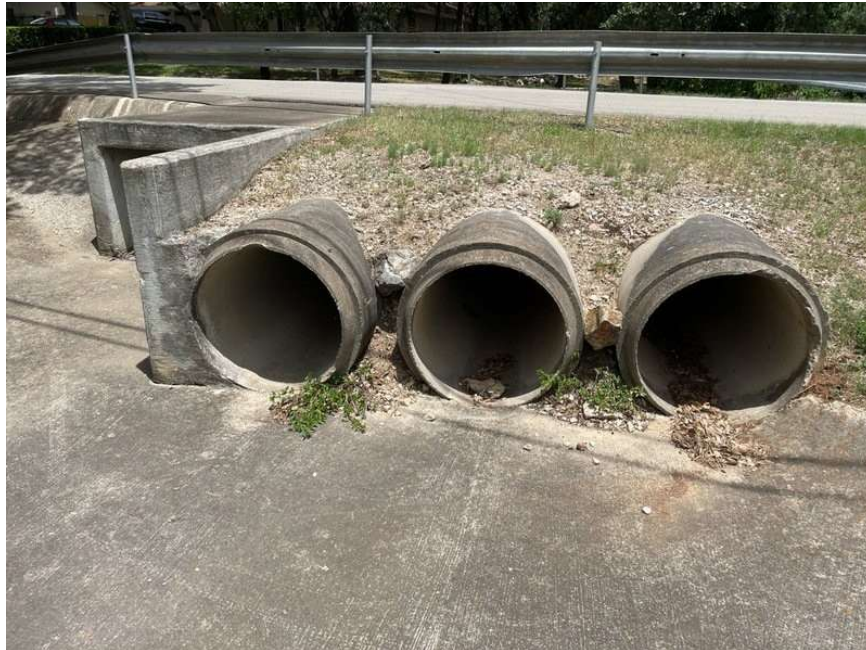
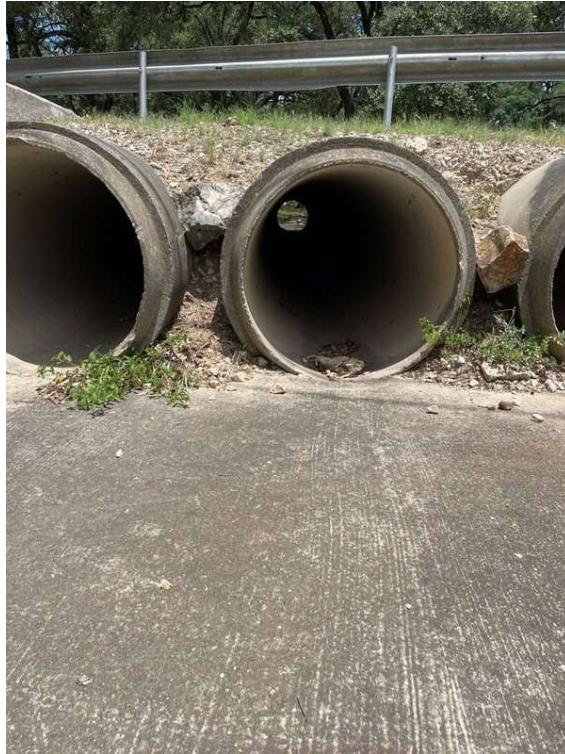
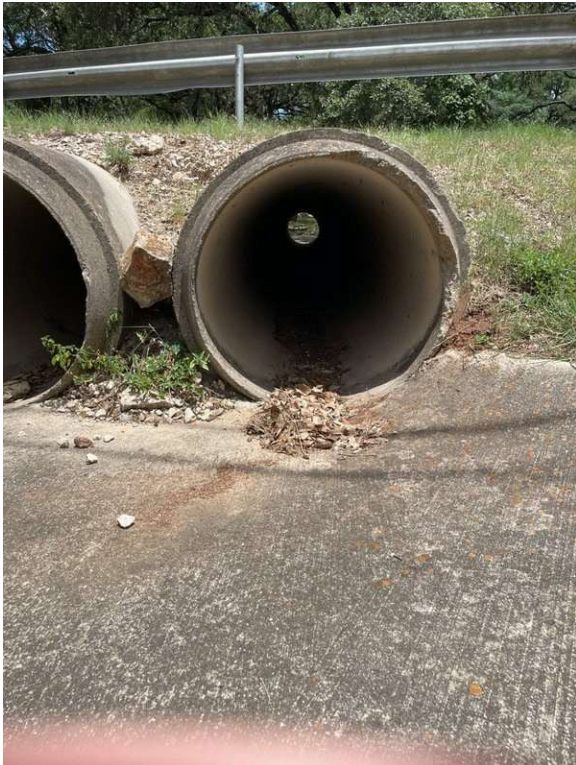
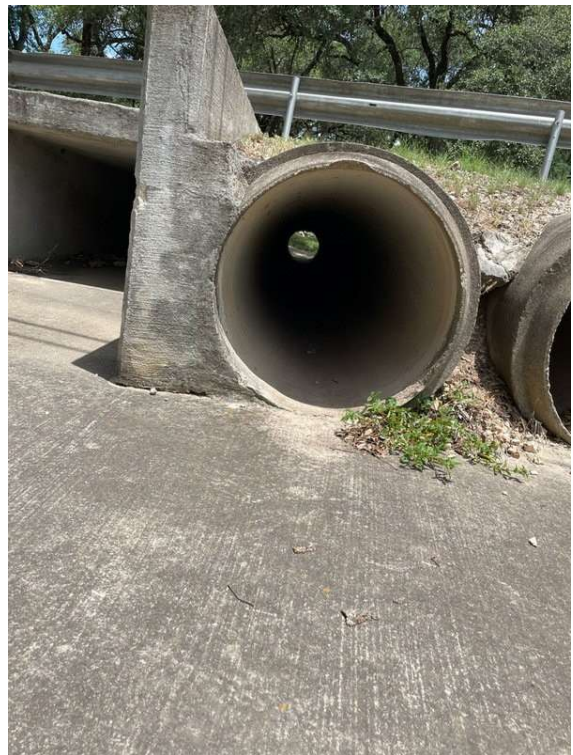
## Fleetwood Outfall

Field Notes: Looks good.

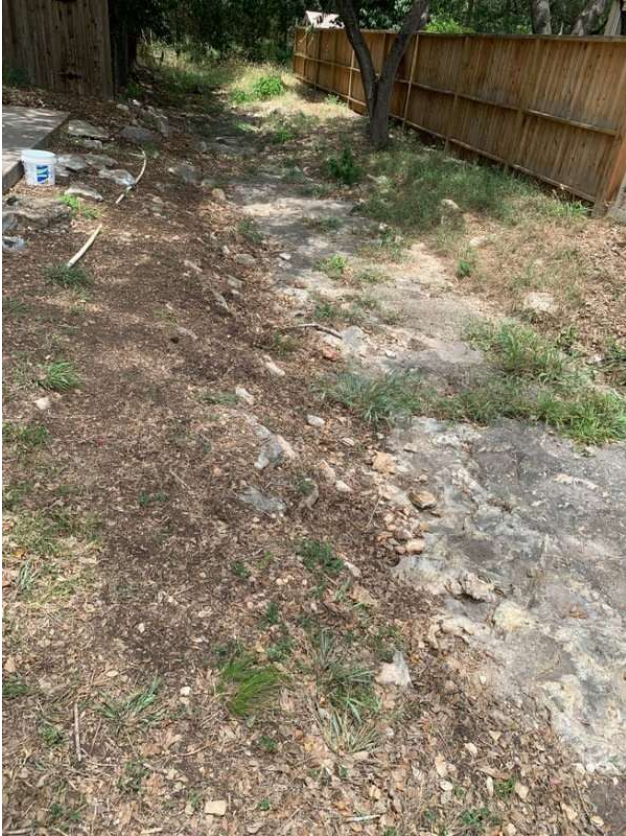
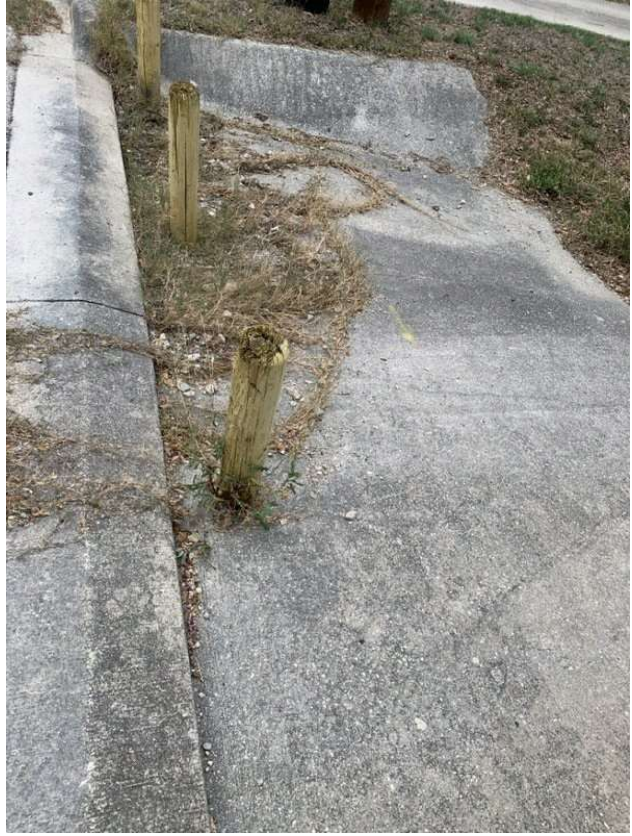
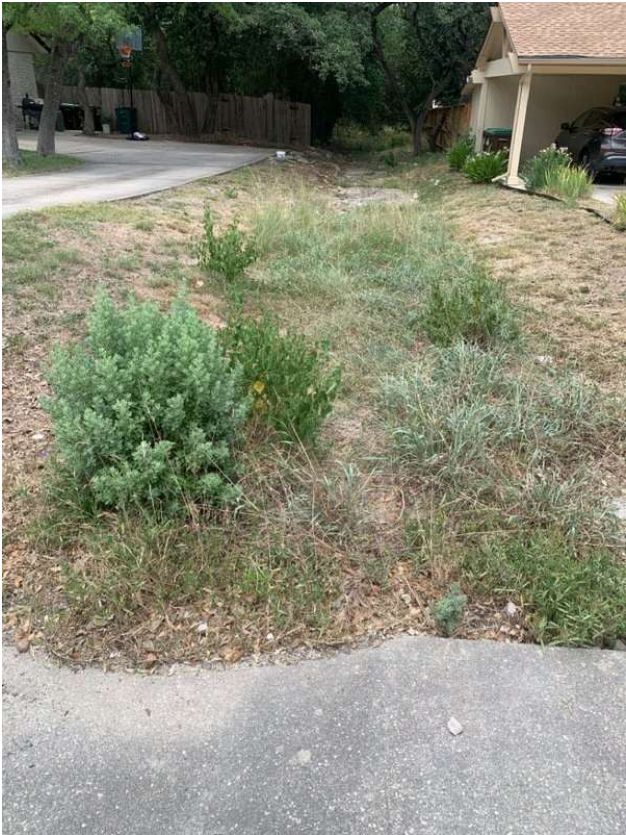
## Garrapata Storm Water Inflow

Field Notes: Trim vegetation, otherwise looks good.

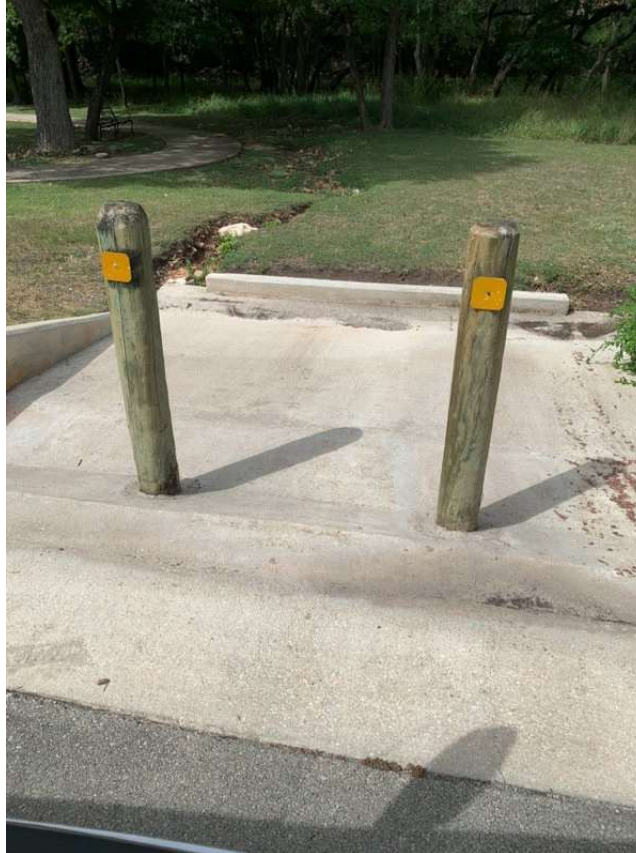
## Great Wood Street Outfall

Field Notes: Looks good.

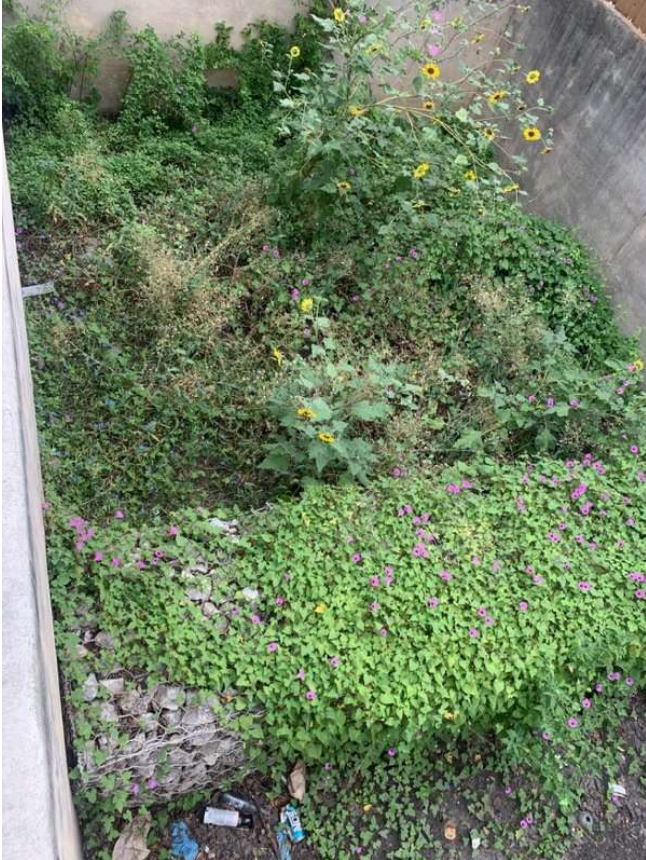
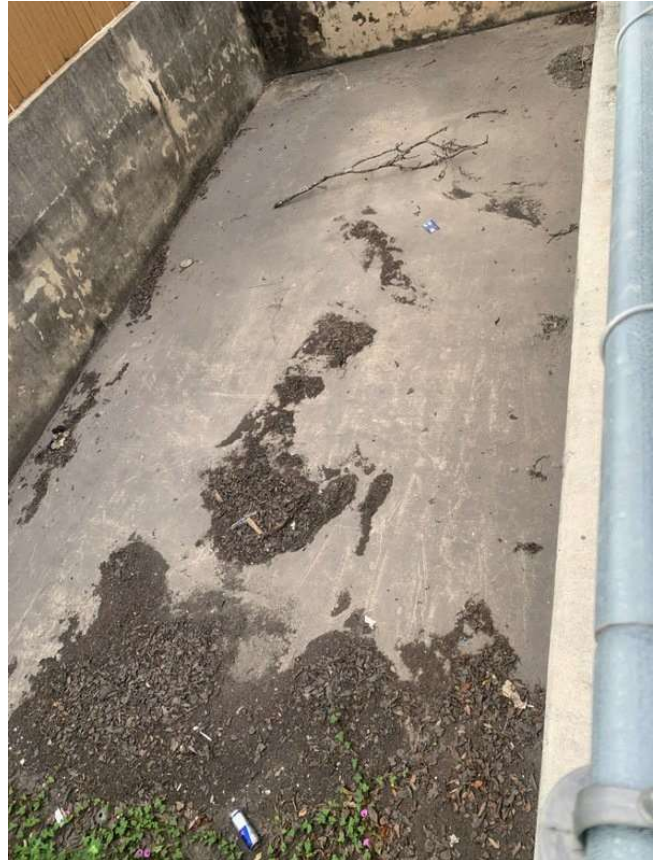
## Holiday Inn PCD

Field Notes: Mow vegetation and clear debris.

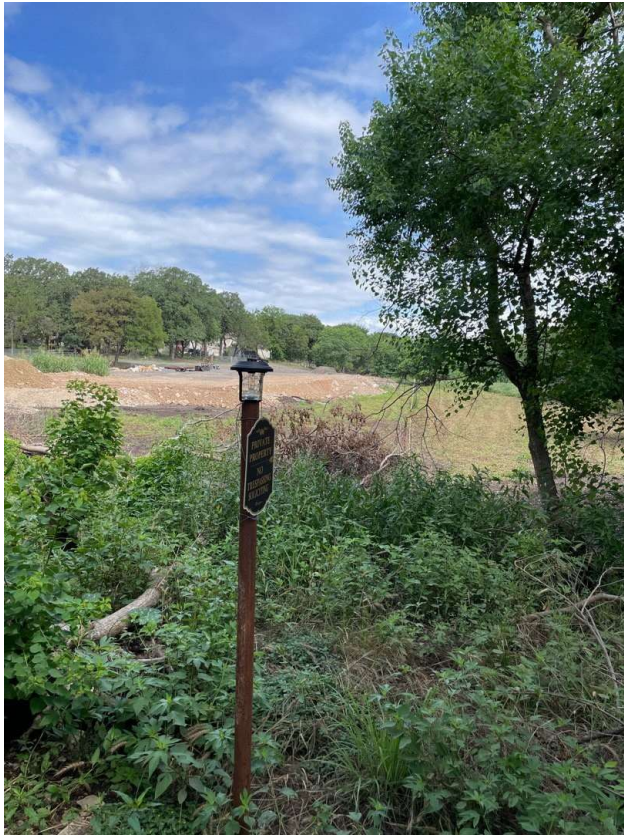
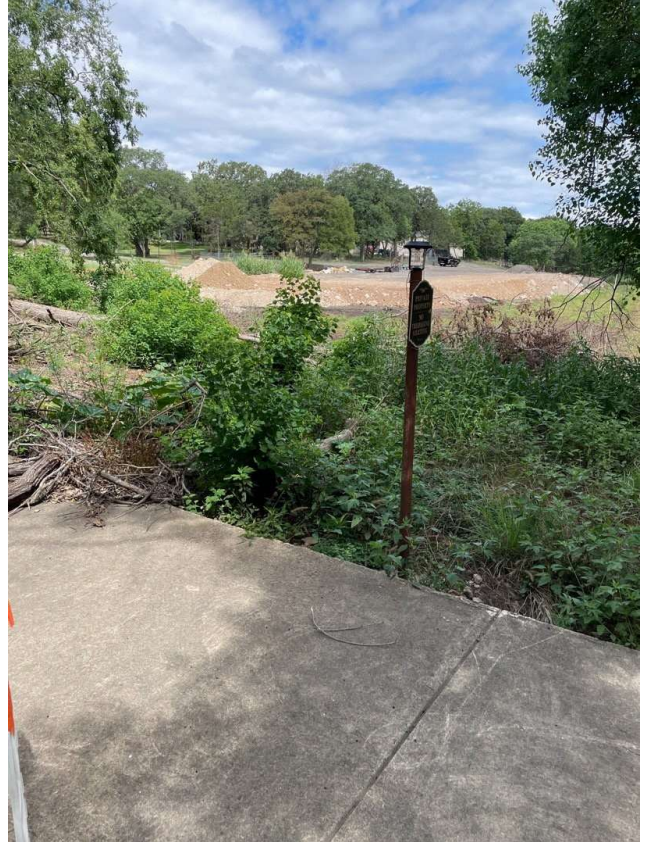
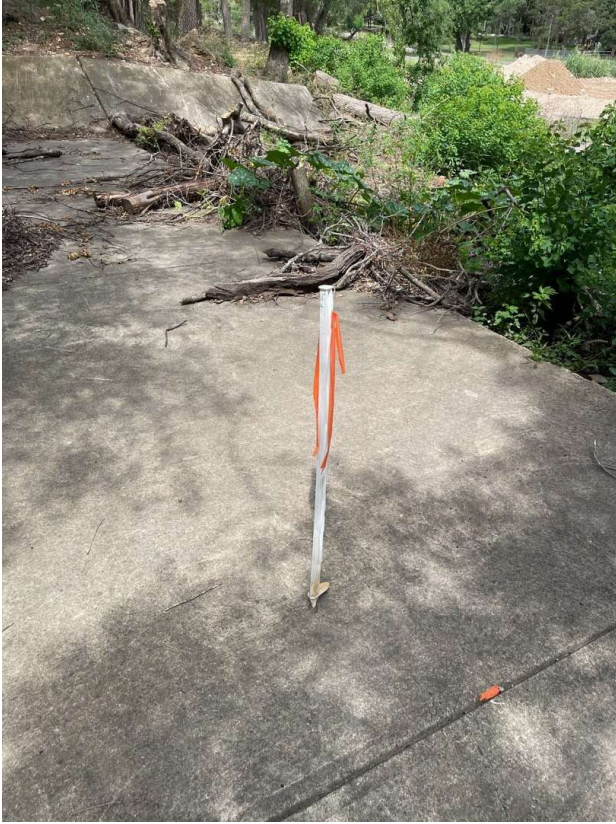
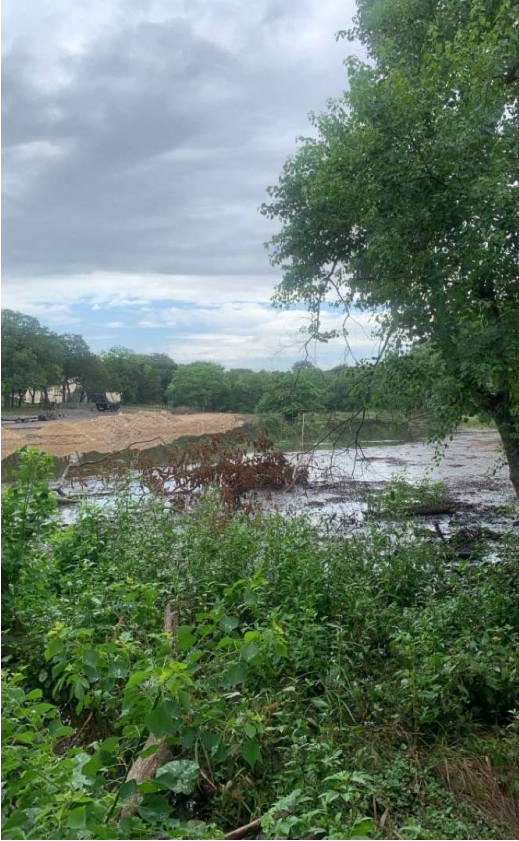
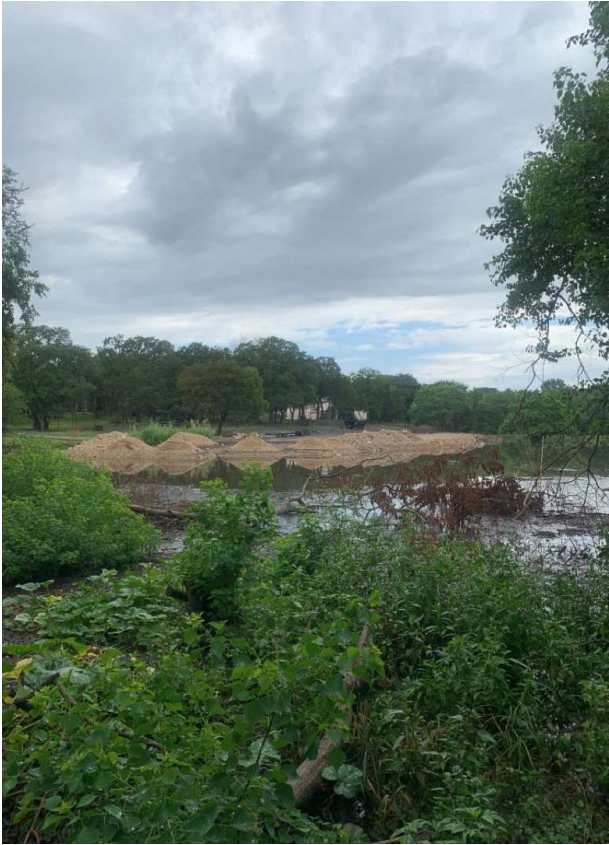
## Lorence Creek Lake Construction

Field Notes: Active construction in what appears to be Lorence Creek Lake. Appears that a survey was also conducted based on monuments.

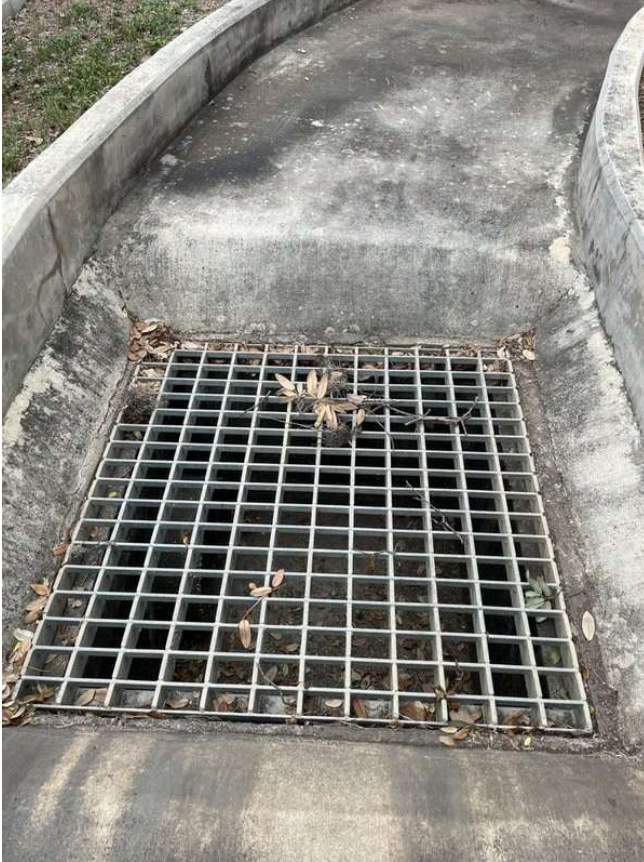
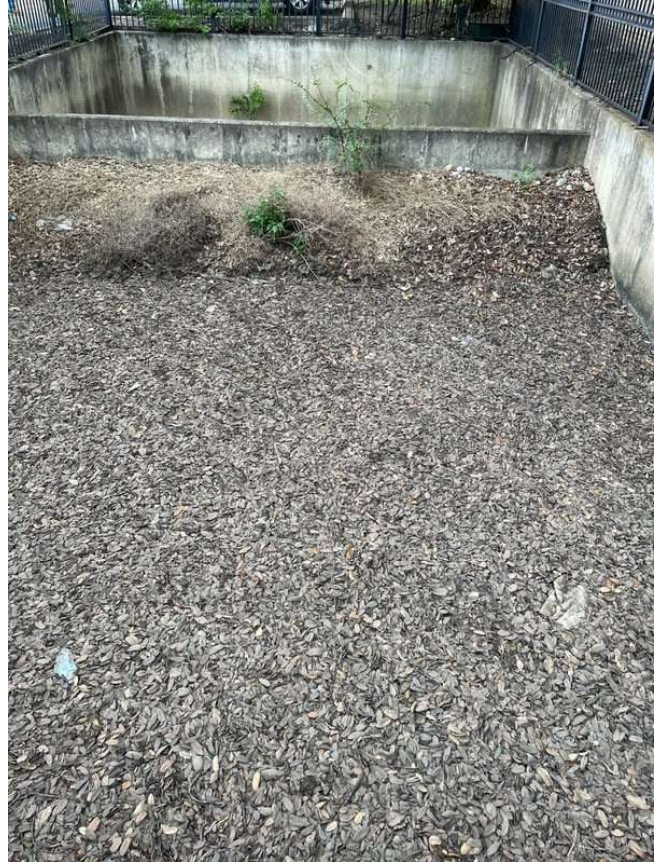
## Marriott Global Reservation PCD

Field Notes: Remove leaves and trash in PCD.

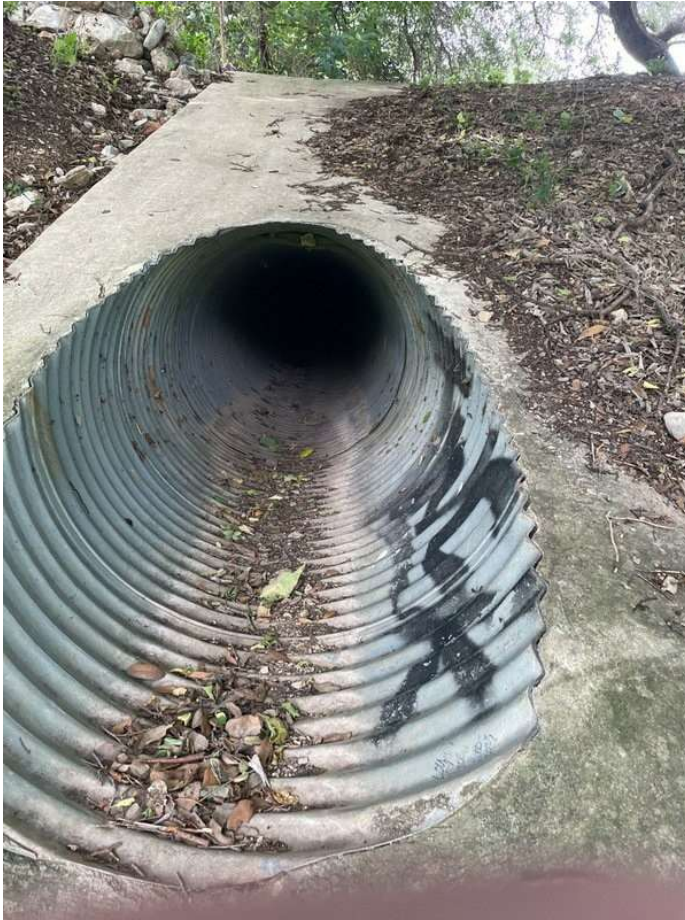
## Mecca Inlets Outfall

Field Notes: Looks good.

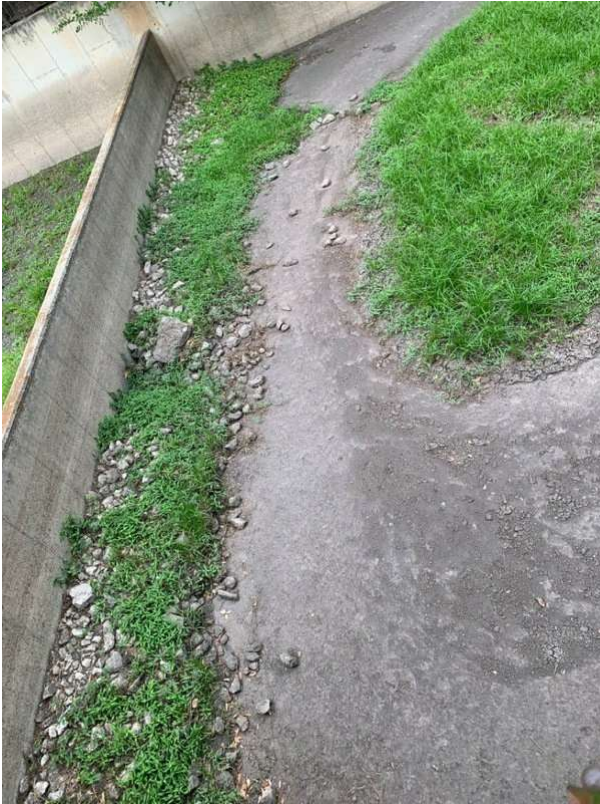
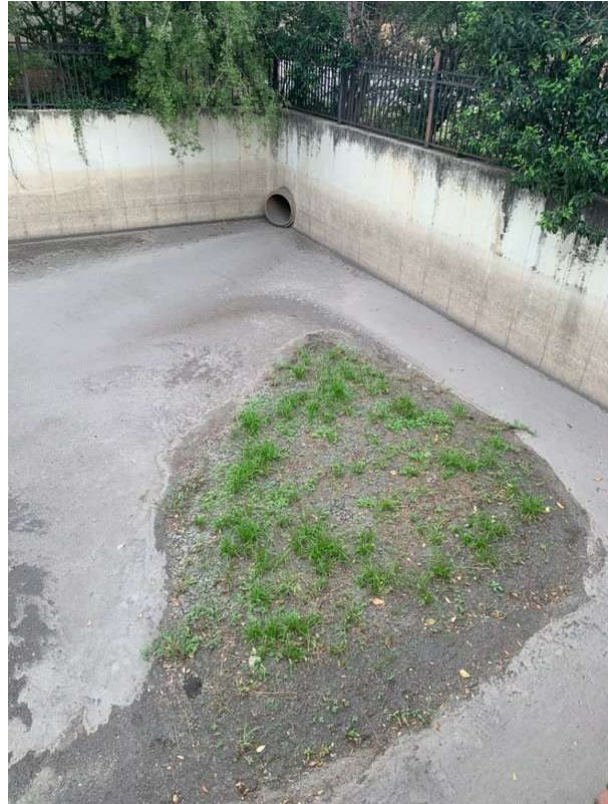
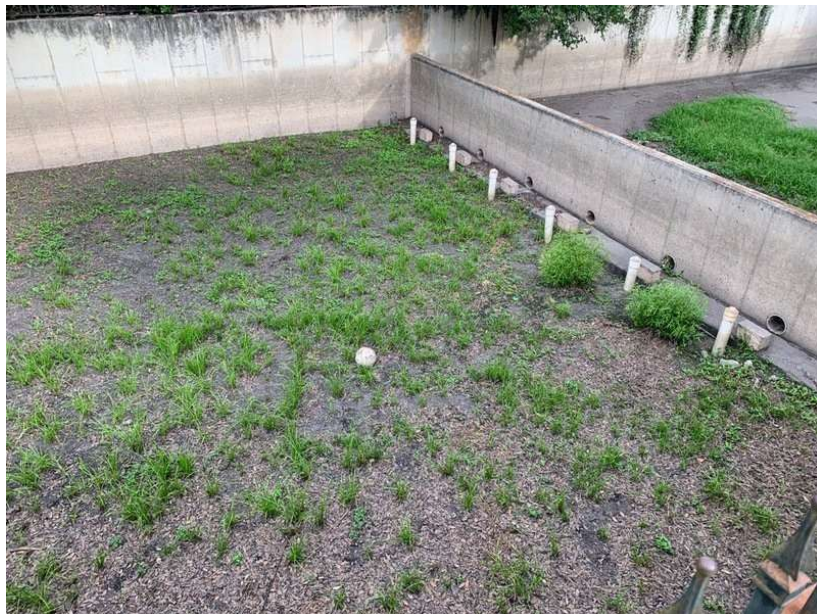
## Miner Fleet Parking Lot Inlet

Field Notes: Clean out trash, sediment, and vegetation.

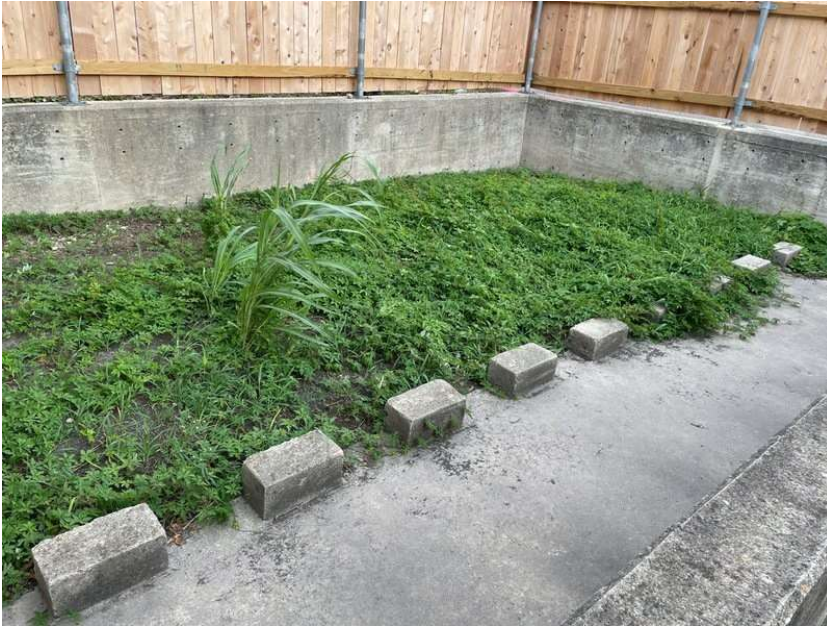
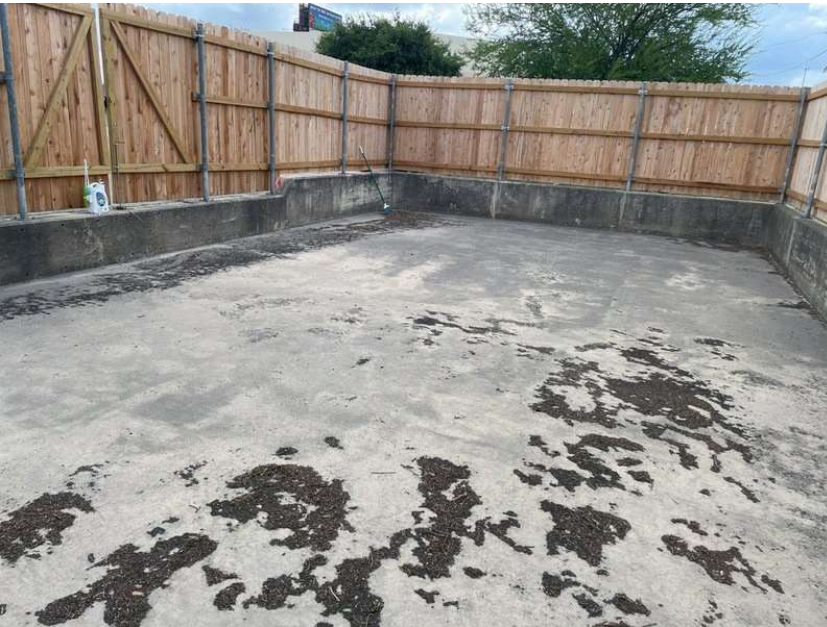
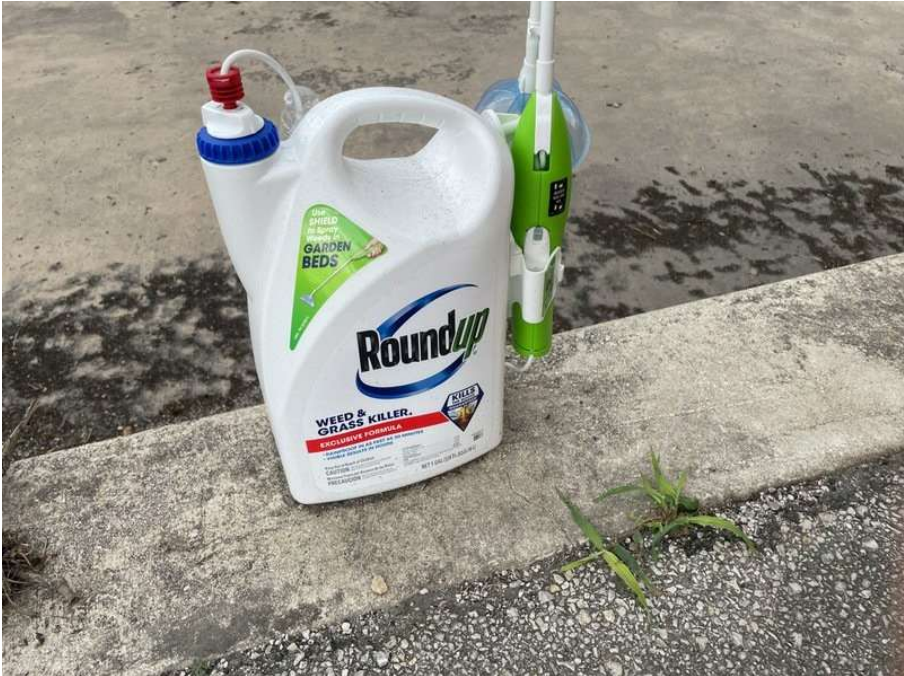
## Monarch Trophy PCD

Field Notes: Remove vegetation, broom, and herbicide container.
