# TOWN OF HOLLYWOOD PARK, TX

2024 Summer Inspection

## HOLLYWOOD PARK 2024 SUMMER INSPECTION REPORT

**Subject:** Annual Municipal Separate Storm Sewer System (MS4) Inspection

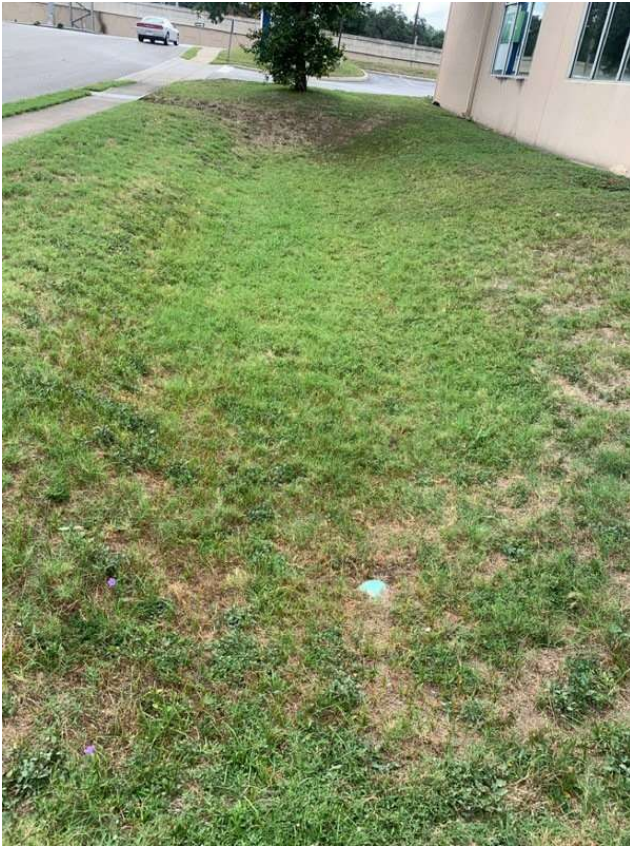
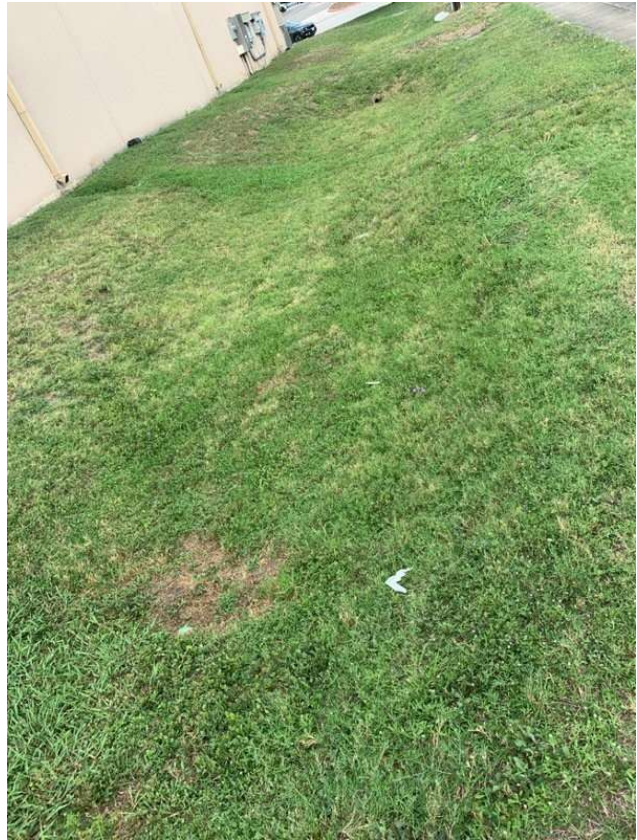
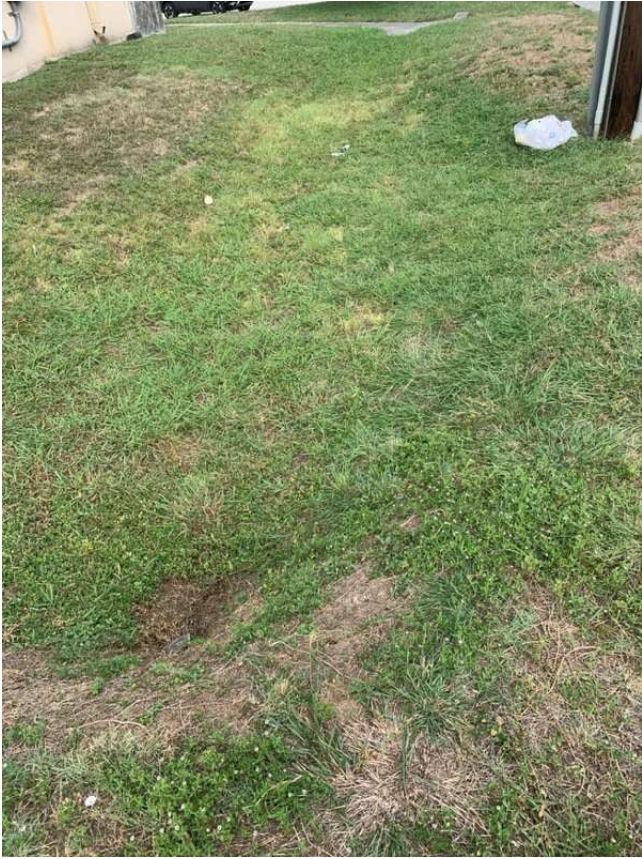
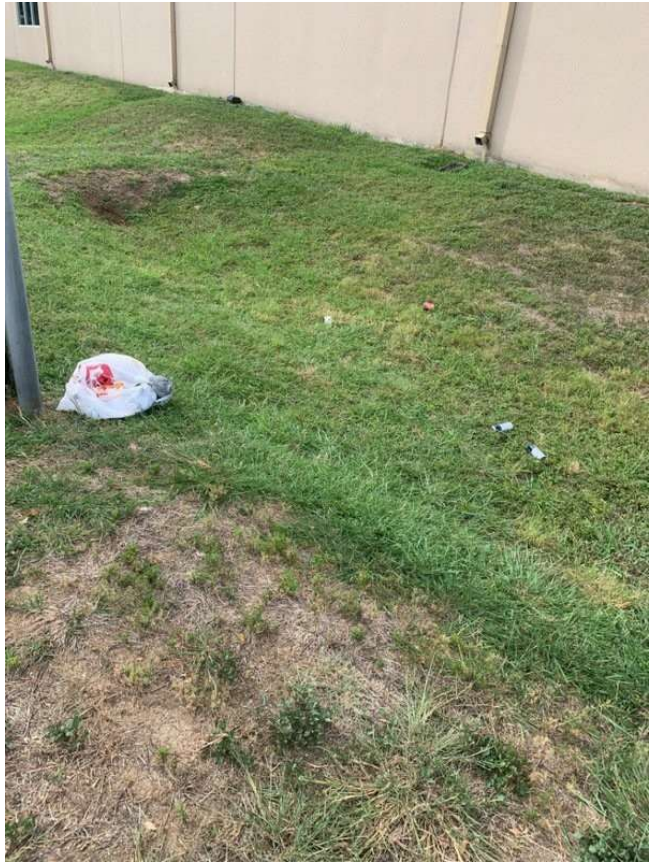
## Monarch Trophy Swale

Field Notes: Trash in swale towards the west end of building, otherwise looks good.

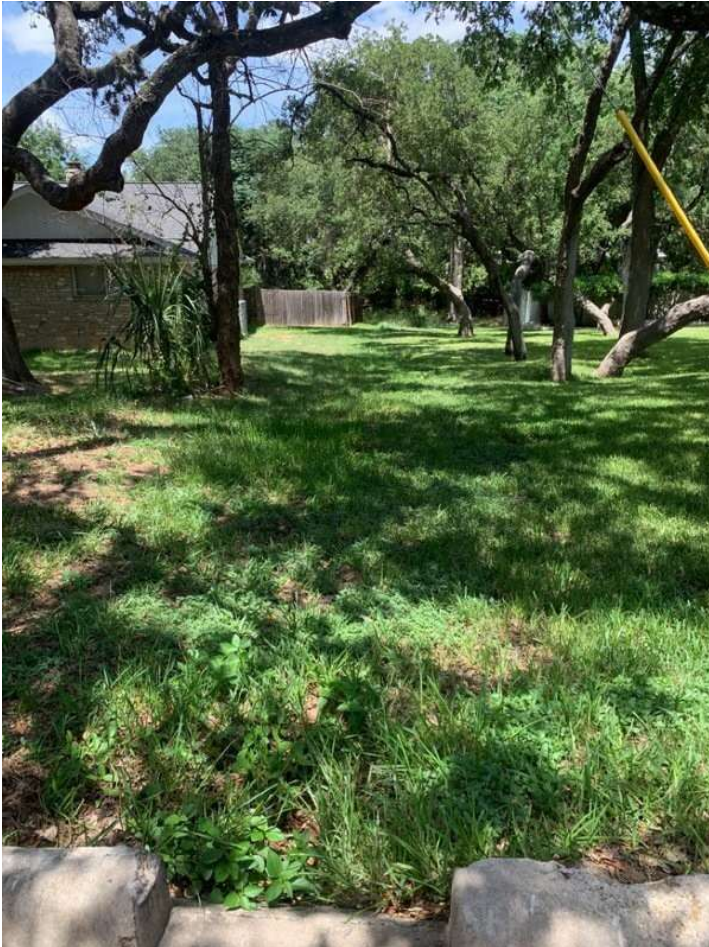
## Mustang Circle

Field Notes: Looks good.

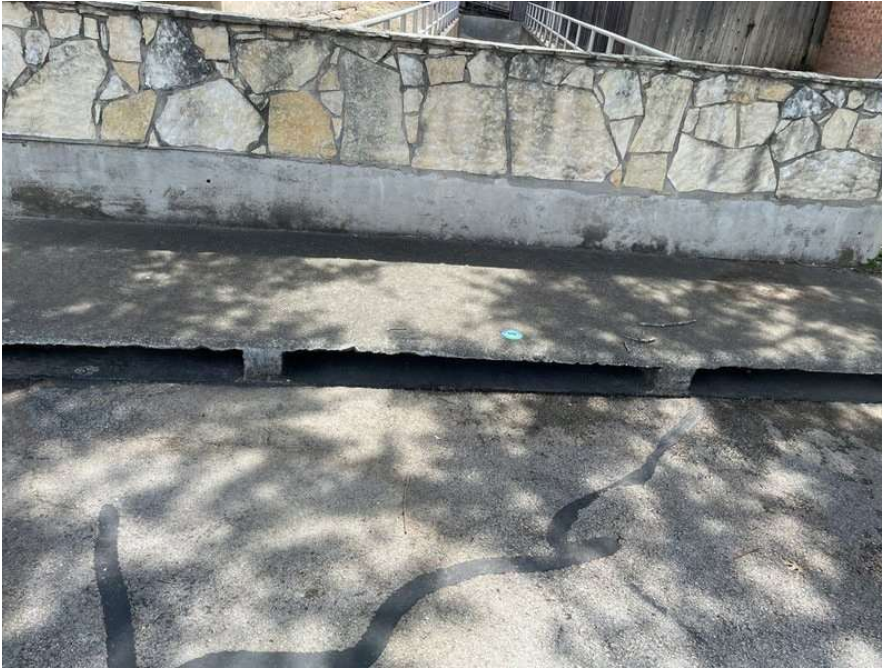
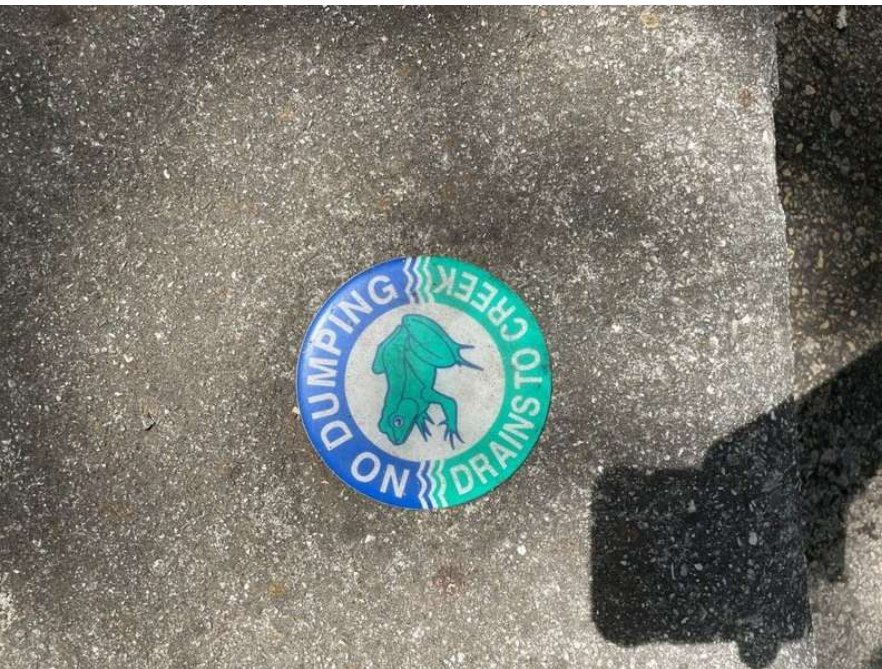
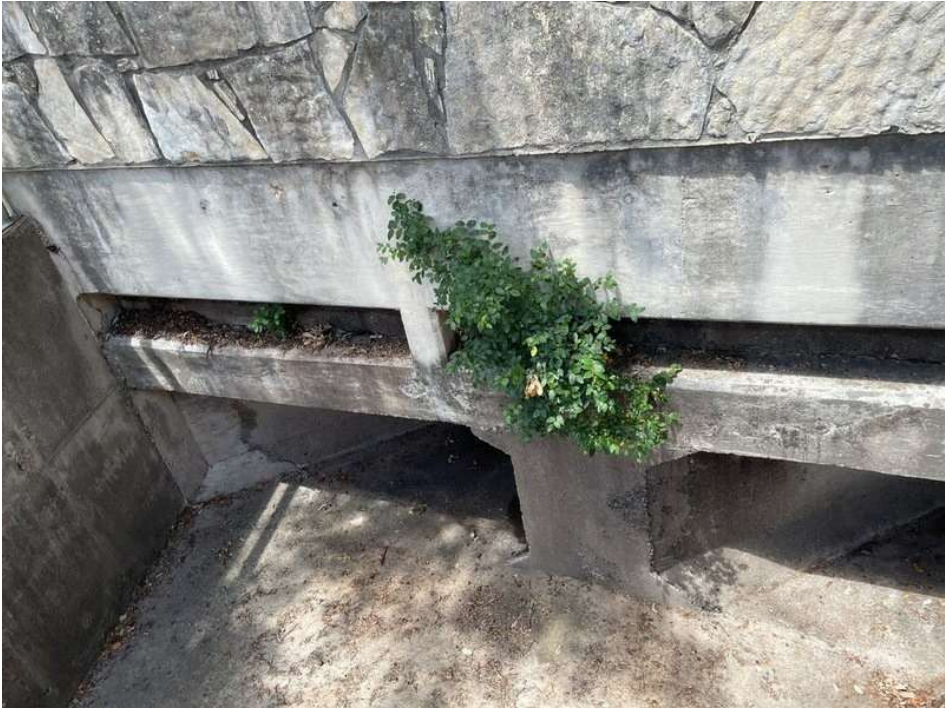
## Navato Residential Drains

Field Notes: Monitor spalling.

Field Notes: Remove vegetation.

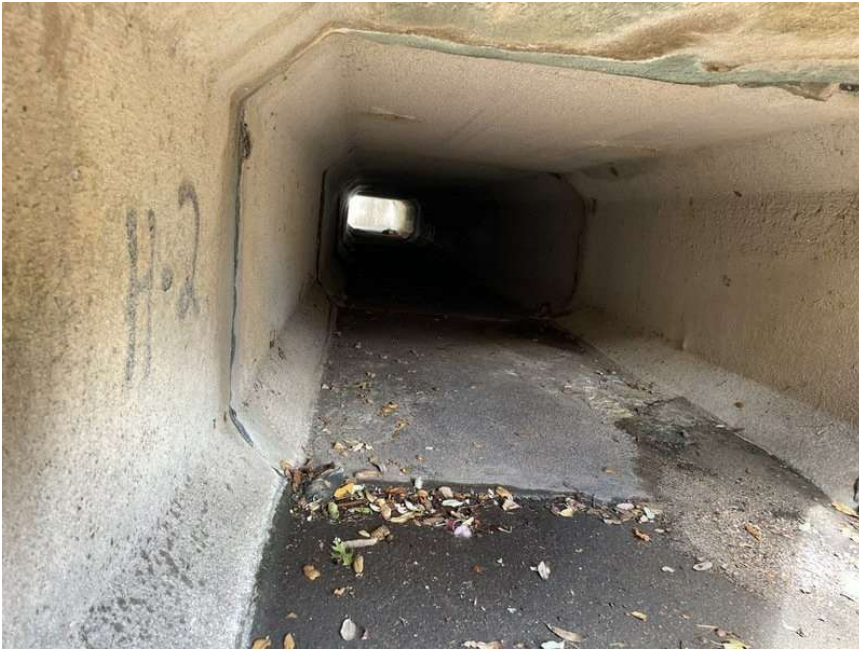
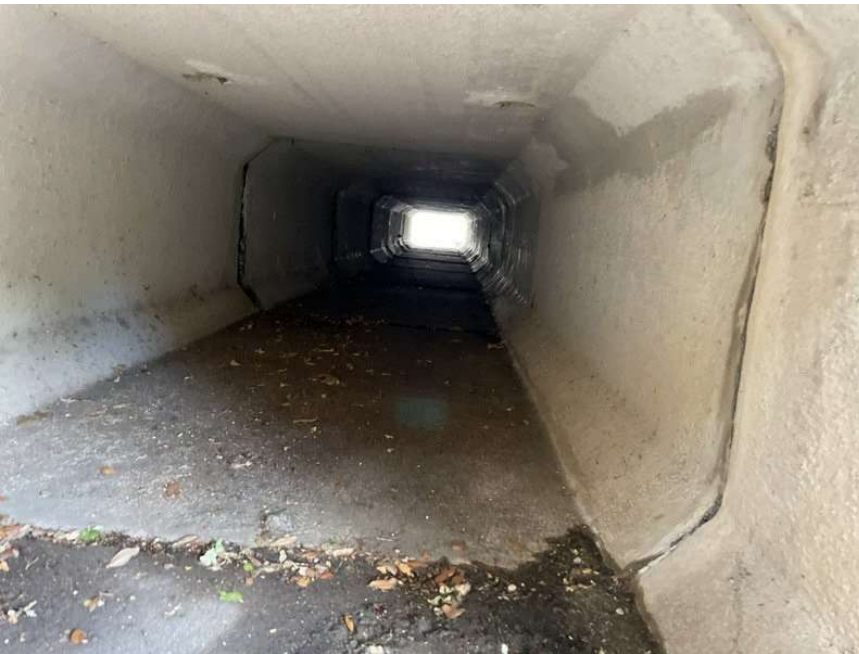
## Navato Storm Sewer Pipe

Field Notes: Looks good.

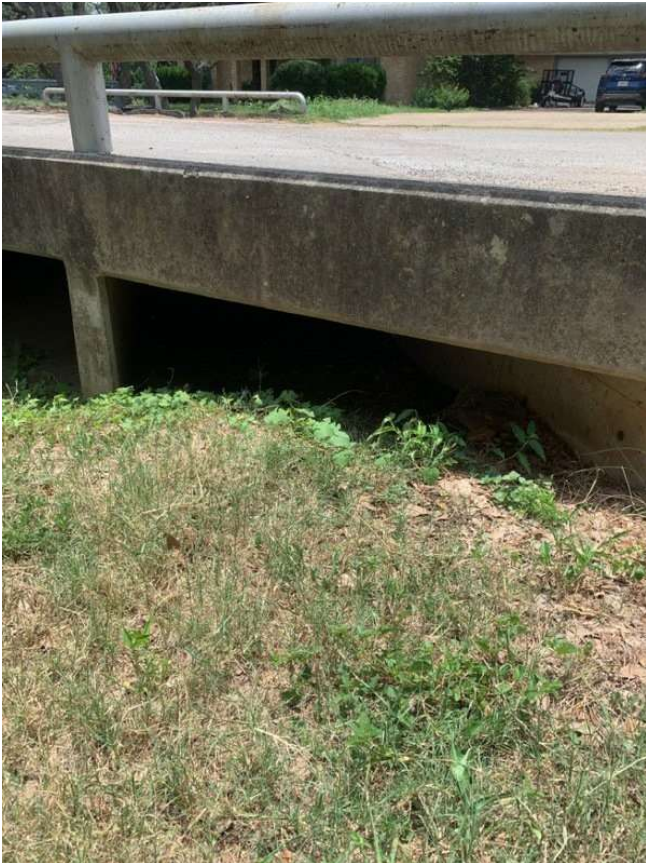
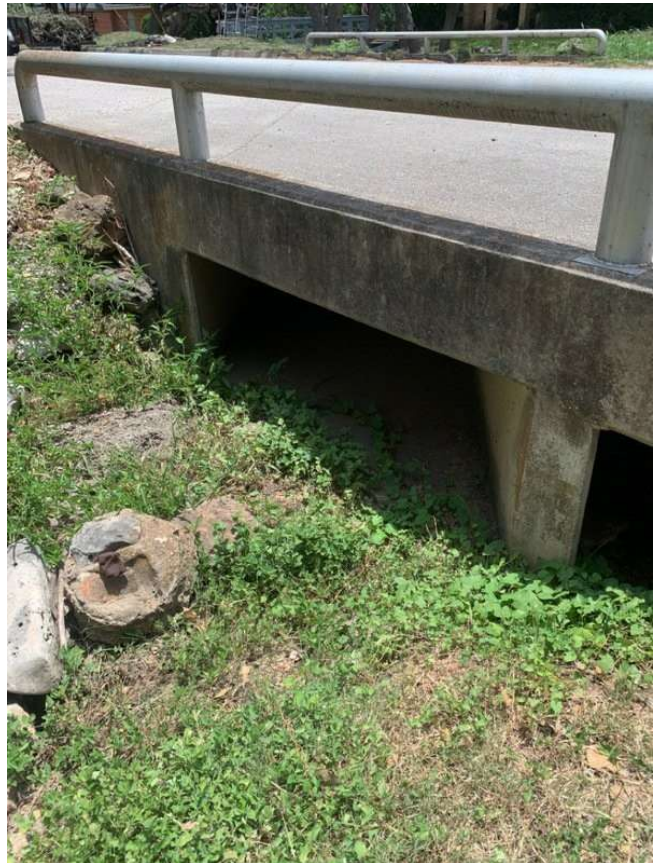
## North Oak Crossing

Field Notes: Trim vegetation in channel and near inlets.

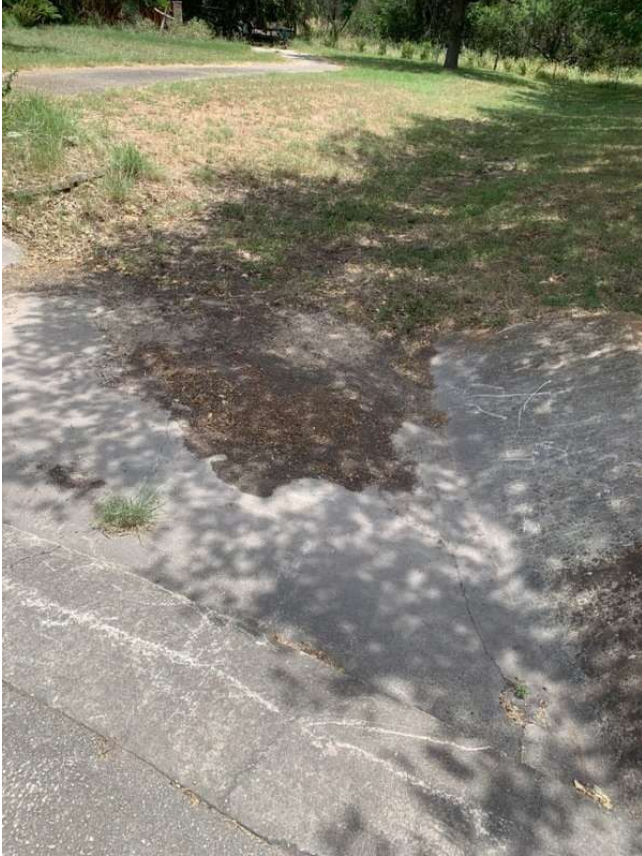
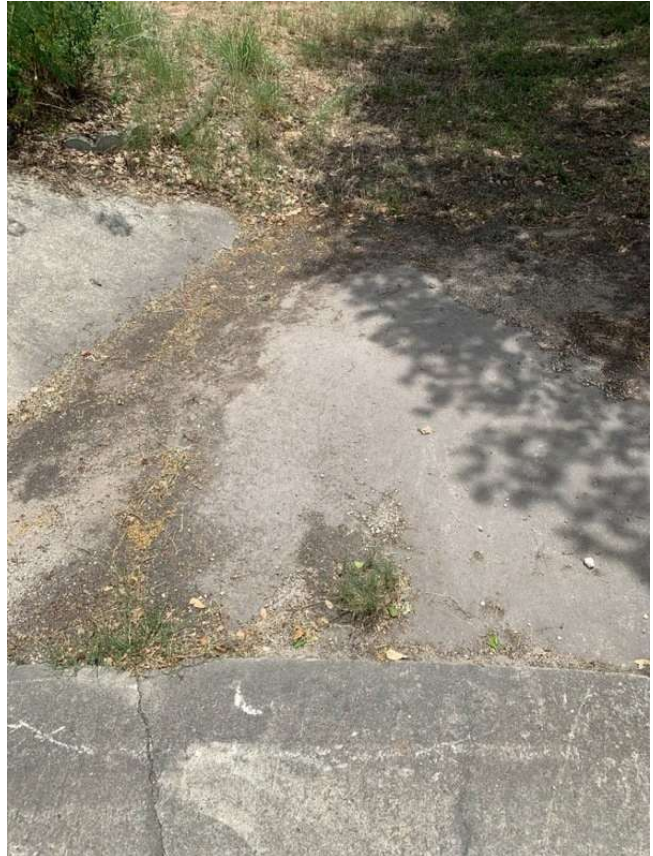
## North Oak Outfall

Field Notes: Clean sediment buildup.

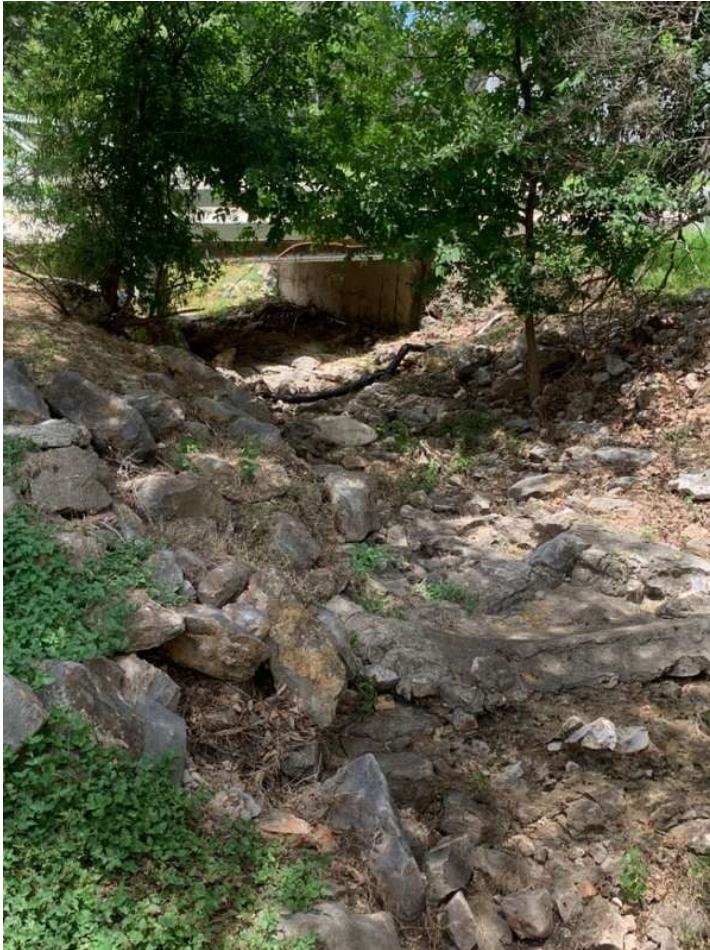
## North Oak Private Crossing East

Field Notes: Looks good.

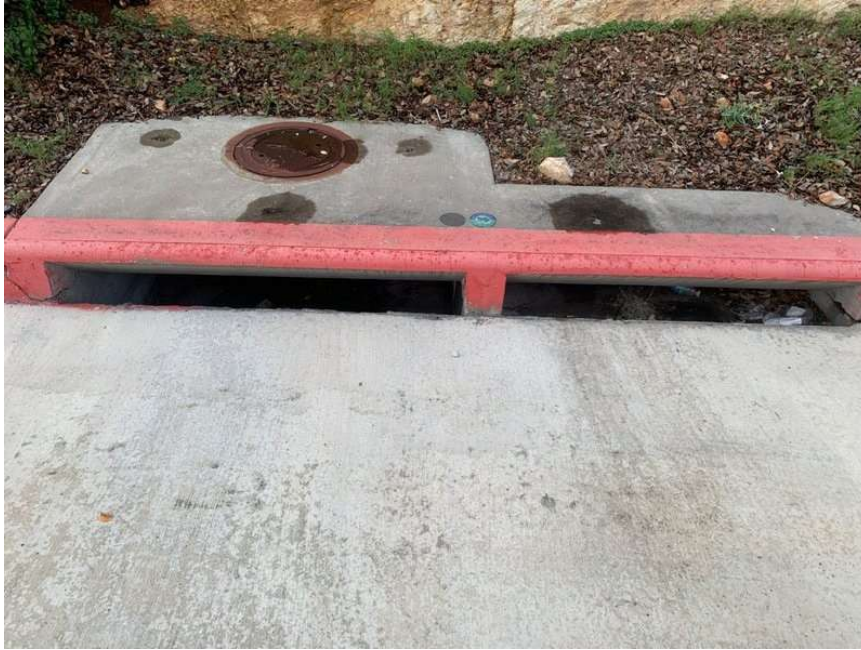
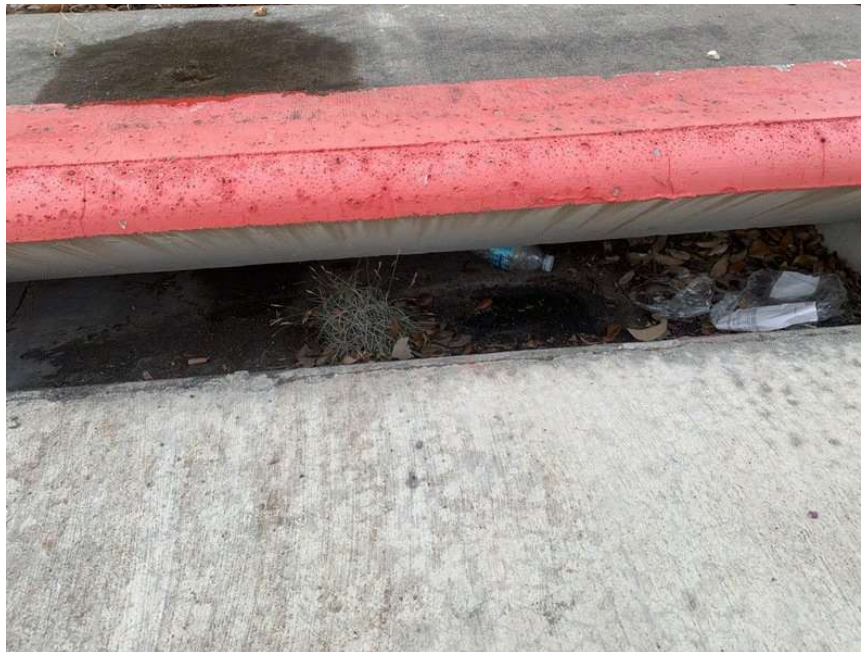
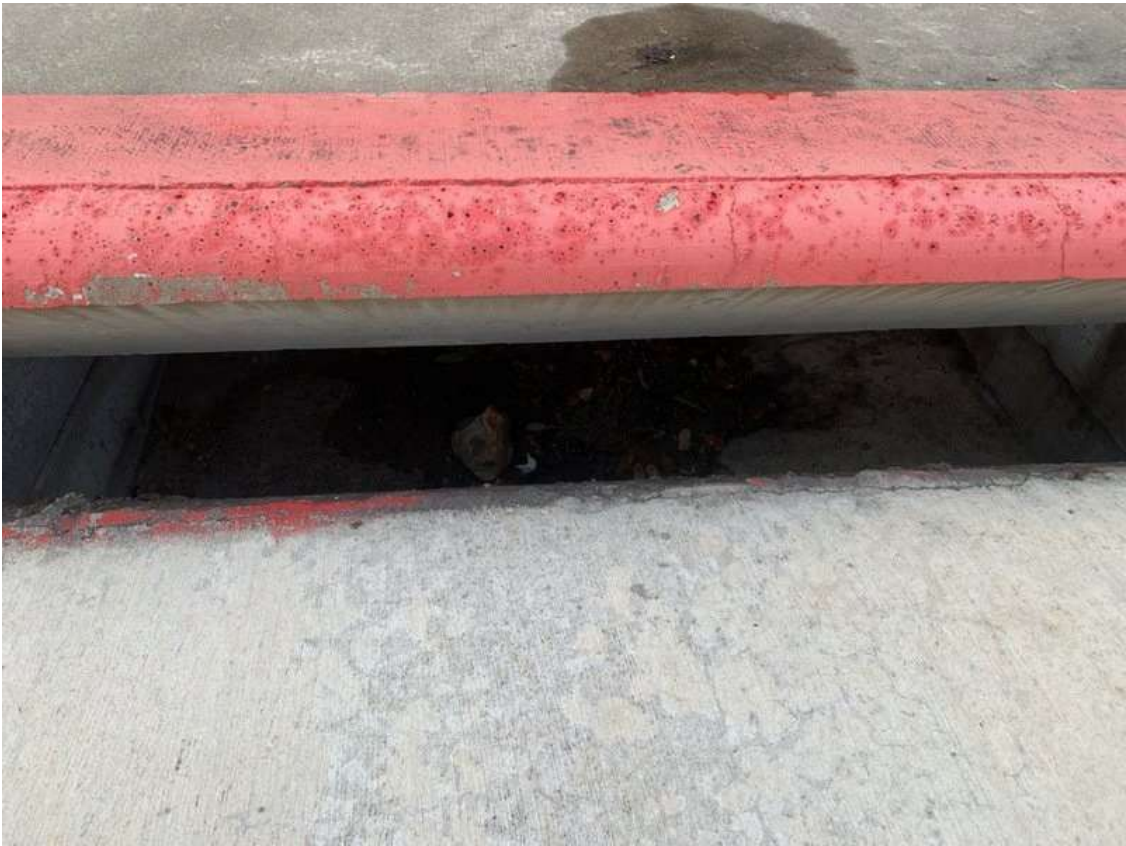
### Oak Circle Creek Inlet

Field Notes: Remove debris from inlet.

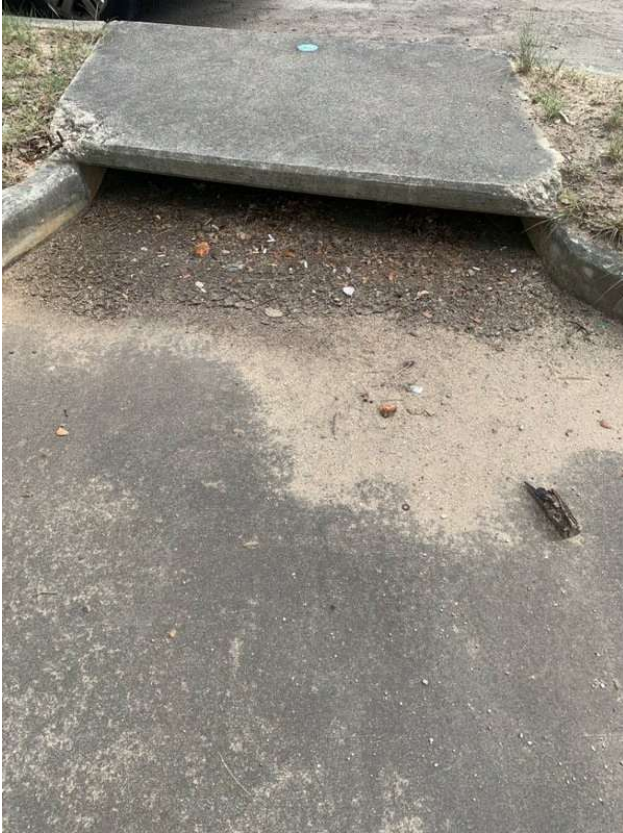
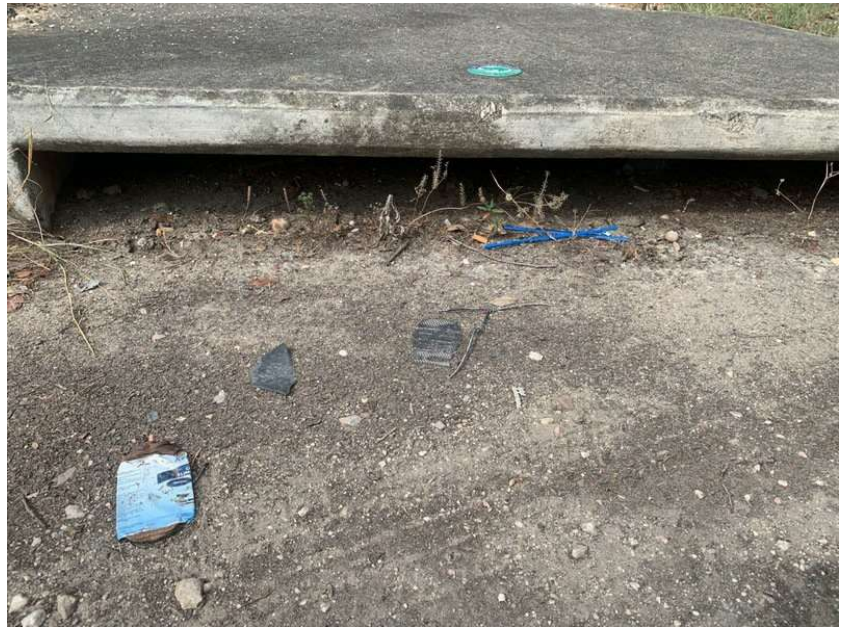
## Oak Creek Circle Inlet 2

Field Notes: Clean sediment and trash.

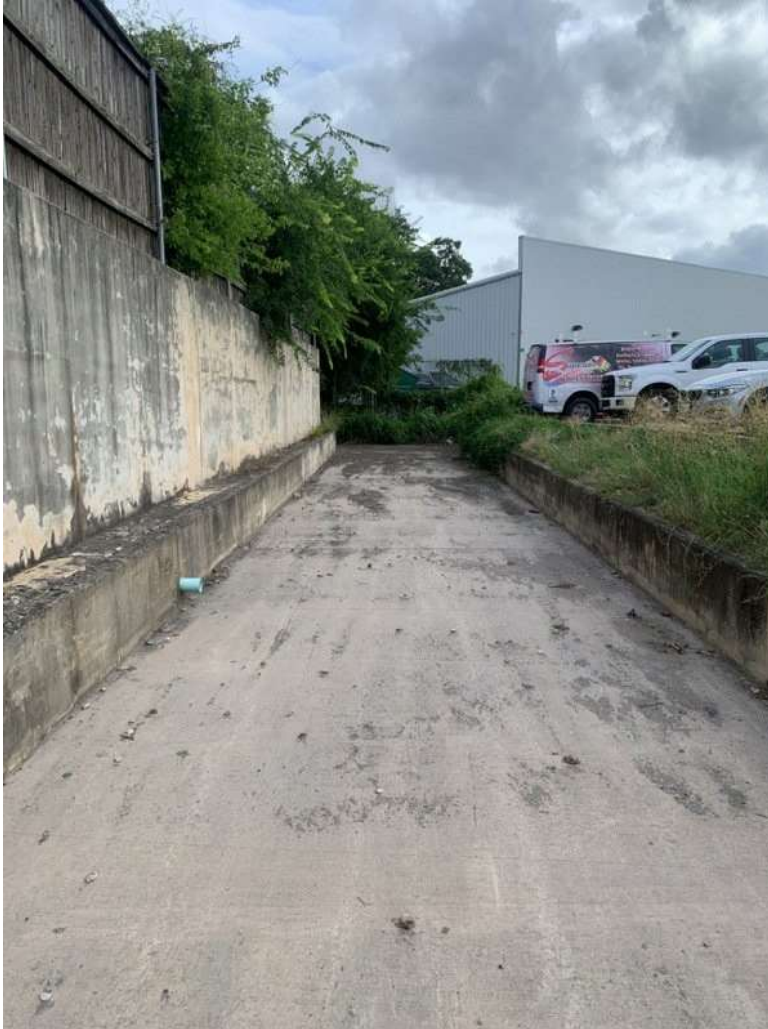
## Oak Creek Circle Channel

Field Notes: Looks good.

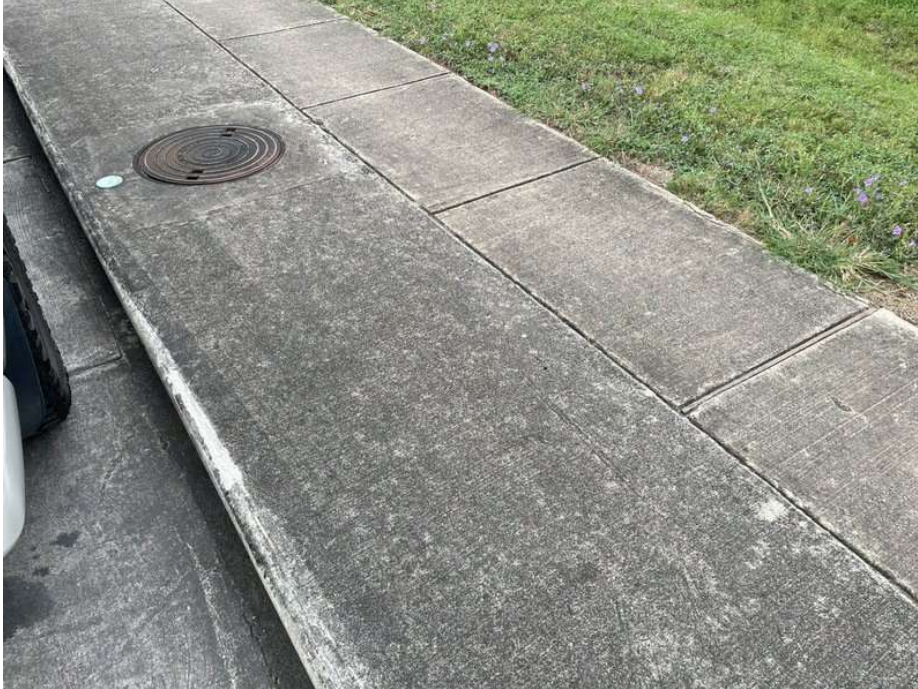
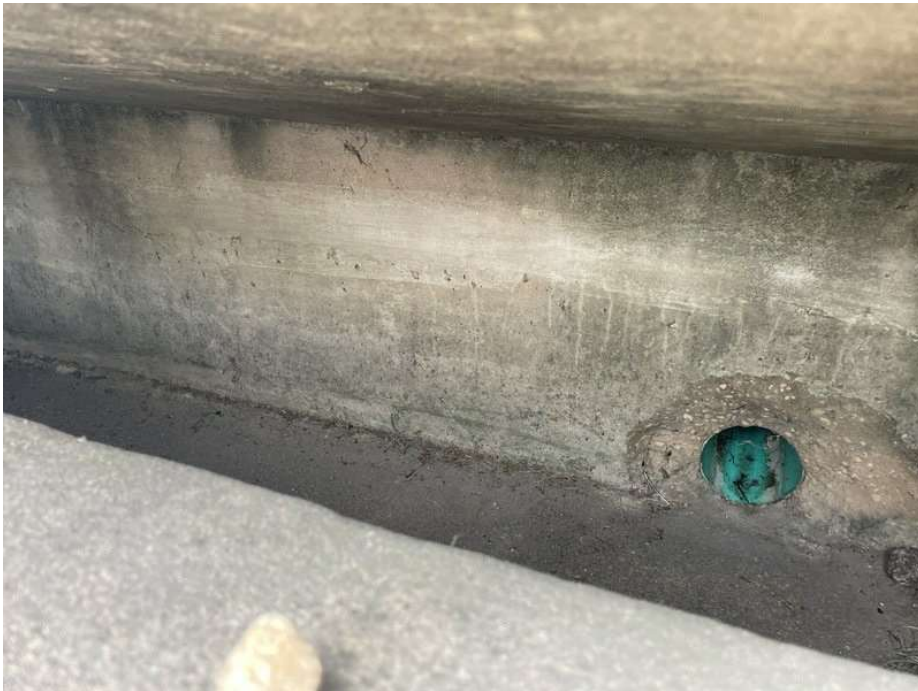
## Oak Creek Circle Storm Sewer Pipe

Field Notes: Looks good.

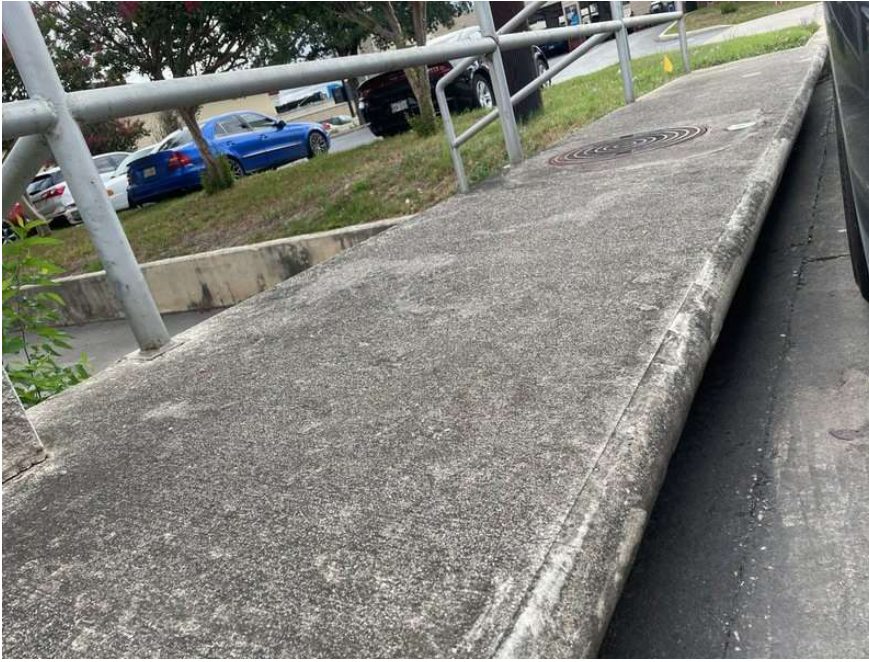
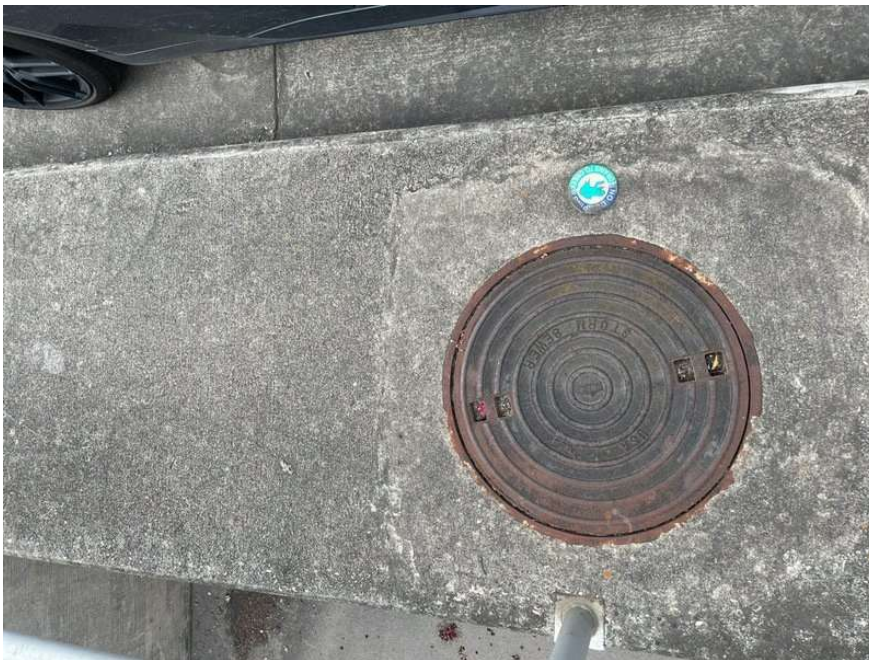
### OAK-I-2(M)

Field Notes: Looks good.

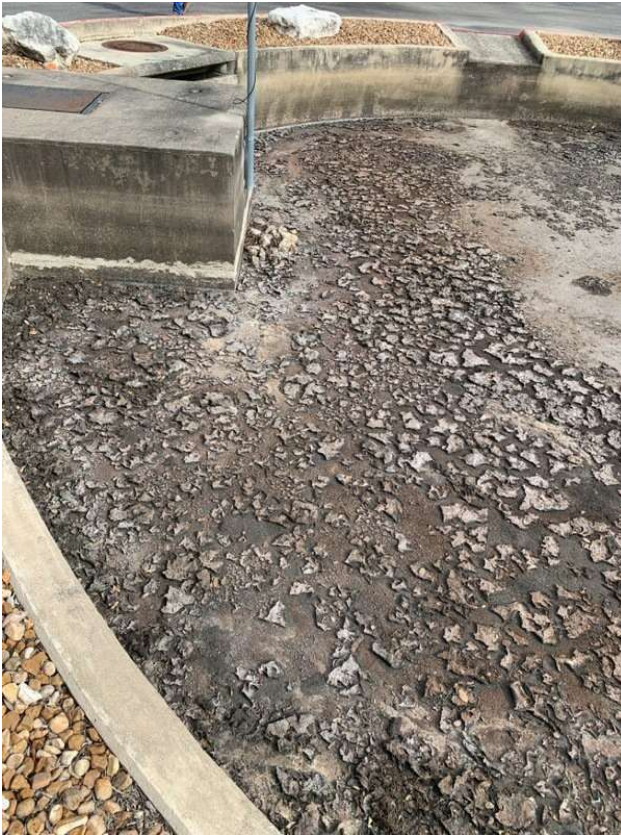
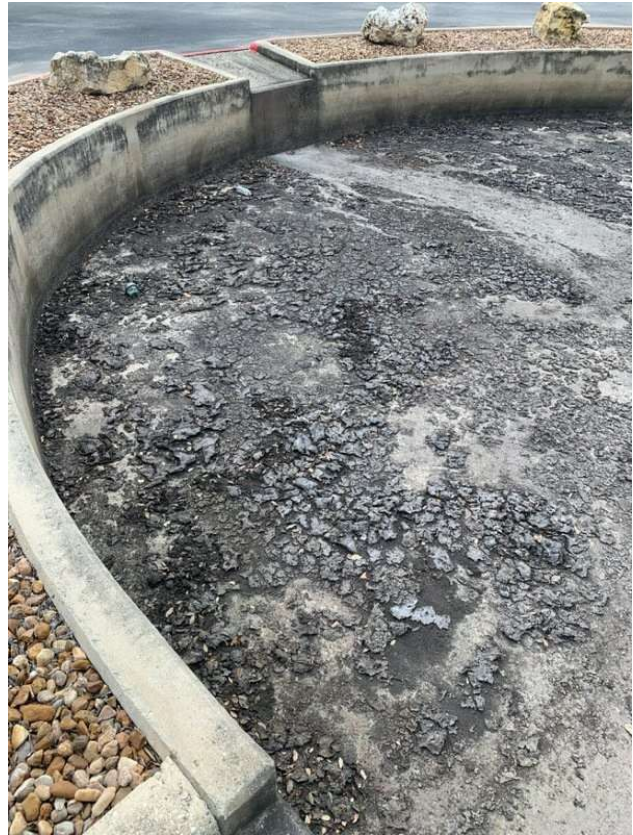
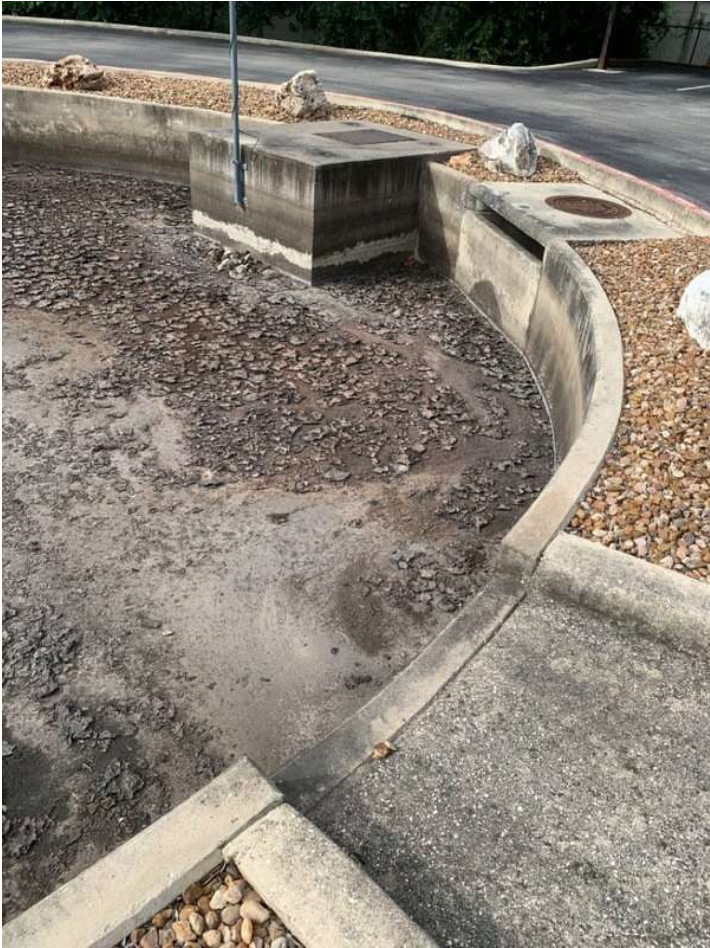
## Optometrist Roundabout PCD

Field Notes: Clean sediment out of basin.

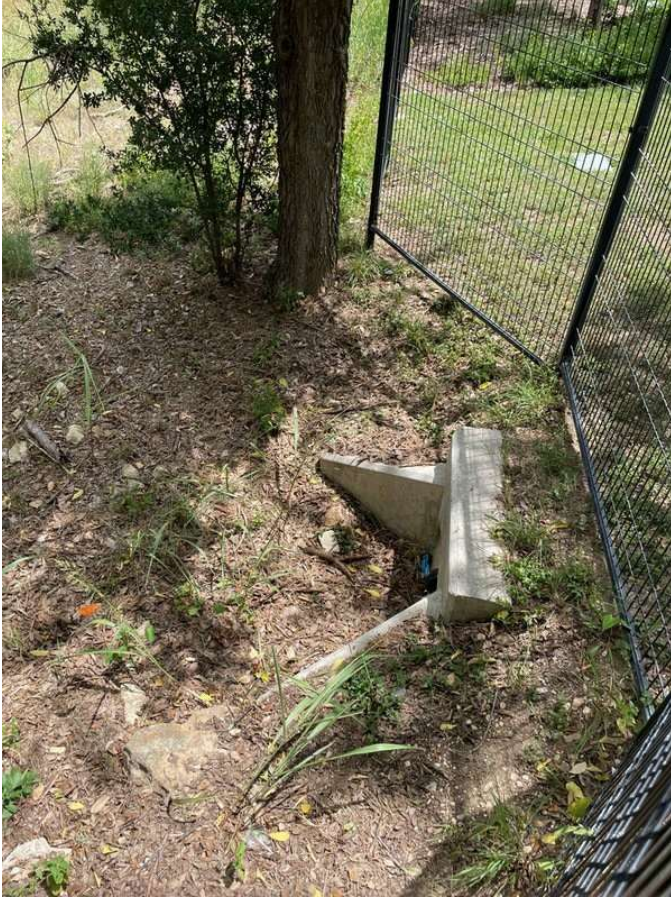
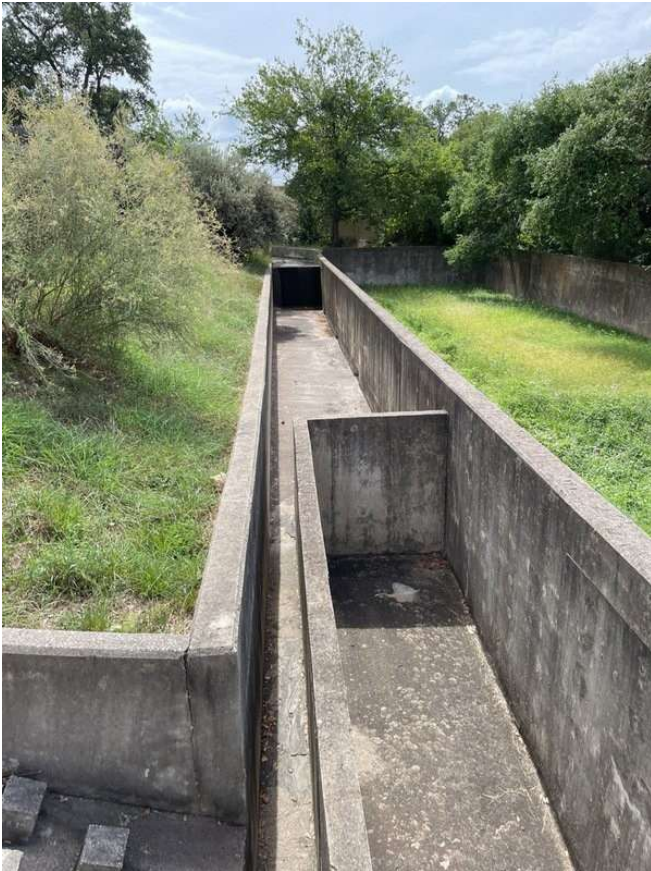
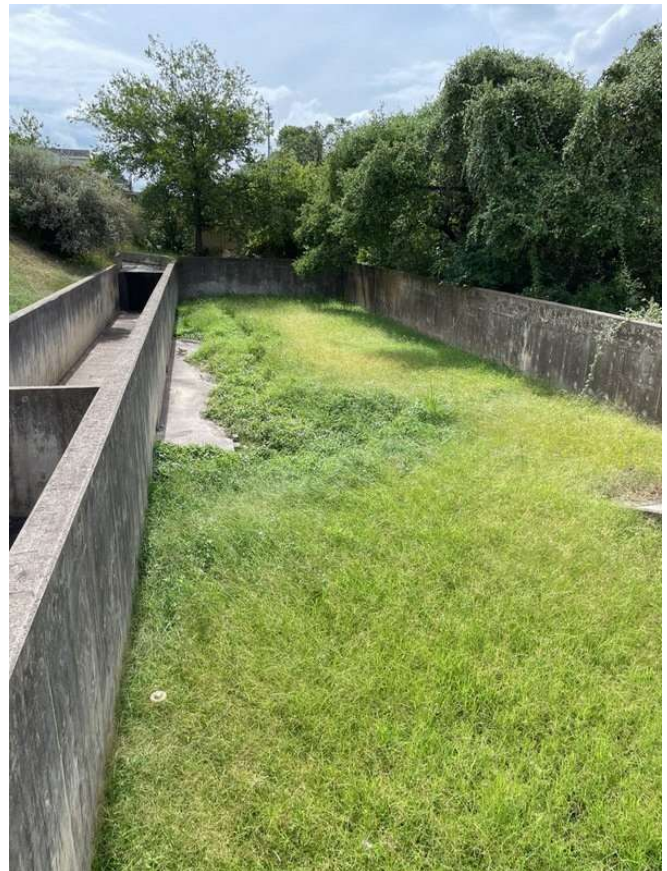
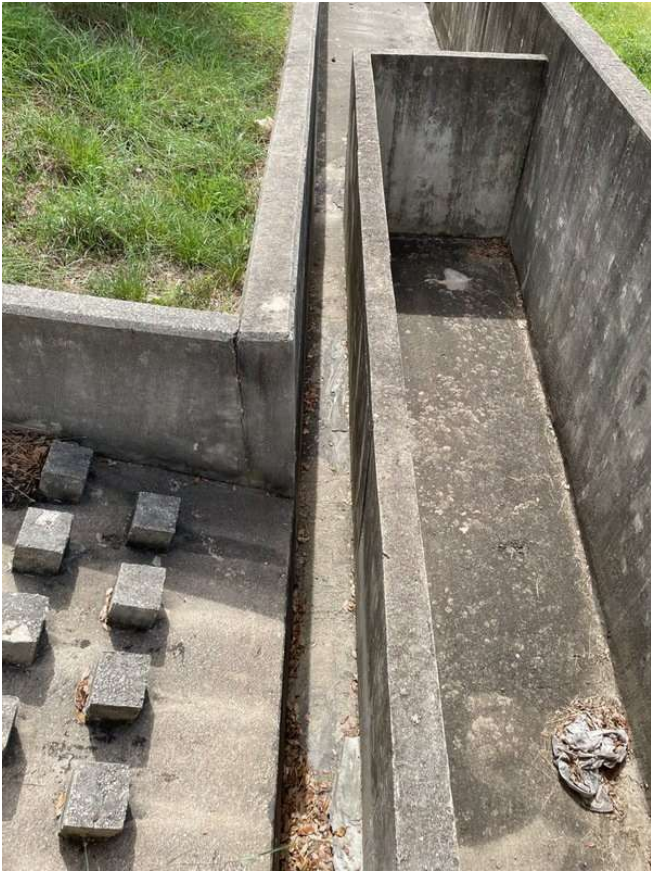
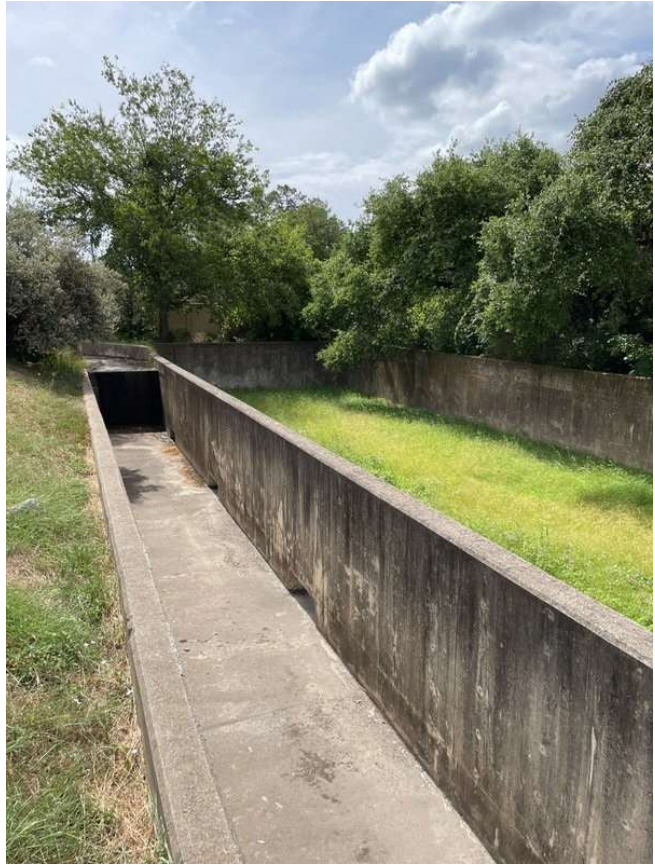
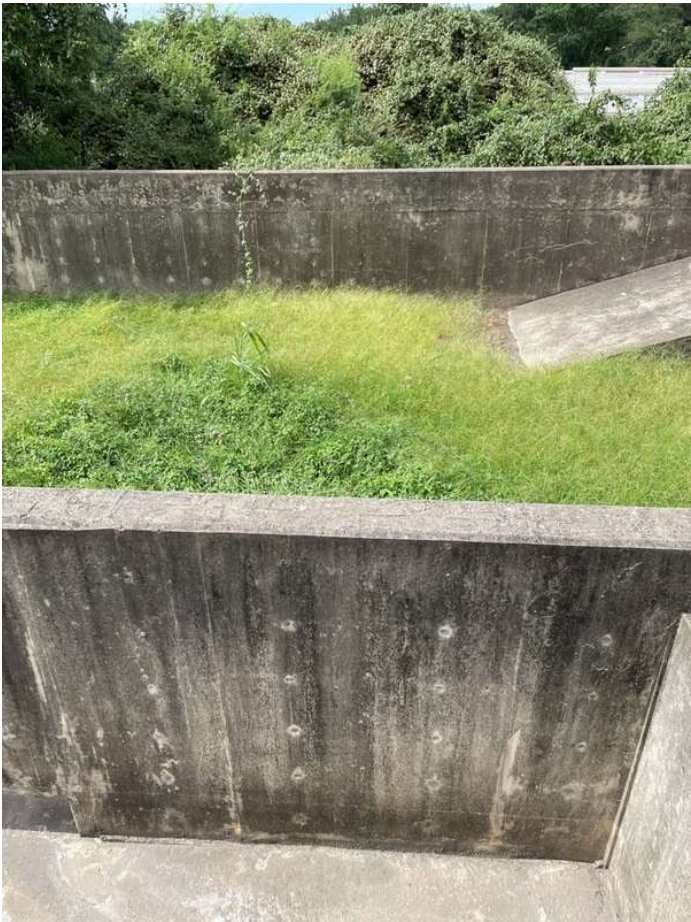
## Outfall

Field Notes: Mow vegetation.

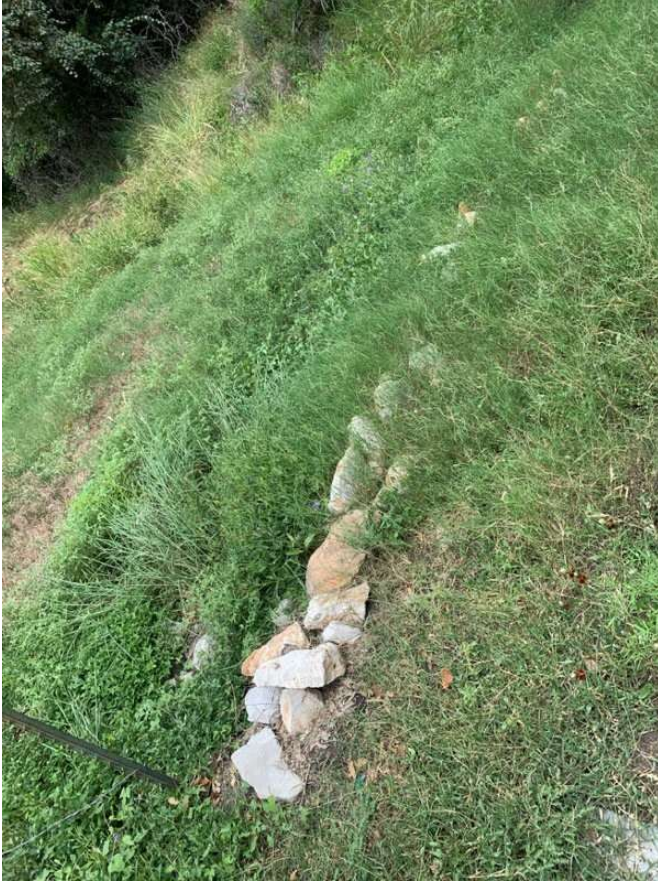
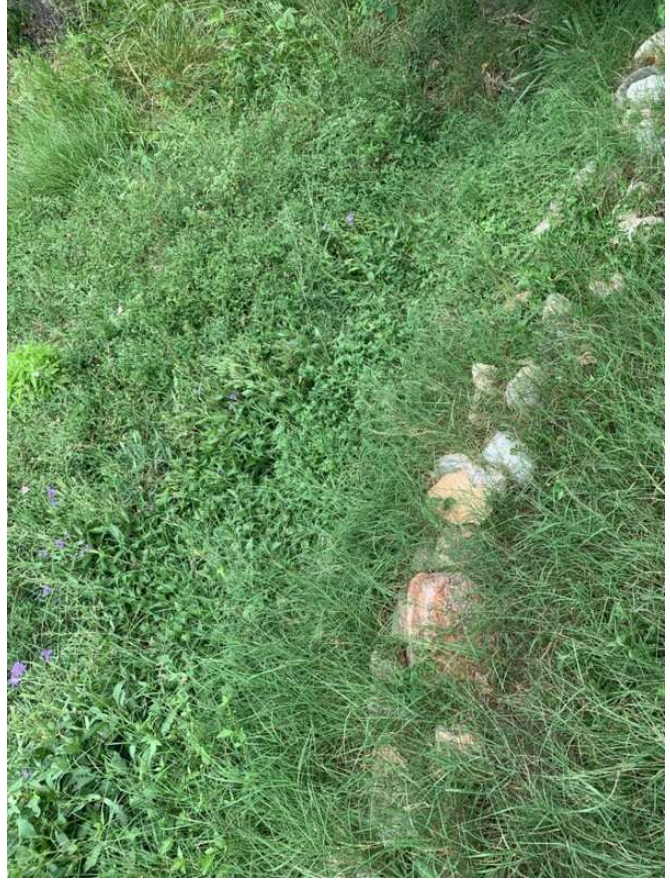
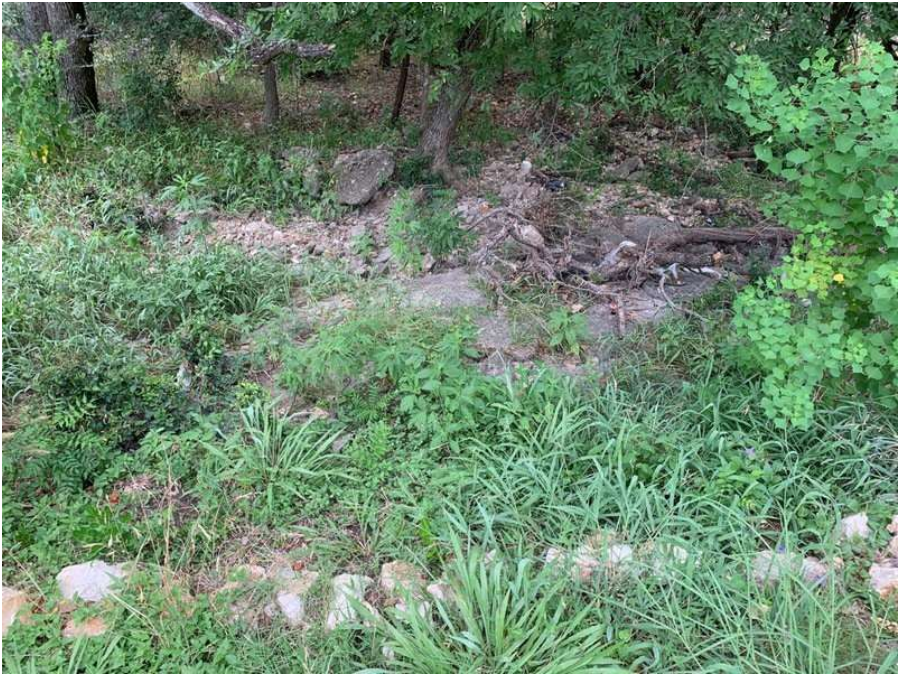
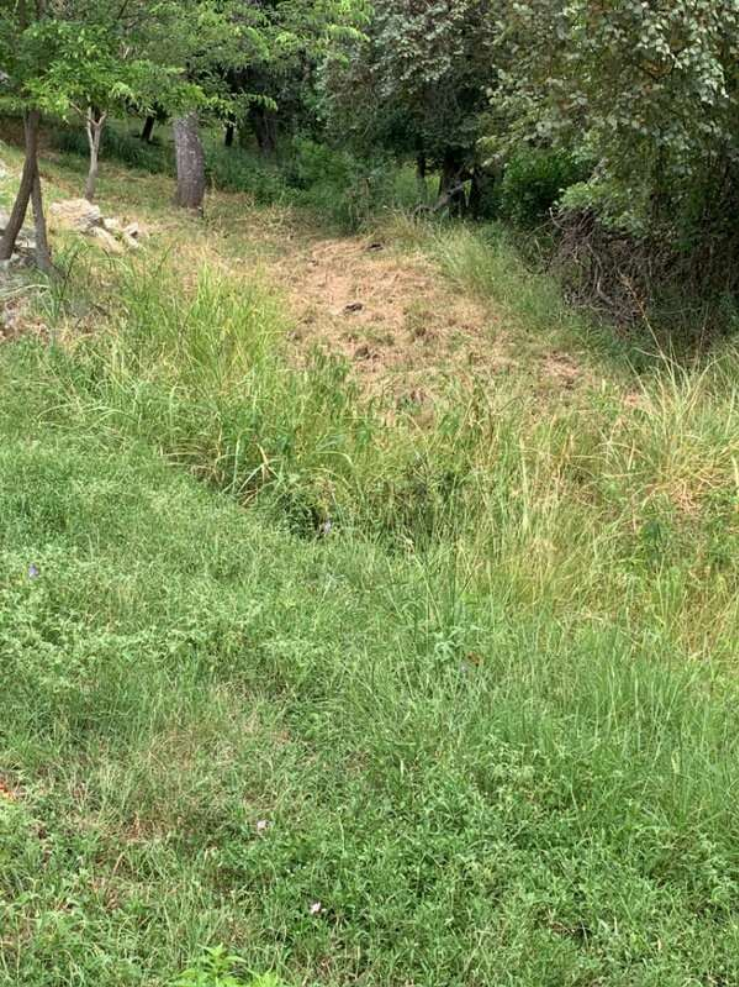
## Park Oak Outfall

Field Notes: Remove trash and trim vegetation.
