# TOWN OF HOLLYWOOD PARK, TX

2024 Summer Inspection

## HOLLYWOOD PARK 2024 SUMMER INSPECTION REPORT

**Subject:** Annual Municipal Separate Storm Sewer System (MS4) Inspection

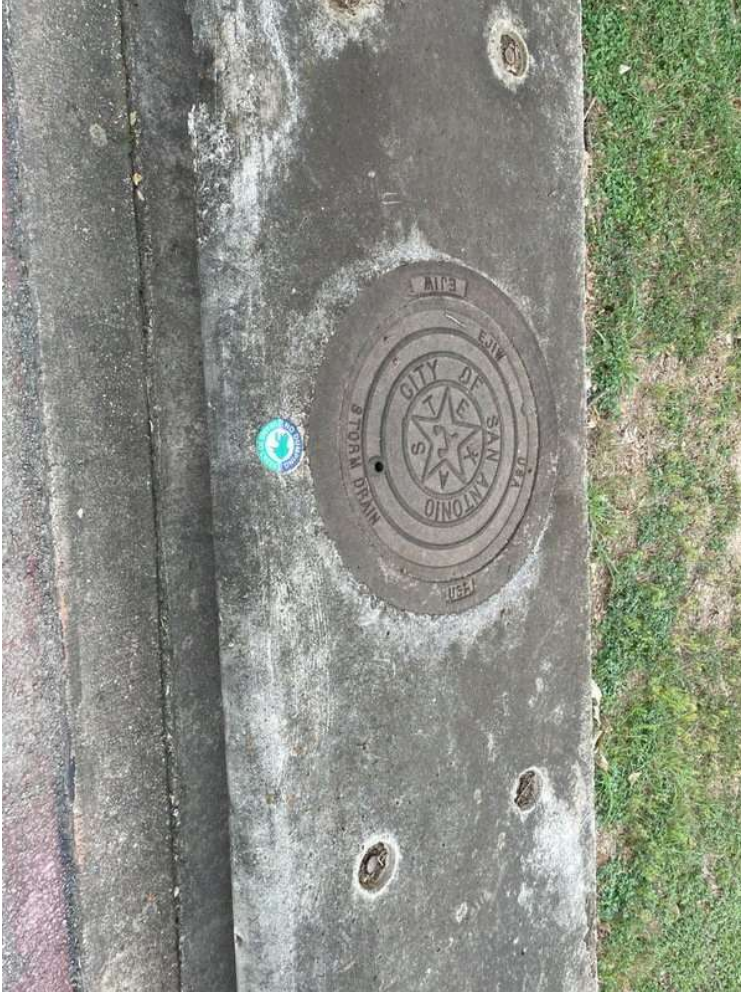
## Parking Lot Box Inlet

Field Notes: Looks good.

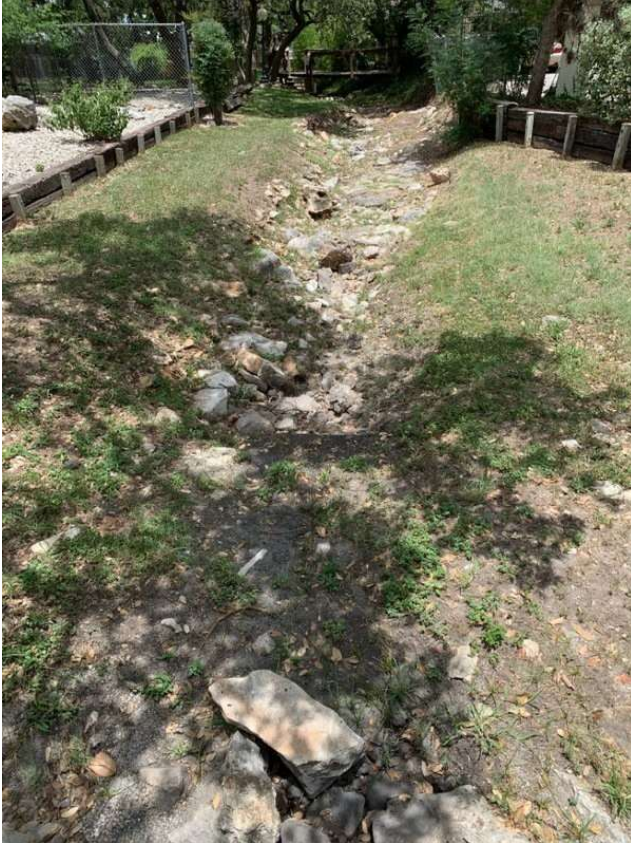
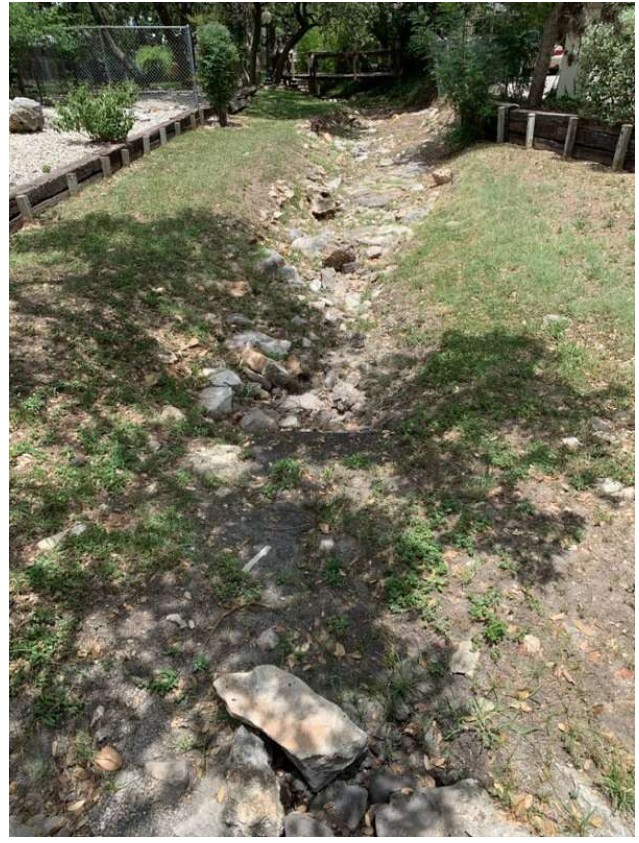
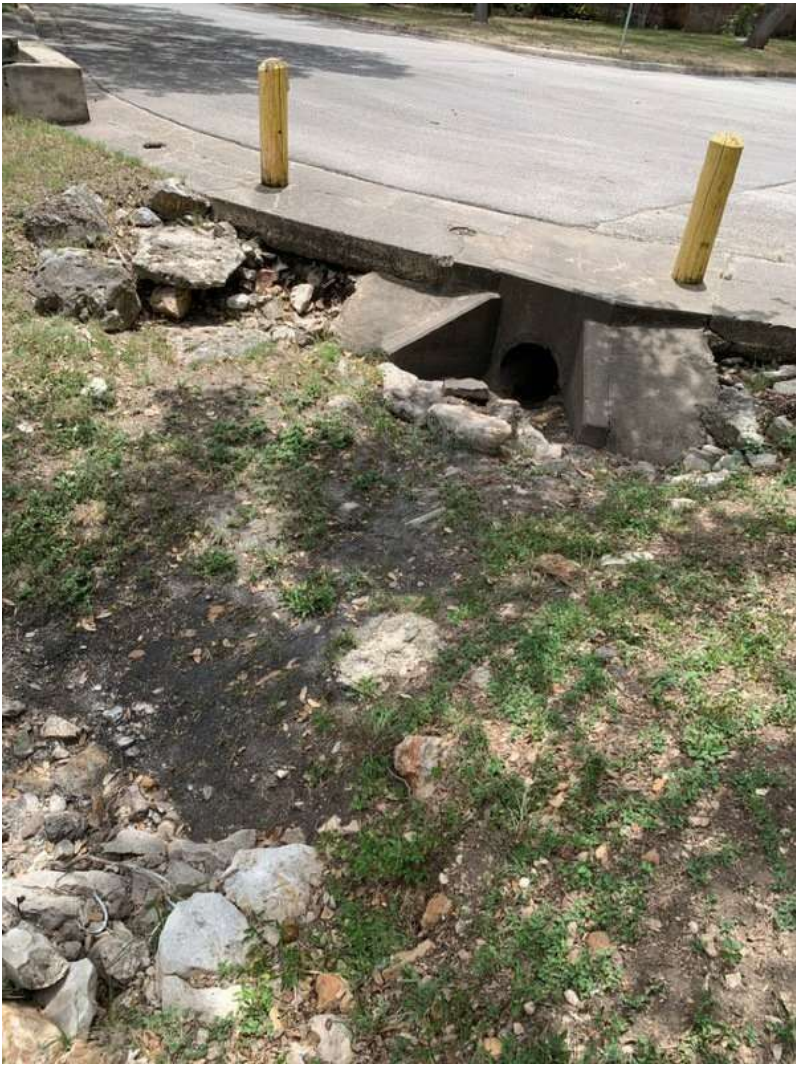
## Paseo Canada Outfall 1

Field Notes: Looks good.

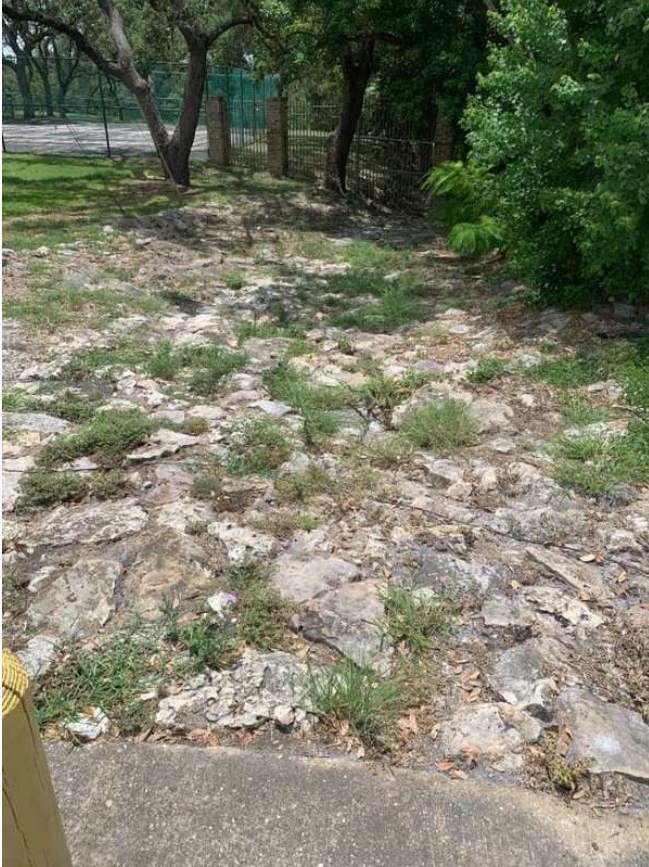
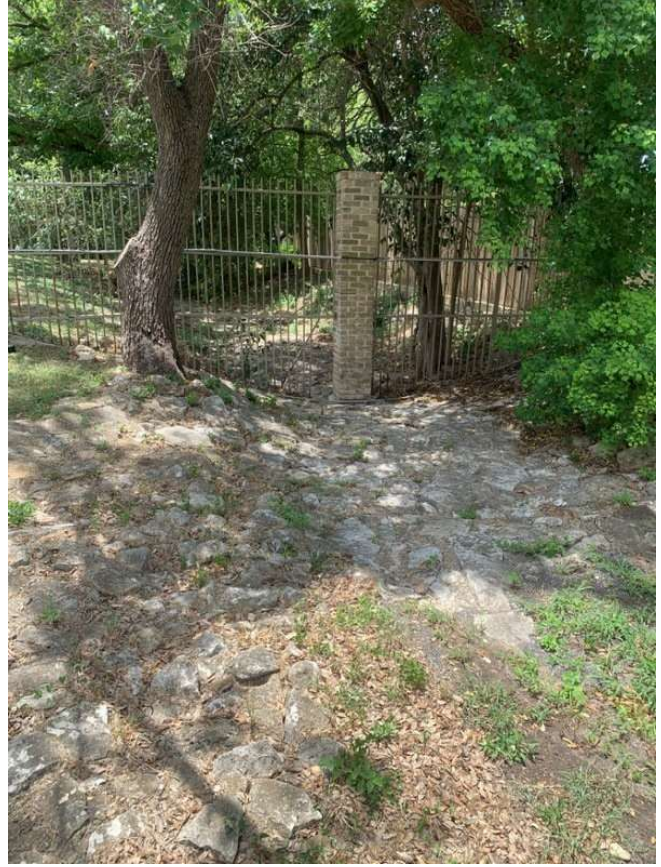
## Paseo Canada Outfall 2

Field Notes: Looks good.

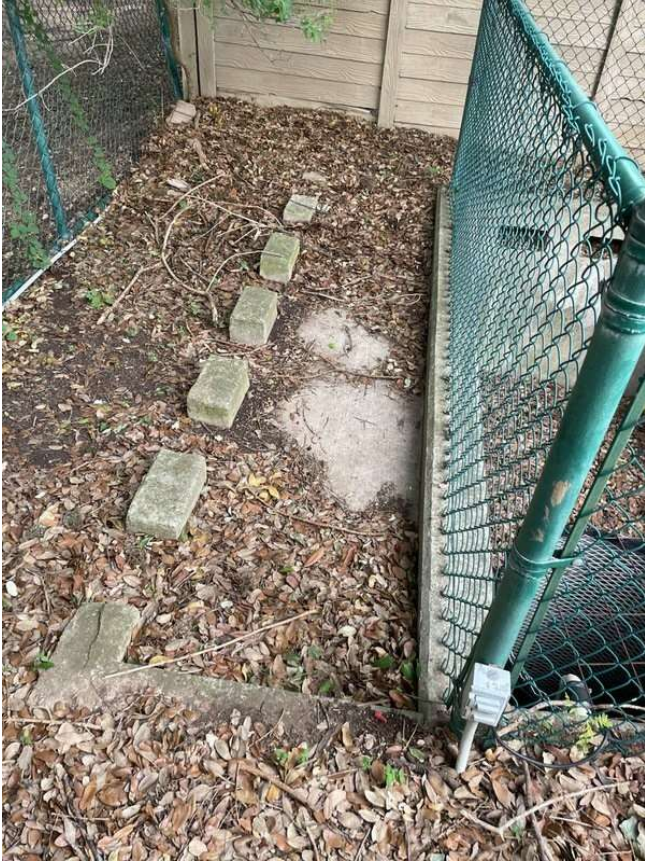
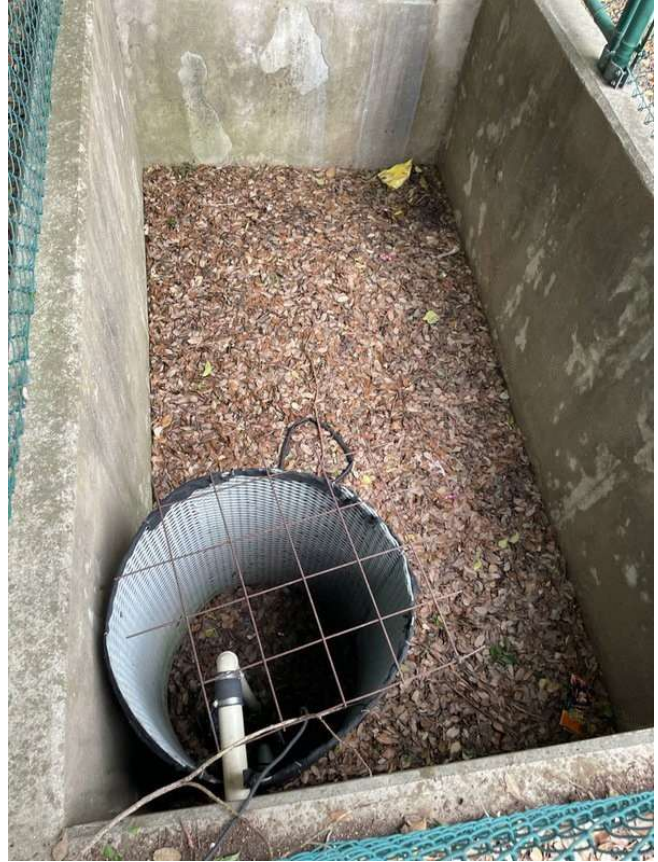
## PCD2 Pediatrics

Field Notes: Remove trash and leaves.

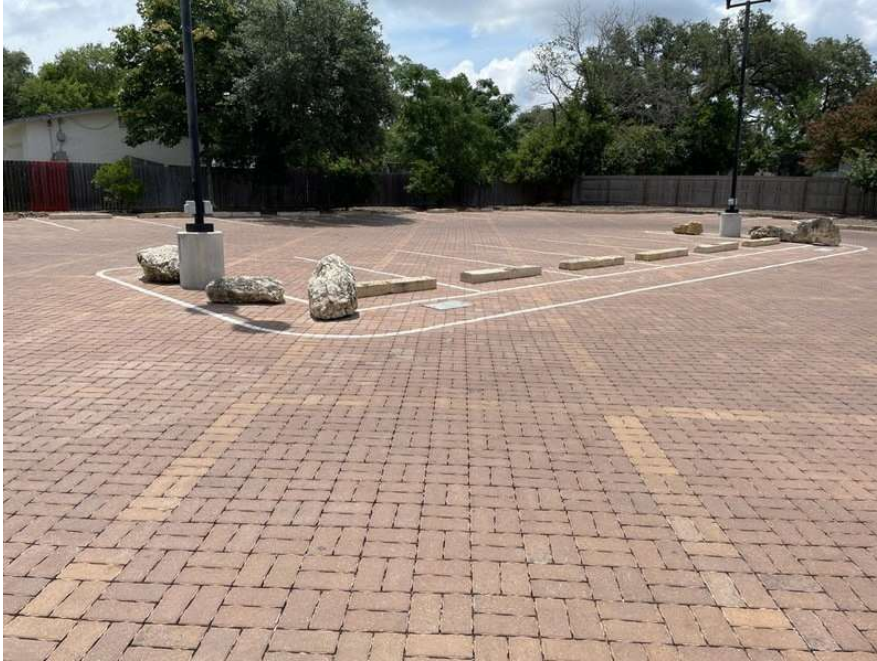
## Permeable Pavers

Field Notes: Looks good.

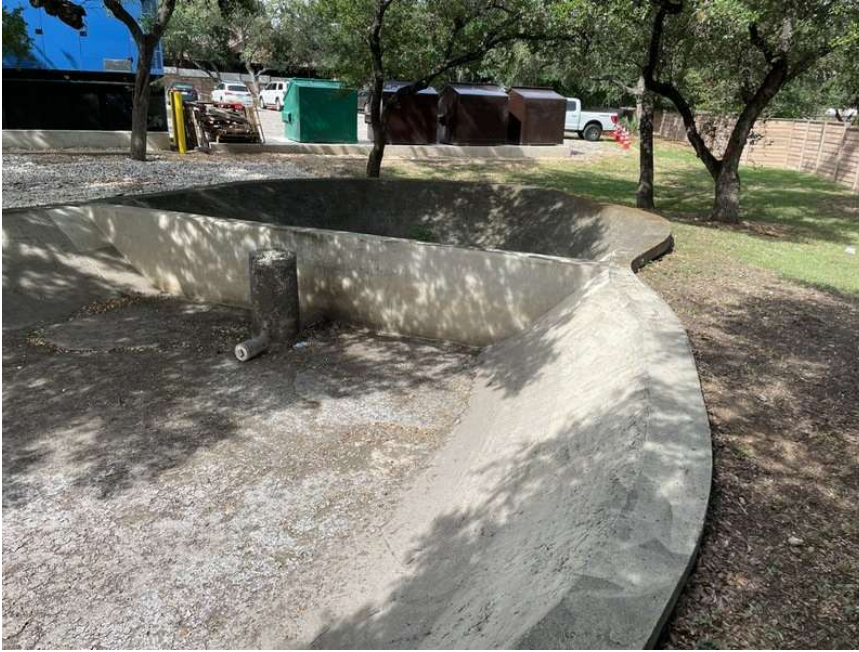
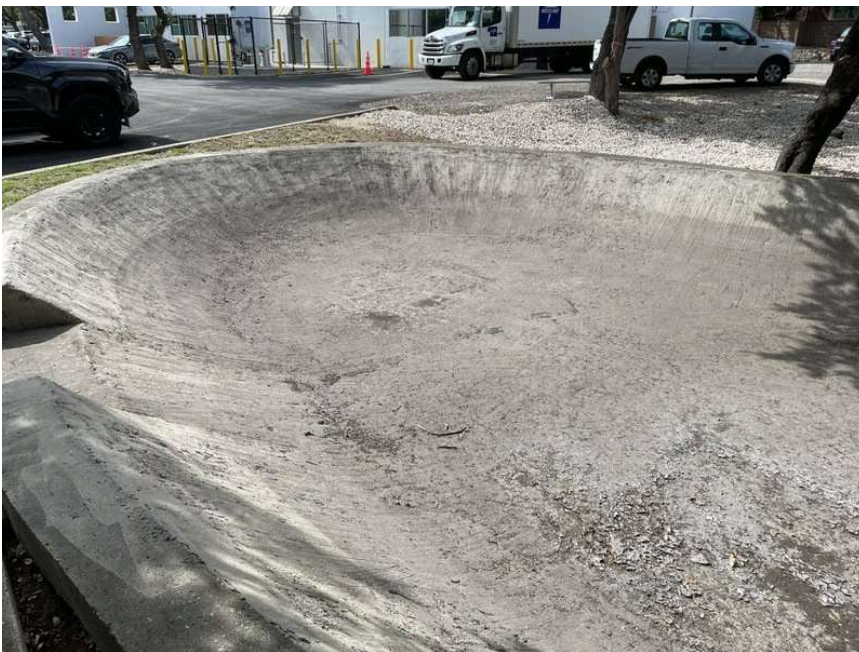
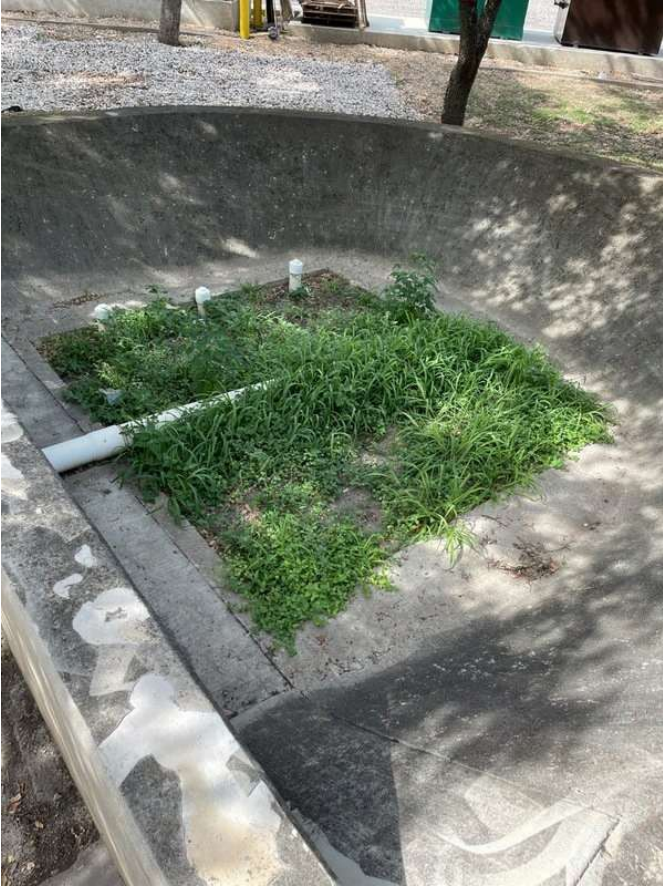
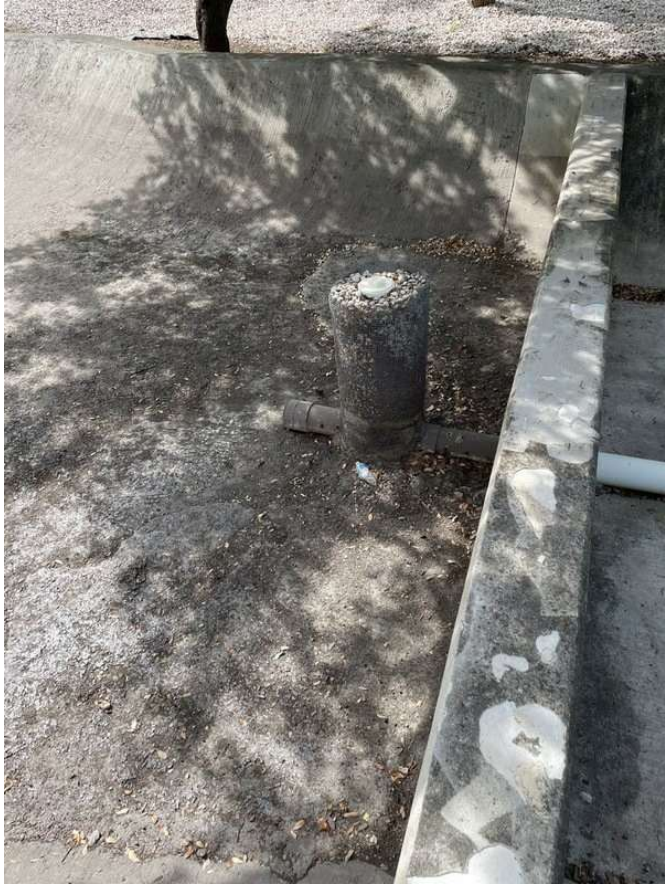
## Retention Pond with Infiltration

Field Notes: Mow vegetation, looks good otherwise.

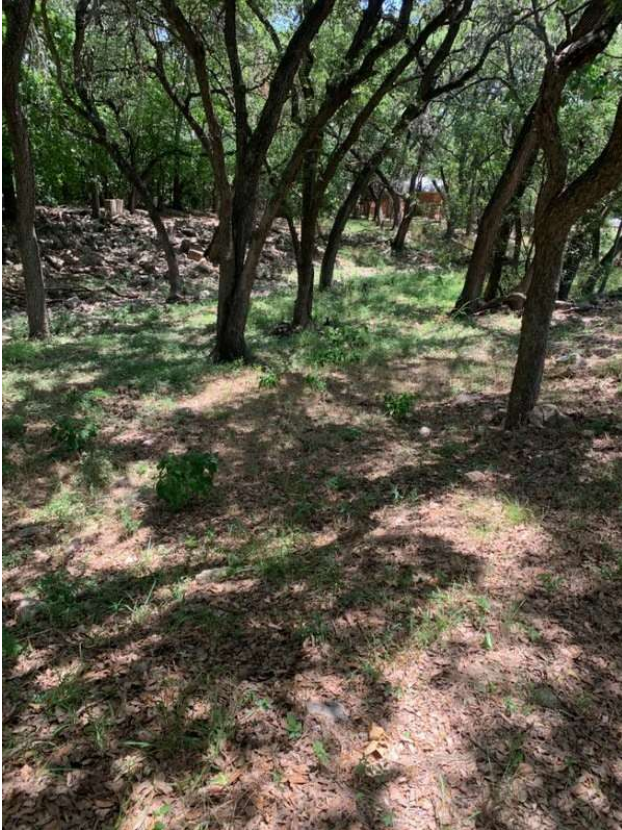
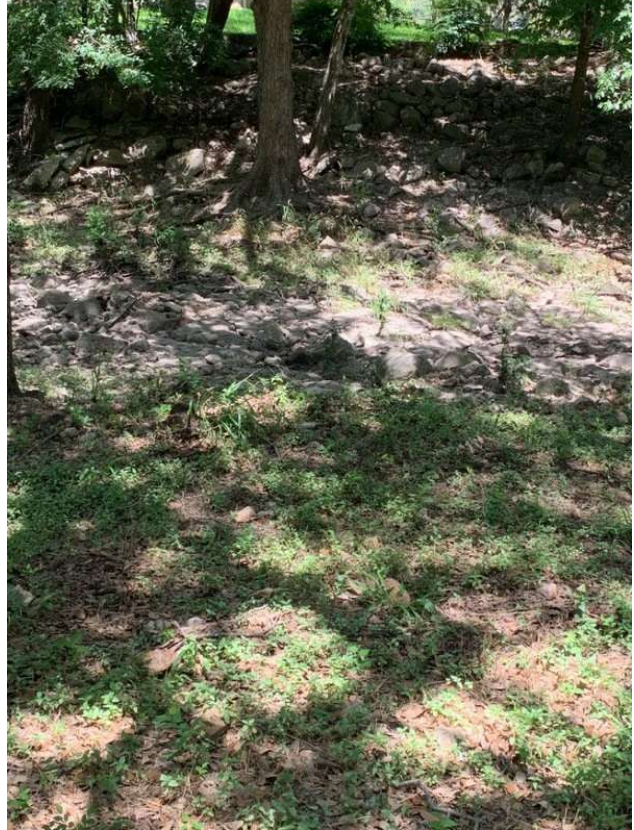
## Rua De Matta

Field Notes: Looks good.

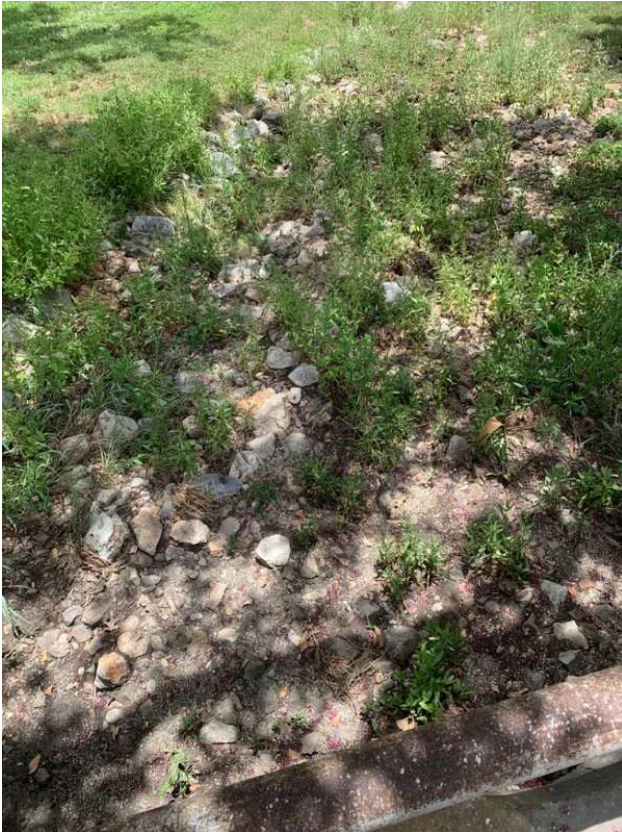
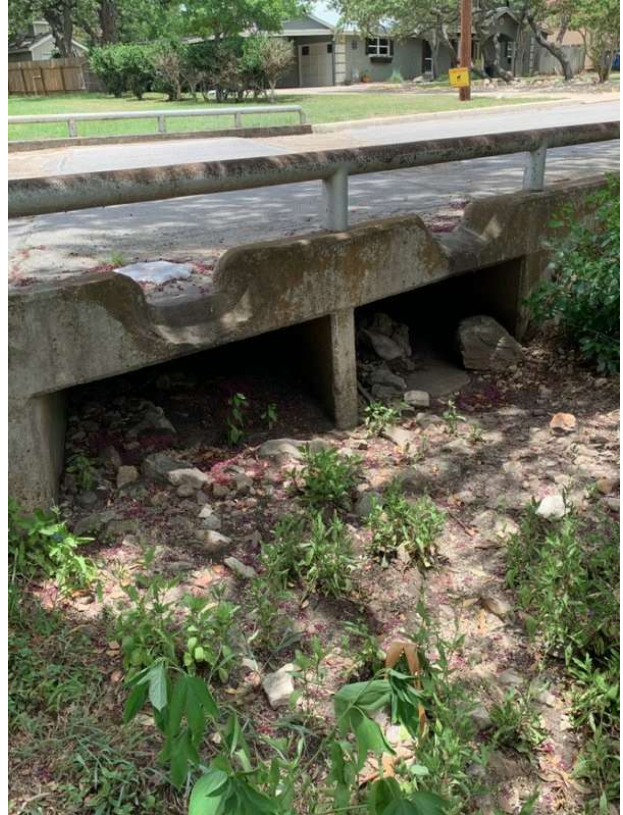
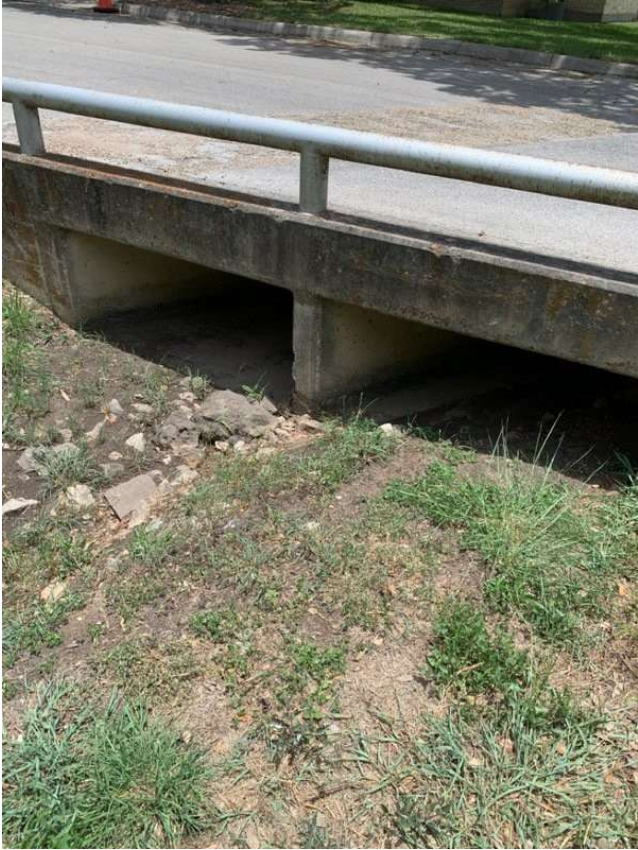
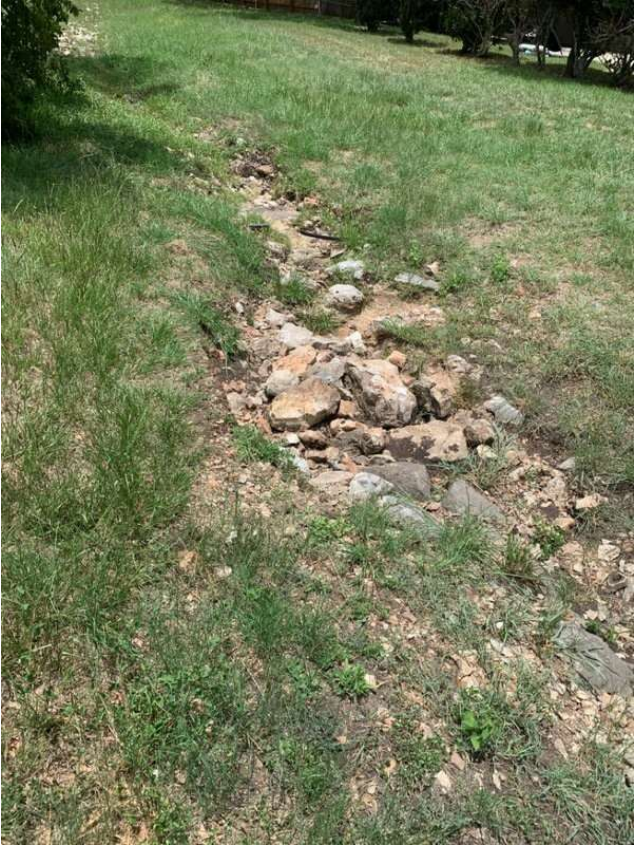
## Sterling Browning Crossing

Field Notes: Remove rocks and sediment from inlets.

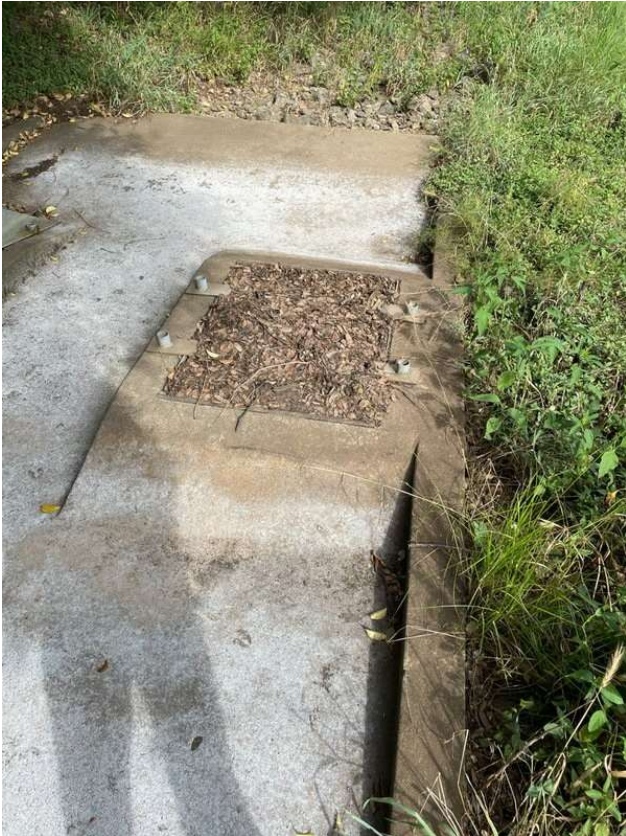
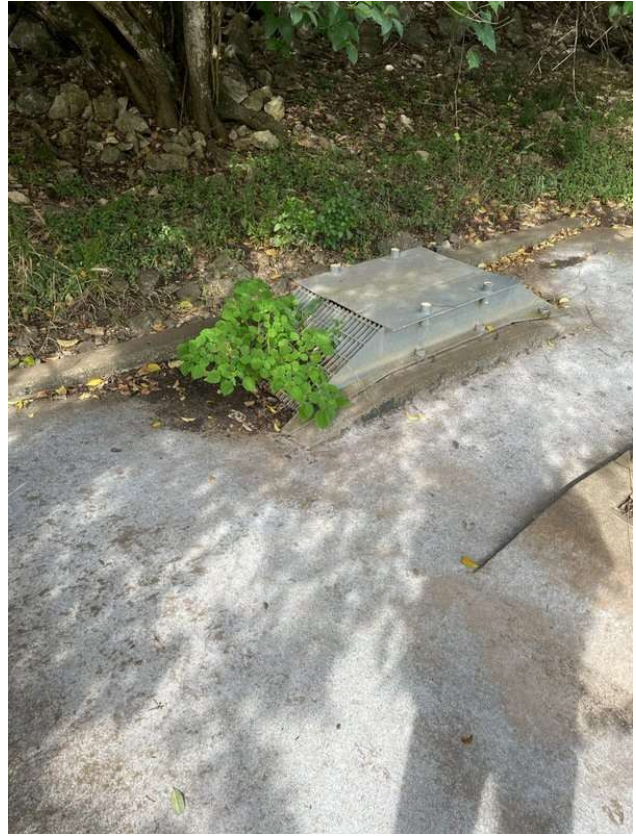
## Stream Gauge

Field Notes: Clear leaves and vegetation from grates.

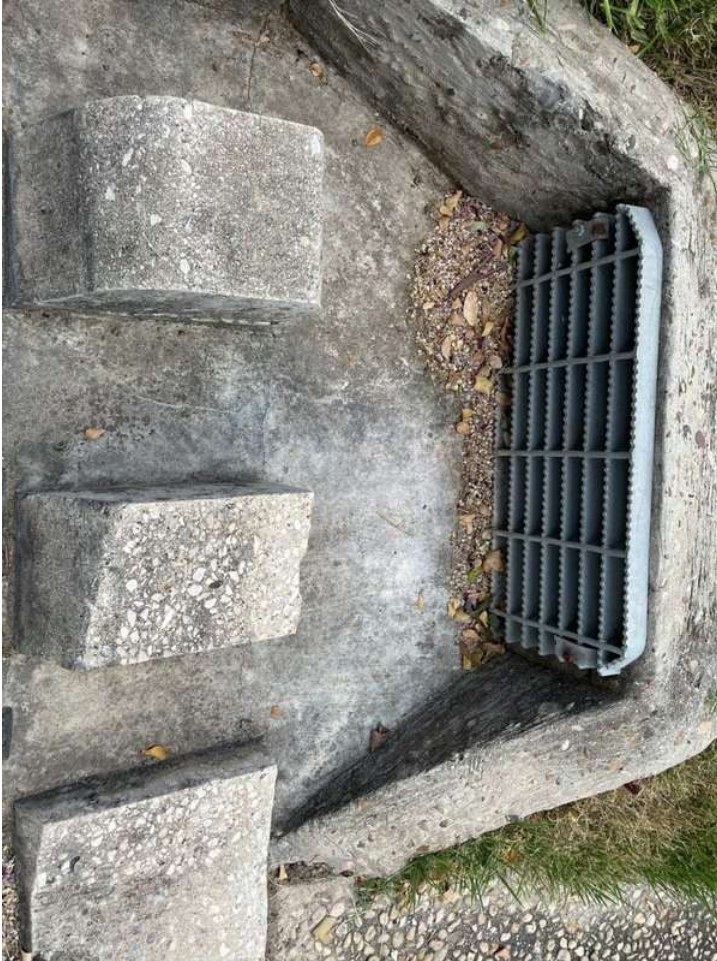
## Street Outlet 1

Field Notes: Looks good.

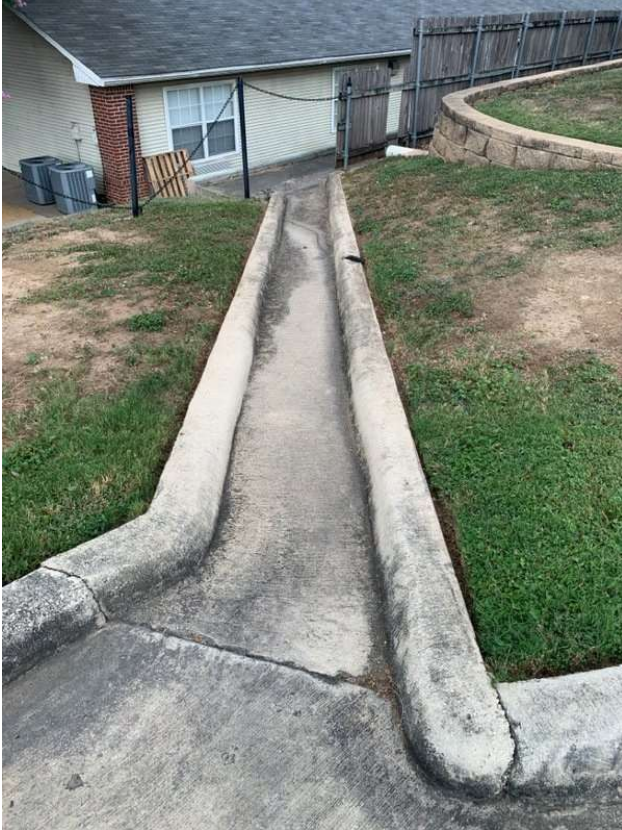
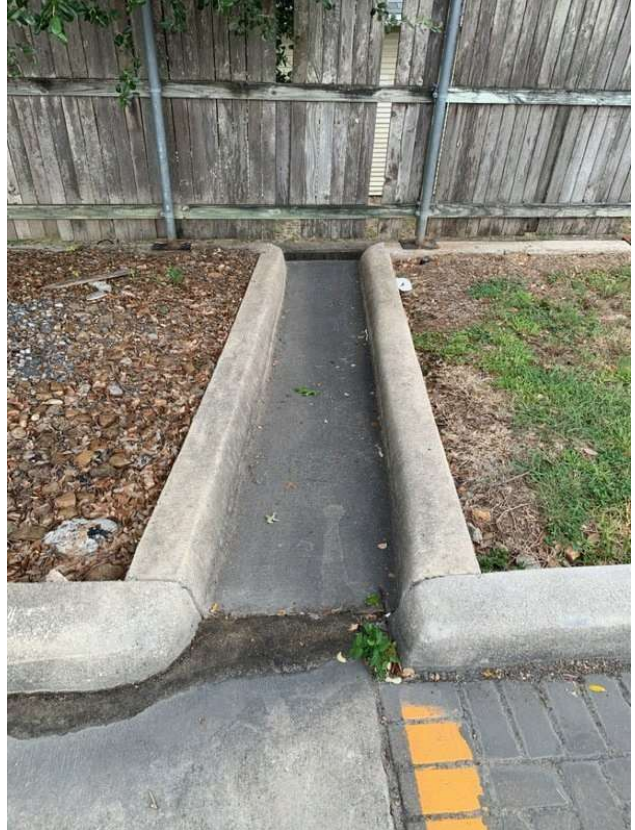
## Tall Oak Outfall

Field Notes: Looks good.

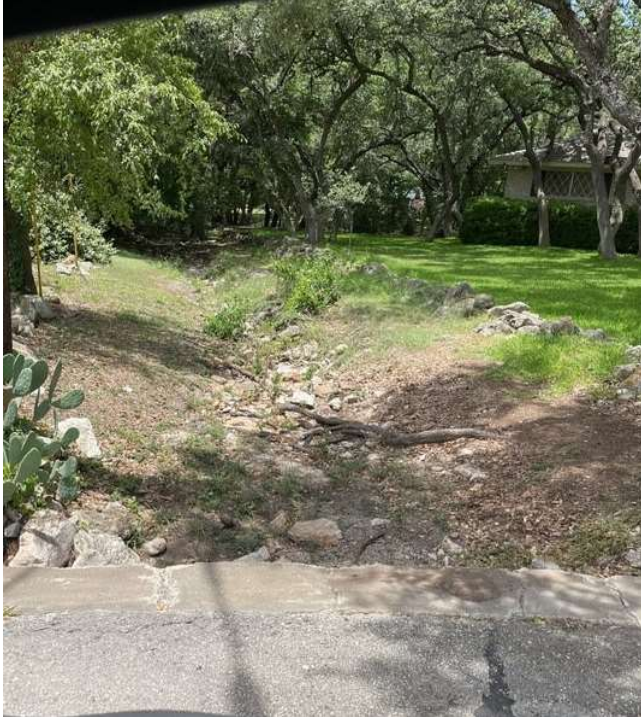
## Tiger Tail Outfall

Field Notes: Looks good.

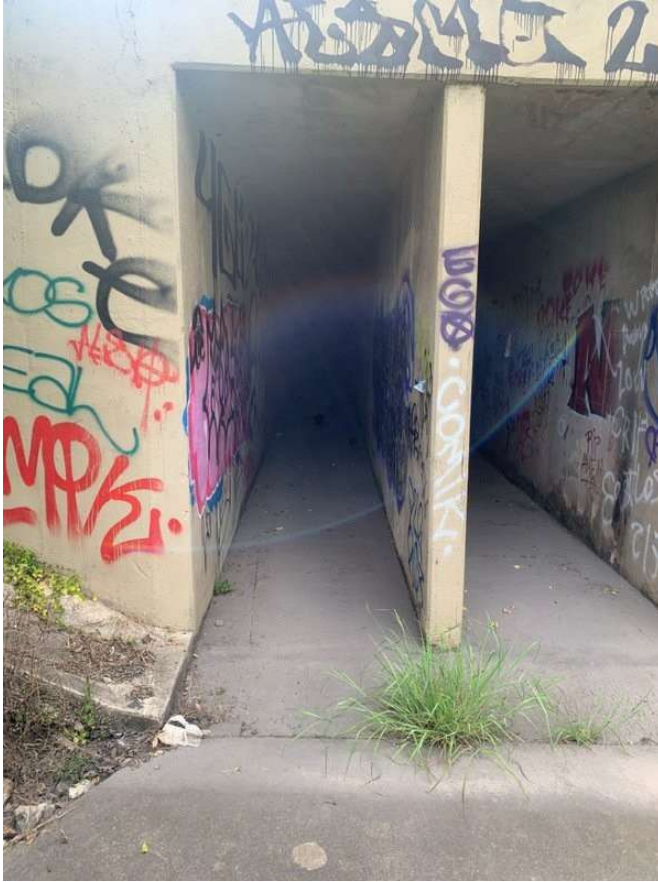
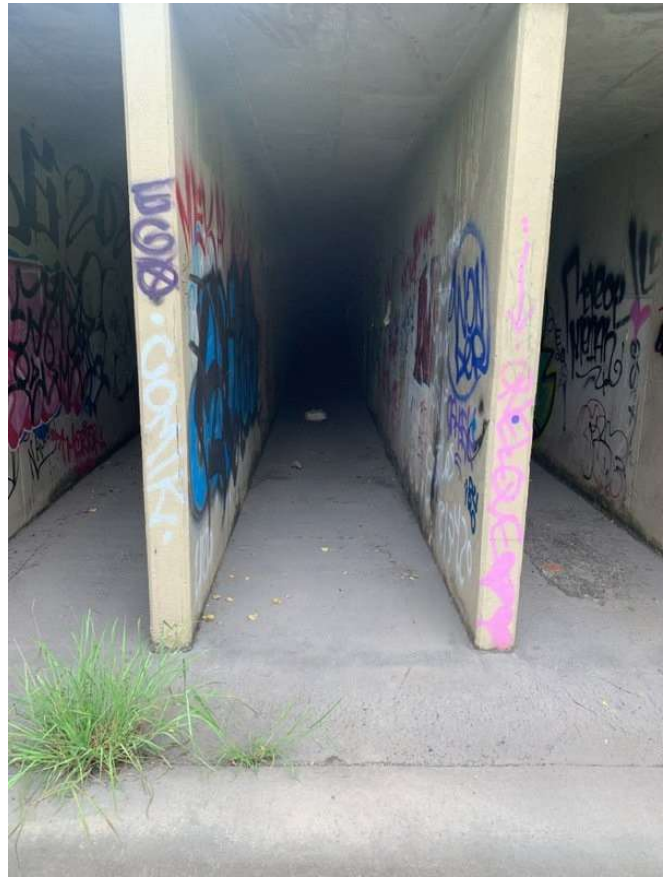
## TXDOT at Lorence Creek

Field Notes: Looks good.

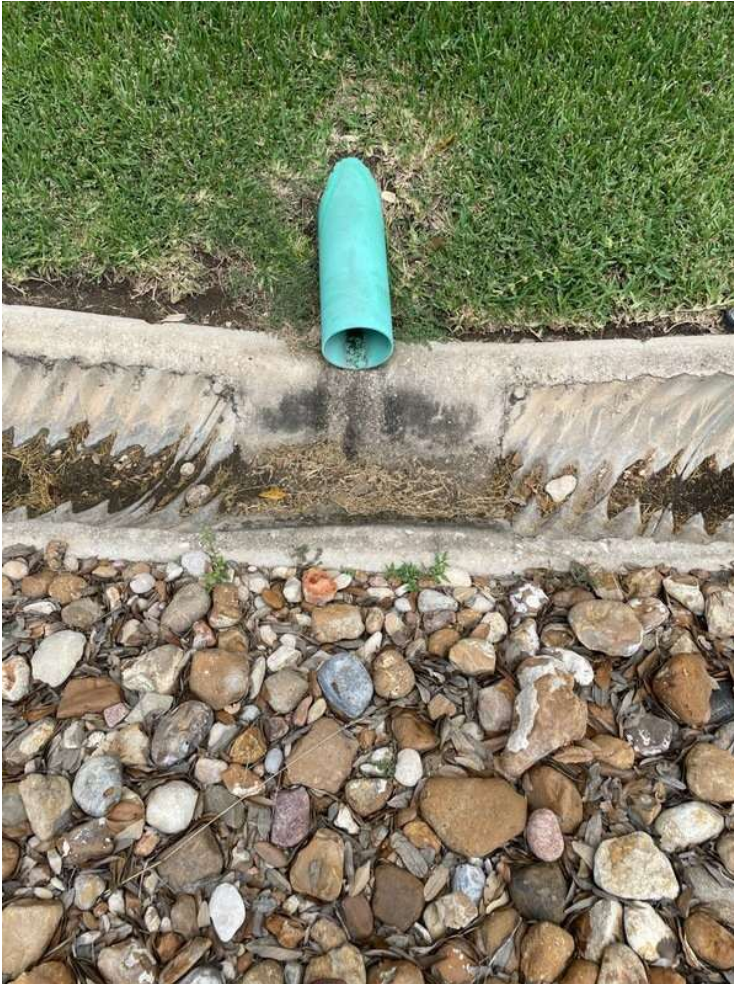
## Unknown Residential Drain Pipe Into MS4 System

Field Notes: Looks good.

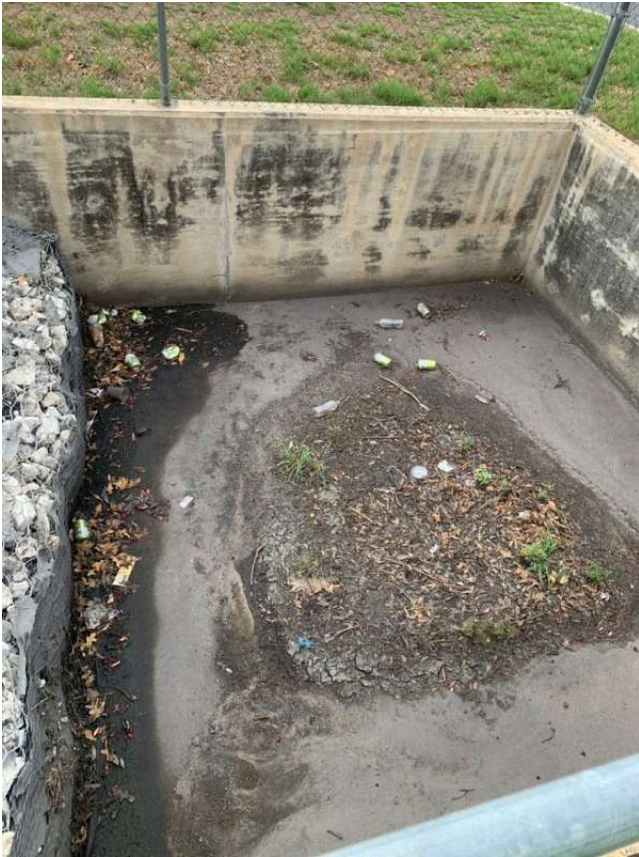
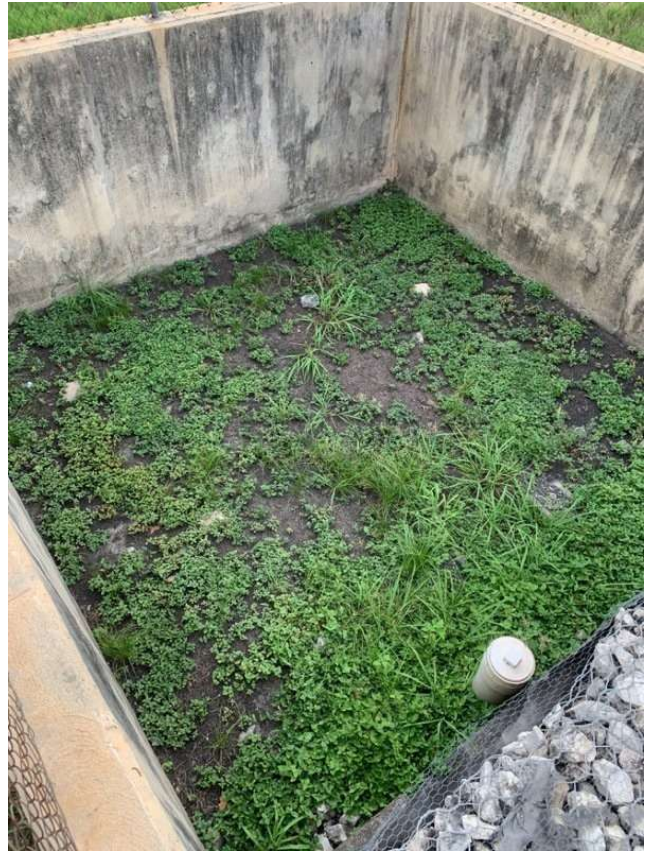
## Valvoline PCD

Field Notes: Clean trash, sediment, and vegetation.

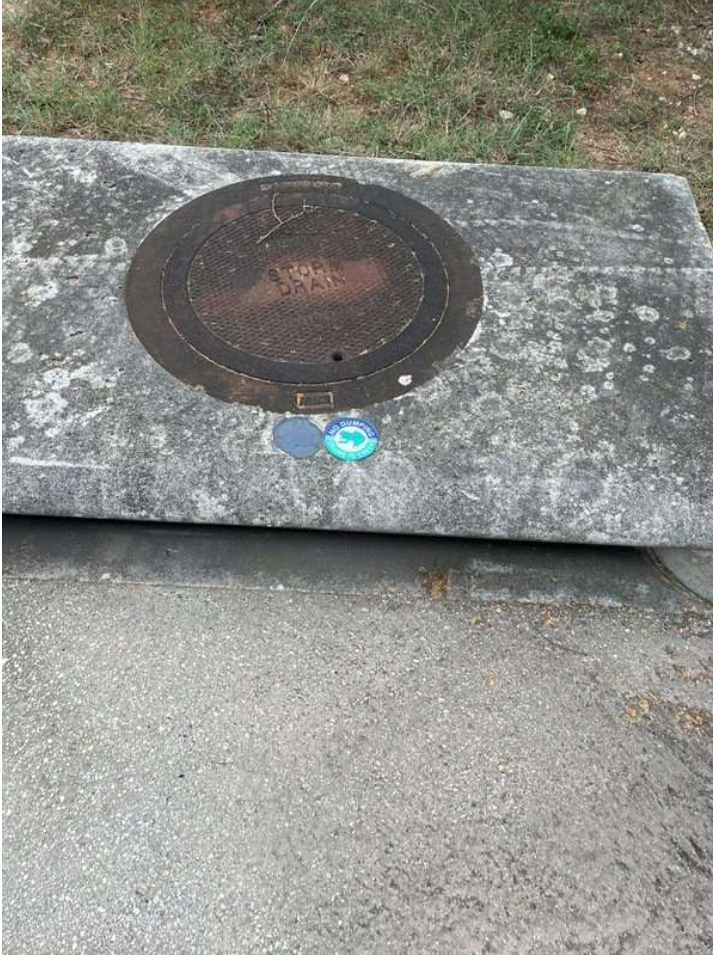
Field Notes: Looks good.

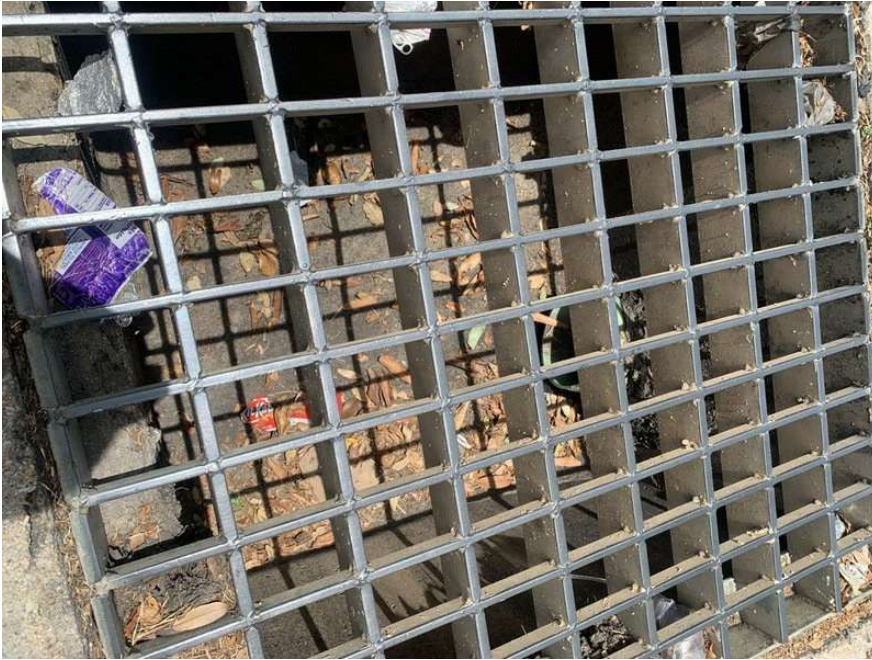
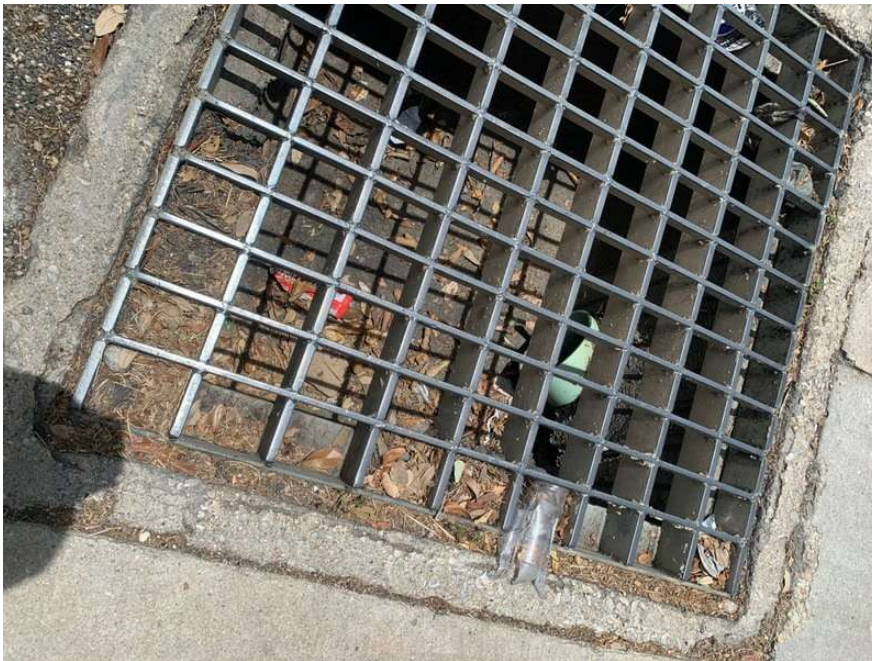
## Voigt Grate Inlet

10072	Service King Collision Repair PCD	BMP	Mow vegetation, note new electrified fence around PCD, verify regulations
10910	Shady trails rundown	Outfall	Trim vegetation and remove sediment at inlet from nearby construction work.
11001	Sky Forest Residential Debris	Other	Debris from demolished mailbox.
11006	Spillway Structure	Skimmer/W eir	Monitor erosion, note development in storage area and property line. Property was revisited after a rainfall event and showed significant flooding.
10653	Sterling Browning Crossing	Pipe	Remove rocks and sediment from inlets.
10906	Stream Gauge	Inlet	Clear leaves and vegetation from grates
10002	Tall Oak Outfall	Outfall	Vegetation needs mowing. Otherwise looks good.
10018	Valvoline PCD	BMP	Clean trash, sediment, and vegetation.
10023	Varco	Inlet	Sediment buildup on east side of inlet. Medallion may need replacement soon.
10050	Voigt Grate Inlet	Inlet	Clean trash in grate

Field Notes: Clean trash in grate.

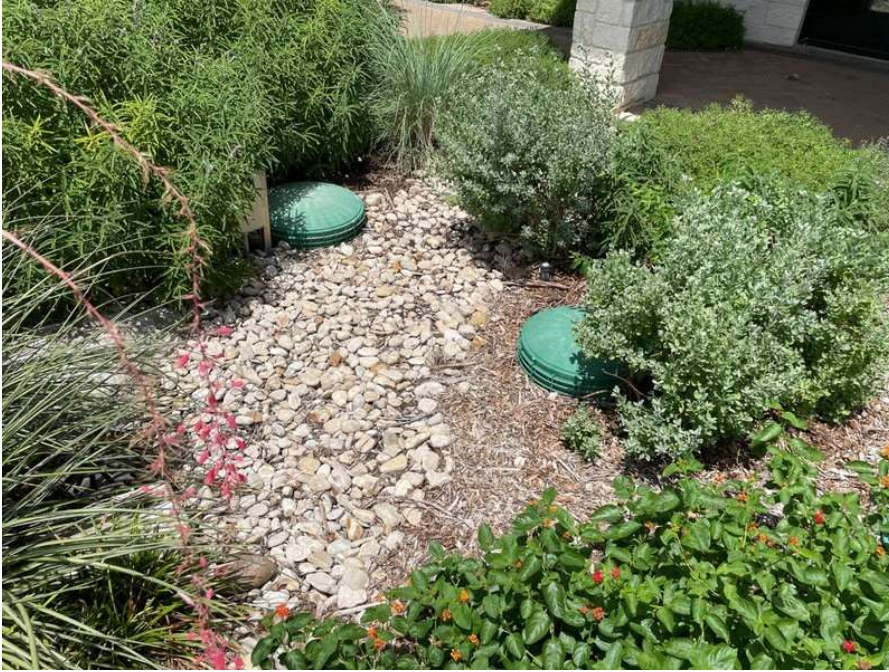
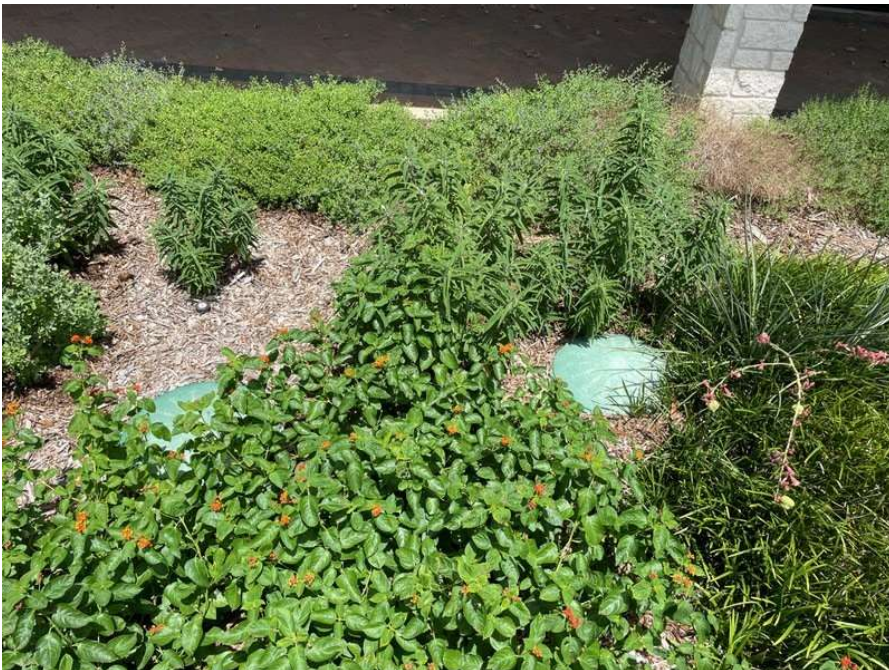
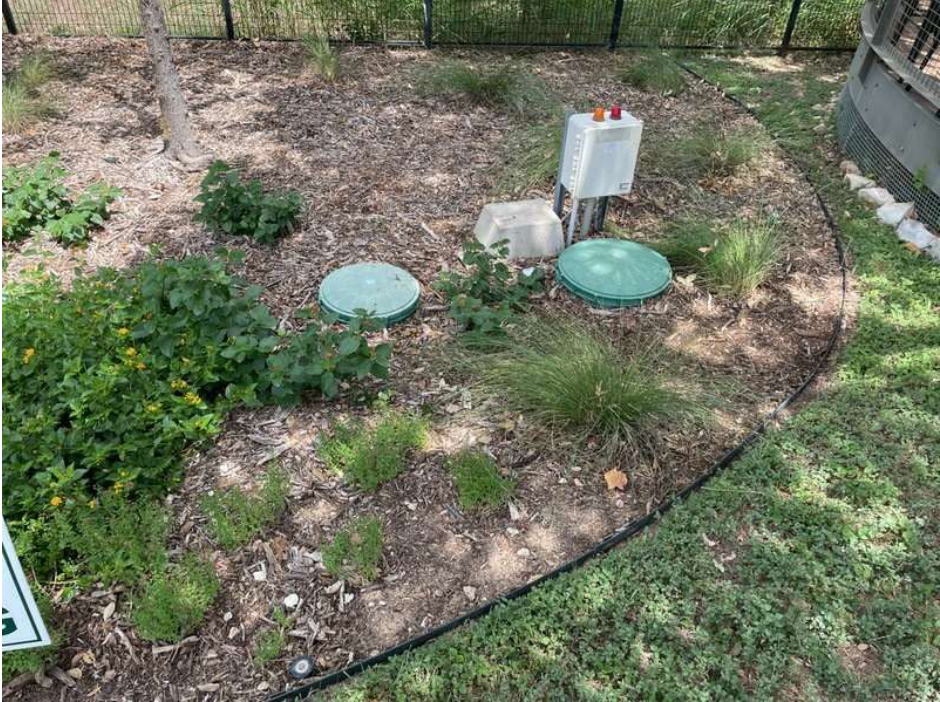
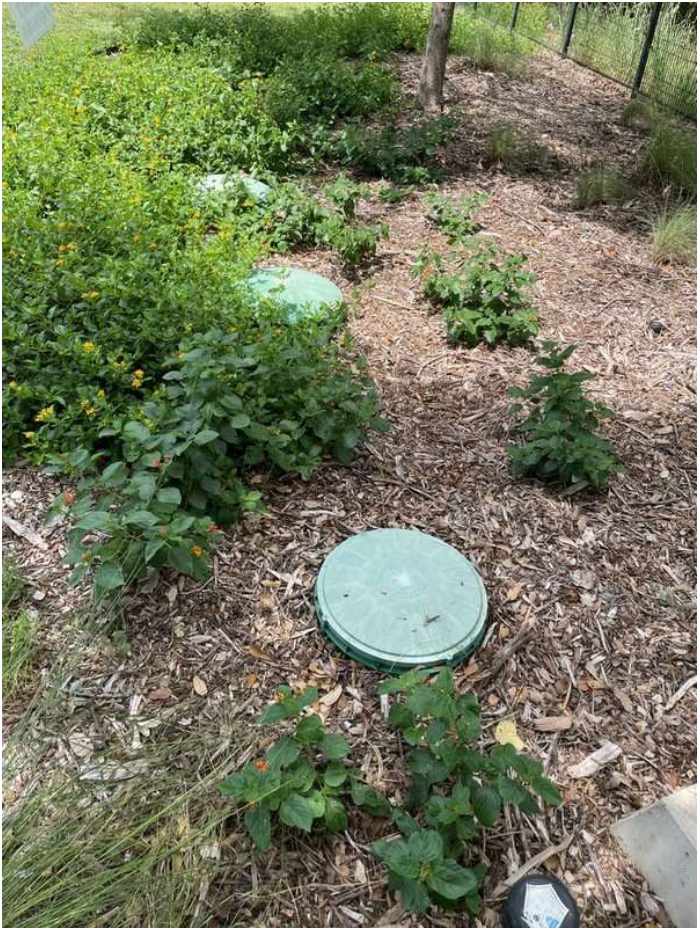
## Voigt Park Inlet

Field Notes: Looks good.
