# TOWN OF HOLLYWOOD PARK, TX

2024 Summer Inspection

## HOLLYWOOD PARK 2024 SUMMER INSPECTION REPORT

**Subject:** Annual Municipal Separate Storm Sewer System (MS4) Inspection

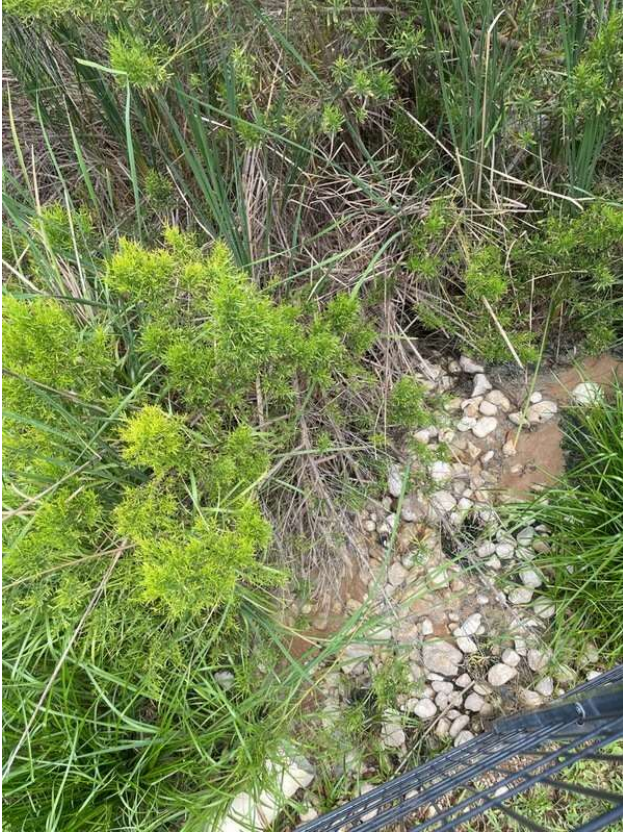
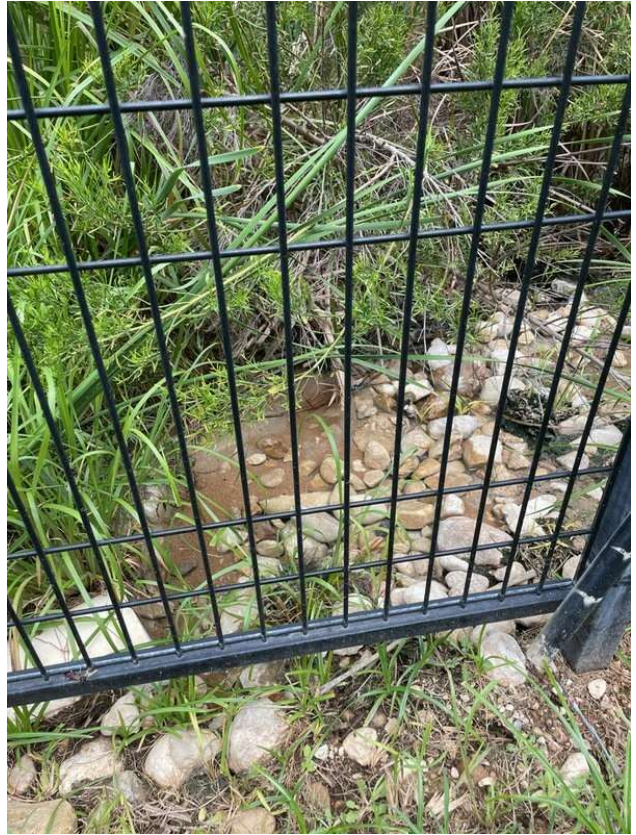
## Voigt Park Outfall

10937	Voigt Park Outfall North	Outfall	Remove debris at outlet preventing positive drainage
10064	Pantheon Commercial Strip PCD	BMP	Mow vegetation
10041	Park Oak Outfall	Outfall	Remove trash and trim vegetation.
10057	PCD2 Pediatrics	BMP	Remove trash and leaves
10066	Pediatric Dentistry Office PCD	BMP	Clean trash and sediment and mow vegetation.
10015	Premier 1 Auto Care Inlet	Inlet	Mow vegetation, remove trash, sediment, and debris
10068	Public Storage Outfall	Outfall	Vegetation overgrown needs mowing
10071	Retention Pond w/ Infiltration	Pond	Mow vegetation, looks good otherwise
10649	Ridge Trail Crossing	Pipe	Remove rocks from inlet
10036	Rua De matta channel outfall	Outfall	Trim vegetation by fence next to outfall.
10661	Sagecrest Crossing East	Pipe	Mow overgrown vegetation and remove branches.
10663	Sagecrest Crossing West	Pipe	Trim vegetation in and near inlets, otherwise looks good.
10003	Service King Collision Repair Extended Parking Lot PCD	BMP	Electric fence put up, verify with city/TCEQ on regulations.

Field Notes: Trim vegetation, regrade at outfall. Wasps and other insects are abundant at the standing water.

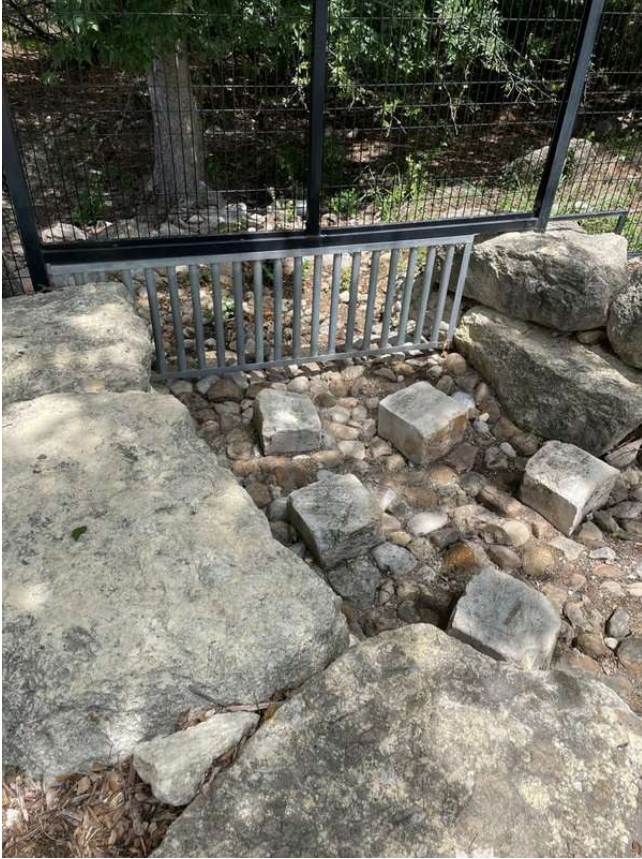
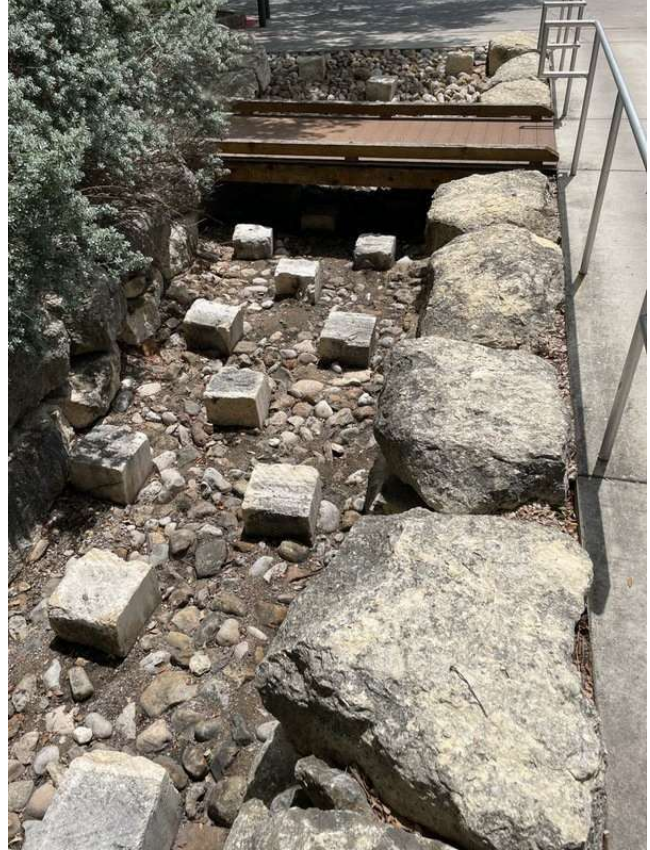
## Voigt Park Storm Sewer Outfall

Field Notes: Looks good.

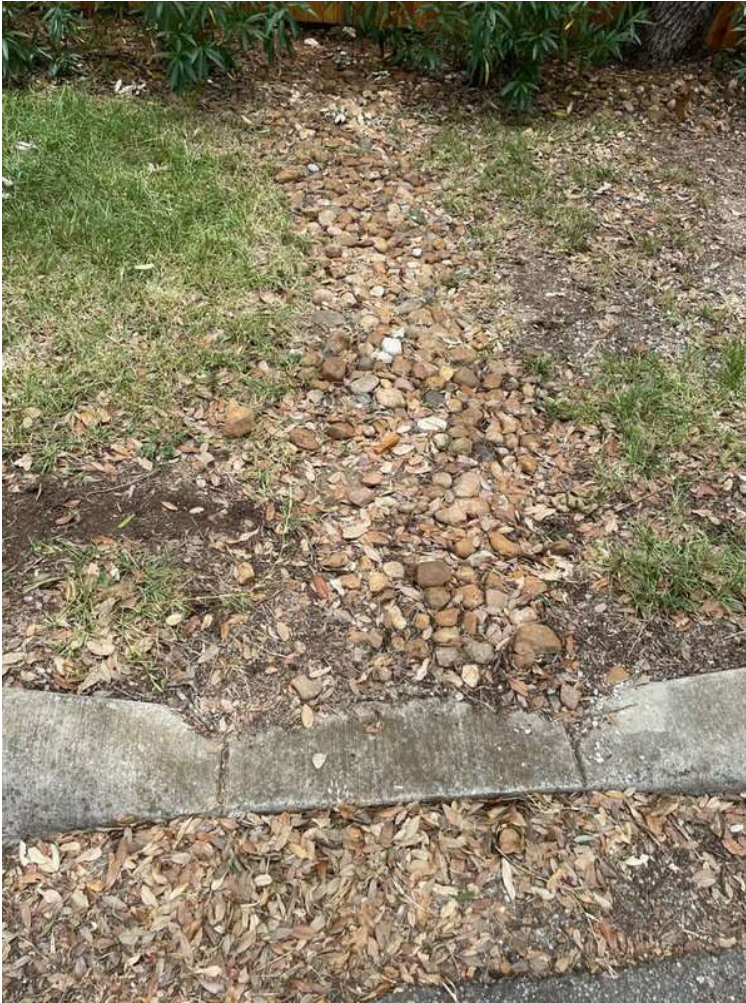
## Voigt UG Pipe

Field Notes: Looks good.

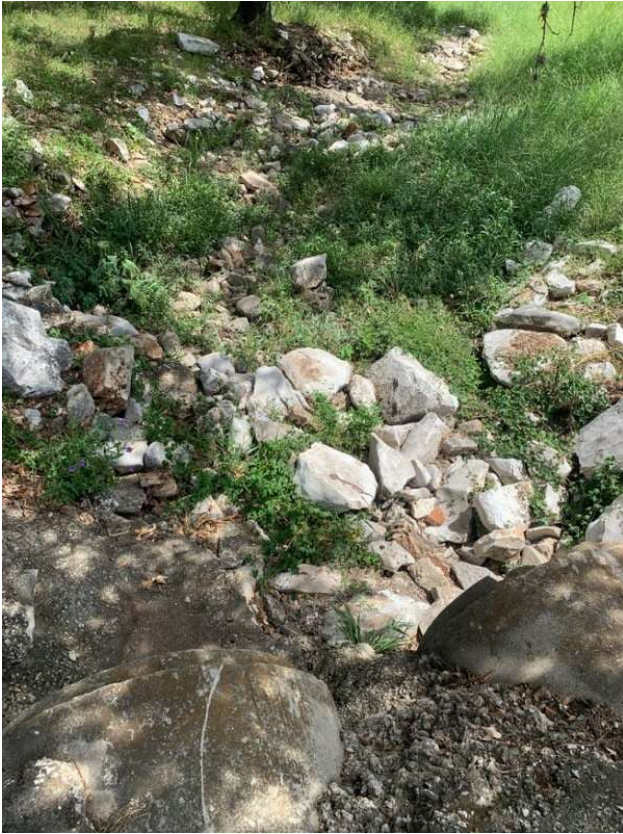
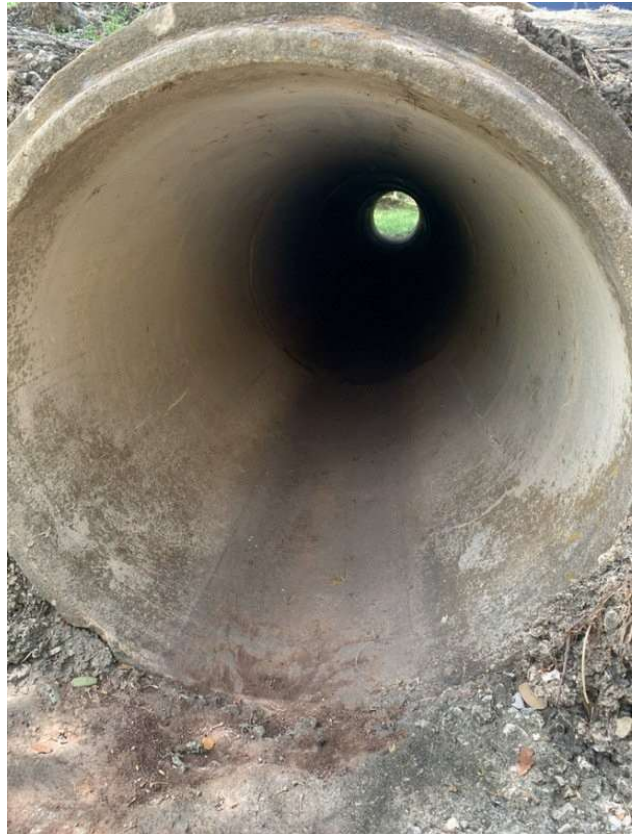
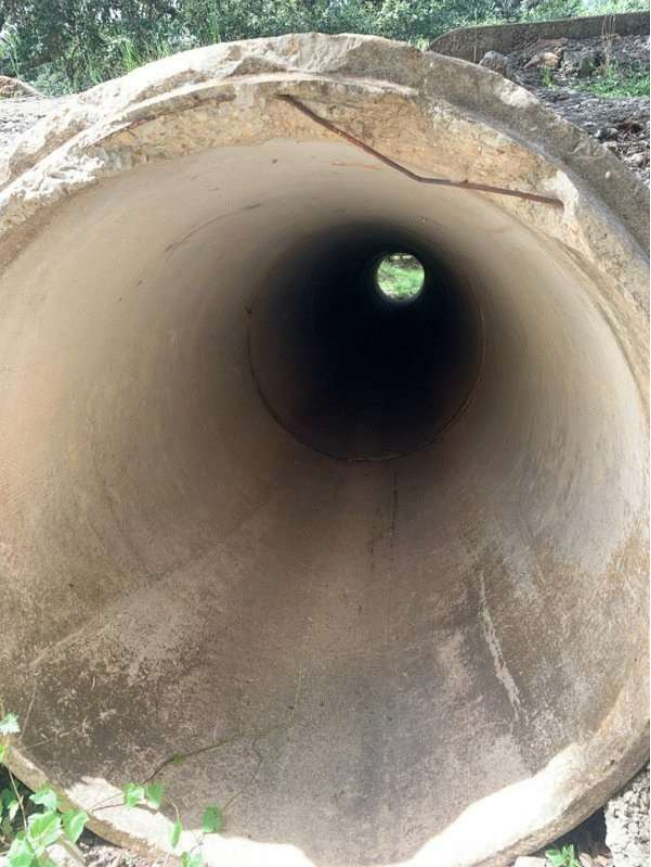
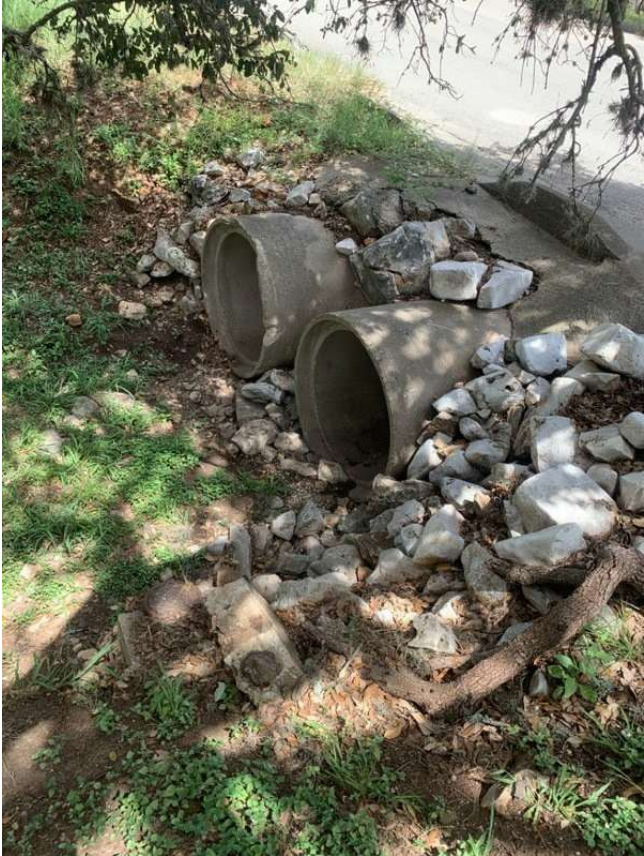
Field Notes: Rocks near inlet appear to be fine but monitor to ensure they don't block inlets.
