TOWN OF HOLLYWOOD PARK, TX

2025 Summer Inspection

HOLLYWOOD PARK 2025 SUMMER INSPECTION REPORT

Subject: Annual Municipal Separate Storm Sewer System (MS4) Inspection

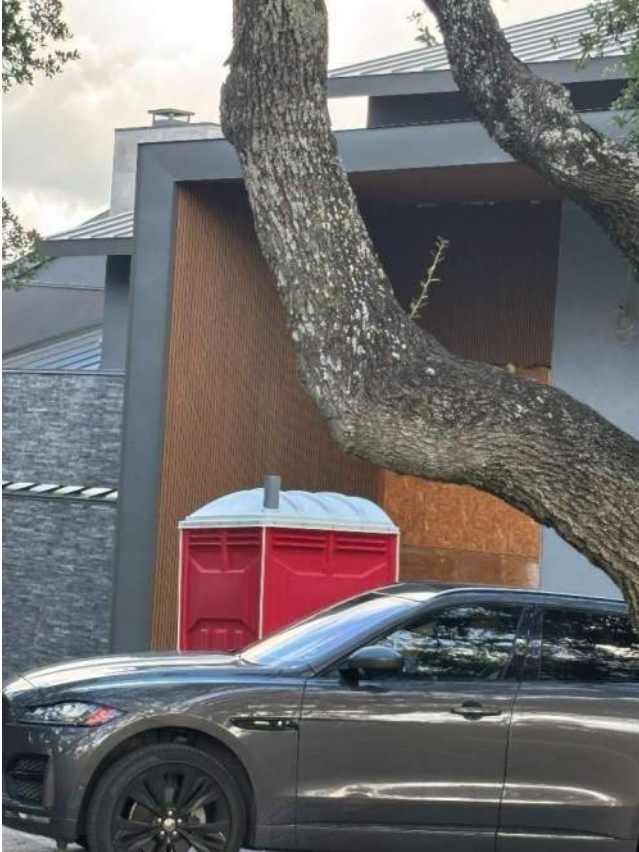
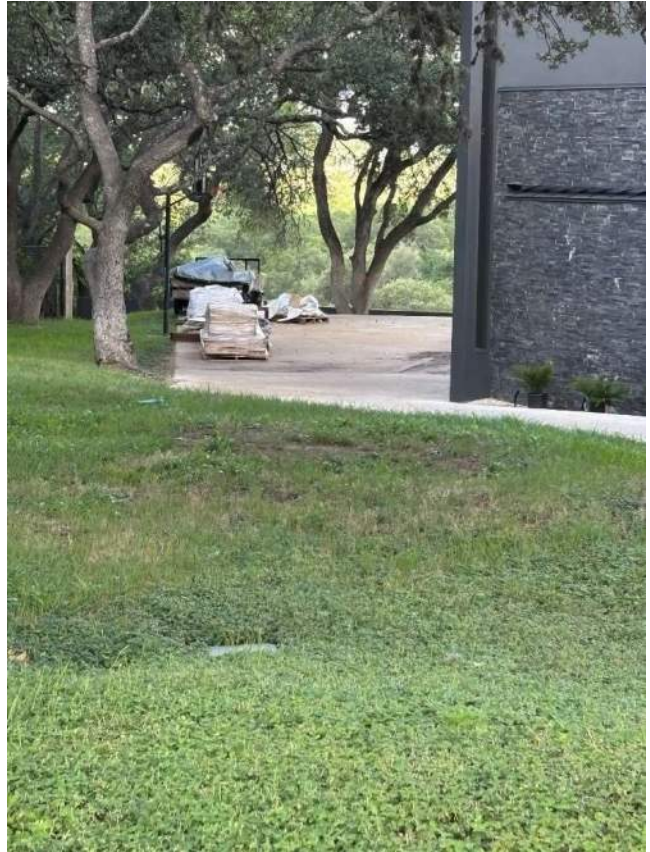
Field Notes: Active construction on property. Monitor, but no maintenance necessary.

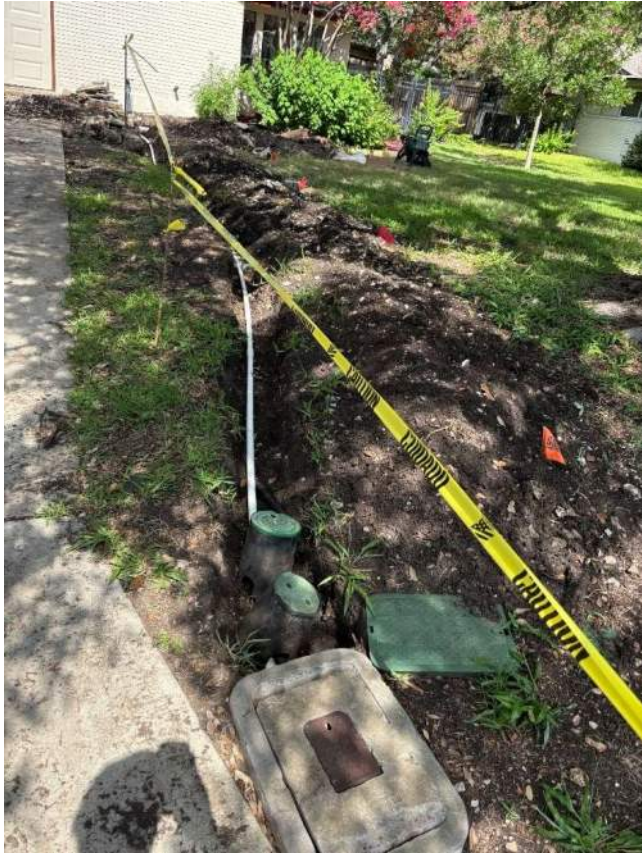
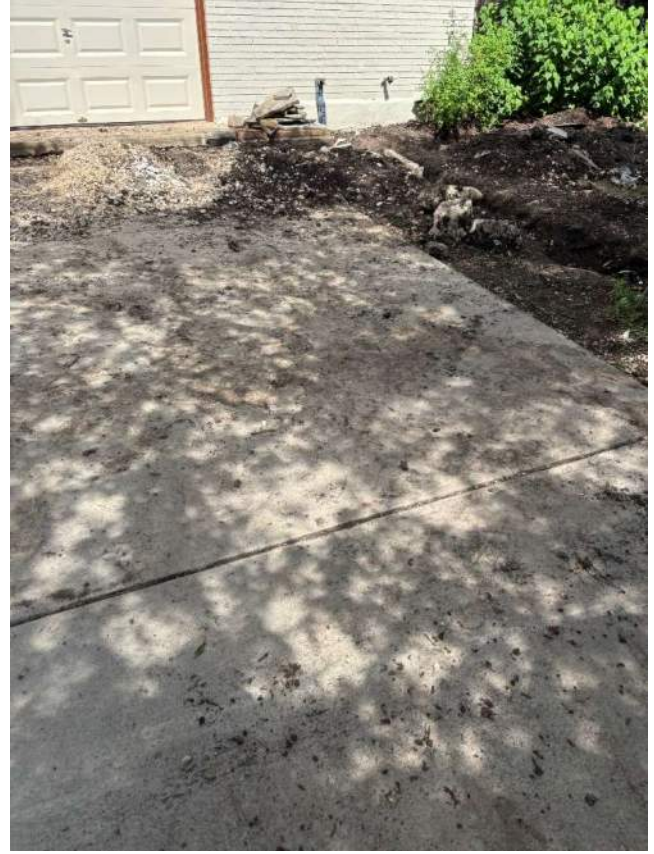
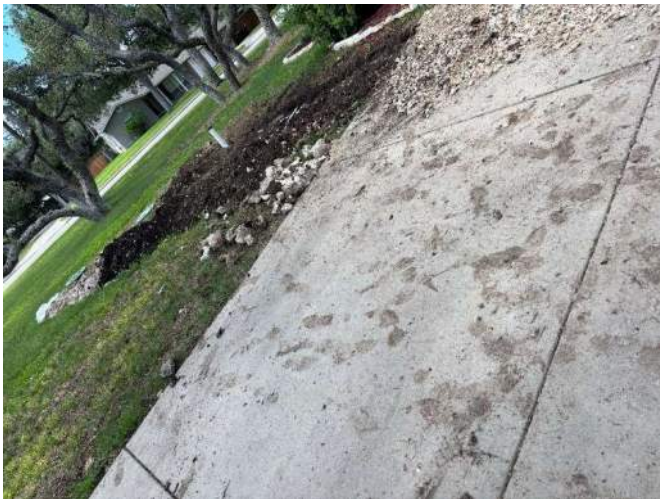
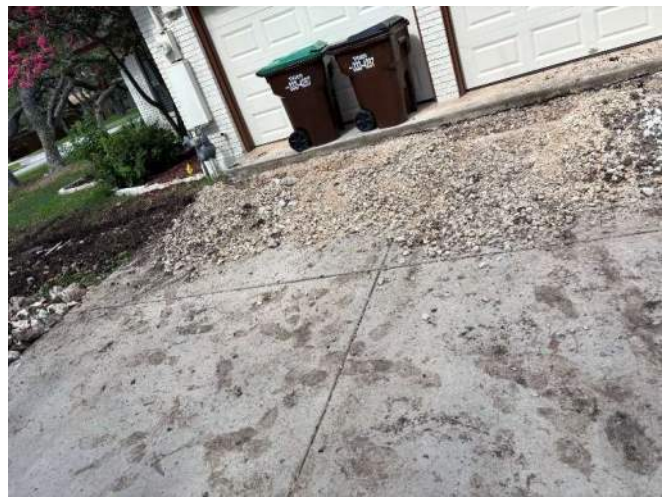
Active Construction 2

Field Notes: Onsite construction. Monitor to ensure dirt and sediment doesn't discharge into the road.

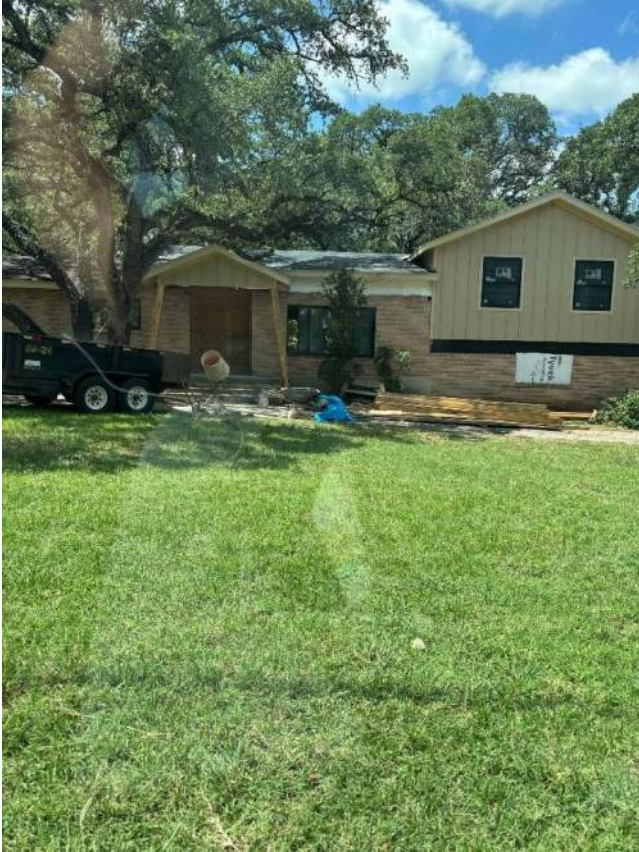
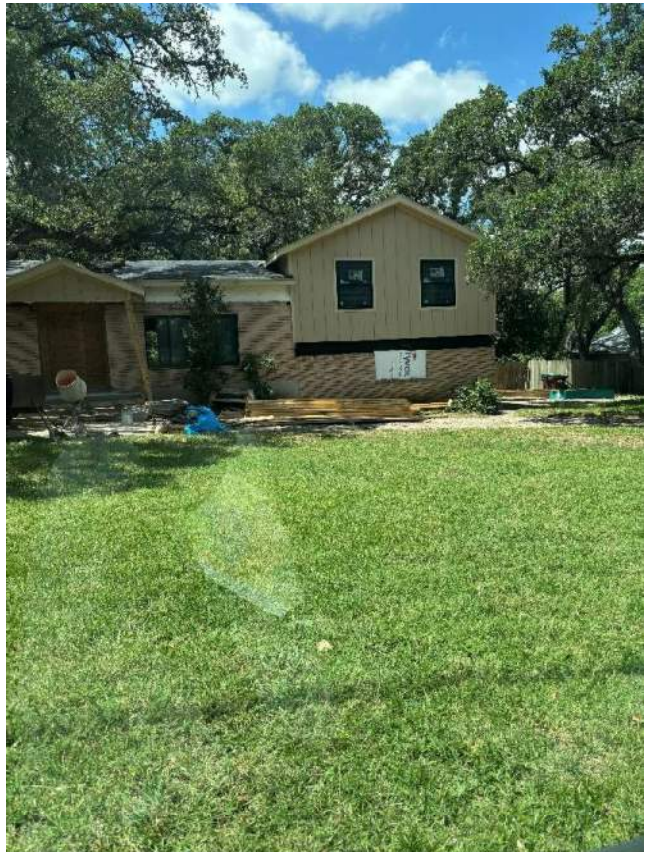
Active Home Build

Field Notes: Active home build. Monitor to ensure stormwater measures are in place.

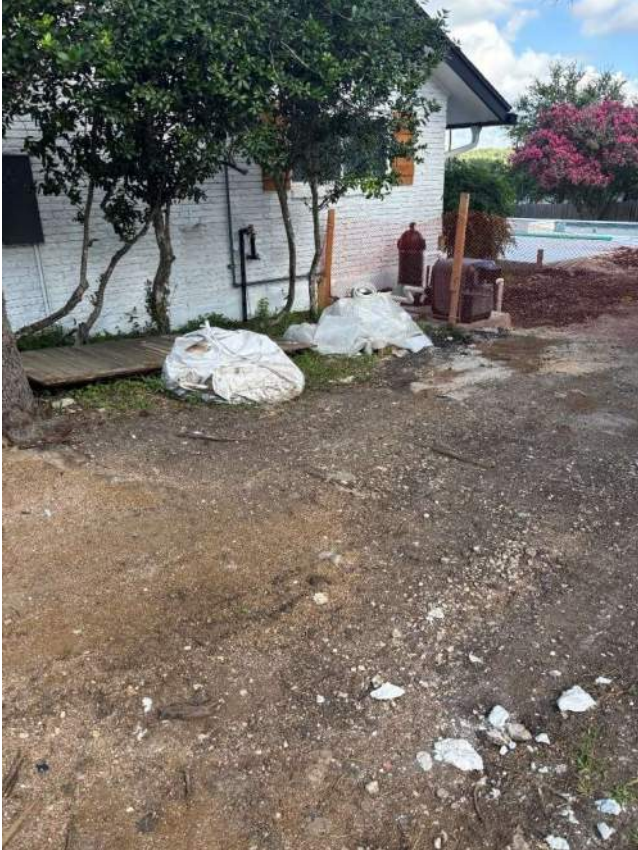
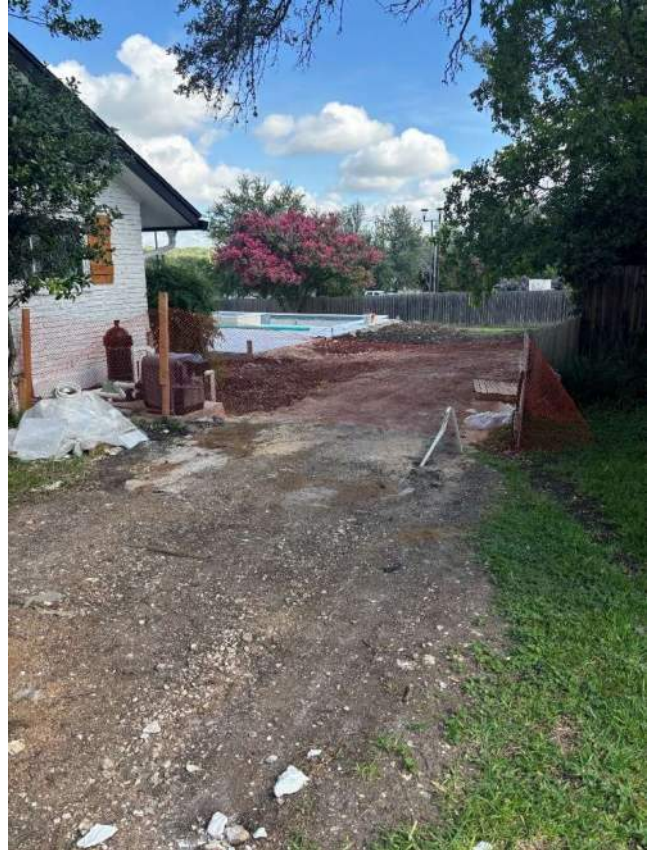
Active Pool Build

Field Notes: Active pool construction. Monitor to ensure construction dirt and materials do not wash offsite.

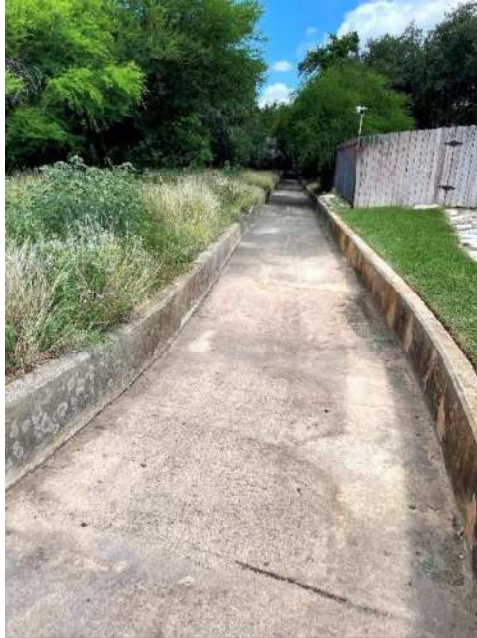
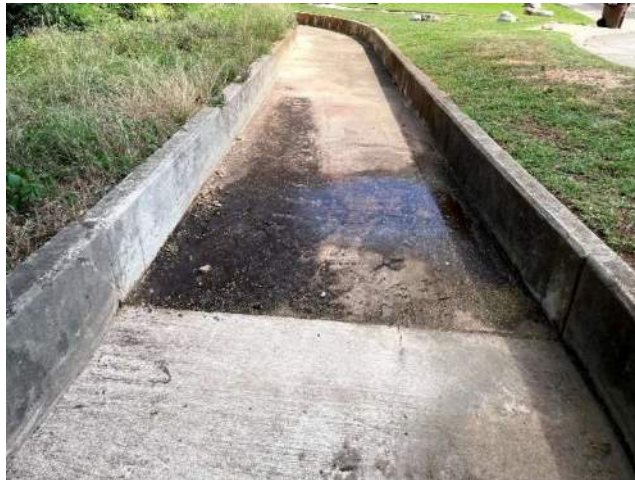
Amber Creek Drainage Channel

Field Notes: Minor sediment build up, looks good otherwise

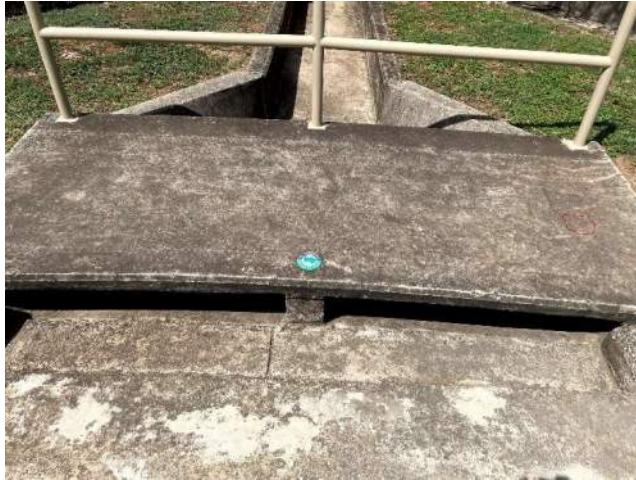
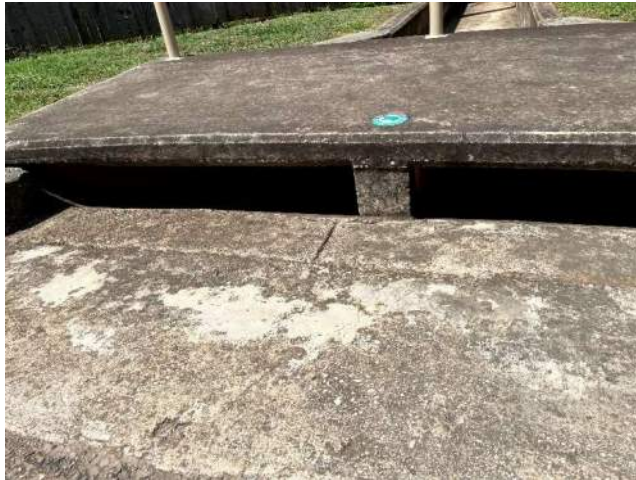
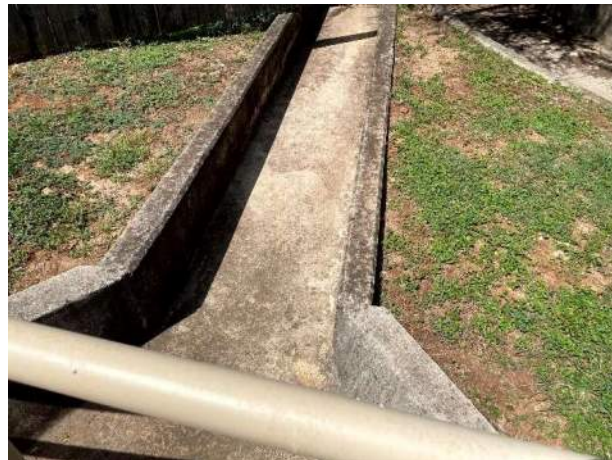
Amber Creek Inlet

Field Notes: Looks good.

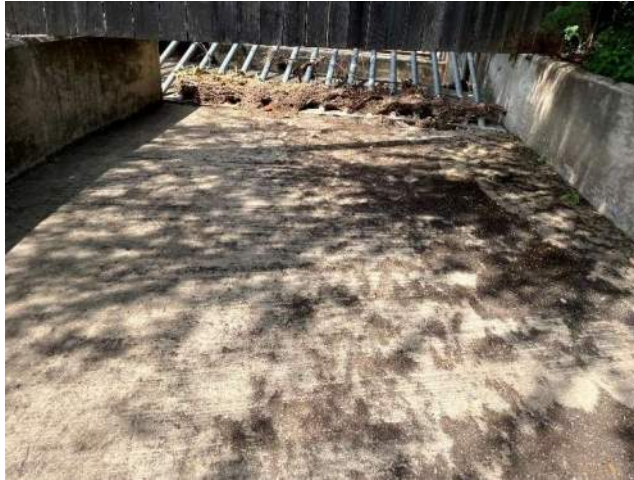
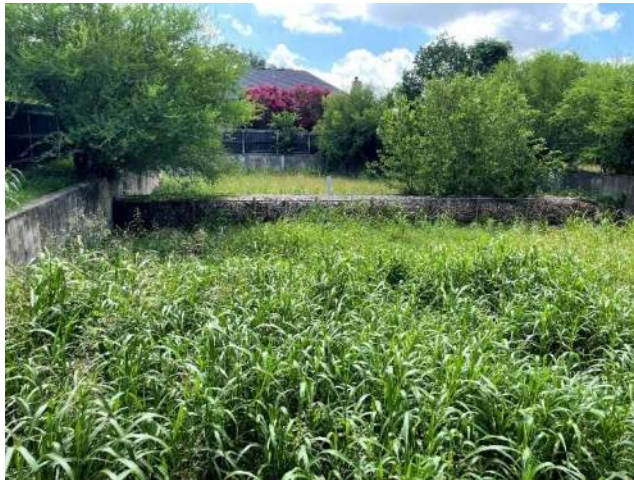
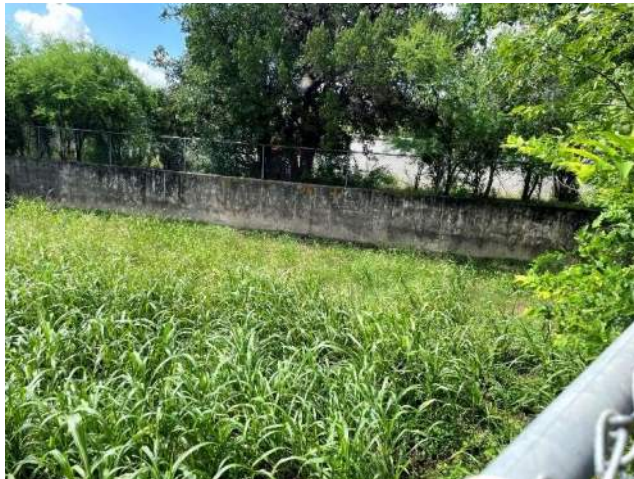
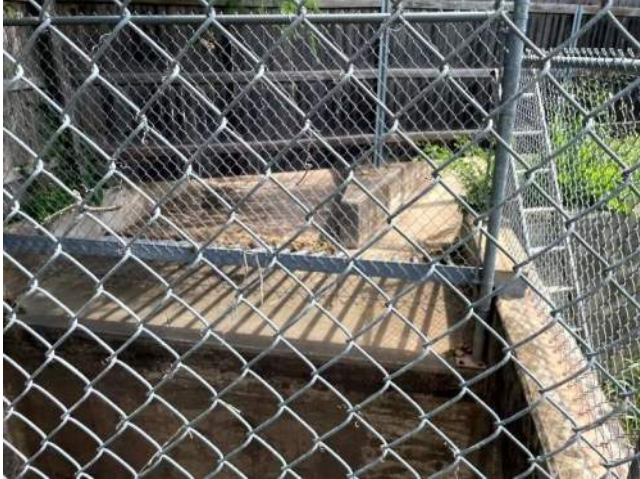
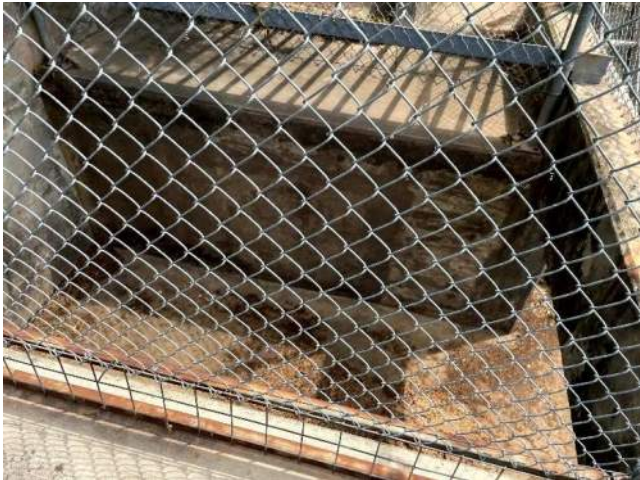
Amber Creek PCD

Field Notes: Mow PCD clear debris from grate inlet.

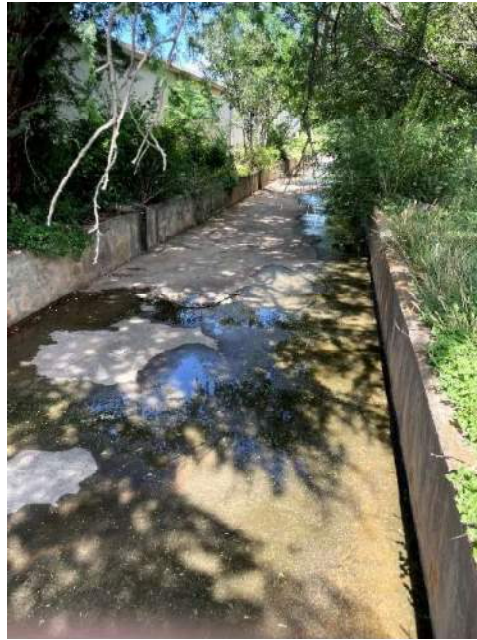
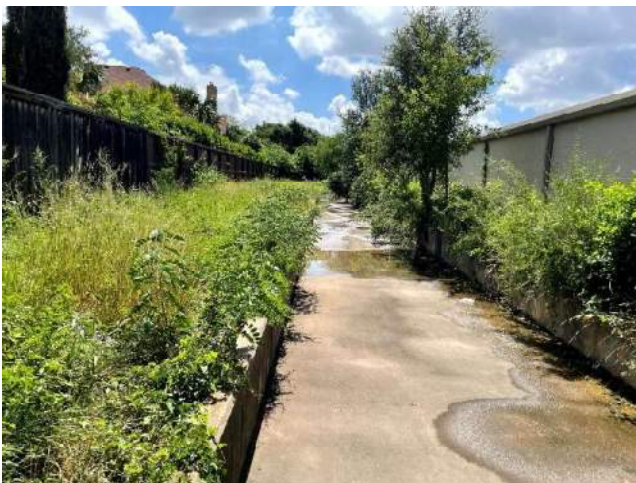
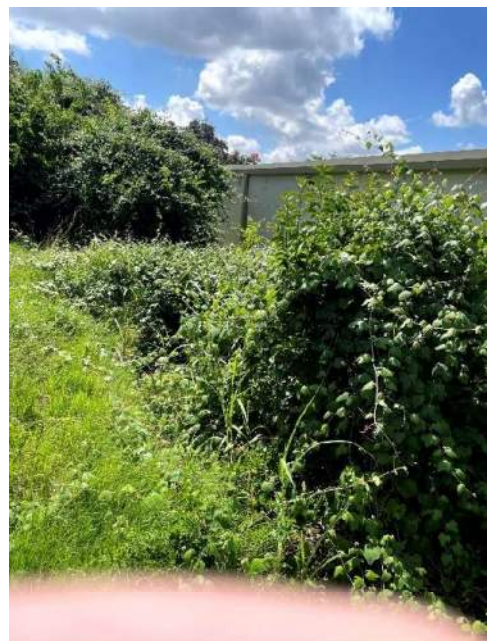
Amber Creek Southern Outfall and Channel

Field Notes: Eastern portion needs vegetation cleared out looks good otherwise.

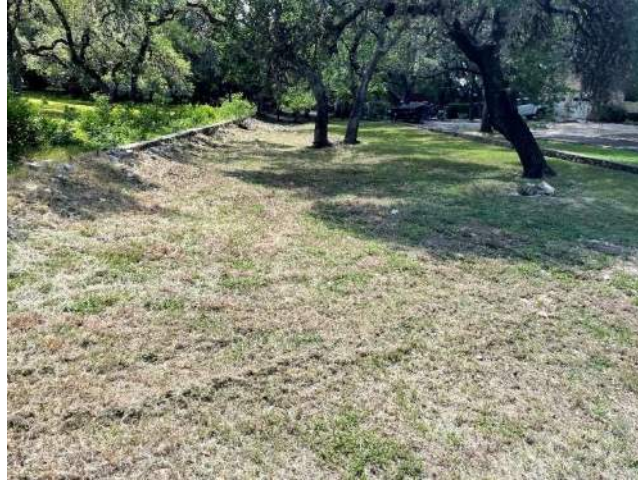
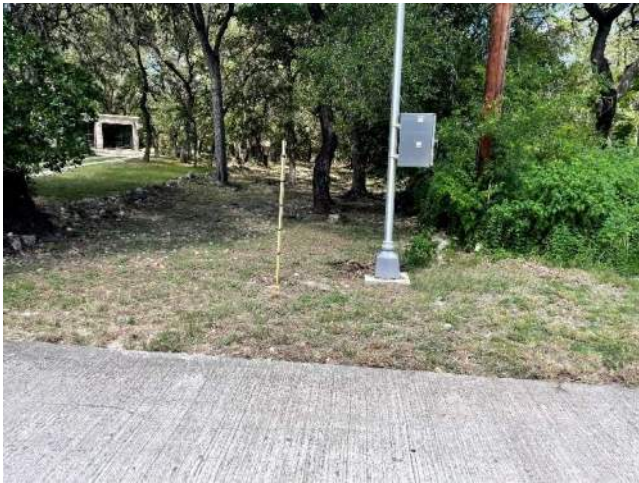
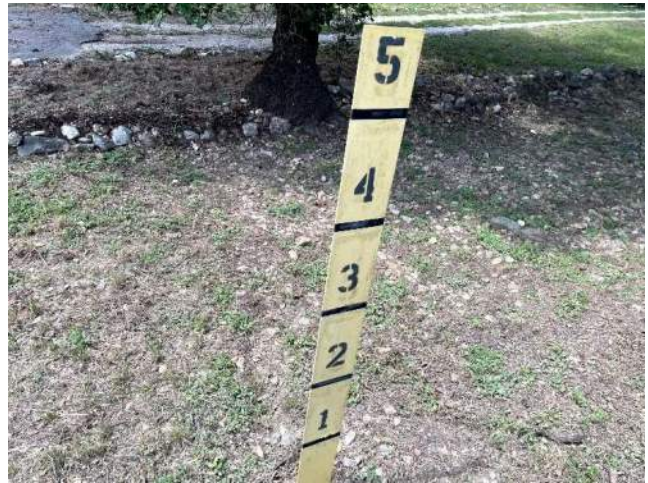
Antelope Dr Low Water Crossing

Field Notes: Looks good.

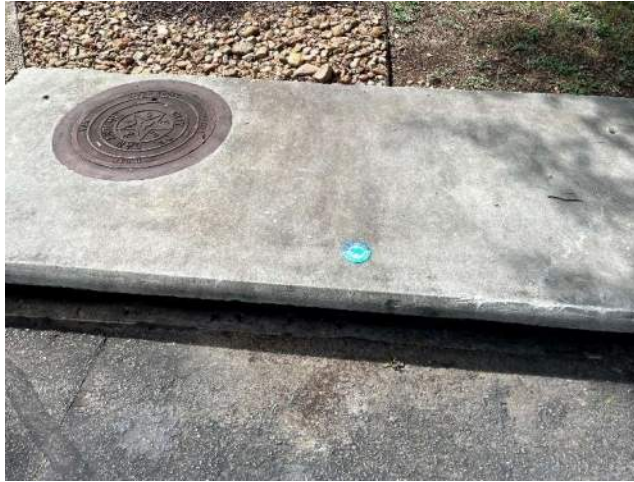
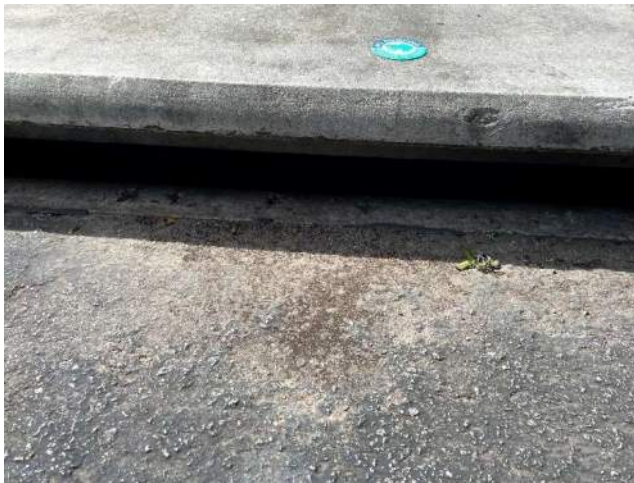
ANT-I-1

Field Notes: Looks good.

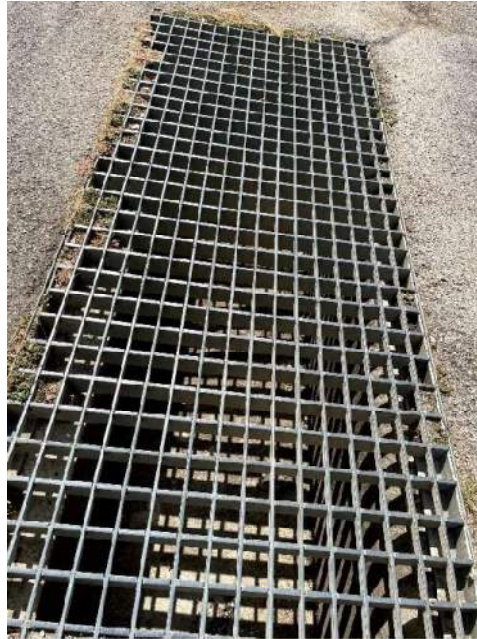
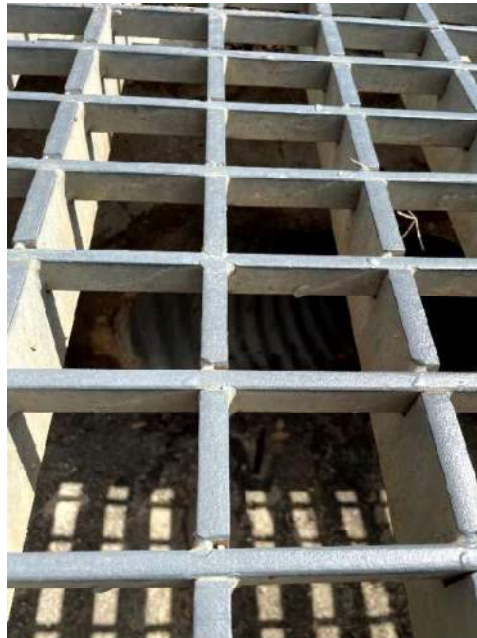
ANT-I-2

Field Notes: Looks good.

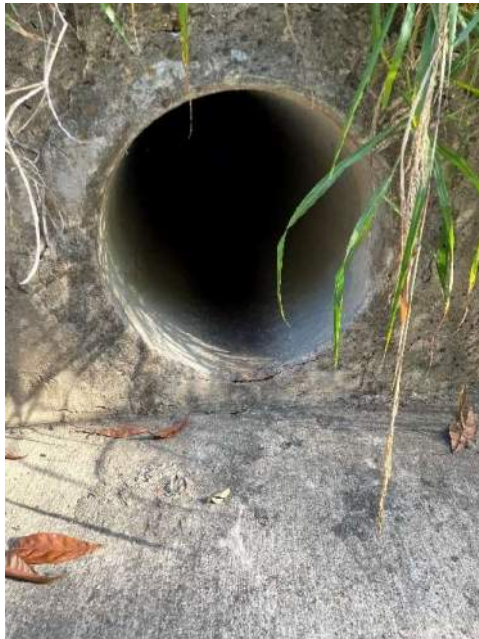
Antler 1 Storm Sewer Pipe

Field Notes: Looks good.

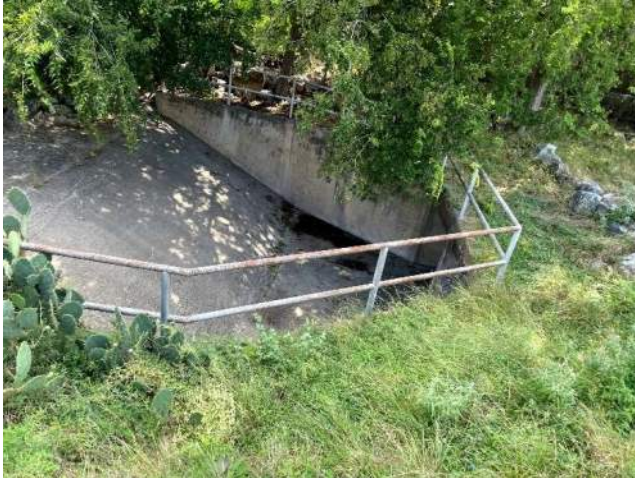
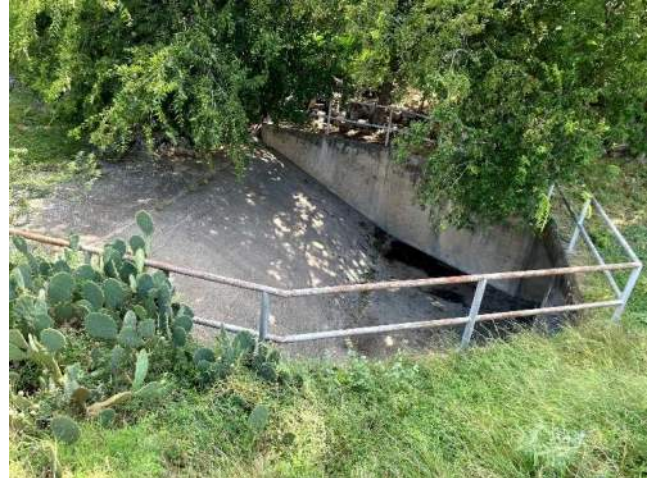
Antler 2 Storm Sewer Pipe

Field Notes: Looks good.

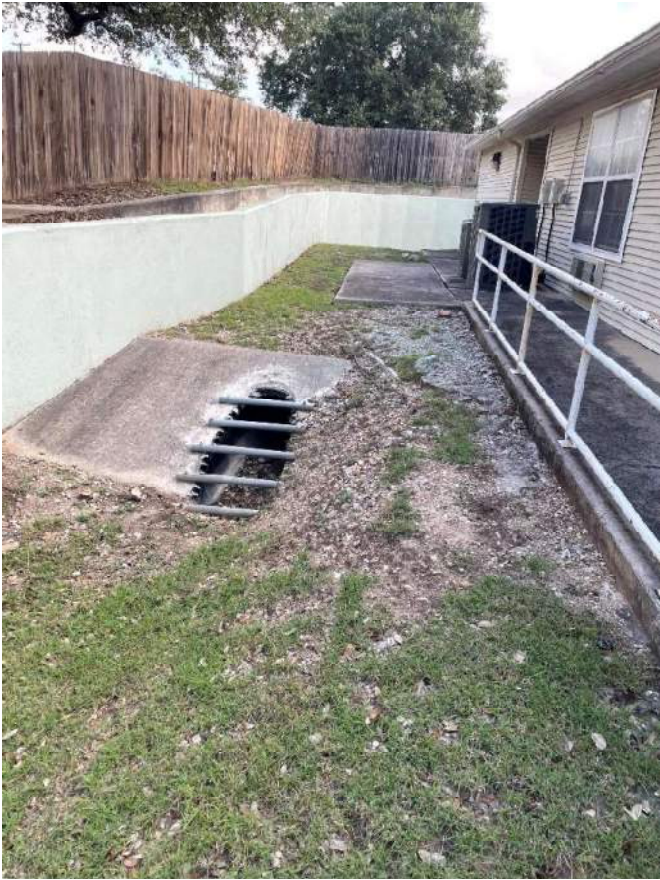
Brookdale PCD

Field Notes: Looks good, fence has been repaired since last inspection.

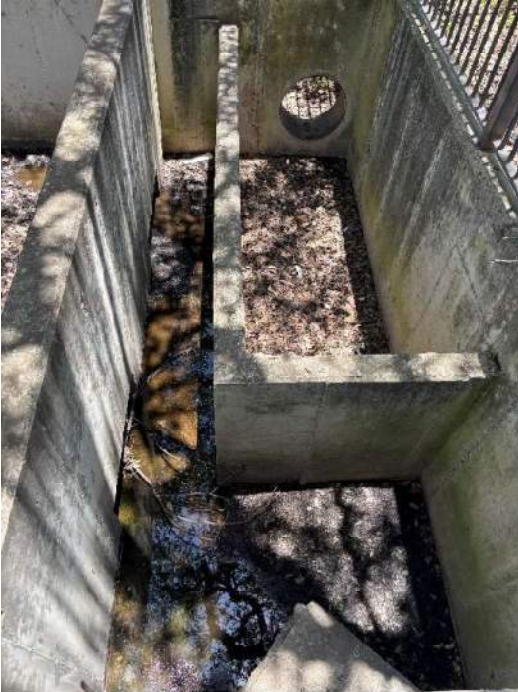
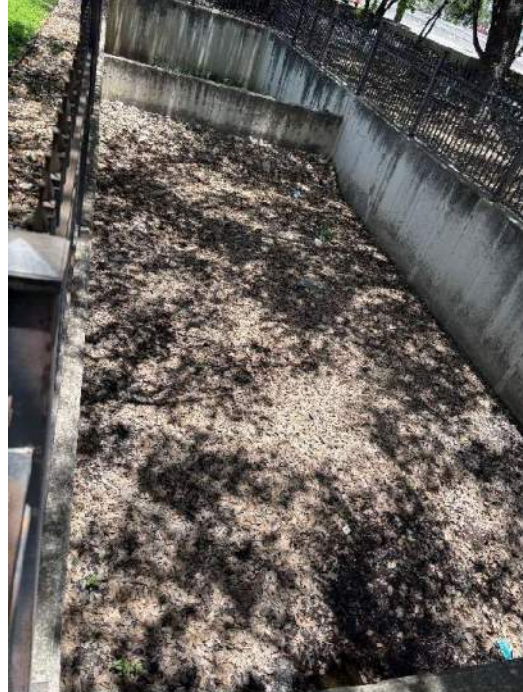
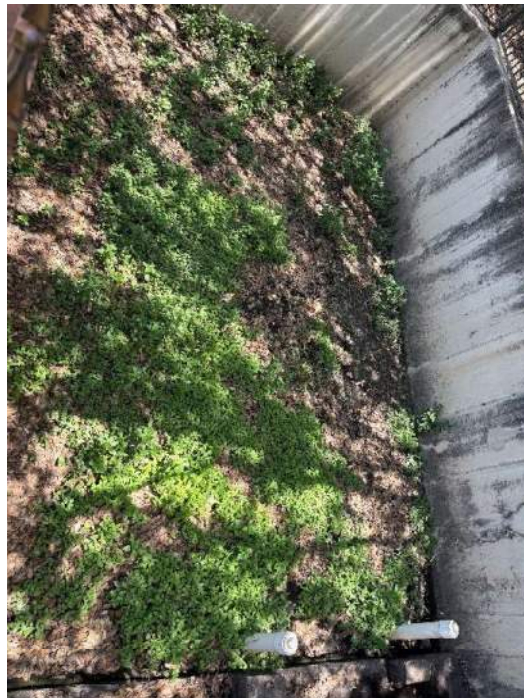
Chandler Signs PCD in North Park Corporate Center Parking Lot

Field Notes: Remove leaves, debris, and vegetation.

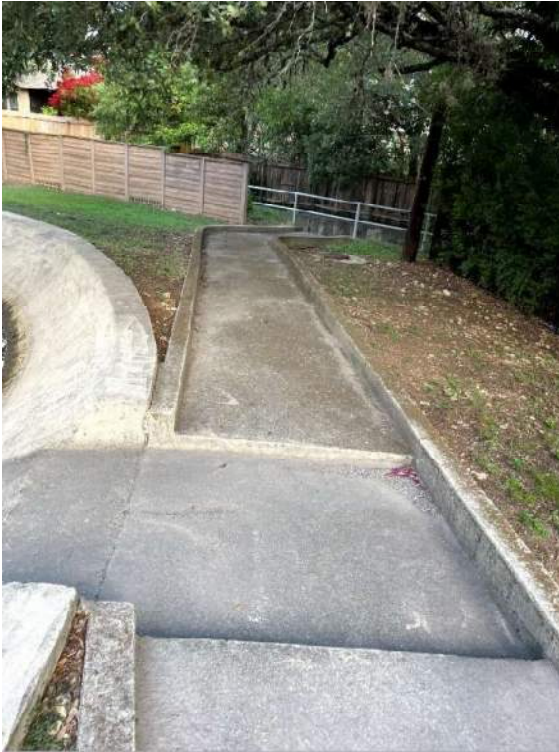
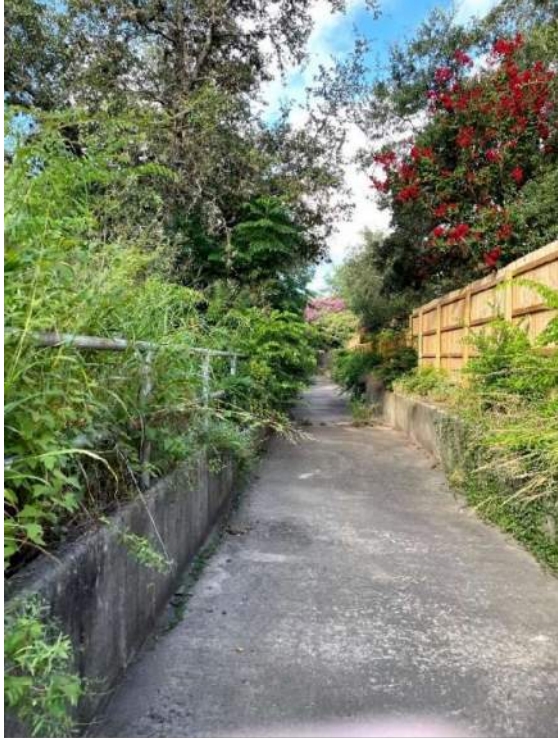
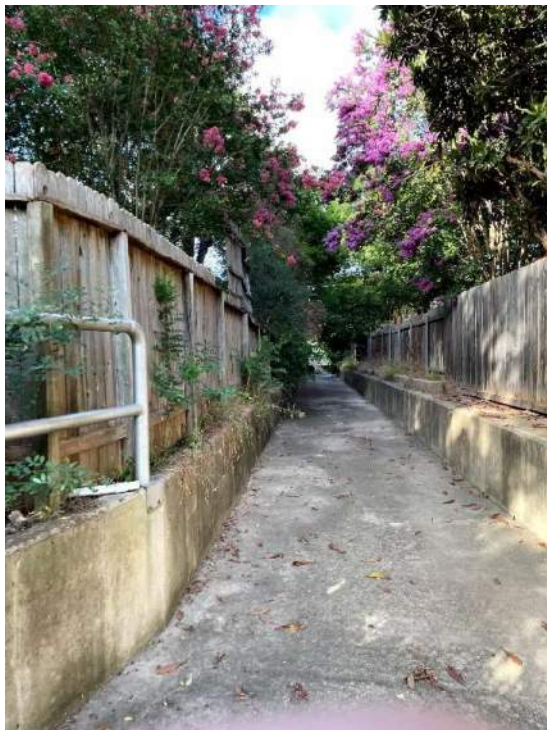
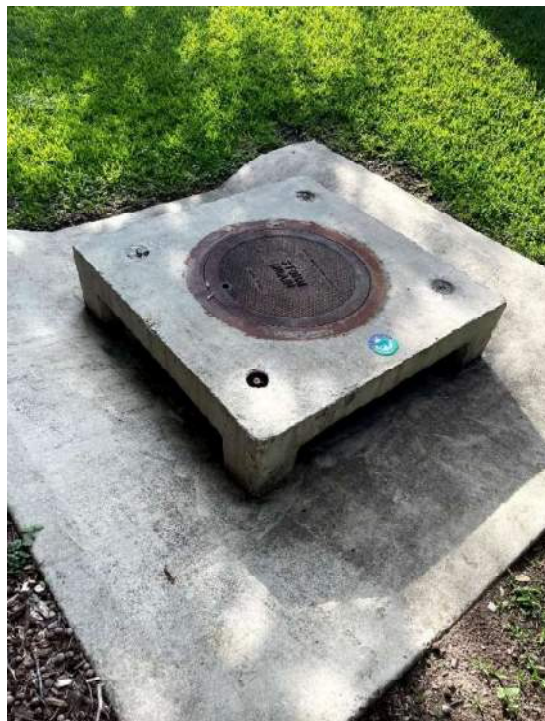
Channel

Field Notes: Trim vegetation along channel.

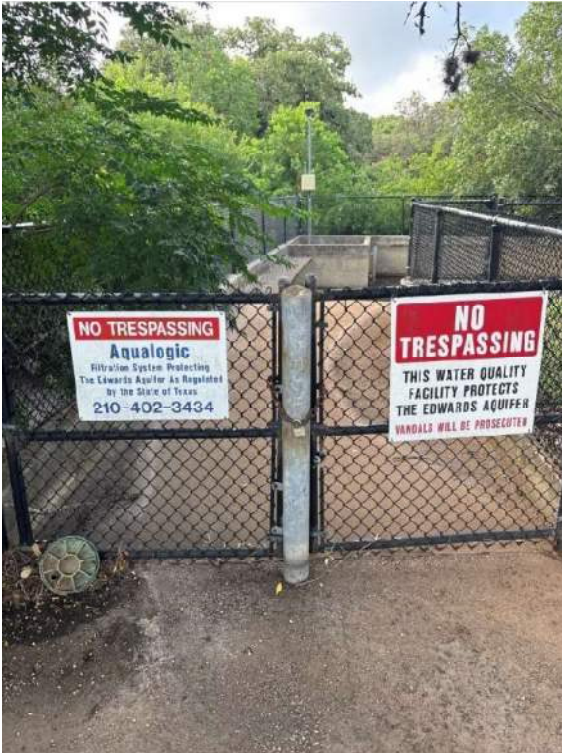
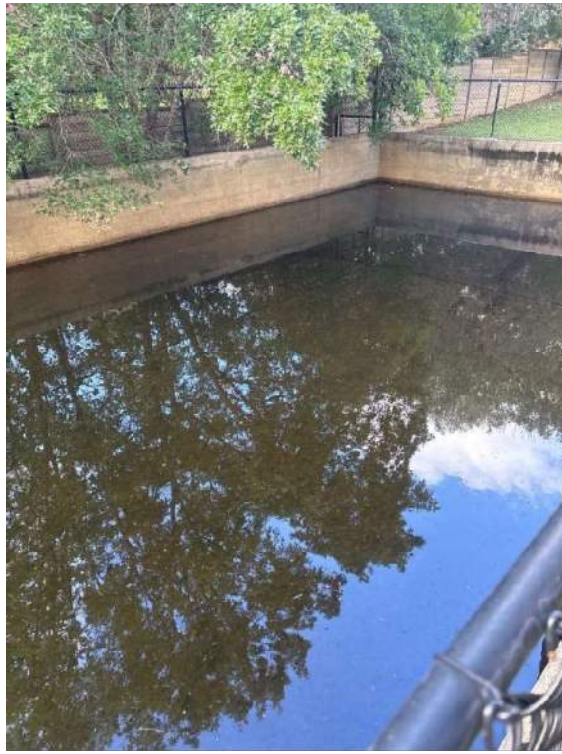
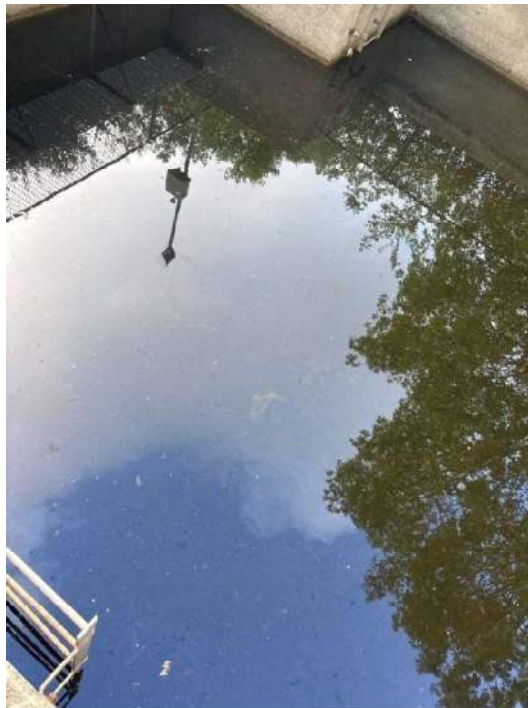
Chicago Title PCD

Field Notes: Bottom of the basin looks pretty dirty. Remove the leaves and sediment from the basin.

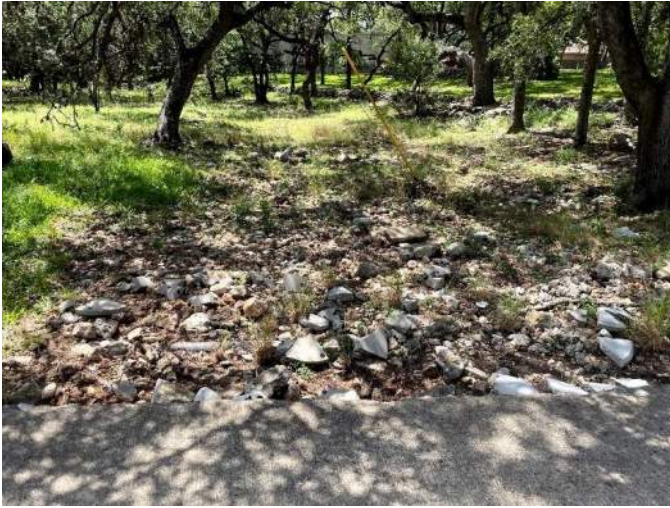
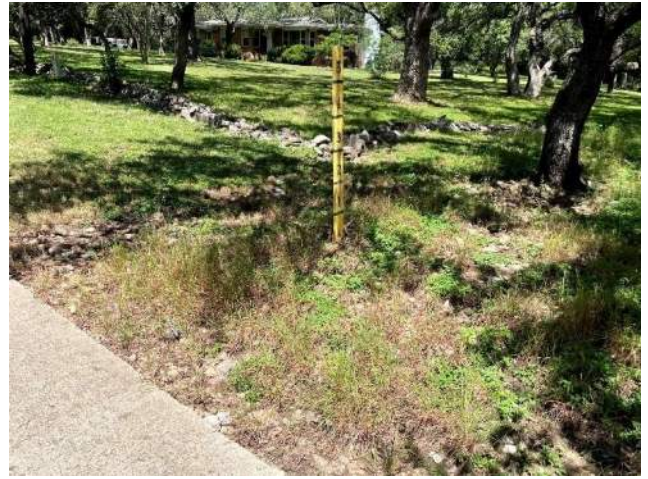
Coolway Dr Low Water Crossing

Field Notes: Mow grass.

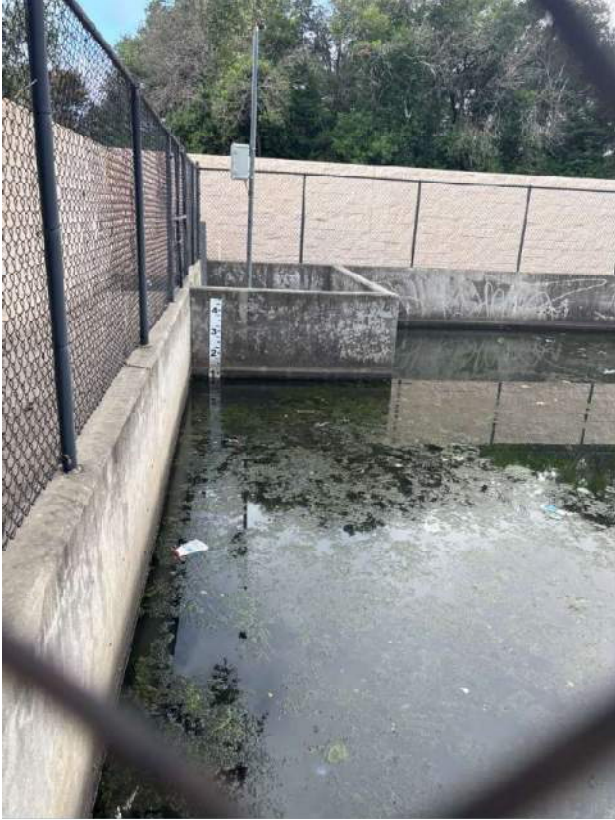
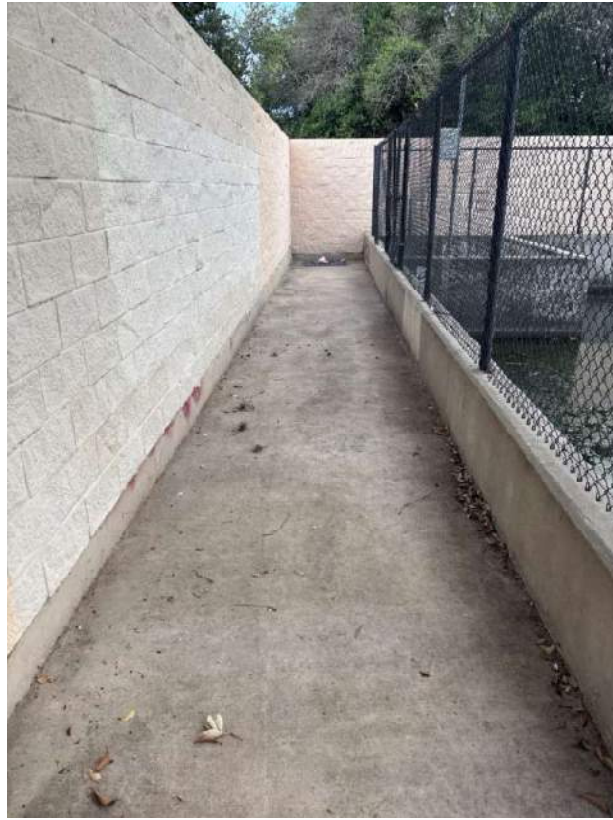
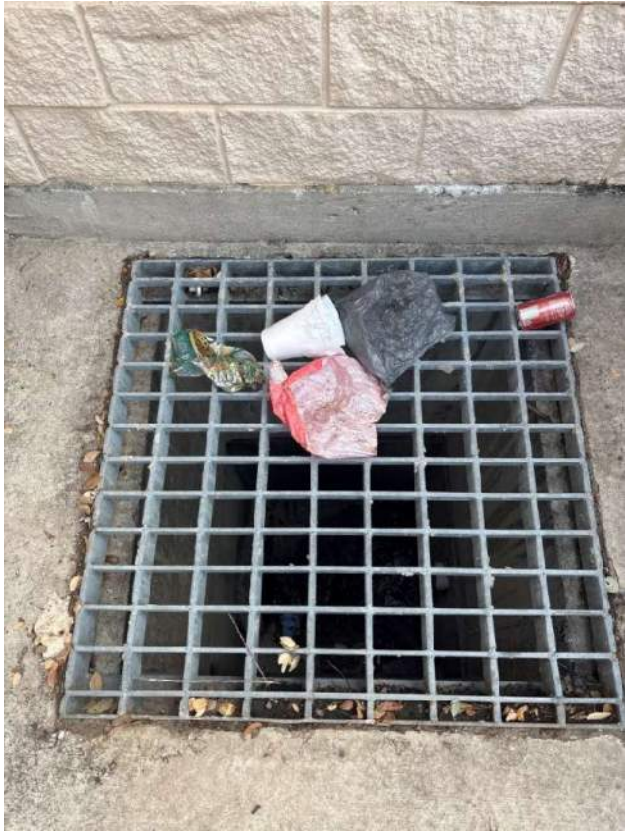
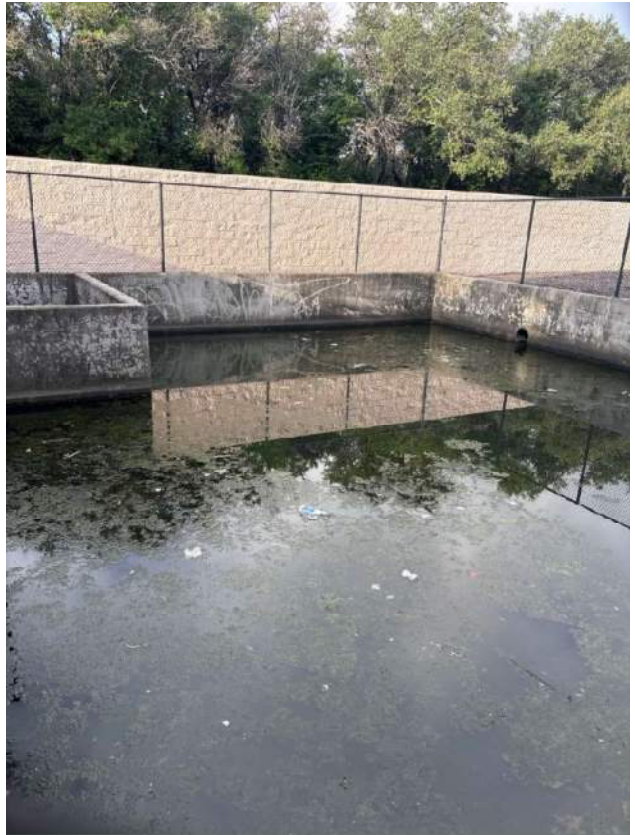
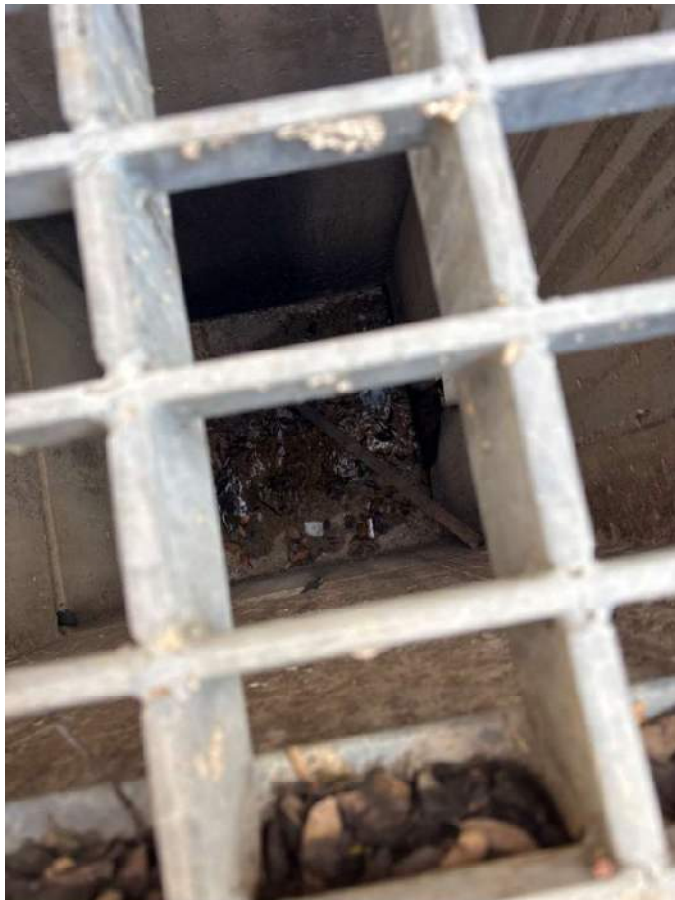
Corner Store PCD

Field Notes: Remove trash from grates and pond basin.

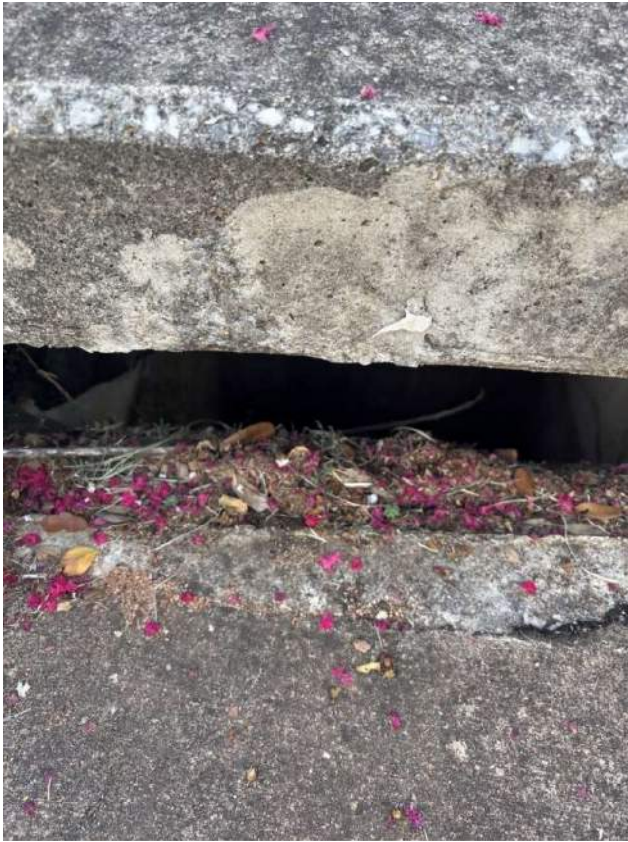
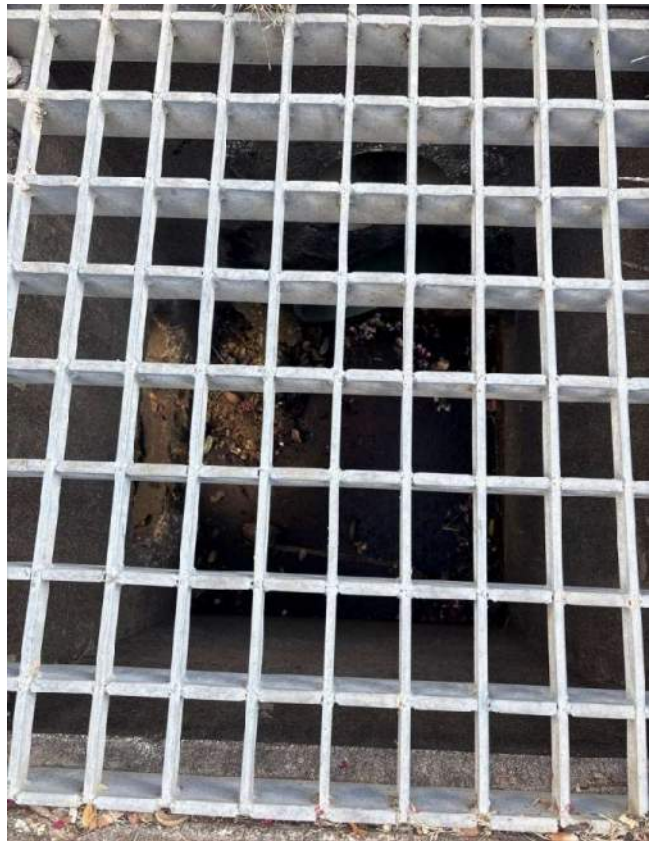
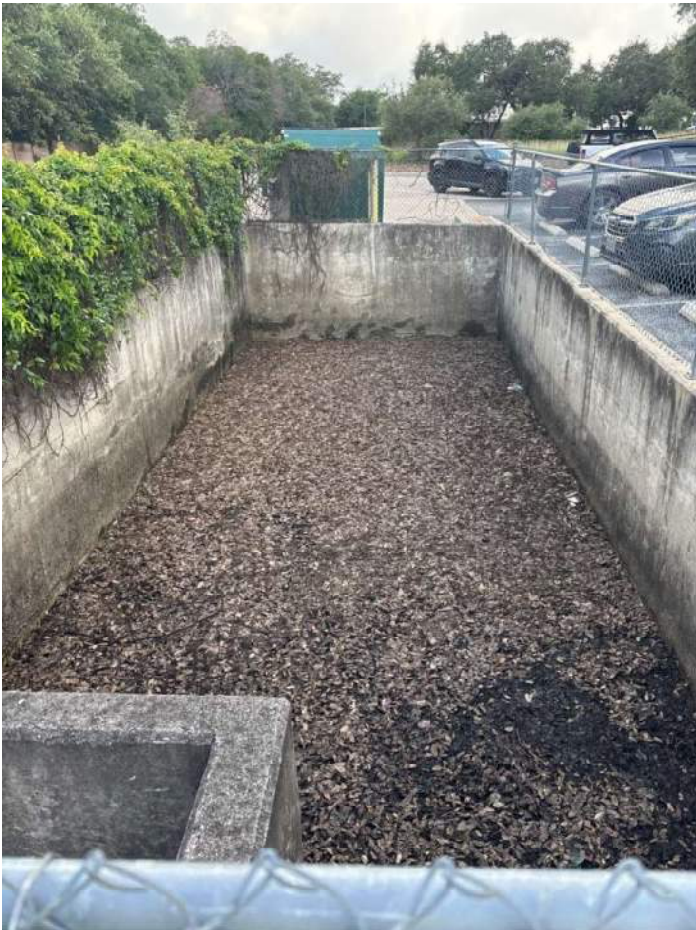
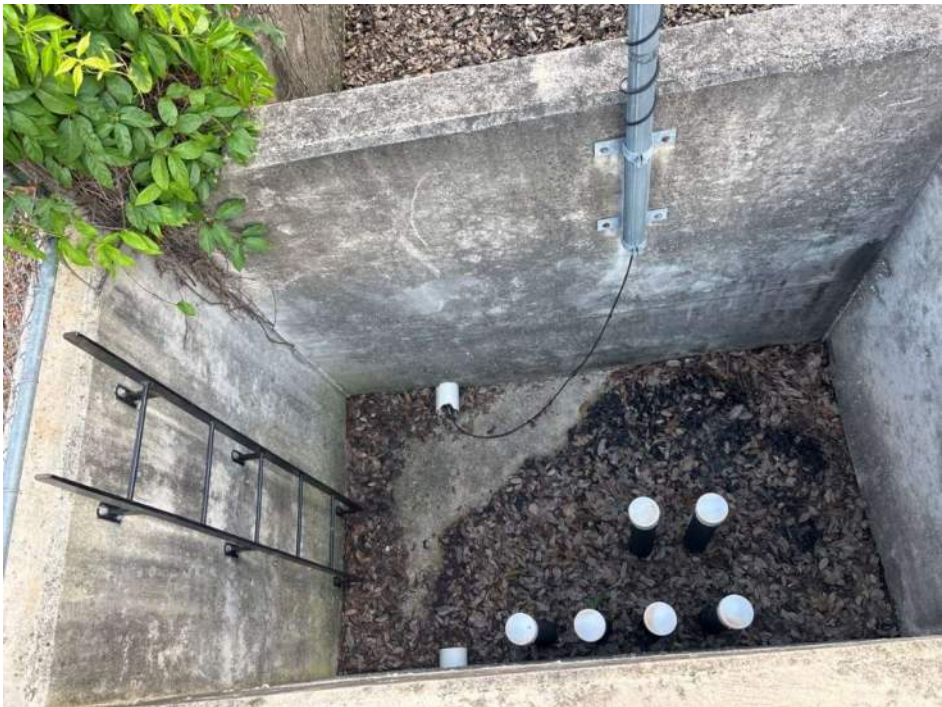
CRT Flooring Concepts PCD

Field Notes: Remove leaves from basin and trim vines off fence.
