TOWN OF HOLLYWOOD PARK, TX

2025 Summer Inspection

HOLLYWOOD PARK 2025 SUMMER INSPECTION REPORT

Subject: Annual Municipal Separate Storm Sewer System (MS4) Inspection

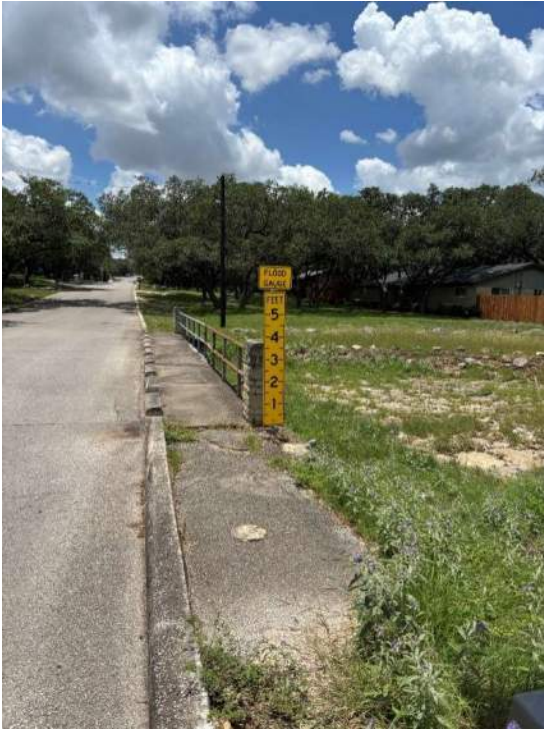
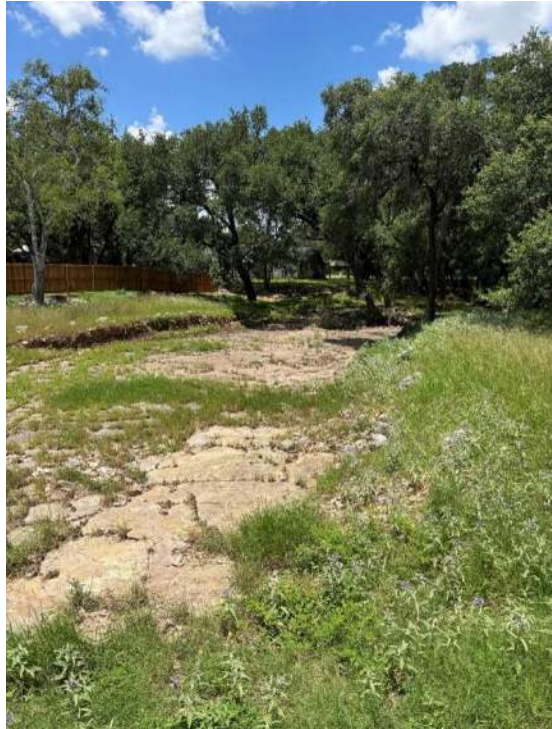
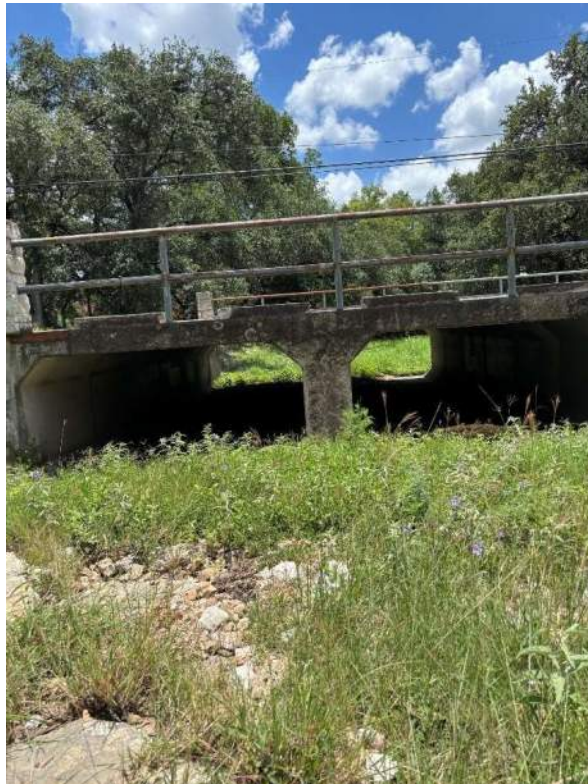
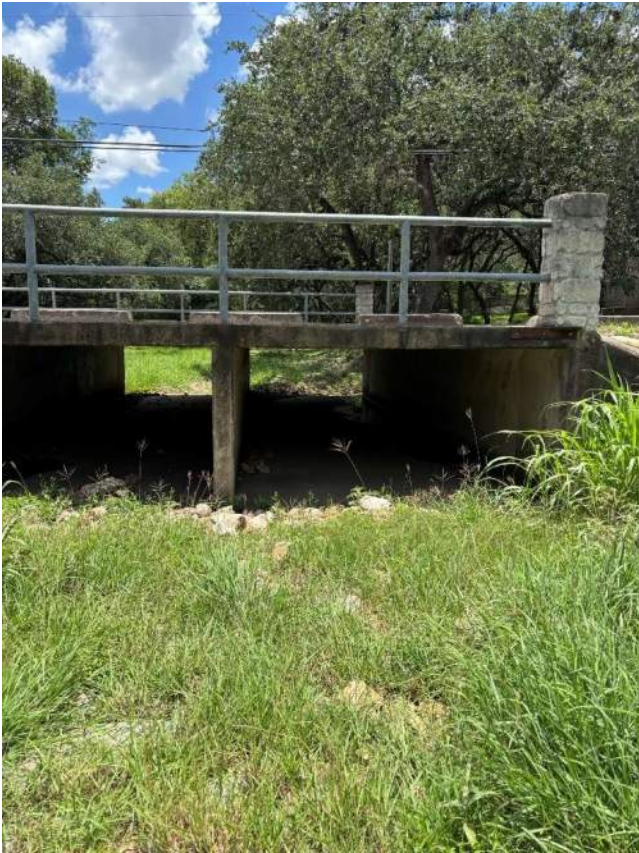
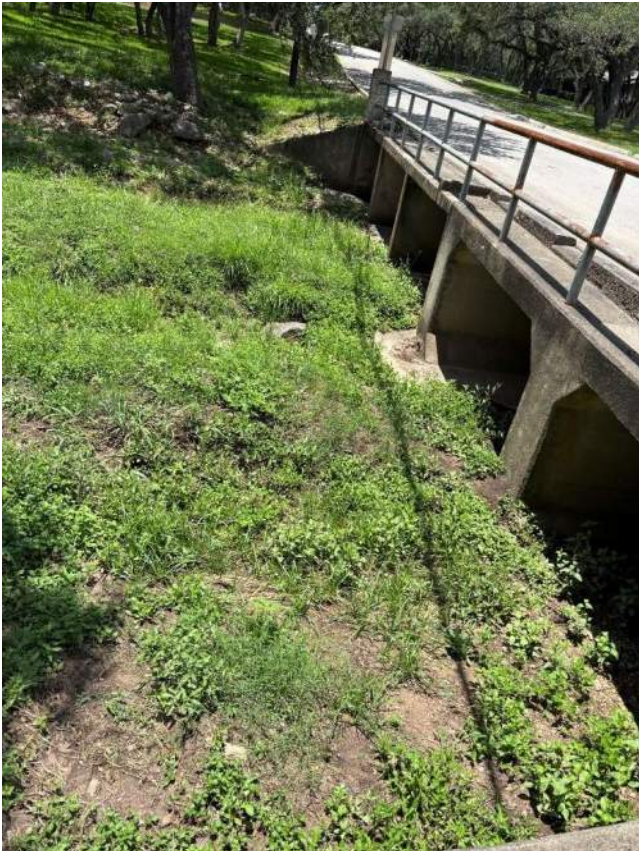
Field Notes: Remove large limbs from culvert entrances; trim vegetation near culvert entrances.

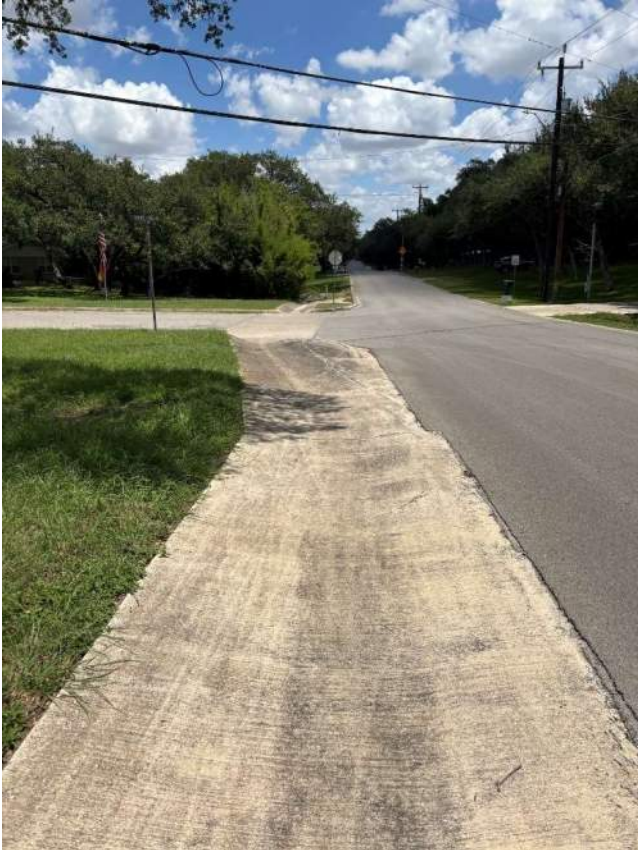
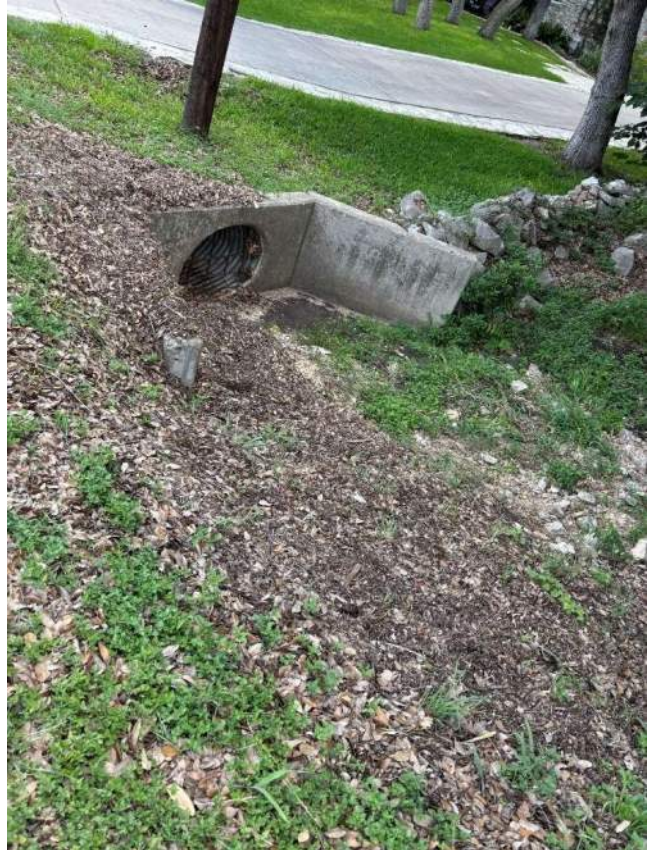
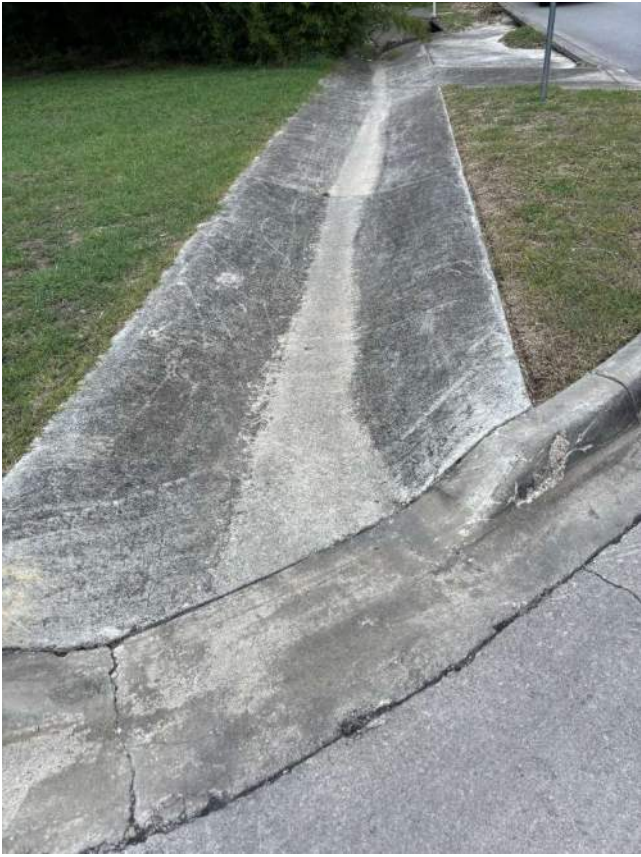
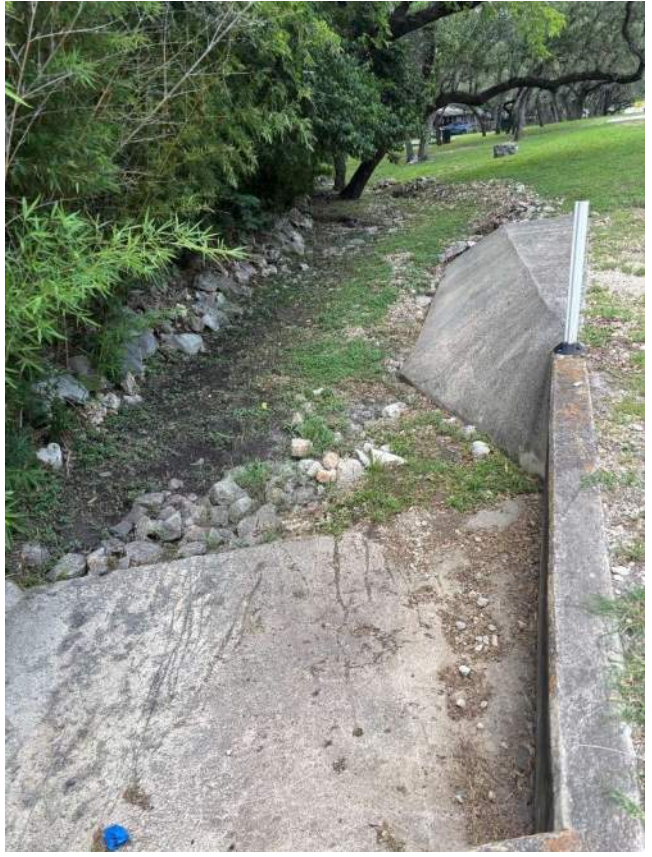
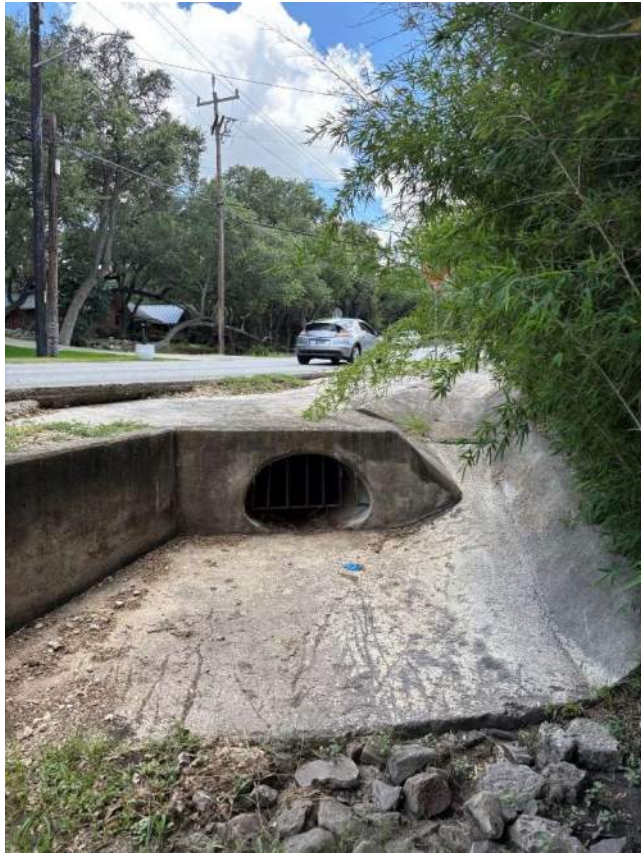
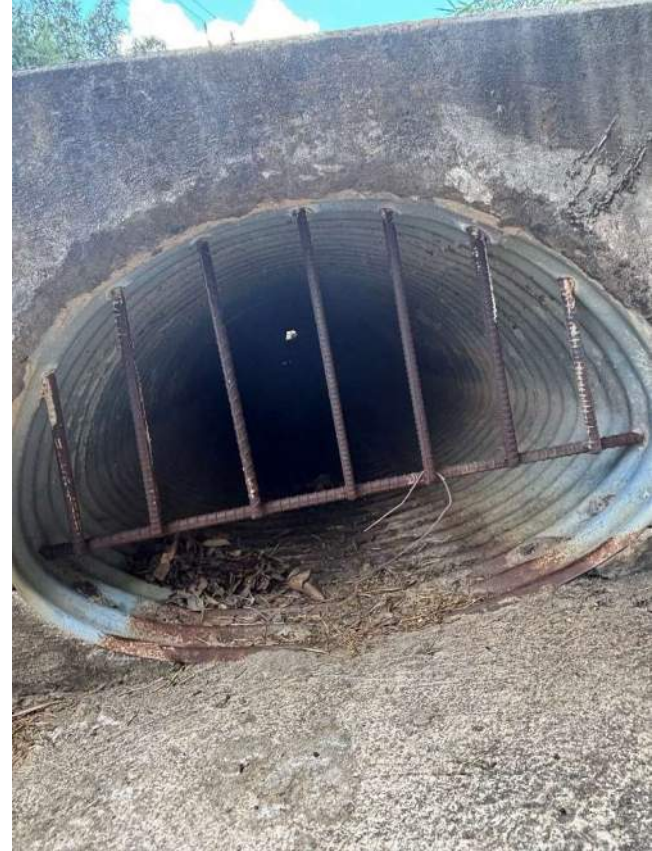
Donella Culvert Crossing at Mustang Circle

Field Notes: Looks good.

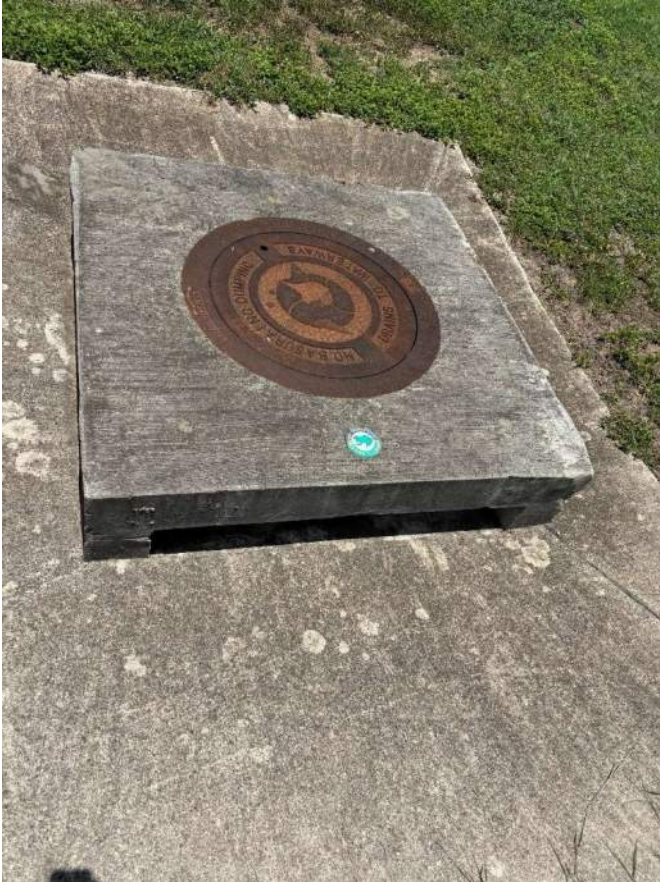
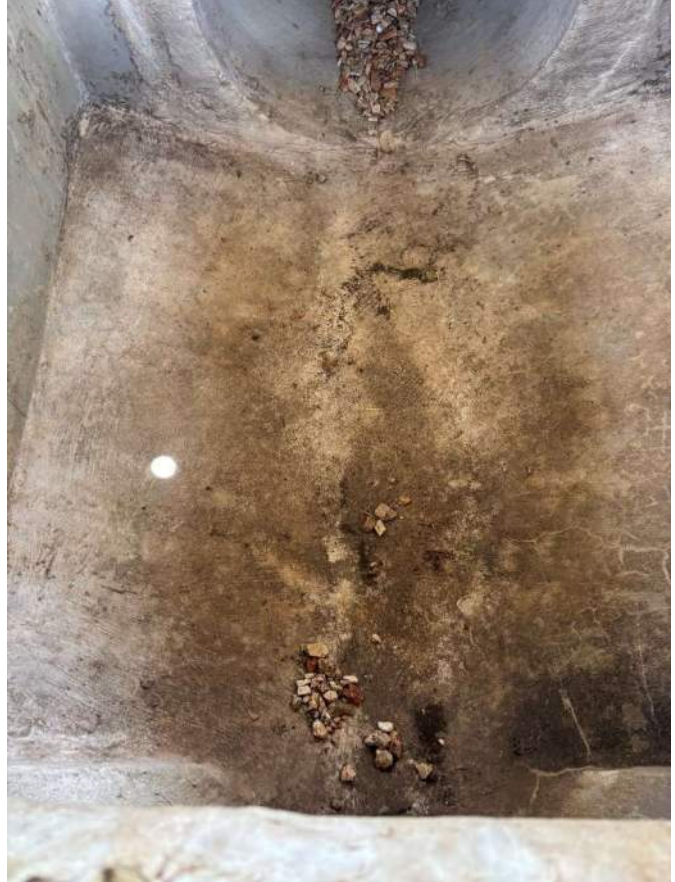
Donella Inlet Box

Field Notes: Minor amount of rocks and sediment in box, looks good otherwise.

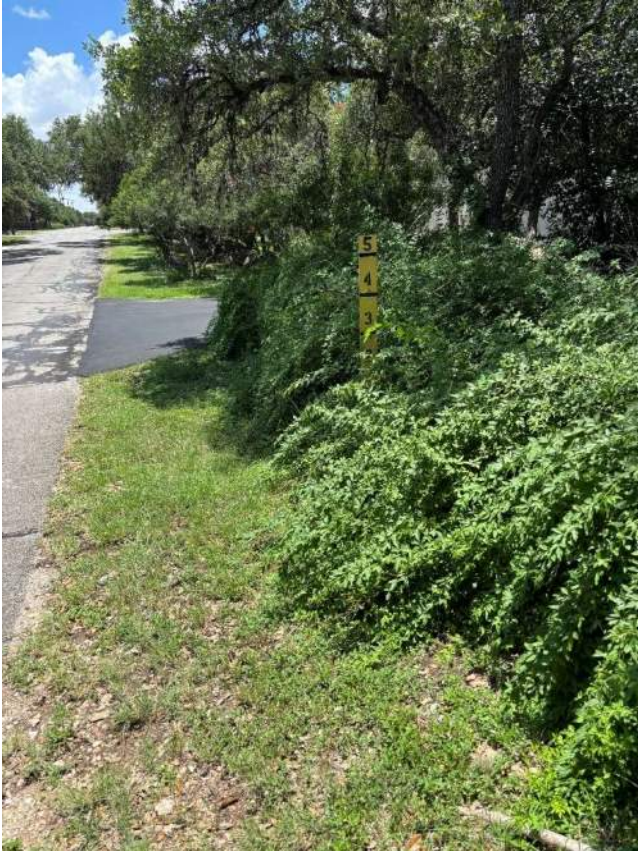
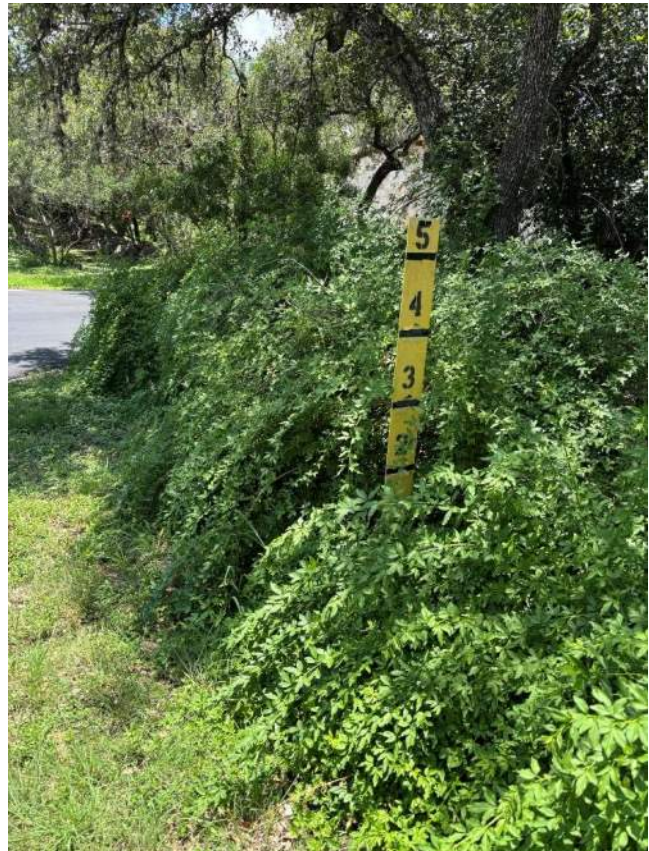
Field Notes: Trim overgrown vegetation surrounding Low Water Crossing.

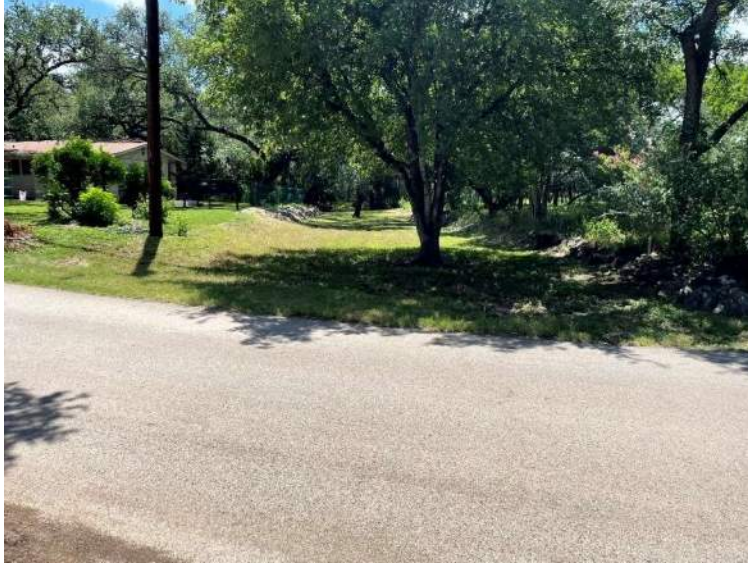
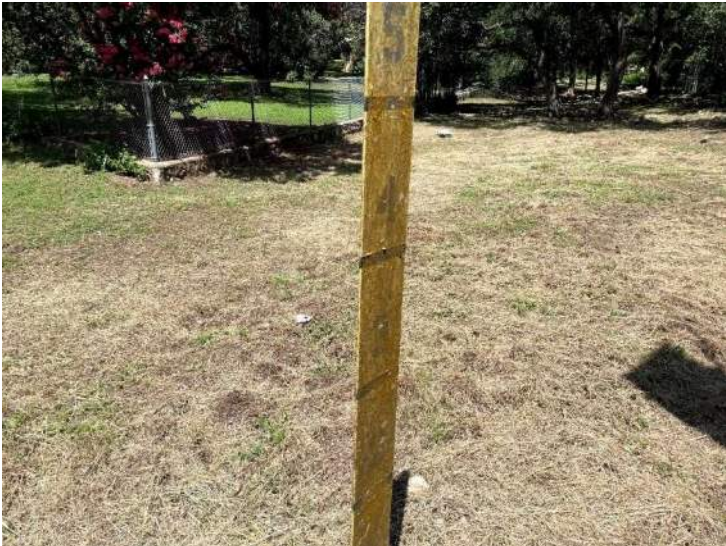
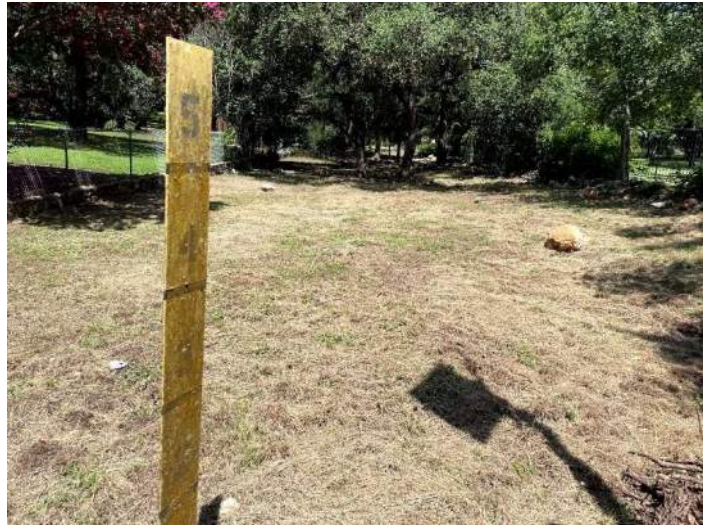
Field Notes: Looks good may need to repaint depth marker soon

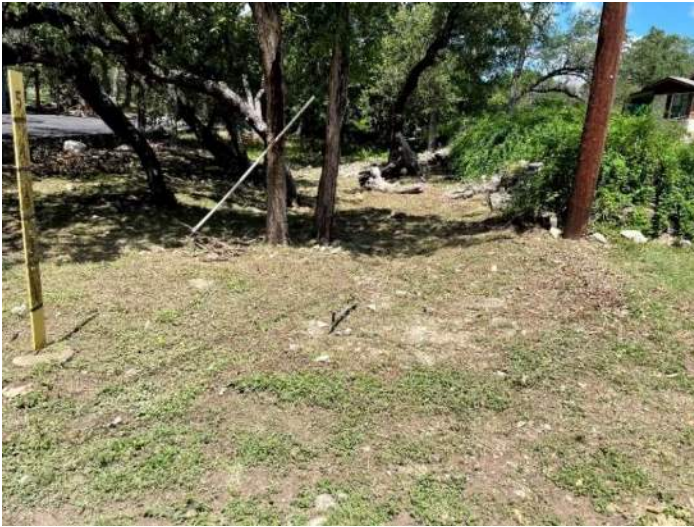
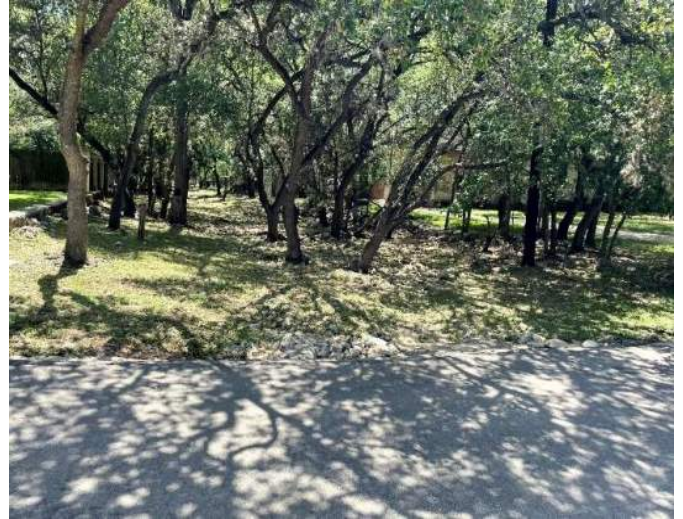
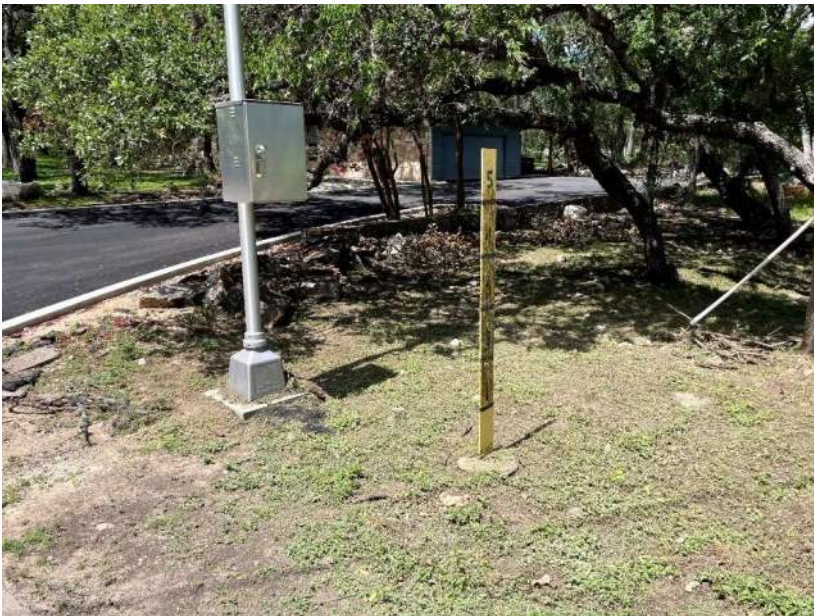
El Cerrito Low Water Crossing West

Field Notes: Looks good.

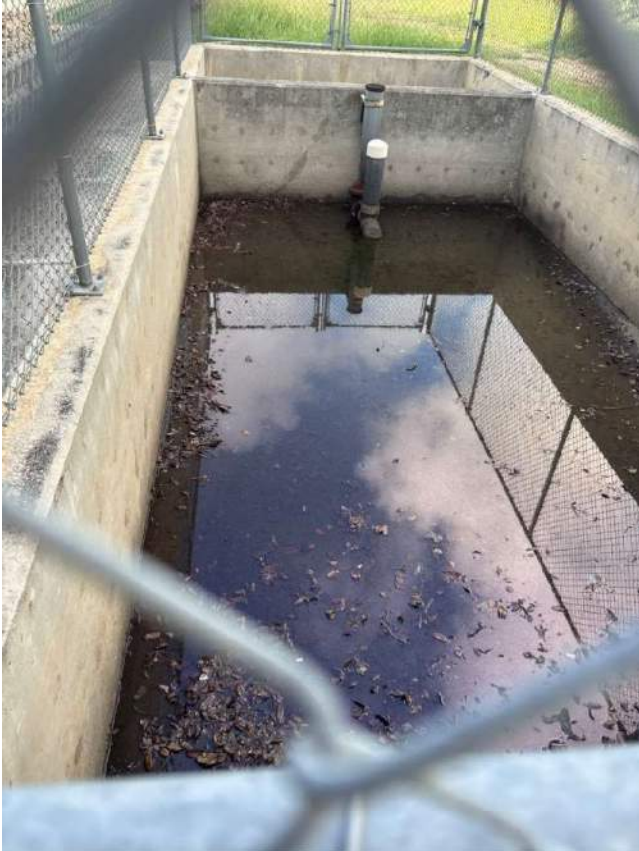
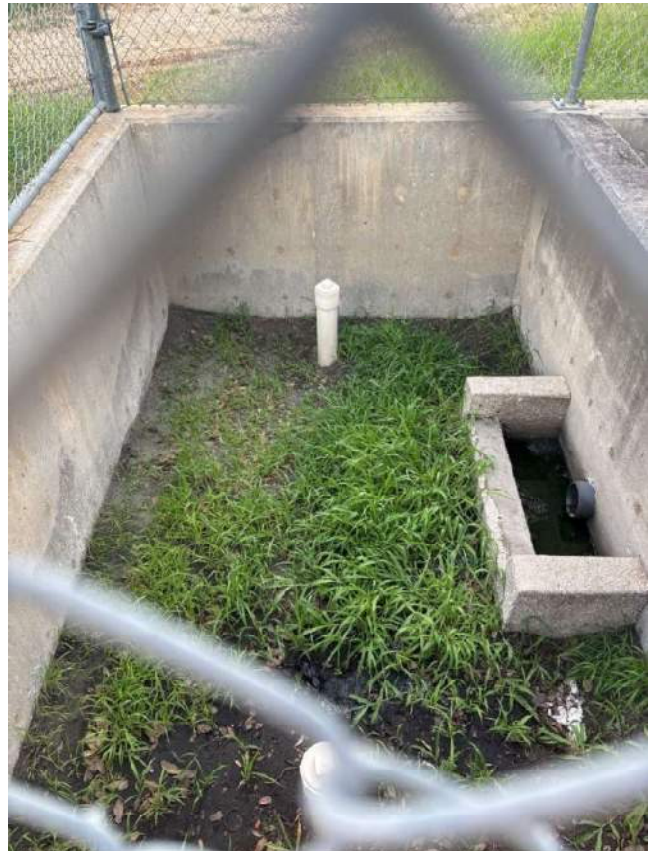
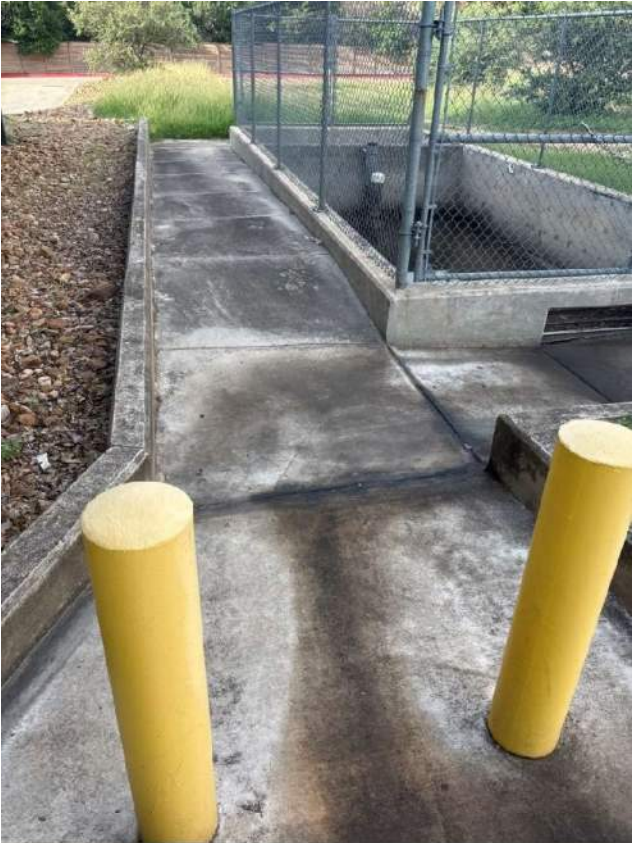
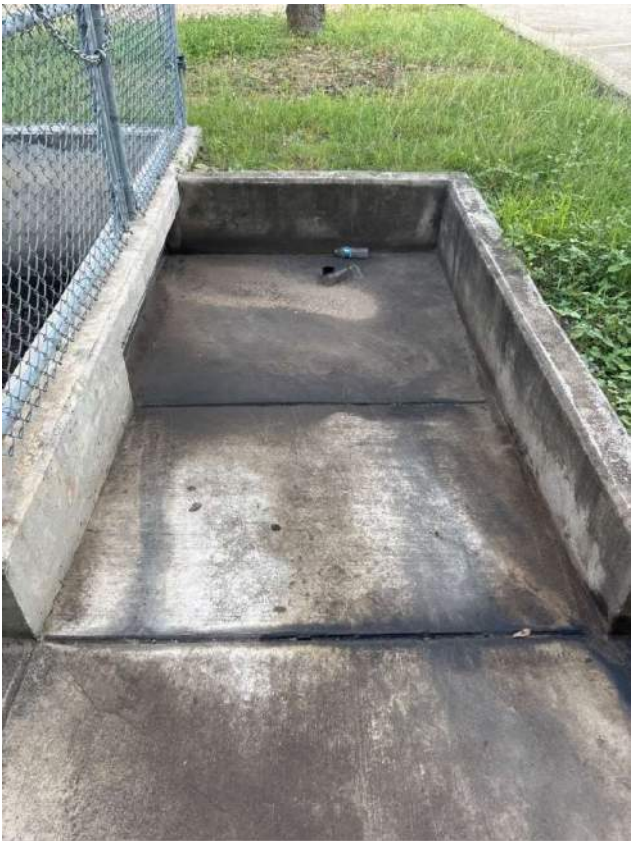
Express Lube PCD

Field Notes: Remove sediment and trash from inlet. Remove leaves and vegetation from basin.

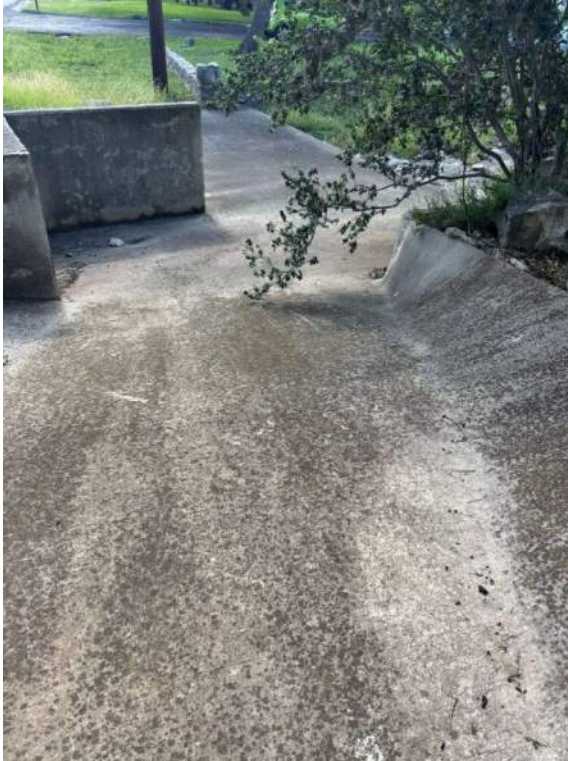
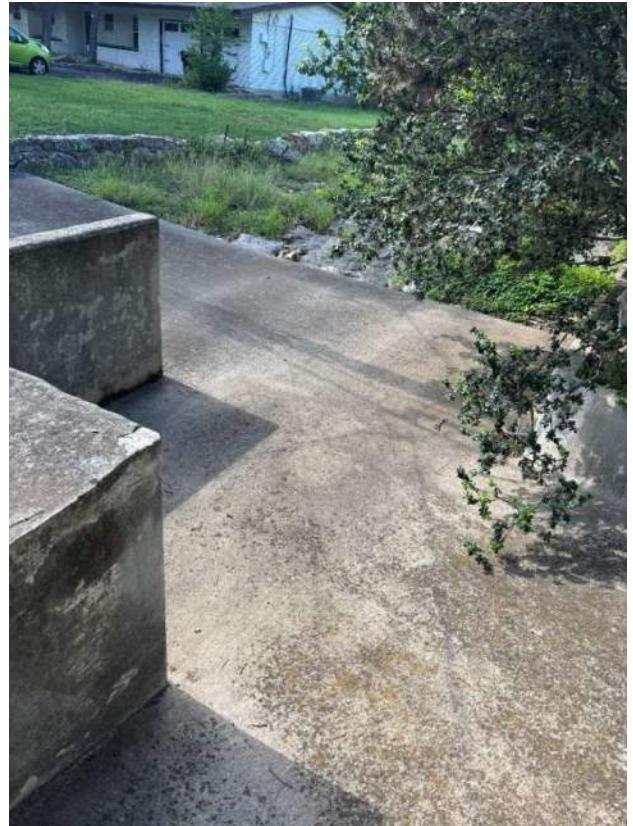
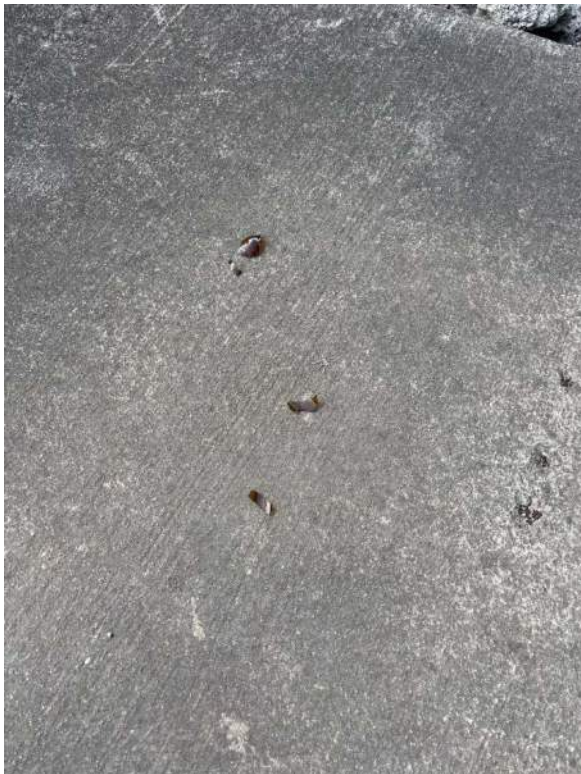
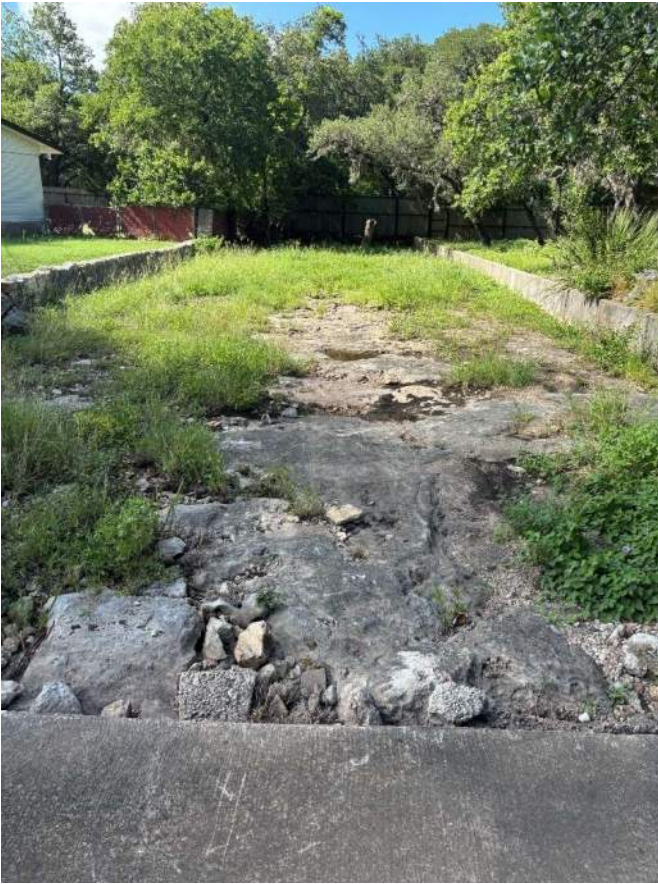
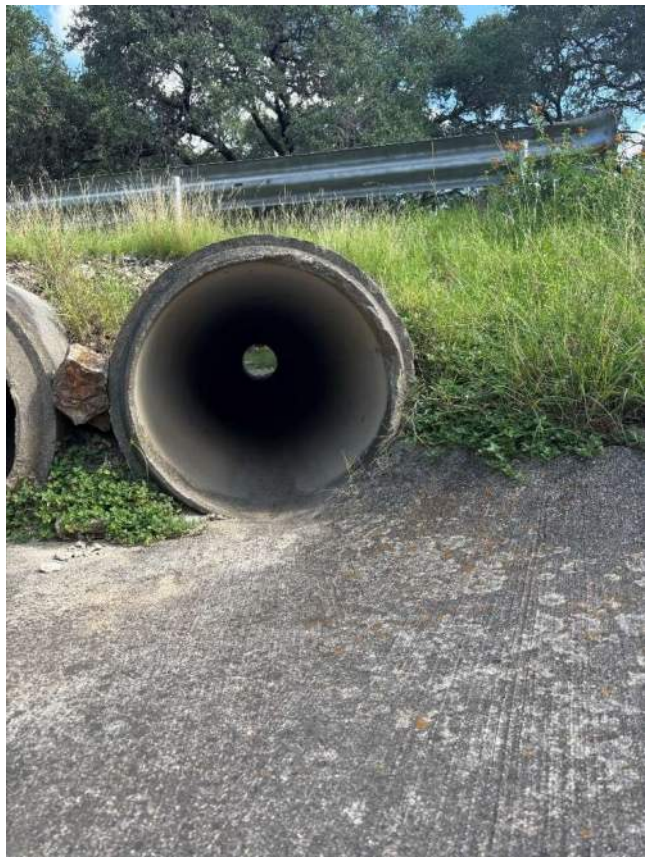
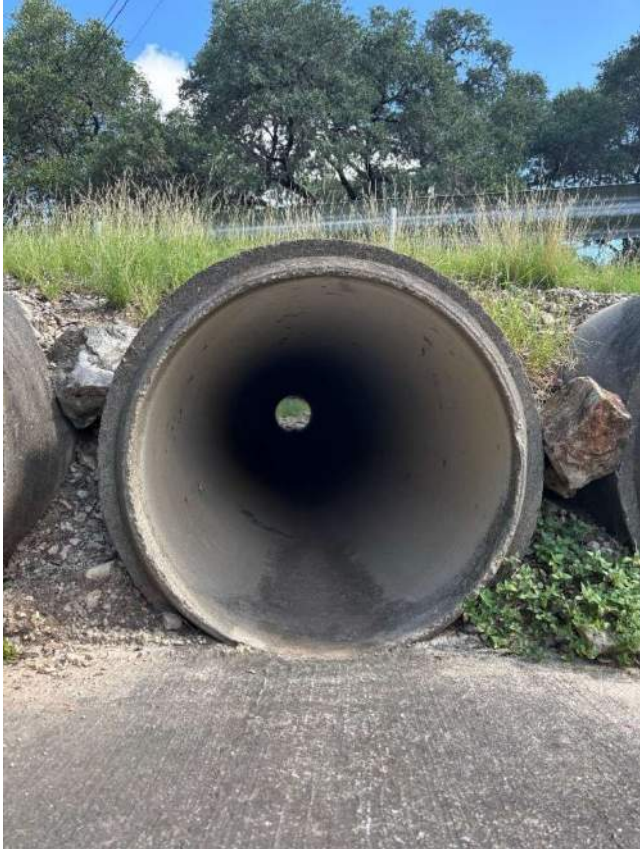
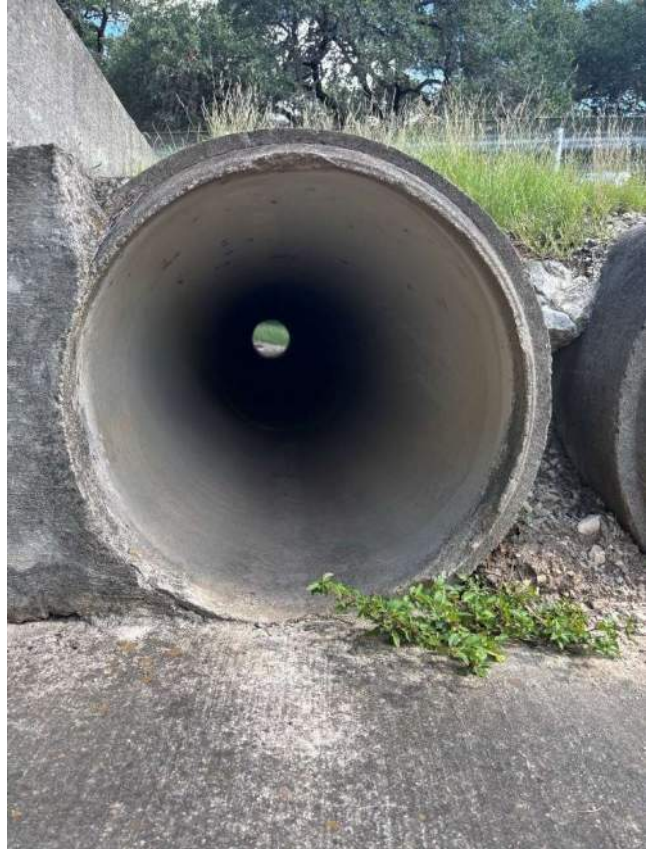
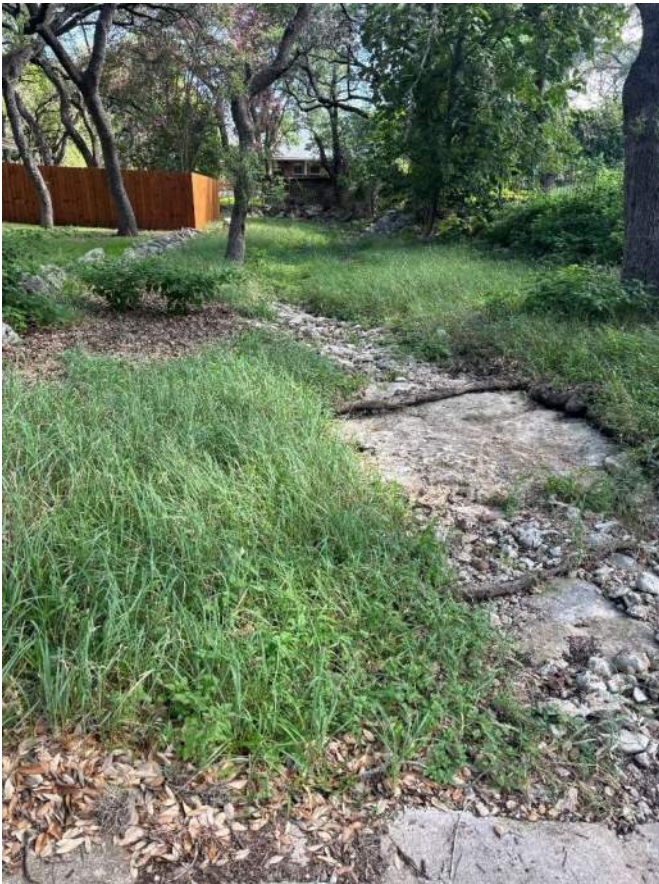
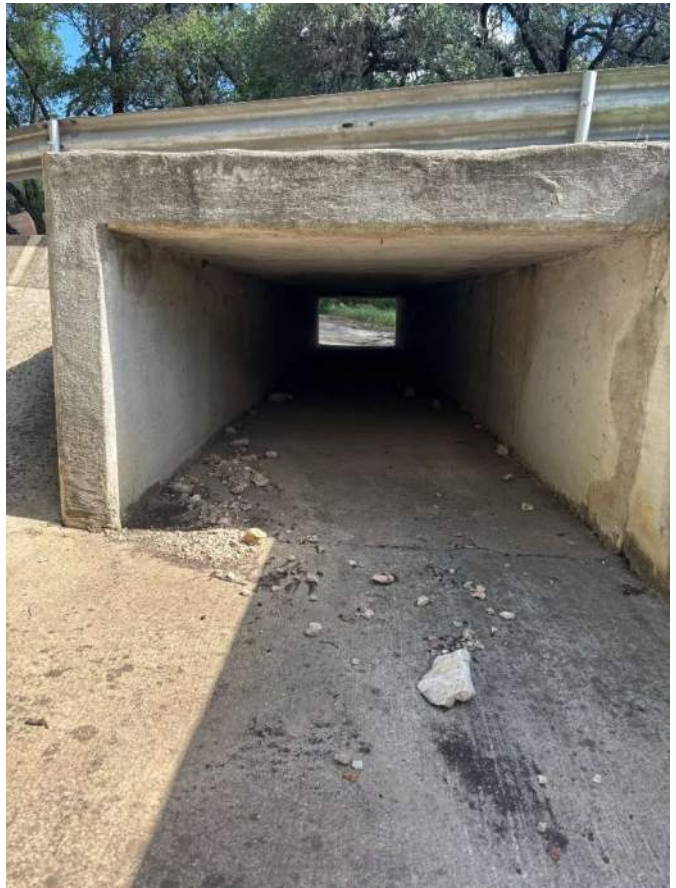
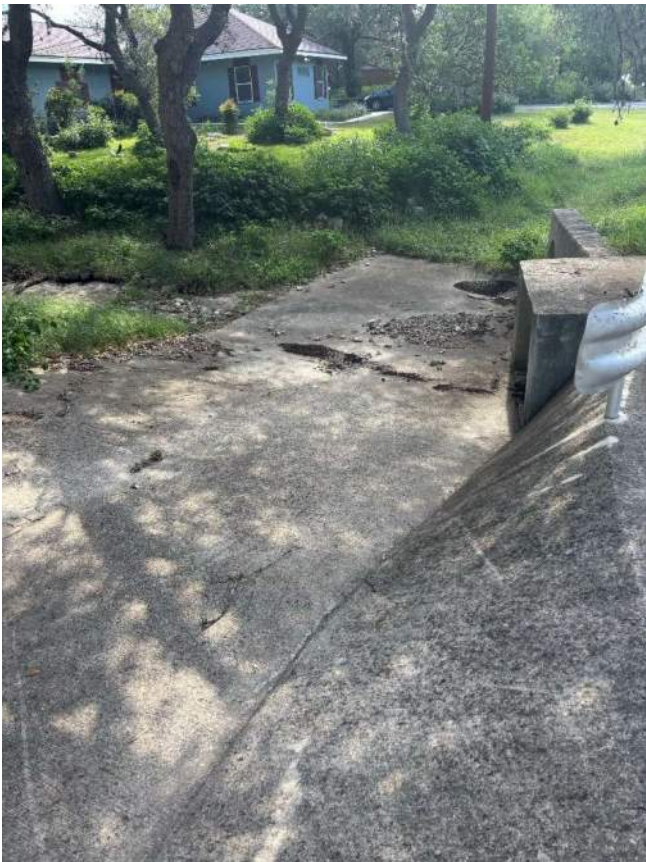
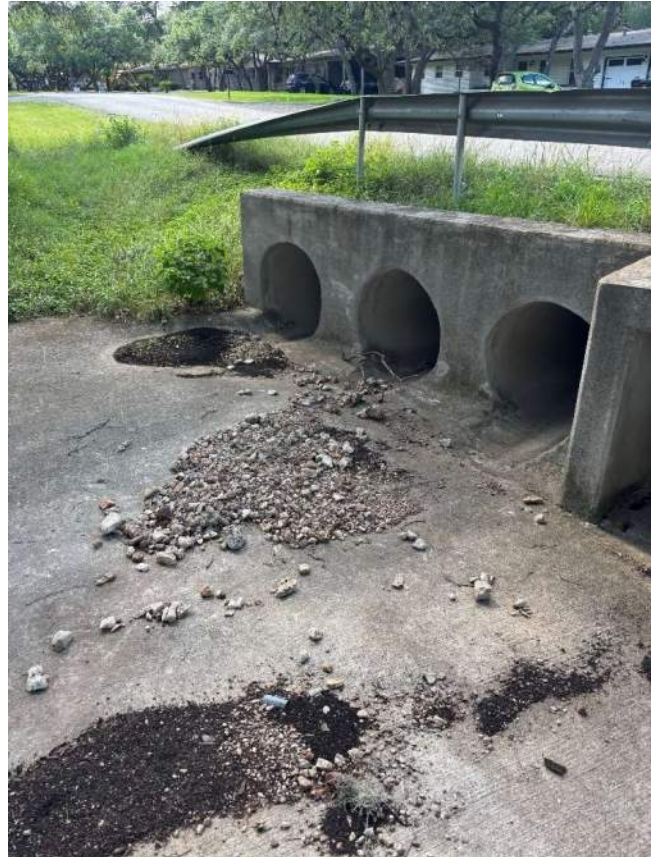
Fleetwood Crossing

Field Notes: Glass on concrete near outfall needs to be cleaned.
Sediment and overgrown vegetation near outfall and in channel needs to be removed.

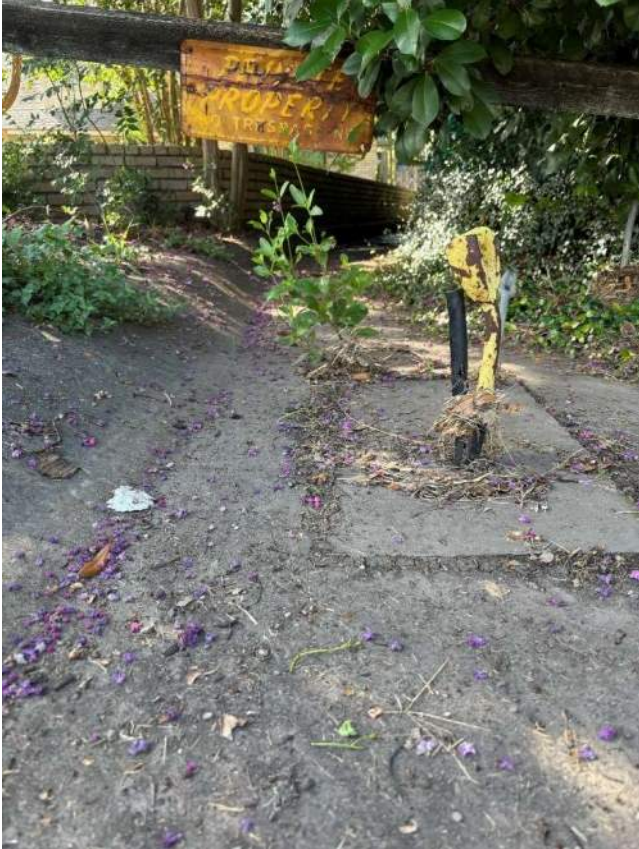
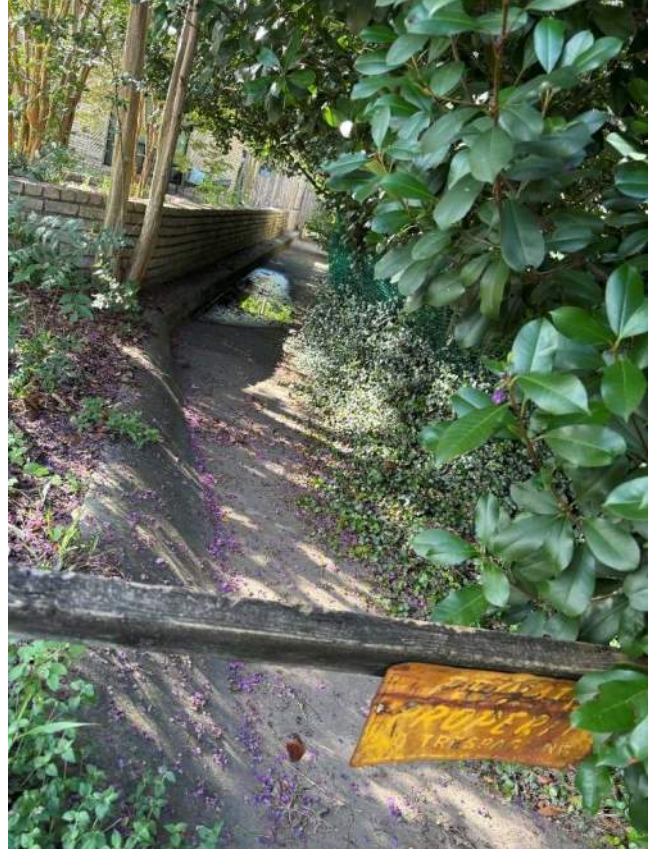
Garrapata Storm Water Inflow

Field Notes: Clean debris and vegetation overgrowth in channel

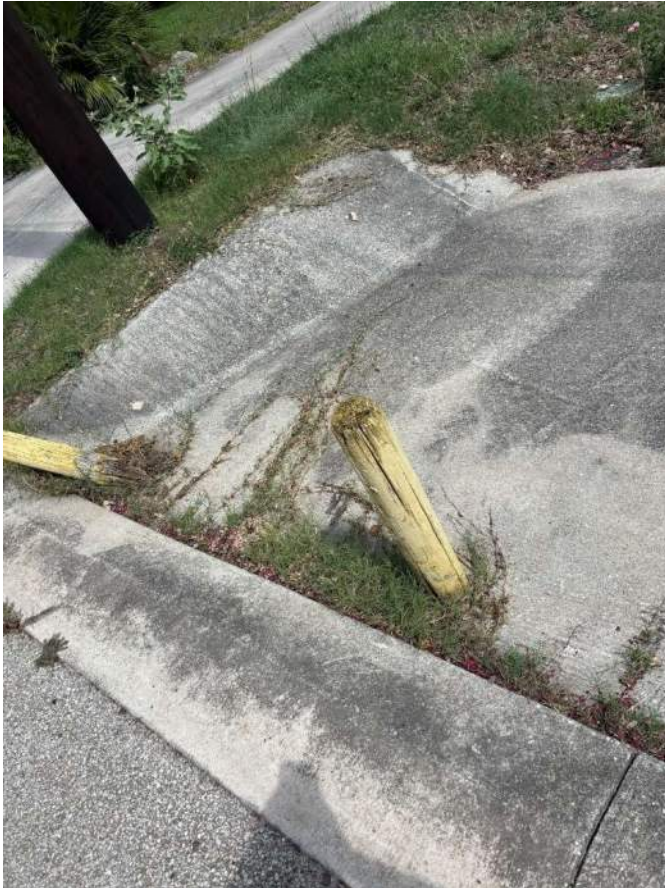
Grand Oak Outfall

Field Notes: Mild vegetation overgrowth; trim.

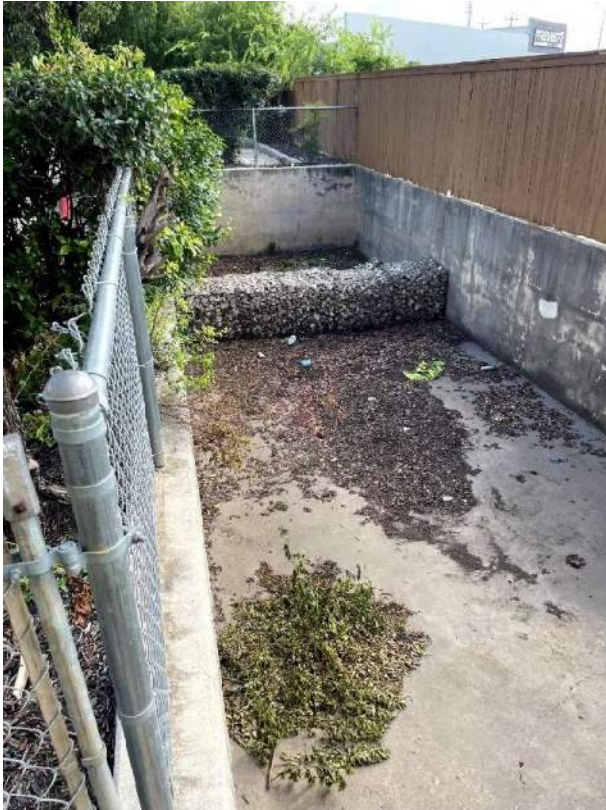
Field Notes: Clear trash out and lock gate, looks good otherwise

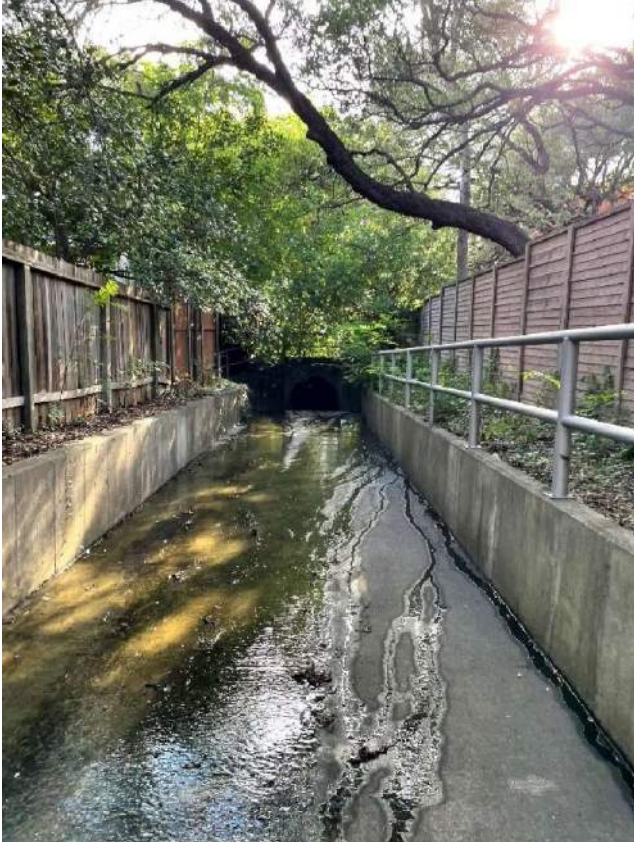
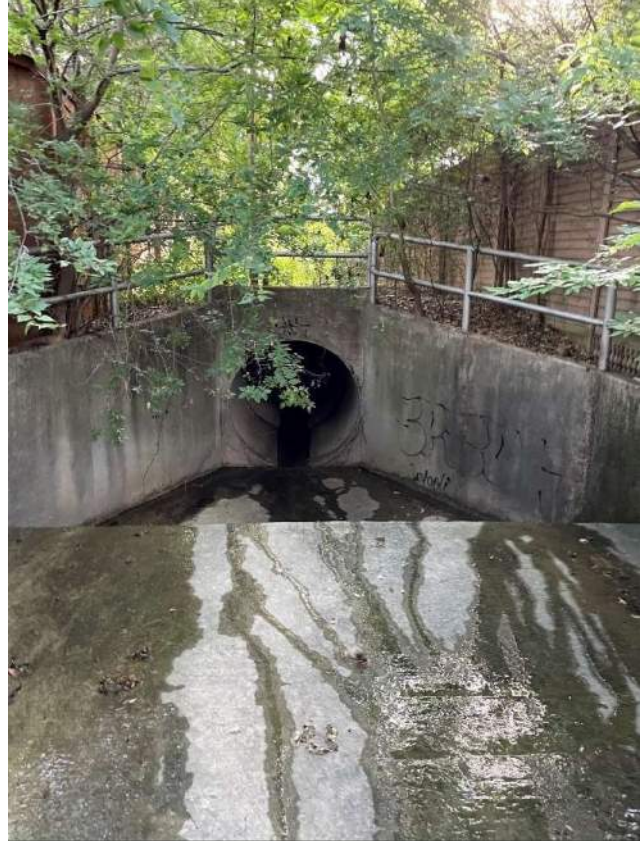
Large Channel Drain Inlet

Field Notes: Looks good, adjacent BMP draining clear water

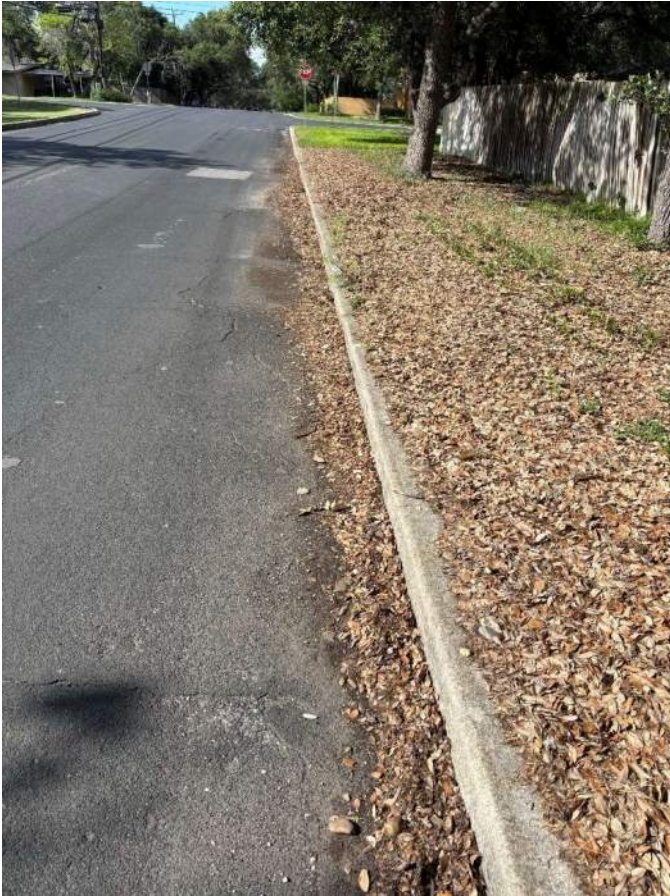
Leaves in Road

Field Notes: Remove the leaves piled up in the roadway towards the curb.
