TOWN OF HOLLYWOOD PARK, TX

2025 Summer Inspection

HOLLYWOOD PARK 2025 SUMMER INSPECTION REPORT

Subject: Annual Municipal Separate Storm Sewer System (MS4) Inspection

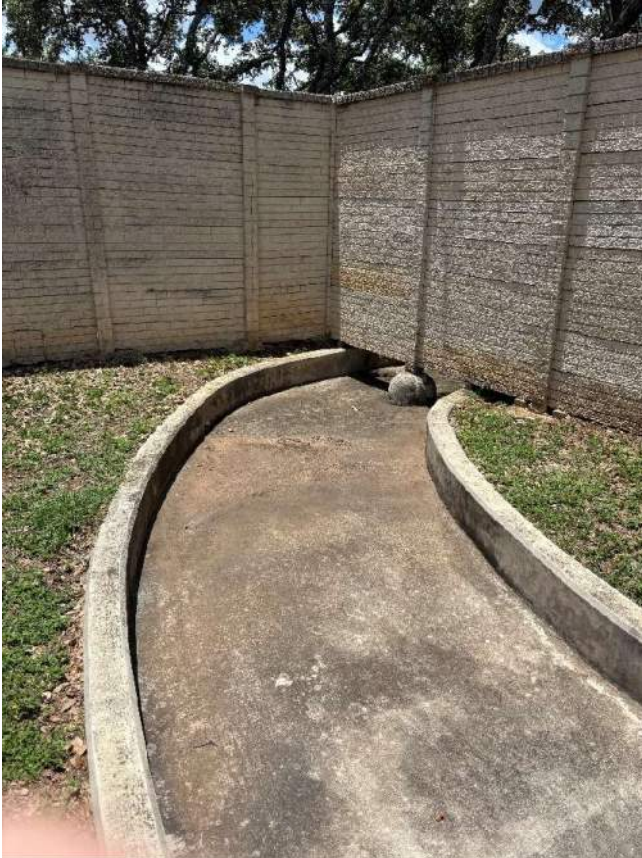
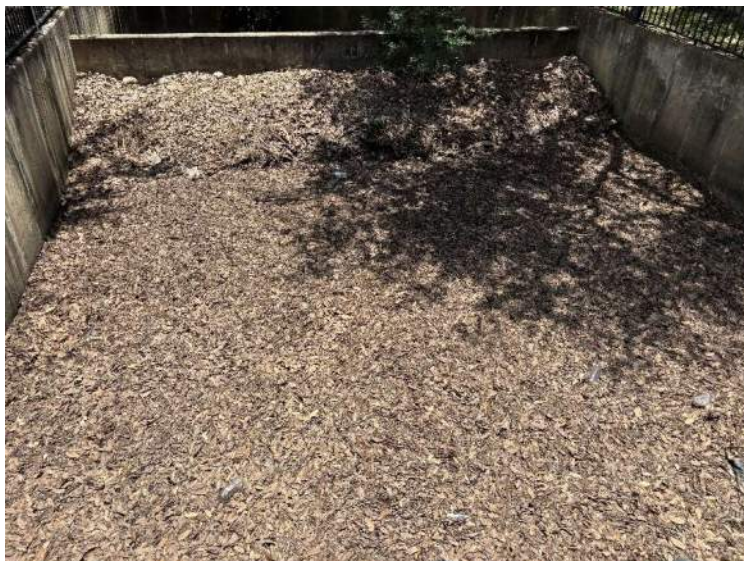
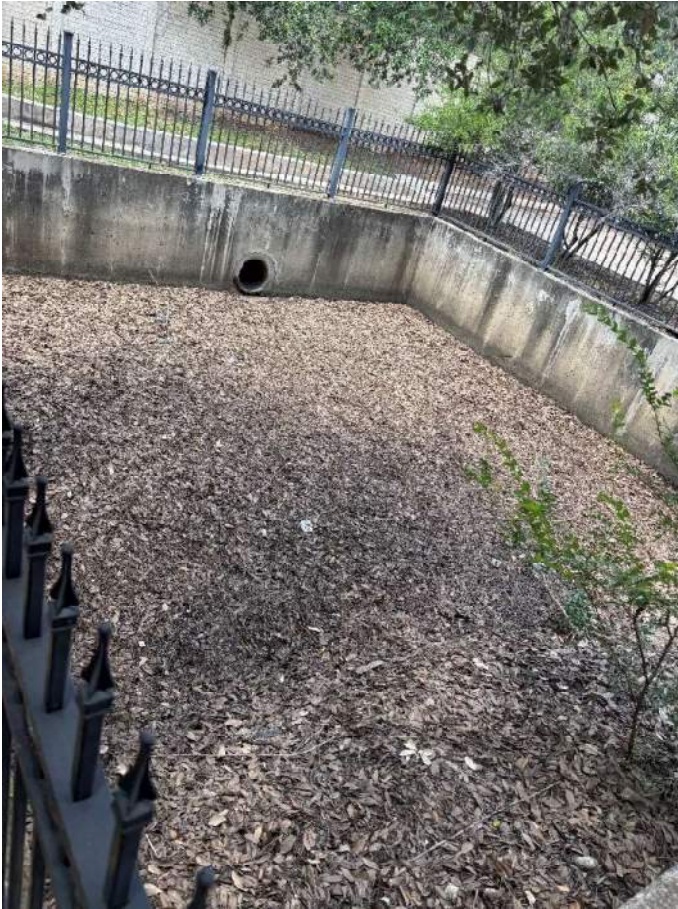
Marriott Global Reservation PCD

Field Notes: Remove leaves from basin.

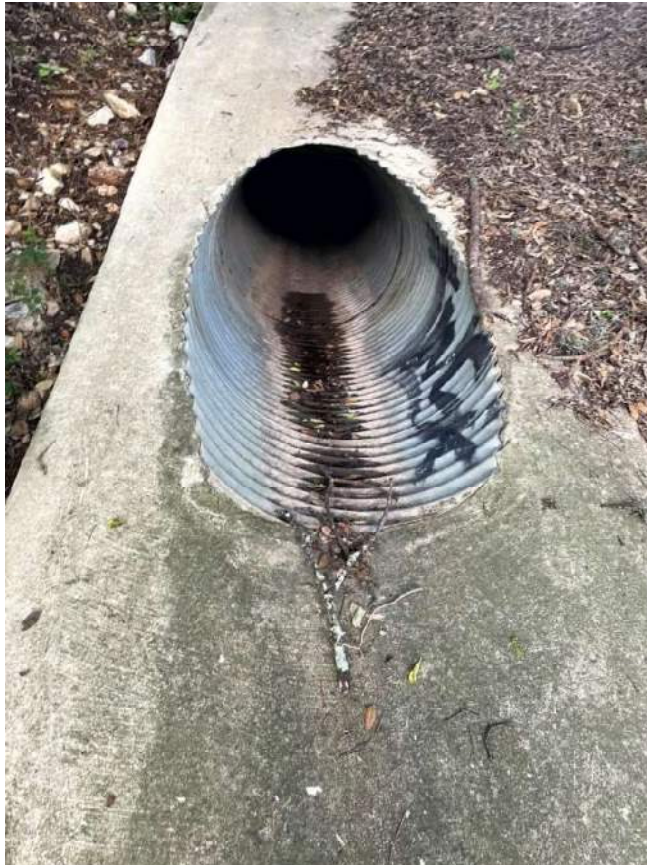
Mecca Inlets Outfall

Field Notes: Looks good.

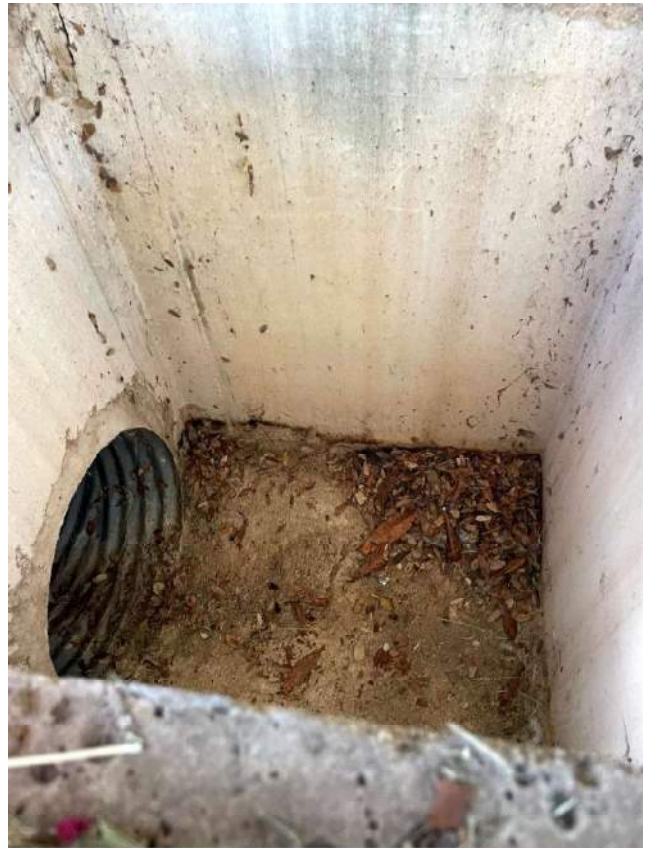
Field Notes: Looks good.

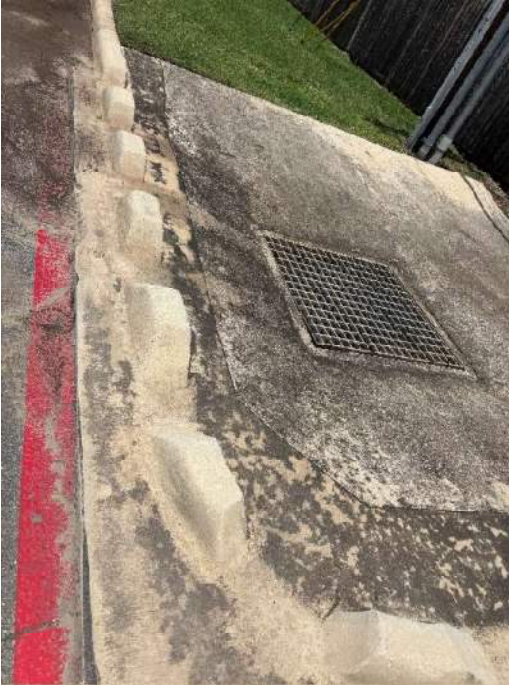
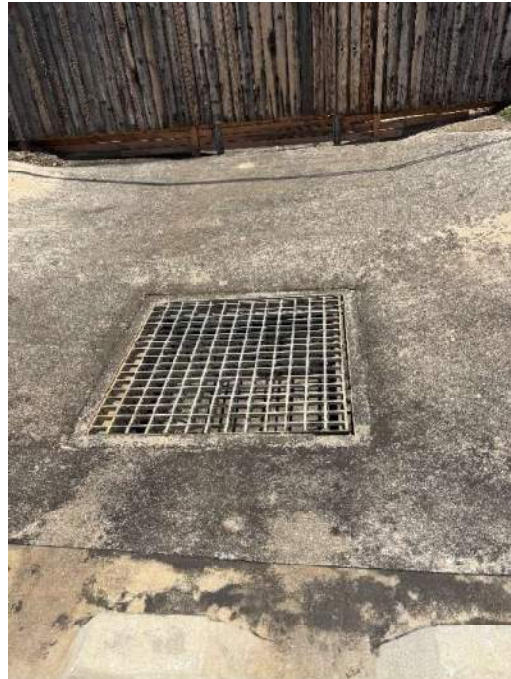
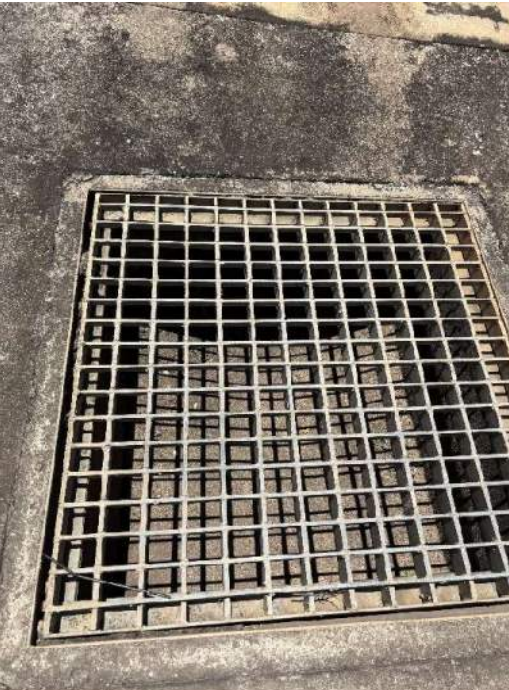
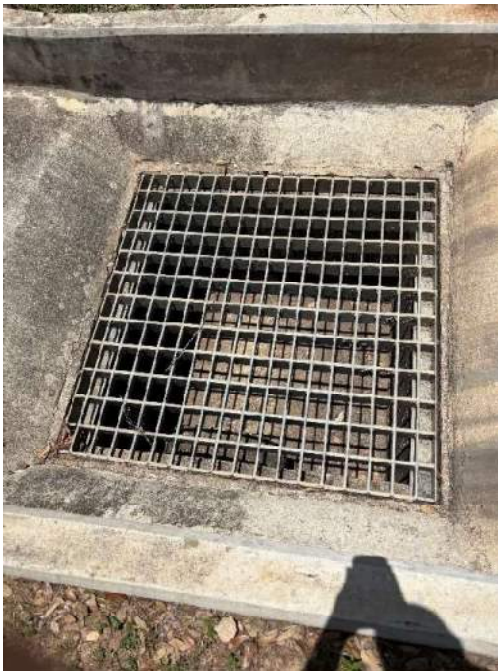
Midas Inlet in Rear

Field Notes: Looks good.

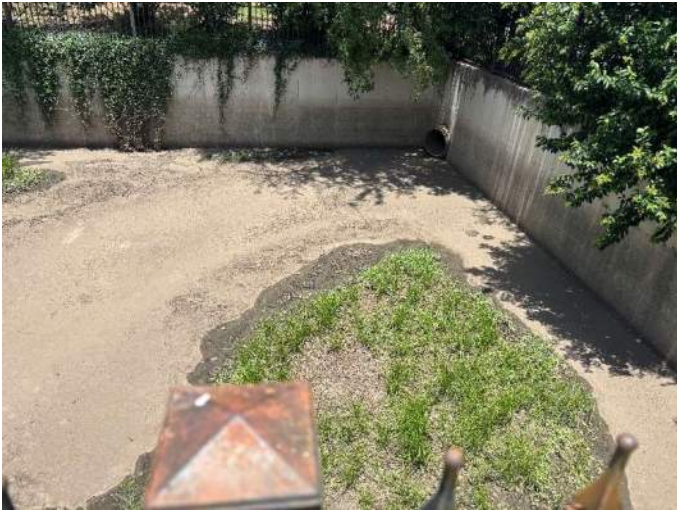
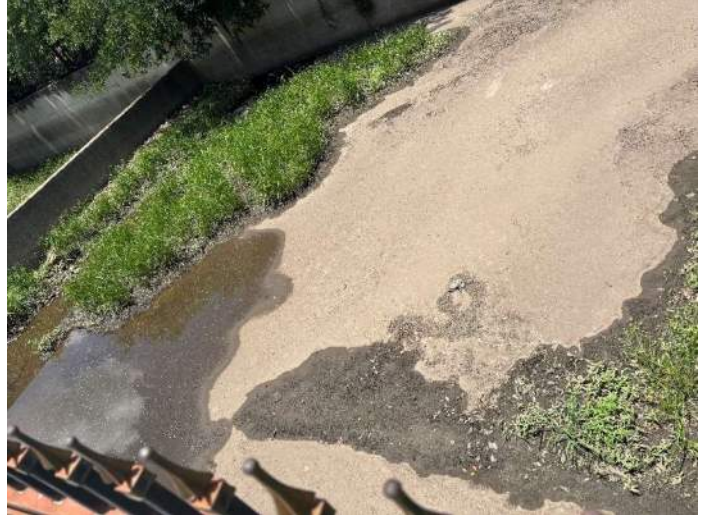
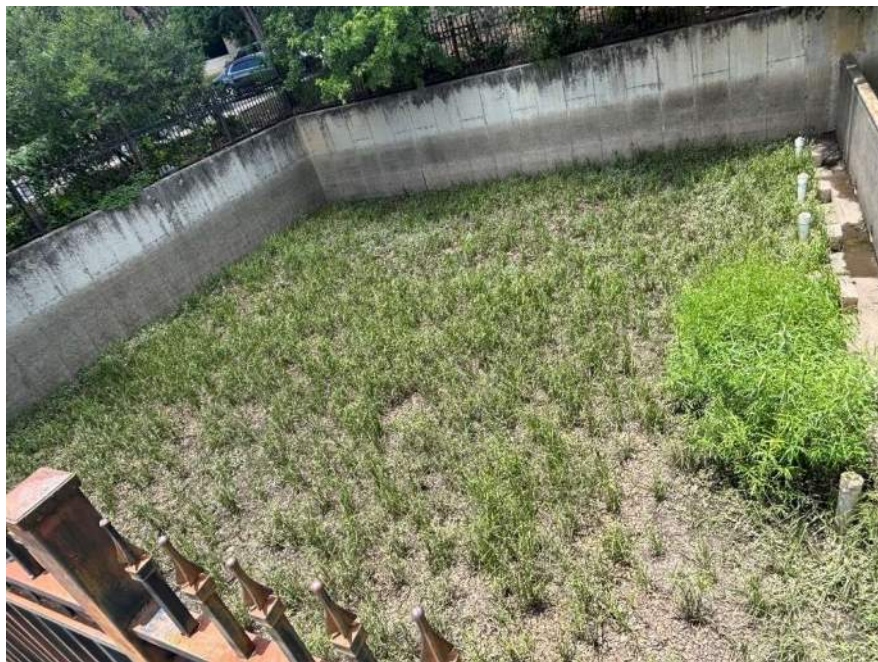
Field Notes: Remove vegetation and mud from basin.

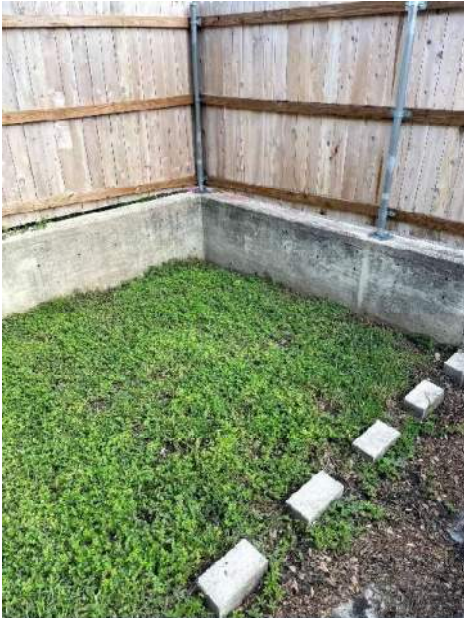
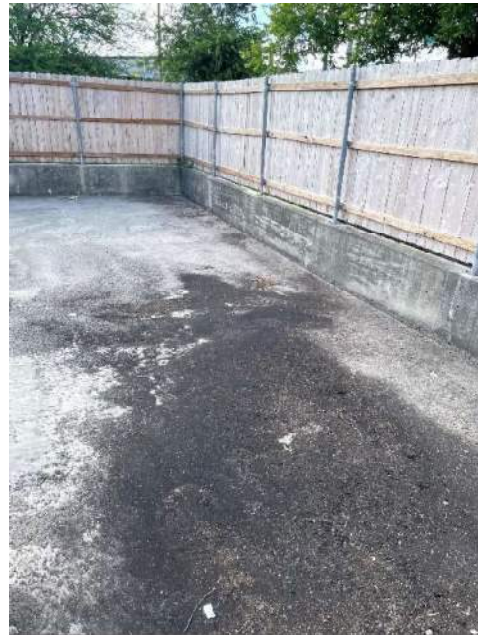
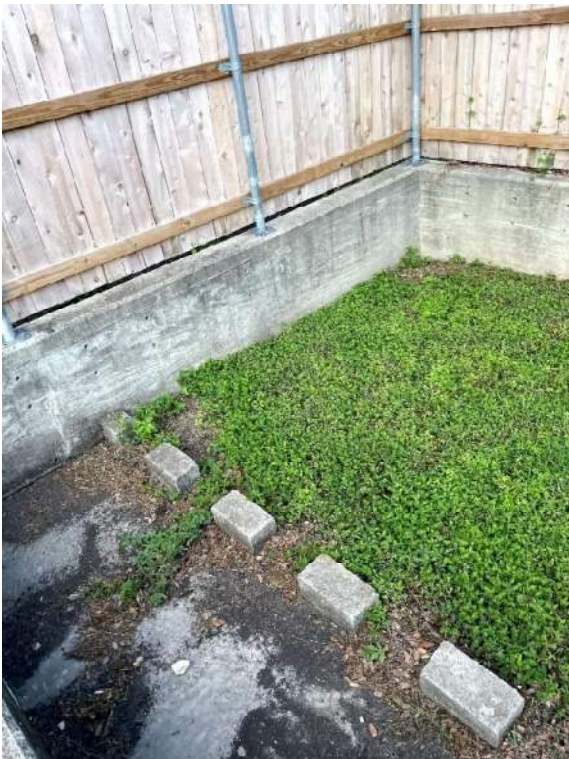
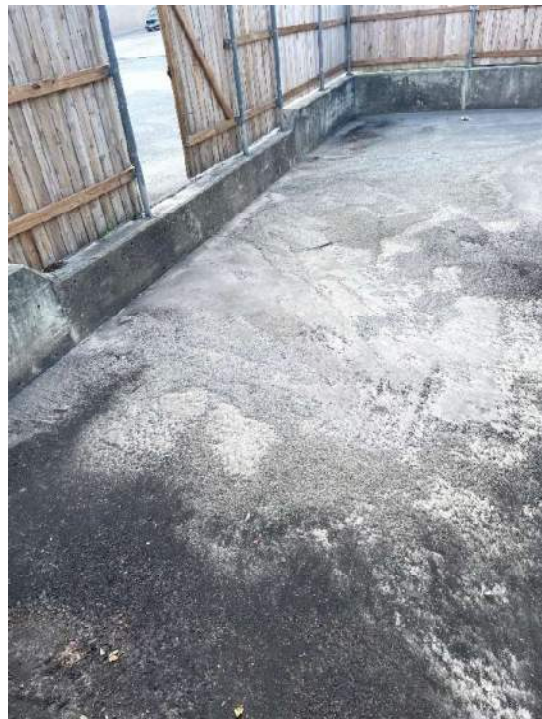
Monarch Trophy PCD

Field Notes: Remove sediment.

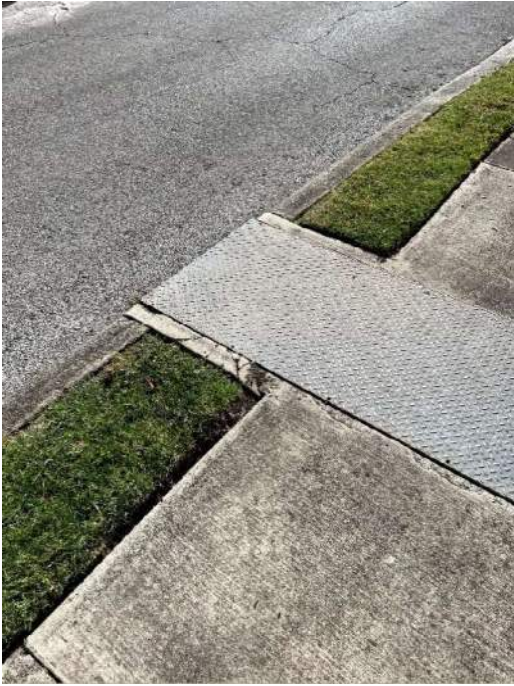
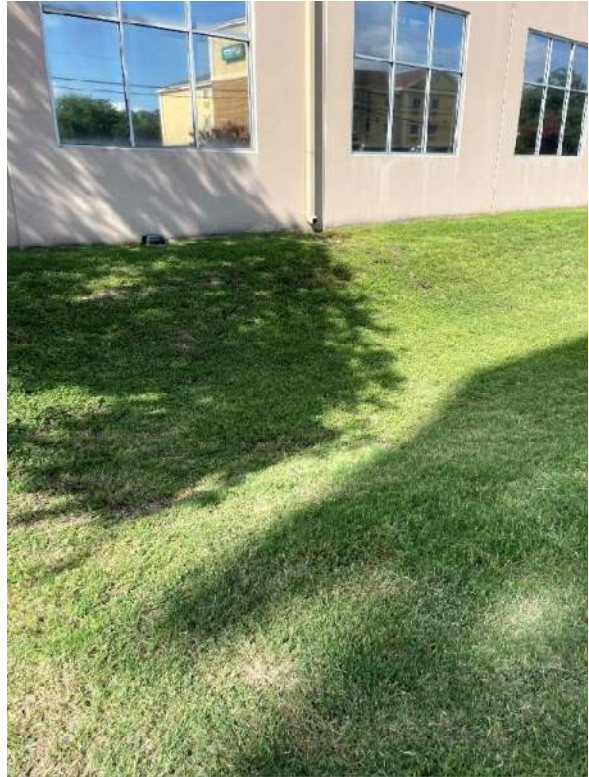
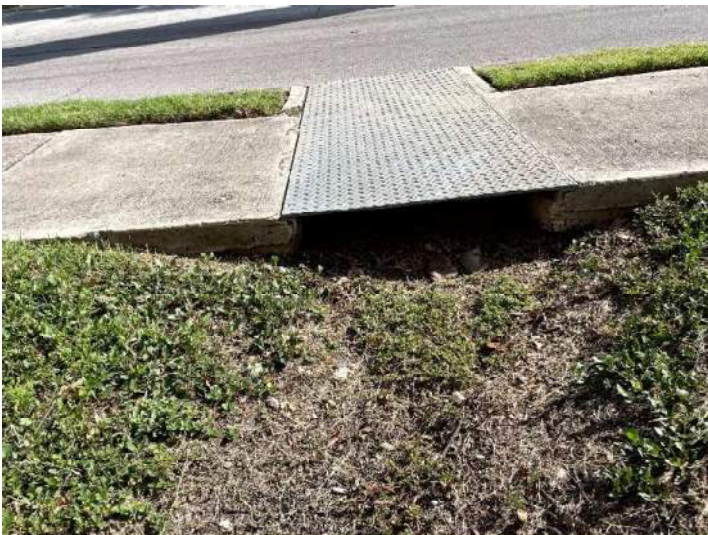
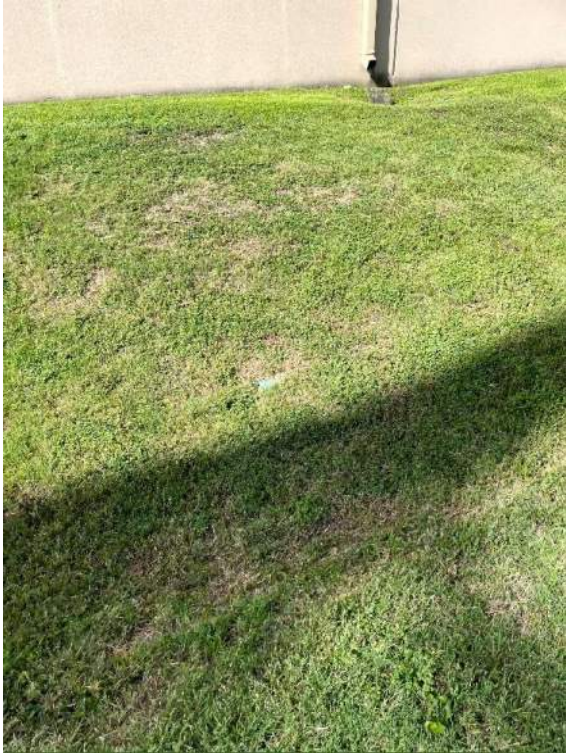
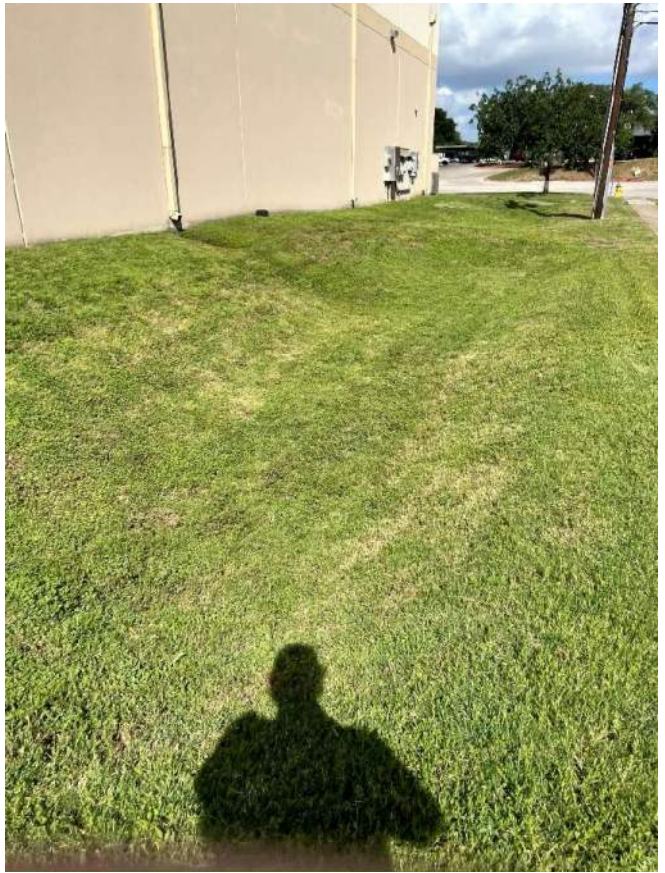
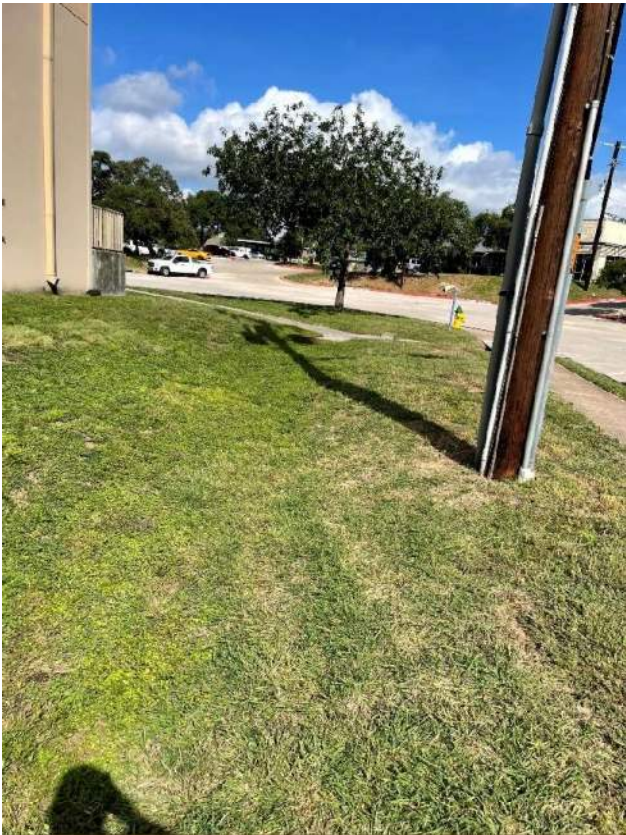
Monarch Trophy Swale

Field Notes: Looks good.

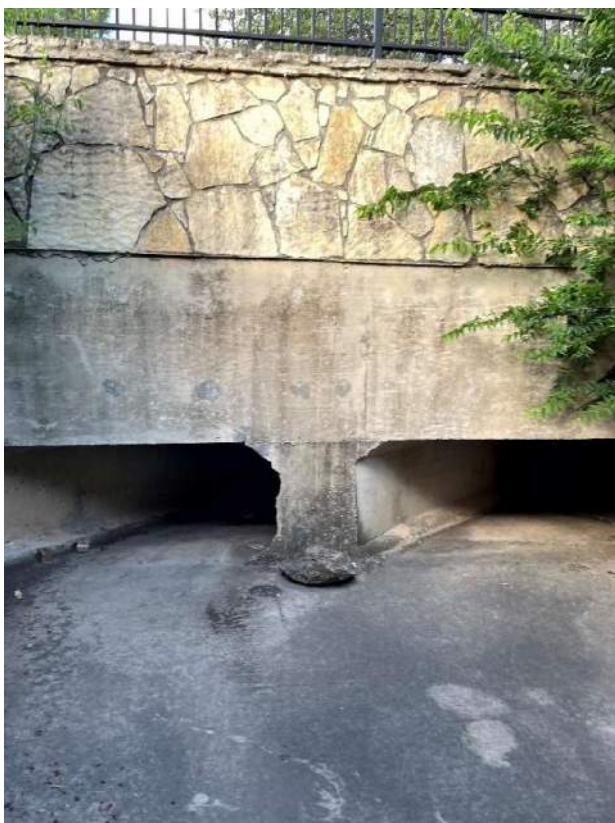
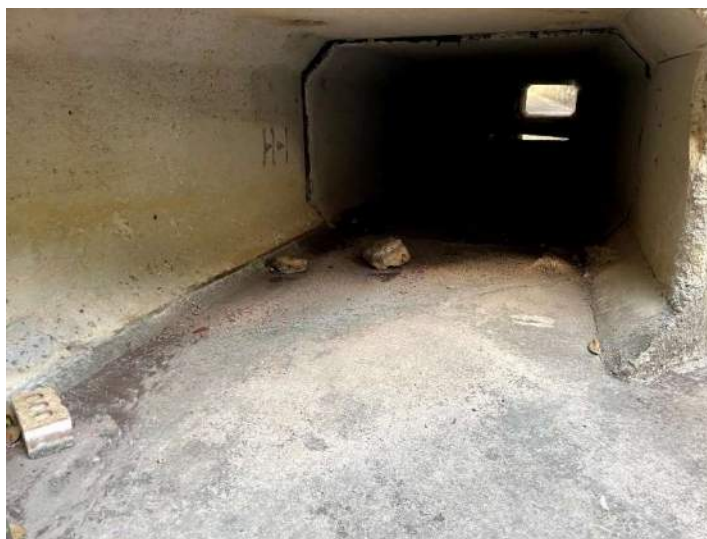
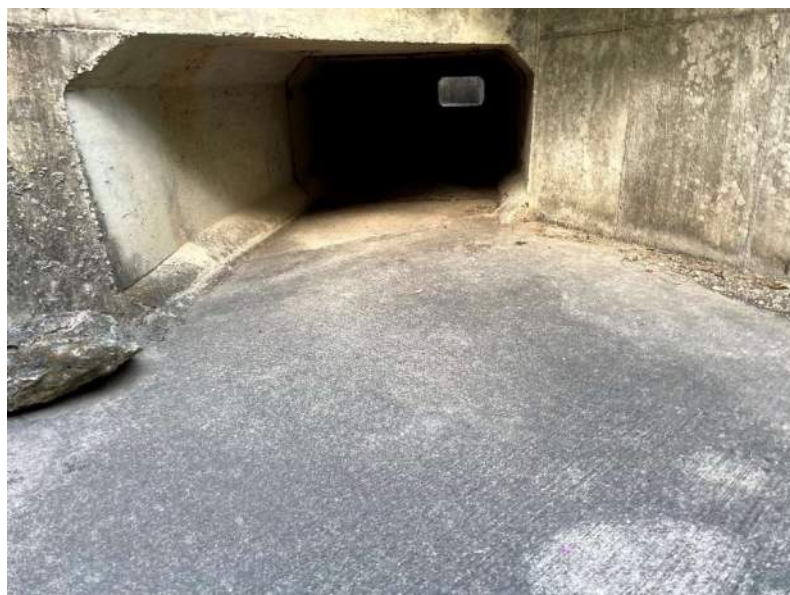
Field Notes: Looks good, monitor spalling.

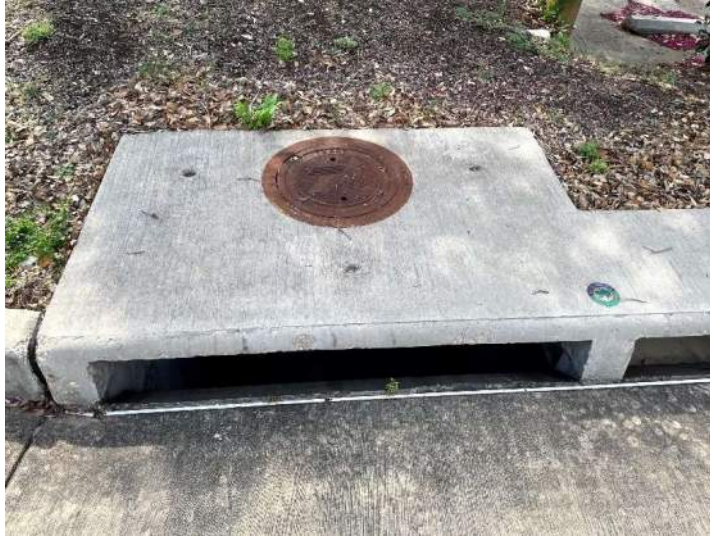
New Drash Parking Lot Inlet

Field Notes: Looks good.

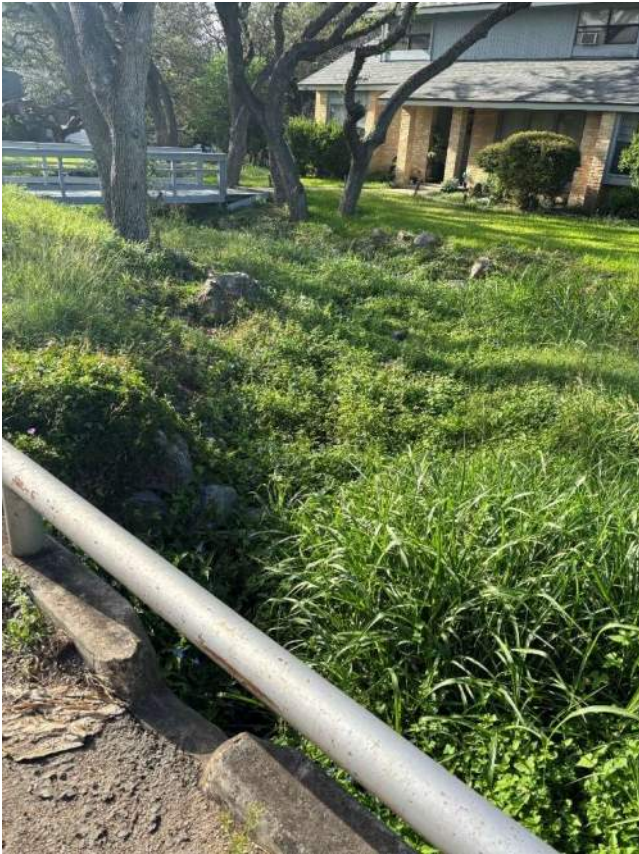
North Oak Crossing

Field Notes: Trim vegetation in channel.

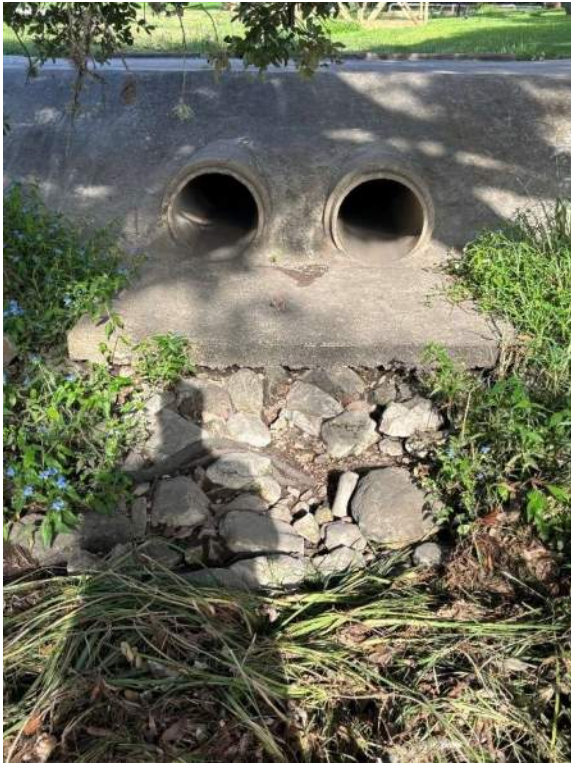
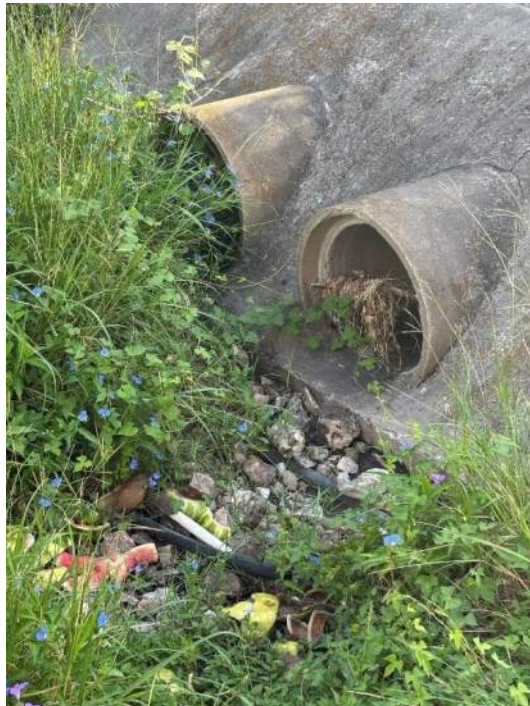
North Oak Private Crossing West

Field Notes: Trim vegetation and remove trash from west side of pipe.

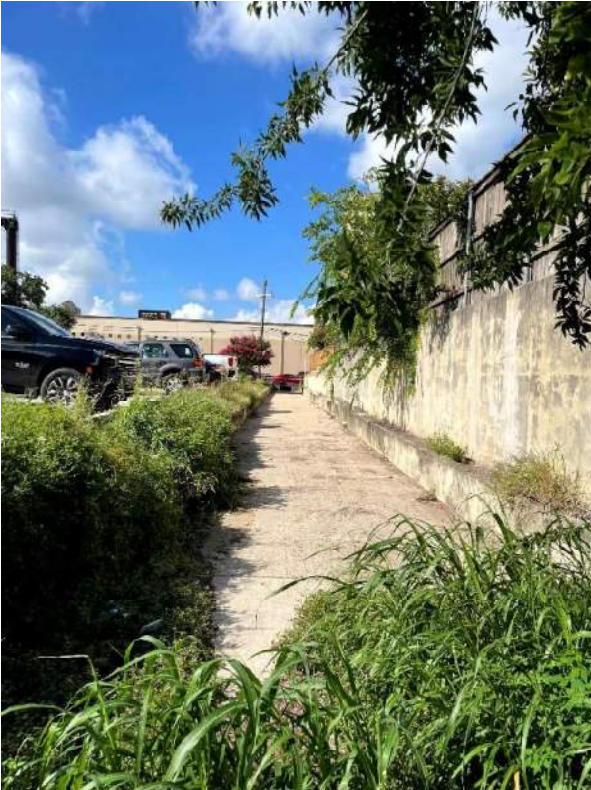
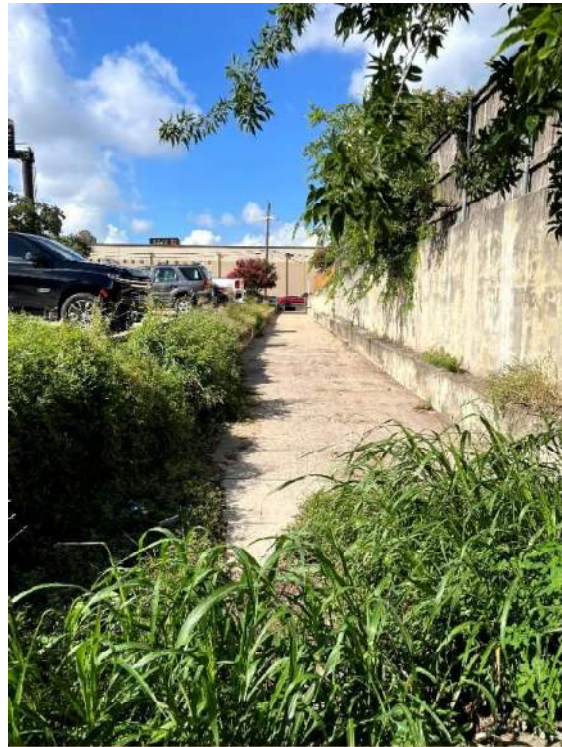
Oak Creek Circle Channel

Field Notes: Looks good, monitor vegetation.

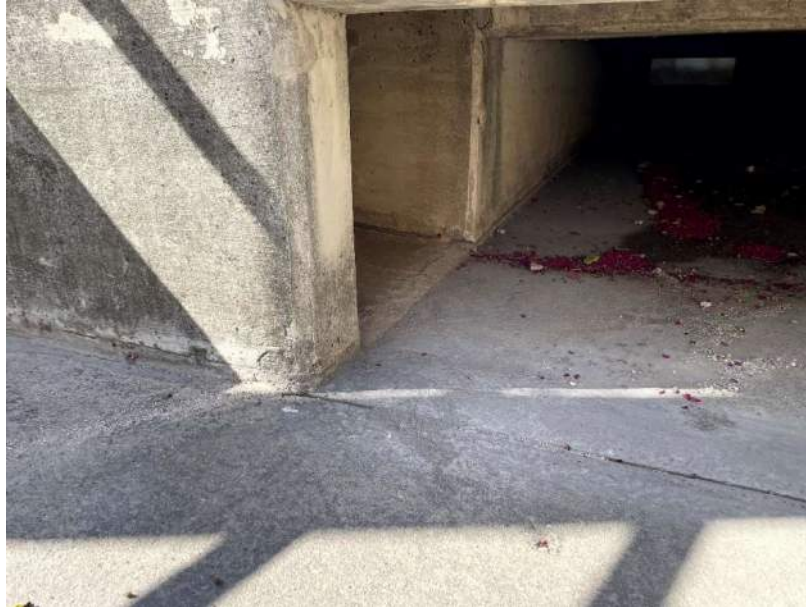
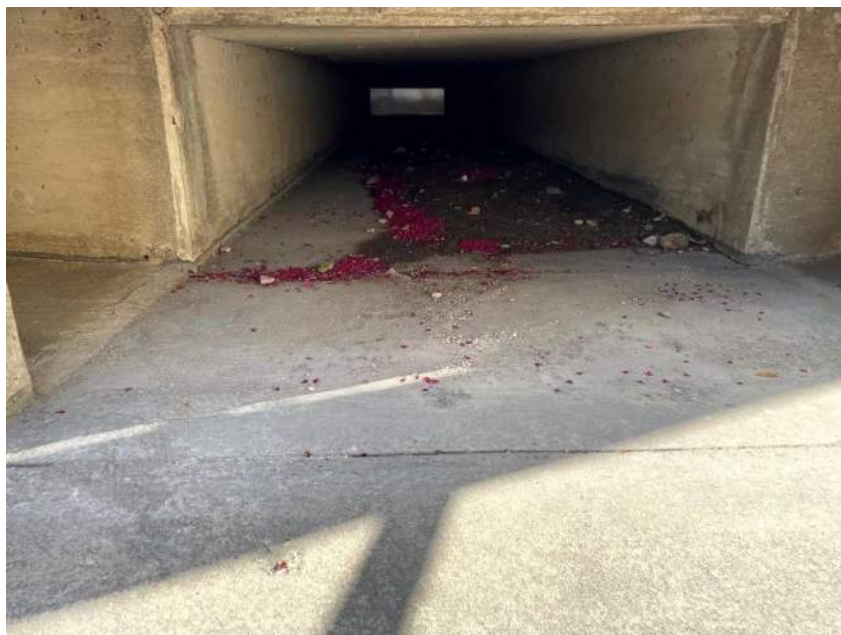
Oak Creek Circle Storm Sewer Pipe

Field Notes: Looks good.

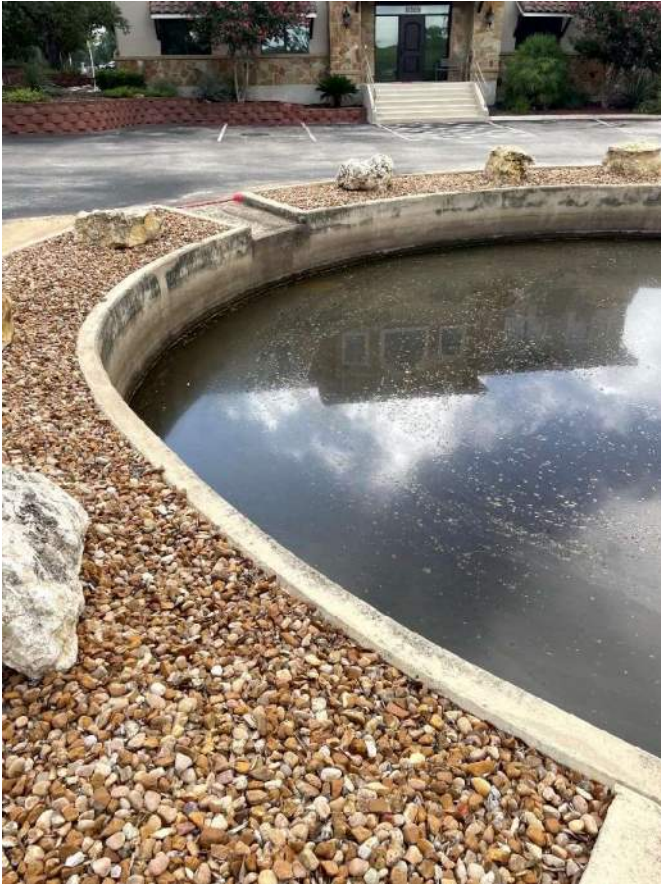
Optometrist Roundabout PCD

Field Notes: Looks good, may need to monitor sediment buildup.
Nearby rain gauge shows 0.5" precipitation

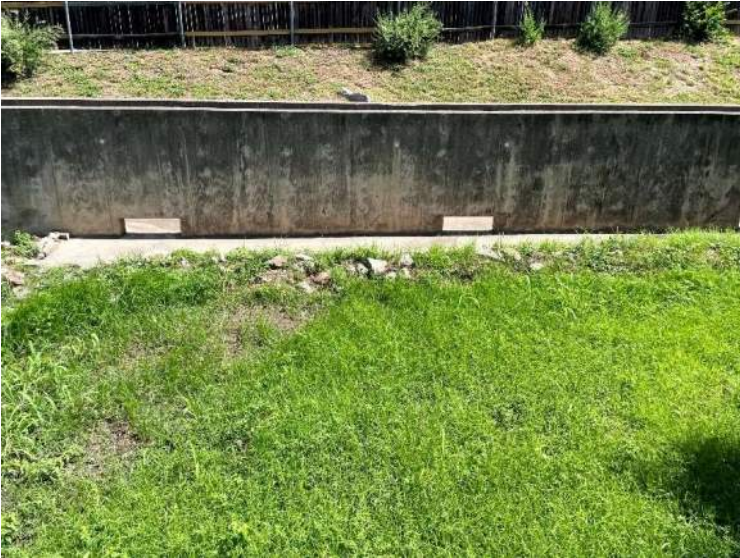
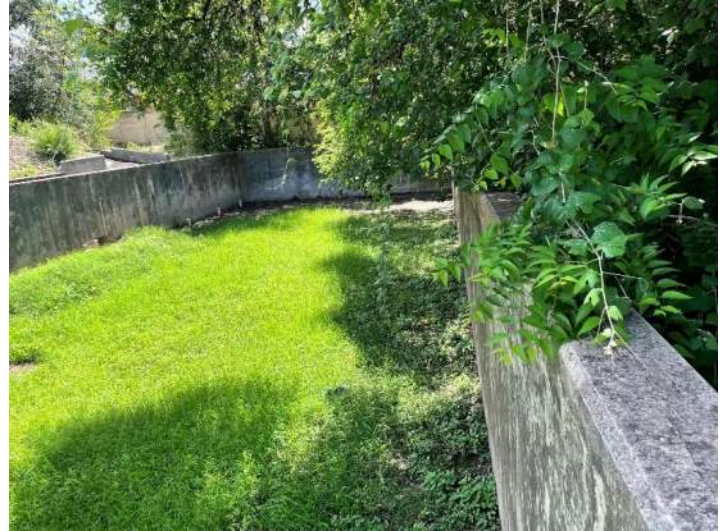
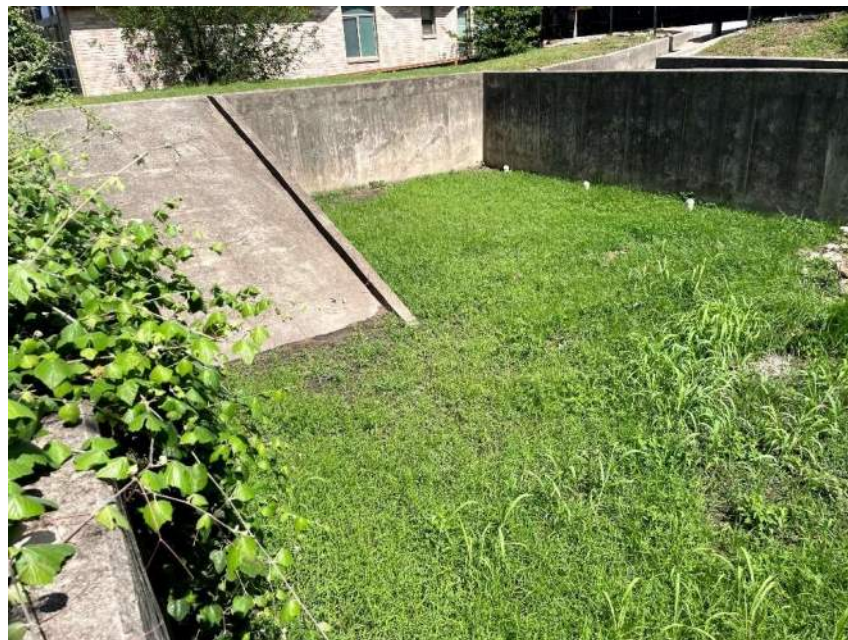
Pantheon Commercial Strip PCD

Field Notes: Looks good.

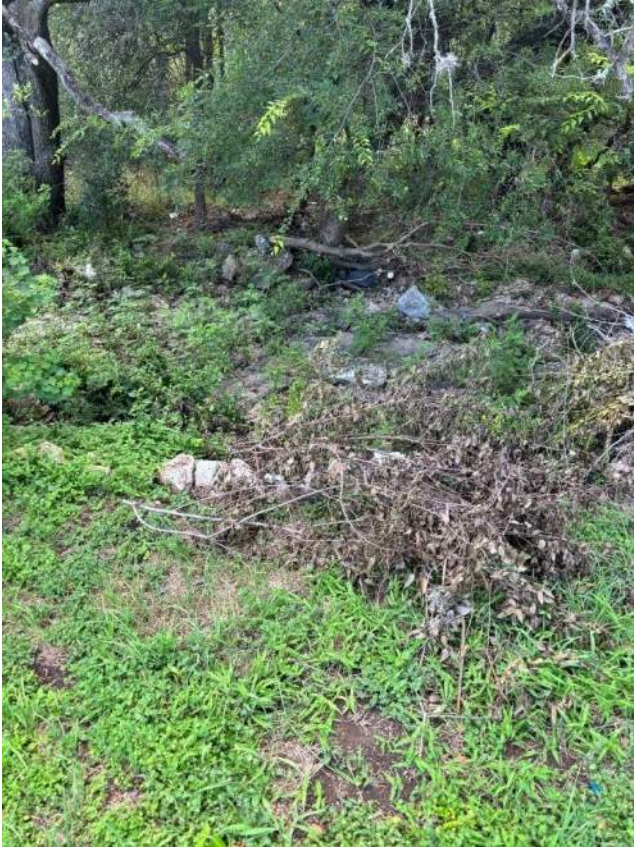
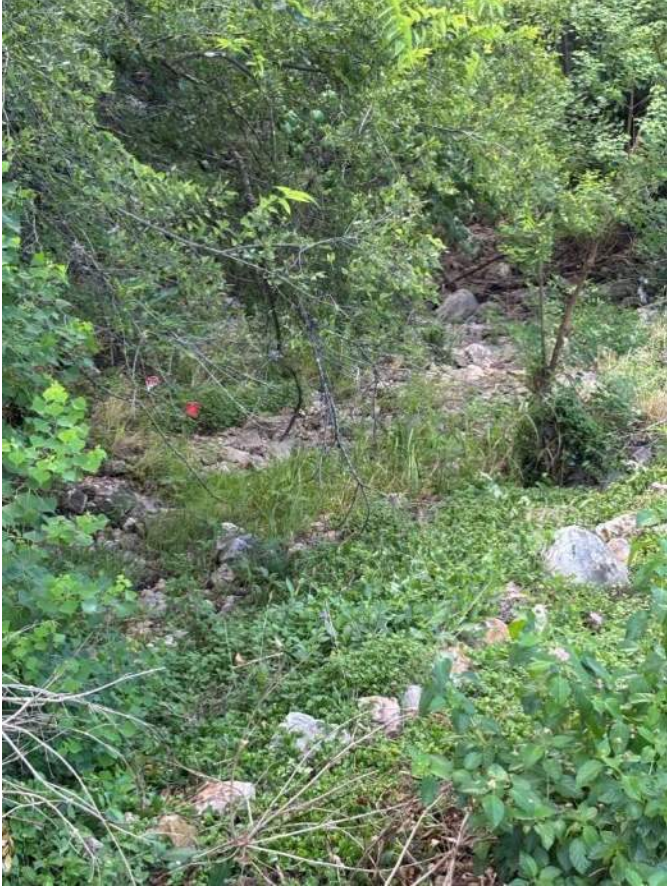
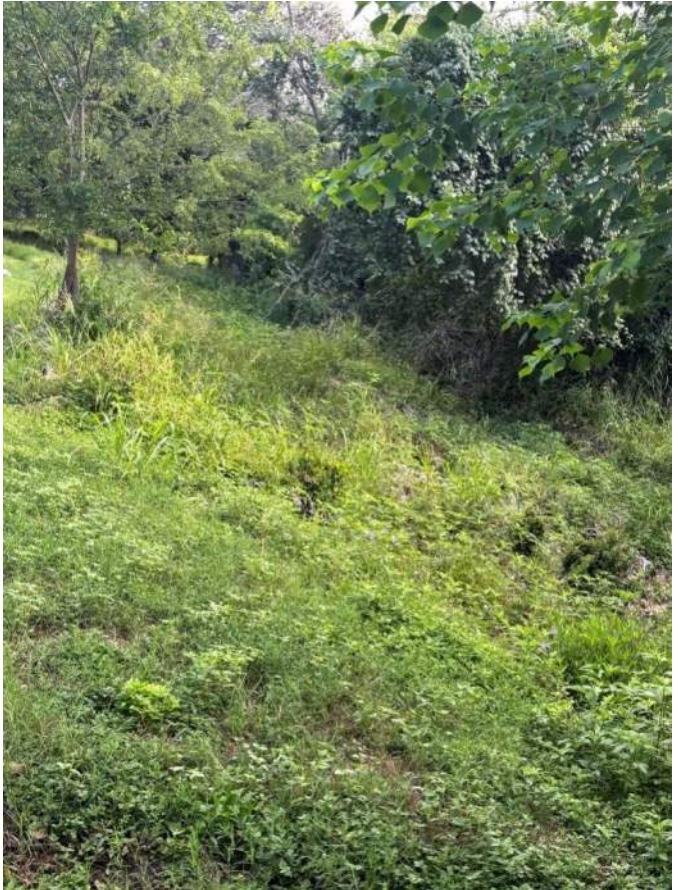
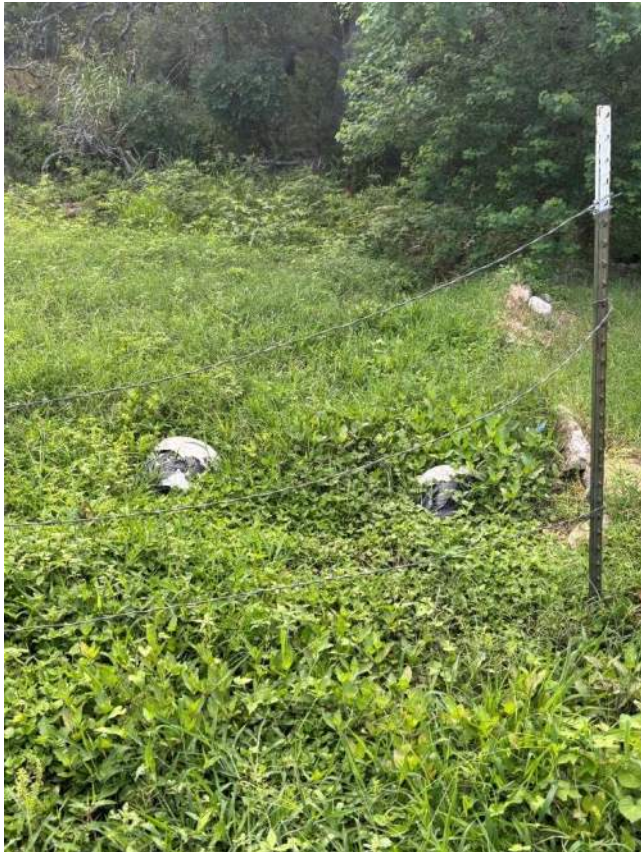
Park Oak Outfall

Field Notes: Lots of vegetation overgrowth and tree debris in channel.
Remove vegetation and debris.

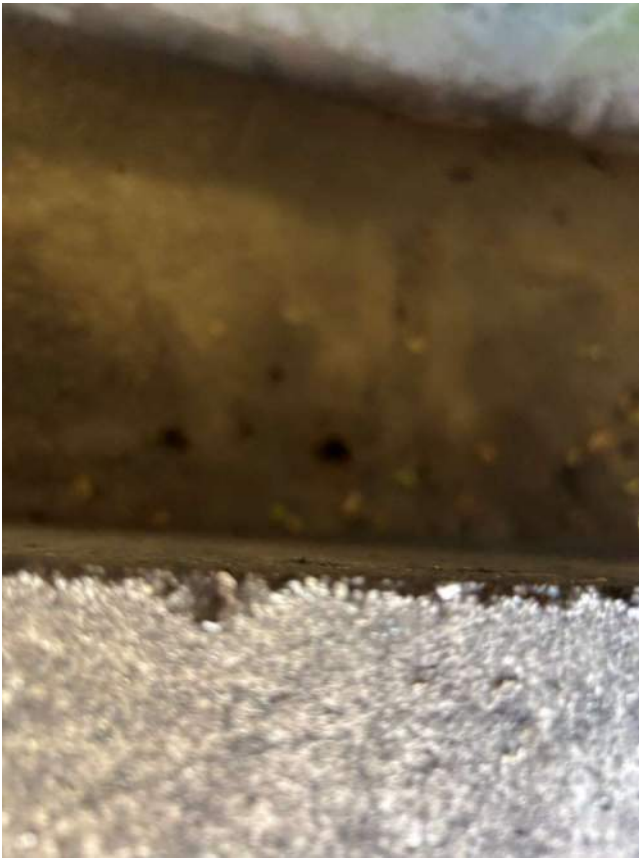
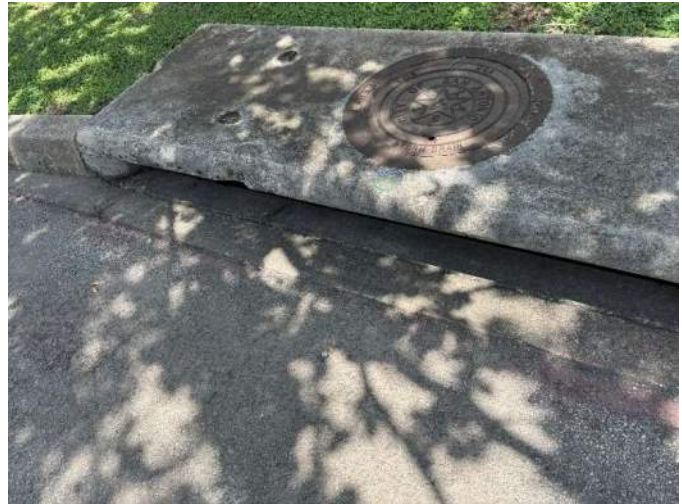
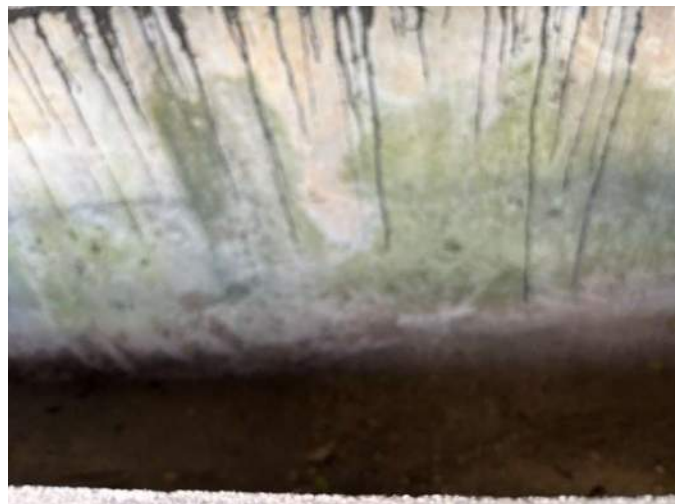
Parking Lot Box Inlet

Field Notes: Looks good.

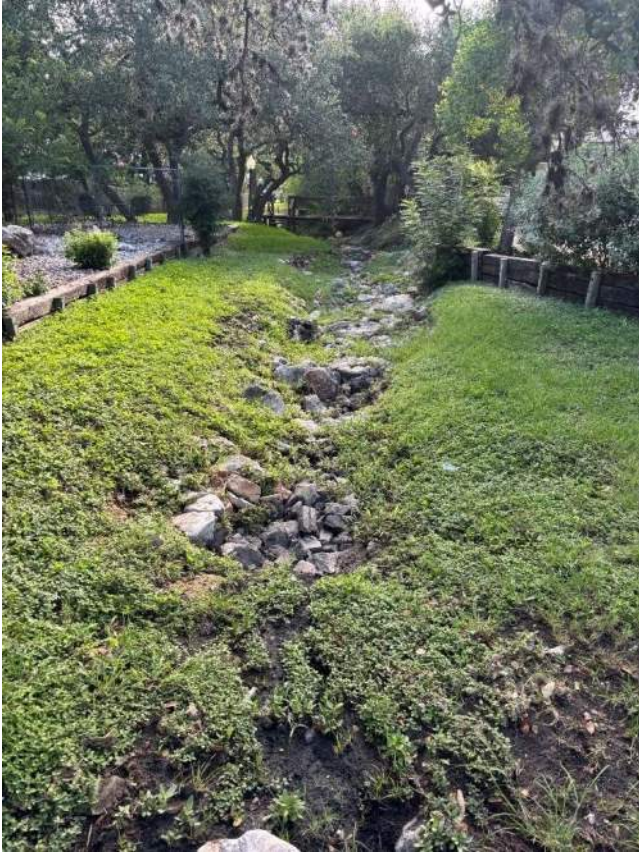
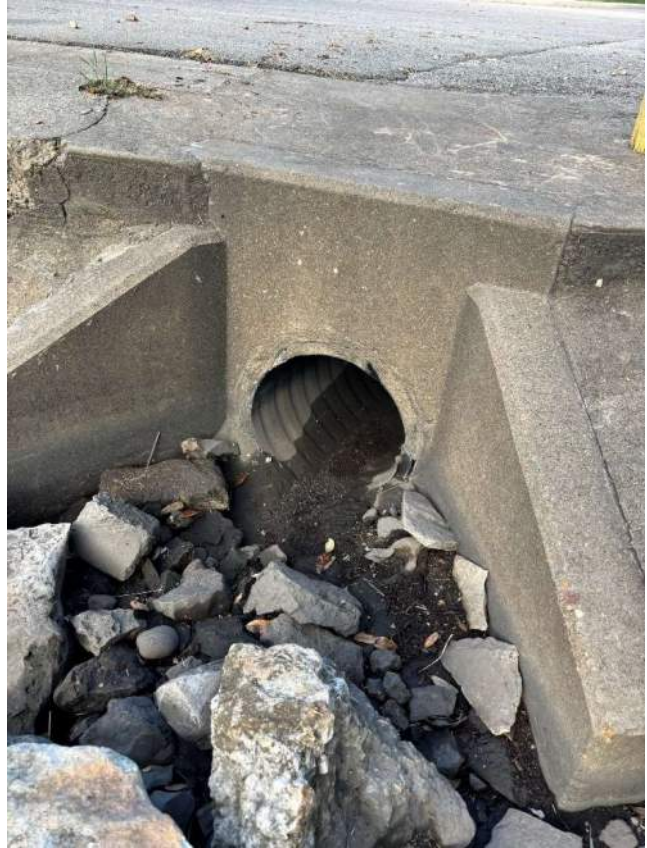
Paseo Canada Outfall 1

Field Notes: Looks good.

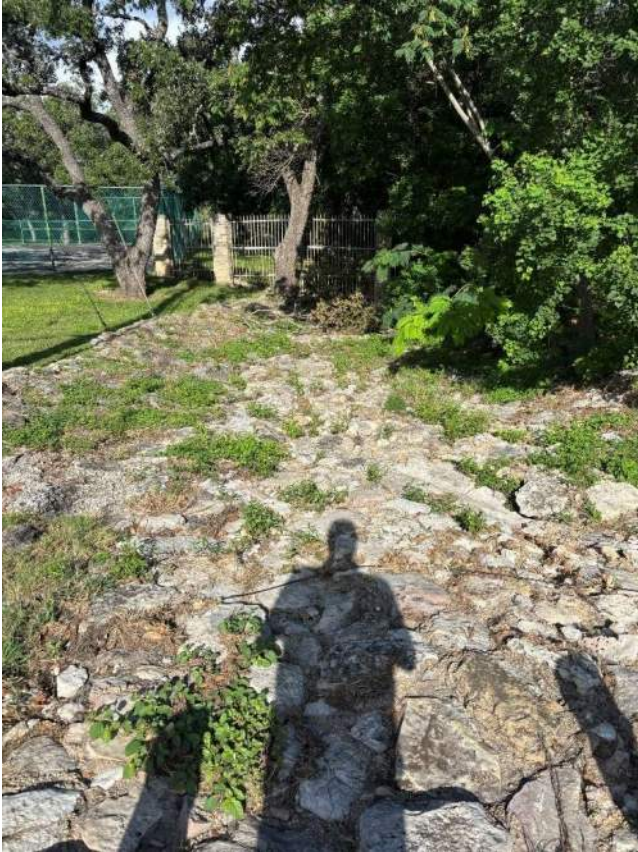
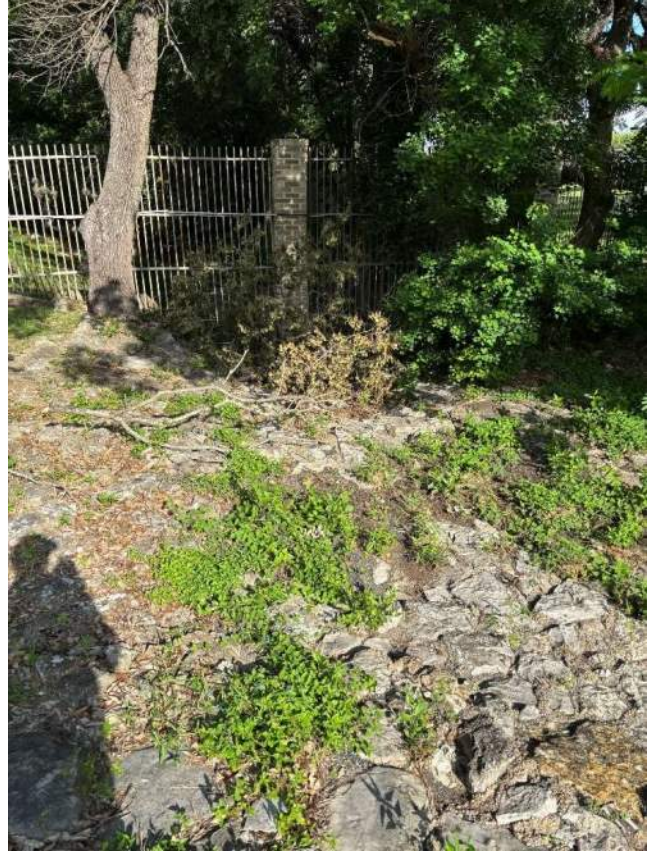
Canada Outfall 2

Field Notes: Remove tree limbs from channel.
