TOWN OF HOLLYWOOD PARK, TX

2025 Summer Inspection

HOLLYWOOD PARK 2025 SUMMER INSPECTION REPORT

Subject: Annual Municipal Separate Storm Sewer System (MS4) Inspection

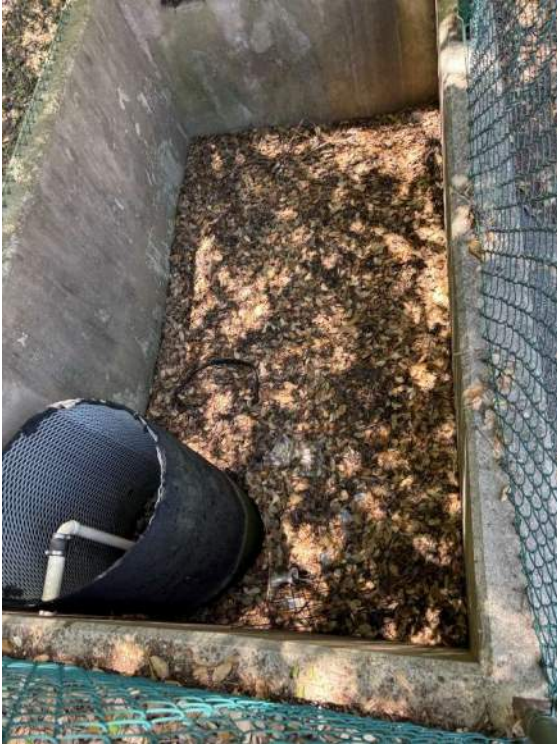
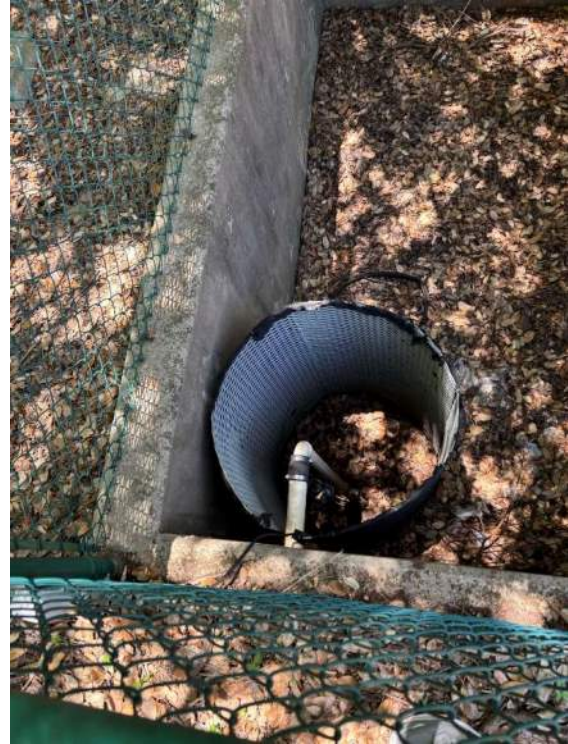
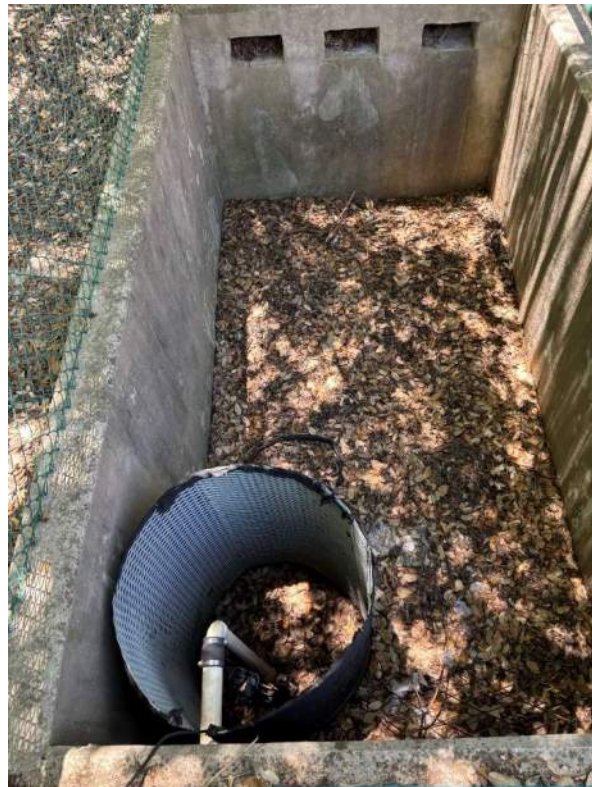
PCD2 Pediatrics

Field Notes: Remove leaves from basin.

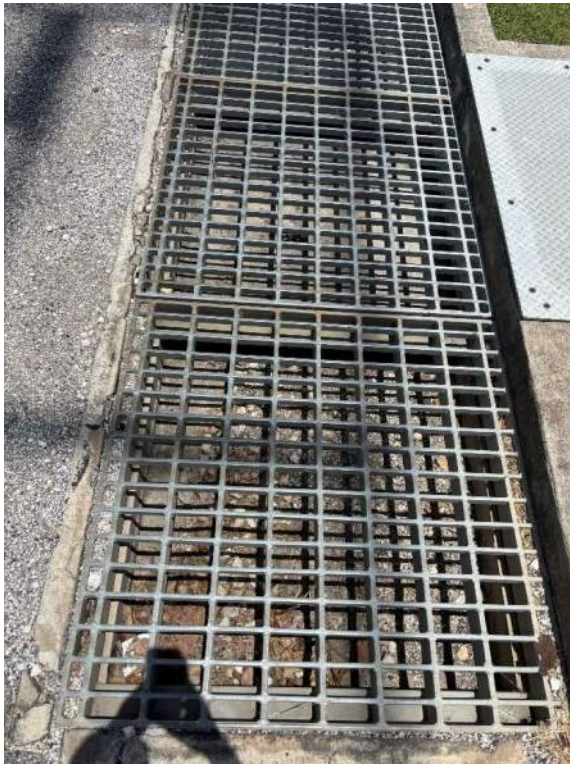
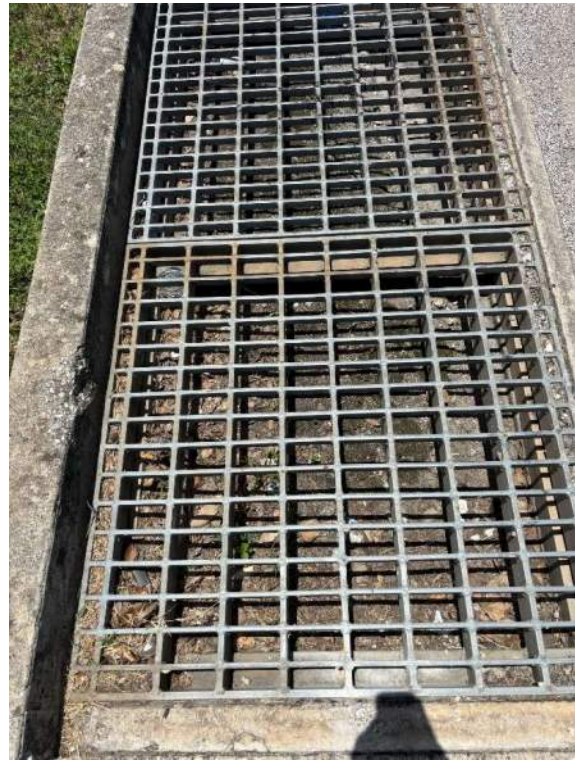
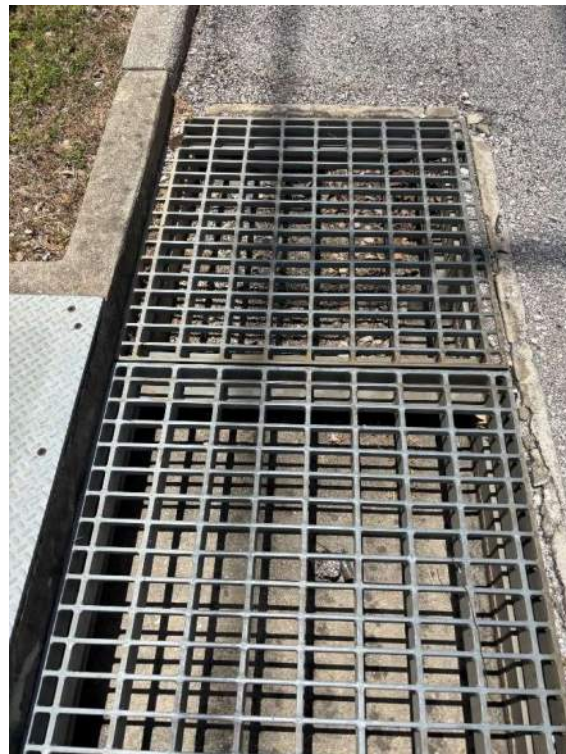
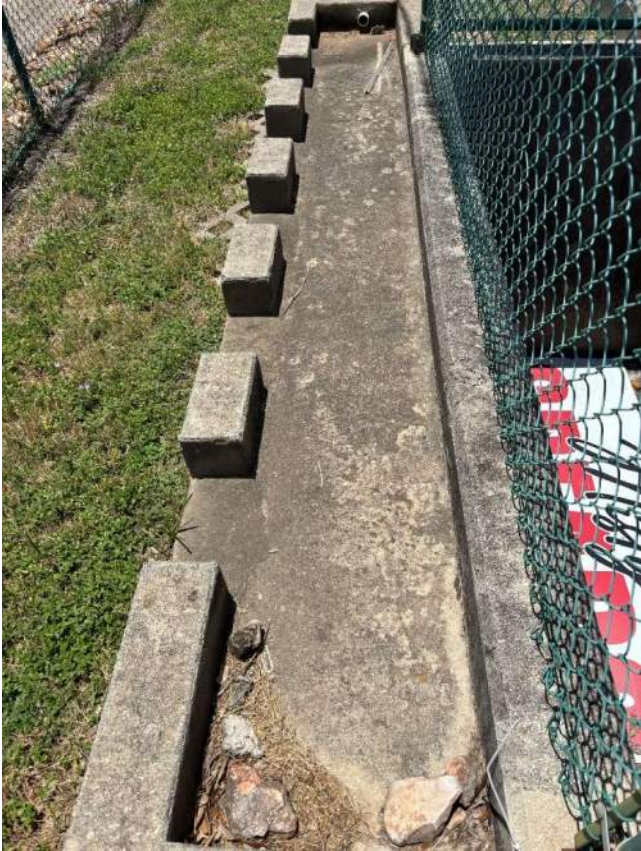
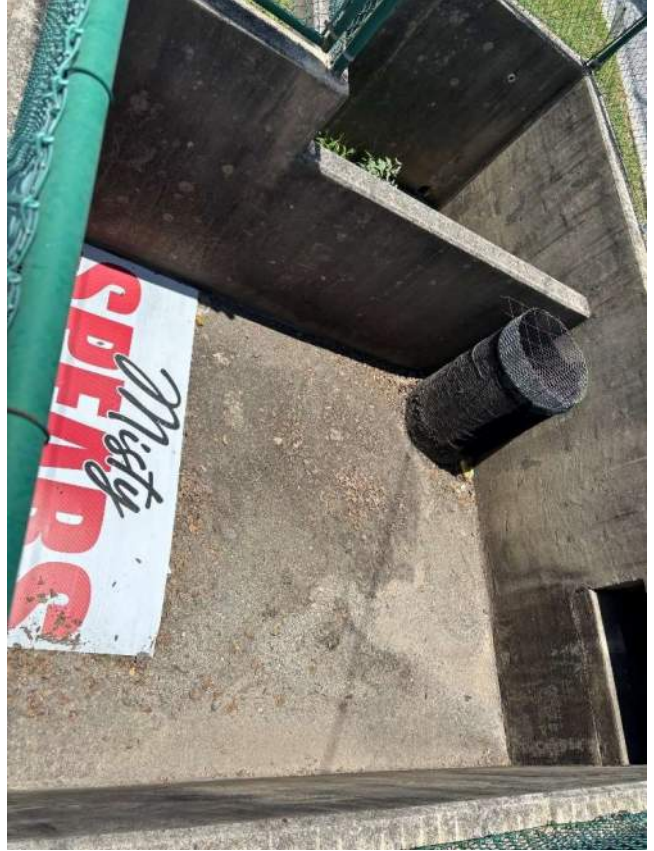
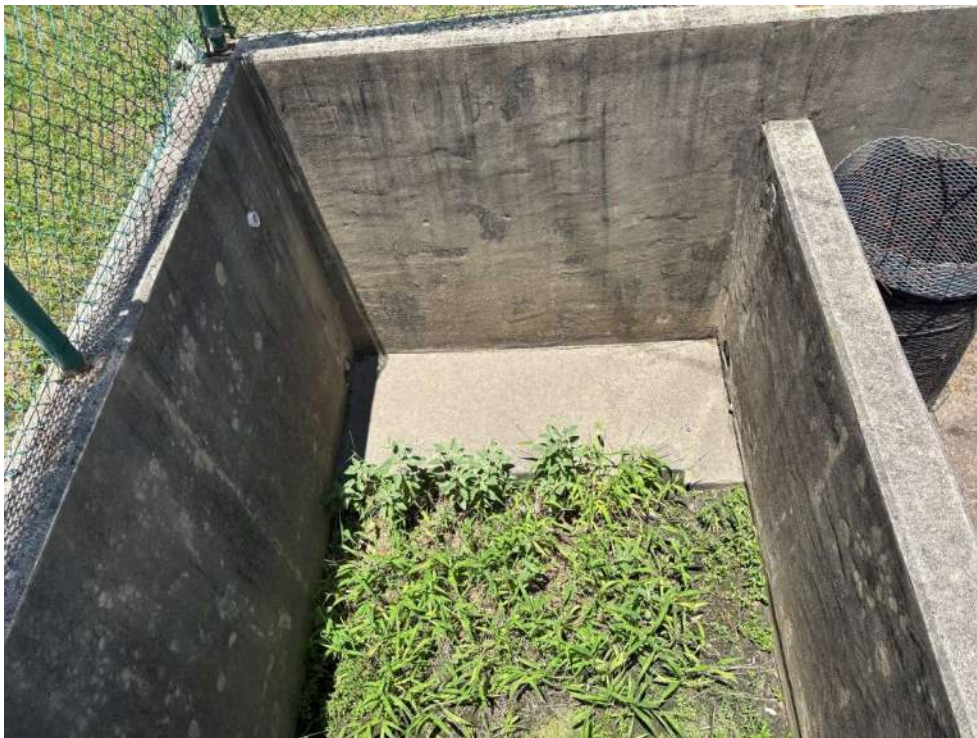
Pediatric Dentistry Office PCD

Field Notes: Remove trash and leaves from grate. Remove signage, debris, and vegetation from basin interior.

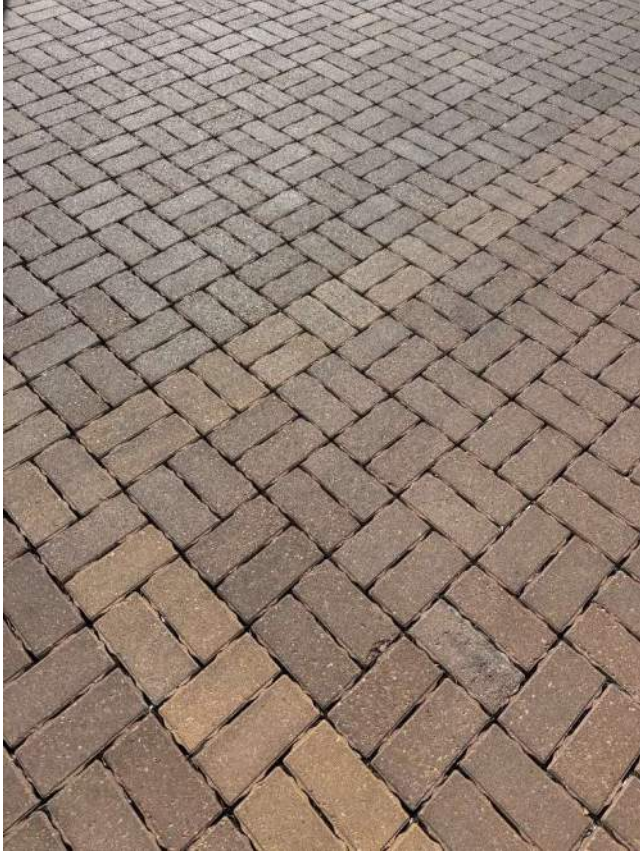
Permeable Pavers

Field Notes: Looks good.

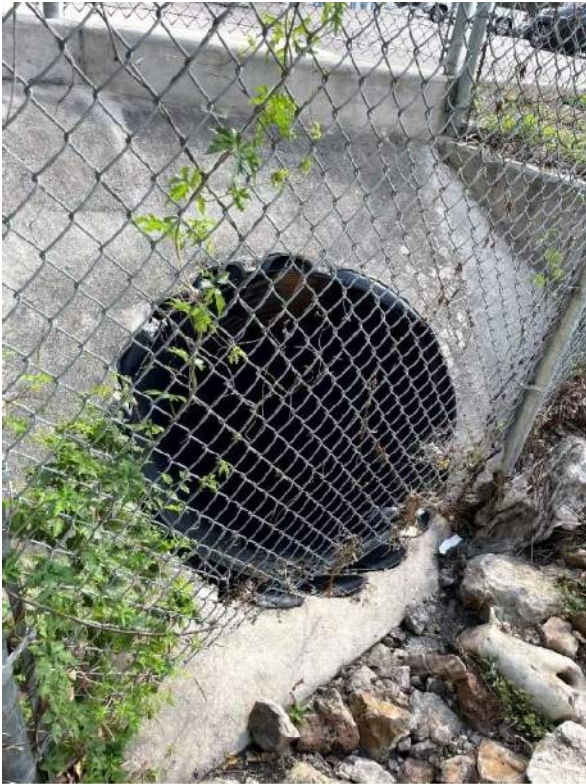
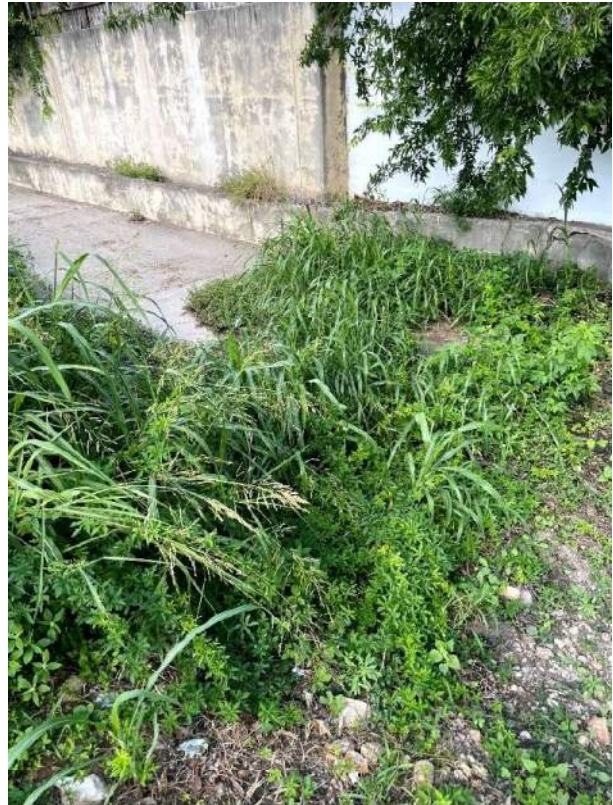
Premier 1 Auto Care Inlet

Field Notes: Looks good, slightly overgrown vegetation.

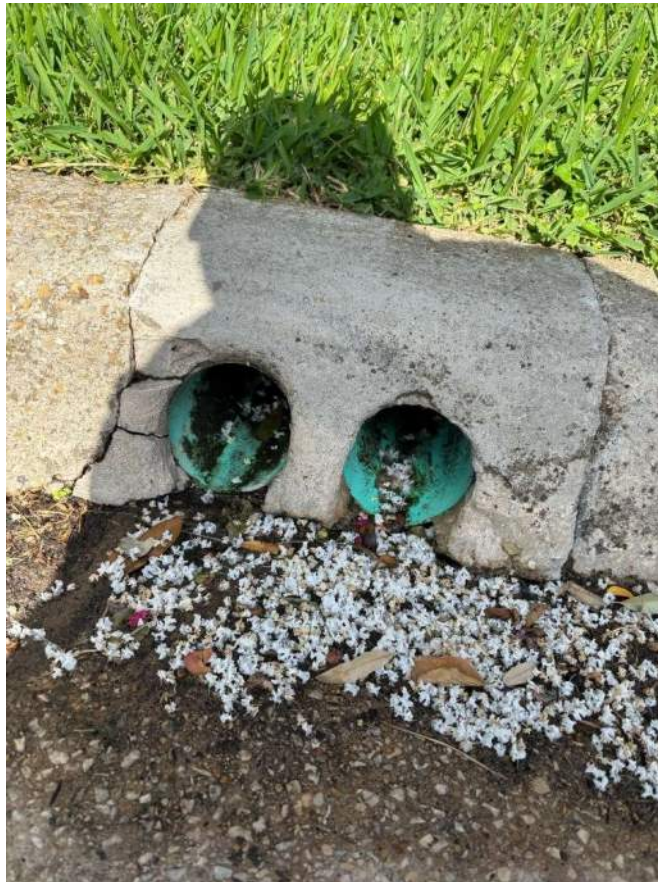
Field Notes: Looks good.

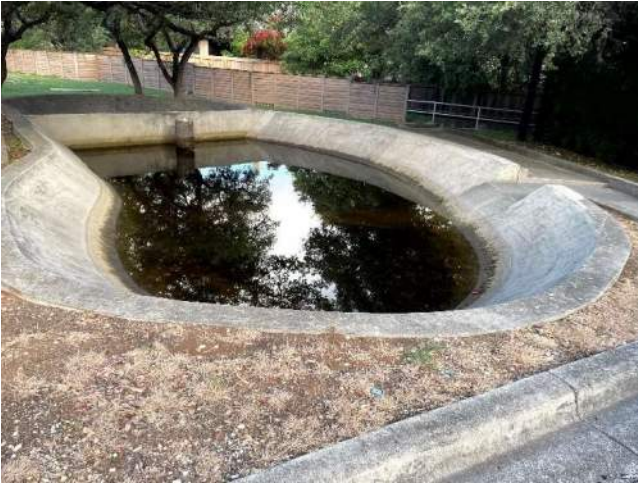
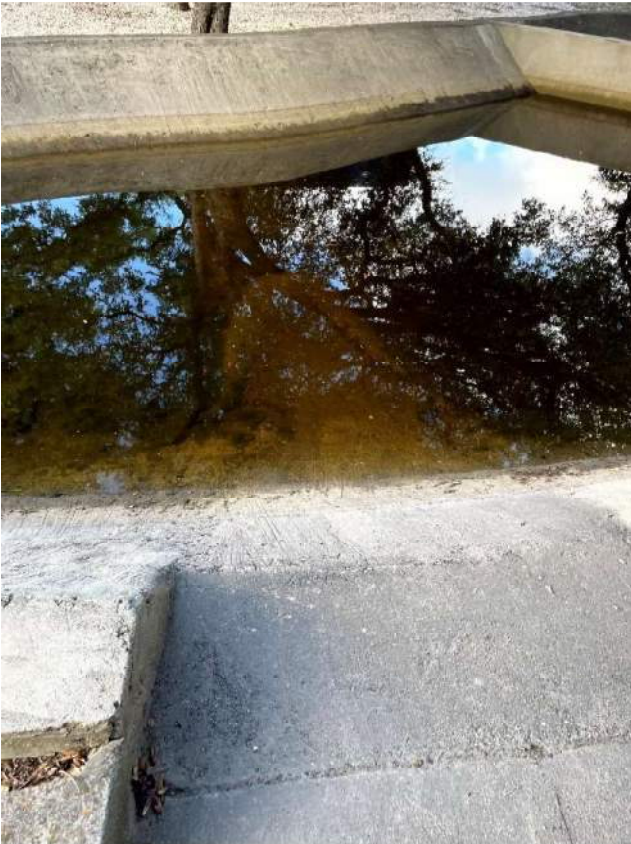
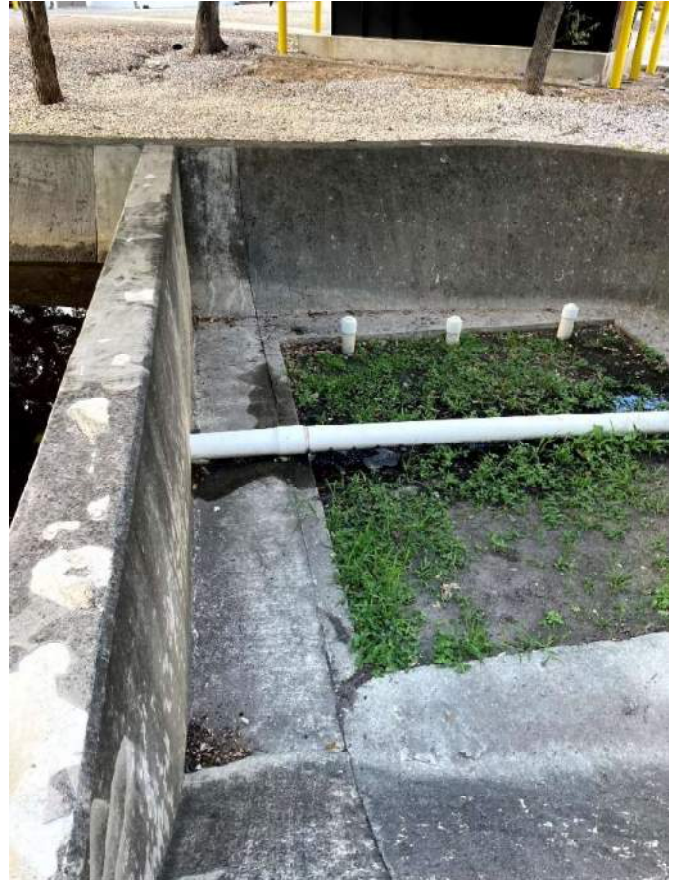
Retention Pond with Infiltration

Field Notes: Looks good, functioning as intended with recent precipitation.

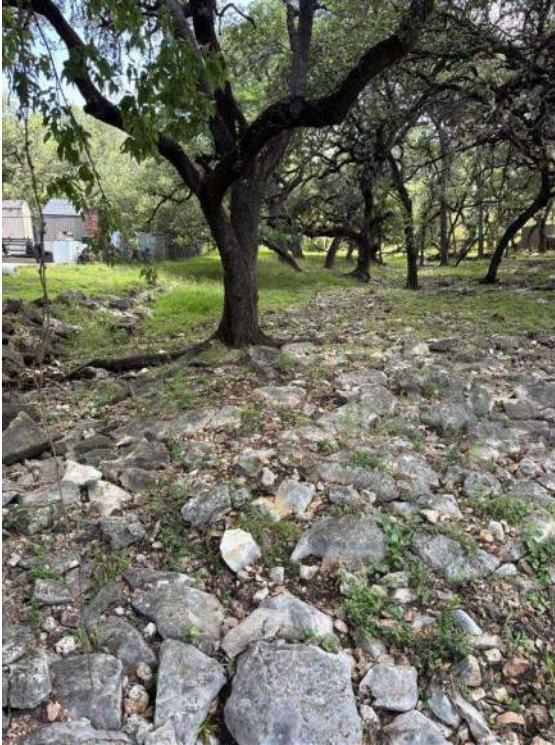
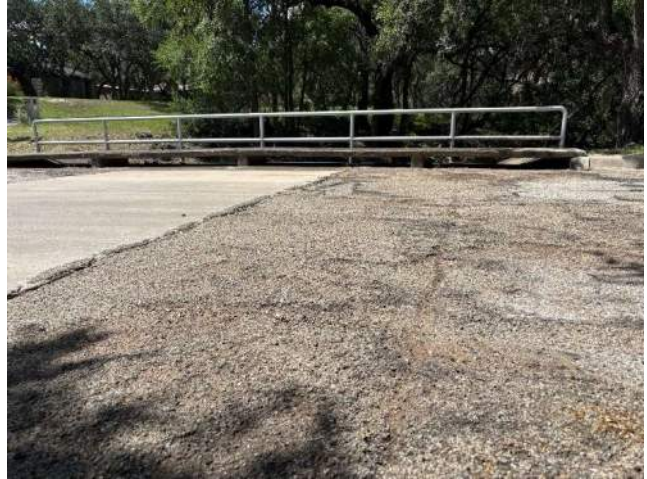
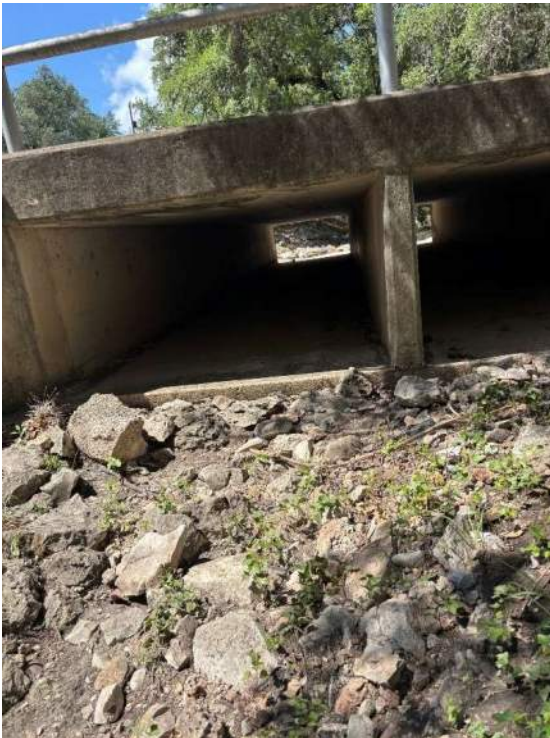
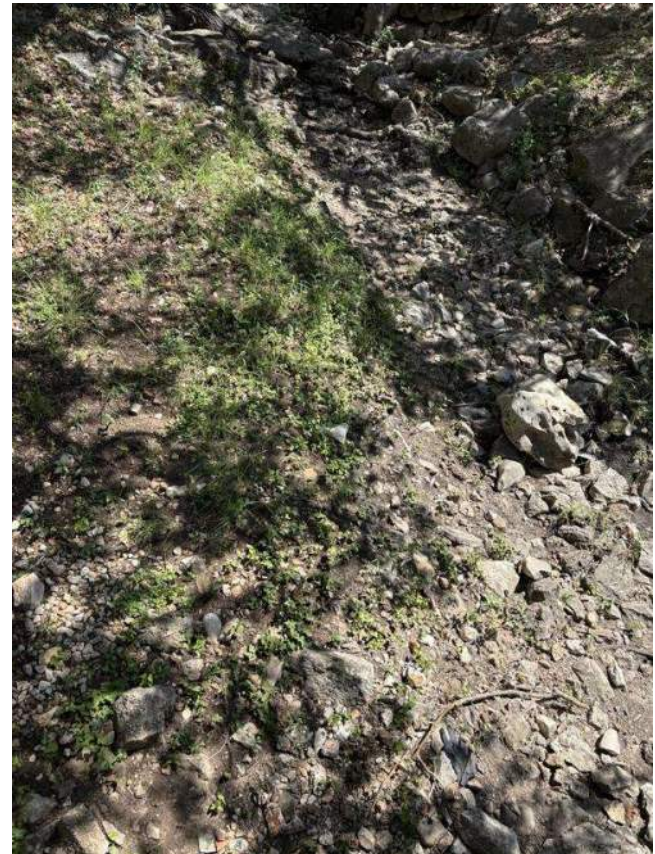
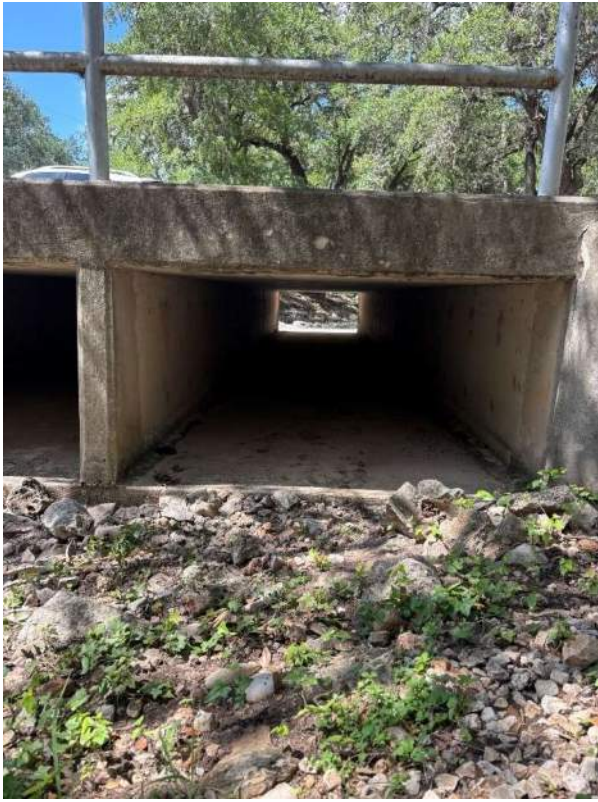
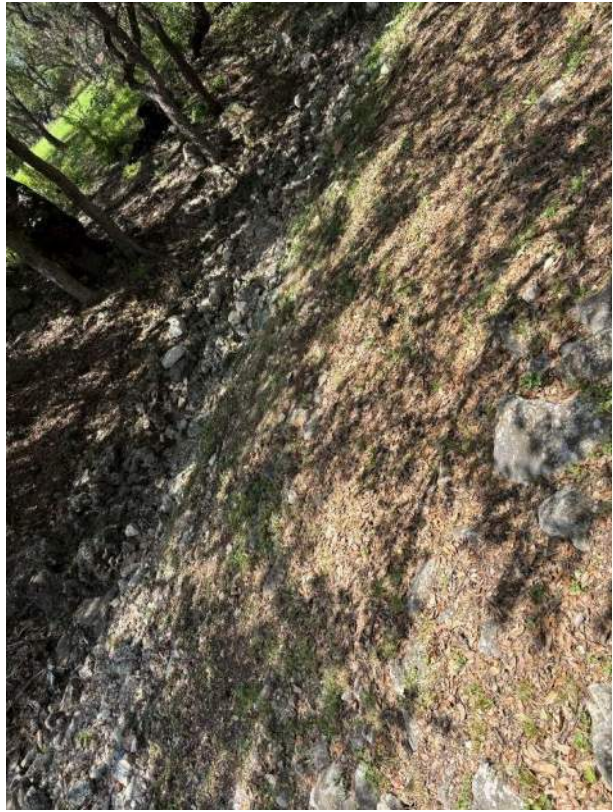
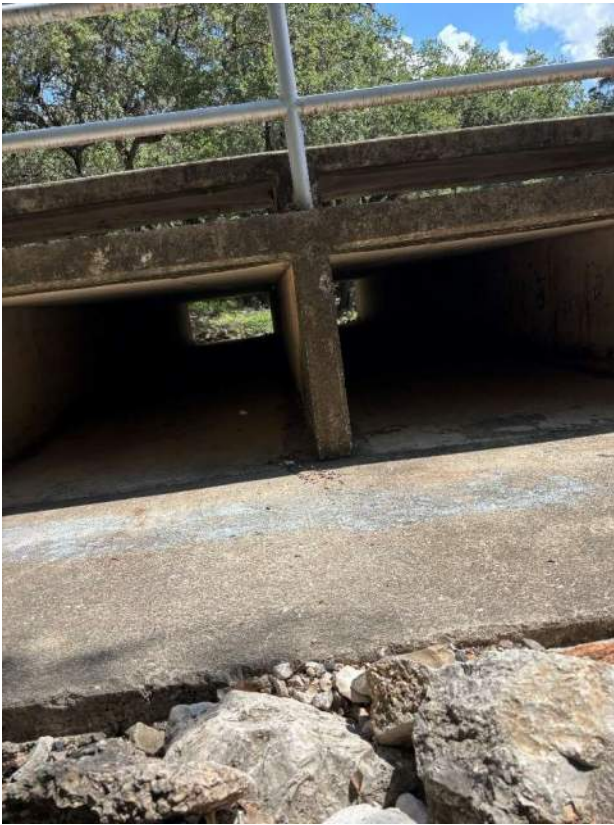
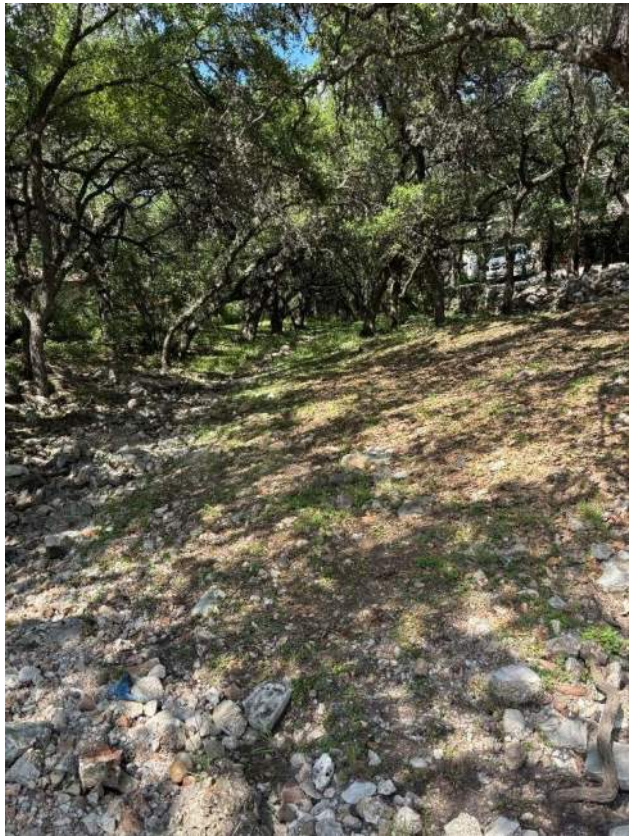
Ridge Trail Crossing

Field Notes: Looks good.

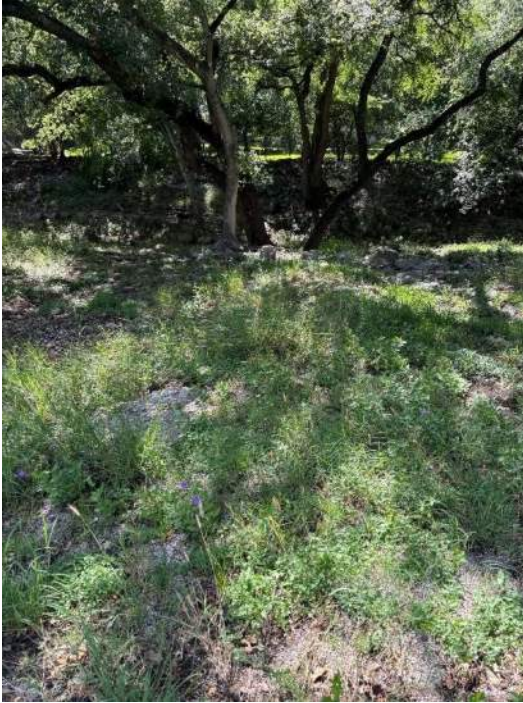
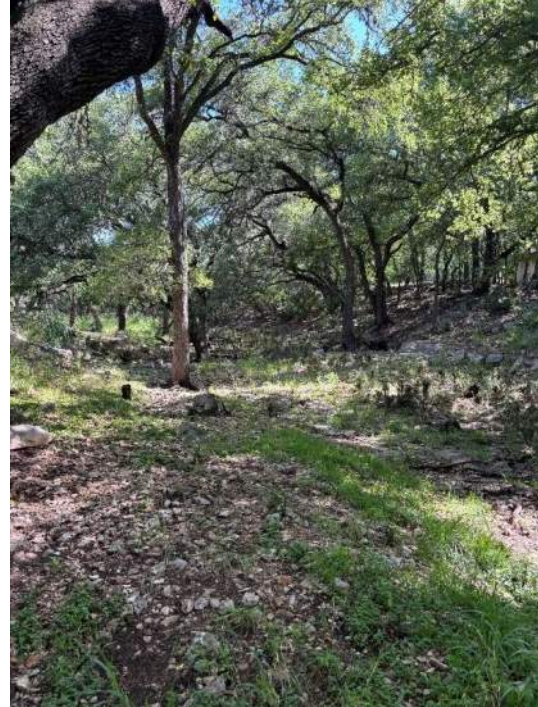
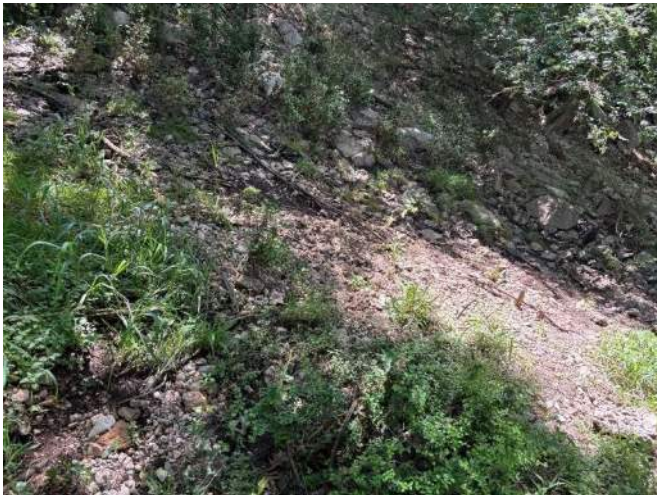
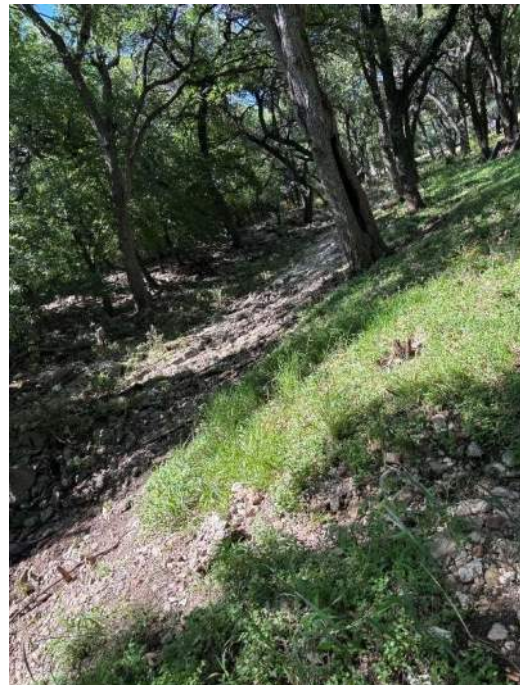
Field Notes: Trim vegetation at entrance near road; otherwise, looks good.

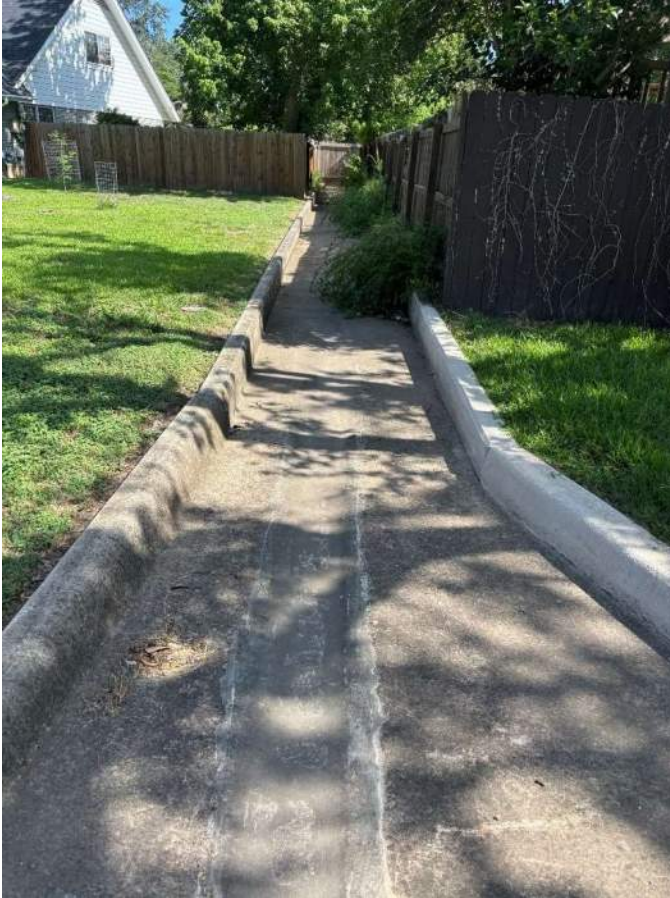
Rua De Matta Street Channel Outfall

Field Notes: Clear vegetation and debris from channel.

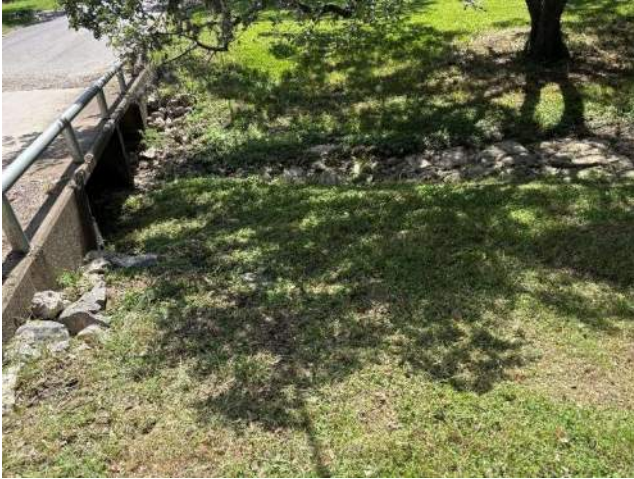
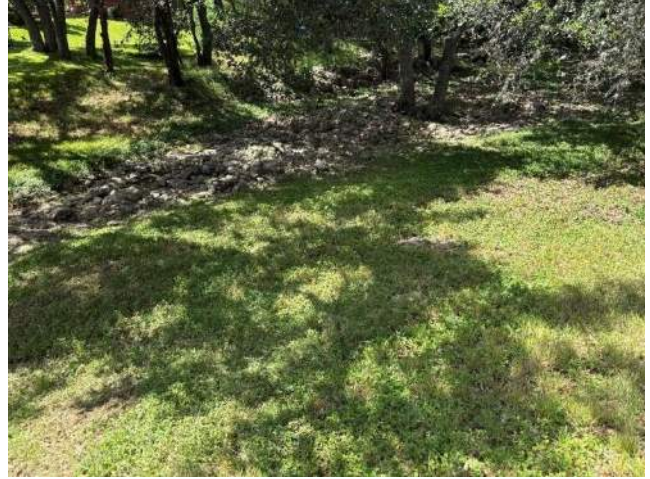
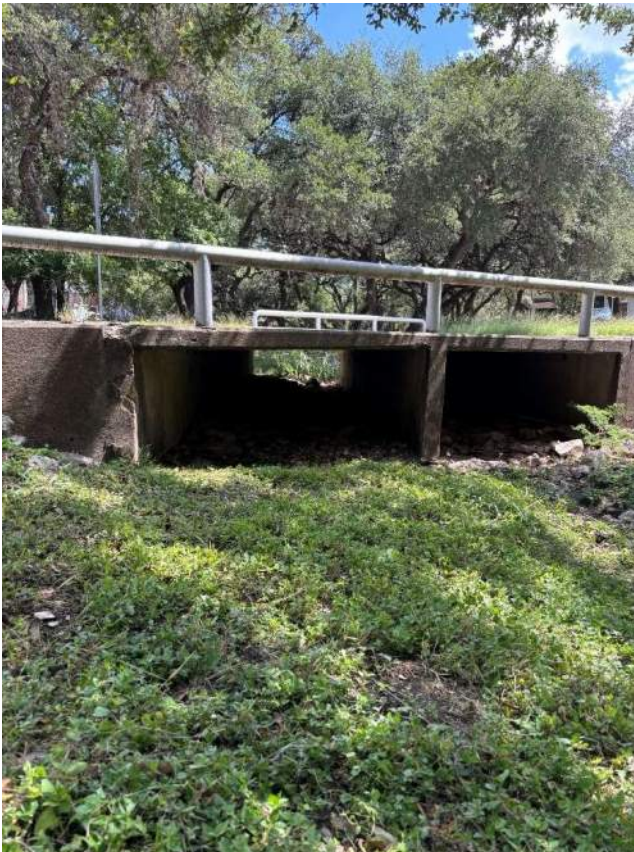
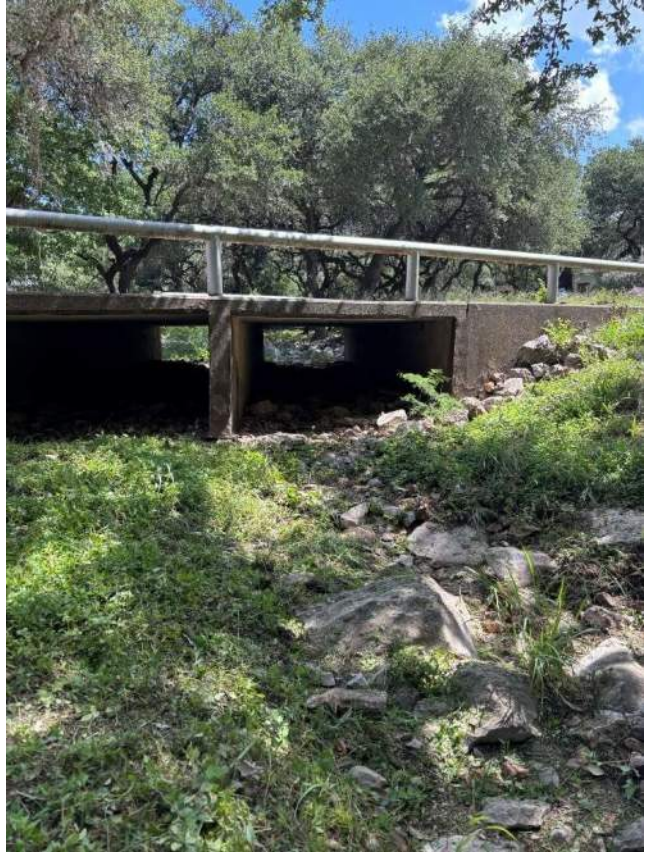
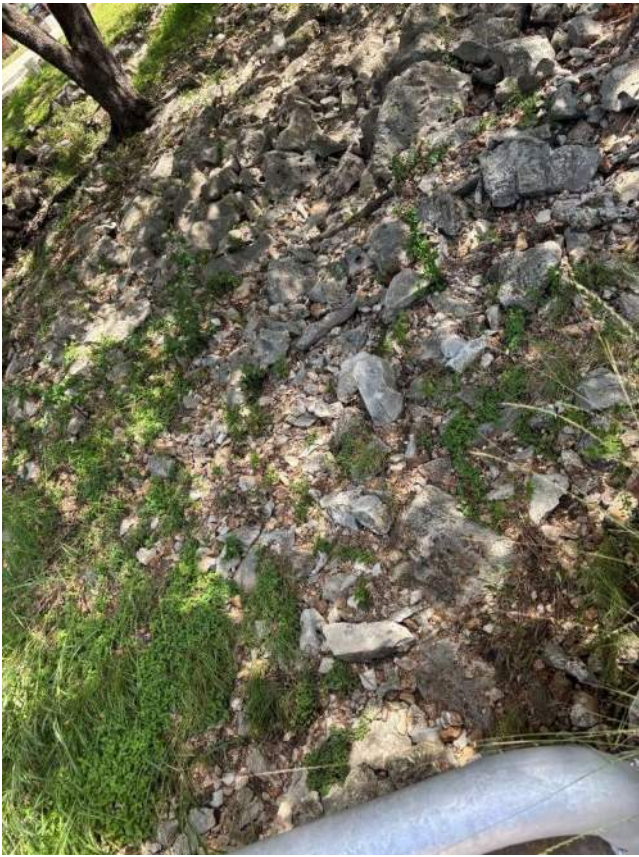
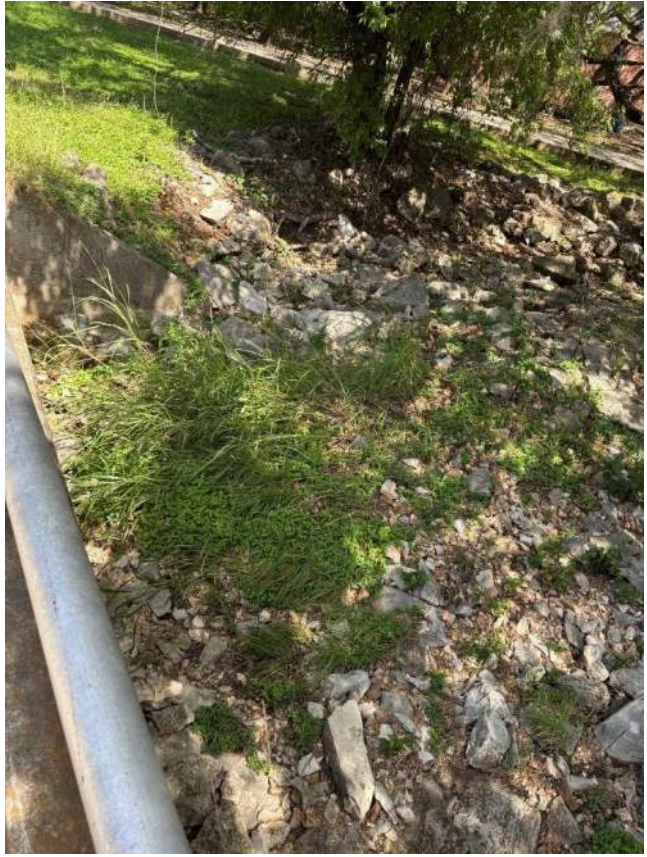
Sagecrest Crossing East

Field Notes: Trim vegetation near north culvert entrance; otherwise looks good.

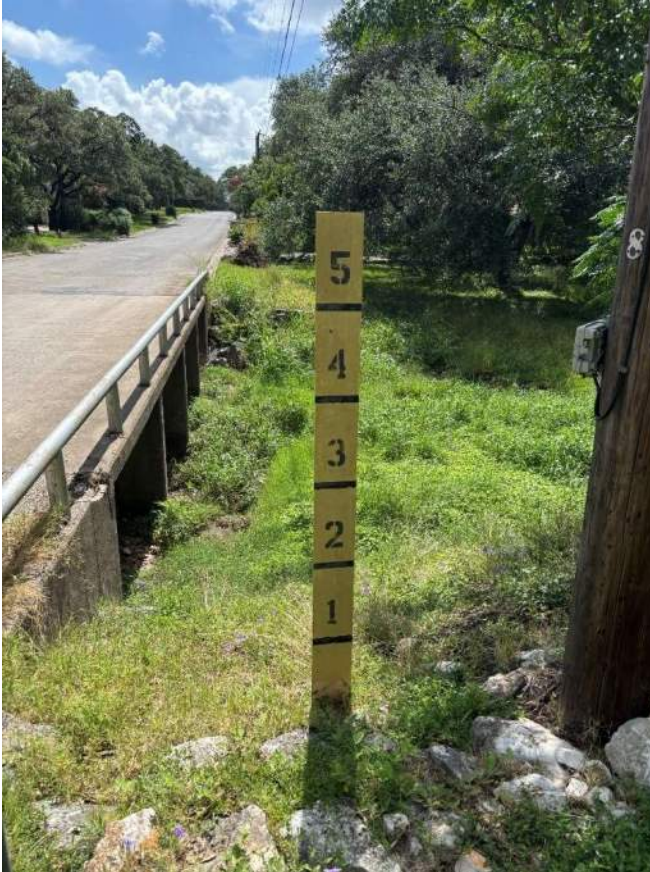
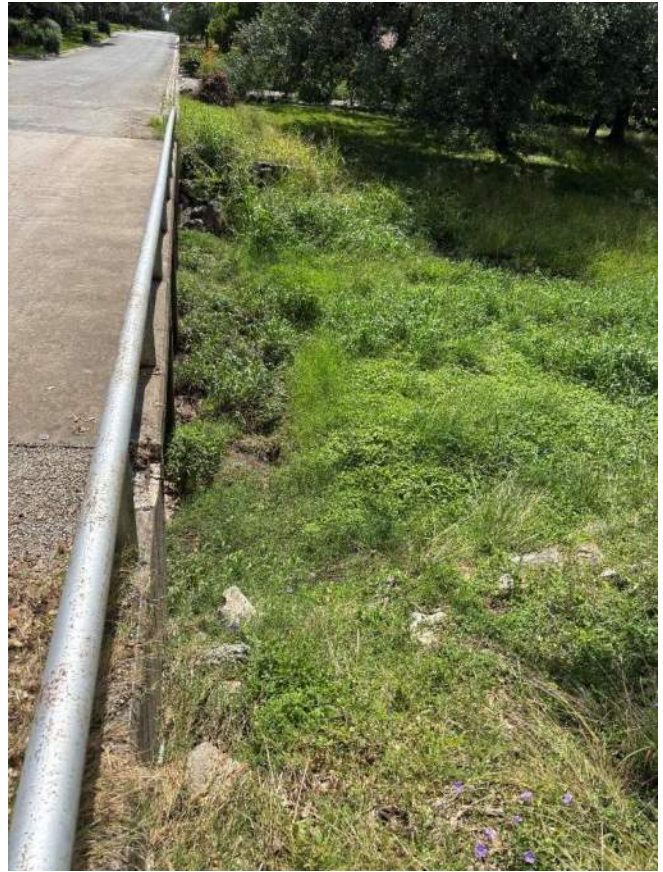
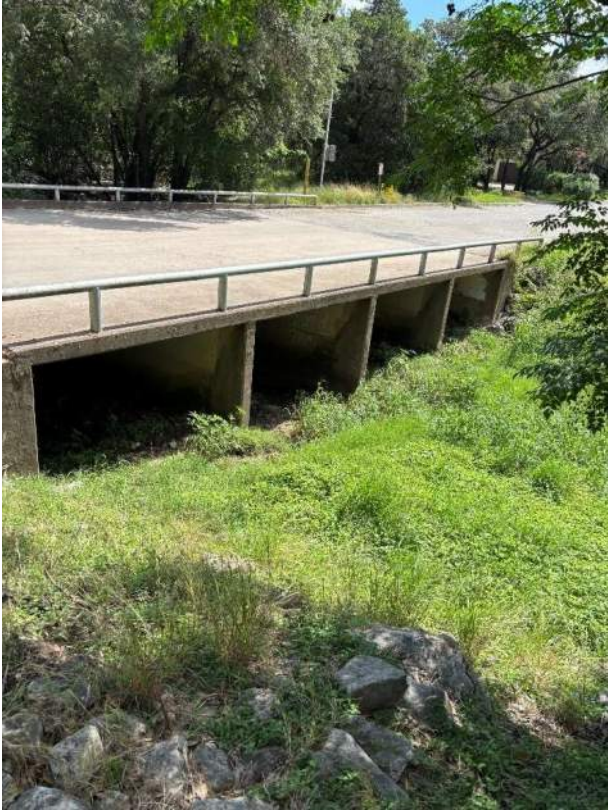
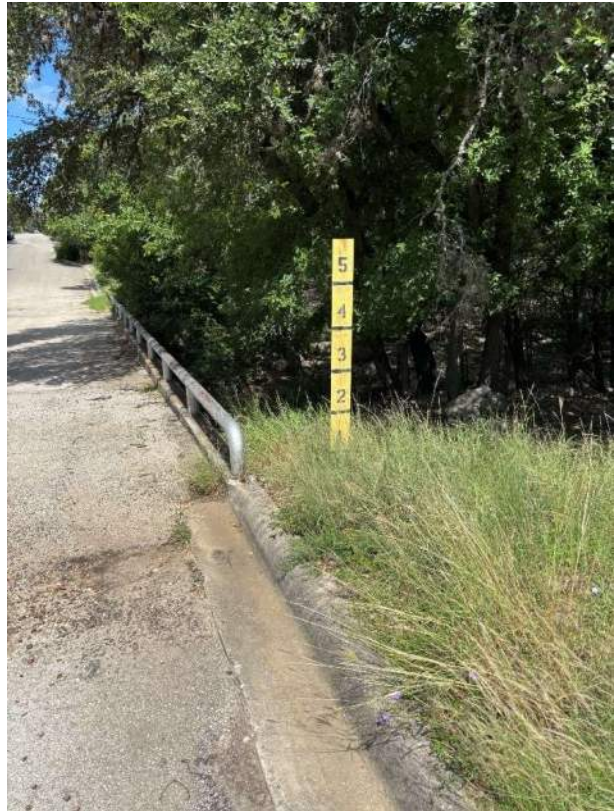
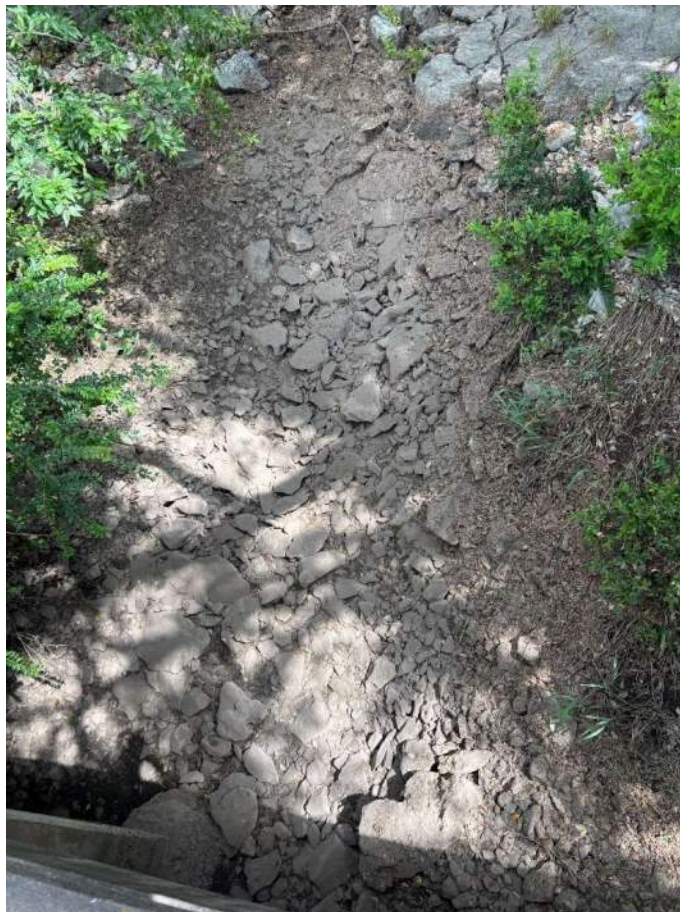
Sagecrest Crossing West

Field Notes: Trim overgrown vegetation in channel and around the low water crossing marks.

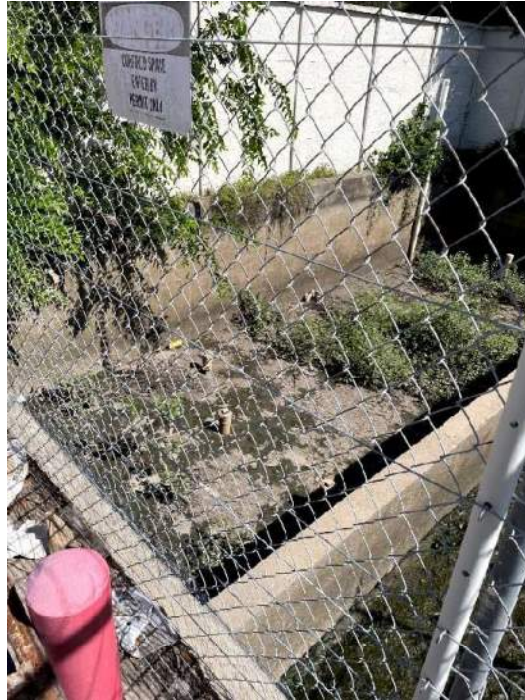
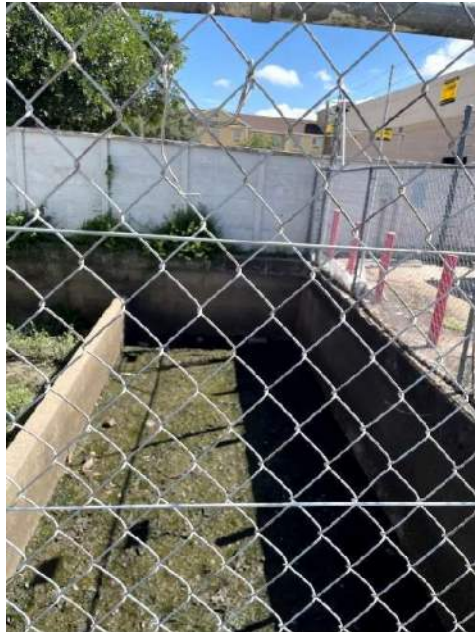
Service King Collision Repair PCD

Field Notes: Remove overgrown vegetation.

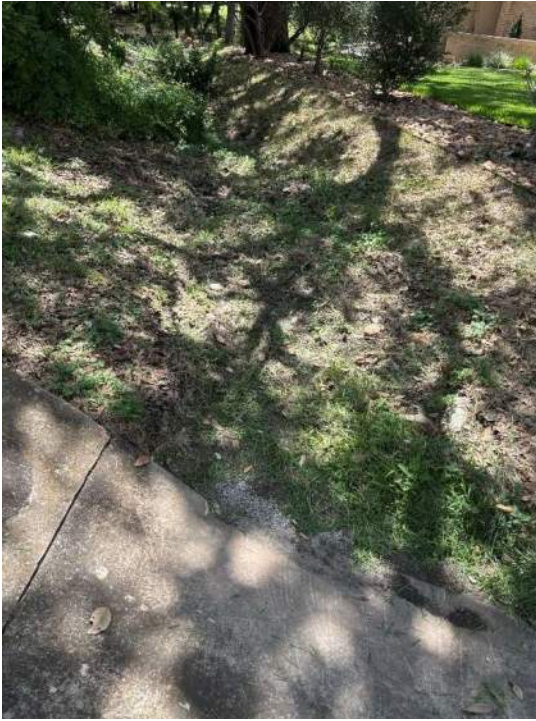
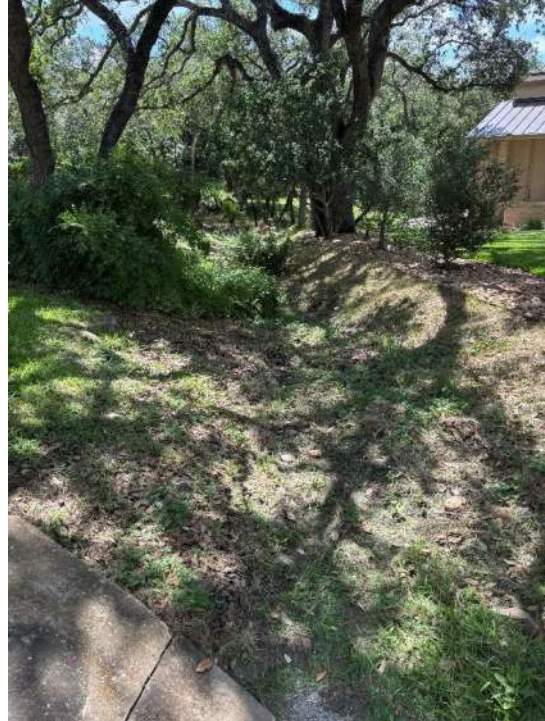
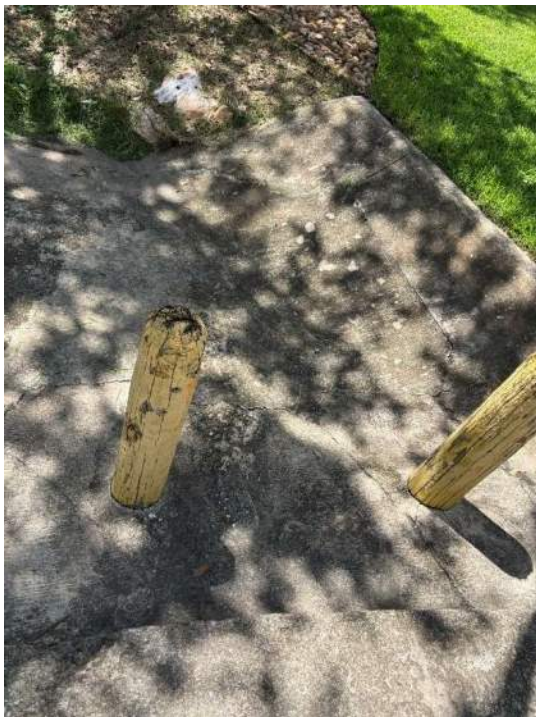
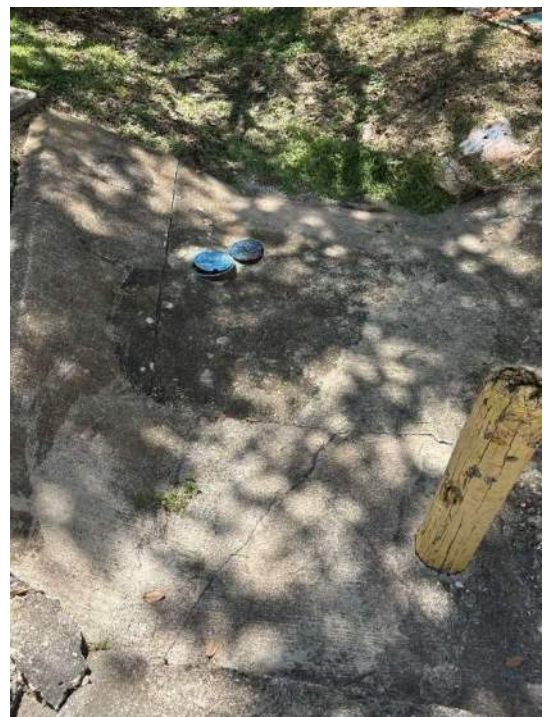
Shady Trails Rundown

Field Notes: Trim down shrubs in channel, otherwise looks good.
