TOWN OF HOLLYWOOD PARK, TX

2025 Summer Inspection

HOLLYWOOD PARK 2025 SUMMER INSPECTION REPORT

Subject: Annual Municipal Separate Storm Sewer System (MS4) Inspection

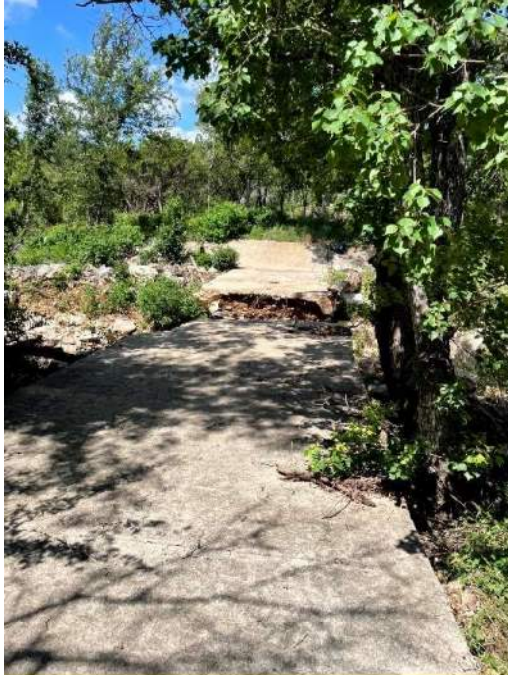
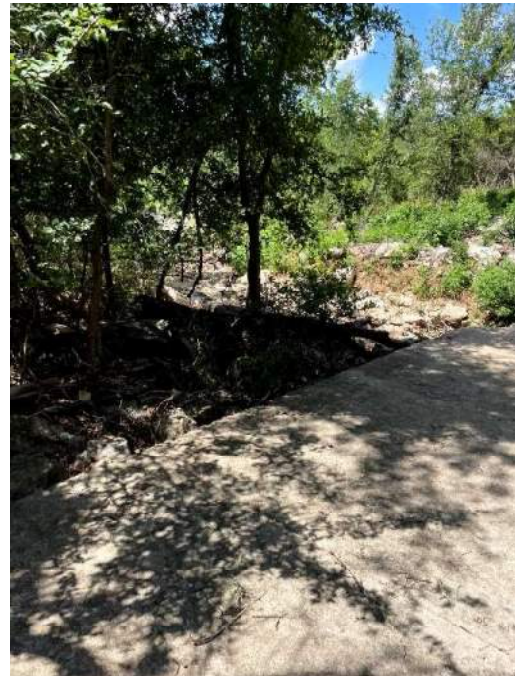
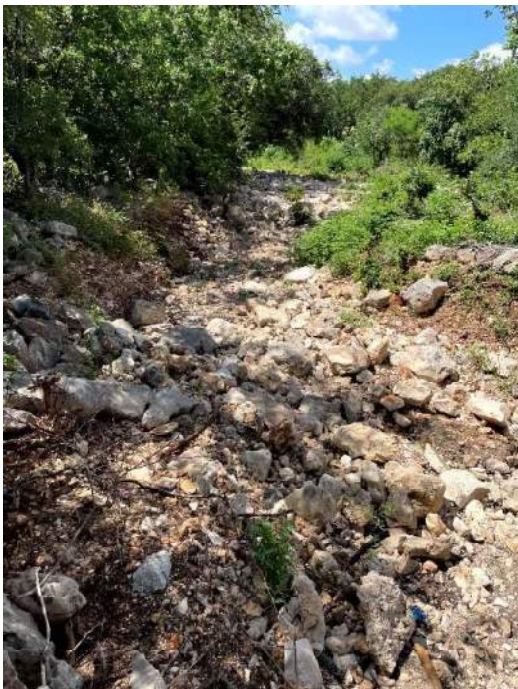
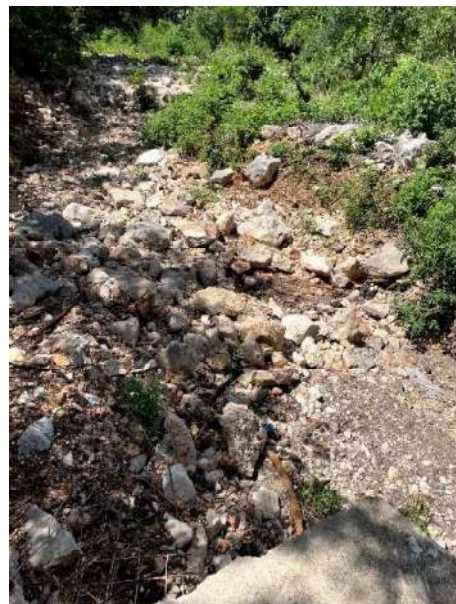
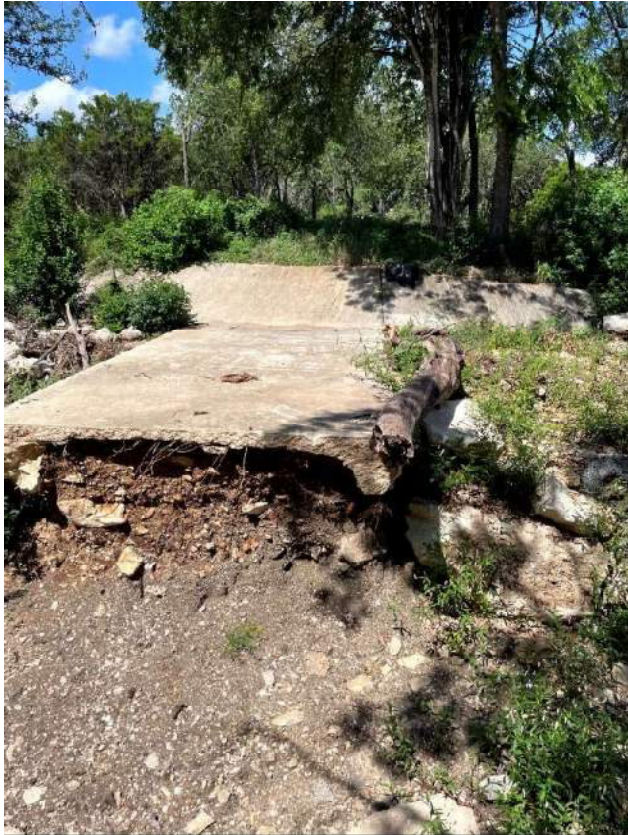
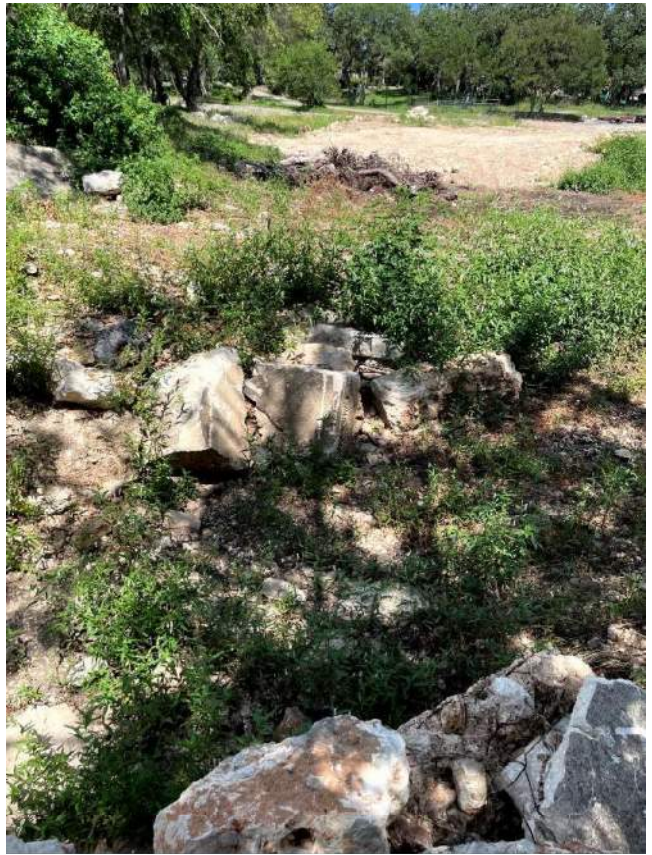
Spillway Structure

Field Notes: No apparent changes since last inspection, continue to monitor structure.

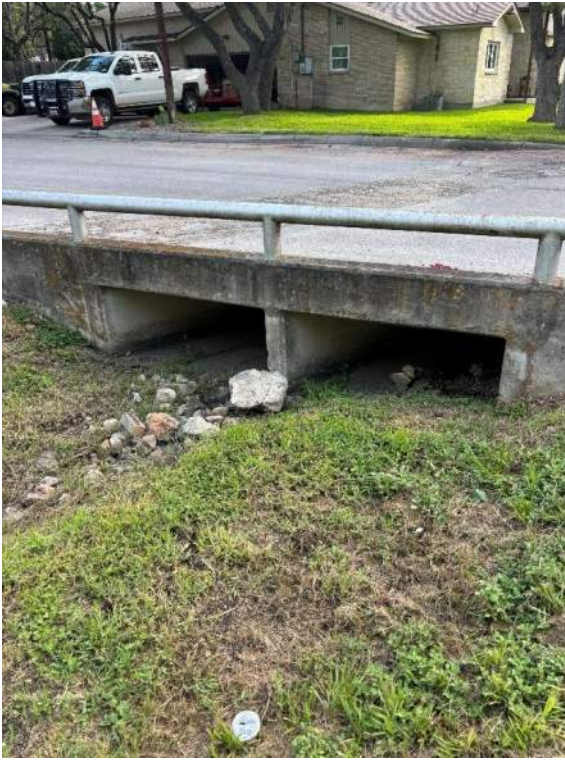
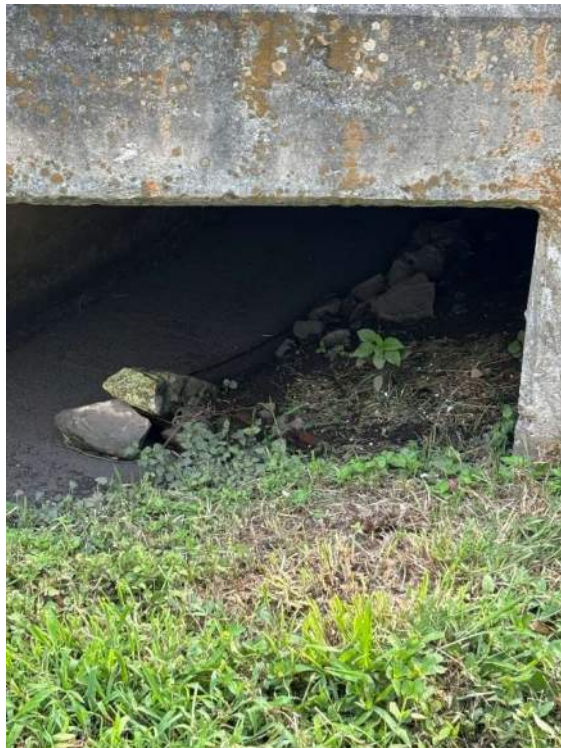
Field Notes: Trim vegetation on east side of culvert and remove sediment and debris inside of culvert on west side.

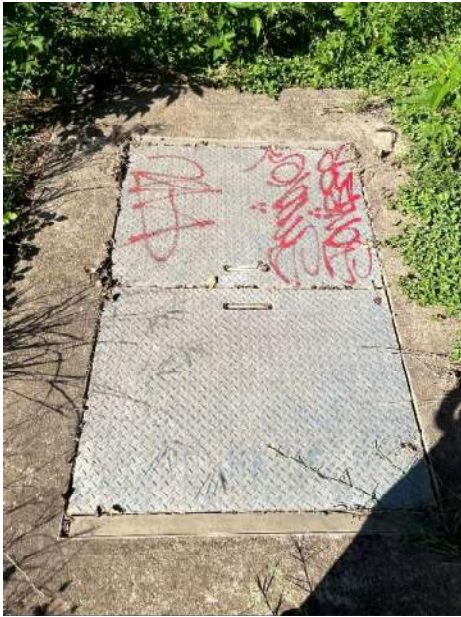
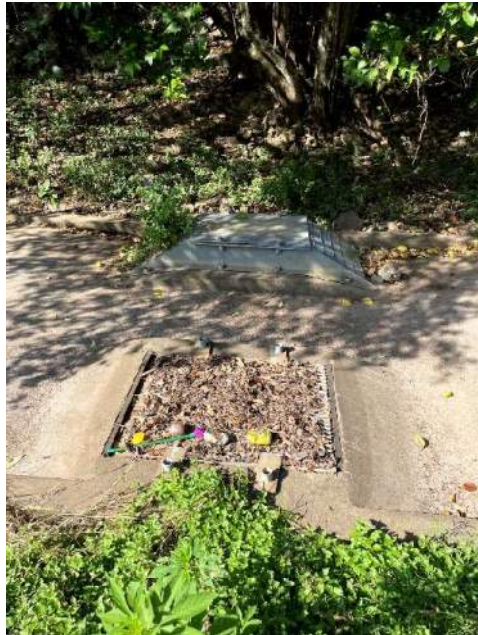
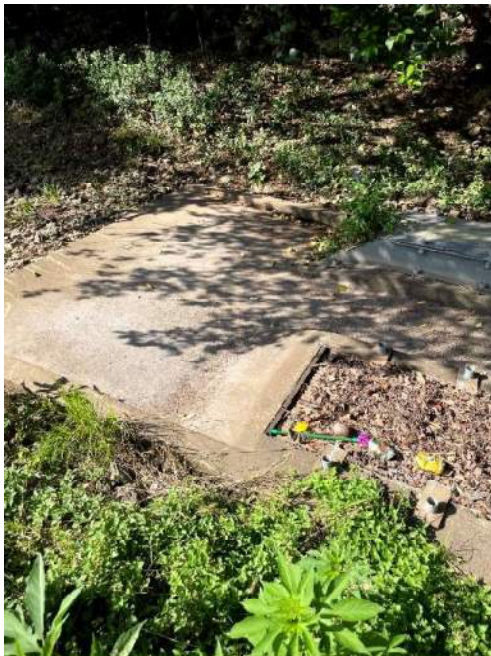
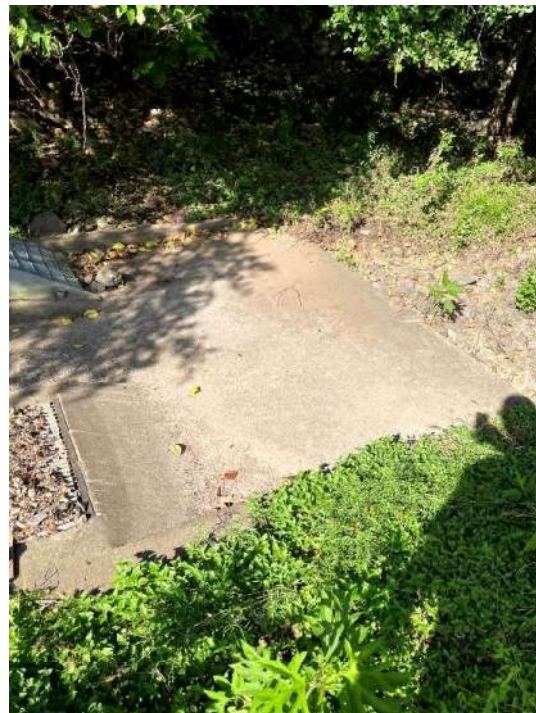
Field Notes: Remove debris looks good otherwise.

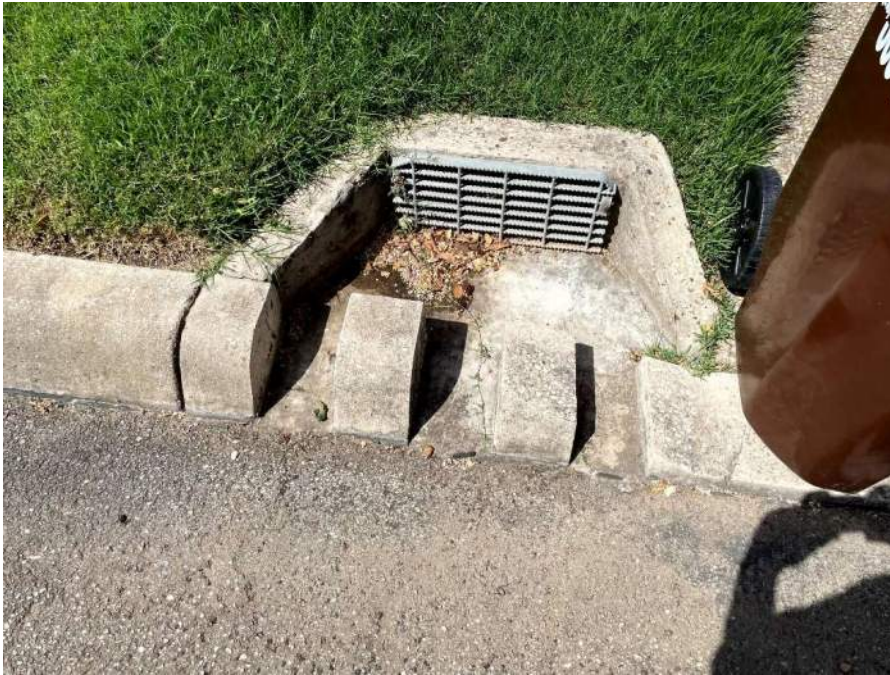
Street Outlet 1

Field Notes: Looks good.

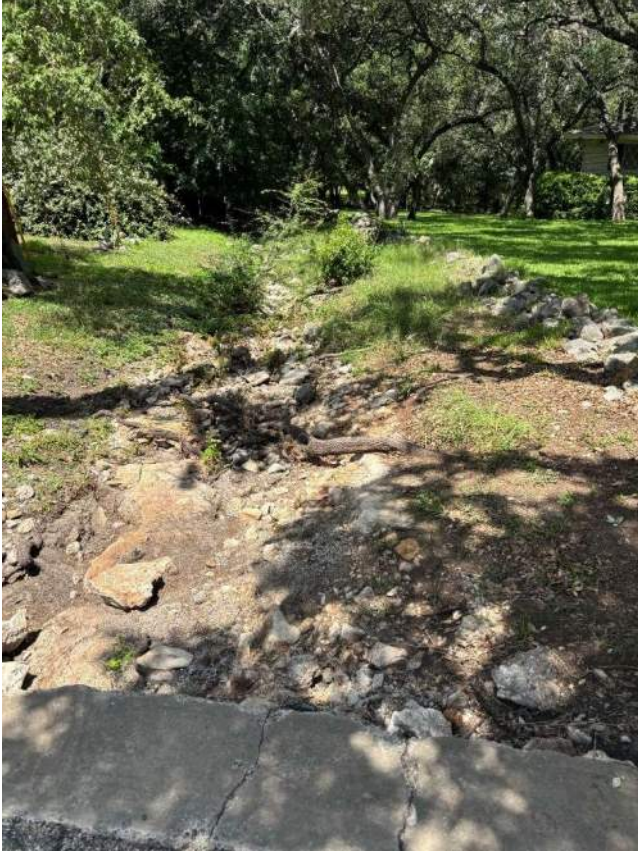
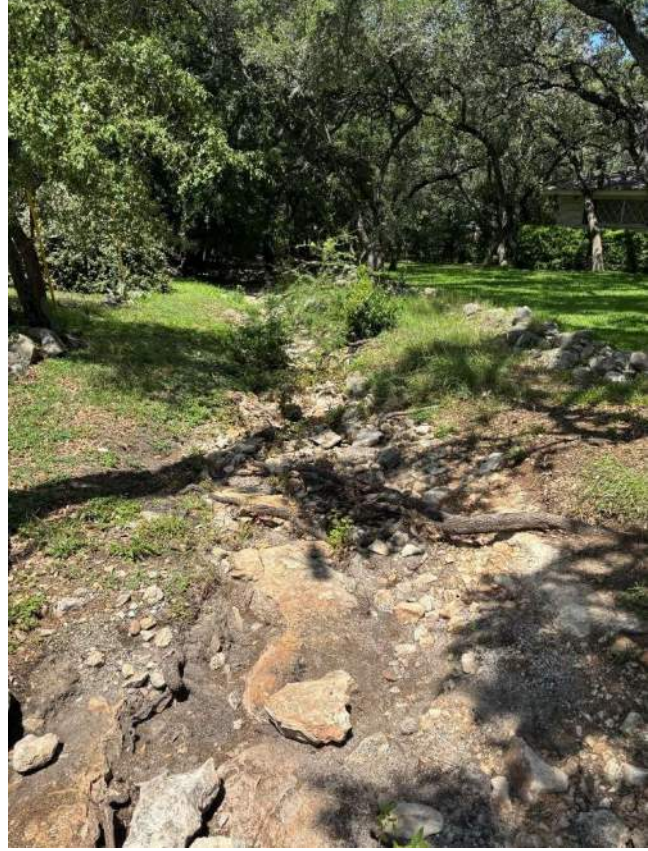
Tiger Tail Outfall

Field Notes: Looks good.

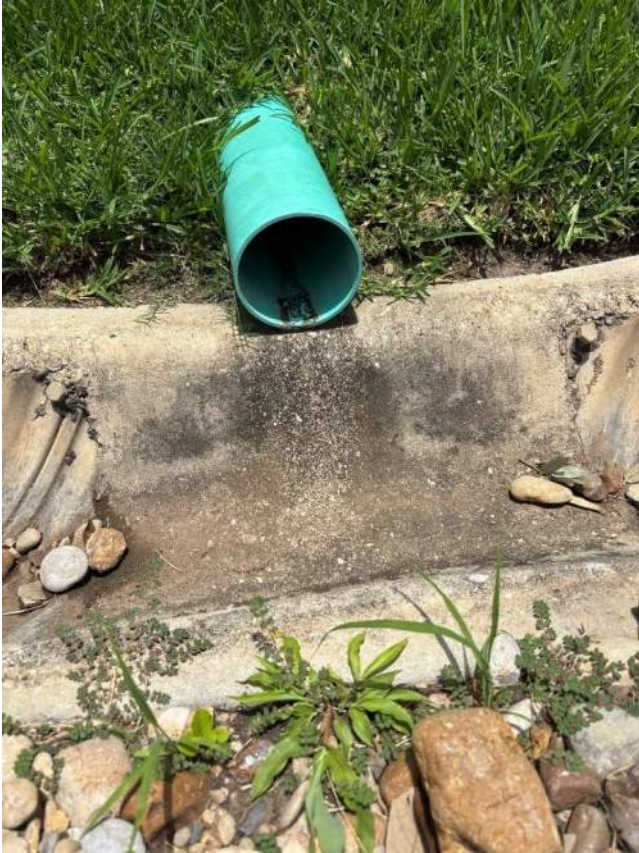
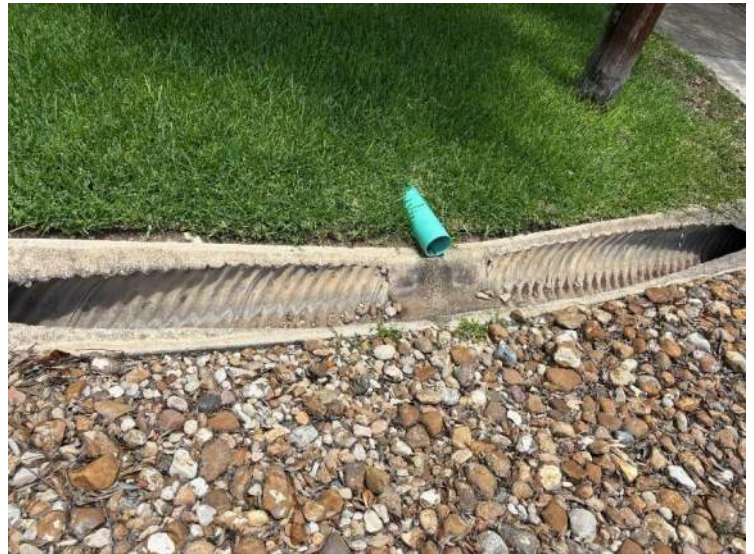
Unknown Residential Drain Pipe Into MS4 System

Field Notes: Looks good.

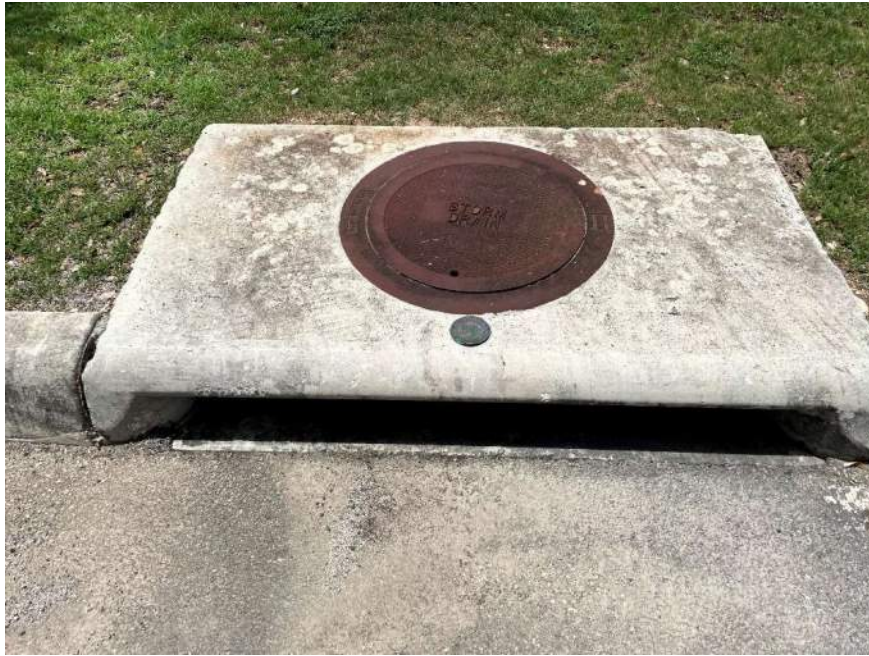
Varco

Field Notes: Looks good.

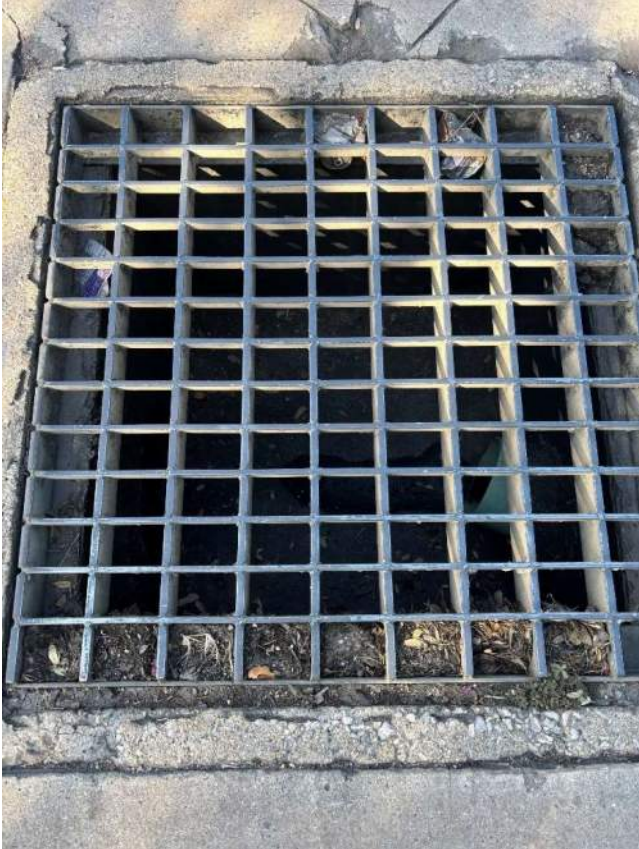
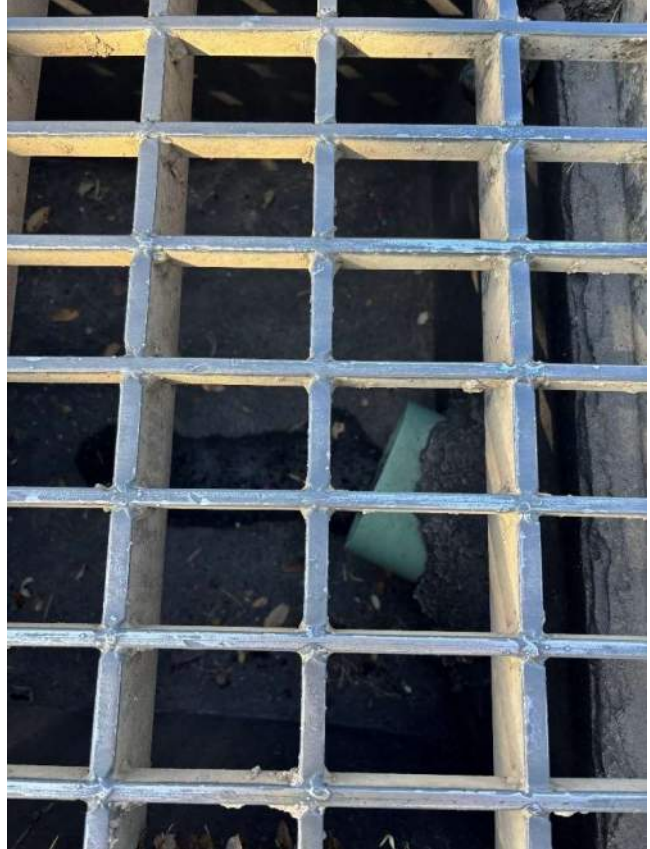
Varco 2

Field Notes: Looks good.

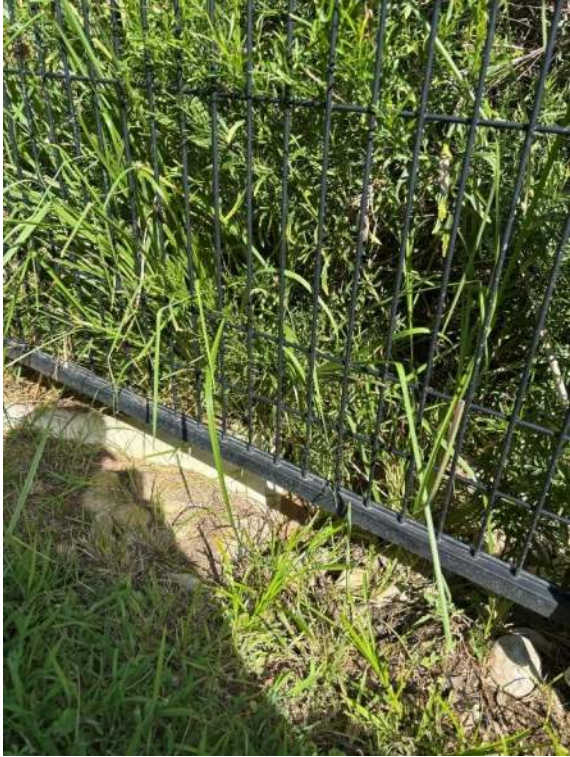
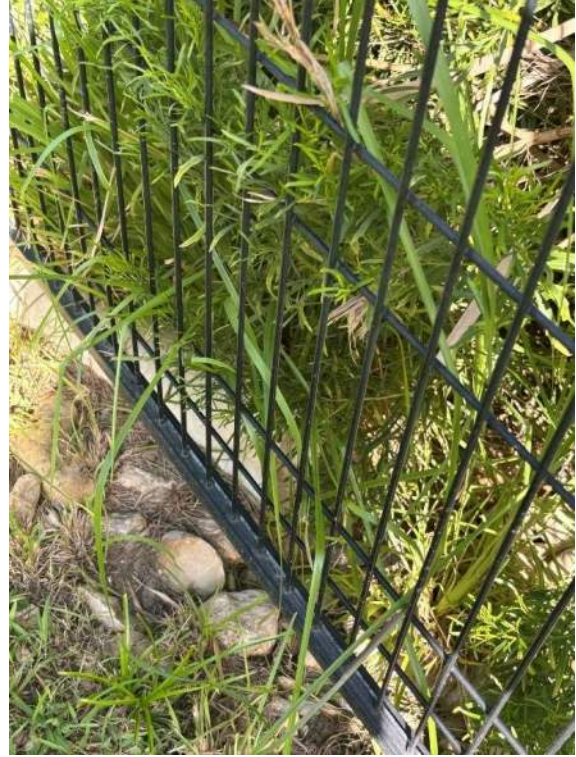
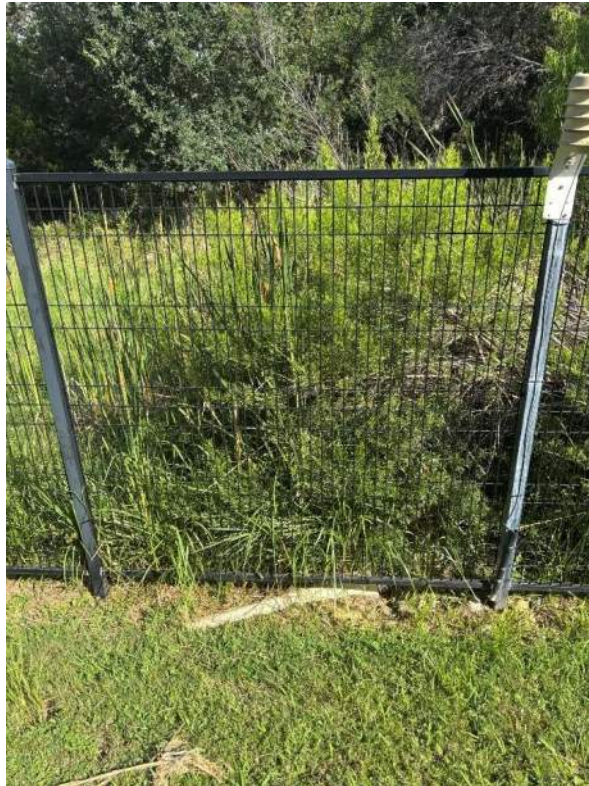
Field Notes Trim overgrown vegetation in front of outfall.

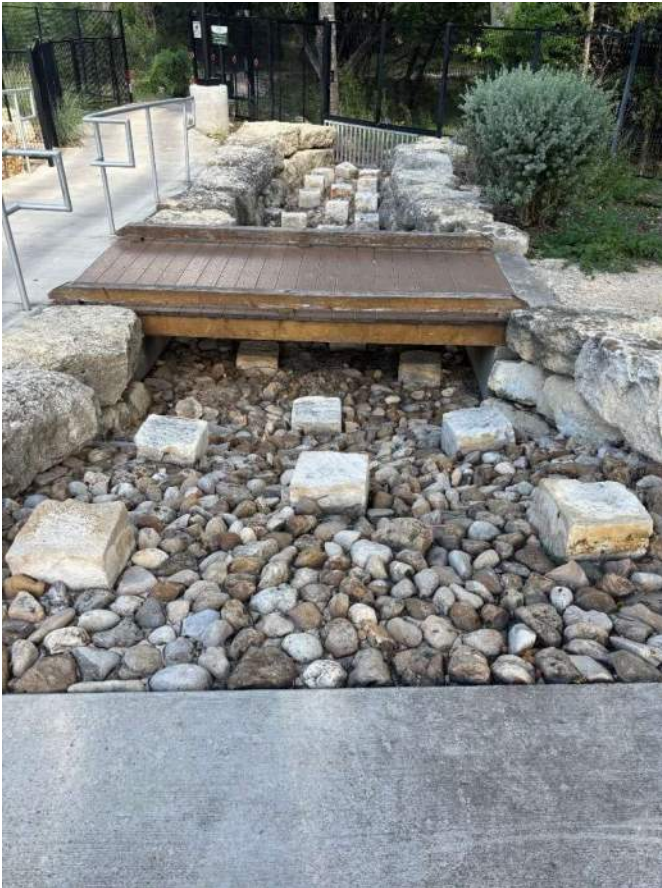
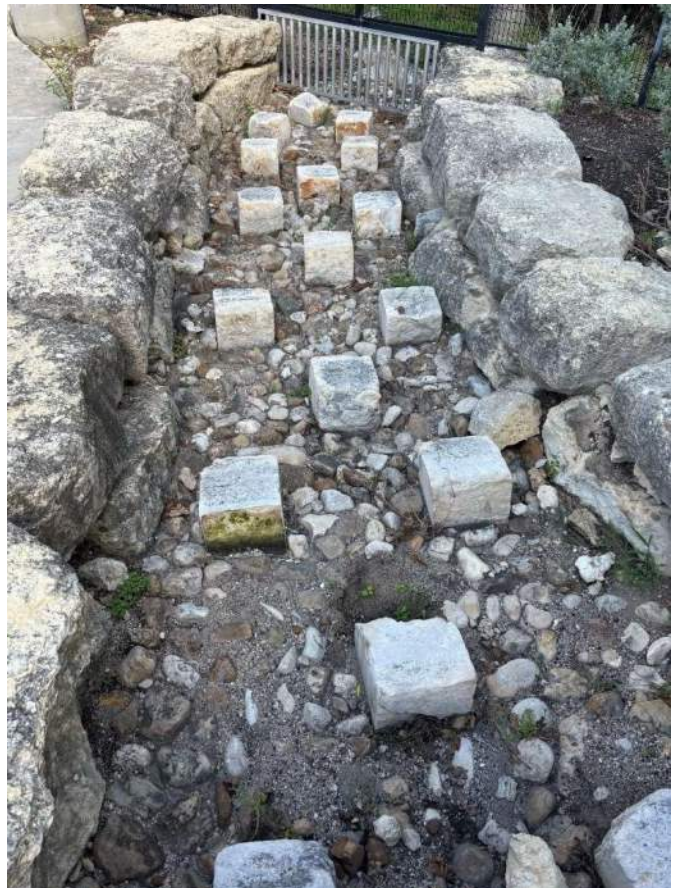
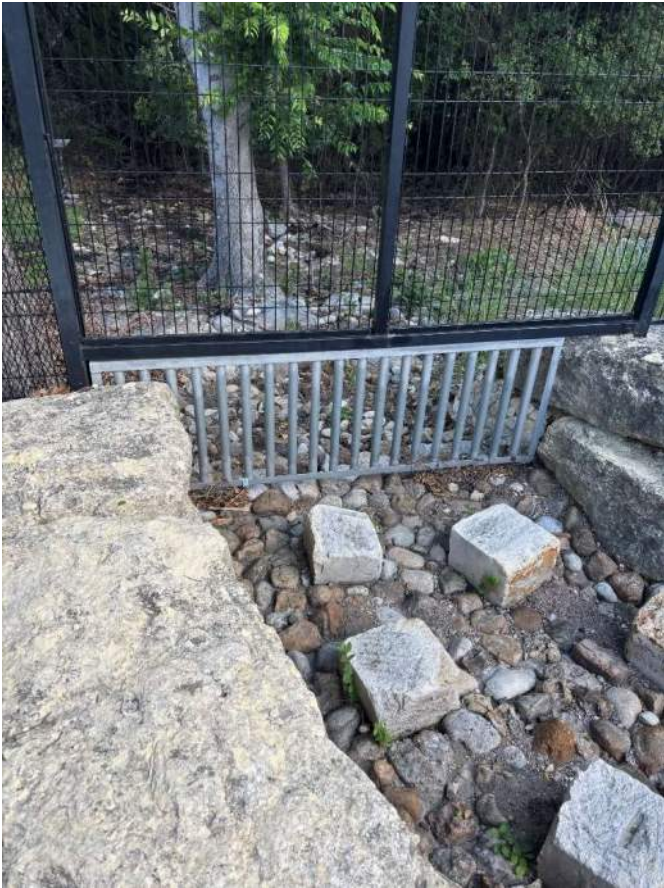
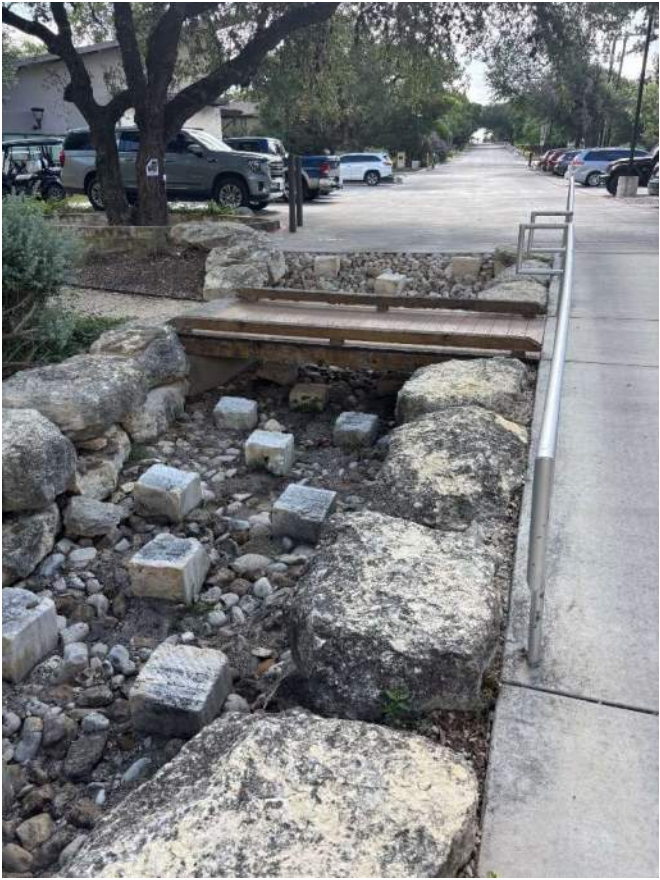
Voigt Park Storm Sewer Outfall

Field Notes: Looks good.

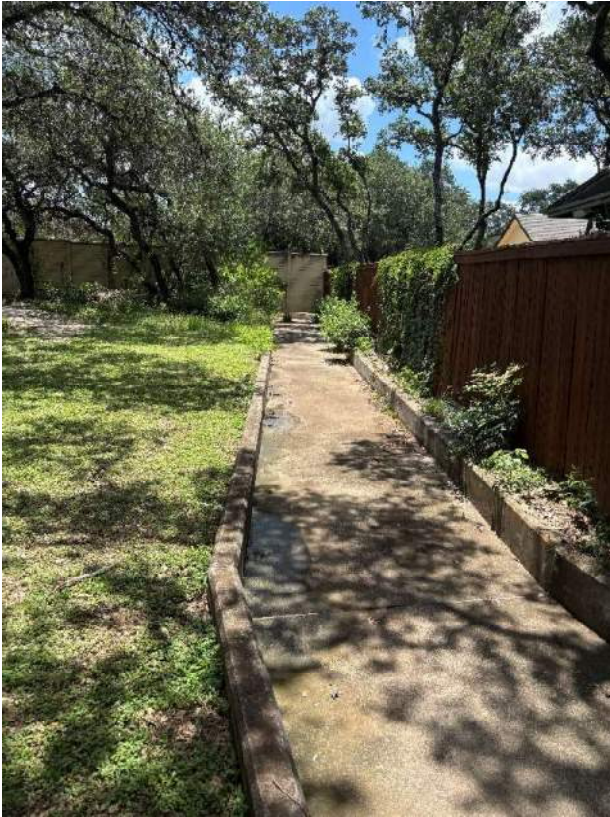
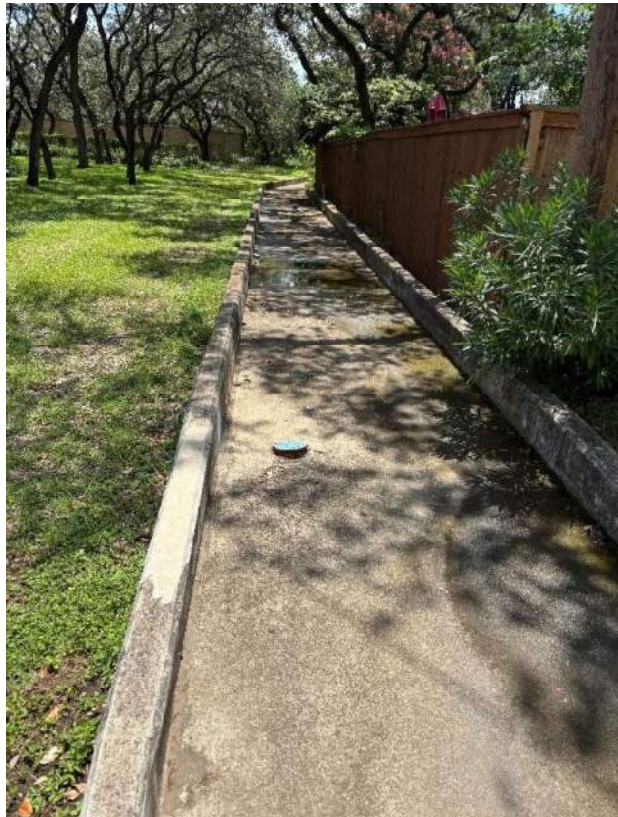
William Classen Outfall

Field Notes: Looks good.

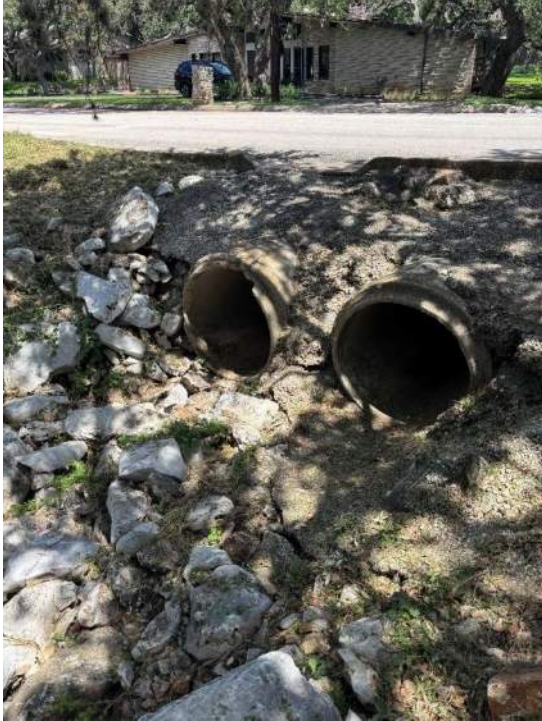
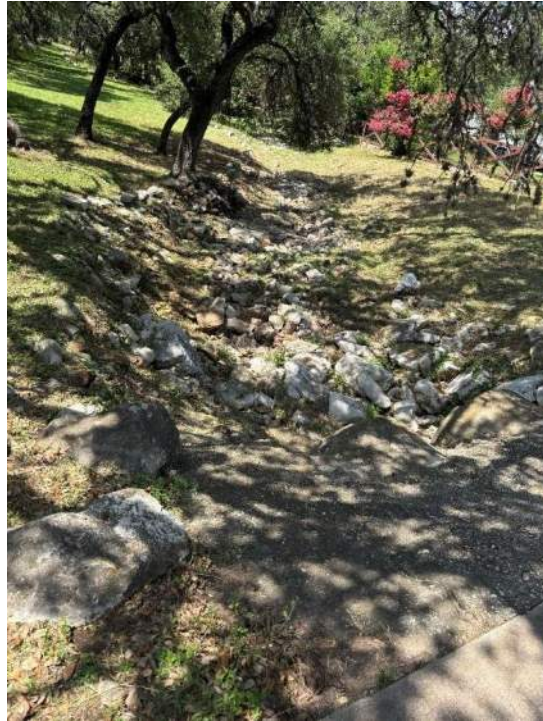
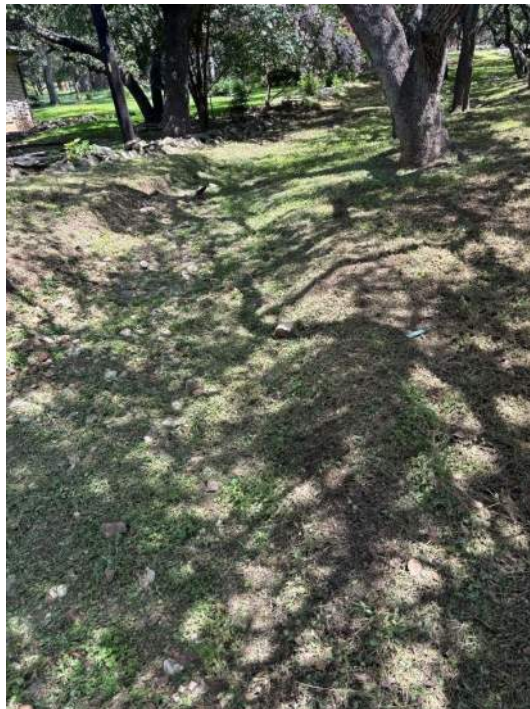
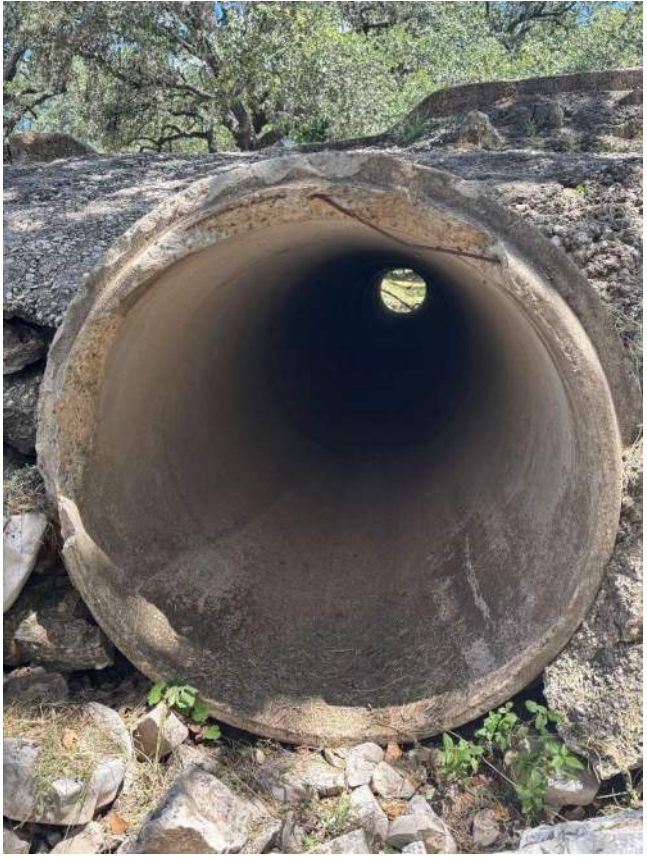
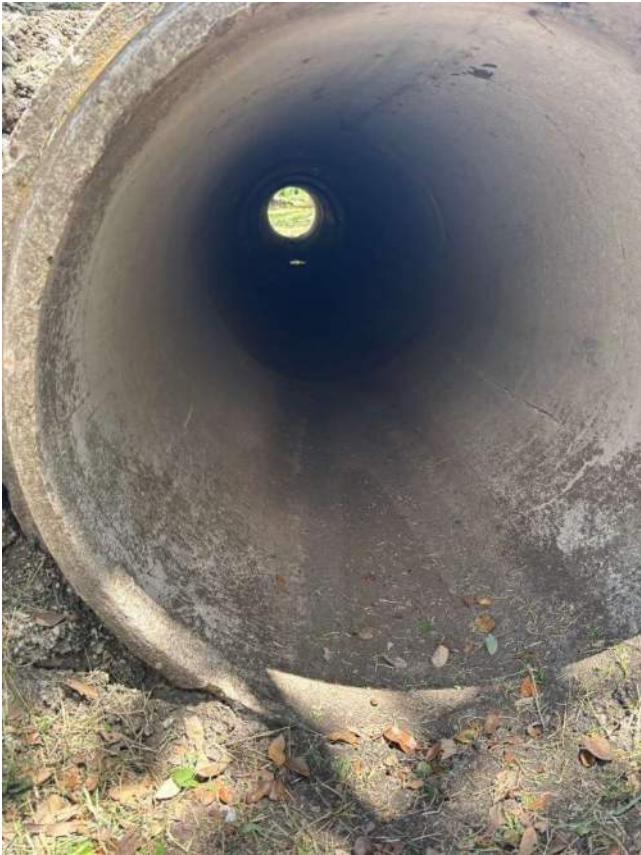
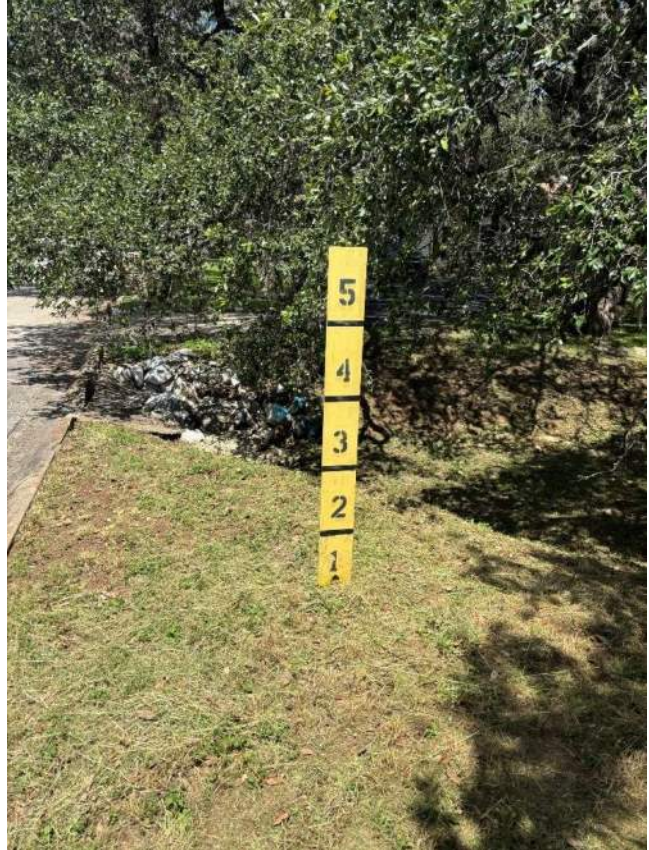
Yosemite Crossing East

Field Notes: Looks good.

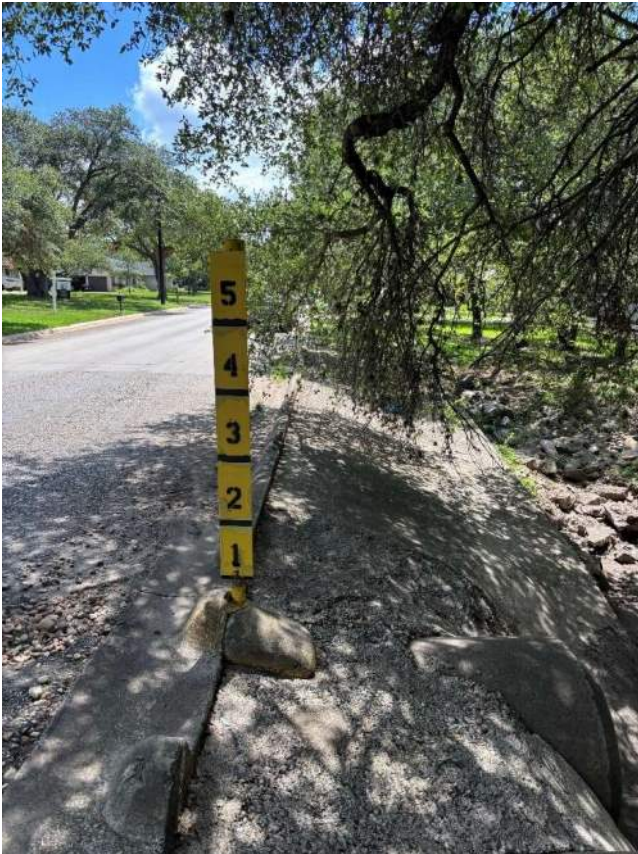
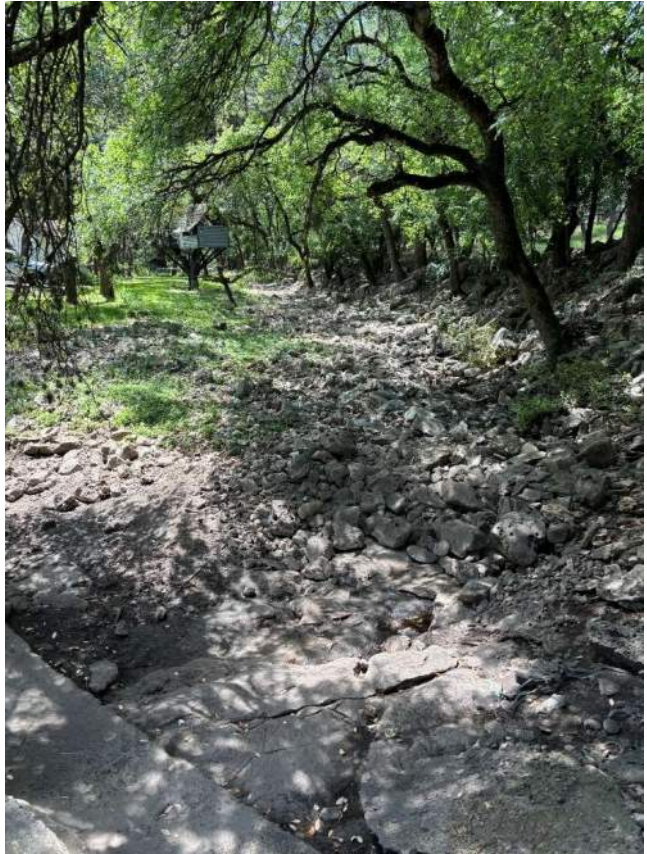
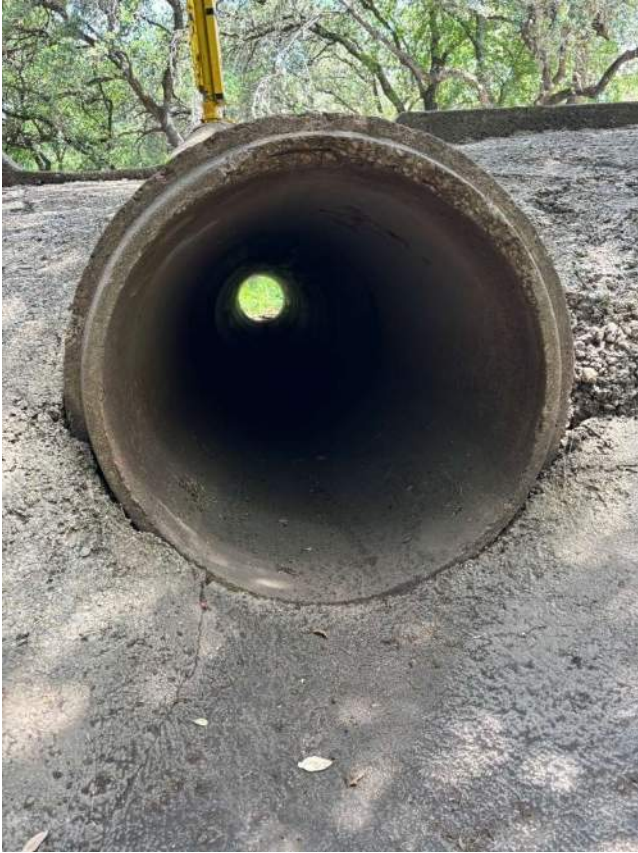
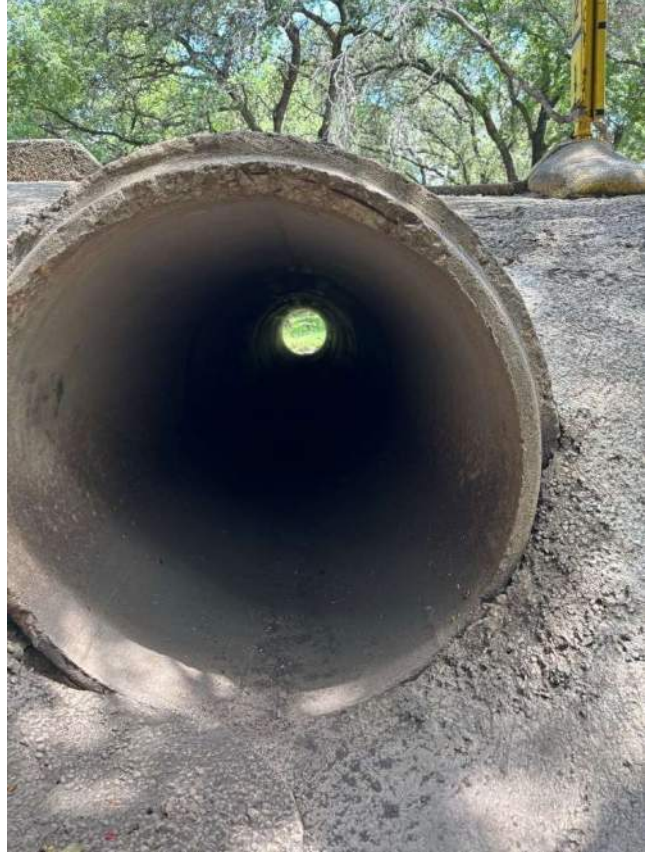
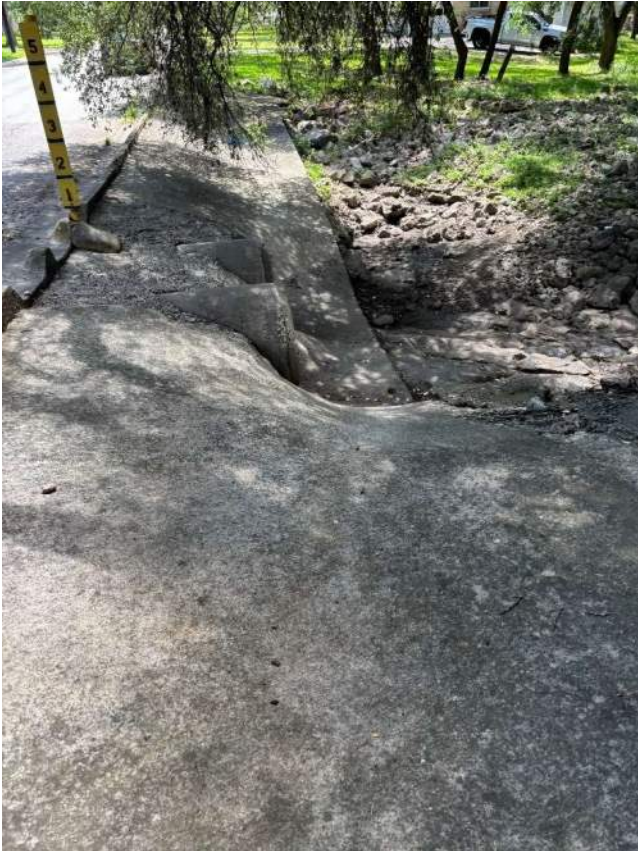
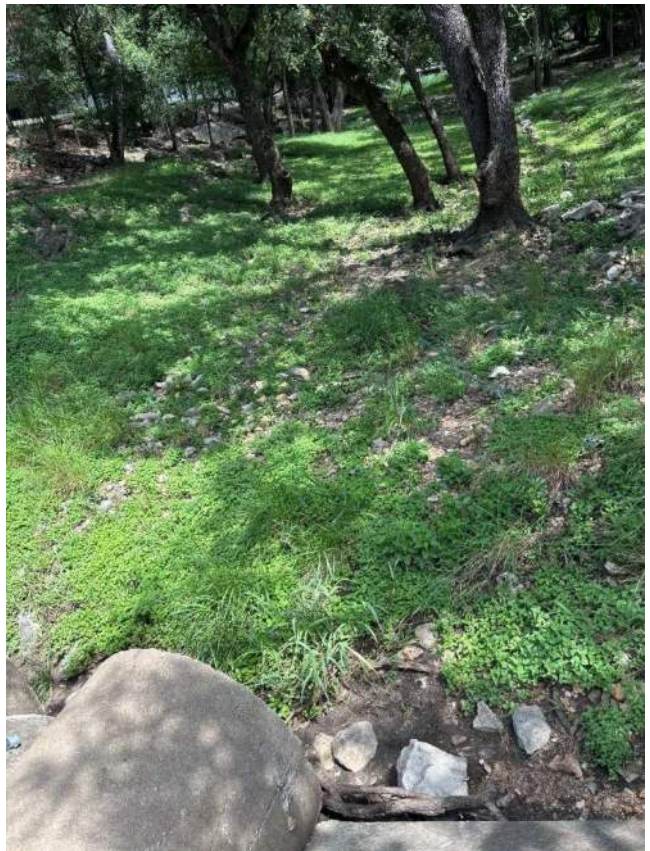
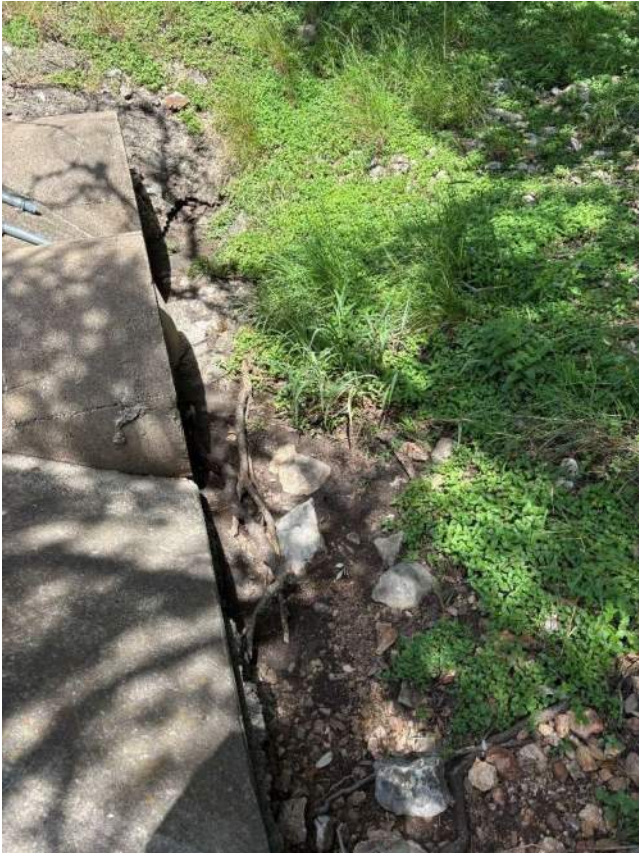
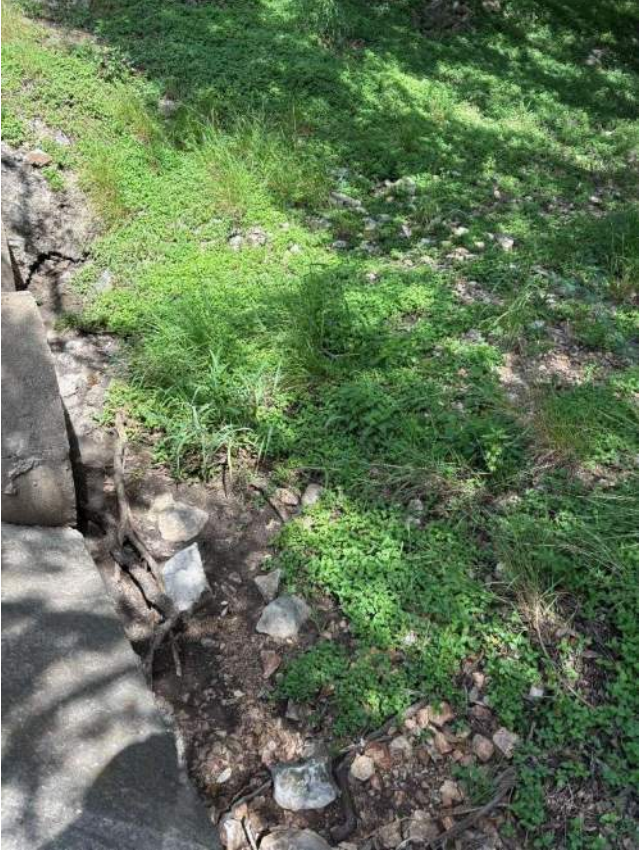
Yosemite Crossing West

Field Notes: Trim vegetation directly in front of north side inlet, otherwise looks good.
